**IMPLEMENTING SPEED REDUCTIONS
AT SPECIFIC INTERSTATE
WORKZONES FROM 65 MPH TO 35 MPH**

Final Report

SPR 751

John A. Gambatese, Fan Zhang, and Ali Moghaddam Vahed
School of Civil and Construction Engineering
Oregon State University
220 Owen Hall
Corvallis, OR 97331

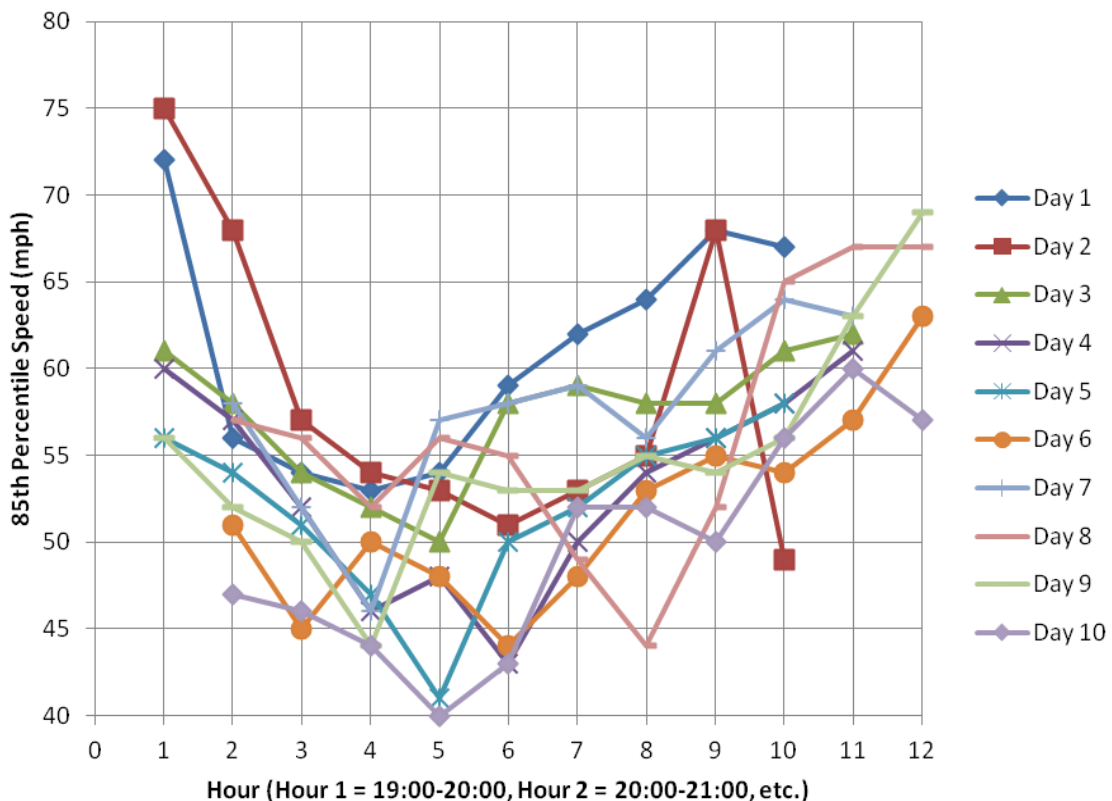
Figure 4.3 below shows a summary of the 85th percentile speed in each hour for all ten days for the I-84 case study project. The figure presents the data recorded from the first work zone traffic analyzer. From the figure, it can be seen that the last hour of data for some days are lower than the hour before. This may be due to the fact that the data for the full hour is not recorded for the last hour of the work period, so the 85th percentile speed of the last hour may not represent the actual traffic speeds over the entire hour.

Figure 4.3: Hourly Vehicle Speed (85th Percentile) for 10 days of I-84 Project

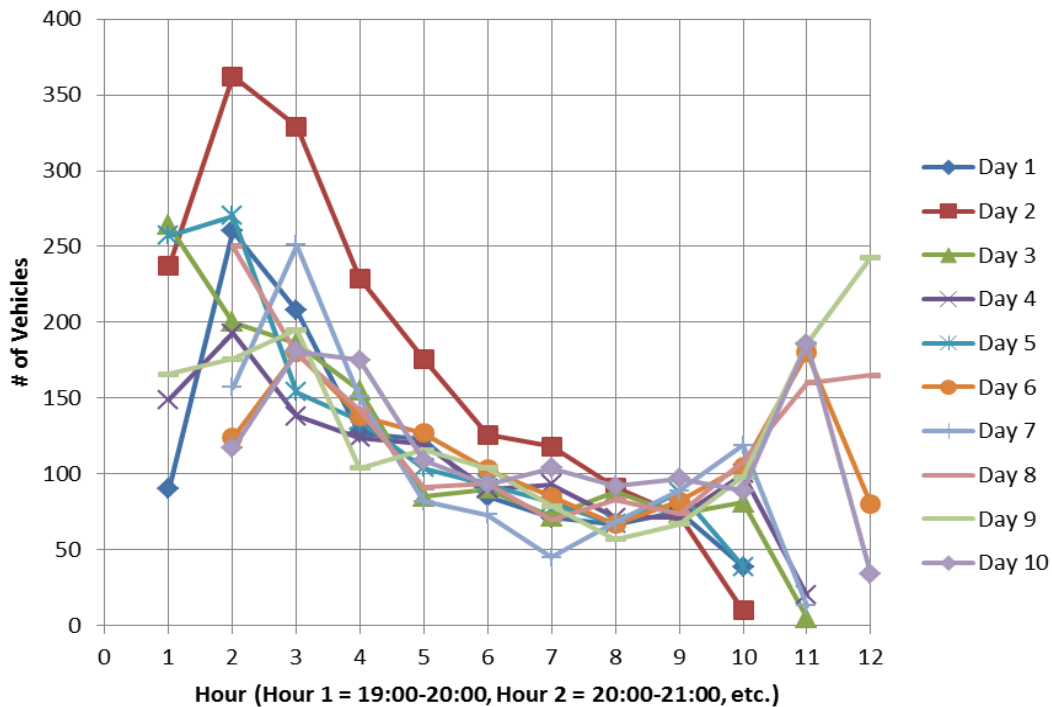
Figure 4.4: Hourly Traffic Volume for All days for I-84 Project

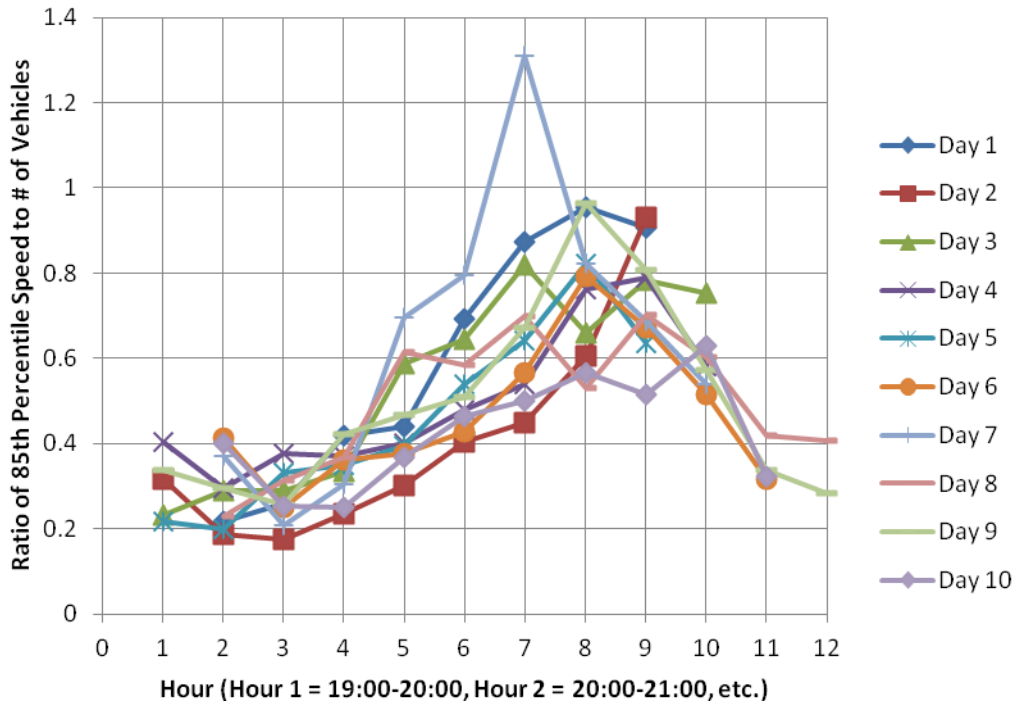
Figure 4.5: Ratio of Hourly Speed (85th Percentile) to Traffic Volume for All Days of I-84 Project

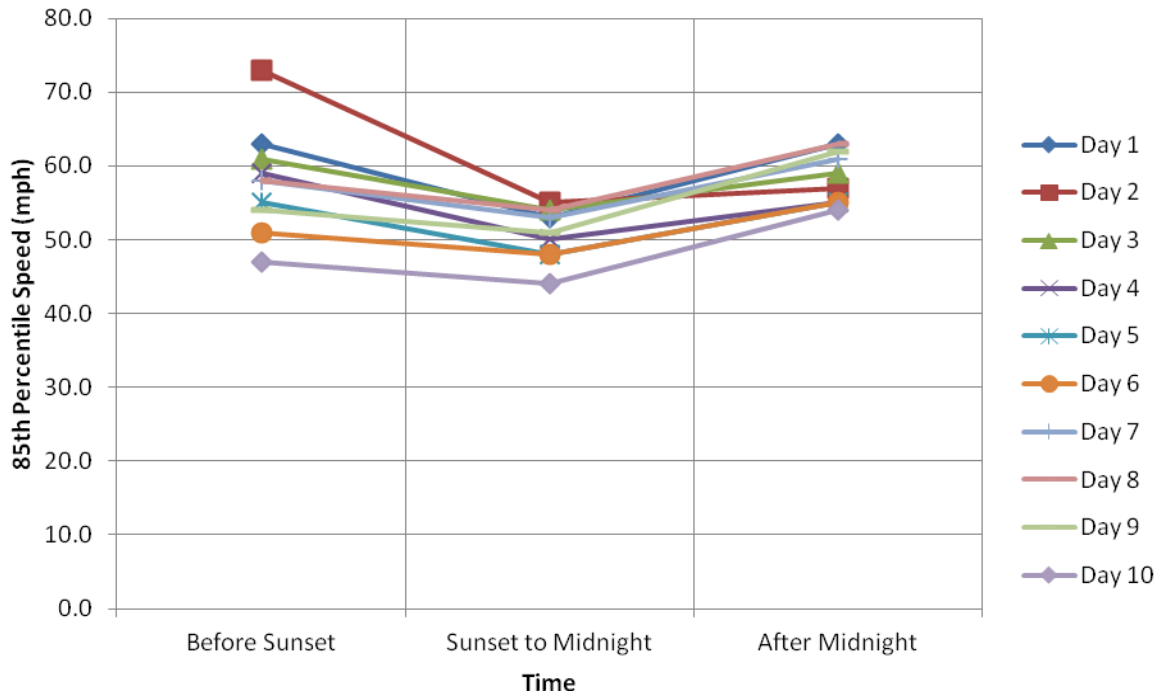
Figure 4.6: Vehicle Speed (85th Percentile) for Different Time Periods for All Days of I-84 Project

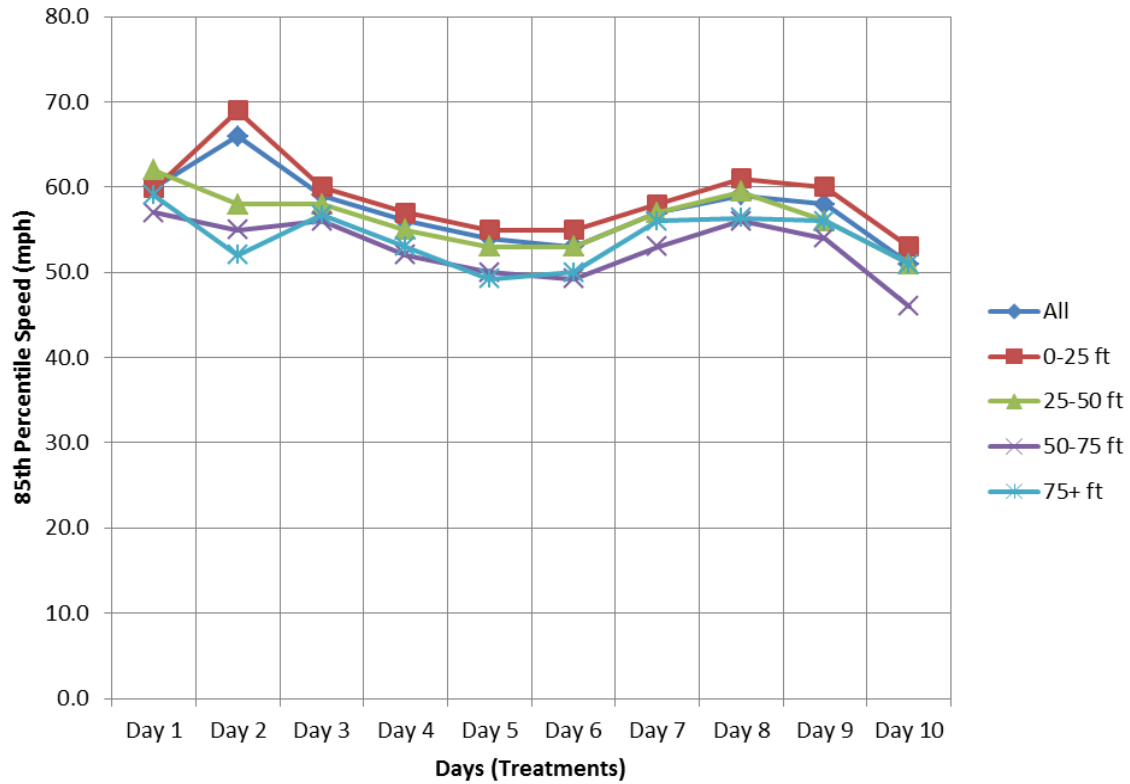
Figure 4.7: Vehicle Speed (85th Percentile) for Different Types of Vehicles for All Days of I-84 Project

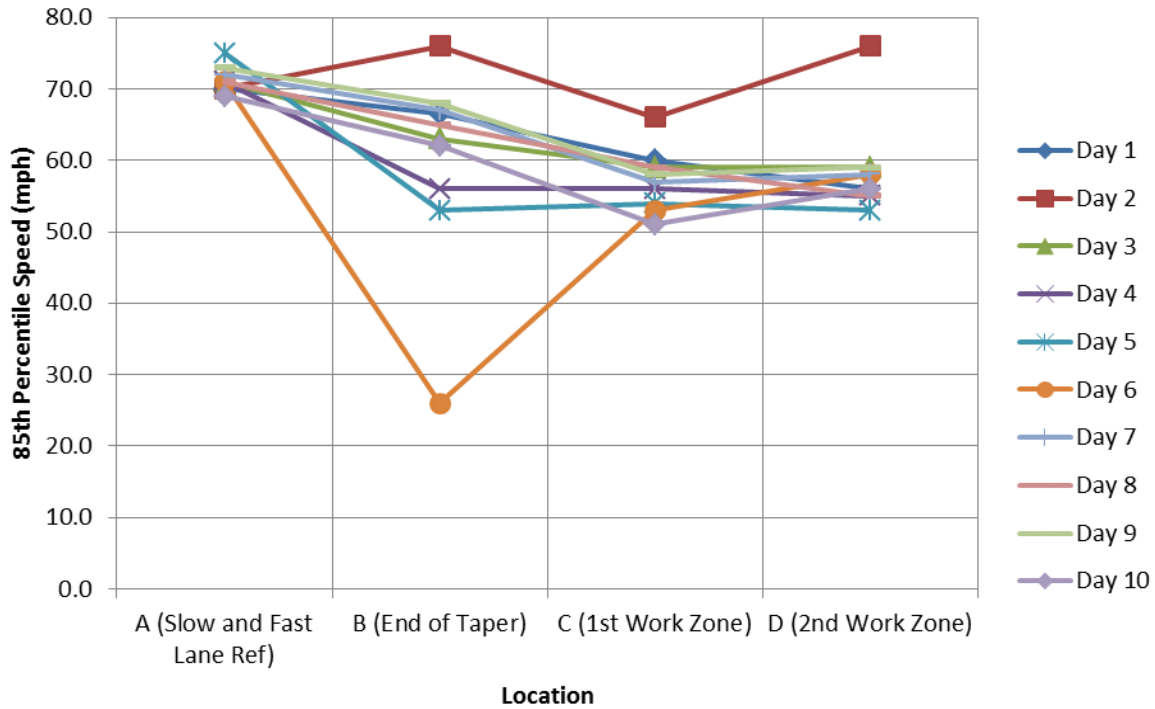
Figure 4.8: Vehicle Speed (85th Percentile) for Different Locations for All Days of I-84 Project

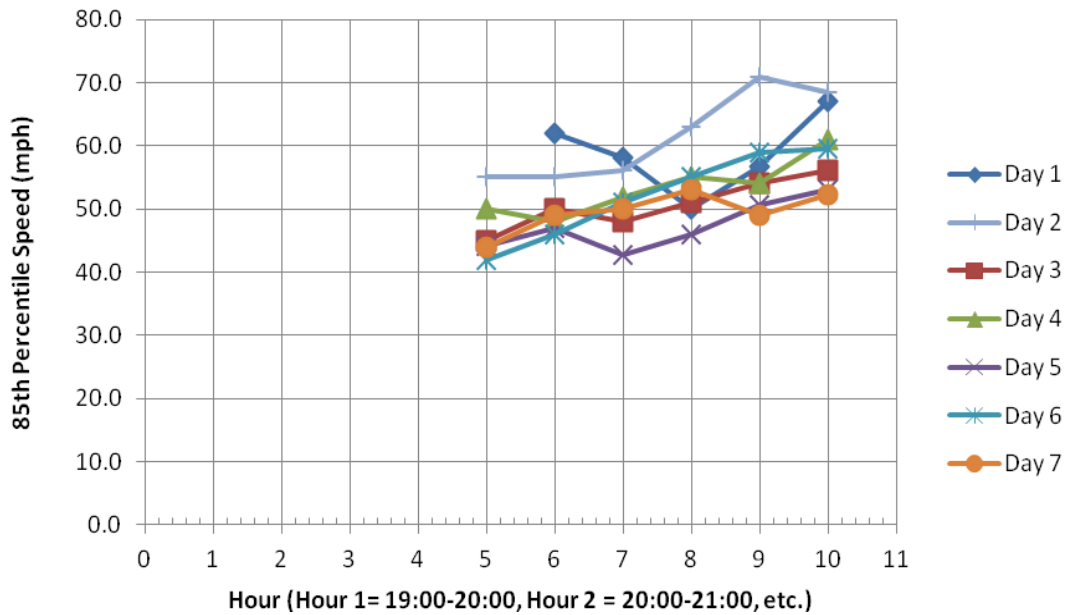
Figure 4.9: Hourly Vehicle Speed (85th Percentile) for All Days of I-5 Project

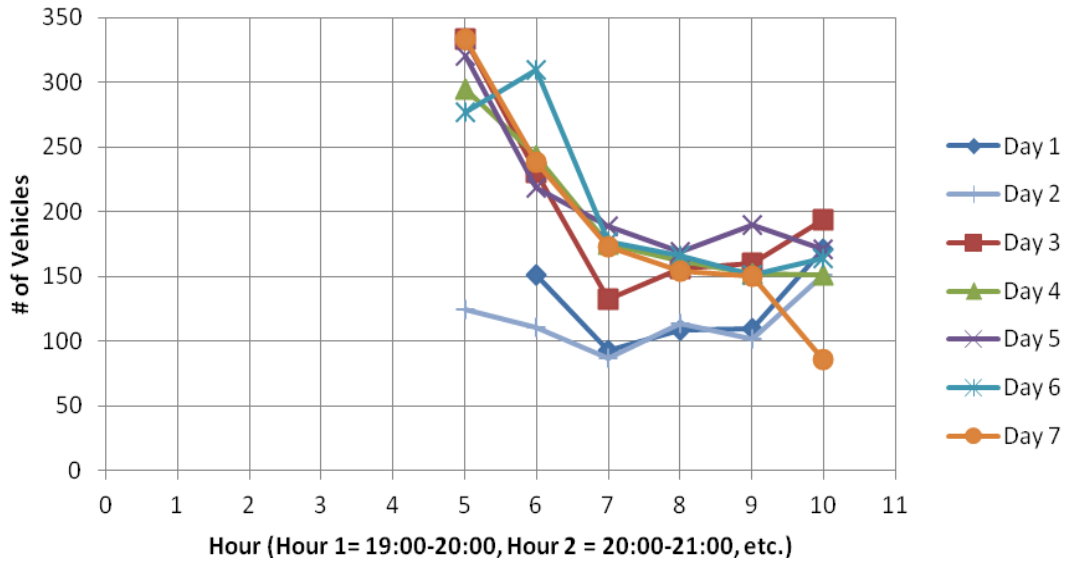
Figure 4.10: Hourly Traffic Volume for All Days for I-5 Project

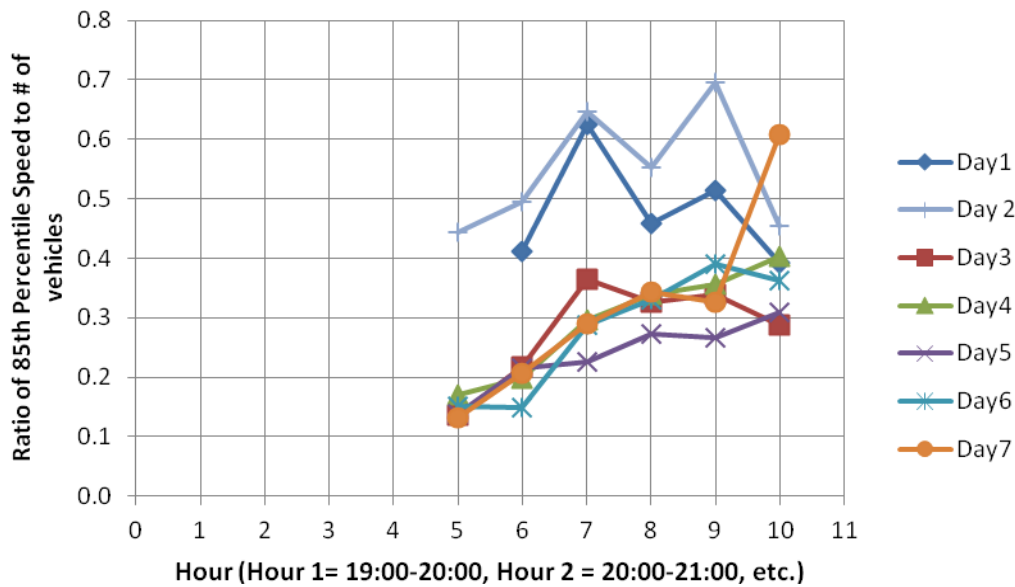
Figure 4.11: Ratio of Hourly Speed (85th Percentile) to Traffic Volume for All Days of I-5 Project

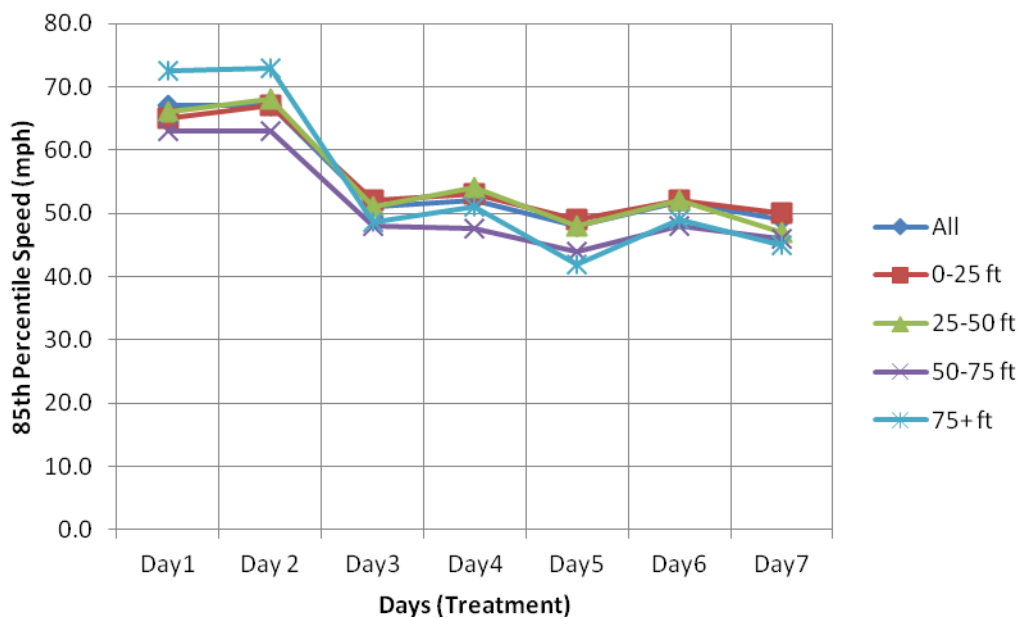
Figure 4.12: Vehicle Speed (85th Percentile) for Different Types of Vehicles for All Days of I-5 Project

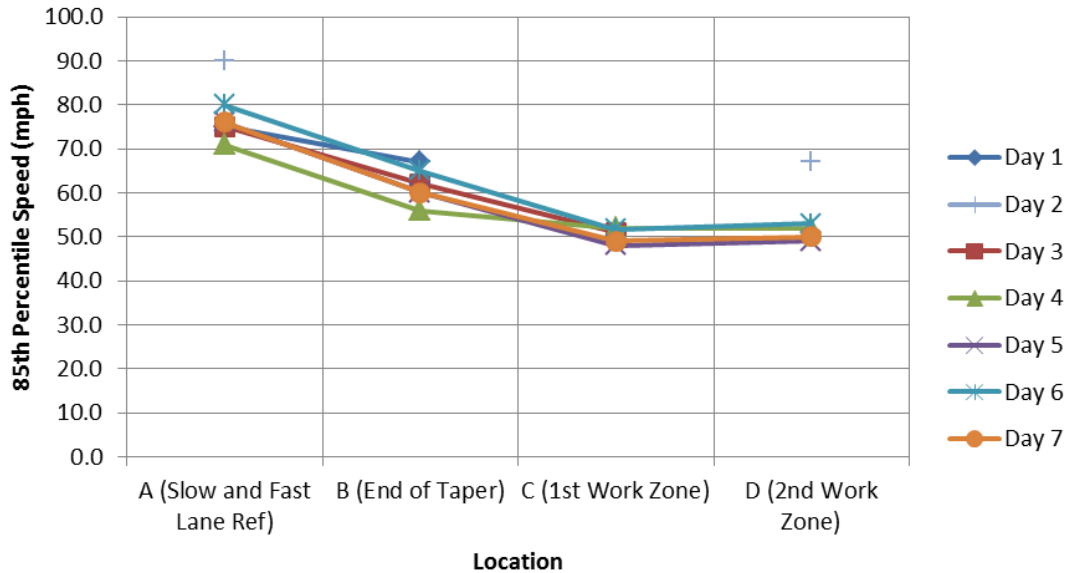
Figure 4.13: Vehicle Speed (85th Percentile) for Different Locations for All Days of I-5 Project

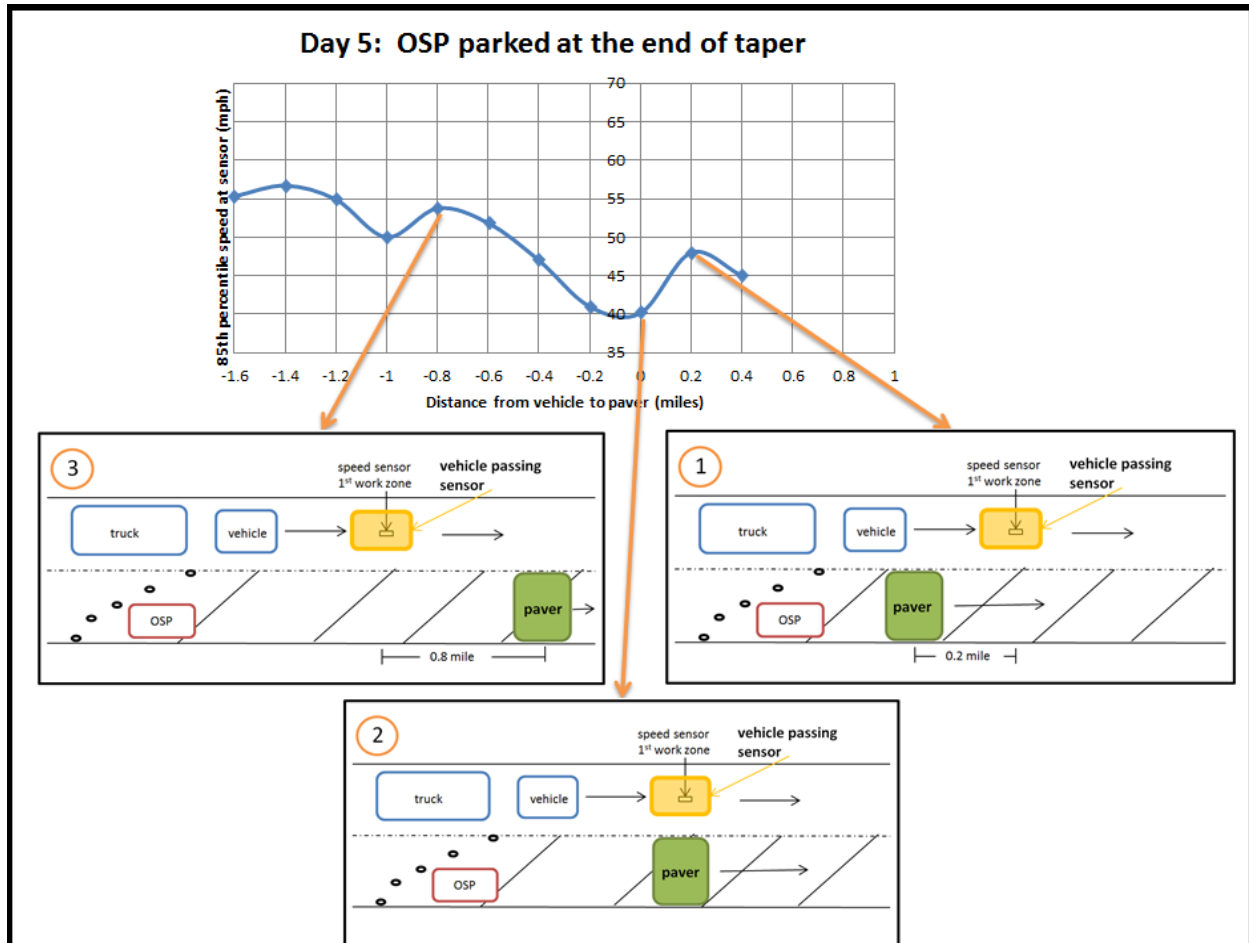
Figure 5.1: Illustration of Distance to Paver Graphs

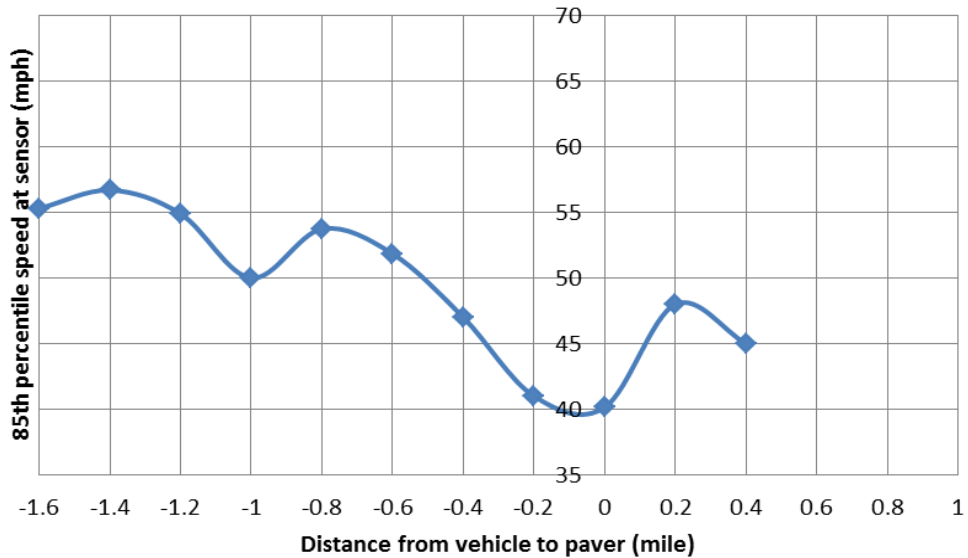
Figure 5.2: Example of Distance to Paver Graphs

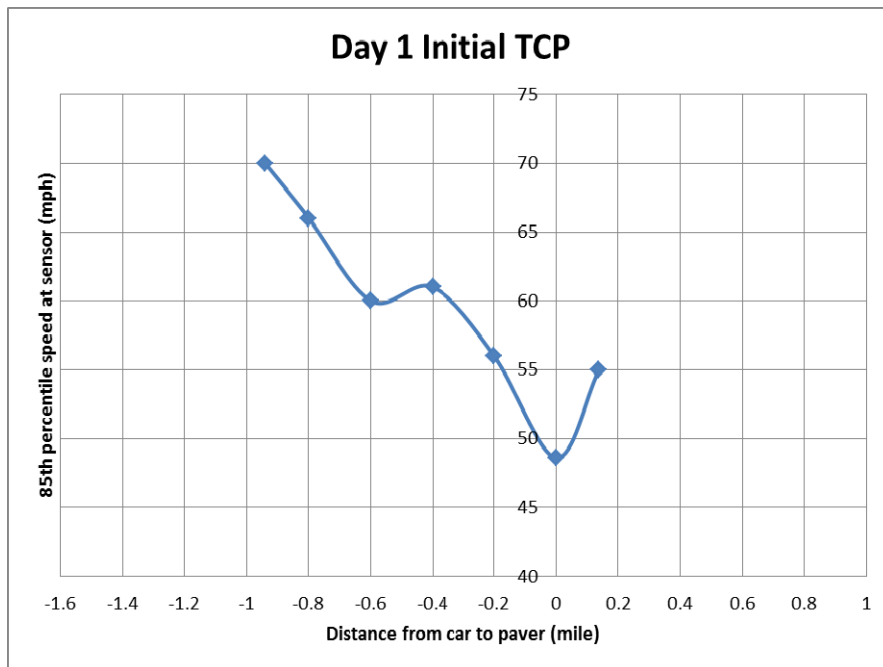
Figure 5.3: Vehicle Speed vs. Distance to Paver - Day 1, I-84 Project

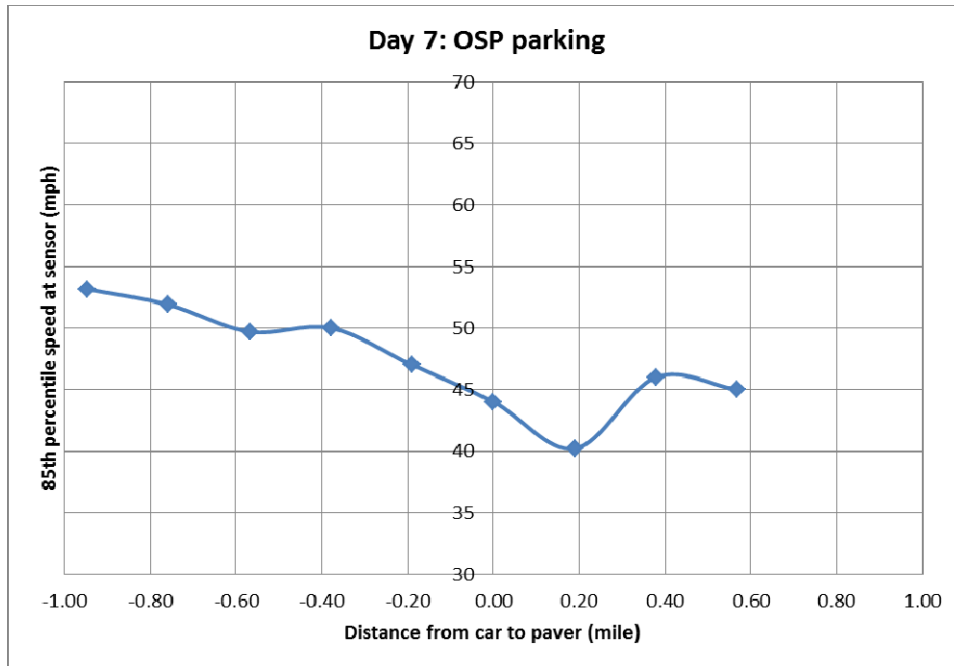
Figure 5.4: Vehicle Speed vs. Distance to Paver - Day 7, I-5 Project

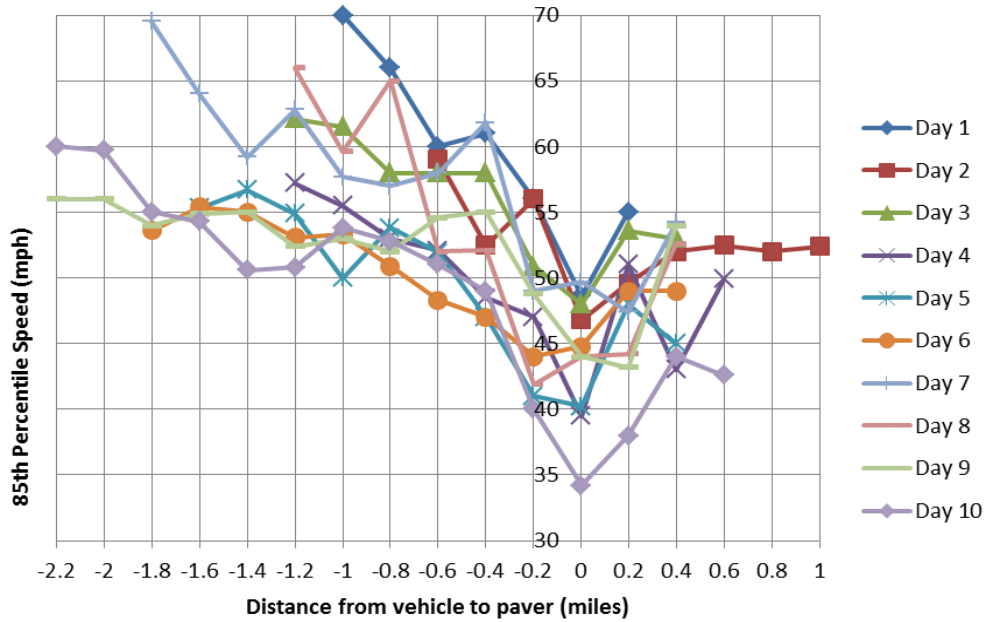
Figure 5.5: 85th Percentile Speed vs. Distance to Paver for All Days Based on First WZ Analyzer for I-84 Project

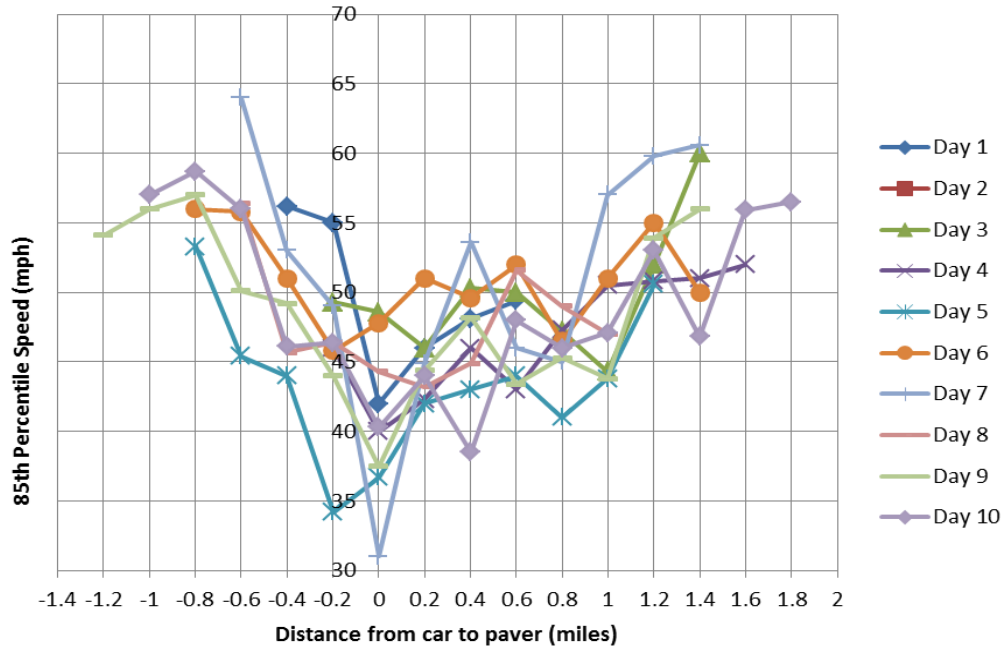
Figure 5.6: 85th Percentile Speed vs. Distance to Paver for All Days Based on Second WZ Analyzer for I-84 Project

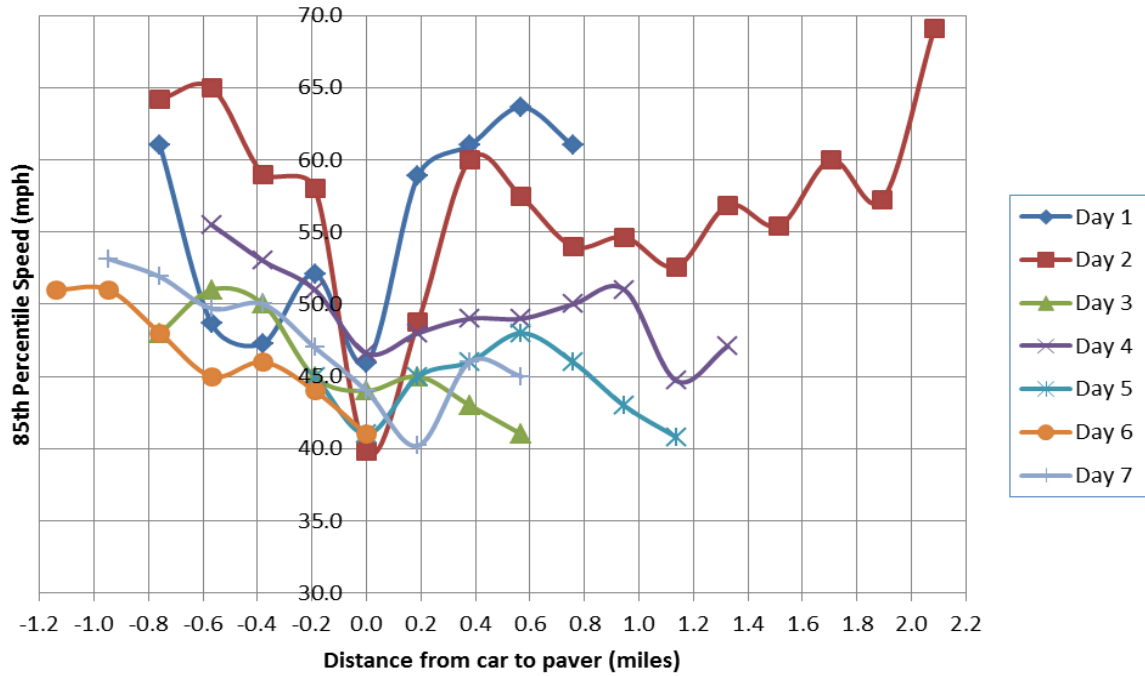
Figure 5.7: 85th Percentile Speed vs. Distance to Paver for All Days Based on First WZ Analyzer for I-5 Project

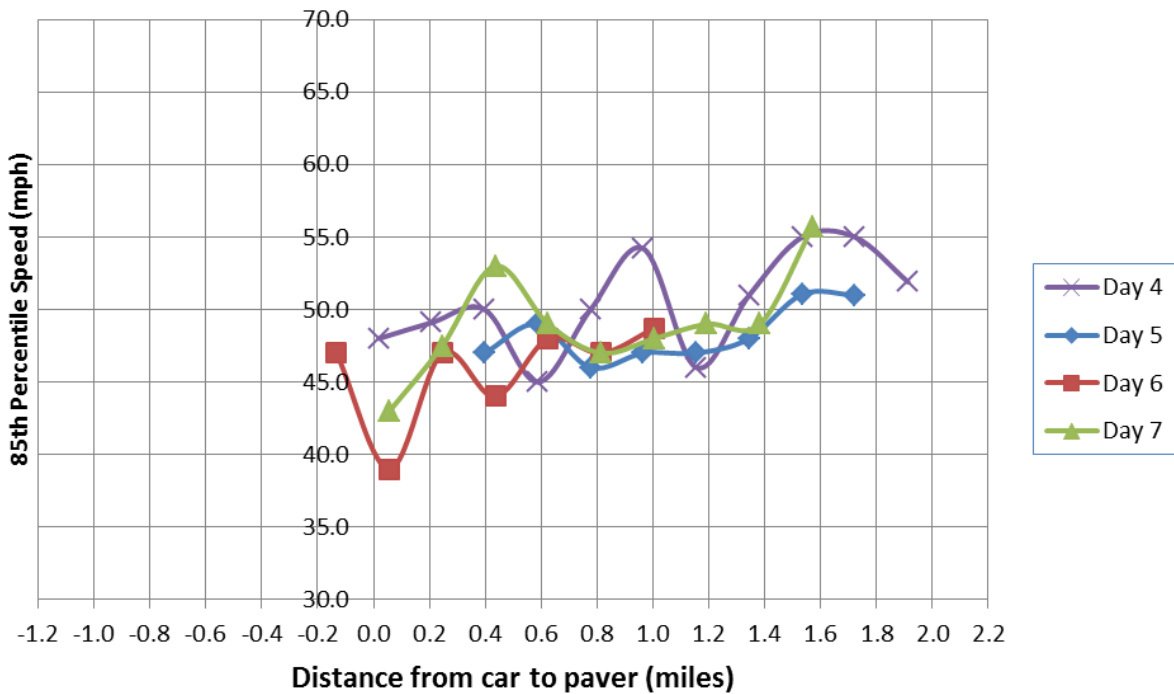
Figure 5.8: 85th Percentile Speed vs. Distance to Paver for All Days Based on Second WZ Analyzer for I-5 Project
