Investigation of Aged Hot-Mix Asphalt Pavements

Report Number: K-TRAN: KSU-09-2 • Publication Date: September 2013

Kansas State University Transportation Center

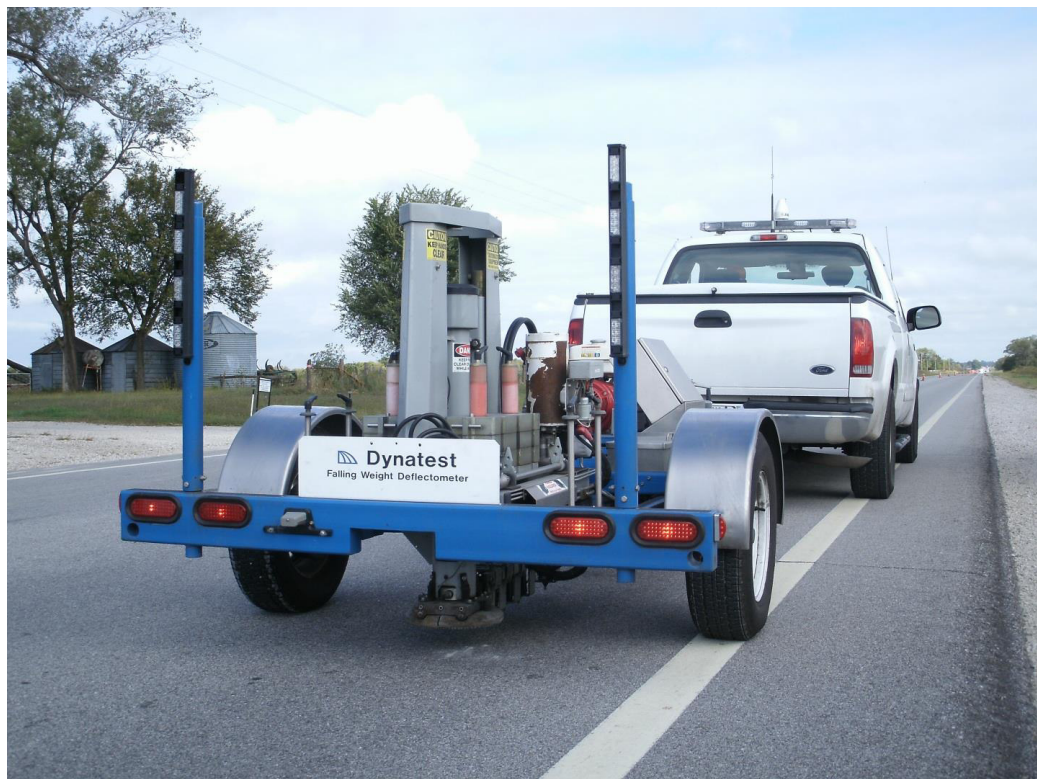
Dynatest 8000 Falling Weight Deflectometer Tester

This study examined structural characterization of six pavement test sections in Kansas using three different test methods: Falling Weight Deflectometer (FWD), Portable Seismic Property Analyzer (PSPA), and Indirect Tensile (IDT) tests. The results were analyzed to determine how the modulus of an AC pavement layer changes over time. The primary goals of this study were:
