EVALUATION OF MAINTENANCE STRATEGIES

Final Report 628

November 2013

Applied Pavement Technology, Inc.

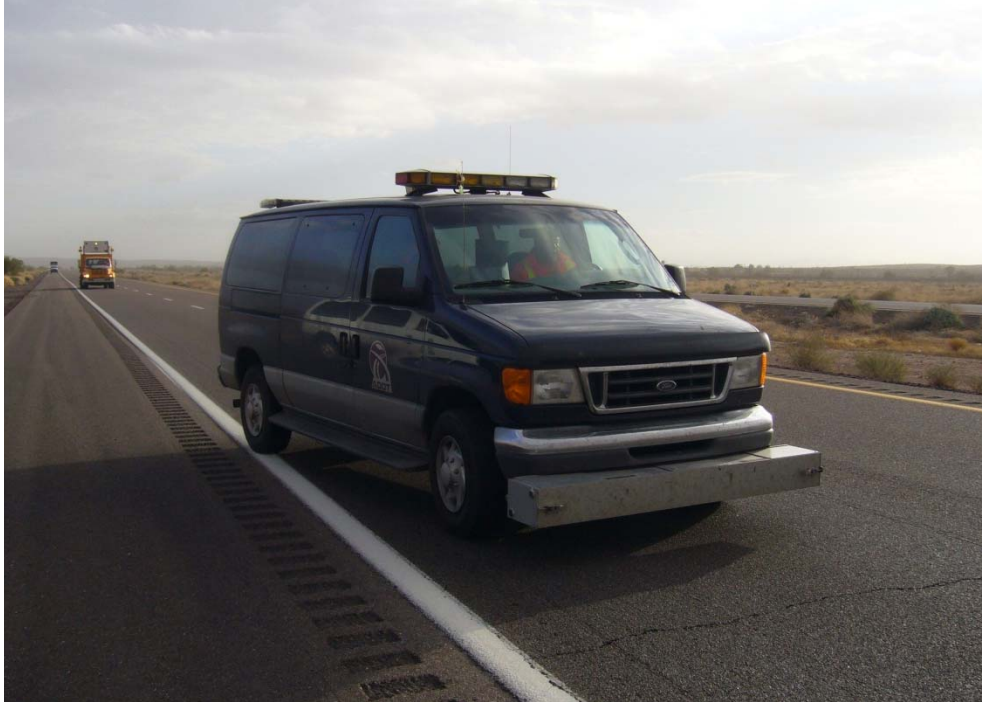
Figure 2. ADOT Profilometer.

ADOT performed surface profile and skid testing surveys using its van-mounted equipment at roughly the same time as the manual pavement condition surveys (between October and December 2007). Figure 2 is a photo of the ADOT profilometer used for surface profile measurement. It uses a series of lasers (mounted at the front of the van), vertical accelerometers (to correct for the effects of the vertical up and down movements of the van), and other internal instrumentation to record the longitudinal and transverse pavement surface profiles.

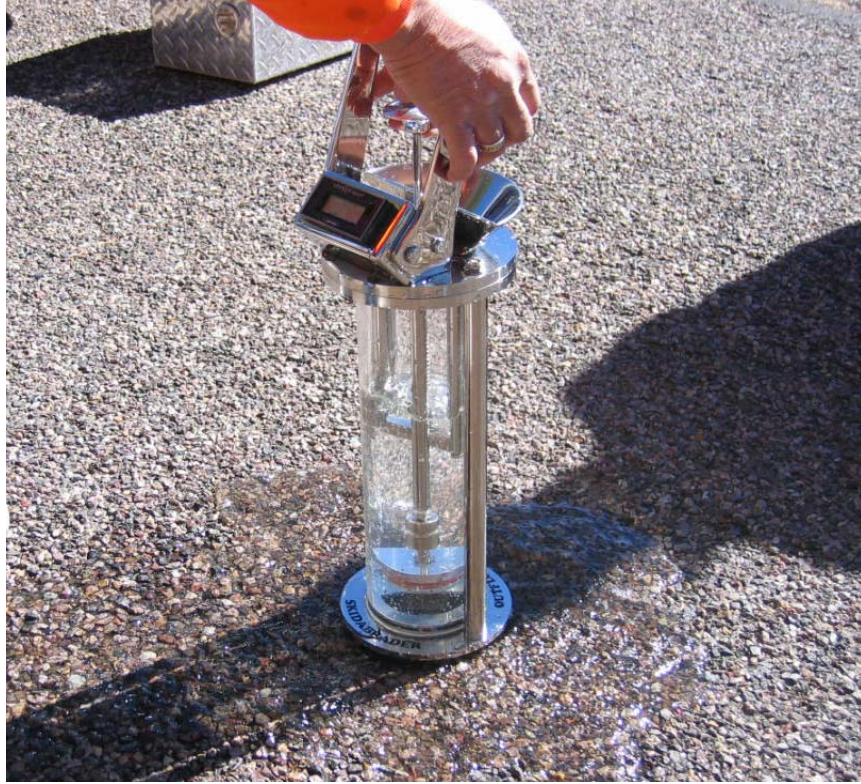
Figure 4. HydroTimer Outflow Meter.

ADOT used its outflow meter (Figure 4), Circular Texture (CT) meter (Figure 5), and Dynamic Friction (DF) Tester (Figure 6) to measure pavement surface and friction characteristics in the test sections. Since all three are manually operated devices, ADOT performed these tests on the test sections at the same time as the manual condition surveys. The outflow meter provides an estimate of the MTD using a correlation that is based upon the amount of time required for water to flow out of the cylinder. The CT meter (ASTM 2012) uses a laser to determine a pavement surface texture characteristic known as the mean profile depth (MPD) within an 11-inch diameter circle. The DF device measures the dynamic coefficient of friction (DCOF) that characterizes the pavement surface's frictional resistance.

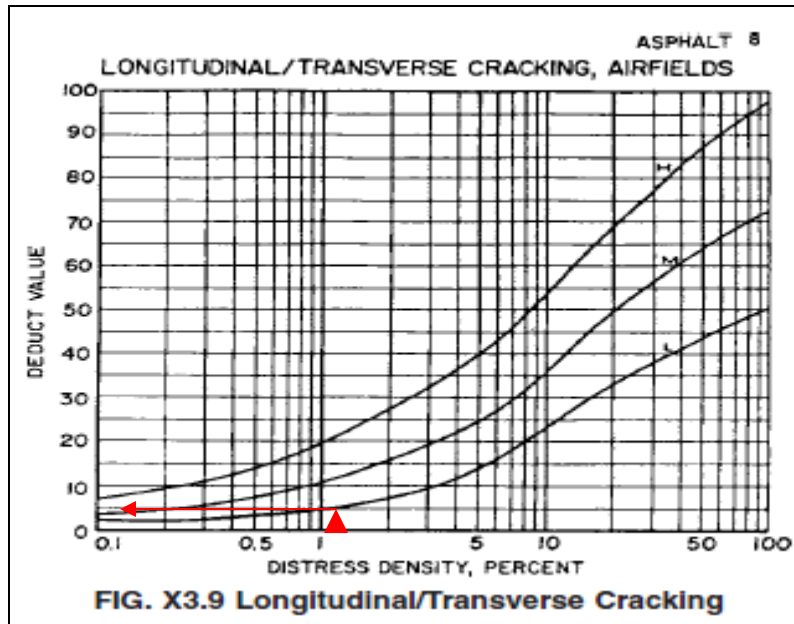
Figure 7. DV Curves for Longitudinal and Transverse Cracking (ASTM 2011).

Referring to the DV curves for longitudinal and transverse cracking (see Figure 7), the DV is 4.8.

The standard curves for distress type and severity level combination can be represented in the form of an equation. The DV can also be determined from these equations. The standard form of the polynomial equation can be represented as follows:
