# Comparison of Observed and Predicted Abutment Scour at Selected Bridges in Maine

By Pamela J. Lombard and Glenn A. Hodgkins

Scientific Investigations Report 2008–5099

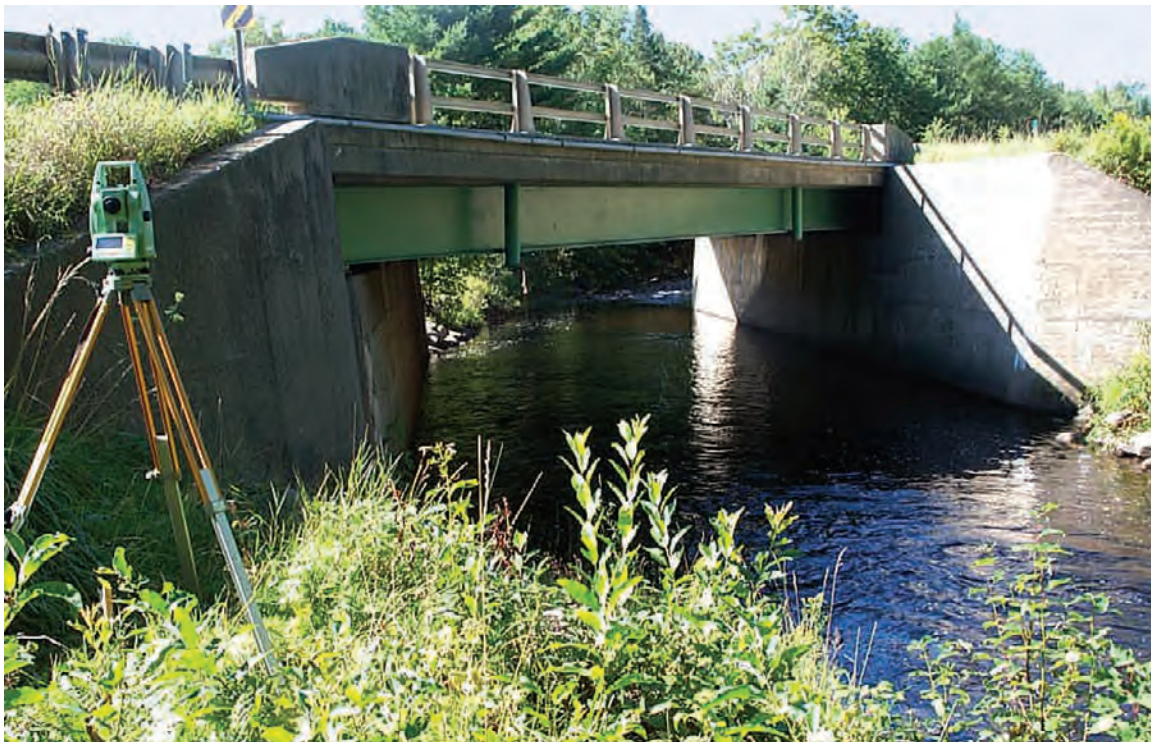
**Figure 2.** Total station theodolite used to collect survey data at the East Branch of the Wesserunsett Stream at Athens, Maine, August 25, 2004.

Bridges were surveyed with a total station theodolite during the summer low-flow seasons of 2003, 2004, and 2005 to determine bridge and channel geometry and characteristics, and to measure the observed abutment scour relative to a local datum. The geometry of the channel and bridge was defined by field surveys of the structure and four local cross

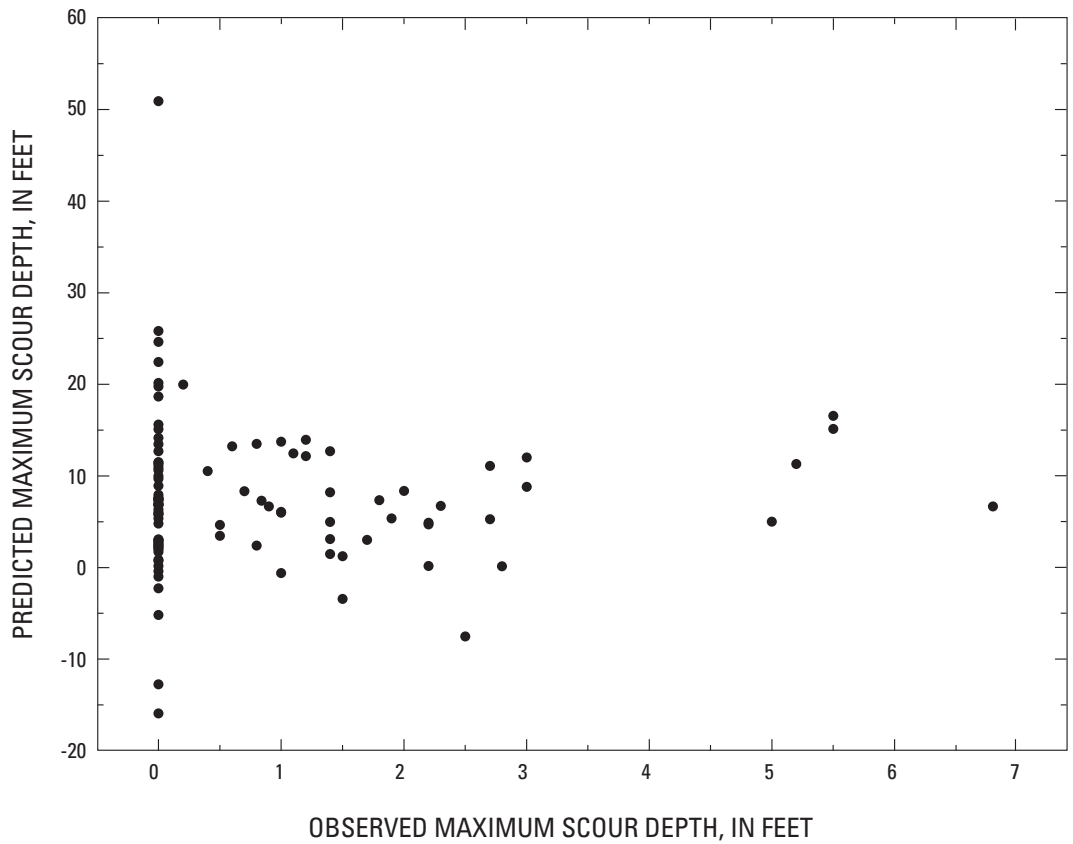
**Figure 5.** Relation of observed maximum abutment-scour depths to predicted maximum abutment-scour depths computed by the Sturm method for 50 bridges in Maine.

In the 50 bridges examined in this study, no correlation was found between maximum observed abutment scour and maximum predicted abutment scour from the four different prediction methods (correlations had  $r$  values of less than 0.1 in all cases) (table 6). The absence of a relation between observed scour and scour predicted with the Froehlich/Hire, Sturm, Maryland, and Melville methods is shown in figures 4 through 7, respectively. Furthermore, none of the individual variables calculated in this study to create envelope equations showed any correlation with maximum observed abutment scour depths; for example, the lack of relation between the length of active flow blocked by the embankment ( $L'$ ) and observed abutment scour is seen in figure 8.

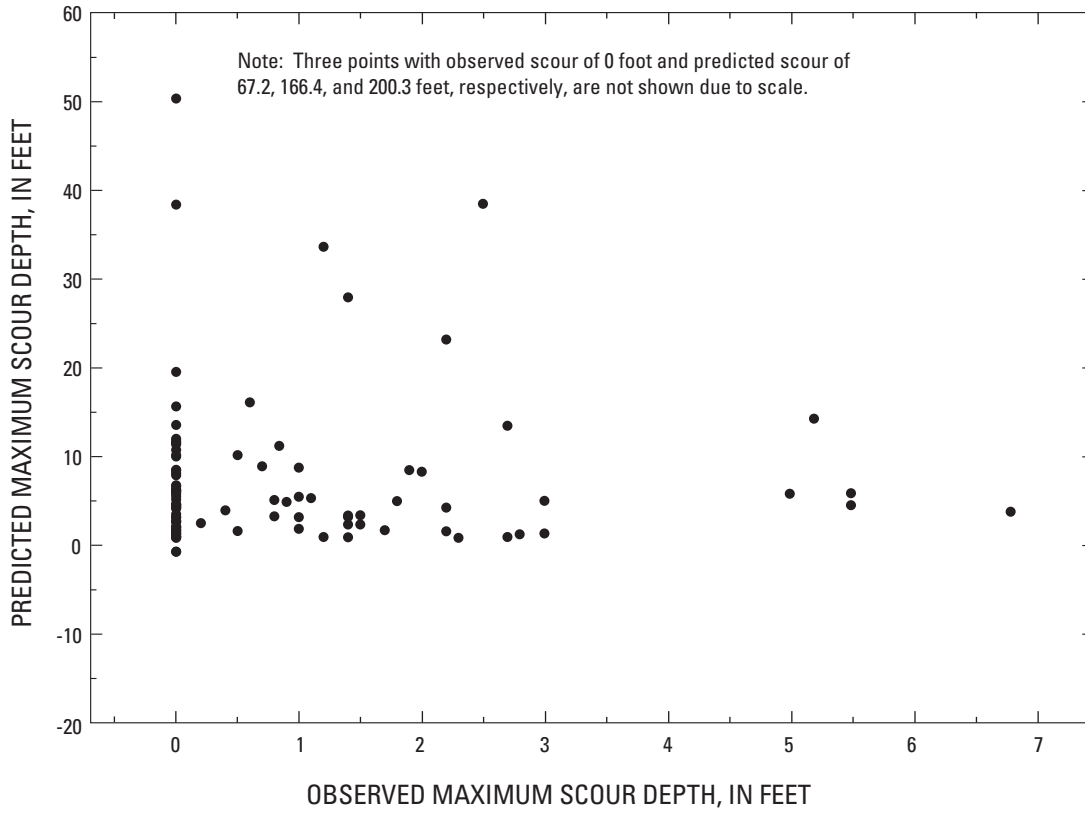
**Figure 6.** Relation of observed maximum abutment-scour depths to predicted maximum abutment-scour depths computed by the Maryland method for 50 bridges in Maine.

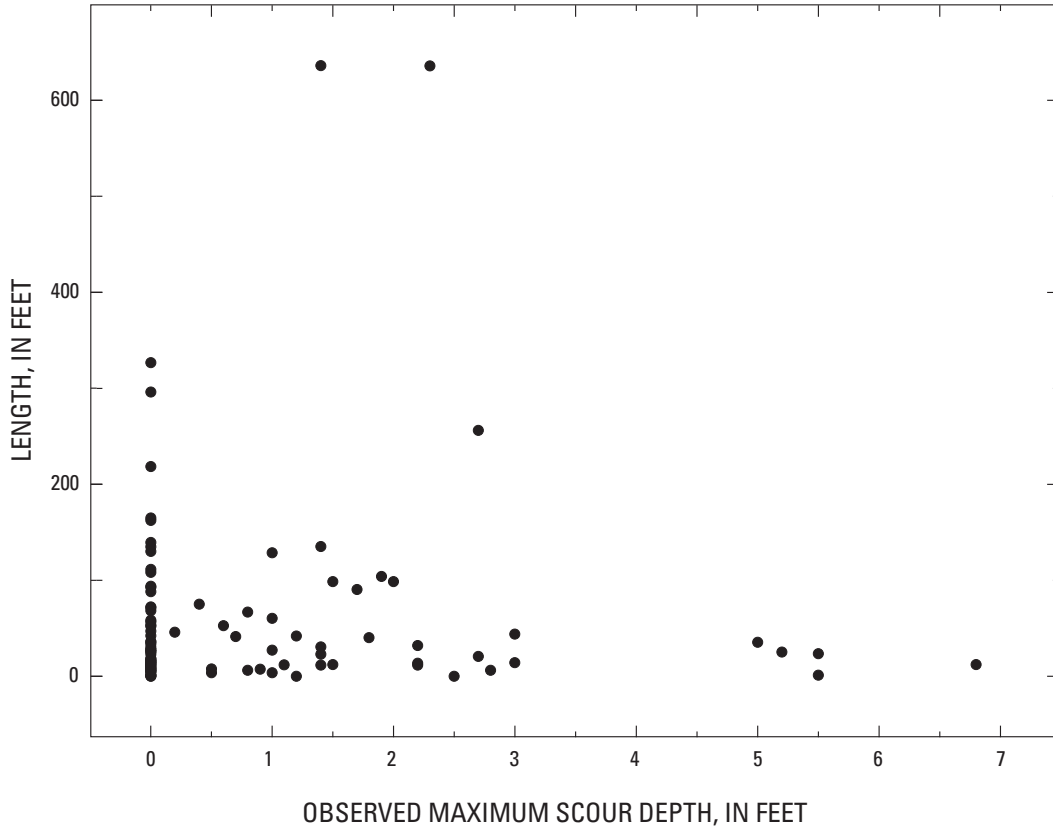
**Figure 8.** Relation of observed maximum abutment-scour depth to the length of the active flow blocked by the bridge embankment at 50 bridges in Maine.
