Final Report

Evaluate the Use of Reclaimed Concrete Aggregate in French Drain Applications

FDOT Contract No.: BDK 78 TWO 977-12

Department of Civil, Environmental, and Construction Engineering
University of Central Florida
4000 Central Florida Blvd.
Orlando, FL 32816-2450

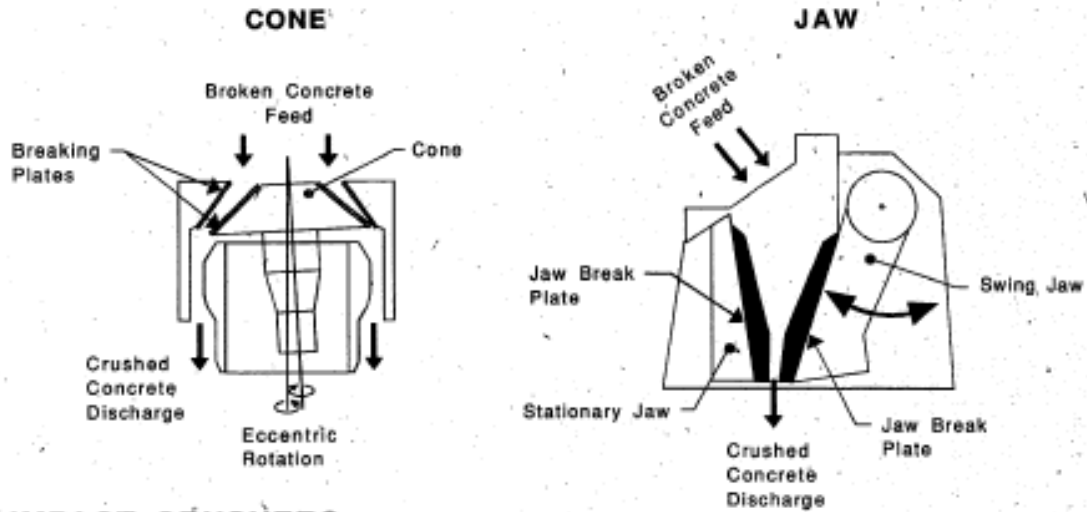
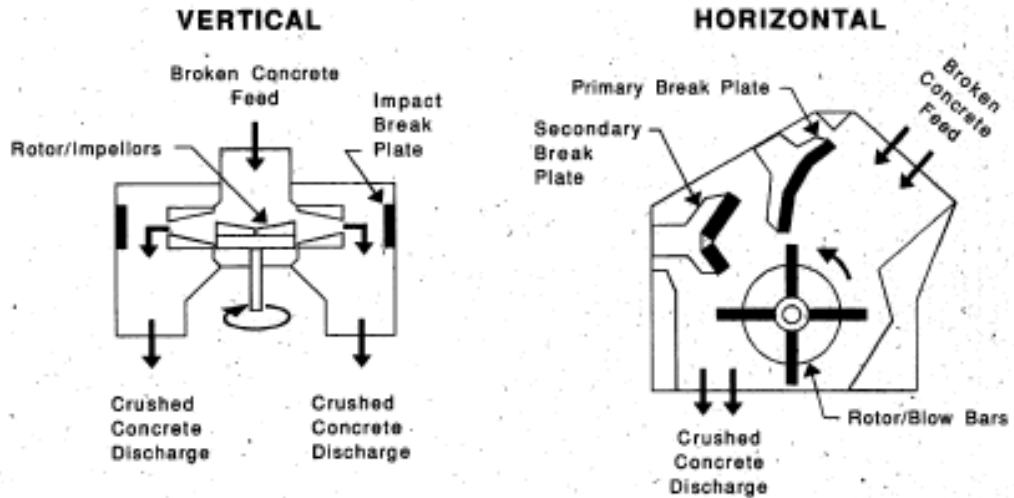
Figure 2.1: Compression and Impact Crushers (Environmental Council of Concrete Organizations, 1999)

There are two main types of crushing devices that recycling plants utilize; compression crushers and impact crushers (Figure 2.1). Common compression crushers used are the cone, and jaw crushers, where two common impact crushers used are impact and horizontal crushers. Recycling plants may use one or two crushers during the production process. The primary crusher is used for larger pieces, in which the resulting aggregates go through a screening process and then onto the secondary crusher, where the RCA is broken down into the desired size. In North America, 61% of recyclers use jaw crushers for the primary crushing, and 43% use cone crushers for secondary crushing (Environmental Council of Concrete Organizations, 1999). And as a result from these processes, the original concrete will yield about 75% course aggregate, and 25% of fines (Environmental Council of Concrete Organizations, 1999). An outline of a typical RCA production process is shown in Figure 2.2.

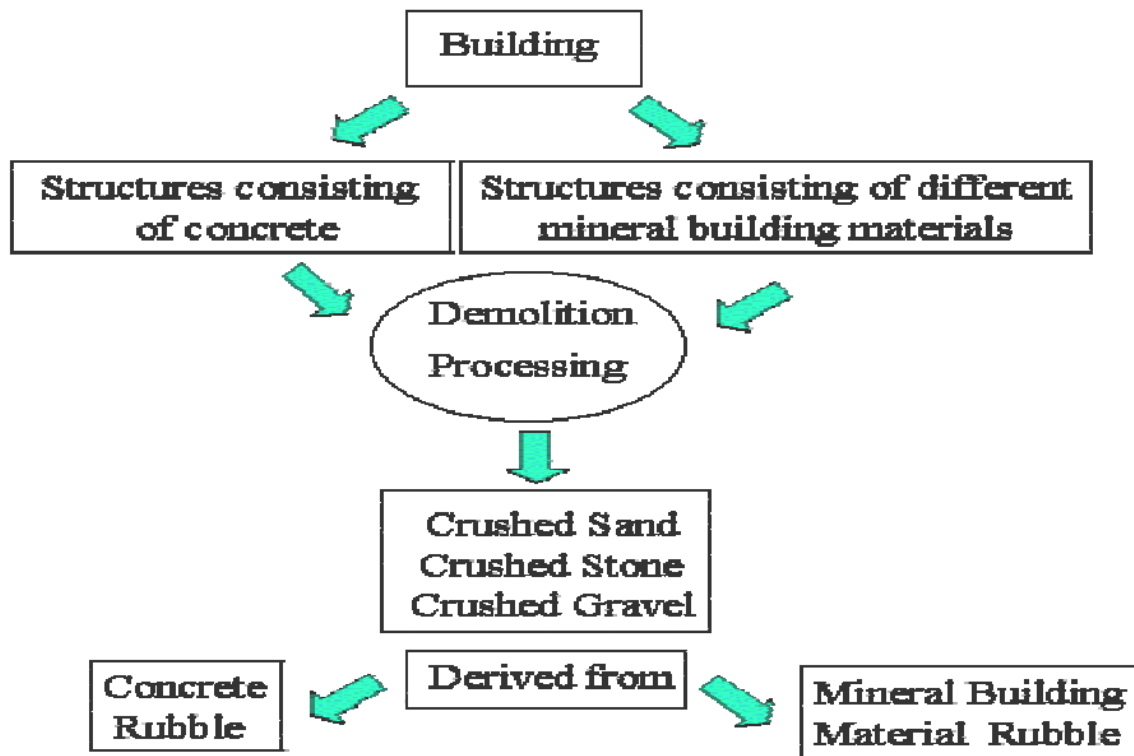
Figure 2.2: RCA Production Process (Kuo, 2001)

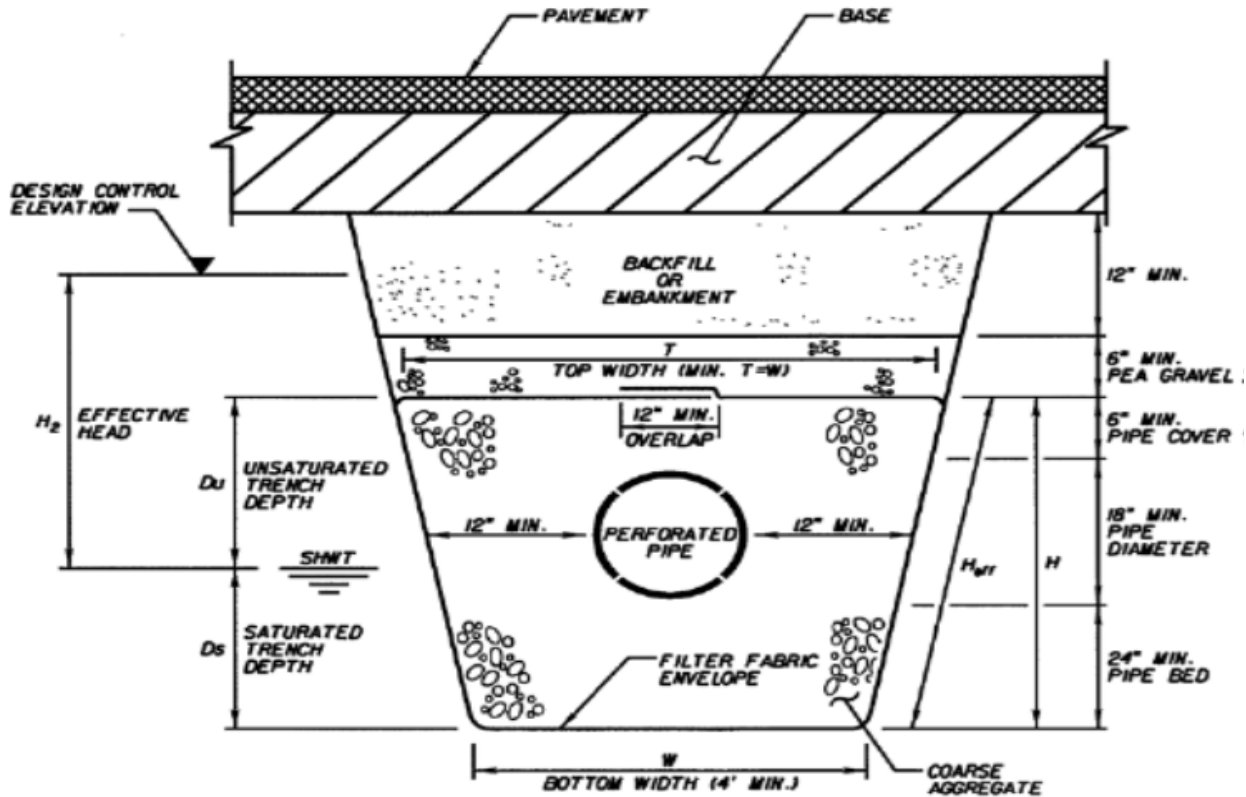
Figure 2.3: Cross Section of an Exfiltration Trench (FDOT Drainage Handbook Exfiltration Systems, 2012)

Exfiltration trench systems are similar to French drain systems (Figure 2.3) in that they are both subsurface structures including a perforated pipe, filter material (coarse aggregate), fine drainage materials (sand and pea gravel), and filter fabric. Exfiltration trenches are most commonly associated with storm water control and treatment. Some drainage fields consists of a series of exfiltration trenches used in conjunction with septic tanks where the effluent from septic tanks are distributed through a drainfield and the water exists the perforated pipes and filters through the aggregate, then the treated water is allowed to percolate into the native soil. Exfiltration trenches are especially useful when there is limited land area to devote to storm water management (St. Johns River Management District, 2010).

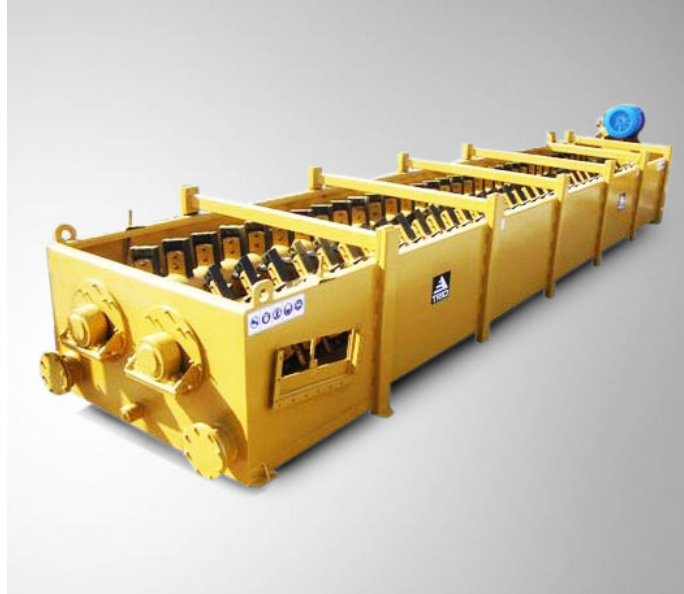
Figure 2.4: Aggregate Log Washer (Trio Engineered Products Inc., 2011)

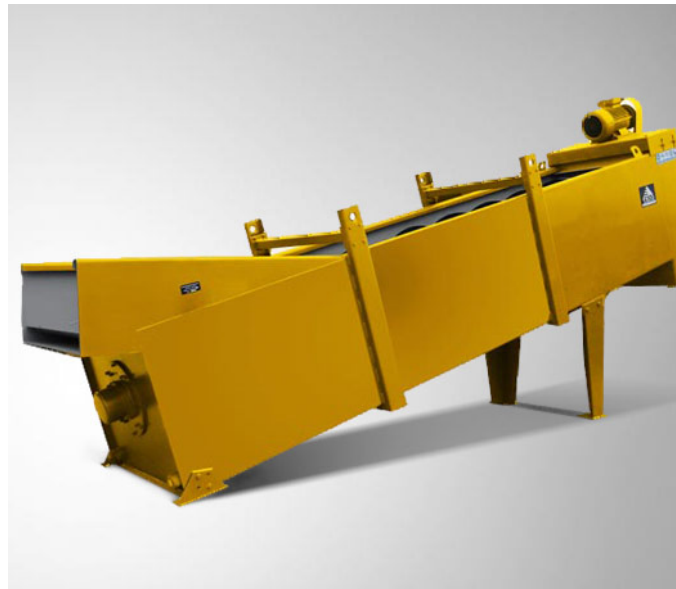
Figure 2.5: Coarse Aggregate Scrubber (Trio Engineered Products Inc., 2011)

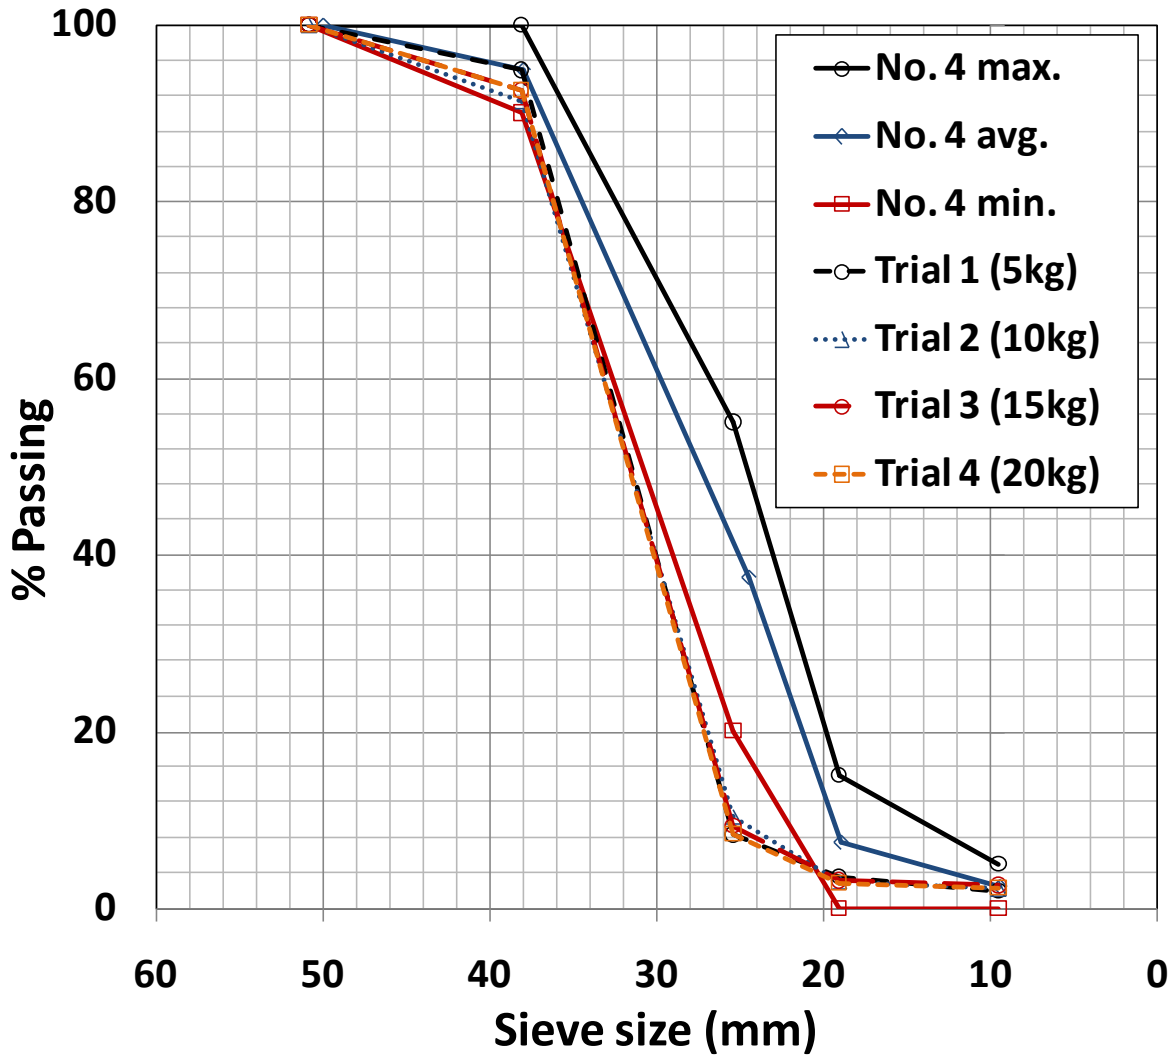
Figure 3.2: Gradation Analysis Results of RCA

RCA was obtained from a local construction and demolition waste recycling facility in Orlando FL. Two 55 gallon drums of RCA were obtained and are shown in Figure 3.1. The material was advertised as the No. 4 gradation, however a gradation analysis test (ASTM D422) was performed (results shown in Figure 3.2) and the actual gradation has failed to comply with the No. 4 gradation.

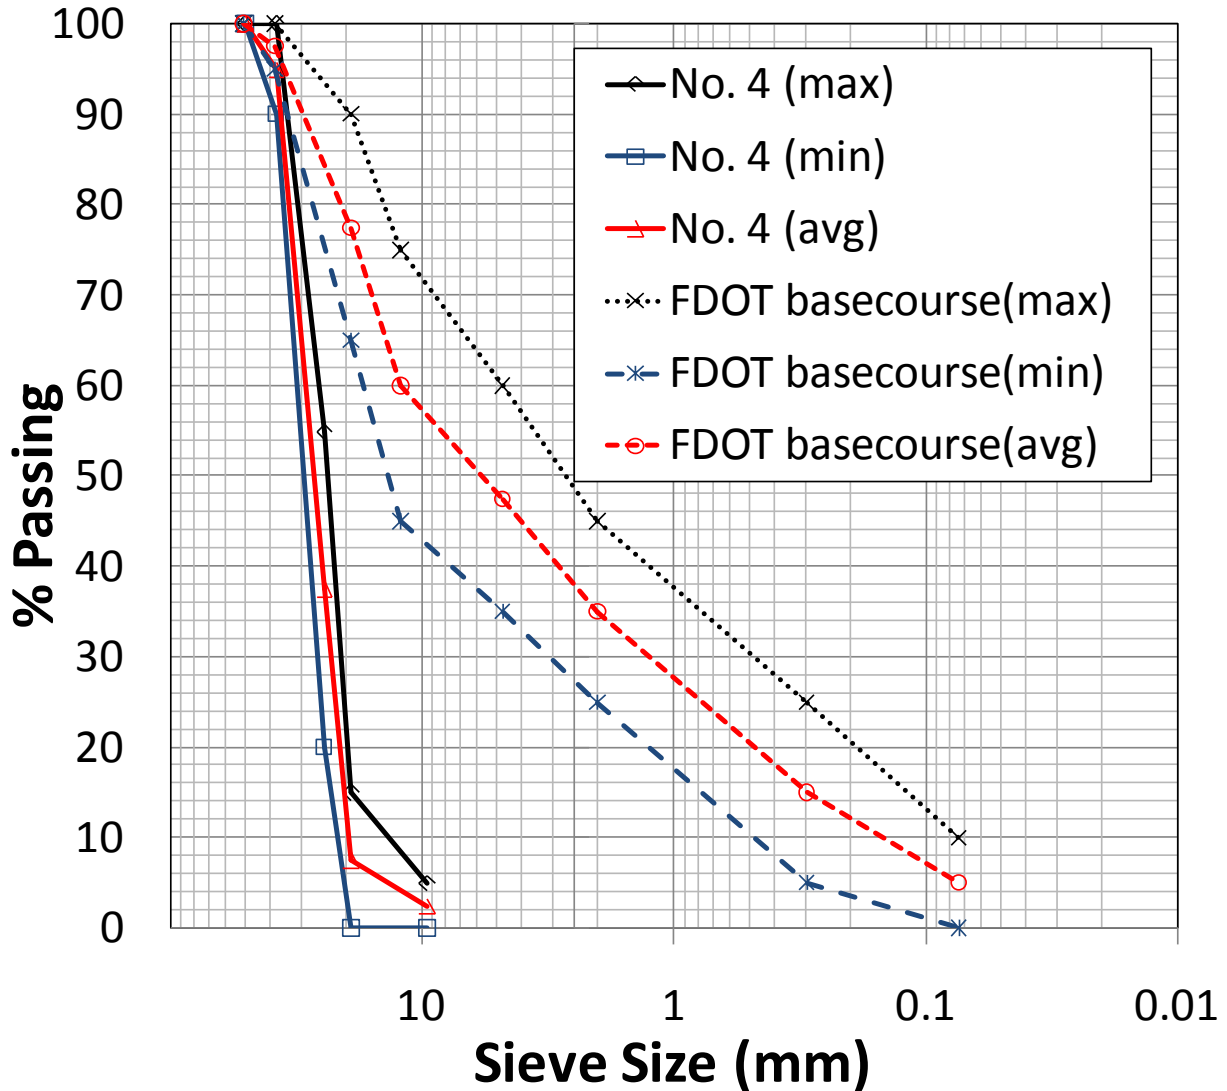
Figure 3.4: Gradation of Base Course Compared to No. 4 Aggregate on Log Scale

Up to 20 kg of RCA was tested using the TS-1 Gilson Testing Screen and the 2, 1.5, 1, 3/4, and 3/8 in. sieves. Using this testing screen the RCA can be separated into different size fractions and recombined according to the No. 4 gradation. Samples were prepared using this process and a 10kg sample of each No. 4 gradation (max, avg, min) was prepared for aggregate handling, physical properties, and permeability testing. Other samples were also prepared with the ‘as received’ (further referred to ‘as is’) RCA and no size proportioning was applied. A photo of the ‘as is’ RCA is shown in Figure 3.3. For comparison, the base course gradation is shown plotted with the No. 4 gradation on a log scale in Figure 3.4.

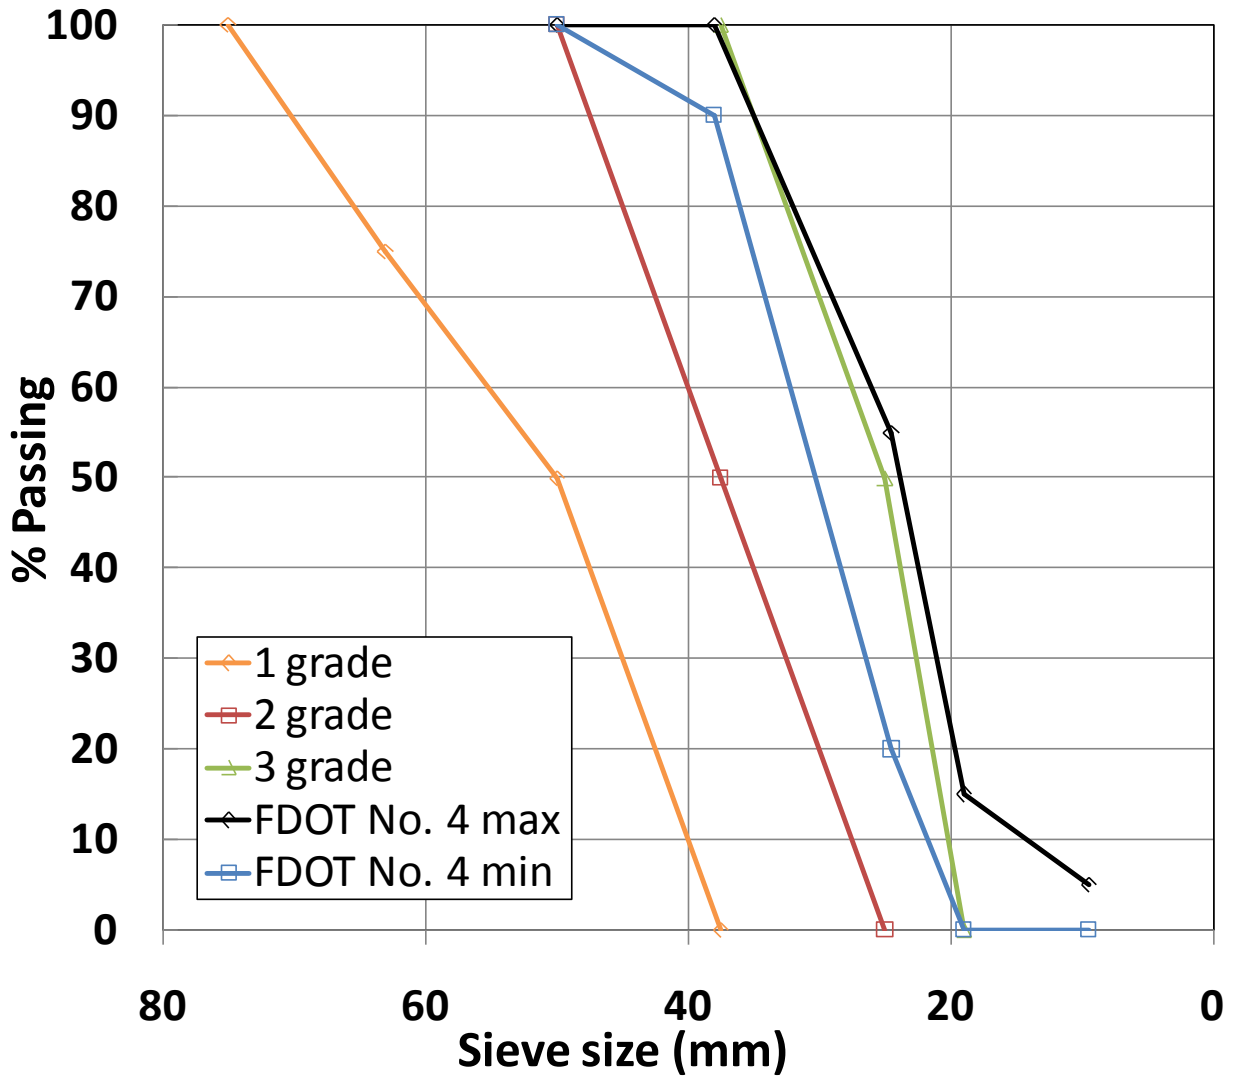
Figure 3.5: Grades Provided by ASTM C535

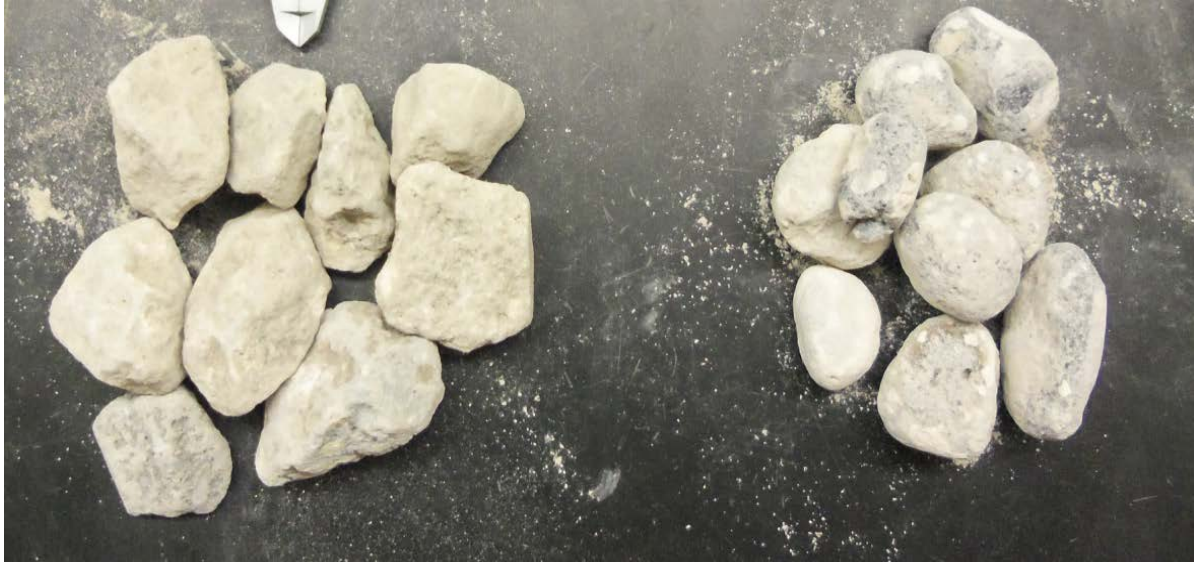
Figure 3.6: RCA Before (Left) and After (Right) L.A. Abrasion Test

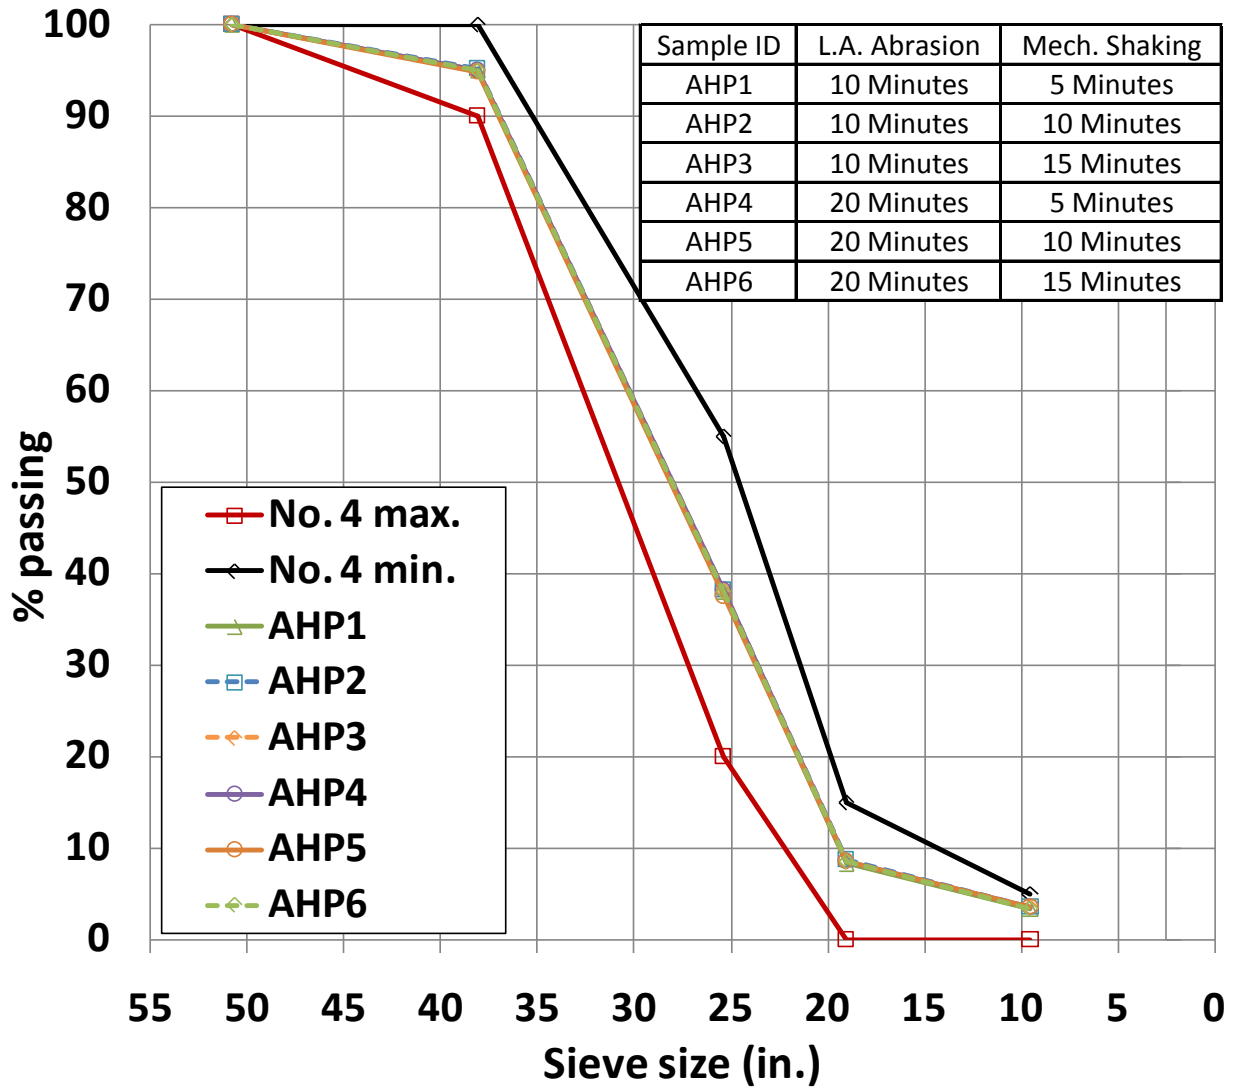
Figure 3.7: Initial Gradation of Aggregate Handling Process Test

The results from the aggregate handling process are shown Figures 3.7 and 3.8. All six samples were combined according to the No. 4 average gradation (Figure 3.7) to serve as a starting point. After the appropriate times in the L.A. abrasion machine and the mechanical shaker the samples were tested again for gradation to see the effect of the simulation. The results shown in Figure 3.8, suggest that the vertical movement and crushing abrasion provided by the L.A. abrasion machine has a more substantial impact on the final gradation than the horizontal movements provided by the mechanical shaker. Samples, AHP1, AHP2, and AHP3 show that the final gradation is very similar, and that with 10 minutes in the L.A. abrasion machine controls the final gradation, while the 5, 10 and 15 minutes of the mechanical shaker have little to no effect. Samples AHP4, AHP5, and AHP6 show that 20 minutes in the L.A. abrasion machine will generate more fines than the samples with 10 L.A. abrasion, and the effect of the mechanical shaker shows slightly more variation. In general the degradation of RCA is highly dependent on the vertical and crushing movements than the horizontal movements.

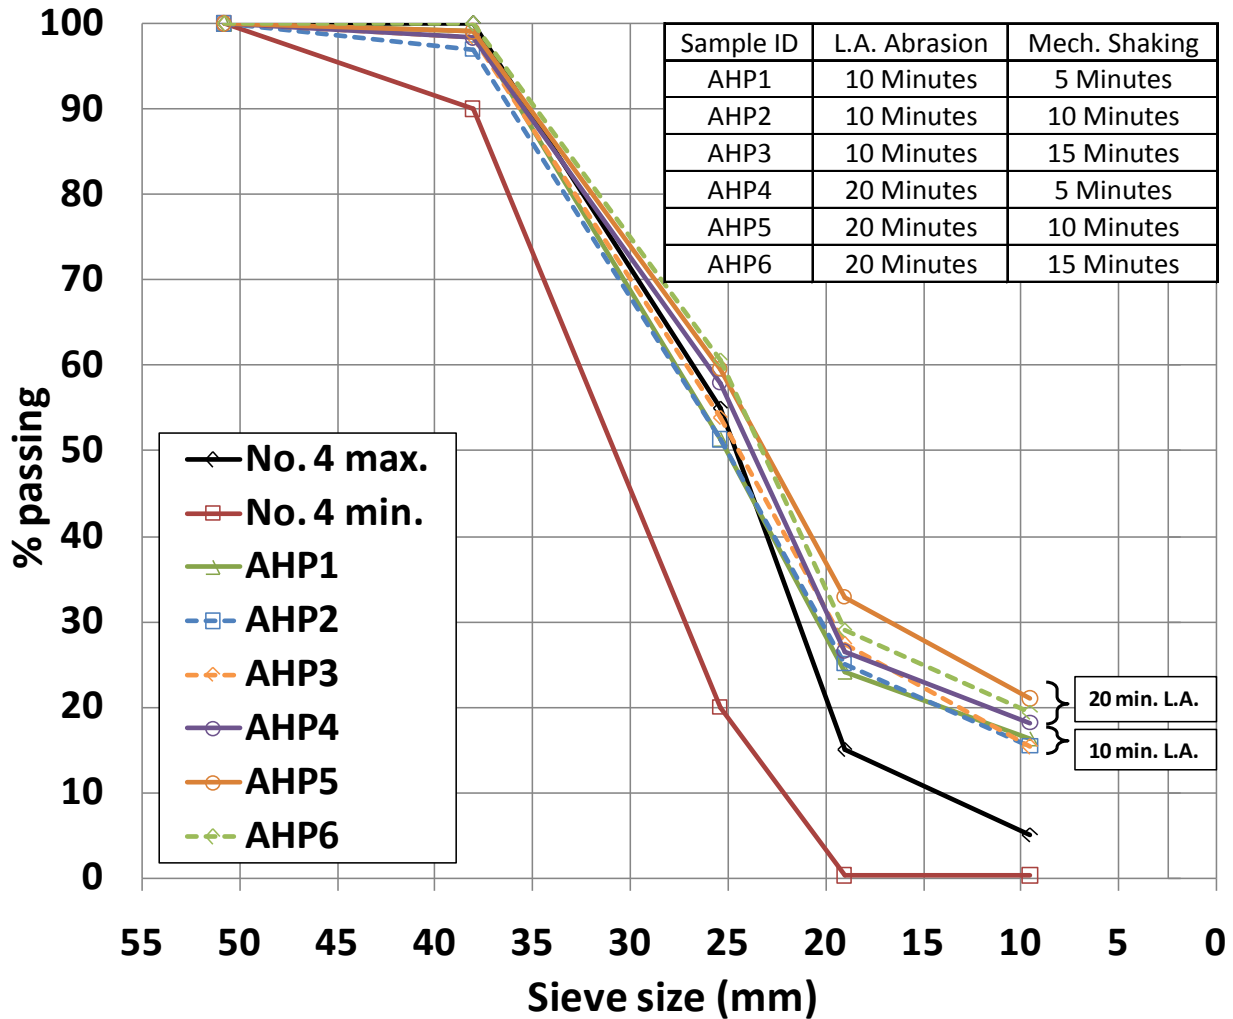
Figure 3.8: Final Gradations after Aggregate Handling Process Test

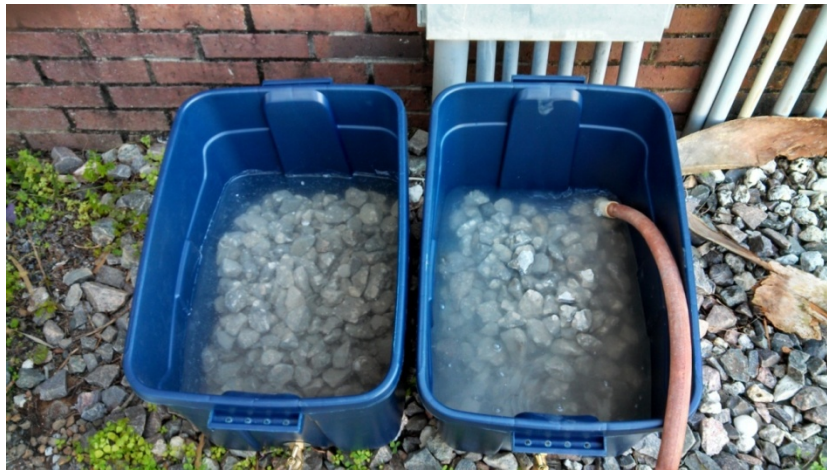
Figure 3.9: Aggregate Washing Setup

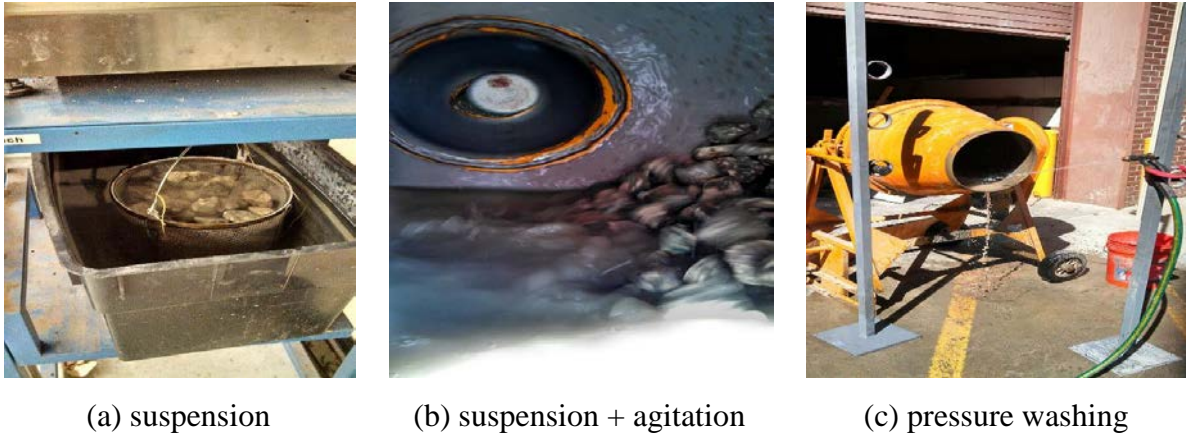
Figure 3.10: Testing Setup for Automated Aggregate Washing

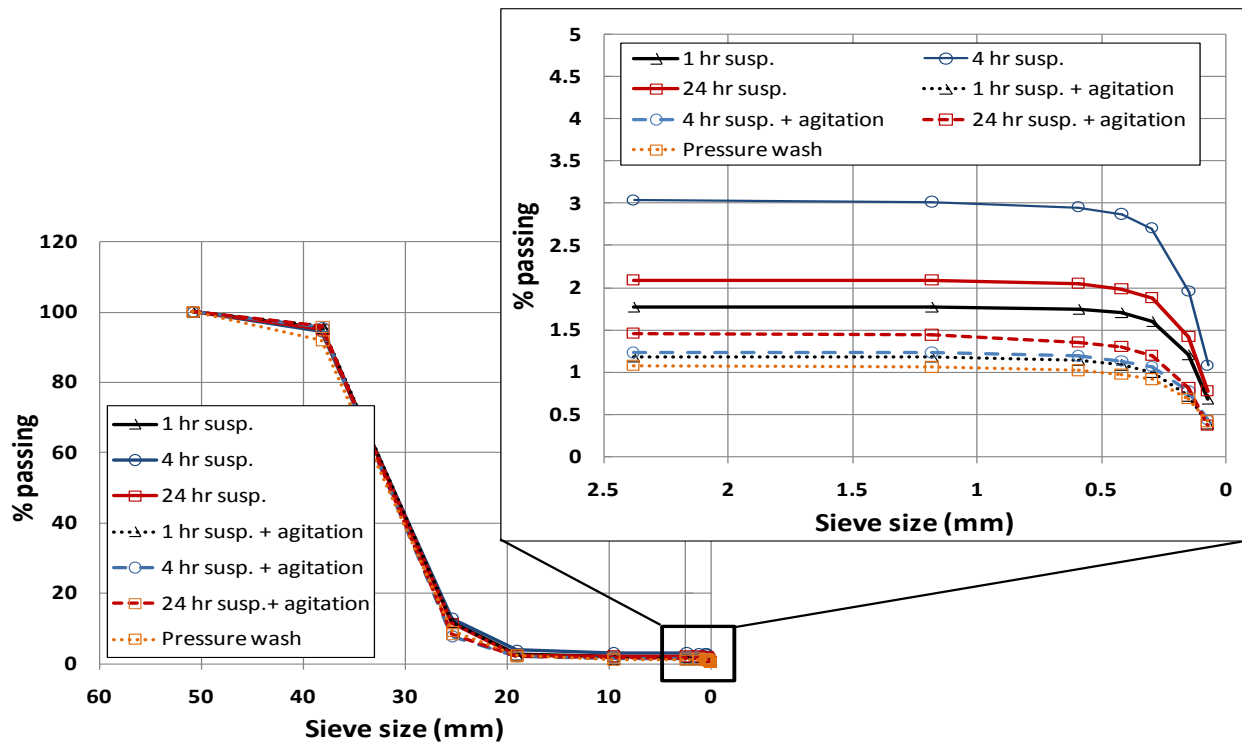
Figure 3.11: Results from Initial Aggregate Washing Test

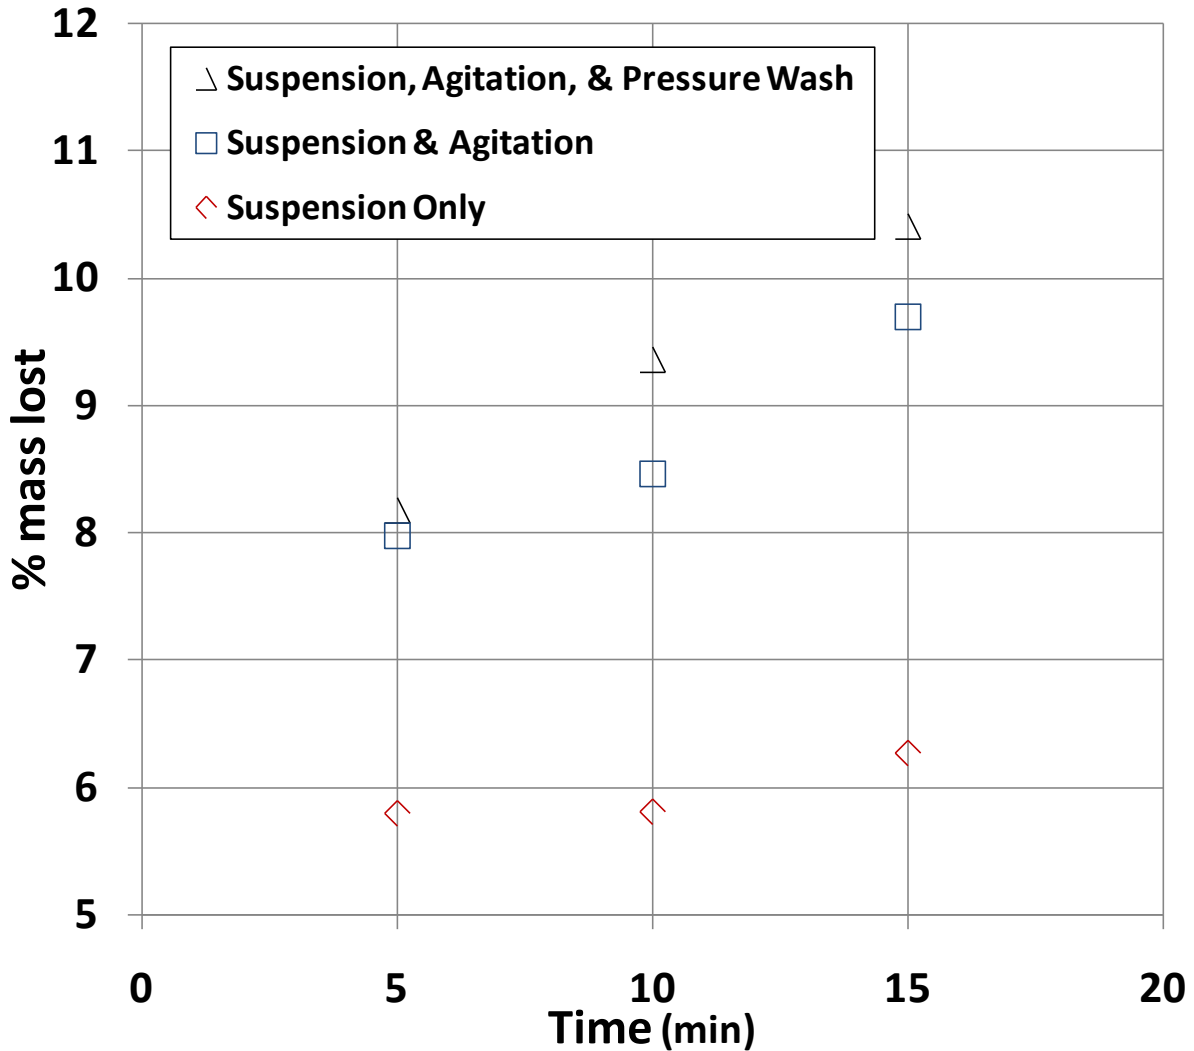
Figure 3.12: Results for Mixer Setup Aggregate Washing Test

The results for the mixer setup washing test are shown in Figure 3.12. A Similar trend appears such that the most effective method for fines removal is pressure washing, suspension + agitation, and suspension only, respectively. The results from this washing test are more conclusive since the entire process was automated, and the trend is as what would be expected.

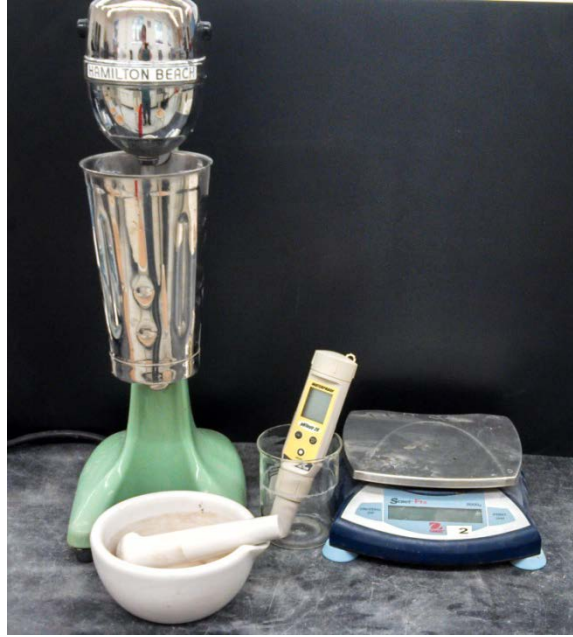
Figure 4.2: pH Testing Setup

The pH tests were conducted by reducing hardened sample segments to less than 75 μm and combined with an equal part of water. These samples were created by crushing and grinding the original samples until 30 g of material passing the No. 200 sieve was collected. The hardened cement was grinded by a mechanical grinder initially to a size of about 1/8 in. diameter size and then ground by hand using a mortar and pestle until particles passing the No. 200 sieve were obtained. The fine material was mixed for 2 minutes with 30 g of deionized water to achieve a 1 to 1 ratio of cement to water as described by the pH slurry method (ESDRED, 2005). The 1 to 1 ratio is necessary for the measurement of pH since the mixture should be of liquid consistency for an accurate reading with the pH meter. The pH meter used is an Oakton pHTestr 20 and the testing equipment is pictured in Figure 4.2.

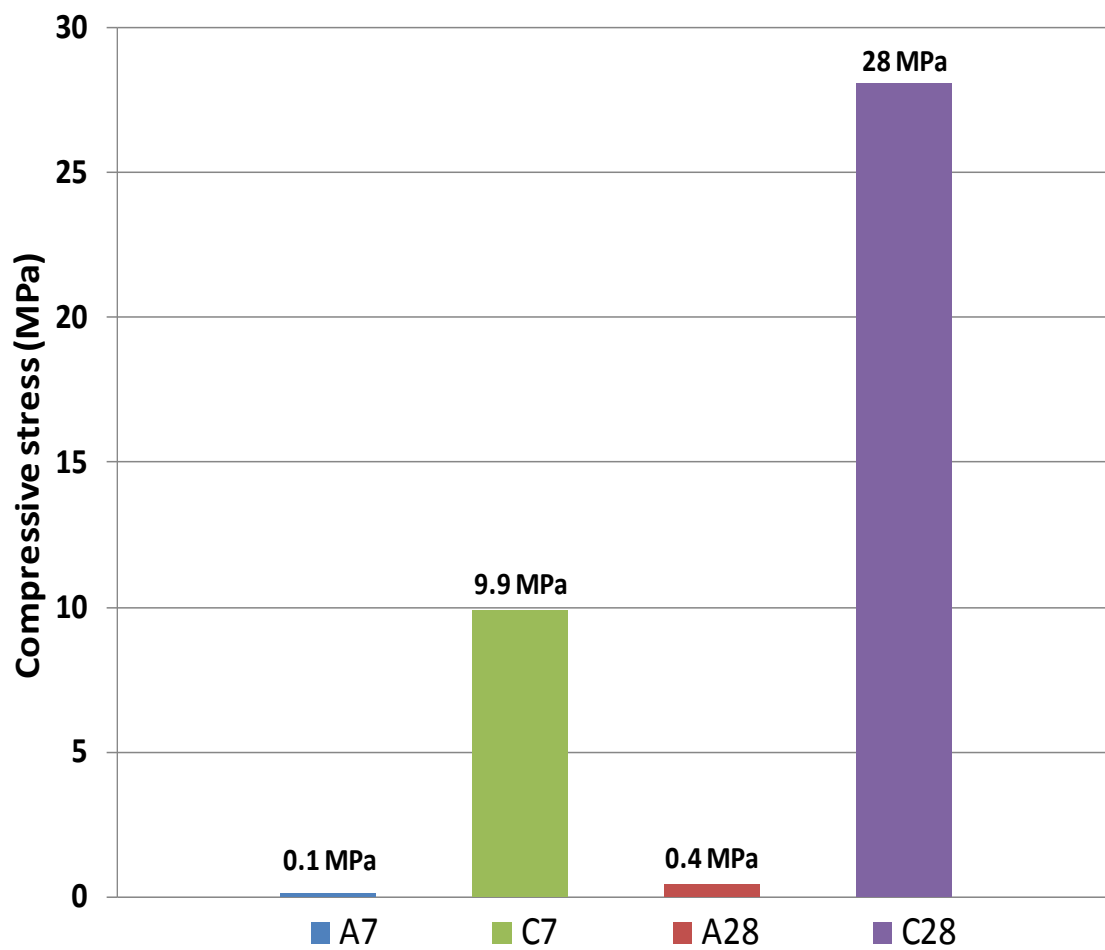
Figure 4.3: Compressive Strength Results for RCA (A7 and A28) and Virgin Cement (C7 and C28)

Compressive strength and pH testing has been conducted on RCA fines and virgin cement mixed with a water to cement ratio of 0.5. The results of the compressive strength tests are shown in Figure 4.3. The virgin cement samples (C7 and C28) increase in strength from about 10 MPa to 28 MPa, however the RCA samples (A7 and A28) resulted in considerably lower strengths at 0.1 and 0.4 MPa for 7 and 28 days respectively. It was observed that the RCA samples were very weak and must be handled carefully as the samples could be broken apart by hand or fall apart if submerged in water for several minutes. Clearly very little to no strength building has developed in RCA samples. The apparent strength of RCA is more likely due to cohesion after a decrease in water content (Dafalla, 2013). Comparatively, RCA possess only 1.6% the strength of virgin cement at 28 days. These results suggest that RCA does not tend to rehydrate under the presence of moisture. Photos of the failed specimens are shown in Figure 4.4. The fracture patterns for virgin cement exhibits type 3, columnar vertical cracking through both ends, with no well-formed cones, while the RCA sample appears to have bearing capacity failure which forms a cone shape shear failure surface (Das, 2006).

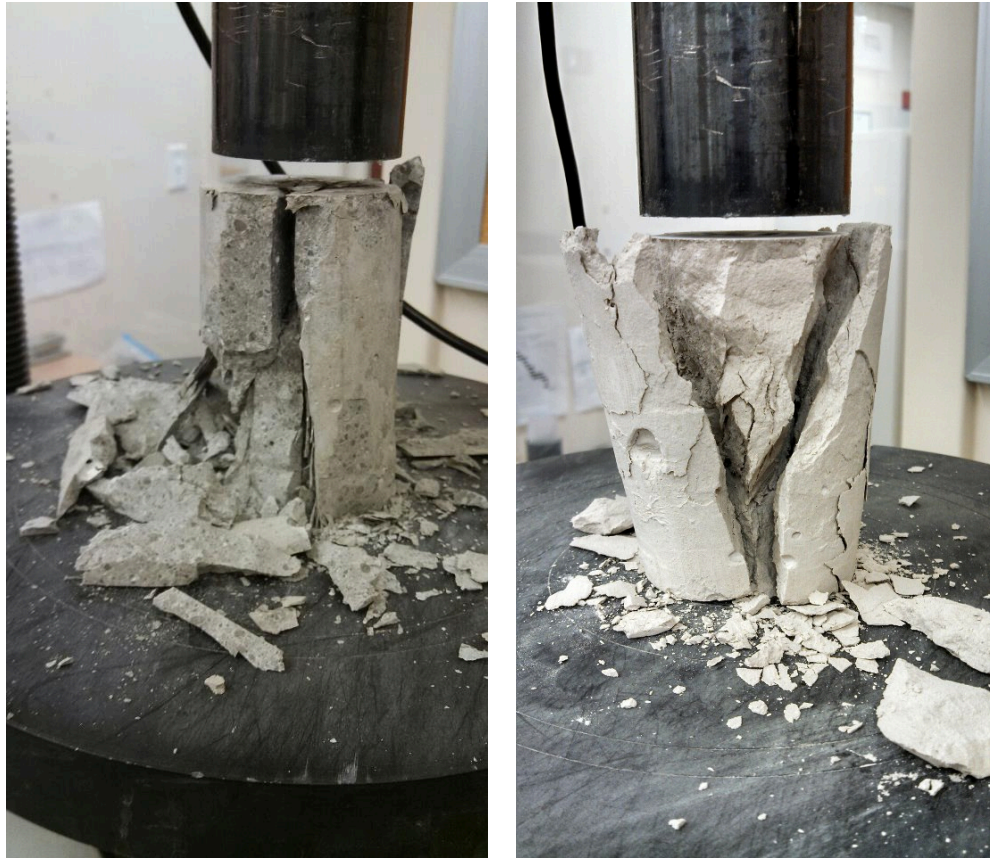
(a) virgin cement

Figure 4.4: Failure Shape of Cylinder Specimens

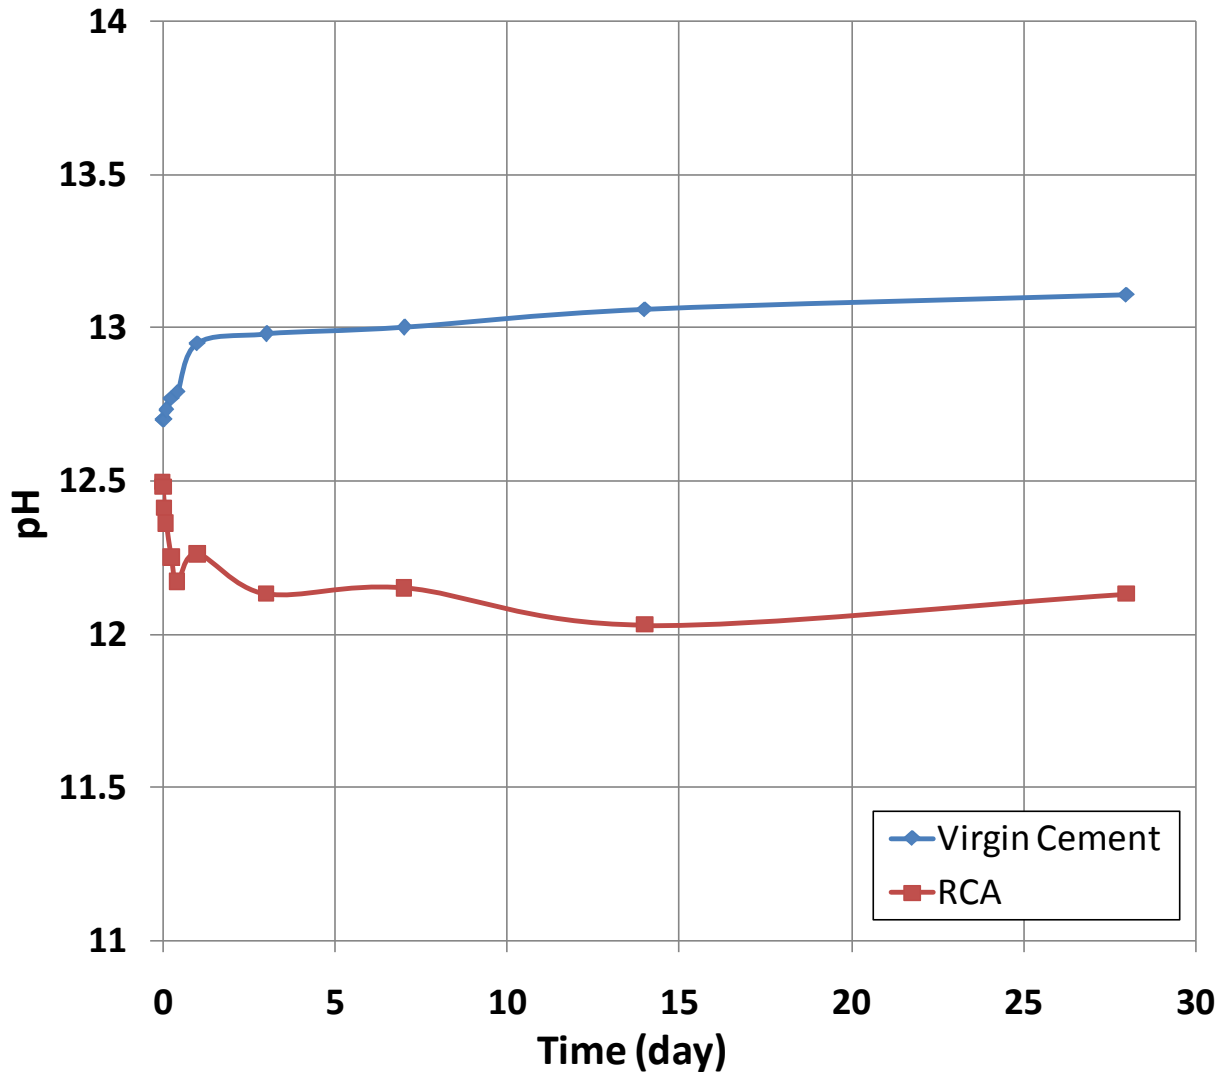
Figure 4.5: pH Testing Results for Virgin Cement and RCA

The results for the pH test are shown in Figure 4.5. Virgin cement had an initial pH of about 12.7 and increases steadily for the first 24 hours to about 13 and the rate of increase slows considerably and reaches a pH of 13.1 after 28 days. The initial increase of pH is likely due to the rapid dissolution of calcium, sodium and potassium hydroxides to produce an alkaline mixture. RCA samples had an initial pH of about 12.5 but quickly decreased to about 12.3 in the first 24 hours. After which the pH becomes relatively constant at about 12.1. The initially high pH is likely due to the already present dissolved calcium, sodium and potassium hydroxides, and with time the precipitation of calcium carbonate may be evidenced by the decrease in pH (Steffes, 1999).

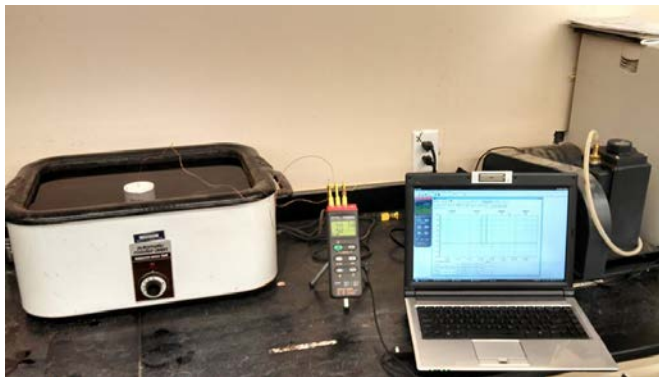
(a) test setup for heat of hydration

All the samples were prepared with water to cement ratio of 0.5 and mixed by hand for 2 minutes. The samples were prepared and tested one at a time. The sample molds were cylinder size (D x L) 4 in. x 6 in. however it is necessary to insulate the samples throughout the hydration stages. Therefore a 2 in. thick Styrofoam capping was used. The thickness of the Styrofoam capping limits the sample heights as seen in Table 4.2. The molds were also placed in a water bath for additional insulation. Insulating the samples will ensure that if any heat generation occurs that the heat will stay within the sample for long enough for the detection by the thermocouple. A thermocouple probe was placed in the centroid of each sample, while another probe was placed in the water bath and a third probe recorded the air temperature in the testing room. The testing setup for this experiment is shown in Figure 4.6. After each mixture was prepared and poured into the mold, the Styrofoam capping with the mounted thermocouple probe (see Figure 4.6 (b)) was immediately placed into the top of the mold and the mold was then placed into the water bath. The thermocouple software began recording and took measurements every 15 seconds for 24 hours.

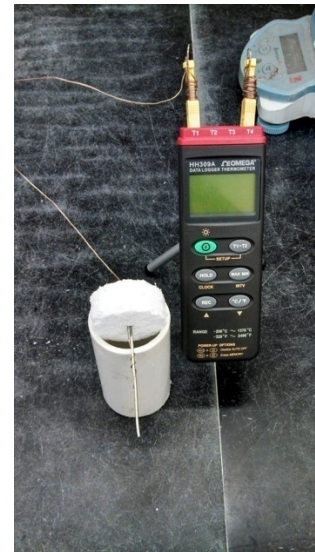
(b) probe placement in specimen

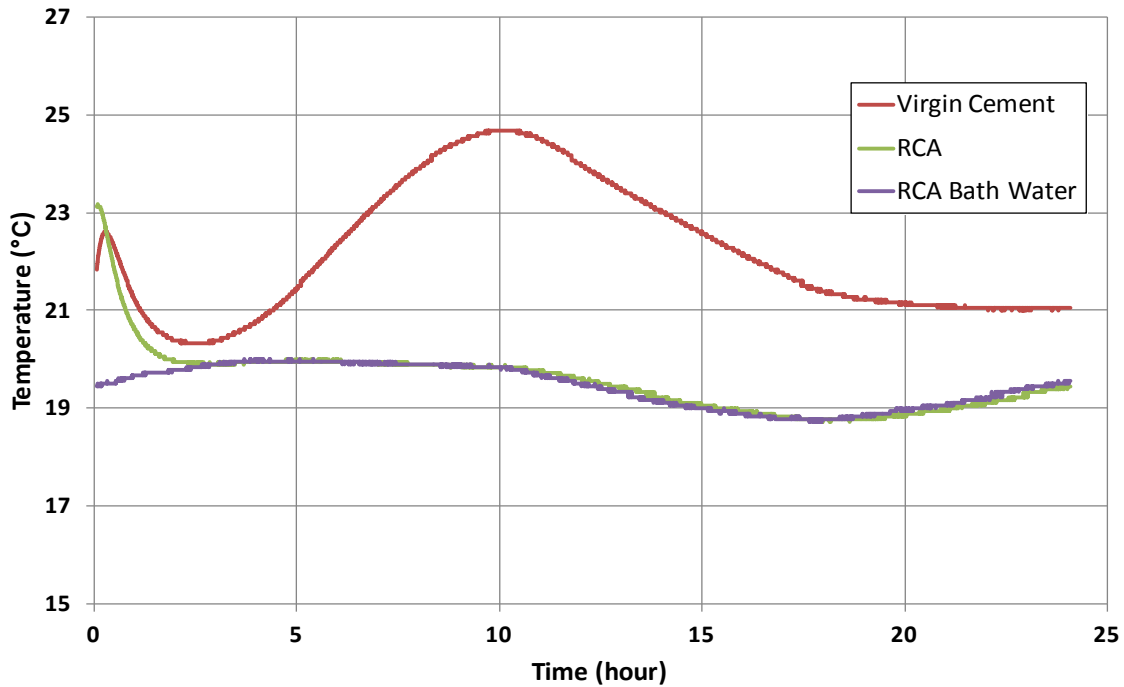
Figure 4.7: Measured Temperature of RCA and Virgin Cement Paste

heat generation occurs. The temperature variations for virgin cement hydration are well established (Mindess, 2003) and the different stages are clearly seen in Figure 4.7. However, the temperature variations of RCA are defined by the temperature of the environment, and no internal heat generation can be observed. The initial temperature of RCA is from the temperature of the mix water, after mixing the temperature steadily decreases and comes to equilibrium with the surround bath water, as shown in the Figure 4.7.

Any increase in temperature of RCA that is observed is due to the temperature of the bath water which may vary throughout the 24 sampling period from the climate controls within the laboratory. The actual data measured was temperature and not heat. This test differs from ASTM C186 for the heat of hydration of hydraulic cement. Where the ASTM C186 utilizes a calorimeter to measure directly the heat generation, this test setup uses a thermocouple to measure the temperature as an indication of the heat generation. Since the purpose of this test is not to report the heat of hydration but to compare the heat generation by hydration between virgin cement and RCA fines, this test is suitable for determining the rehydration potential of RCA.

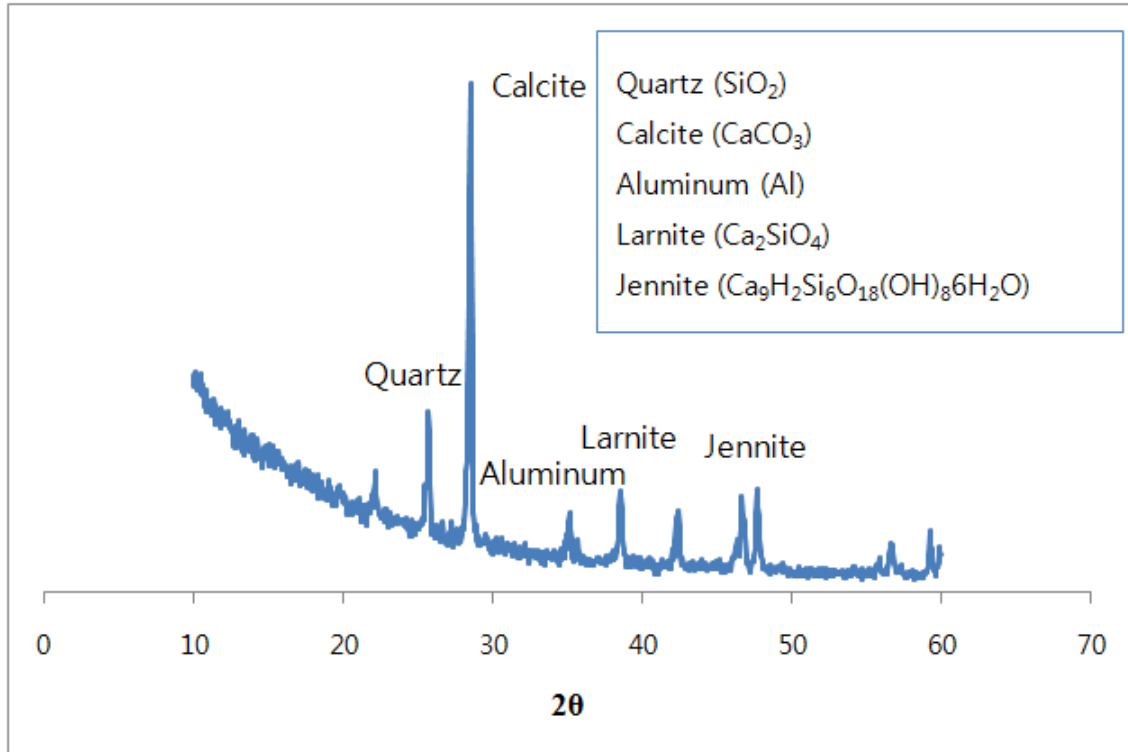
Figure 4.9: XRD Spectrum of RCA Fines
