Final Report

Evaluate the Use of Reclaimed Concrete Aggregate in French Drain Applications

FDOT Contract No.: BDK 78 TWO 977-12

Department of Civil, Environmental, and Construction Engineering
University of Central Florida
4000 Central Florida Blvd.
Orlando, FL 32816-2450

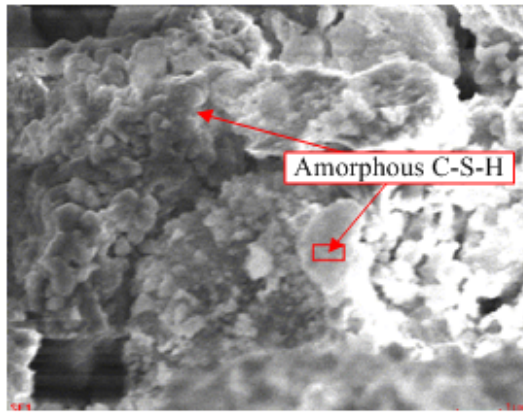
Element	Weight %	Atomic %
C	26.18	37.95
O	41.61	45.27
Al	3.15	2.03
Si	11.46	7.10
Ca	17.60	7.64
Total	100.00	99.99

(a) Amorphous region of C-S-H and its chemical compositions (Ca/Si ratio = 1.07)

The microscopic morphology and corresponding chemical compositions of the RCA paste obtained from SEM and EDX are shown in Figure 4.10. The EDX data presented in the Figure are sourced from the locations selected in the SEM images (either red spot or rectangular box). A large number of pores are clearly observed from all SEM images, which may lead to intrinsic characteristics of high water absorption and low density of RCA paste. Similar to the previous EDX results from the RCA fines, the major elements present within RCA paste are Ca, Si, and Al, but with different ratios. Calculated Ca/Si ratios based on chemical compositions are also presented along with each SEM image. The Ca/Si ratio is directly related to the lime (CaO) concentration (Bergaya, 2011) and therefore, Ca/Si ratio is one of the main factors that

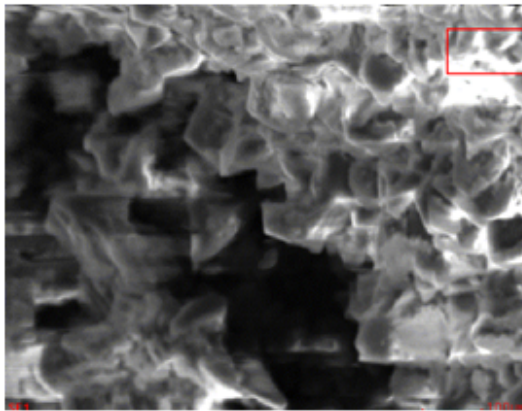
Element	Weight %	Atomic %
C	23.17	33.93
O	44.44	48.86
Al	8.58	5.59
Si	6.16	3.86
Ca	17.65	7.75
Total	100.00	99.99

(b) Jennite and its chemical compositions (Ca/Si ratio = 2.01)

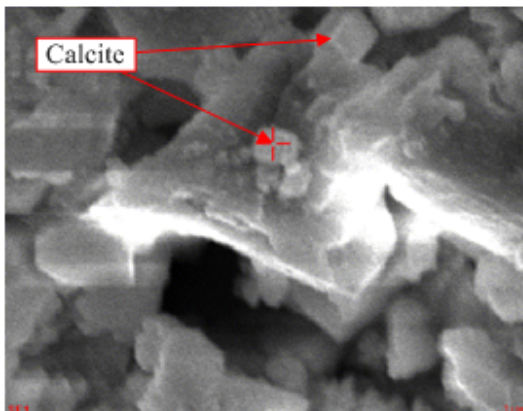
Element	Weight %	Atomic %
C	18.13	32.51
O	27.44	36.95
Al	2.37	1.89
Si	2.90	2.22
Ca	49.16	26.42
Total	100.00	99.99

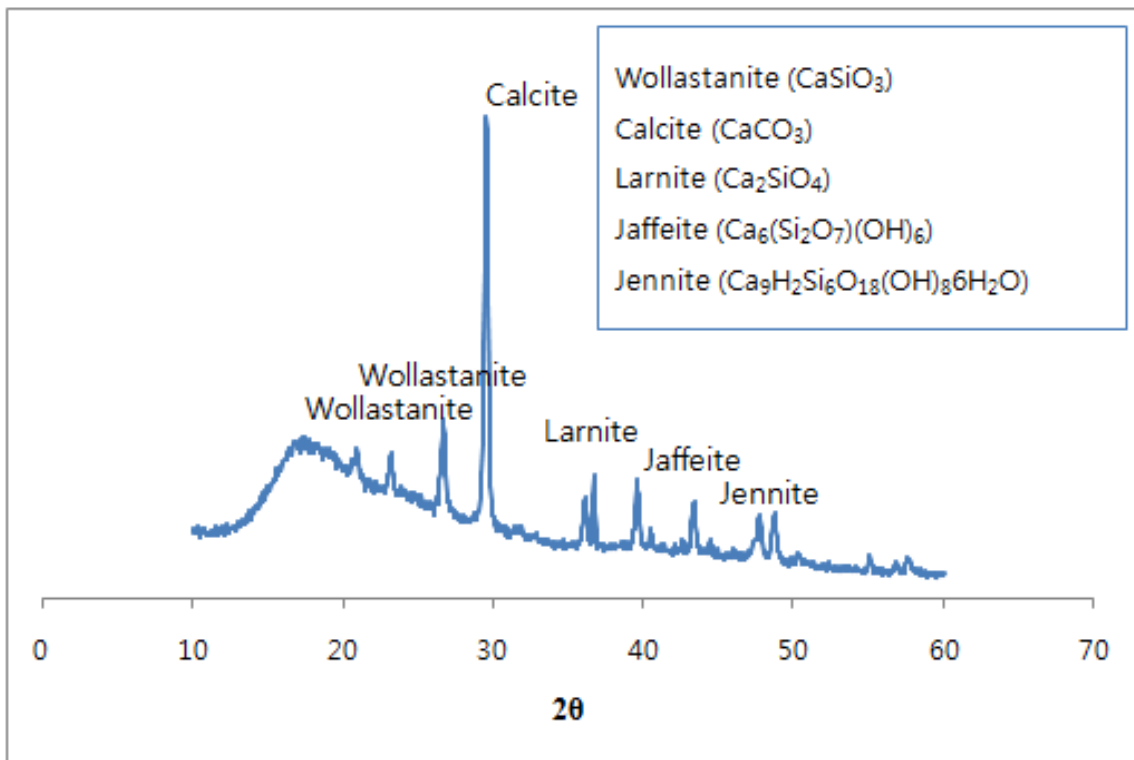
Figure 4.11: XRD Spectrum of RCA Paste

The XRD spectrum shown in Figure 4.11 indicates that the main components of RCA paste are calcite (CaCO_3) and Wollastonite (CaSiO_3), which agrees with the SEM and EDX analyses presented in Figure 4.10. It is important to note that no peaks of Portlandite ($\text{Ca}(\text{OH})_2$), byproduct of hydration, were detected from this analysis, which indicate that there is little probability of re-cementation or pozzolanic reaction within the RCA paste.

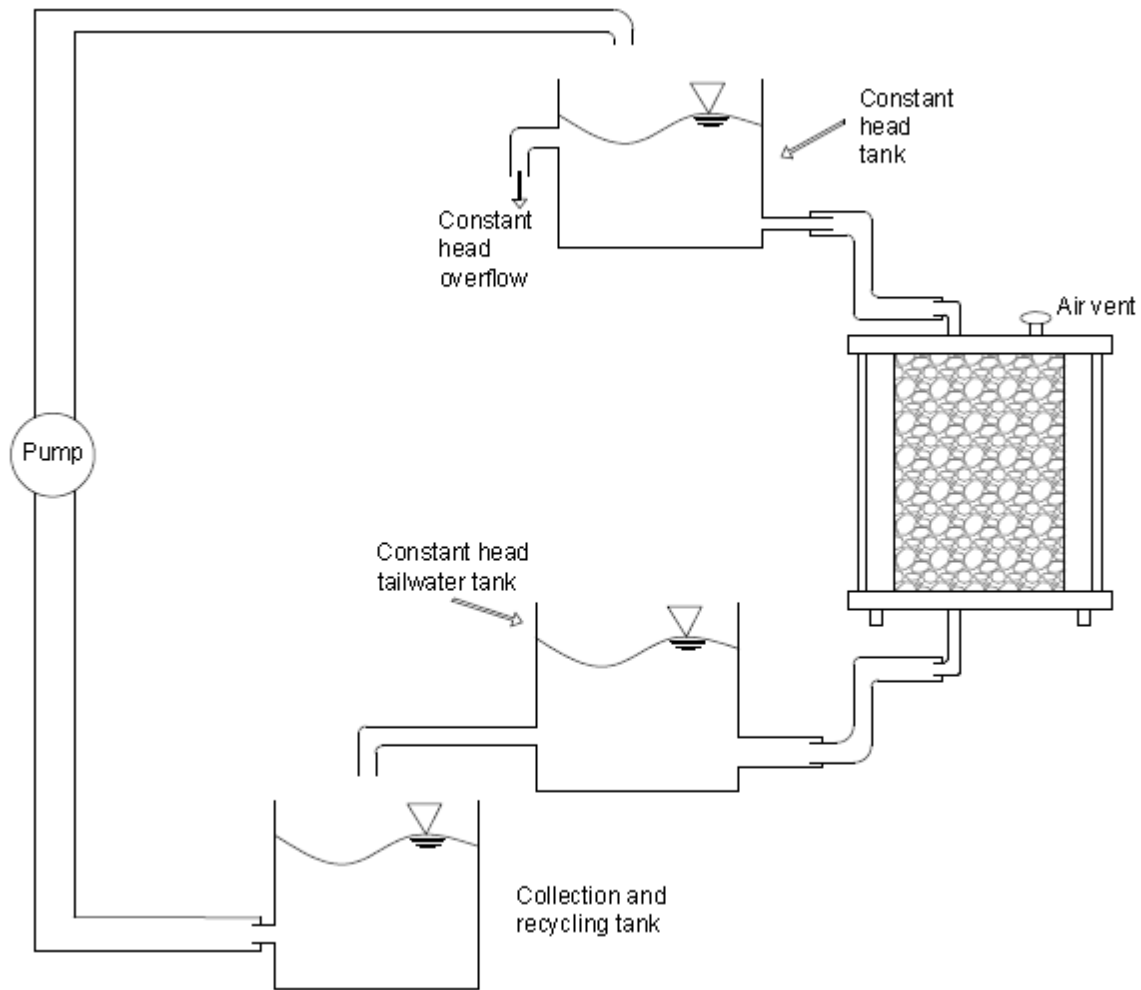
Figure 5.1: Constant Head Test Schematic

Permeability testing was conducted by means of the constant head permeability test (ASTM D2434). The testing setup consists of a permeameter, a constant head tank, a constant head tailwater tank and the testing specimen. The test setup used in this study is shown in Figure 5.1. Since the large voids in RCA No. 4 aggregate allow for much faster flows than say a more traditional soil specimen such as sand or clay, the falling-head permeability test setup should be avoided. As a result of high flow rates, it is necessary to collect and recycle the water. In addition, the permeability setup was designed to better simulate a continuous source of fines from surrounding soils in the field; thus, water flow through the RCA No.4 aggregate was re-circulated.

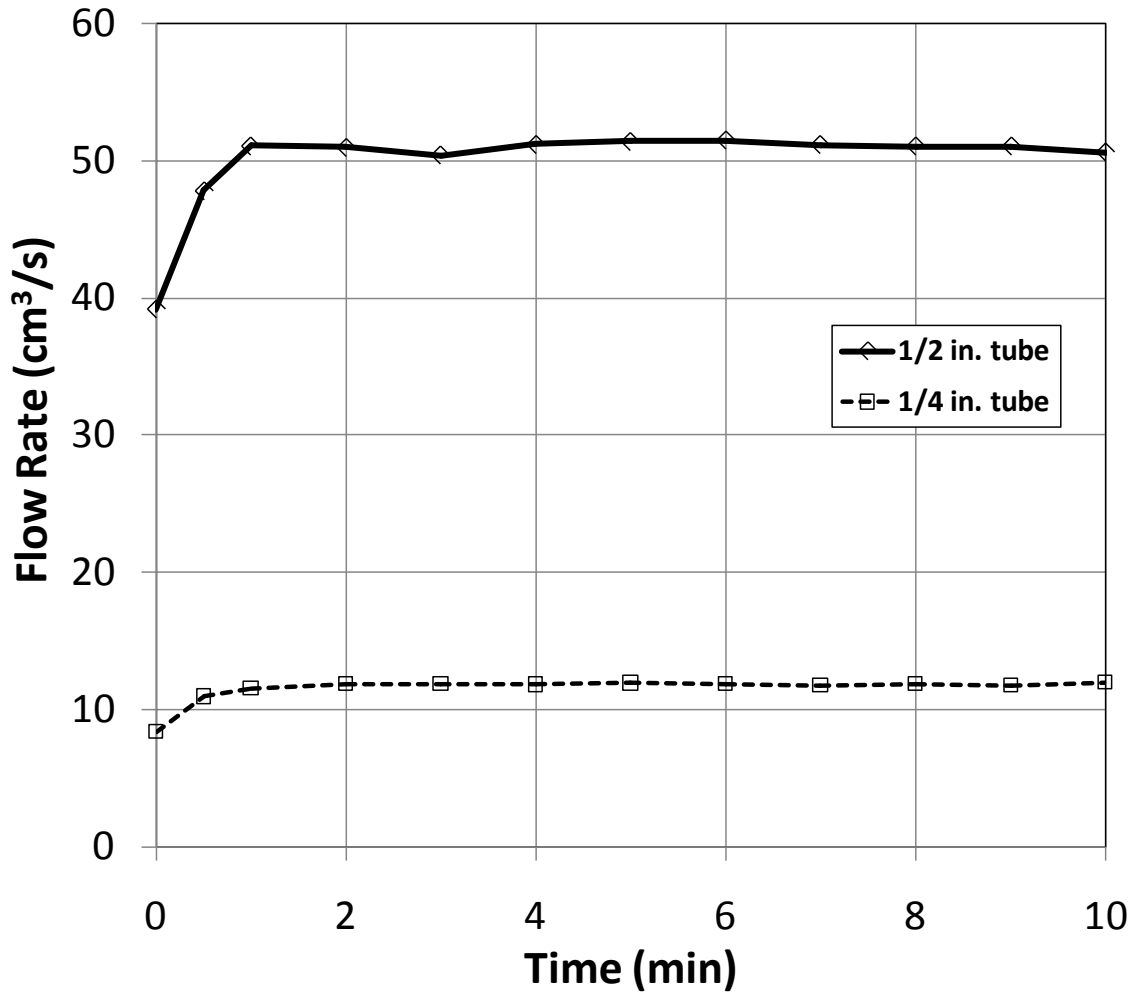
Figure 5.2: Time to Stability Using 9 in. Permeameter and No. 4 Average Gradation

observed that the system adjusts fairly quickly when changing from one head to another, by two minutes, the hydraulic system had completely stabilized, therefore during testing, two minutes are allowed from the time of changing the head to the time of taking a reading. The time to steady state flow results are shown in Figure 5.2.

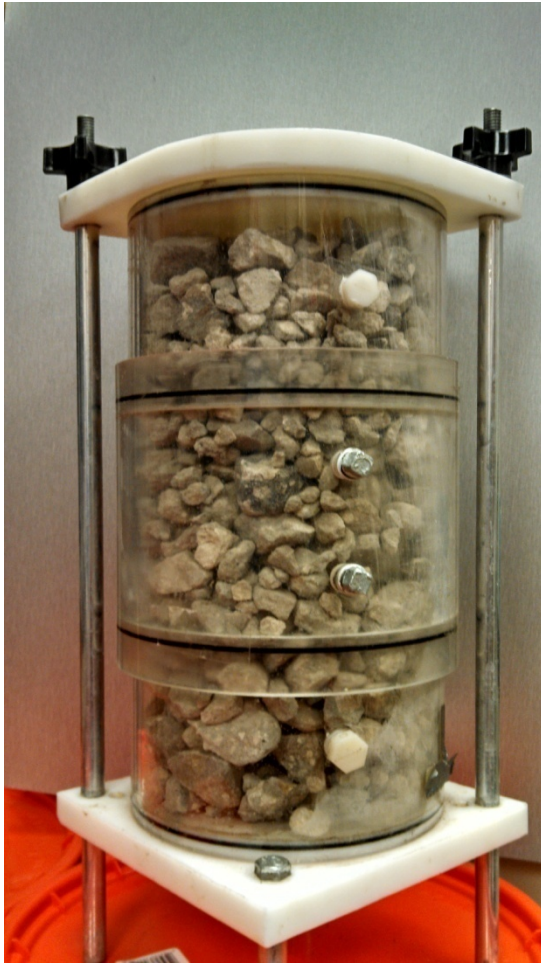
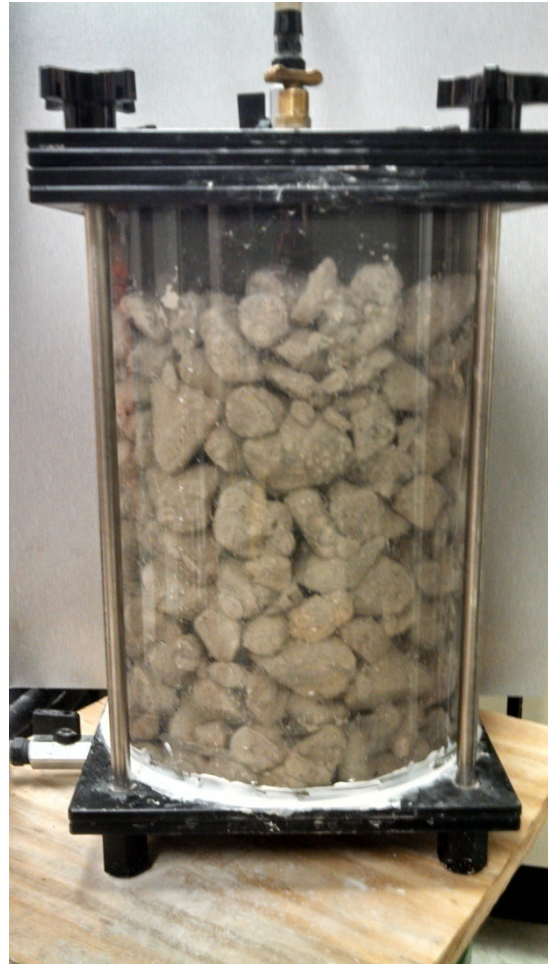
(a) 6-in. permeameter

(b) 9-in. permeameter

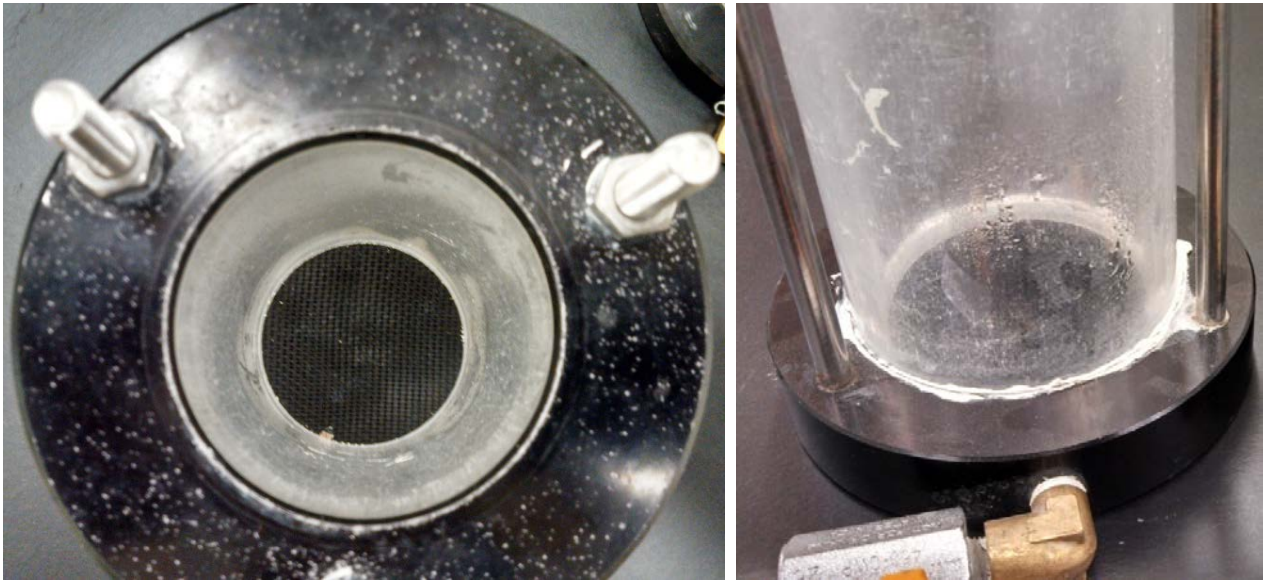
(a) top

Figure 5.4: Geotextile Placement in Permeameter

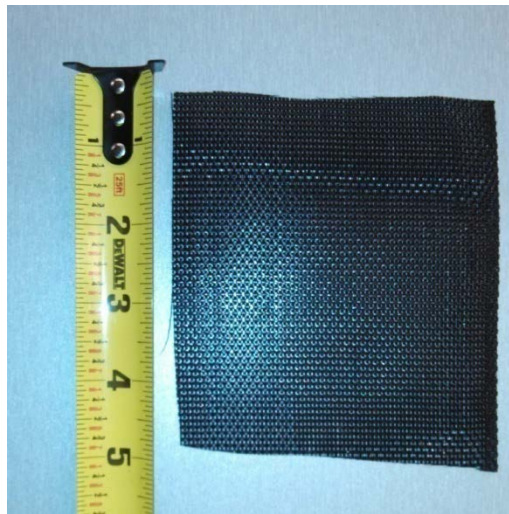
Figure 5.5: Photograph of Geotextile

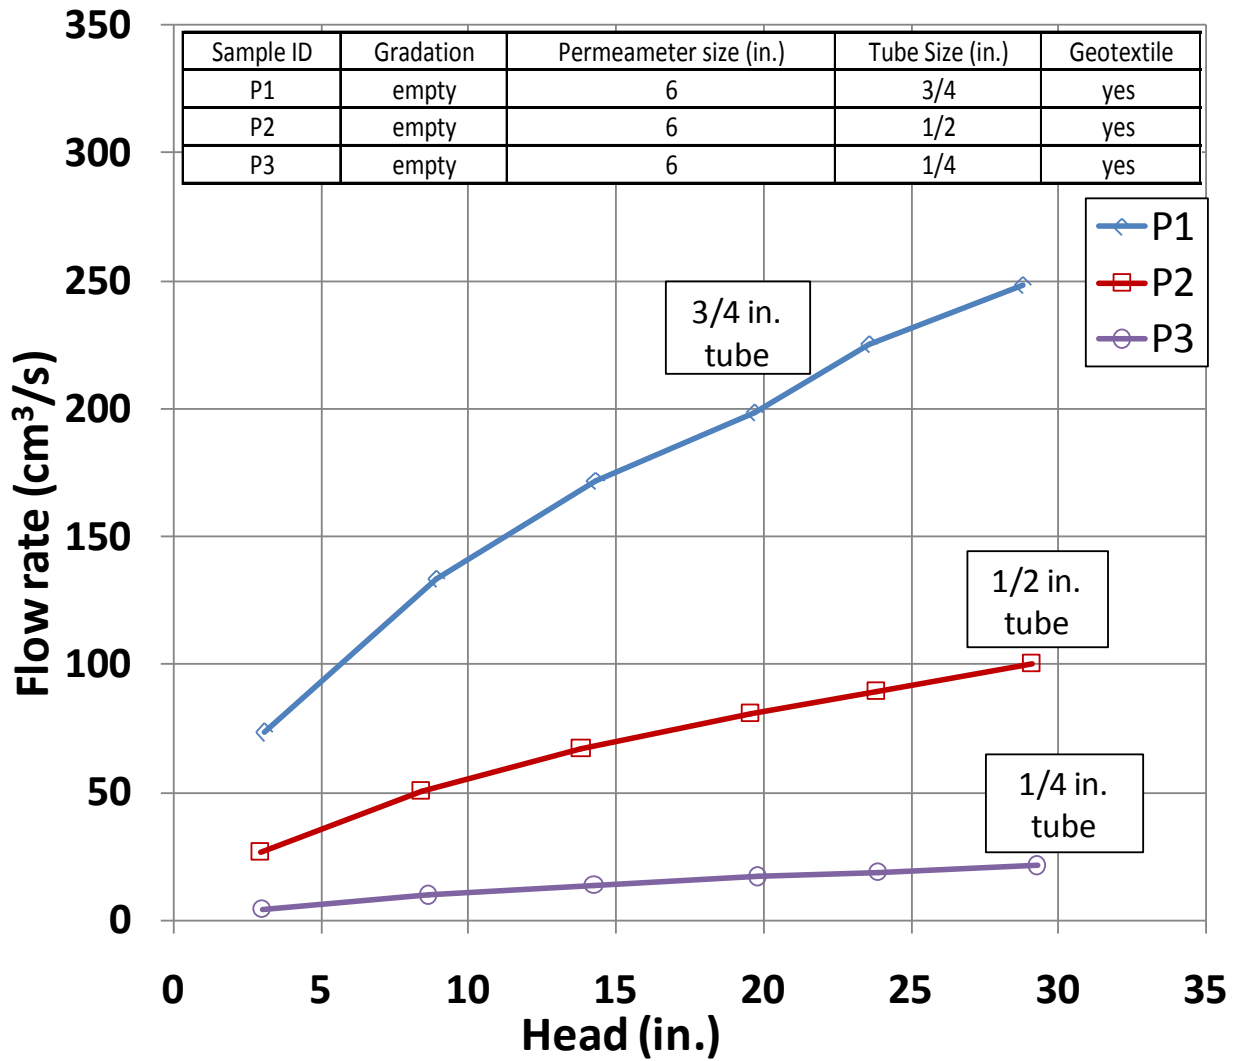
Figure 5.6: Influence of Tube Size on Flow Rate with 6-in. Permeameter

With the 1/4-in. tube, the flow rate is proportionally increased with head increase. To accommodate more materials of the RCA No. 4 aggregates, larger sizes of permeameter would be more desirable. Thus, considering the effects of sizes of permeameter and tube, the researchers concluded that using a 9-in. diameter permeameter and 1/4-in. diameter tube is an optimum design of permeability testing system.

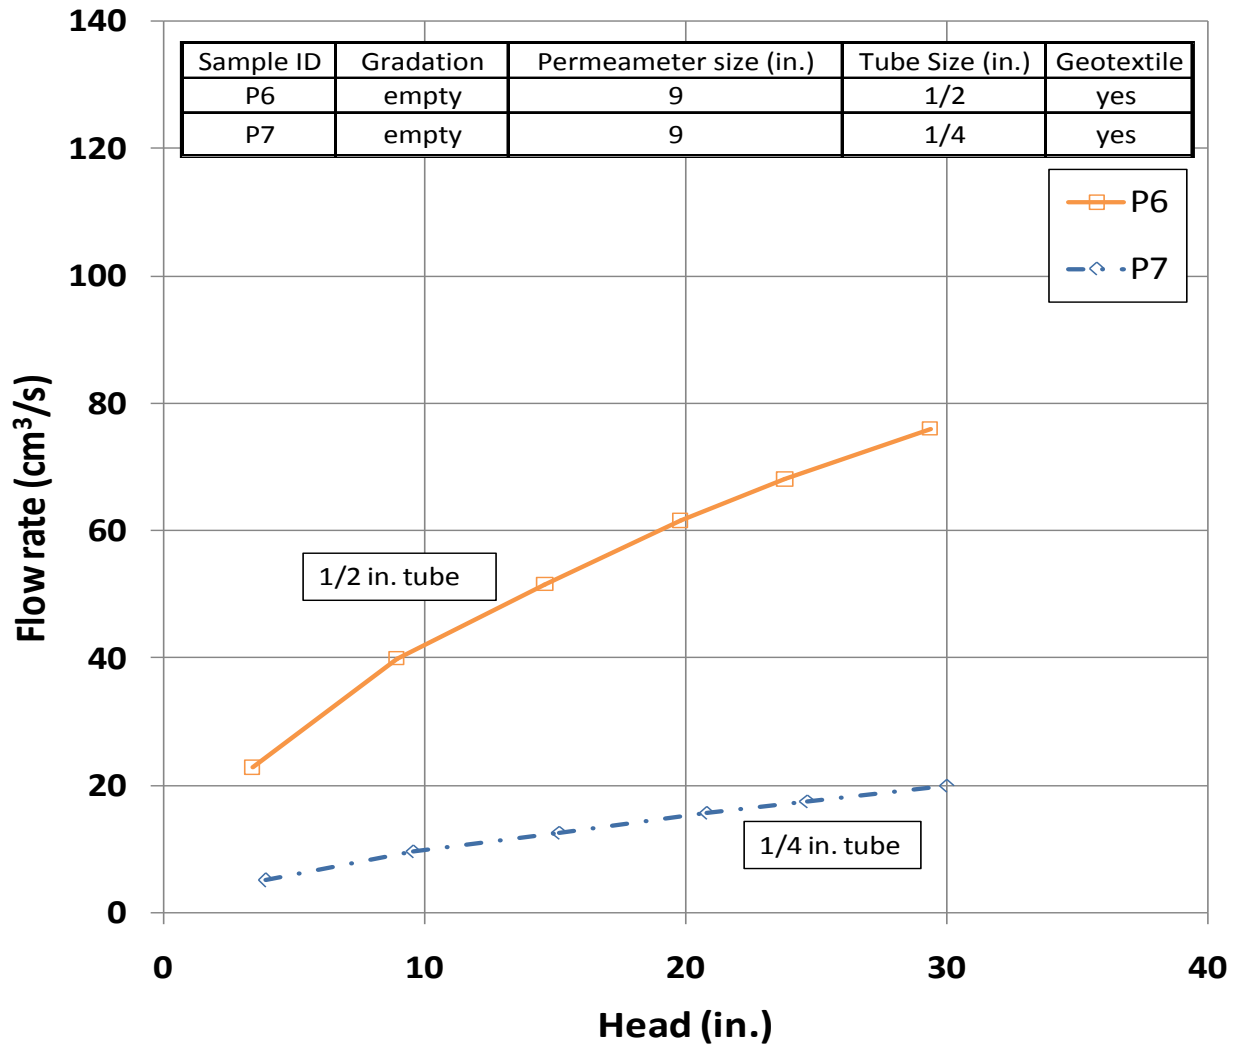
Figure 5.7: Influence of Tube Size on Flow Rate with 9-in. Permeameter

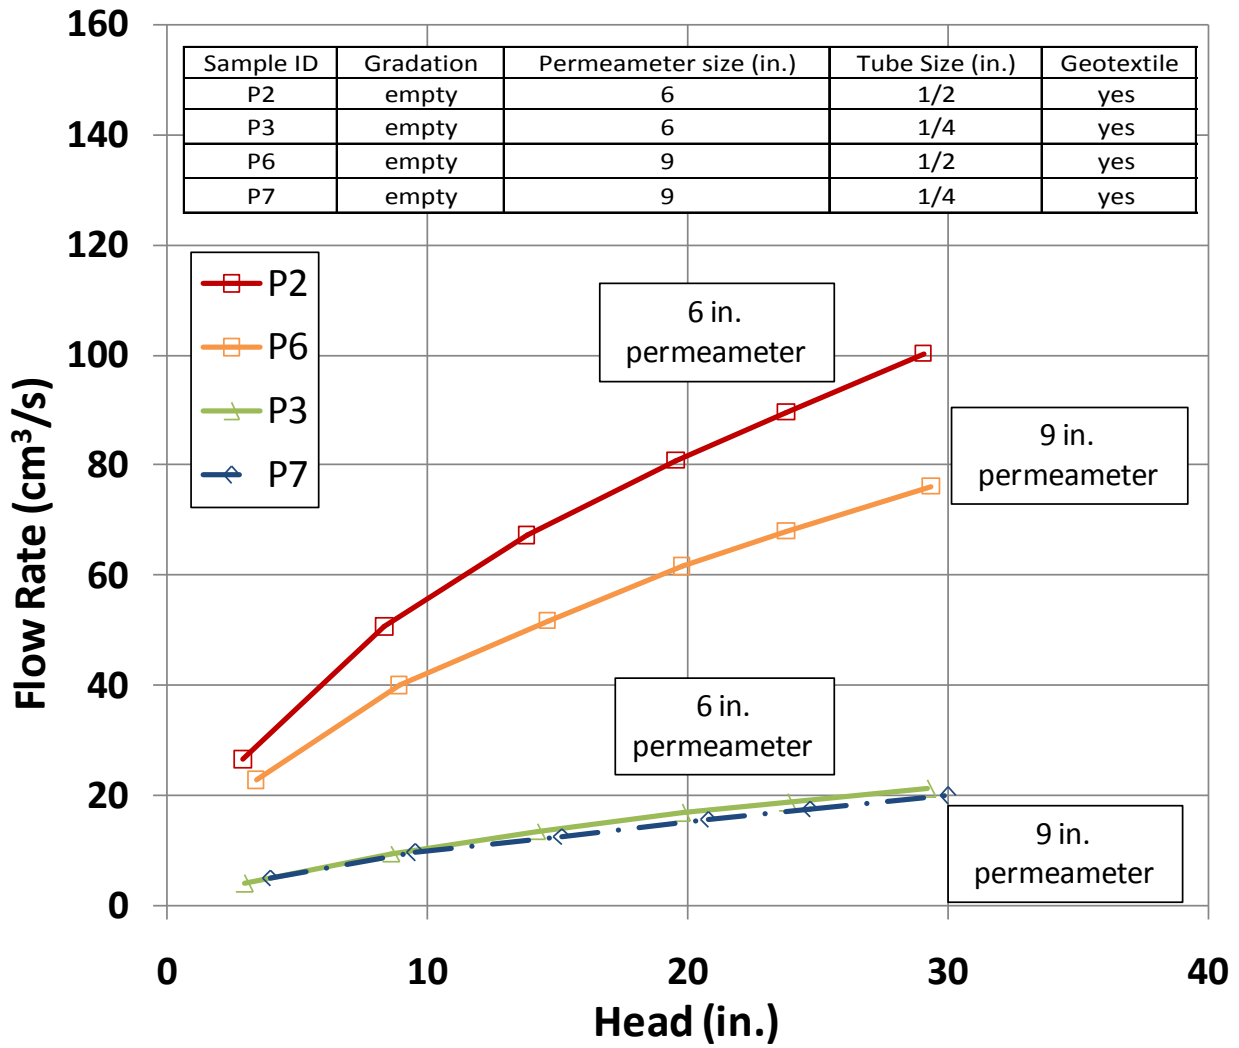
Figure 5.8: Effect of Permeameter Size with 1/2- and 1/4-in. Tube on Flow Rate

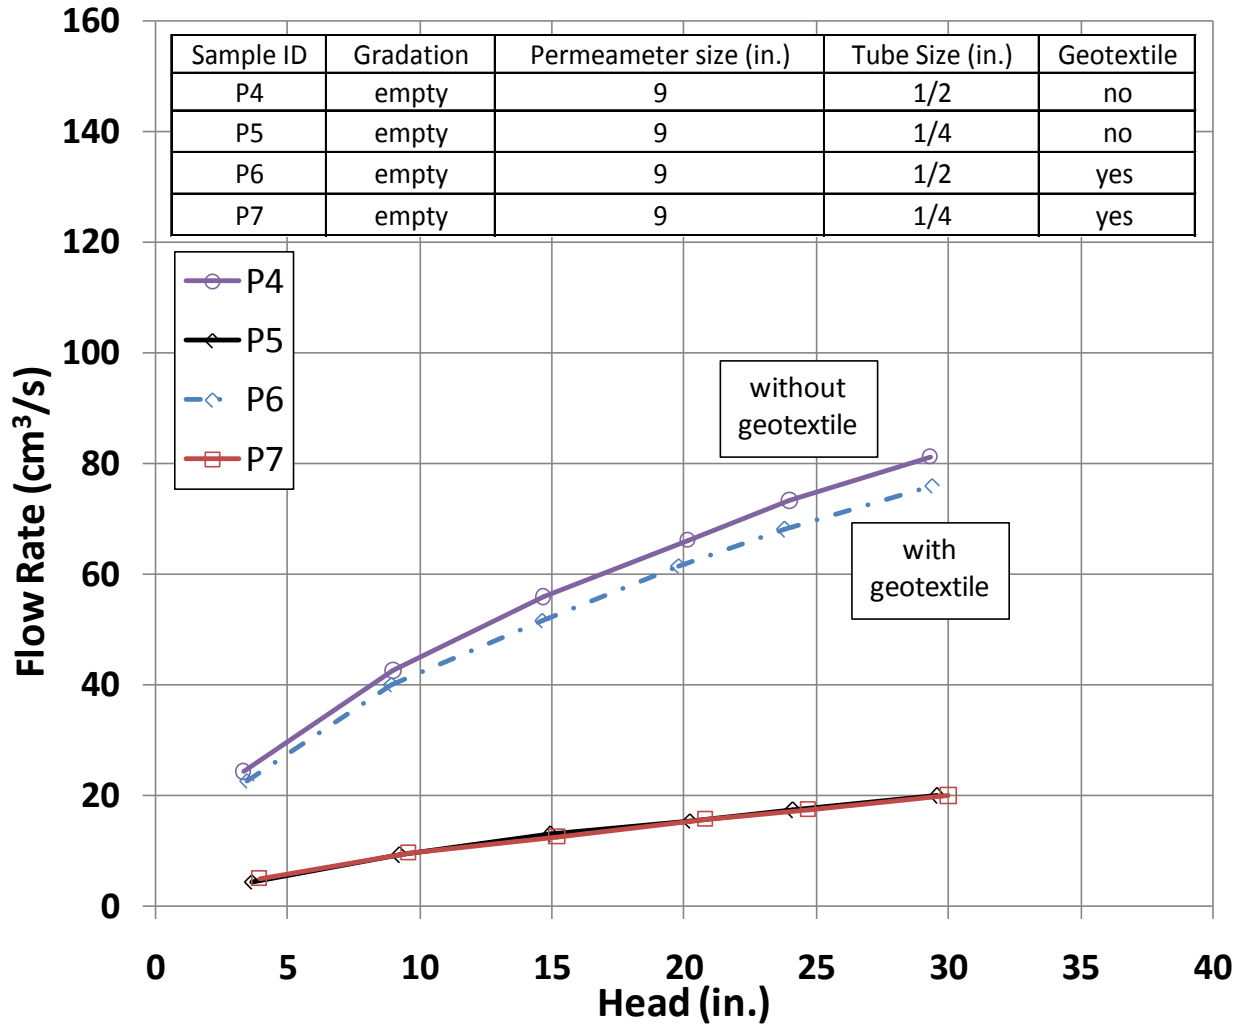
Figure 5.9: Effect of Addition of Geotextile with 1/2- and 1/4-in. Tube Sizes on Flow Rate

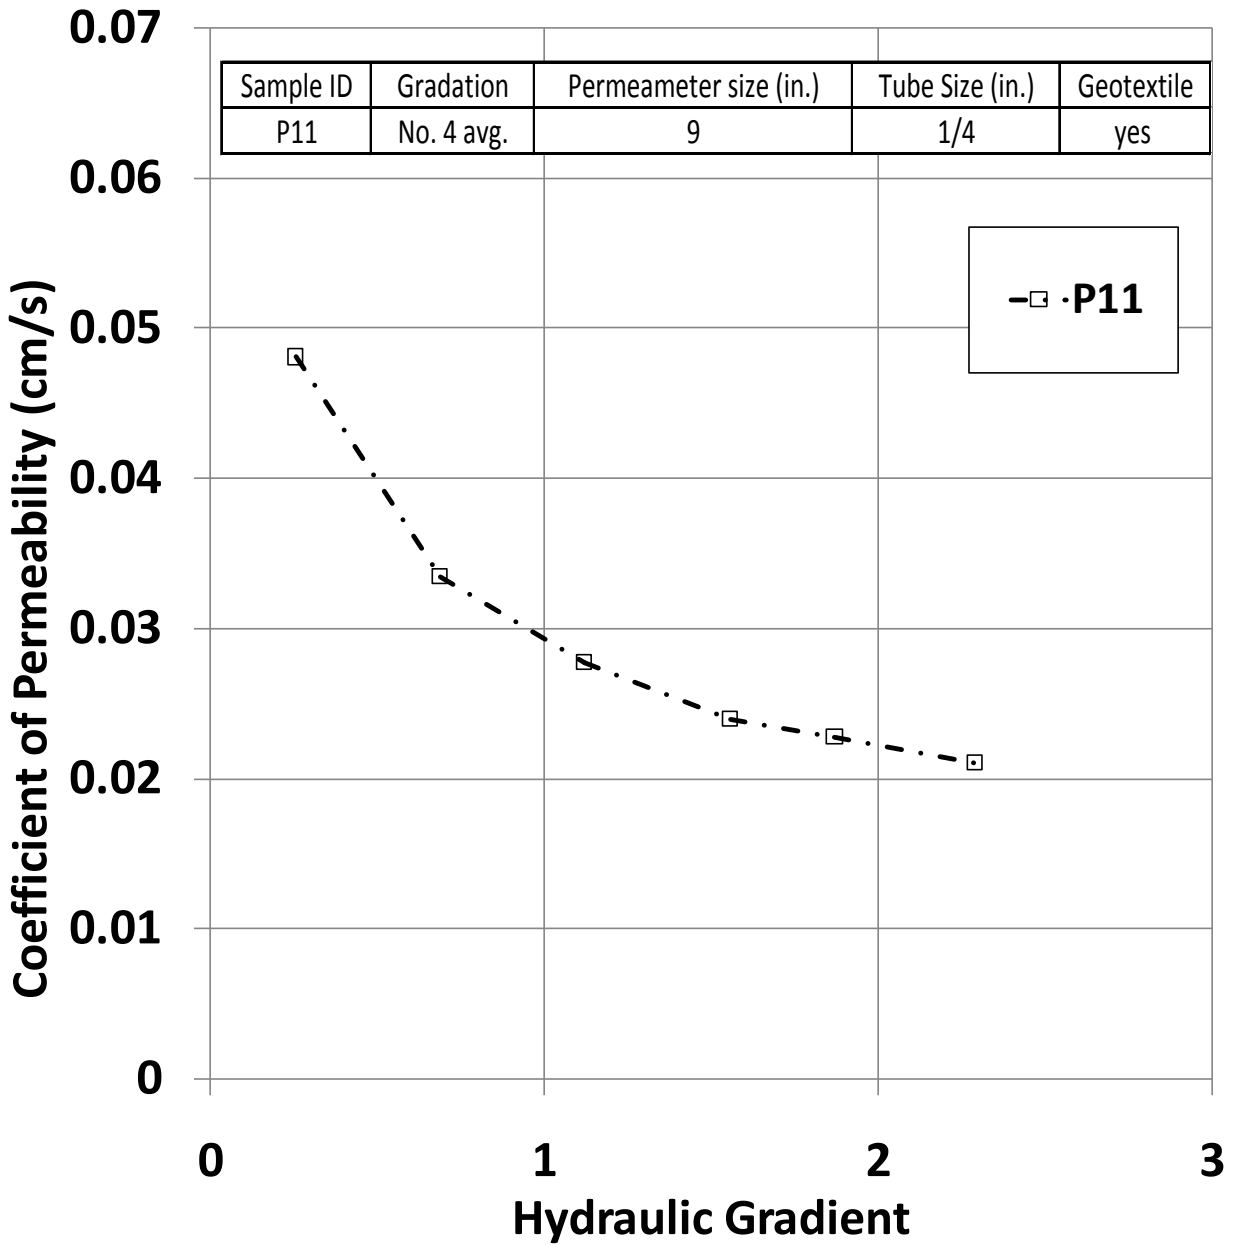
Figure 5.10: Results Plotted as Coefficient of Permeability vs. Hydraulic Gradient

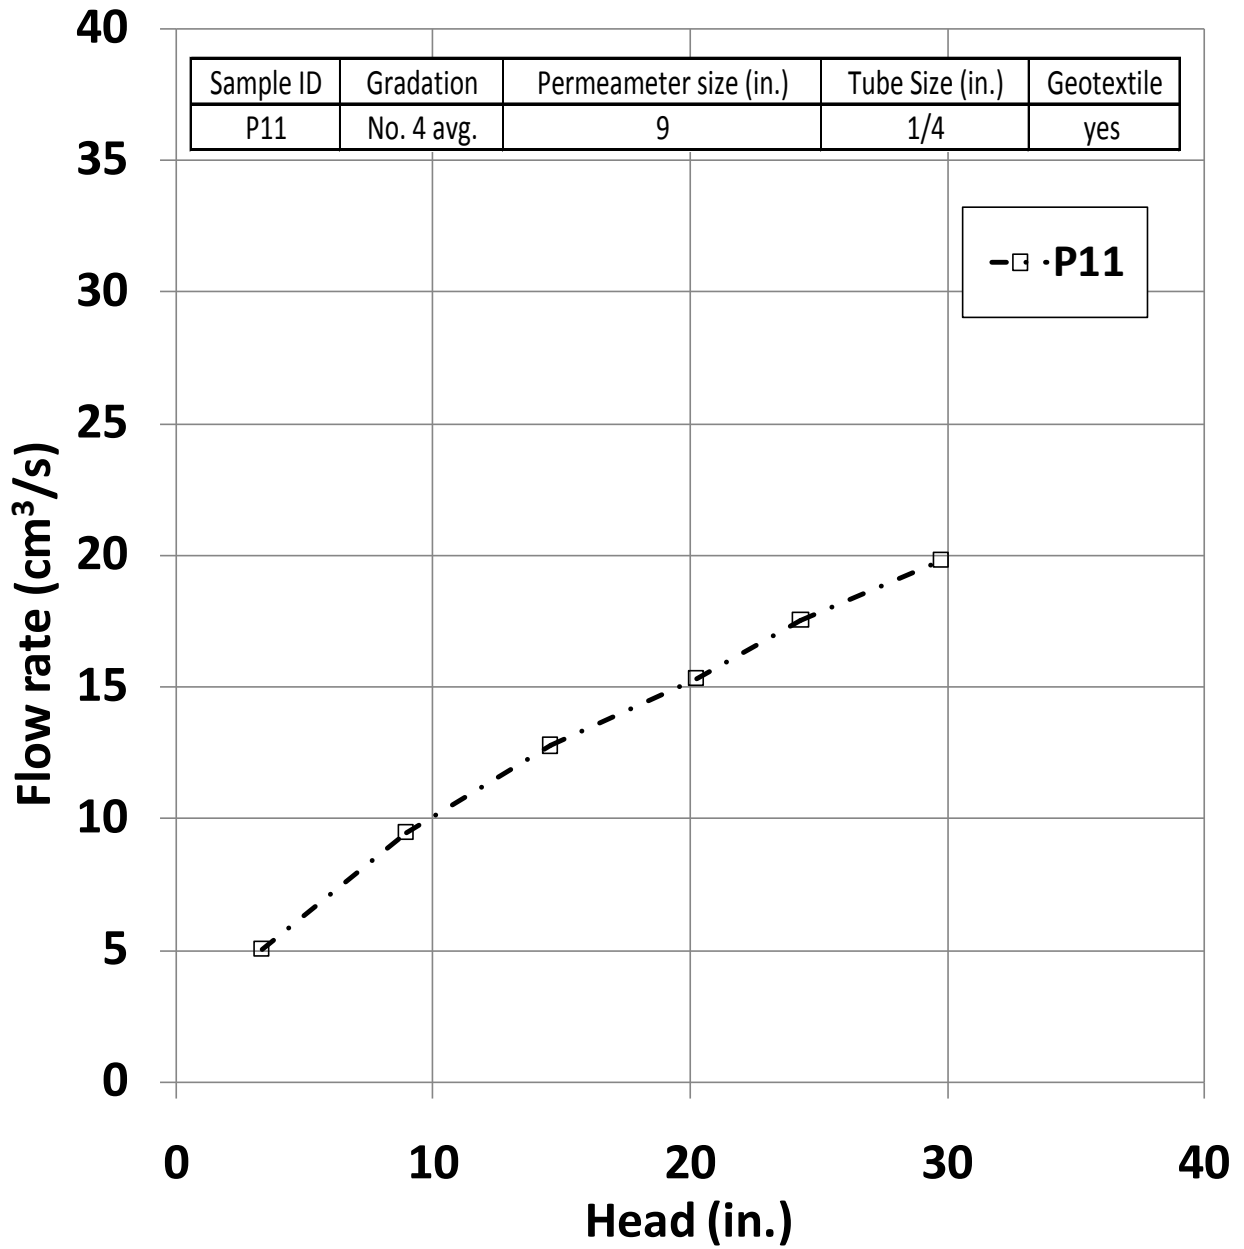
Figure 5.11: Results Plotted as Flow Rate vs. Head

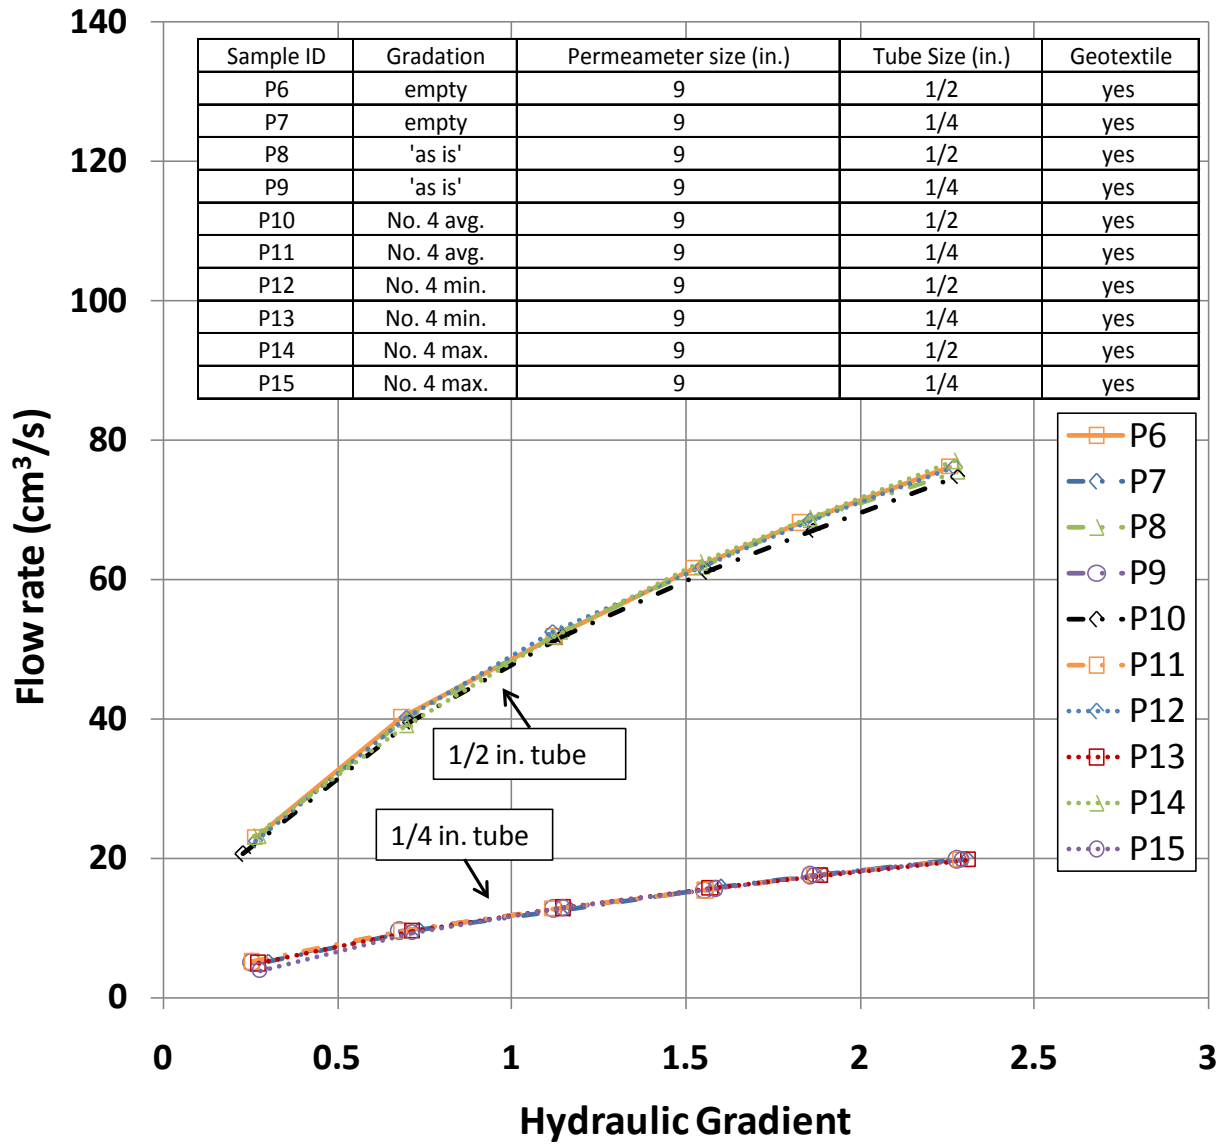
Figure 5.12: Results for Different RCA Gradations in the 9-in. Permeameter as Flow Rate

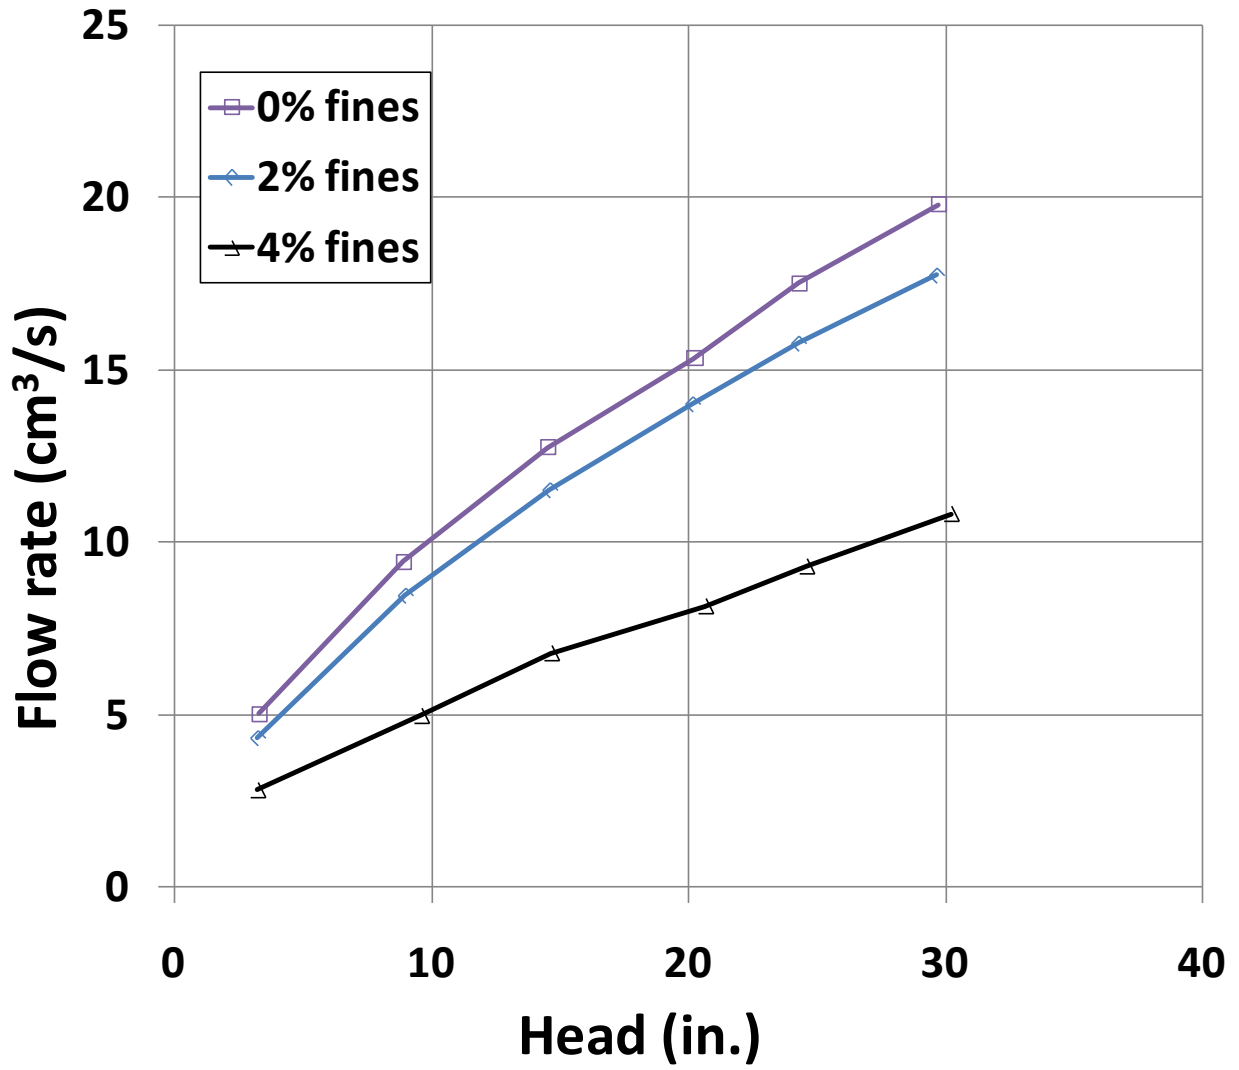
Figure 5.13: Flow Rate vs. Head with 0, 2, and 4 % Fines Addition

The results of the permeability tests are shown in Figure 5.13. As expected, increasing the fine content decreases the flow of water. An interesting observation is that the 2% fines slightly decreases the flow while the 4% fines significantly decreases the flow. The influence of fine content is not proportional to the reduction in flow. The increase of the flow with increasing with the head exhibits almost linear relationship; thus the influence of the head on water flow can be easily estimated in the field.

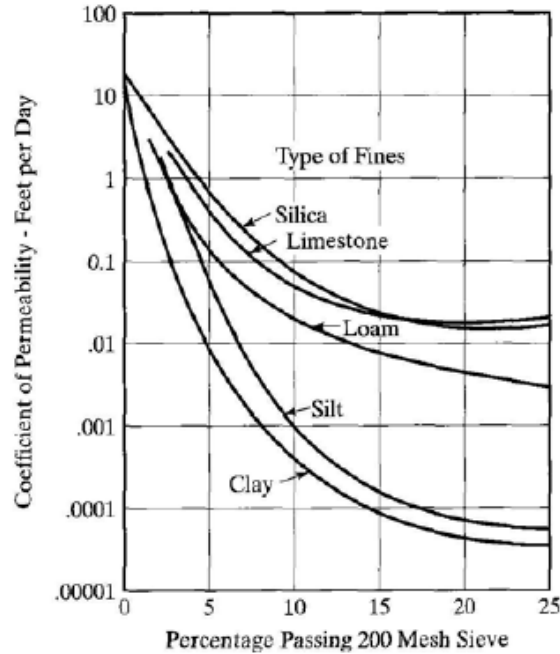
Figure 6.1: Effect of Different Types of Fines on Permeability of Coarse Aggregate (Haung, 2004)

Aggregates used in drainage layers and French drains should be sound, clean, and open-graded. Aggregates should have a high permeability to accommodate the free passage of water and be protected from clogging by means of a filter (Huang, 2004). It has long been recognized that proper gradation and density are critical to the permeability of granular materials. To obtain the desired permeability, the fine particles need be deleted; thus, the stability of the drainage layer may be reduced. The effect of fines can have a substantial impact on the permeability as seen in Figure 6.1.

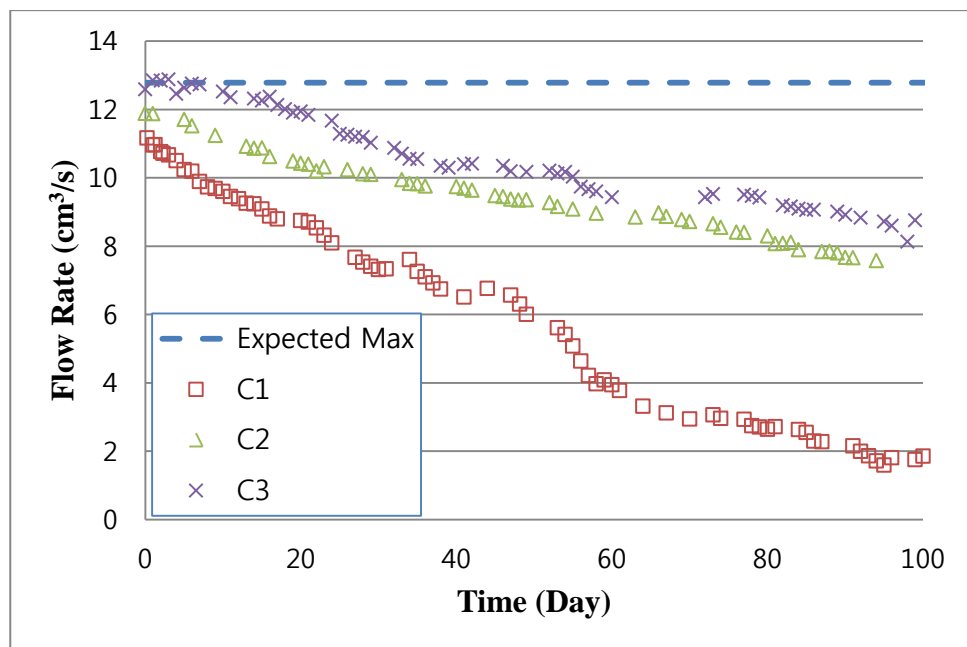
Figure 6.2: Results for Samples C1, C2, and C3 Plotted as Flow Rate vs. Time

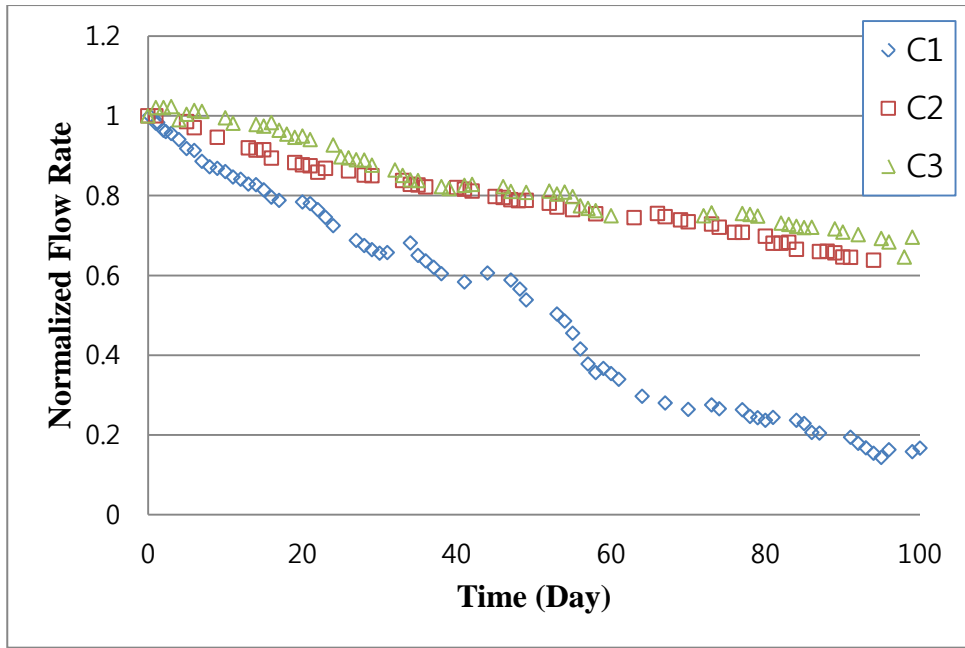
Figure 6.3: Results for Samples C1, C2, and C3 Plotted as Normalized Flow Rate

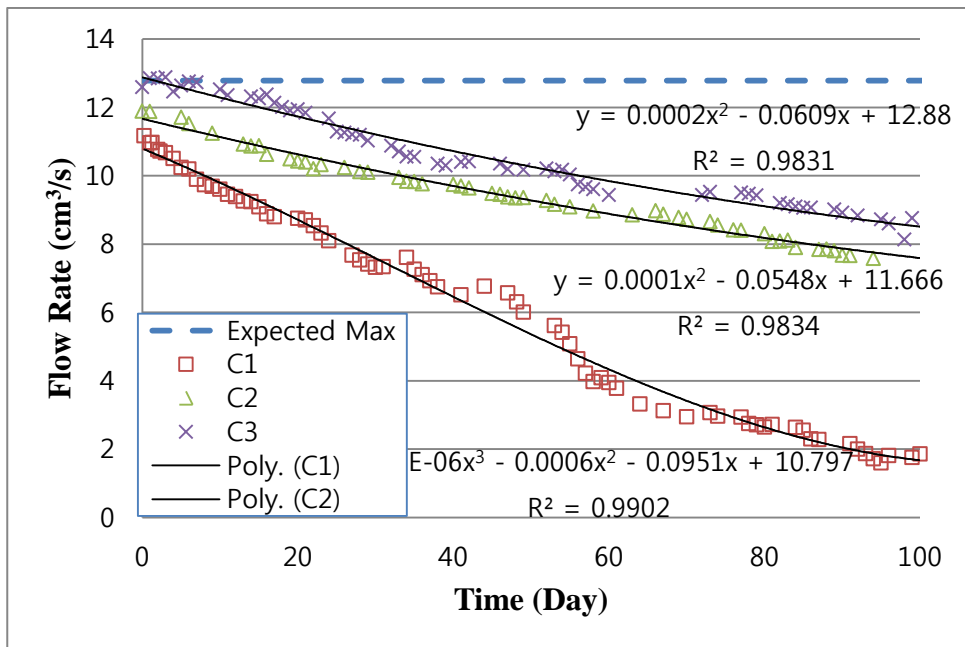
Figure 6.4: Best-Fitting Trend lines of the Flow Rate Measurements for C1, C2, and C3 Samples

- The reduction rate, which is the slope of time vs. flow rate, can be used as rough prediction of long-term drainage performance after 100 days. The best-fitting trend lines of C1, C2, and C3 samples were developed and the details of trend lines are shown in Figure 6.4.

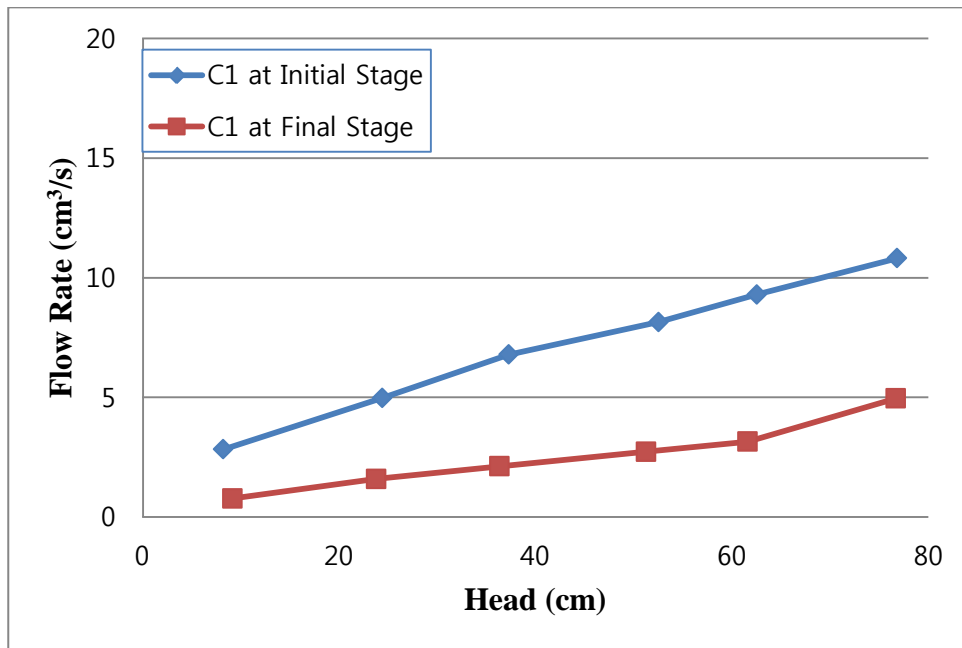
Figure 6.5: Flow Rate vs. Head for Sample C1 (4% fine) Measured at Initial and Final Stages

At initial and final stages of clogging tests, the flow rate of each sample was measured under varied head to evaluate the influence of clogging buildup on the flow rate with increasing head. The initial-stage measurements were made when the flow rate reached to steady-state flow, which was approximately one week or less after testing was run. The final-state measurements were made after 100 days before testing setup was taken apart. The measurements are shown in Figures 6.5 to 6.7. As seen in the figures, C3 sample exhibits the highest sensitivity to head change (the steepest slope in flow rate vs. head) while C1 sample shows the lowest sensitivity to head change. C1 sample containing 4% fines involve more clogging buildup; thus less sensitivity to the head change is shown.

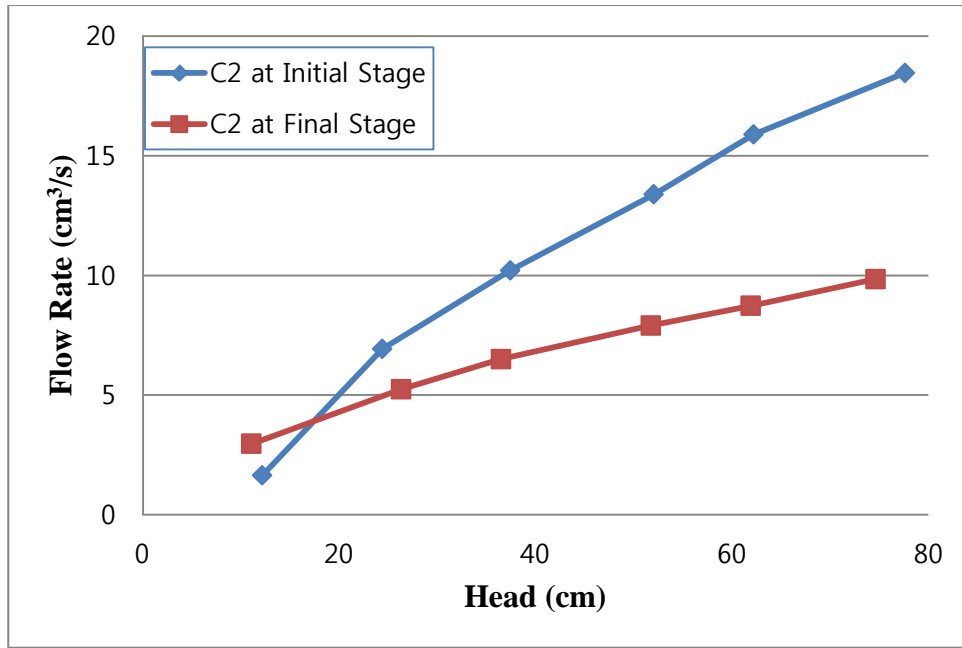
Figure 6.6: Flow Rate vs. Head for Sample C2 (2% fine) Measured at Initial and Final Stages

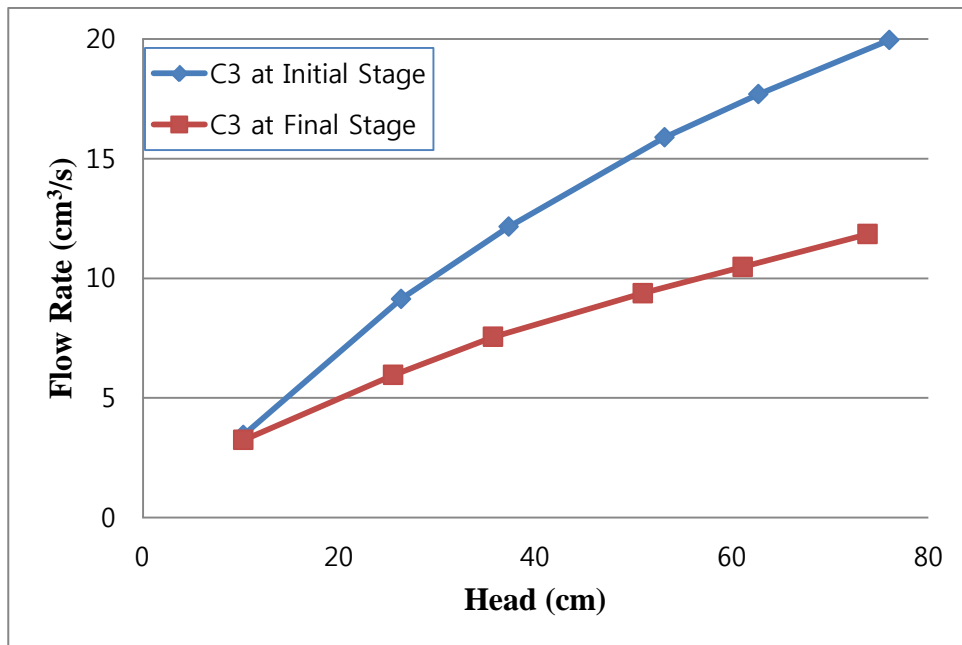
Figure 6.7: Flow Rate vs. Head for Sample C3 (0% fine) Measured at Initial and Final Stages
