Final Report

Evaluate the Use of Reclaimed Concrete Aggregate in French Drain Applications

FDOT Contract No.: BDK 78 TWO 977-12

Department of Civil, Environmental, and Construction Engineering
University of Central Florida
4000 Central Florida Blvd.
Orlando, FL 32816-2450

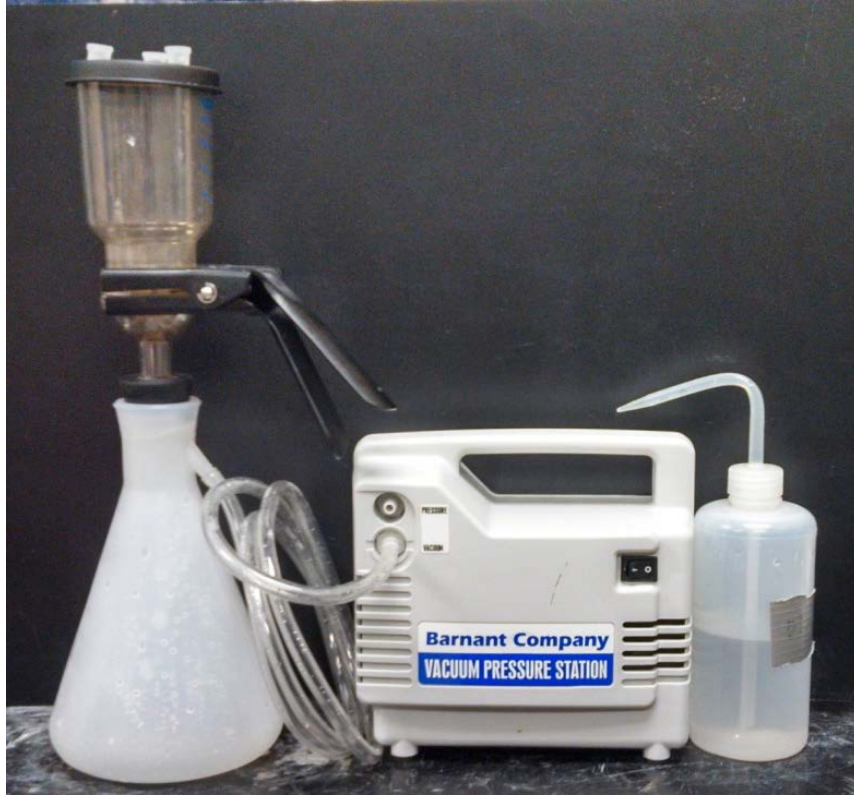
Figure 6.9: Filtration Equipment Required for ASTM D5907

CO₂ content in the solution also increases the dissolution of calcium ions (decreased calcium carbonate solids). It should be noted that equations 6.1, 6.2, and 6.3 are all reversible reactions, that is, the reaction can occur towards the right hand side of the equation or to the left hand side of the equation. This experiment takes advantage of this principle by dissolving the most possible calcium ions, filtering RCA solids, and then precipitating the calcium carbonate out of solution. The calcium carbonate is precipitated by heating up the calcium-rich solution in the oven to decrease the solubility of CO₂ in the water. Figure 6.8 shows the solubility of CO₂ in water at different temperatures. A photo of the filtration equipment (as required by ASTM D5907) is shown in Figure 6.9.

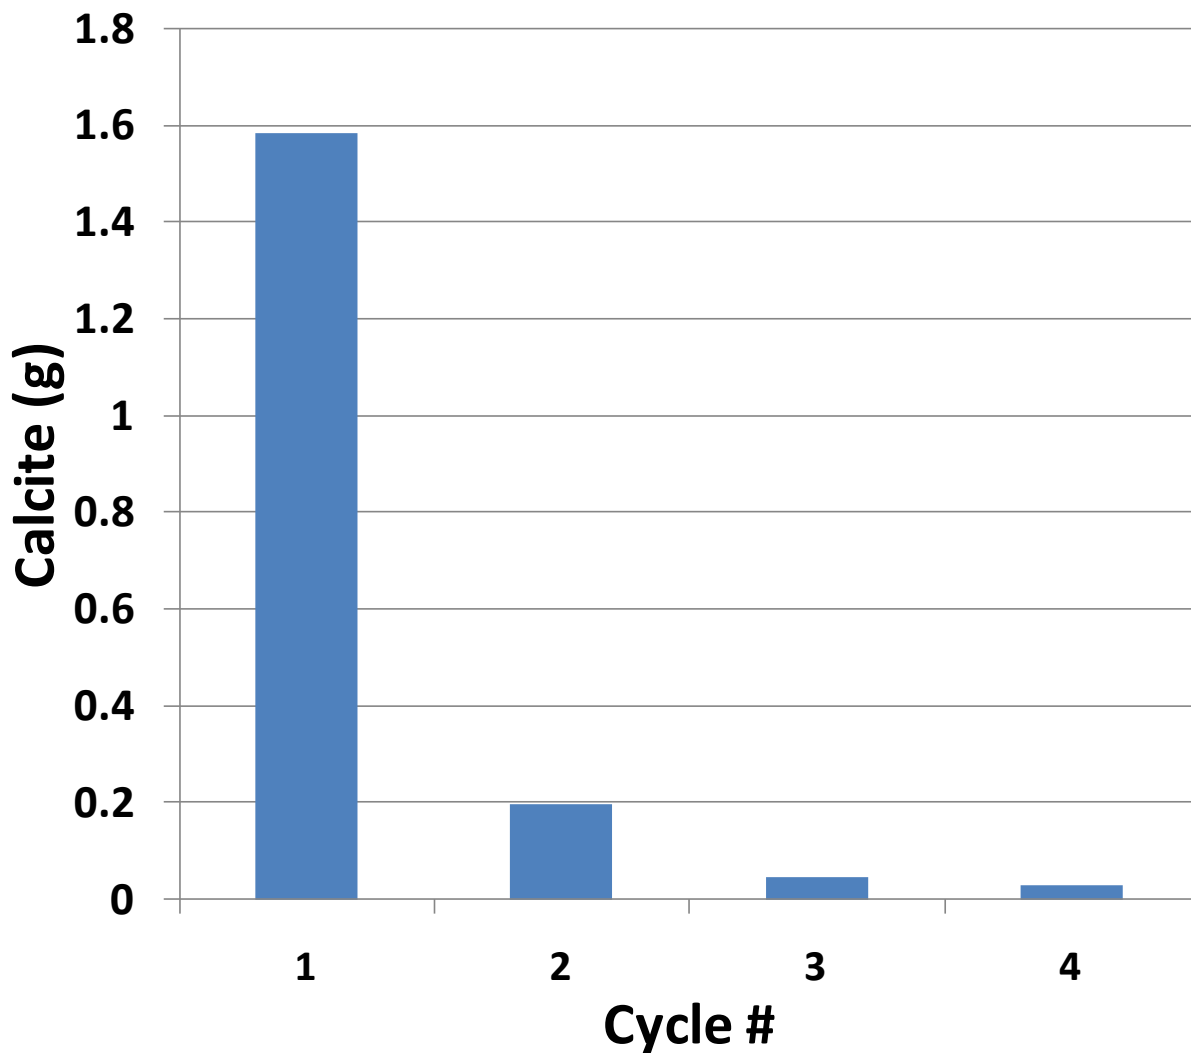
Figure 6.10: Calcium Carbonate Obtained from Initial 5 hours of CO₂ Injection

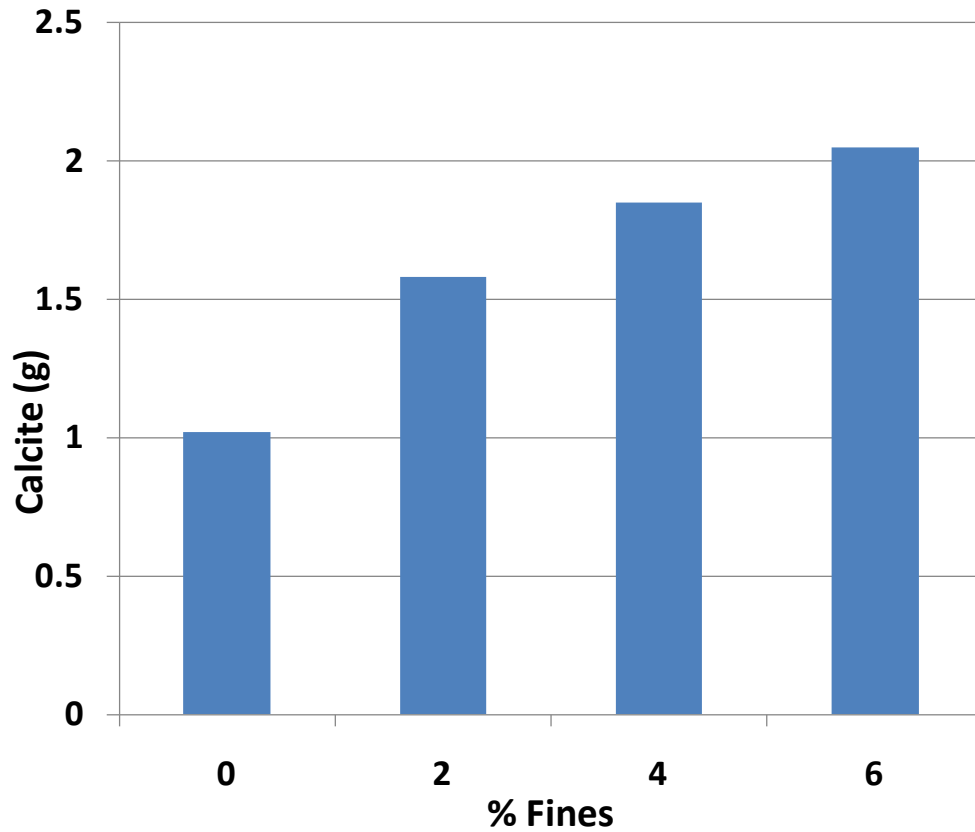
Figure 6.11: The Effect of Fines on Calcite Precipitation

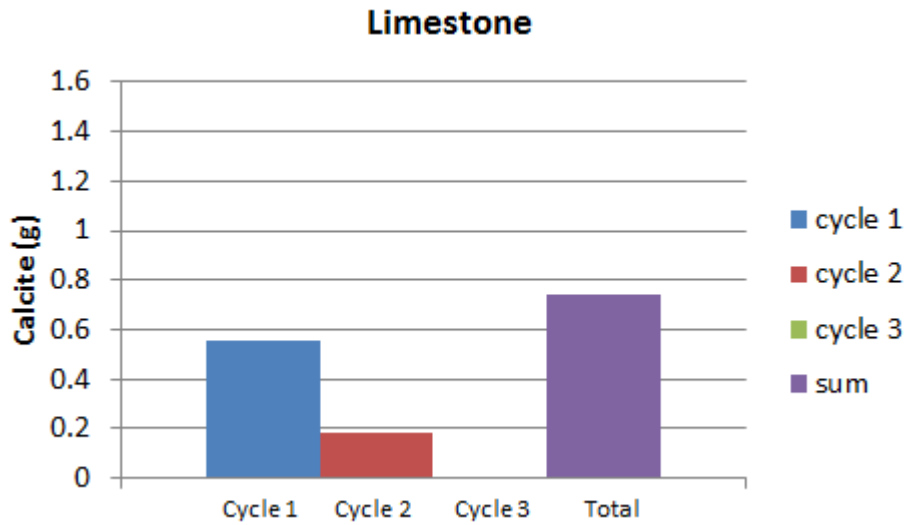
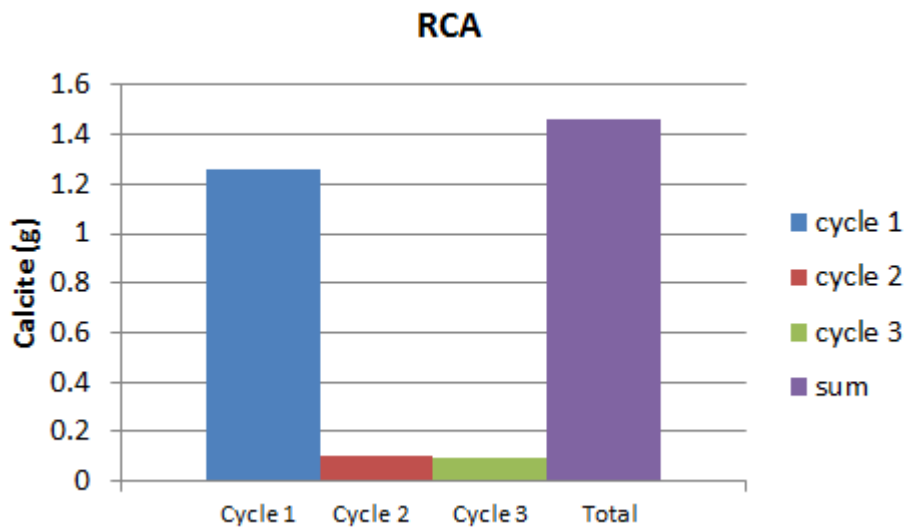
(a) limestone

(b) RCA

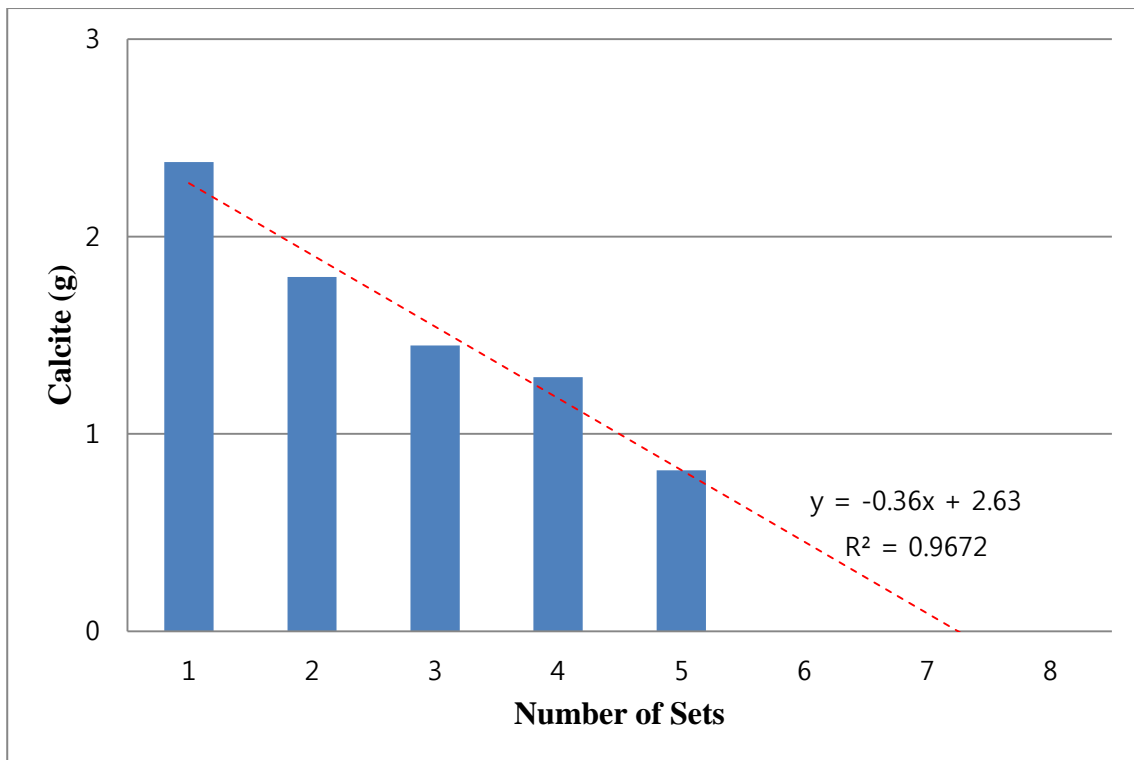
Figure 6.13: Decreasing Trend of Consecutive Calcium Carbonate Precipitation Cycles and Predicted Calcium Carbonate Reduction (1 Set = 6 Calcite Simulation Cycles)

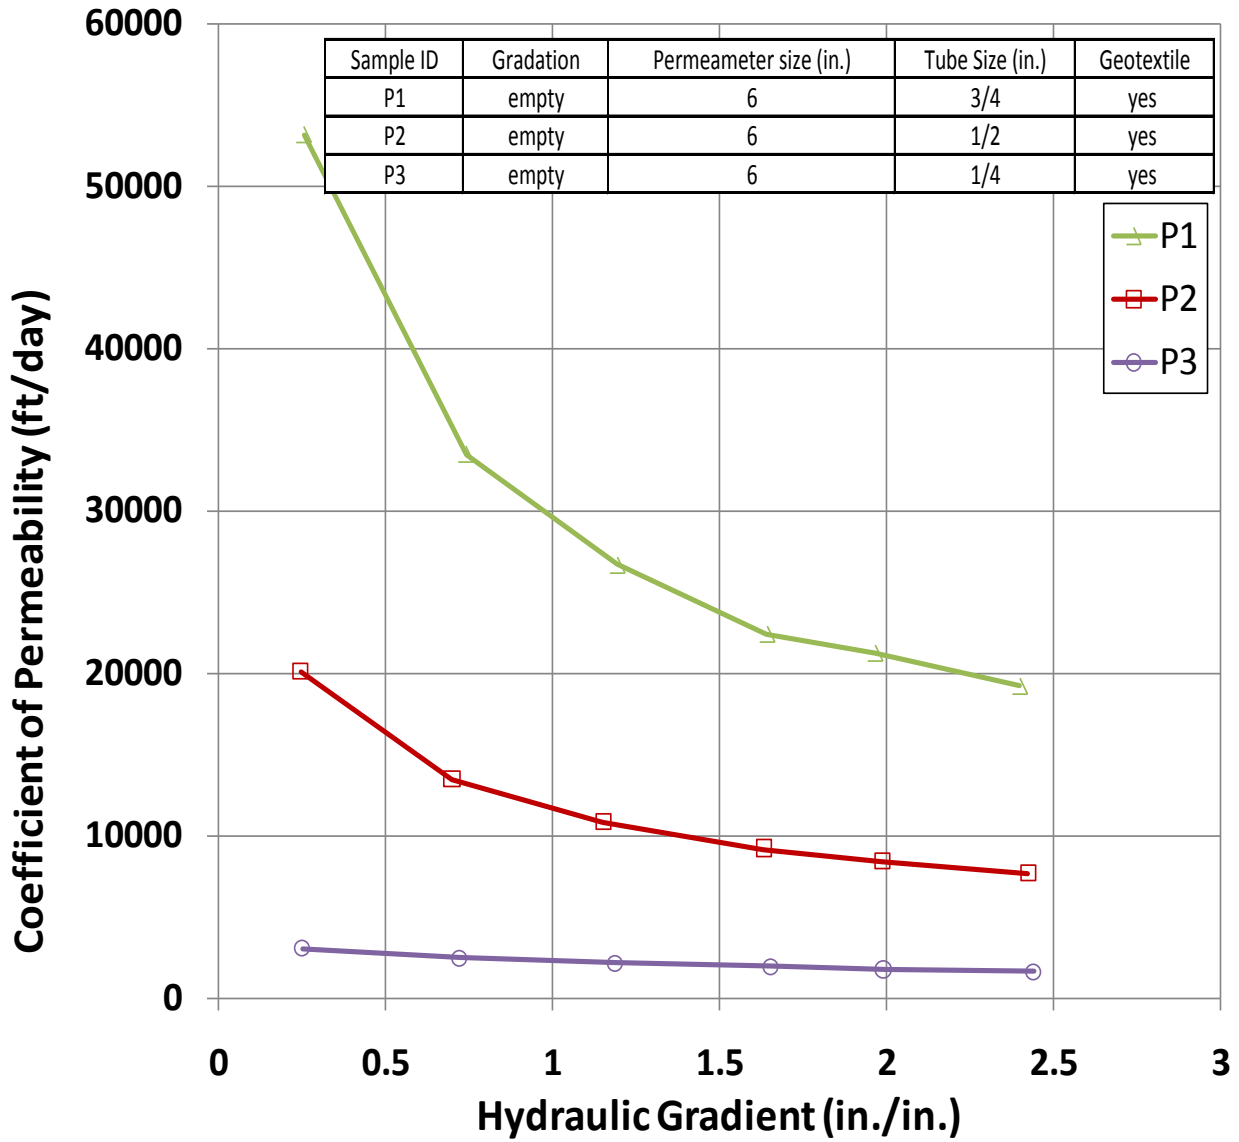
Figure A.1: Influence of Tube Size on Permeability with 6-in. Permeameter

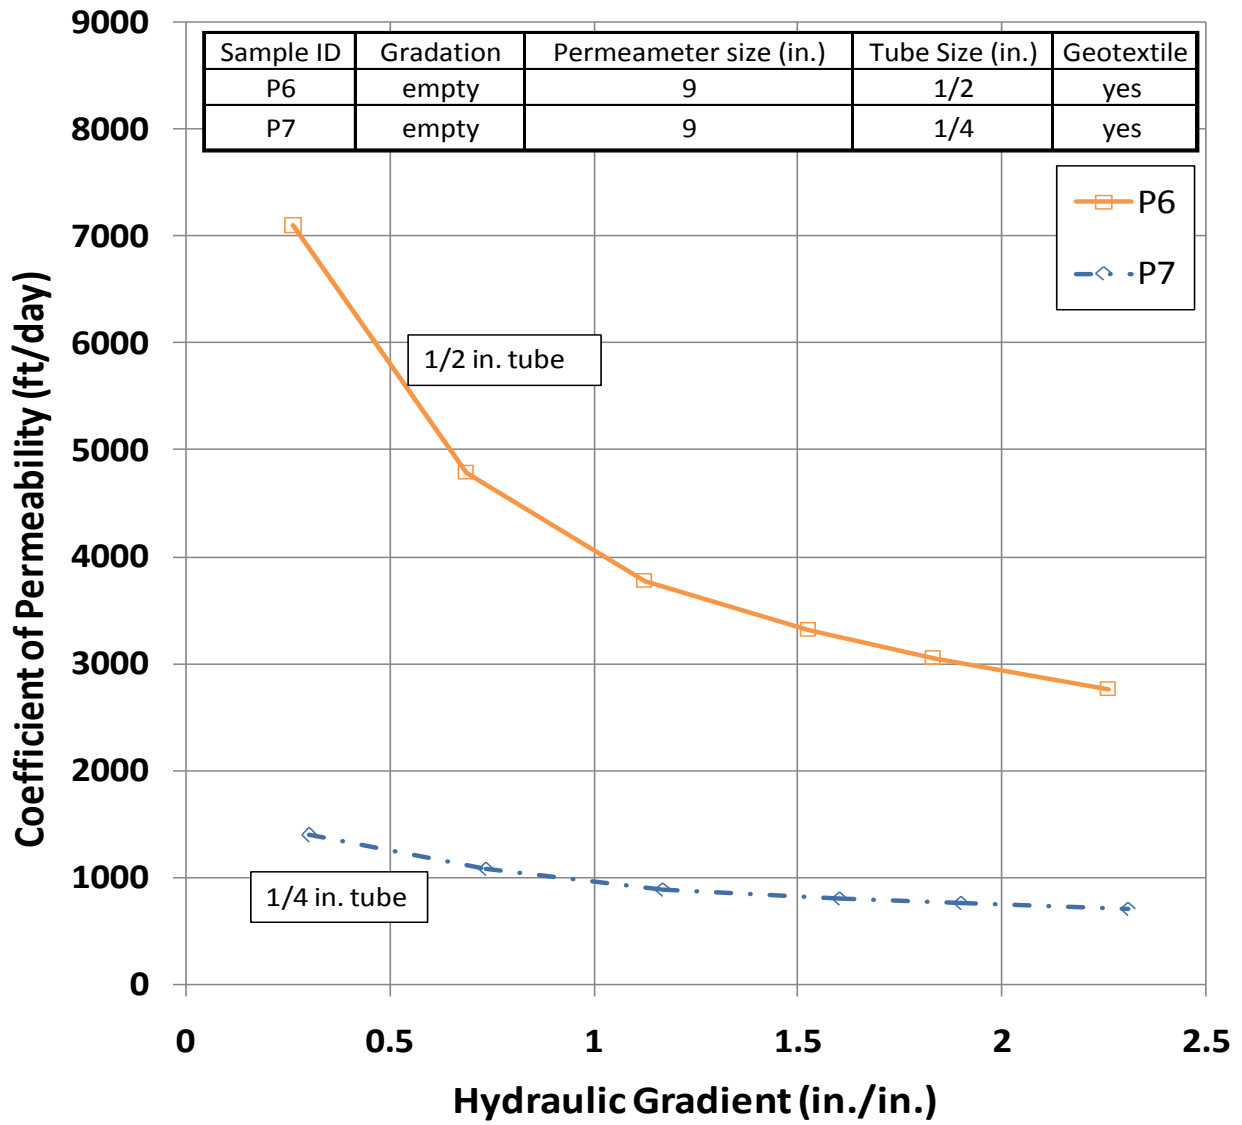
Figure A.2: Influence of Tube Size on Permeability with 9-in. Permeameter

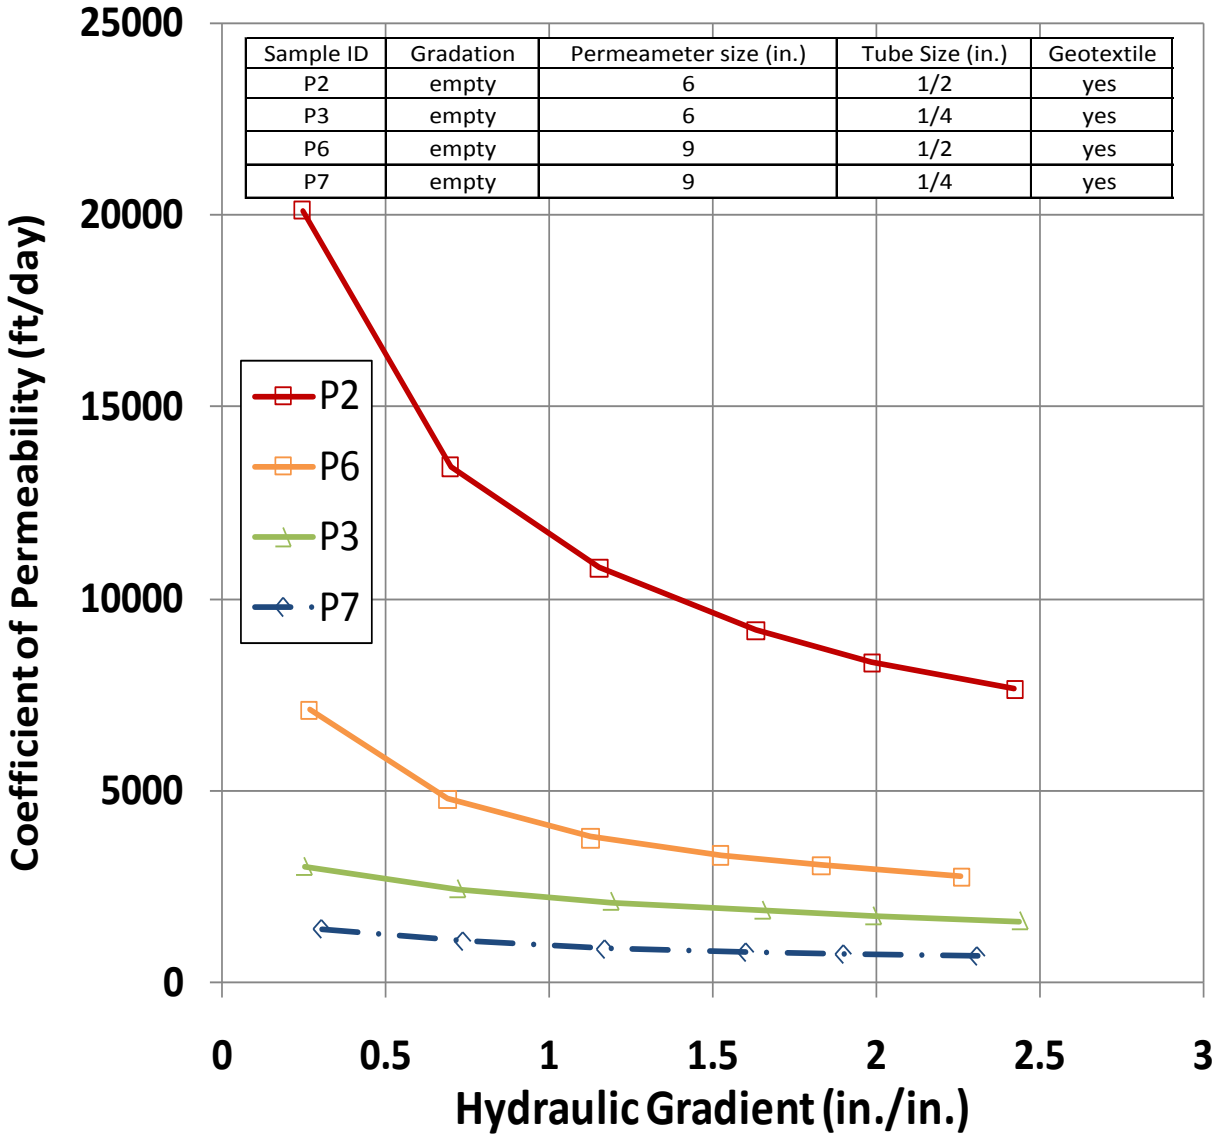
Figure A.3: Effect of Permeameter Size with 1/2- and 1/4-in. Tube on Permeability

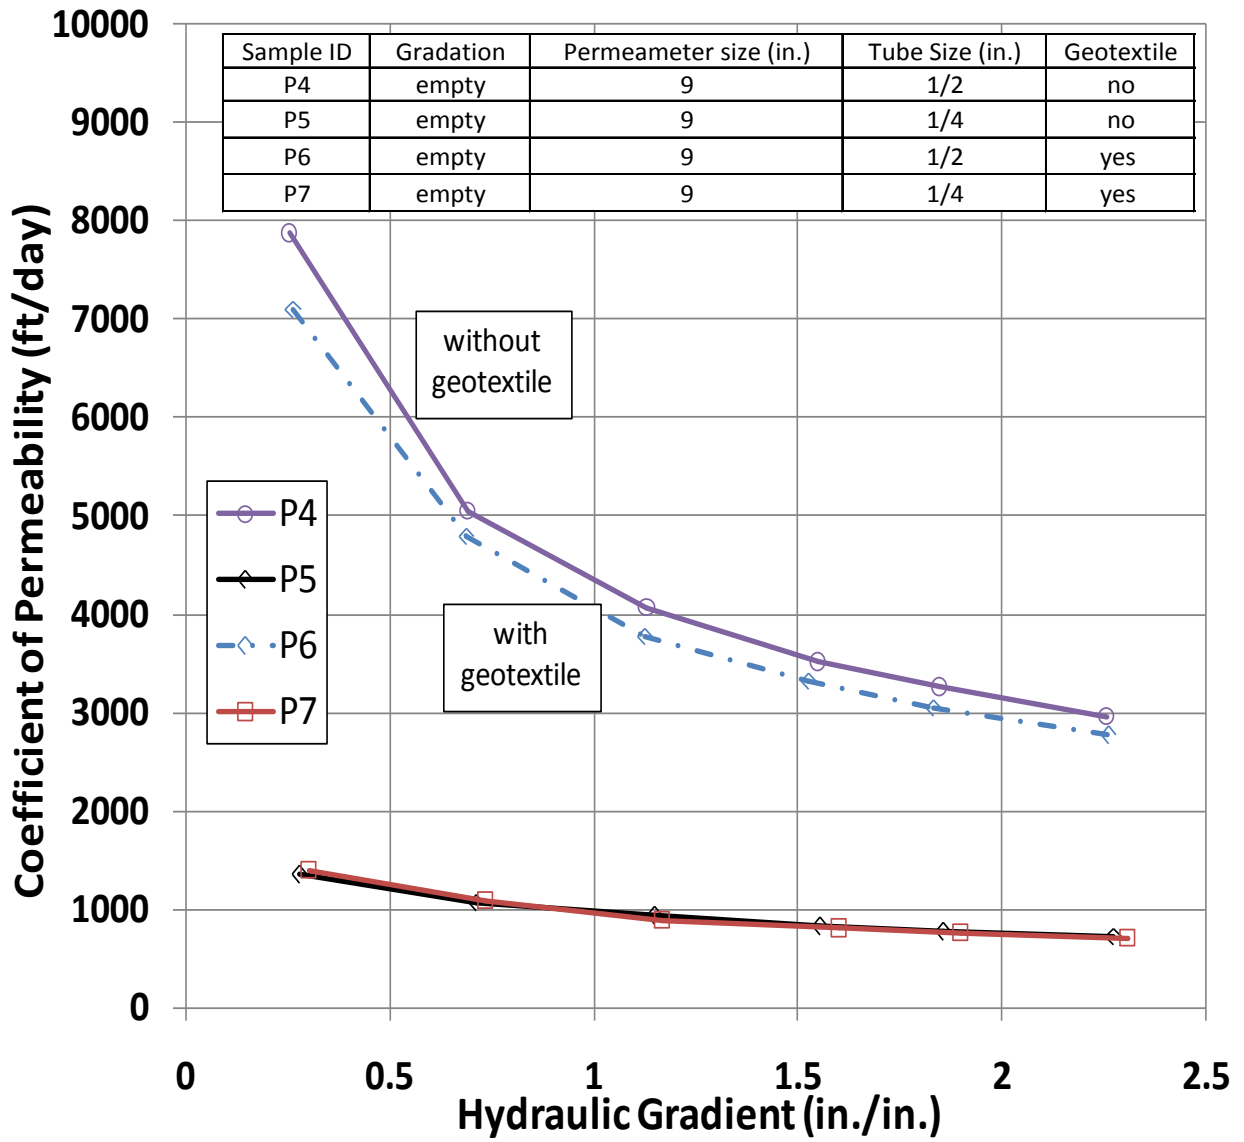
Figure A.4: Effect of the Addition of Geotextile with 1/2- and 1/4-in. Tube Sizes on Permeability

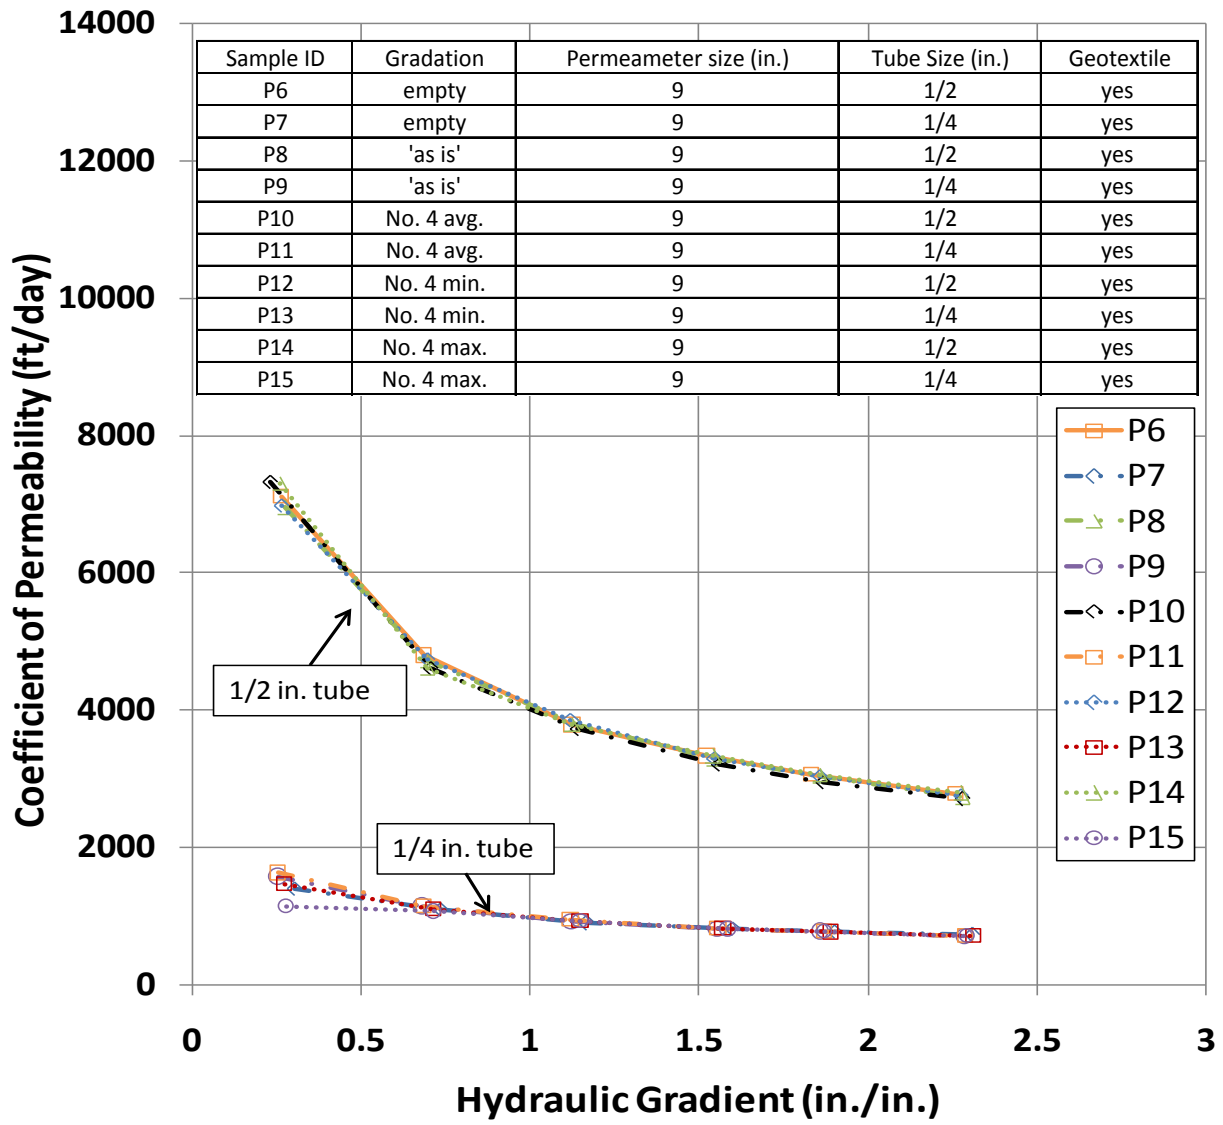
Figure A.5: Results for Different RCA Gradations in the 9-in. Permeameter as Permeability

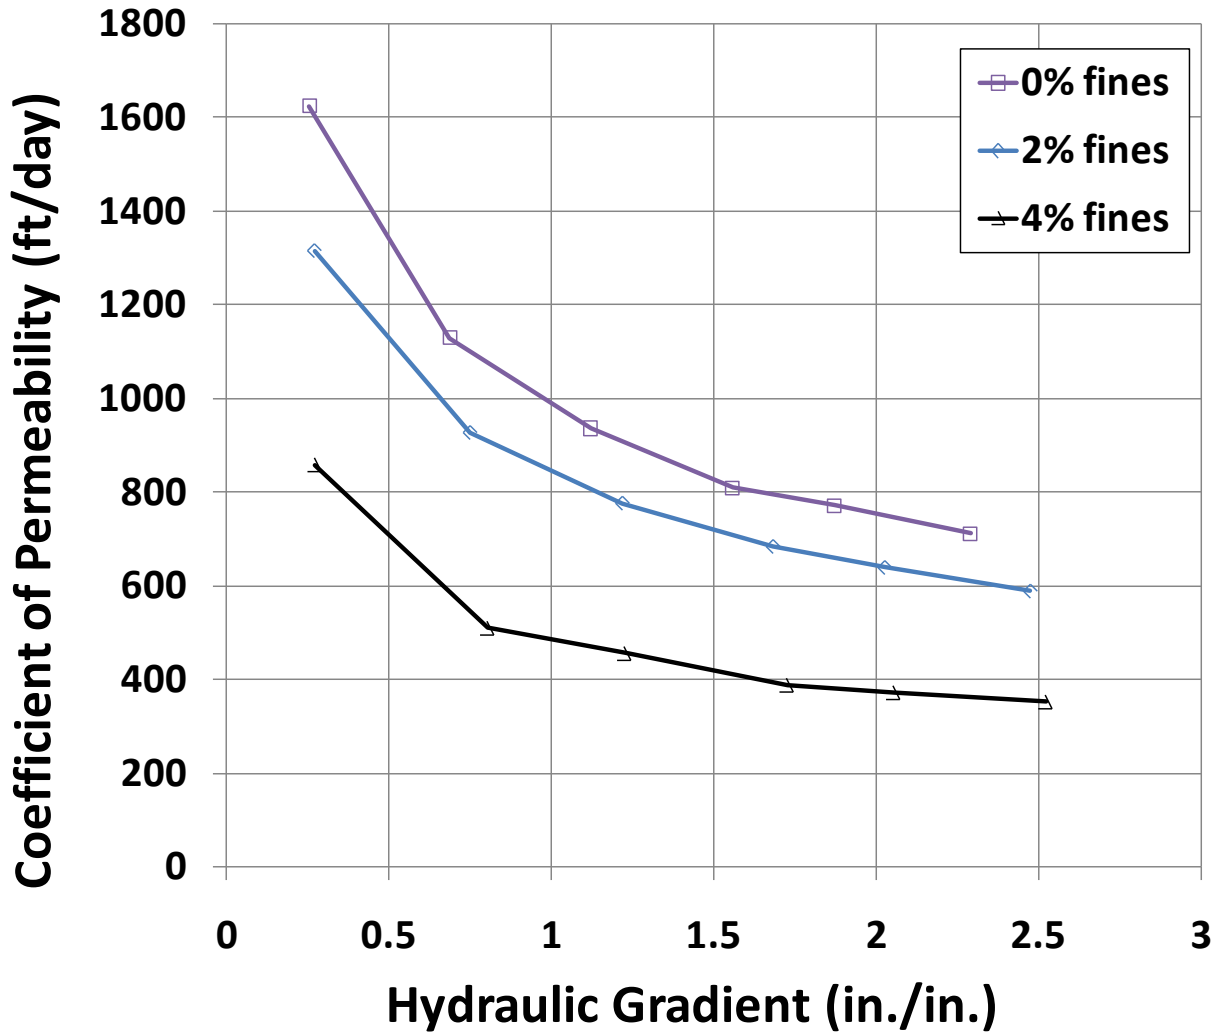
Figure A.6: Permeability vs. Hydraulic Gradient with 0, 2, and 4 % Fines Addition
