## Florida Department of Transportation Research

### Evaluate the Use of Reclaimed Concrete Aggregate in French Drain Applications

BDK78-977-12

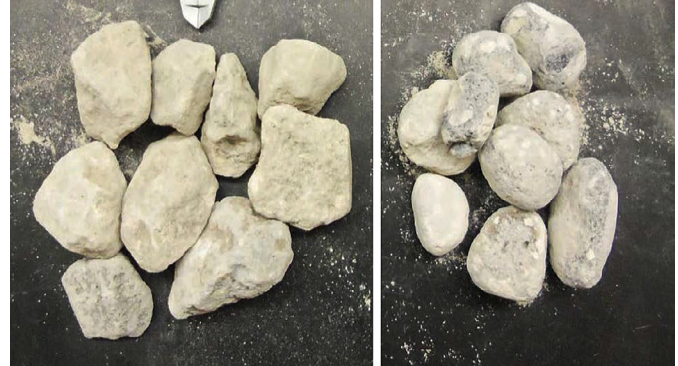
*RCA before (left) and after (right) standard abrasion testing. The rounding and general loss of size shows significant susceptibility to abrasion.*

Study results showed that RCA has a high abrasion value, that is, it is very susceptible to breakdown from abrasion during aggregate handling such as transportation, stockpiling, or placing. The most effective cleaning method was found to be pressure washing with agitation. RCA did not demonstrate the tendency to rehydrate and harden when mixed with water. The permeameter test results showed that the No. 4 gradation did not restrict the flow of water; flow rate was highly dependent on the permeameter system (e.g., tube size and head); however, excessive fines were able to cause large reductions in flow rate over time. Based on these studies, the researchers determined that No. 4 gradation of RCA can provide a suitable drainage medium if the RCA is properly washed to remove excess fines before use.
