DYNAMIC TESTING OF A NON-PROPRIETARY, HIGH-TENSION, CABLE END TERMINAL SYSTEM

MwRSF Research Report No. TRP-03-294-14

March 21, 2014

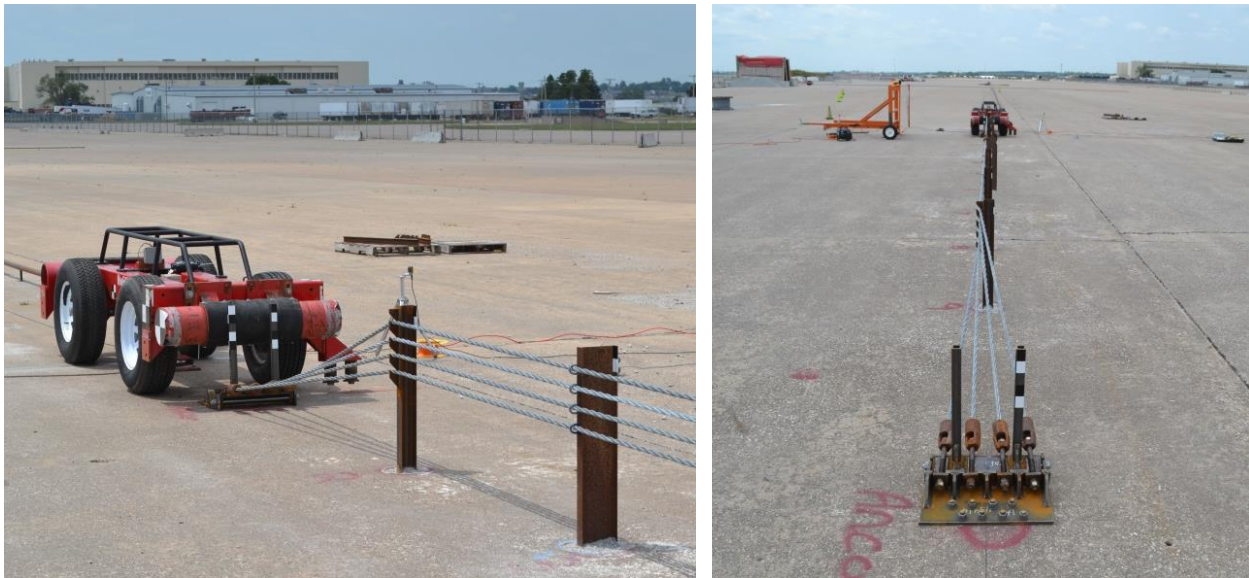
Figure 22. Impact Location, Test No. HTCT-2

The 1,861-lb (844-kg) bogie impacted the high-tension cable terminal system at a speed of 52.8 mph (85.0 km/h) and at an angle of 0 degrees. The impact location is shown in Figure 22. The cables were tensioned to approximately 4,300 lb (19 kN). The cables were numbered from 1 to 4 as shown in Figure 23. Cable no. 1 corresponded to the bottom cable, and cable no. 4 corresponded to the top cable. A sequential description of the impact events is contained in Table 2. The times are approximate as the bogie wheel obstructed the view of the cable releases. Sequential photographs are shown in Figures 24 through 26.

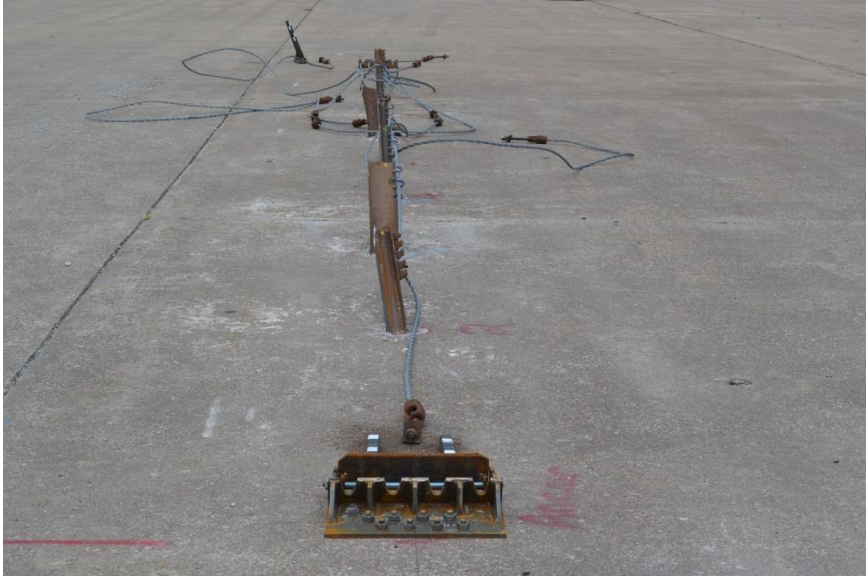
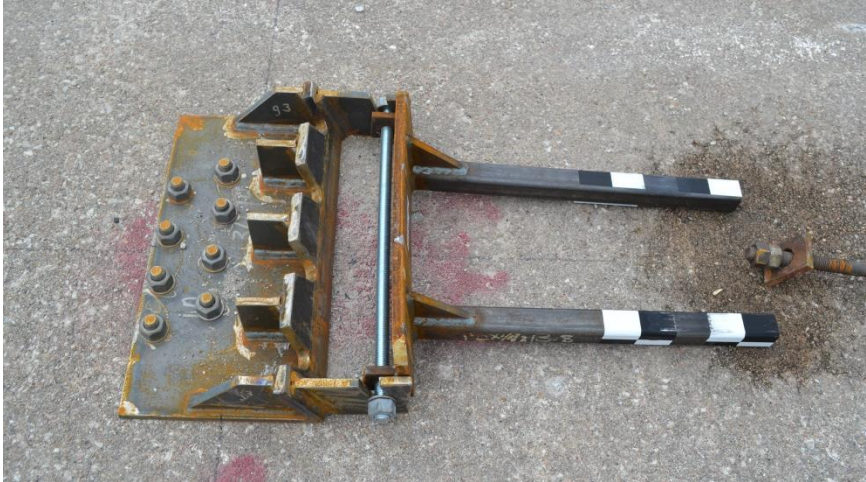
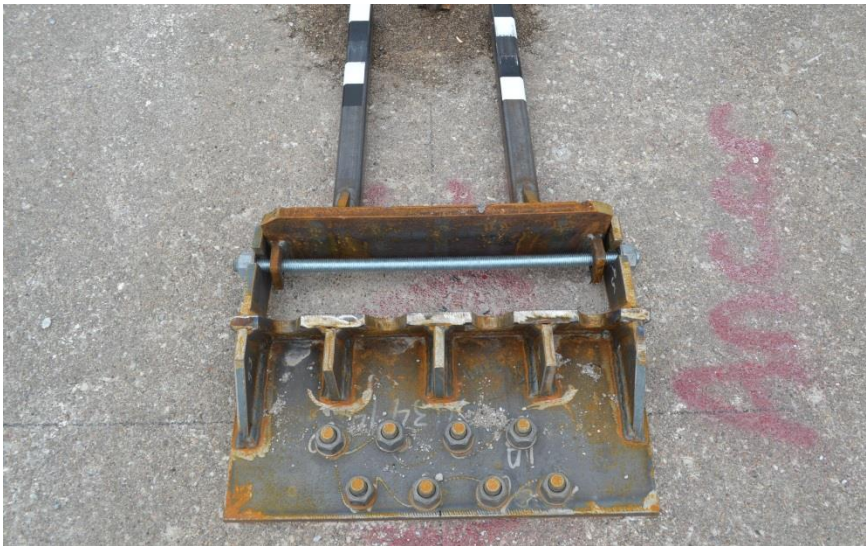
Figure 27. System Damage – Upstream Cable Anchor Bracket, Test No. HTCT-2

Damage to the end terminal system was moderate, as shown in Figures 27 through 30. The cable release lever was retained in the upstream cable anchor bracket. The kick plate had some minor permanent deformation. Post nos. 2 through 9 were all bent downstream. Posts with holes in the flanges at groundline all buckled at the holes, and the flanges tore from the upstream edge to the location of the weakening holes.

Cable nos. 1, 3, and 4 released from the upstream cable anchor bracket early on the event, However cable no. 2 did not release until the cable lost tension and the stress wave propagation caused the cable to lift out, which occurred very late in the event. Cable no. 2 not releasing and post no. 2 bending downstream may have contributed to the bogie becoming airborne during most of the event.

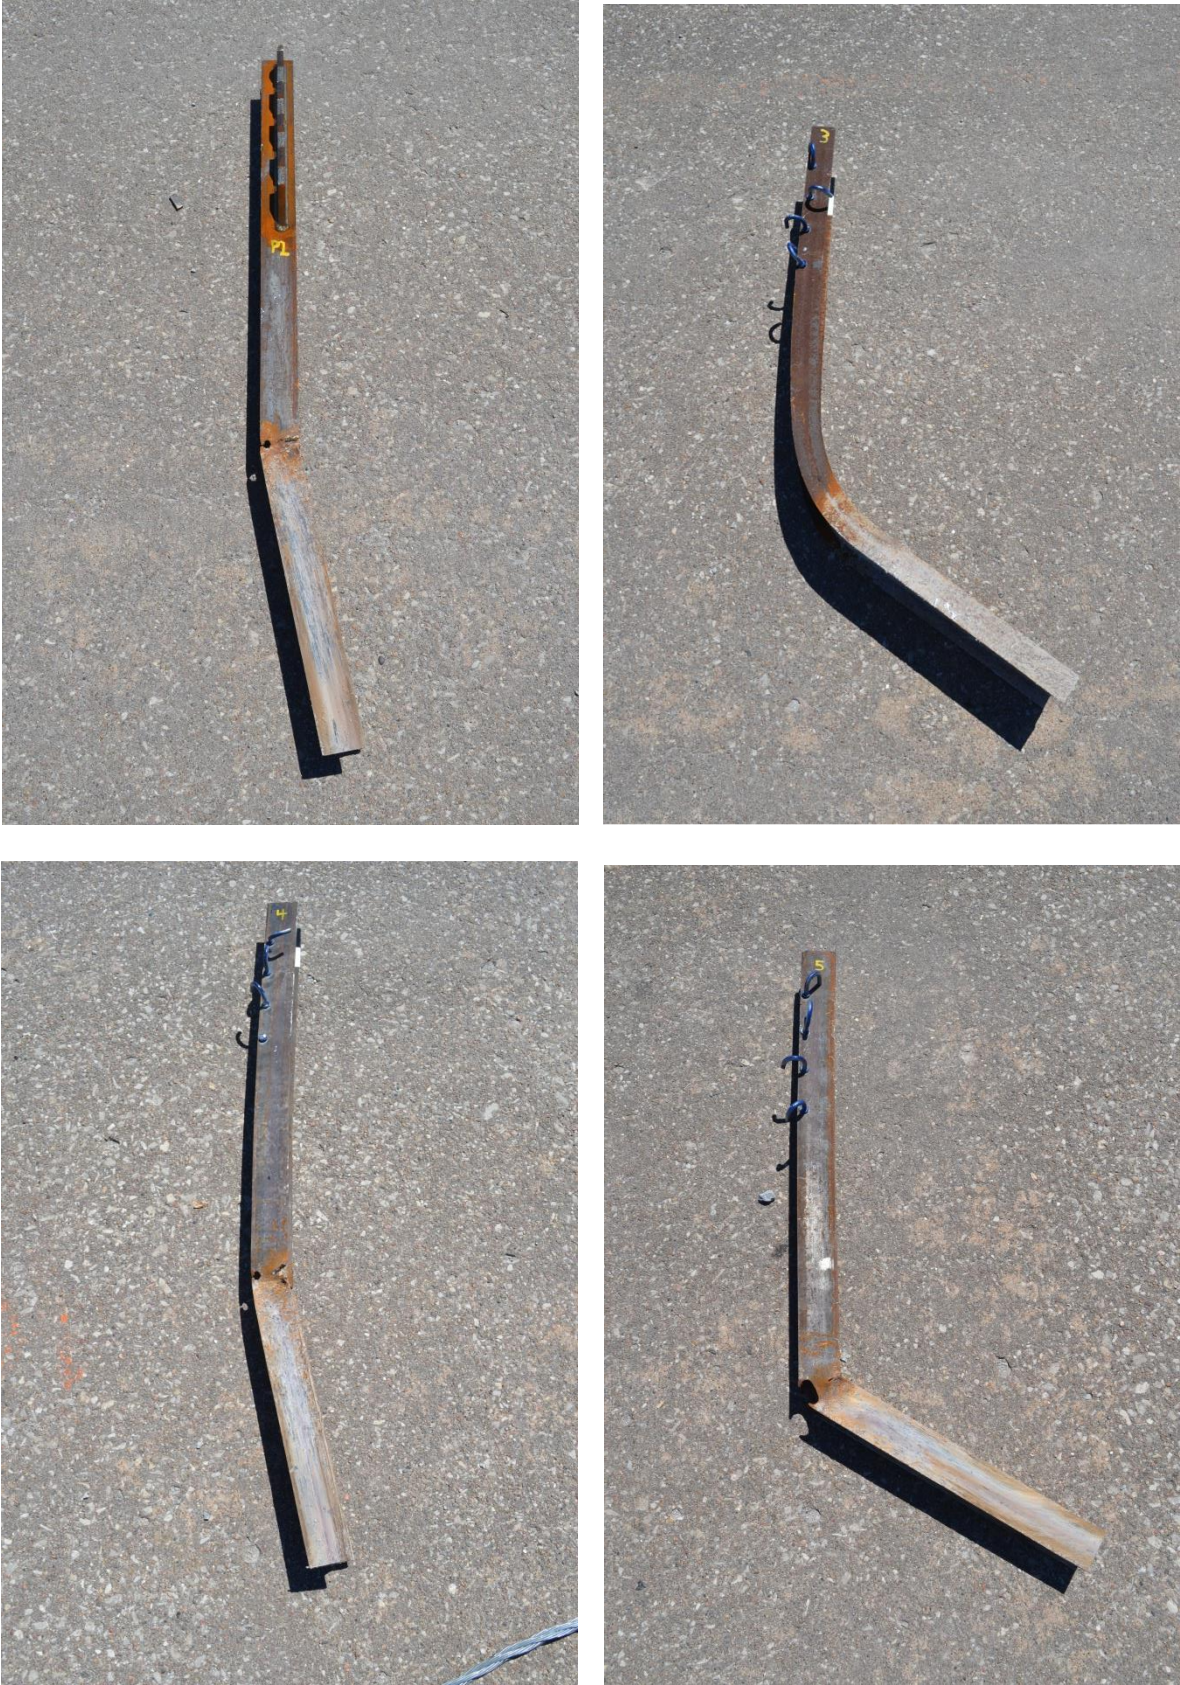
Figure 28. System Damage – Post Nos. 2 through 5, Test No. HTCT-2

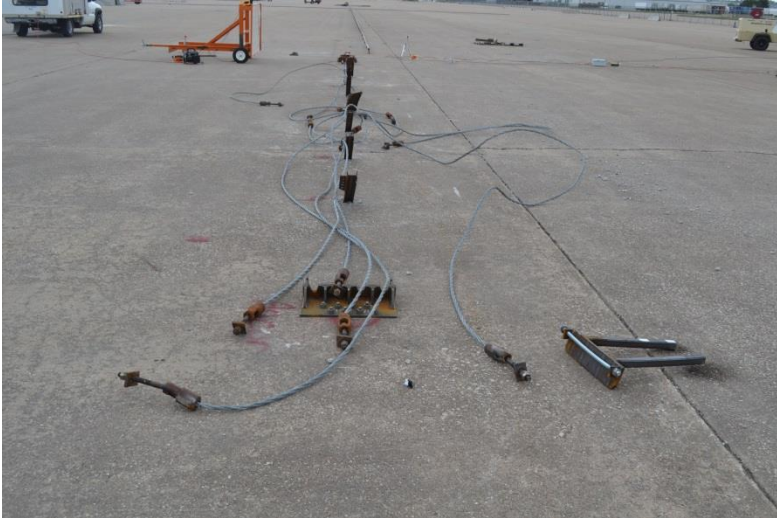
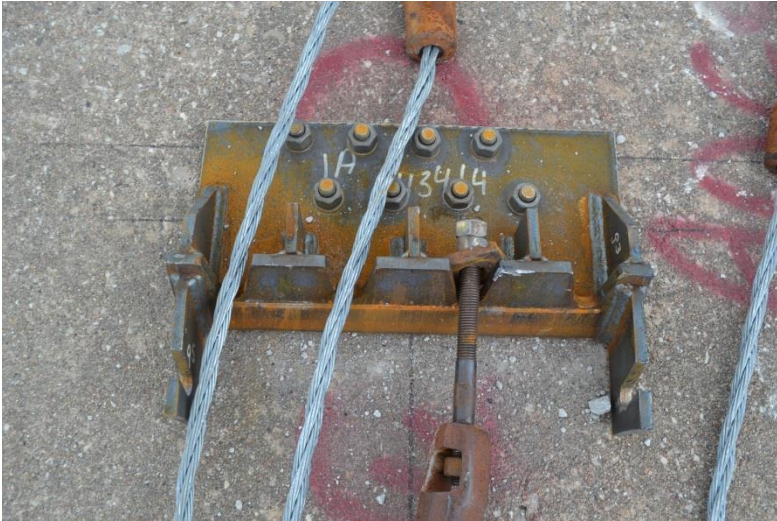
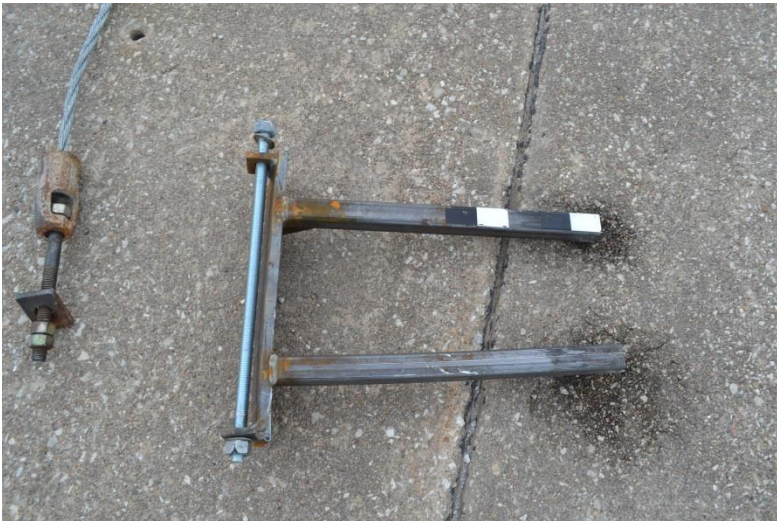
Figure 30. System Damage – Downstream Cable Anchor Bracket, Test No. HTCT-2

The cable release lever released from the downstream cable anchor bracket. Cable nos. 1, 3, and 4 released from the downstream cable anchor bracket. Gouging was found in the steel plate around the second cable notch on the downstream cable anchor bracket. The kick plate had some minor permanent deformation. The bogie also sustained minor damaged to the tires and tow pin.
