# Investigation of Carbon Fiber Composite Cables (CFCC) in Prestressed Concrete Piles

Contract Number BDK83-977-17

**Florida Department of Transportation**

April 2014

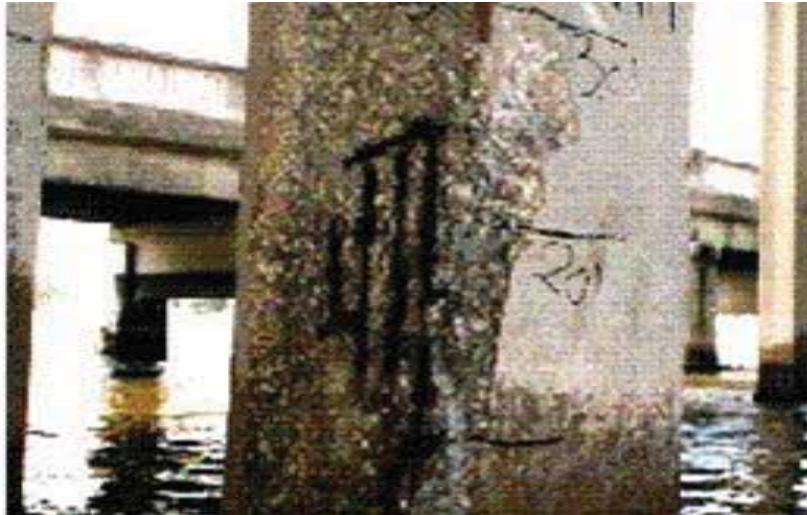
**Figure 1.1:** Splash zone corrosion

high-strength, prestressing steel strands and are fabricated under controlled conditions in a casting yard. However, they are often exposed to salt water (aggressive) environments, which results in rapid degradation. The major area of concern is near the water level, also called the “splash zone” (Figure 1.1). In this area, the concrete

experiences periodic wet and dry spells. Consequently, salt deposits on the concrete surface and slowly penetrates the concrete, resulting in corrosion of the prestressed steel strands. This causes loss of concrete material surrounding the strand due to spalling of the concrete and a loss of the steel cross-sectional area. The bridge may no longer be usable, or may require major retrofitting to strengthen the piles, which is very expensive.

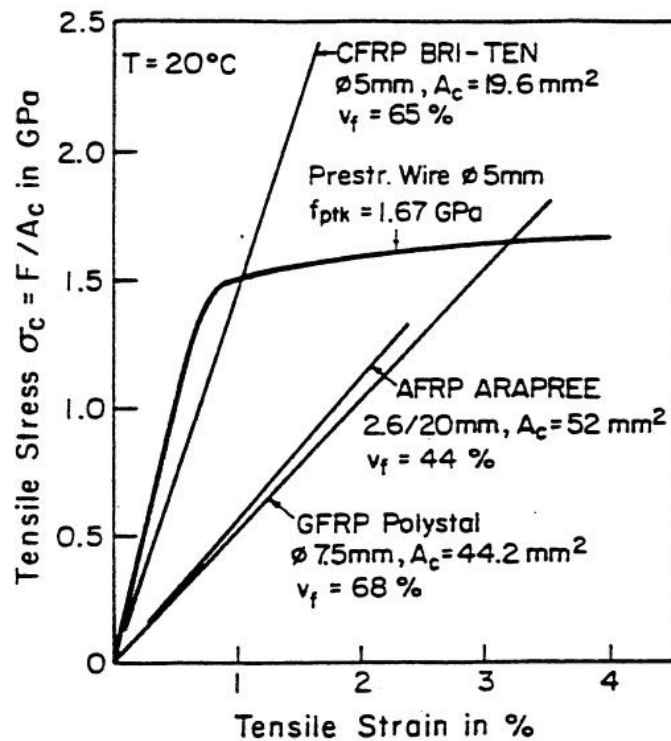
Figure 2.1: FRP stress-strain relationships (Domenico, 1995)

Tensile properties of reinforcement made from Carbon Fiber Reinforced Plastic (CFRP), Aramid Fiber Reinforced Plastic (AFRP), and Glass Fiber Reinforced Plastic (GFRP) are compared to steel in Figure 2.1. Steel exhibits ductile behavior, while the other materials do not.

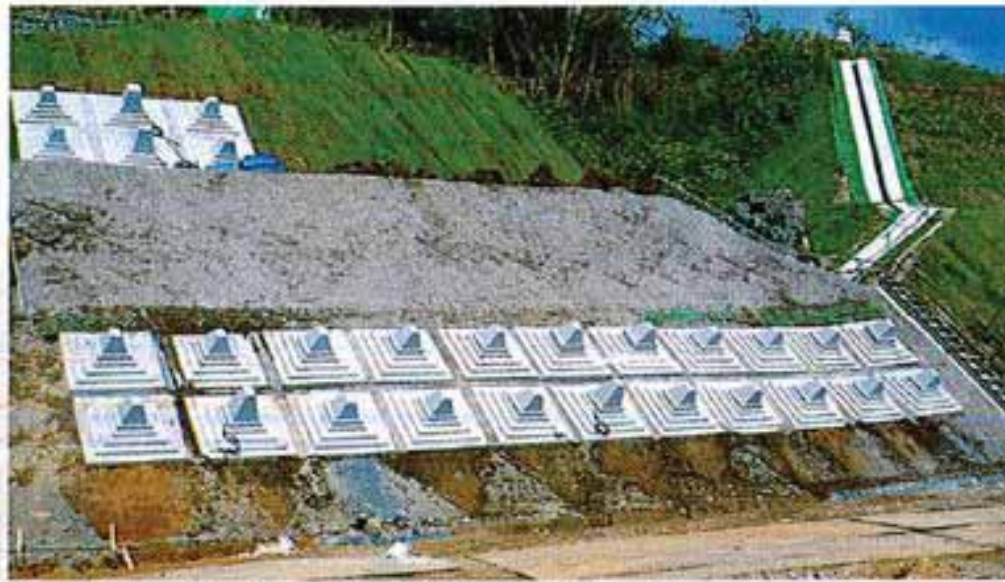
Tendons of the New Material ground anchor  
 "Excellent corrosion resistances and light weight"

Figure 2.2: Corrosion-resistant ground anchors made of CFCC (Source: Tokyo Rope)

1. Reinforcement of structures in corrosive environments
2. Corrosion-resistant ground anchors (Figure 2.2)

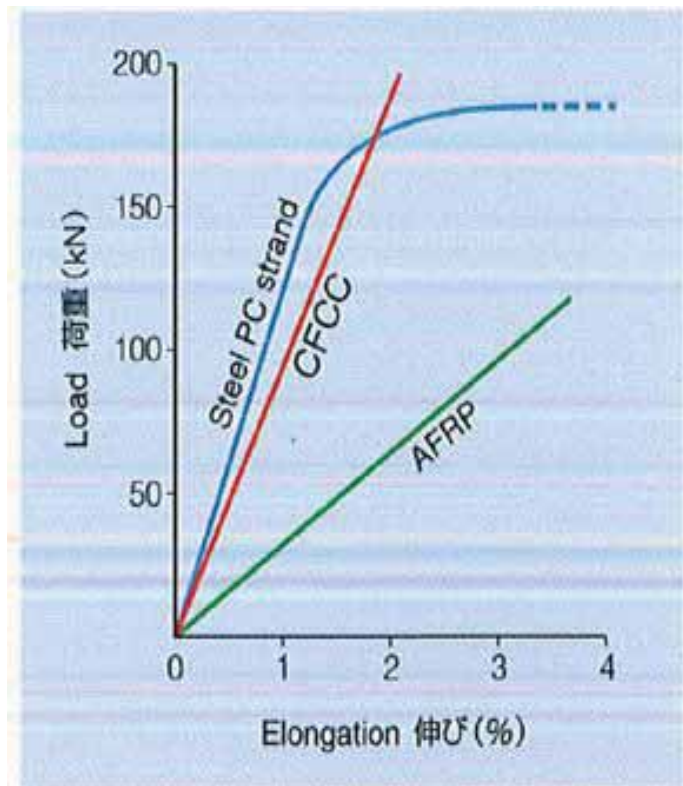
Figure 2.3: Load and elongation diagram (Source: Tokyo Rope)

As illustrated by Figure 2.3, CFCC does not yield before failing like steel does, but fails immediately once it reaches the maximum capacity.

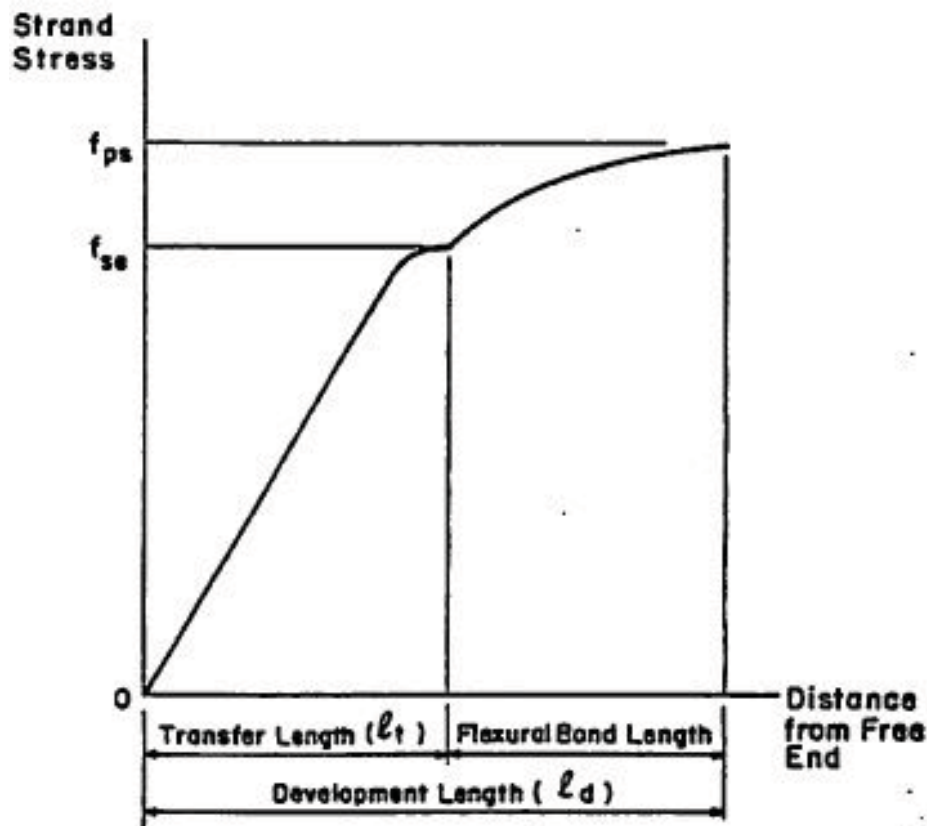
Figure 2.4: Variation of strand stress within the development length (Cousins et al., 1990)

The additional length required to develop the strand strength from the effective prestressing stage to the ultimate stage is called the flexural bond length. The sum of these two lengths is called the development length. These lengths are explained by Cousins et al. (1990) and shown in Figure 2.4.

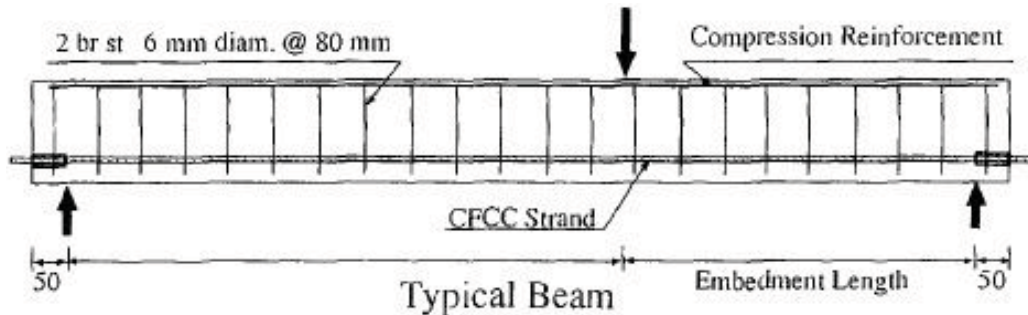
**Figure 2.6:** Experimental setup (Mahmoud et al., 1999)

The test setup used by the researchers was used in our study to assess the development length of CFCC via flexural tests. From their proposed model, it is evident that the transfer length is a function of  $f'_{ci}$ , as the increase in concrete strength gives a shorter transfer length due to the improved bond characteristics.

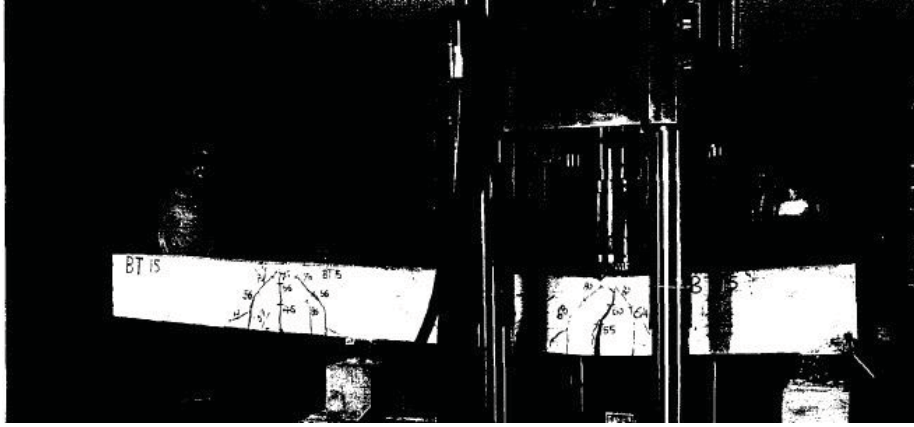
**Figure 2.7:** Crack pattern observed by Zaki (Mahmoud and Rizkalla, 1996)

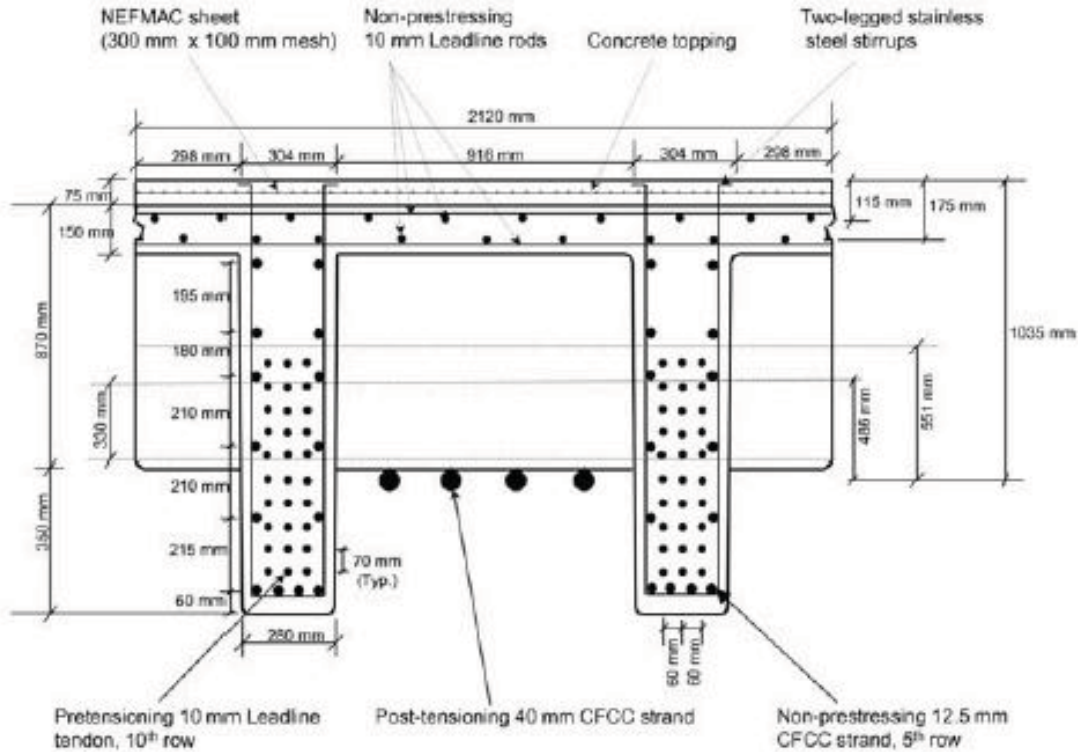
**Figure 2.9:** Carbon fiber reinforced double-T beam cross section (Grace, 2003)

Instead of steel, each web was reinforced with the following: ten (10) rows of three (3) 10-mm bonded pretensioned CFRP tendons; six (6) rows of two (2) 12.5-mm non-prestressed CFCC strands; and one (1) row of three (3) 12.5-mm non-prestressed strands in each web. The external longitudinal and transverse unbonded CFCC strands provide post-tensioning. The longitudinal 40-mm CFCC strands are externally draped, and 60% of the final post-tensioning force was applied to the longitudinal strands before transporting the beam. Flexure testing was done on the beam before the bridge span was constructed. The researchers observed that all 60 pre-

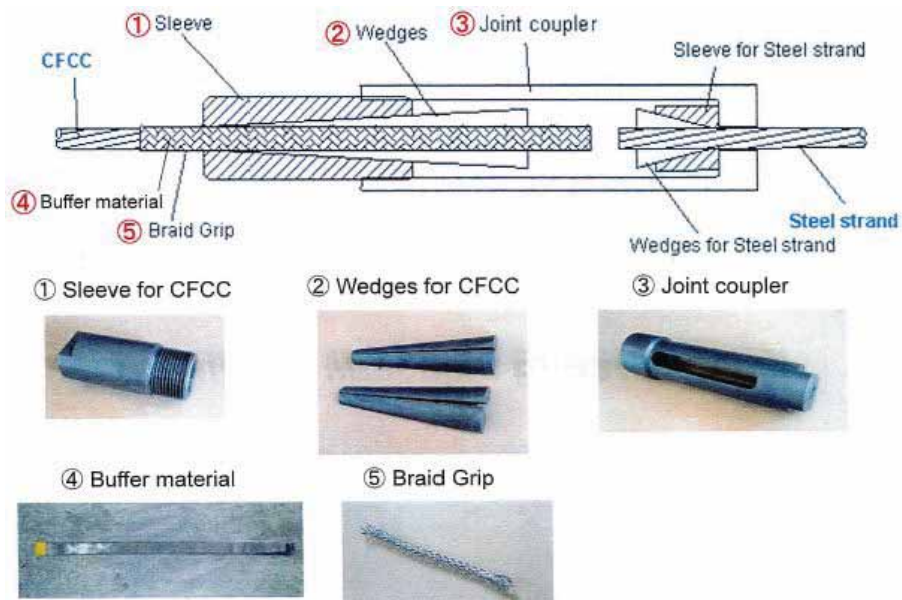
**Figure 3.3:** Tokyo Rope coupling device (Tokyo Rope CFCC handling manual)

The anchoring device was a stainless steel coupler (Figure 3.3) that is produced by Tokyo Rope. It consists of a stainless steel sleeve for the CFCC and an attached joint coupler in which to anchor the steel strand. Before Tokyo Rope manufactured this coupler, Mahmoud et al. (1999) wrapped synthetic yarns around each strand because the CFCC is vulnerable to objects gripping on it directly. Recently, Tokyo Rope introduced a steel mesh sheet (Figure 3.4) and a steel braid grip that provide friction between the CFCC and the stainless steel sleeve and also to avoid direct

contact of the wedges with the CFCC, thus avoiding mechanical abrasion. The mesh sheet comprises interlocked layers of stainless steel sheets and Polinet sheets. This provides adequate buffer to the CFCC strands and resists the bite from the wedges during seating, thus protecting the strand from getting damaged. The braided grip provides a second layer of buffering while creating frictional forces against the wedges. To anchor the conventional steel strand to the coupler, a chuck is used.

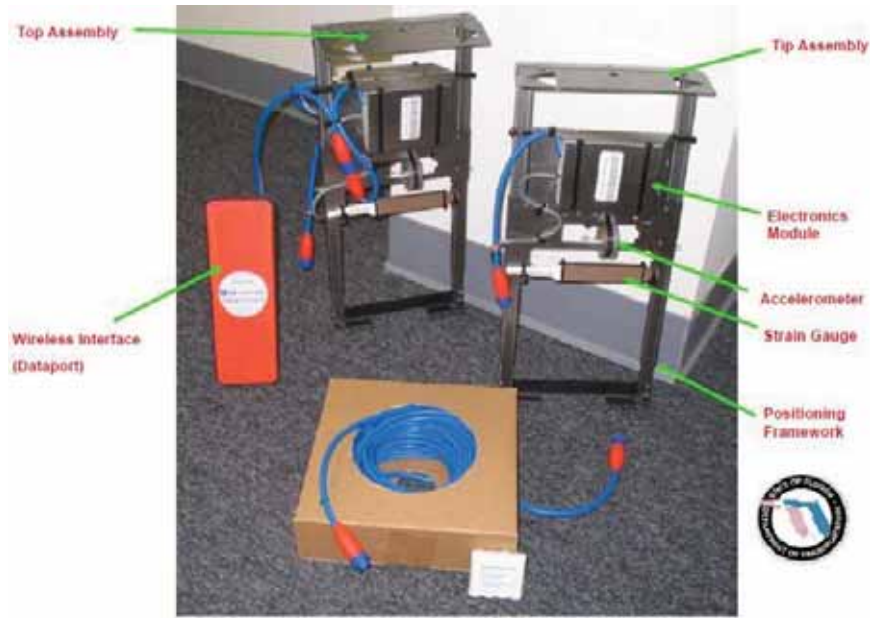
**Figure 3.7:** Typical EDC set of instruments (Source: FDOT)

Embedded Data Collectors are strain transducers and accelerometers that are embedded in a concrete member. The EDC system was developed as a result of the FDOT project, “Estimating Driven Pile Capacities during Construction” (Herrera et al., 2009). Before EDC was developed, pile monitoring during driving was done

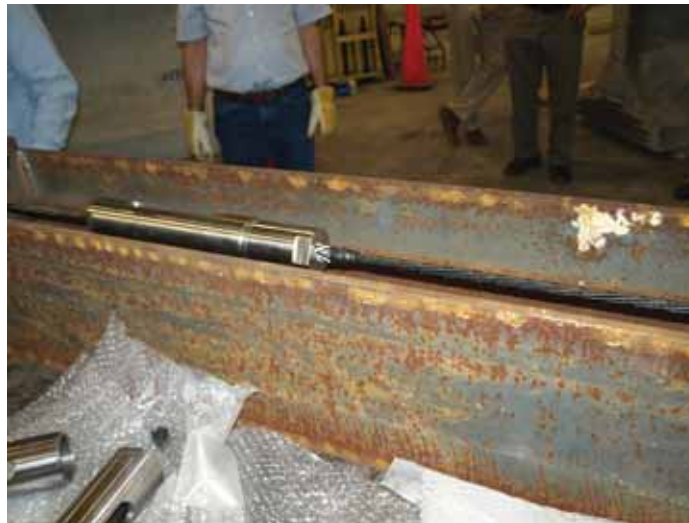
**Figure 4.1:** Setup for coupling demonstration

For the initial demonstration session, 4-ft lengths of 0.5-in. diameter CFCC strands were stressed using couplers supplied by the CFCC manufacturer, Tokyo Rope. The coupler connects the CFCC strand to a conventional steel strand. A small mock-up of the precasting bed was built by FDOT to simulate the procedures that would be used during the actual pretensioning of the pile specimens at GATE's precasting yard (Figure 4.1).

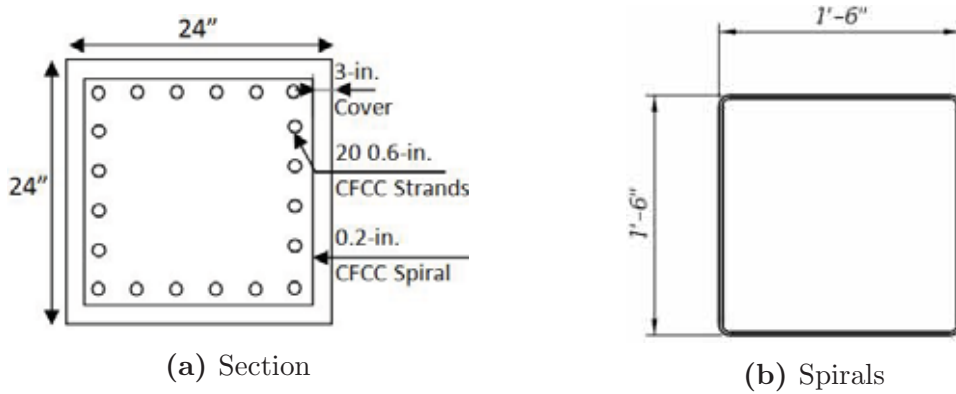
**Figure 4.2:** Section view of the pile specimens. (See Appendices A and C for manufactured dimensions.)

The prestressing strand pattern was based on FDOT’s standard details for a 24-in. square pile with 20 0.6-in. diameter (15.2-mm) strands (Figure 4.2a). The 20-strand option was chosen because of GATE’s casting bed strand template. The spirals were 5.0-mm diameter (0.2-in.) CFCC, with approximate dimensions shown in Figure 4.2b. The number of turns and pitches for the CFCC spirals was based on FDOT standards for conventional steel spirals (Figure 4.3), which is designed to provide confinement to the concrete core and to avoid premature failure at the ends due to prestress release and impact load during driving. More details of the piles are provided in Appendix C.

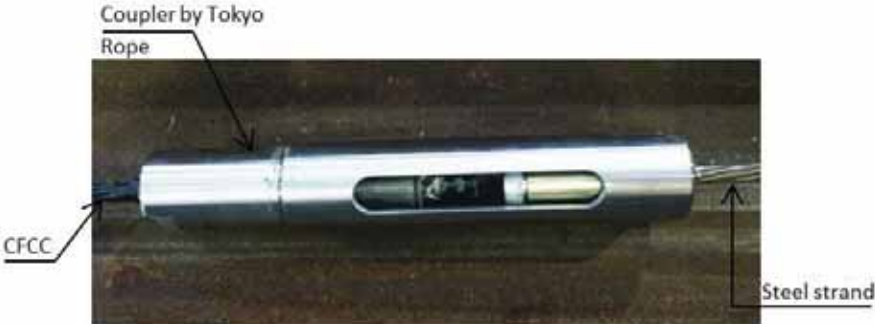
**Figure 4.15:** CFCC coupled with steel strand

The CFCC strand end with installed wedges and buffer materials was coupled to the steel strand end by twisting together the threaded ends of the sleeve and the coupler (Figure 4.14). The coupler was turned until it was taut and then drawn out by a thread, so that there would be no damage to the coupler while tensioning. Figure 4.15 is a photo of the completed installation of a coupler. Note that there should be no interaction between the CFCC and the steel strand within the coupler.

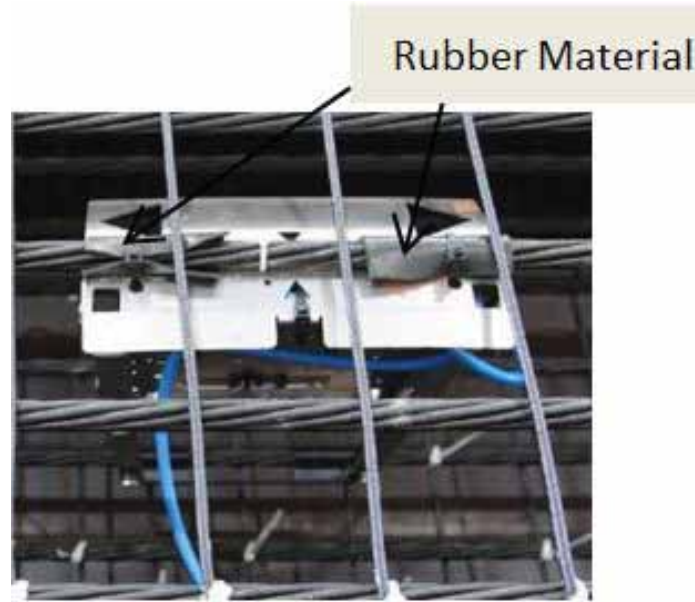
**Figure 4.21:** EDC clamped with a rubber material

The instrument set located in the center was kept clear of the lifting hooks, at 48 in. and 51 in. from the pile head for Pile No. 1 and Pile No. 2, respectively (refer to Figure 4.5 for casting bed layout). The spirals in the vicinity of the EDCs were tied to the CFCC strands after the EDC installation was complete. Figure 4.21 shows the EDC secured to the CFCC strands. The EDC was fixed using a rubber material to prevent the hard edge of the steel frame from interacting with the strands and to minimize any steel and carbon interaction. The entire setup was checked for quality

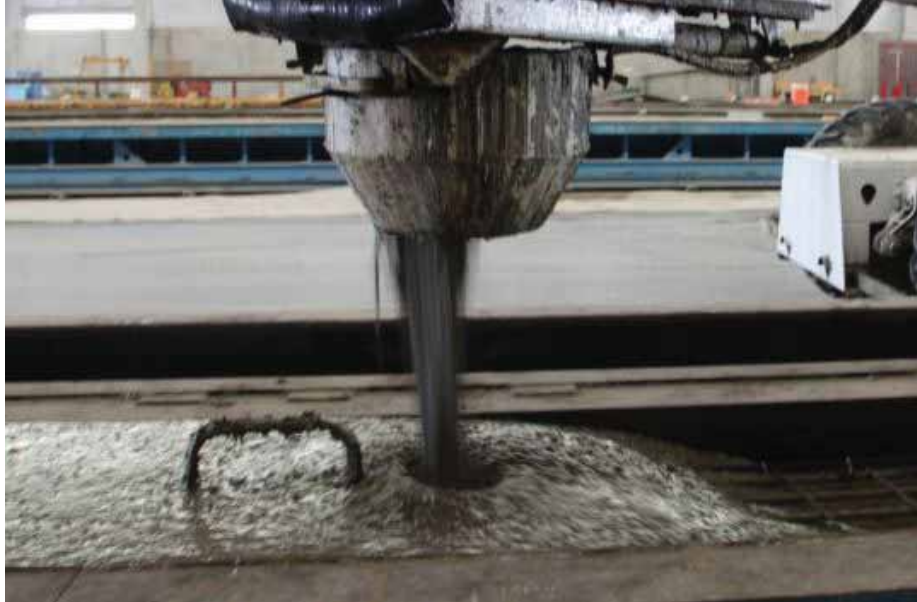
**Figure 4.22:** Casting using SCC

vibrator head and the CFCC strands. Instead, self-consolidating concrete was used so that a vibrator would not be needed during placement operations (Figure 4.22). This would avoid altogether the potential of impacting the CFCC with a vibrator.

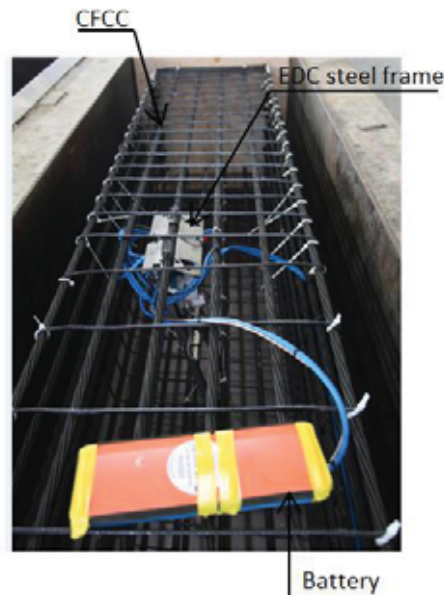
**Figure 5.4:** EDC installation

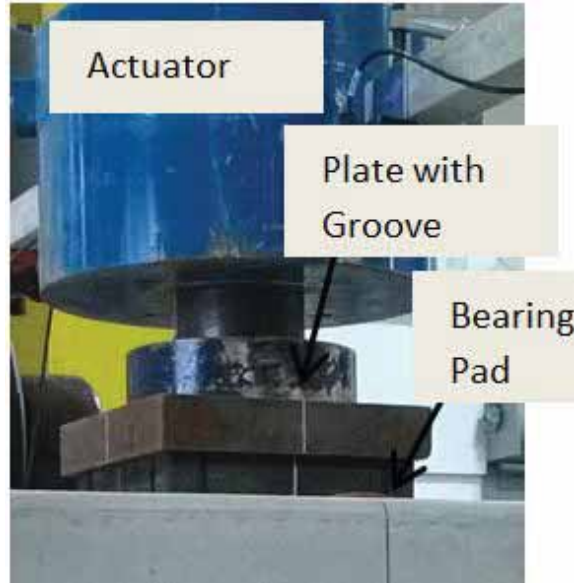
**Figure 5.6:** Loading setup

Test parameters are summarized in Table 5.1. For the development length tests, parameters were chosen to ensure the structural integrity of the cantilever end of the beam, so that two (2) experiments could be performed on one (1) pile specimen. Test P-6-22 Dev, for example, indicates a pile specimen tested for development length of strands, having an embedment length of 6 ft and a cantilever length of 17 ft. After the first test was completed, approximately 6.5 ft of the pile’s tested/damaged end

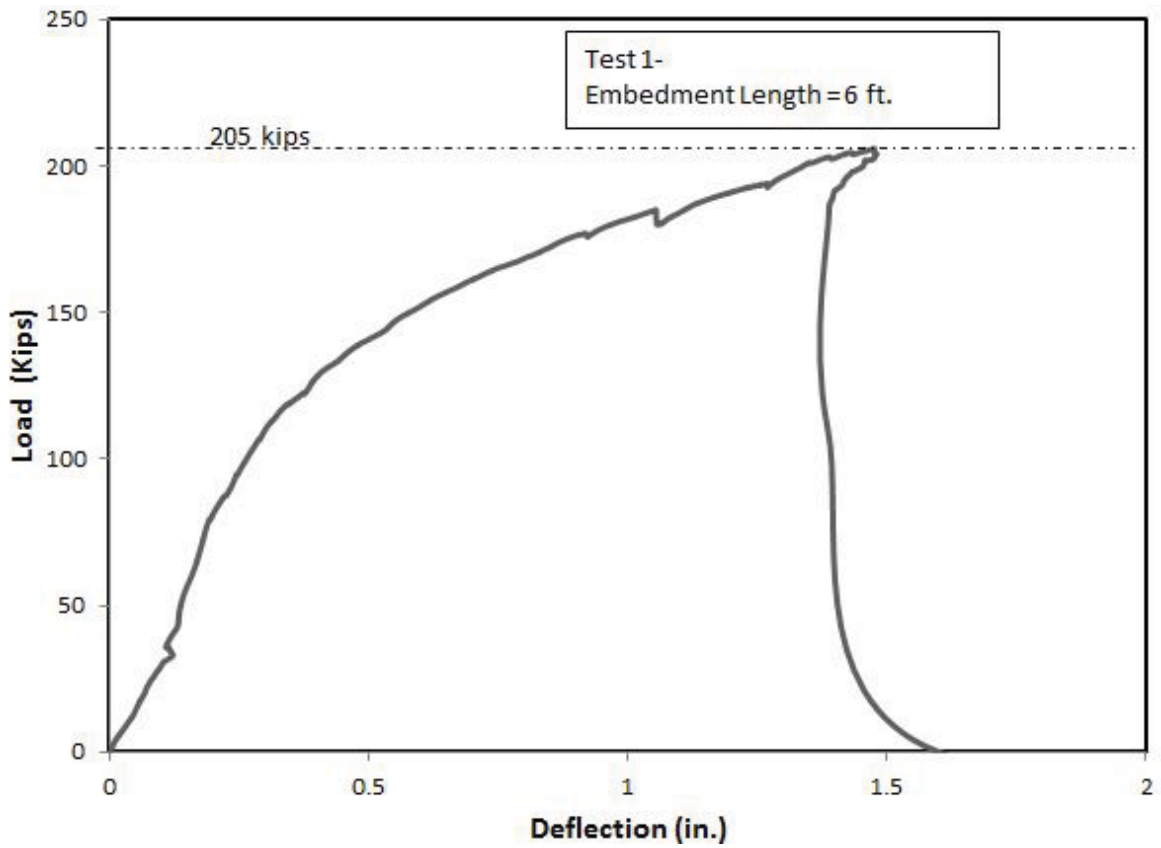
Figure 6.15: Load vs. Deflection for Test 1

The pile specimen was prepared for testing as explained in Chapter 4. For the first test, the embedment length was 6 ft, the simply-supported span length was 22 ft, and the cantilever length was 17 ft. The plot of applied load versus deflection, calculated from the average of deflection gages D3 and D4 adjacent to the applied load, is shown in Figure 6.15. The first flexural crack was observed at a load of 175 kips and extended up to 2 ft from the load point to the free end of the pile. The flexural cracks had propagated to 4 in. from the top fiber. The load was applied until failure occurred at 205 kips. The final crack pattern is shown in Figures 6.16 and 6.17. The maximum top fiber strain in the vicinity of the load point at failure was 0.0012. The applied load versus the average strain in the four (4) gages around the load point (Figure 5.7) is shown in Figure 6.18. During loading, one of the strain gages next to the load point location gave erroneous data at 40 kips, but after 43 kips, both the strain gages gave similar readings. There was no observable strand end slip on any of the four (4) instrumented CFCC strands throughout the test.

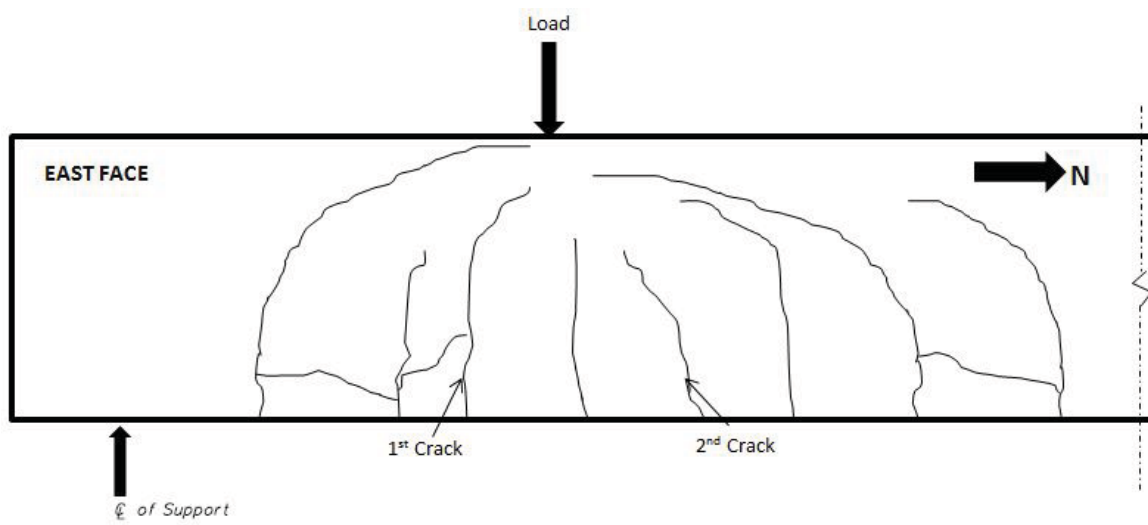
Figure 6.16: Failure crack pattern on east face for Test 1

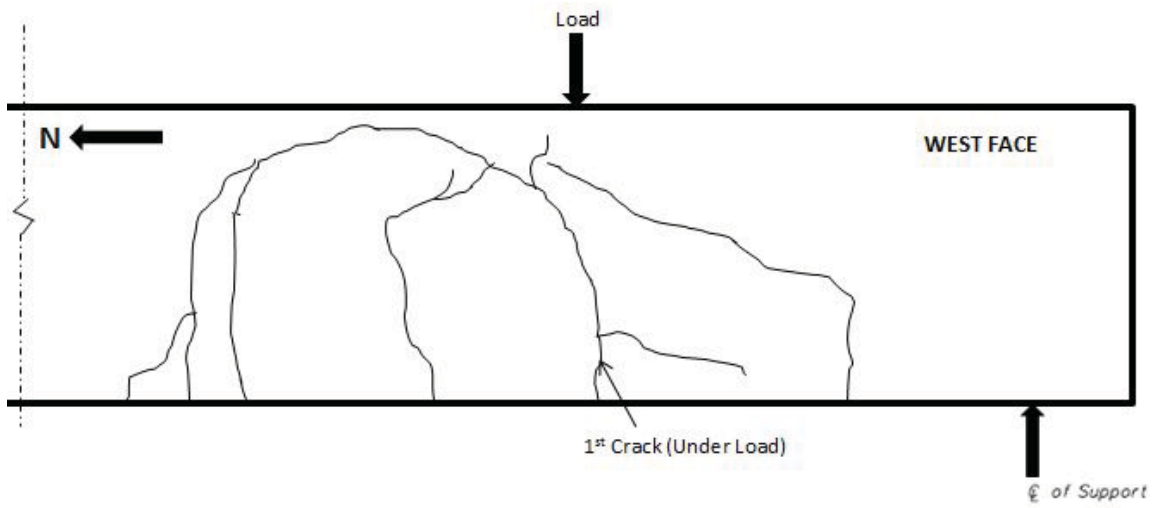
Figure 6.17: Failure crack pattern on west face for Test 1

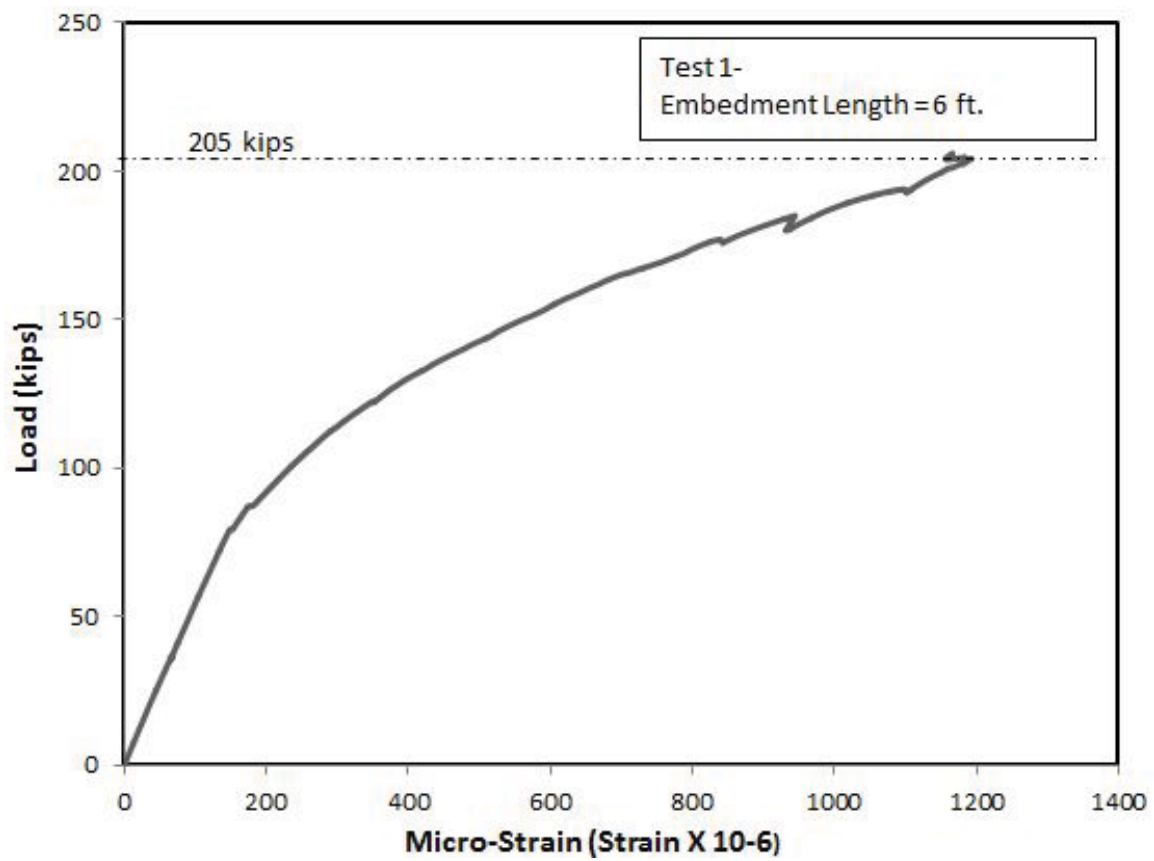
Figure 6.18: Load vs. Strain for Test 1

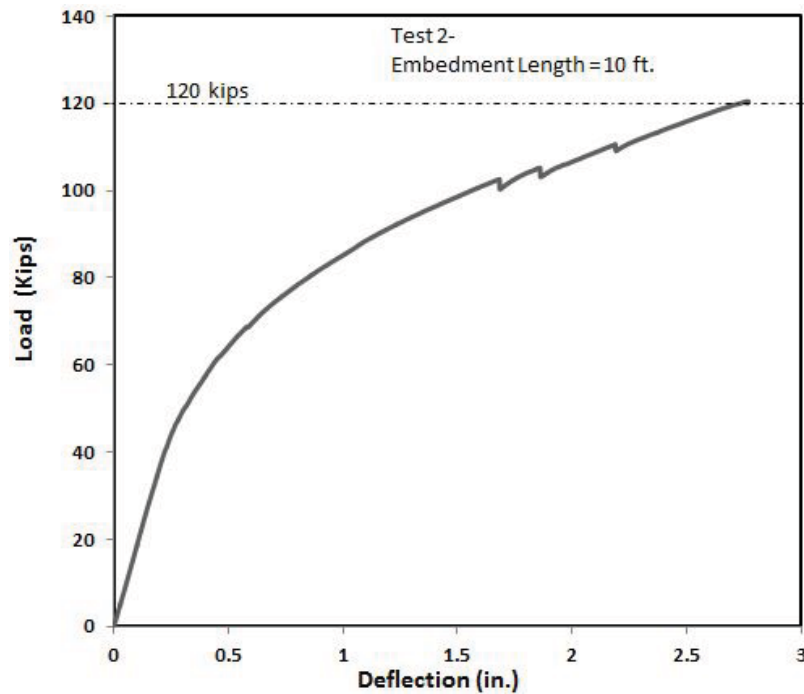
Figure 6.19: Load vs. Deflection for Test 2

The pile specimen from Test 1 was used again for Test 2. The structural integrity of the cantilevered end from the Test 1 setup remained undisturbed throughout Test 1, so this pile end (opposite the tested end from Test 1) was used to perform Test 2. For this second test, the embedment length was 10 ft, the simply-supported span length was 27 ft, and the cantilever length was approximately 5.5 ft. The loading procedure was similar to Test 1, as were the strain gage and deflection gage layouts. A plot of applied load versus deflection, calculated from the average of deflection gages D3 and D4 adjacent to the applied load, is shown in Figure 6.19.

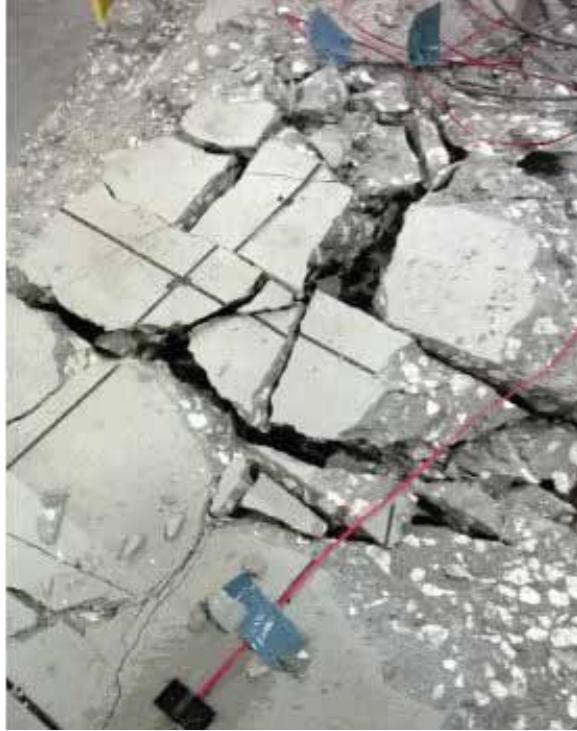
Figure 6.20: Concrete crushing at top in Test 2

The first flexural crack occurred at a load of 101 kips, on the bottom of the pile under the load application point. The cracks propagated up to 3 in. from the top fiber and extended up to 3 ft from the load point towards the free end of the pile. The test resulted in a flexural failure at a load of 120 kips and a deflection of 2.8 in. The maximum strain in the top fiber in the vicinity of the load point at failure was 0.00138. Local concrete crushing occurred on the top of the pile near the load point at failure (Figure 6.20). Sketches of the crack patterns on the east and west faces are shown in Figures 6.21 and 6.22. There was no observable strand slip in any of the four (4) instrumented CFCC strands throughout the test.

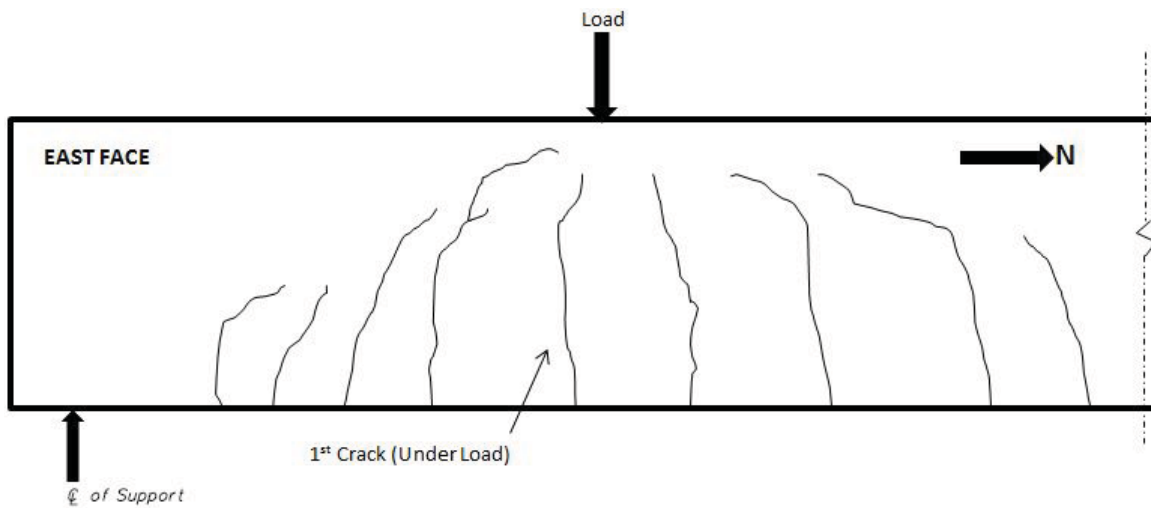
Figure 6.21: Failure crack pattern on east face for Test 2

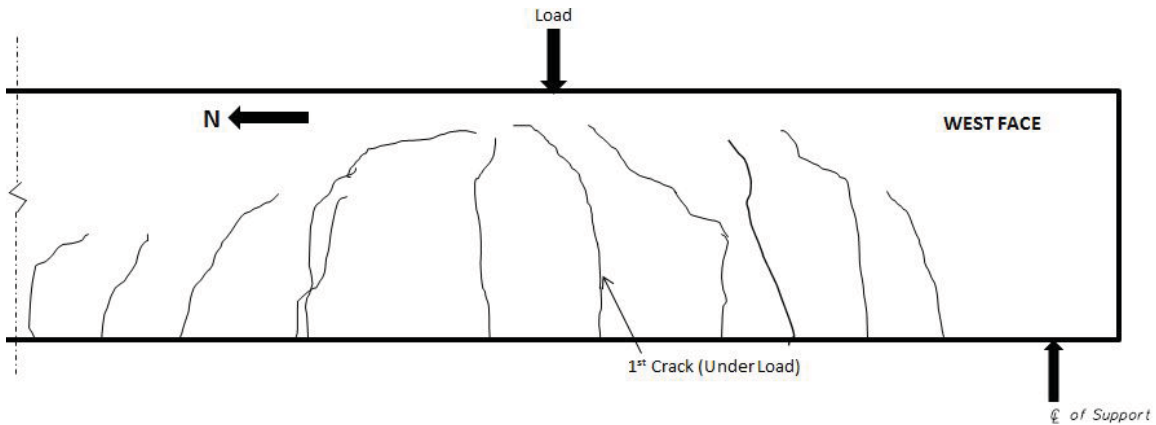
Figure 6.22: Failure crack pattern on west face for Test 2

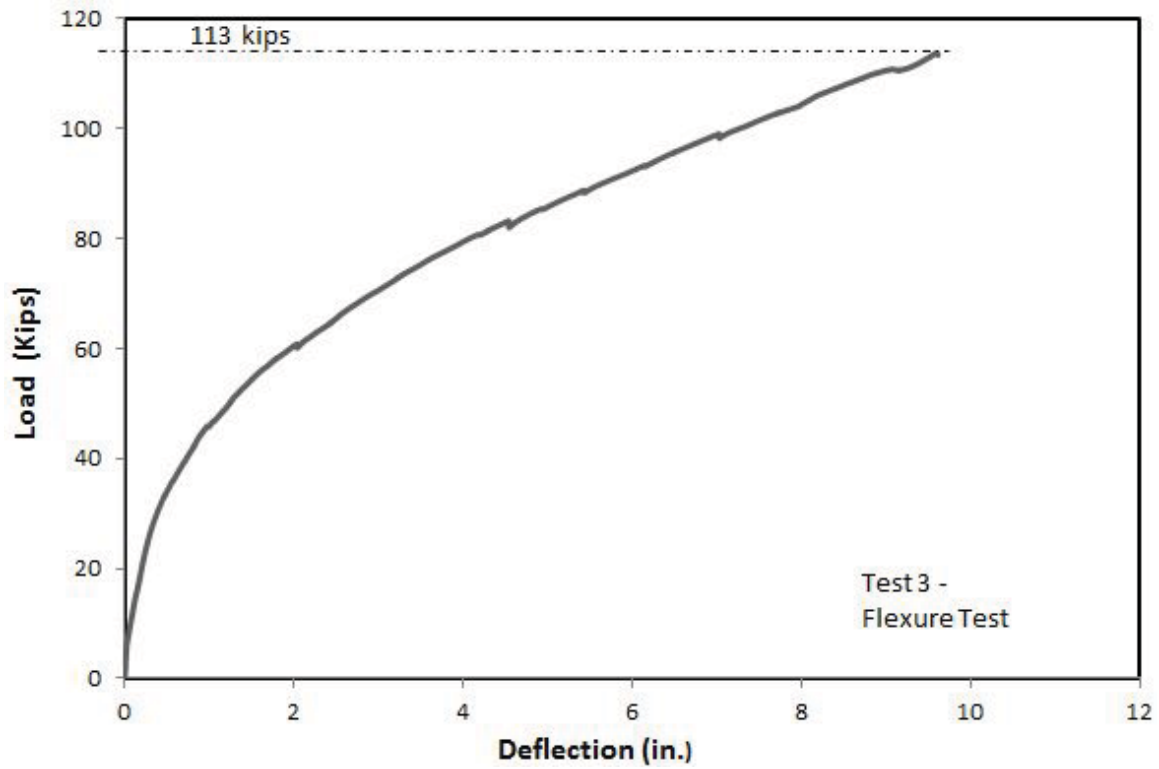
Figure 6.23: Load vs. Deflection for flexure test

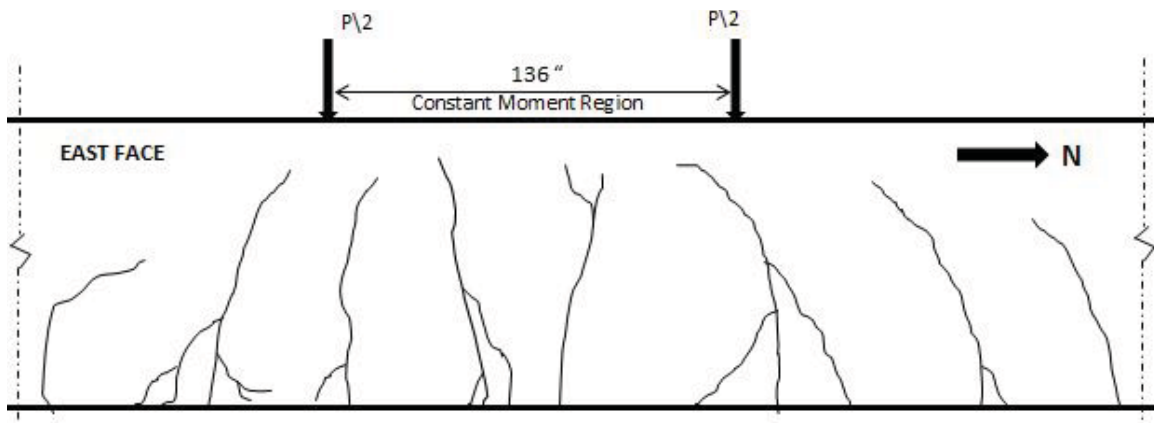
Figure 6.24: Failure crack pattern on east face for flexure test

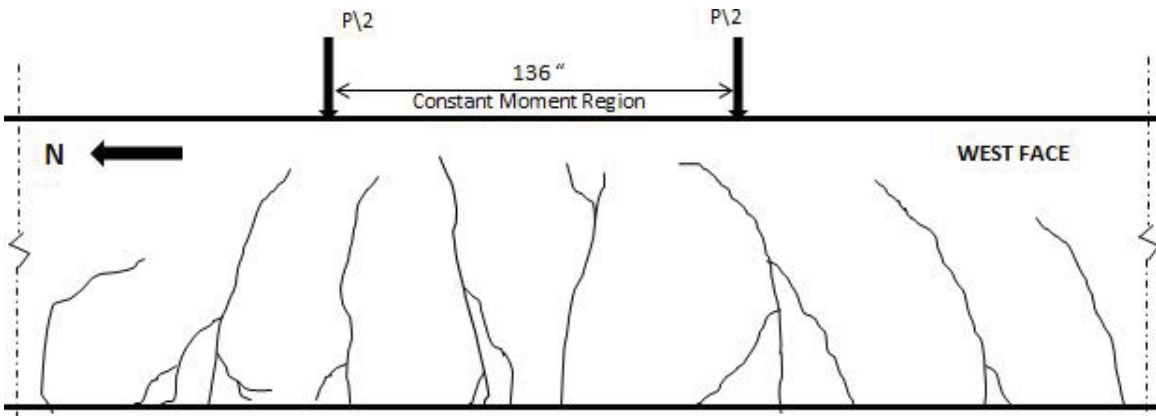
Figure 6.25: Failure crack pattern on west face for flexure test

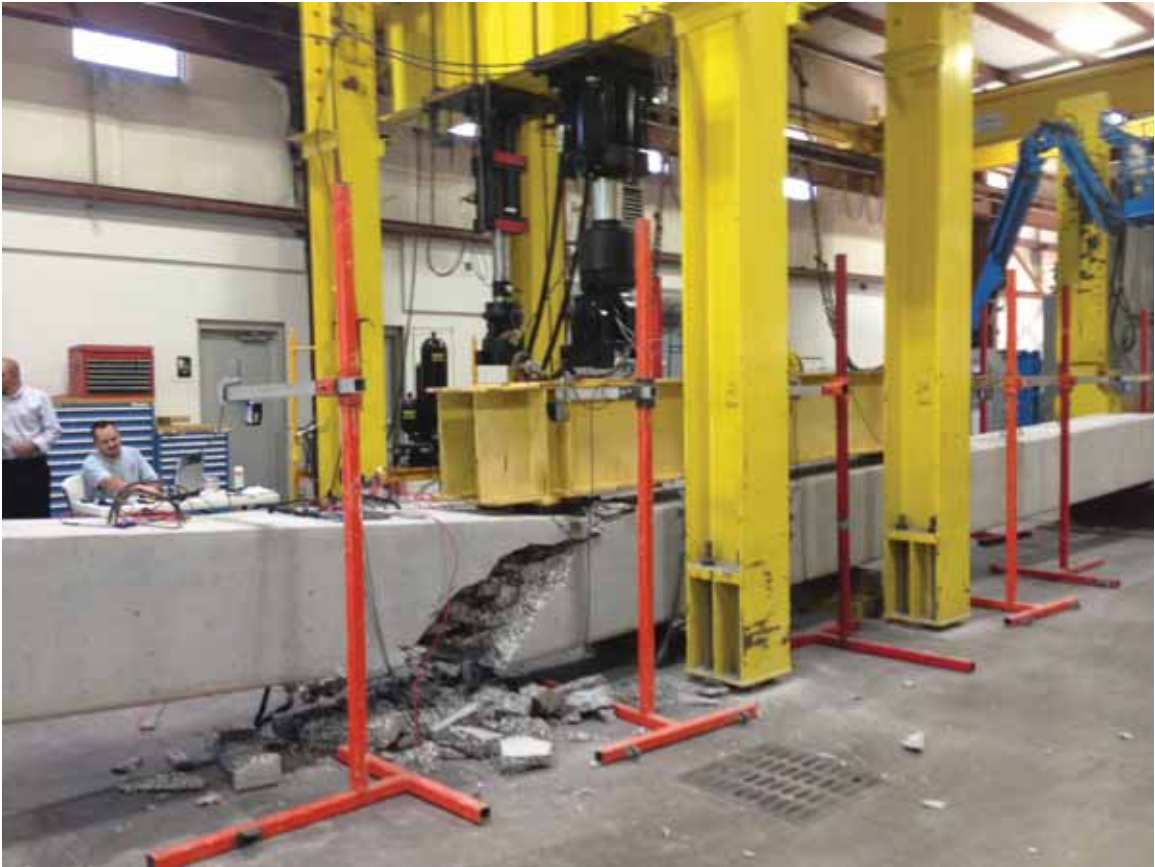
Figure 6.26: Failure under one of the load points

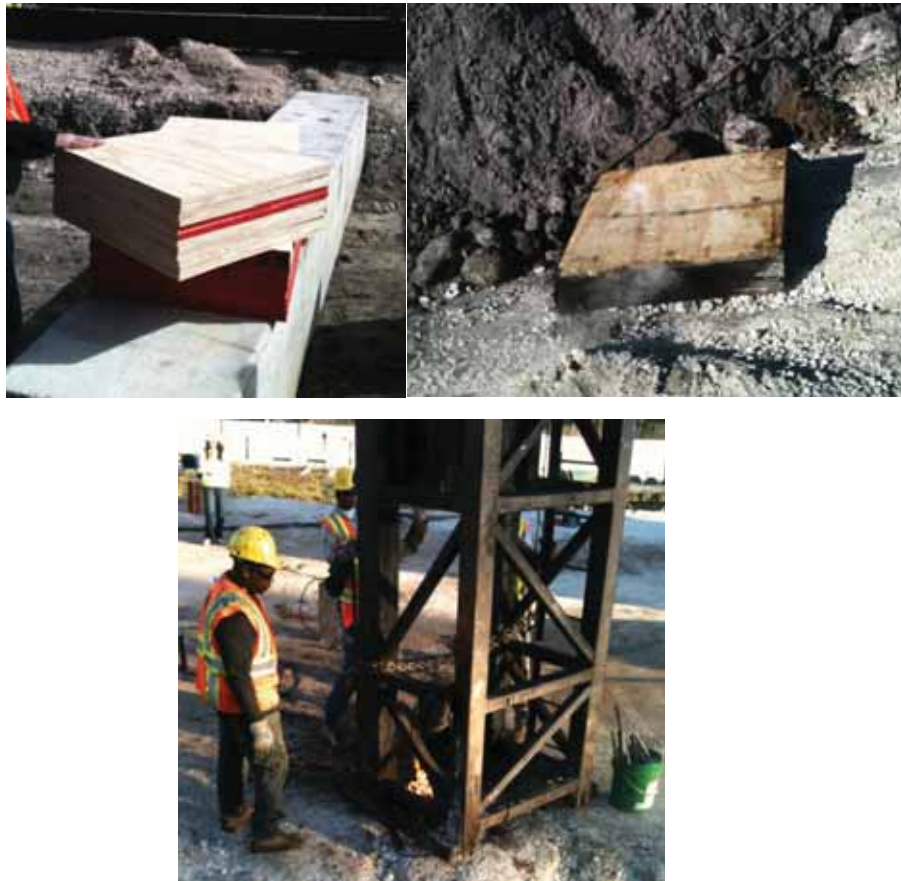
Figure 3 –Pile Cushions

The initial pile cushion experienced approximately 50 percent compression from its original thickness during the drive, and a slight eccentricity in the hammer strike was noted by the difference between the average stress (CSX), and the maximum stress recorded by an individual set of gages on one face of the pile (CSI) using the PDA system. No visible cracks were noted on the pile during this time. At approximate pile tip elevation -24 ft. pile driving was stopped to replace the pile cushion and remove the guide bars in the template, to allow continued driving without damaging the externally attached instrumentation. Upon resuming driving operations it was noted that the eccentricity on the strike had improved and a more even distribution of stress was recorded, as shown in Figure 4. The pile was subjected to a total of 2765 blows.

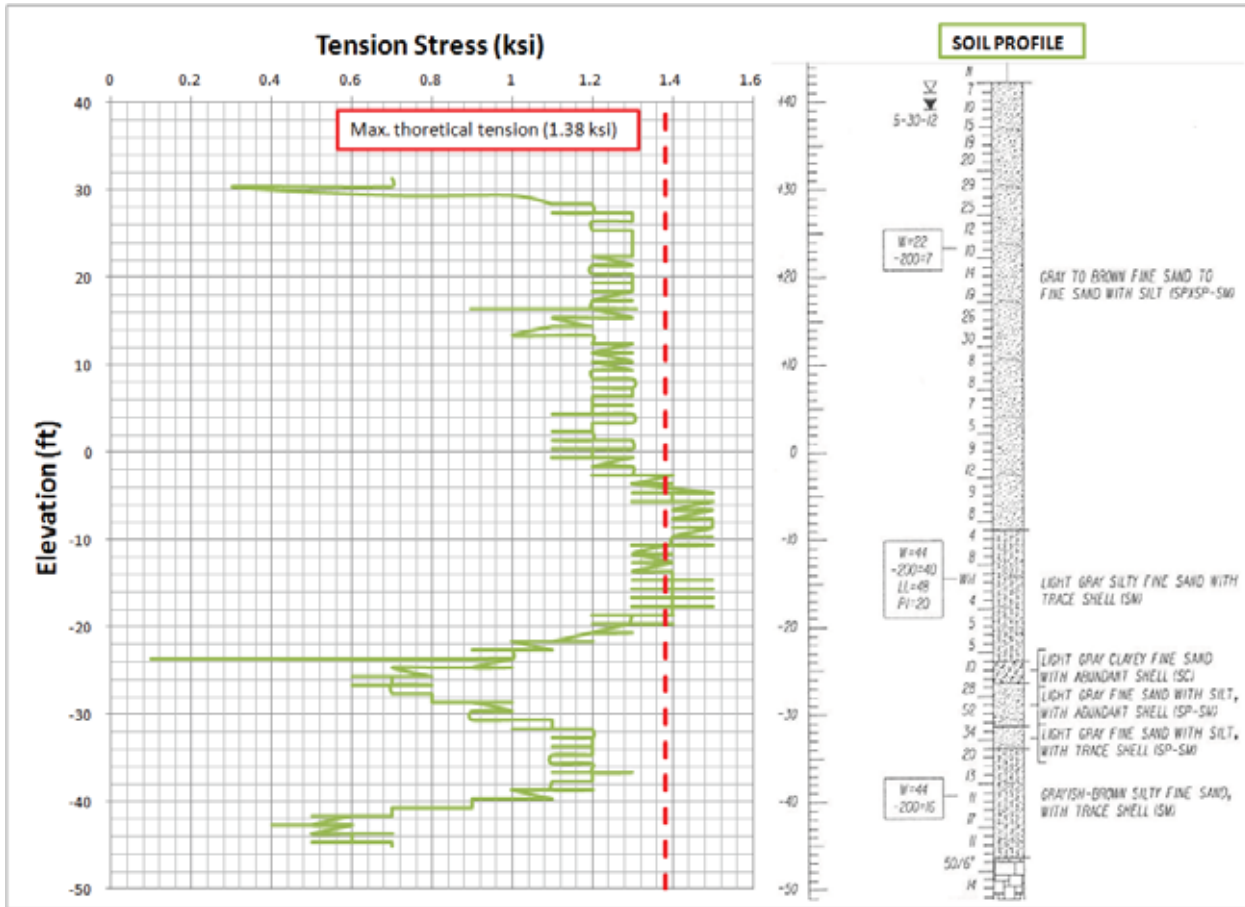
Figure 6 – PDA Tension Stress and Soil Profile

As shown in Figure 6, the theoretical limit on tension was exceeded (slightly) in portions of the drive between elevation -6.0 and -18.0 ft. without any visible cracking along the pile. As anticipated, high tensile stresses were induced as the pile tip entered a weaker layer in the profile, with SPT “N” blow count in the single digits and weight of hammer conditions.

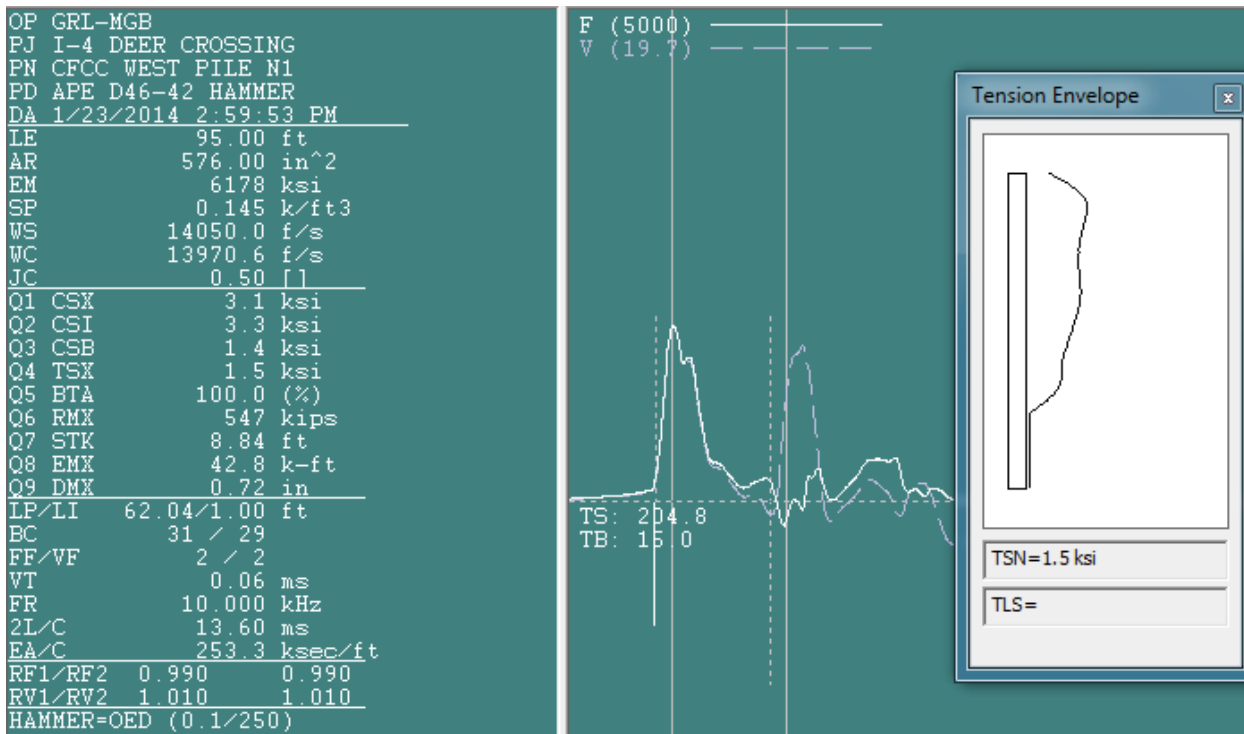
Figure 7 – PDA Screen Capture and Tension Envelope

Figure 7 provides a general picture of the estimated tension envelope along the pile at blow number 790 at approximate tip elevation -8.6 ft., indicating high tension values in the upper two-thirds of the object. It should be noted that production pile driving at this level of stress would not be continued without modifications (e.g., lower stroke, increased pile cushion) as it would be in violation of the Specifications.
