# Investigation of Carbon Fiber Composite Cables (CFCC) in Prestressed Concrete Piles

Contract Number BDK83-977-17

**Florida Department of Transportation**

April 2014

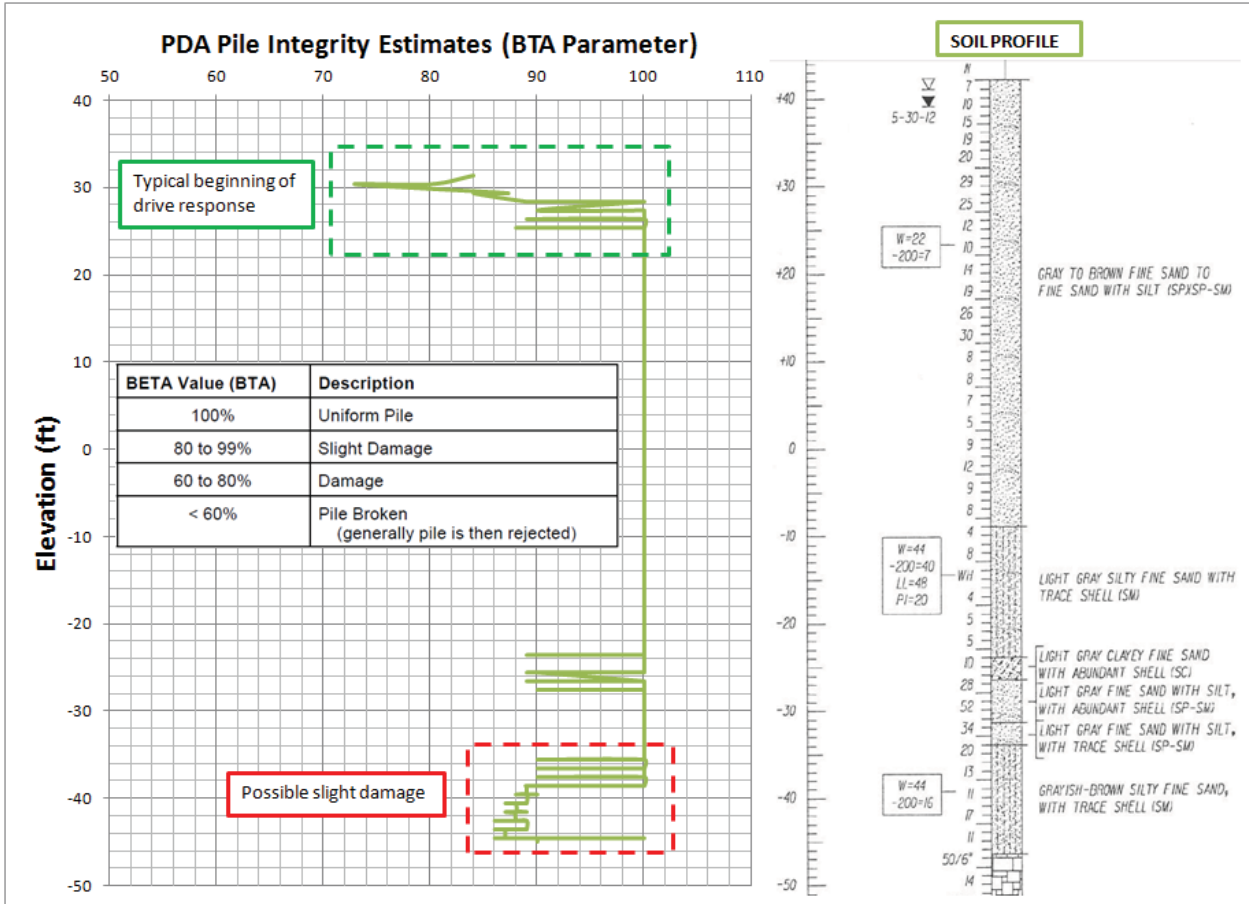
Figure 8 – BTA Parameter

Relatively minor changes in BTA (in the neighborhood of 10%) can be the result of non-uniform resistance as the pile goes through layers of varying magnitudes of friction and could have caused the readings obtained by the PDA. The conservative assumption based on the proposed relationship between damage and BTA included in Figure 8, is that slight damage may have occurred near the pile tip beginning at blow number 2400 (approximate elevation -34.5 ft.), where the recorded BTA values went below 90%. As shown in Figure 8, the slight damage (87%) is estimated to have taken place at a depth of approximately 80 feet below the location of the instruments, or 15 feet above the pile tip as shown in Figure 9.

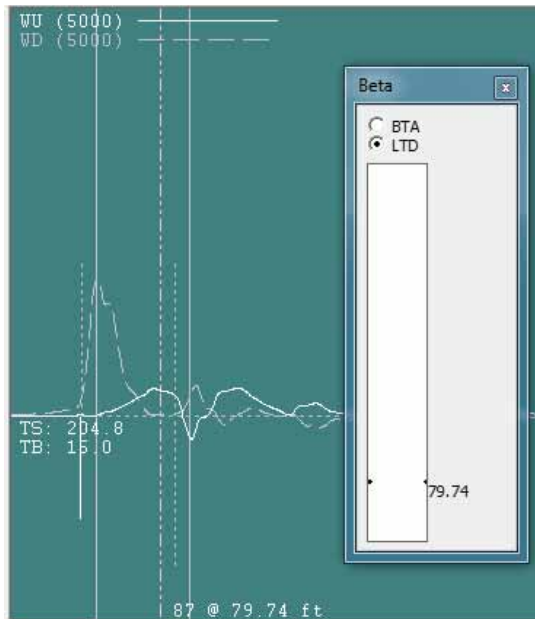
Figure 9 – Wave-down / Wave-up Traces and Estimated Depth of Slight Damage (79.74' below gauges)

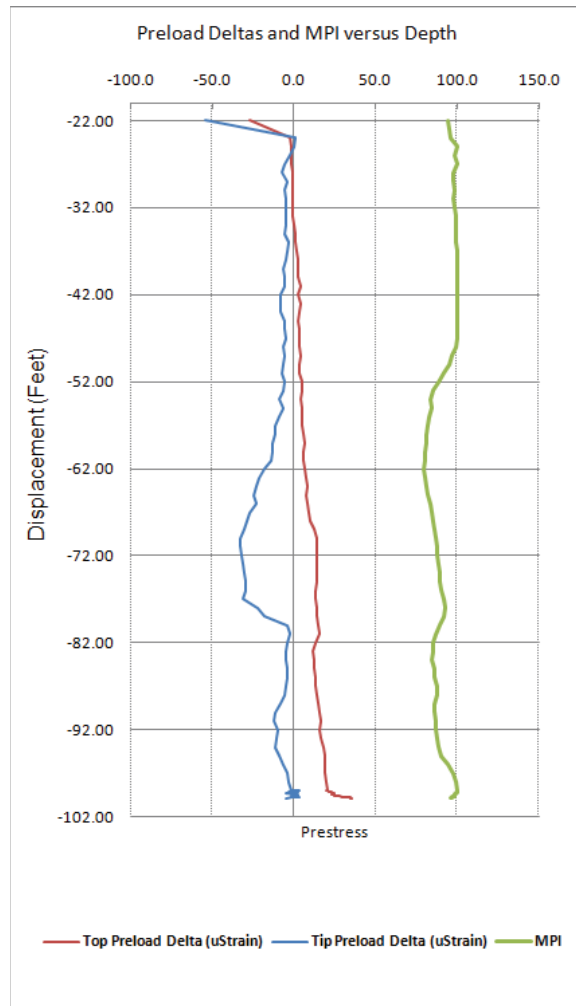
Figure 10 – EDC MPI Record (Green Line)

Based on the readings obtained from both PDA and EDC it can be concluded that the pile did not suffer any major damage during the drive in terms of integrity or pre-stress level, other than the observed spalling at the pile head during the last few hammer blows.

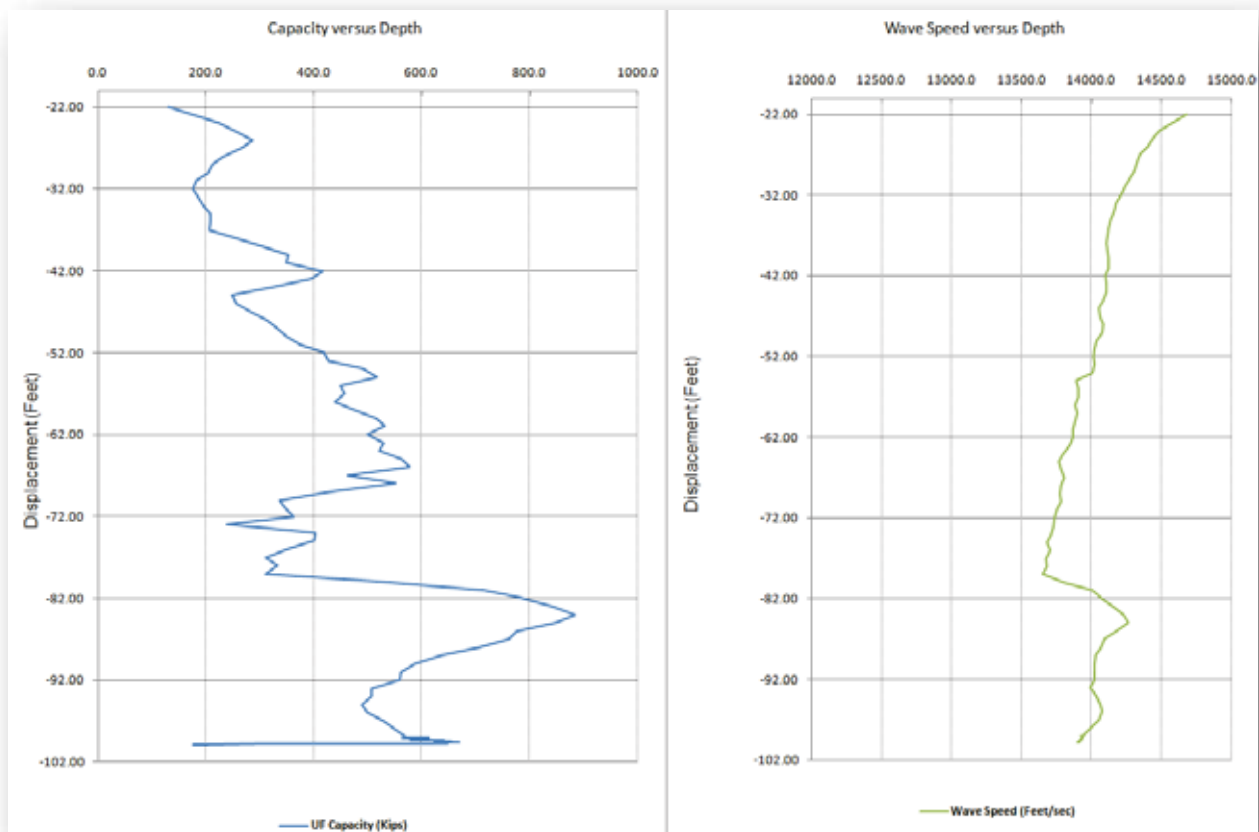
Figure 11 – Pile Resistance and EDC Estimated Wave Speed vs. Depth

As the pile enters the bearing layer, the final portion of the drive shows a relative increase of the wave speed to approximately 14,200 ft/s as the horizontal cracks close in compression and allow the wave to travel unimpeded, followed by a slight decrease towards the end of the drive. Although the calculated wave speeds appear to be larger than normal, the relative variations suggest the development of micro-cracks, which has also been observed in conventionally reinforced piles.

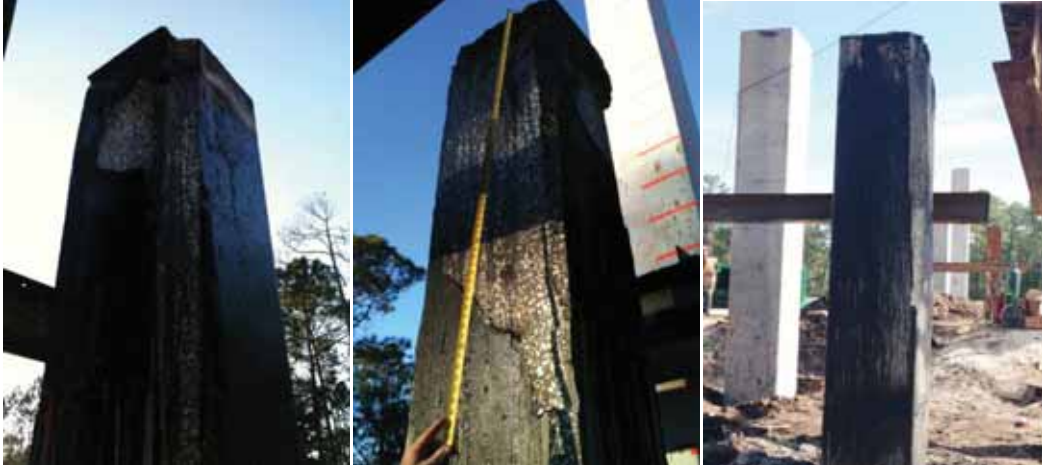
Figure 12 – Diesel Covered Pile with Spalled Sections

Towards the end of the drive the second pile cushion was no longer capable of providing adequate protection and the concrete at the pile head spalled as shown in Figure 12. Driving was stopped at that point.

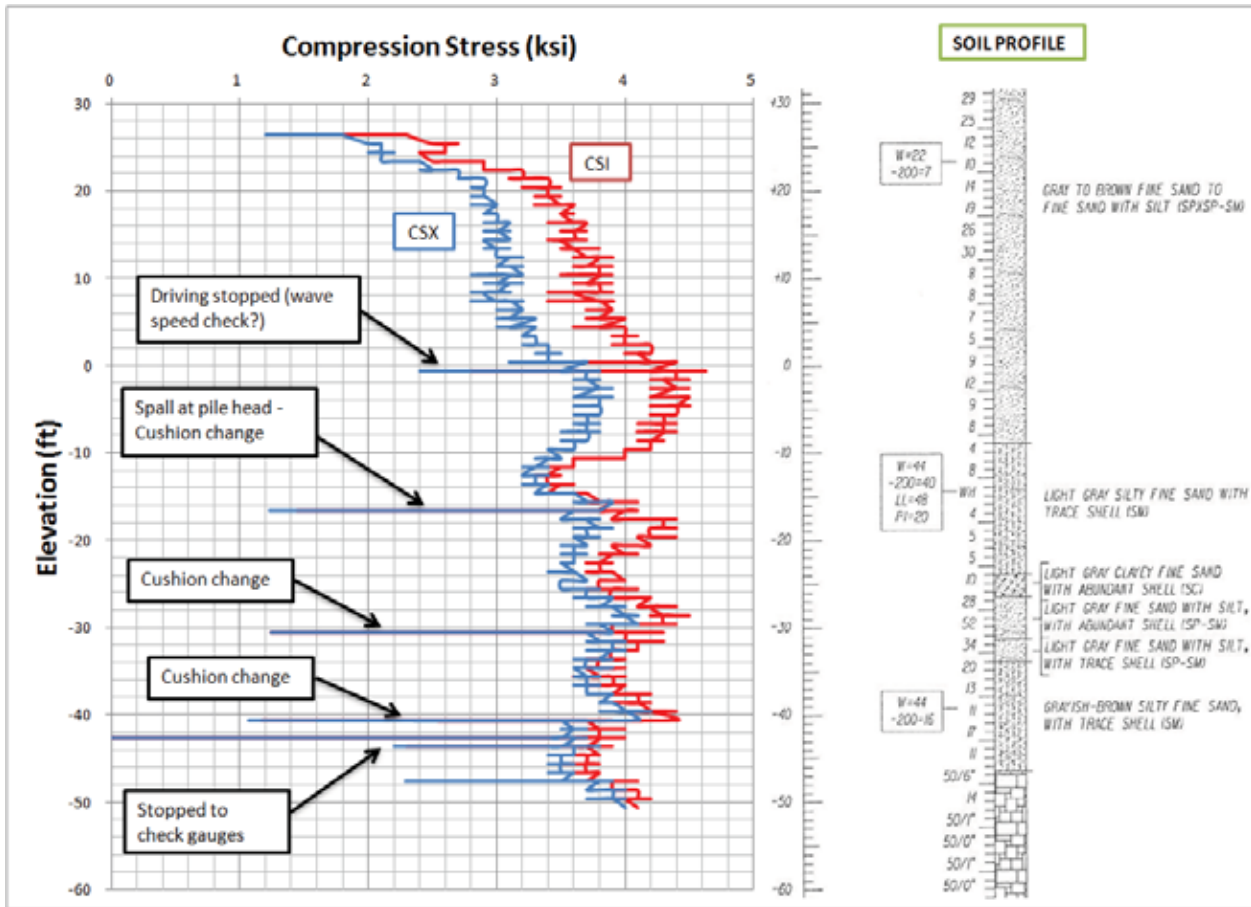
Figure 13 – Average (CSX) and Maximum Compression Stress (CSI) at the Pile Top During the Drive

Eccentricity of the hammer strike was recorded by PDA, and persisted with some improvement upon the subsequent two pile cushion changes as seen on Figure 13. As with the previous pile, the compressive stress delivered to the pile head did not approach the theoretical limit of 6.25 ksi, however it should be noted that the pile inspector’s log indicates that concrete spalled at the pile head immediately prior to the first change in cushion at approximate pile tip elevation -16.5 ft. It is possible that the continued hammering of the pile under eccentric loading with a thin pile cushion was the cause of the noted damage. No additional spalling was recorded in the field log.

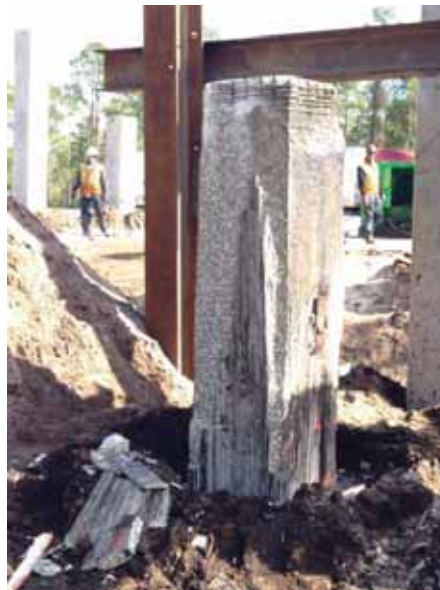
Figure 14 – Spalling near the Top of Pile N2

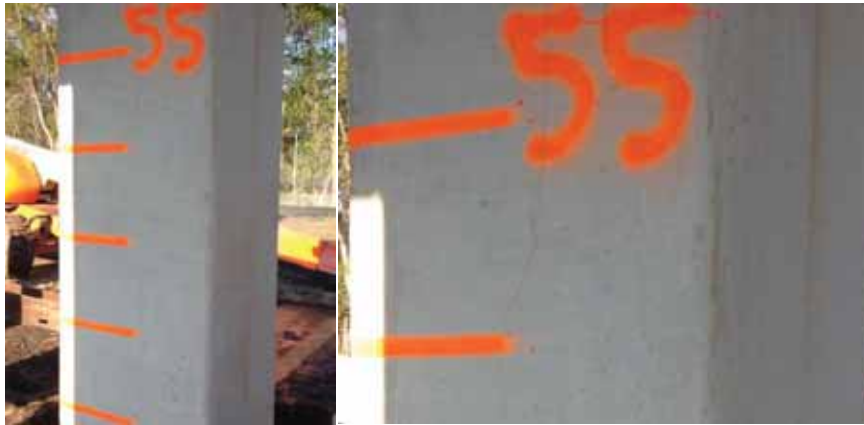
Figure 15 – Vertical Crack and Close up

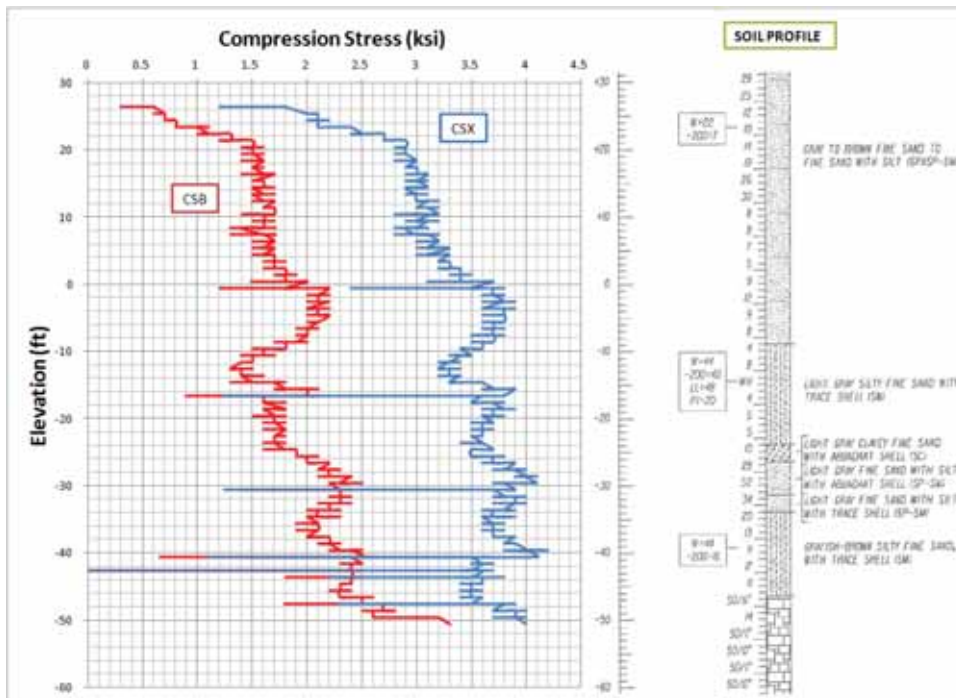
Figure 16 – Tip (CSB) and Top (CSX) Compression for Pile N2

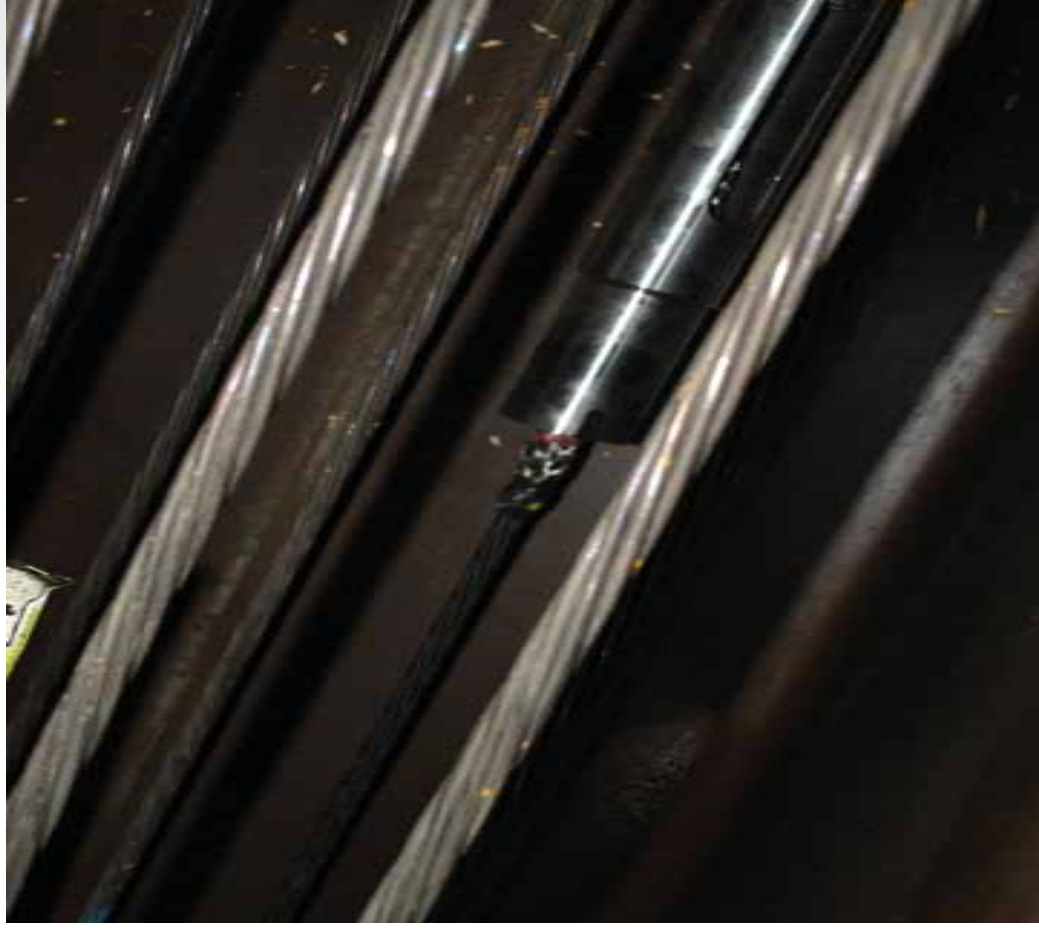
Photos taken after Strand #15 slipped out of coupler.

- After the first strand (#15) was stressed to the final force, elongation was measured at the jack. The measured elongation matched well with the theoretical.
- The second strand (#13) was stressed to the final force.
- While the jack was about to be installed on the third strand, the first CFCC strand slipped out of the coupler with the braided grip and mesh sheet still attached to the strand.
- Due to safety concerns, further stressing activities were stopped.
- The second strand was torch-cut to release the tension force.
- The cutting and the initial coupler failure resulted in damage to the spirals and also minor damage to the surrounding strands.

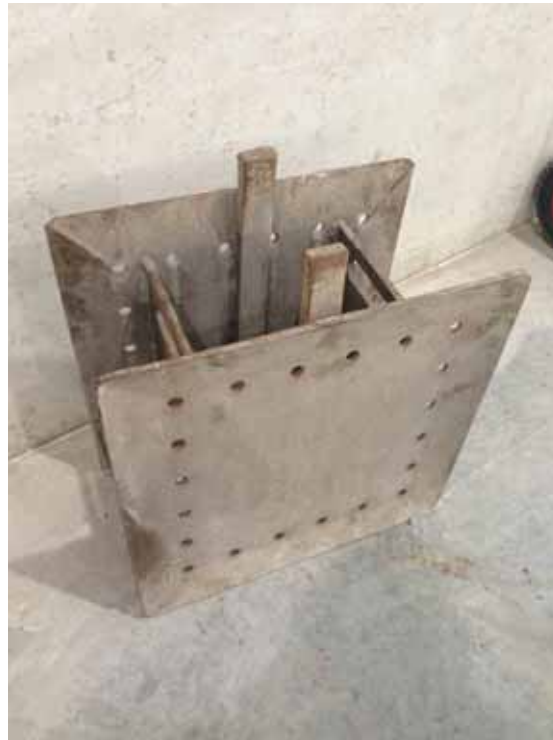
**Figure H.2:** Steel header used for a conventional steel-prestressed concrete pile (Replaced by wooden header for this research)

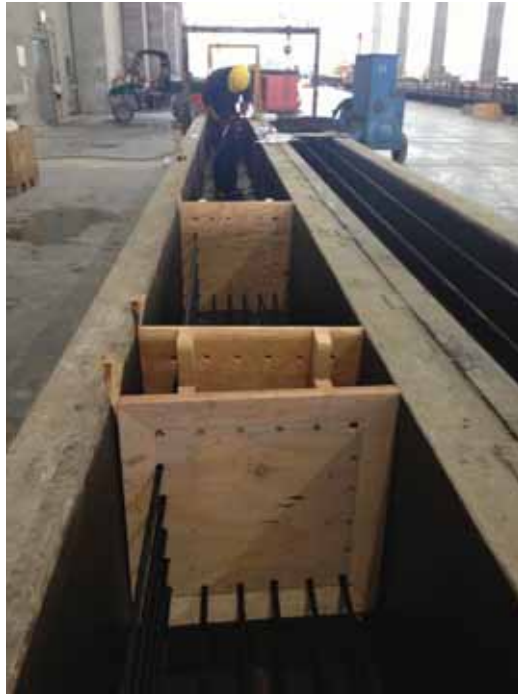
**Figure H.3:** View of precasting bed, showing wooden headers

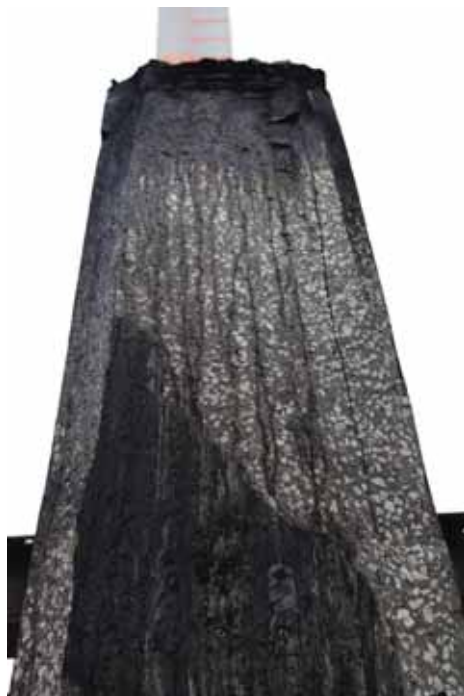
**Figure H.34:** Concrete spalling on head of Pile 1 after being driven

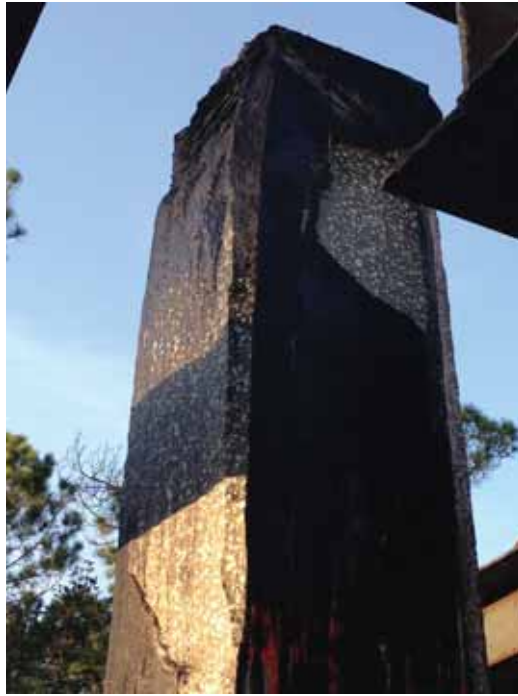
**Figure H.35:** Leaked diesel and concrete spalling on head of Pile 1 after being driven

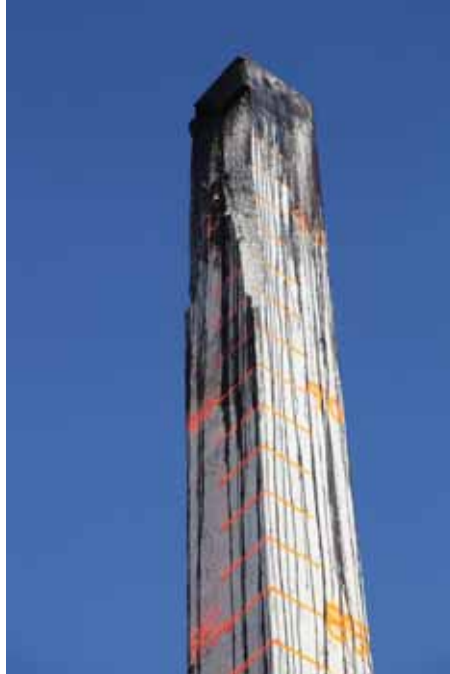
**Figure H.37:** Concrete spalling on head of Pile 2 during driving

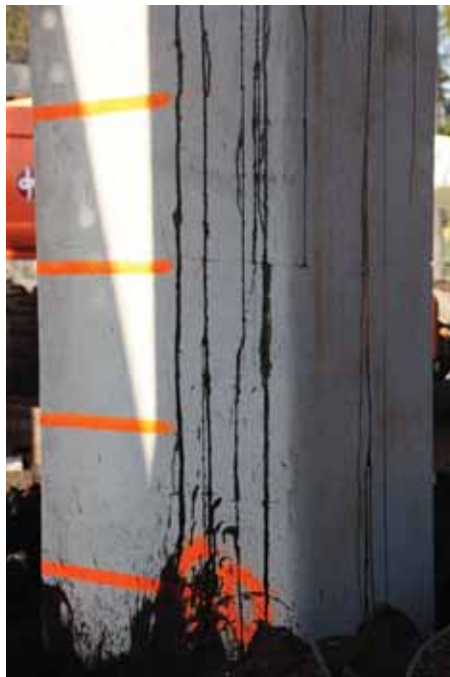
**Figure H.38:** Horizontal (tension) crack in Pile 2

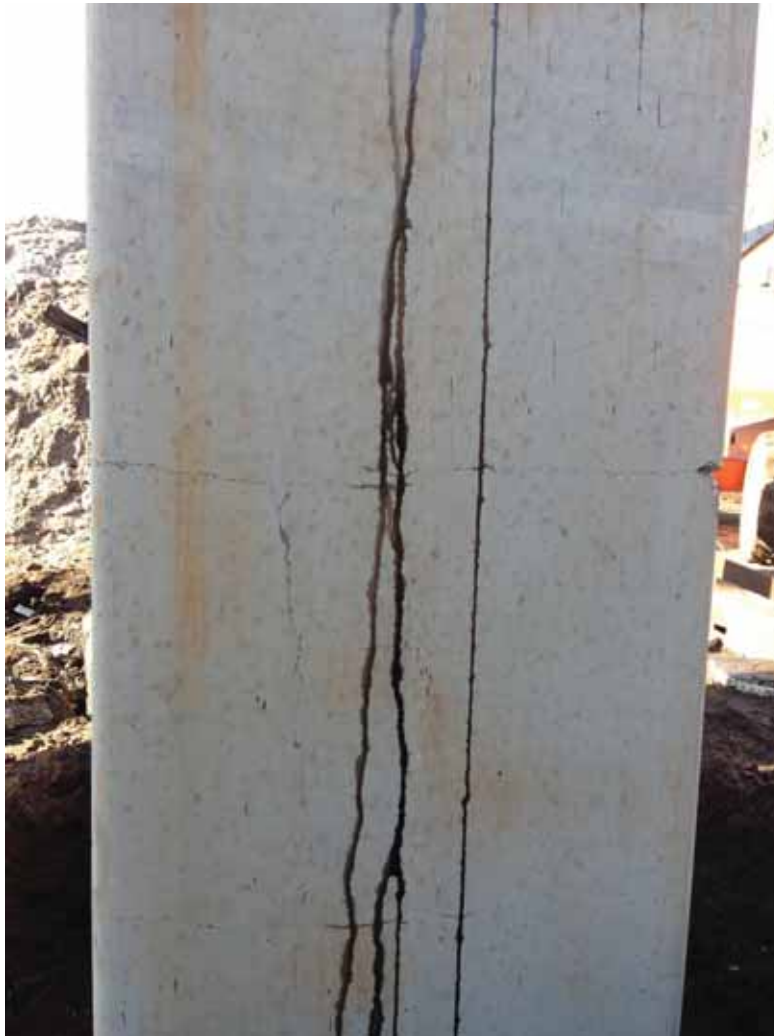
**Figure H.39:** Horizontal (tension) crack in Pile 2, on other side
