**Seismic Performance of an I-Girder to  
Inverted-T Bent Cap Connection**

**Submitted to the  
California Department of Transportation  
Caltrans Project: 05-0160**

**SEPTEMBER 2011**

**Final**

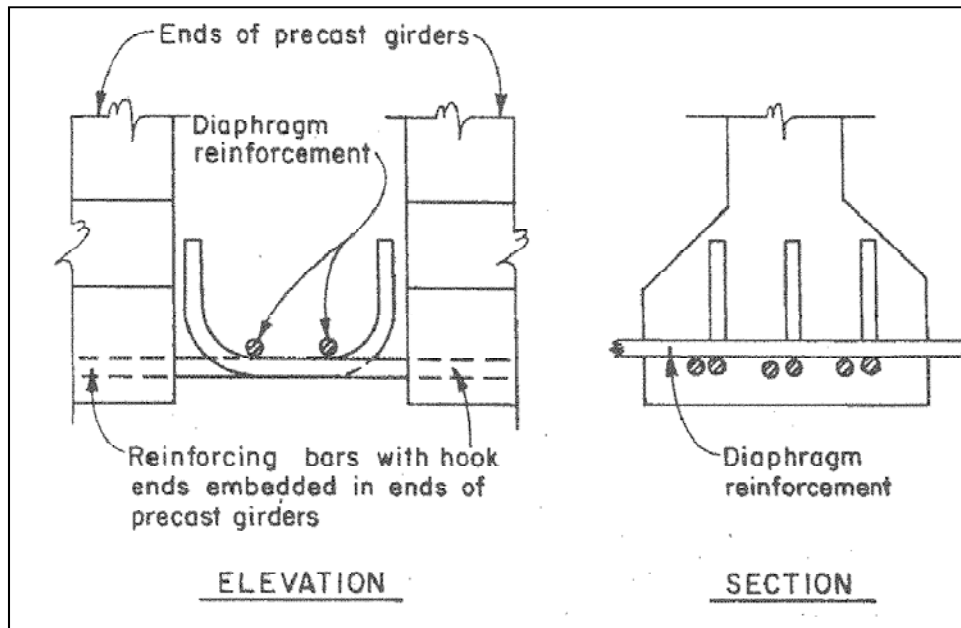
Figure 2.1. Connection Selected for Testing by Freyermuth (1969)

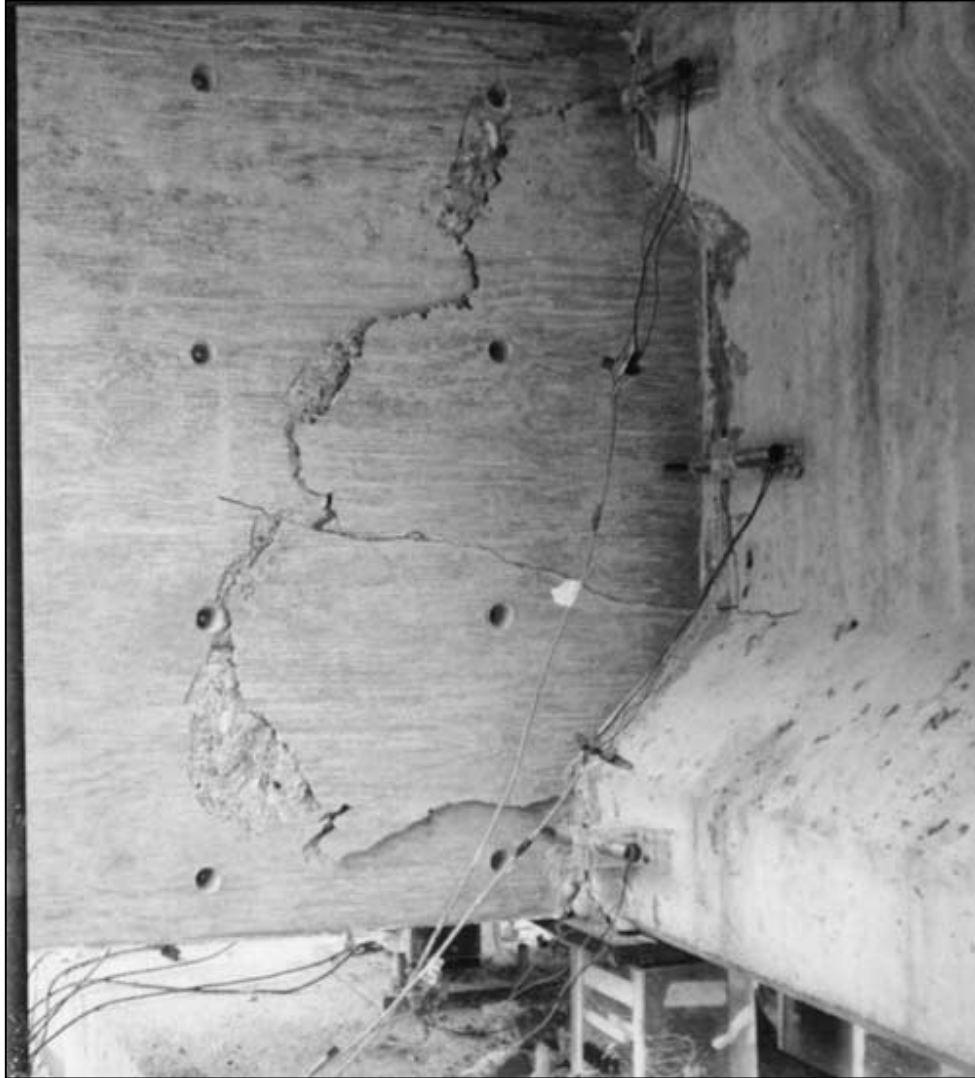
Figure 2.2. Diaphragm Cracking from Positive Moment (Hastak et. al., 2003)

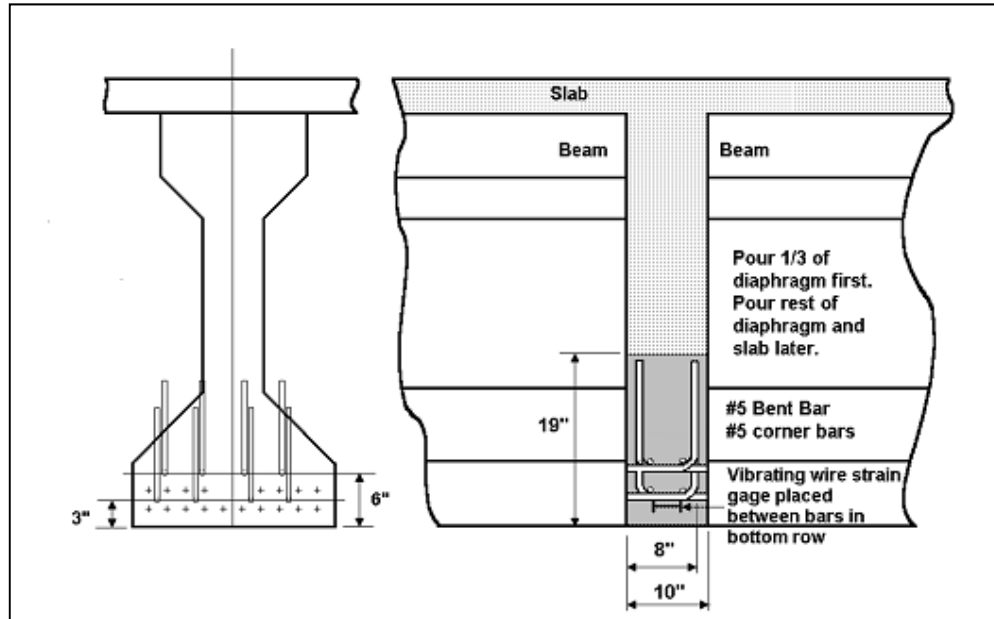
Figure 2.3. NCHRP Bent Bar Specimen (Miller et. al., 2004)

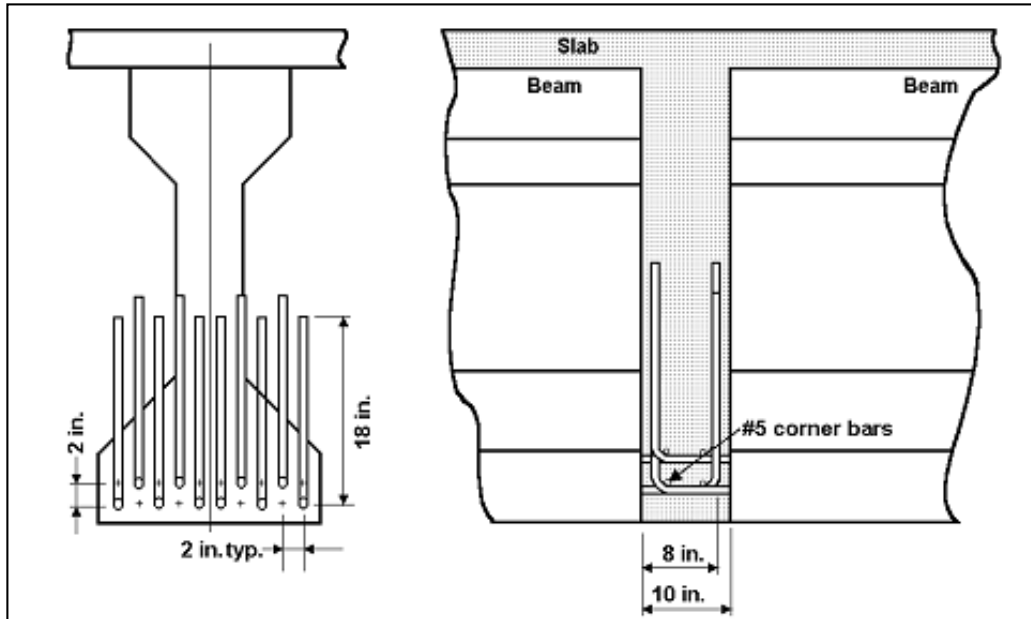
Figure 2.4. NCHRP Bent Strand Specimen (Miller et. al., 2004)

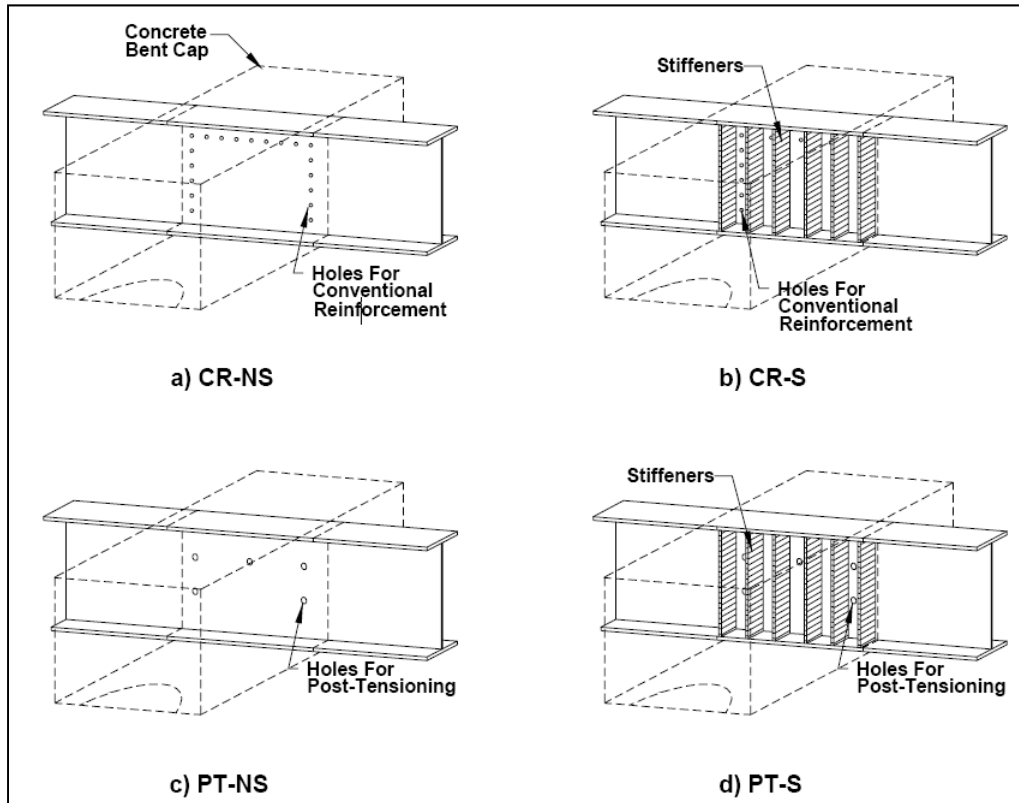
Figure 2.5. Test Concepts for Torsional Behavior of Integral Cap Beam (Patty et. al., 2002)

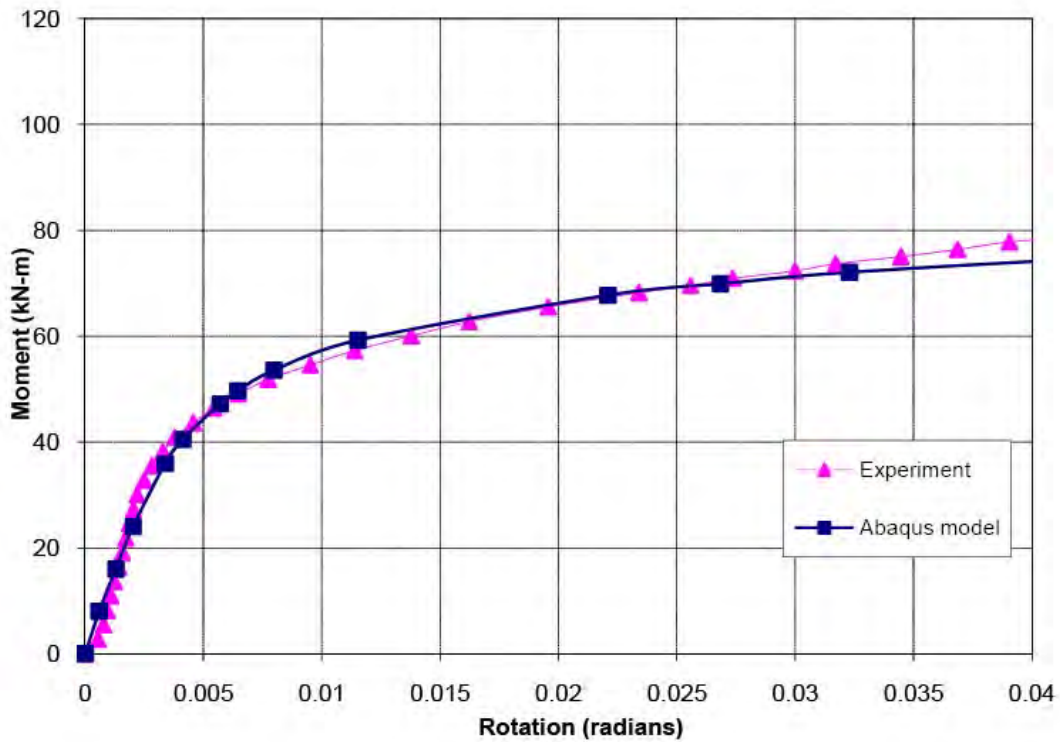
Figure 2.9. Comparison of moment-rotation curves (1 kN-m = 0.737 kip-ft) (Prabha et. al., 2007)

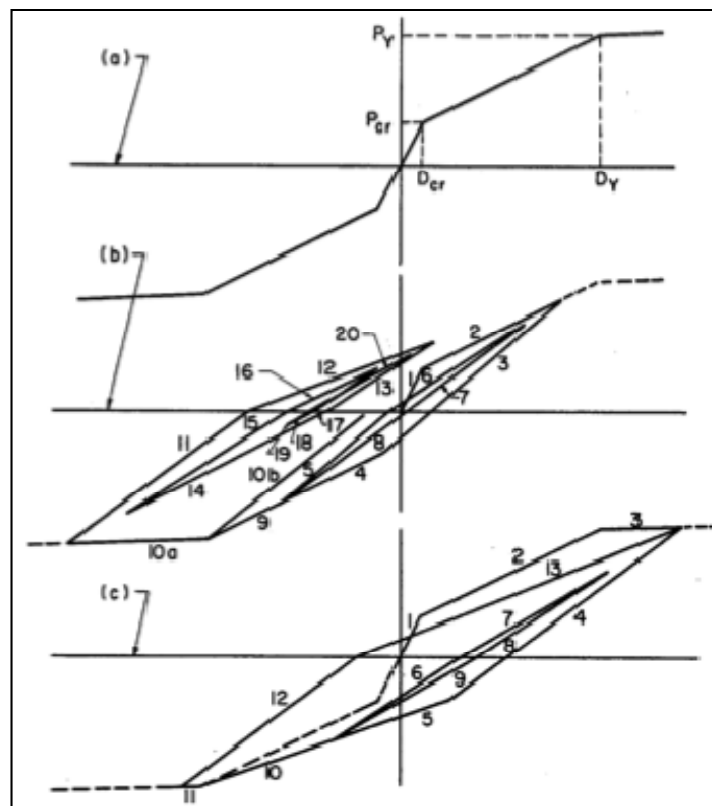
Figure 2.10: Takeda Model (Takeda et. al., 1970)

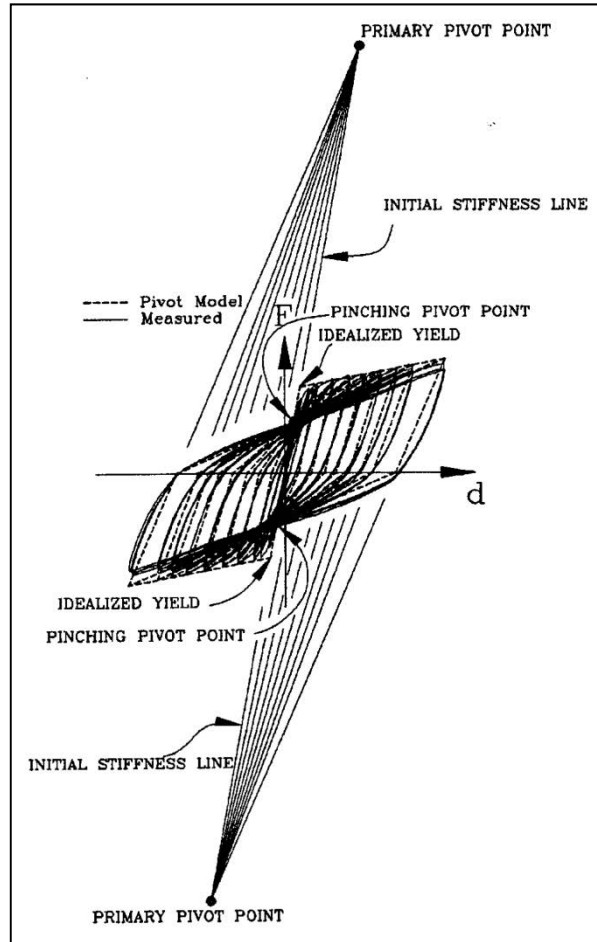
Figure 2.11: Pivot Model Observations (Dowell et. al., 1998)

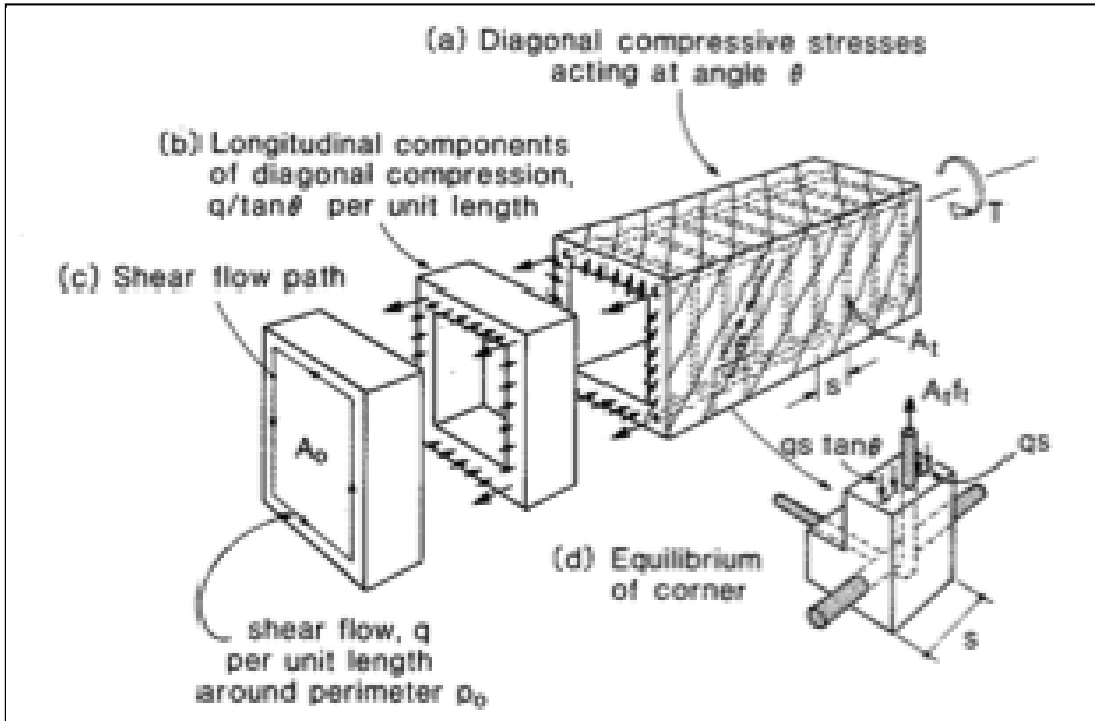
Figure 2.15: Torsional Behavior Post-Cracking (Collins & Mitchell, 1991)

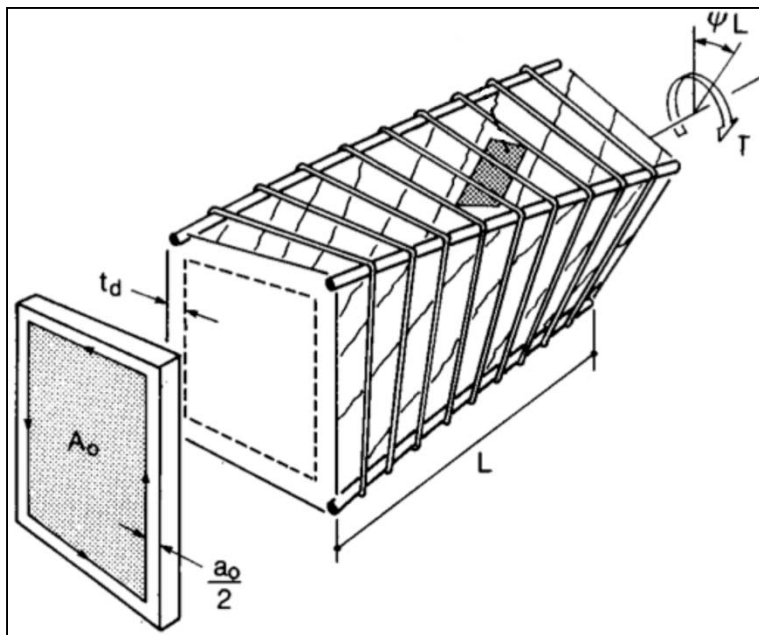
Figure 2.16: Post-Cracking Hollow Tube Analogy (Collins & Mitchell, 1991)

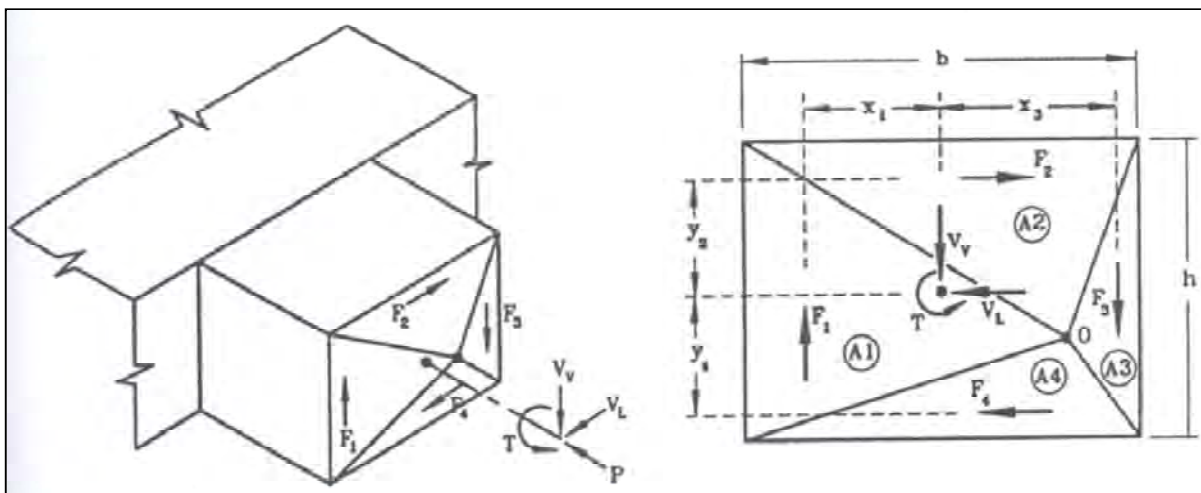
One commonly used method for determining the torsional capacity of a section is the torsion shear-friction model shown below in Figure 2.17. The model assumes a constant shear friction stress over the section and that it is subjected to horizontal and vertical shear forces  $V_V$  and  $V_L$ , torque  $T$ , and a clamping force acting normal to the section  $P$ . The clamping force  $P$  is defined in Equation 2.12, where  $F$  is the prestressing force on the section,  $V_T$  is an axial force acting on the section produced by any transverse shear, and  $A_{st}$  is the total area of the reinforcement in the section. The constant term in the equation, 0.0006, corresponds to the assumed maximum dilation strain in the steel, due to doweling action of the reinforcement, at the point of torsional failure.

Figure 2.17: Torsion Shear-Friction Model (Priestley et. al., 1996)

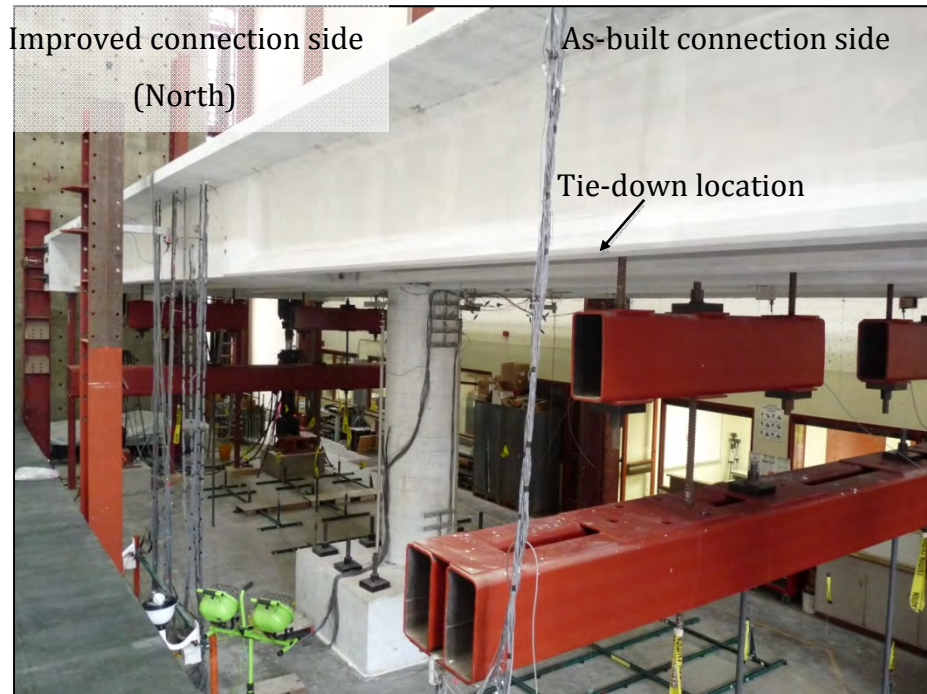
connection types. Given the orientation of the test unit within the lab at UCSD, the South side represented the as-built condition while the North represented the behavior of the improved connection, as shown in Figure 3.2.

Figure 3.2: Test Unit Orientation

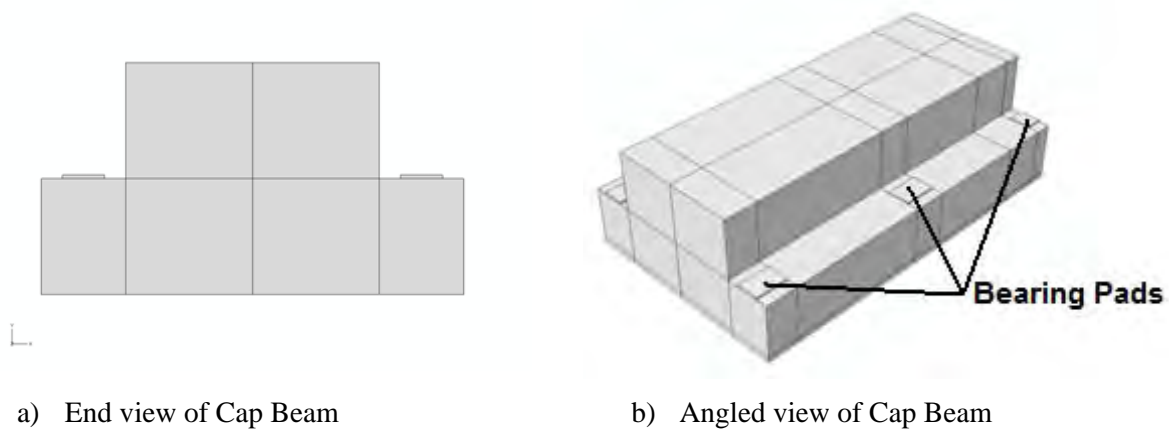
The cap beam was modeled according to the structural drawings. On the cap beam, the bearing pads were included monolithically to the ledges. However, the area of the bearing pads was modeled with a material property corresponding to the bearing materials. The rest of the cap beam was modeled with the damage plasticity model with a concrete strength of 4.5 ksi, which is the expected material strength of the concrete in the field. Figure 4.5 shows the cap beam model that was created using solid elements that were used for the modeling of the cap beam. The same element type was used for the bearing pads.

Figure 4.5. Views of modeled Cap Beam

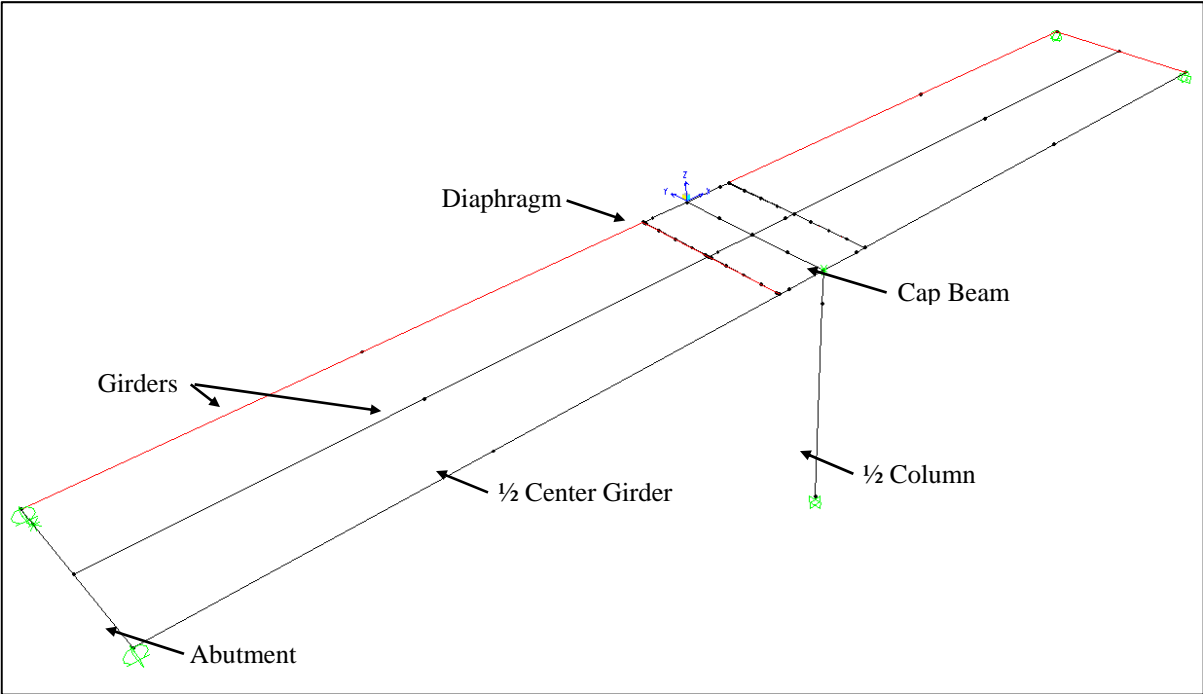
Figure 4.8: Test Unit Grillage Model

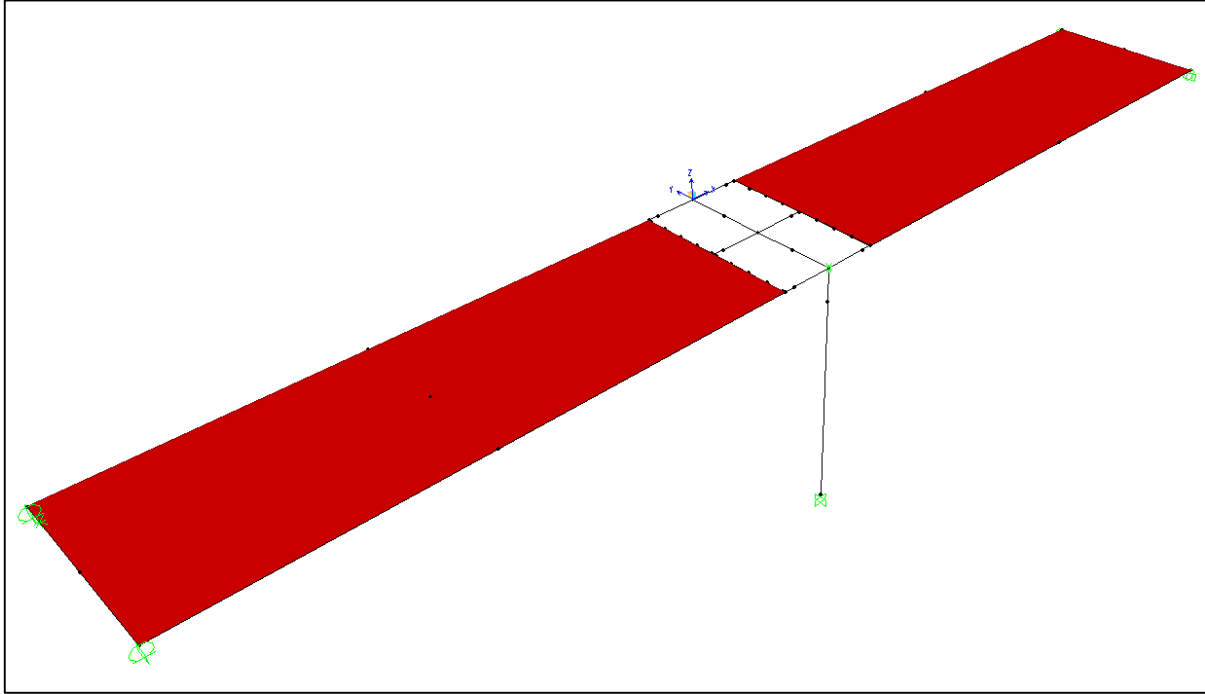
Figure 4.10: Grillage Model after Adding the Area Deck Elements

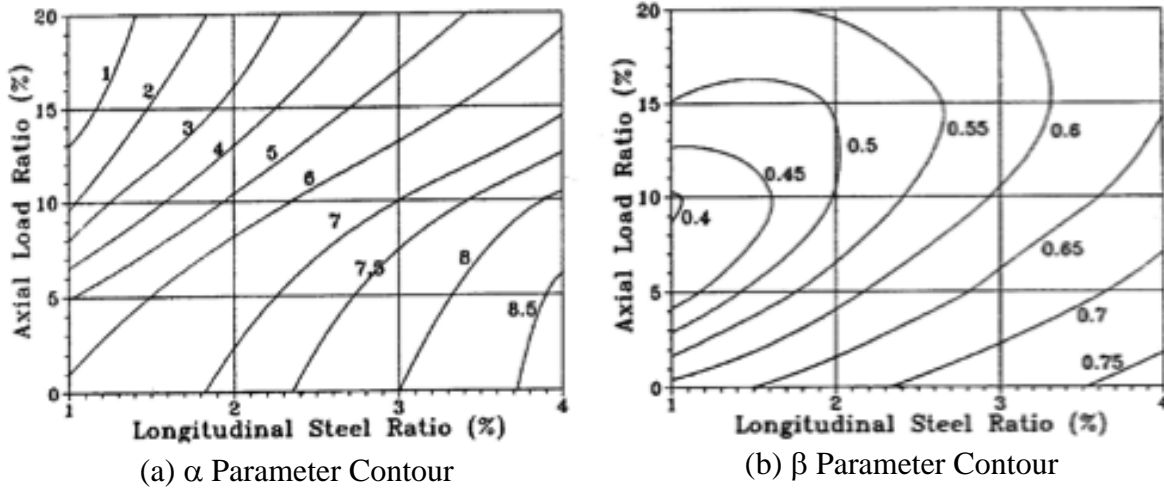
Figure 4.16: Pivot Hysteresis Parameters (Dowell et. al., 1998)

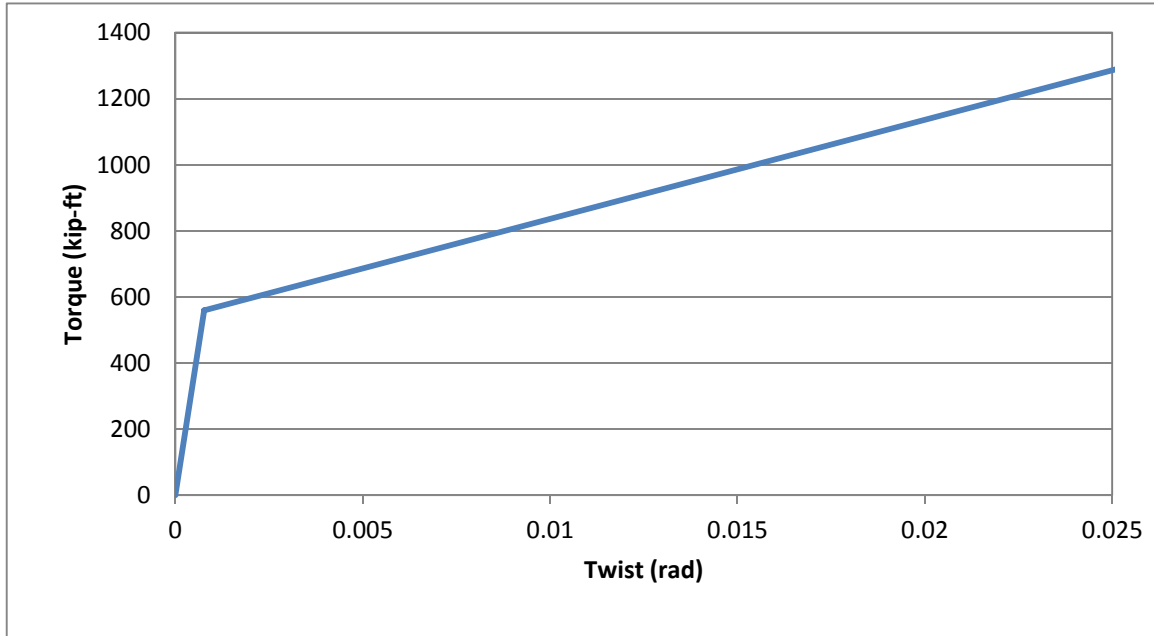
Figure 4.17: Predicted Inverted-T Cap Beam Torque-Twist Response

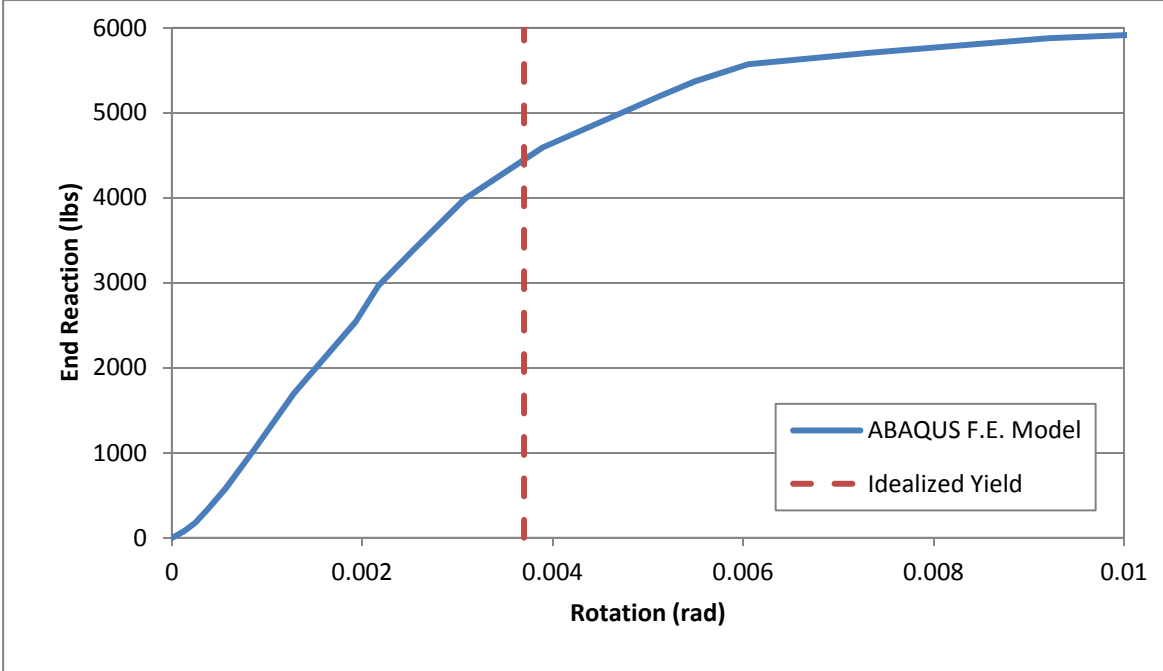
Figure 4.21: Idealized Yield Moment Derivation

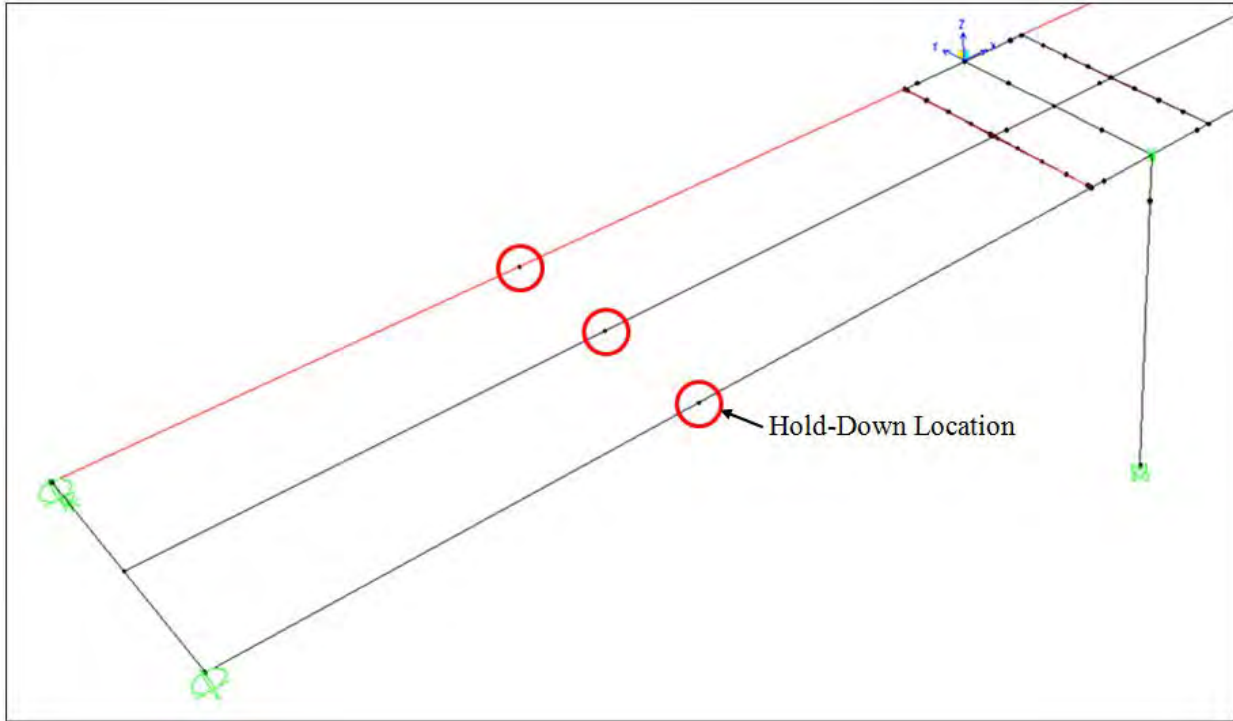
Aside from including the dead load within each analysis, hold-down forces were also applied during each phase of the stage construction in the same manner as they were in the lab. Each of the hold-down forces were applied at nodes that were placed 16ft away from the centerline of the cap beam, as shown in Figure 4.27. More information regarding the hold-down forces is presented in Section 5.1.3. As mentioned previously, an additional distributed load of 0.00416 k/in was placed along each girder in order to reflect stay-in-place formwork and the thickened portion of the deck. It should be noted that this value was halved for the center girder as only half of it was modeled.

Figure 4.27: Grillage Model Hold-Down Node Locations

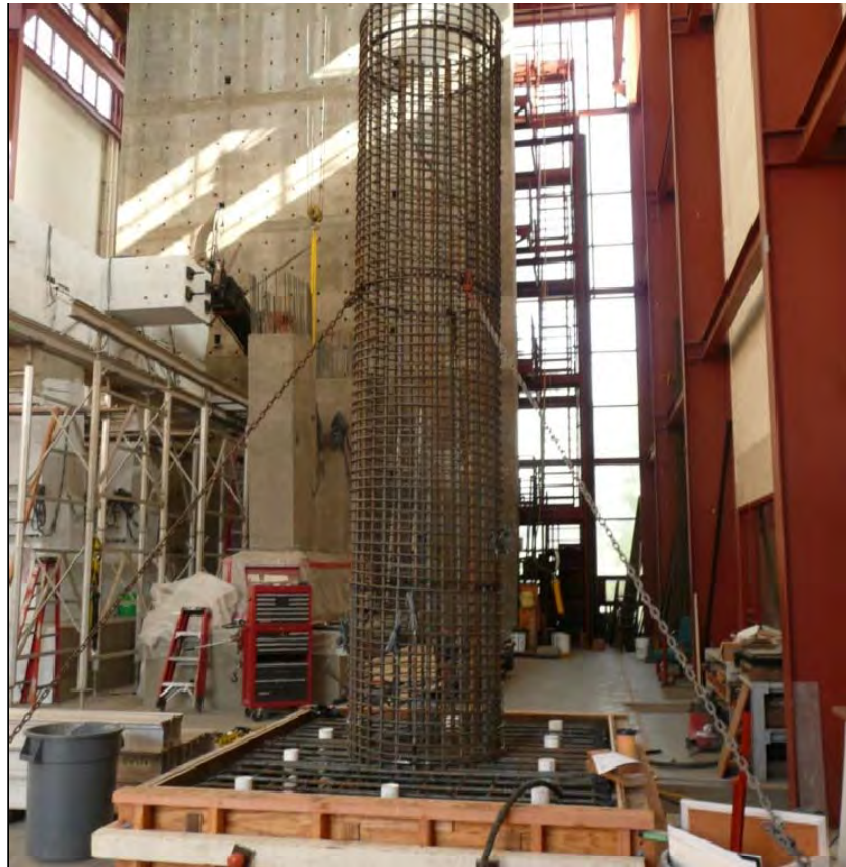
1. The footing was first constructed within an available portion of the lab space. The column cage and formwork was then constructed on top of the footing (Figure 5.2).

Figure 5.2: Completed Column and Footing Cage

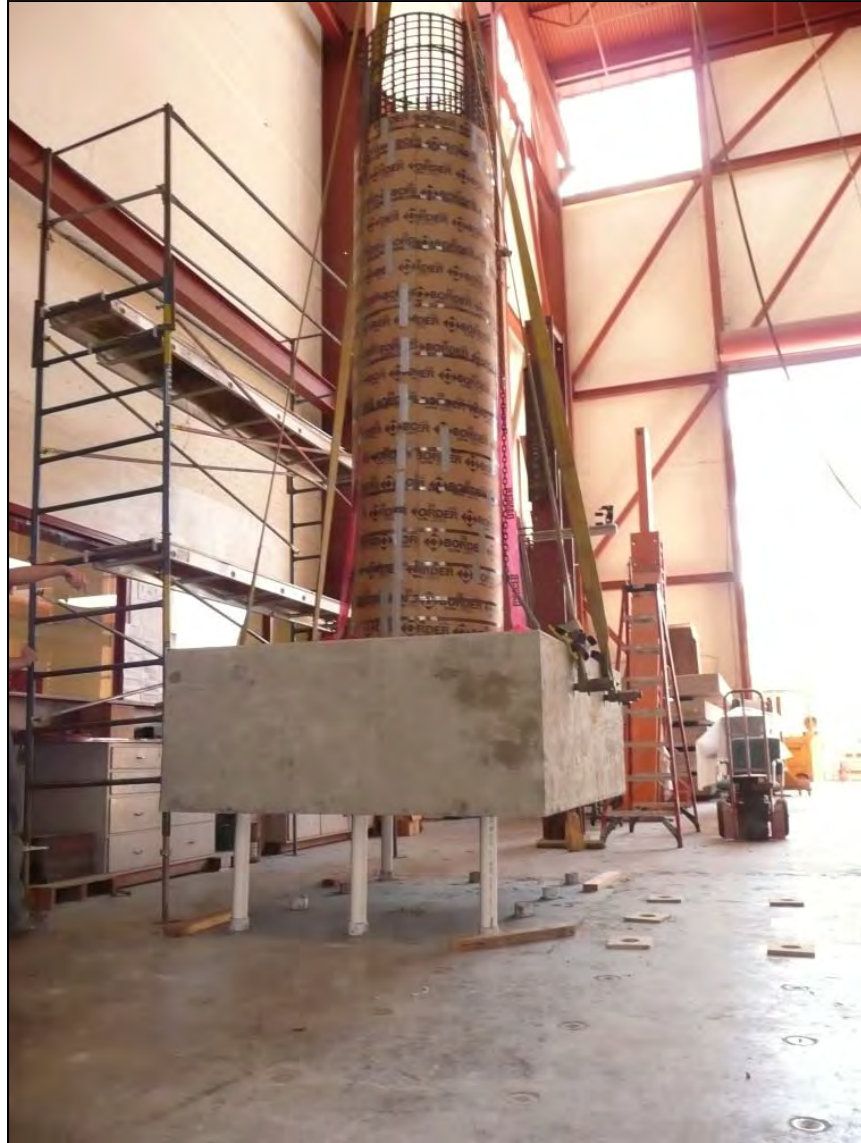
2. As space within the lab opened, the footing and column cage were moved and placed in the space designated for testing (Figure 5.3). Hydrostone was then poured underneath the footing to ensure an even bearing surface. Once this was complete, the concrete was poured for the column. The pour for the column was terminated at the height of the base of the inverted-T cap beam.

Figure 5.3: Repositioning the Column and Footing

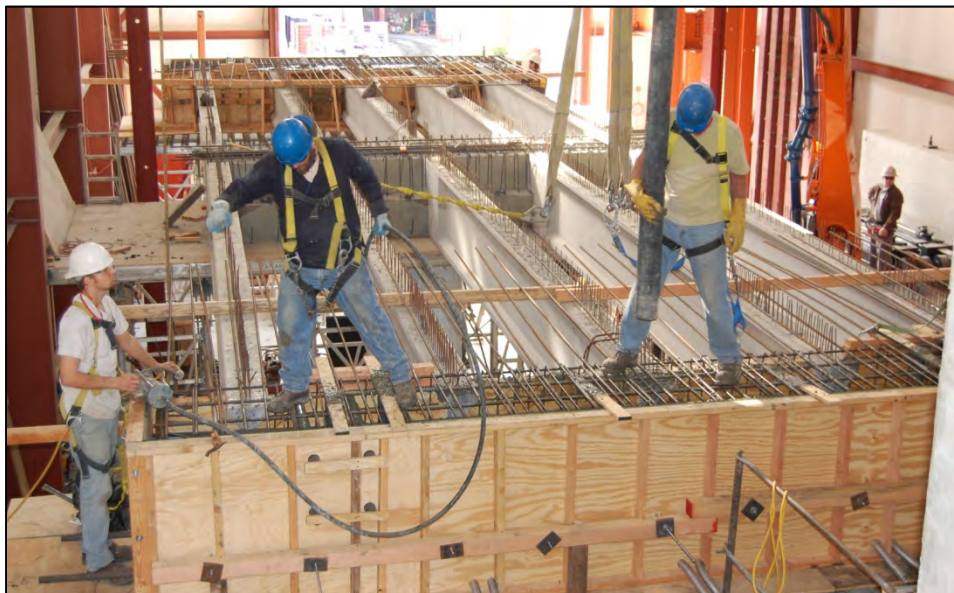
6. The abutment cage was then constructed on the ground, lifted into place, and the concrete was partially poured to a height corresponding to the underside of the deck (Figure 5.6). The South side was again constructed first and was followed by the North side.

Figure 5.6: Casting of the North Abutment

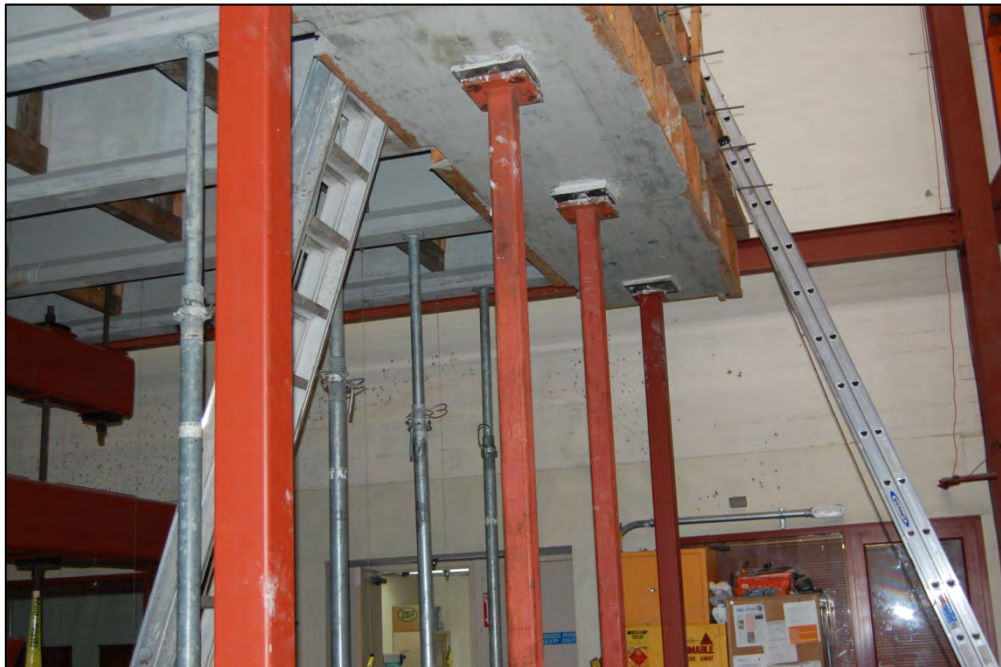
7. Prior to removing the falsework under the abutment and placing it on the pinned support system, a partial pour of the diaphragm was completed, adjacent to the cap on both sides, in order to provide added stability to the system. Only the 6 in. wide portion next to the corbel of the inverted-T cap was poured, up to the full height of the corbel.
8. Four support columns were placed beneath each abutment. Half-rounds were welded to the top of each column, which were used to create a pinned condition at the abutments (Figure 5.7). The falsework under both the abutments and the column was removed and the loads at the abutments were subsequently transferred to the support columns.

Figure 5.7: Temporary Support System Used Under Each Abutment

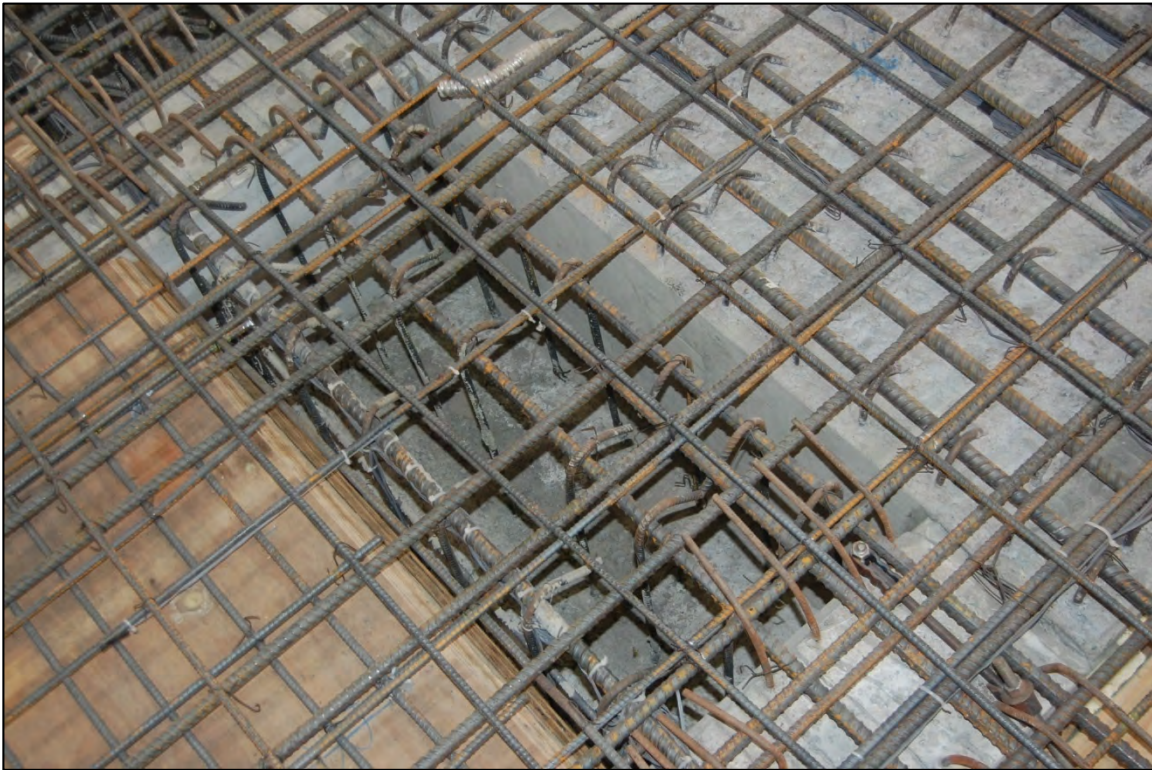
Figure 5.12: Partial Diaphragm Pour between Girders

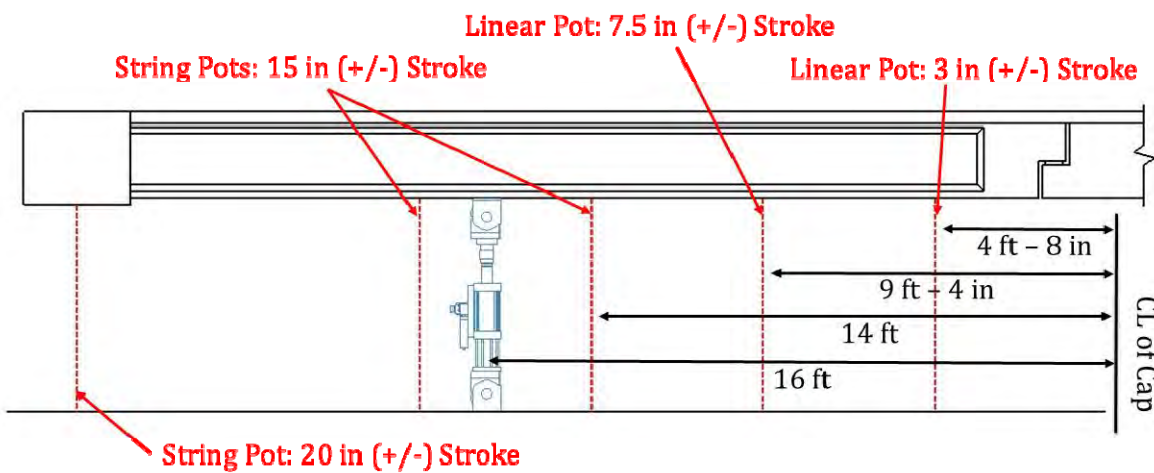
Figure 5.39: Phase 2 Vertical Girder Displacement Device Locations

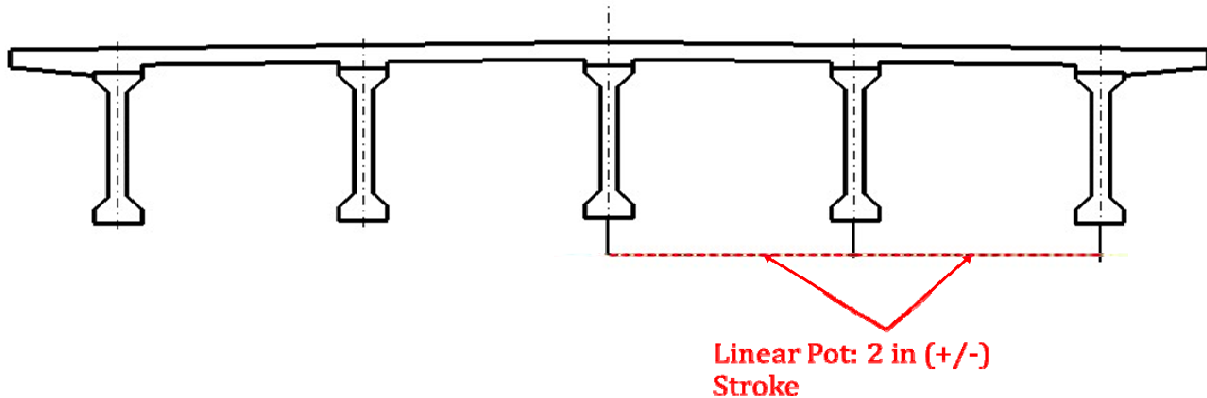
Figure 5.44: Lateral Displacement between Girders Device Locations

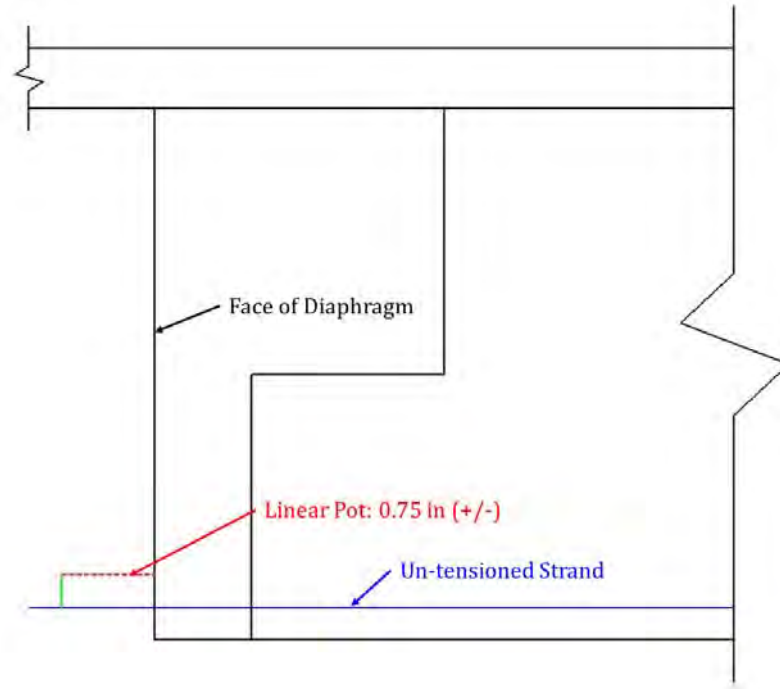
Figure 5.45: Strand Slip Device Location

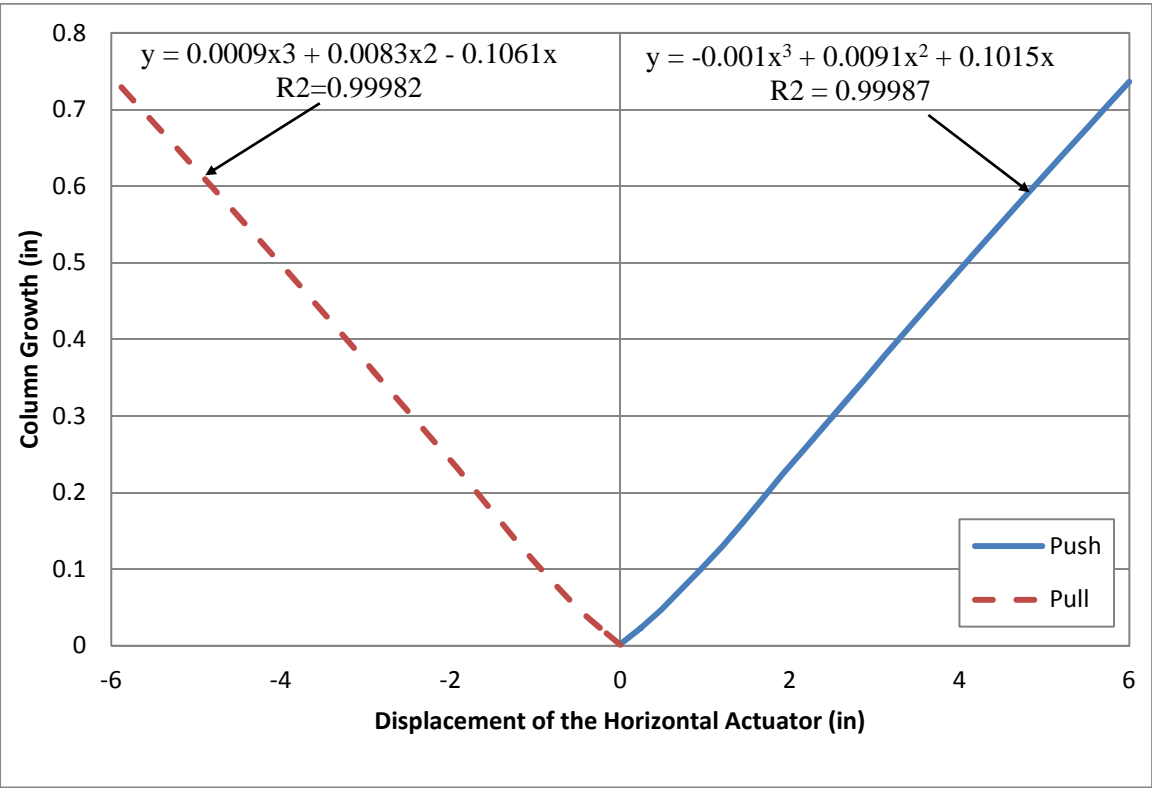
Figure 5.50: Horizontal Actuator Displacement vs. Column Growth

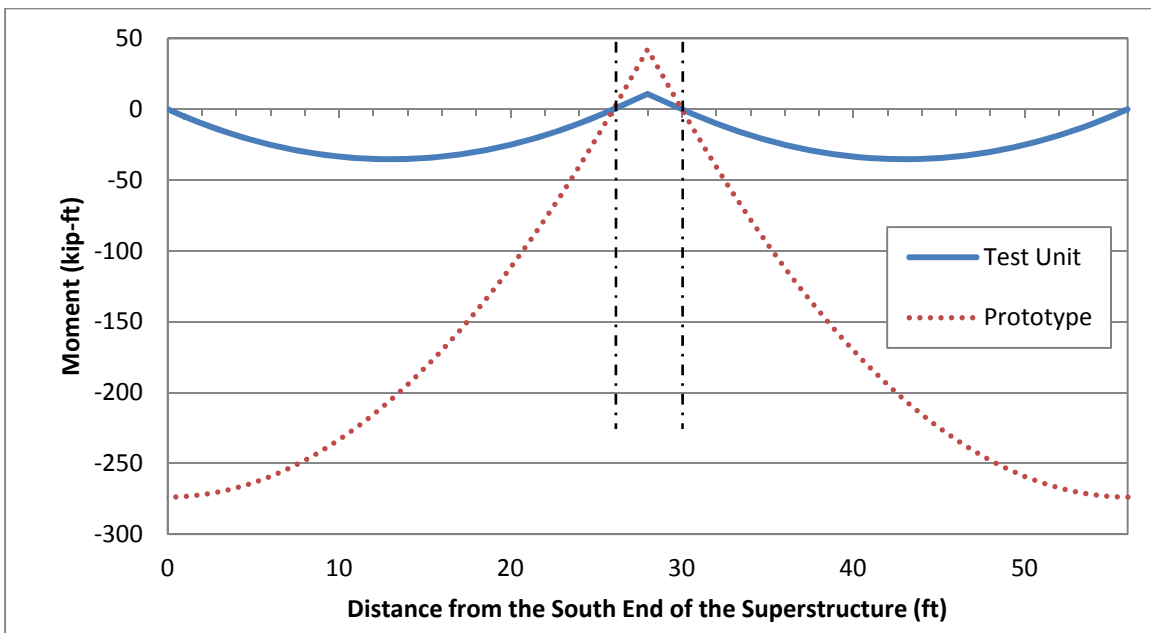
Figure 5.51: Stage 1 Prototype-to-Test Unit Moment Profile Comparison along the Length of the Superstructure without Scaling Compensation

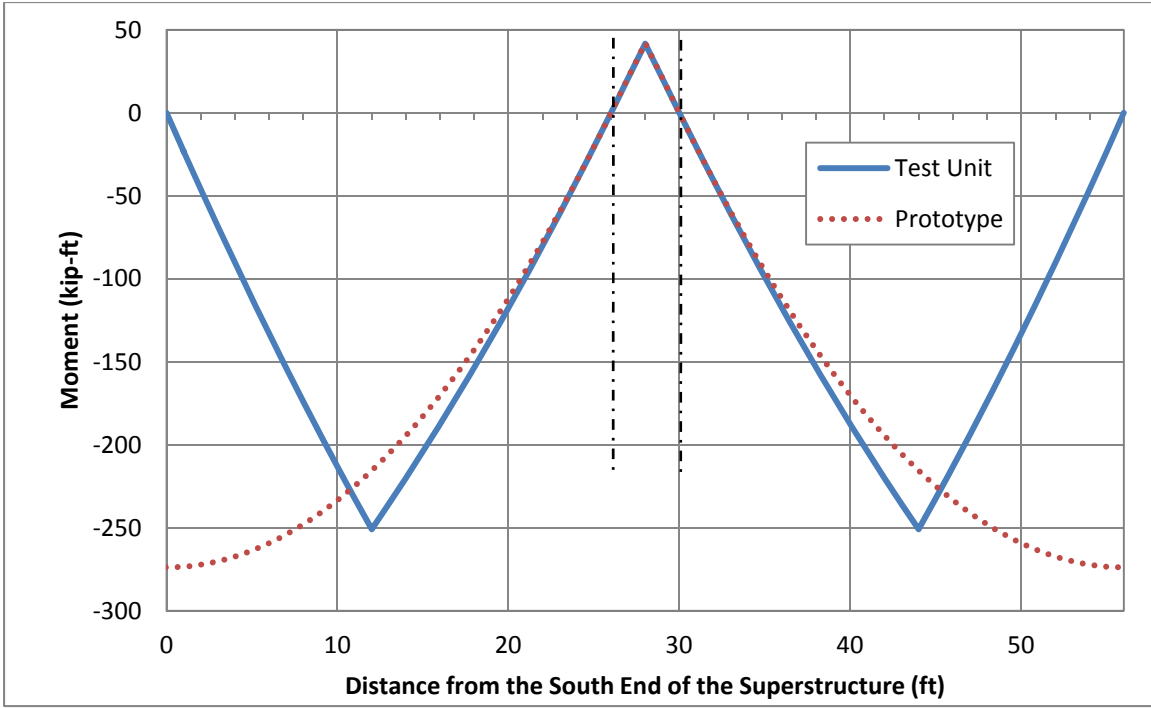
Figure 5.53: Stage 1 Prototype-to-Test Unit Moment Profile Comparison along the Length of the Superstructure after Applying Stage 1 Hold-Down Force
