**Seismic Performance of an I-Girder to  
Inverted-T Bent Cap Connection**

**Submitted to the  
California Department of Transportation  
Caltrans Project: 05-0160**

**SEPTEMBER 2011**

**Final**

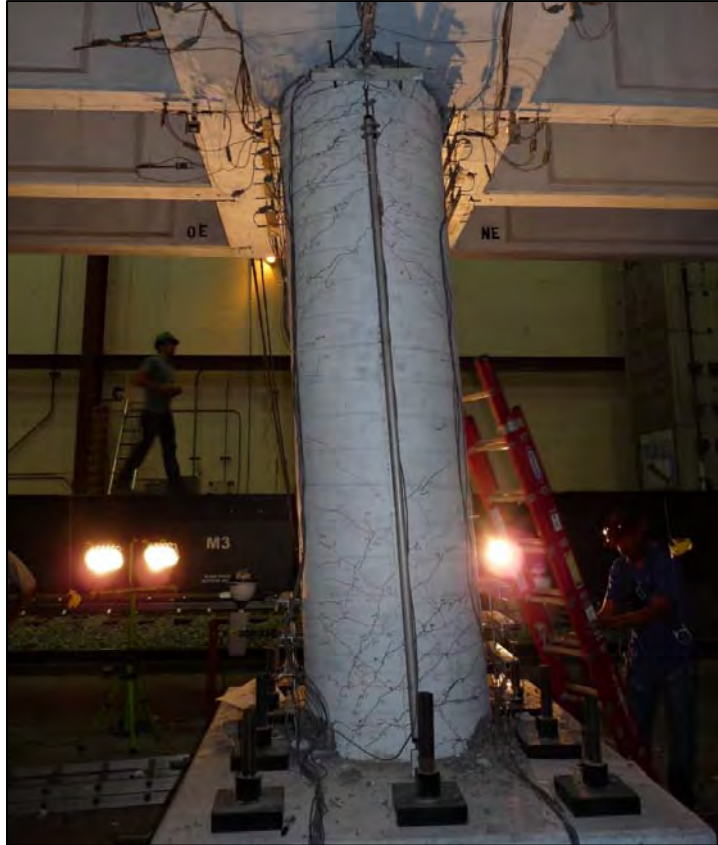
Figure 6.1: A Close-Up View of the Column Performance at +7.0 in. of Lateral Displacement ( $\mu_{\Delta}=+10$ )

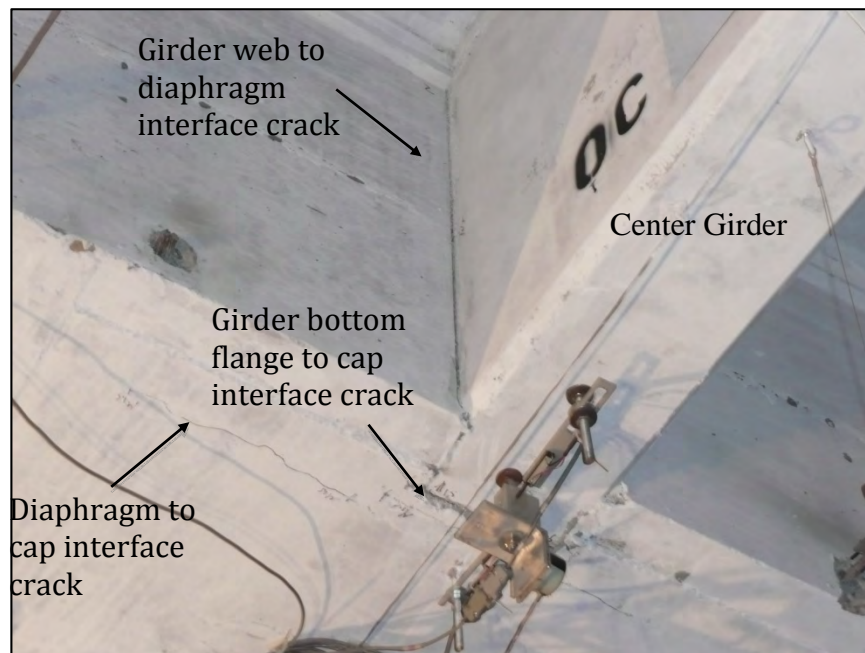
Figure 6.2: Condition of As-Built Center Girder-to-Cap Connection at  $\mu_{\Delta}=+8$

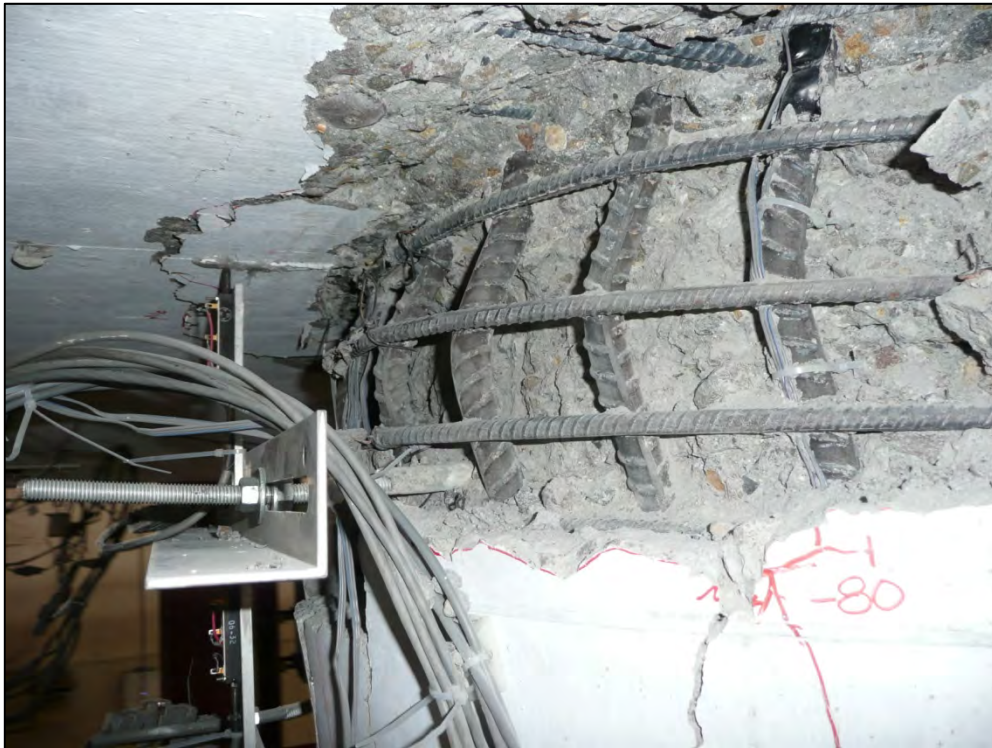
Figure 6.3: Buckling in the Top Column Hinge on the North Side at  $\mu_{\Delta}=10$

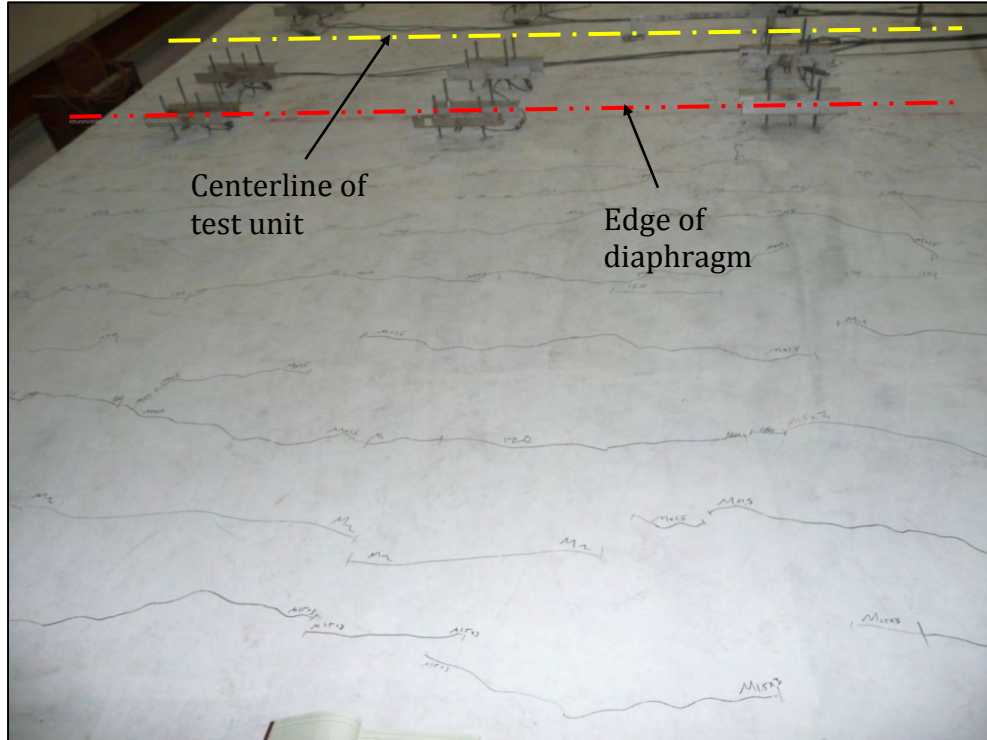
Figure 6.4: Distribution of Flexural Cracking on the Top Side of the Deck at  $\mu_{\Delta}=+10$

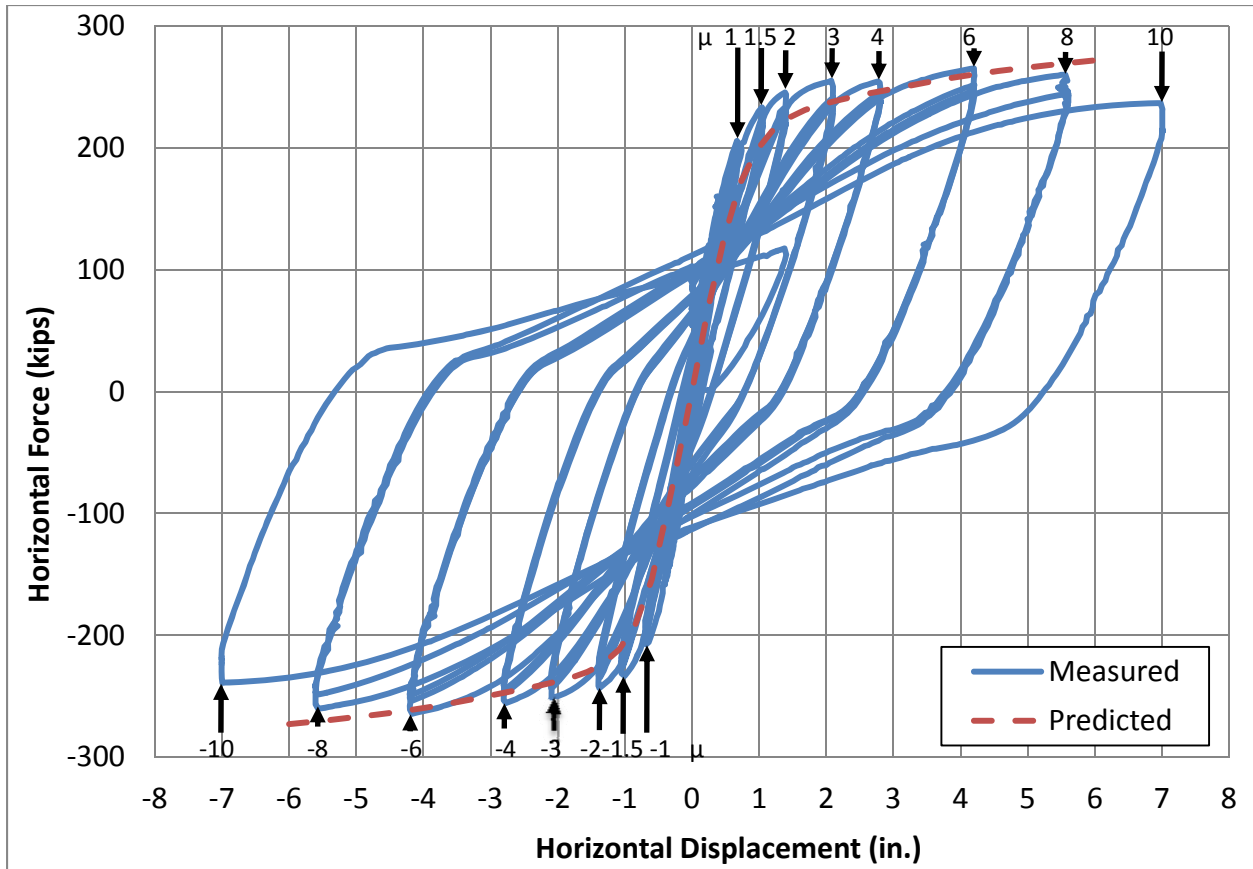
Figure 6.5: Force vs. Displacement Response of Test Unit during Phase 1 Testing

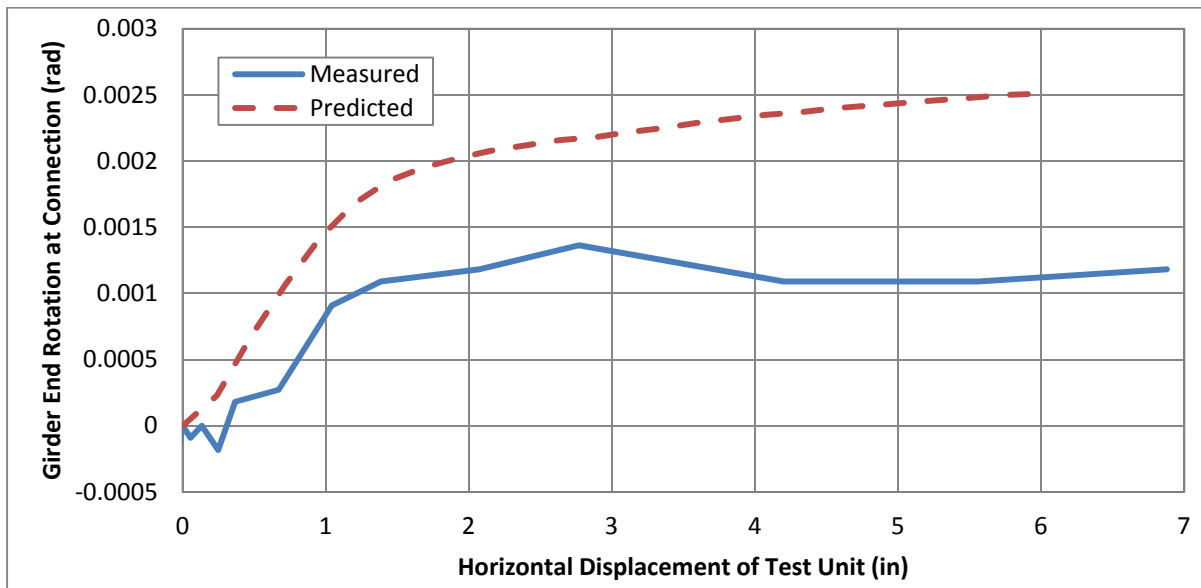
Figure 6.6: Center Girder End Rotation within Girder-to-Cap Connection vs. Horizontal Displacement during Phase 1 Testing

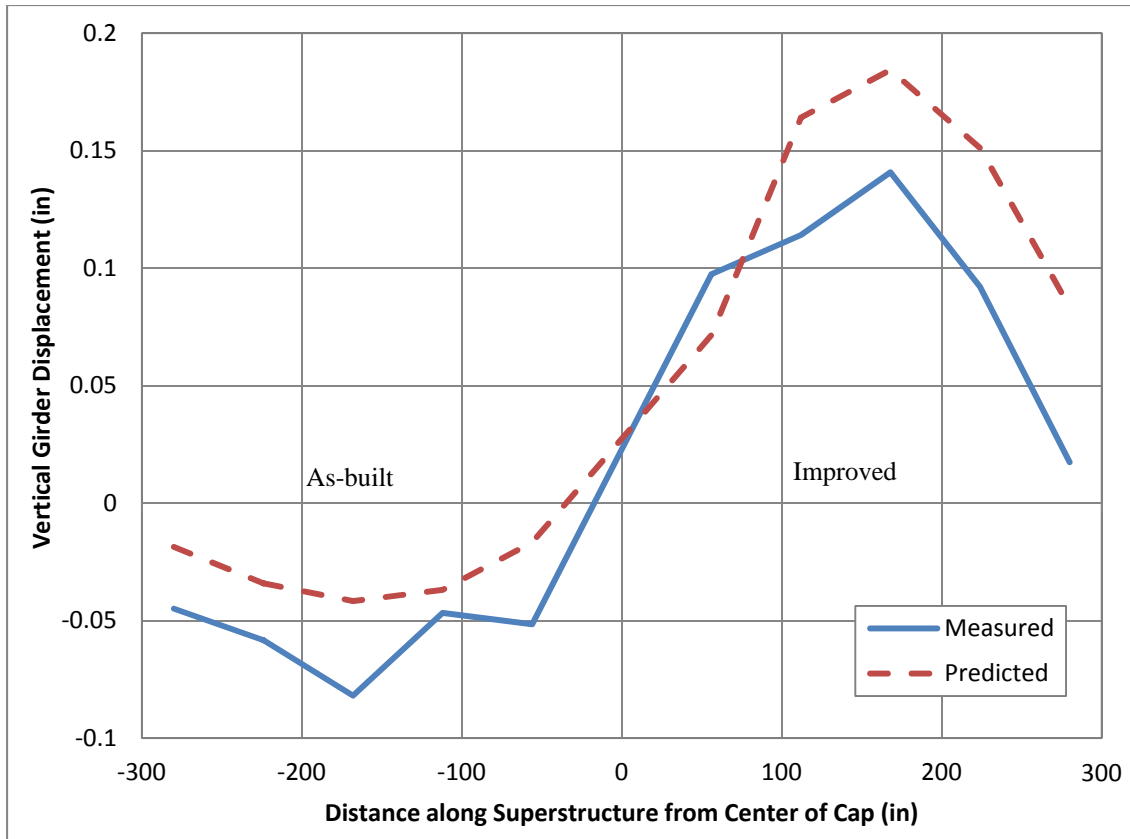
Figure 6.7: Center Girder Vertical Displacements at  $\mu_{\Delta} = +3$

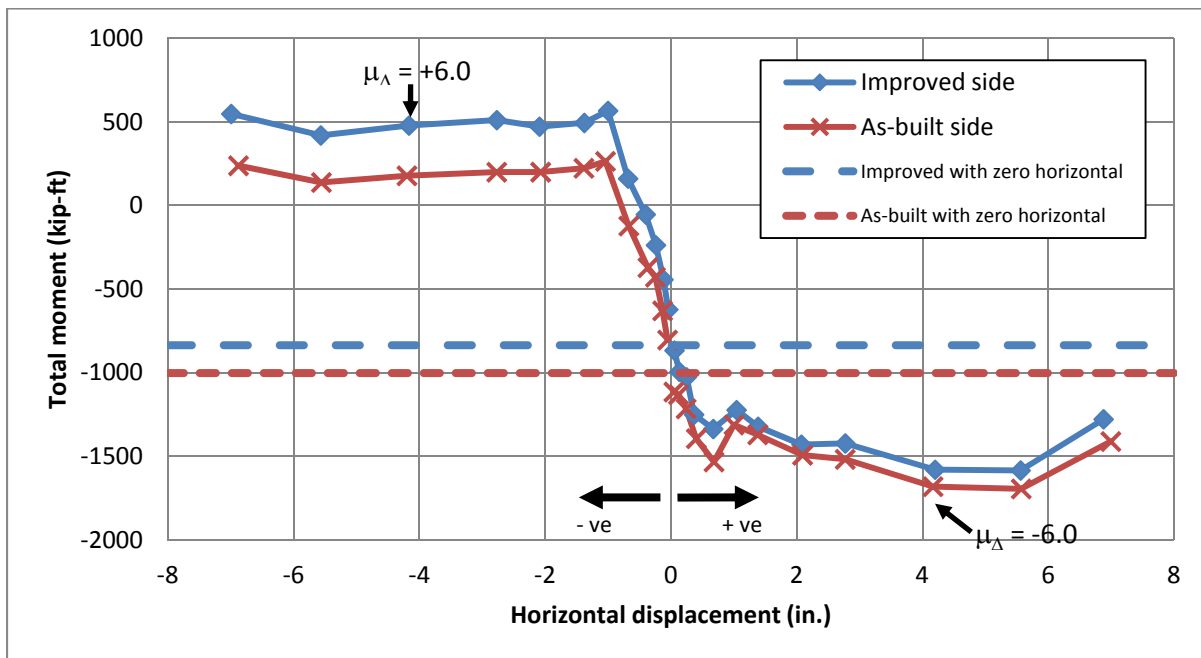
Figure 6.18: Total Moment in all Five Girders at Peak Load Conditions

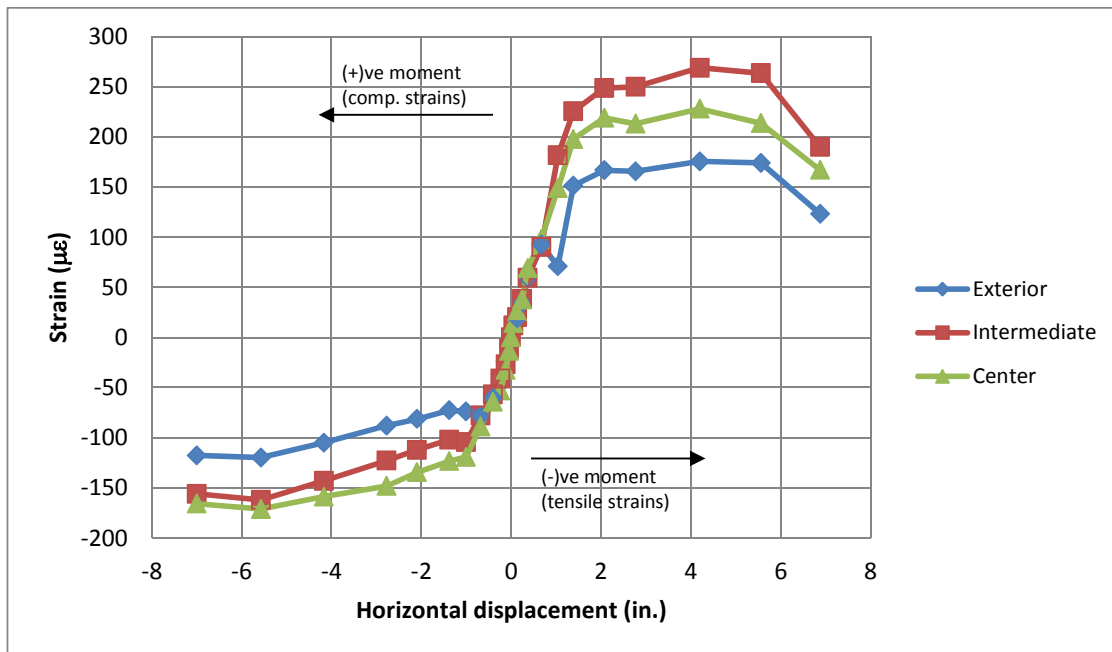
Figure 6.23: Deck Reinforcement Strains on Improved Connection Side 1.5 feet from Diaphragm Edge, above the Exterior, Intermediate, and Center Girders

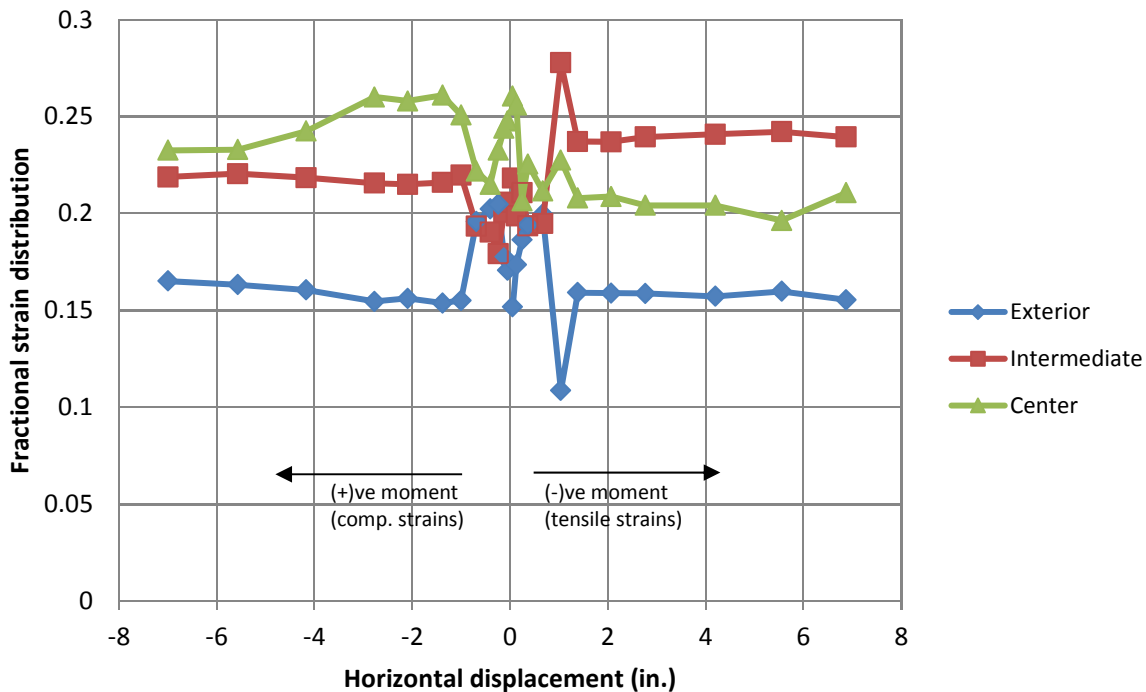
Figure 6.24: Contribution of Moment Resistance by Girders on the Improved Connection Side 1.5 feet from the Diaphragm Edge

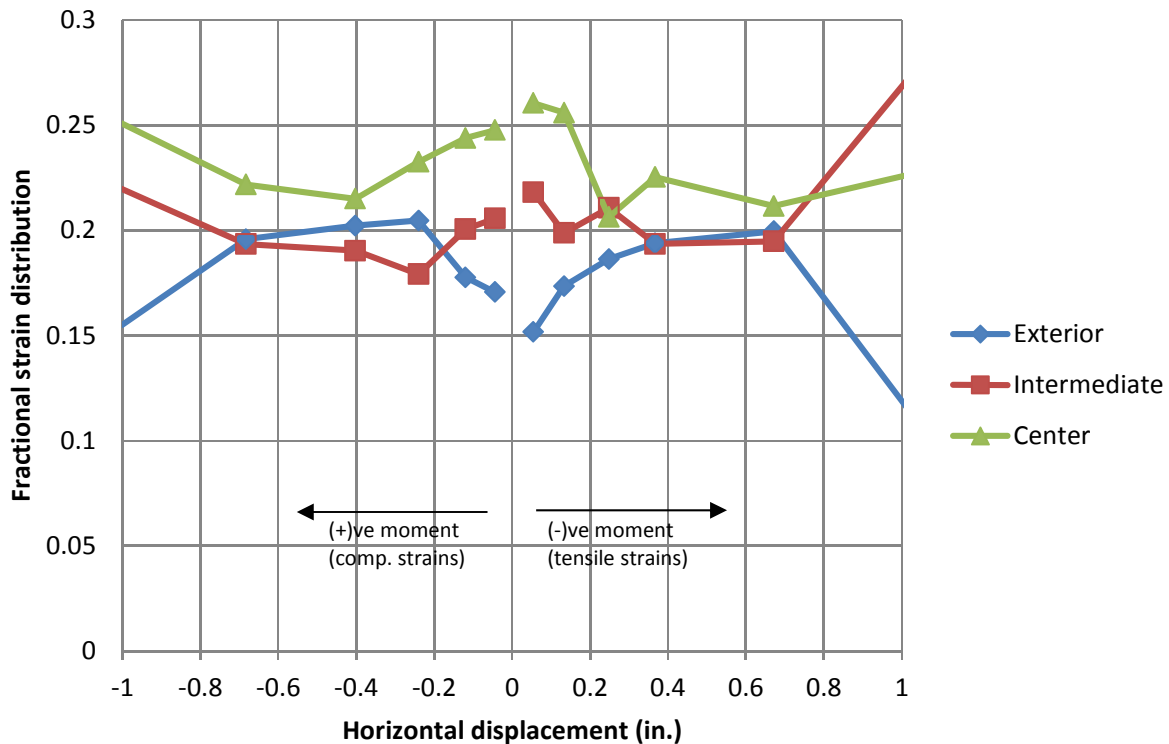
Figure 6.25: Figure 6.24 Repeated, with Horizontal Axis Range Reduced to focus on Small Lateral Displacements

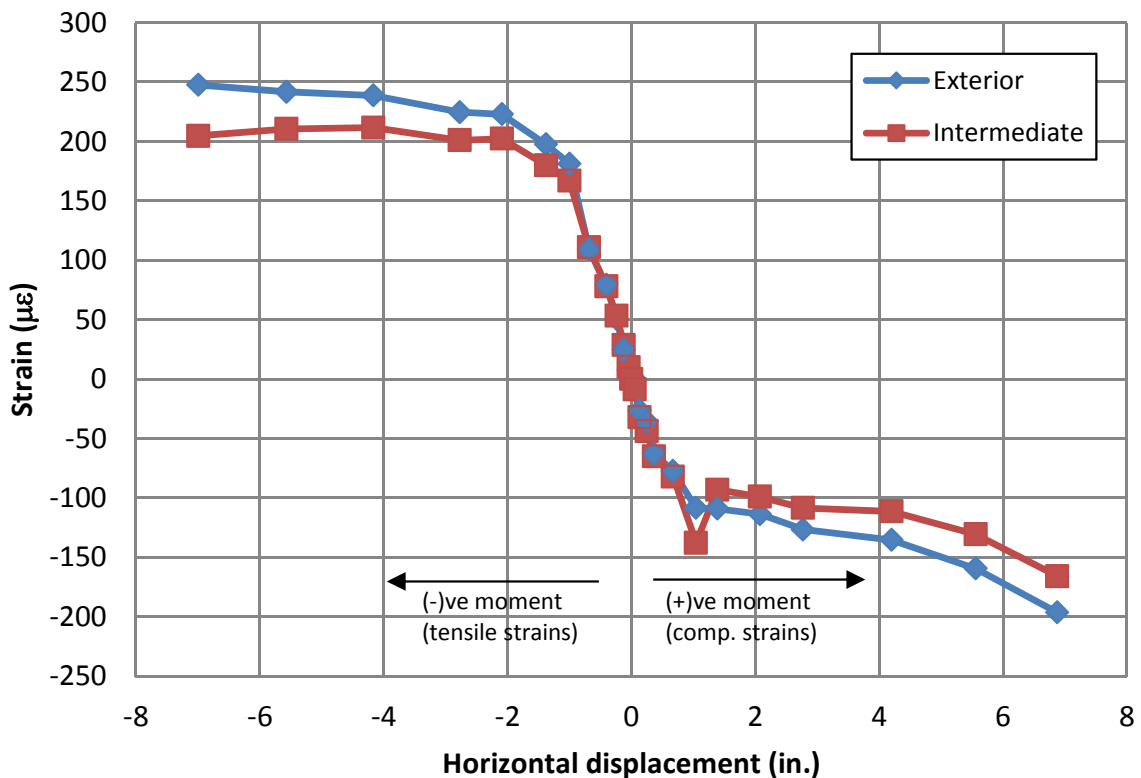
Figure 6.26: Deck Reinforcement Strains on As-built Connection Side, 1.5 feet from Diaphragm Edge, above the Exterior and Intermediate Girders

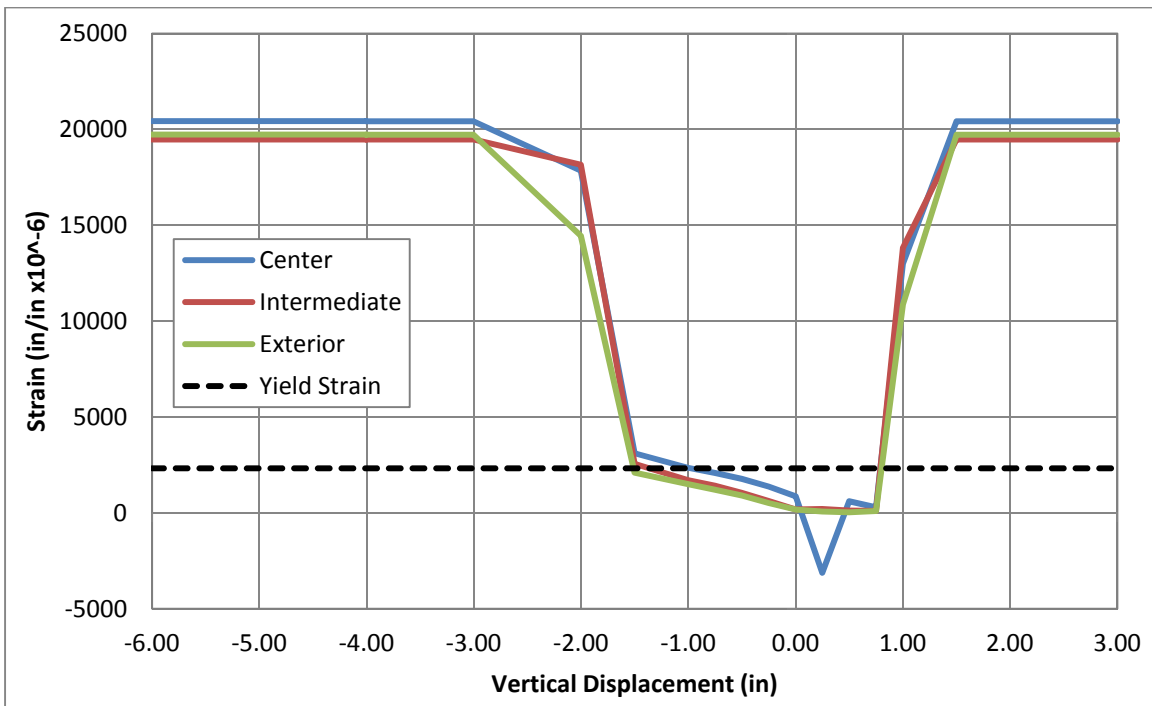
Figure 6.29: Vertical Displacement vs. Deck Reinforcement Strain above the Inverted-T Stem on the As-built Connection Side of the Cap Beam at Each Girder

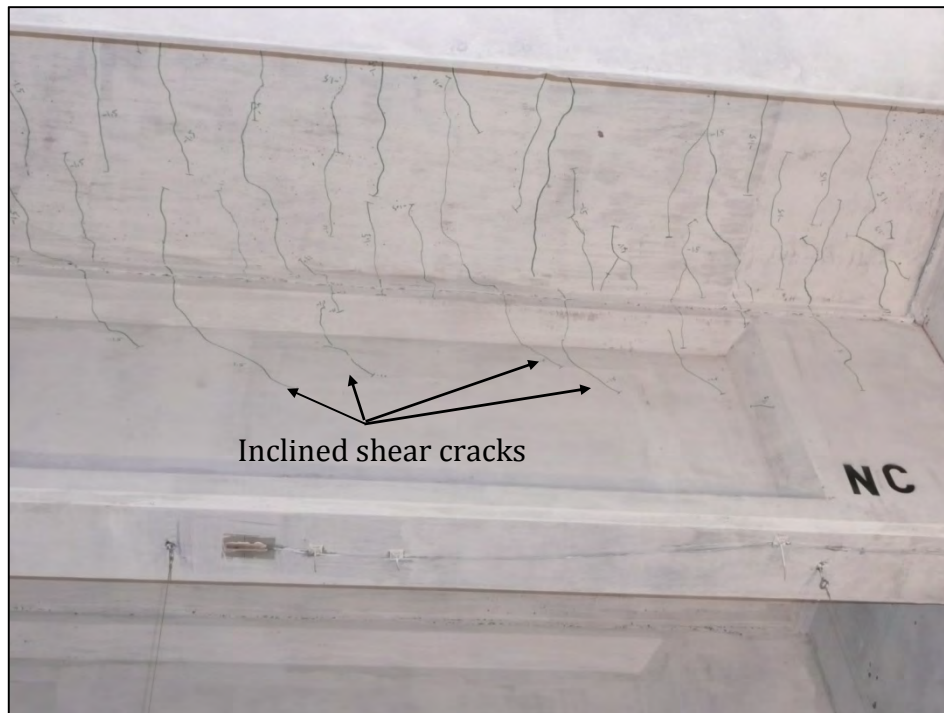
Figure 6.30: Inclined Shear Cracking Observed on the Center Girder on the Improved Connection Side at  
-1.5 in. Vertical Displacement

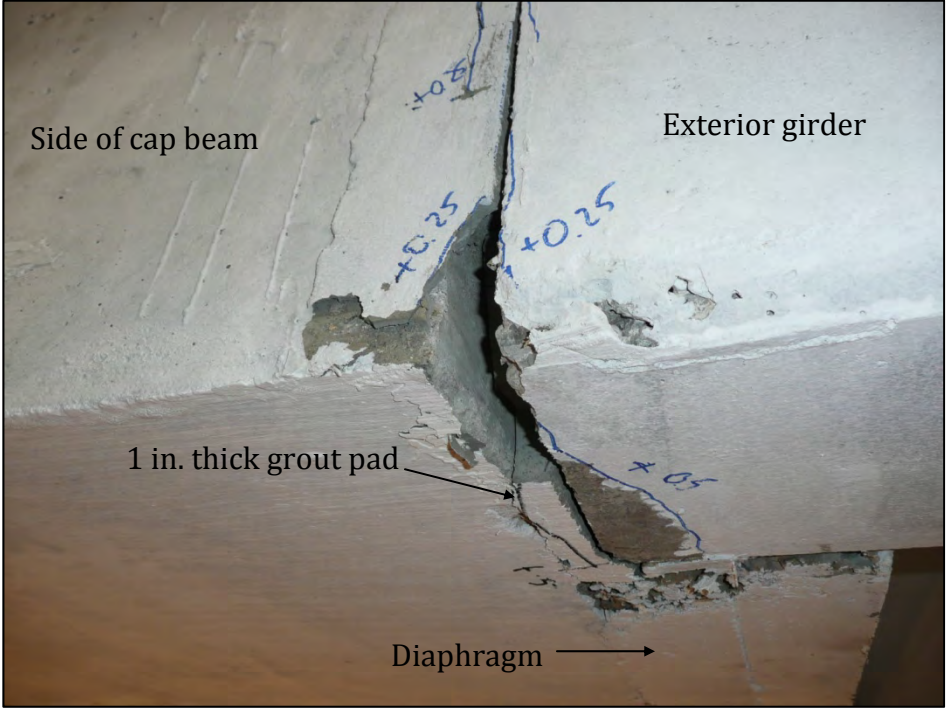
Figure 6.31: Partially Spalled Grout Pad at Girder-to-Cap Interface on the As-built Connection Side at +0.75 in. Displacement

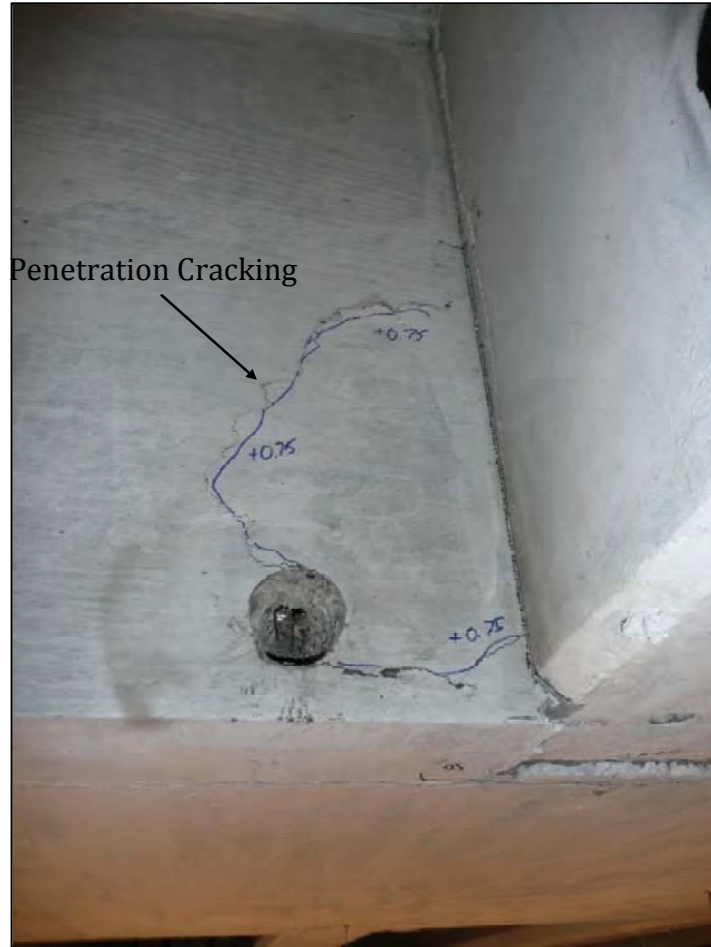
Figure 6.32: Penetration Cracks on the Face of the Diaphragm on the As-built Connection Side at +0.75 in. Displacement (Repeated)

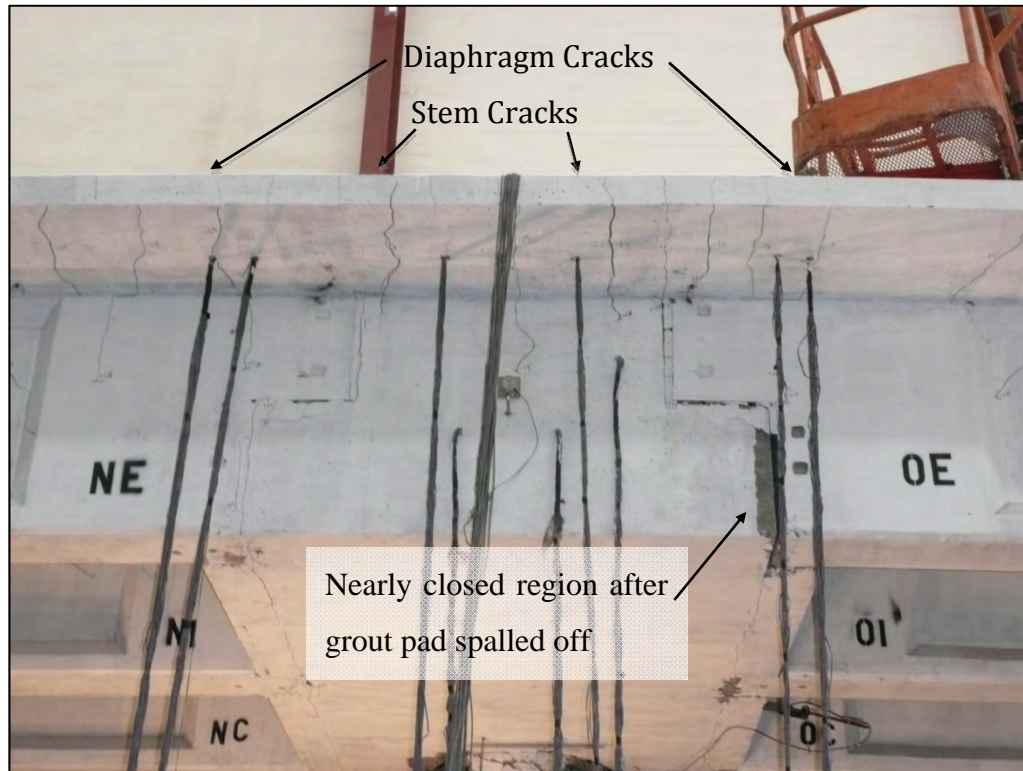
Figure 6.33: Deck Cracking Observed near the Cap Beam at -2 in. Displacement

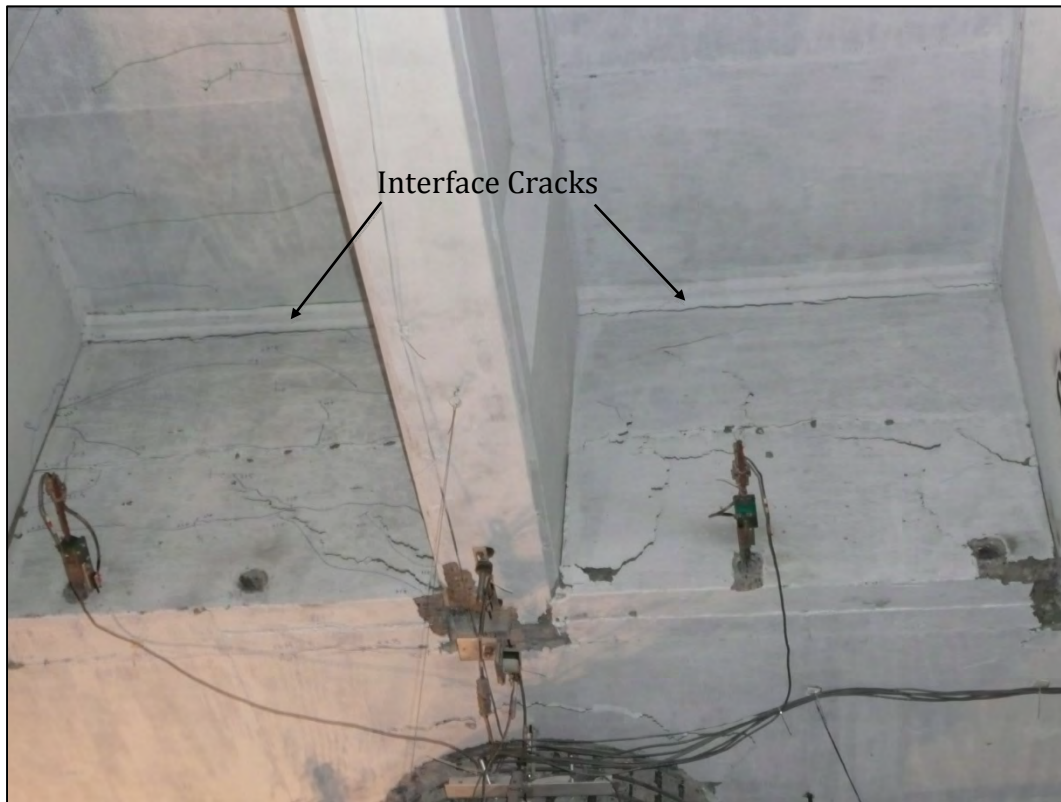
Figure 6.34: Deck-to-Diaphragm Interface Cracking at +1 in. Displacement

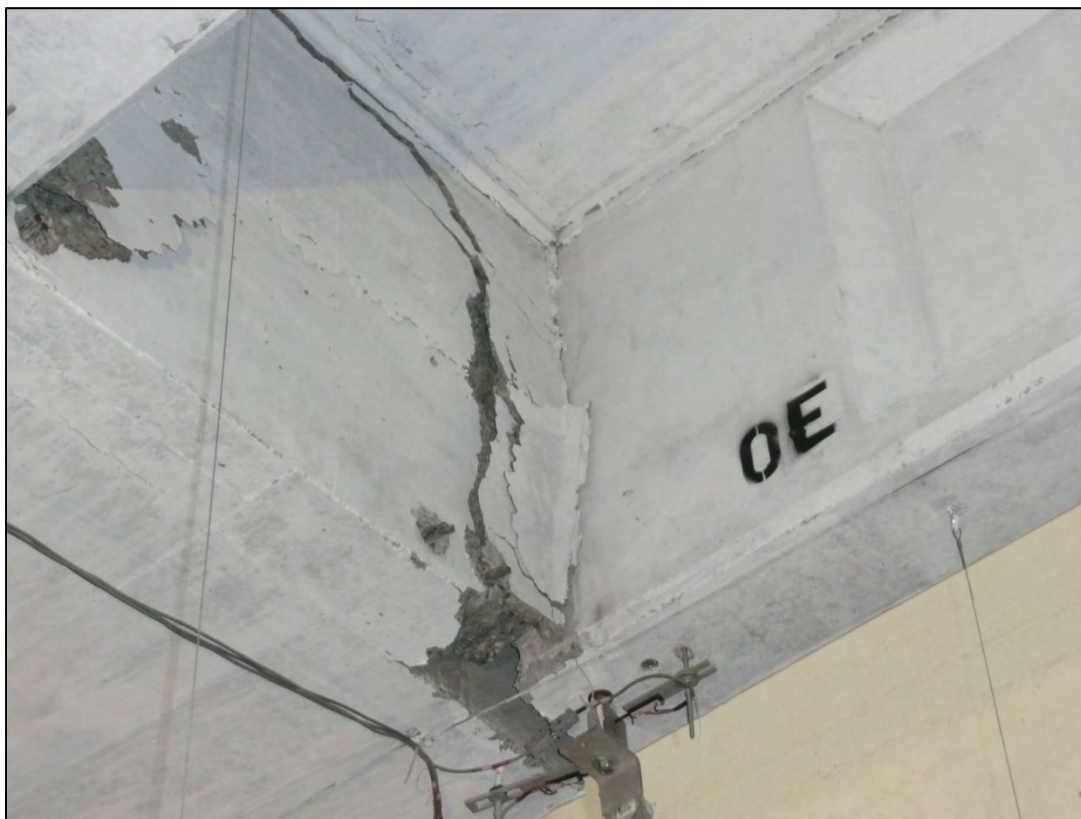
Figure 6.35: Damage to As-built Connection Exterior Girder at +2 in. Displacement

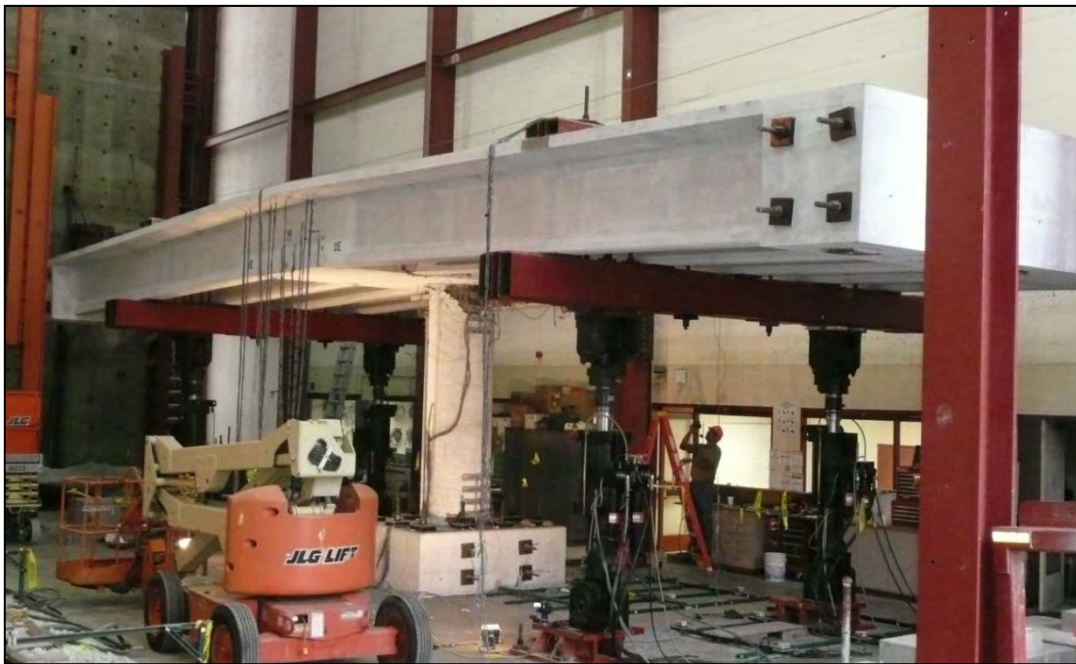
Figure 6.36: Displaced Test Unit at -6 in. of Displacement

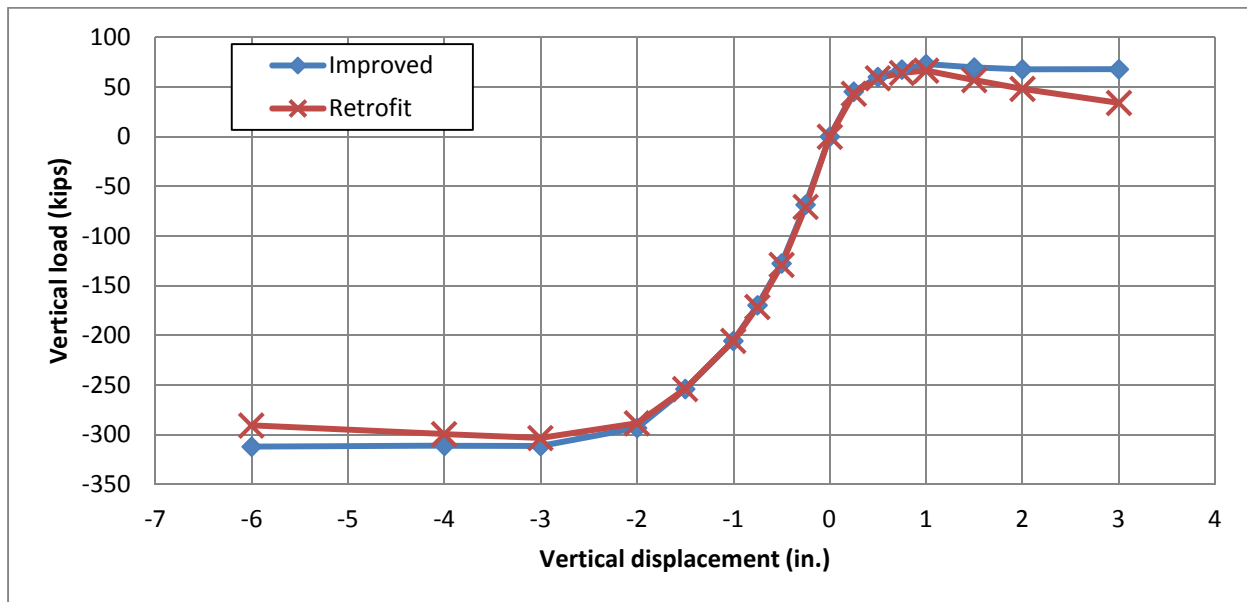
Figure 6.39: Comparison of Peak Load-Displacement Behavior

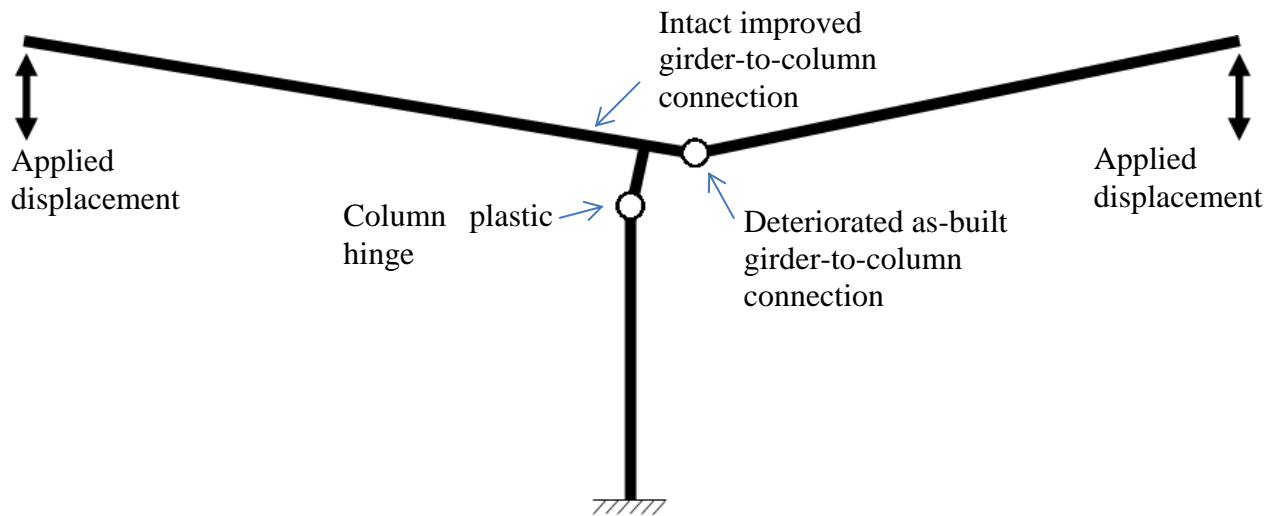
Figure 6.40: Rotation of girders about as-built connection

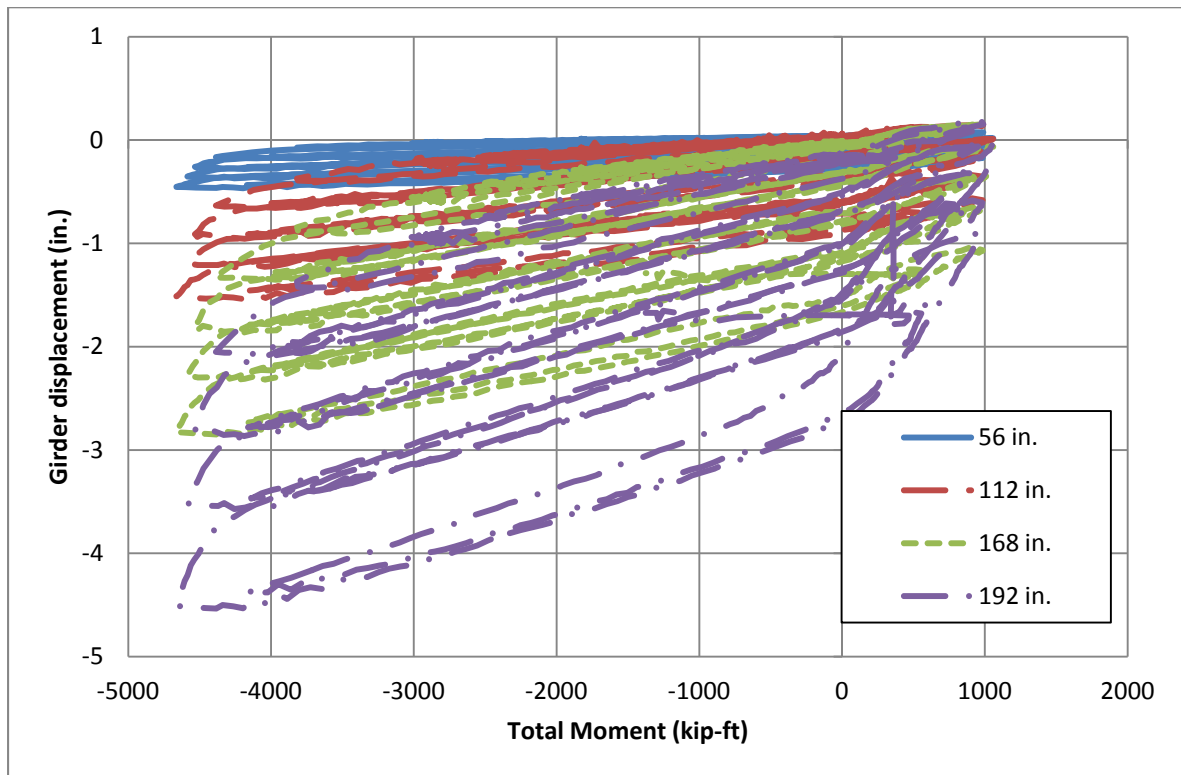
Figure 6.43: Vertical Displacement Histories from Transducers along the Length of the Improved Side Center Girder

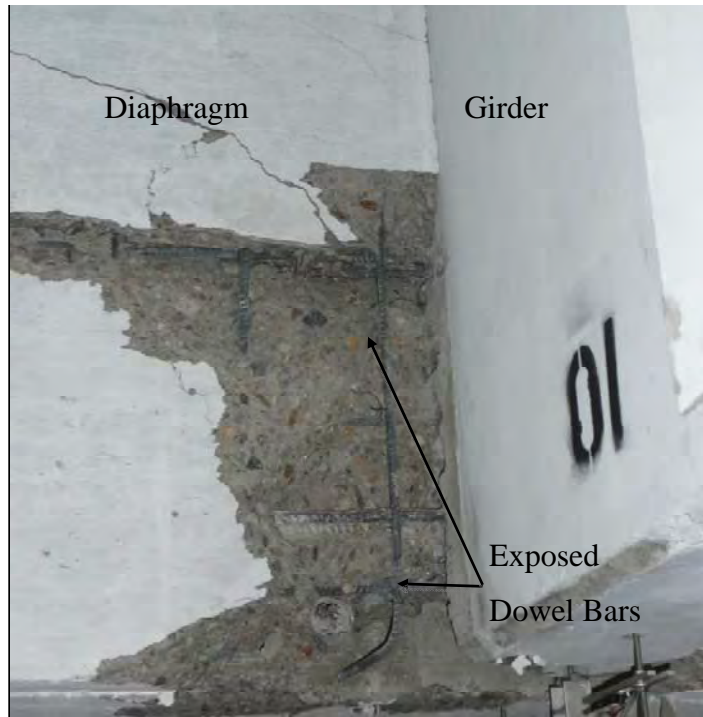
Figure 6.48: Damage Surrounding the Interior Girder in the As-built Connection Region

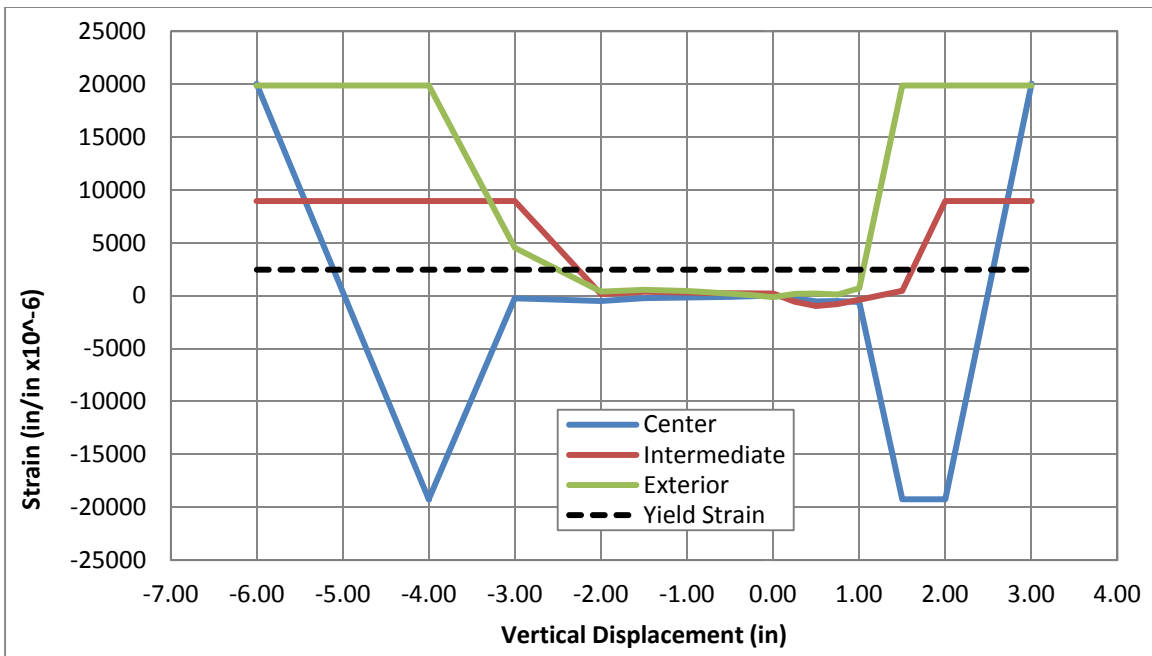
Figure 6.49: Vertical Displacement vs. Bottom Row Dowel Bar Strain on the As-Built Connection Side of the Cap Beam

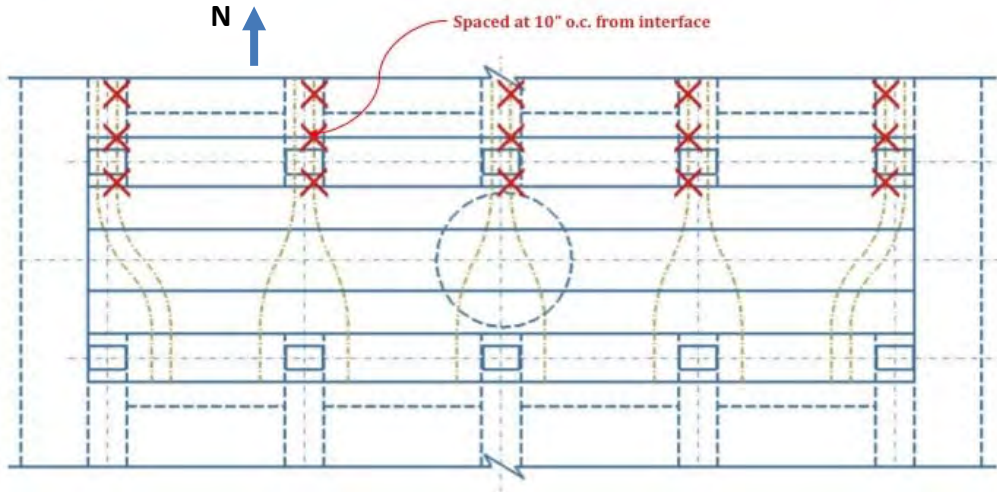
Figure 6.52: Unstressed strand strain gauge locations

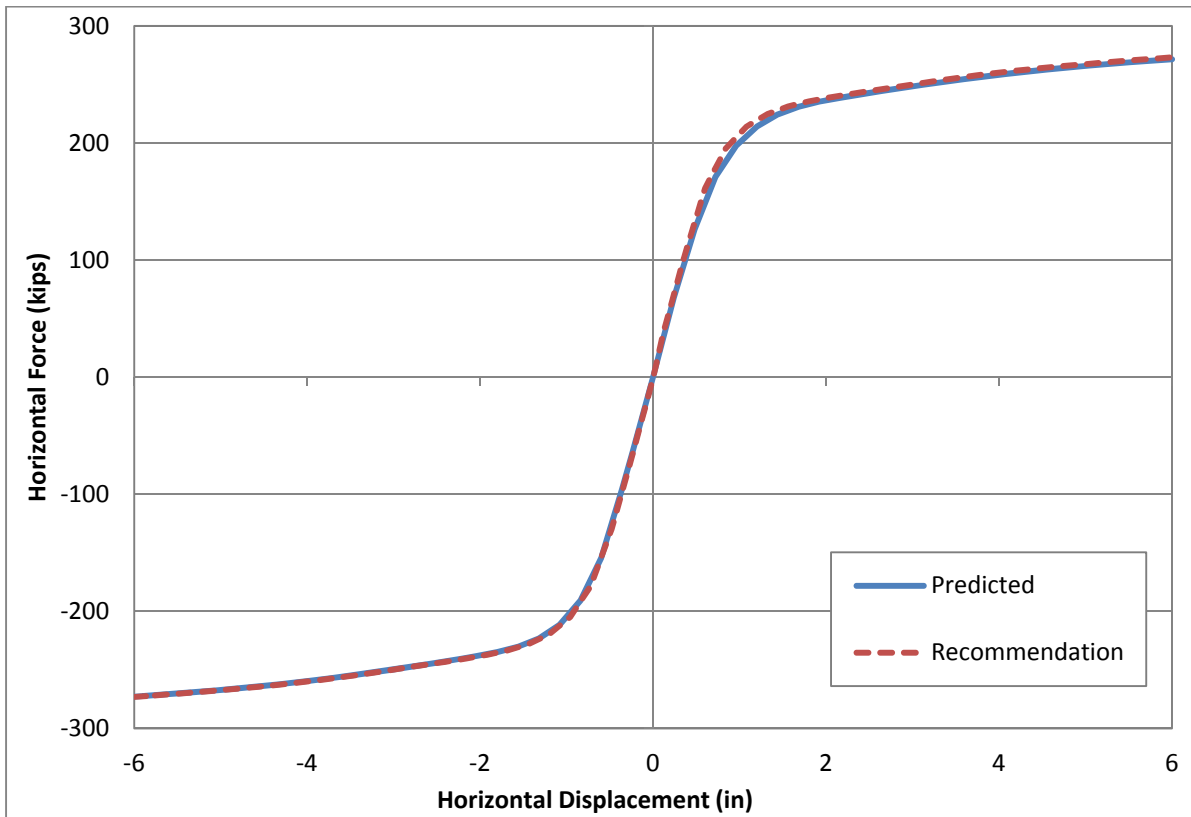
Figure 7.1: Recommended Girder-to-Cap Connection Grillage Modeling Force vs. Displacement Response

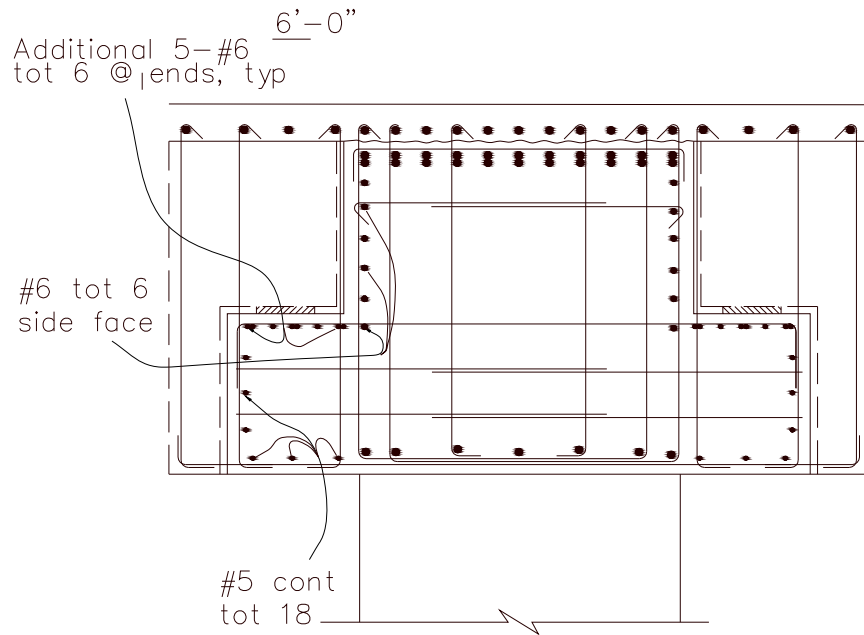
Figure B.11. Longitudinal corbel reinforcement at the exterior girder
