## **Dalton Highway 9 to 11 Mile Expedient Resistivity Permafrost Investigation**

FHWA-AK-RD-13-08

# **Expedient Permafrost Resistivity Investigation**

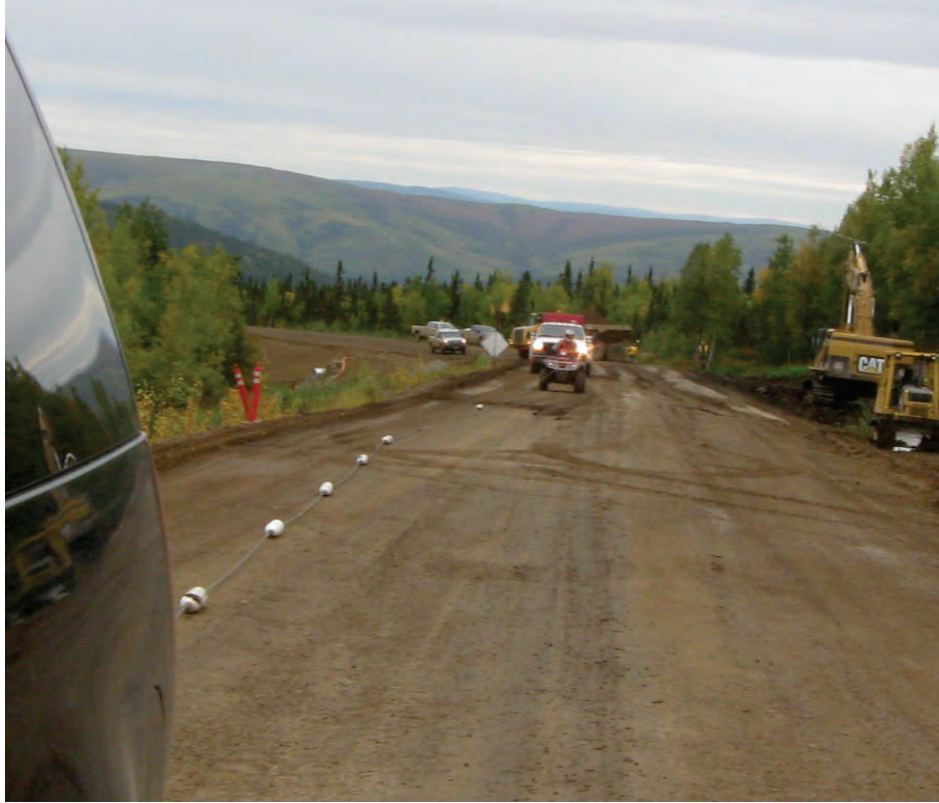
Figure 3. Photo taken during the survey with five receivers in the foreground and behind the black towing vehicle, and the transmitter in the background with the ATV guide at the very end of the system.

Our goal was to survey along the center line of the roadway as much as possible, but due to heavy equipment and pilot-car traffic, we primarily surveyed the right or north-bound lane. Also, because of the excessive length of the total array, the system cannot directly track behind the pulling vehicle and tends to ‘cut’ the short radius curves by tracking into the opposite lane. We were able to counter this some degree by providing a ‘tail’ guide consisting of a person riding an ATV guiding the rear of the array with an attached rope. This was only an issue on curves to the left where the system would tend to track to the opposite lane. For curves to the right, generally there existed a windrow of dirt at the road edge caused by road grading operations, and that prevented the array from sliding into the ditch.

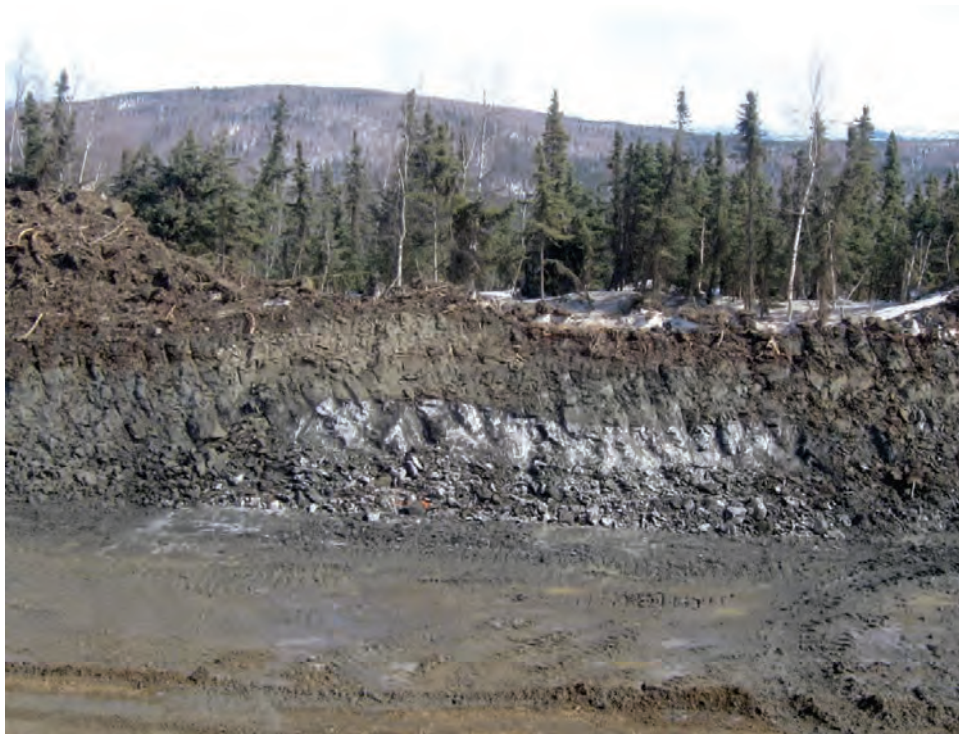
Figure 8. Wedge ice exposed on the right side at station 477+00. Tracing the wedge in the floor of the cut revealed with wedge was cut at an oblique angle.

Borehole #3 was drilled on the right side of the roadway at station 477+00 (the top of 9 Mile Hill) and encountered massive ice (foliated ice) from the top of permafrost at 3.0-m (10.0-ft). to bottom-of-hole at 5.2-m (17.0-ft). Figure 8 is a photograph of this ice wedge exposed on the right side of the cut during the excavation and prior to covering of the back-slope. It can be seen that the surrounding sediment is not dripping, sloughing, or running onto the ice and sediment below. Figure 9 is a photograph of wedge ice further down-station and still at the 9 Mile Hill cut on the left side. Again although the air temperature is well above freezing, these sediments are not exhibiting ice-rich thawing behavior. These very low moisture content sediments can help to explain the undulating nature of the high resistivity sections seen in the pseudo-sections.

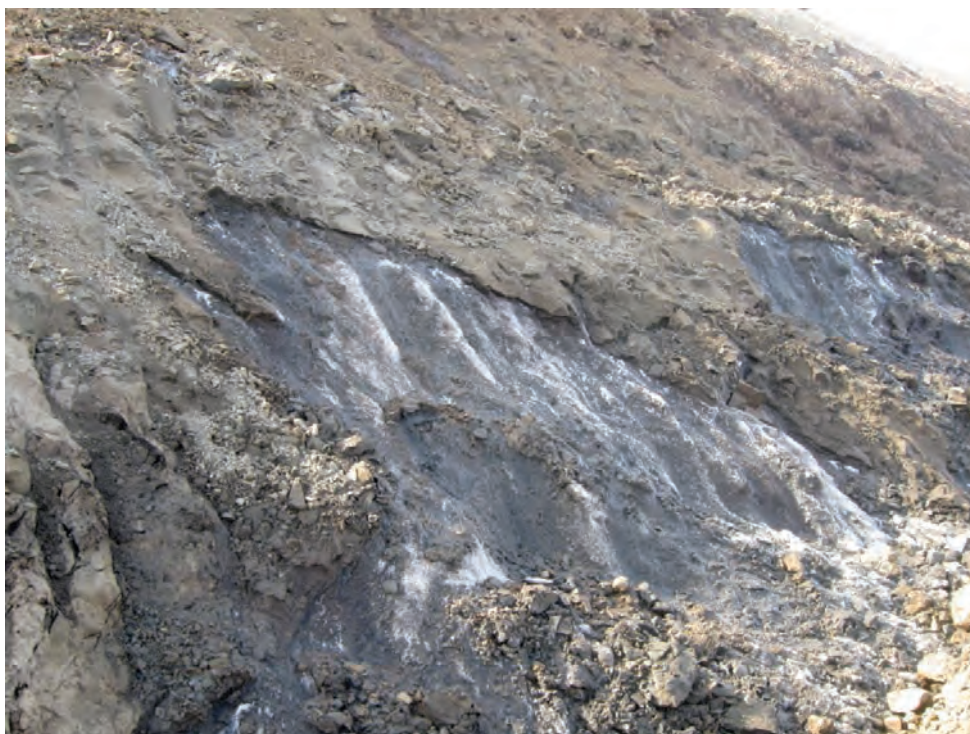
Figure 9. Close up view of wedge ice further down-station from Figure 8, and on the left side. The surrounding sediments are not dripping and sloughing although the temperature is well above freezing.

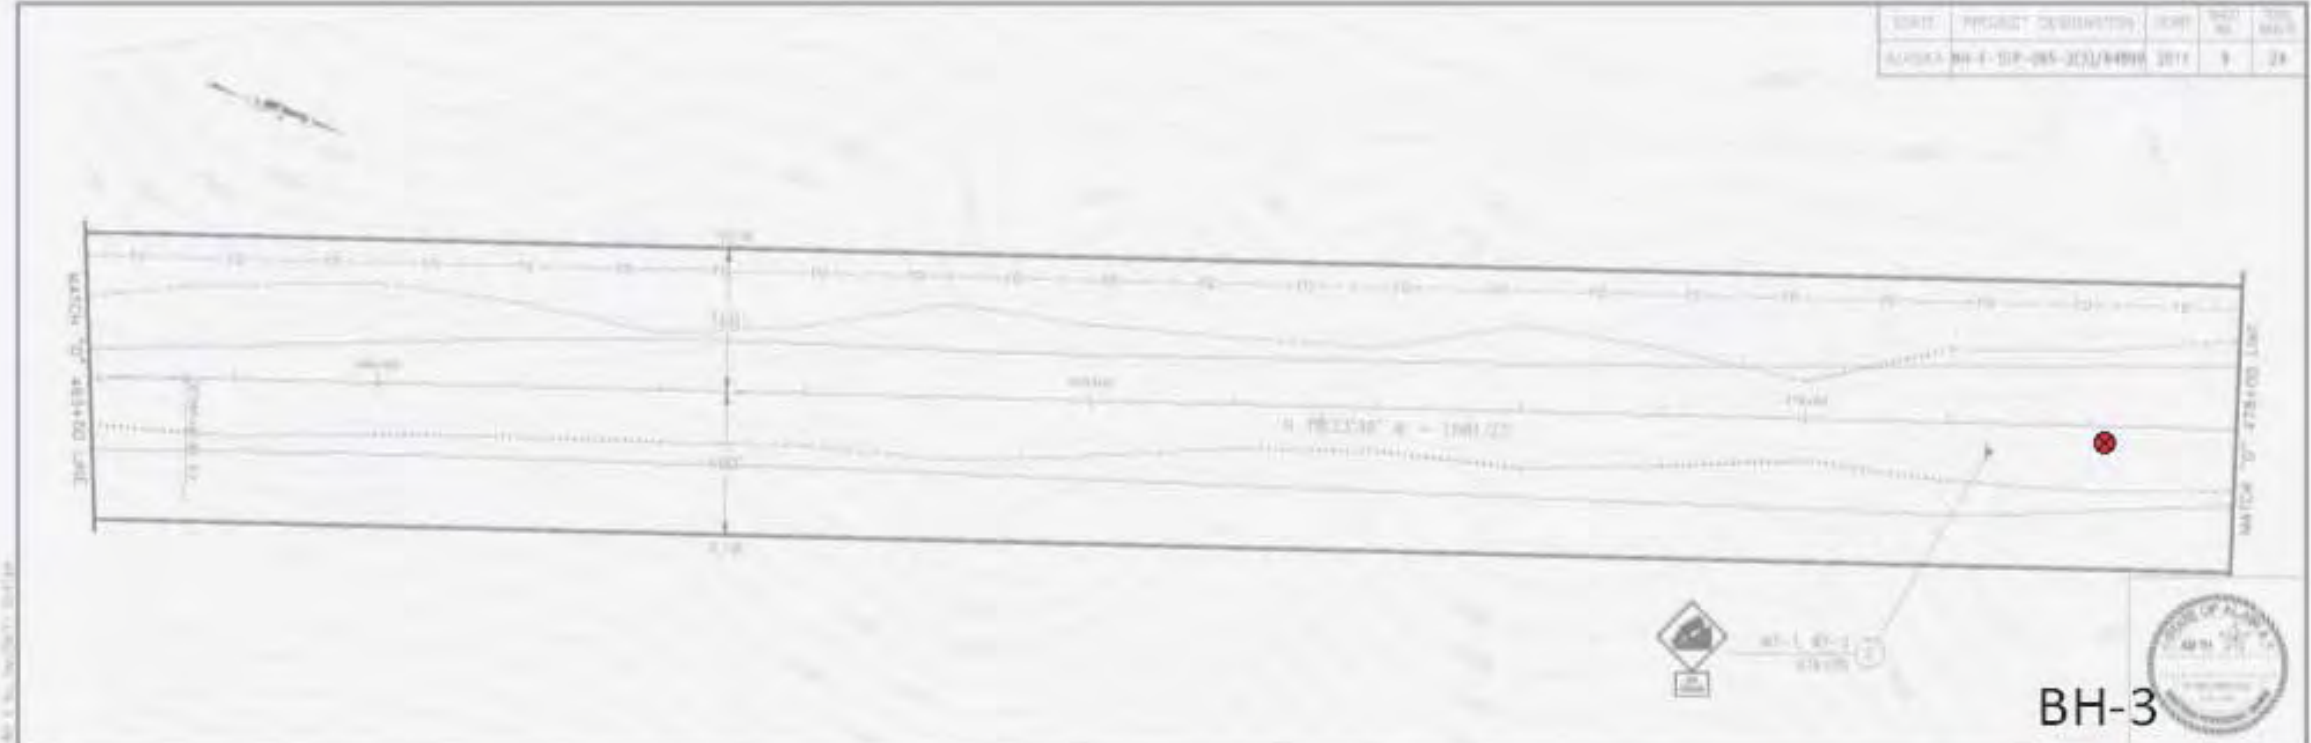
Utilizing the Plan and Profile images for this project provided by DoT, topography data was extrapolated and included into the inversion process. The result is a topographically accurate pseudo-section which was then overlaid onto the Plan and Profile images. Additionally, the inversion color scheme was altered to illustrate a definitive change from thawed (seasonally thawed layer) to frozen (permafrost table). A gradational blue color scheme was chosen for all contours with less than 100 ohm-m, and a gradational red color scheme was chosen for all contours with greater than 100 ohm-m. The results are shown in Appendix B with the CRREL borehole locations also illustrated.
