Maine Department of  
Transportation  
**Transportation Research  
Division**

**Technical Report 99-8**  
*Experimental Use of Geogrids as an Alternative to  
Gravel Placement*

*Interim Report - Second Year, August 2002*

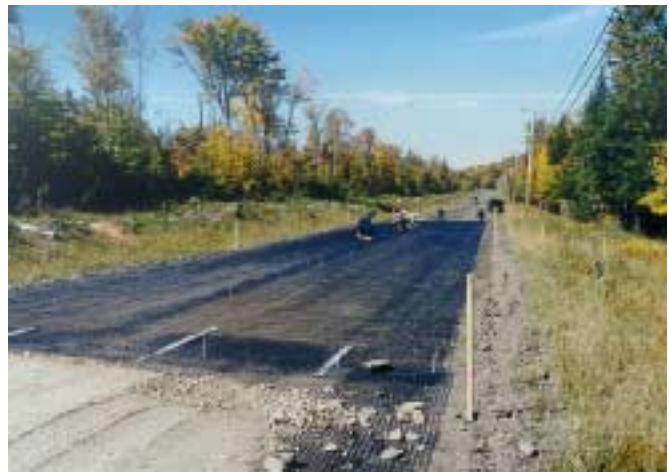
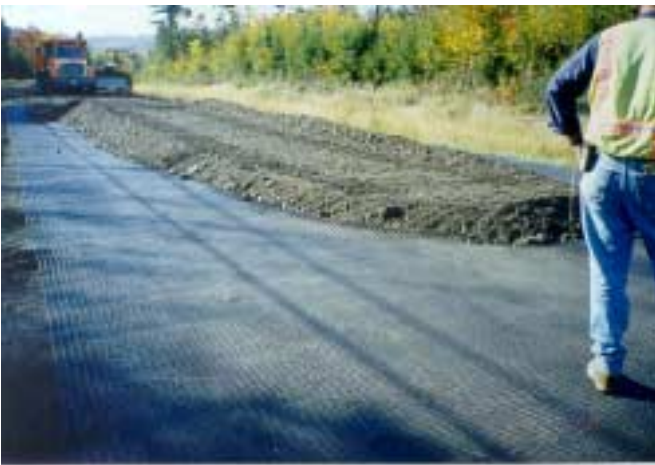
In the four Geogrid sections (2, 5, 7 and 9), existing pavement material and 25 mm of gravel base material were ground in-place and leveled to grade using a grader to eliminate excessive crown. Two rolls of geogrid product, each measuring 4 meters in width and approximately 50 meters in length were then placed on top of the reclaimed material at full roadway width. Construction of each Geogrid section was completed using this 50-meter interval to minimize traffic interruptions.

The geogrid product were overlapped and attached at the center and ends using “tie connectors”. These ties were rated at 75 pounds tensile strength. After initial application, it was determined that a single tie did not supply adequate strength and two connectors were used at each tie location.

Both lanes of traffic were stopped during this process, until a single lane width layer of gravel of varying depth (300 mm minimum) could be placed over the longitudinal seam at the center of the roadway. Once single lane traffic flow was reestablished, the left and right side of the geogrid

was covered to a total width of 7.3 meters. Some “pushing” or “waving” of the geogrid product was

observed during gravel application. This movement was not considered critical but it did create concern with respect to ease of application.

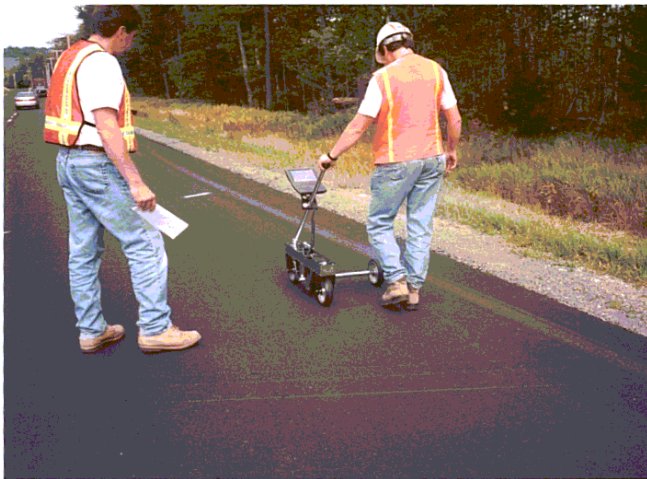
As detailed in the Construction report for this project, a Rolling Dipstick was utilized in an effort to monitor vertical movement of eight cross culverts along the project. Data was collected in April 2001 and again in August 2001 as part of the annual evaluation process. Comparisons of IRI readings were made for fall 1999, 2000, and 2001 seasons to monitor movement of the culverts on a yearly basis. Results are summarized in Table VI.
