NURail Project ID: NURail2012-UIC-R07

**Pedestrian/Bicyclist Warning Devices and Signs at  
CTA Rail-Highway Grade Crossings**

# **PEDESTRIAN/BICYCLIST WARNING DEVICES AND SIGNS AT CTA RAIL- HIGHWAY GRADE CROSSINGS**

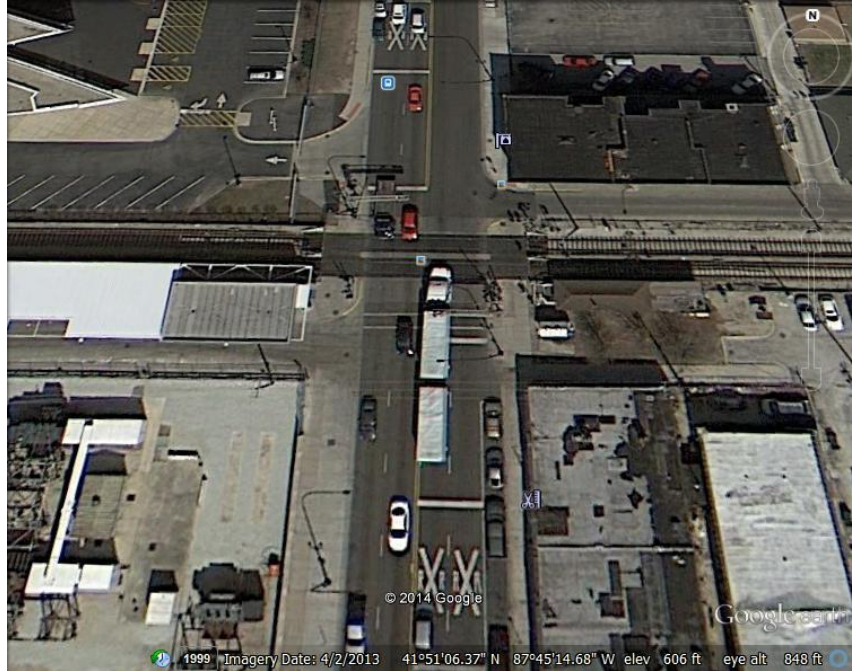
Figure 1 - Laramie Avenue crossing (view from above)

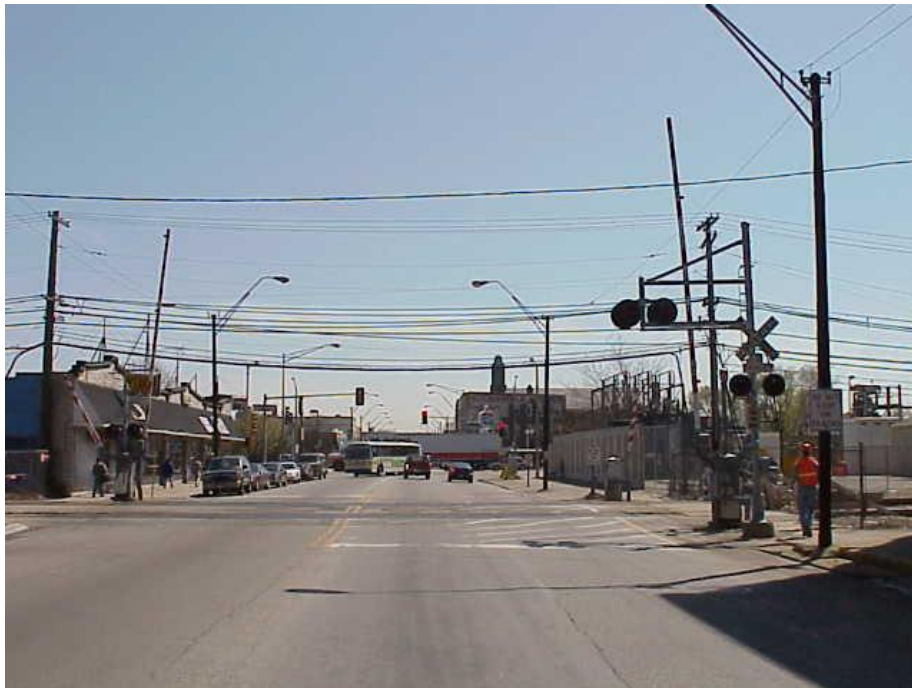
Figure 2 - Laramie Avenue crossing (street view)

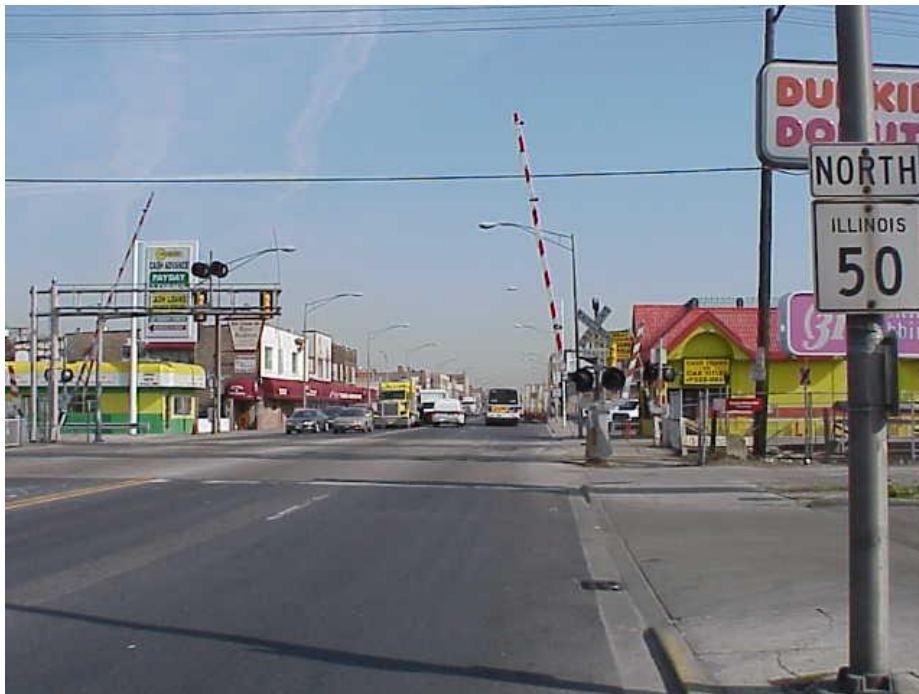
Figure 4 - Cicero Avenue crossing (street view)

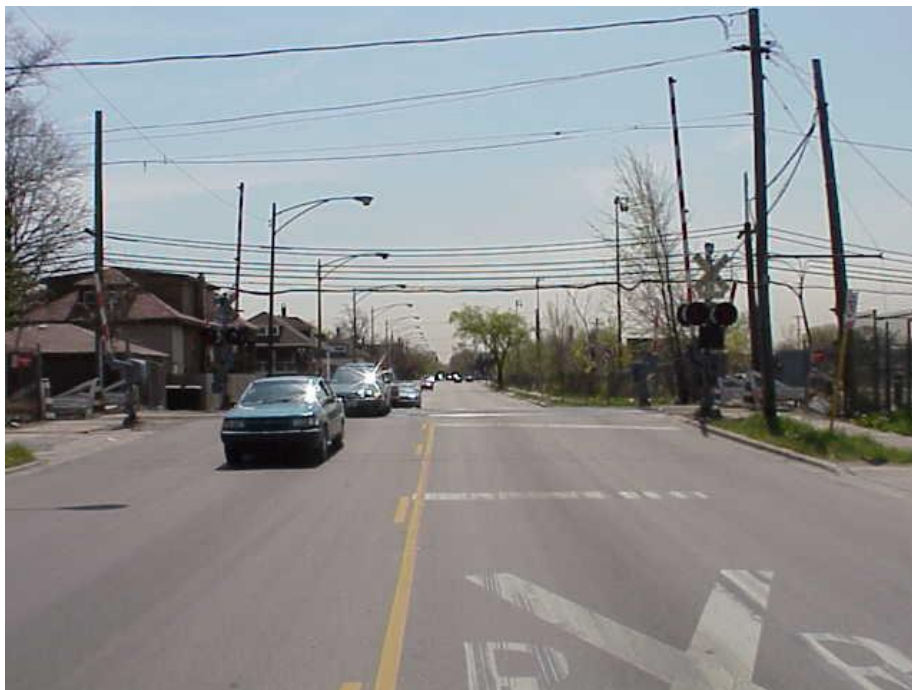
Figure 6 - Kostner Avenue crossing (street view)

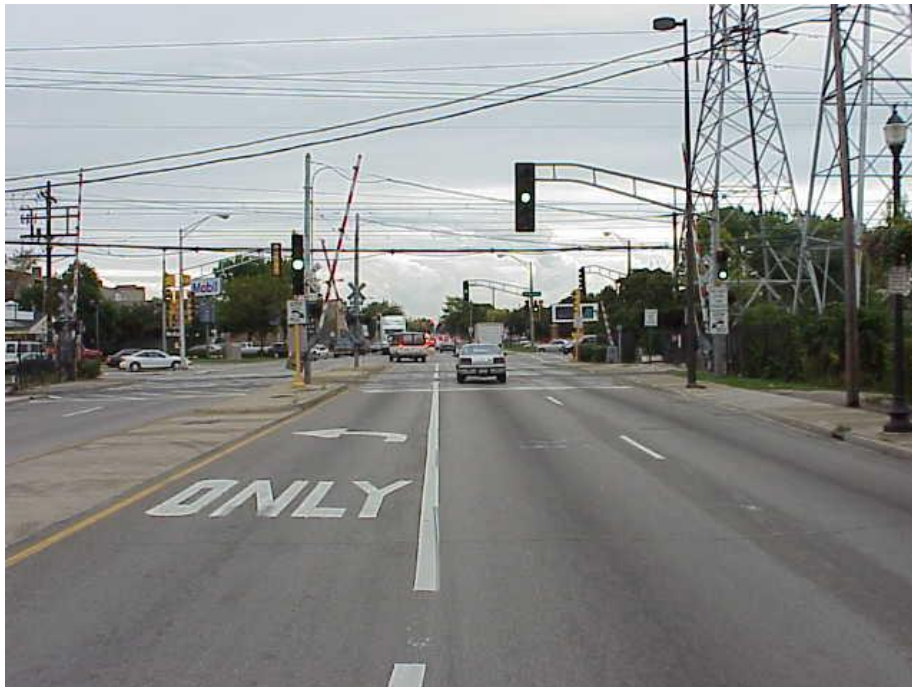
Figure 8 - Oakton Street crossing (street view)

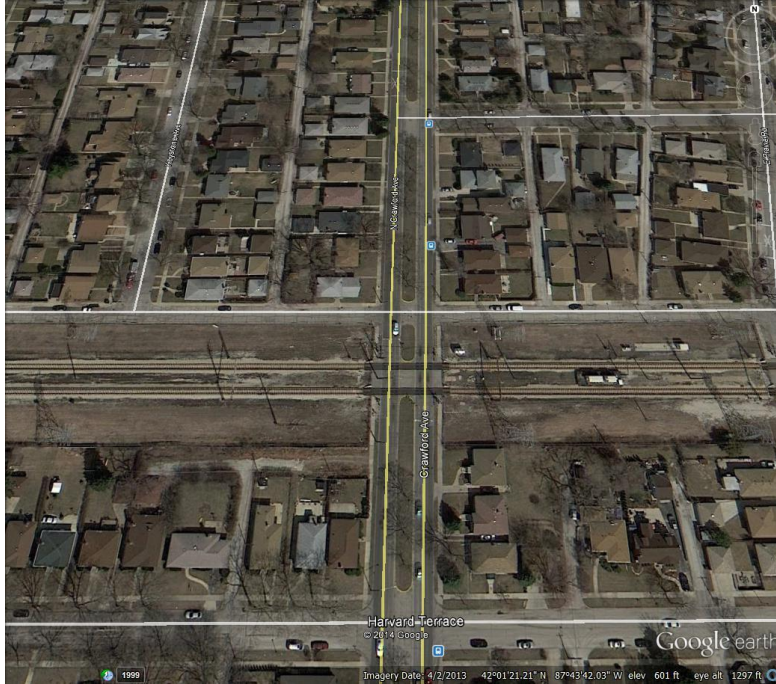
Figure 9 - Crawford Avenue crossing (view from above)

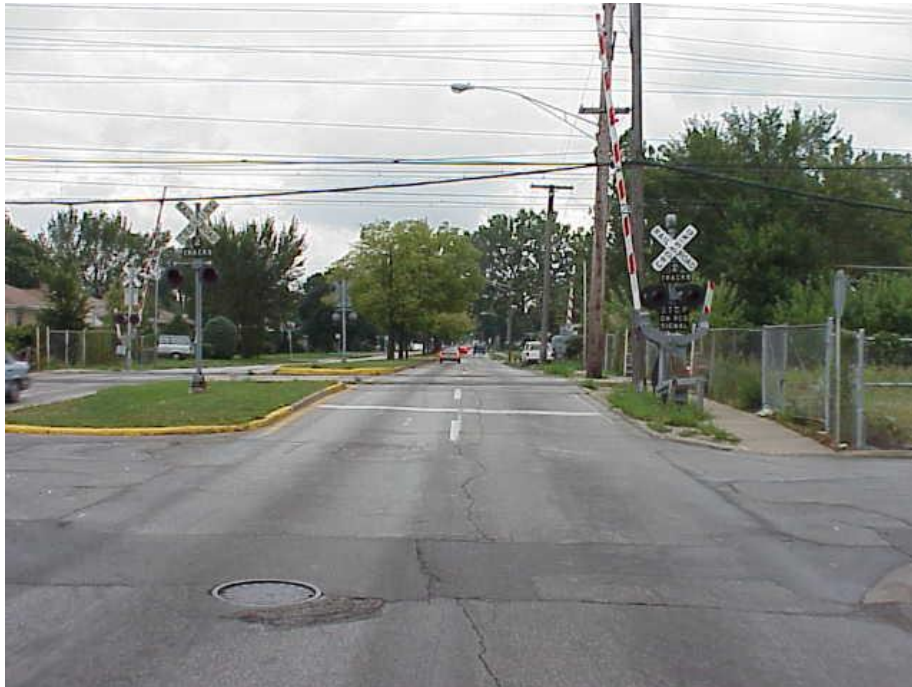
Figure 10 - Crawford Avenue crossing (street view)

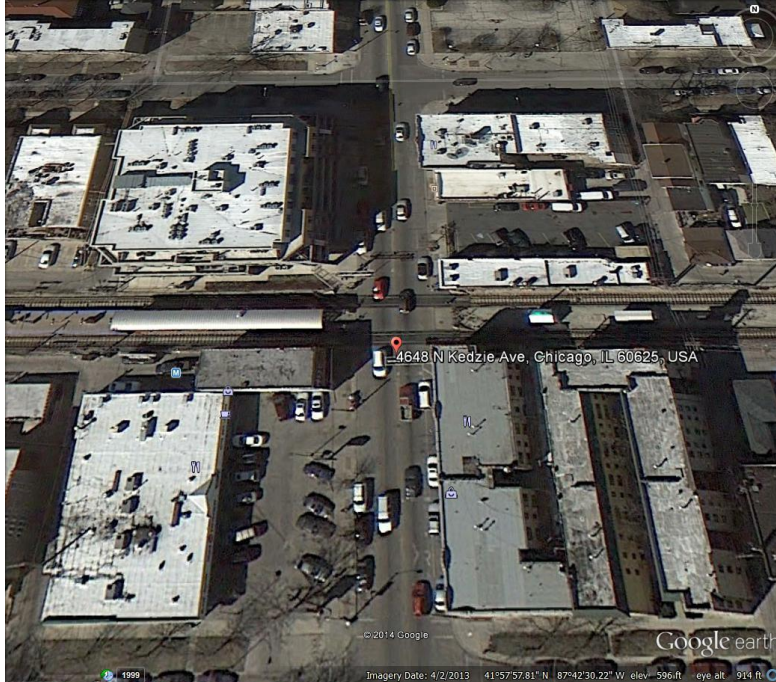
Figure 11 - Kedzie Avenue crossing (view from above)

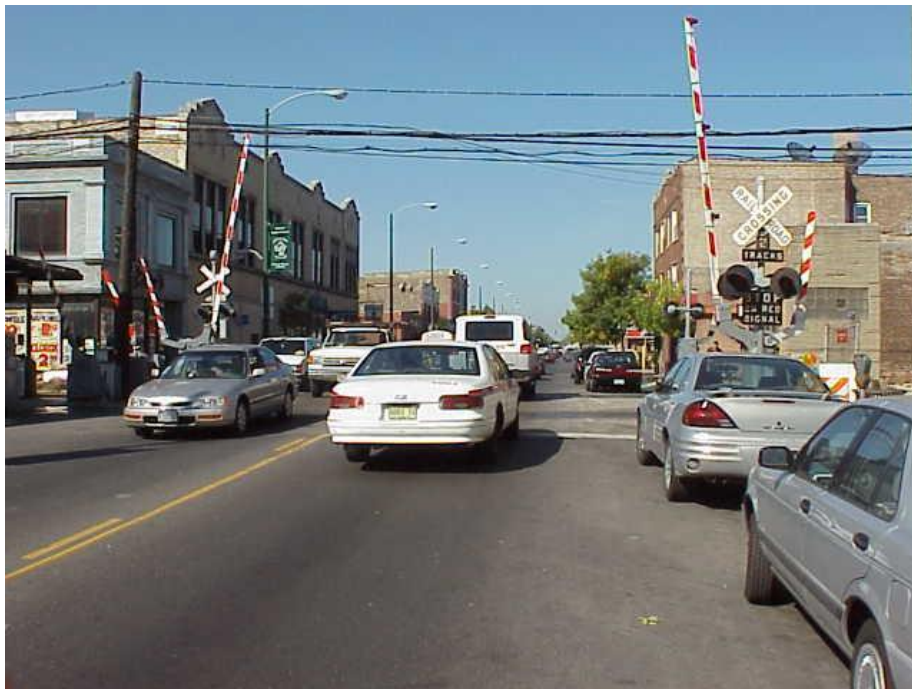
Figure 12 - Kedzie Avenue crossing (street view)

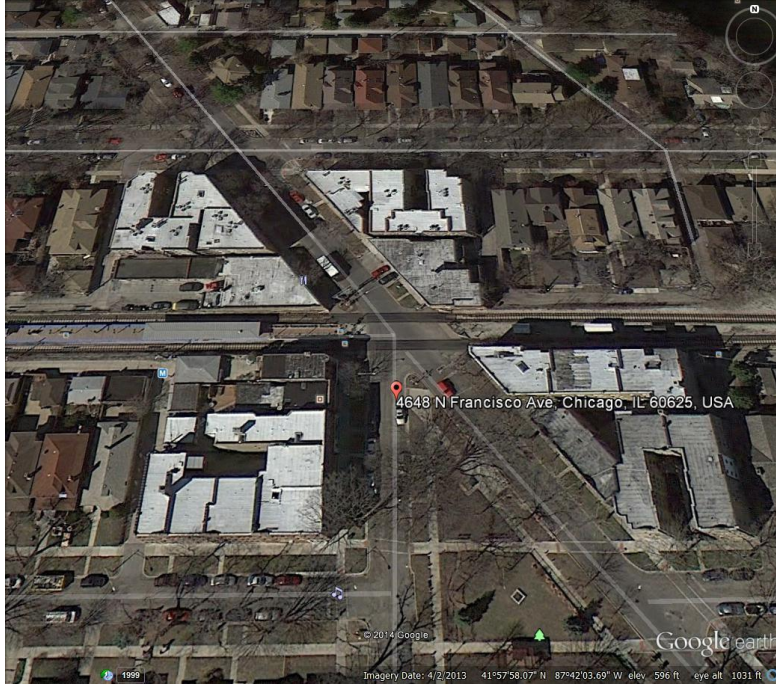
Figure 13 - Manor Avenue crossing (view from above)

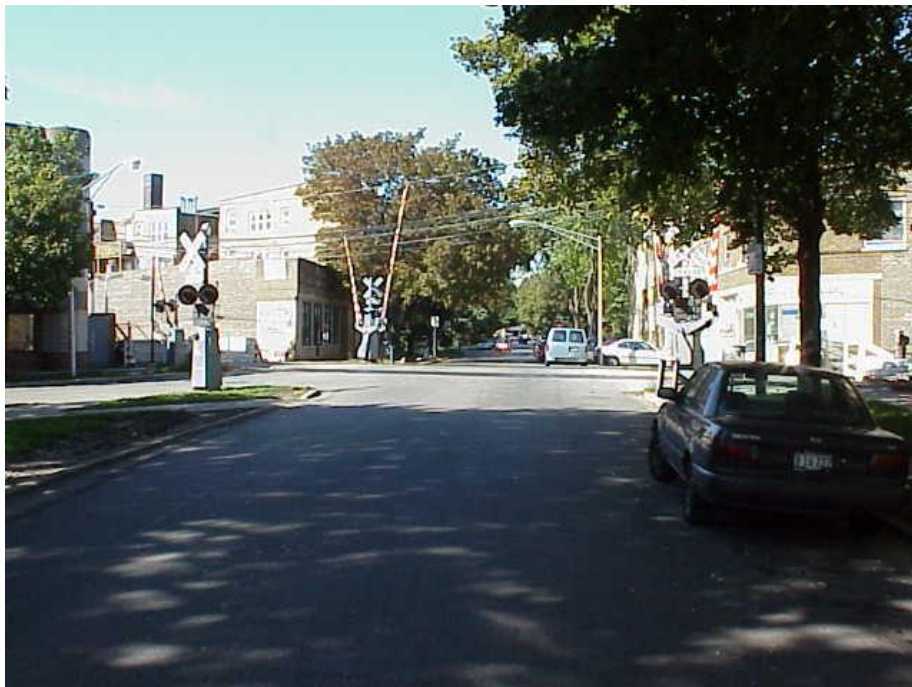
Figure 14 - Manor Avenue crossing (street view)
