# CONTINUED DEVELOPMENT OF A NON-PROPRIETARY, HIGH-TENSION, CABLE END TERMINAL SYSTEM

MwRSF Research Report No. TRP-03-332-16

April 29, 2016

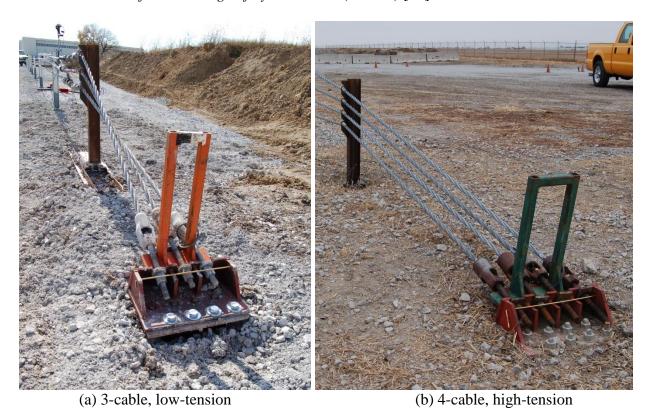
Figure 1. Cable End Terminal Systems

A three-cable, low-tension, end terminal system, shown in Figure 1a, was previously developed and successfully tested at the Midwest Roadside Safety Facility [1] according to the safety performance criteria specified in the National Cooperative Highway Research Program (NCHRP) Report No. 350 [2]. The low-tension, end terminal system was modified to add a fourth cable, as shown in Figure 1b, during the development of a four-cable, high-tension cable median barrier [3-14]. However, the high-tension end terminal was never subjected to full-scale crash testing according to the safety performance criteria specified in NCHRP Report No. 350 or the current *Manual for Assessing Safety Hardware* (MASH) [15].

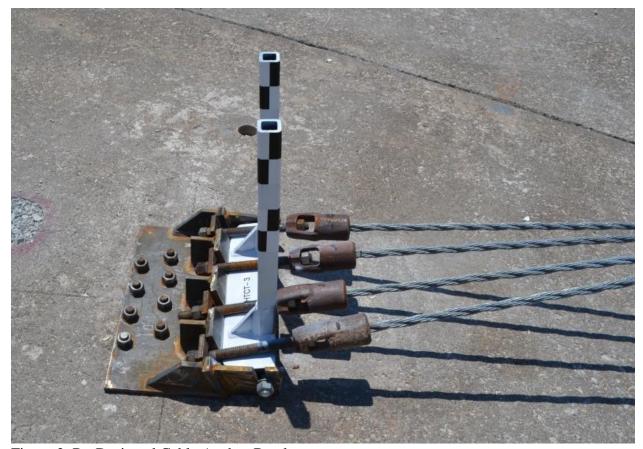
Figure 2. Re-Designed Cable Anchor Bracket

Eliminating permanent deformations in the anchor bracket and release lever and adding more clearance around the cable anchorage fittings were also desired. So, the cable end terminal was redesigned in a prior project, and finite element analysis demonstrated that the new end terminal design met the desired goals [16]. This cable anchor bracket concept is shown in Figure 2.

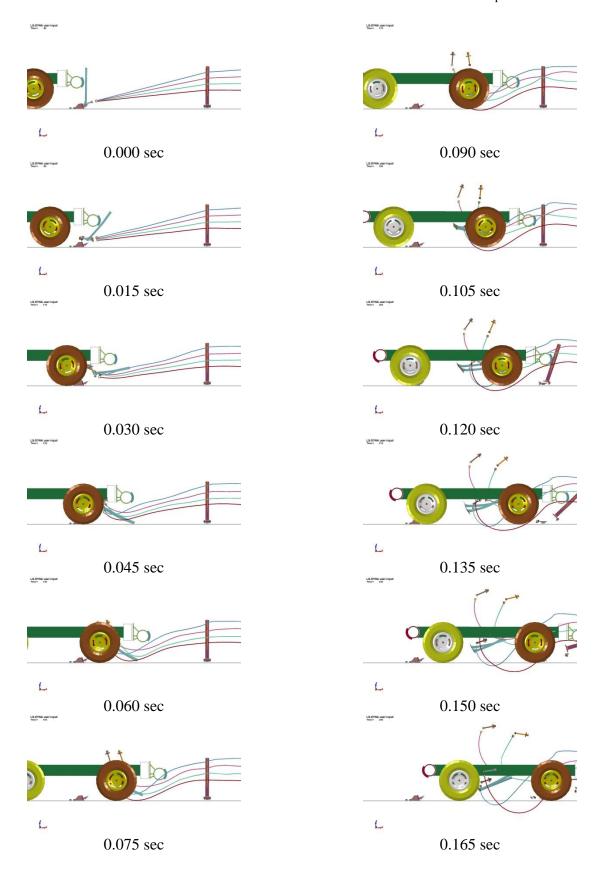
Figure 22. Sequential Photographs, Simulated Test No. 3-30

mm/ms) and at an angle of 0 degrees. Sequential photographs are shown in Figures 22 through 24. The cable release lever began rotating upon impact and all the cables were fully released within 13 ms, and the bogic continued without a significant change in velocity. The cable release lever experienced minor permanent deformations during the initial impact with bogic impact head, and the cable anchor bracket components experienced no permanent deformation. However, the cable release lever was not constrained with a cable, as would be expected in real world installations, so the lever subsequently contacted the bottom of the bogie, was drug downstream, and experienced significant deformation.

Due to the ease in which the cables released from the cable anchor bracket, significant damage to an actual vehicle was not expected. This simulation was only intended to evaluate the initial impact with the cable anchor bracket and post no. 2. The end terminal line posts will need to be evaluated in the future to ensure that the posts do not cause vehicle instabilities or cause excessive occupant compartment intrusion or penetration, such as floorboard penetration. There was no indication that occupant impact velocities or occupant ridedown accelerations would exceed the limits established in MASH.

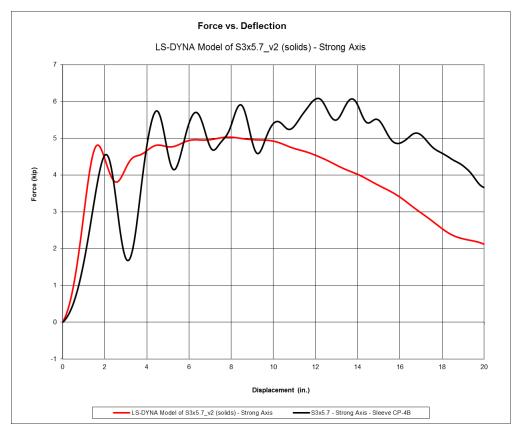
Figure 38. Comparison of S3x5.7 Post with Dynamic Test Data

A simulation model of the standard MWP post had previously been compared with dynamic component testing during its development [9], and was found to provide good correlation with physical testing. Similar comparisons were made with the S3x5.7 (S76x8.5) post and available test data. No data was available at the time of this research for comparison of the weak-axis behavior of the model. However, comparison of the force and energy versus deflection data taken from previous strong-axis testing of S3x5.7 (S76x8.5) posts, as shown in Figure 38, found that the model of the S3x5.7 (S76x8.5) post correlated well with the physical test. Because both the standard MWP and S3x5.7 (S76x8.5) post models correlated well with previous physical tests, it was believed that they could be used to investigate the weak-axis performance of the posts.
