**Federal Railroad  
Administration**

## Side Impact Test and Analyses of a DOT-111 Tank Car

| 9. SPONSORING/MONITORING AGENCY NAME(S) AND ADDRESS(ES)<br>U.S. Department of Transportation<br>Federal Railroad Administration<br>Office of Research, Development, and Technology<br>Washington, DC 20590 | | 10. SPONSORING/MONITORING<br>AGENCY REPORT NUMBER<br><br>DOT/FRA/ORD-15/30 | |

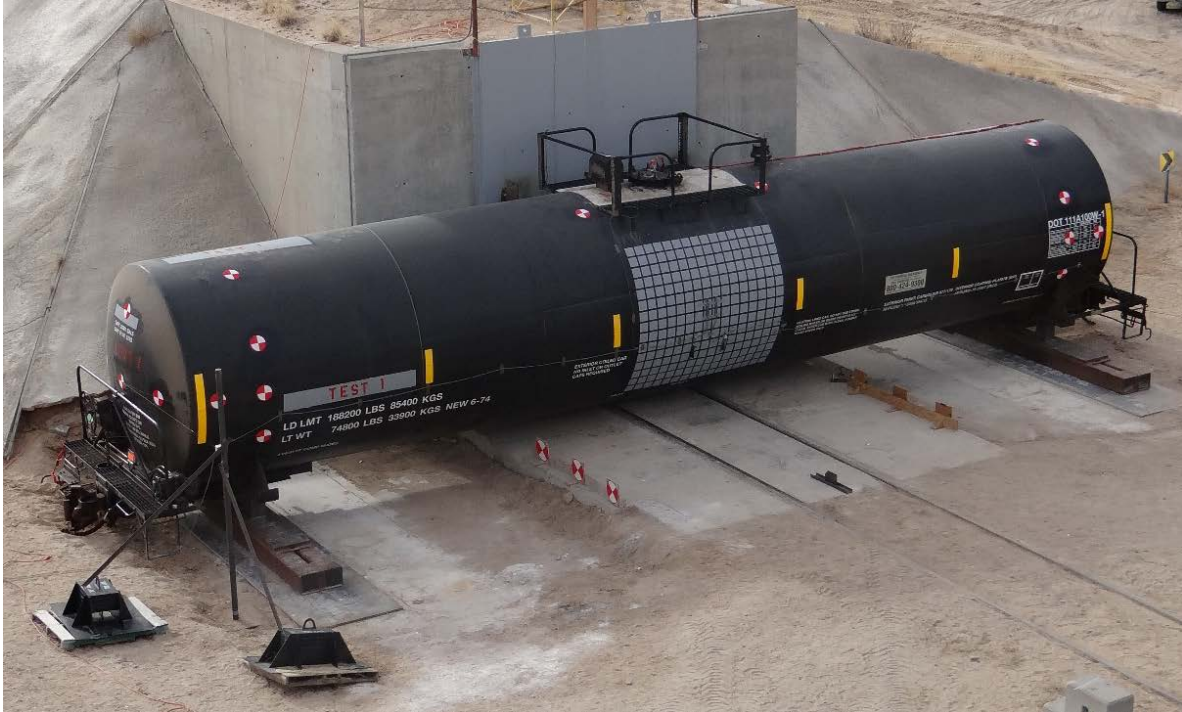
**Figure 2. Target tank car mounted on support skids.**

The side impact test was performed on December 18, 2013, at the TTCI's site in Pueblo, Colorado [1]. In this test, a ram car with a 12 in x 12 in impactor head was impacted into the side of a DOT type 111A100W tank car that was backed by a rigid impact barrier. The tank car configuration prior to the test is shown in Figure 2.

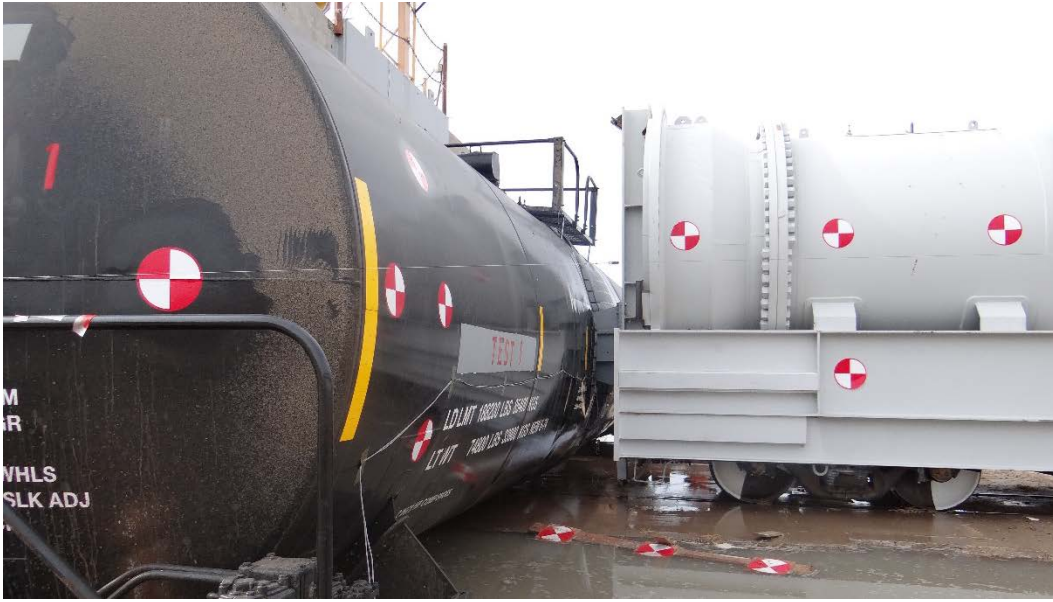
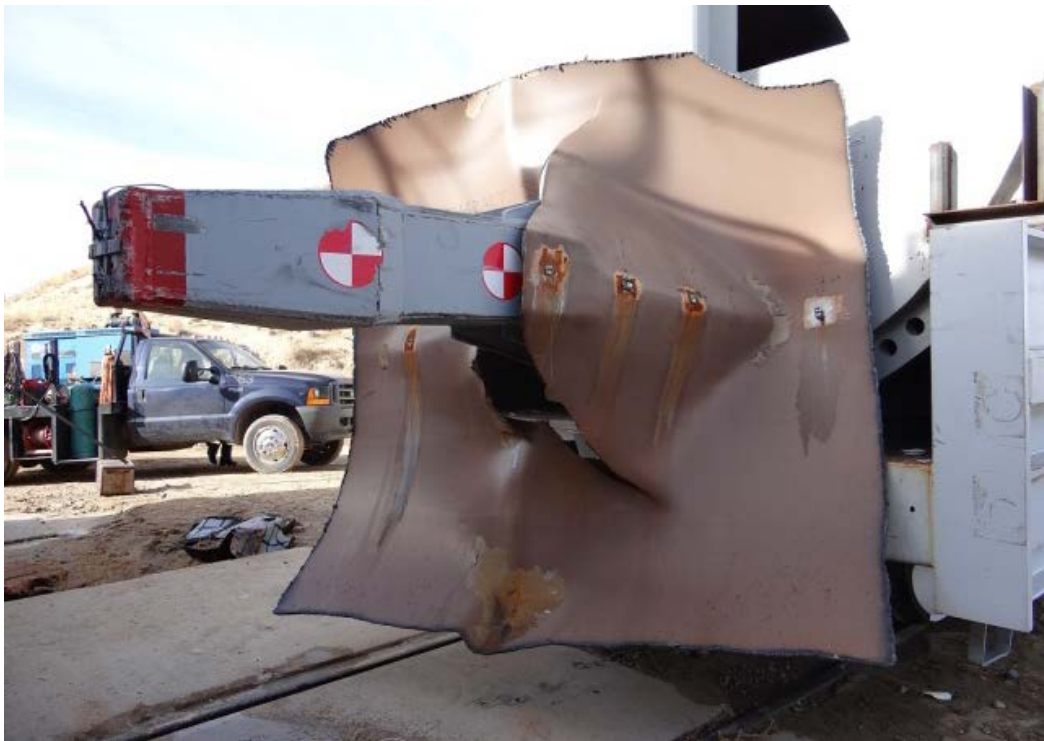
**Figure 10. Post-test damage and puncture response of the test tank car.**

Target speed for the test was 14 mph and the simulation predicted a puncture at that speed. The actual calculated impact speed from the speed trap was 14.04 mph and the impact resulted in large dents and penetration of both the jacket and tank shell by the ram arm. The states of the tank car and ram car after impact are shown in Figure 10(a). The impact also caused one of the weld joints on the jacket near the impact area to fail, and the back of the tank car was also deformed by the reaction against the rigid impact barrier.

**(a) Test tank car and ram car post impact**

**(b) Punctured tank shell**

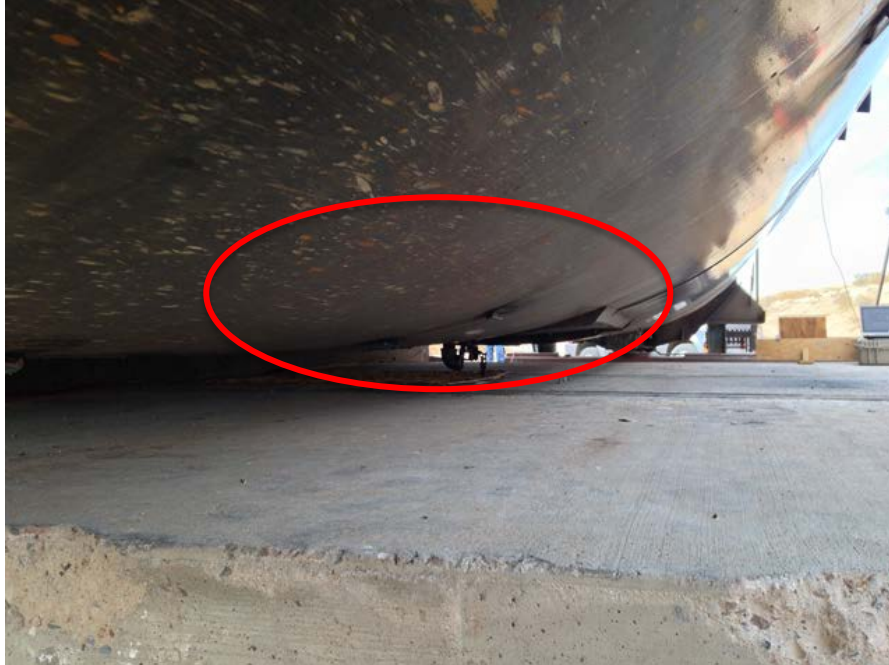
**Figure 39. Observed details on tank underside, not included in pre-test models.**

Prior to the test, a few features were noted on the underside of the test tank that were not in the pre-test models. Figure 39 shows a heater coil fitting and what appears to be a cutout in the outer jacket in the vicinity of the fitting. These features were to the left of the tank centerline by about 2 ft. These features were not expected to significantly influence the test response and were not included in the pre- or post-test FEA models. Lastly, it was noted at the test site that the concrete pad shown in Figure 39 is in close proximity to a significant portion of the bottom of the tank center. This pad was not included in pre-test predictions. Evidence of tank/pad interaction was not clear from reviewing the test video and it was unclear whether contact and support from the concrete had any influence on overall tank motion. The pad was added to post-test simulations, which indicated that it had a slight interaction with the jacket near the tank centerline but the effect on overall response was negligible.

**a) Localized jacket/tank transition**

**b) Concrete pad in close proximity to tank underside**

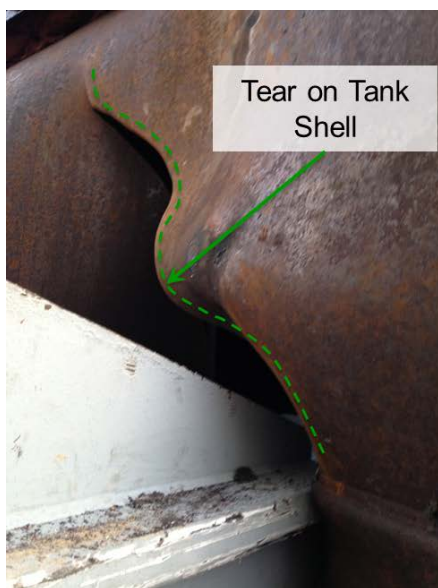
**Figure 41. Post-test impact face and tank rupture detail—right side of ram**

Shortly after the test, the outer jacket was cut away from the impact zone to expose the punctured inner tank. Figure 40 and Figure 41 show the puncture zone from the left and right side of the impactor head, respectively. Looking at the post-test impressions and fracture patterns, it can be deduced that the tank rupture initiated on the right side of the ram head. The denting on the heater coils from the initial impact seen in Figure 40 slid to the left, relative to the ram tip, as a vertical tear opened on the right edge of the impact face. The tear, which extends above and below the impactor head, is shown in Figure 41.

**a) View above ram**

**b) View below ram**
