## **Next-Generation Foundations for Special Trackwork Phase III**

| 4. TITLE AND SUBTITLE<br>Next Generation Foundations for Special Trackwork - Phase III | | | 5. FUNDING NUMBERS<br>DTFR53-11-00008<br><br>Task Order 308 | |
| 7. PERFORMING ORGANIZATION NAME(S) AND ADDRESS(ES)<br>Transportation Technology Center, Inc.<br>55500 DOT Road<br>Pueblo, CO 81001 | | | 8. PERFORMING ORGANIZATION<br>REPORT NUMBER | |
| 13. ABSTRACT (Maximum 200 words)<br>Transportation Technology Center, Inc. (TTCI) conducted a series of tests, funded by the Federal Railroad Administration, which evaluated the potential beneficial effects of various configurations of high angle frogs and frog foundations on wheel-rail vertical forces and frog performance. The tests were conducted under 315,000-pound cars with nominal 39-ton axle loads at the High Tonnage Loop of the Facility for Accelerated Service Testing at the Transportation Technology Center in Pueblo, CO.<br><br>Results from previous phases of this project were used to develop this testing plan, and the project had previously determined that track stiffness, track damping and frog flexibility (i.e., the capability for differential vertical movement b

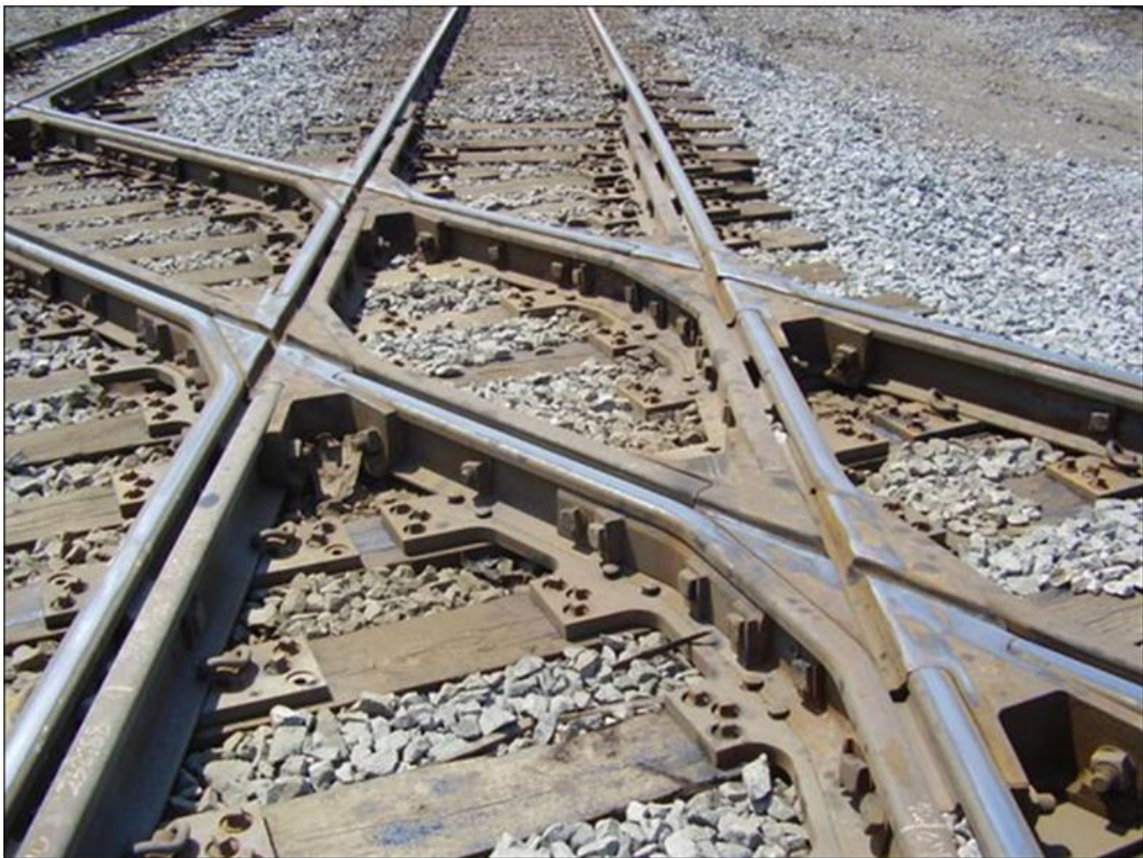
**Figure 1. An Intermediate Angle Cast Crossing in Revenue Service**

- The cast crossing with running rails and the flangeway cast in one piece with the crossing connected to the running rails through bolts, as Figure 1 shows, or through the leg rail and bolts as Figure 2 shows. This type of diamond is generally stiffer and has fewer parts.
- The three-rail crossing where the running rails in two lines are cut through and connected with leg rails, as Figure 3 shows. This type of diamond is easier to fabricate and does not require a casting pattern (mold). It can be made to any angle using the same basic pieces. There is a definite mainline route for this design. As Figure 3 shows, the running surfaces do not conform to the wheels on the crossing route.

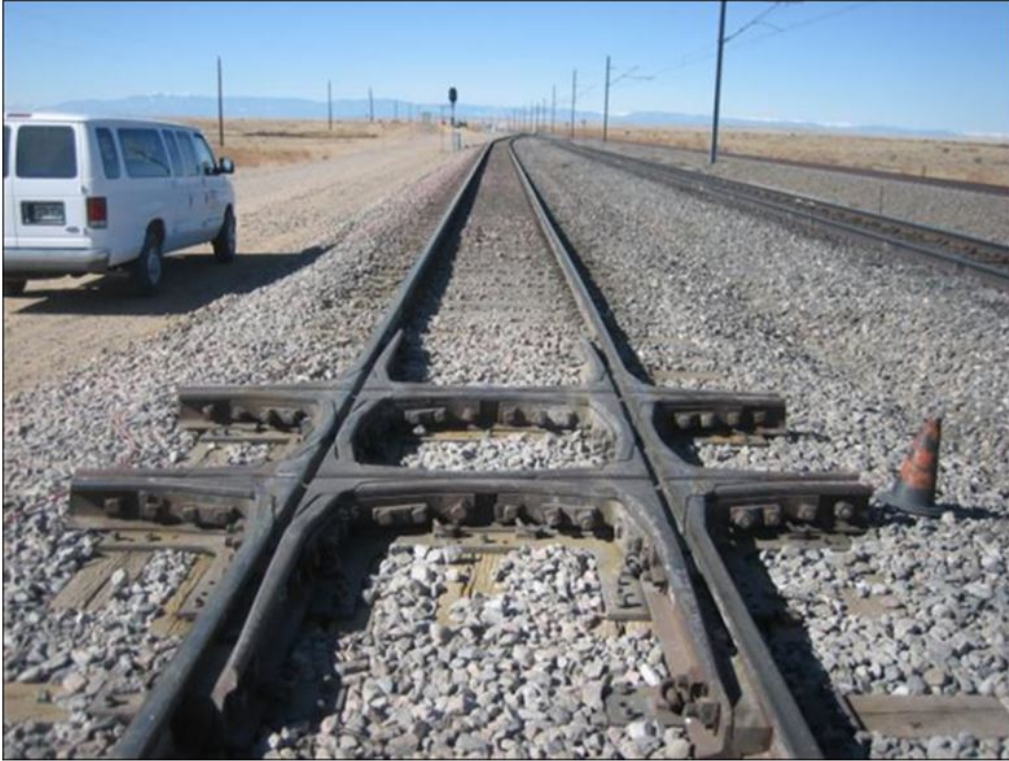
**Figure 2. Cast Diamond Crossing Tested at FAST**

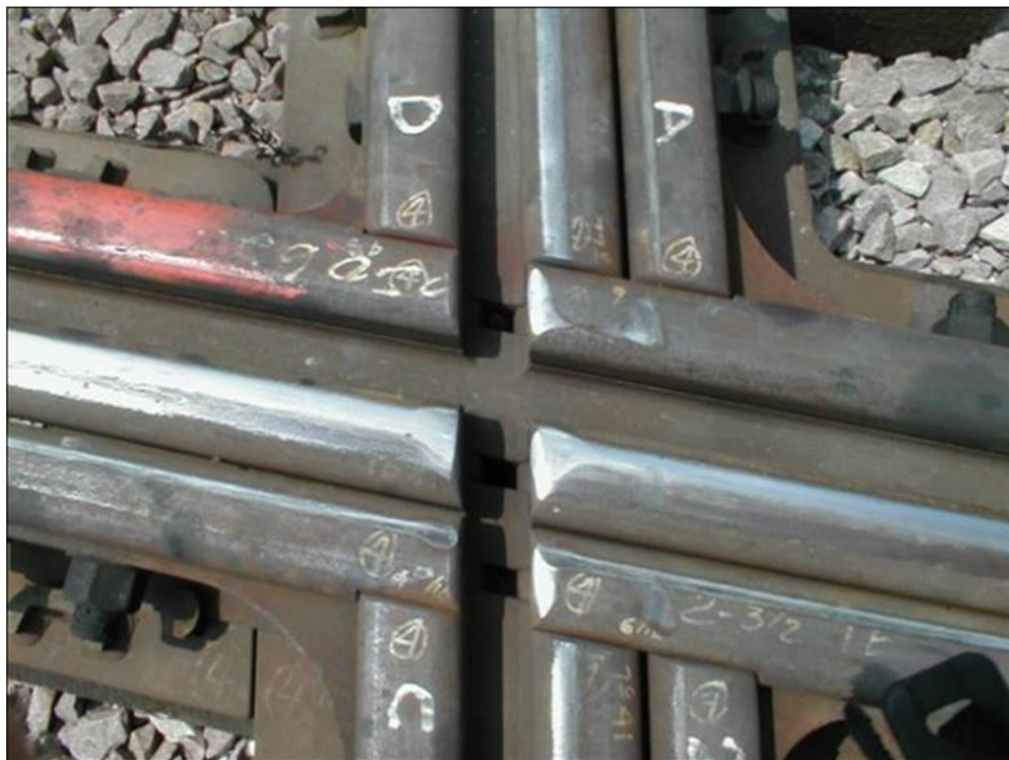
**Figure 3. Three-Rail Crossing Diamond**

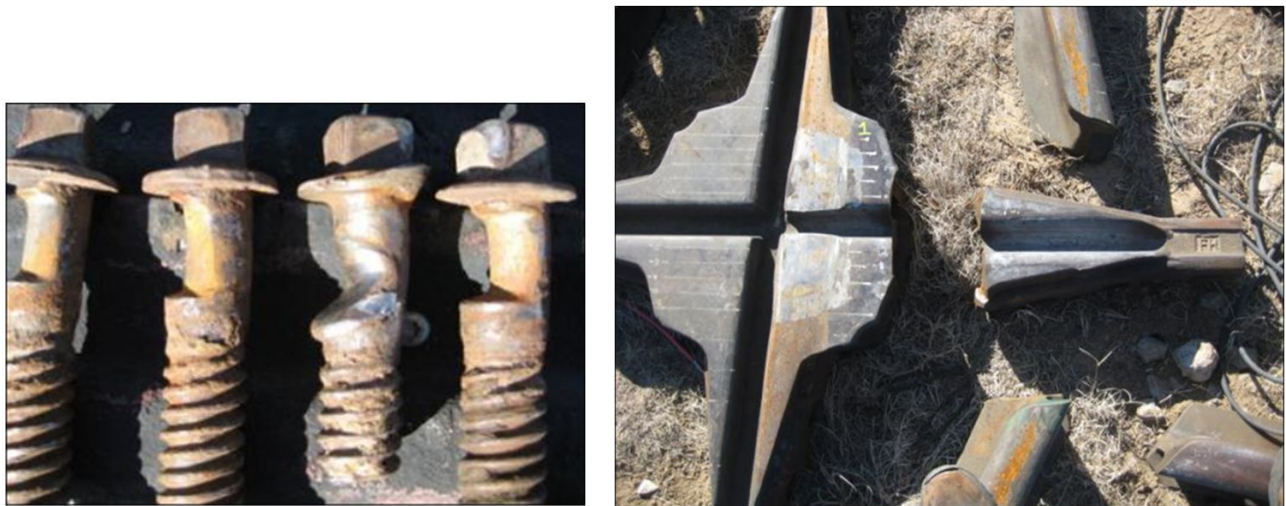
**Figure 4. Components Failures in Cast Crossing**

However, both testing at FAST and practice in revenue service showed that the cast flangeway wore faster than expected, and the crossing performance deteriorated quickly because of the impact. The stronger, stiffer frogs cause higher dynamic loading at the same speeds as the three-rail design crossing diamond. At FAST, the high wheel-rail impacts broke not only the fastening components and the leg rail, but also the arm of the casting itself, as Figure 4 shows.

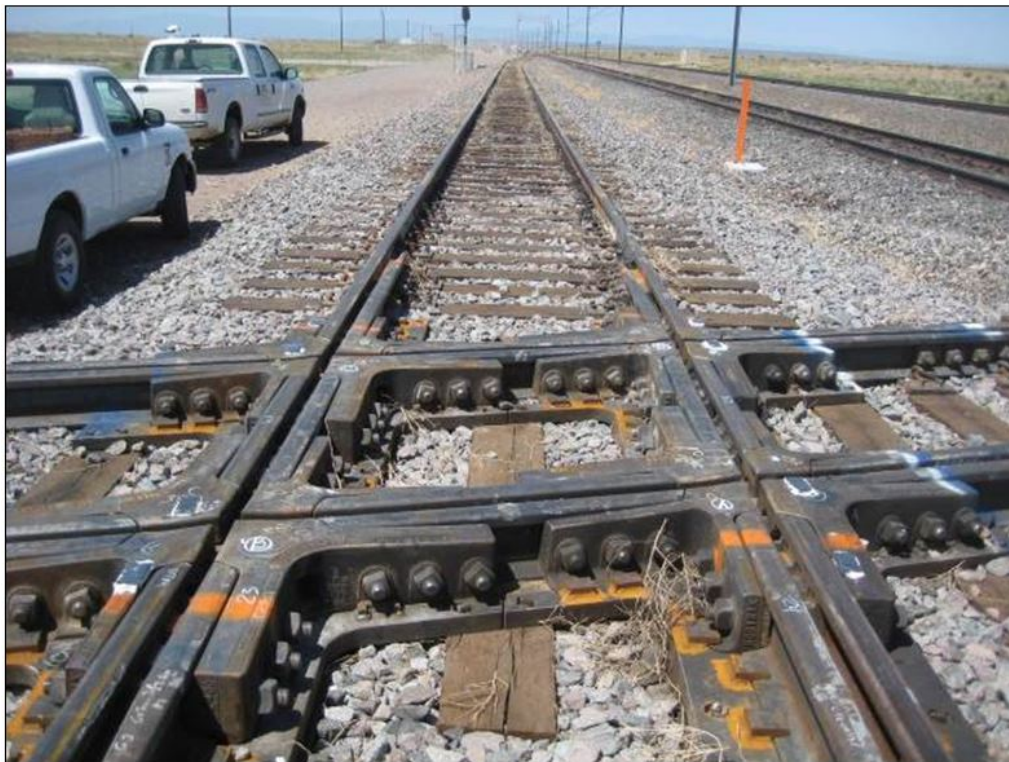
**Figure 5. The test prototype crossing diamond as installed is a modified version of the basic SRR crossing diamond design**

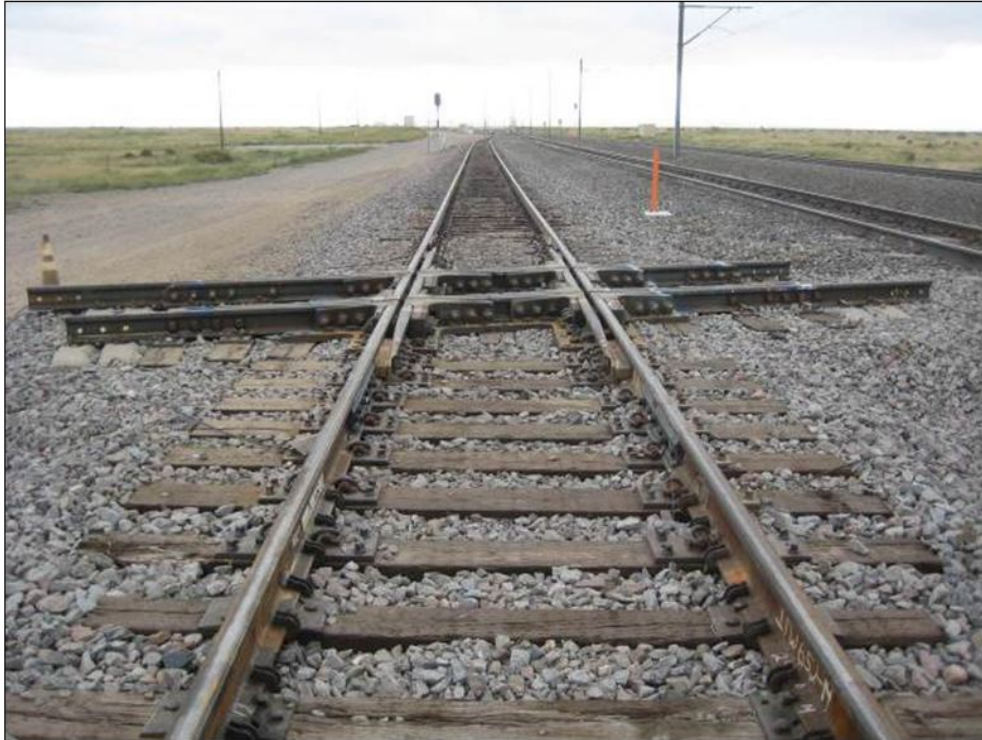
**Figure 6. The crossing diamond was installed in typical HTL test configuration, where traffic runs over a single route**

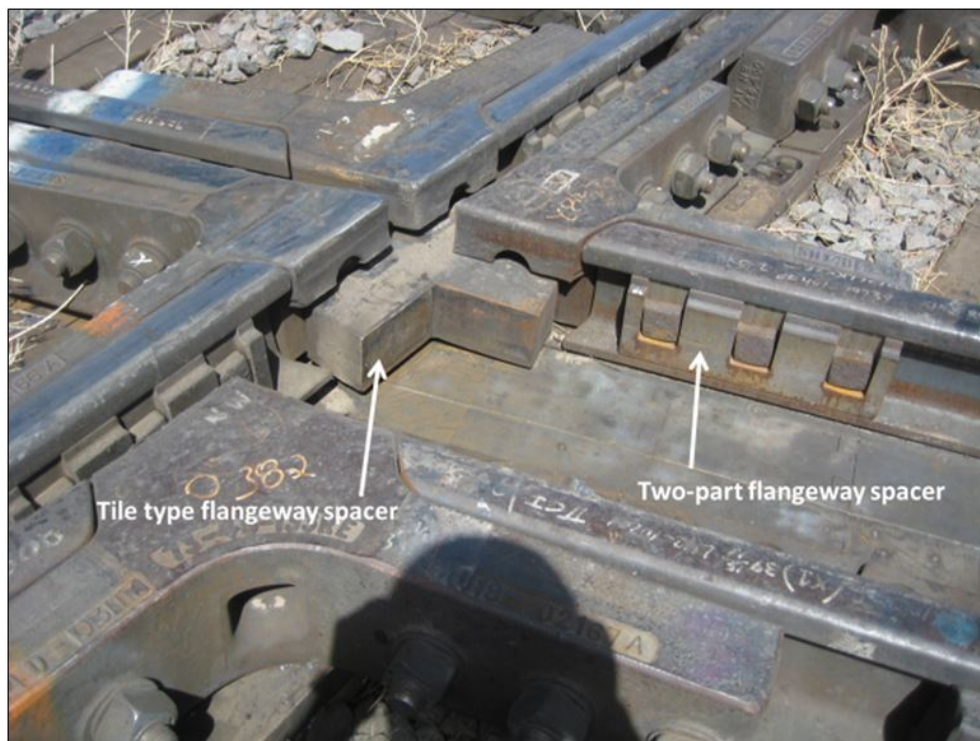
**Figure 7. Tile type flangeway spacer at the casting corners and two-part (split) running rail/guardrail flangeway spacer**

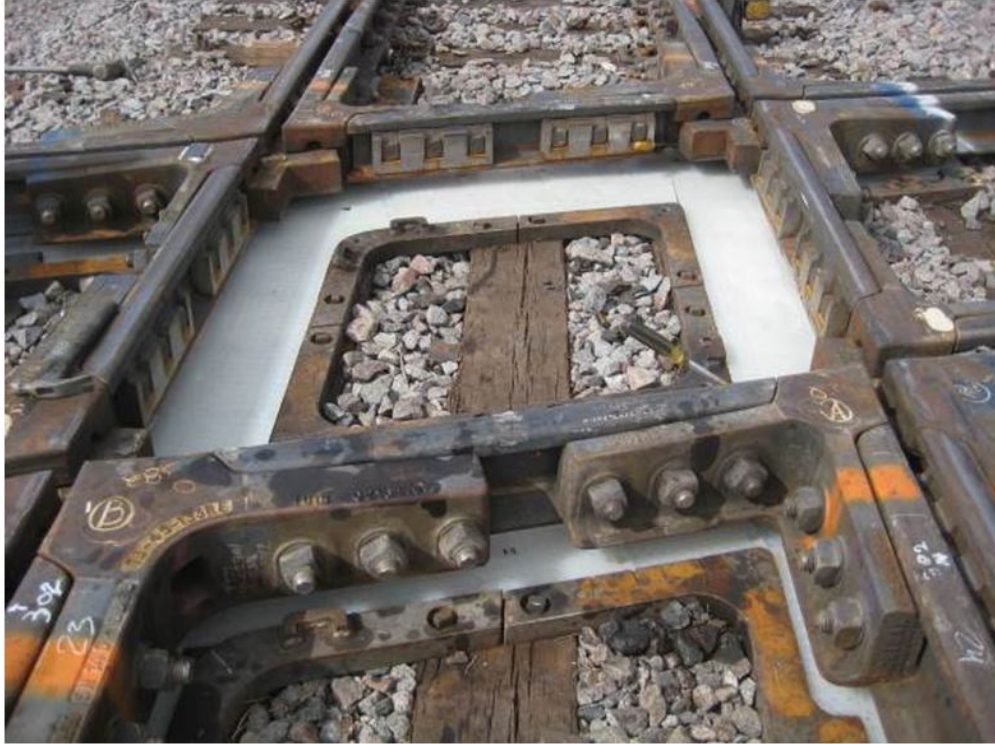
**Figure 11. Nortrak-designed pad in place between the milled platework and the castings. View with the center guardrail piece removed.**

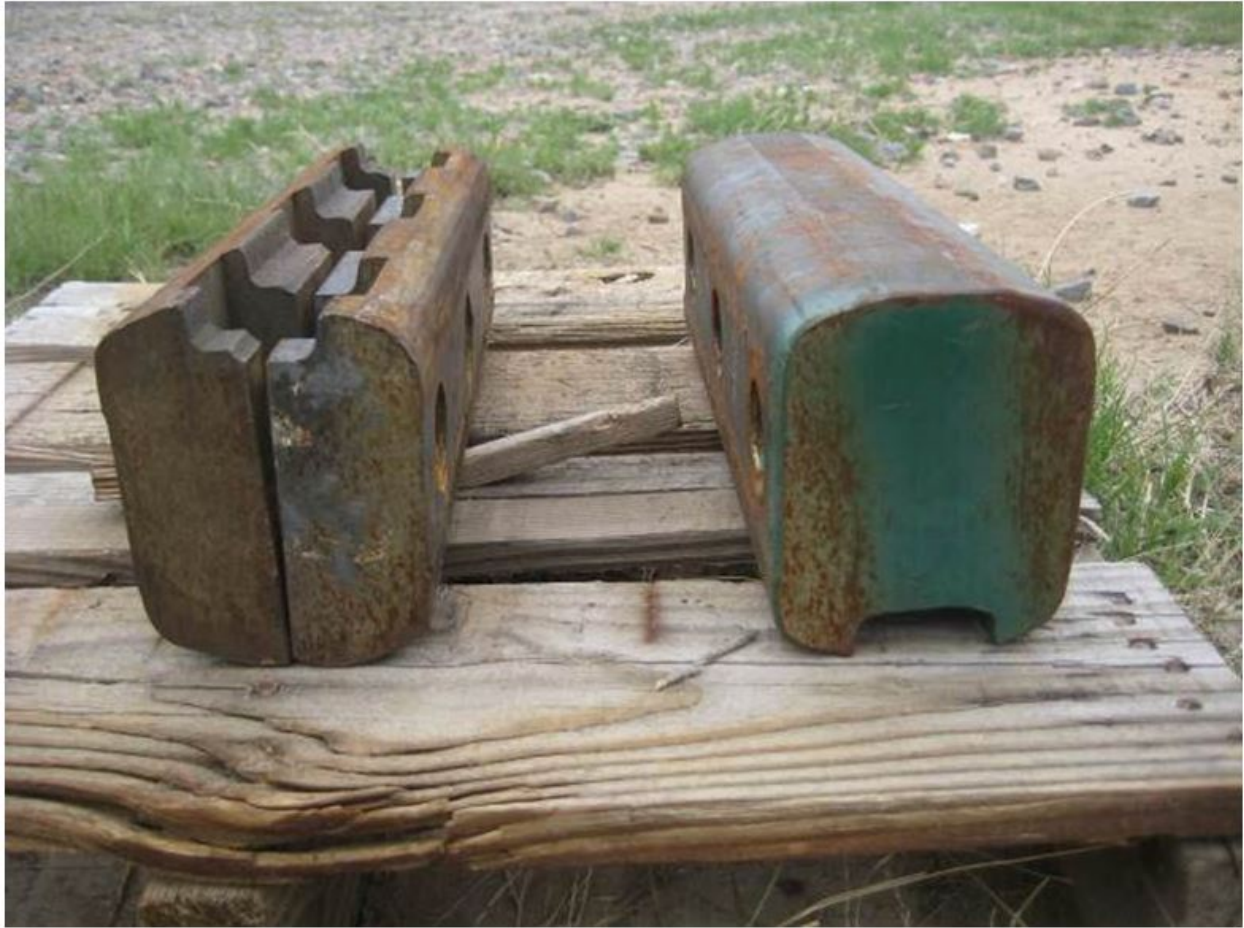
**Figure 12. Split flangeway spacer on the left. Solid spacer for use with through bolts on the right (upside down in the photo)**

For Test Case 3, selected split spacers were replaced with solid spacers and through bolts to evaluate the effect of reduced freedom of movement between components and reduced design flexibility on the performance of the crossing diamond. In this configuration, the common corner of the frog was isolated from the other three corners. This still allowed relative movement of the two sides of the frog on each route. But, it limited lateral and longitudinal relative movement of the frog castings. Figure 12 shows a split spacer and a solid spacer. Figure 13 shows the locations where each type of spacer was installed for Test Case 3 and kept the same through Test Case 10.

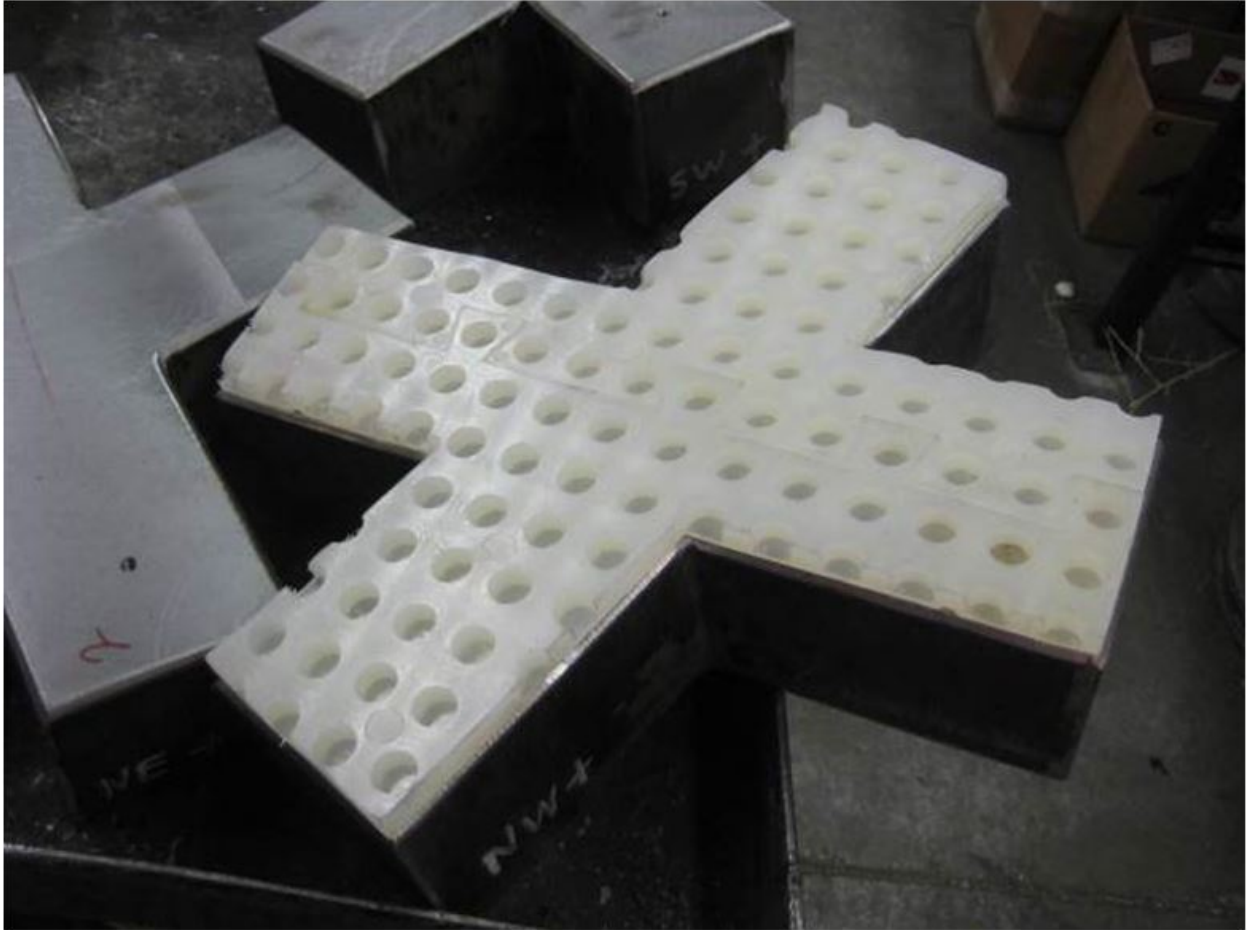
**Figure 14. Nortrak pad material was cut and placed under the flangeway spacer tile to evaluate the effect of double padding**

Test Case 4 was designed to evaluate the effect of doubling the Nortrak pad material directly under the flangeway spacer tile. A piece of the Nortrak pad material was cut to the shape of the tile (Figure 14) and placed above the existing full-coverage rail seat pad to evaluate the effect of double padding directly under the flangeway spacer tile.

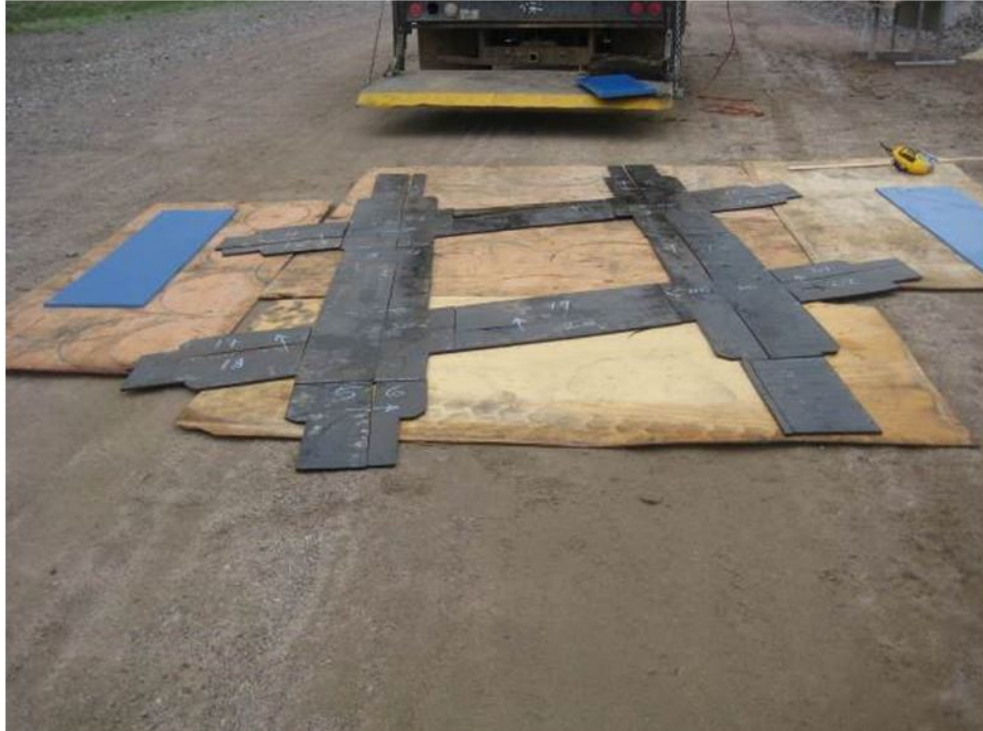
**Figure 15. Getzner Type A pad intended for under-tie use was tested as a full-coverage rail seat pad**

For Test Case 5, the Getzner Type A pad material is intended for under-tie use. In this case, it was used as the full-coverage rail seat pad between the platework and the castings (Figure 15). As in Test Case 4, a piece of the Getzner Type C material (Figure 16) intended for the layered tile configuration of Test Case 9 was placed above the full-coverage rail seat pad to evaluate the effect of double padding directly under the flangeway spacer tile.

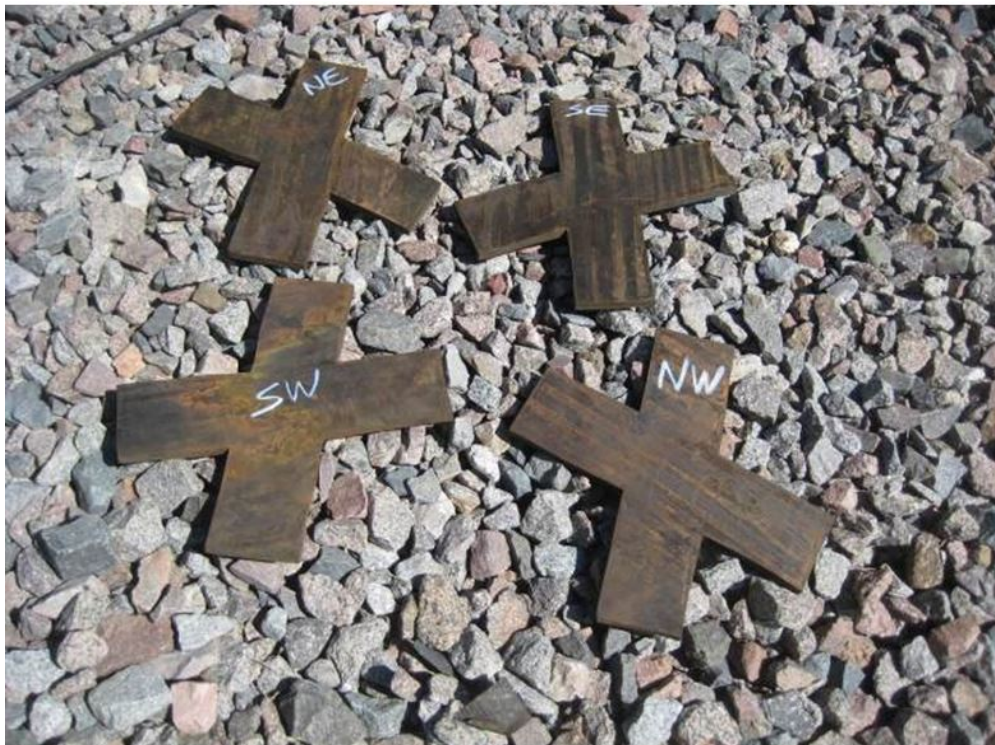
**Figure 16. The Getzner Type C pad designed for the layered configuration of Test Case 9 was used to evaluate the effect of double padding under the flangeway spacer tile**

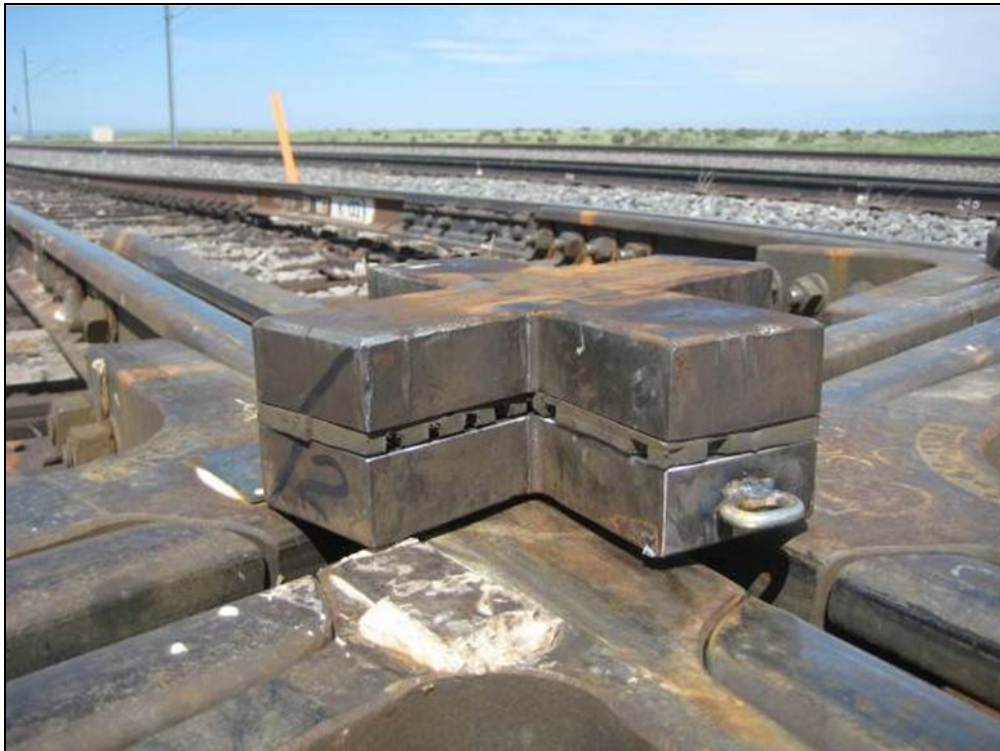
**Figure 19. The steel flangeway spacer tile was cut in half and  $\frac{1}{4}$  in of material was milled from each half to accommodate a layer of the  $\frac{1}{2}$ -in Nortrak pad material**

For Test Case 8, the full-coverage rail seat Nortrak pad tested in Test Case 4 was reinstalled and the Nortrak layered-tile configuration was introduced as a variable to determine if raising the pad material higher in the superstructure and closer to the source of impact affected the pad's performance (Figure 19).

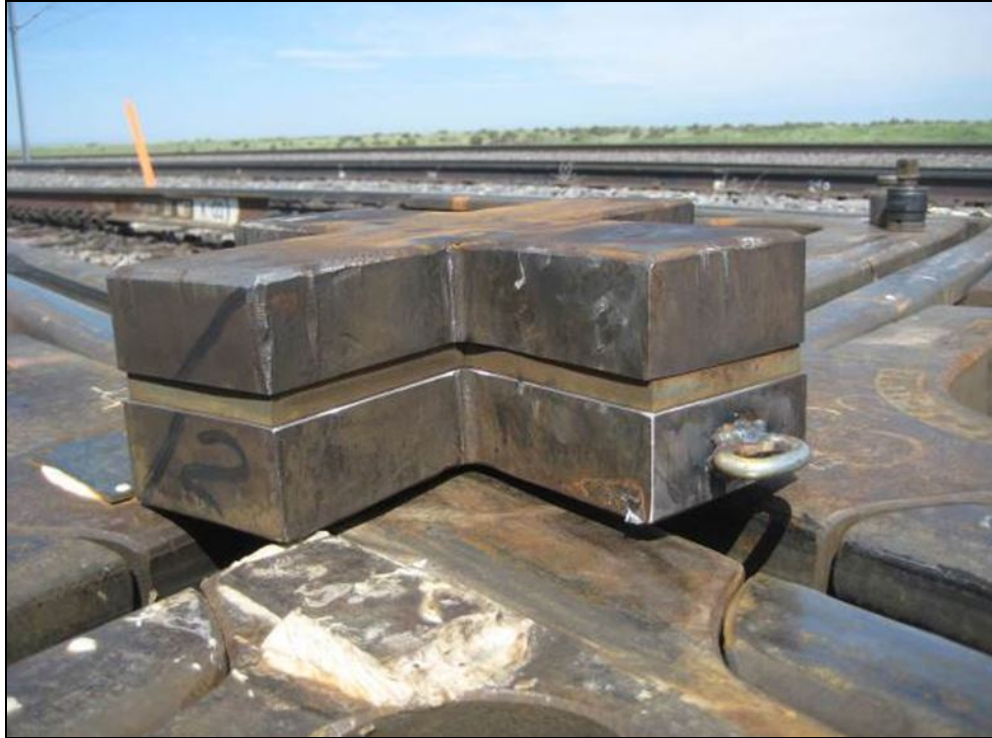
**Figure 20. The steel flangeway spacer tile was cut in half and  $\frac{1}{4}$  in of material was milled from each half to accommodate a layer of the  $\frac{1}{2}$ -in Getzner Type C pad material**

For Test Case 9, the full-coverage rail seat Getzner type B pad from Test Case 7 was reinstalled and the Getzner Type C material layered-tile configuration was introduced as a variable to determine if raising the pad material higher in the superstructure and closer to the source of impact affected its performance (Figure 20).

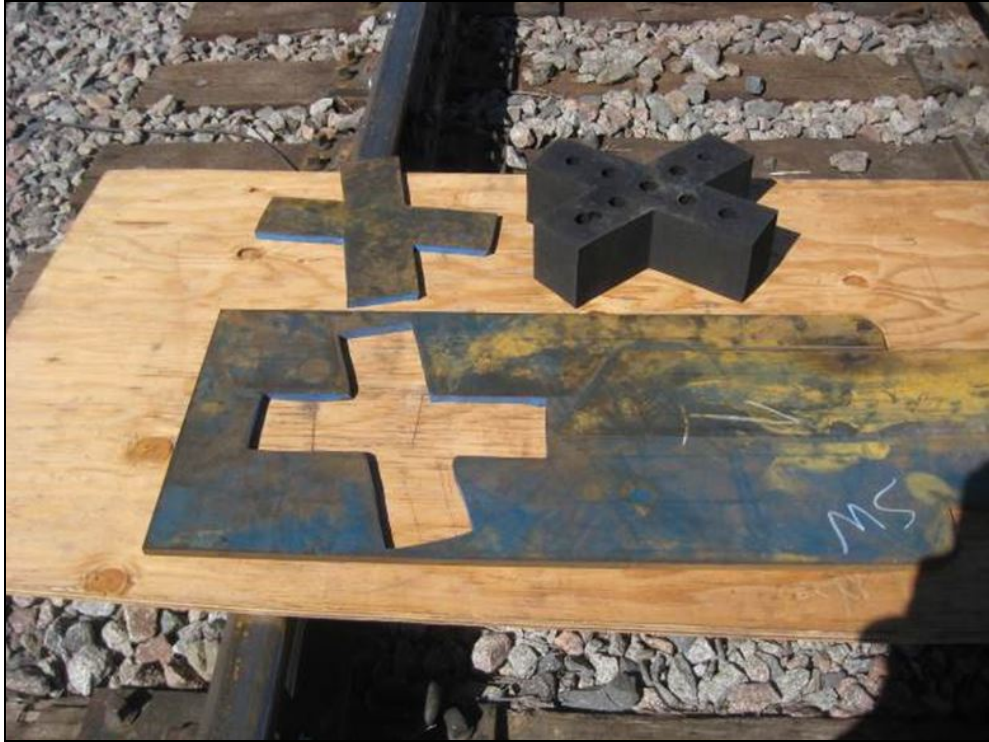
**Figure 21. The solid rubber flangeway spacer tile and its shape cut out of the full-coverage rail seat section of Getzner Type B pad that fits directly under the tile**

The rest of the crossing diamond remained on the full-coverage rail seat Getzner Type B pad, but the shape of the tile was cut out in order to place the rubber tile directly on the platework, as Figures 21, 22, and 23 show.

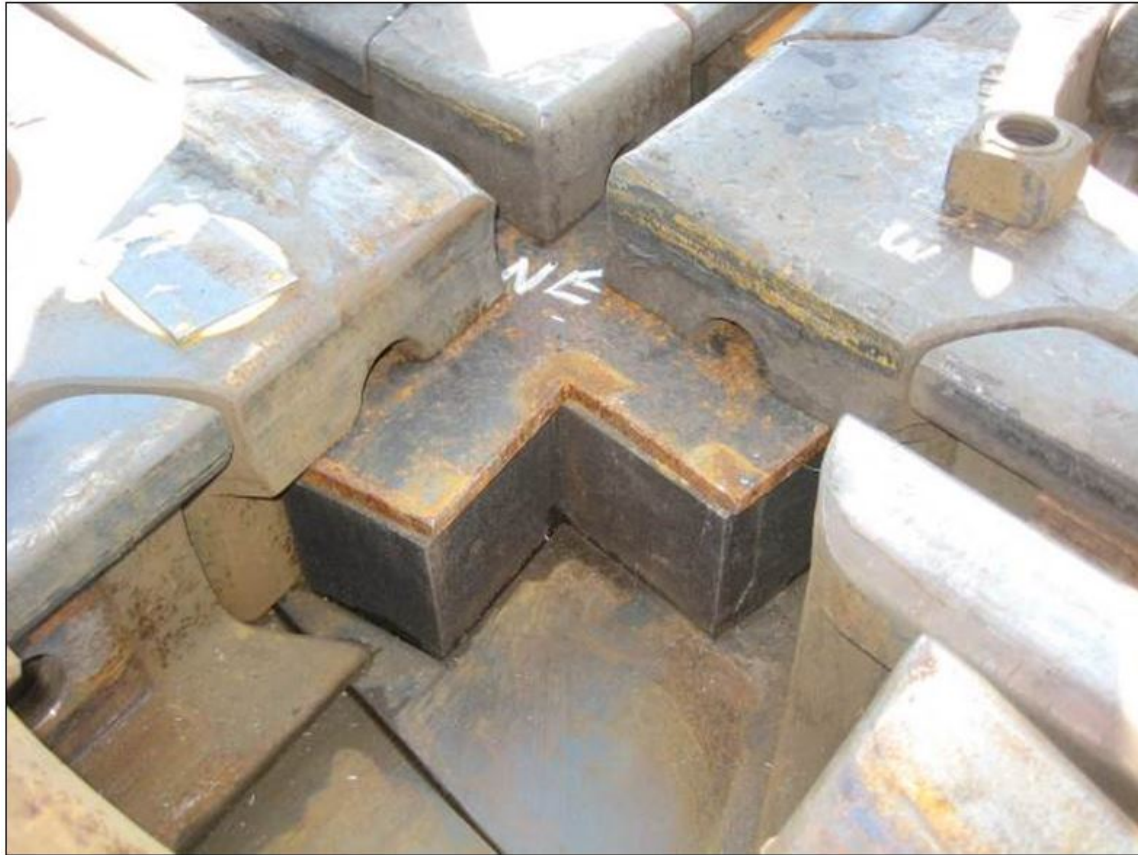
**Figure 23. The solid rubber flangeway spacer tile embedded in the Getzner Type B full-coverage rail seat pad resting directly on the platework. The strike plate between the rubber tile and the bottom of the casting corners was designed to protect the rubber.**

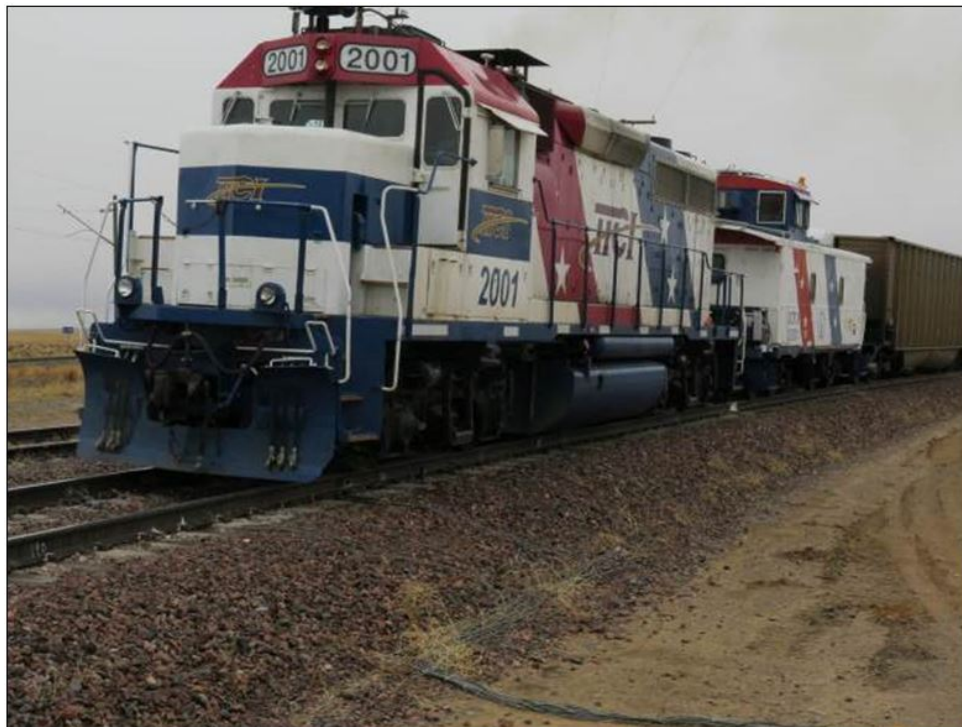
**Figure 24. IWS test consist on the HTL approaching the crossing diamond in a CCW run**

TTCI's two instrumented wheelsets (IWS) were installed on the leading truck of a loaded (315,000-pound GRL) high sided gondola car. This car was one of four loaded cars, along with the data collection caboose and locomotive, that made up the test train shown in Figure 24. The IWS data provided the vertical and lateral load conditions over the crossing diamond. This data was used to determine the effect that the changing variables of each test case had on the load environment.

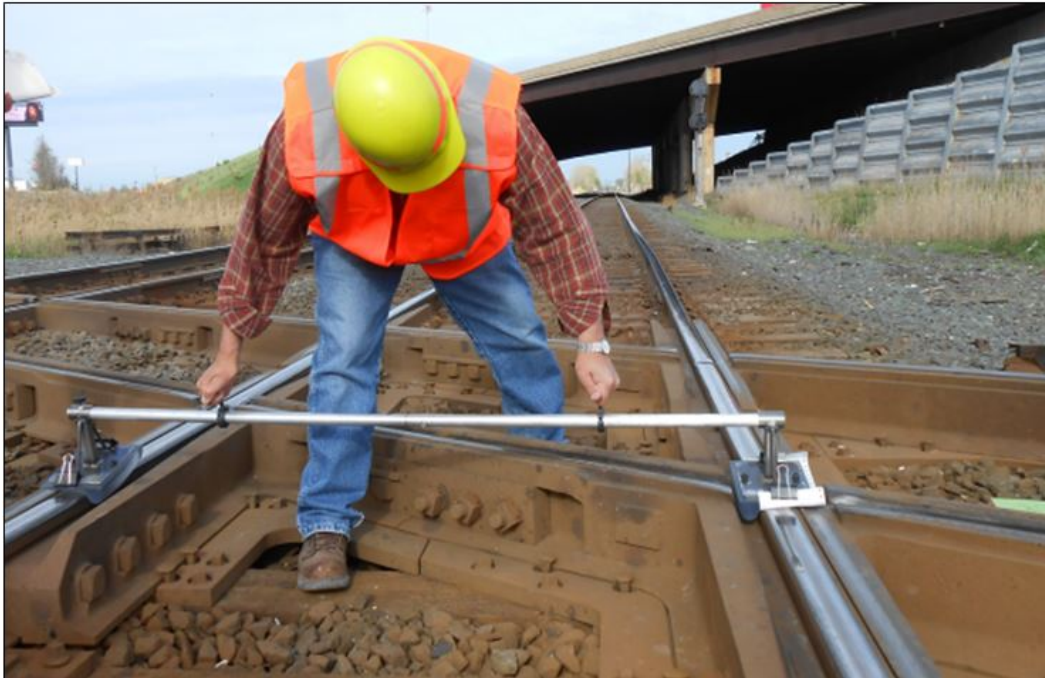
**Figure 30. TTCI's prototype Effective Flangeway Gap and Wheel Drop gage in wheel gap measurement mode at a revenue service crossing diamond**

In the flangeway gap measurement mode, the leveling rod is removed. A two-layer piece of carbonless paper is clipped to the wheel section; the wheel section is placed to span the flangeway gap; the gage is rocked over the gap with downward force (Figure 30) to create an imprint of the effective gap that is then measured (Figure 31).

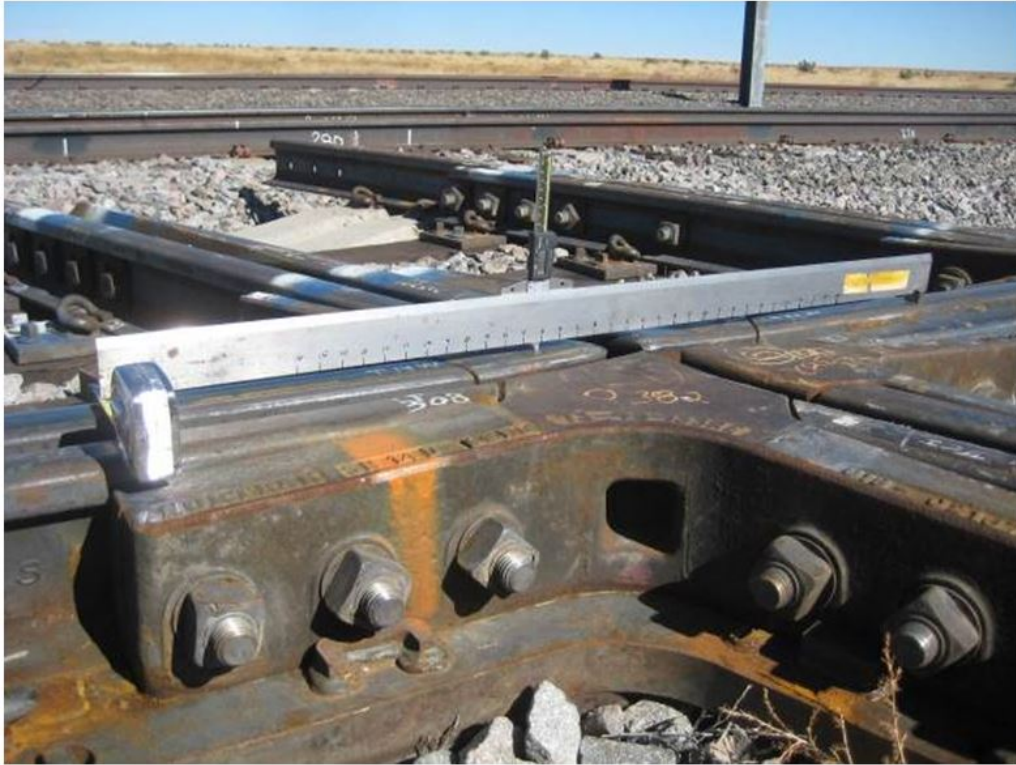
**Figure 32. Longitudinal profile measurements at 1-in intervals across the casting corners using a steel straightedge and digital depth gage**

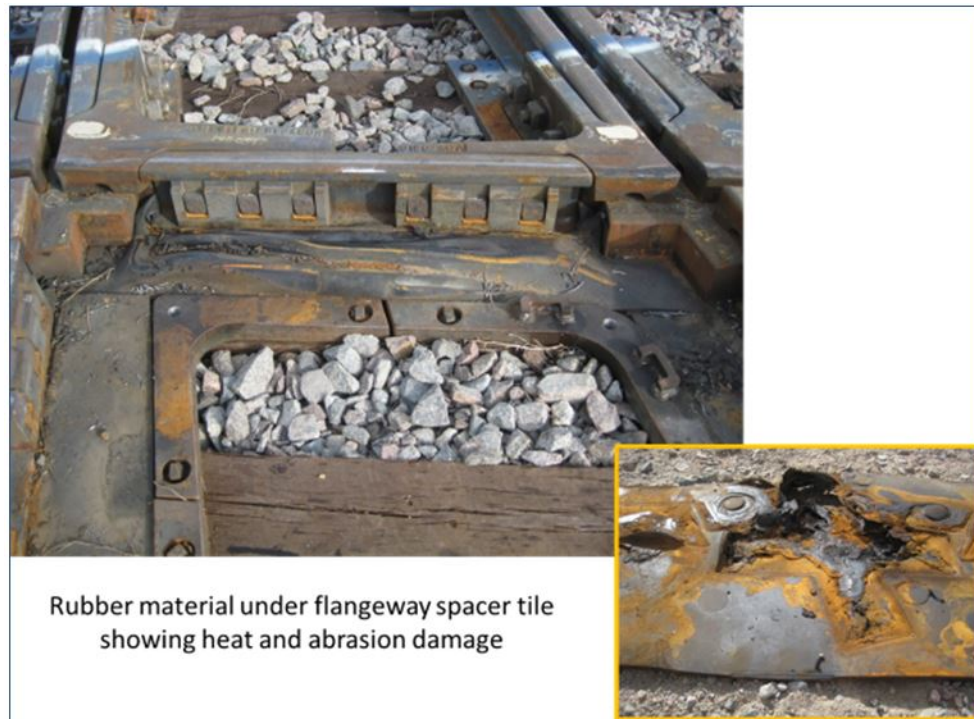
**Figure 93. The full-coverage rubber pad failed to resist heat and abrasion between components. Removed after 102 laps of the HAL train**

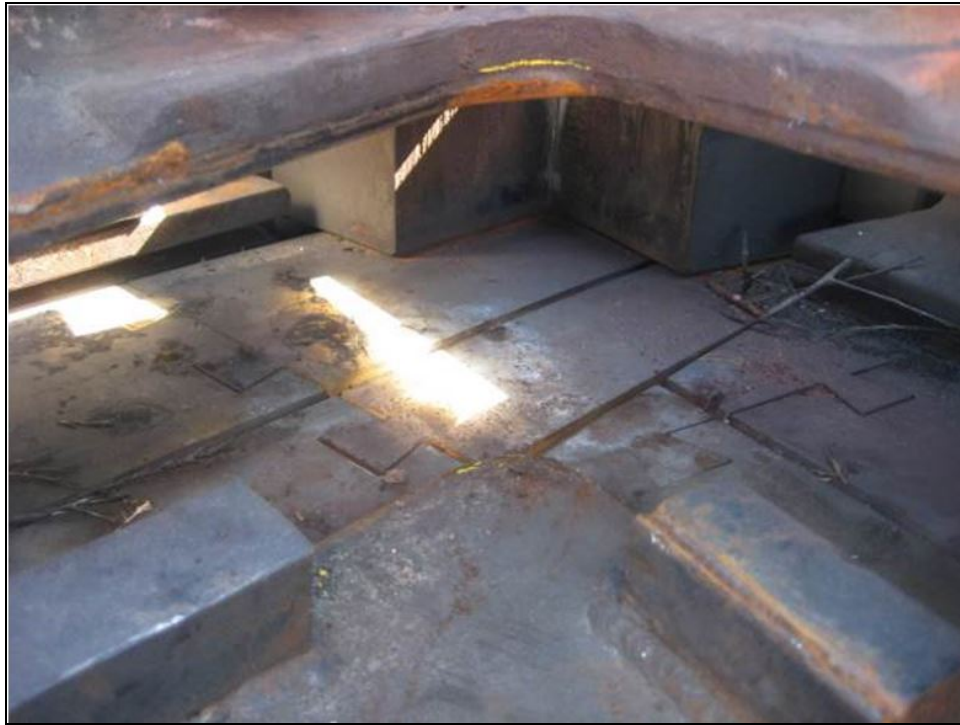
**Figure 94. Nortrak pad material in good condition after 35 MGT**

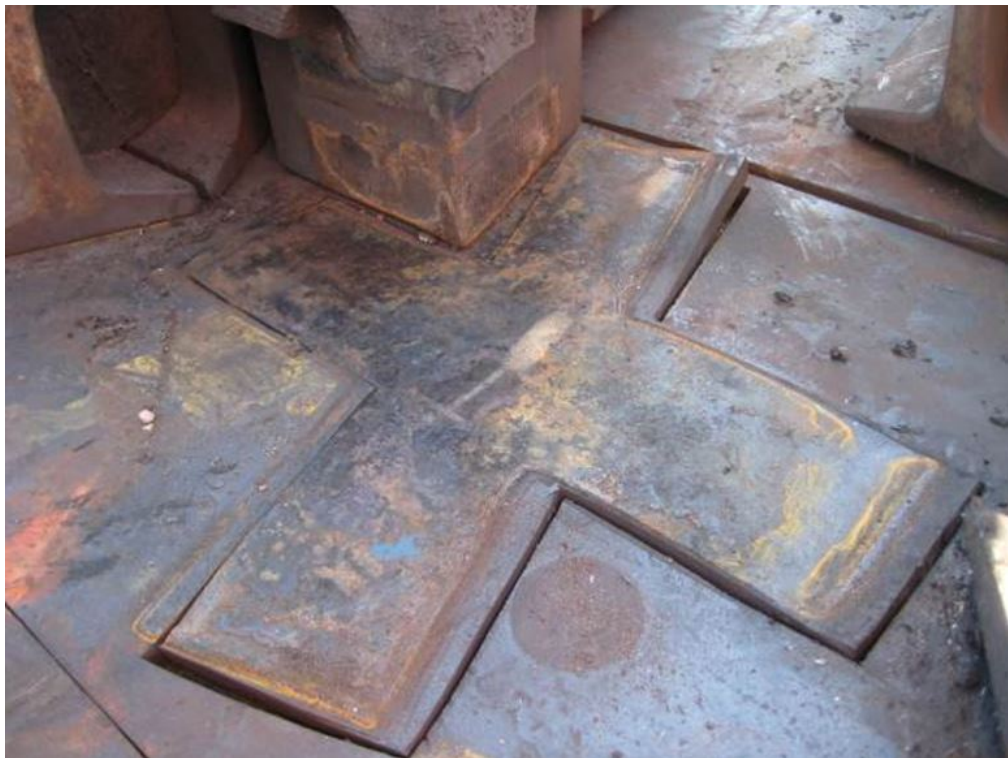
**Figure 96. Getzner Type B full-coverage pad with separate under-tile piece performing well after 27 MGT**

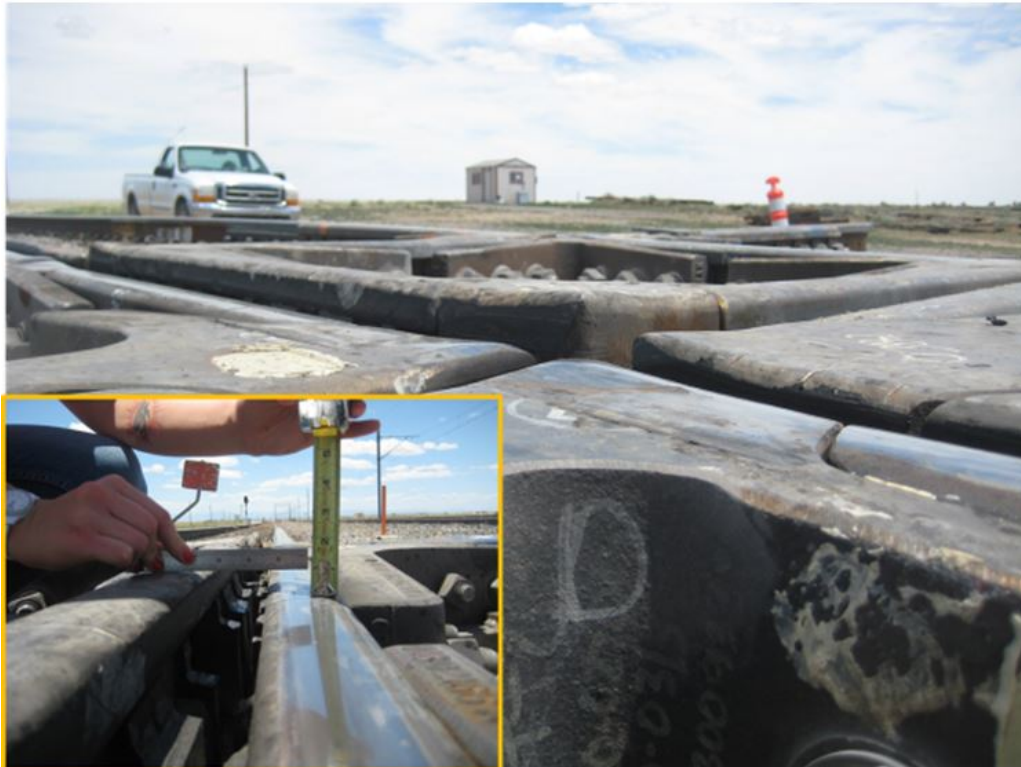
**Figure 97. Differential elevation between the guardrail (left) and the running rail (right), about 1 in**

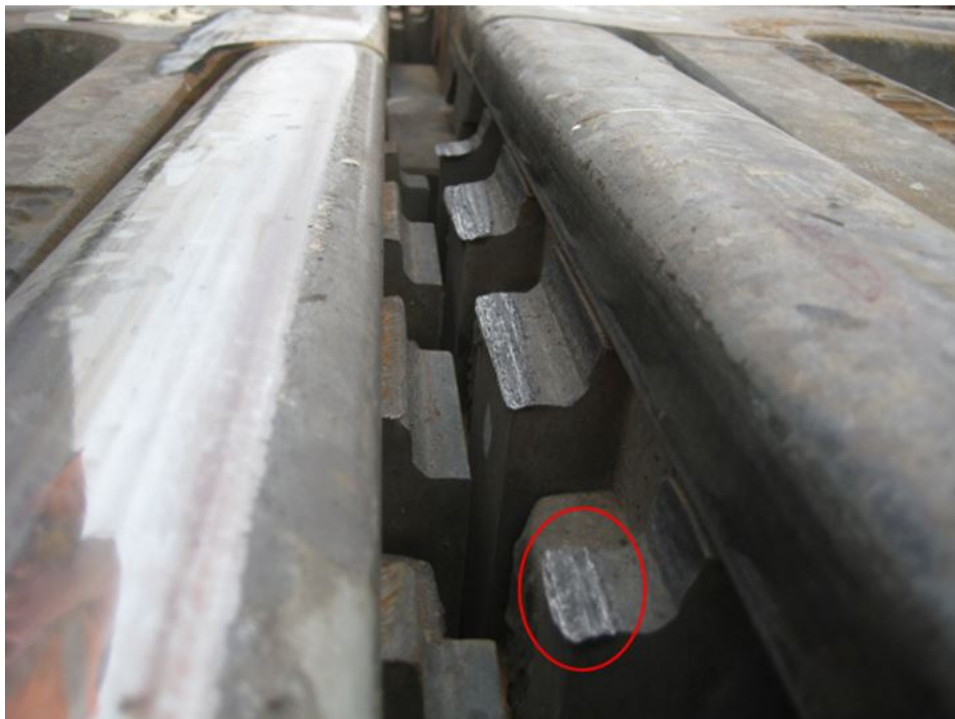
**Figure 99. Wheel flange marks on the split spacer fastened to the rising guardrail**

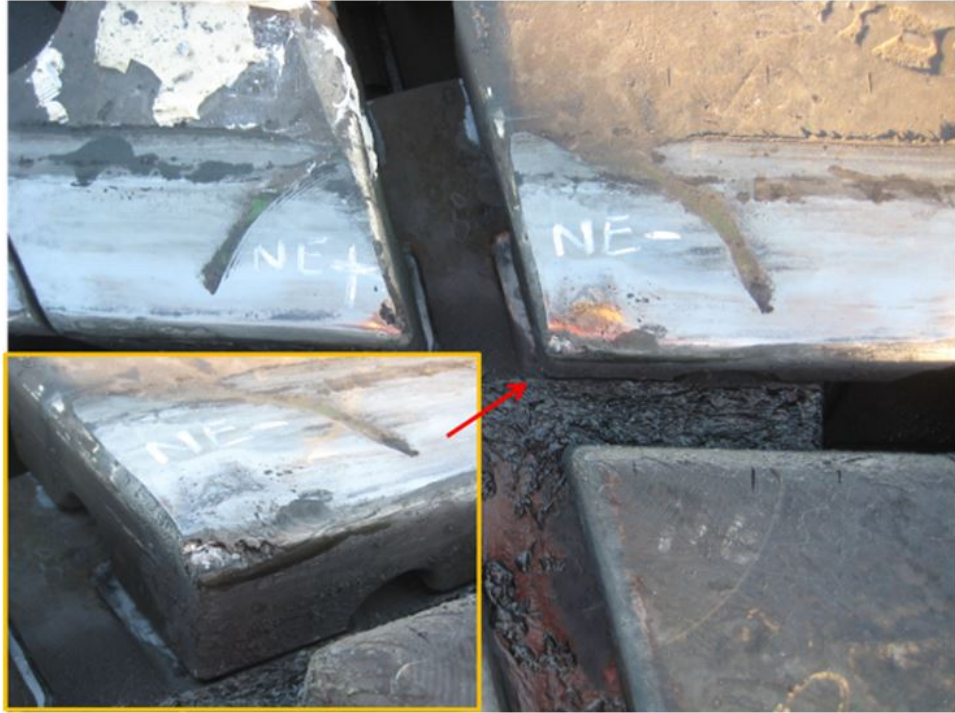
**Figure 101. Casting corners were ground as required to remove metal flow**

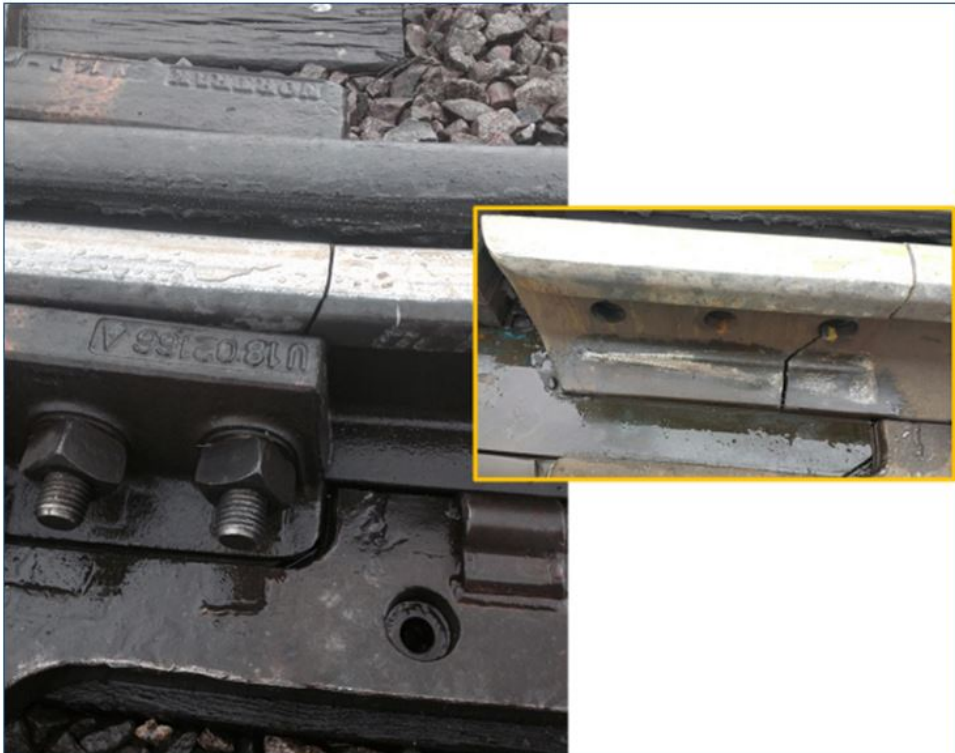
**Figure 102. The leg rail on the northwest frog broke after 59 MGT**
