## **Next-Generation Foundations for Special Trackwork Phase III**

| 4. TITLE AND SUBTITLE<br>Next Generation Foundations for Special Trackwork - Phase III | | | 5. FUNDING NUMBERS<br>DTFR53-11-00008<br><br>Task Order 308 | |
| 7. PERFORMING ORGANIZATION NAME(S) AND ADDRESS(ES)<br>Transportation Technology Center, Inc.<br>55500 DOT Road<br>Pueblo, CO 81001 | | | 8. PERFORMING ORGANIZATION<br>REPORT NUMBER | |
| 13. ABSTRACT (Maximum 200 words)<br>Transportation Technology Center, Inc. (TTCI) conducted a series of tests, funded by the Federal Railroad Administration, which evaluated the potential beneficial effects of various configurations of high angle frogs and frog foundations on wheel-rail vertical forces and frog performance. The tests were conducted under 315,000-pound cars with nominal 39-ton axle loads at the High Tonnage Loop of the Facility for Accelerated Service Testing at the Transportation Technology Center in Pueblo, CO.<br><br>Results from previous phases of this project were used to develop this testing plan, and the project had previously determined that track stiffness, track damping and frog flexibility (i.e., the capability for differential vertical movement b

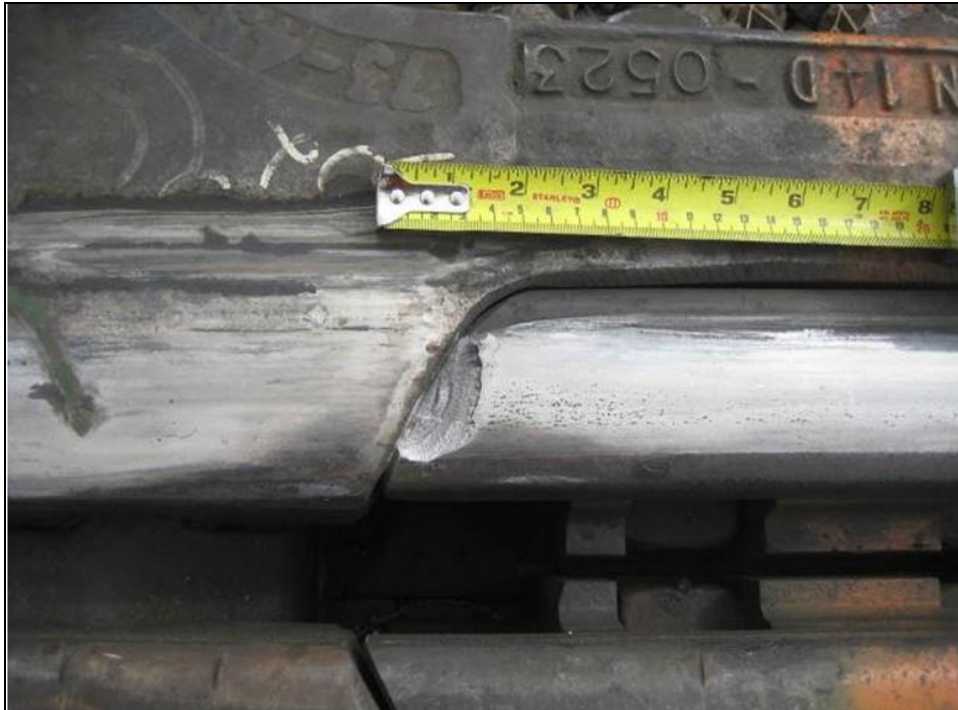
**Figure 104. Chipped leg rail at the southwest frog was slotted**

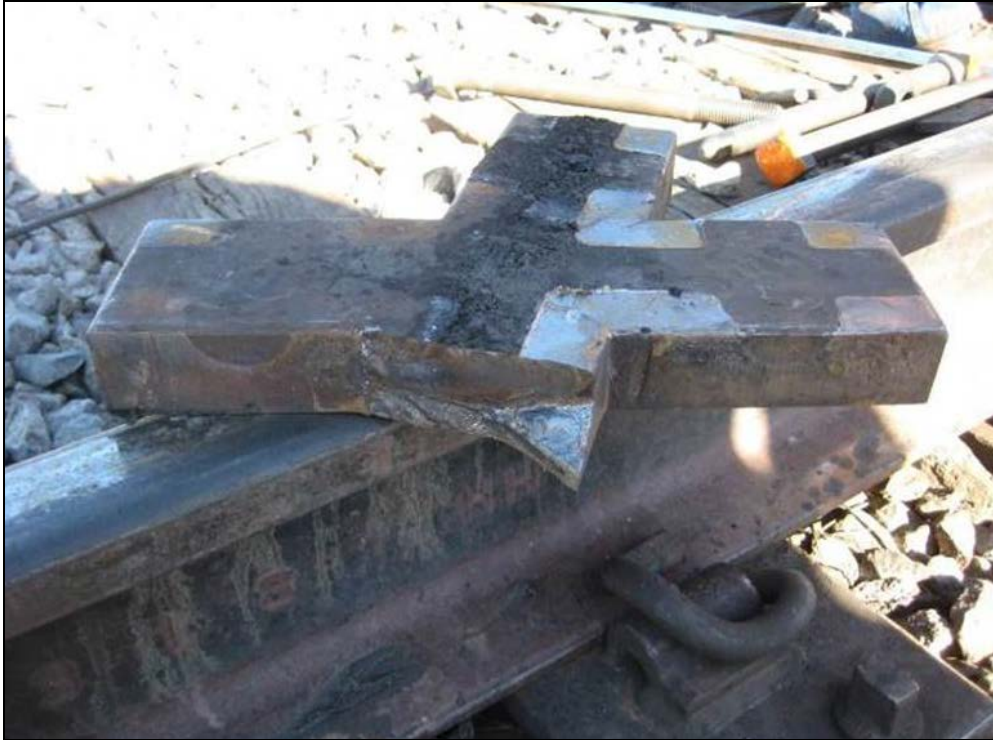
**Figure 105. The top half of a layered flangeway spacer tile broke and was replaced**
