Deliverable #3 (Final Report)

**Commercial Truck Parking Detection Technology Evaluation for
Columbia County Rest Areas**

University of Florida
Department of Civil and Coastal Engineering

November 2016

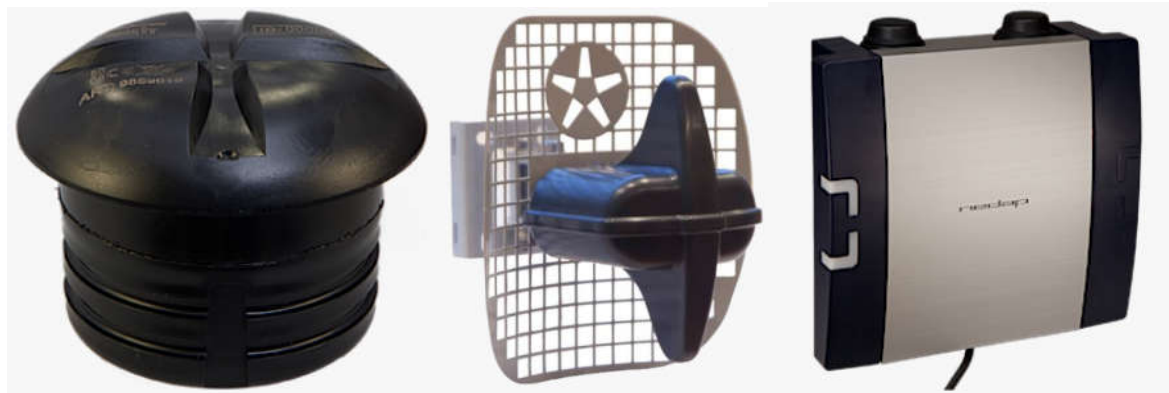
Figure 1. SENSIT vehicle detection technology components

Note: From left to right is SENSIT IR, Relay Node 2G and Data Collector IP65 GPRS.
(Source: <http://www.nedapidentification.com/products/sensit/>)

The Data Collector IP65 GPRS is the interface between the vehicle detection sensors, the Relay Node and the IPsens software. The Data Collector IP65 GPRS collects actual status data from the

individual sensors via the Relay Node through the wireless mesh network. Offering a variety of communication options, the Data Collector IP65 GPRS automatically inserts all the collected data in the database. Integration with parking guidance, traffic guidance, and enforcement systems can be realized on a server level. The Data Collector IP65 GPRS allows users to operate, maintain, or configure the equipment in the wireless mesh network using bidirectional communication with the systems components. The Data Collector features a back-up battery to ensure the wireless mesh network will remain operational even in case of power failure. Additionally, the Data Collector can be connected to the power source of a light pole or solar power panel. Detailed product specifications are included in Appendix A.

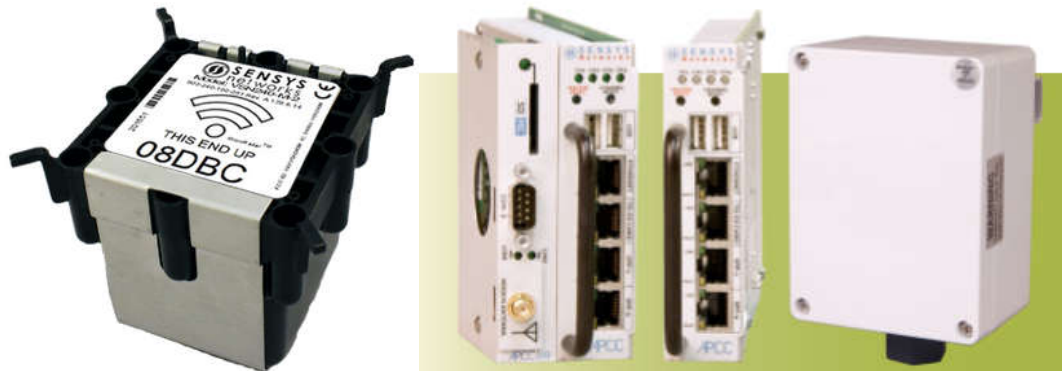
Figure 2. Sensys vehicle detection technology components

Note: From left to right is Sensys MicroRadar and Access Point Controller Card (APCC).
(Source: <http://www.sensysnetworks.com/products/flexradar#parkingdetection>)

Sensys Networks VSN240-MP-2 MicroRadar sensor incorporates an extremely low power, wide-band, fixed-position radar with a Sensys NanoPower (SNP) Protocol radio. This compact in-pavement sensor works on the same principle as any other radar. High frequency radio frequency (RF) pulses are transmitted, reflected off a target object, and measured by a time-gated return RF mixer. The MP-2 version incorporates a higher sensitivity radar design and a modified case with tabs to aid installation flush with the road surface—allowing the installation to avoid issues with snowplows and ADA compliance/pedestrian tripping hazards. The MP-2 has specific stability tracking algorithms optimized for parking.

The Sensys Networks Access Point Controller Card (APCC) is a second-generation controller card that maintains low power consumption, supports multiple radios, and allows for additional communication and processing power. The APCC, which is compatible with all of the Sensys Networks VDS240 Wireless Vehicle Detection System products, receives and processes data from the sensors. The APCC then relays the sensor detection data to a roadside traffic controller or remote server traffic management system. Detailed product specifications are included in Appendix B.

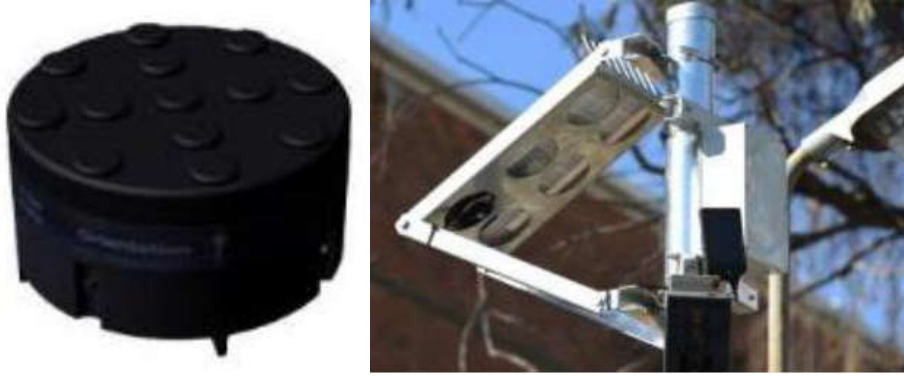
Figure 3. CivicSmart vehicle detection technology components

Note: From left to right is in-pavement sensor and solar-powered gateway.
(Source: <http://www.civicsmart.com/>)

For Florida's truck parking occupancy program, CivicSmart proposed the use of in-pavement vehicle detection sensors. The patented vehicle detection sensors use microwave radar-based technology to detect a vehicle entering or leaving a space. According to CivicSmart, the accuracy of the sensors is immune to environmental conditions, passing or adjacent vehicles, and electromagnetic interference. The sensors feature directional radar, which means that they can be installed anywhere near a parking space. Additionally, the sensors use radio waves to transmit data, which means that they are not affected by conditions that plague other sensor technologies (ambient light, color, weather, night/low light, etc.).

The sensors communicate through solar-powered gateways that transmit sensor data to a backend management system for action and analysis. Diagnostic data is sent to CivicSmart so it can monitor the health and "heartbeat" of each node in the State's truck parking system. In-pavement sensors will completely self-configure and communicate directly via a gateway to the server system (either directly to SunGuide® or to their Parking Enterprise Management System). These gateways will be located within a few hundred feet of the sensor, and are typically installed on light poles, parking signs, or traffic signal poles.

The solar-powered gateways feature proprietary low latency, noise-tolerant communications technology, which receives sensor data and can send it to the traffic management center either wirelessly or via a fiber connection. Detailed product specifications are included in Appendix C.

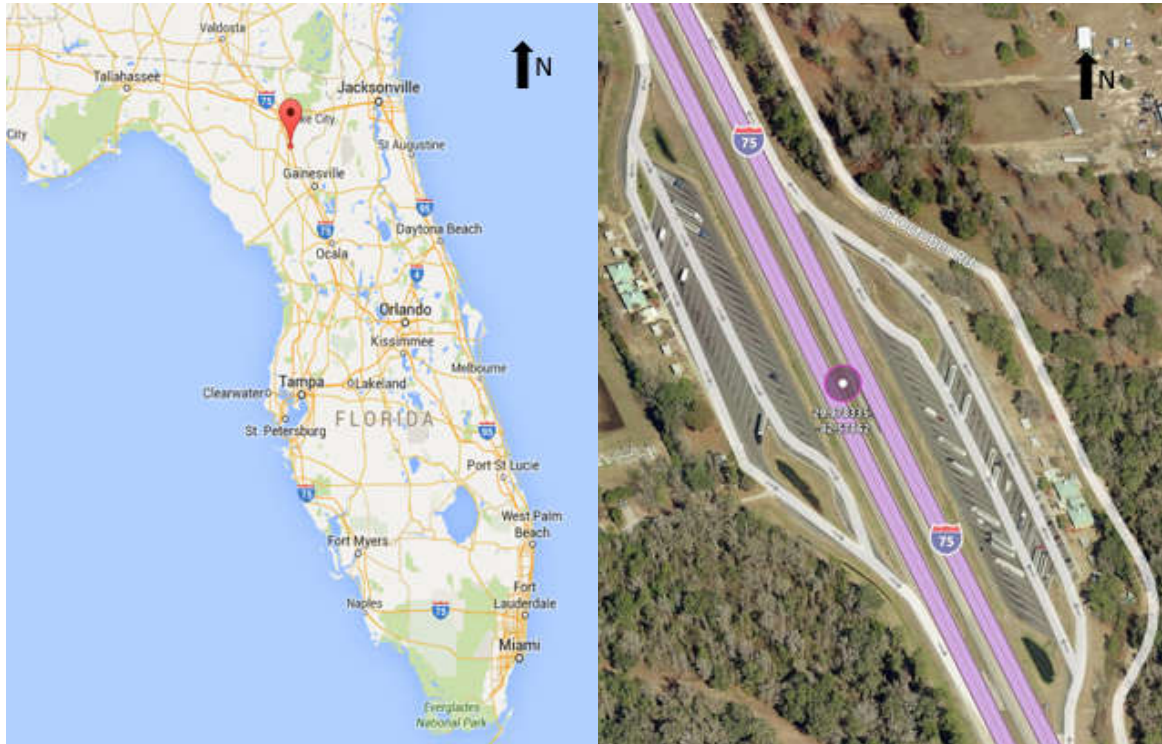
Figure 4. Location and aerial view of Columbia County rest area

The vehicle parking technology was tested at two rest areas within FDOT District 2. The sites are located in FDOT rest area facilities 20161 (I-75 northbound) and 20162 (I-75 southbound) in Columbia County at milepost 413 of I-75 (GPS coordinates: 29.978335, -82.57862). An aerial view of this site is shown in Figures 4-6. The Columbia county site has two truck parking areas, as listed in Table 3.

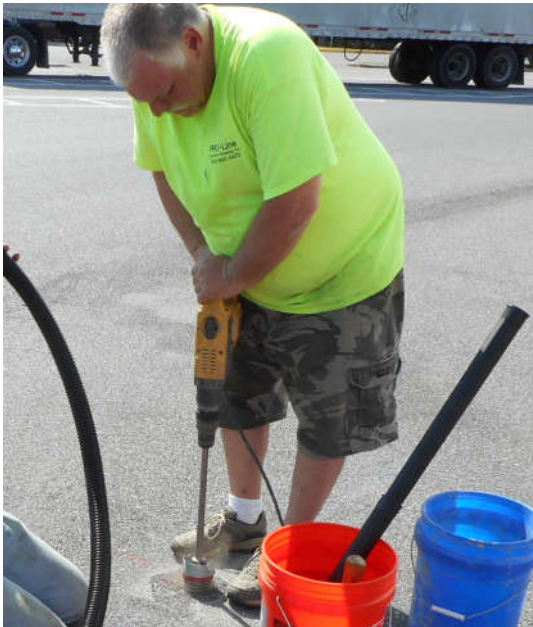
1. Find and mark the desired sensor location.
2. Core a hole 3 inches (7.6 cm) deep into the pavement.

Figure 8. Core a hole into the pavement

The sensors are placed in a 3-inch-deep core-drilled hole in the pavement. The sensor is designed for use of non-toxic standard mortar mix to hold it in place. The research team observed that the installation was easy, and the water-based mortar makes for easy clean-up after installation.

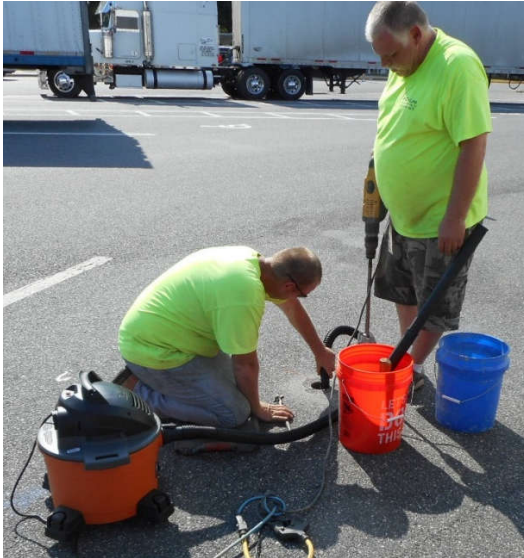
3. Vacuum or brush the hole clear of dust and debris.

Figure 9. Vacuum the hole

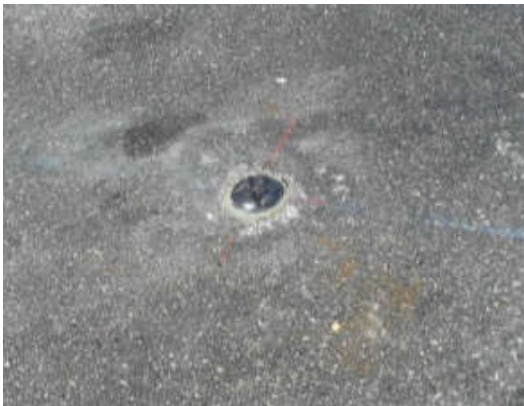
4. Place sensor until the ring sits flush against the pavement and apply the non-toxic standard mortar mix to hold it in place.

Figure 10. Place sensor to the hole

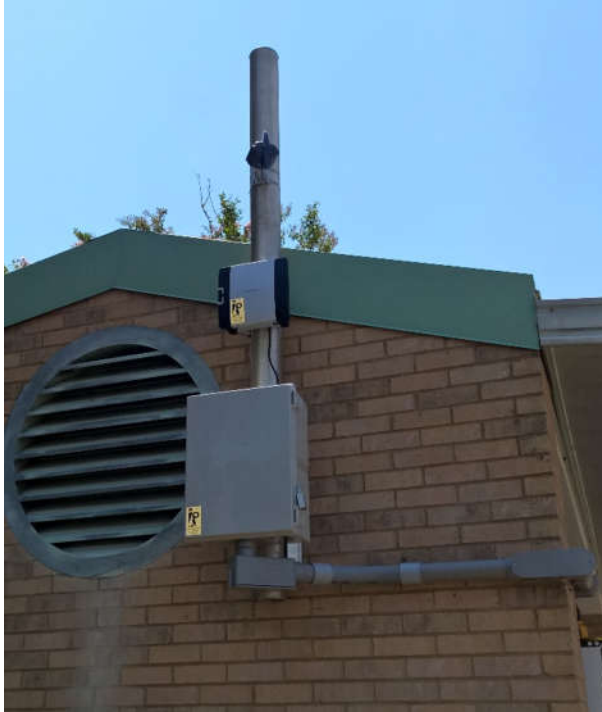
The Site Controller is mounted on the wall of a building of the rest area. The Site Controller is the main interface point connecting all sensors in its service area with the Cloud Host Server through a cellular modem to the internet or alternative hardline TCP/IP, fiber connection to Host Server. The Site Controller incorporates the Data Collector IP65 GPRS, which is the end data termination point for the local sensor network. If the Site Controller is configured for direct TCP/IP connection, cellular modem can be offered as a backup connectivity option.

The Site Collector is equipped with UPS power supply, which offers additional redundancy to the system's ability to store information on the Sensors in case of loss of connectivity to the site. Site Controller also includes surge protection and power supply to convert from 120V AC to 5V DC to power all internal components.

Figure 12. Installed site controller

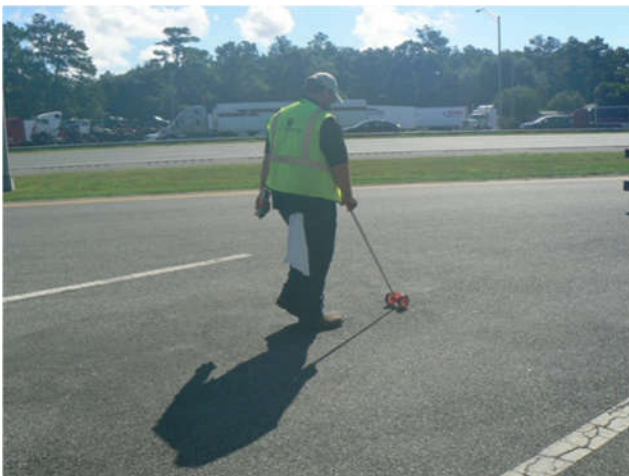
1. Find and mark the center of the desired sensor location.

Figure 13. Find and mark the sensor location

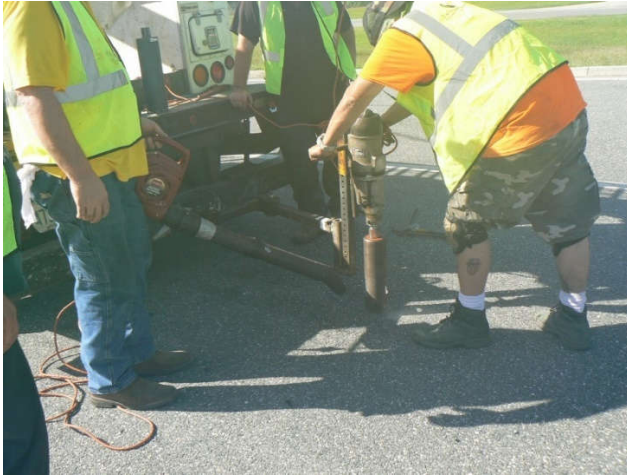
2. Core a hole approximately 4 inches (10.2 cm) in diameter, and 3 inches (7.6 cm) deep into the pavement. Check depth as you drill, remove debris periodically.

Figure 14. Core a hole into the pavement

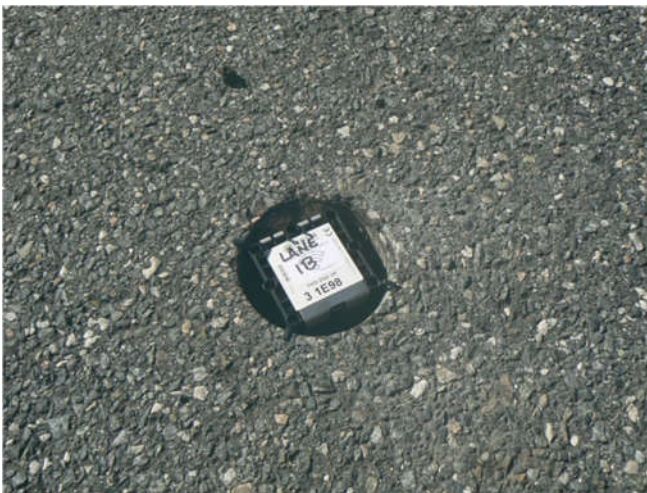
3. Vacuum or brush the hole clear of dust and debris. Ensure that the hole is dry as moisture may impede the curing of the epoxy. If moisture is observed, use the heat-gun or torch to dry the inside of the hole completely.
4. Apply epoxy to the bottom of the hole to half of the sensor height.
5. Place sensor until the ring sits flush against the pavement.

Figure 15. Place sensor in the hole

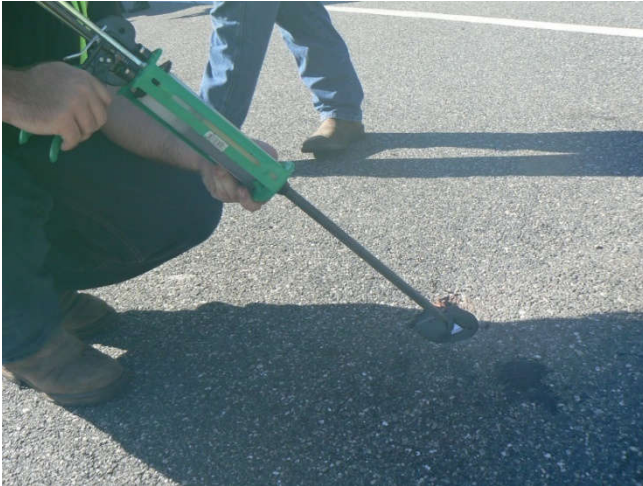
6. Fill hole with epoxy until level to road surface.

Figure 16. Fill hole with epoxy

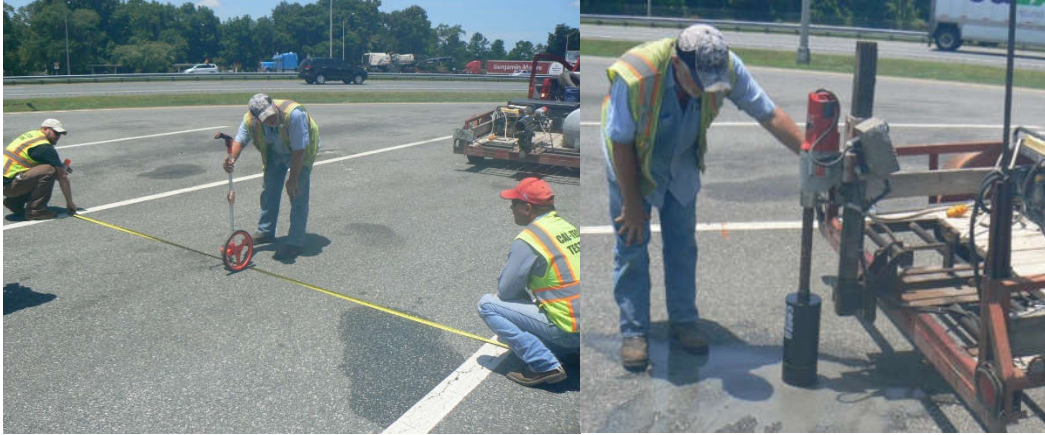
1. Ensure the pavement is solid and stable for each sensor that is to be installed. Mark the drilling point for each parking space, and place drilling equipment over mark. Using a 140-mm core drill bit, drill to a depth of 80 mm into the concrete or asphalt surface. Remove plug.

Figure 17. Mark the drilling point and drill a hole

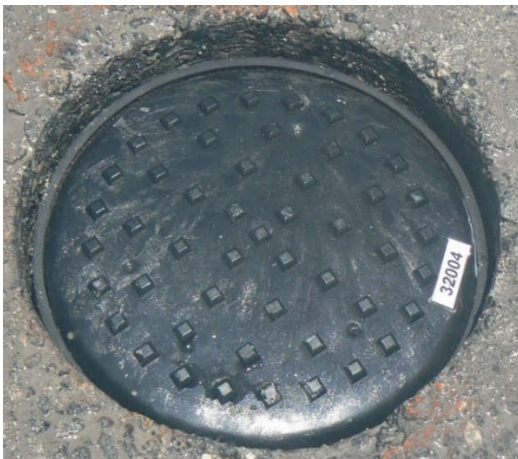
2. Align the orientation of the sensor on the node (as shown above) to the corresponding type of parking space.
3. Place the sensor node into the hole. Confirm that the top of the sensor enclosure is 6 mm above the ground surface. Then apply epoxy glue around the sensor node.

Figure 18. Put sensor into the hole

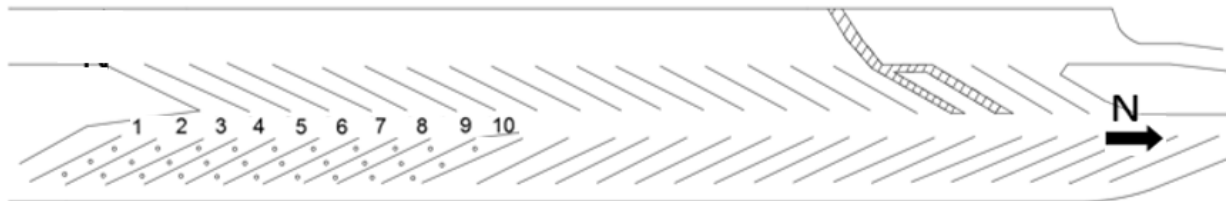
Figure 19. Southbound rest area vendor parking space distribution (Sensys)

The parking space assignment for the vendors is illustrated in Figures 19 and 20. CivicSmart was the second vendor that installed their sensors at the northbound rest area, so there were constraints about their equipment locations in order to avoid possible interference with the SENSIT equipment that had already been installed. However, it is not known whether this had any impact on the performance of the CivicSmart system.

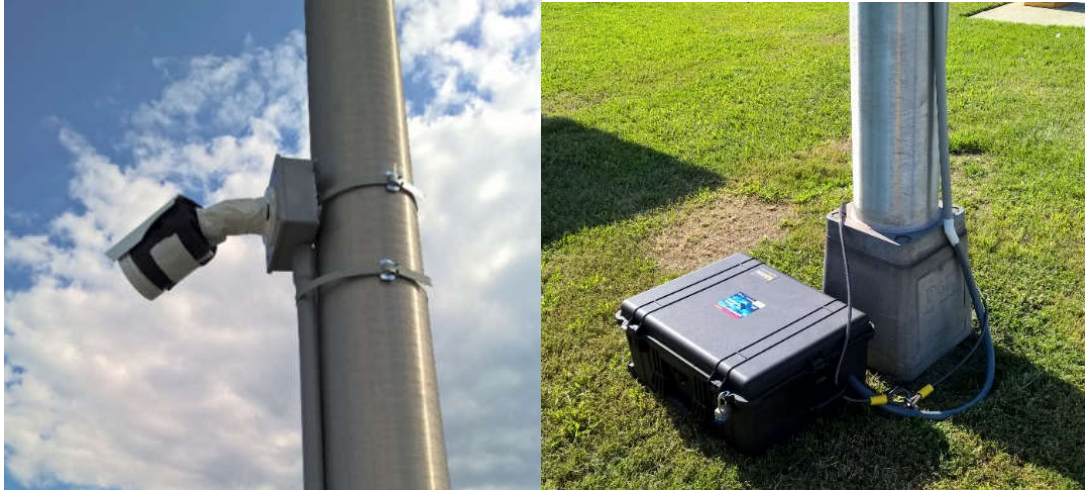
Figure 22. Installed camera, PVC conduit, and Pelican case

The project used video cameras to record the truck parking area as the ground-truth data—two cameras for the northbound rest area and one camera for the southbound rest area. The cameras were mounted to the top of light poles in the rest area. Figure 21 illustrates the video camera installation set up and approximate fields-of-view for the two northbound side camera installations. Figure 22 shows a picture of one of the camera installations—camera mounted to the top of the light pole (35 ft), which is connected with video and power transmission cables running through PVC conduit, which connect to a battery and digital video recorder (DVR) inside a Pelican case that is chained to the light pole. Figure 23 shows the fields-of-view from the three cameras.

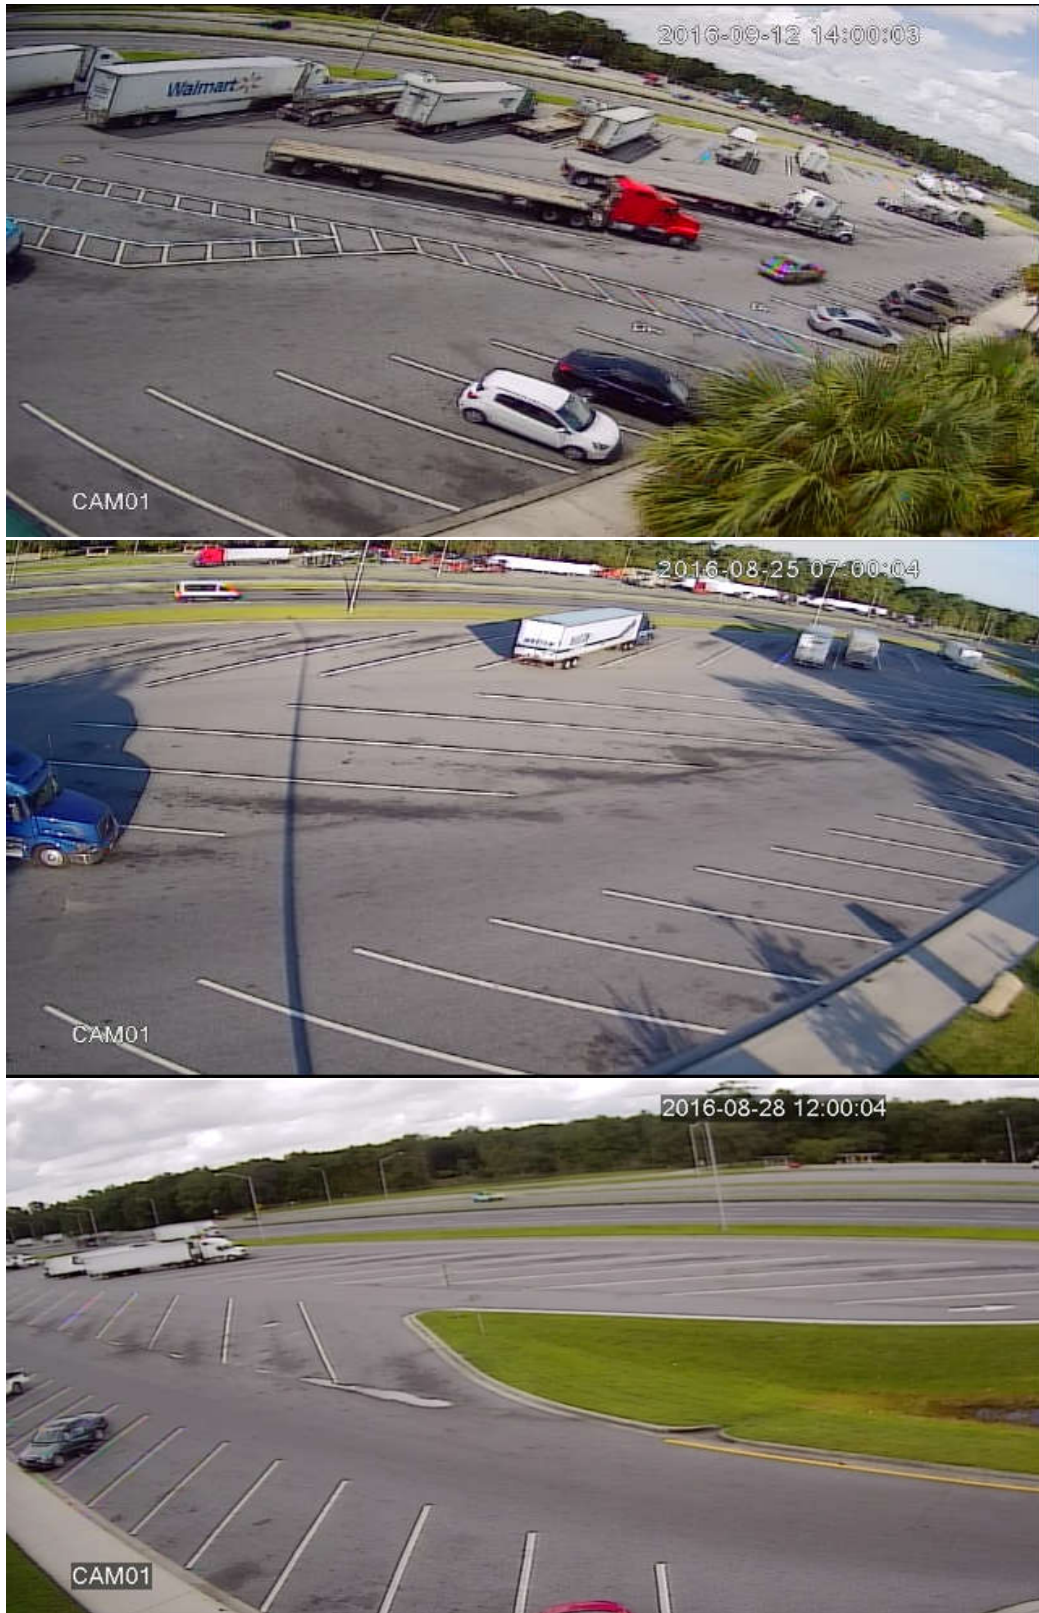
Figure 23. Camera view (From top to bottom: SENSIT, Sensys, and CivicSmart)

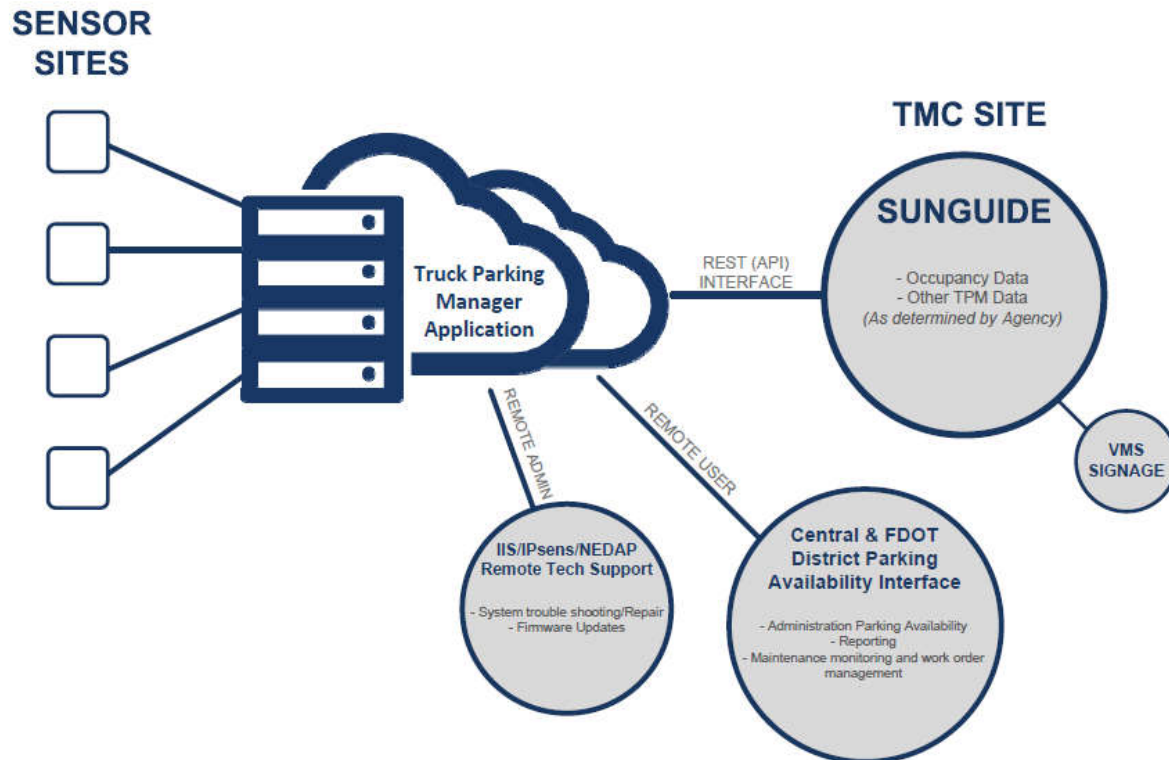
6. Open IP data exchange through a secure REST web service for further data integration into other 3rd party enterprise type systems.

Figure 27. IPsens integration with SunGuide®

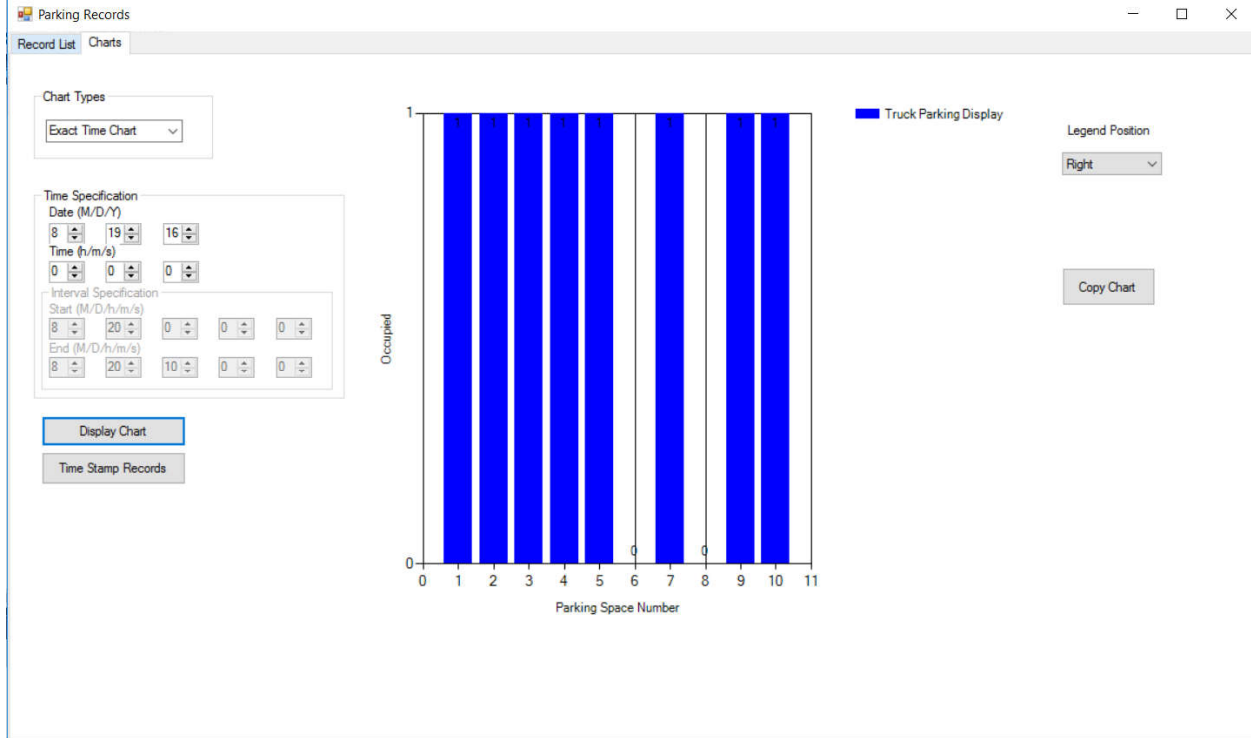
Four kinds of charts could be displayed in the software: exact time chart, interval trucks chart, interval occupancy chart, and timeline chart.

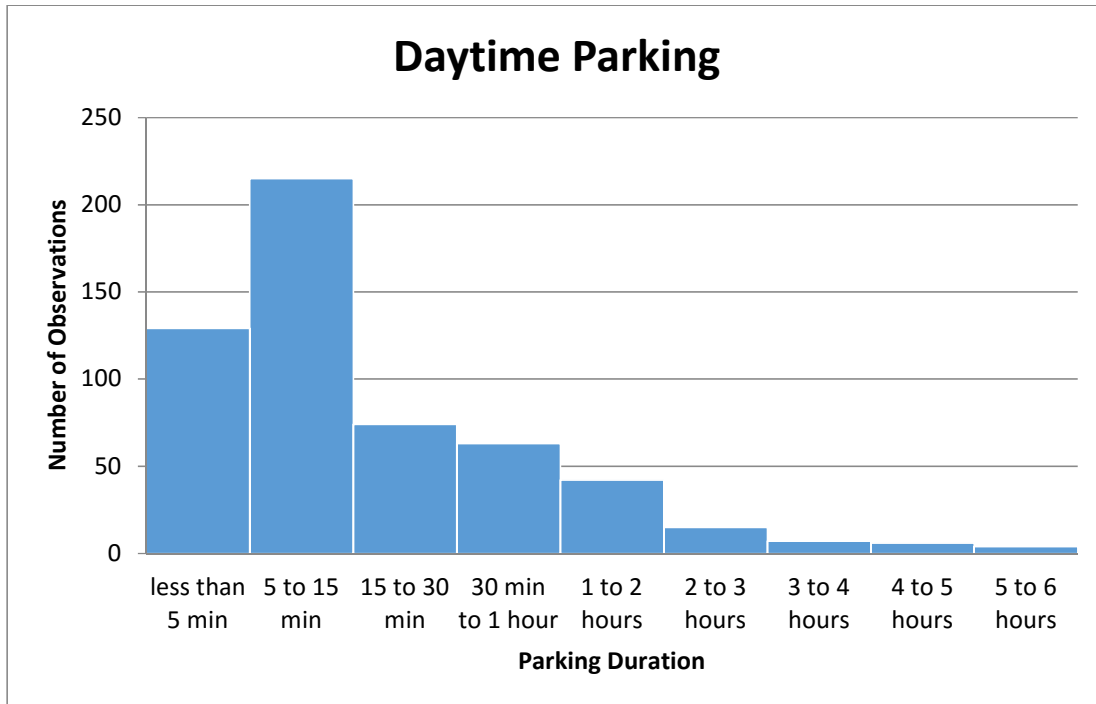
Truck parking hours (8/18/16 to 8/20/16 and 9/4/16 to 9/8/16):

Average	Standard Deviation	Number of Observations
30 min 10 sec	3.63%	555

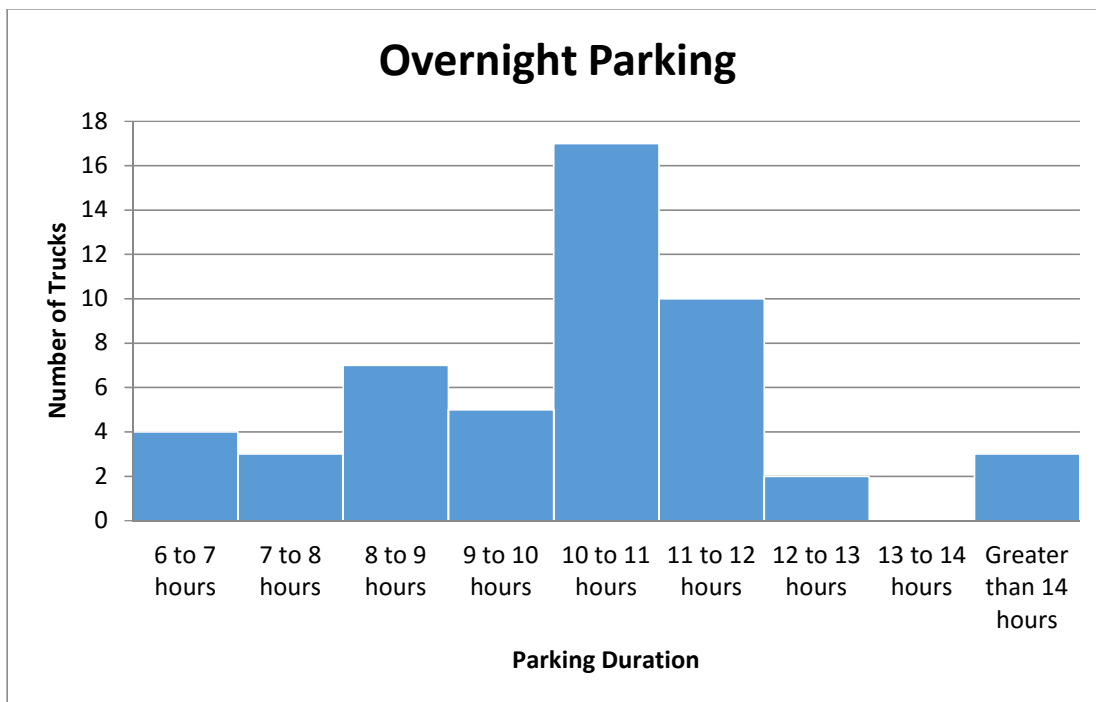
Average	Standard Deviation	Number of Observations
10 hrs 12 min 17 sec	9.32%	51
