1. REPORT NUMBER CA14-2338	2. GOVERNMENT ASSOCIATION NUMBER	3. RECIPIENT'S CATALOG NUMBER
4. TITLE AND SUBTITLE Continued Evaluation of Pothole Patching Equipment, Materials, and Processes		5. REPORT DATE 06/14/2014

7. AUTHOR Duane Bennett, Steven A. Velinsky		6. PERFORMING ORGANIZATION CODE
9. PERFORMING ORGANIZATION NAME AND ADDRESS Advanced Highway Maintenance and Construction Technology (AHMCT) Research Center Department of Mechanical & Aerospace Engineering University of California, Davis Davis, California 95616-5294		8. PERFORMING ORGANIZATION REPORT NO. UCD-ARR-14-06-30-03

Abstract

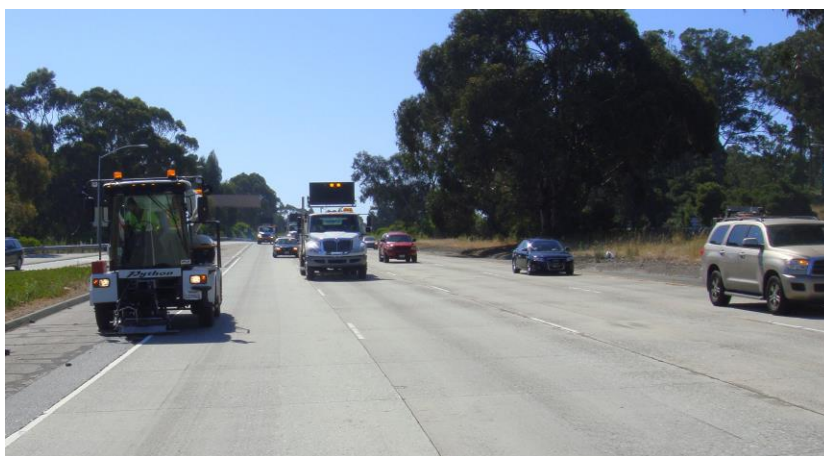
Figure 4. Caltrans Moving Closure Patching Operation

In these highway trials, the District 4 deployment strategy consisted of the semi-automated patching machine traversing the district once or twice a week depending on the demand. Area supervisors would contact the machine’s base of operation, the Caltrans San Jose maintenance station, with patching requests and their priority levels. For urgent requests, the patching machine was routed immediately; less critical patching requests were combined with others in the vicinity along a planned, larger-area, high-production route. With the Caltrans crews in the destination area providing all necessary traffic control resources, the dedicated operator could drive the semi-automated patching machine anywhere in the district in a single day.

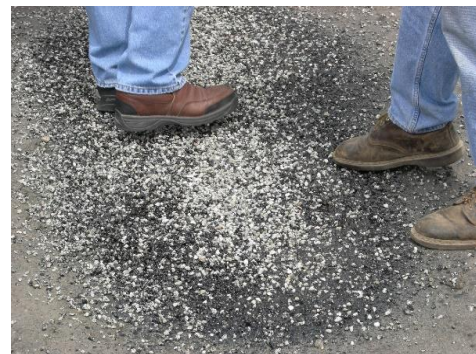
Figure 6. Spray Patch

The semi-automated spray patch method involves filling the pothole with an incompressible mixture of small gravel and liquid emulsion binder. Figure 6 displays a photograph of a spray patch pothole repair. The spray patch process utilizes the following modified four-step method to patch potholes:

- 1) Clean pothole with a compressed air blast
- 2) Apply tack spray
- 3) Spray patch mixture into the pothole
- 4) Apply a no-tack top coat

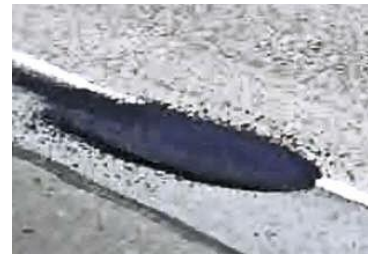
Figure 8. Hot Asphalt Patch

- 1) Clean pothole with air jet blast
- 2) Apply tack oil spray
- 3) Fill the pothole with hot asphalt
- 4) Compact the patch with the compaction roller

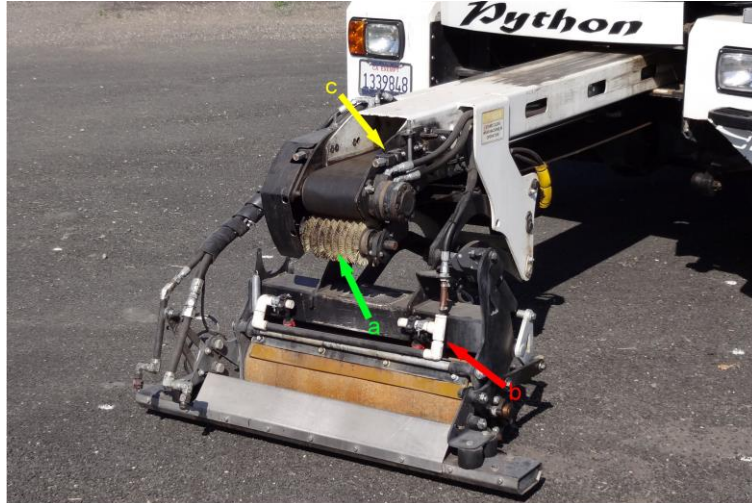
Figure 10. AHMCT Belt Tensioner

The AHMCT Research Center worked with Python Mfg. to develop a spiral brush attachment at the end of the conveyor (location a in Figure 10) that physically scrubs the belt clean to prevent sticking asphalt from building up on the belt or getting pulled back into the machine. The spiral brush is chain-driven off of the conveyer drive roller shaft and geared up such that the brush spins faster than the belt. The Python PHP machine was returned to UC-Davis for the brush modification, which also involved the modification of the compaction roller water spray heads (location b in Figure 10). The modified Python PHP machine was then returned to the D4 San Jose maintenance station for testing on the highway. The successful conveyor brush development completely prevented asphalt from building up on the material belt and the patching head.

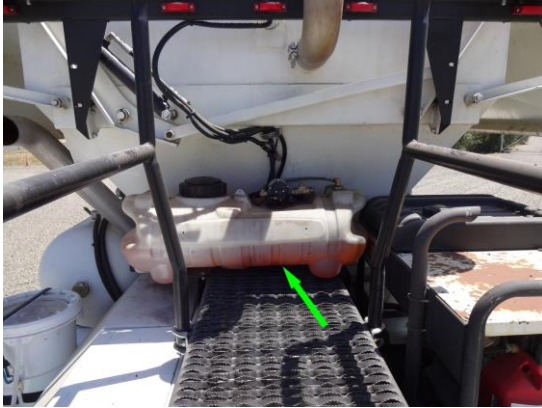
Figure 11. Citrus Cleaner System

The standard Python PHP cleaner, and the most commonly utilized asphalt cleaning fluid, is diesel fuel. Caltrans favors the use of an environmentally safe alternative fluid for asphalt clean-up operations. The AHMCT Research Center purchased the Python PHP machine modified to operate with concentrated citrus solvent instead of diesel fuel, as shown in Figure 11. Unfortunately, Python Mfg. used their standard diesel seals and hose materials, which dissolved over a short period of time. AHMCT Research Center personnel identified new materials that are chemically resistant to the citrus cleaner and replaced the machine's cleaning system hoses and an all Viton seals fluid pump. The level of difficulty involved in changing the rubber hose in the spring return mechanical reel led to the decision to replace the hose reel at regularly scheduled intervals, as needed.

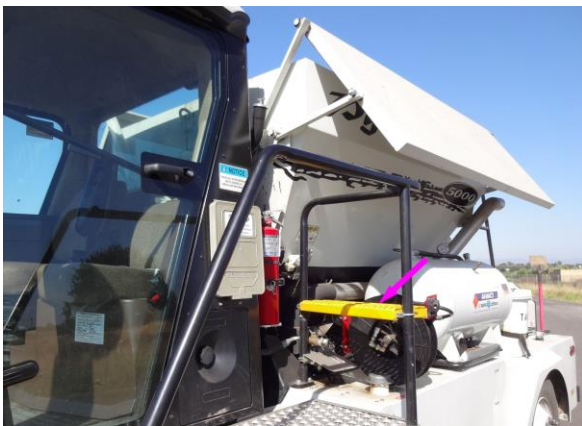
Figure 13. Hopper Viewing Footstep

Python Mfg. provides a slide-out stairway up the rear of their machine for the operator to gain access to the hopper, which is mostly useful for soaping the hopper walls prior to loading asphalt and for post-operational cleaning. However, sometimes during highway patching operations, the operator may want to quickly look in the hopper to examine the state of the remaining hot asphalt. The rear step is not readily accessible on the highway in moving closure operations. AHMCT Research Center personnel added a step adjacent to the cab access door, such that the operator can step out the door and onto the gangway and then step up on the footstep to safely look into the hopper while out on the highway (Figure 13).

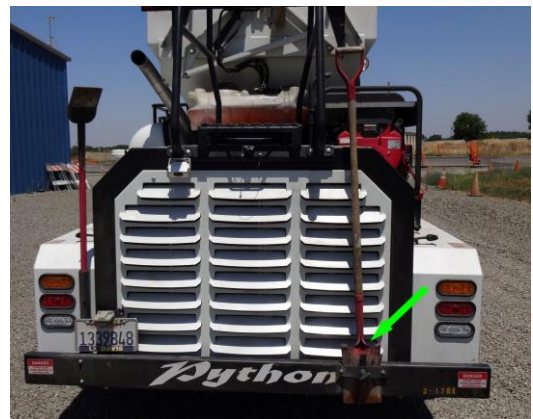
Figure 14. Hopper Shovel

head. The pole scraper's lack of reach limits this tool's usefulness in the hopper. The AHMCT Research Center fabricated a long-reach shovel scraper, which enables the operator to reach into the hopper from the rear gangway and chip loose any remaining clumps of stuck asphalt so it falls into the auger during the machine's post-operational cleaning (Figure 14). The shovel scraper contains a perpendicular end grip to maximize the power and reach of the shovel. AHMCT Research Center personnel designed a spring-clamp mounting, which stores the shovel scraper securely on the Python PHP rear bumper and can be released with the pull of a single T-pin.

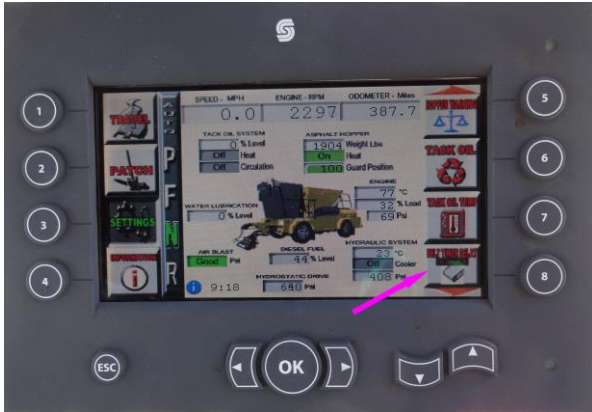
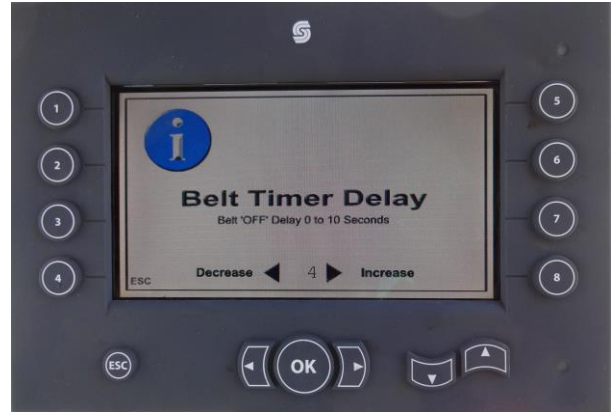
Figure 15. Settings Screen – Belt Delay

enhancement eliminates the initial material delivery delay and the asphalt stop delay time to shave roughly twenty seconds off the Python PHP machine’s patch application time. This practice proves especially effective with potholes spaced minutes apart on the highway such that the asphalt on the conveyor remains appreciably heated. For longer distances of travel, the operator can choose to clear the asphalt off the conveyor in a pothole or off the side of the highway away from traffic.

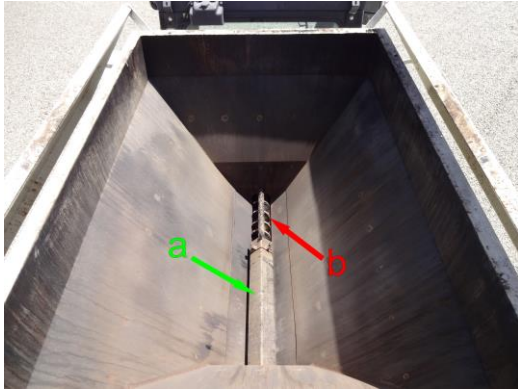
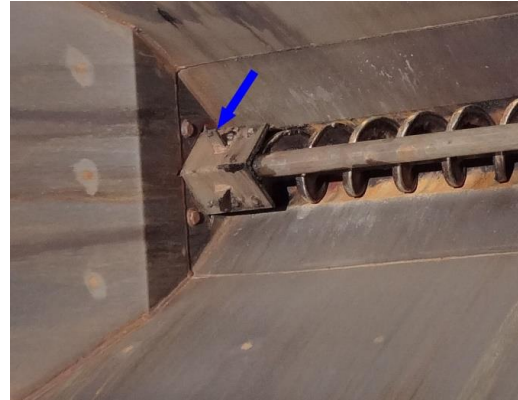
Figure 17. Python PHP Hopper with Guard Closed

An auger screw drive in the bottom of the Python PHP V-shaped hopper feeds hot asphalt forward toward a chute, which discharges over the material conveyor belt. When the operator presses the asphalt feed button on the command joystick, the auger rotates and asphalt drops onto the conveyor belt and then moves forward to the end roller, where the asphalt falls off into the pothole (location b in Figure 17). The auger is incapable of spinning with the weight of a full load of sticky asphalt pressing against the auger in the hopper. The Python PHP design relies on a retractable guard riding along a support pipe to partially cover the auger and thereby reduce the dead weight pressing against the auger (location a in Figure 17). On the leading edge of the guard resides a set of three fins (Figure 18), which breaks up asphalt chunks or frees the auger should it jam by hydraulically driving the guard back and forth over the auger. The Python PHP machine’s standard operating procedure permits the operator to periodically retract the guard as the asphalt discharges from the hopper, ensuring at least a couple of feet of auger stays covered with hot asphalt. In practice, however, the operator retracts the guard only after noticing the asphalt beginning to thin out unexpectedly or stop coming off the conveyor altogether.

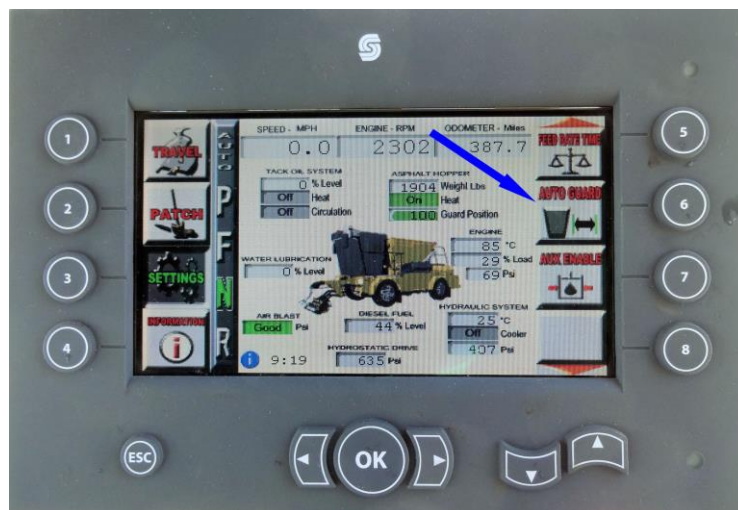
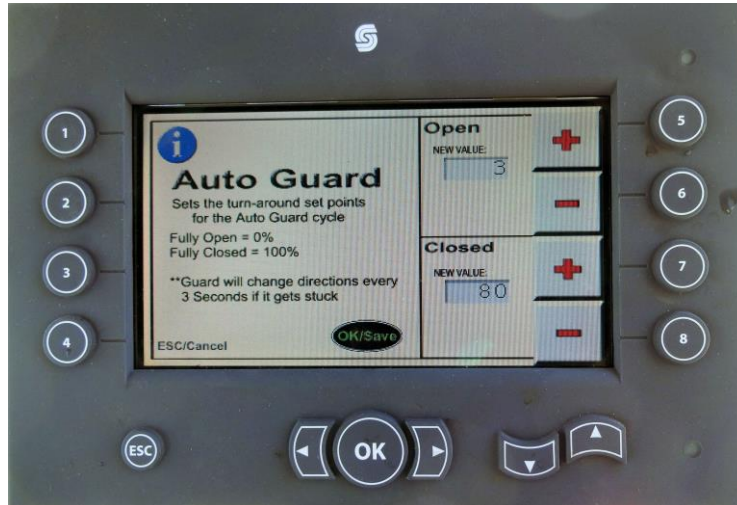
Figure 19. Settings Screen - Auto Guard

The quick delivery of hot asphalt material to potholes without any delays remains an essential aspect for Caltrans mainline moving closure patching operations. The operator does not have time to access the guard settings when stopped at a pothole or while driving along the highway between potholes. Therefore, the AHMCT Research Center collaborated with Python Mfg. to add an automated guard control function to the control program. Based on the weight of the asphalt in the hopper, the controller opens the guard as the asphalt depletes from the hopper. The Auto Guard program settings can be accessed through the **SETTINGS** tab on the control panel (Figure 19). Selecting the **AUTO GUARD** button displays the auto guard adjustment screen, where the desired end positions of the guard can be entered (Figure 20). The initial set-up process required the use of this adjustment; however, the operator unlikely would ever need to access this setting under normal operating conditions.

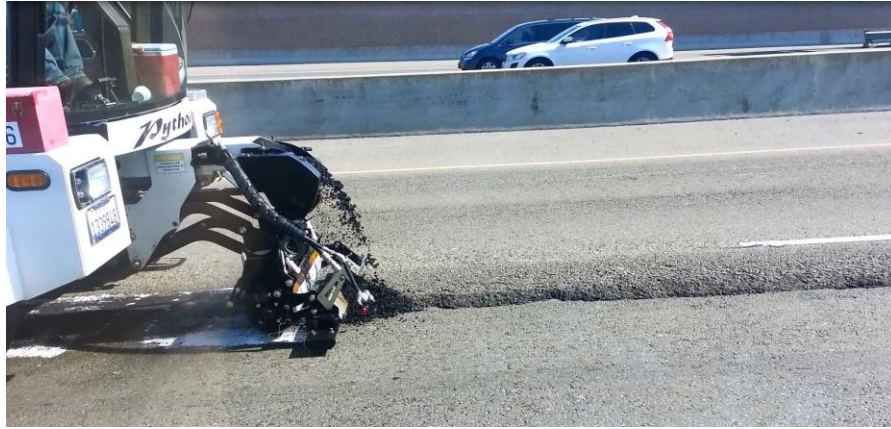
Figure 21. Linear Pavement Gap Patching

By definition, potholes primarily represent a single, finite hole, as opposed to the linear, unbounded gaps often found along longitudinal asphalt concrete/ Portland Cement Concrete (AC)/ (PCC) transitions and ramp transitions. Semi-automated pothole patching application heads are designed to apply finite area patches. However, patching an unbounded linear pavement gap can be accomplished by applying a series of spot patches as the machine moves along the linear gap. This patching approach is feasible for short segments, but it quickly becomes infeasible in a moving lane closure as the length of a linear pavement gap stretches past three or four patches (Figure 21). The strategy towards solving this problem involved developing a continuous, linear hot asphalt patching process, which would improve the quality and efficiency of linear gap patching. The new capability would serve as an add-on to the existing patching capability and should be easily selectable by the operator in the cab.

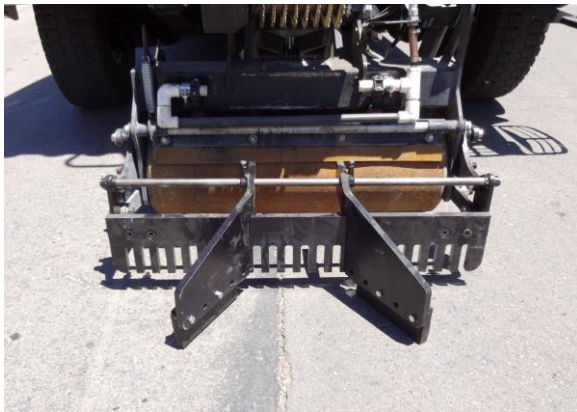
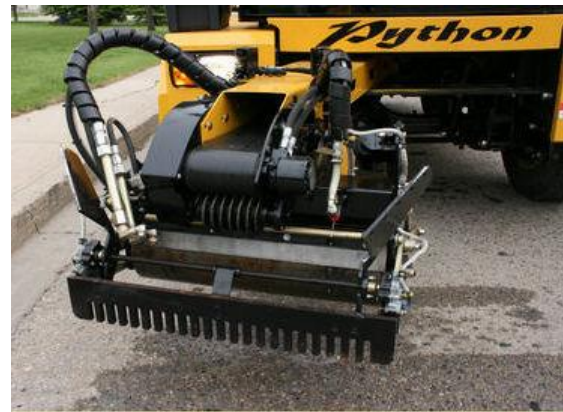
Figure 22. Python PHP Rake & Funnel Attachment

rake (Figure 23). Both of these modifications greatly benefitted patch quality by enabling the operator to effectively move and evenly distribute the asphalt around the pothole.

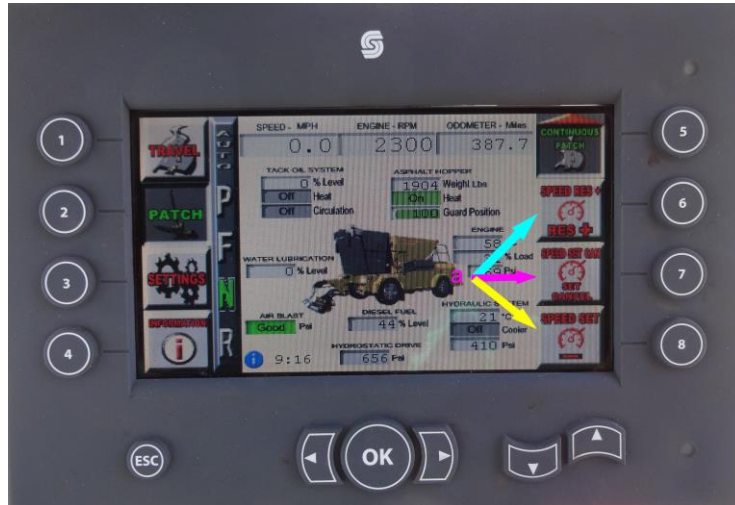
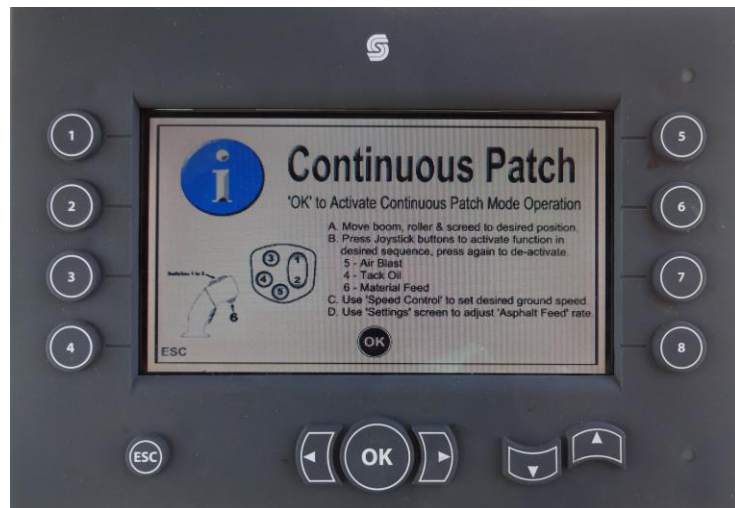
Figure 24. Continuous Mode

The addition of continuous patching capability required minor modifications to the Python PHP machine control program. AHMCT Research Center personnel added a **CONTINUOUS PATCH** mode selection on the control panel, which configures the Python PHP machine for continuous patching operation (Figure 24). Upon selection, a second screen appears showing the operator how the machine controls transform to accommodate continuous patching mode operation (Figure 25). The operator can adjust two interdependent machine settings on the control panel prior to running in continuous patching mode to produce the desired patch. The asphalt delivery rate can be adjusted in the control **SETTINGS** screen (Figure 26) and relates to both the machine speed and the size of the pavement gap. The machine speed setting essentially acts as a low-speed cruise control that drives the Python PHP machine at a continuous but adjustable speed, which is set for each specific application. The operator drives the Python PHP machine at the desired speed and presses the **SPEED SET** button, which holds that speed. The operator can then make fine speed adjustments by pressing the **SPEED RES +** button or cancel the setting with the **SPEED SET CAN/ SET CANCEL** button (location a in Figure 24).

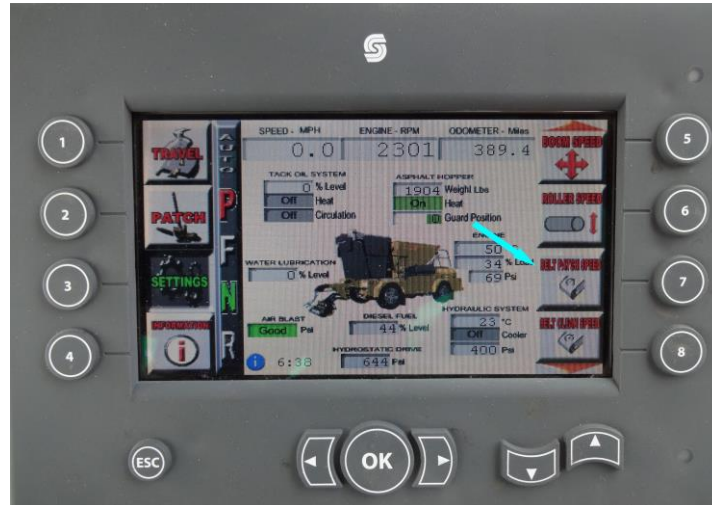
Figure 26. Asphalt Delivery Rate Setting

Once the operator configures the continuous mode, he or she can quickly switch the Python PHP machine between the normal pothole patching mode and the continuous mode as needed in the moving closure operation. Switching into continuous mode on the Python PHP machine changes the buttons on the joystick from momentary to on/off toggle controls for the air blast, tack oil, and material feed functions. The operator initiates the continuous patching process, which the machine automatically continues. With the machine operating in continuous mode, the operator only needs to steer the machine, remaining centered on the linear pavement gap. The AHMCT Research Center verified that the continuous patch functionality on the Python PHP machine correctly functioned in trials at UC-Davis, but it has yet to be utilized on the mainline highway in a Caltrans moving closure patching operation.

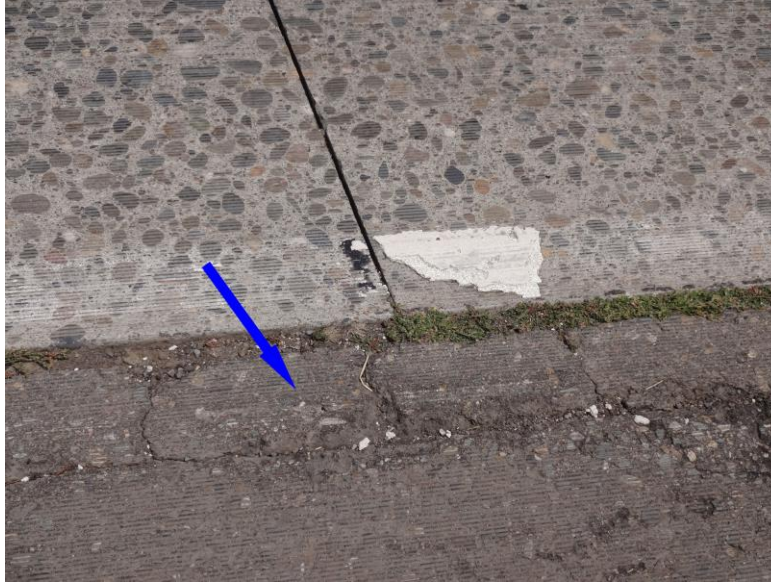
Figure 27. Edge Drain Pavement Failure

During deployment testing with Caltrans, maintenance personnel identified an innovative application of the continuous patching function. In the 1990s, Caltrans retrofitted many miles of highway shoulder edge drains to reduce damage occurring in existing PCC pavements [5]. The process involved cutting a four-inch wide trench in the asphalt shoulder along the PCC edge, installing a drainage pipe, backfilling with aggregate, and then patching with asphalt. These retrofits are extremely susceptible to block cracking and are difficult to crack seal, leading to quick deterioration of the retrofit edge drain pavement (Figure 27). The block cracking eventually loosens, allowing chunks to be dislodged by traffic impacts until the retrofit edge drain pavement resembles a linear series of small potholes. Caltrans maintenance expressed strong interest in utilizing the Python PHP machine to patch these failures. Adapting the Python PHP machine's continuous patching mode to patch these failures would be especially beneficial when pavement deterioration reaches an advanced stage; e.g., when there is a significant amount of dislodged pavement blocks.

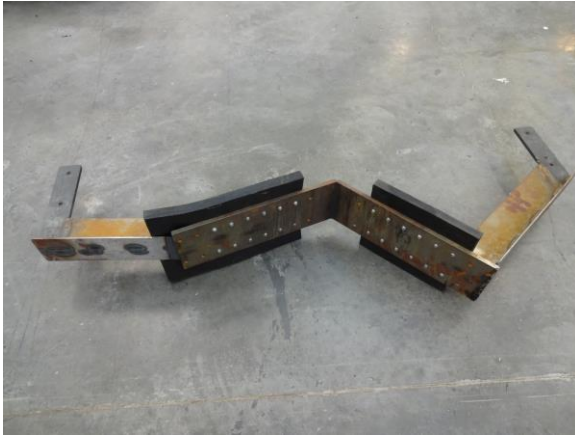
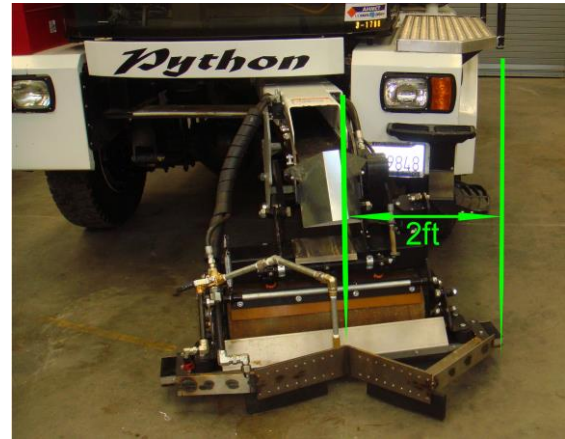
Figure 28. Edge Drain Attachment

for this offset (Figure 28). Utilizing the edge drain attachment limits the machine's encroachment into the traffic lane to approximately two feet (Figure 29). The edge drain attachment simply bolts onto the flat rake and can be flipped for either left or right side patching operations. Similar to the Python PHP funnel attachment wings, thick rubber edge strips form the sides of the funnel, and their width dictates the asphalt mound height.

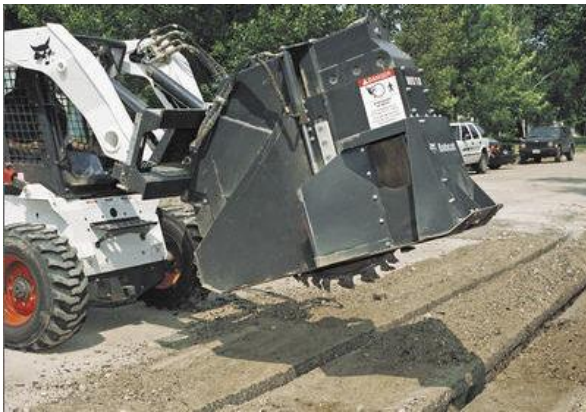
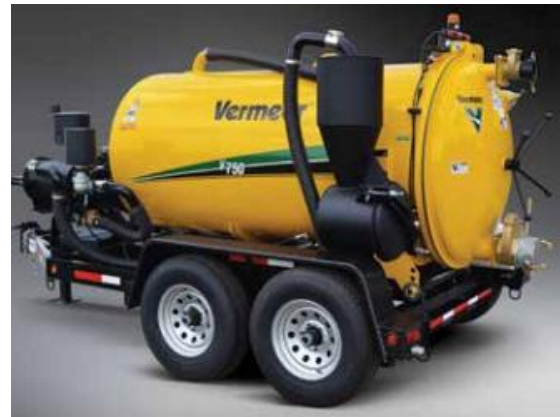
Figure 30. Bobcat Wheel Saw Attachment

Asphalt cutting or routing, which far surpasses all other types of passive cleaning methods like wire brushing and compressed air either separately or in combination, remains the most consistent and cost-effective method of clearing pavement gaps. This clearing technique especially applies in the case of patching edge drains where the relatively large asphalt chunks must be removed in order to enable the new asphalt patch to properly adhere to the intact pavement sidewalls. Commercially available pavement cutters like the Bobcat Wheel Saw attachment (Figure 30) would be a suitable cutter in the development of a high production routing machine.

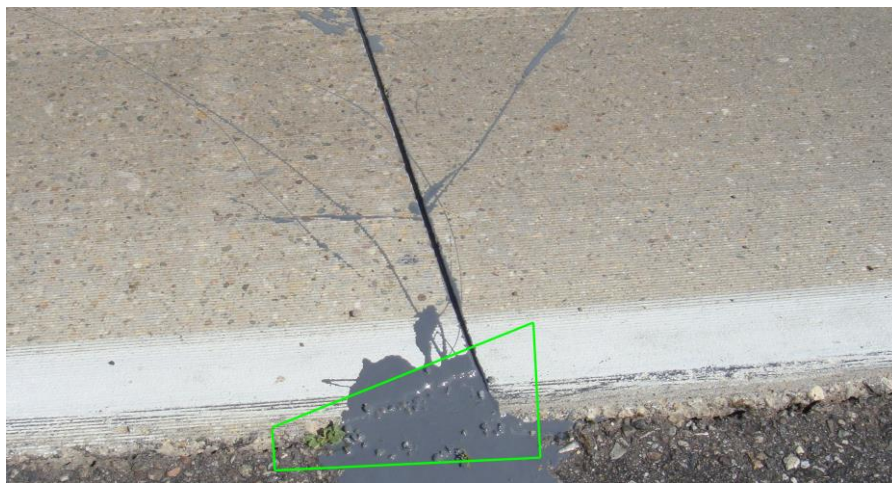
Figure 32. Caltrans Urethane and Gravel Spall Patch – Interstate 8

Once Caltrans makes the investment in establishing a mainline stationary lane closure to repair a spall, the focus is on creating a long-lasting patch by taking the time necessary to make a quality repair. Therefore, Caltrans crews are instructed to remove all damaged concrete in the repair area and cut or chip vertical faces and square corners in the pavement around the spall to guarantee a maximum strength repair. Removing all loose dust and debris helps ensure a clean and dry spall before applying the patch to promote optimum adhesion. Then, coating the spall with an epoxy resin material before adding pea gravel (i.e., the incompressible filler material) ensures consistency. Next, adding additional epoxy resin such that the gravel stays completely immersed in the epoxy and brought up to grade completes the patch application. Generally dispensed with a 20-minute set time, the two-part epoxy gravel repair patch should not be subject to traffic until the epoxy fully hardens (Figure 32). A two-part epoxy gravel patch installed within these guidelines will generally remain intact indefinitely while exposed to mainline highway traffic.

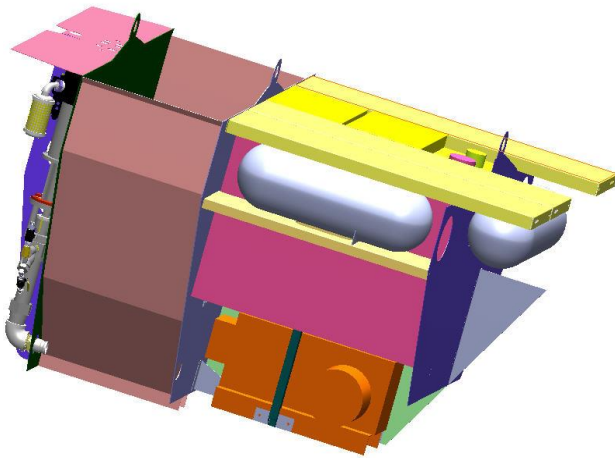
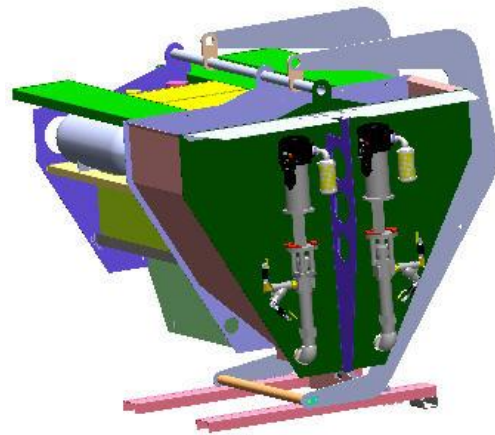
Figure 35. Python PHP Urethane Module

The urethane module contains the resin and catalyst tanks, the air compressor, the material pumps, and the pea gravel filler (Figure 35). The design of the urethane module permits it to slip down flush into the Python PHP asphalt hopper. This design allows the hopper doors to be closed, leaving a six-inch gap to maintain an exit passage for the umbilical. Due to the angular positioning of the Python PHP hopper, the urethane module must share the same shape, which leaves the module unstable when standing alone out of the hopper. Therefore, a module stand is required to stabilize the module when it is out of the hopper for maintenance and storage (Figure 36). Ideally, Caltrans would use standard forklifts or loaders normally found in Caltrans maintenance yards to load the urethane module into the Python PHP hopper. The greatest vertical height measured in the San Jose maintenance station occurred with their loader with bucket fork attachments, which clear approximately thirteen feet (Figure 37). Since the top rim of the Python PHP hopper measures approximately twelve feet high, the loader must be able to attach to the bottom of the urethane module to attain the necessary height for insertion. However, in order to lower the module down into the hopper, the urethane module must be hung from the top. Therefore, the design of the module stand also must allow the stand to act as a mechanism to facilitate the insertion of the urethane module into the hopper using an ordinary Caltrans bucket loader.

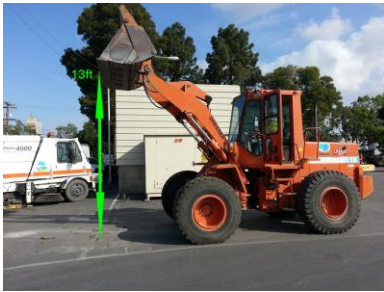
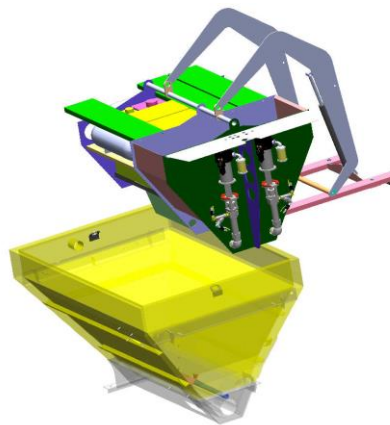
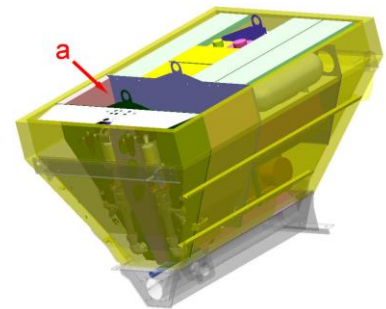
Figure 37. Bucket Loader

Current Voltage (Vdc) hydraulic pump unit mounted on the stand's base and controlled by a wireless remote controller. Inserting the urethane module inside the Python PHP hopper involves lifting the module unit to a preset position above and adjacent to the Python PHP hopper. Then, the operator extends the hydraulic lift cylinder that lowers the module down into the hopper (Figure 38). The lifting pipe slides out and disconnects the hopper stand. Connecting the umbilical and plugging the air compressor's electrical power into the generator fully links the urethane module to the Python PHP machine. The module contains a specific compartment for the management of the pea gravel, which stays open to the material feed auger screw on the bottom (location "a" in Figure 39). The standard Python PHP asphalt feed system feeds the pea gravel to the urethane patch. Since the partition stays open on the bottom, the gravel must be emptied via the material belt before removing the urethane module from the hopper. The pea gravel used in urethane gravel is specially graded and washed, so the aggregate should be collected and reused in a custom designed bucket insert, which also assists with the loading of the aggregate when using conventional bucket loaders.

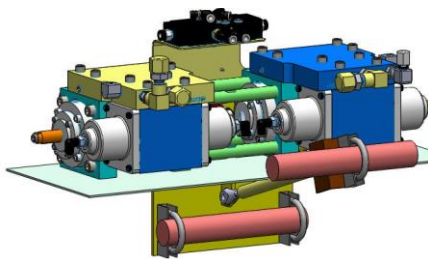
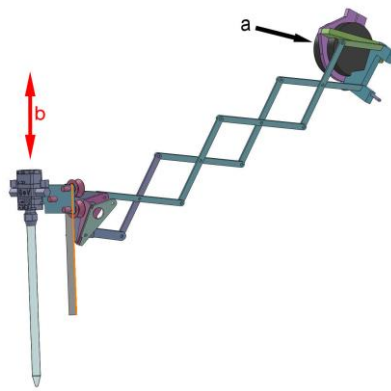
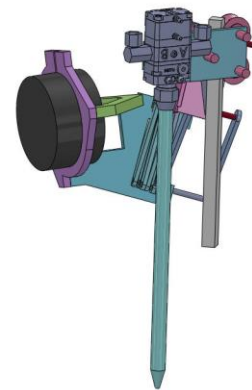
Figure 40. Metering Block

dispensing head, a simple on/off valve, controls the urethane's flow through the attached mixing nozzle. The mixing head and nozzle mount to the end of the injection linkage, which provides both positional extension and a vertical translation for the nozzle. The preliminary design of the injection linkage simply clamps over the case of the Python PHP material belt drive hydraulic motor (location a in Figure 41). Note that Figure 41 displays this partial model, with the second scissor mechanism hidden to improve visibility and clarity. The scissor mechanism design extends the urethane applicator assembly out and down to a spot two feet out from the center of the material belt and four inches above the pavement. This area approximates where the pea gravel rolls off the material belt and lands on the pavement. Applying the urethane binder and aggregate matrix at this common spot promotes a natural blending of these two components in the spall. In addition, the nozzle can be moved vertically six inches, enabling the urethane to inject directly into the patch matrix as needed (location b in Figure 41). In the retracted position, the applicator assembly closes into a compact position out of the way of the Python PHP material belt (Figure 42). Mounted below the nozzle in the retracted position, a disposable spoils bucket catches the urethane expelled during the nozzle refreshment stage.

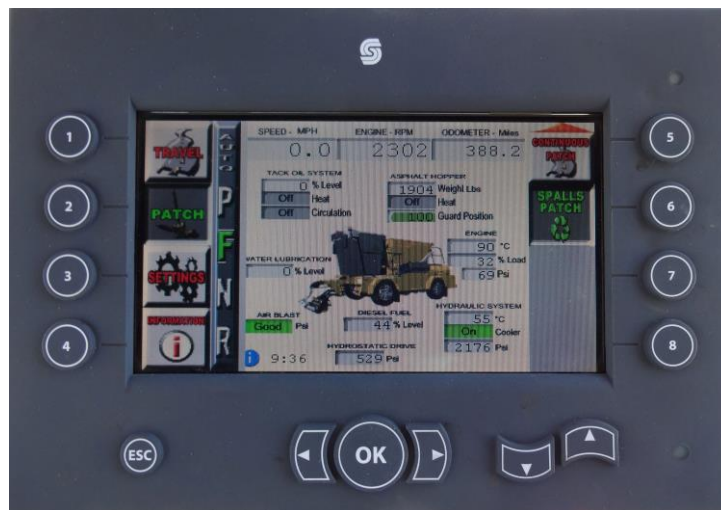
Figure 43. Spall Repair Screen

configured and loaded for urethane patching operations, it can be parked on stand-by, ready to be deployed at short notice to patch spalls. To patch, the dedicated operator drives the Python PHP machine to a safe location near the beginning of the work site and installs a fresh mixing nozzle. In the cab, the operator selects the **SPALL PATCH** mode on the control panel (Figure 43). The control panel displays an informational screen describing how the Python PHP operational control changes when dispensing urethane (Figure 44). In this example, the **#3-EPOXY ON/OFF BUTTON** on the joystick controller activates the pumping of urethane through the nozzle. After the establishment of urethane flow through the mixing nozzle, the Python PHP controller automatically purges the mixing nozzle at regular intervals with new urethane to prevent clogging. Now, the Python PHP machine is ready to be driven out on the highway to begin patching operations. The patching crew and traffic control personnel establish the moving closure, and the operator drives the Python PHP machine into the closed lanes and patrols for spalls. The Python PHP machine and the traffic control vehicles can accelerate up to and travel at near highway speeds on the mainline between repairs.

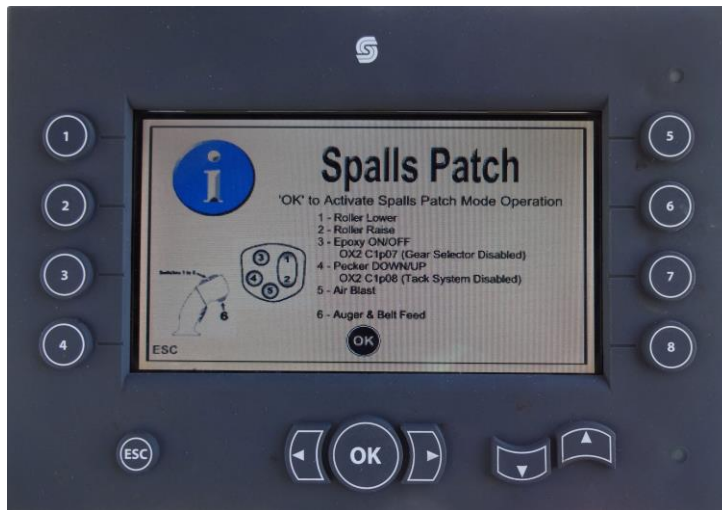
Figure 44. Spall Controls Screen

telescoping boom. Using the joystick, the operator moves the applicator around the spall and applies an even coating of primer. After a set time, the dedicated operator similarly applies the urethane as a coating in the spall before adding the pea gravel matrix. For maximum patch strength and adhesion, mixing the gravel and the urethane uniformly is important. The method to accomplish this is to apply urethane at the bottom of the spall, urethane on top of the gravel filler, and then inject urethane directly into the gravel filler by randomly poking the nozzle into the gravel patch. To apply pea gravel, the operator presses the **#6-AUGER & BELT FEED BUTTON** on the joystick, which runs gravel off the material belt and into the spall. The operator works the urethane nozzle and gravel filling in concert to fill the spall, striving to ensure the pea gravel remains immersed in urethane. The urethane nozzle may also be driven down into the gravel with the **#4-PECKER BUTTON** on the joystick to inject urethane directly into pockets of dry pea gravel. A plastic cover on the rake provides the operator with a means of tooling the surface of the patch if necessary. The Python PHP machine and all traffic control vehicles avoid driving over the fresh patch to provide an undisturbed set time before being exposed to the trailing highway traffic.
