DOT/FAA/AR-97/69

Automated Inspection of Aircraft

Final Report

This report describes the multiphase design and development of a prototype robot (the Automated Nondestructive Inspector or ANDI) capable of walking on an aircraft fuselage and, using an eddy-current probe, inspecting the skin for cracks and corrosion.

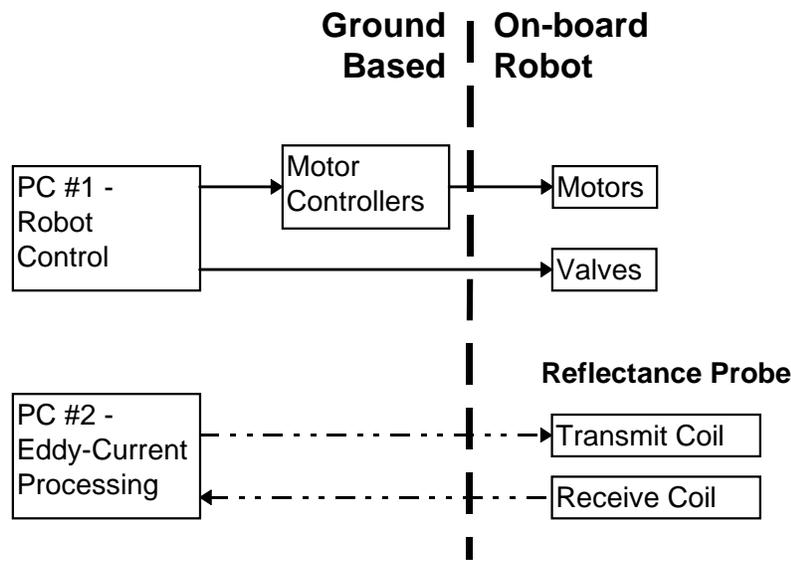
As shown in figure 1, one ground-based personal computer (PC) controlled the scanning and walking motions of the robot while a second ground-based PC controlled the data acquisition functions for the eddy-current data. There was no communication between these computers; data acquisition was initiated manually by the operator.

FIGURE 1. FIRST-PHASE SYSTEM ARCHITECTURE

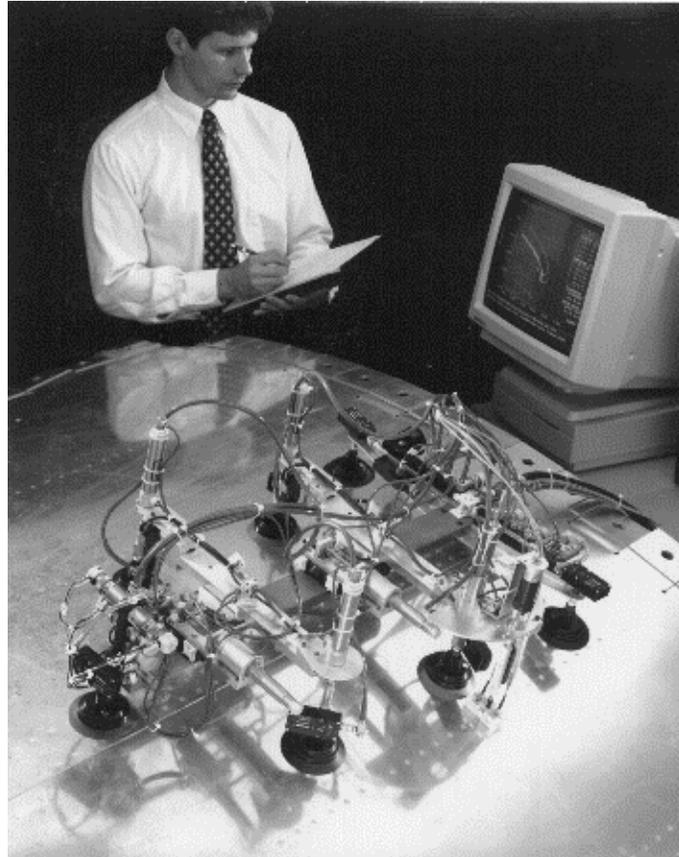
A simulated aircraft panel manufactured by Foster-Miller, Inc., was provided to the CMU Automated Inspection of Aircraft Project by the FAA Aging Aircraft Nondestructive Inspection Validation Center (AANC). The panel's curvature and fastener layout are similar to that of a Boeing 737. During the initial phase of development, the simulated aircraft panel was mounted horizontally in the lab; all testing on the panel during this phase was performed with the panel mounted in this position. Because the panel was a curved surface, the robot was also tested on a modest slope during this phase. The lab setup is shown in figure 2.

FIGURE 2. FIRST-PHASE ROBOT AND LAB SETUP

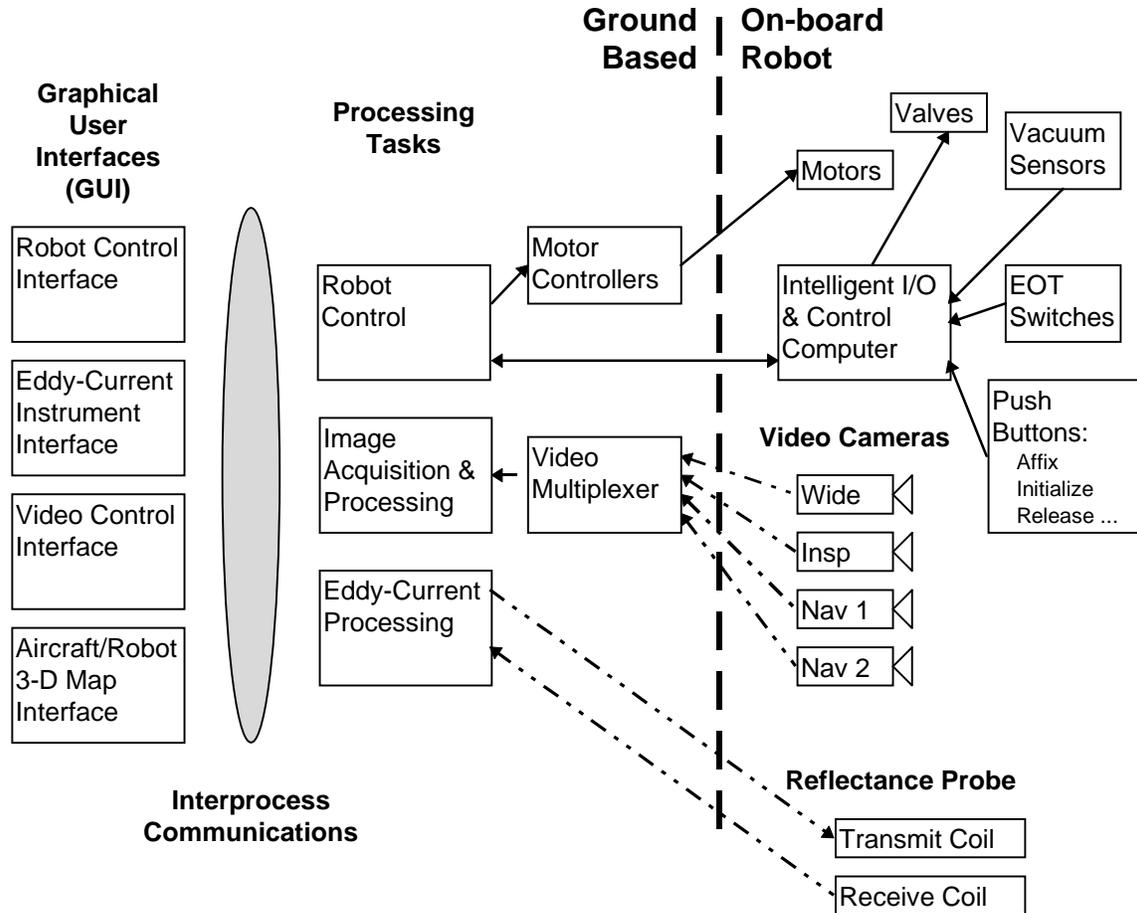
The electronic and computer system architecture was upgraded to provide a more flexible, modular architecture shown in figure 3. Multiple computers were employed to divide the processing load with communications between the individual computers using both point-to-point and network connections. A computer was installed on board the robot to control the low-level sequencing of mechanical operations and to monitor the status of the robot in real-time.

FIGURE 3. SECOND-PHASE SYSTEM ARCHITECTURE

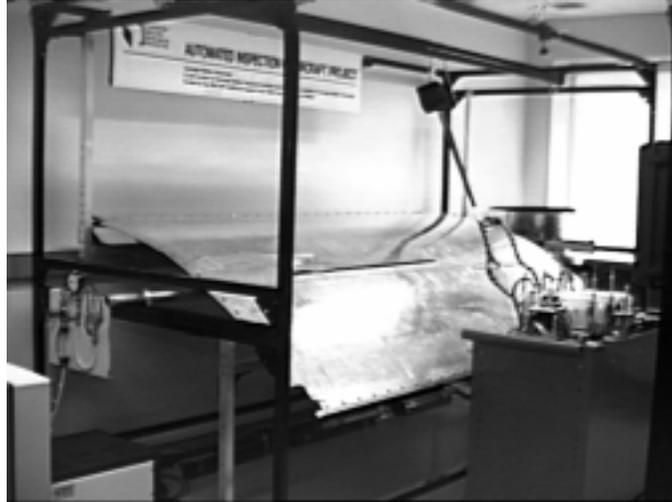
The second-phase robot was demonstrated at the Air Transport Association's Nondestructive Testing Forum on November 2, 1994, at the FAA Aging Aircraft NDI Validation Center (AANC). Prior to this demonstration, extensive tests were conducted in the laboratory and at the AANC hangar. A picture of the robot walking on the DC-9 nose section is shown in figure 5. The safety tether had a passive mobile follower that ran along a strap suspended above the nose section. The umbilical cable is supported to the right of the robot and had sufficient slack to accommodate a moderate range of motion.

FIGURE 4. LABORATORY TEST PANEL FIXTURE WITH TETHER

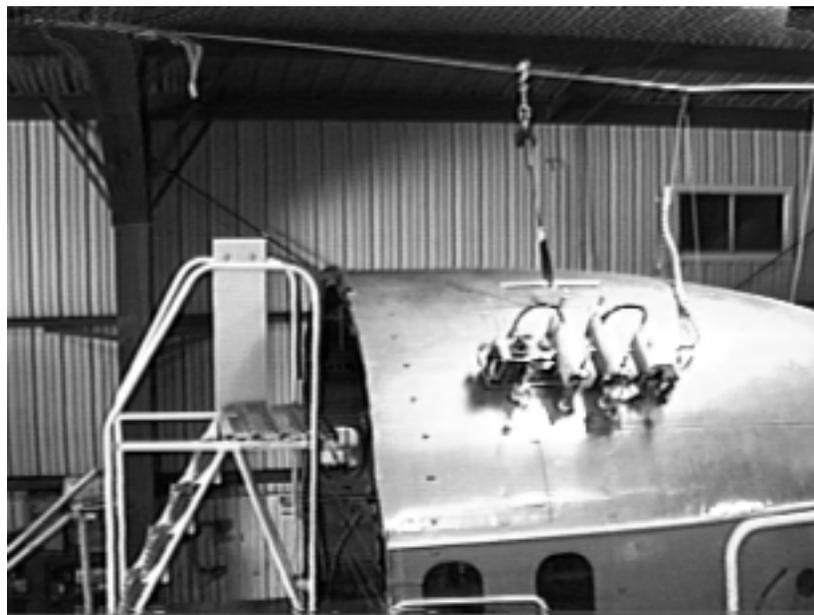
FIGURE 5. SECOND-PHASE ROBOT ON DC-9 NOSE SECTION

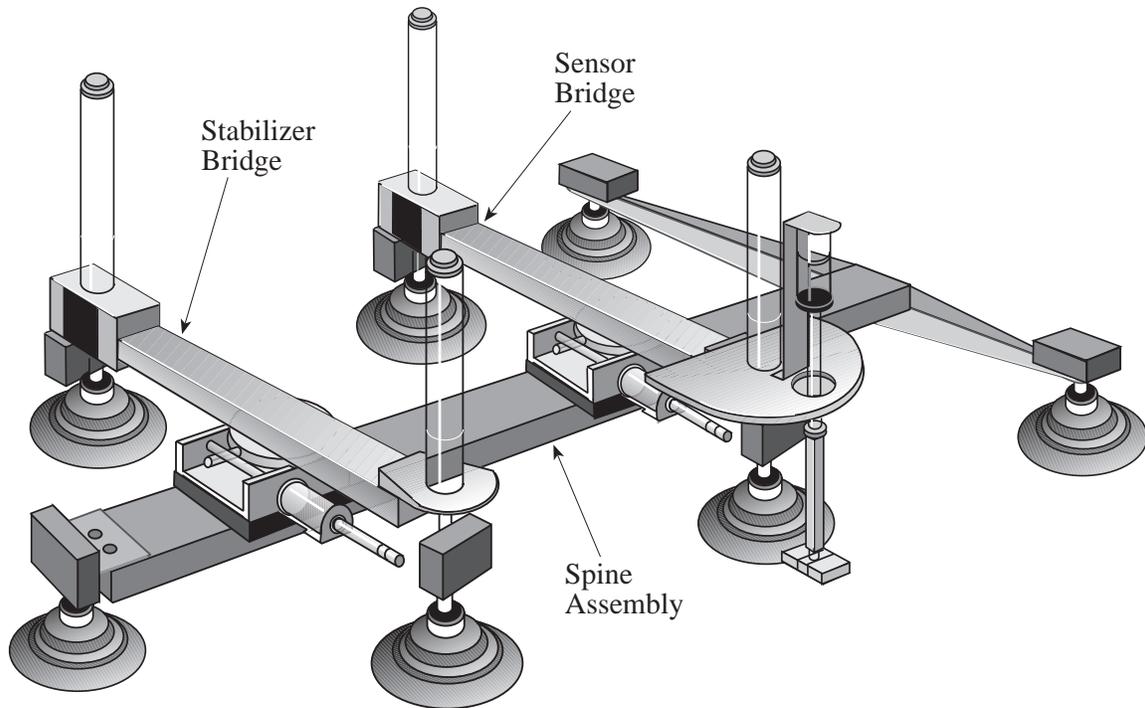
deploy sensors, and to walk across a curved surface. The major mechanical components of the robot design is shown in figure 6; pneumatic and electrical connections are not shown in this figure.

FIGURE 6. DRAWING OF THE CRUCIFORM ROBOT

The robot is comprised of a spine assembly and two bridges. The spine assembly is the main member upon which the bridges move. The sensor bridge possesses dual functionality; it is used to deploy the eddy-current sensor during scanning and is also used for support during walking. The stabilizer bridge is used only for support during walking, although it may be expanded to have an inspection role. Each of these structures and the basic robot motions will be discussed in more detail below. The relevant dimensions of the robot are shown in figures 7, 8, and 9 indicates the reference directions which will be used when describing the system components.

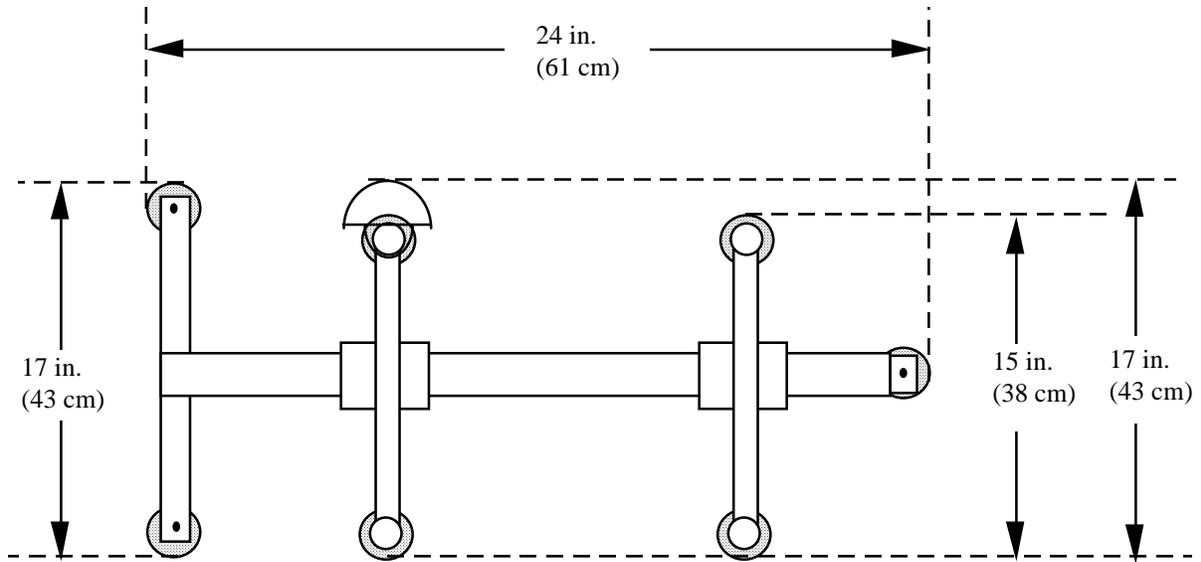
FIGURE 7. ROBOT DIMENSIONS (OVERHEAD VIEW)

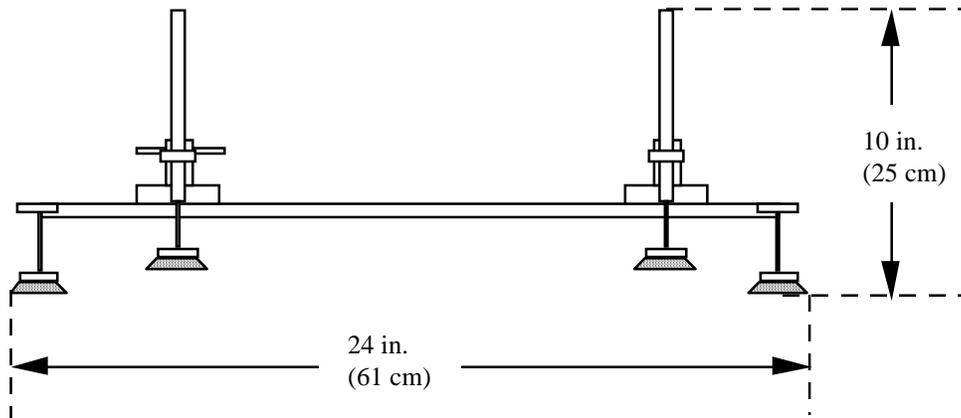
FIGURE 8. ROBOT DIMENSIONS (SIDE VIEW)

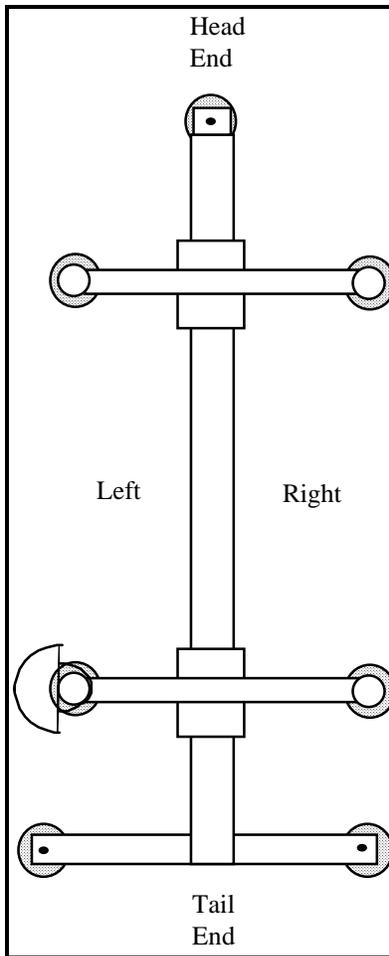
The robot design is symmetrical, permitting many possible configurations. The sensor bridge is the bridge closest to the tail end of the spine assembly. The sensor platform is mounted on the sensor bridge so that it is positioned on the left side of the robot. The stabilizer bridge is the bridge closest to the head end of the spine assembly.

FIGURE 9. REFERENCE DIRECTIONS

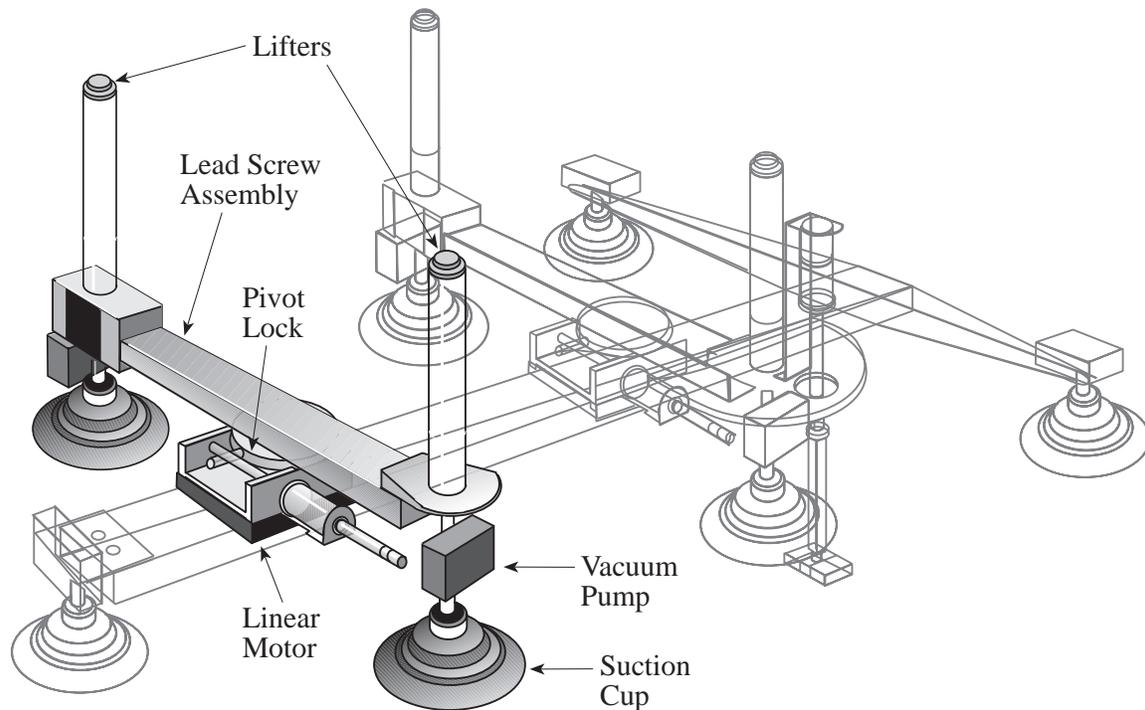
- Suction Cups—These are 3 inches (8 cm) in diameter and are made of silicone rubber. At a vacuum of 28 inches of mercury (711 mm Hg), the lifting power for each suction cup on a smooth and clean surface is 44.0 pounds (196 N) in the direction normal to the surface and 24.2 pounds (108 N) in shear.
- Pivot Lock—This is a floating pneumatic-type pivoting mechanism that allows ± 20 degrees of motion about its reference (locked) position. It consists of an air bearing support and a single-acting cylinder with a spring return.

FIGURE 10. DRAWING OF THE STABILIZER BRIDGE

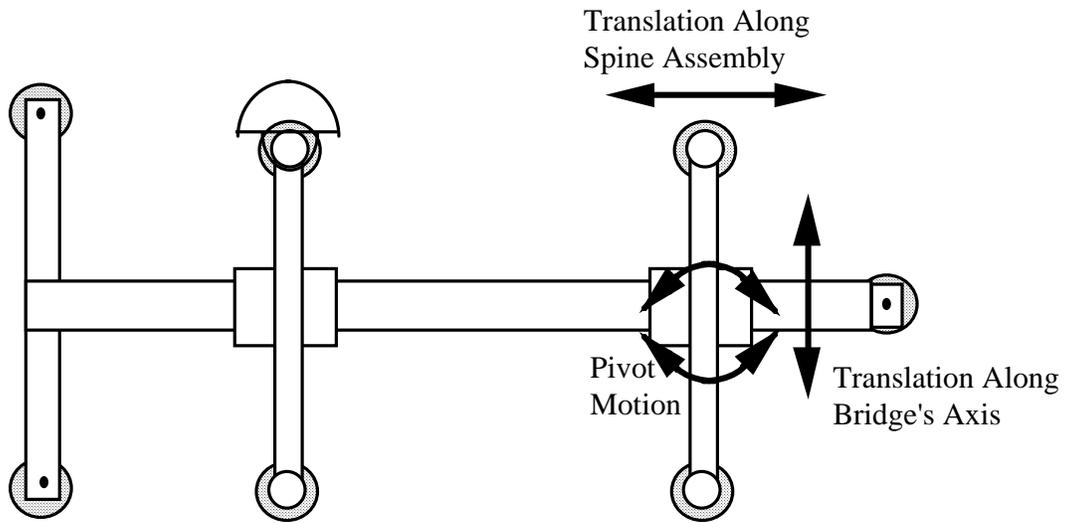
The stabilizer bridge can pivot with respect to the linear motor, can translate along the spine assembly, and can translate along its own axis. These motions are shown in figure 11. The stabilizer bridge can travel a maximum distance of 15 inches (38 cm) along the spine assembly, and the stroke of the bridge's lead screw assembly is 6 inches (15 cm). The pivot locks give ± 20 degrees of motion as shown in figure 12. The locking mechanism consists of a single-acting/spring-return cylinder floating in an air bearing. In the position shown in figure 12, the cylinder is in its extended position, allowing the lead screw assembly to pivot with respect to the linear motor. When the cylinder is retracted, as shown in figure 13, the clamps lock the pivot into position securing the lead screw assembly perpendicular to the spine. This is the position used for the scanning and walking motions; the pivots are unlocked only when using the alignment motion. The details of these motions are described in section 4.

FIGURE 11. STABILIZER BRIDGE MOTIONS

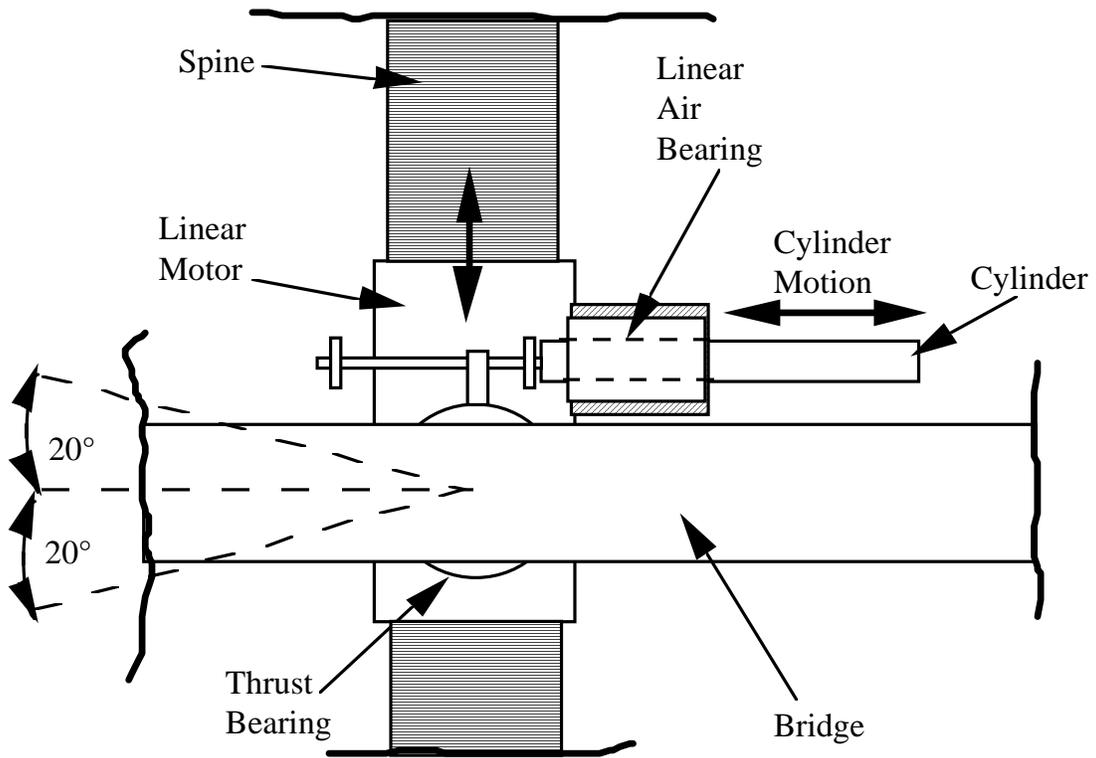
FIGURE 12. PIVOT LOCK SCHEMATIC (UNLOCKED)

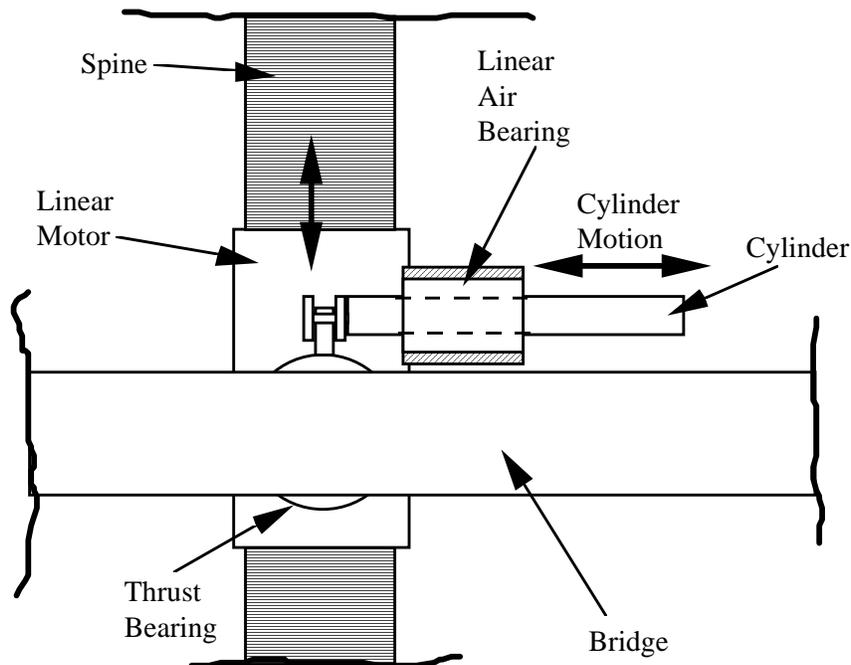
FIGURE 13. PIVOT LOCK SCHEMATIC (LOCKED)

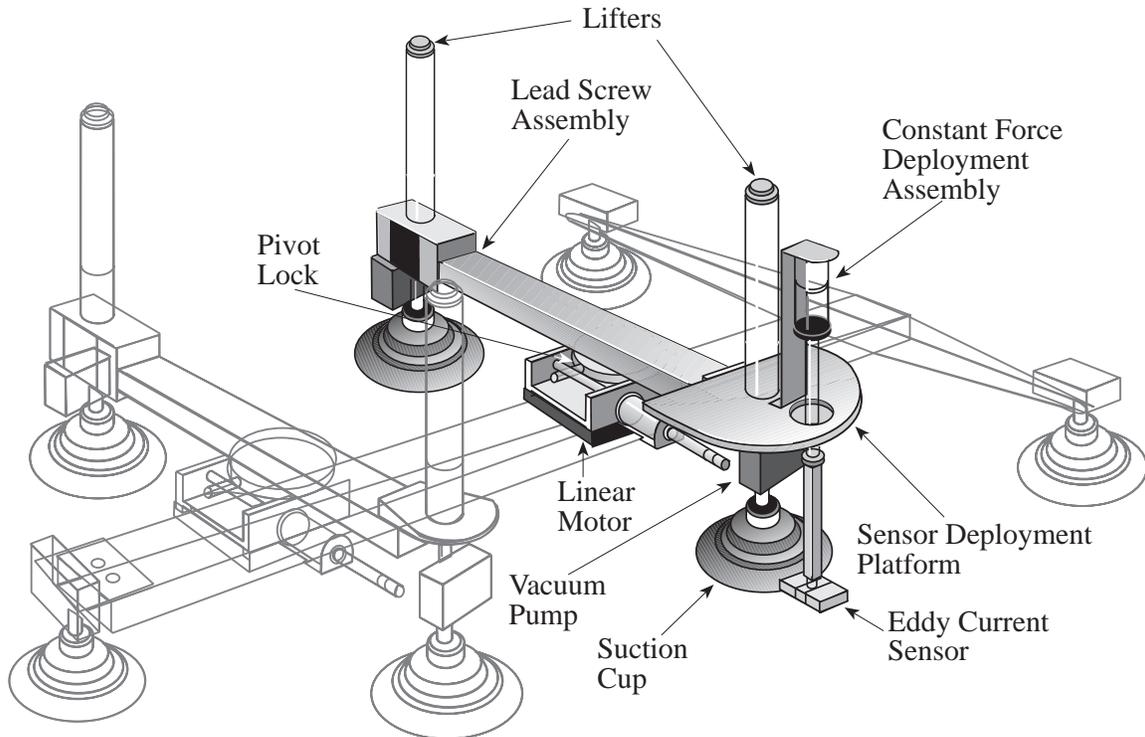
Because the sensor bridge is mechanically identical to the stabilizer bridge, its motions are the same. It can translate along the spine assembly a maximum distance of 15 inches (38 cm), translate along its own axis a maximum distance of 6 inches (15 cm), and pivot with respect to the linear motor ± 20 degrees.

FIGURE 14. DRAWING OF THE SENSOR BRIDGE

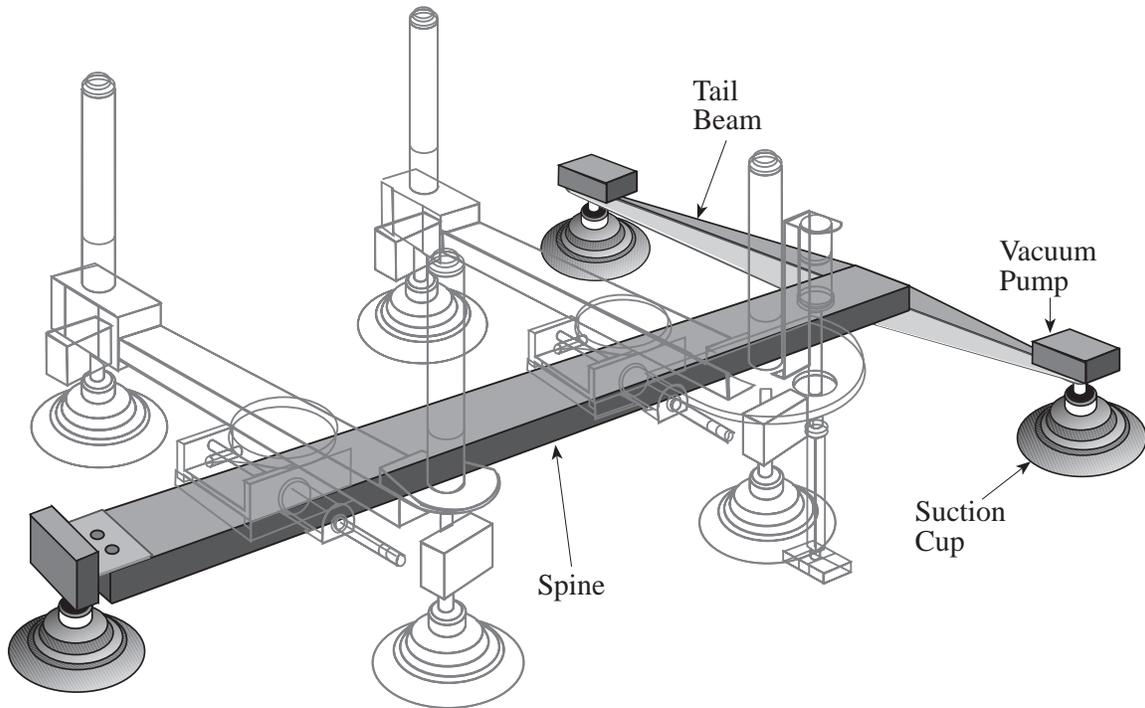
FIGURE 15. DRAWING OF THE SPINE ASSEMBLY

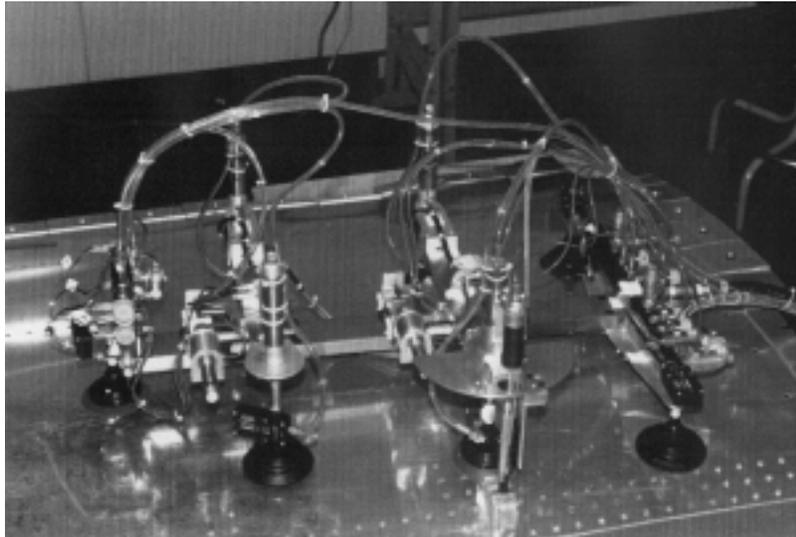
A photograph of the finished first-phase robot including the air and electrical supply lines is shown in figure 16.

FIGURE 16. PHOTOGRAPH OF THE FIRST-PHASE ROBOT

The first-phase robot was able to affix to flat horizontal surfaces such as tables, flat vertical surfaces such as walls, and curved surfaces such as the simulated aircraft panel. No limitations were observed with respect to the ability of the robot to adhere to surfaces, regardless of the orientations of the surfaces. The alignment, scanning, and walking motions of the robot were tested to ensure that they functioned as specified. The manually controlled alignment procedure

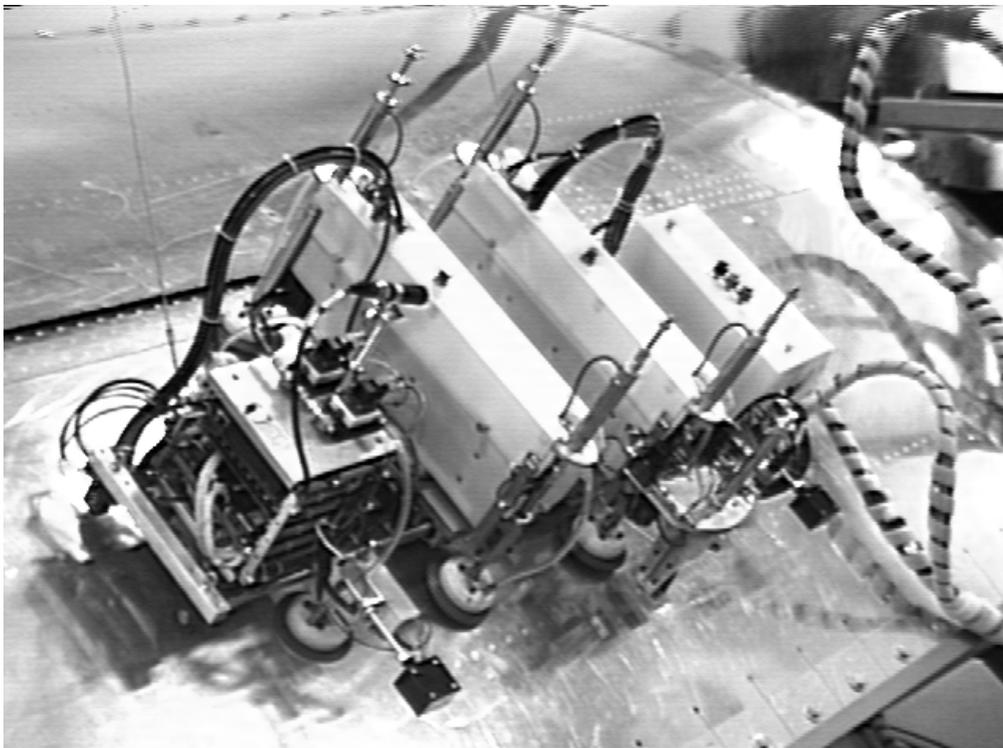
The basic mechanical design of the second-phase robot was identical to that of the first-phase robot. The robot's mobility was enhanced by implementing the improvements identified during the first phase. It was capable of operation around the entire circumference of the fuselage. The robot was made modular in this phase, meaning that each of the three subassemblies contains all of the components (e.g., valves, manifolds, etc.) necessary for its operations. A photograph of the second-phase electromechanical assembly is shown in figure 17.

FIGURE 17. SECOND-PHASE ROBOT

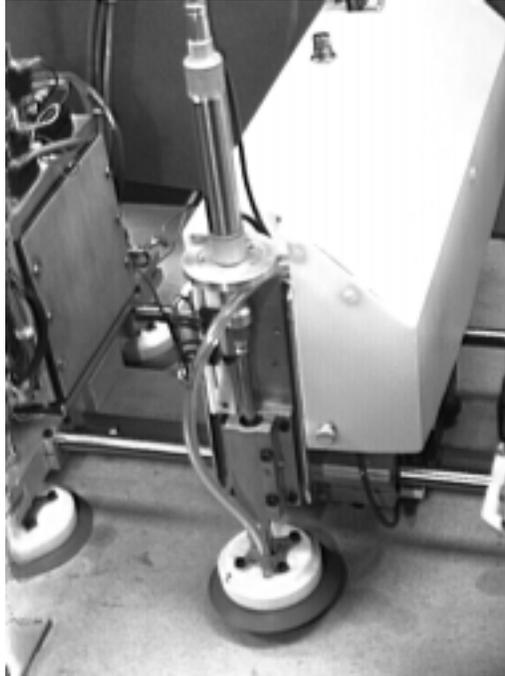
It was desired that the robot operate in a variety of orientations, simulating various positions on an aircraft fuselage. For the robot to be able to withstand the forces present in all orientations, its legs were stiffened. Two enhancements over the previous leg designs were implemented: the suction cup fittings were redesigned to reduce the tipping moment and to reduce the effect of the maximum shear force; and a linear bearing assembly was added to withstand the maximum shear force. Figure 18 shows the second-phase leg assembly.

FIGURE 18. LEG ASSEMBLY

The suction cup from the first phase was a commercially available, off-the-shelf item. It consisted of a 3-inch-diameter silicone suction cup, an aluminum suction cup fitting, and a ball and socket joint. There were two problems with this suction cup: the length of the tipping moment arm from the surface to the ball and socket joint created a large tipping moment, and according to the manufacturer, the ball and socket joint was not designed to withstand a shear stress. These problems had to be addressed to prevent a failure during the tests. A new suction cup fitting was designed and fabricated. The new fittings contained an integral ball and socket joint and were machined from P.E.T., a lightweight, easily machinable plastic material. The joint was designed to withstand the expected forces, and by lowering it into the suction cup fitting, the length of the tipping moment arm was reduced, thereby reducing the tipping moment.

The leg assembly from the first phase was composed of the suction cup, suction cup fitting, the ball and socket joint discussed in the previous paragraph, and an air cylinder. Besides the problems with the suction cups, there was also a problem with attaching the air cylinder directly to the suction cup assembly. Exposing an air cylinder to shear loads over a prolonged period of time could break the seal around the rod, causing air leaks. To correct this problem, a linear pillow block bearing assembly was added to the leg configuration. The shaft of the bearing assembly was attached to the ball of the custom ball and socket joint previously described. The other end of the bearing shaft was connected to the cylinder rod via a linear coupler. Thus, in this design, all of the forces acted upon the bearing assembly, and the cylinder was used only for motion. The air cylinder was not exposed to shear loads, thus, protecting the seal around the rod.

The legs on the spine assembly are fixed in place. A standard 1/4-20 stainless steel stud is attached to the ball of the custom ball and socket joint. The studs are mounted through holes at the ends of the head and tail beams, and they are held in place using locking nuts.

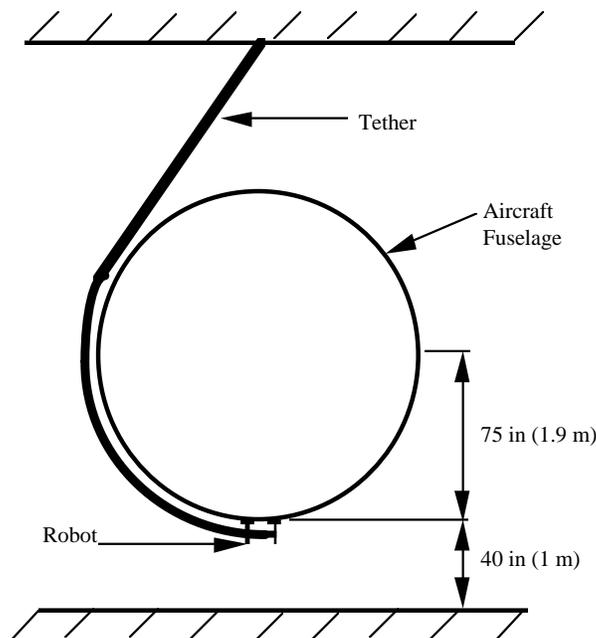
The tether arrangement for the robot is not effective when the robot is positioned on the underside of the aircraft. The clearance underneath a typical mid-size jet aircraft (e.g., McDonnell Douglas DC-9 or Boeing 737) is about 40 inches (1 m), and the approximate radius of the fuselage is 75 inches (1.9 m). If the robot were positioned on the belly of the aircraft as shown in figure 19, the tether would follow the circumference of the fuselage to this point. If air is lost when the robot is in this position, the tether will not prevent the robot from hitting the ground since the tether would be too long. This is illustrated in figure 20. One of the designs for tethering the robot for this special case under consideration is shown in figure 21; in this design, when the robot is inspecting the belly of the aircraft, a second tether suspended from the opposite side of the fuselage would be attached to the robot in order to prevent the device from falling if the air supply is lost. This tether configuration has been used in the laboratory on the Foster-Miller panel to protect the robot while working inverted.

FIGURE 19. ROBOT TETHERED TO BOTTOM OF AIRCRAFT

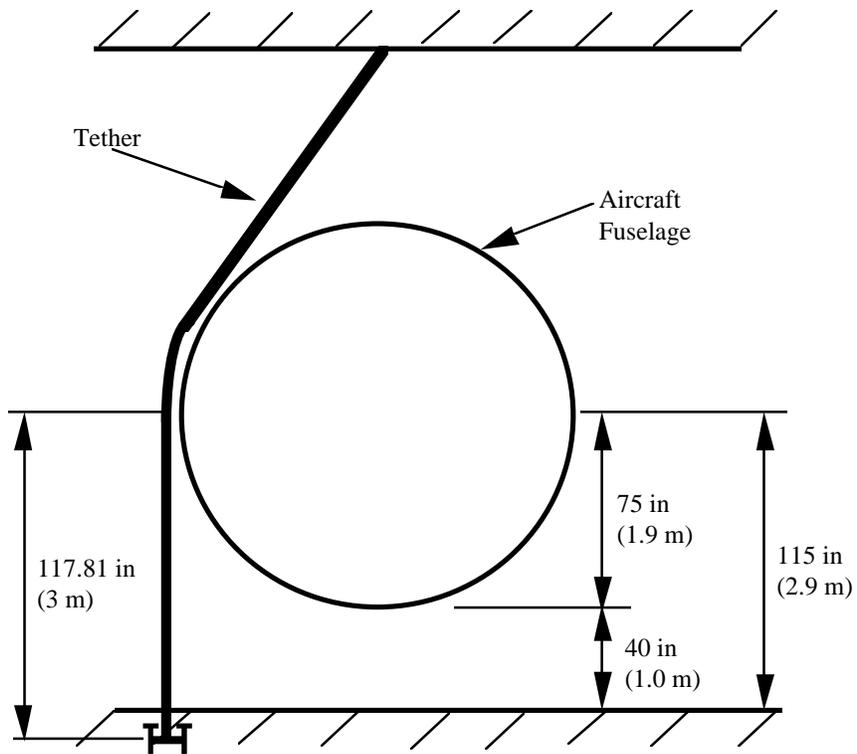
FIGURE 20. TETHER LIMITATION

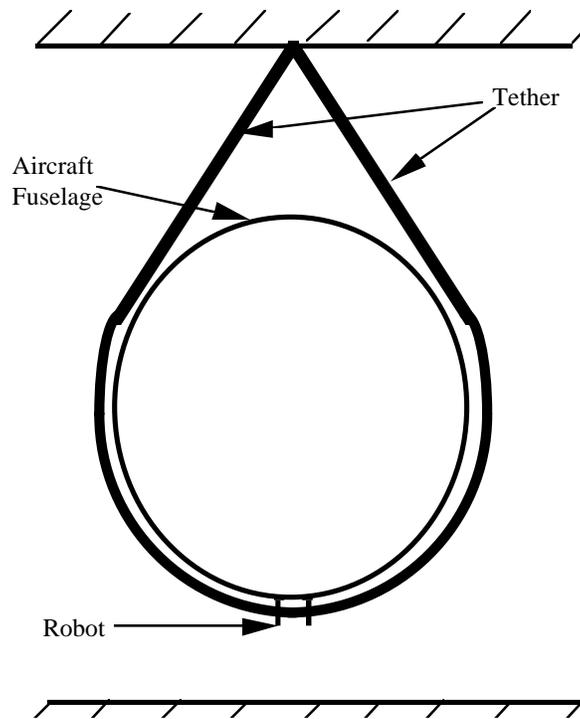
FIGURE 21. SPECIAL CASE TETHER

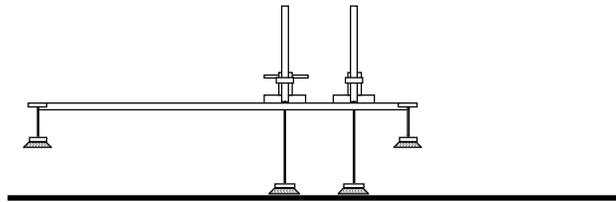
Next, the lifters extend until the bridges' suction cups touch the surface. The suction cups on the bridges are activated, and all eight suction cups are affixed to the surface. The suction cups on the spine assembly are then deactivated, allowing the lifters to extend completely (see figure 23, lift exaggerated). The spine assembly is now lifted off of the fuselage surface.

FIGURE 23. WALKING MOTION: SPINE ASSEMBLY RAISED

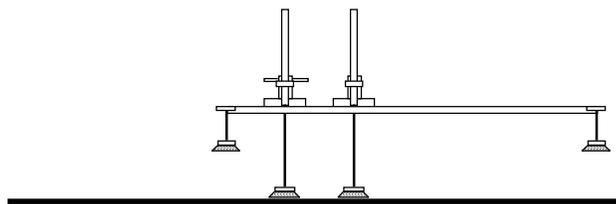
Both linear motors run simultaneously (and at an identical rate), moving the spine assembly with respect to the bridges (which are affixed to the surface). When the spine assembly has moved a preset distance, the robot will be in the configuration shown in figure 24.

FIGURE 24. WALKING MOTION: SPINE ASSEMBLY MOTION

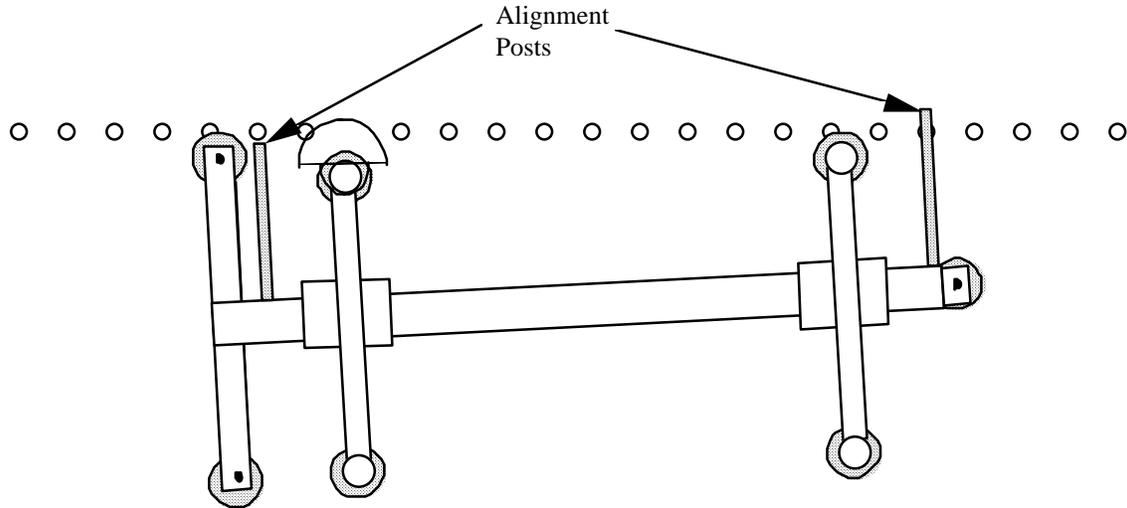
The alignment motion is used in two basic circumstances: when the operator initially affixes the robot to the aircraft surface and, if necessary, after the robot takes a step. As shown in figure 27, two interim alignment posts were attached to each end of the first-phase robot's spine. During the second phase, these posts were replaced with a pair of video cameras. When its spine is not parallel to the fastener row and the tips of the alignment posts are not in line with the rivet row, the robot needs to be aligned; this is the situation shown in figure 27.

FIGURE 27. UNALIGNED ROBOT (OVERHEAD VIEW)

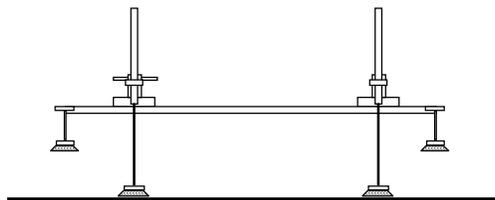
To start the alignment procedure, the lifters are extended, the suction cups on the bridges are activated, and the suction cups on the spine assembly are deactivated; these actions must be performed in this order. A profile of the robot in this position is shown in figure 29 (the lift is exaggerated for clarity).

FIGURE 29. STEP 1 OF THE ALIGNMENT PROCESS

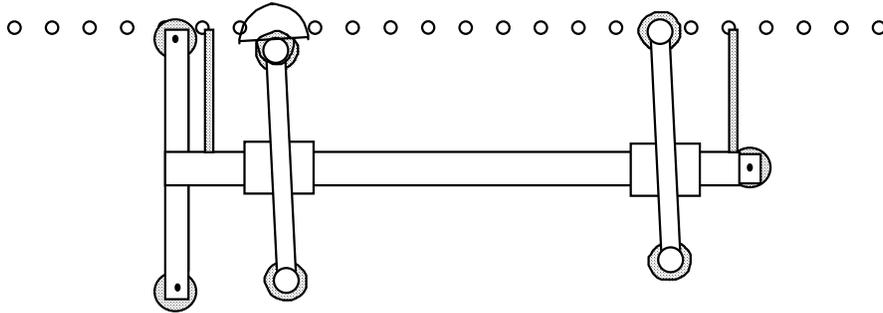
spine is parallel to the rivet row and the tips of the alignment posts are in line with the fasteners as shown in figure 30, the robot's spine is properly aligned to perform a scan.

FIGURE 30. STEP 2 OF THE ALIGNMENT PROCESS

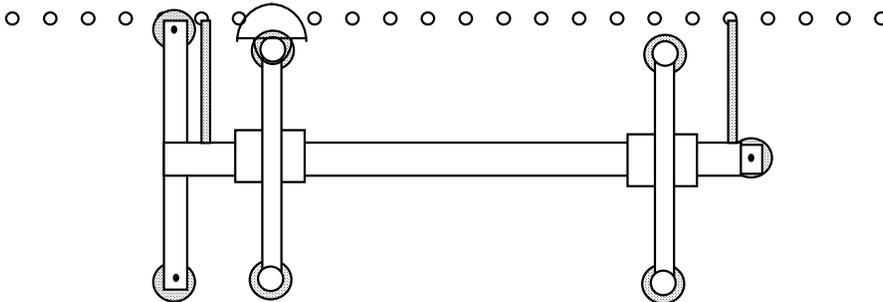
The lifters on both bridges are retracted, the suction cups on the spine assembly are activated, and the suction cups on the bridges are deactivated; as before, these actions must be performed in this order. Finally, the pivot locks on both bridges are engaged, locking the bridges into position perpendicular to the spine. The alignment has been completed and the robot is oriented as shown in figure 31. The sensor is moved to its starting position, and the robot is ready to scan a line of fasteners.

FIGURE 31. ALIGNED ROBOT (OVERHEAD VIEW)

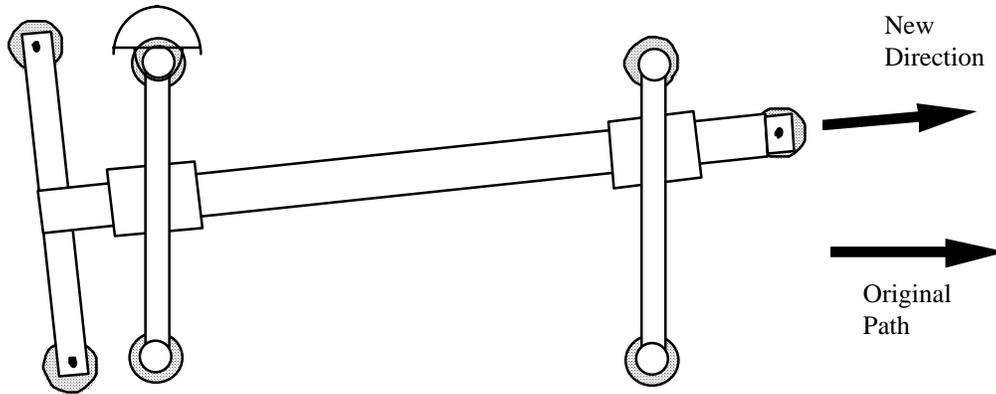
The alignment motion can also be used to provide a degree of steering for the robot. For example, if obstacles are encountered, the direction of motion can be changed. Figure 32 illustrates how the alignment motion is used to steer the robot.

FIGURE 32. ROBOT STEERING

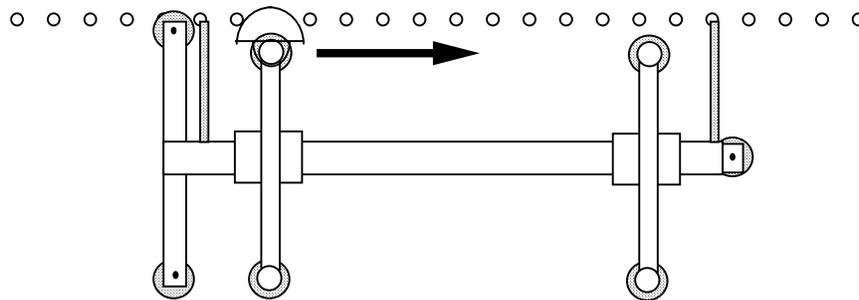
After the inspector instructs the robot to perform a scan, the robot deploys the eddy-current sensor on the surface of the aircraft; the sensor is deployed with a light constant pressure simulating that provided during manual scanning. The eddy-current system then begins acquiring data. The robot moves its sensor bridge a preset distance in the direction indicated in figure 33 until it reaches the position shown in figure 34. Acquisition of eddy-current data is then halted.

FIGURE 33. DIRECTION OF SCANNING MOTION

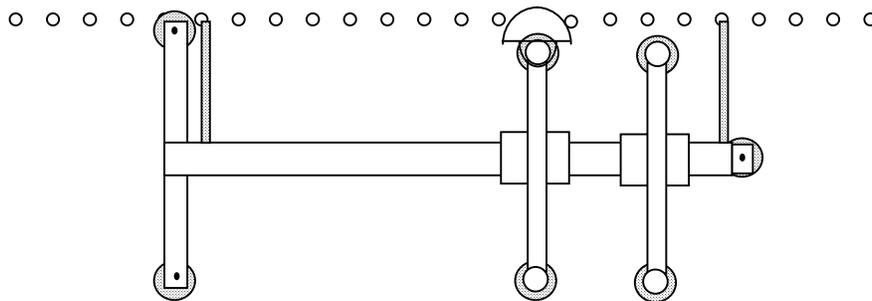
FIGURE 34. ROBOT'S CONFIGURATION AFTER SCANNING MOTION

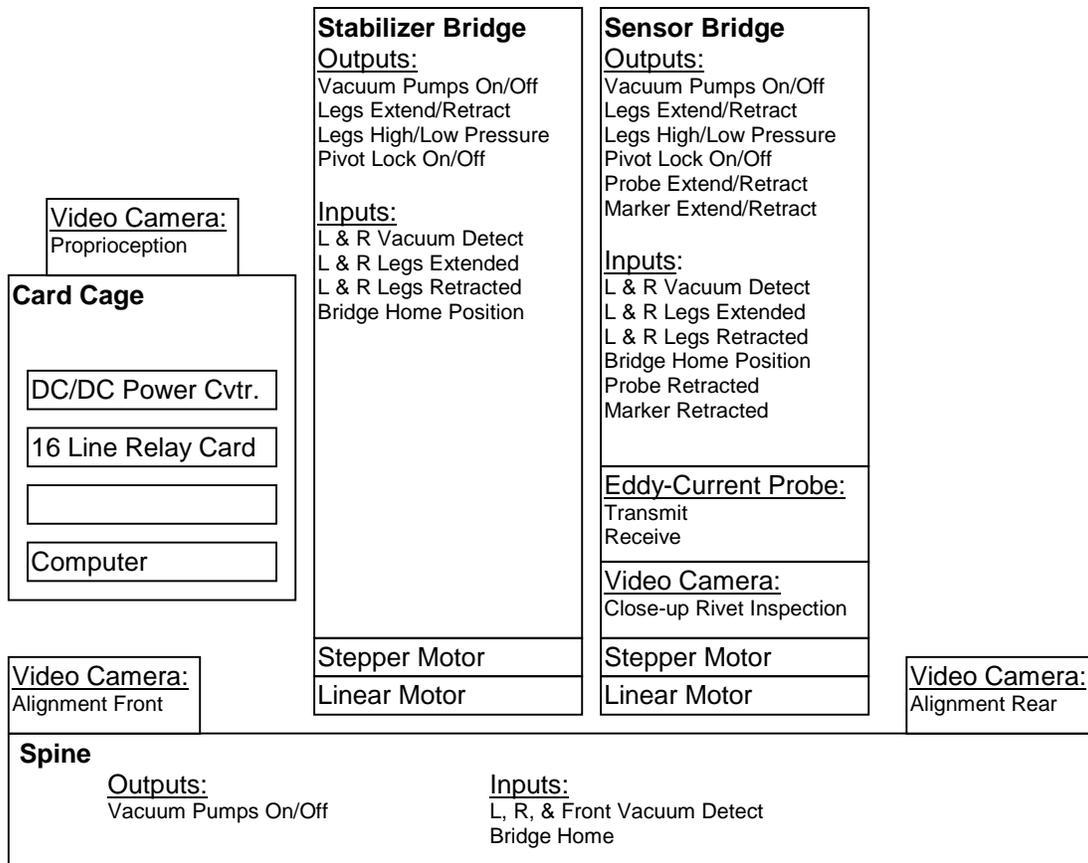
A block diagram of the electronic systems carried on board the robot is shown in figure 35. A major improvement to the second-phase robot was the addition of a dedicated computer carried on the robot. This processor manages all of the low-level robot control, feedback, and sequencing. A commercially available single-board industrial computer is used for the on-board computer. This processor card provides integrated input/output capabilities over a -40 to 85°C operating range. Mechanical limit switches and vacuum switches provide TTL level signals to the CPU card for monitoring the robot's status. A reed relay expansion card provides the 12 VDC outputs used to drive the solenoid valves for operation of the pneumatic systems. The circuit boards for the on-board computer are housed in a card cage mounted on the head end of the robot, as shown in figure 36. Commands are received, and status information is sent via an RS-232 serial communication link with the ground-based operator workstation. The eddy-current and video signals, as well as the motor drive signals, are managed directly from the ground. A DC/DC power converter is used to generate the 5 VDC power required for the computer cards from the robot's normal 12 VDC supply.

FIGURE 35. ON-BOARD COMPUTER AND ROBOT ELECTRONICS

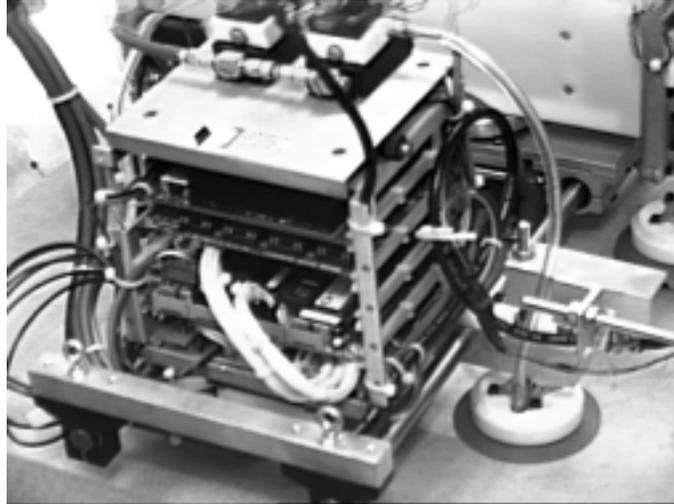
FIGURE 36. ON-BOARD PROCESSOR

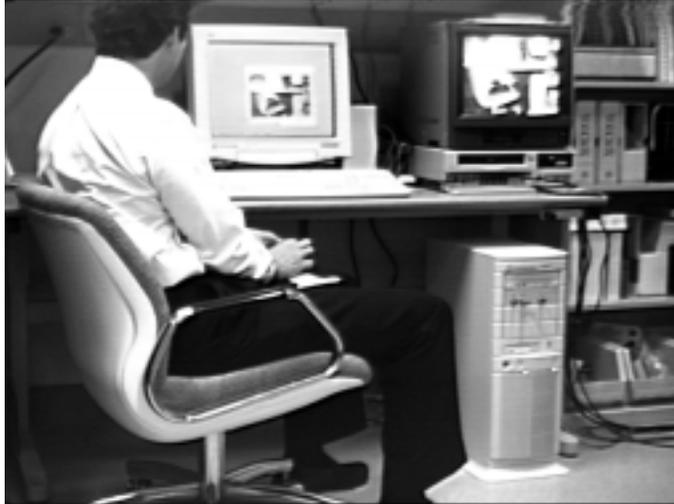
The operator workstation computer is the main control point for the robotic system. It provides the display and interface resources required by the operator to control and monitor the robot. These interfaces are described in further detail in section 5.3. All high-level robot control and coordination are performed by this machine. Communication channels are provided to the motor controllers, the on-board computer, and the video-processing computers. The eddy-current instrument is contained in and controlled by this machine. A photograph of the operator workstation is presented in figure 37.

FIGURE 37. OPERATOR WORKSTATION AND VIDEO MONITOR/RECORDER

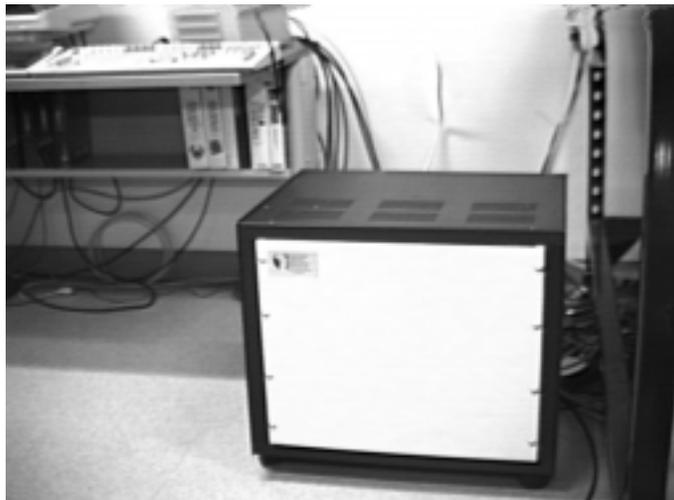
All electrical lines between the robot and the ground terminate at this enclosure. Communication and eddy-current signal lines are then routed to the operator workstation, while video lines go to the video processor. A photograph of the satellite equipment enclosure is presented in figure 38.

FIGURE 38. SATELLITE EQUIPMENT ENCLOSURE

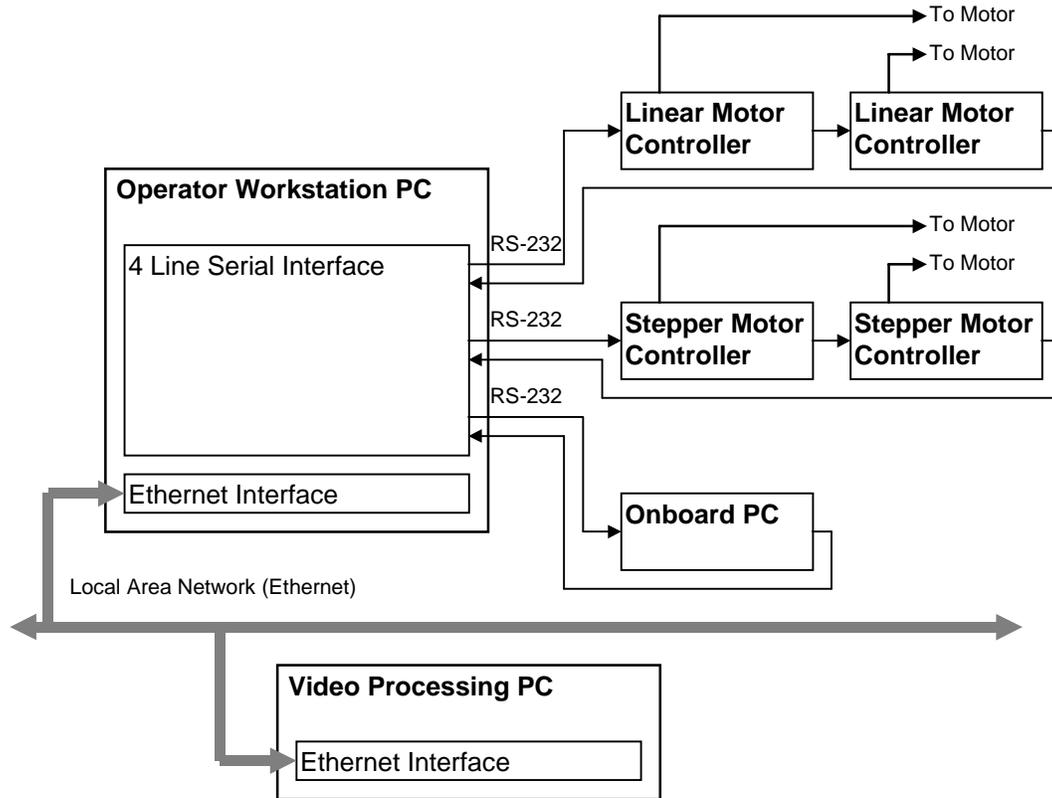
RS-422 and optical isolation will be used in the hangar to support longer line lengths and to provide greater noise immunity. A four-line serial interface is used to provide the additional communication lines from the PC. Software drivers enable these additional lines to be accessed in the same manner as standard PC communication (com) ports. The original 16450 UART ICs on the communication board were replaced with 16550 UARTs (with on chip character buffers) to provide more reliable high-speed serial communication links in the multitasking environment.

FIGURE 39. COMMUNICATIONS SUBSYSTEM
