DOT/FAA/AR-97/69

Automated Inspection of Aircraft

Final Report

This report describes the multiphase design and development of a prototype robot (the Automated Nondestructive Inspector or ANDI) capable of walking on an aircraft fuselage and, using an eddy-current probe, inspecting the skin for cracks and corrosion.

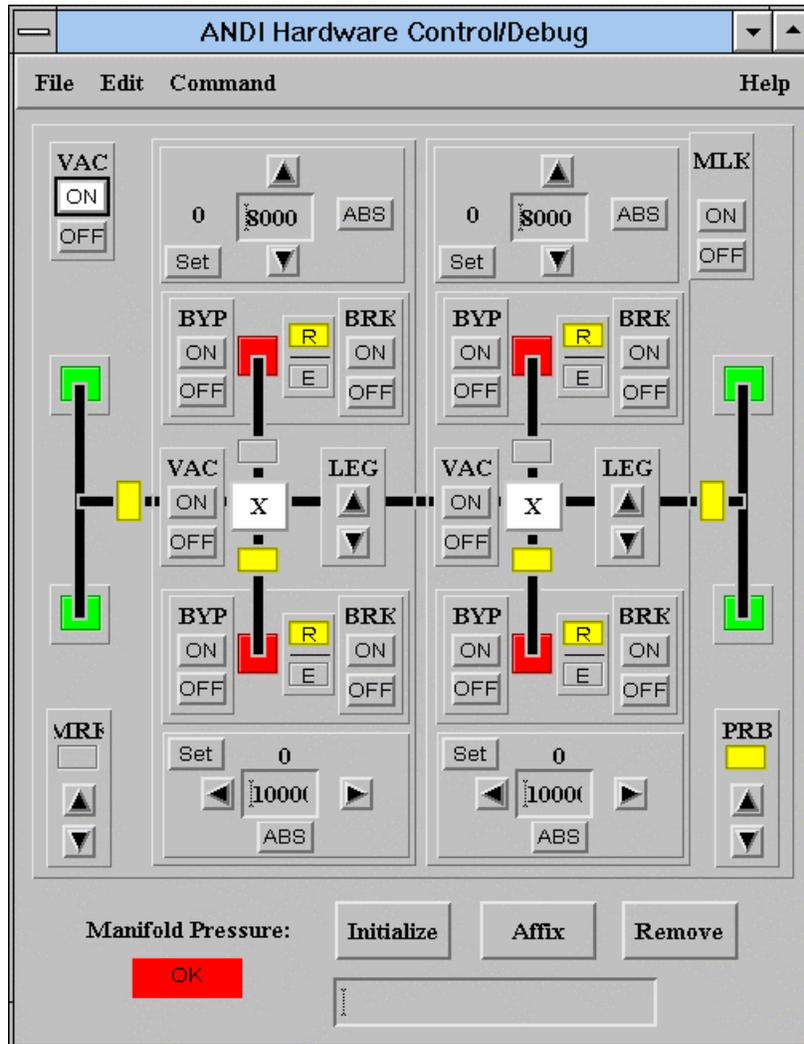
- control points (On=White, Off=Gray)
- limit switches (On=Yellow, Off=Gray)
- suction cups (Vacuum=Green, Ambient pressure=Red)

FIGURE 40. ROBOT CONTROL INTERFACE

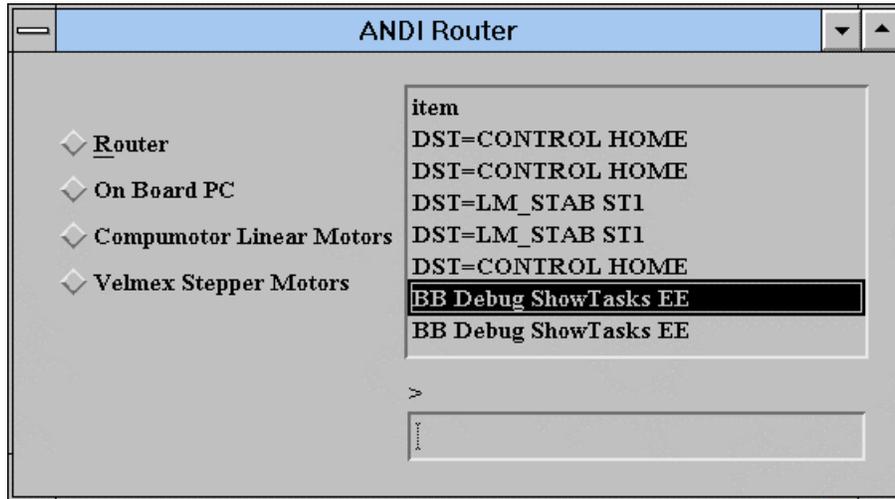
Output transitions, text messages generated by tasks, and text responses to debugging commands are also displayed here.

FIGURE 41. COMMAND INTERFACE

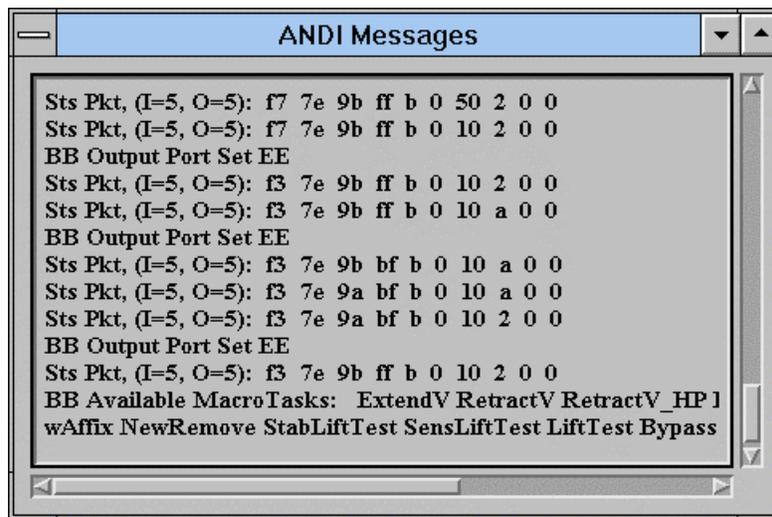
FIGURE 42. COMMUNICATION DISPLAY

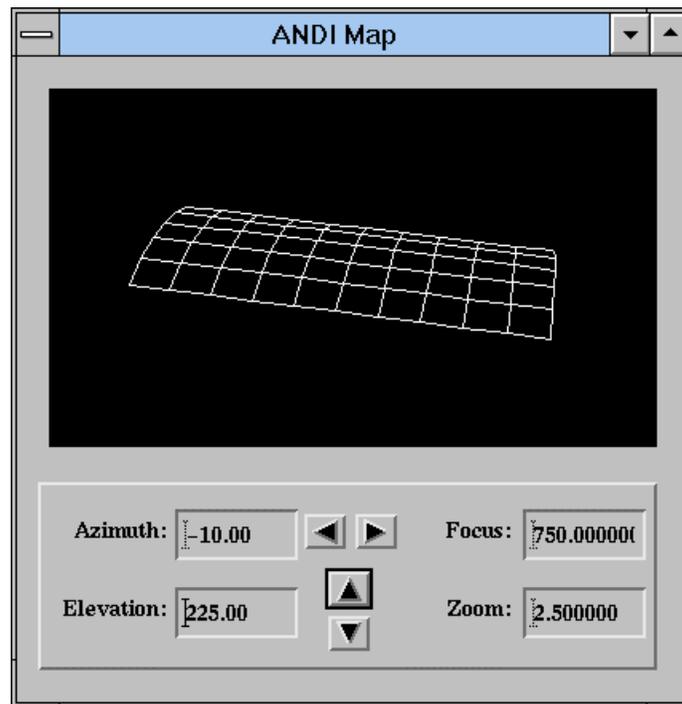
The operator has the ability to import various map data files into the viewport and select the point of view. Rivet lines are indicated in a contrasting color. In the envisioned system, the operator would be able to define, via an input device such as a mouse, the robot path by selecting appropriate lines of rivets for inspection. Areas that are selected for inspection or have been inspected or where anomalies have been found may all be indicated through the color used to display the segment. It is also possible to overlay an image of the robot on this display to monitor the position and configuration of the robot on the aircraft being inspected.

FIGURE 43. AIRCRAFT MAP DISPLAY (FOSTER-MILLER PANEL)

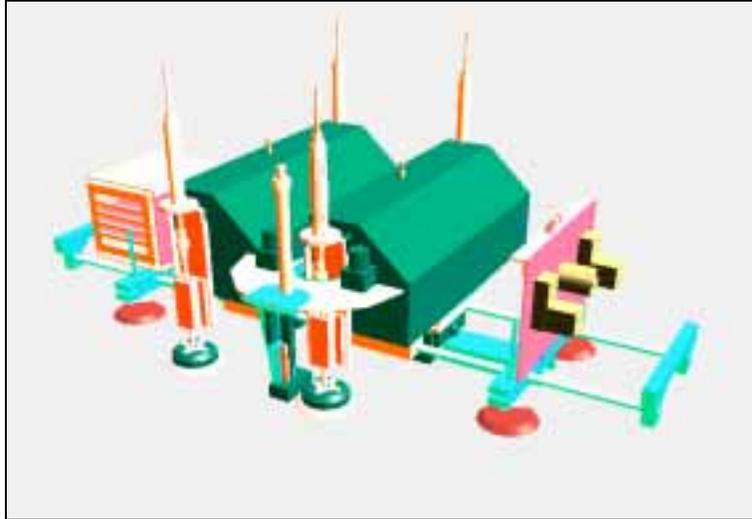
Components of the robot rendering software were rewritten during the third phase of effort to allow them to execute on the operator workstation computer. A view of the three-dimensional rendering of the robot is presented in figure 44. By coupling this display capability to the robot control system and the map of the aircraft, a virtual inspection environment that would be much more realistic than the wire-frame display shown in figure 43 could be presented to the operator.

FIGURE 44. THREE-DIMENSIONAL RENDERING OF THE ROBOT

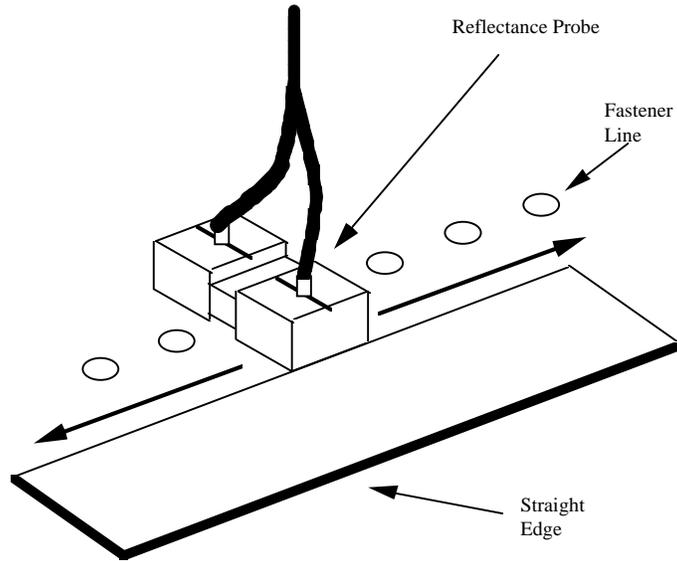
holes and those with cracks are noted. Because of its universal acceptance, the reflectance probe is a good choice to be included in the robotic system.

FIGURE 45. REFLECTANCE EDDY-CURRENT SENSOR

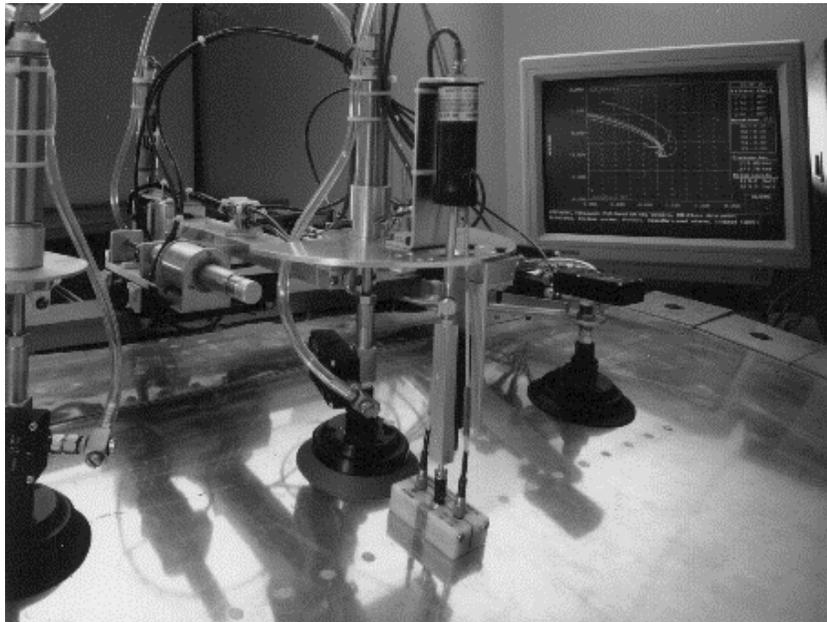
The Nortec SPO-1958 eddy-current sensor is the reflectance-type sensor chosen for the robotic system. This probe can operate at frequencies between 100 Hz and 40 kHz, allowing for both subsurface crack detection at low frequencies and surface crack detection at high frequencies. At its lowest frequencies, the SPO-1958 produces eddy-currents that have a working depth of 0.50 inch (13 mm). A photograph of the first-phase robot deploying the eddy-current sensor on the simulated aircraft panel is shown in figure 46.

FIGURE 46. EDDY-CURRENT SENSOR DEPLOYED BY FIRST-PHASE ROBOT

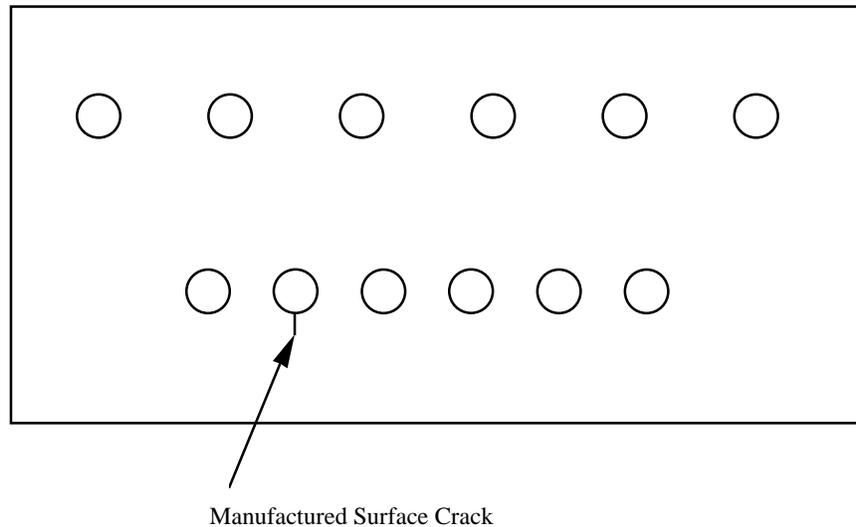
The method of calibrating the eddy-current sensor of the robotic system was based upon the accepted methods of calibrating eddy-current sensors for manual inspections. Those methods require eddy-current sensors to be initially deployed on a calibration standard before they are deployed on an aircraft. A calibration standard contains both areas without flaws which result in a consistent trace on eddy-current instruments and areas containing flaws which result in traces that differ from those produced by the flaw-free areas. A standard is shown in figures 47 and 48, depicting the front and back of the standard, respectively. The front of the standard represents the outside skin which is normally accessible to inspectors while the back represents the substructure which is normally inaccessible to inspectors.

FIGURE 47. CALIBRATION STANDARD (FRONT)

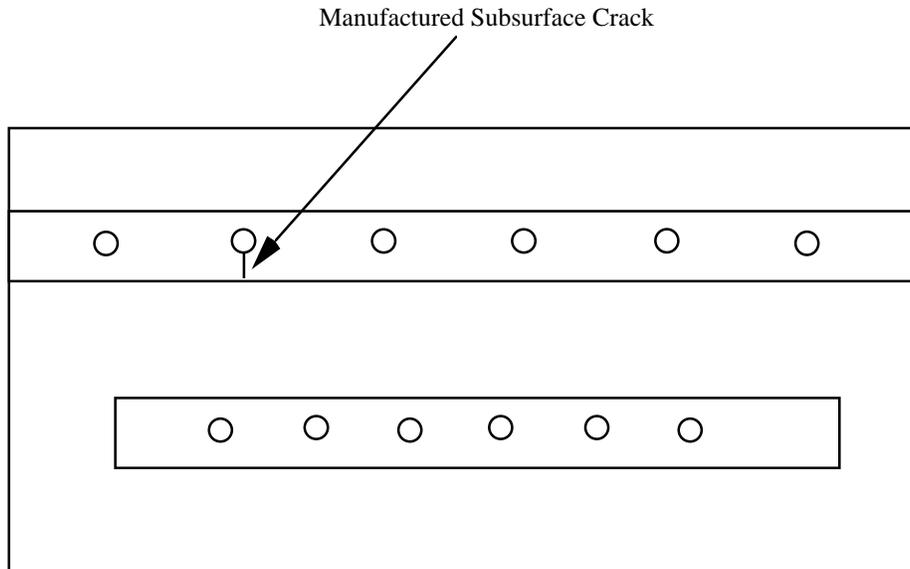
eddy-current sensor on the simulated aircraft panel, the sensor is first deployed on a calibration standard. To keep the automated inspection system consistent with airline procedures, the inspection frequencies and calibration standards used in manual inspection procedures were also used by the robot.

FIGURE 48. CALIBRATION STANDARD (BACK)

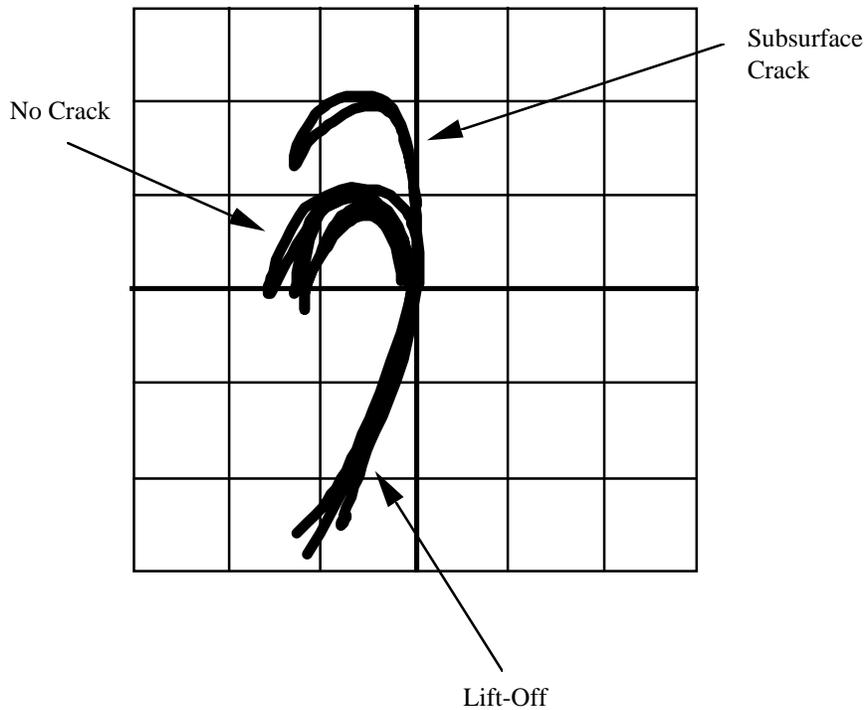
FIGURE 49. EDDY-CURRENT INSTRUMENT DISPLAY FOR SUBSURFACE CRACK

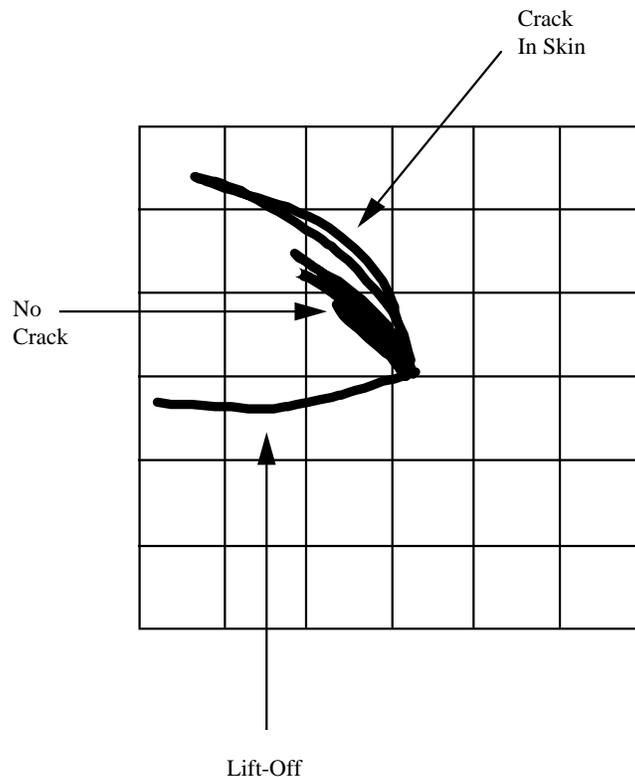
Similarly, the high-frequency setting is calibrated when the robot deploys the sensor and scans the bottom row of rivets in the standard. The system parameters for the high-frequency calibration are set such that the eddy-current instrument display resembles figure 50.

FIGURE 50. EDDY-CURRENT INSTRUMENT DISPLAY FOR SURFACE CRACK

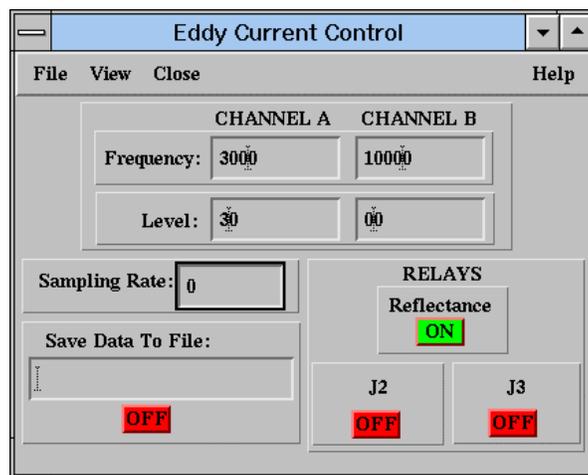
The eddy-current control interface is used by the operator to set the inspection parameters of the eddy-current instrument, as well as to display the acquired data. The inspection parameters that can be set in the eddy-current control screen in figure 51 include the A and B channel oscillator frequencies and levels, the reflectance or impedance inspection mode via the signal selection relays, and the data sampling rate. Although the instrument supports impedance mode operation, reflectance mode was required for the sample inspection tasks that were chosen for this project.

FIGURE 51. EDDY-CURRENT INSTRUMENT INTERFACE

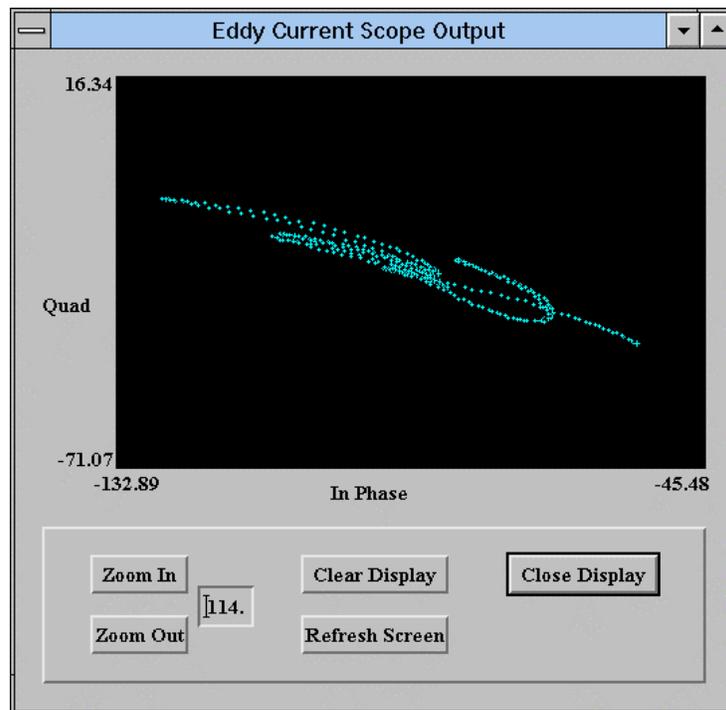
FIGURE 53. EDDY-CURRENT IMPEDANCE PLANE DISPLAY

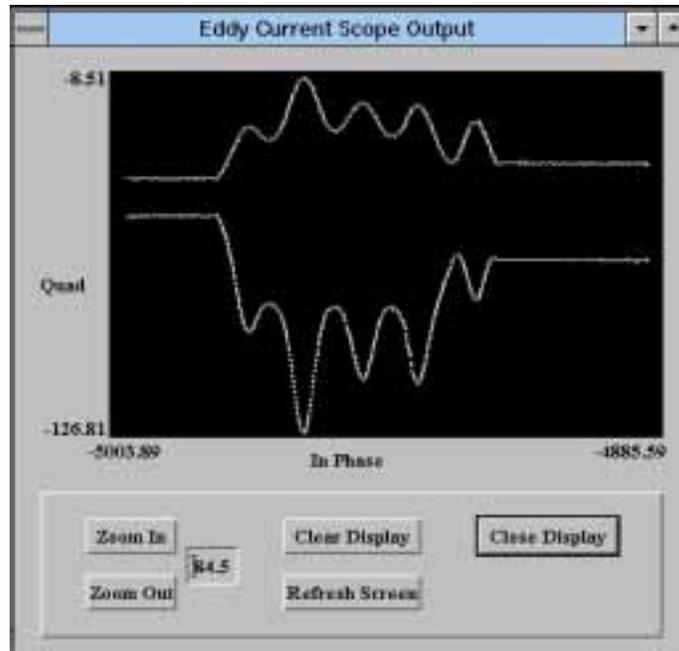
FIGURE 54. EDDY-CURRENT IN-PHASE/QUADRATURE VERSUS TIME DISPLAY

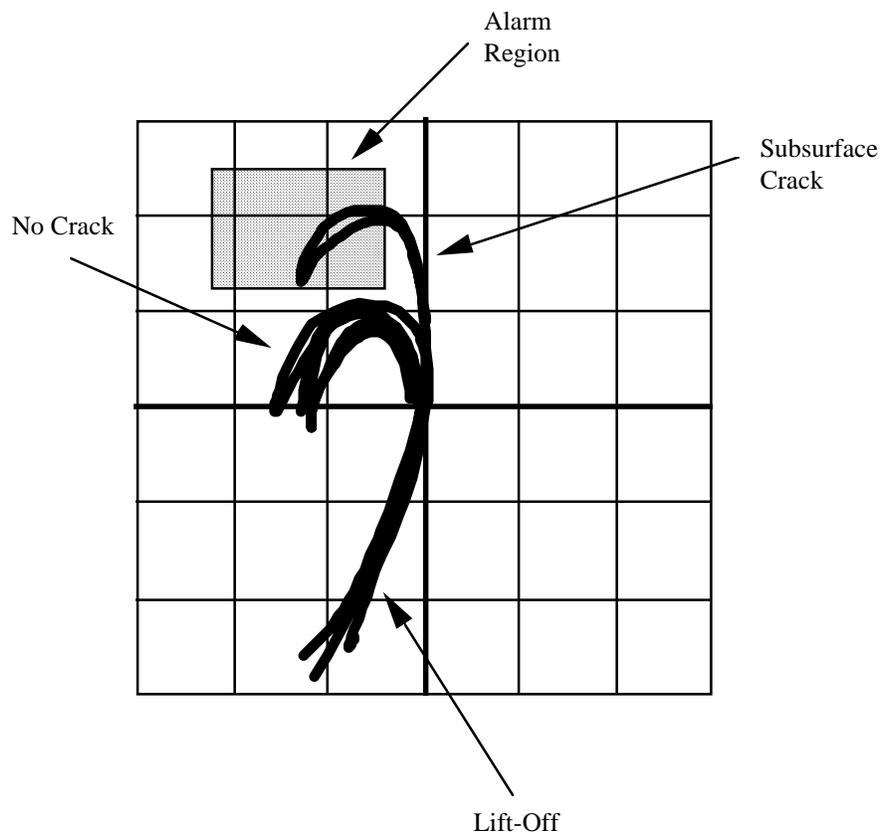
FIGURE 55. ALARM REGION ON AN IMPEDANCE-PLANE DISPLAY

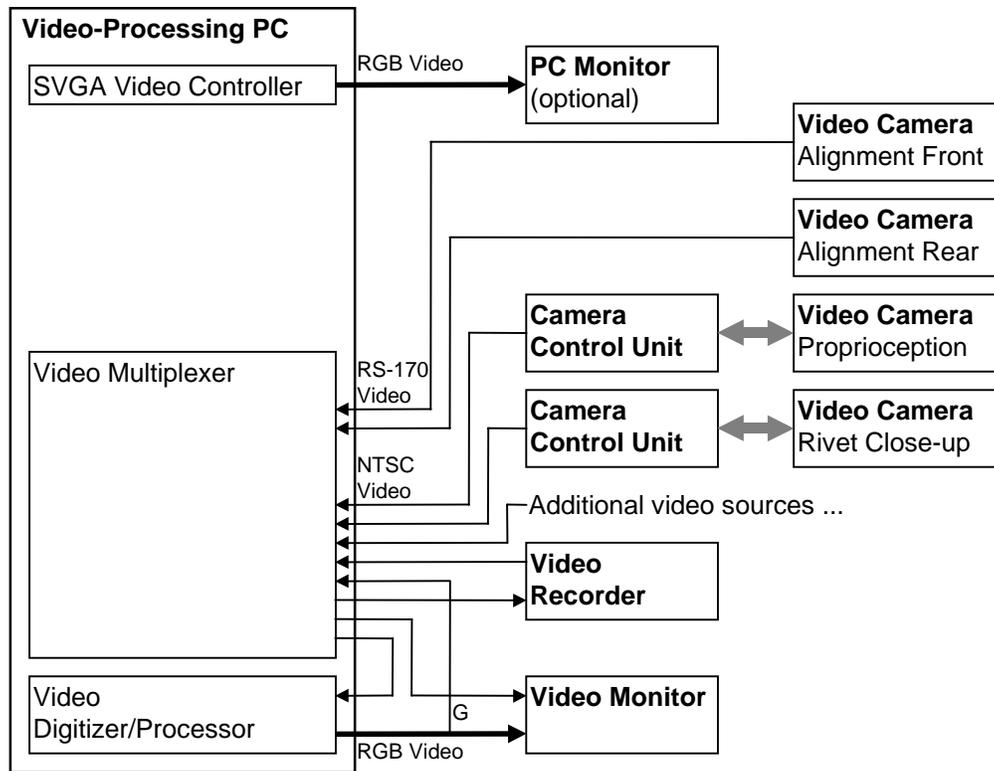
FIGURE 56. VIDEO SUBSYSTEM

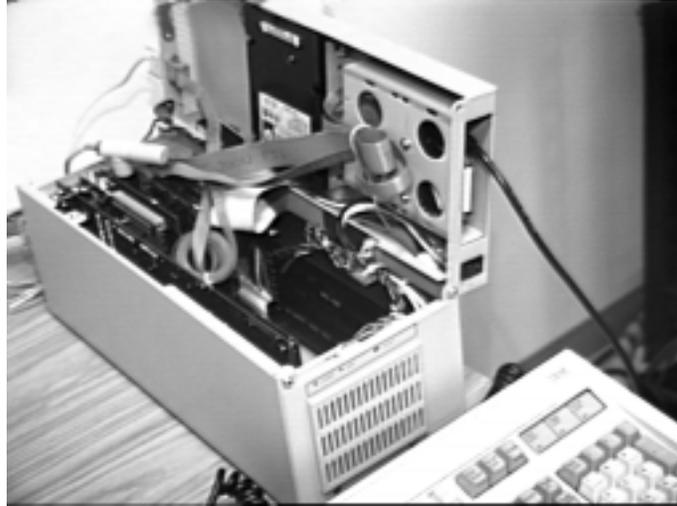
FIGURE 57. VIDEO-PROCESSING COMPUTER

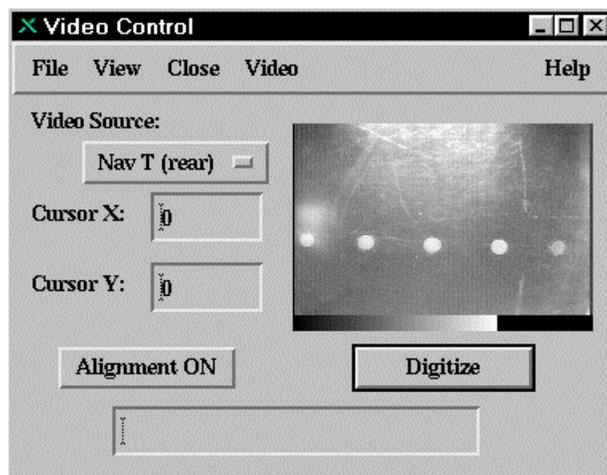
FIGURE 58. VIDEO CONTROL INTERFACE

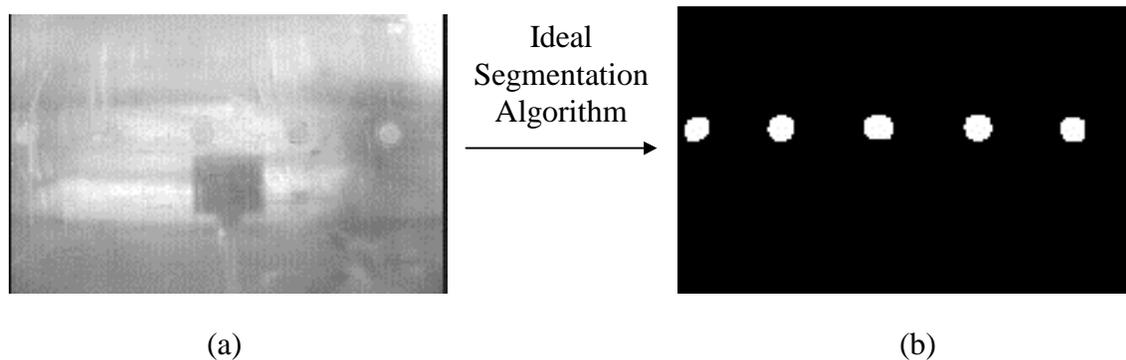
FIGURE 62. (a) AN IMAGE FROM A NAVIGATIONAL CAMERA, (b) AN IDEAL SEGMENTATION

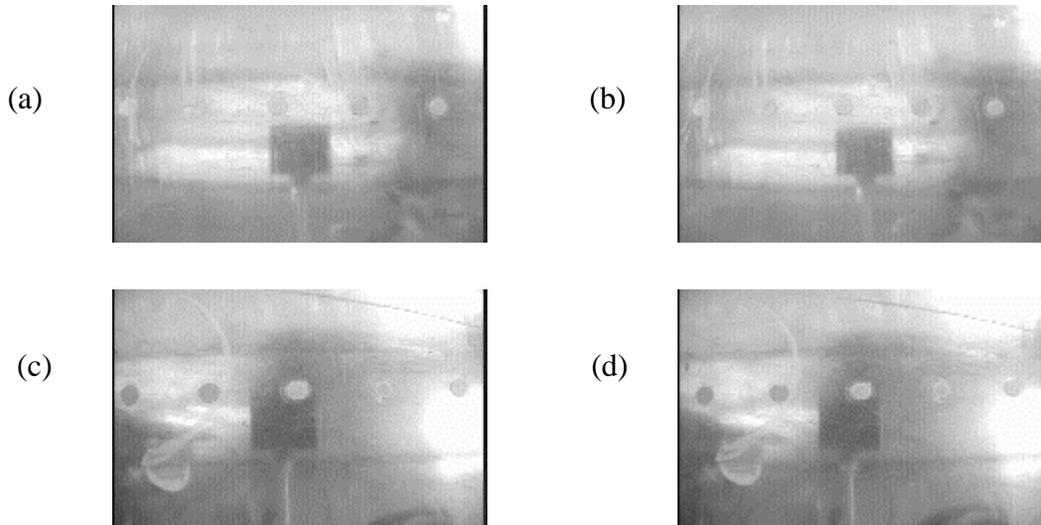
FIGURE 63. EXAMPLES OF IMAGES FROM (a) HEAD CAMERA, LEGS RETRACTED;
(b) HEAD CAMERA, LEGS EXTENDED; (c) TAIL CAMERA, LEGS RETRACTED; (d)
TAIL CAMERA, LEGS EXTENDED

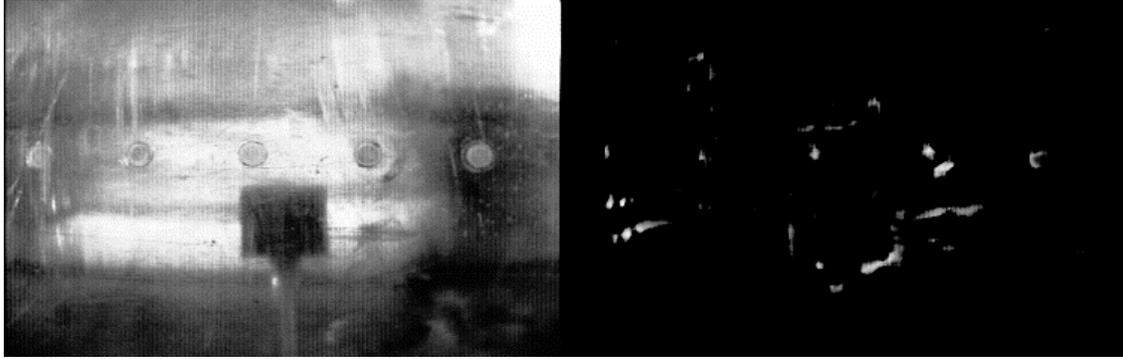
FIGURE 67. LEFT: REDUCED-BY-2 IMAGE, ENHANCED BY HISTOGRAM EQUALIZATION, RIGHT: NN SEGMENTED OUTPUT

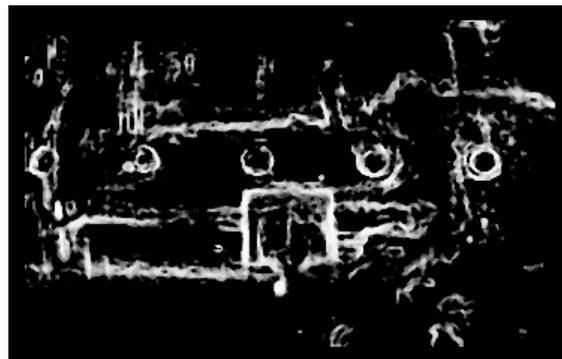
FIGURE 68. EFFECT OF IMAGE ENHANCEMENT ON GRAY SCALE CAMERA IMAGE

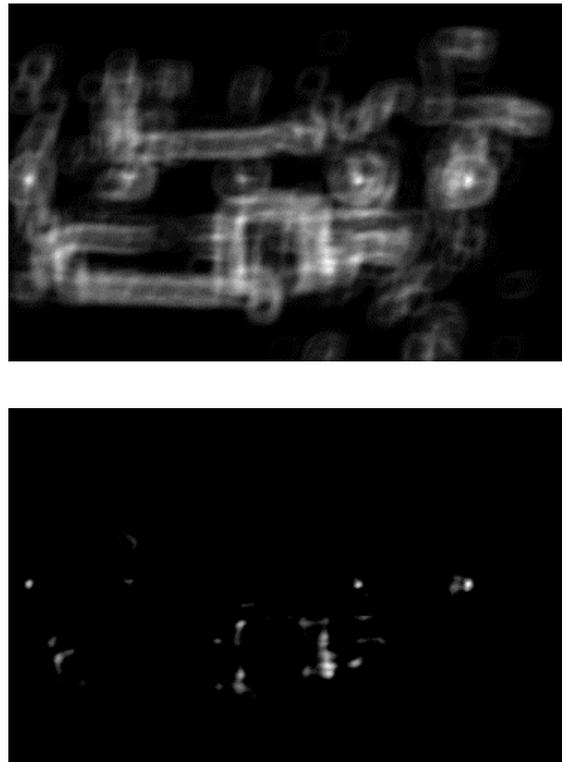
FIGURE 70. (TOP) MATCHED FILTER OUTPUT, (BOTTOM) AFTER THRESHOLD

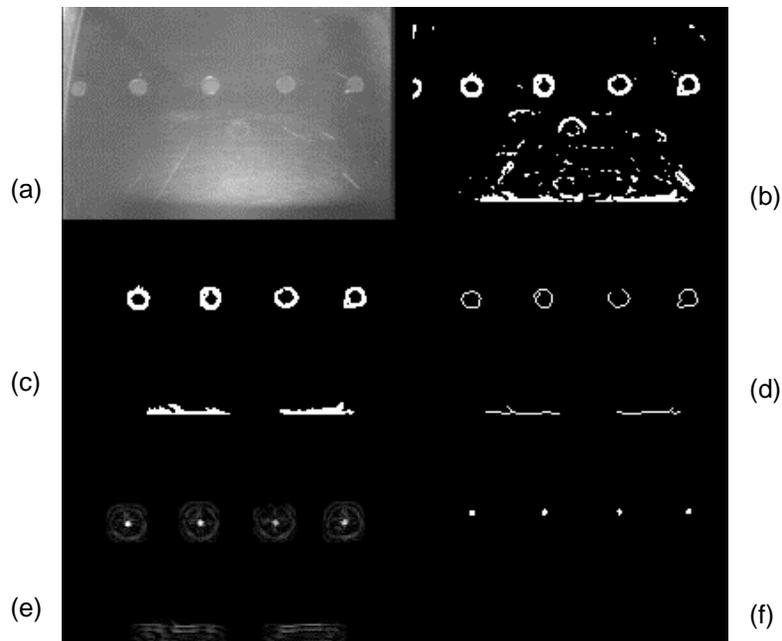
FIGURE 71. SEGMENTATION OF IMAGE TAKEN FROM FOSTER-MILLER PANEL USING CAMERA HOOD AND LIGHT SOURCE
