**USE OF ADDITIONAL LIGHTING
FOR TRAFFIC CONTROL AND
SPEED REDUCTION IN WORK
ZONES**

Final Report

SPR 791

Oregon Department of Transportation

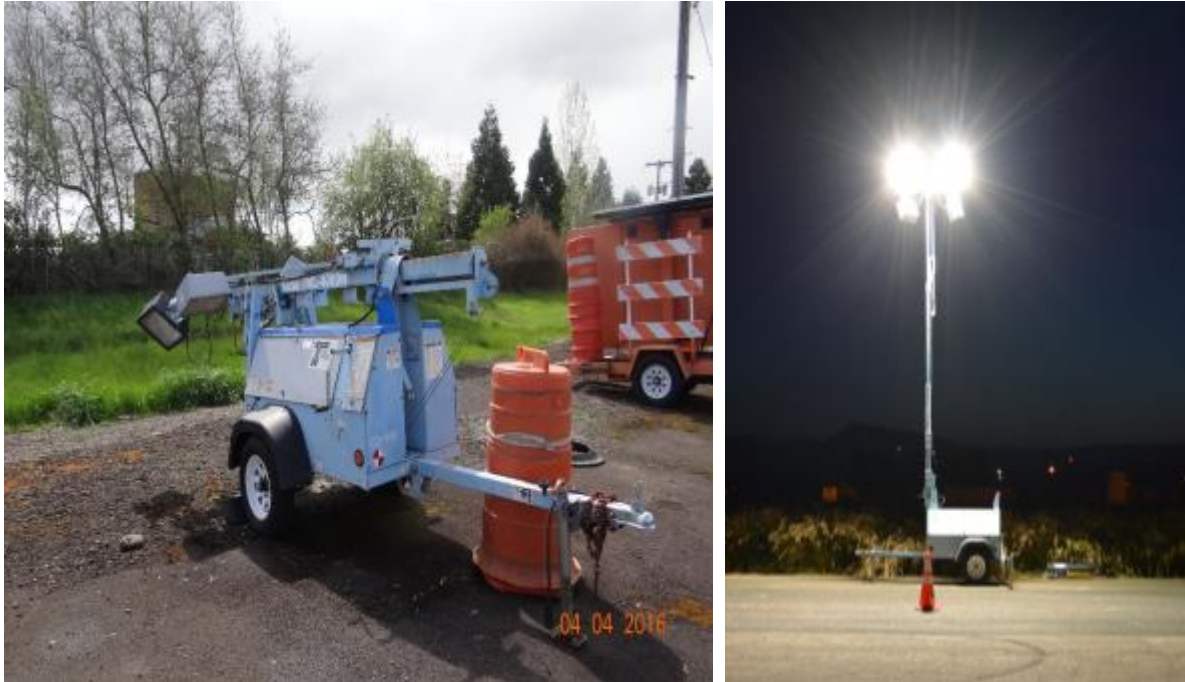
Portable light towers, also referred to as light plants, consist of numerous luminaires (typically two to six light fixtures) mounted to a mast arm that is capable of holding the luminaires at various mounting heights. The mast arm is attached to a trailer with a generator that can be towed by a vehicle (Figure 2.1). The light fixtures are typically outfitted with 1,000 or 1,500 watt metal halide bulbs. If the number of watts is increased, the area illuminated also increases. The bulbs are not limited to metal halide and some light towers have the option of using high pressure sodium or tungsten halogen lights.

Figure 2.1: Portable Trailer-mounted Light Tower with Mast Lowered and Mast Raised

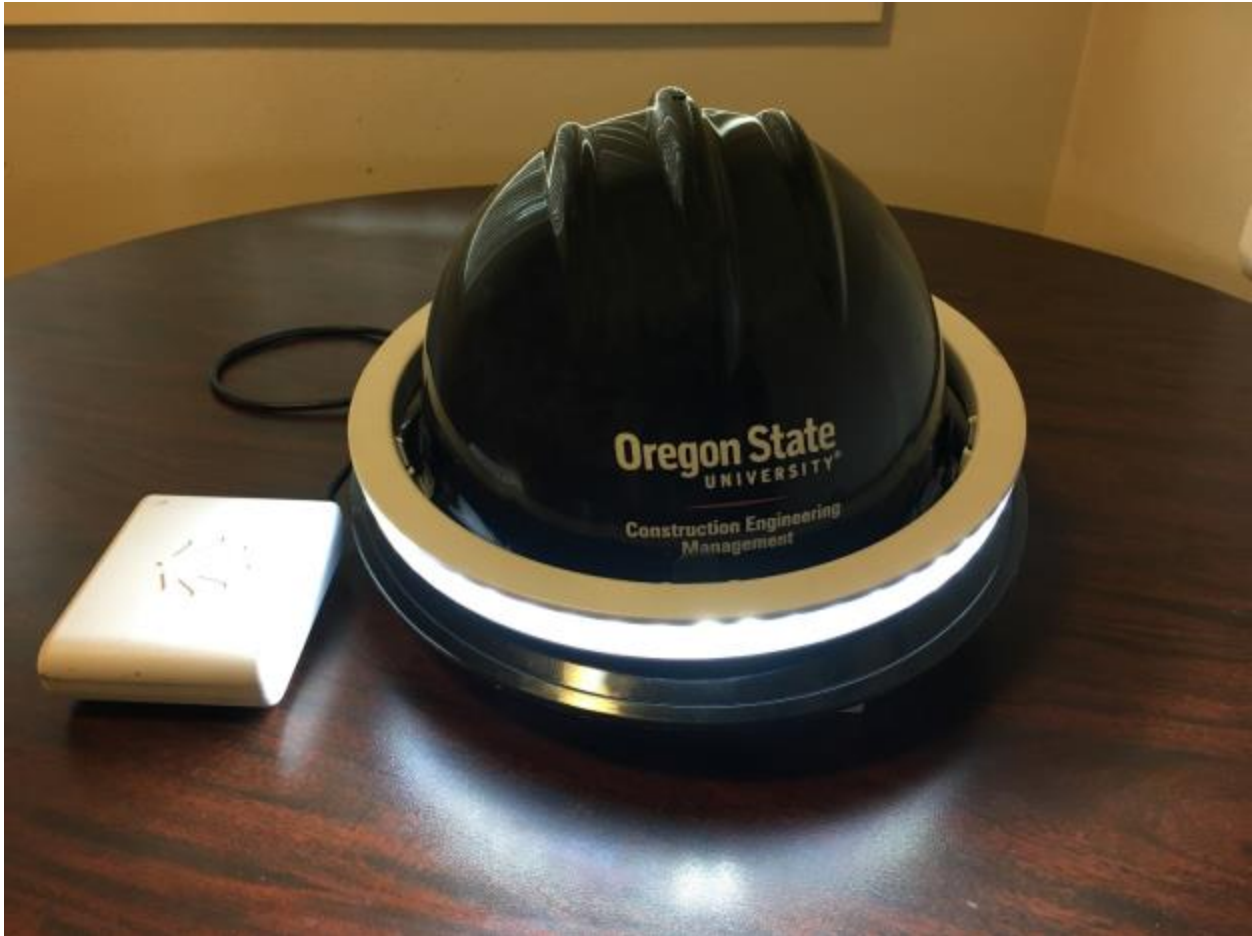
Some workers may choose to wear personal lighting (“wearables”) while performing their work. Personal lighting devices are small, wearable lights that provide lighting to illuminate the work area and work task, and for illuminating the worker to improve visibility of the worker by others. The lights may be different colors, and are typically worn on the worker’s arm, hardhat, or vest. The Halo Light™ by Illumagear is an example of a light that is attached to a hardhat (Figure 2.5).

Figure 2.5: Halo Light™ by Illumagear (<https://illumagear.com/safety-products/the-halo-light>)

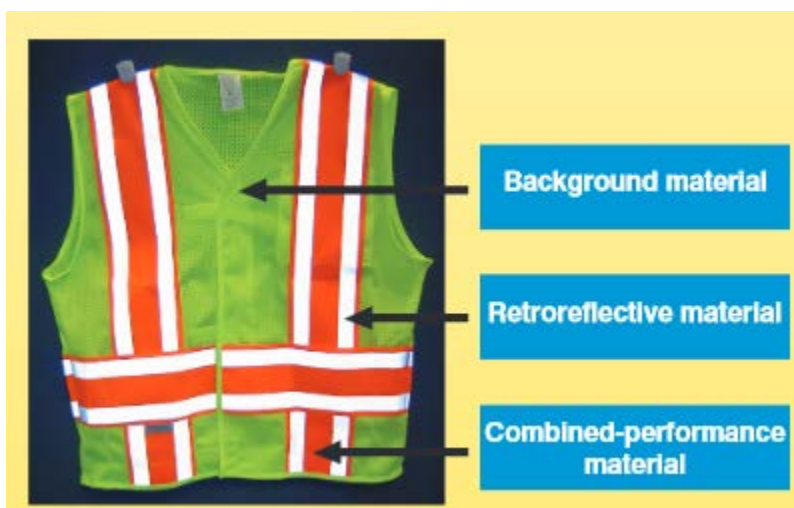
These safety garments consist of background material, retroreflective material, and combined-performance material. The background of the apparel is a colored fluorescent material intended to be highly visible. The retroreflective material consists of a material that reflects and returns the light back in a direction close to the direction from which it came. The combined-performance material is a combination of retroreflective and fluorescent material that can be counted towards the minimum area requirements for background material (see Figure 2.6). Each of the apparel classes is described in further detail below.

Figure 2.6: High Visibility Apparel (ATSSA, 2009)

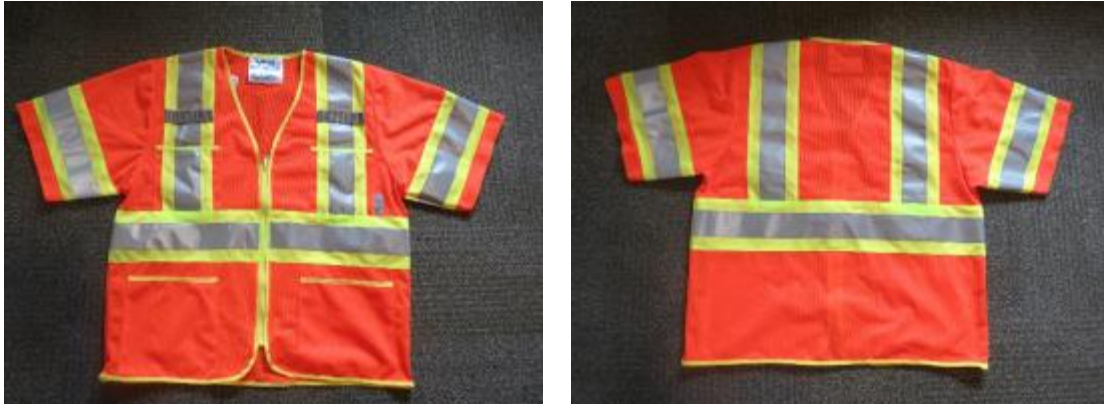
Class 3 garments are worn by workers exposed to high speed traffic and/or conditions where visibility of workers may be reduced, and for conditions where equipment operators perform tasks near pedestrian workers. These garments are needed when workers must be conspicuous through a full range of body motions at a minimum distance of 1,280 feet and identifiable as a person. Examples of such uses include: flaggers, roadway construction workers, utility workers, survey crews, and emergency responders. Figures 2.9 and 2.10 show examples of Class 3 high visibility vests.

Figure 2.9: Class 3 High Visibility Vests

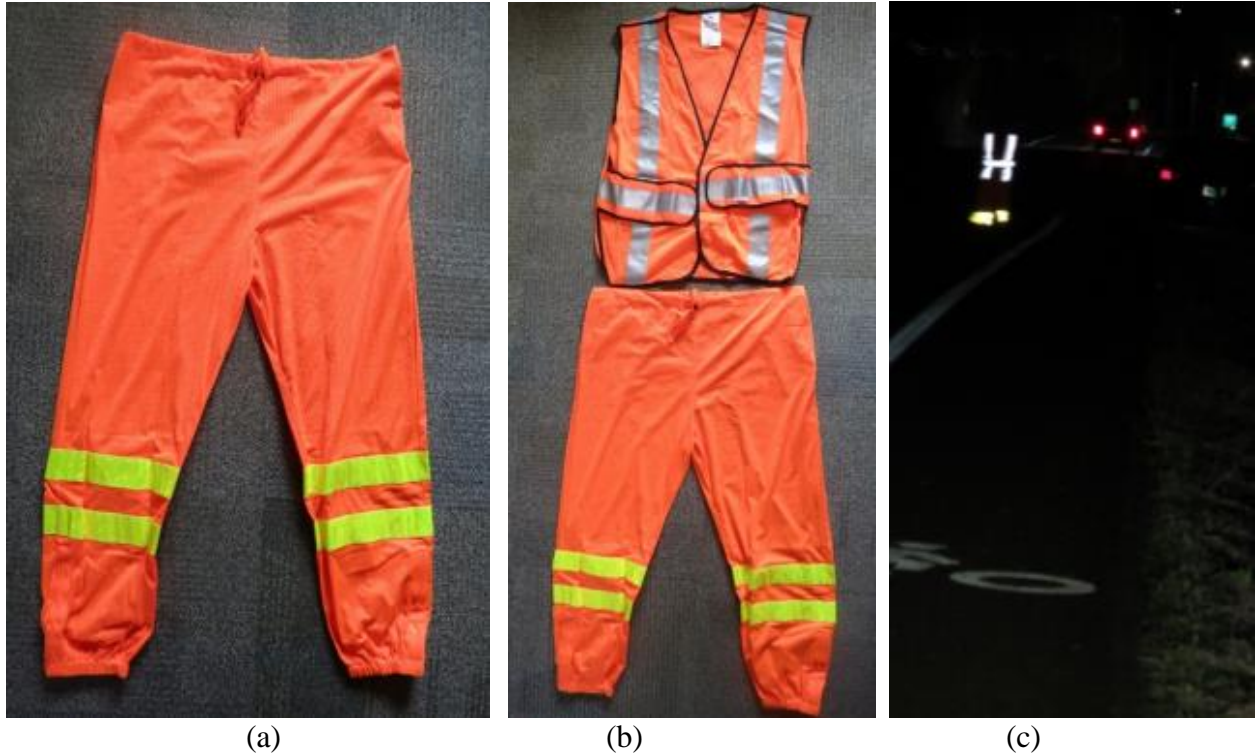
Class E garments consist of the combination of a Class 2 or Class 3 vest with Class E pants or shorts. This combination creates a Performance Class 3 ensemble. The MUTCD recommends Performance Class 3 apparel for nighttime flagging even though illumination of the flagging station is required for night time work.

Figure 2.11: (a) Class E Pants; (b) Class 3 High Visibility Apparel (combination of Class 2 and Class E); and (c) Class 3 High Visibility Apparel as Seen at Night from 500 feet (camera zoomed to show it better)

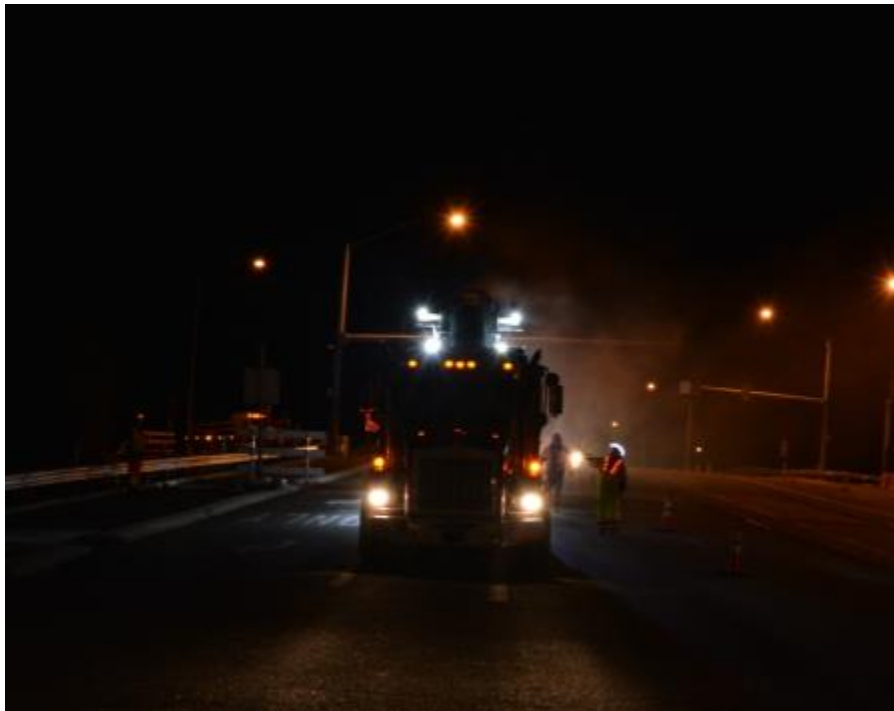
A spotter was present who controlled backing up of equipment during the operation. The spotter wore a yellow Class 3 vest and Class E pants, and used a Halo light around his hard hat. The spotter also wore a red LED flashing vest. Figure 5.2 shows the spotter working near the grinder and dump truck while wearing the high visibility apparel with the red LED flashing vest.

Figure 5.2: Spotter Working around Grinder and Dump Truck with Halo Light on Hard Hat and Flashing LED Vest

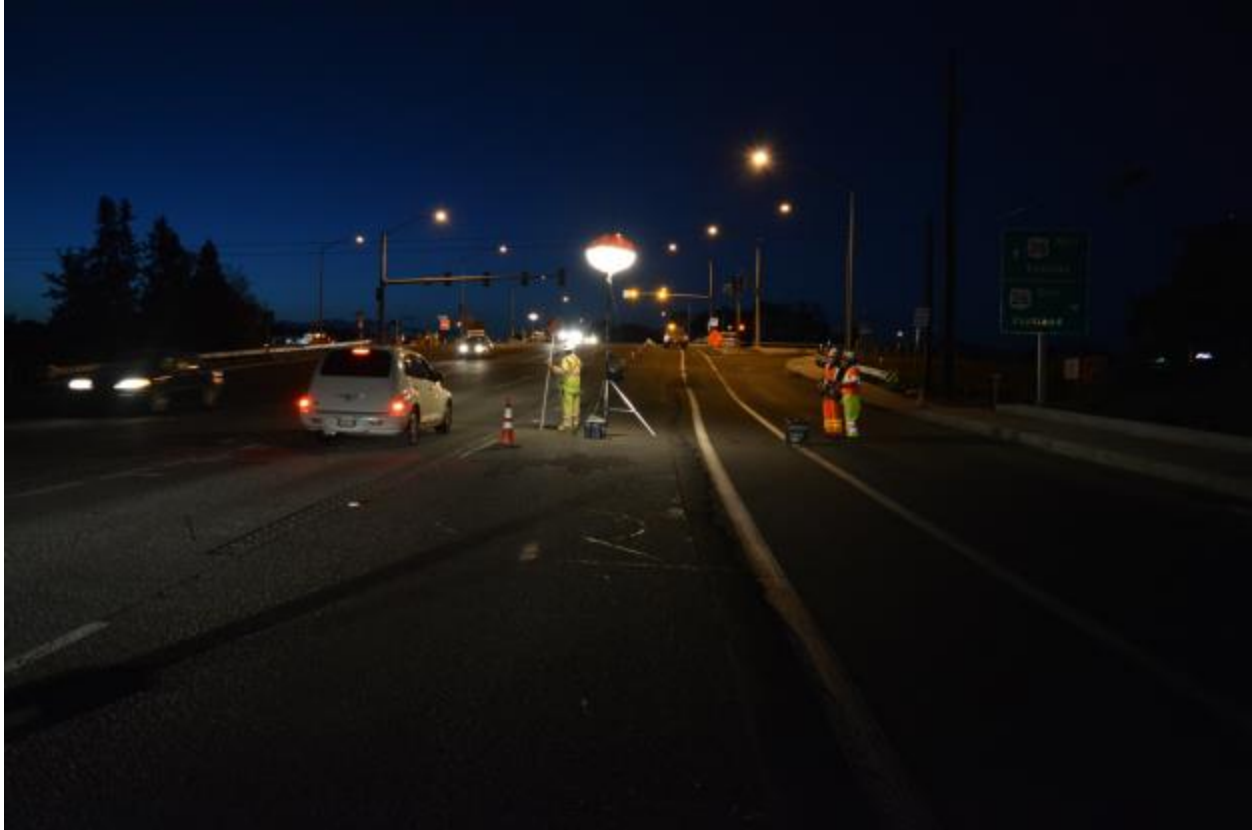
Using portable lights with a suitable height for the flaggers when they wear Class 3 vest and pants makes the flaggers highly visible for the drivers. Also, having additional personal protective equipment such as a Halo light around their hard hat and a flashing wand or flashlight could increase the safety of workers through better recognition during nighttime operations. When the spotter is located around the grinder (within 10 feet), there is enough light to highlight the spotter both for construction equipment operators and passing motorists. However, beyond that immediate area, in the case where no other permanent or portable lights are present, there is no light to illuminate the spotter. In that situation, high visibility apparel and personal protective equipment are two measures which help drivers to recognize the workers.

Figure 5.4: Flagger under Portable Balloon Light and Researchers within approximately 15 feet Distance from the Light

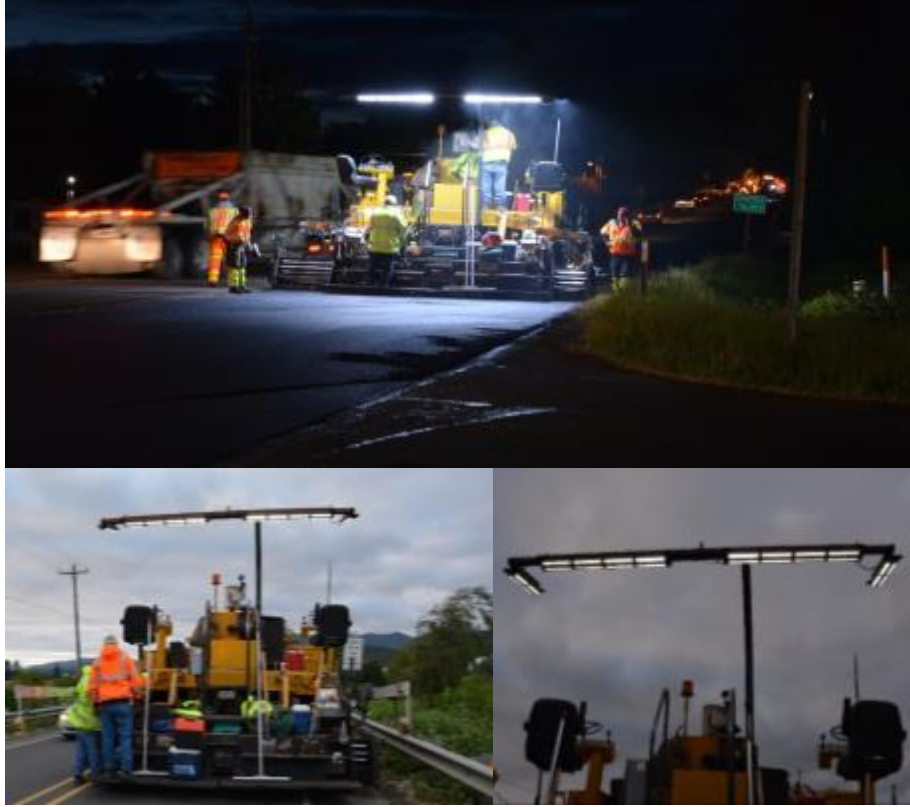
Figure 5.9: Paver with LED Lights

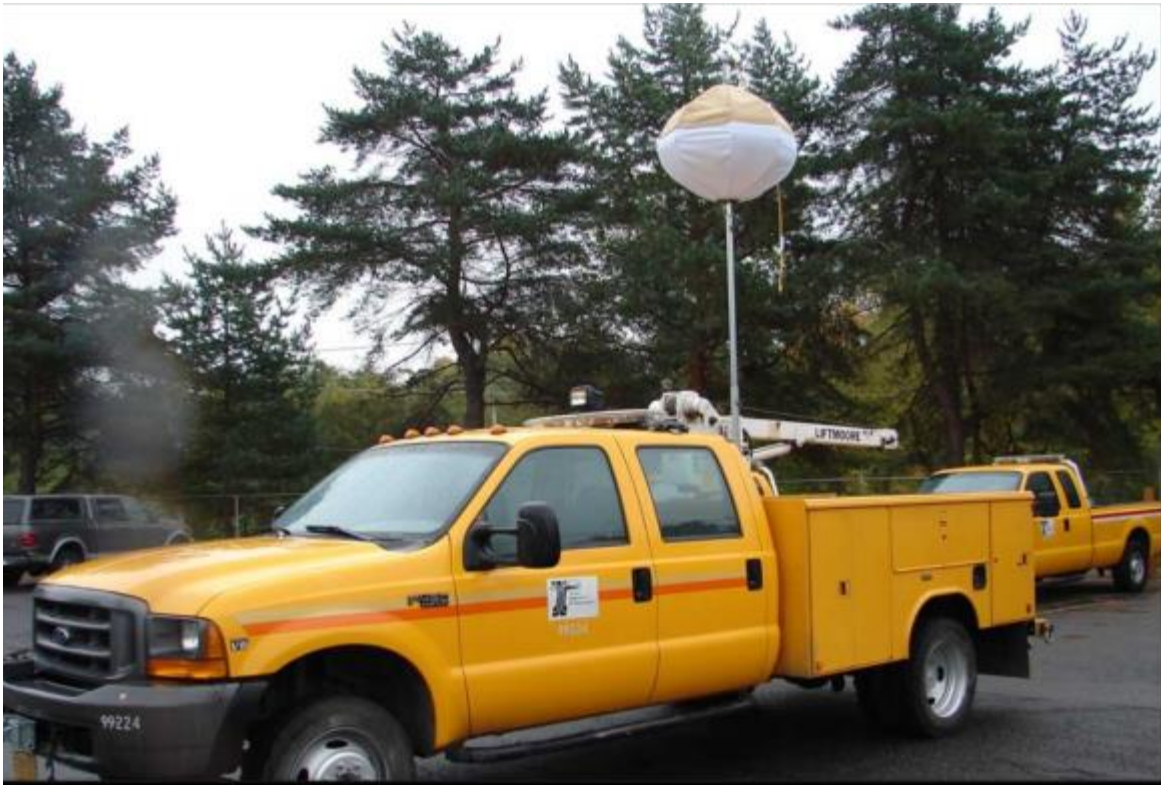
in addition to Class 3 vest and pants would help to increase the visibility of the density technicians to passing motorists. A personal, wearable light can also help provide better visibility of the work operation for the worker. Another option for providing density technicians more light is to add an additional light on top of their trucks. The light could be attached to the hitch at the rear of the truck. However, for a density technician, because he/she needs to frequently access the equipment through the tailgate of the truck, the light may be better located immediately behind the truck cab (Figure 5.11).

Figure 5.11: Example of Balloon Light Mounting for Density Technician Truck

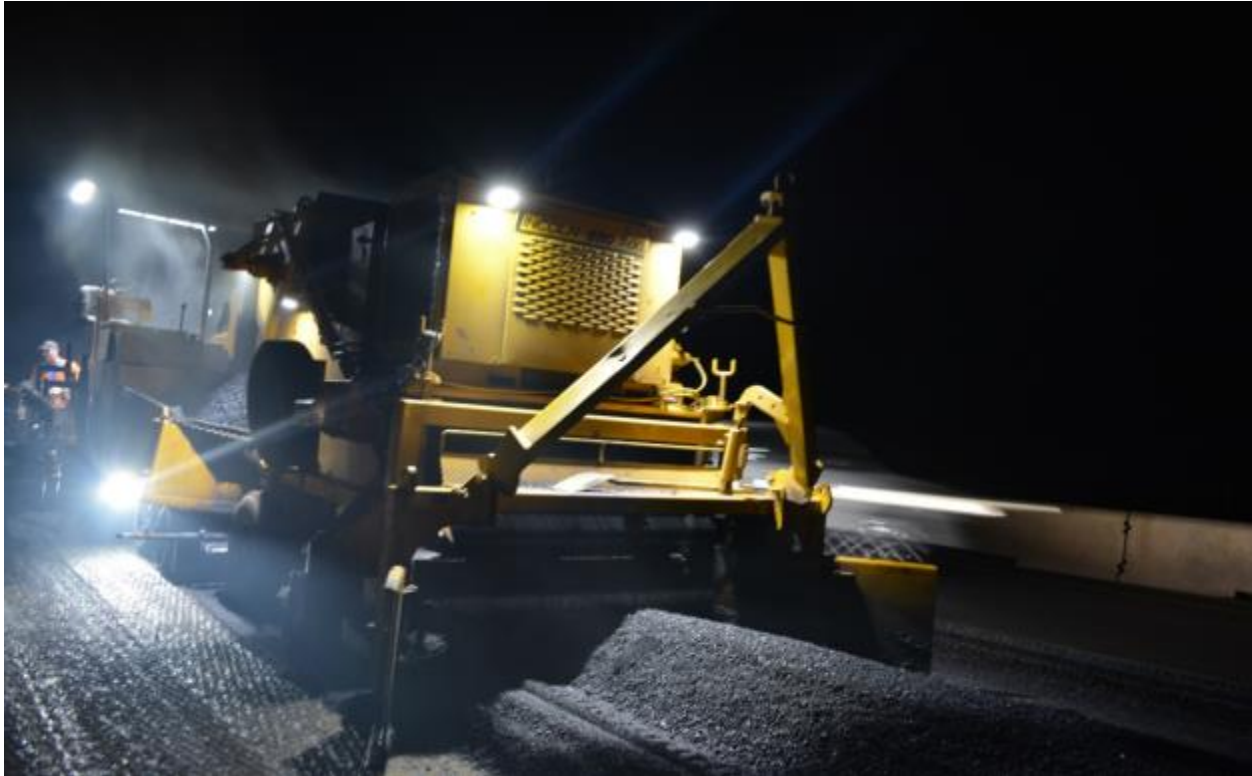
direction and for workers in the area. To reduce the glare, the lights should be pointed towards the roadway surface. Locating a similar light on the front of the paver, and directing the light towards the construction worker (dump person), would help illuminate the worker for oncoming traffic (Figure 5.14). Having the dump person wear a Halo light would be another option to increase the visibility of the worker for equipment operators and oncoming motorists.

Figure 5.14: Front of Paver with Recommended Location for Adding a Spotlight (red circle)

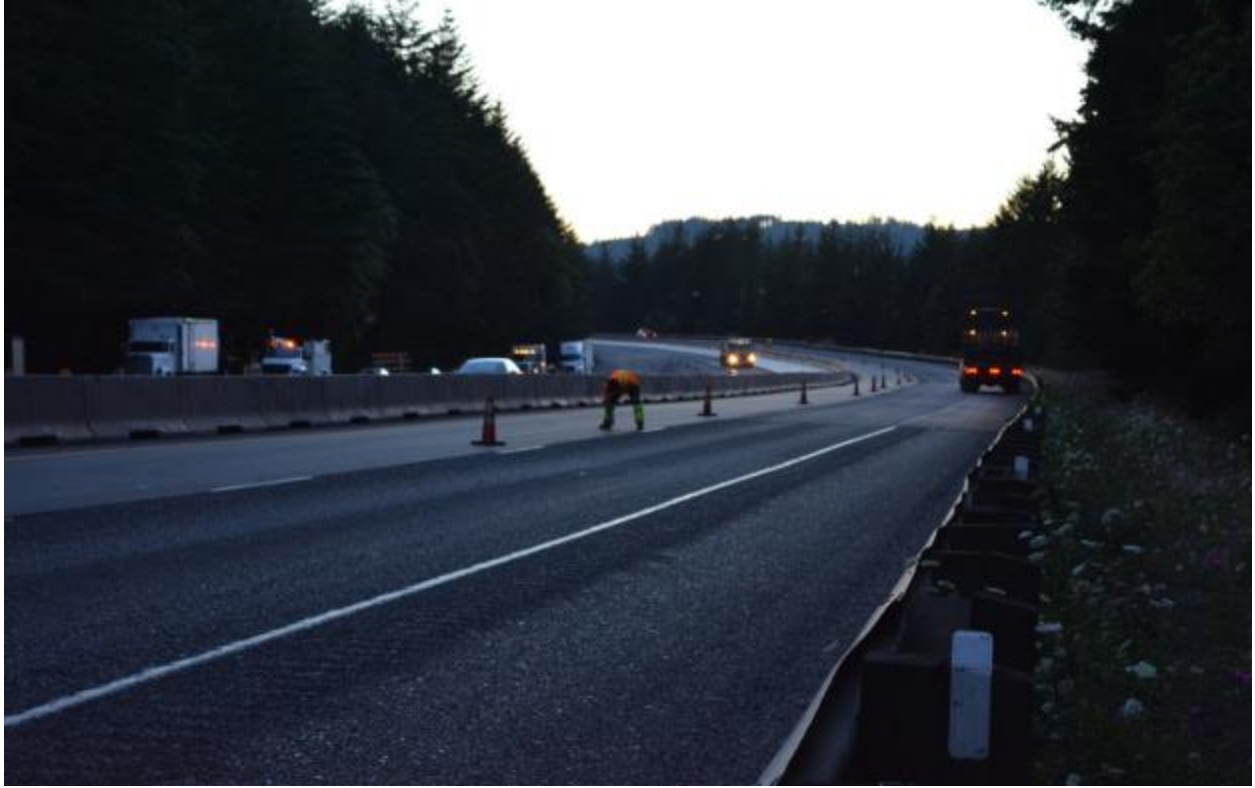
When no light system is present (temporary or permanent), the light meter recorded between 0.2 and 0.5 fc in the middle of the working lane (closed lane) when a passenger car with its headlights on passed by in the opposite direction. Based on the low value of illumination recorded without any other light systems present, workers in these locations may not be very visible to passing motorists (Figure 5.15).

Figure 5.15: Worker in Location without any Temporary or Permanent Lighting

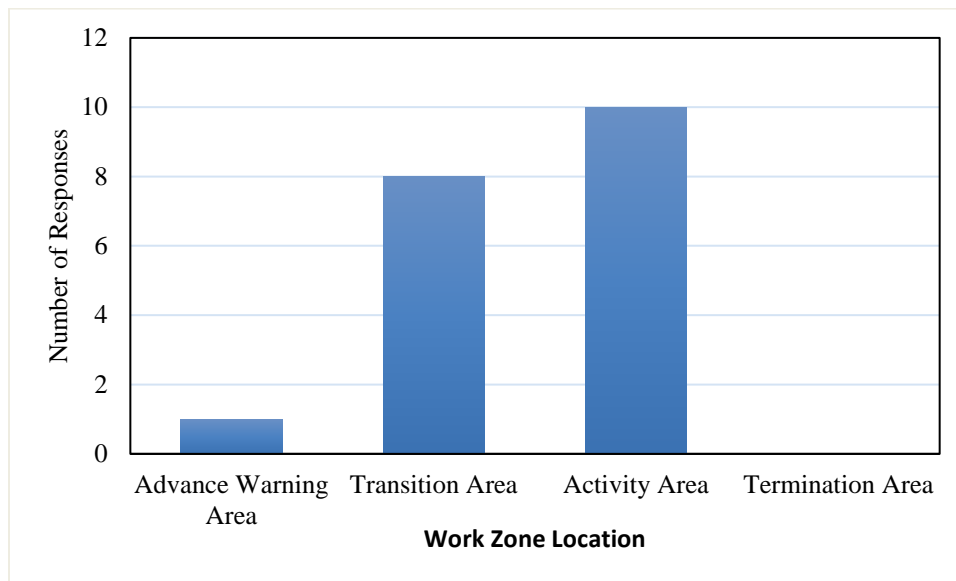
Each highway construction work zone is composed of four distinct areas including (1) advance warning area, (2) transition area, (3) activity area, and (4) termination area. In this section of survey, participants were asked to choose between the four work zone areas the most effective area for setting up the light equipment to reduce the vehicle speeds. Figure 6.5 shows the results from this question. The activity area was identified by the most participants (10 participants, 91%) as the best location for the lighting equipment. Eight participants also indicated that the transition area would be a beneficial spot for the equipment. One of the participants also suggested locating the light equipment in the advance warning area to enable speed reduction of passing vehicles. The termination area was not recognized as an area where the light equipment would have an impact on speed reduction, likely because it is downstream of the work area.

Figure 6.5: Recommended Location for Adding Additional Lighting to Reduce Vehicle Speed

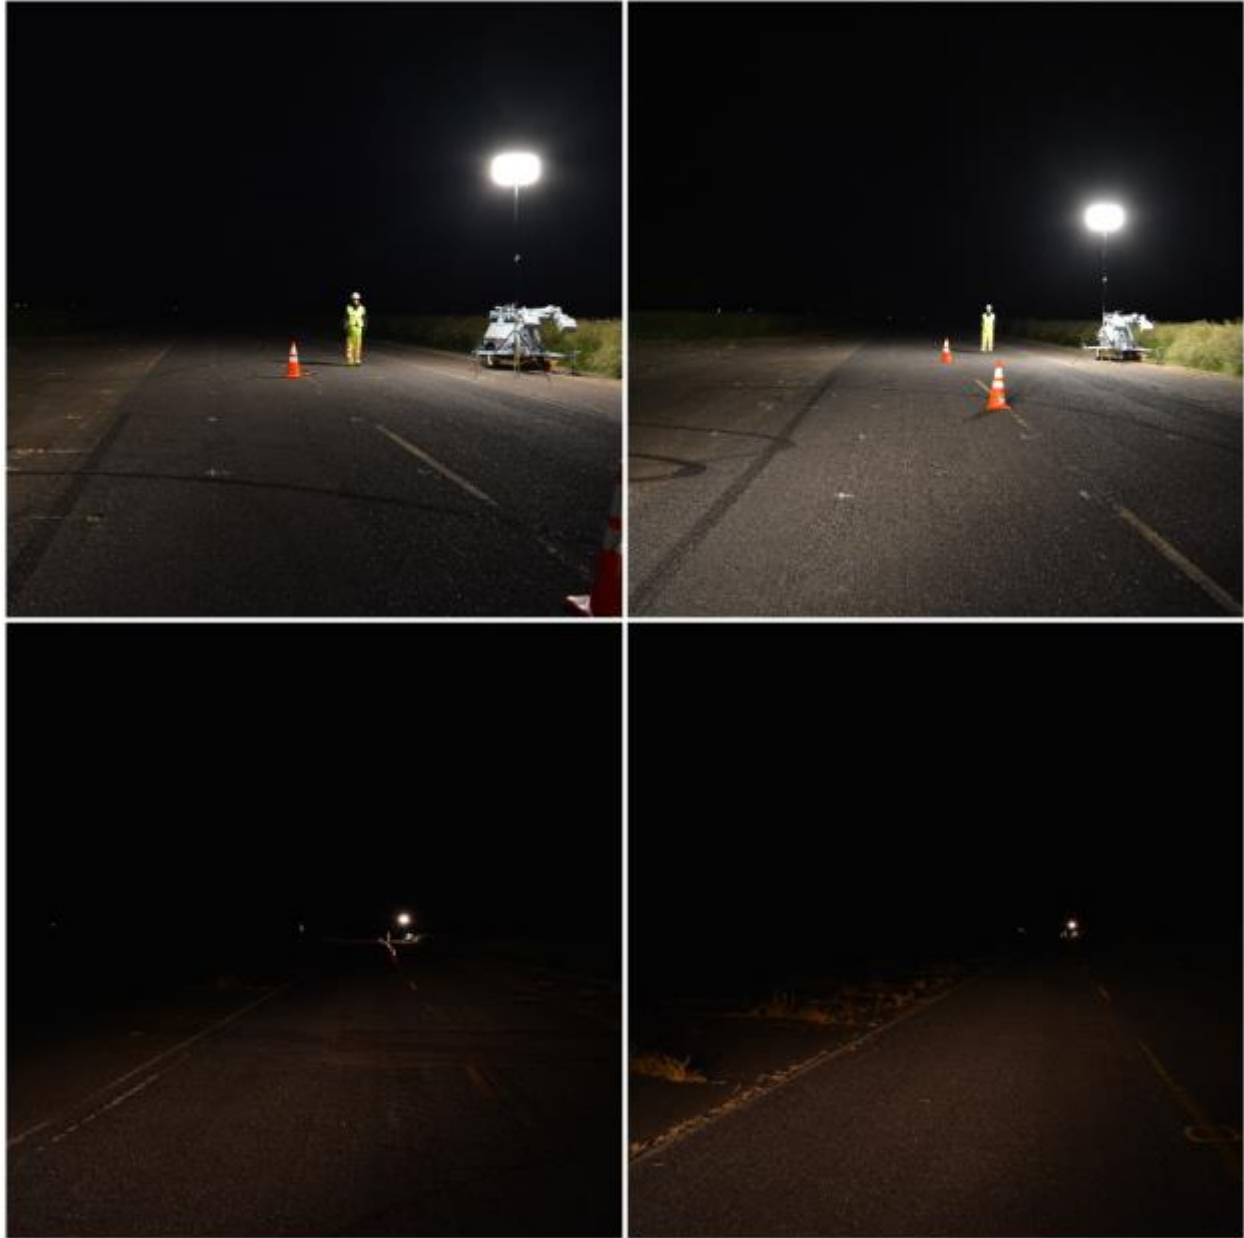
The researchers observed the worker from 50, 100, 500 and 1,000 feet away from the balloon light to see how well the worker was recognizable at different distances. Photos from every distances were taken while the apparel, location to the light, and presence of Halo light were varied. Figure 7.4 shows an example when for the case when the worker wore a Class 2 vest and pants at position 2 (upstream of the light in the lane adjacent to the light), and when the Halo light was turned off.

Figure 7.4: Worker at Different Distances from Balloon Light

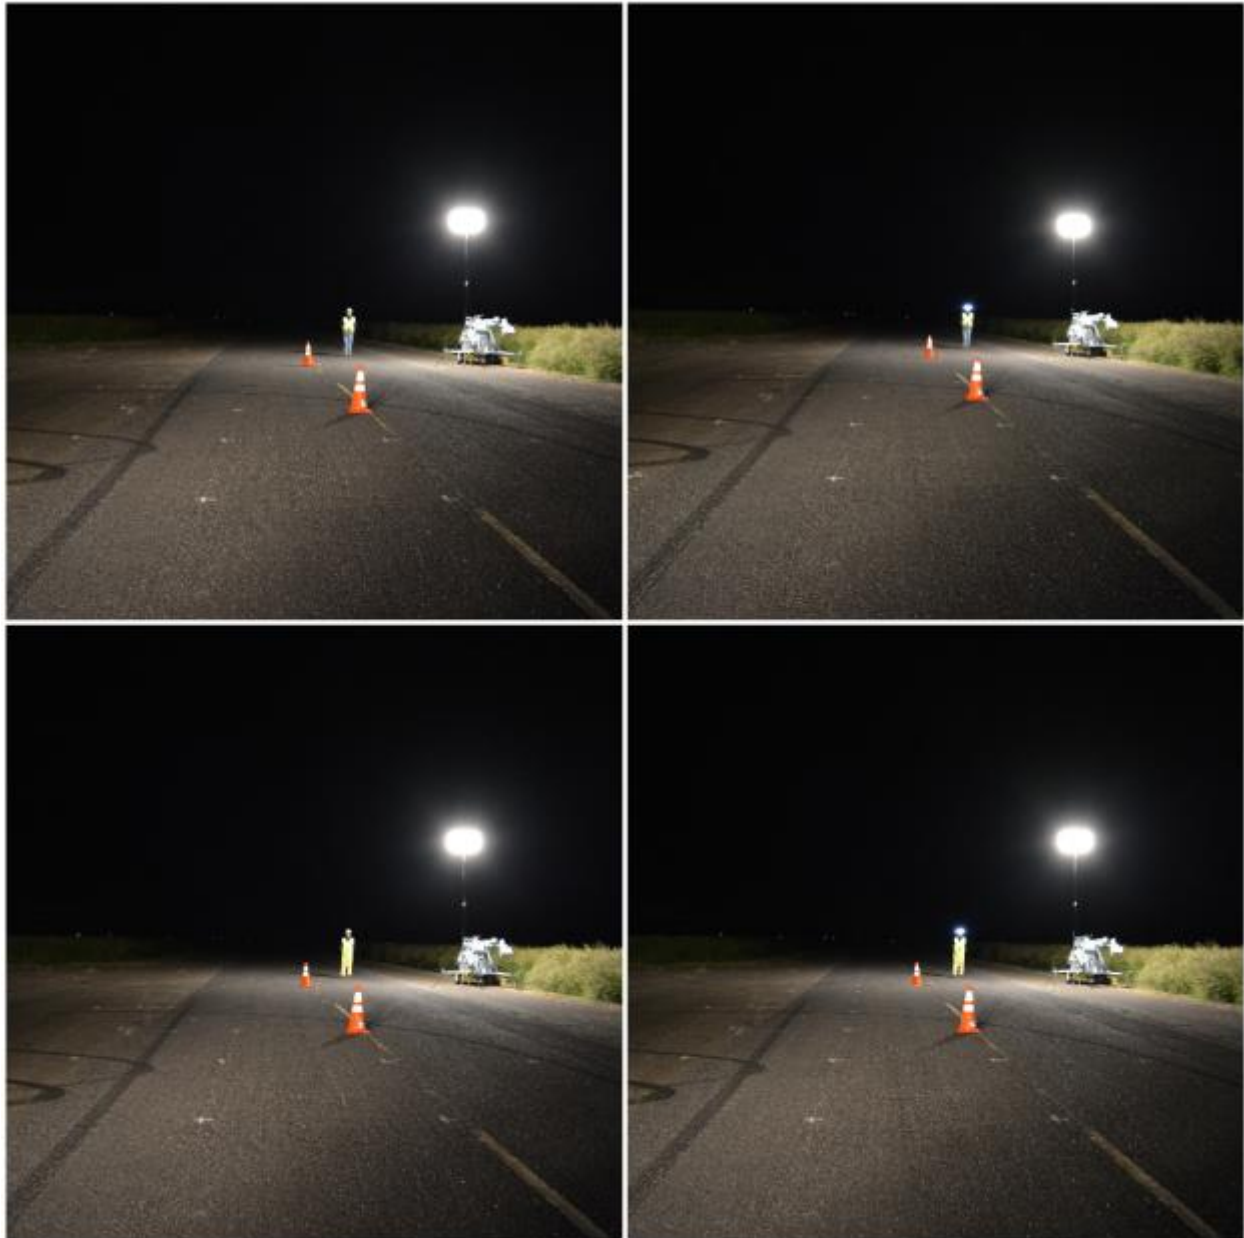
combination of a Class 2 vest and pants. Therefore, just the comparisons of the Class 2 vest and Class 2 vest plus pants with the Halo light on and off were considered.

Figure 7.5: High Visibility Apparel under Balloon Light from 100 feet Away

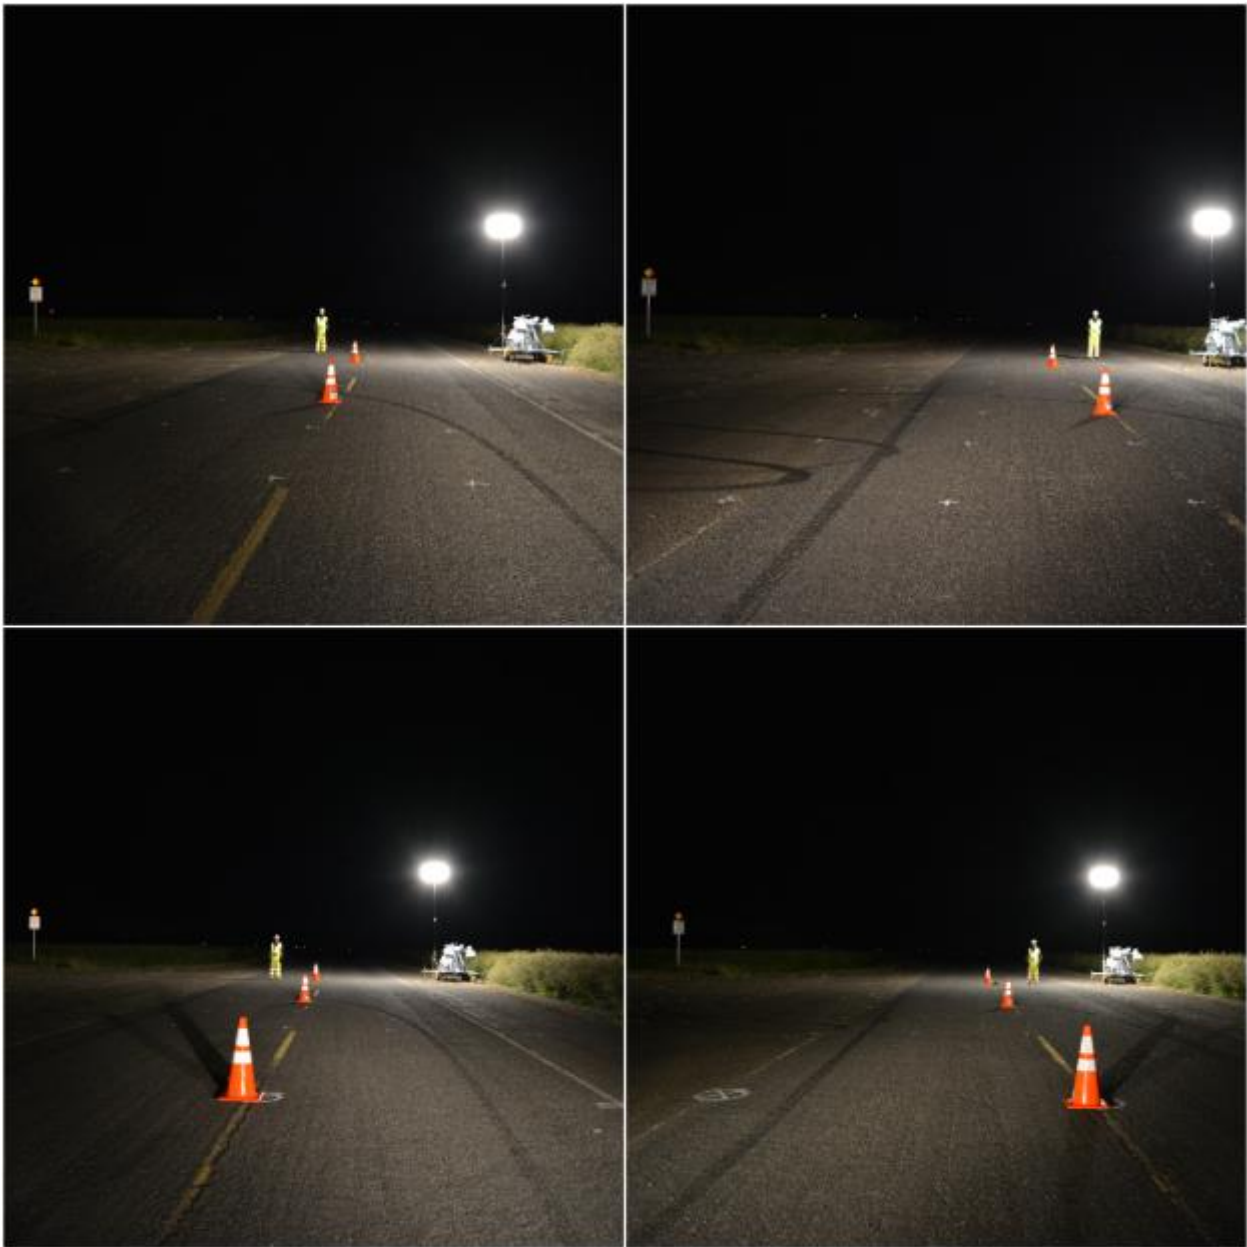
7.6 shows a comparison between different locations of worker relative to the light. Based on this picture comparison, when the worker is located 20 feet downstream of the balloon light, the worker appears brighter than when located immediately adjacent to the light.

Figure 7.6: Worker at Different Positions relative to Balloon Light

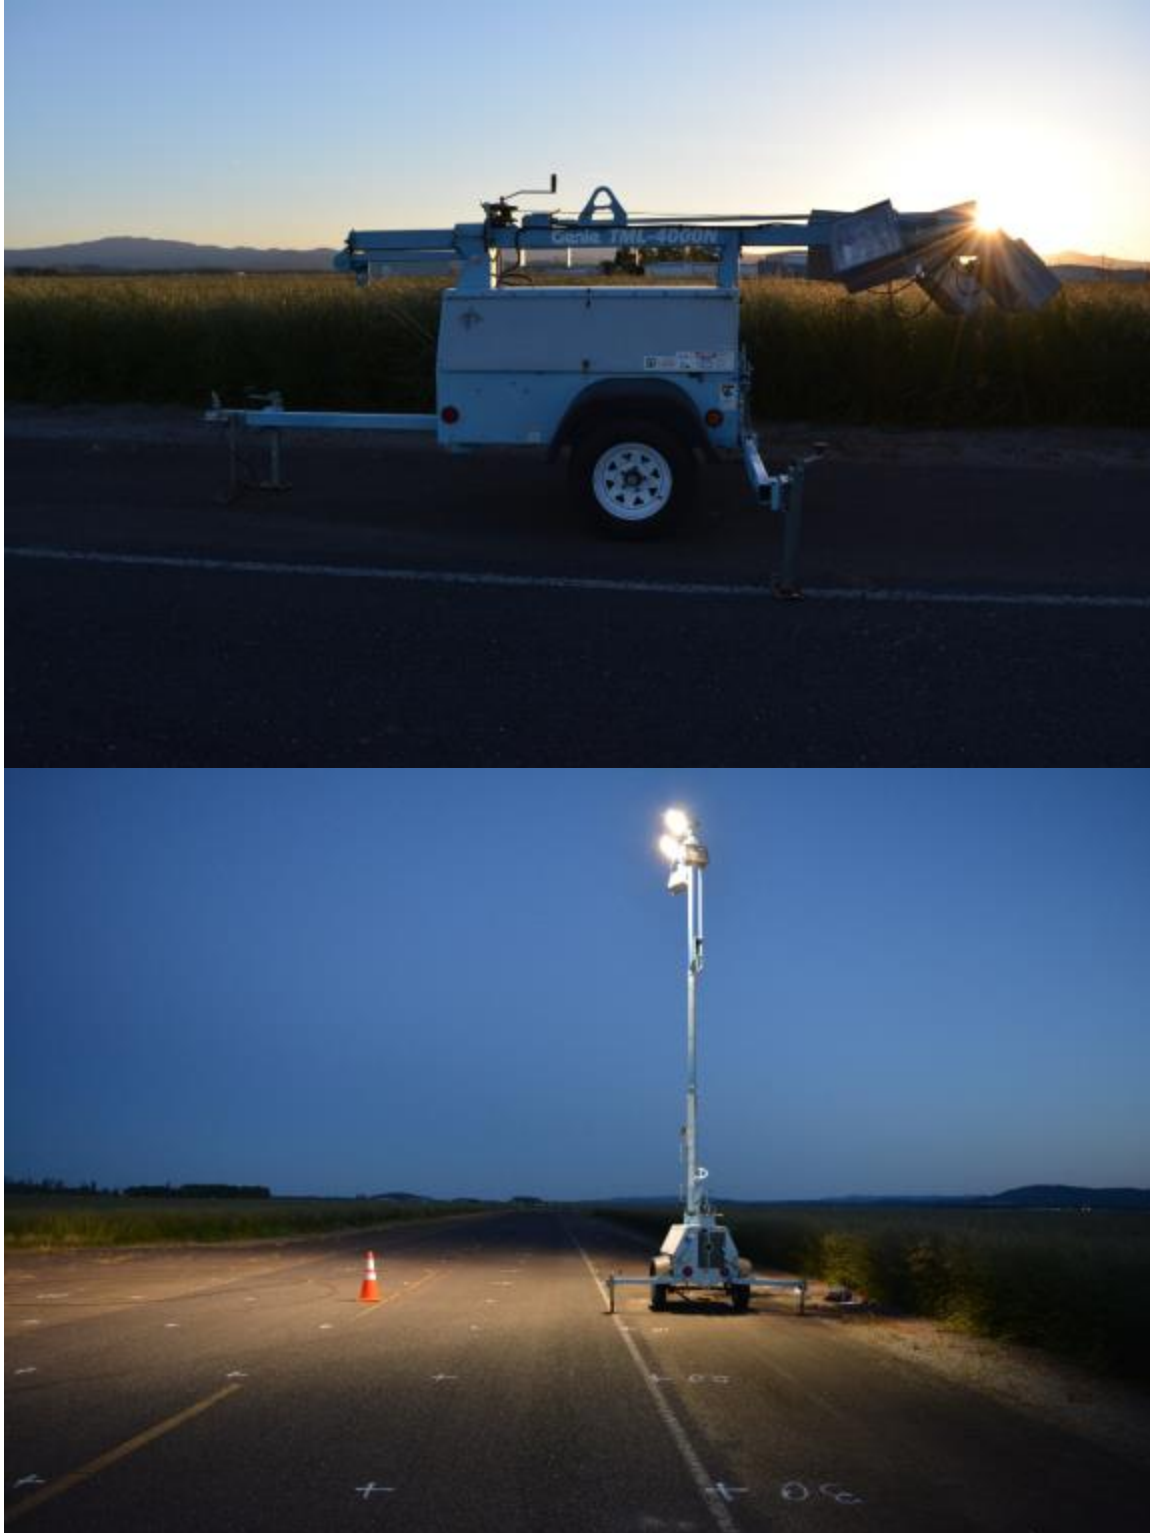
The light tower used for this study was a Genie TML-4000, owned by the OSU Facilities Services Department. The tower has four luminaires, each one containing a 1,000-watt metal halide HID lamp. The luminaires are mounted on a mast that can extend up to 28.5 feet in height. Each luminaire is made of durable cast aluminum and contains a tempered glass lens. The mast is connected to a generator that powers the lights. The generator sits on a trailer for towing behind a vehicle. Figure 7.9 shows a picture of the light tower with and without the tower raised and two luminaires turned on.

Figure 7.9: Light Tower Used in Pilot Testing

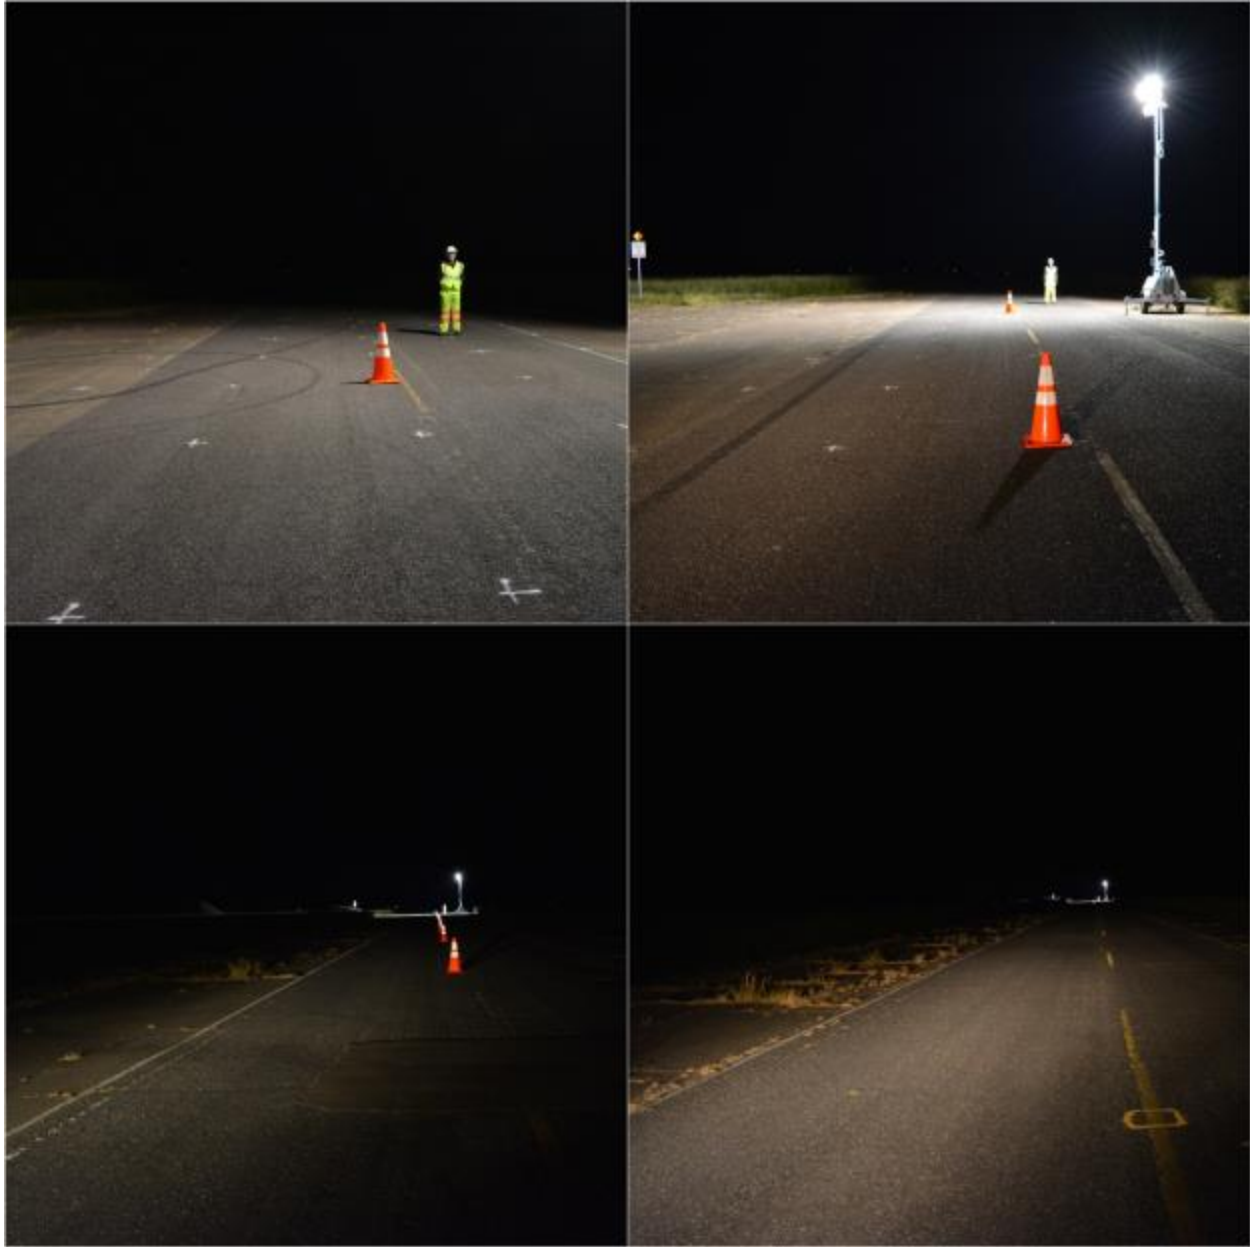
Figure 7.10: Visibility of Worker from Different Distances to Light Tower

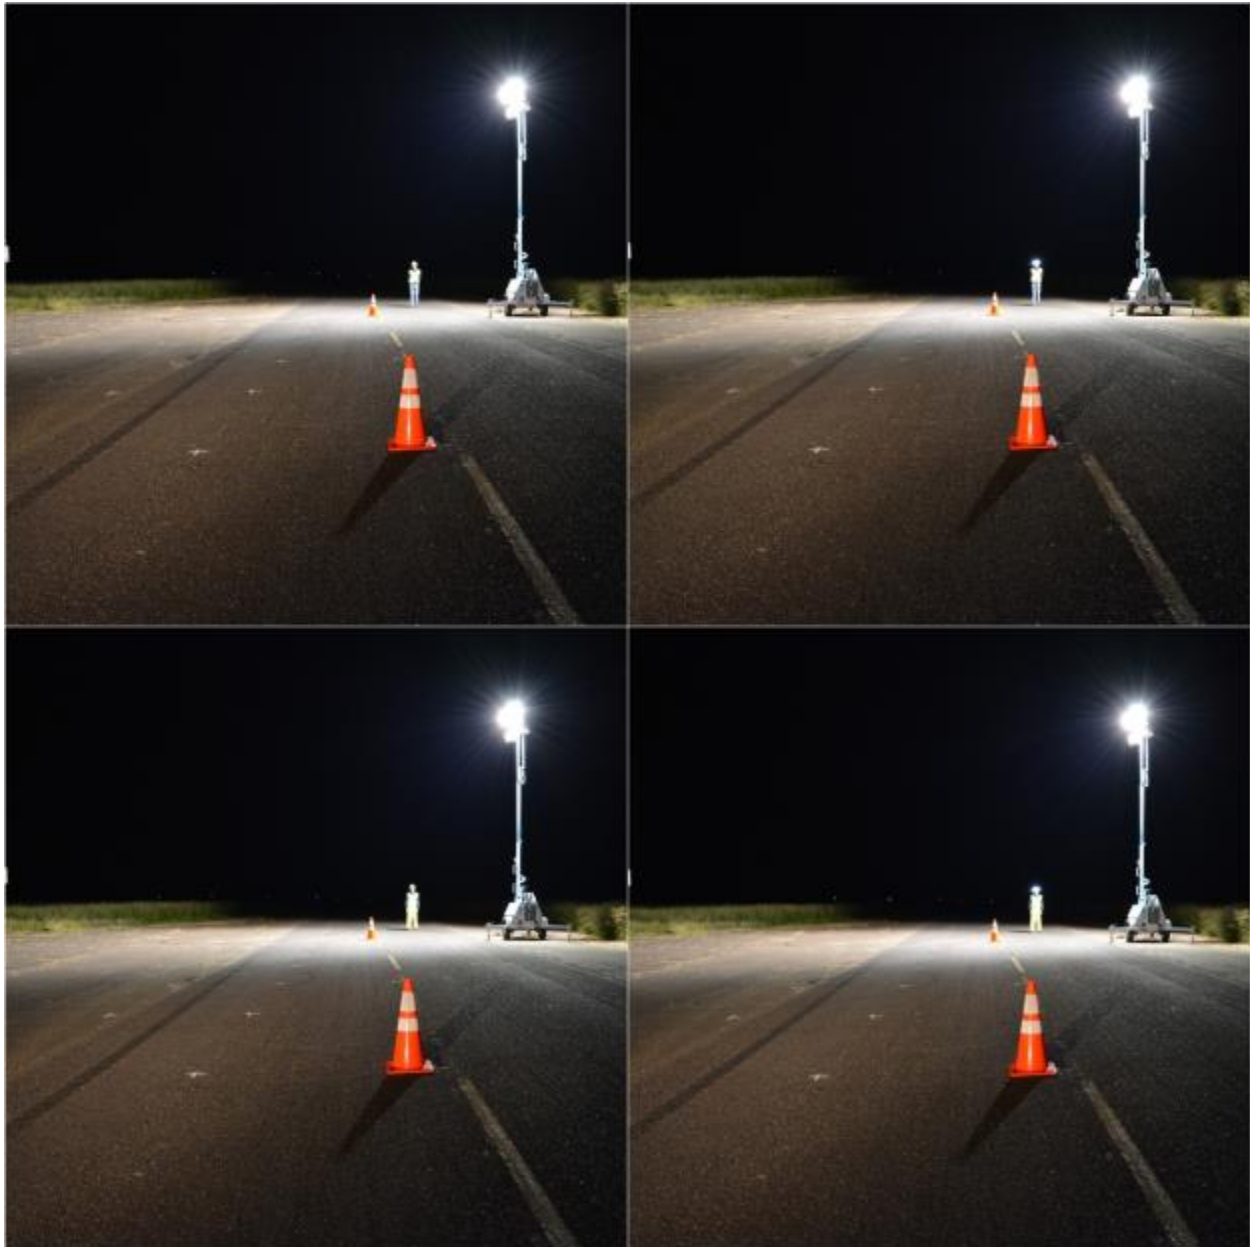
Figure 7.11: Comparison of High Visibility Apparel under Light Tower from 100 feet Away
