**USE OF ADDITIONAL LIGHTING
FOR TRAFFIC CONTROL AND
SPEED REDUCTION IN WORK
ZONES**

Final Report

SPR 791

Oregon Department of Transportation

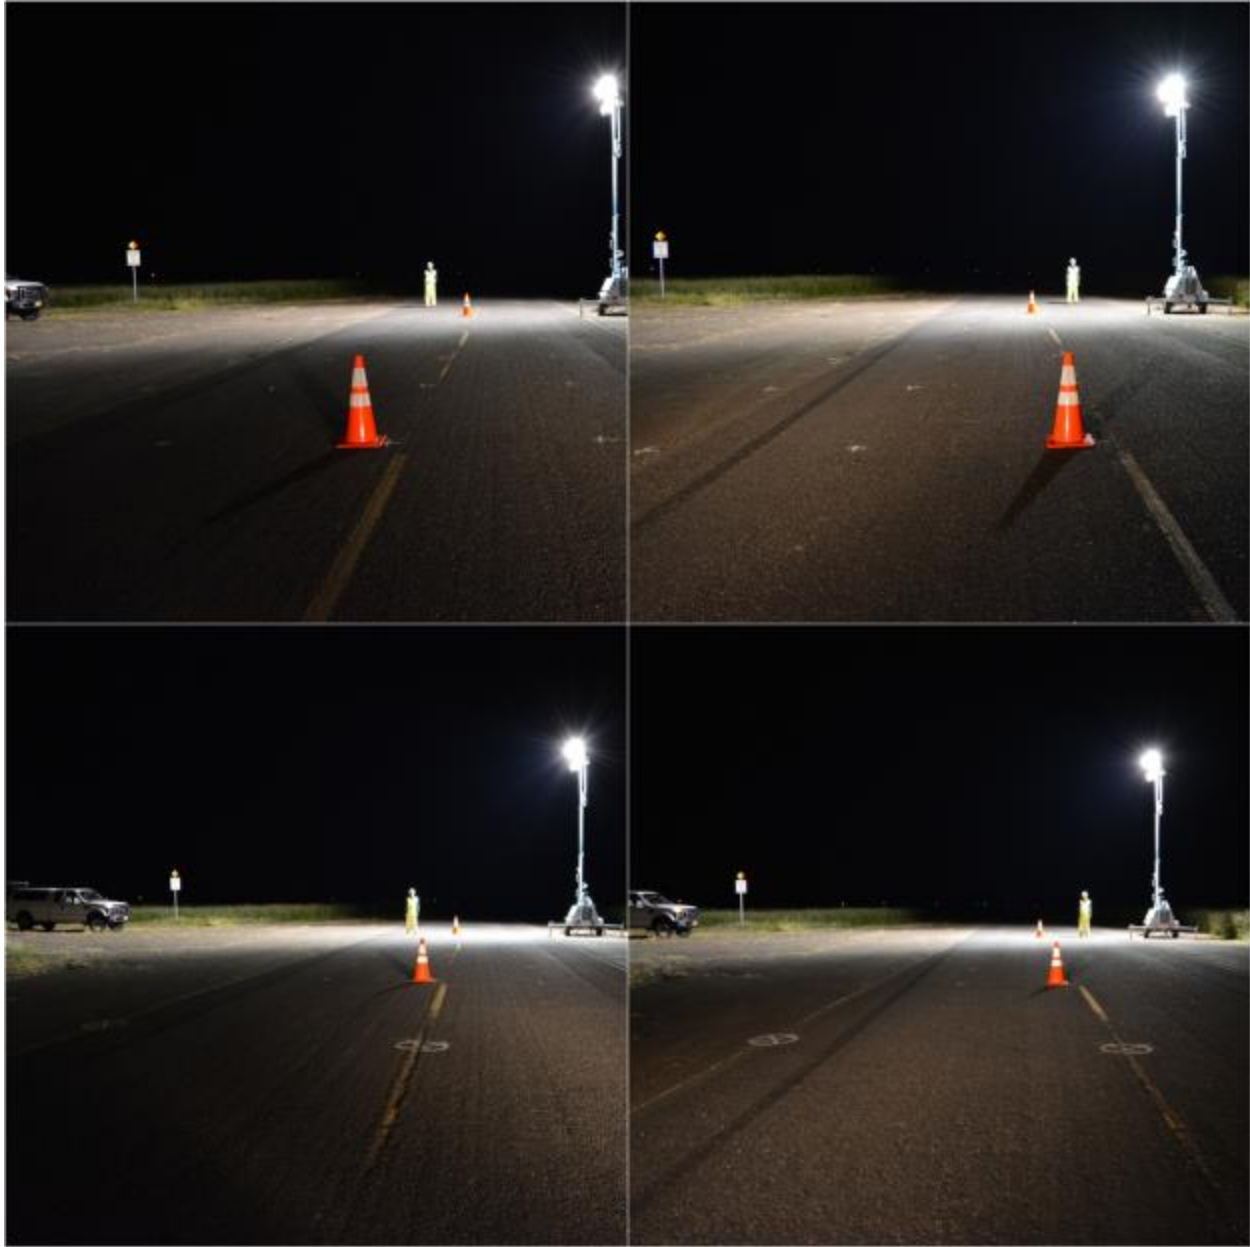
Figure 7.12: Comparison of Worker Visibility at Different Positions relative to Light Tower

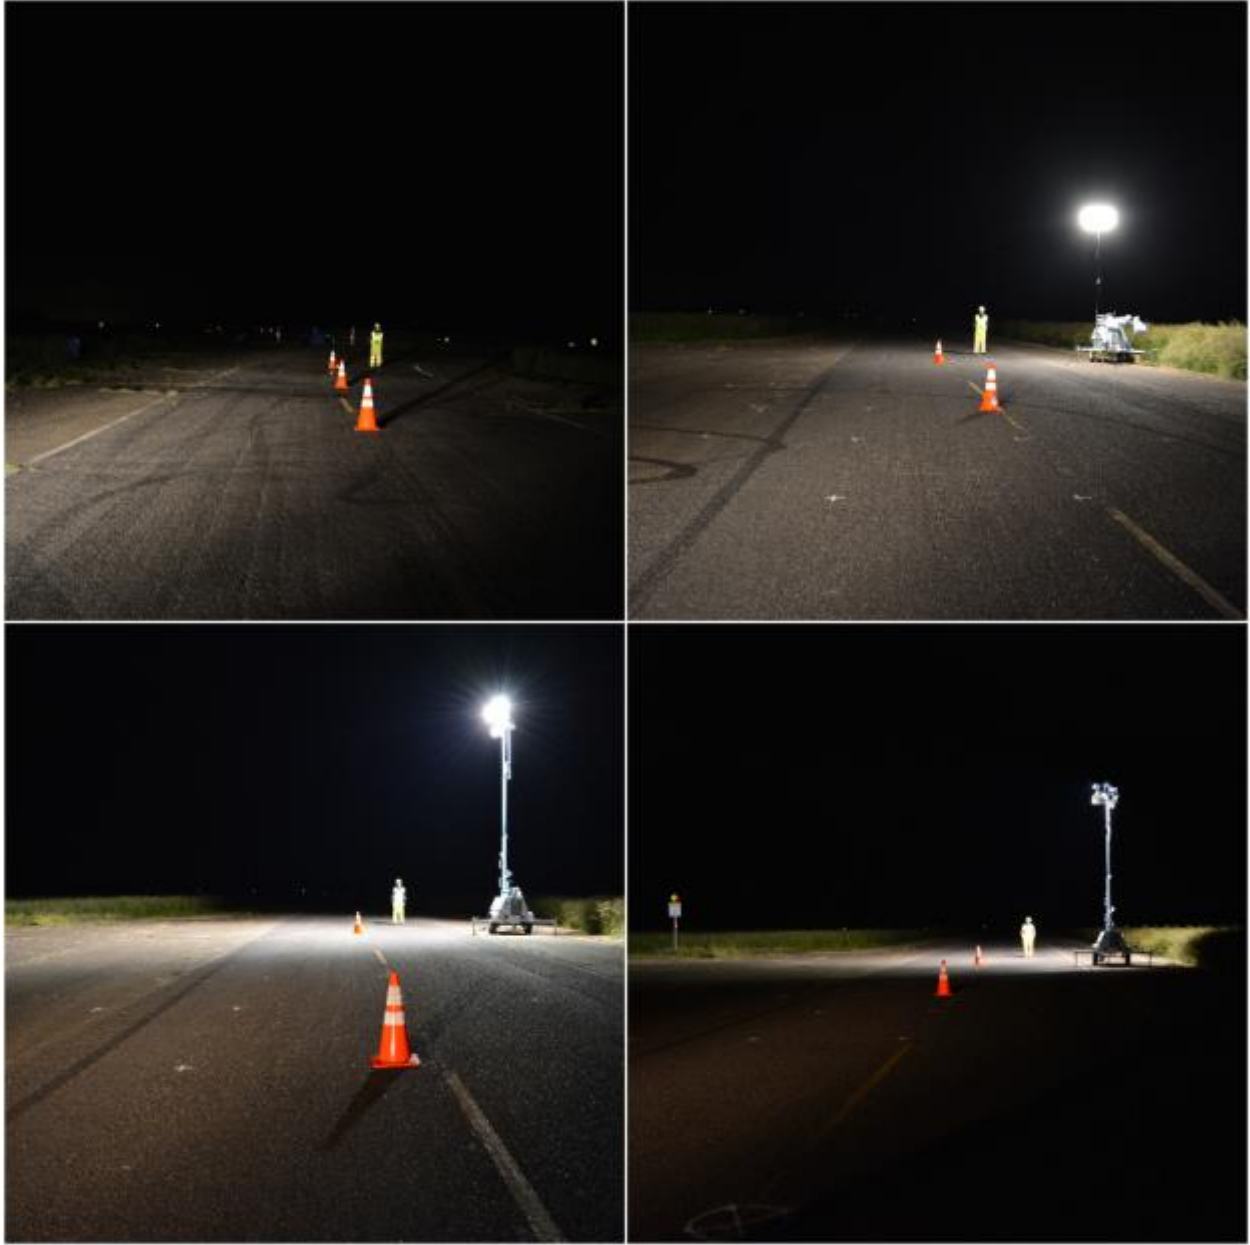
Figure 7.15: Visibility of Worker under Different Lighting Equipment from 100 feet Away

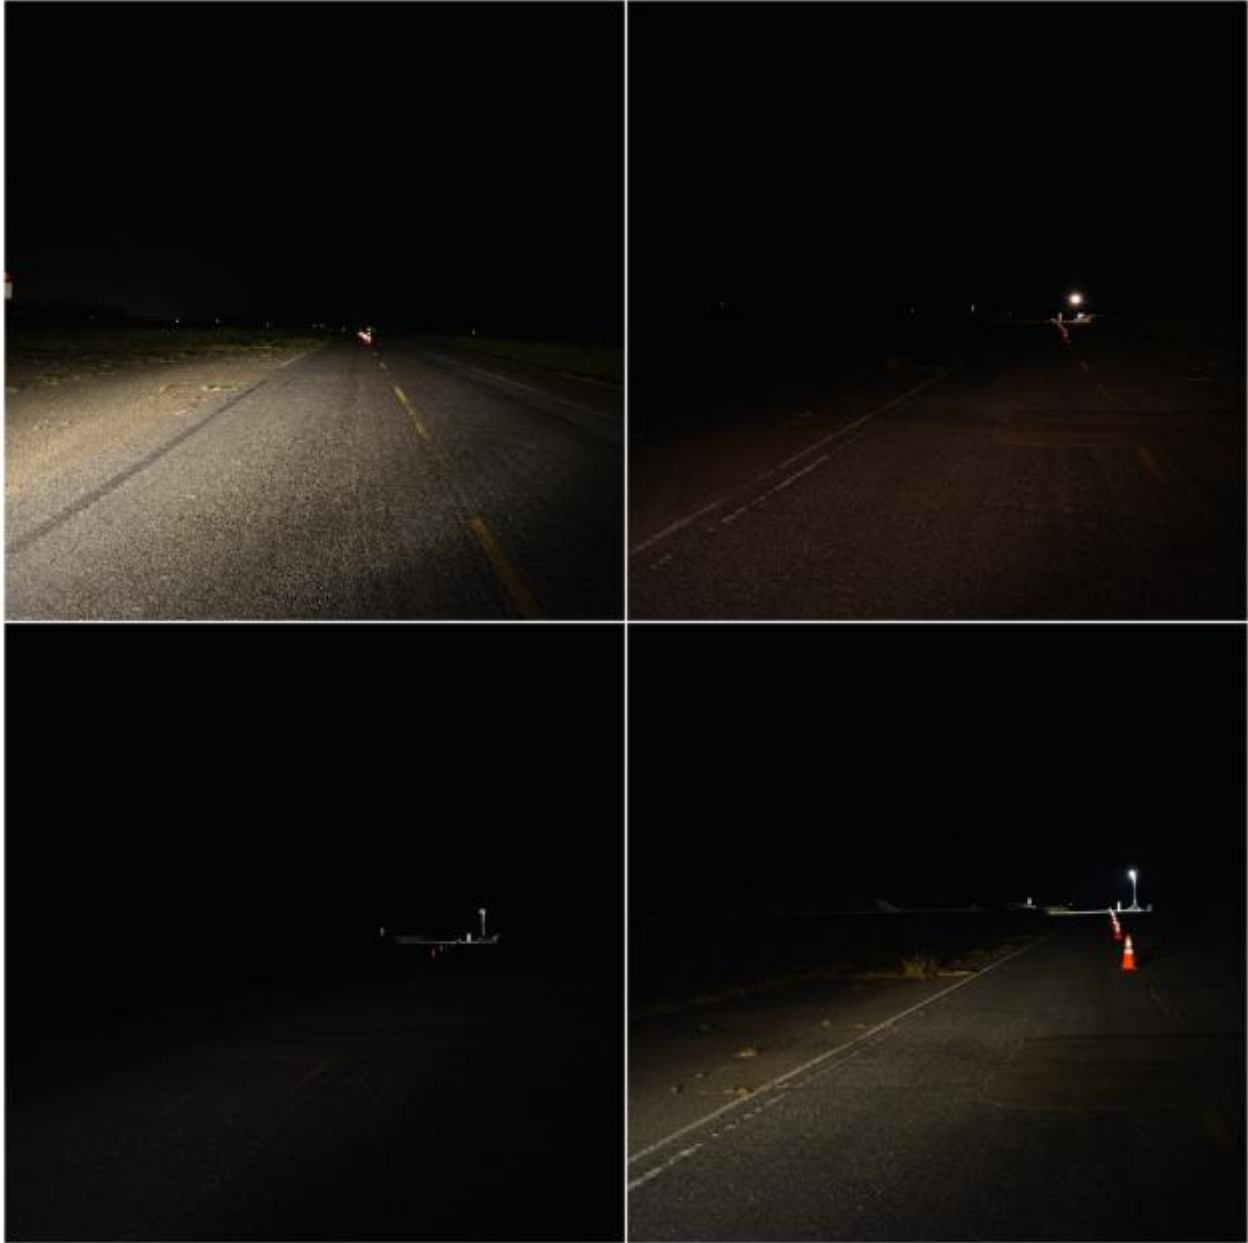
Figure 7.16: Visibility of Worker under Different Lighting Equipment from 500 feet Away

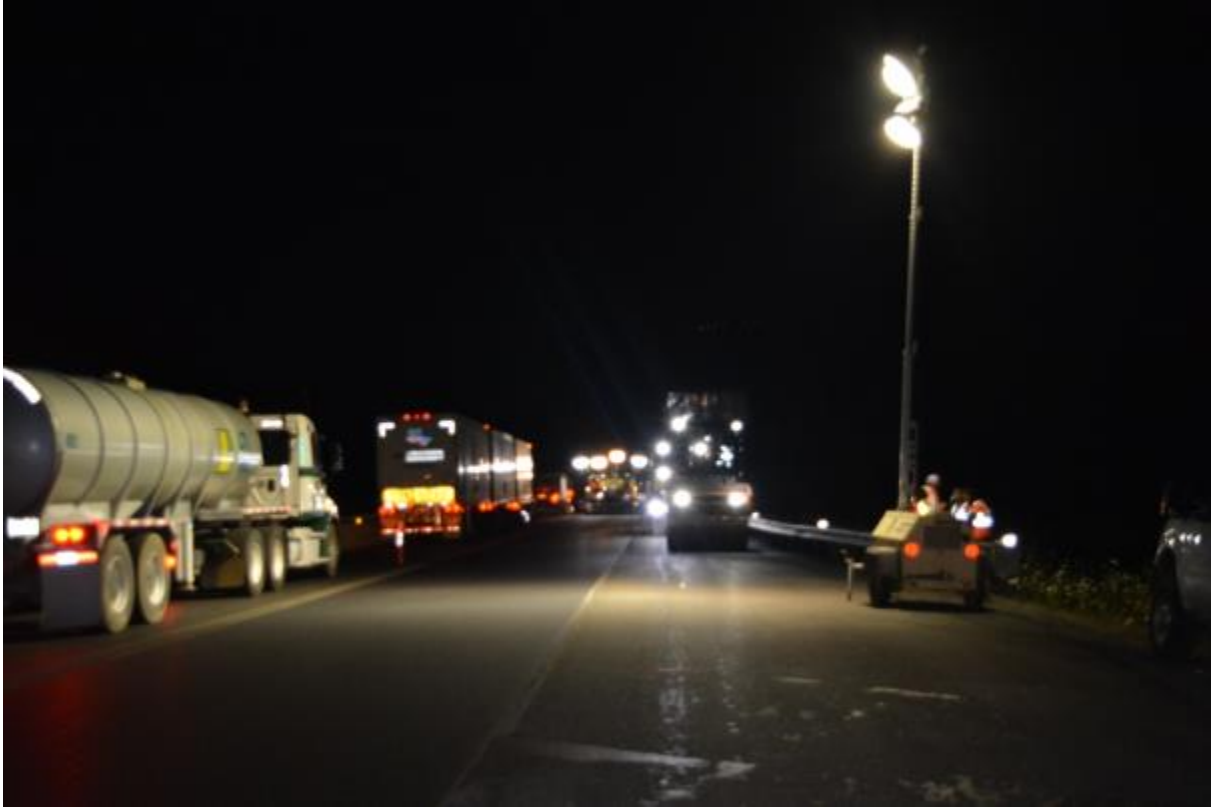
Figure 8.1: Light Tower used on I-84 Jordan Road to Multnomah Falls (Case Study #1)

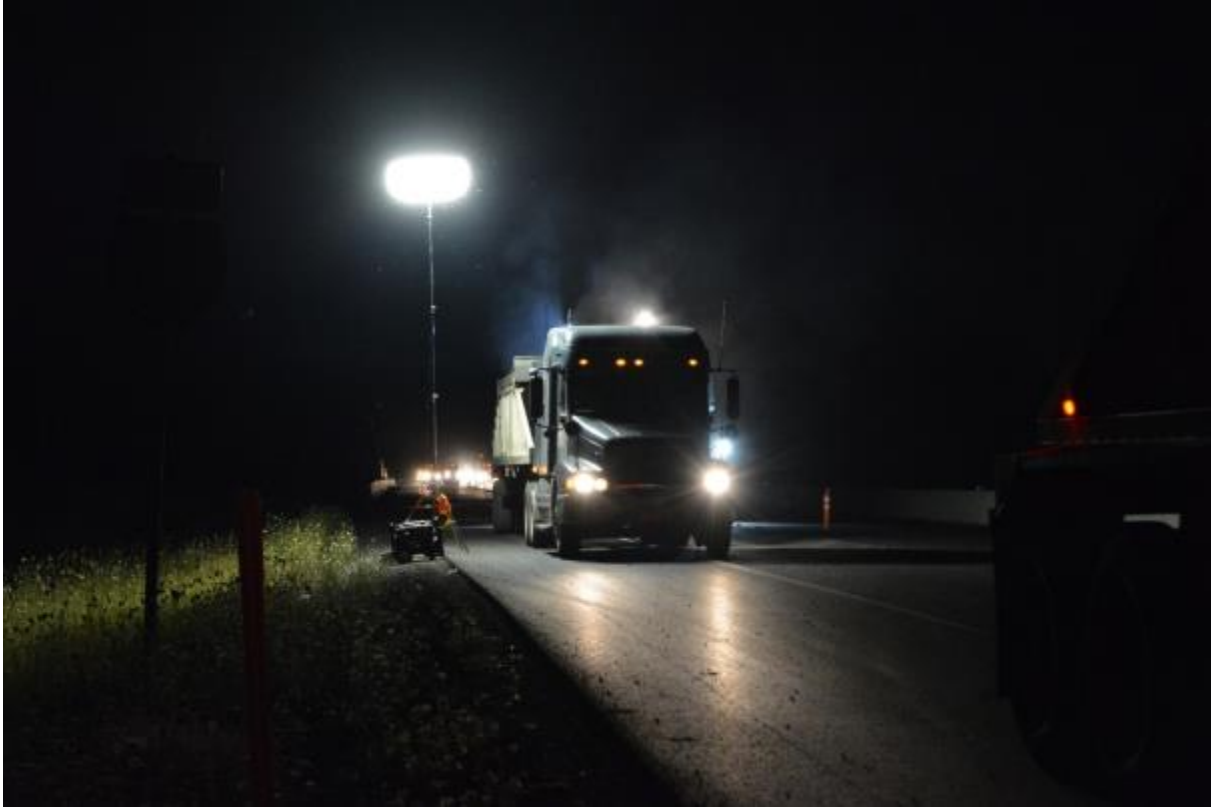
Figure 8.2: Balloon Light used on I-84 Jordan Road to Multnomah Falls (Case Study #1)

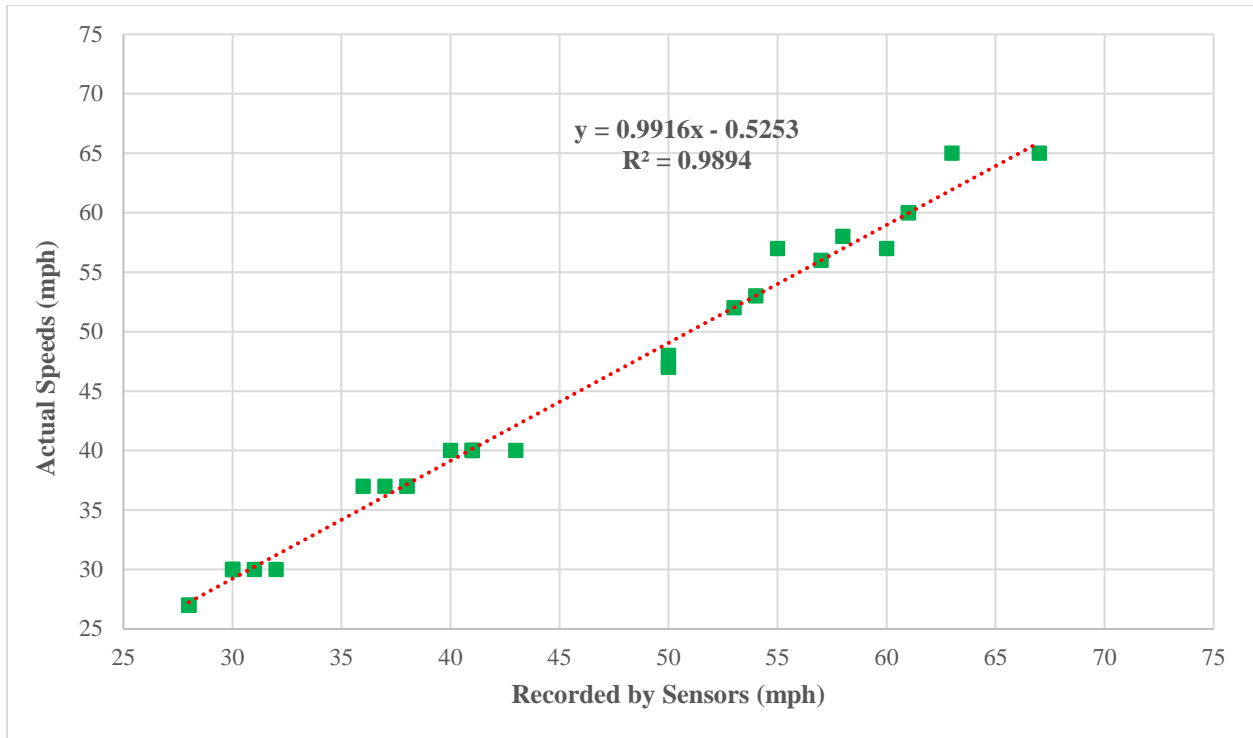
Figure 8.4: Sensor Calibration: Recorded Speed vs. Actual Speed for Sensor #101

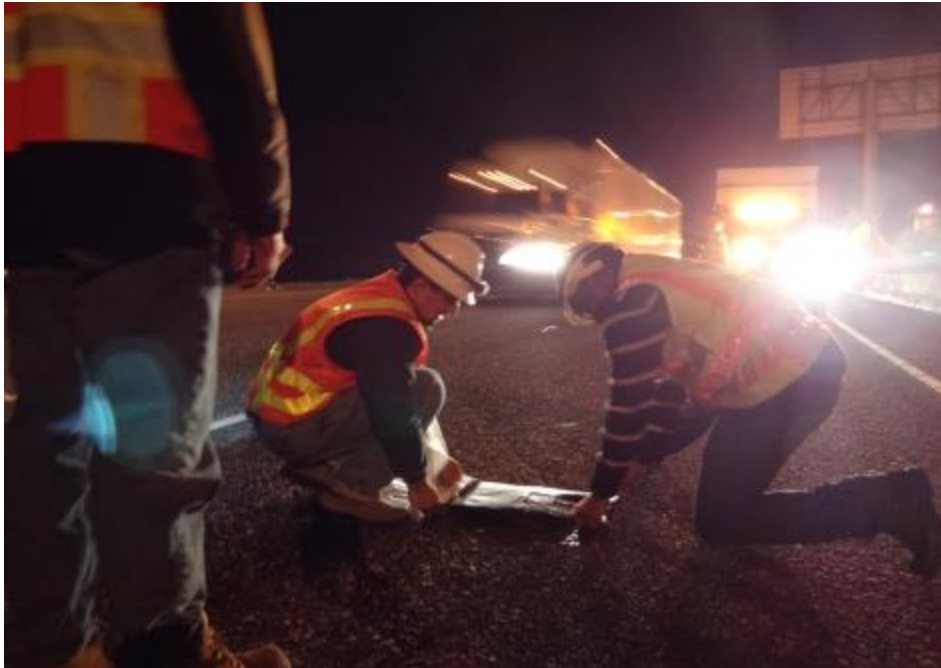
Figure 8.5: Placement of Portable Traffic Analyzer using Adhesive Tape (Gambatese and Jafarnejad, 2015)

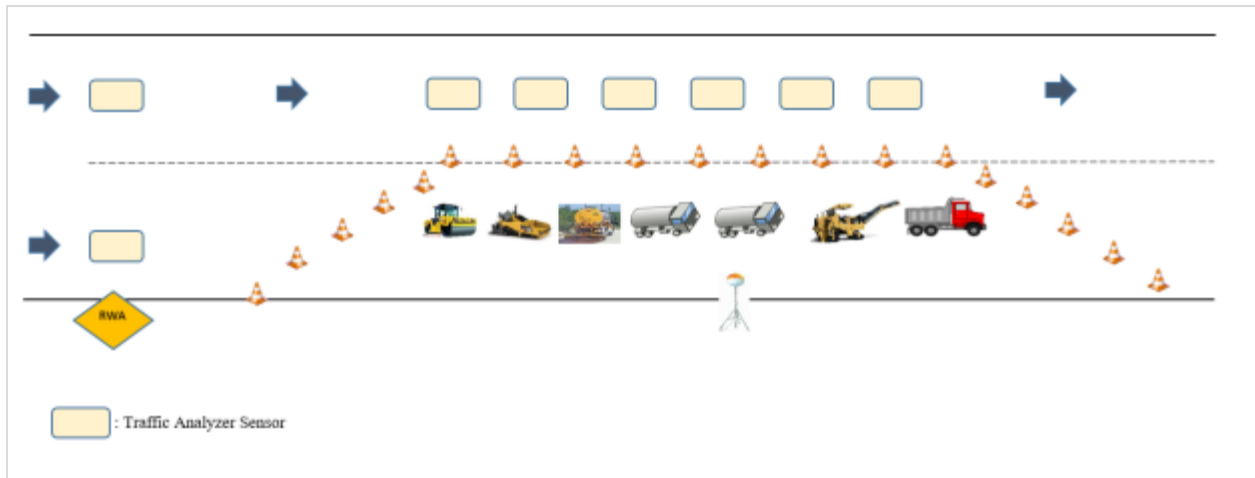
Figure 8.6: Example of Traffic Analyzer Layout and Location in Work Zone

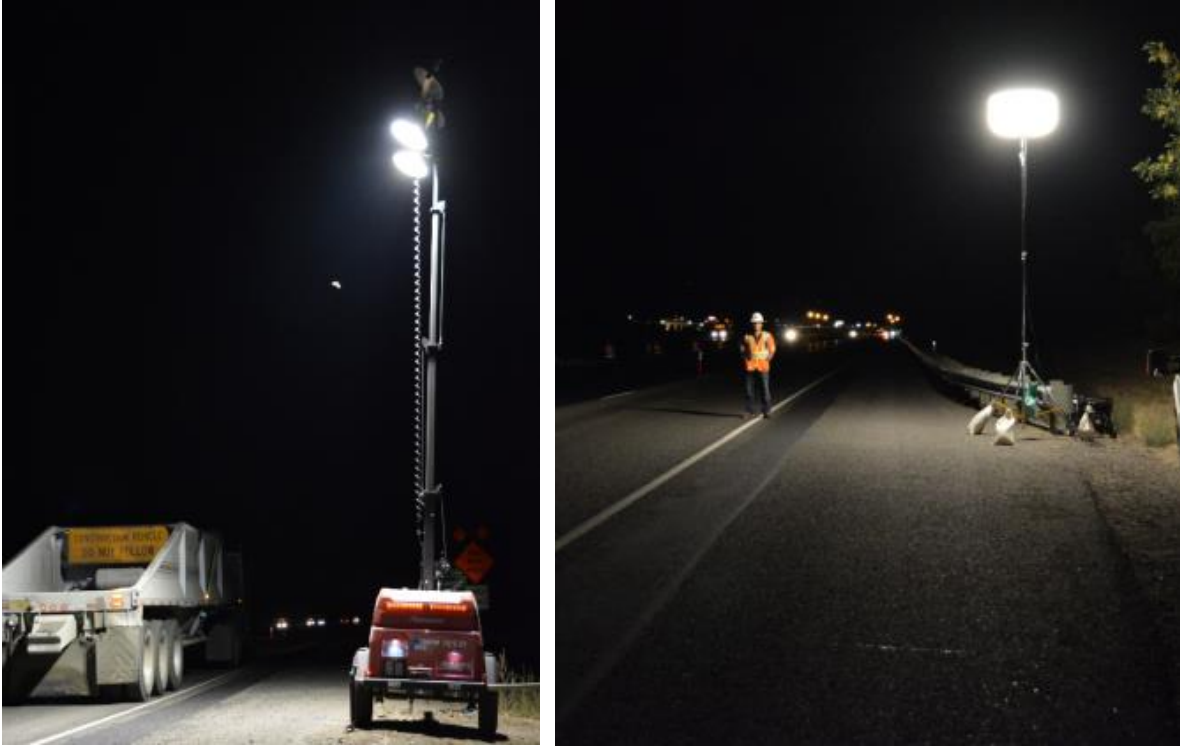
Figure 8.14: Lighting Equipment used for I-5 Medford to Ashland-(Case Study #2)

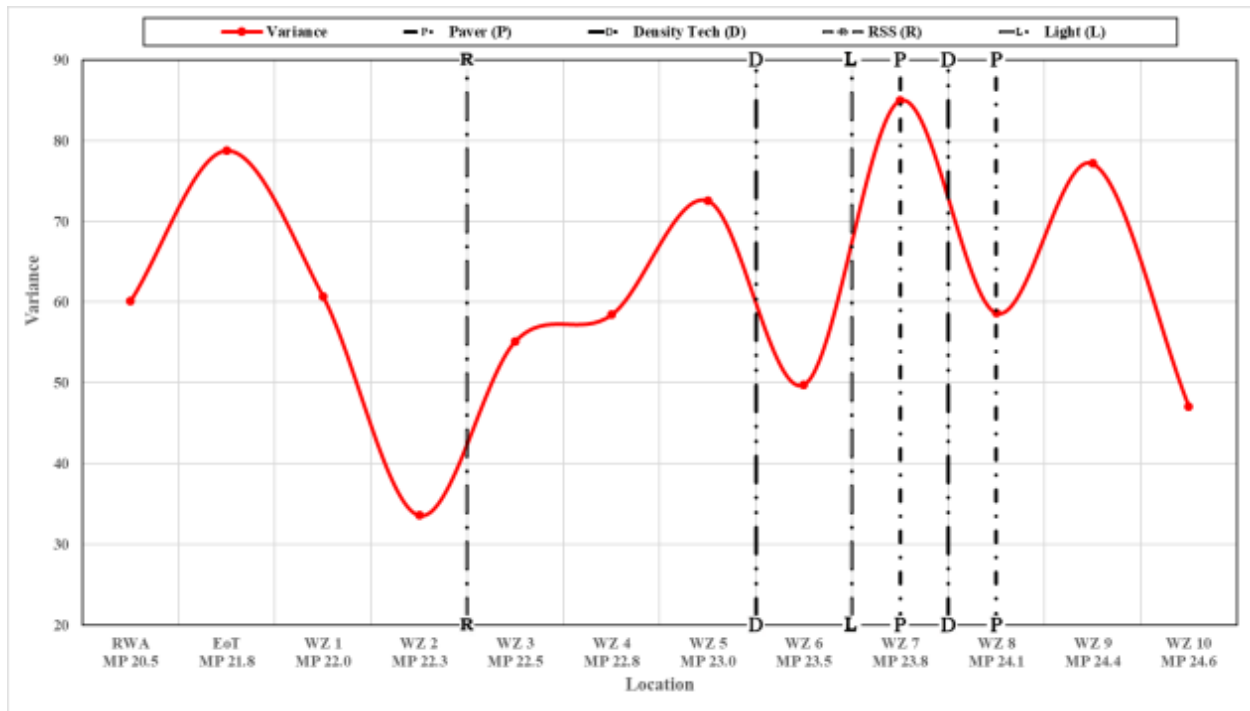
Figure 9.13: Variance in Vehicle Speed, Day 3, 01:00-02:00 (Case Study #1)

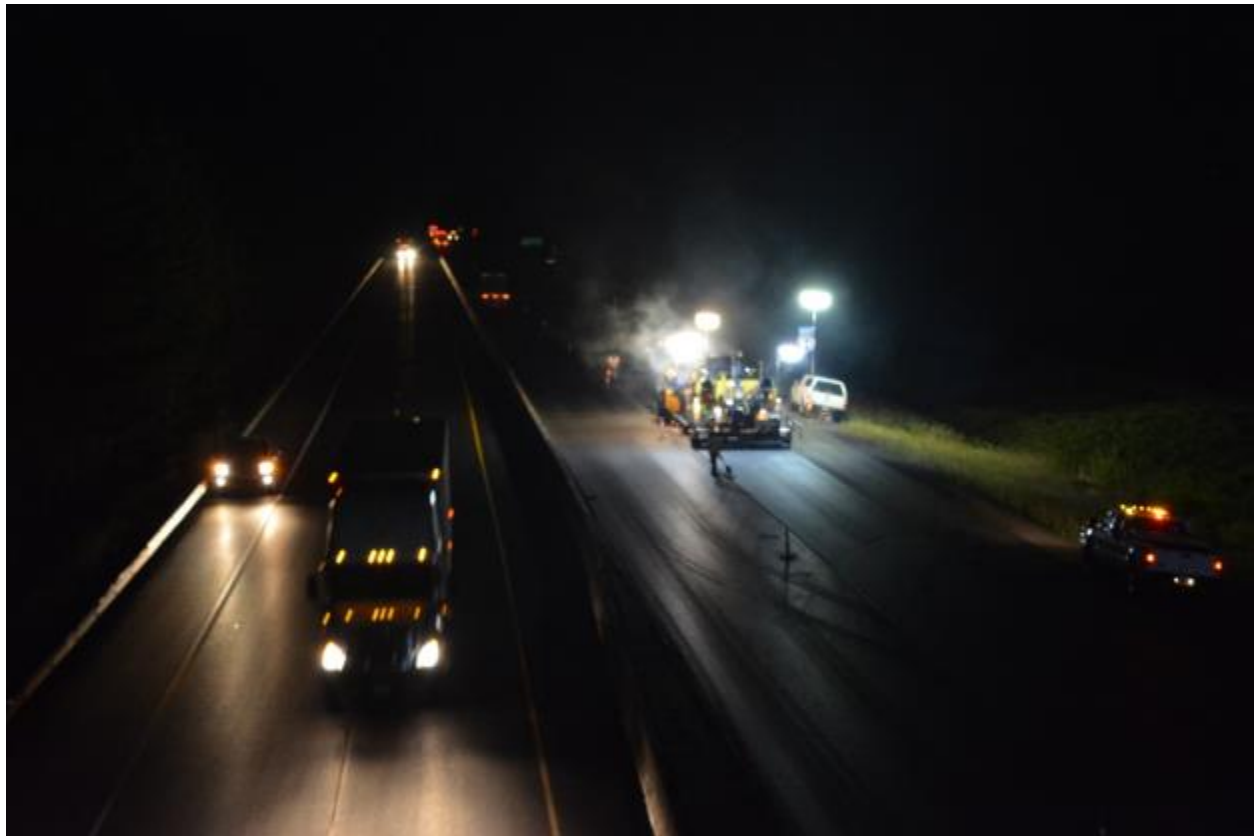
Figure 9.33: Visibility of Workers Upstream and Downstream of Light

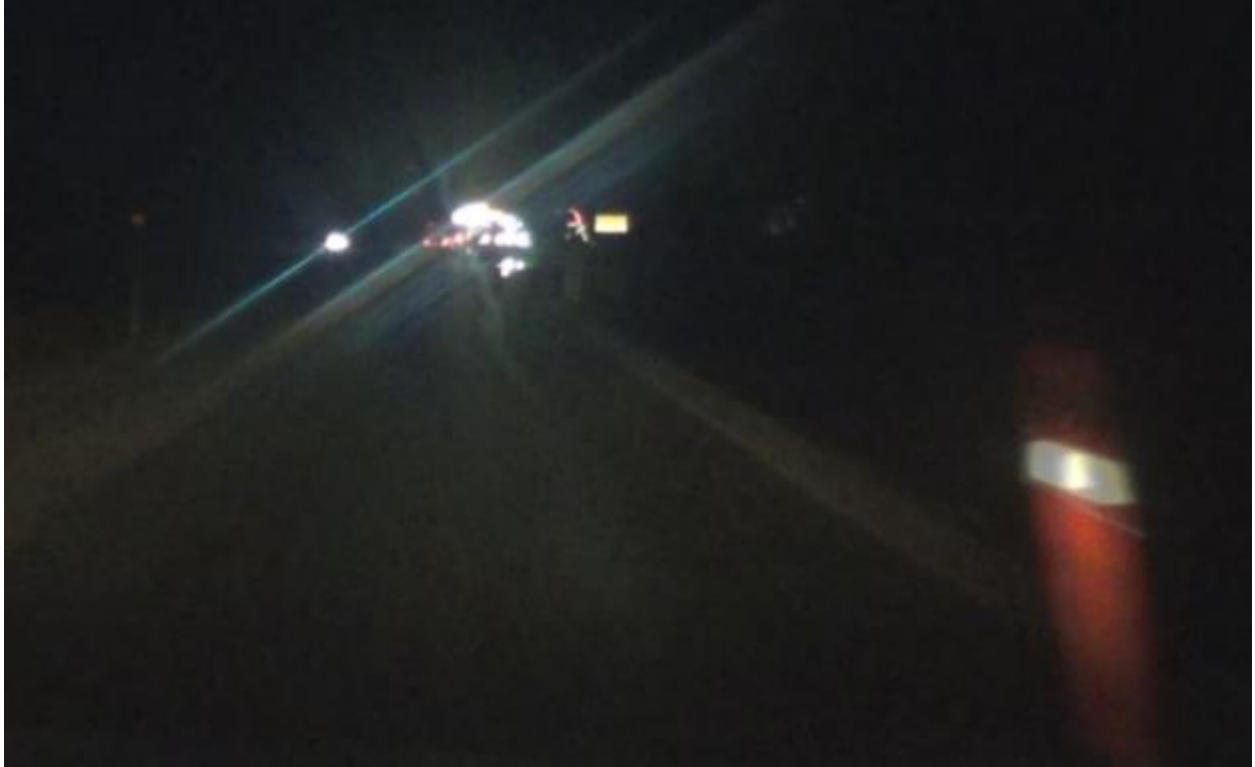
Figure 9.34: Visibility of Worker on Roadway without Additional Lighting

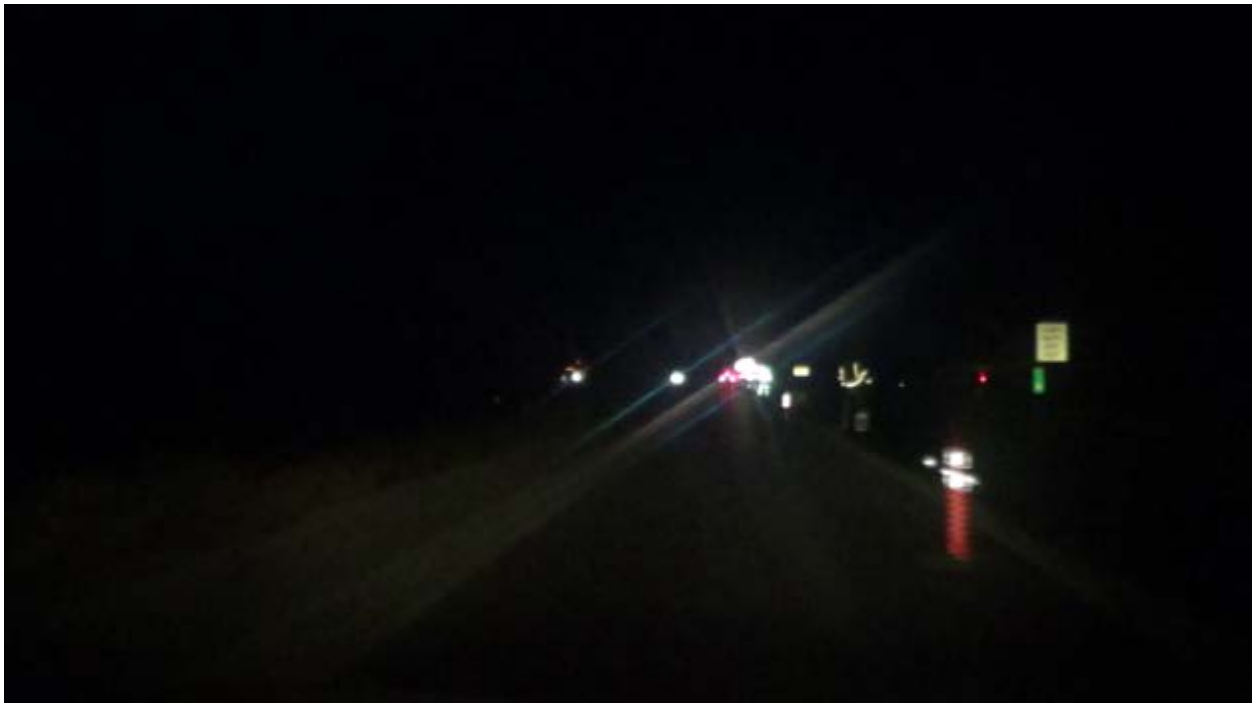
Figure 9.35: Visibility of Worker on Roadway with Class 3 Vest

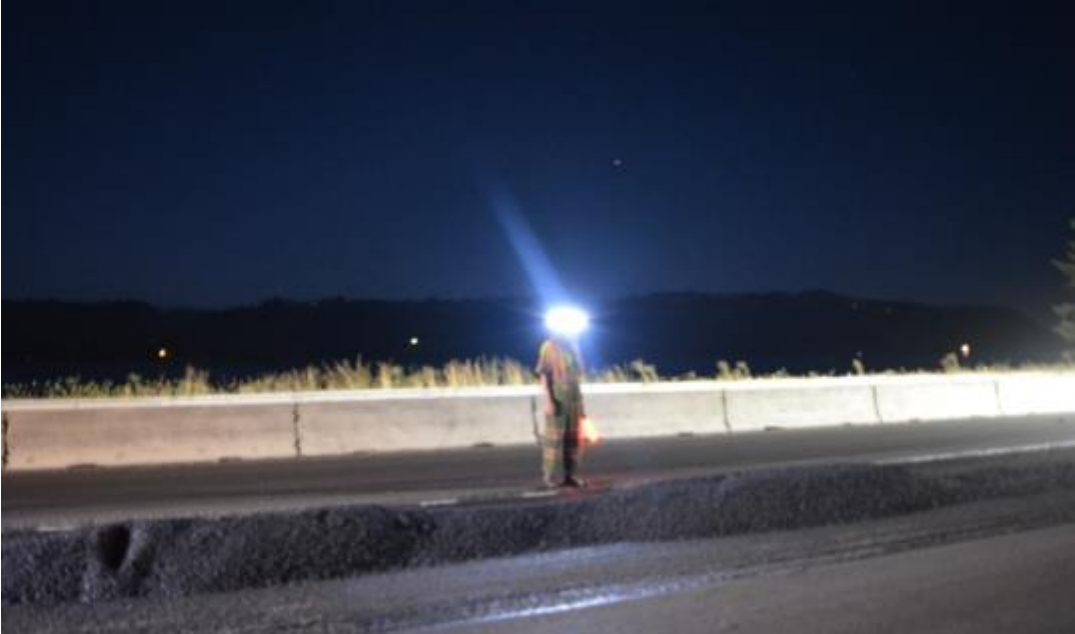
Figure 9.38: Visibility of Worker Wearing Dirty Reflective Garments and Halo Light

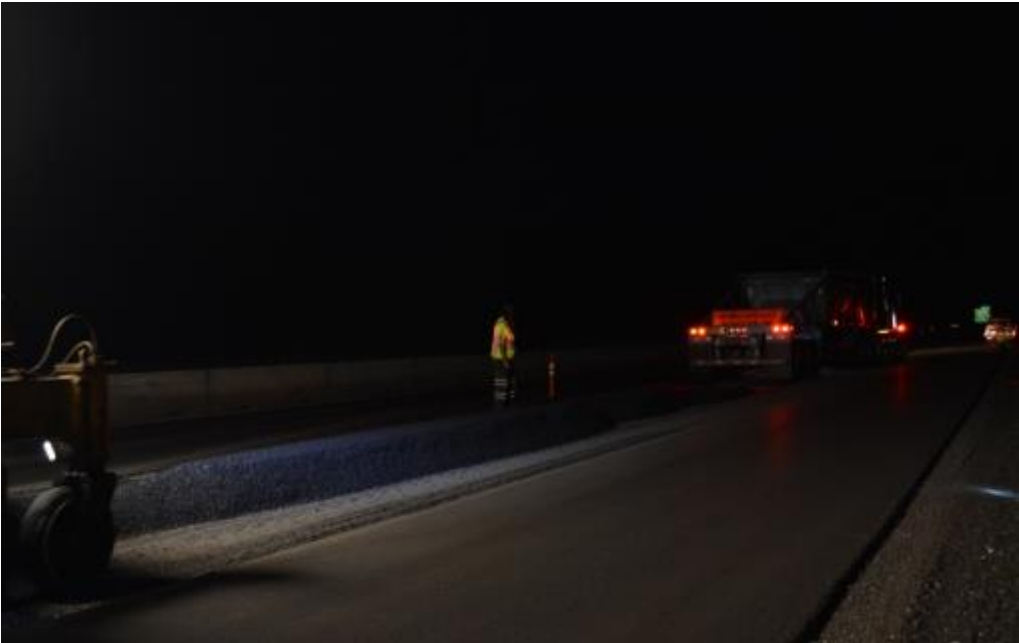
Figure 9.39: Visibility of Worker Wearing Clean Reflective Garments without Halo Light

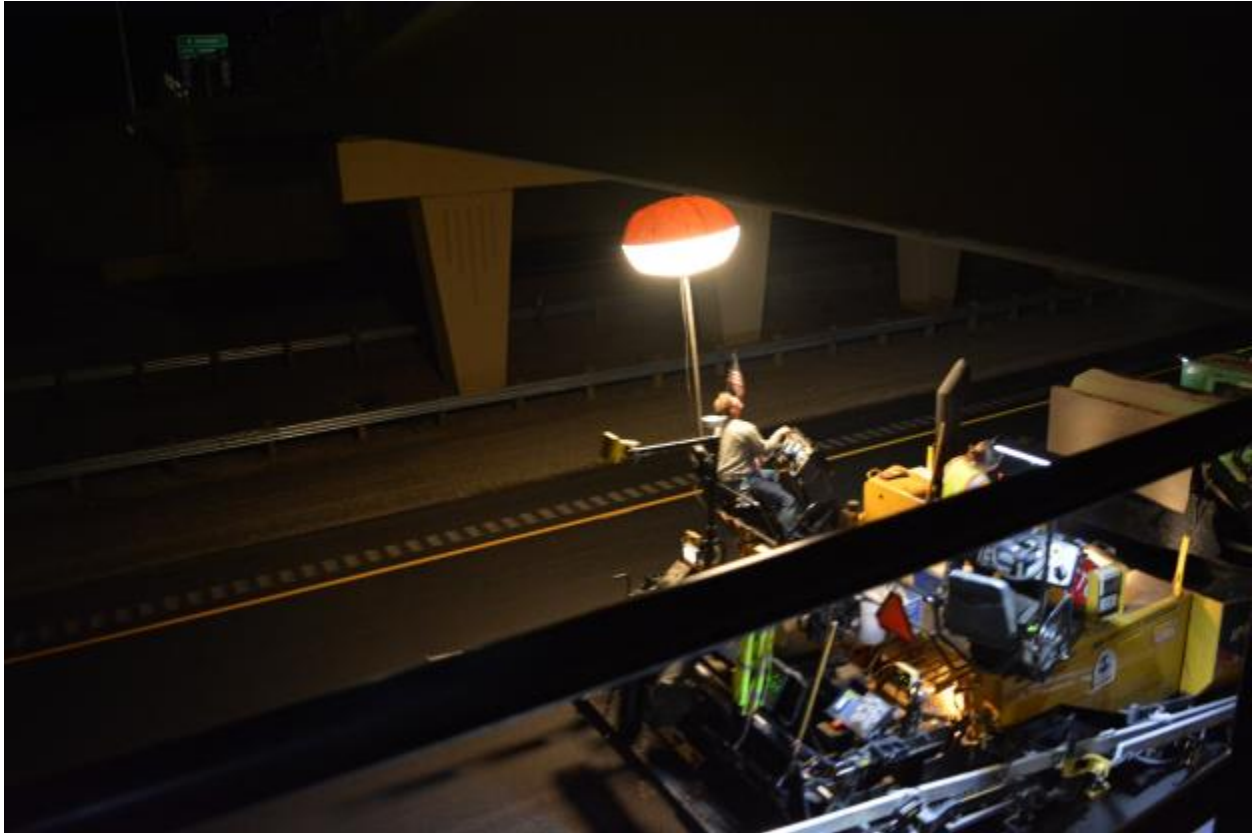
Figure 9.40: Paver Progress being Obstructed by Overpass due to Height of Balloon Light
