**MULTI-MODAL INTERSECTIONS:
RESOLVING CONFLICTS
BETWEEN TRAINS, MOTOR
VEHICLES, BICYCLISTS AND
PEDESTRIANS**

Final Report

SPR 794

Oregon Department of Transportation

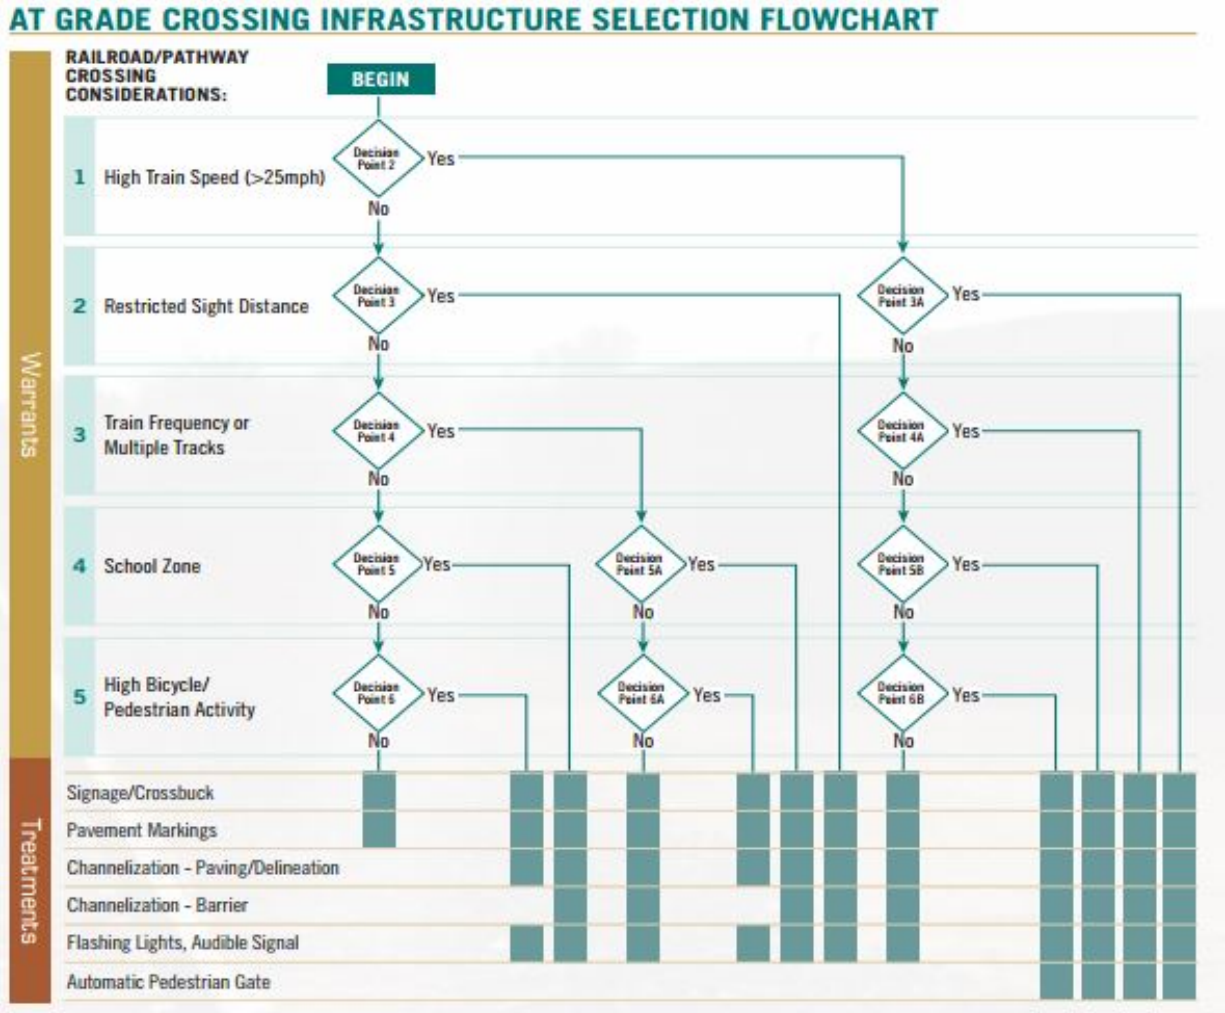
Figure 2.1: At-grade crossing infrastructure selection flowchart (MAG, 2014)

The Arizona-based regional planning organization Maricopa Association of Governments published a report in 2014 with recommendations for improving safety for pedestrians and bikes at crossings. With the report, they developed a flowchart to decide which treatments should be used at an at-grade crossing. The flowchart is shown in full below.

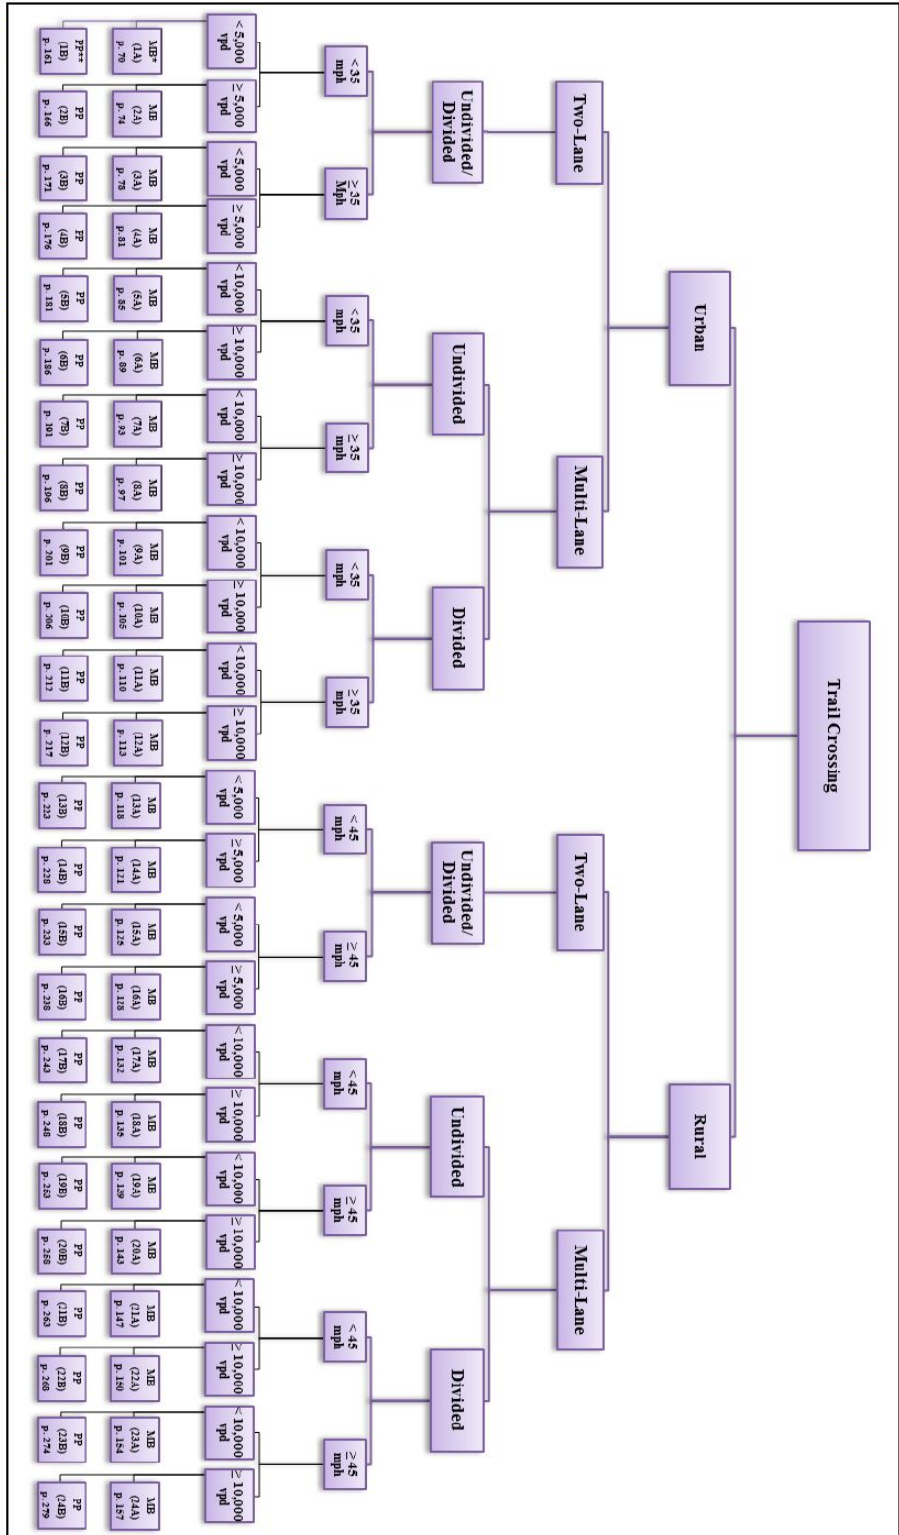
*MB denotes the Middleblock trail-roadway crossing;
 **PP denotes the Parallel Path trail-roadway crossing; and,
 () denotes the look-up table that contains all alternative treatments for the corresponding type of trail crossing.

A similar approach was completed previously, where a thorough study from Minnesota resulted in the decision tree in figure 2.3, which is used to determine which type of treatment should be utilized

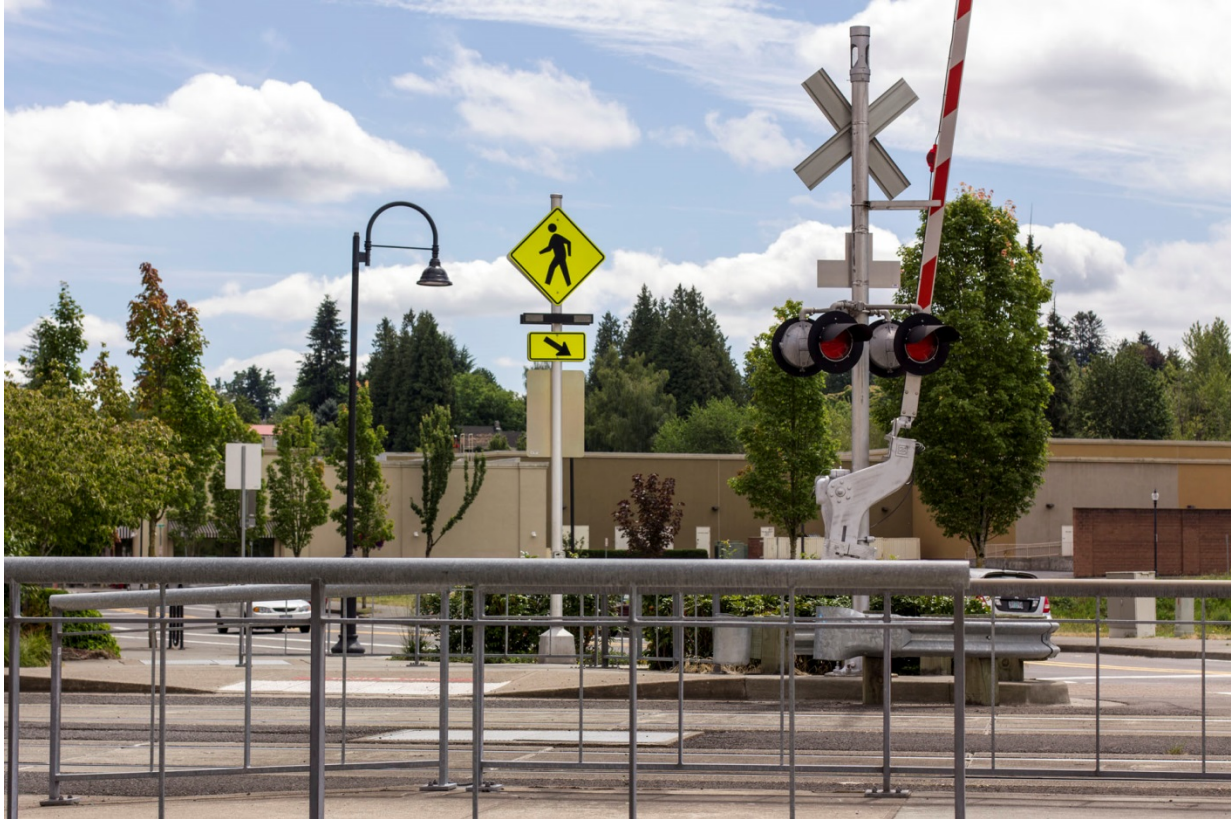
Figure 3.3: Active and passive treatments at the NW Civic Dr crossing

The current treatments at this site includes a variety of active and passive equipment. The crossing is fitted with active gates, lights and bells. Signage includes a 2-tracks cross buck, a sign telling pedestrians to look both ways, and signs pointing out the sites of the pedestrian crosswalk field. Underneath the pedestrian crosswalk sign, which can be illuminated with the help of a push button (Rectangular Rapid Flash Beacon), a sign telling drivers to not stop on tracks is installed. Where the tracks can be crossed, channelization has been installed to make pedestrians look both ways. The Z crossing enables the pedestrian and the train operator to be in nearly constant eye contact during the crossing movement. The use of a median refuge island separates the crossing into two movements. These are accompanied by an active mini pedestrian light and bell between the two sets of tracks, and a sign telling pedestrians to look both ways. There is a stop line for road users and no median. The pedestrian crosswalk zone is furthermore marked using a different type of surfacing.

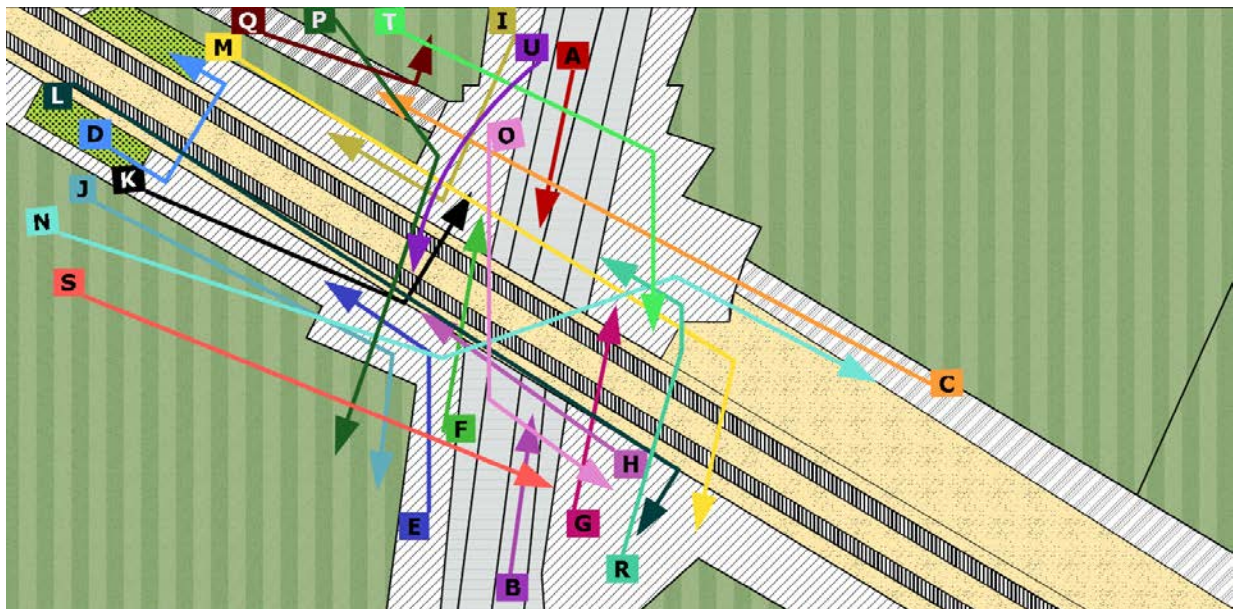
Figure 3.9: Diagram depicting observed pedestrian and bike movements

Most frequently observed pedestrian movements, Movements I & J involve keeping to the sidewalk.

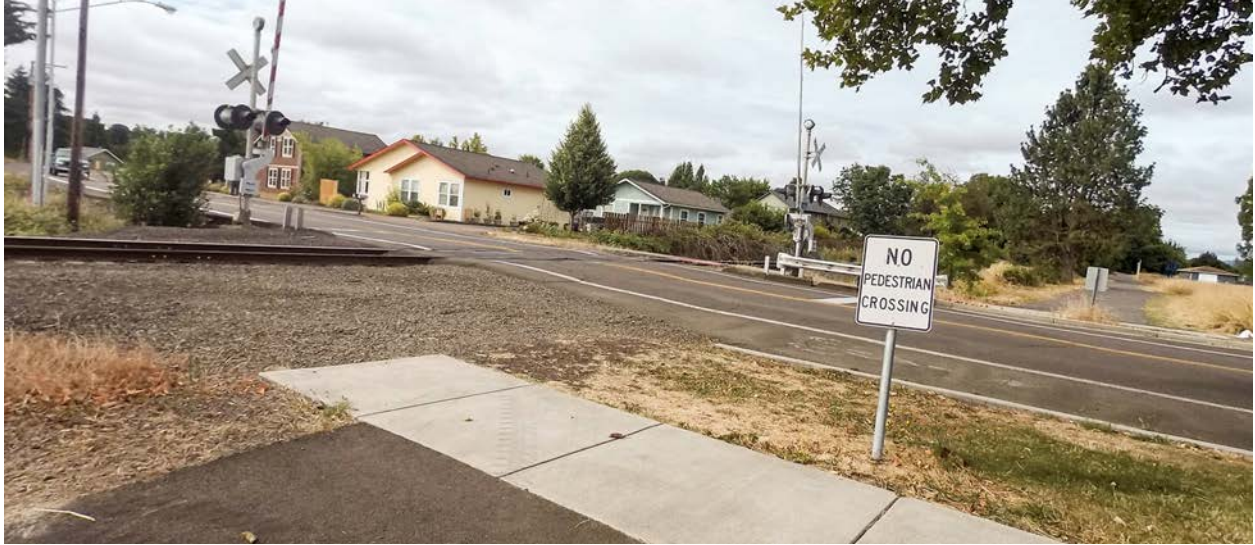
Figure 3.35: The sidewalk suddenly stops at the tracks

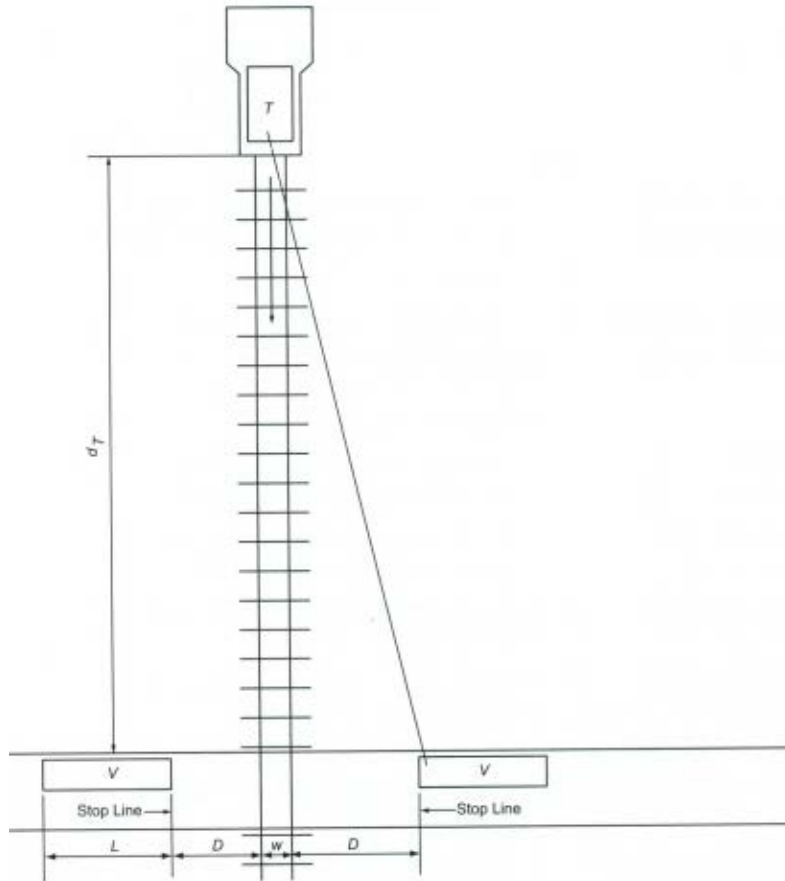
Figure 4.3: Sight line for stopped vehicles (AASHTO, 2012)

$$d_a = \frac{V_G^2}{2a_1} = \frac{(8.8)^2}{(2)(1.47)} = 26.3 \text{ ft} = \text{Distance vehicle travels while accelerating to maximum speed in first gear (ft)}$$
