JOINT REMOVAL IMPLICATIONS – THERMAL ANALYSIS AND LIFE-CYCLE COST

Report No. CDOT-2018-12

April 2018

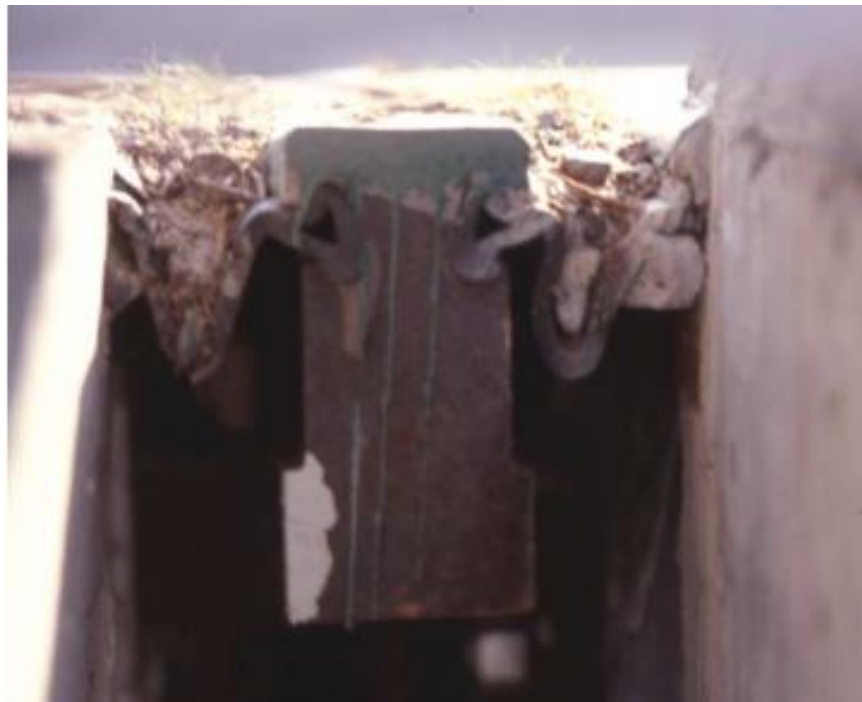
Figure 2-2. Debris in expansion joint in service for less than six months (Chen, 2008)

In order to function properly, expansion joints must be able to freely expand and contract without significantly affecting the driving surface of the road. As illustrated in Figure 2-2, debris build up in an expansion joint less than six months old can prevent it from closing in warmer weather to accommodate thermal loads (Chen, 2008). Routine maintenance is required to keep expansion joints in working order.

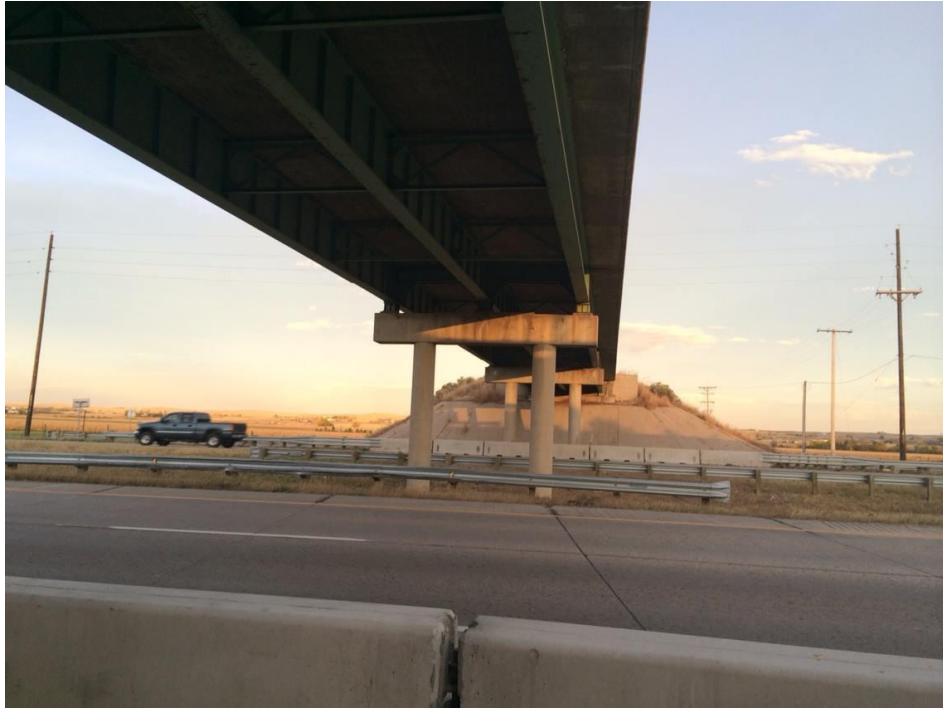
Figure 3-2. B-16-FM Superstructure from the West Abutment (photo by Authors)

The bridge possesses three steel plate girders with varying flange thicknesses, bearing and intermediate stiffeners, and steel diaphragms. Traffic crosses the bridge through one east bound and one westbound lane. Figure 3-2 the superstructure from under the west abutment of the bridge.

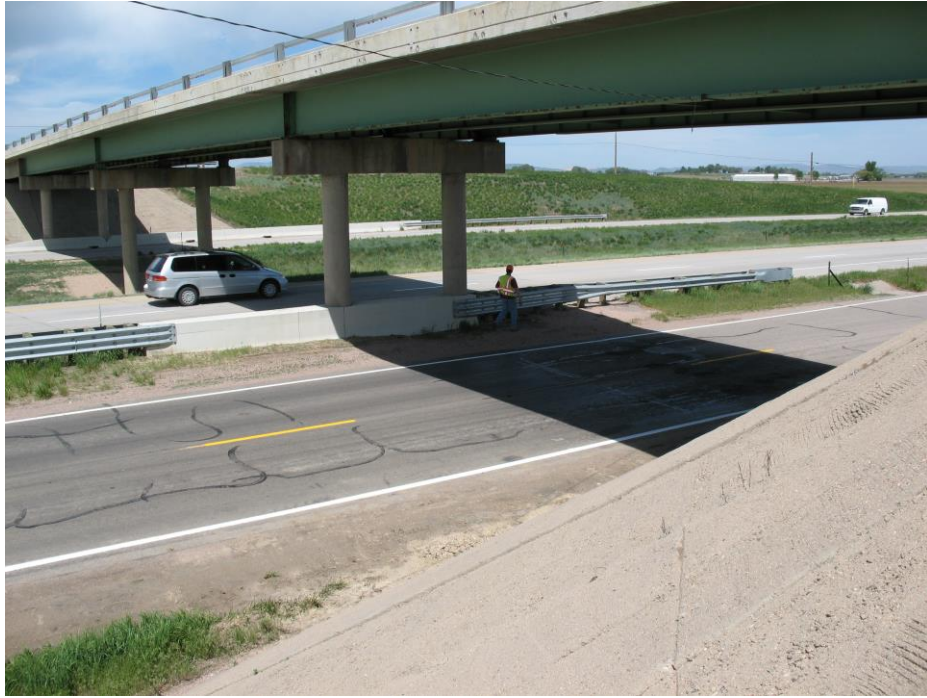
Figure 3-3. View of B-16-FM from East Abutment (Photo courtesy of CDOT)

The bridge consists of 4 spans (3 steel spans and 1 short, concrete approach span). The three steel spans are 74'6" feet in length, simply supported, and separated by expansion joints. Figure 3-3 shows another view of the superstructure and piers. Finger joints, a common type of expansion joint, shown in Figure 3-4, are in place over the expansion joints to allow thermal movement. The spans are supported on rocker bearings that transfer the loads to the piers.

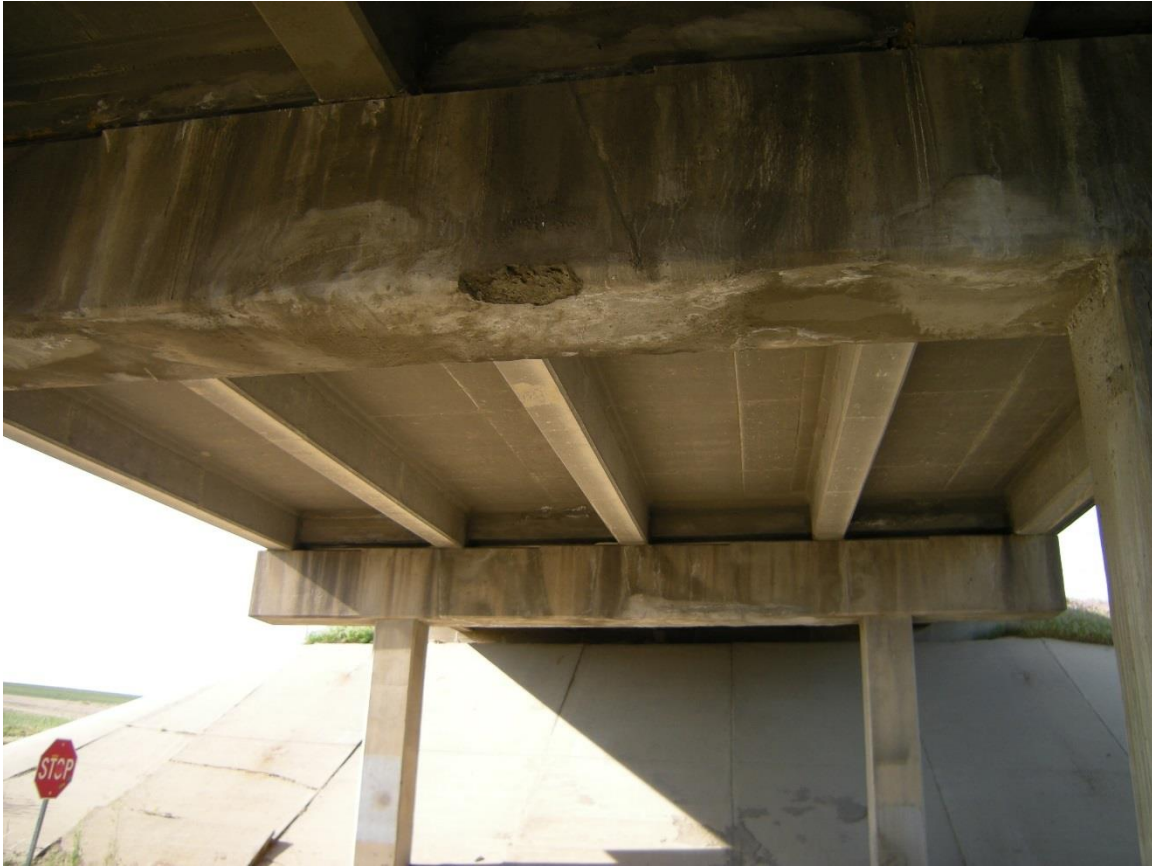
Figure 3-7. Discoloration under expansion joint on C-17-AT (Photo courtesy CDOT)

The concrete girders are traditionally reinforced, the spans are simply supported, and two expansion joints separate the three spans. Extensive corrosion and damage is observable below the deck joints. Figure 3-7 shows the discoloration of the pier caps that are directly below the expansion joints.

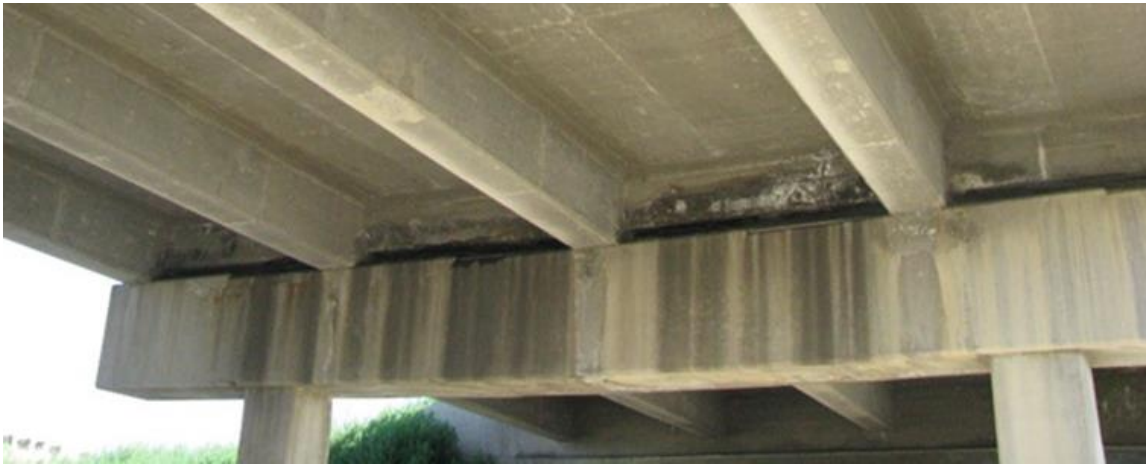
Figure 3-10 C-17-AT Underside – Corrosion & Leakage

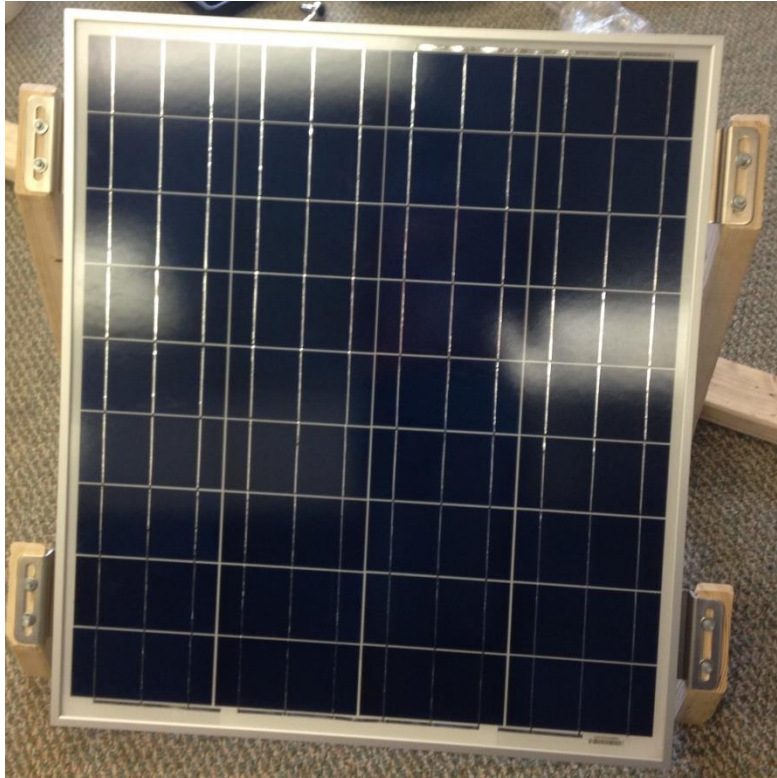
Figure 3-30 Solar Panel, 70 Watt

The location of bridge C-17-AT does not provide access to electricity, consequently alternative sources of energy for powering the CR9000X system were considered. First, rechargeable batteries were considered. These would be switched out and recharged by either CSU or CDOT personnel. The second option considered was a rechargeable battery charged by solar panel attached to the abutment. This second option proved to be both more cost and time effective because it would not require regular trips out to the bridge. The cost of the solar panel proved to be comparable to a second rechargeable battery and significantly cut maintenance hours. The battery chosen is a deep cycle 12 Volt marine battery, a Diehard Group 27M. The solar panel chosen is a Newpowa 70-Watt panel with a 12-Volt solar charge controller to prevent over charging of the battery. The solar panel weighs 13 pounds and is 30.48 in x 26.57 in x 1.18 in and is shown in Figure 3-30 below.

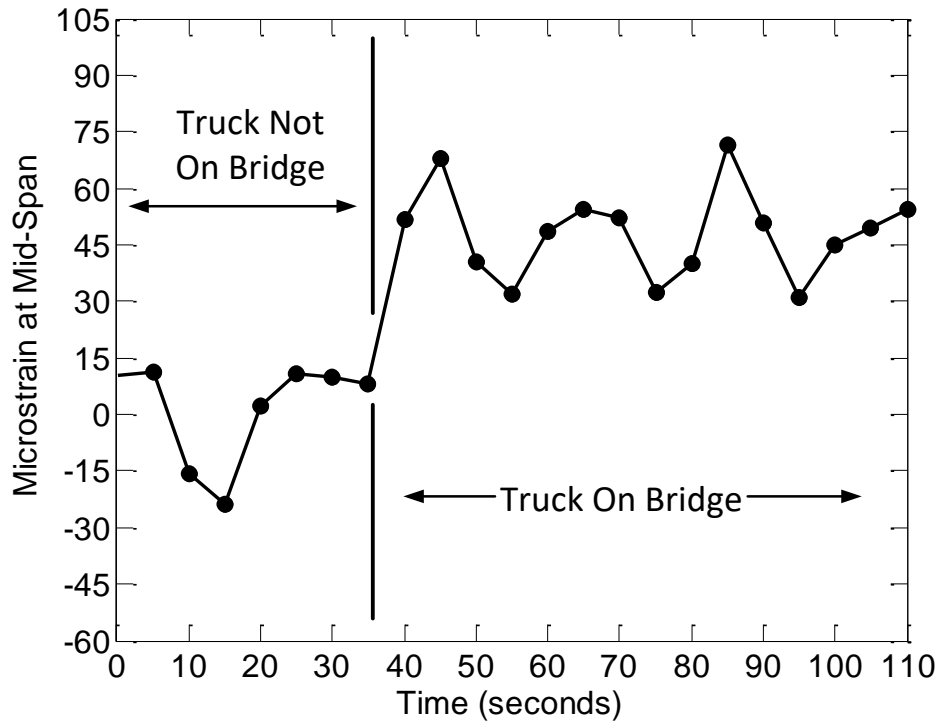
Figure 4-4. Field Control Load Test with Front Axle of A-40 Truck at Mid-Span

Control load tests were performed with the front axle at mid-span and again with the rear axles at mid-span to match the scenarios that were modeled. During each test the data from the mid-span strain gauge was collected in the field at five second intervals for approximately one minute. Some noise in this data was expected due to the length of the wires being approximately 240 ft. Collecting several data points allowed a moving average to be applied to the data to determine the actual strain. Figure 4-4 shows the microstrain at mid-span when the truck was parked with its front axles at mid-span. Figure 4-5 shows the microstrain at mid-span when the truck was parked with its rear axles at mid-span.

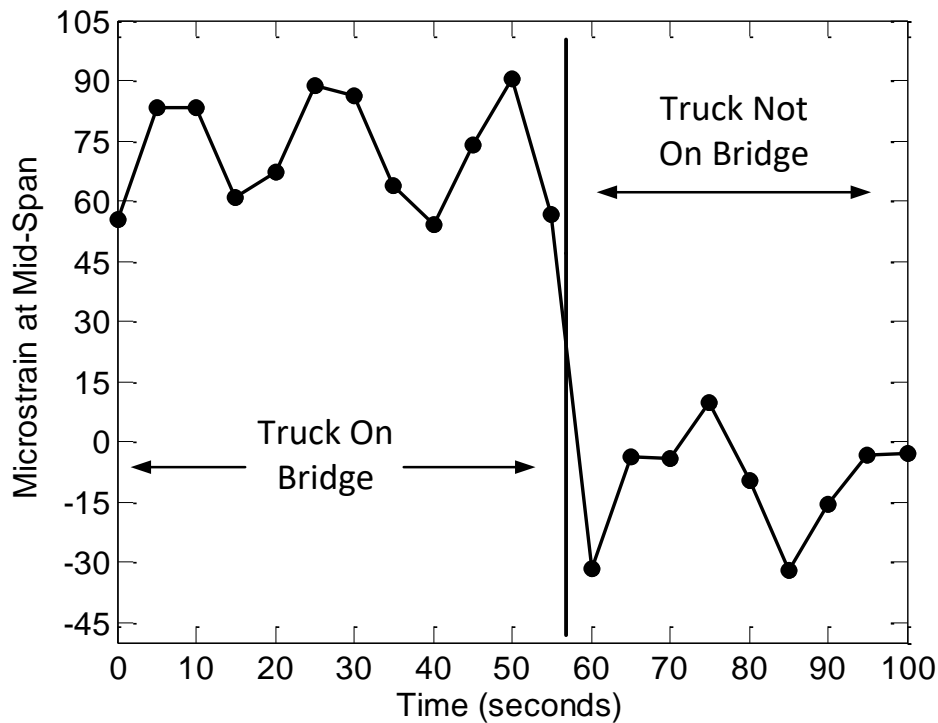
Figure 4-5. Field Control Load Test Microstrain with Back Axles at Mid-Span

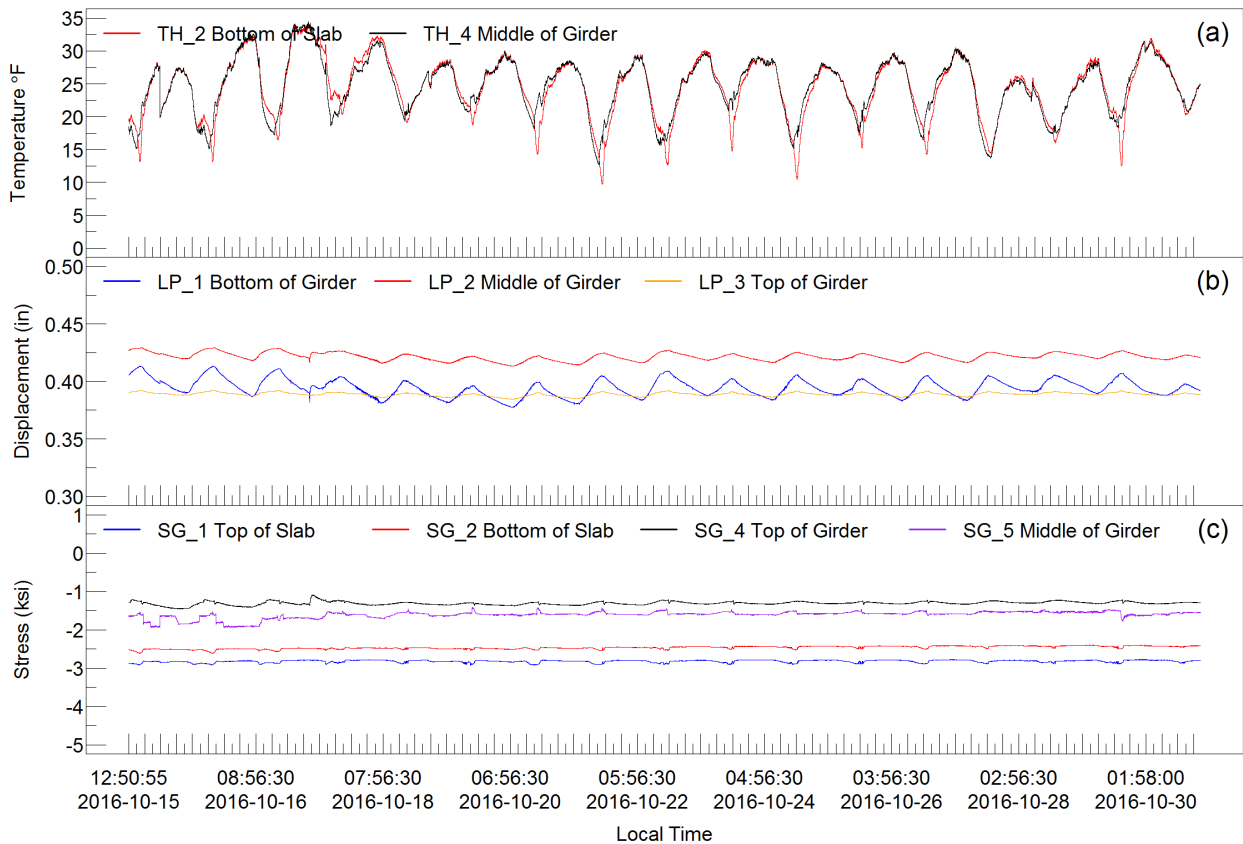
Figure 5-1 C-17-AT Bridge Sensor Data Oct.15th through Oct. 30th, 2016
 (a) Thermocouple Data, (b) Linear Potentiometer Data, (c) Change in Stress Data.

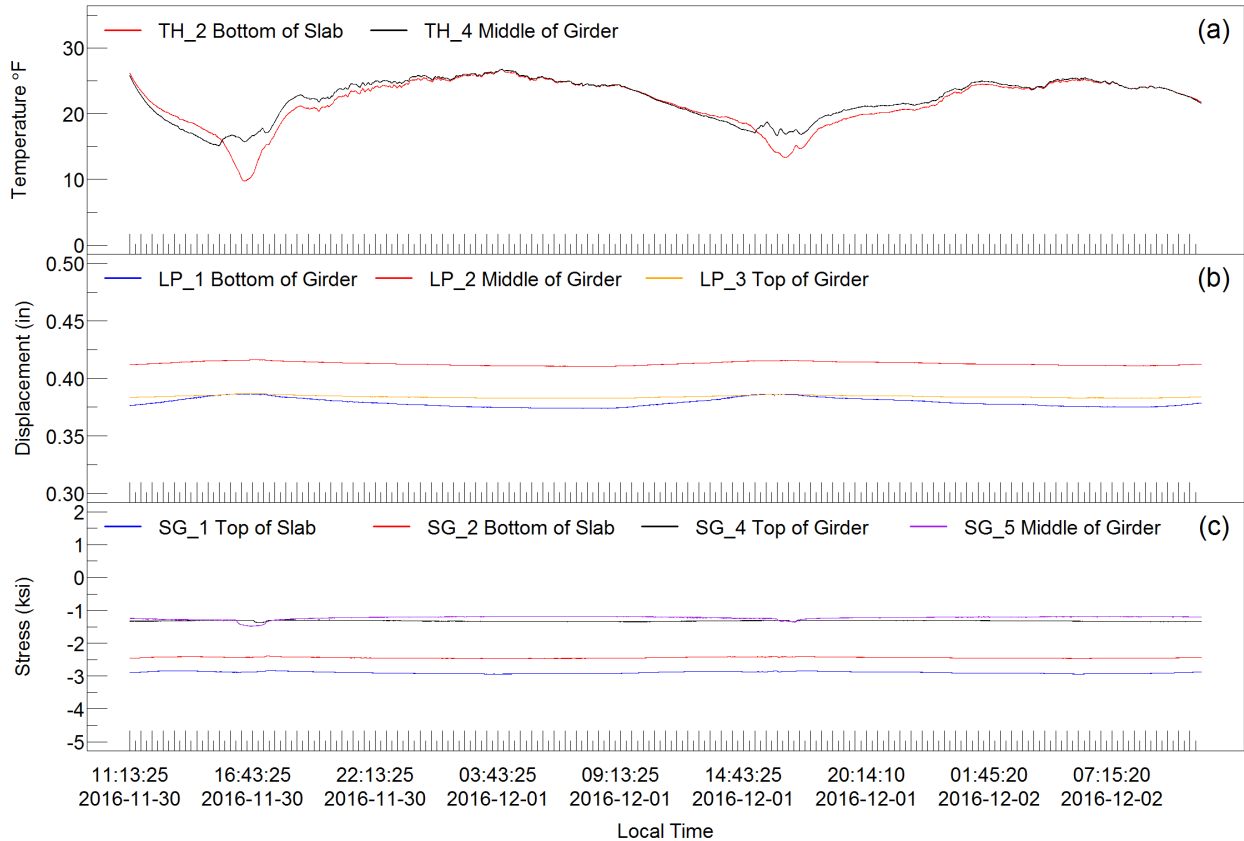
Figure 5-2 C-17-AT Bridge Sensor Data Nov.30th through Dec. 2nd, 2016
 (b) Thermocouple Data, (b) Linear Potentiometer Data, (c) Change in Stress Data.
 Note: $^{\circ}\text{C} = (^{\circ}\text{F} - 32)/1.8$; 1 in = 25.4 mm; 1psi = 6.89 kPa

through October 18th. In Figure 5-2 the temperature range is only approximately 10 degrees and the displacement in (b) shows minimal change, a maximum of 0.05 inches of change in displacement. The stress also shows very little change in (c). On the other hand, looking at Figure 5-3, the temperature range is around 15 degrees and the displacement (b) shows a little more change, a maximum of about 0.09 inches and the stress (c) shows some variance. All of which indicates the importance of the temperature range on the joint and bridge's overall health.

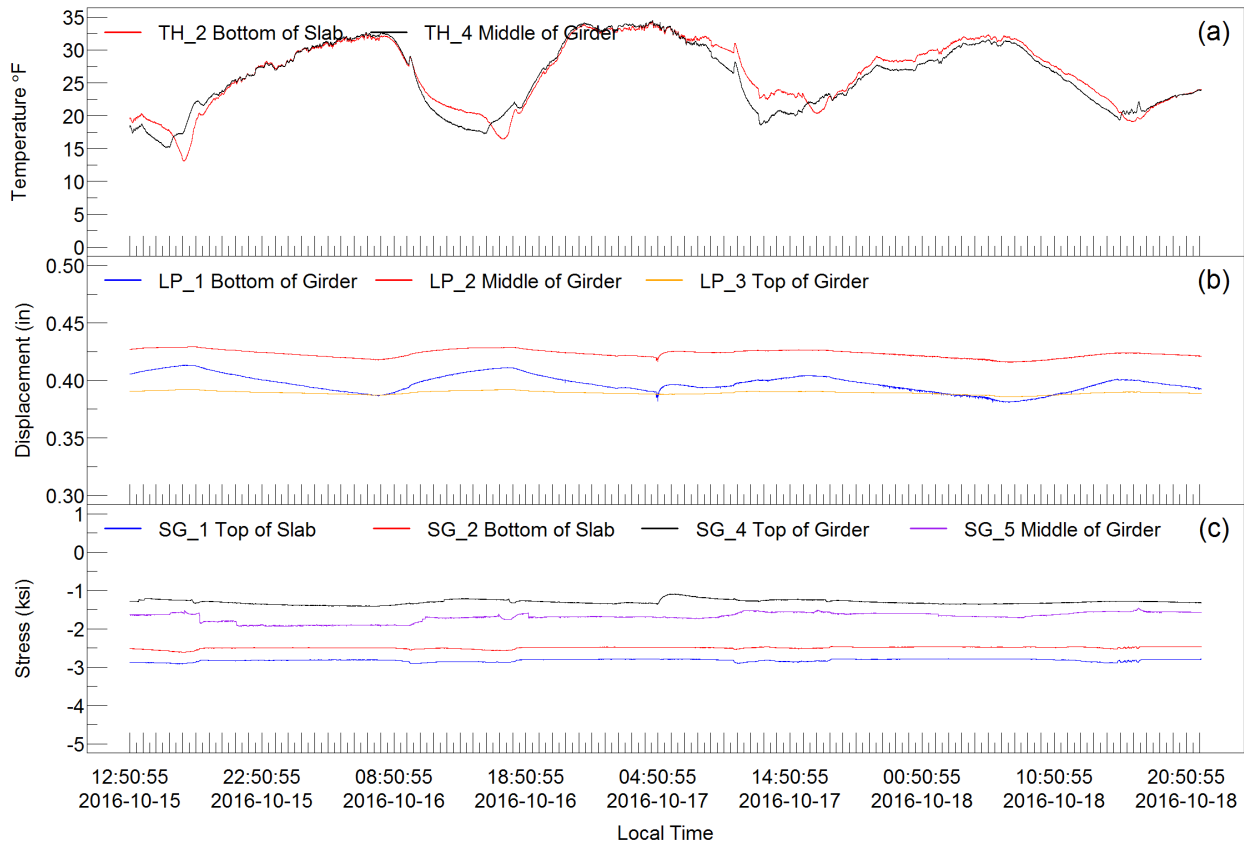
Figure 5-3 C-17-AT Bridge Sensor Data Oct. 15th through Oct. 18th, 2016
(c) Thermocouple Data, (b) Linear Potentiometer Data, (c) Change in Stress Data.
Note: °C = (°F - 32)/1.8; 1 in = 25.4 mm; 1psi = 6.89 kPa

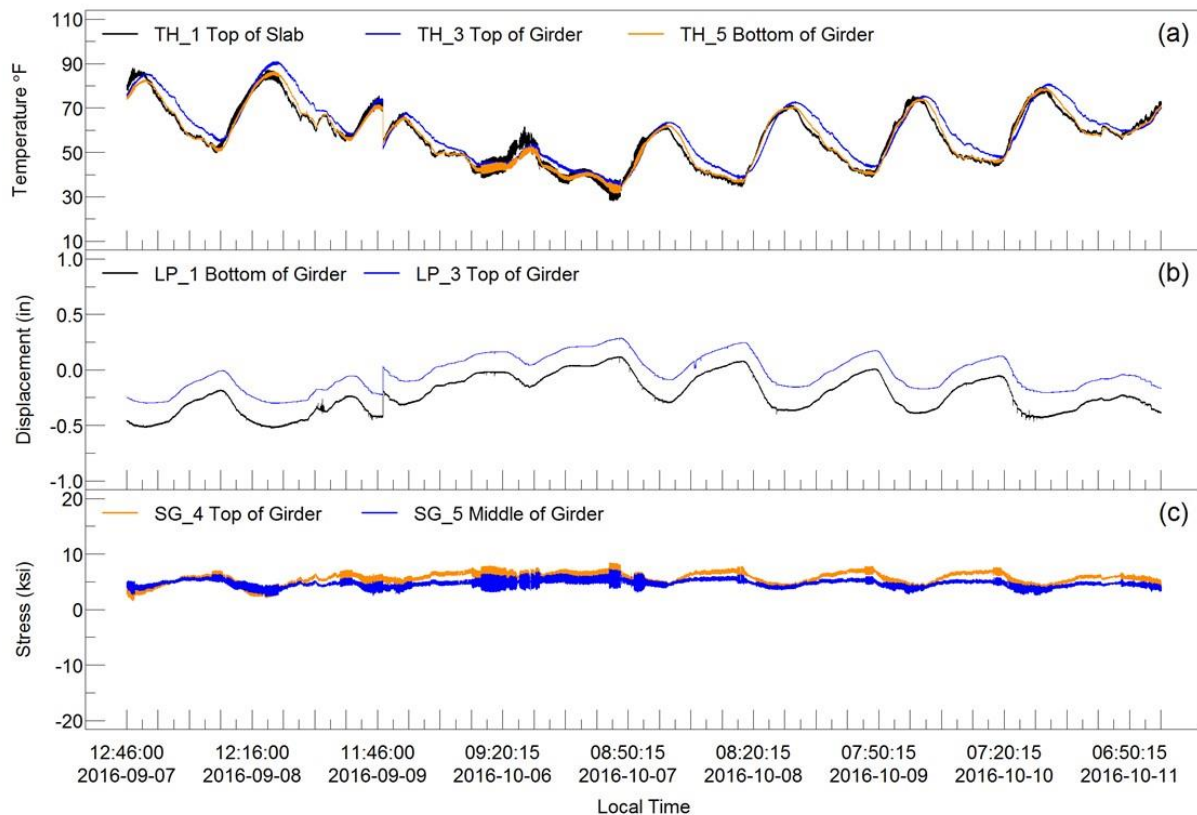
Figure 5-4 B-16-FM Bridge Sensor Data Sept. 7th through Oct. 11th, 2016
 (d) Thermocouple Data, (b) Linear Potentiometer Data, (c) Change in Stress Data.
 Note: $^{\circ}\text{C} = (\text{F} - 32)/1.8$; 1 in = 25.4 mm; 1 psi = 6.89 kPa

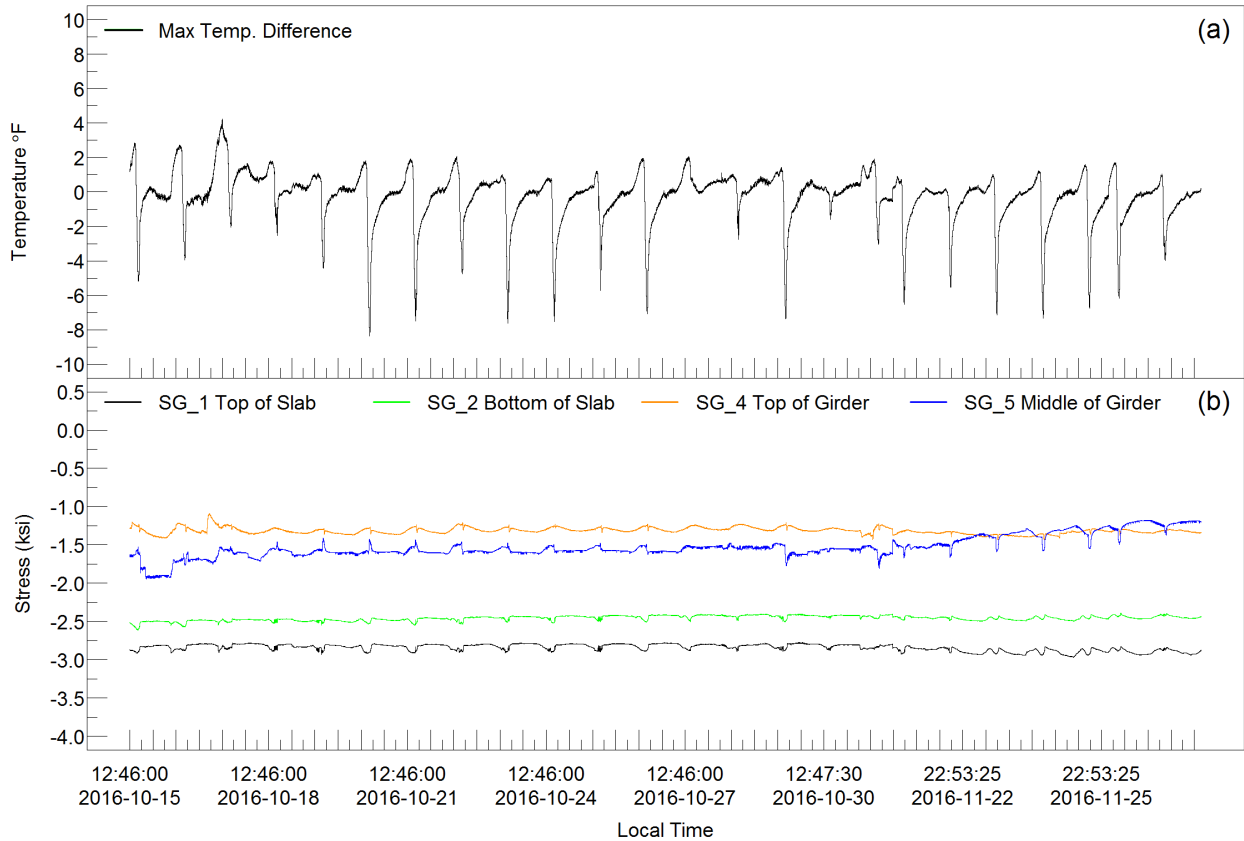
Figure 5-5 Maximum Temperature Difference Through Depth vs Stress Data.
 (a) Max Temperature Difference, (b) Change in Stress Data.
 Note: $^{\circ}\text{C} = (\text{F} - 32)/1.8$; 1 in = 25.4 mm; 1psi = 6.89 kPa

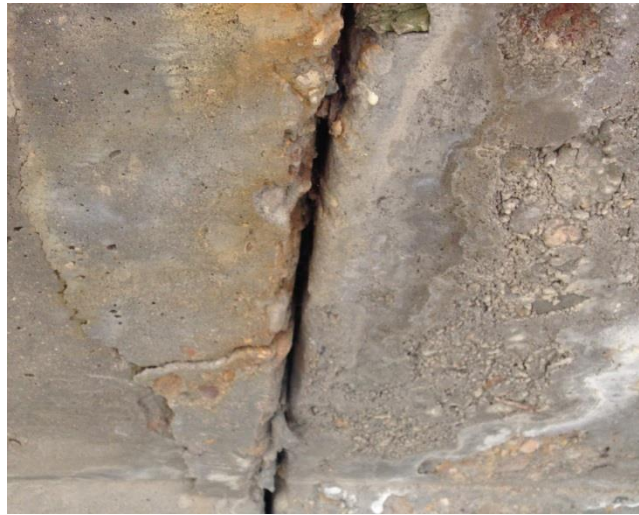
Figure 5-7 Deterioration of C-17-AT Abutments and Joints

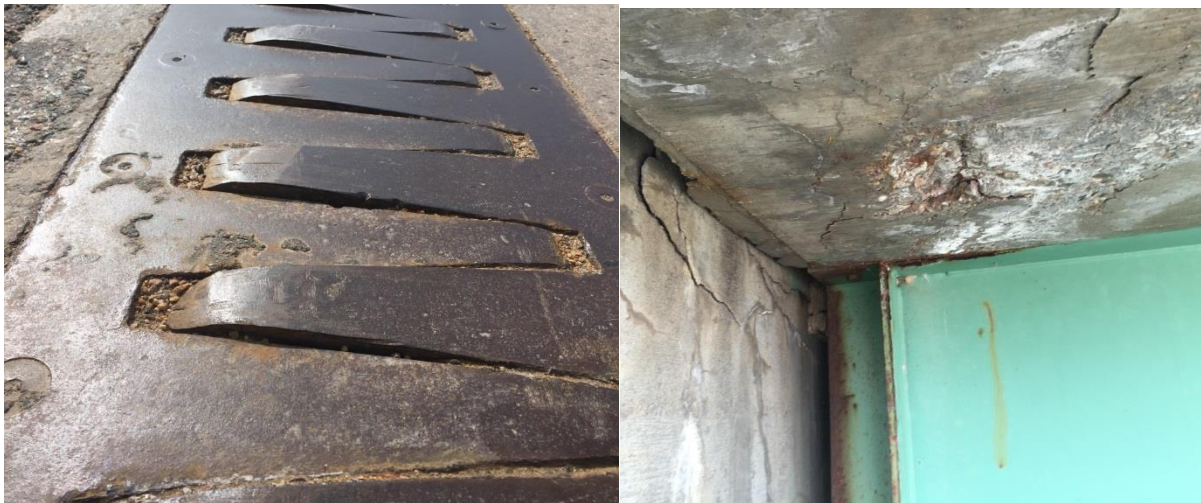
Figure 5-8 Deterioration of B-16-FM Abutments and Joints

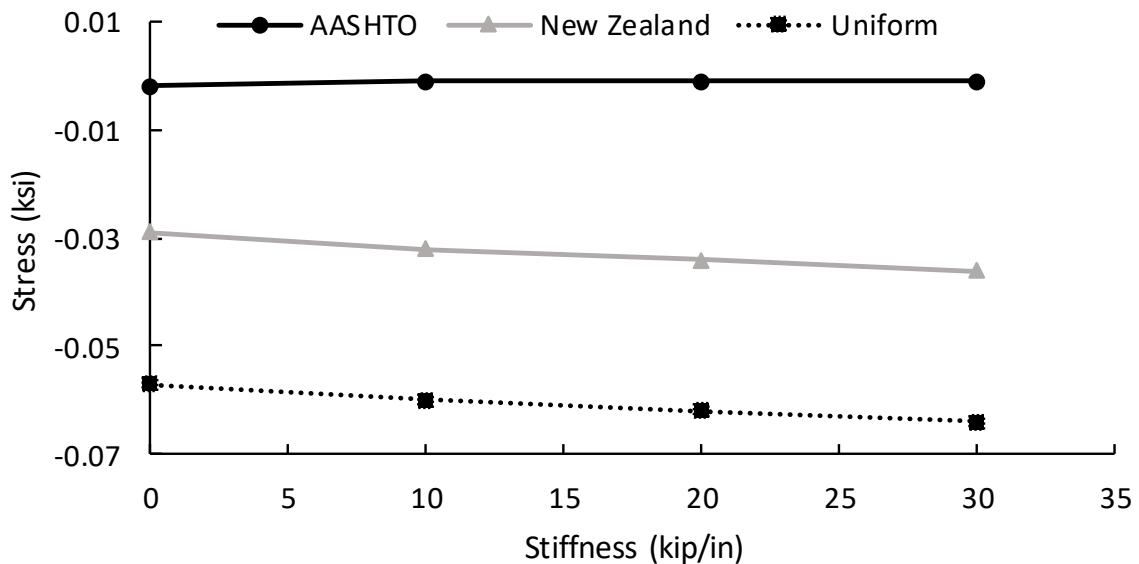
Figure 6-7 Maximum Stress in Bottom of Girder at End

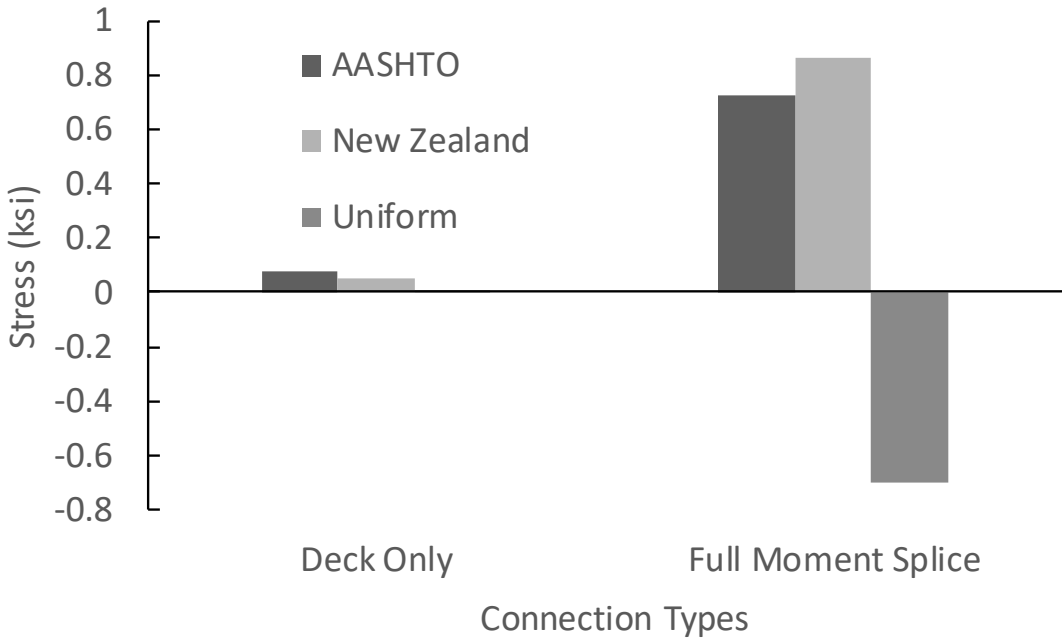
Figure 6-15 Maximum Stress at Bottom of Girder due to Thermal Gradients and Truck Load Combined

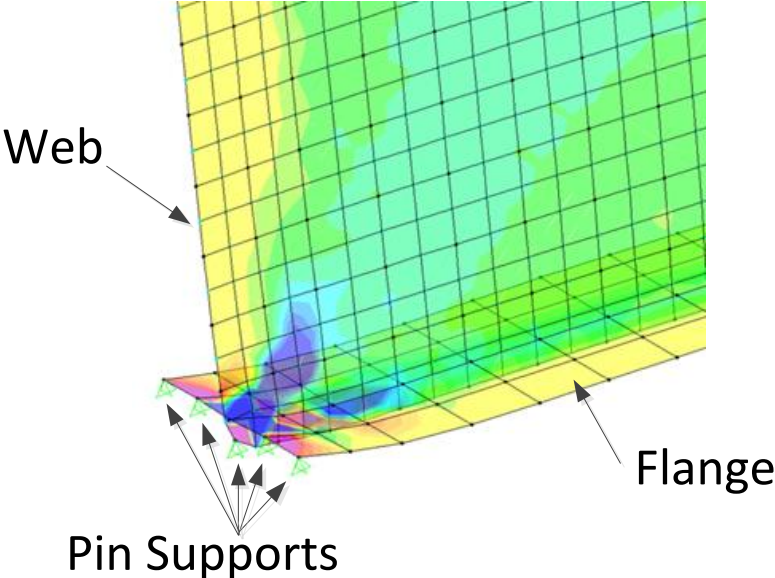
Figure 7-8. Girder Stress Distribution under Self-Weight Showing Shear Lag Behavior

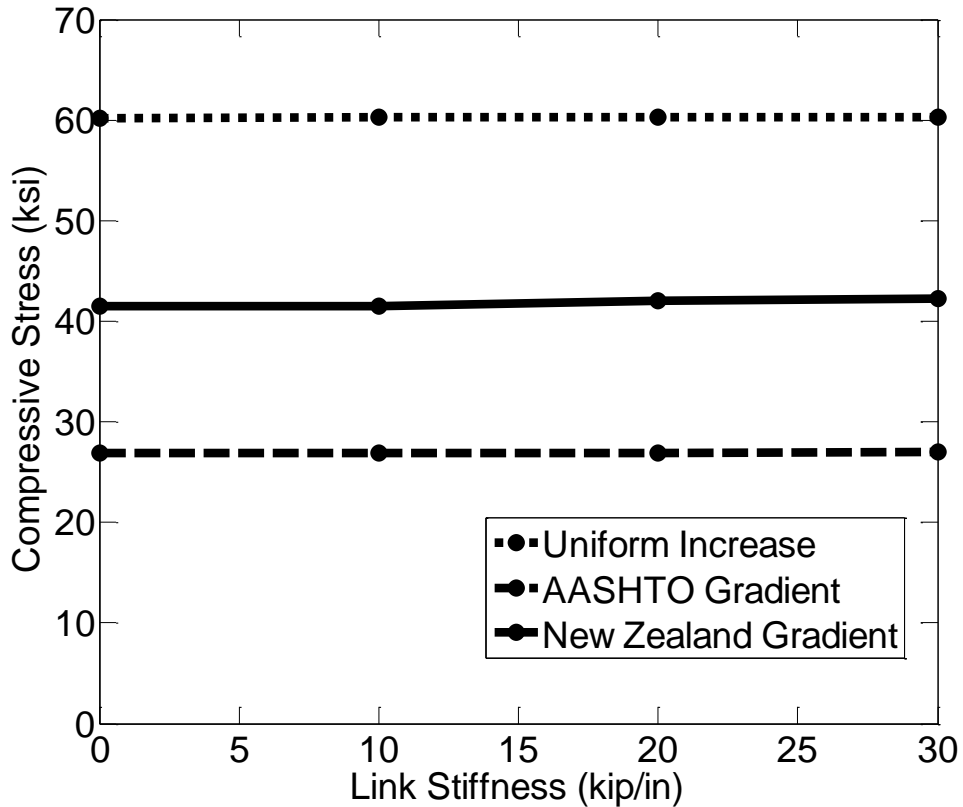
Figure 7-11. Compressive Stress at Bottom of Girder

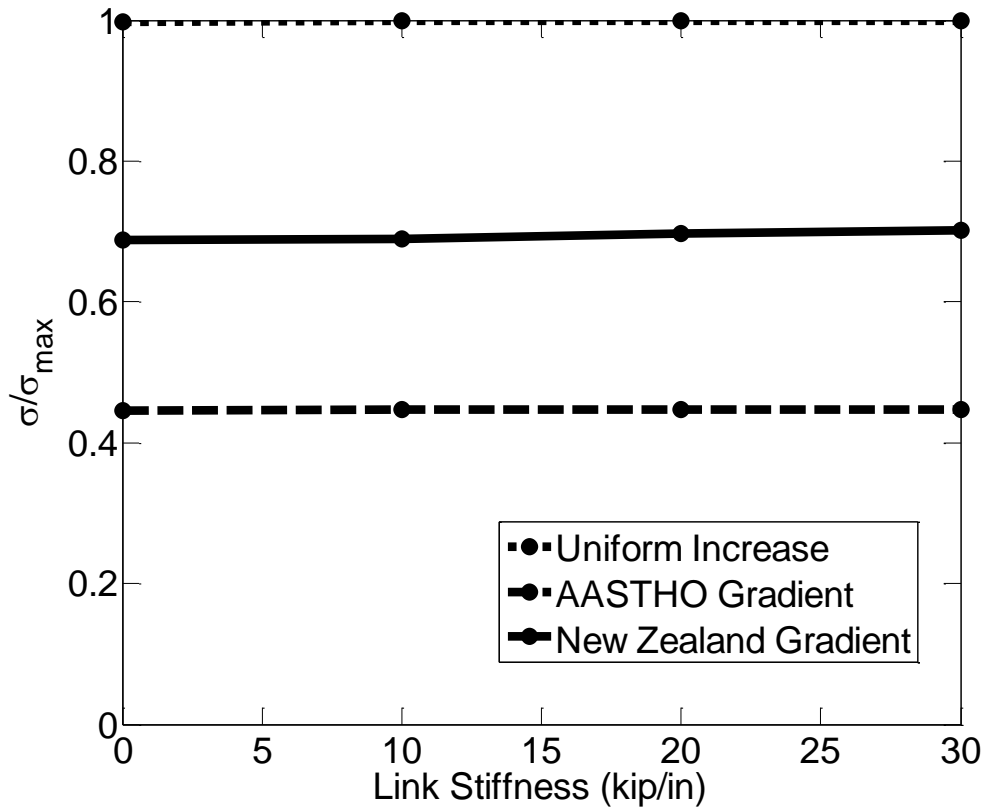
Figure 7-12. Compressive Stress at Bottom of Girder (Normalized)

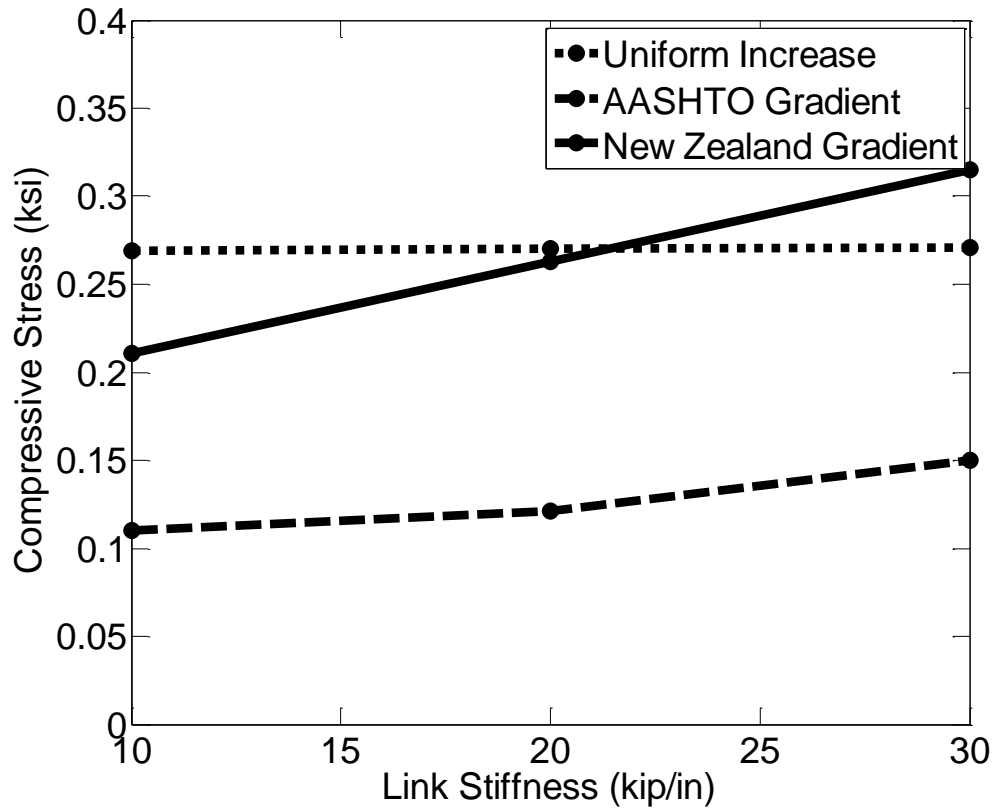
Figure 7-13. Local Compressive Stress in Deck due to Thermal Loading

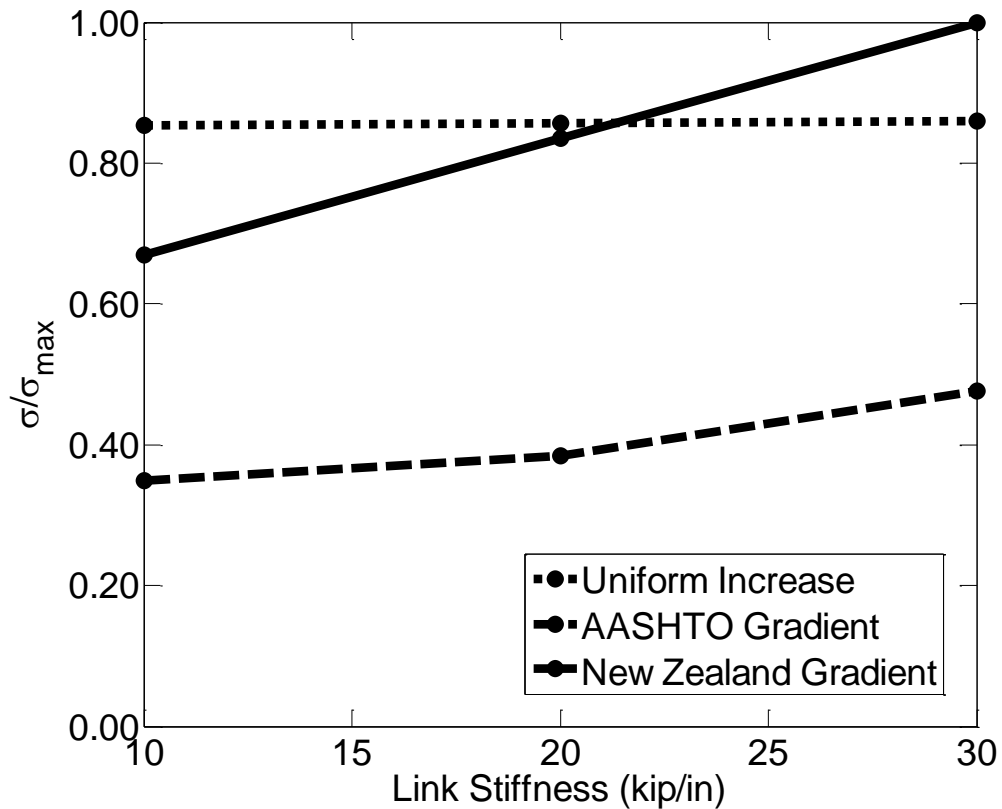
Figure 7-14. Local Compressive Stress in Deck due to Thermal Loading (Normalized)

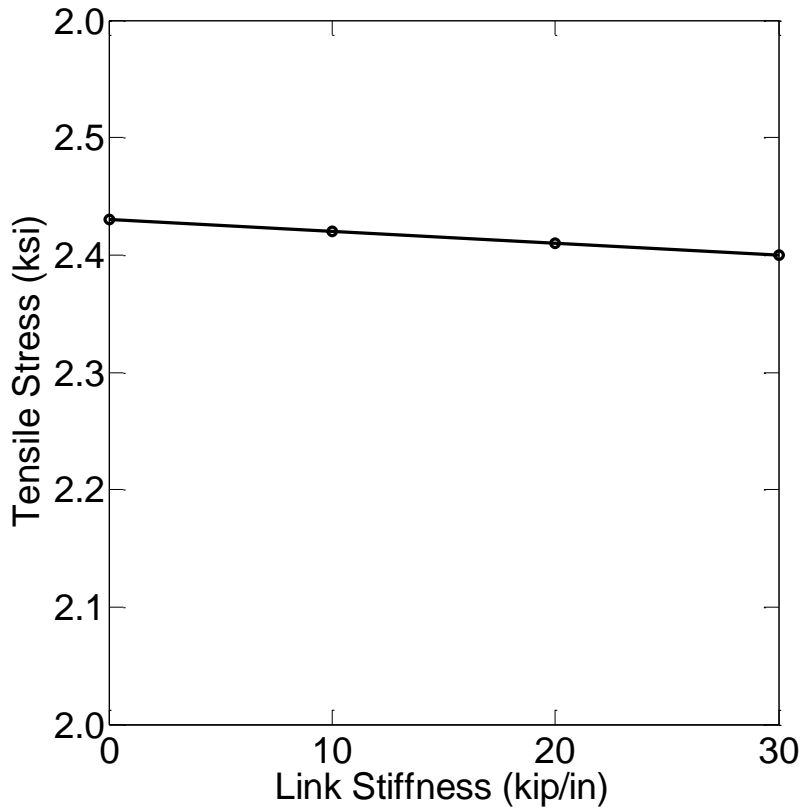
Figure 7-15. Tensile Stress at Bottom of Girder due to Only Truck Loading

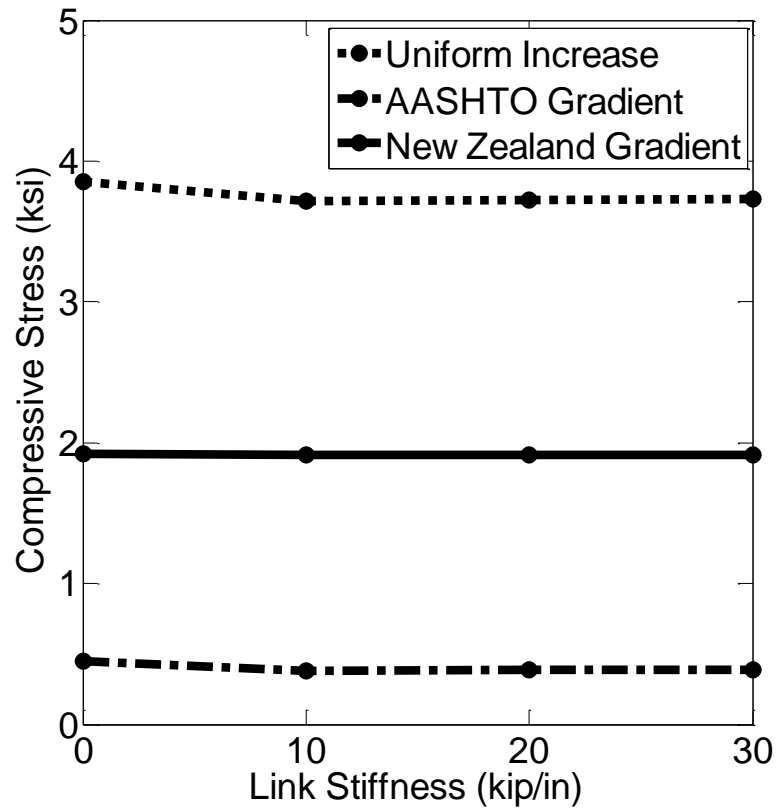
Figure 7-16. Stress at Bottom of Girder under the Truck Load due to Thermal and Truck Loading

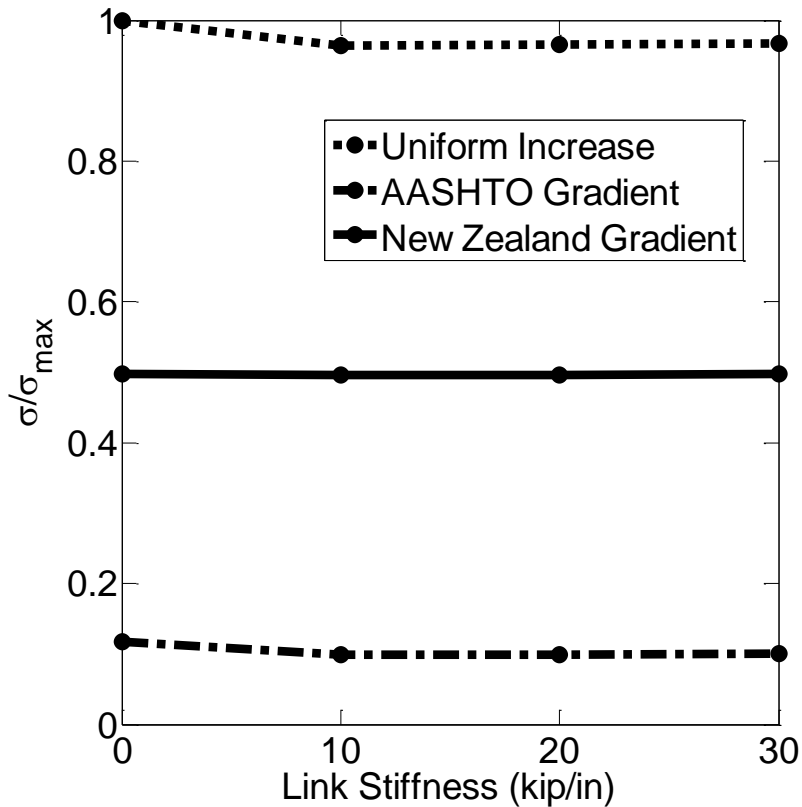
Figure 7-17. Stress at Bottom of Girder due to Thermal and Truck Loading (Normalized)

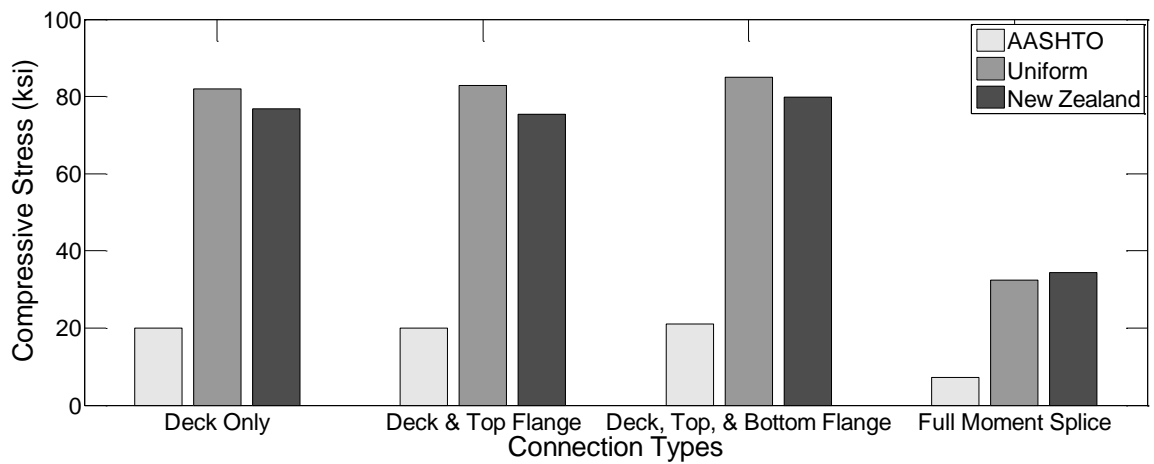
Figure 7-18. Compressive Stress at Bottom of Girder due to Only Thermal Loading

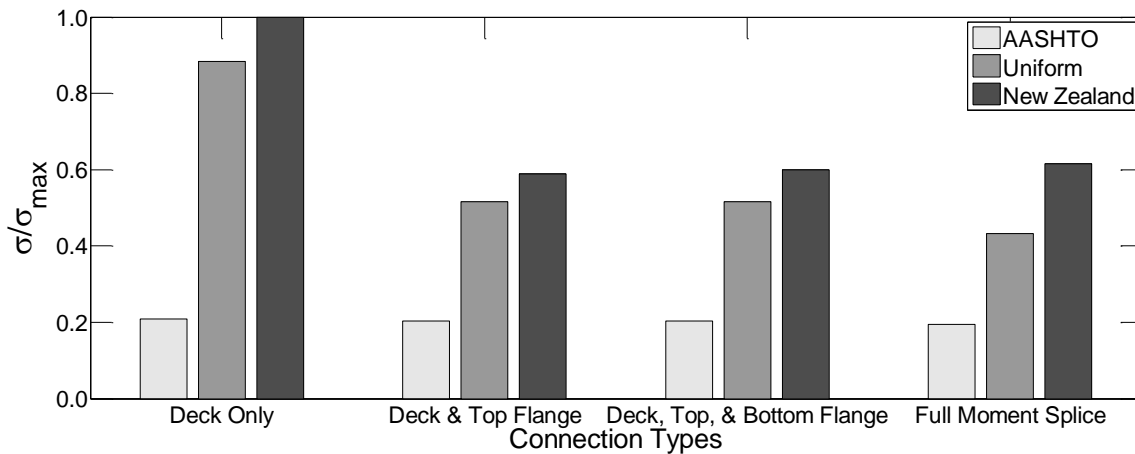
Figure 7-21. Local Compressive Stress in Concrete Deck due to Only Thermal Loading (Normalized)

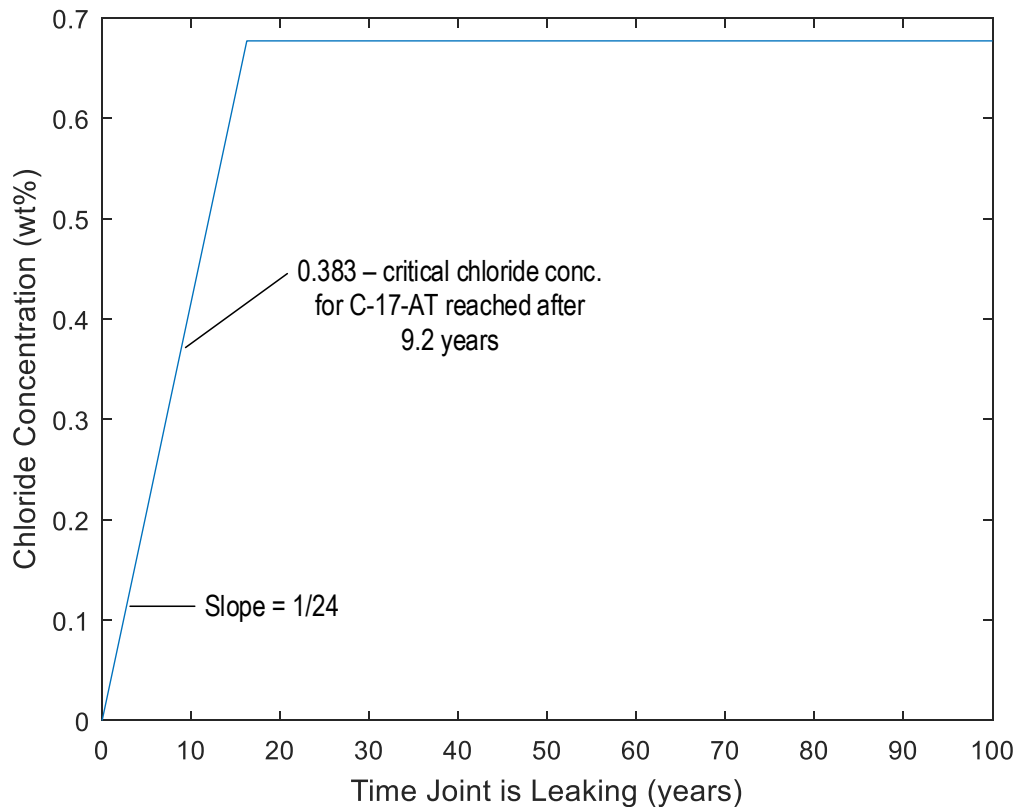
Figure 8-2 Life 365 Chloride Surface Concentration Vs. Time (years) for Colorado
