# Clear-Water Abutment and Contraction Scour in the Coastal Plain and Piedmont Provinces of South Carolina, 1996-99

Water-Resources Investigations Report 03-4064  
Version 1.1, August 2016

*By* Stephen T. Benedict

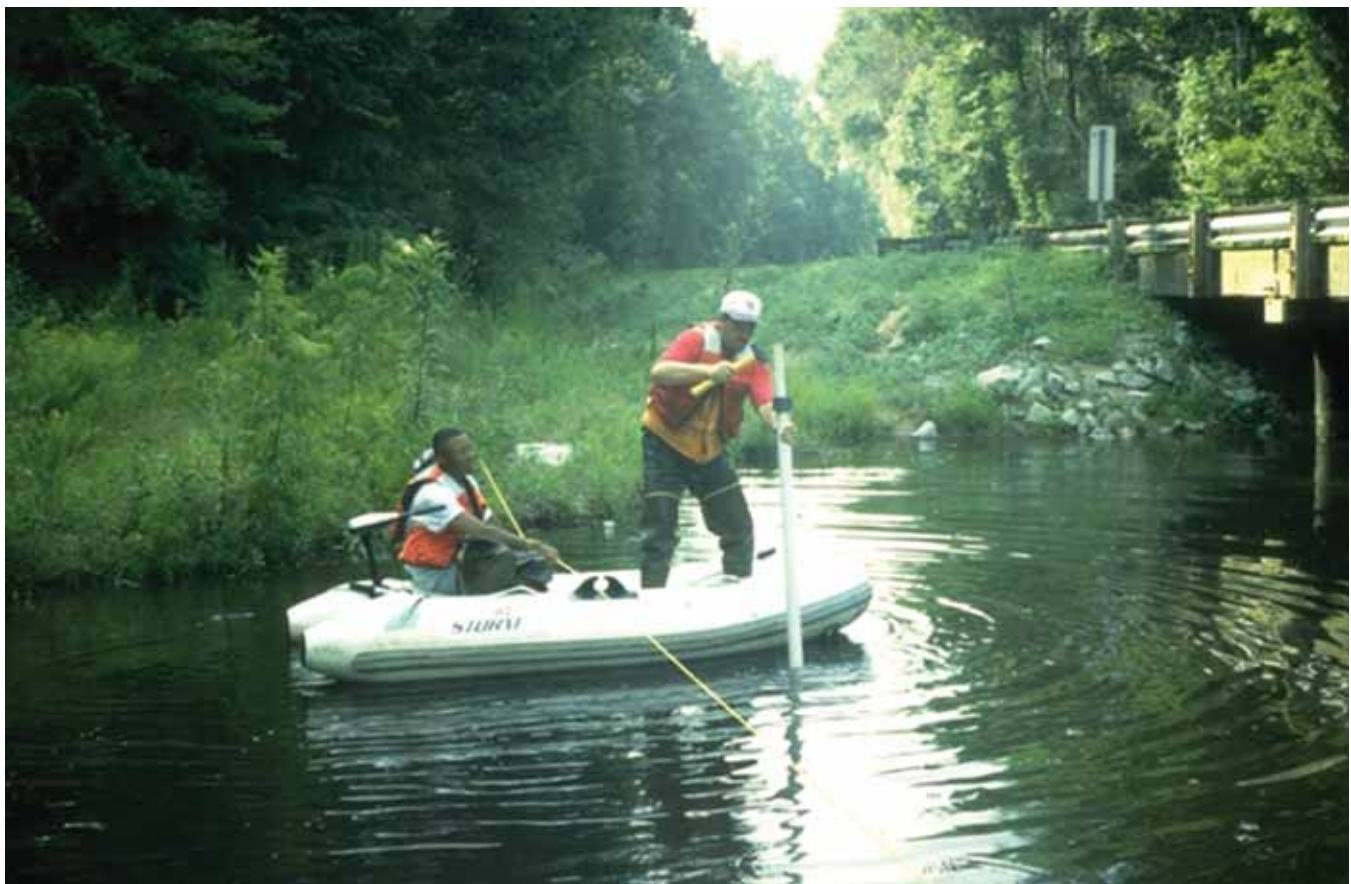
**Figure 8.** Inflatable boat used to collect field data at swampy sites in the Coastal Plain of South Carolina. (Photograph by the South Carolina District, U.S. Geological Survey, 1996.)

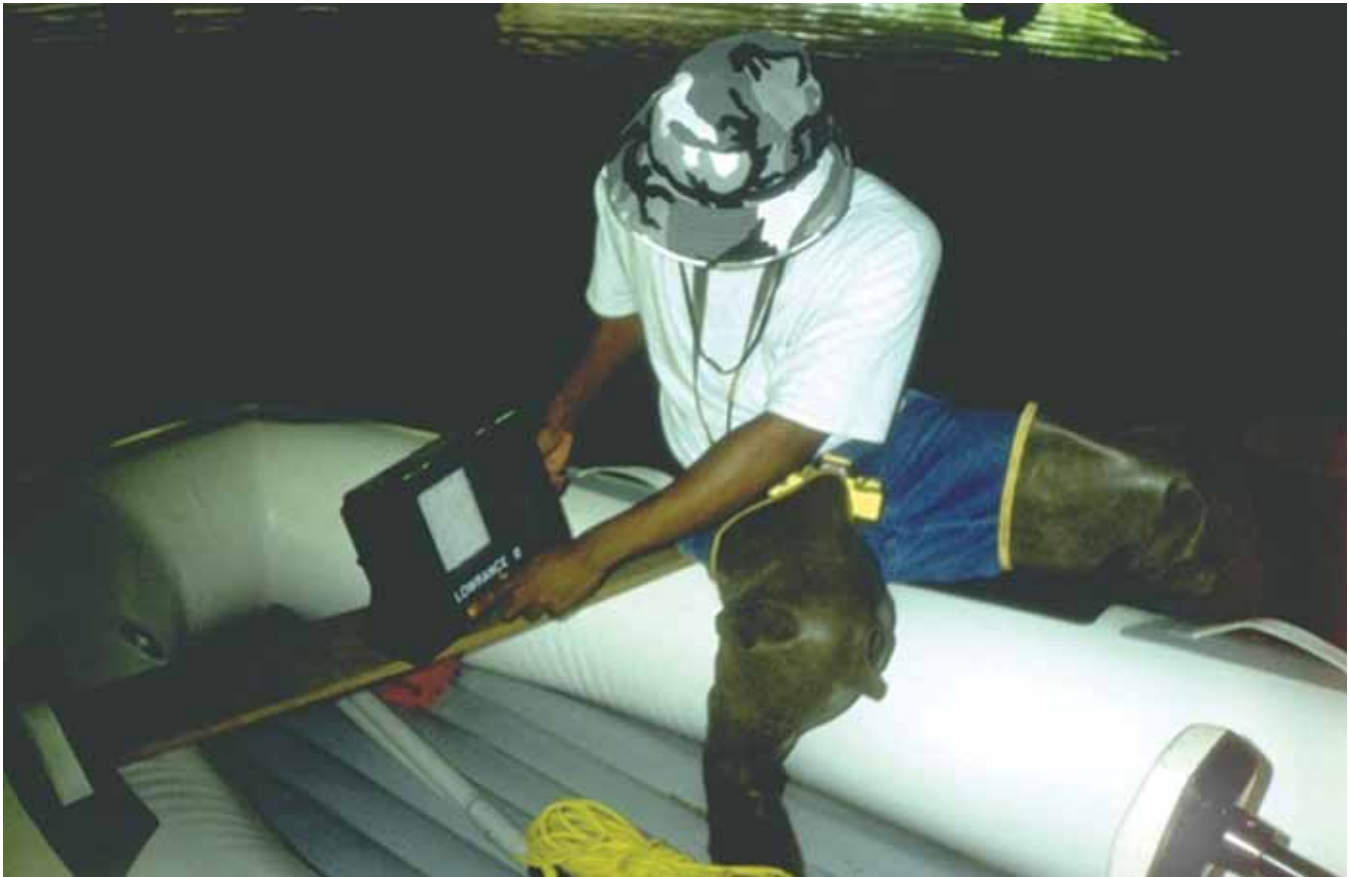
**Figure 9.** Paper-chart fathometer mounted on inflatable boat used to investigate limits of scour holes in the Coastal Plain of South Carolina. (Photograph by the South Carolina District, U.S. Geological Survey, 1996.)

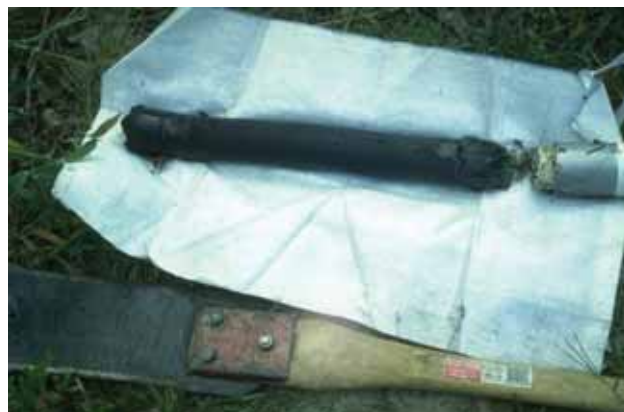
**Figure 12.** Example of sediment core collected from the bottom of a submerged scour hole using the drive-tube coring device. (Photograph by the South Carolina District, U.S. Geological Survey, 1996.)

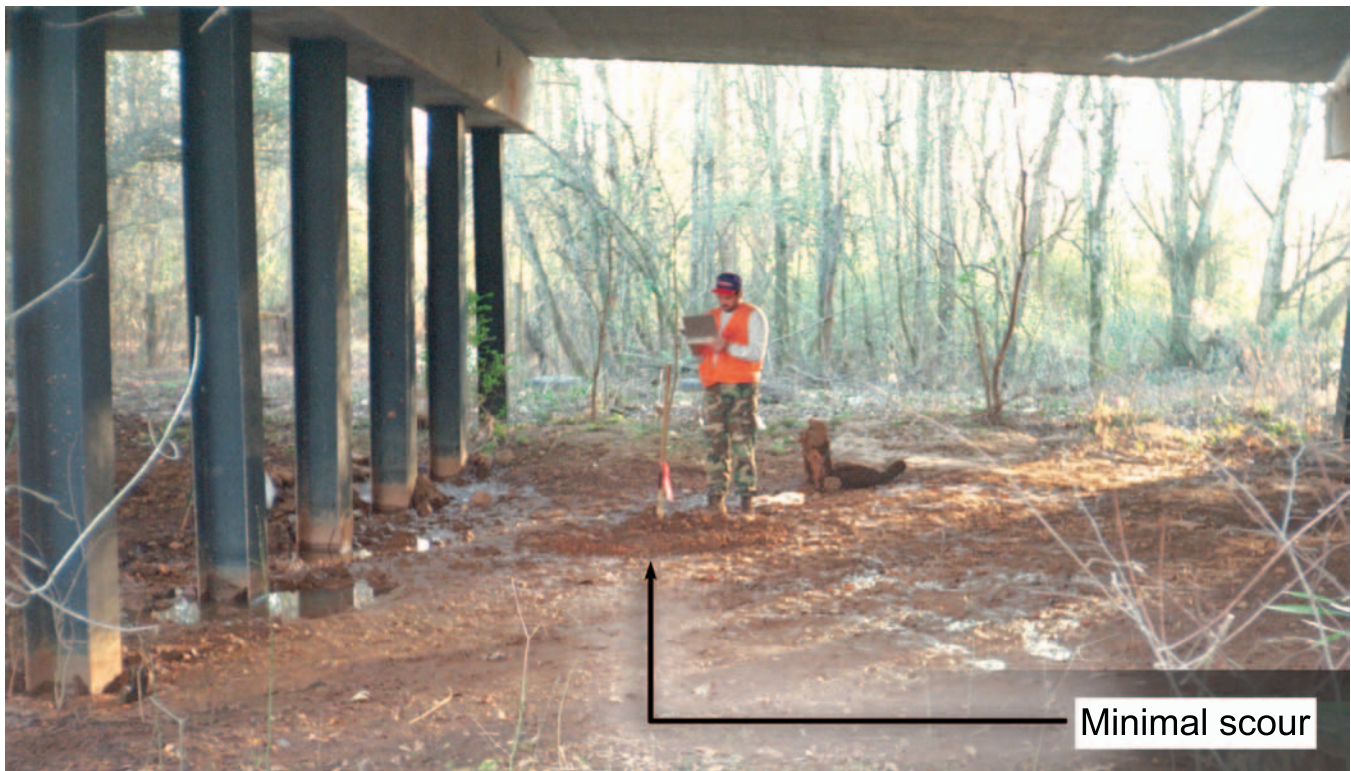
**Figure 13.** Example of minimal scour in the clayey soils of the Piedmont at Structure 047026300100 on Road S-263, crossing the Rocky River in Anderson County, South Carolina. (Photograph by the South Carolina District, U.S. Geological Survey, 1997.)

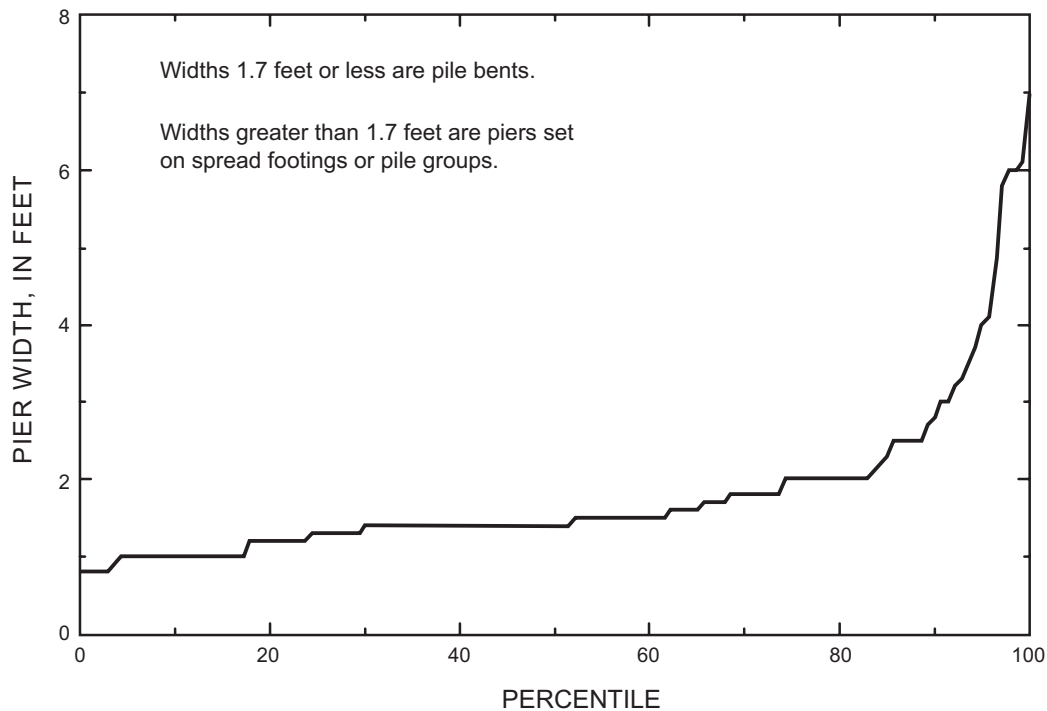
**Figure 15.** Percentile plot for the maximum pier or pile width for bridge-scour study sites in the Piedmont and Coastal Plain of South Carolina.

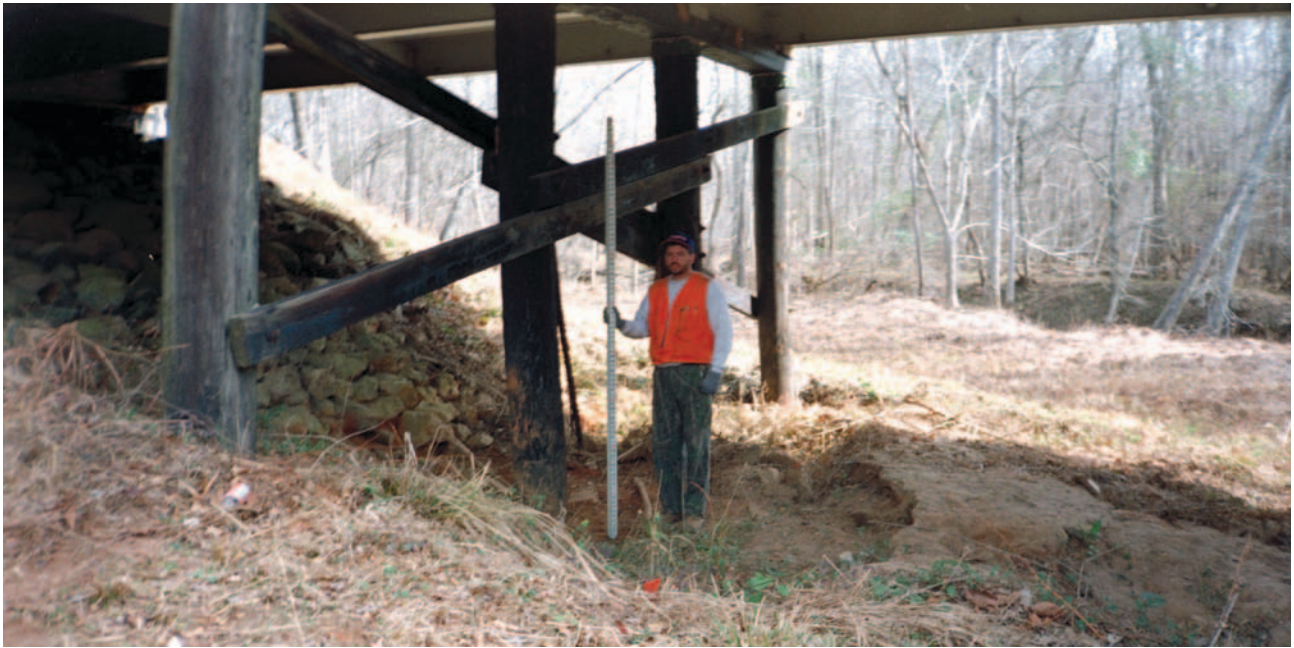
**Figure 19.** Timber pile bent at Structure 194023000500 on S.C. Route 230, crossing Horne Creek in Edgefield County, South Carolina. (Photograph by the South Carolina District, U.S. Geological Survey, February 6, 1997.)

Pile bents are a common foundation for bridges in South Carolina and were the primary foundation at approximately 70 percent of the bridges studied in this investigation (fig. 15). Pile bents consist of a row of piles driven into the ground and interconnected by a bent cap at the top of the piles (fig. 18) that provides support for the bridge deck. The three types of piles observed in this study were round timber, steel H, and square concrete (figs. 19, 20, and 21, respectively). The widths for these piles varied from 0.8 to 1.7 ft.

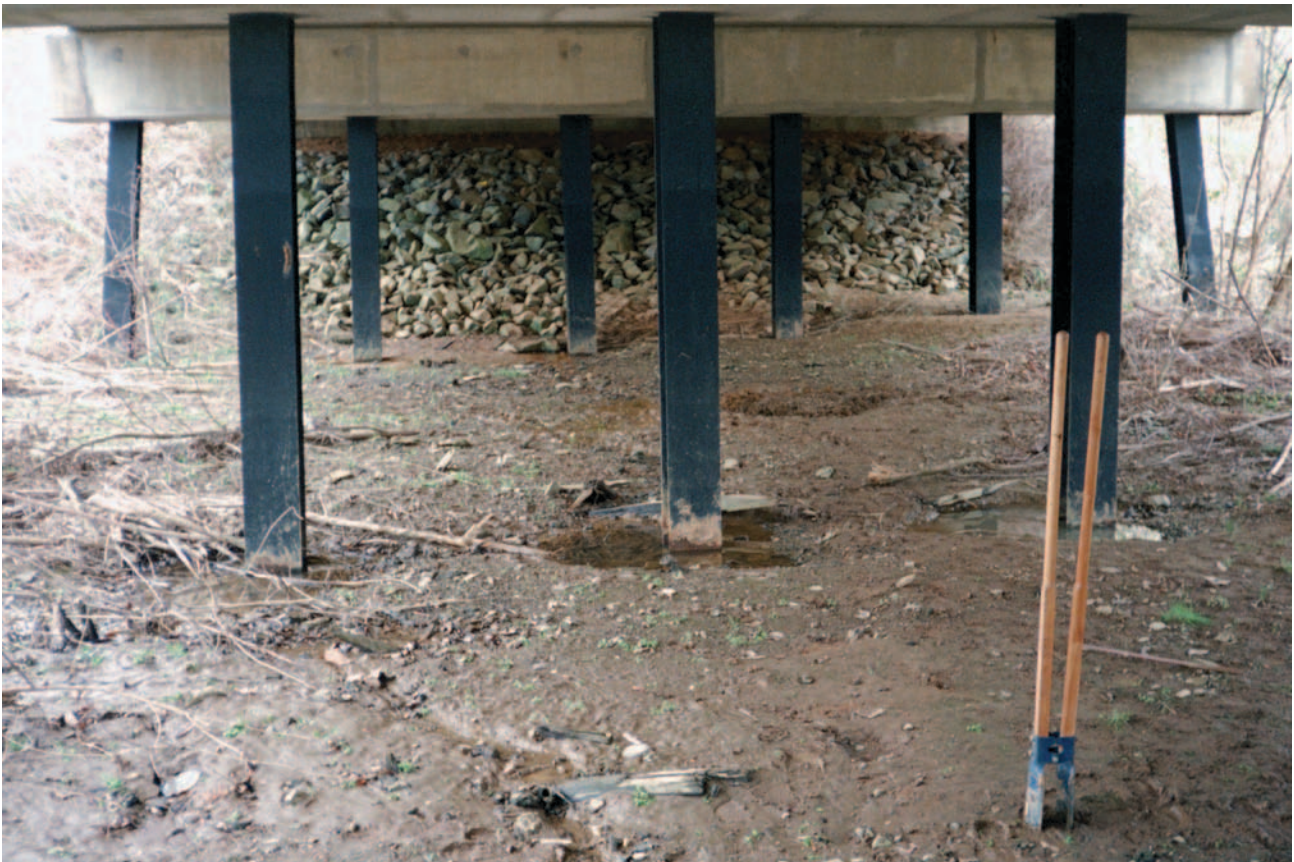
**Figure 20.** Steel H-pile bent at Structure 467072100100 on Road S-721, crossing Taylors Creek in York County, South Carolina. (Photograph by the South Carolina District, U.S. Geological Survey, January 29, 1997.)

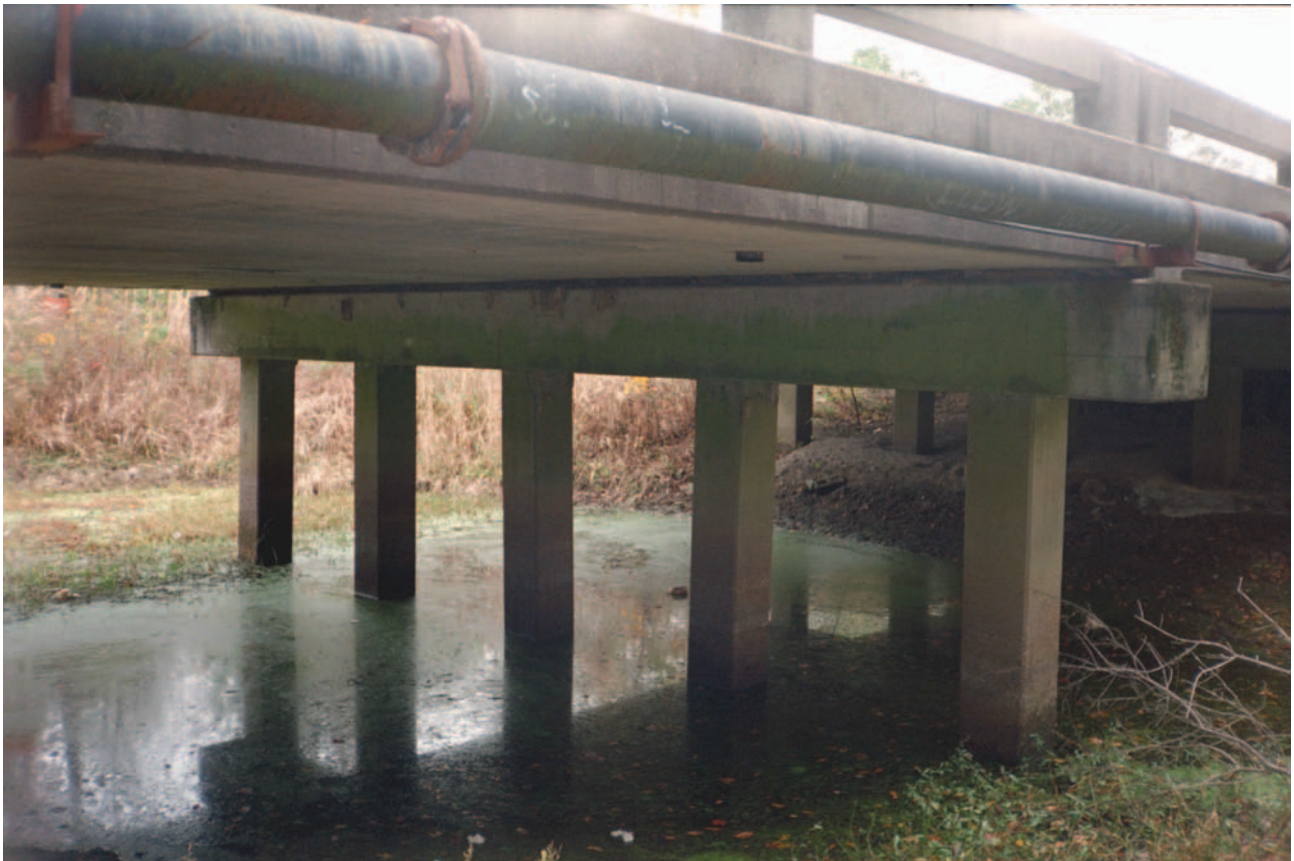
**Figure 21.** Concrete pile bent at Structure 182007800200 on U.S. Route 78, crossing Polk Swamp in Dorchester County, South Carolina. (Photograph by the South Carolina District, U.S. Geological Survey, November 26, 1996.)

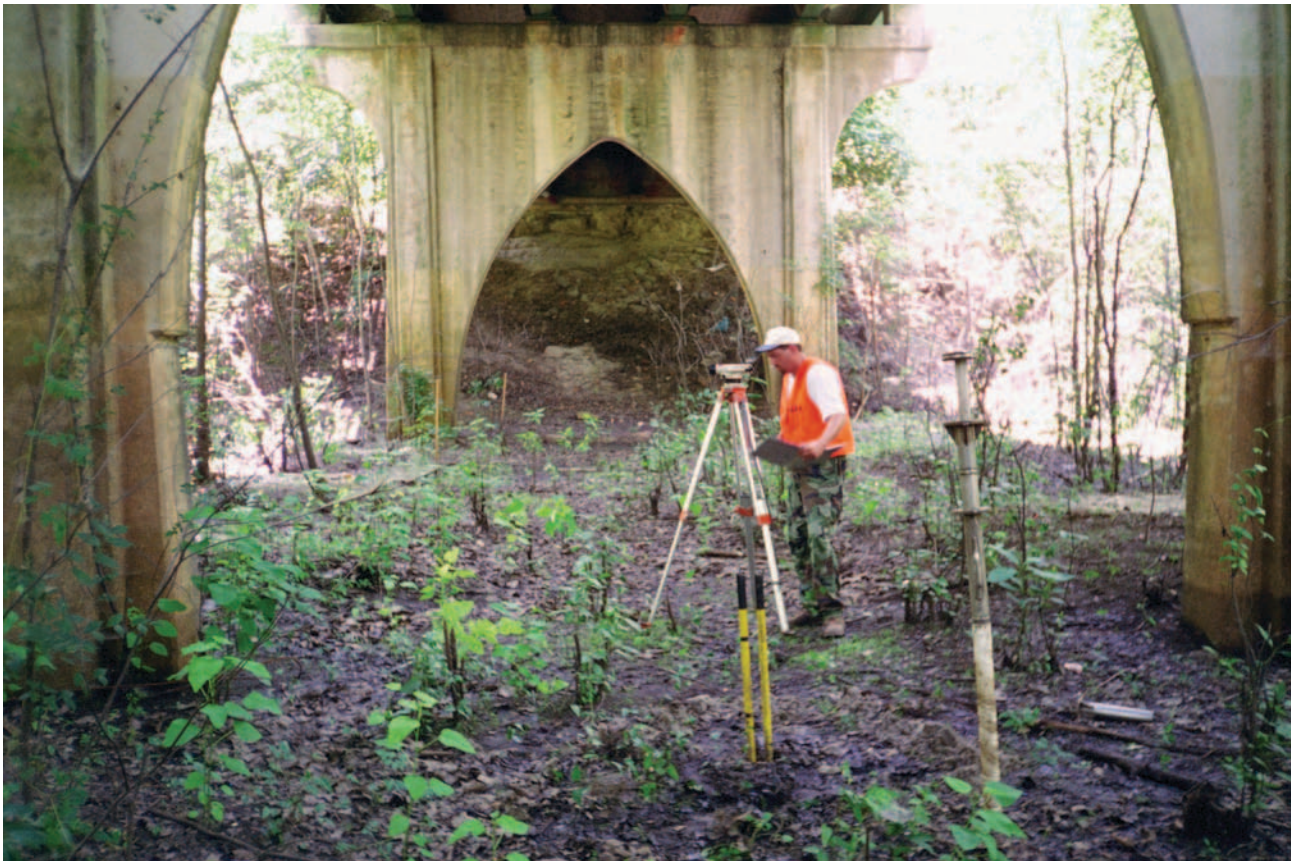
**Figure 23.** Pier at Structure 262050103100 on U.S. Route 501, crossing the Waccamaw River in Horry County, South Carolina. (Photograph by the South Carolina District, U.S. Geological Survey, June 13, 2000.)

Another type of bridge foundation was a pier supported on spread footings or pile groups (figs. 22 and 23) that existed at about 30 percent of the bridges in this study (fig. 15). The piers were generally larger than piles and ranged in width from 1.8 to 6.1 ft. On bridges that had been widened to accommodate additional traffic lanes, it was common to find a combination of piers and piles forming a composite bent to support the bridge. Composite bents typically have piers supporting the original structure with piles added upstream and downstream from the old piers to support the newly added lanes (figs. 24 and 25).

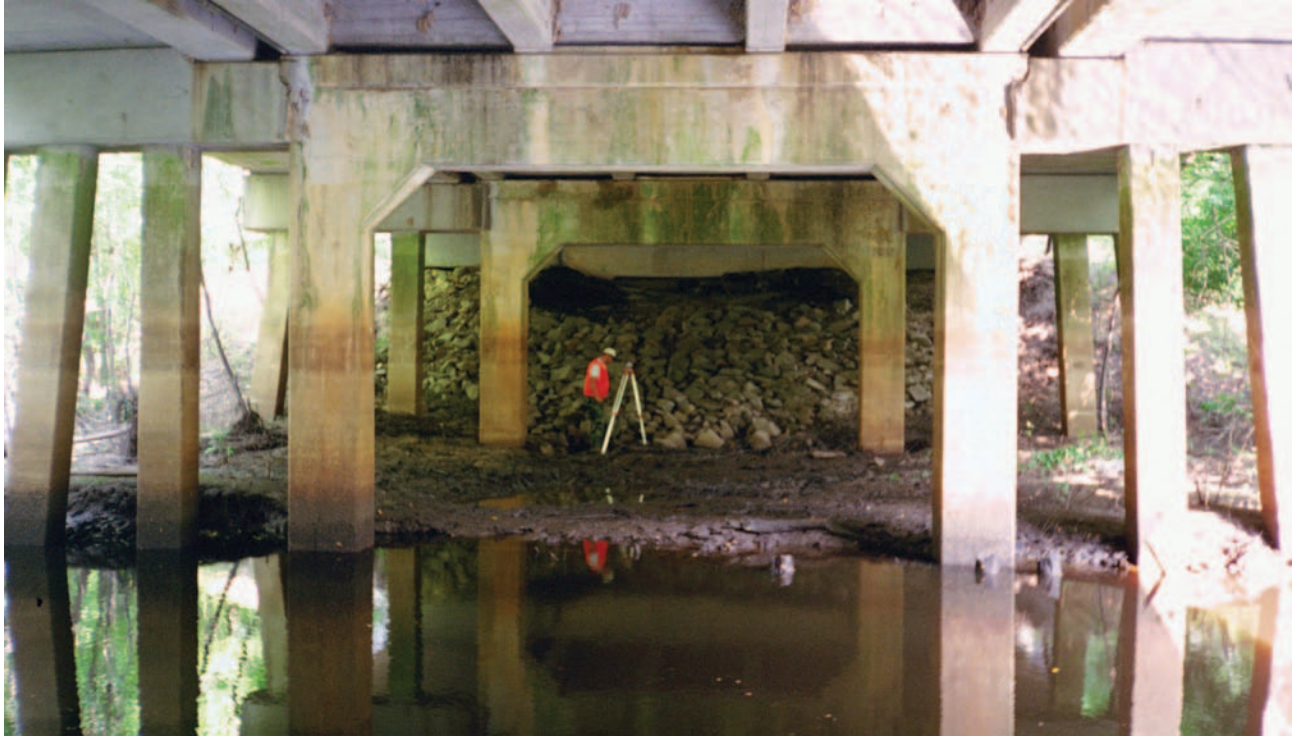
**Figure 25.** Composite bent at Structure 262050103200 on U.S. Route 501, crossing the Waccamaw River in Horry County, South Carolina. (Photograph by the South Carolina District, U.S. Geological Survey, June 13, 2000.)

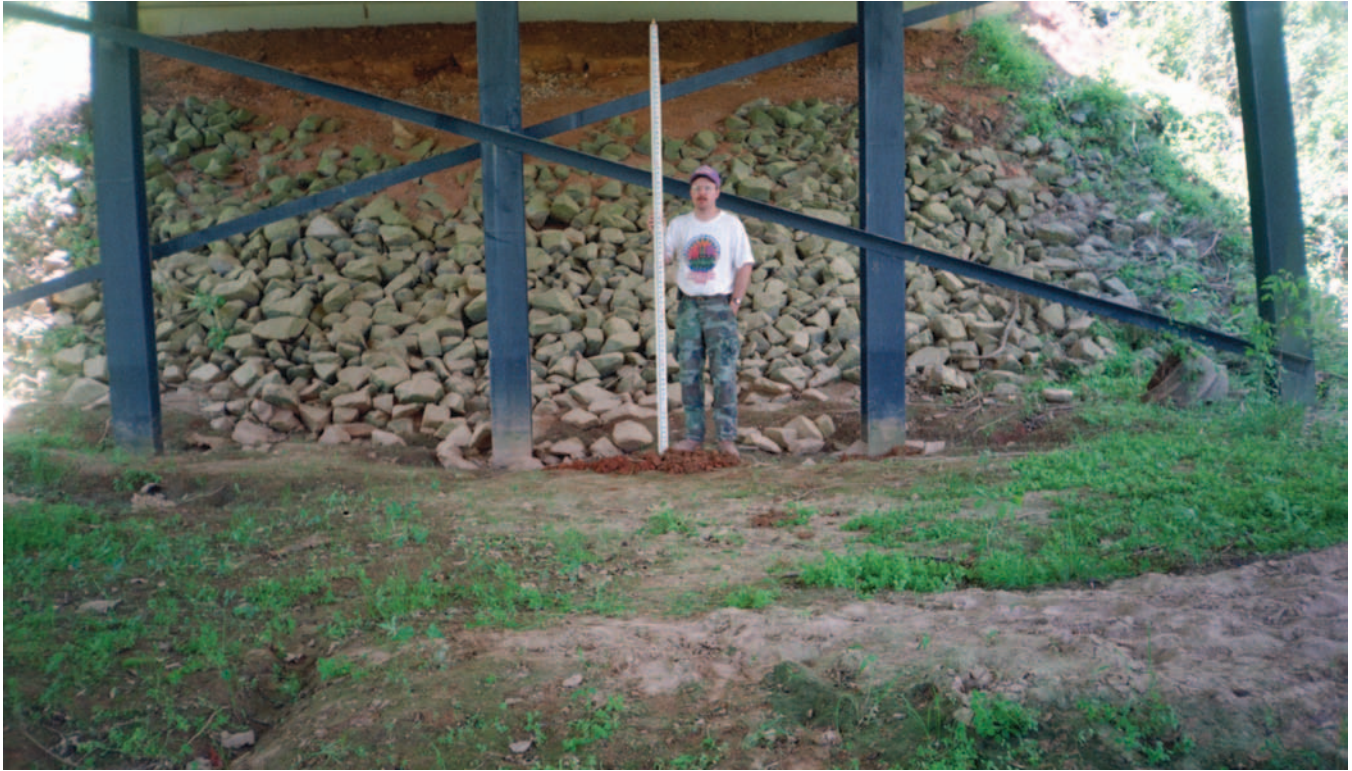
**Figure 31.** Spill-through abutment at structure 307011200100 on Road S-112, crossing the Enoree River in Laurens County, South Carolina. (Photograph by the South Carolina District, U.S. Geological Survey, April 2, 1997.)

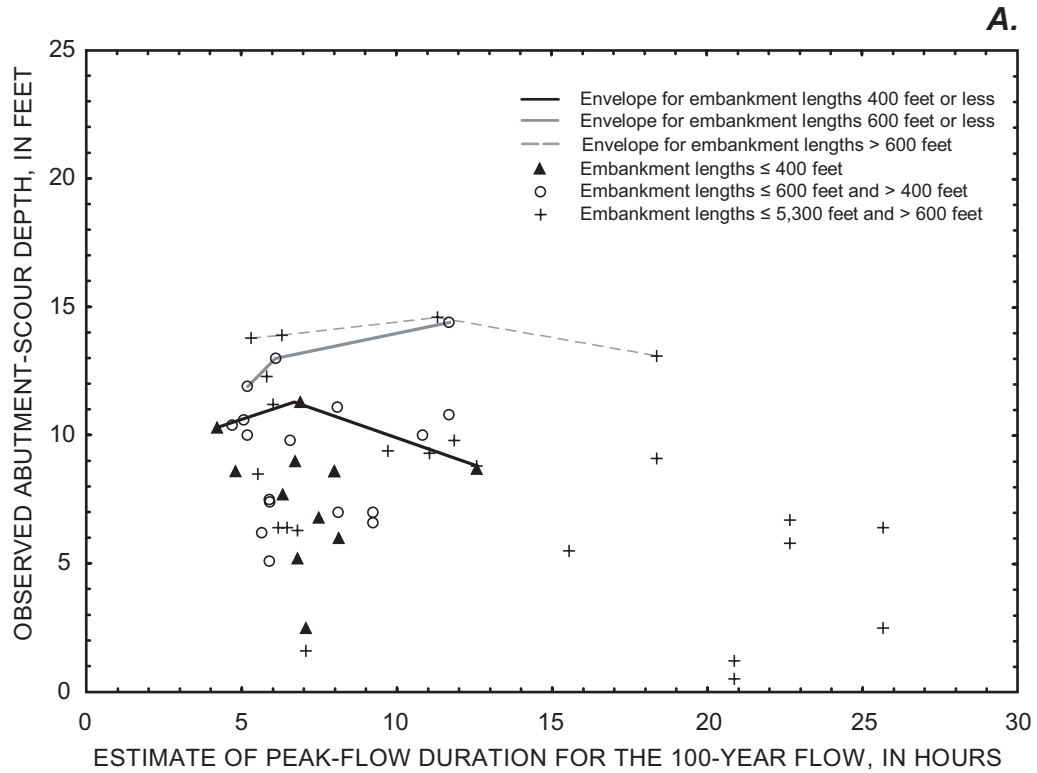
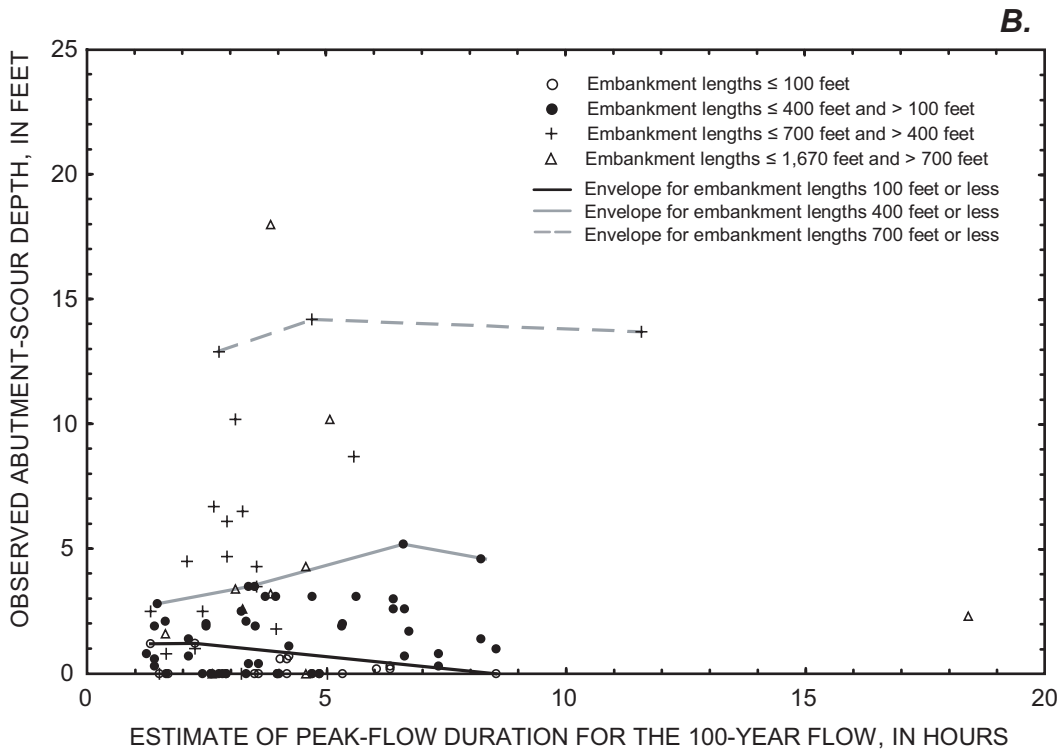
**Figure 37.** Relation of observed clear-water abutment-scour depth and the estimated peak-flow duration for the 100-year flow at single-bridge openings in the (A) Coastal Plain and (B) Piedmont of South Carolina.

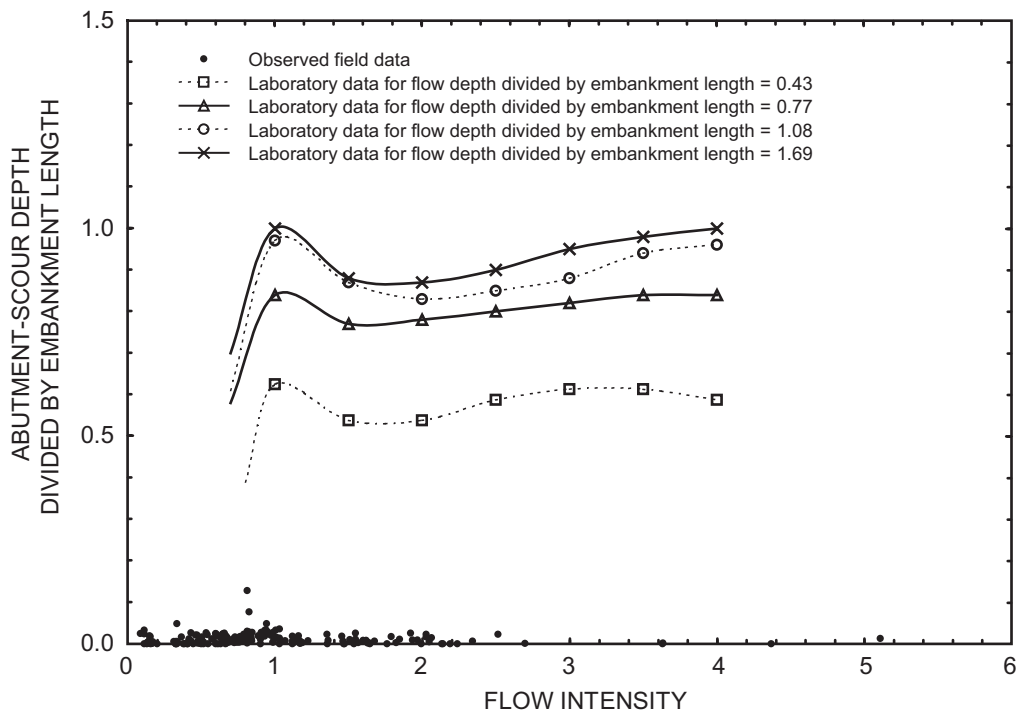
**Figure 39.** Relation of abutment-scour depth, normalized by embankment length, and flow intensity for laboratory data (Dongol, 1993) and observed data in the Piedmont and Coastal Plain of South Carolina.

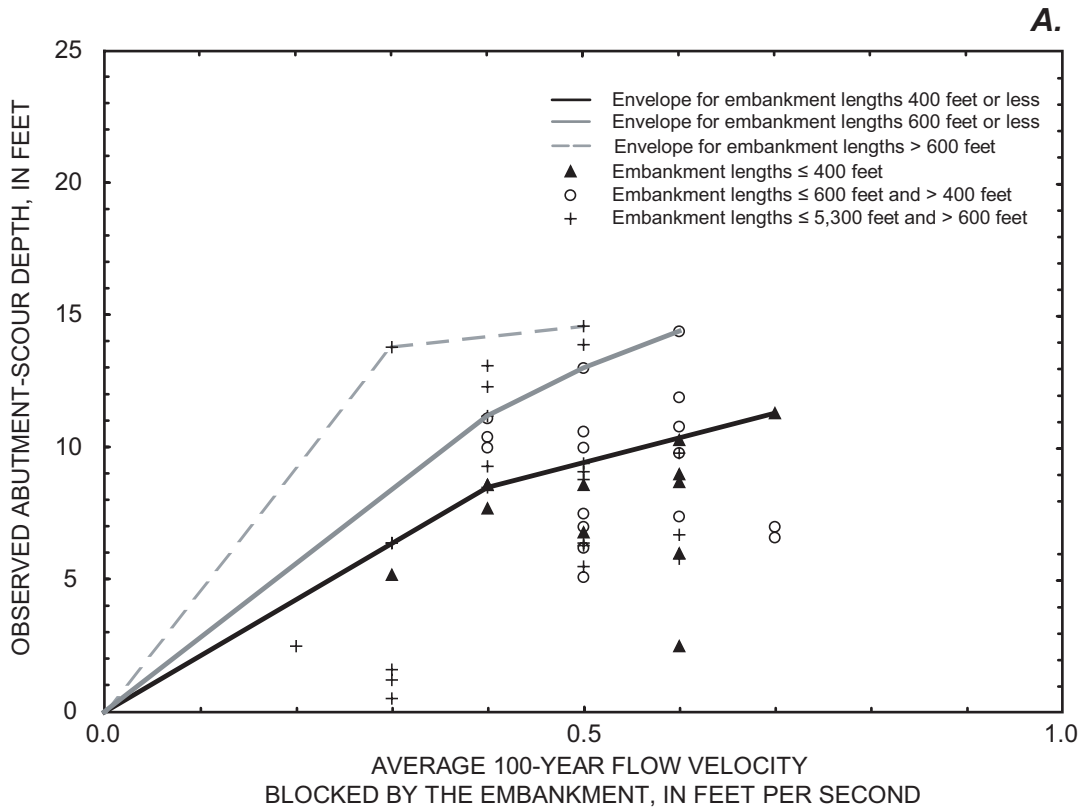
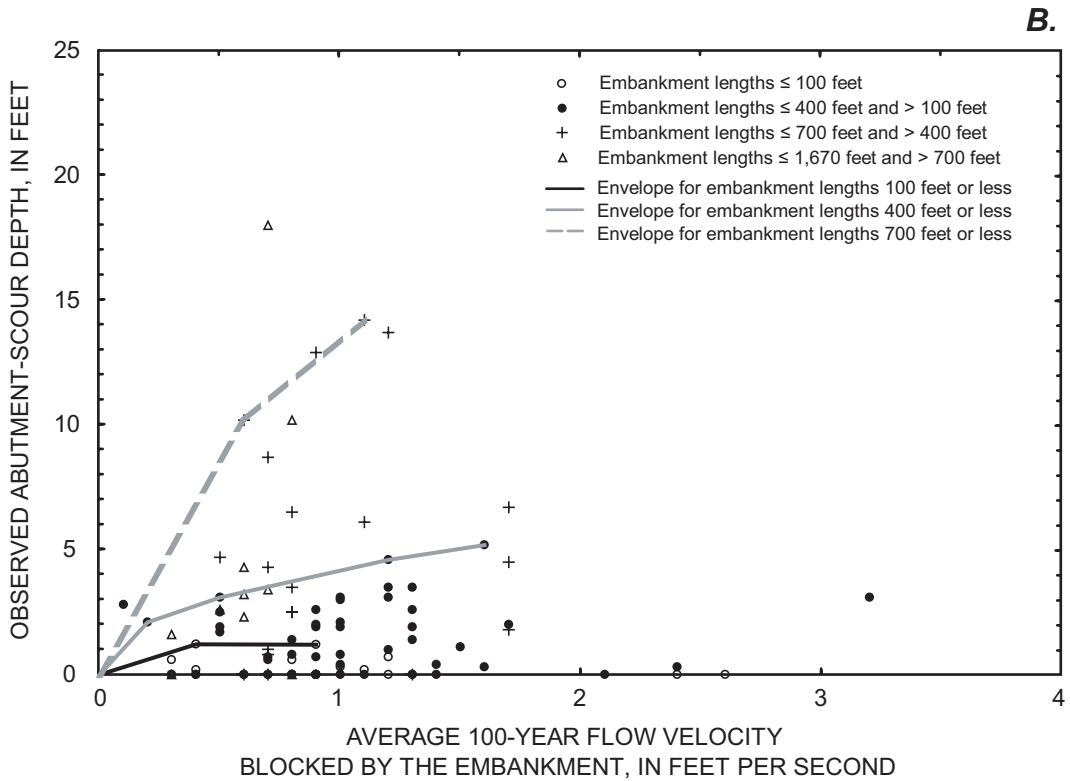
**Figure 40.** Relation of observed clear-water abutment-scour depth and the average 100-year-flow velocity, blocked by the embankment, at single-bridge openings in the (A) Coastal Plain and (B) Piedmont of South Carolina.

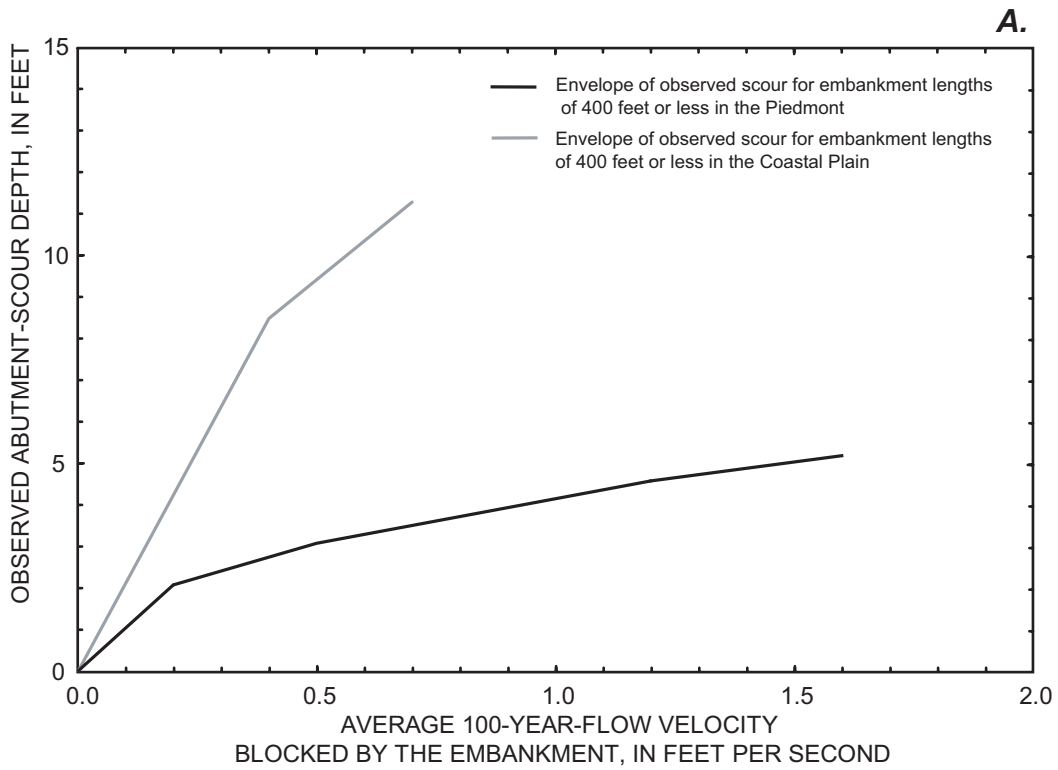
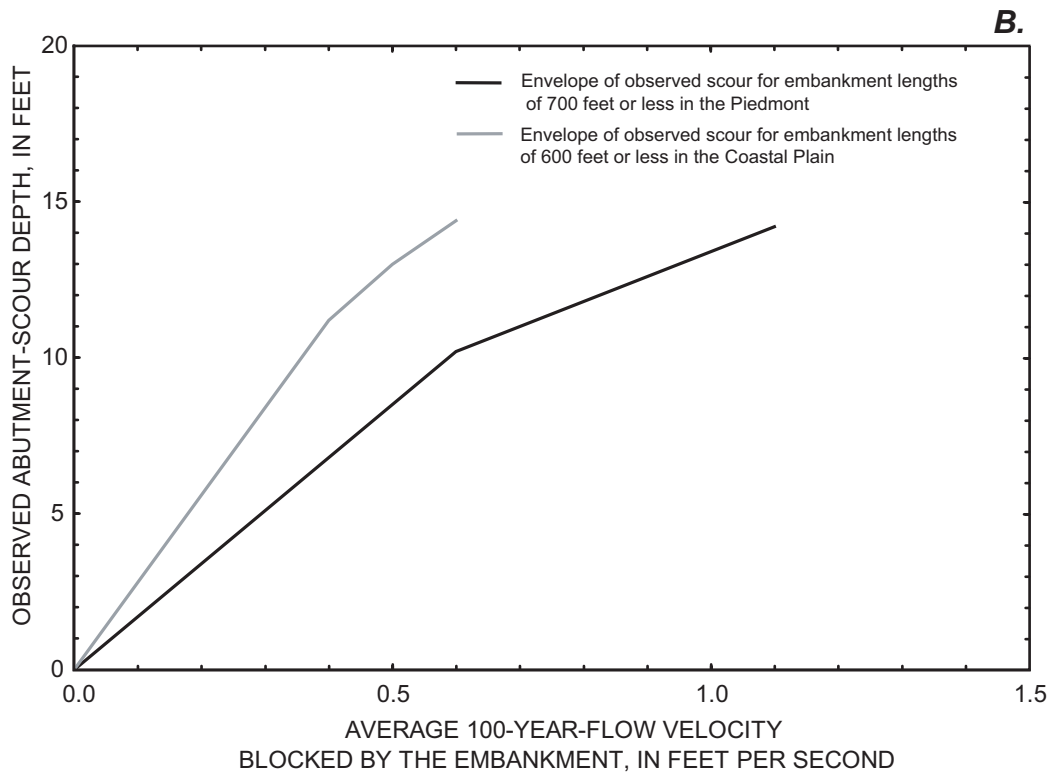
**Figure 41.** Comparison of envelopes for the relation of observed clear-water abutment-scour depth and the average 100-year-flow velocity, blocked by the embankment, for (A) embankment lengths of 400 feet or less in the Coastal Plain and Piedmont, and (B) embankment lengths of 600 feet and 700 feet or less in the Coastal Plain and Piedmont of South Carolina, respectively.

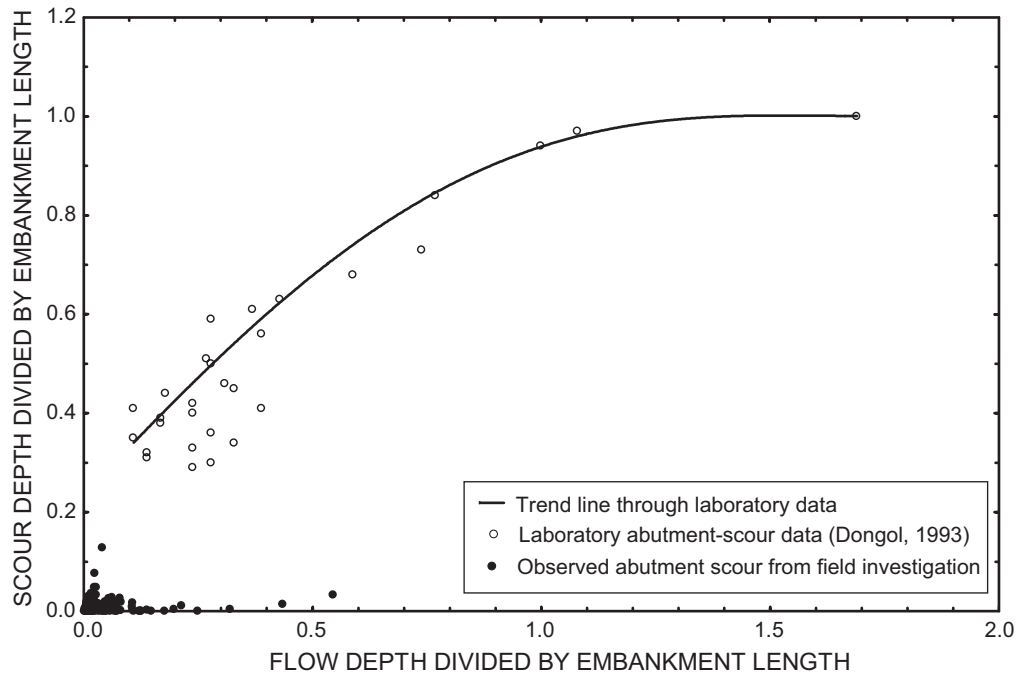
**Figure 42.** Relation of clear-water abutment-scour depth and flow depth, normalized by embankment length, for selected laboratory data at spill-through abutments (Dongol, 1993) and field data collected in the Piedmont and Coastal Plain of South Carolina.

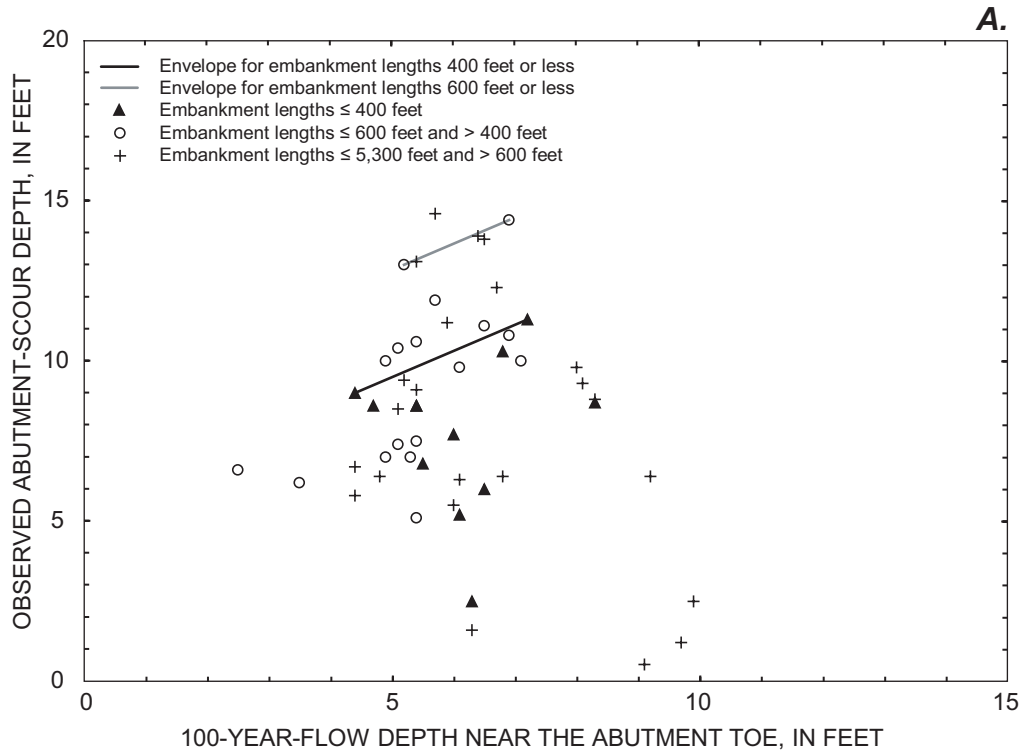
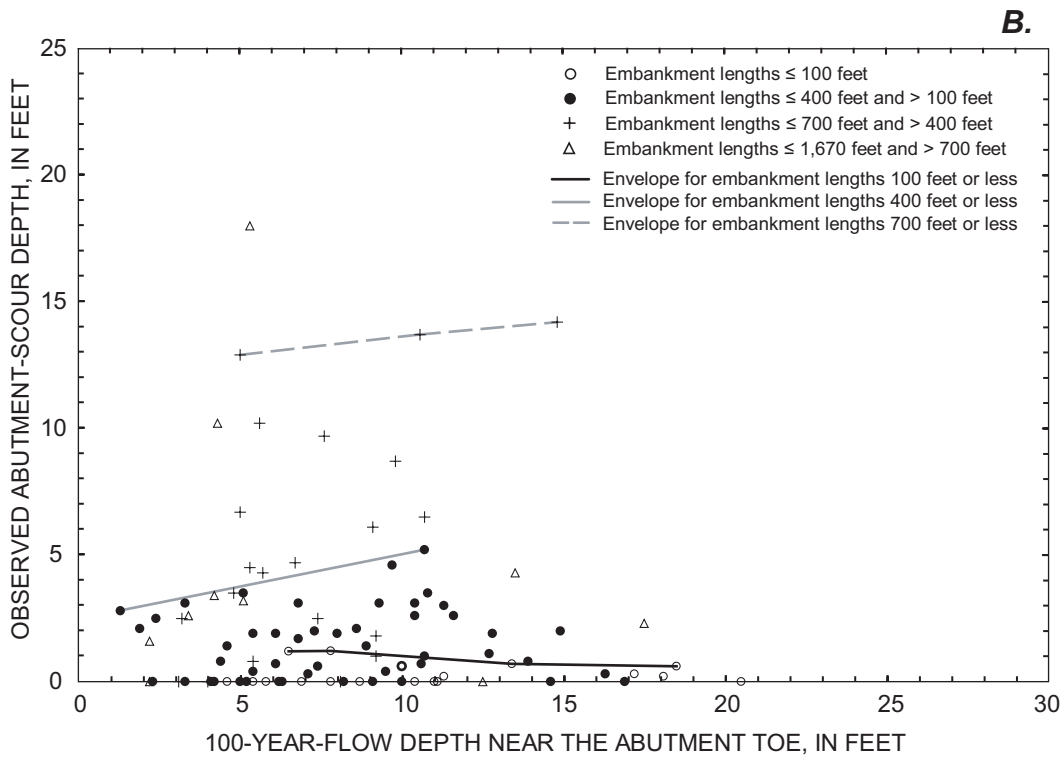
**Figure 43.** Relation of observed clear-water abutment-scour depth and the 100-year-flow depth near the abutment toe for single-bridge openings (A) in the Coastal Plain and (B) Piedmont of South Carolina.

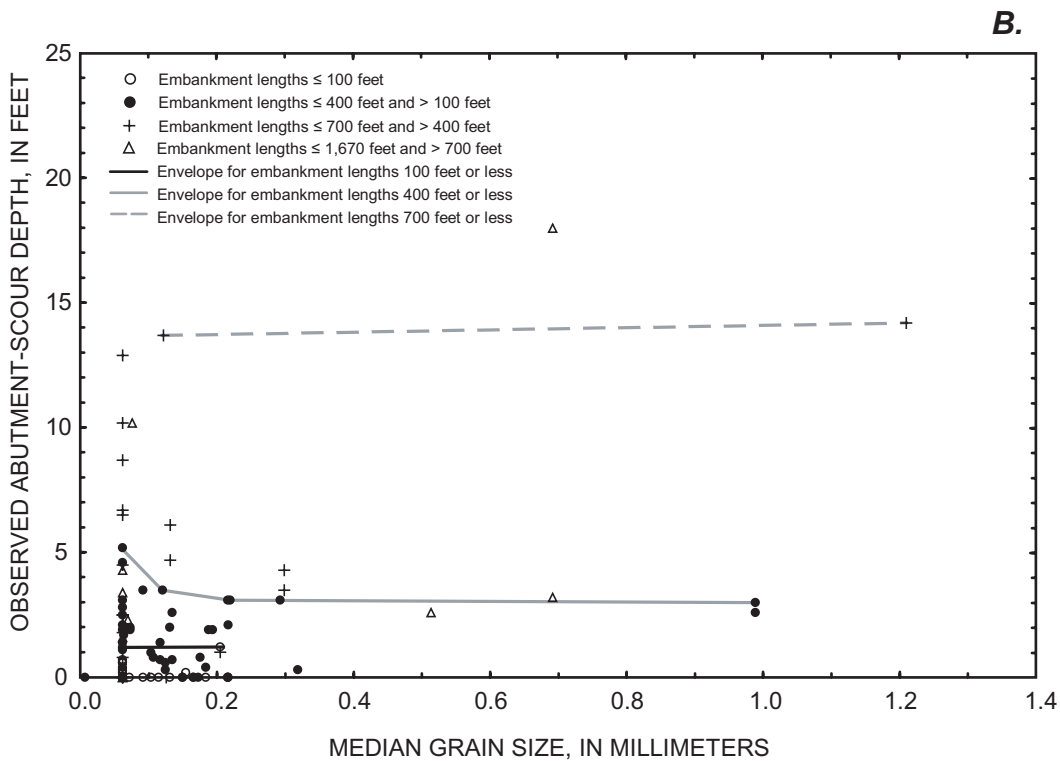
**Figure 44.** Relation of observed clear-water abutment-scour depth and the median grain size of the original sediment sample for surface soils at single-bridge openings in the (A) Coastal Plain and (B) Piedmont of South Carolina.

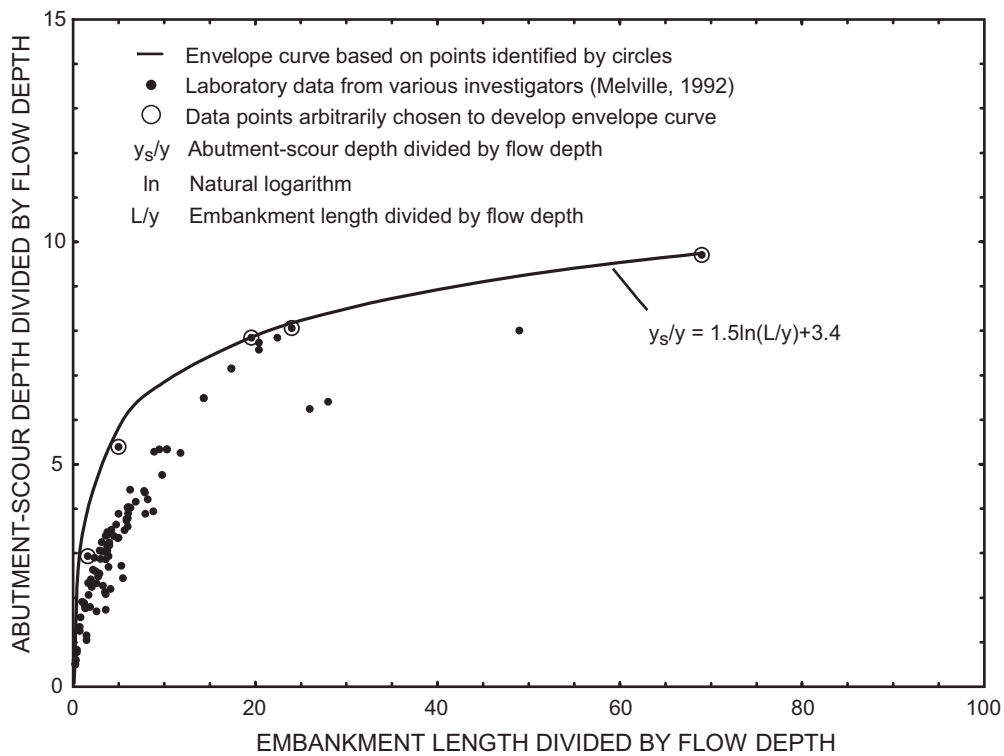
**Figure 45.** Relation of abutment-scour depth and embankment length, normalized by flow depth, for laboratory data collected at flow intensities of 1. (Modified from Melville, 1992.)

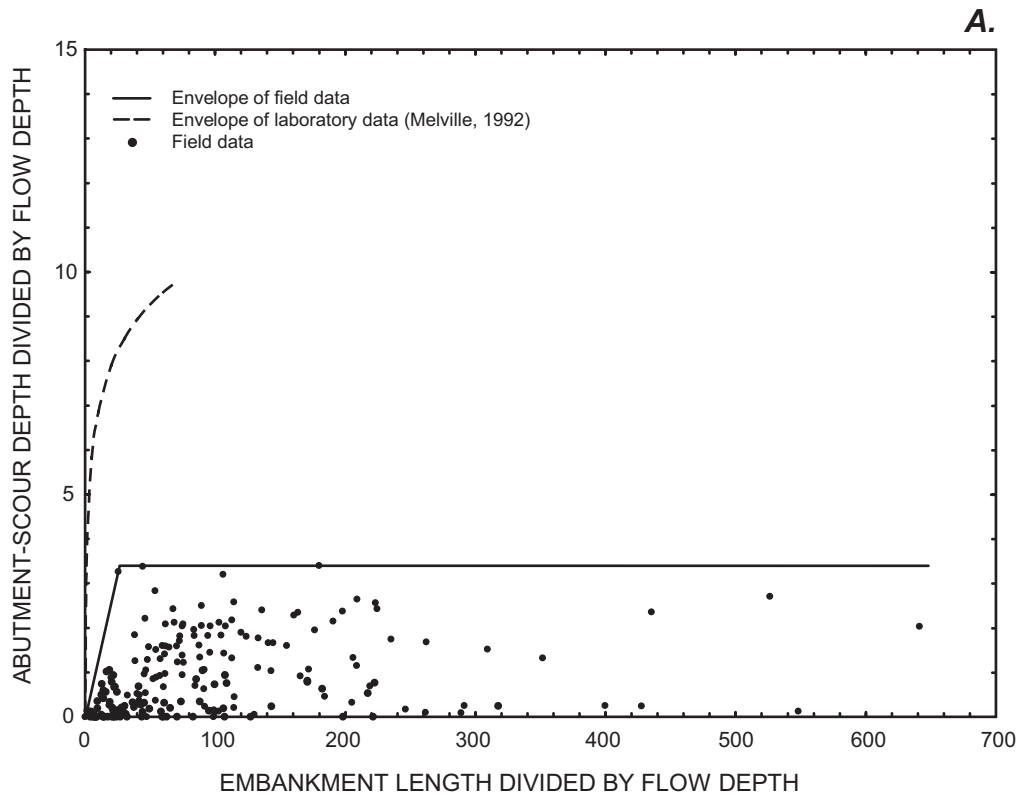
**Figure 46.** Relation of observed clear-water abutment-scour depth and the 100-year-flow embankment length, normalized by the 100-year-flow depth near the abutment toe, for the Piedmont and Coastal Plain of South Carolina with a (A) complete horizontal axis, and a (B) truncated horizontal axis.
