# Clear-Water Abutment and Contraction Scour in the Coastal Plain and Piedmont Provinces of South Carolina, 1996-99

Water-Resources Investigations Report 03-4064  
Version 1.1, August 2016

*By* Stephen T. Benedict

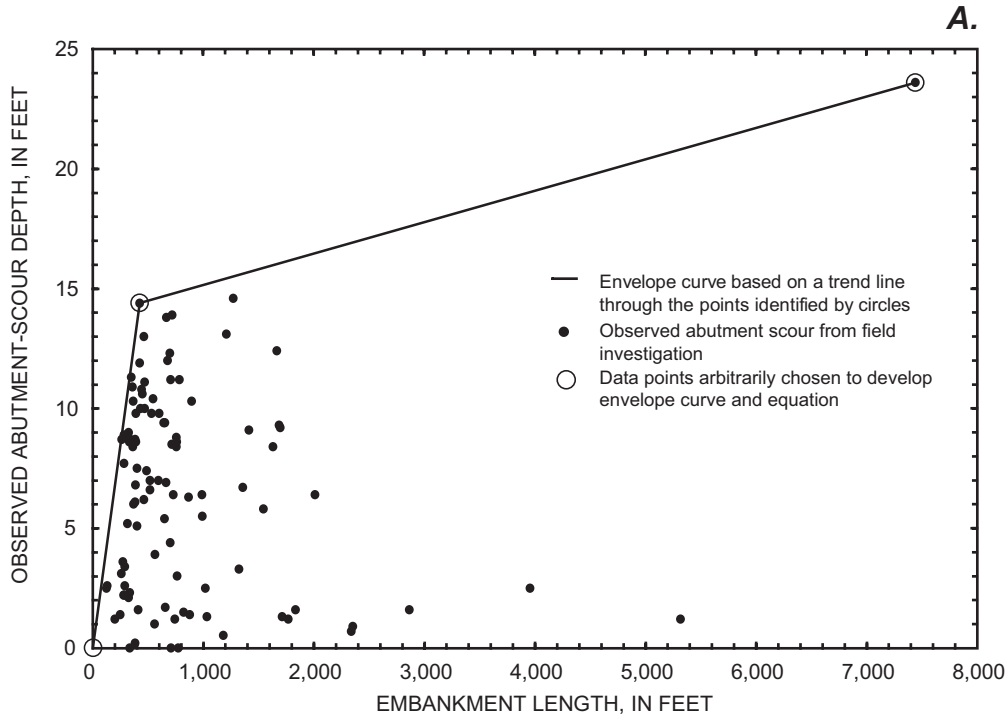
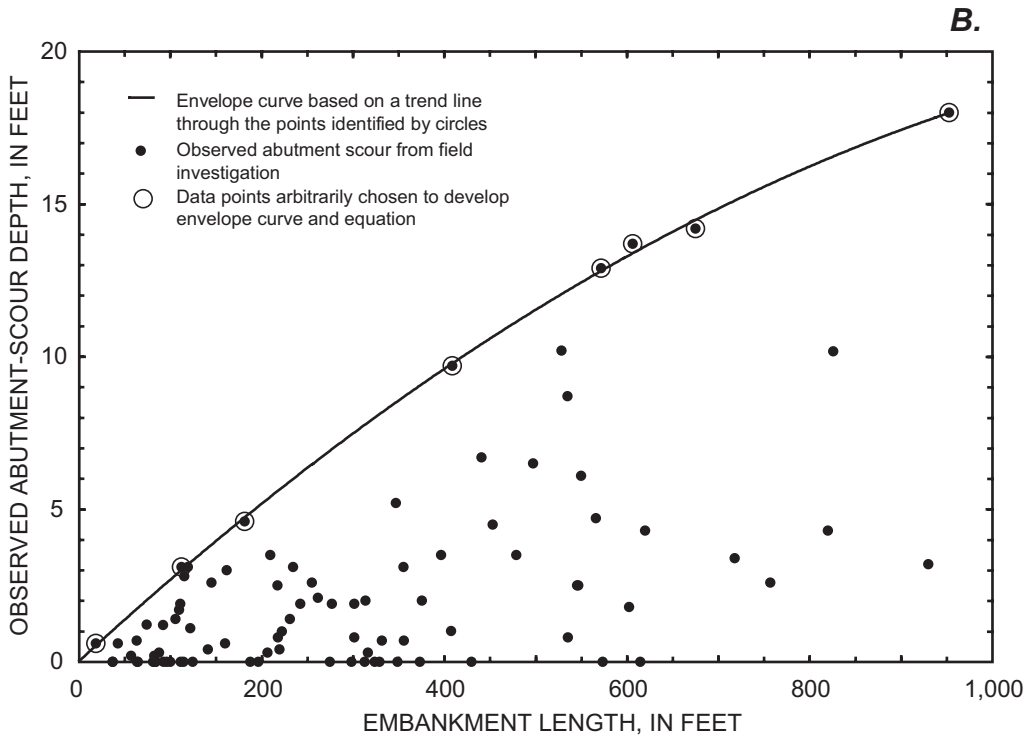
**Figure 47.** Relation of observed clear-water abutment-scour depth and the 100-year-flow embankment length for the (A) Coastal Plain and (B) Piedmont of South Carolina.

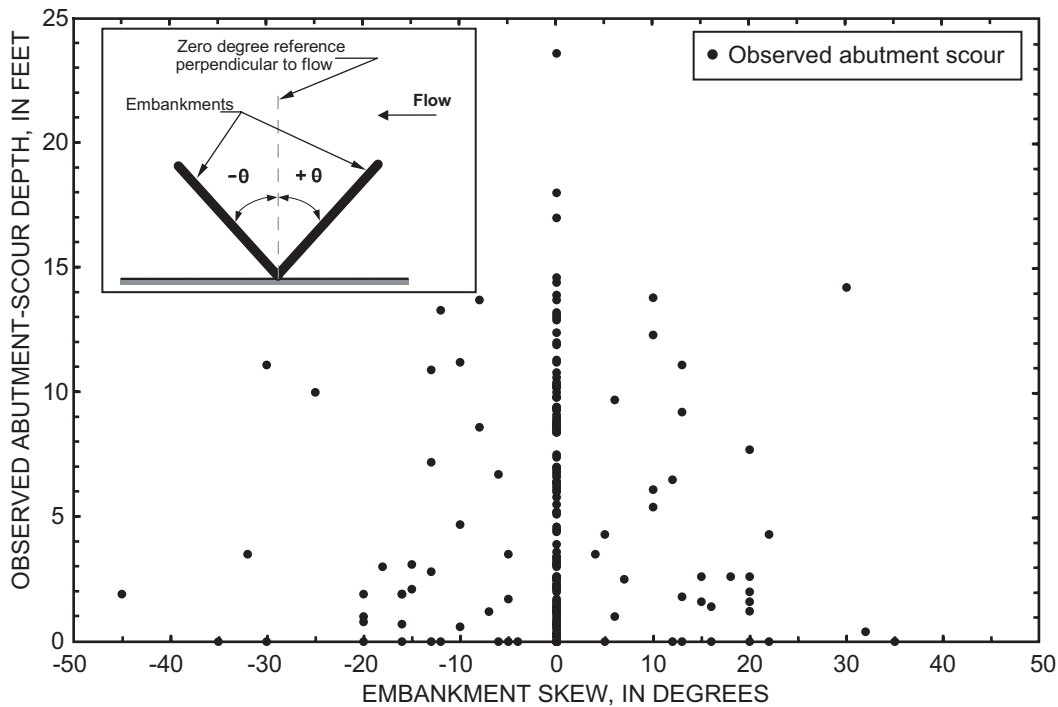
**Figure 50.** Relation of observed clear-water abutment-scour depth and embankment skew for selected sites with left and (or) right abutment scour in the Piedmont and Coastal Plain of South Carolina.

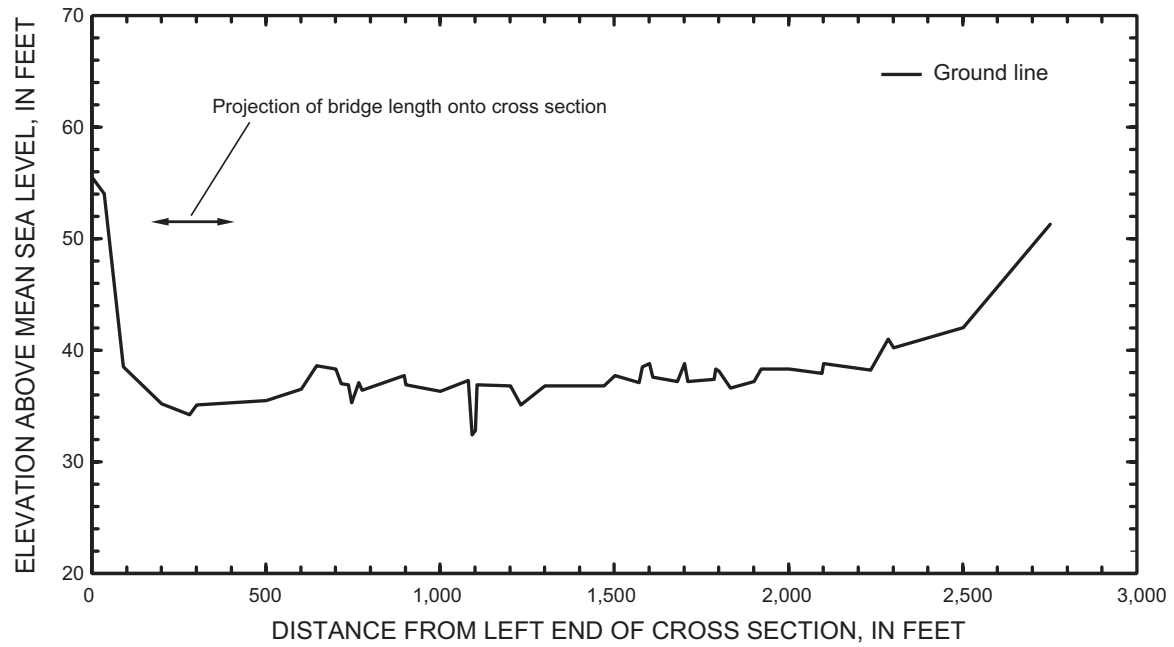
**Figure 54.** Example of Coastal Plain natural cross section at Structure 212037801000 on U.S. Route 378, crossing Big Swamp in Florence County, South Carolina. (Data from the South Carolina Department of Transportation road plans, File Number 21.253, dated 1947.)

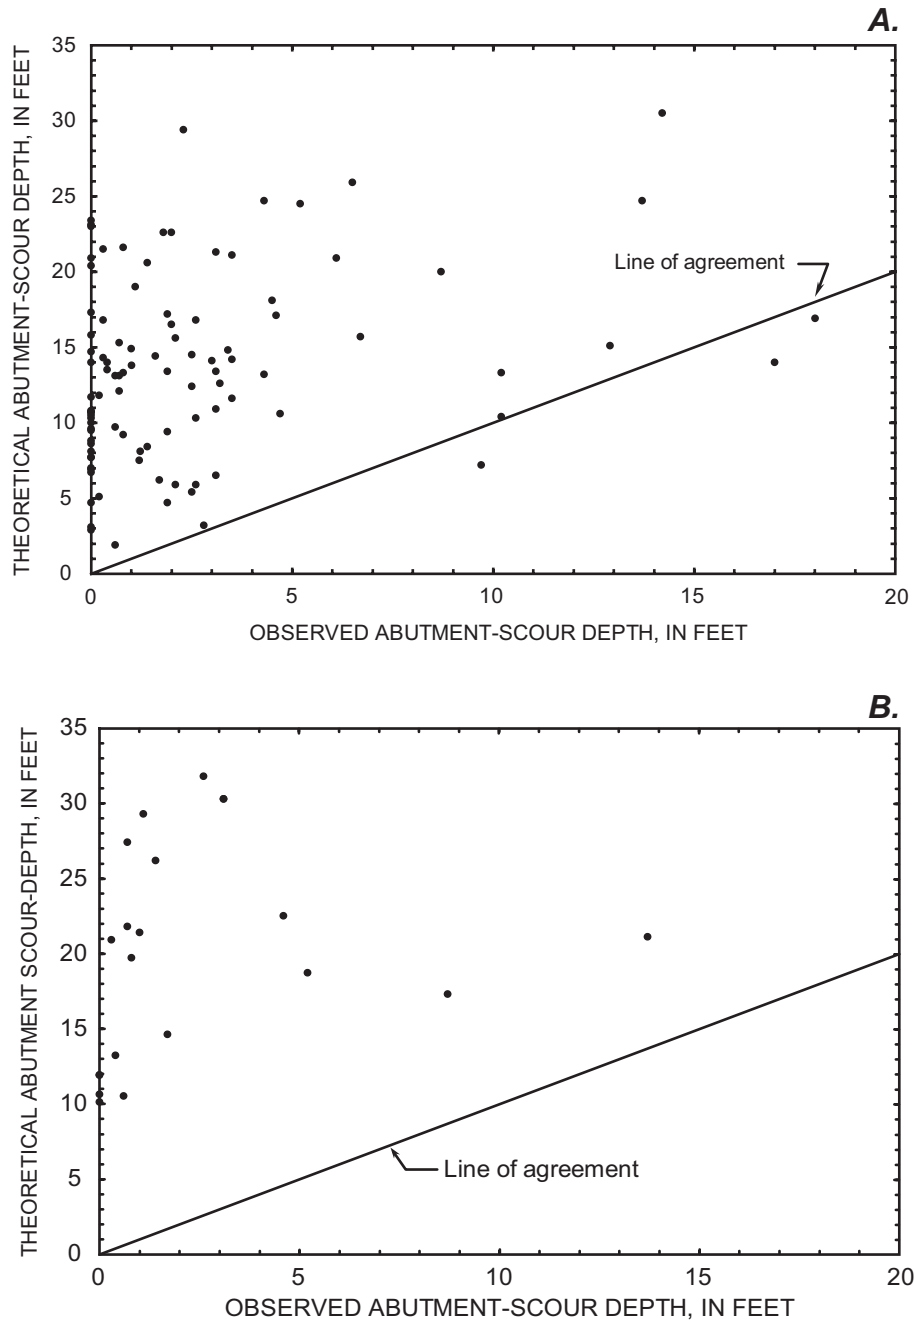
**Figure 58.** Relation of observed clear-water abutment-scour depth and theoretical abutment-scour depth for the (A) 100-year flow, and the (B) August 1995 flood at selected sites in the Piedmont of South Carolina. (Theoretical abutment scour calculated with the Froehlich (1989) equation.)

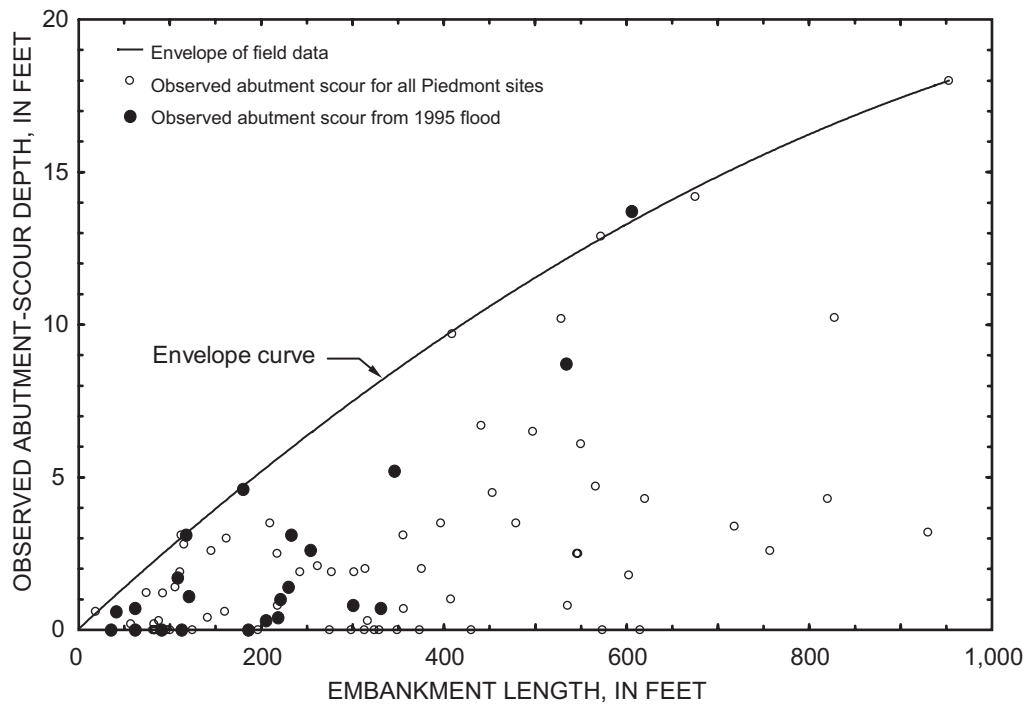
**Figure 61.** Relation of observed clear-water abutment-scour depth and the 100-year-flow embankment length with identification of the 1995 flood sites in the Piedmont of South Carolina.

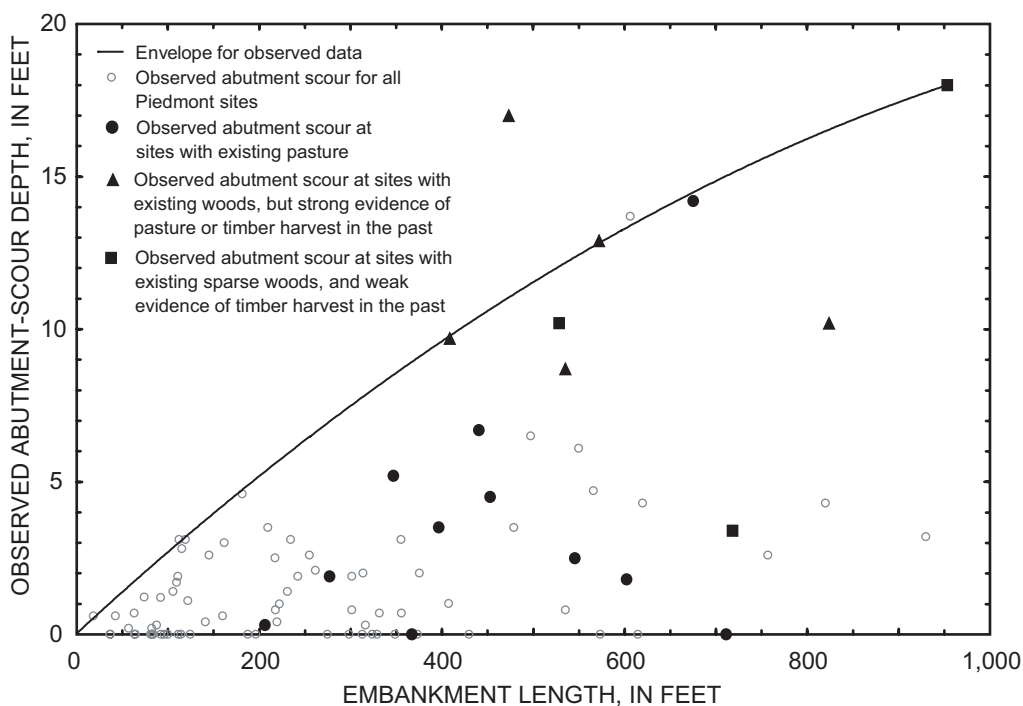
**Figure 66.** Relation of observed clear-water abutment-scour depth and the 100-year-flow embankment length with the identification of sites with lowered floodplain flow resistance for the Piedmont of South Carolina.

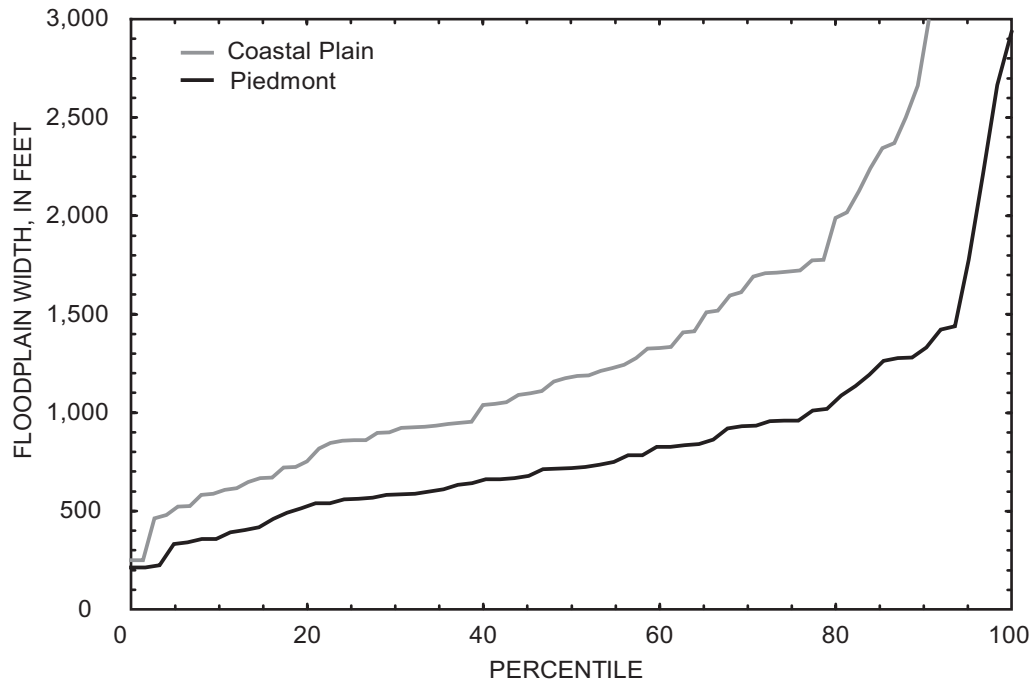
**Figure 68.** Percentile of the 100-year-flow floodplain width for study sites in the Piedmont and Coastal Plain of South Carolina. (NOTE: The vertical scale has been truncated in order to provide detail for the smaller floodplain widths.)

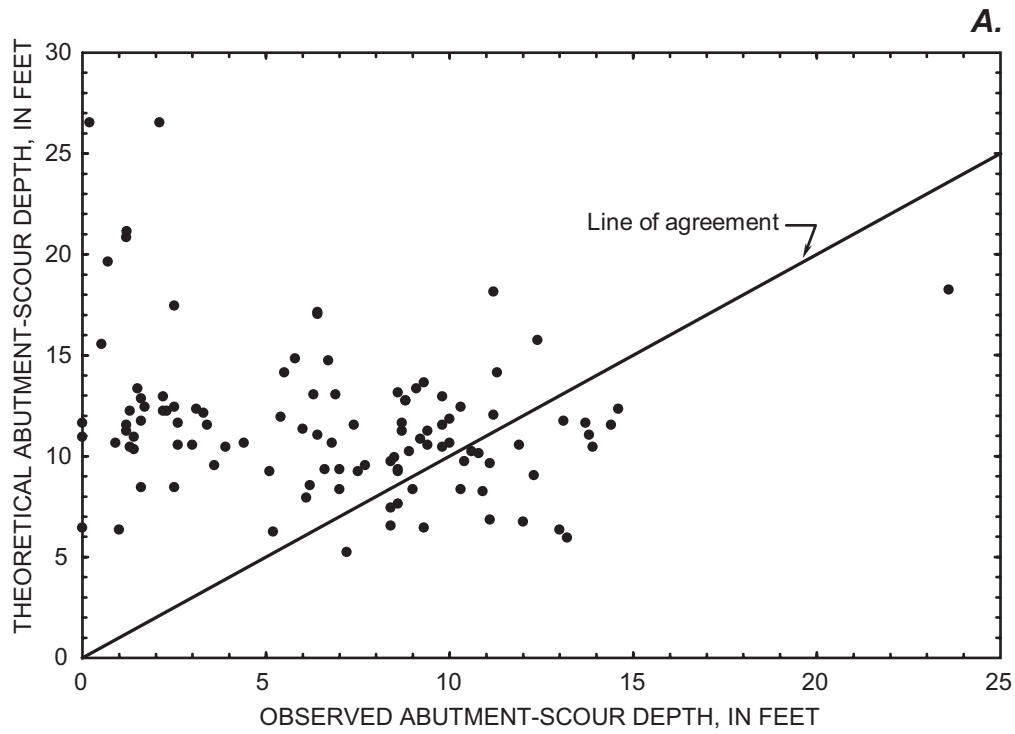
**Figure 71.** Relation of observed clear-water abutment-scour depth with theoretical abutment-scour depth for the (A) 100-year flow, and the (B) maximum historic flow at selected sites in the Coastal Plain of South Carolina. (Theoretical abutment scour calculated with the Froehlich (1989) equation.)

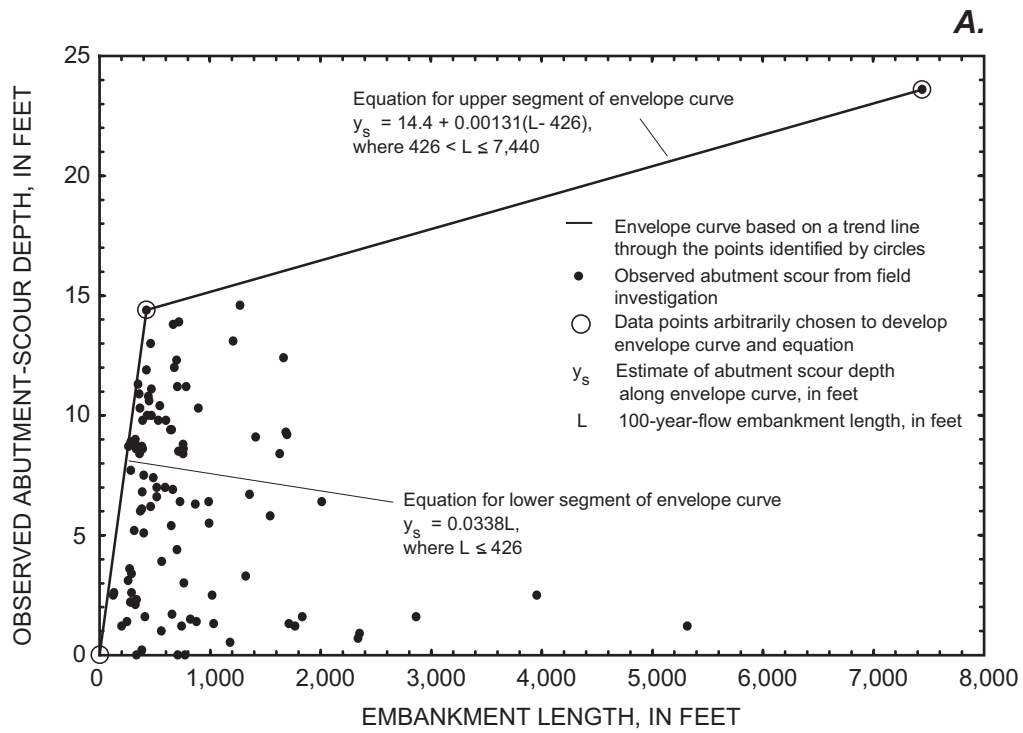
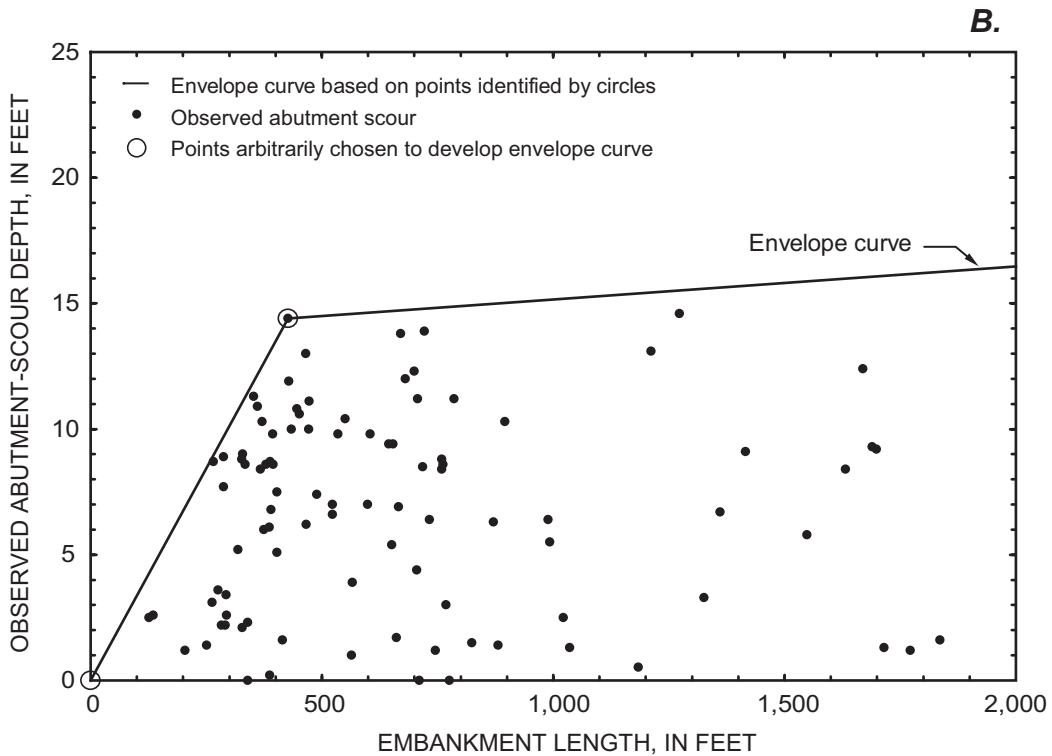
**Figure 72.** Relation of observed clear-water abutment-scour depth and the 100-year-flow embankment length for the Coastal Plain of South Carolina with a (A) complete horizontal axis and a (B) truncated horizontal axis.

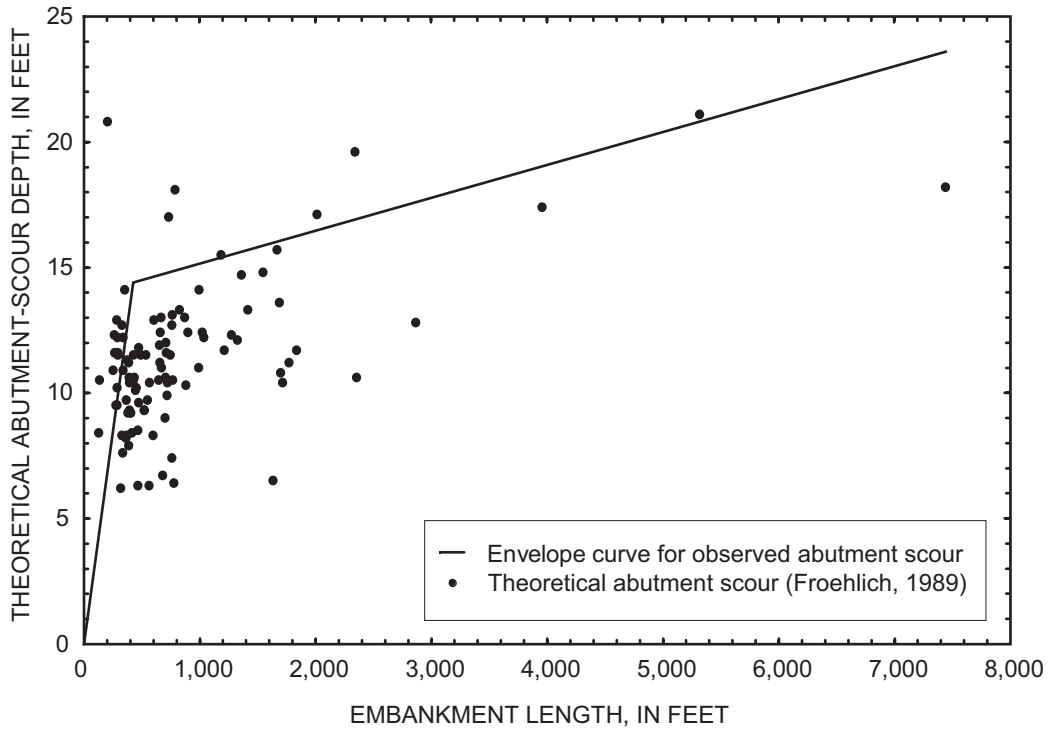
**Figure 74.** Relation of theoretical 100-year-flow abutment-scour depth and the 100-year-flow embankment length compared with the envelope of observed abutment scour for selected sites in the Coastal Plain of South Carolina. (Theoretical abutment scour calculated with the Froehlich (1989) equation.)

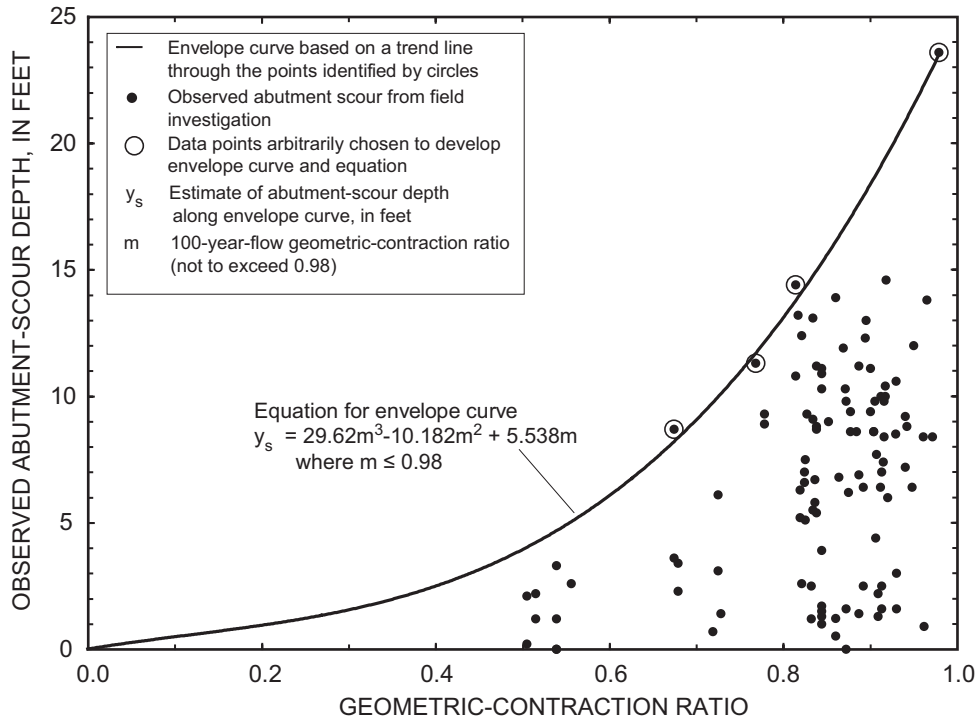
**Figure 75.** Relation of observed clear-water abutment-scour depth and the 100-year-flow geometric-contraction ratio for the Coastal Plain of South Carolina.

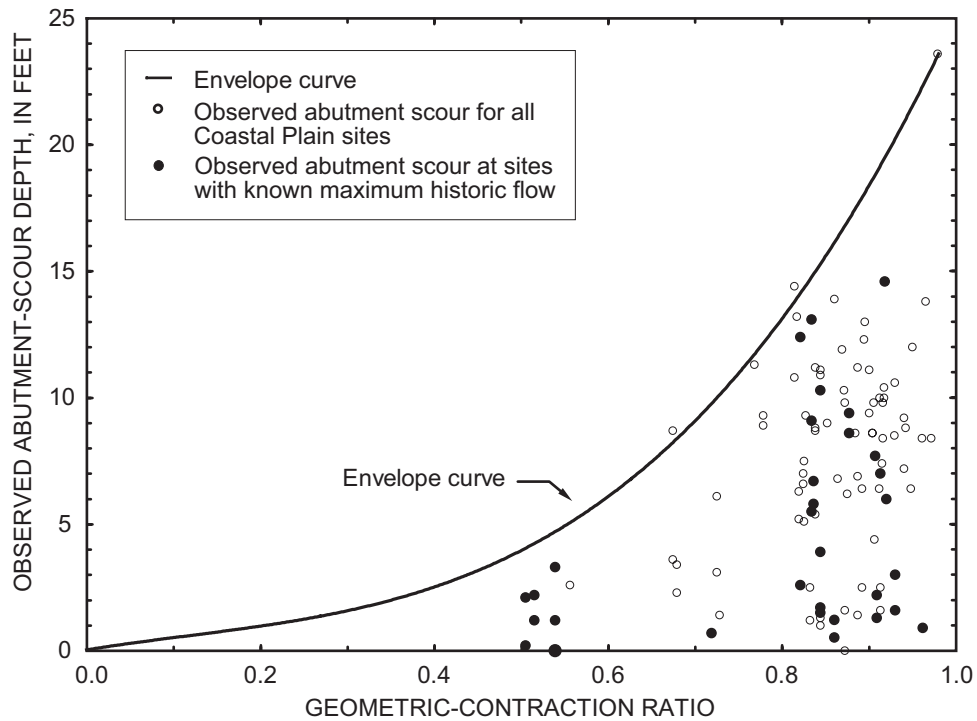
**Figure 76.** Relation of observed clear-water abutment-scour depth and the 100-year-flow geometric-contraction ratio identifying sites with known maximum historic flows in the Coastal Plain of South Carolina.

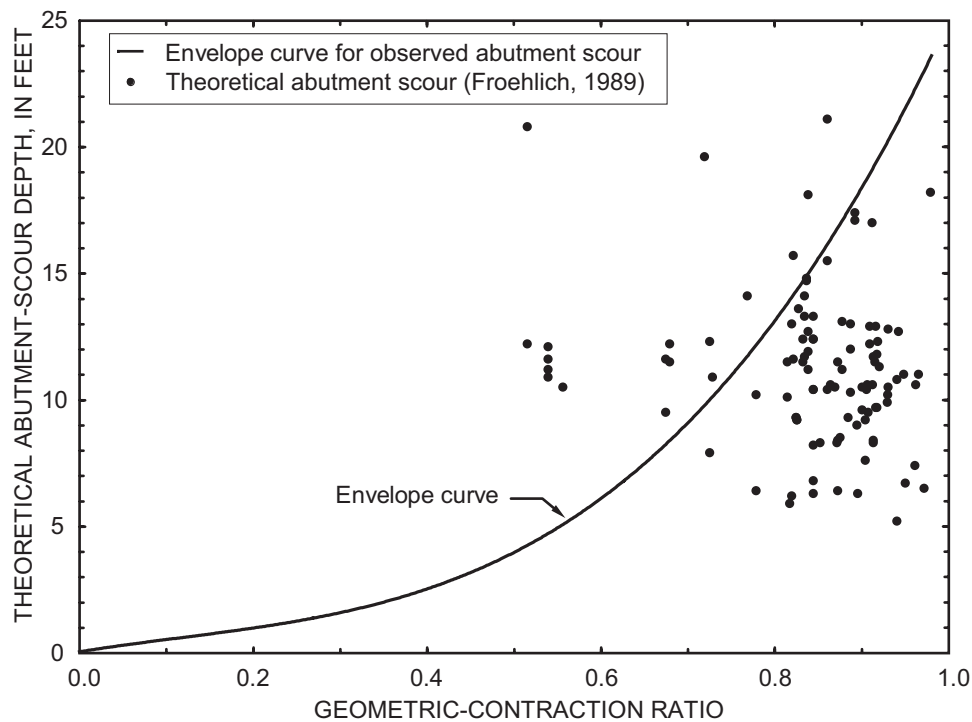
**Figure 77.** Relation of theoretical 100-year-flow abutment-scour depth and the 100-year-flow geometric-contraction ratio compared with the envelope of observed abutment scour in the Coastal Plain of South Carolina. (Theoretical abutment scour calculated with the Froehlich (1989) equation.)

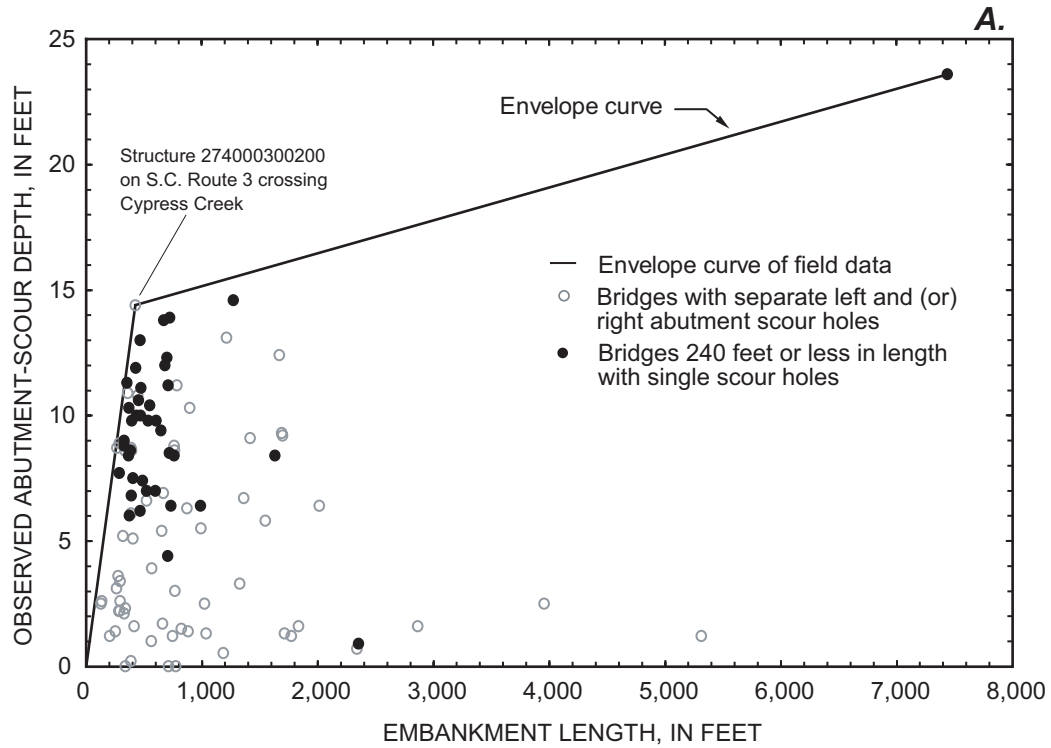
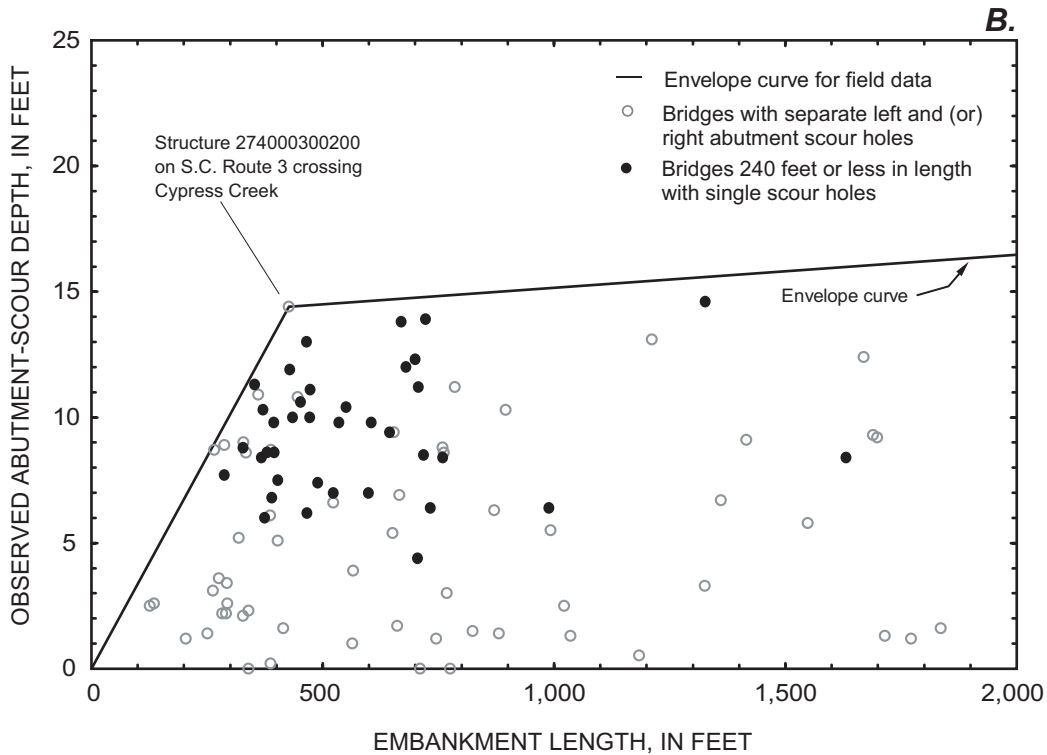
**Figure 78.** Relation of observed clear-water abutment-scour depth and the 100-year-flow embankment length identifying sites with bridge lengths of 240 feet or less and single scour holes in the Coastal Plain of South Carolina with a (A) complete horizontal axis and a (B) truncated horizontal axis.

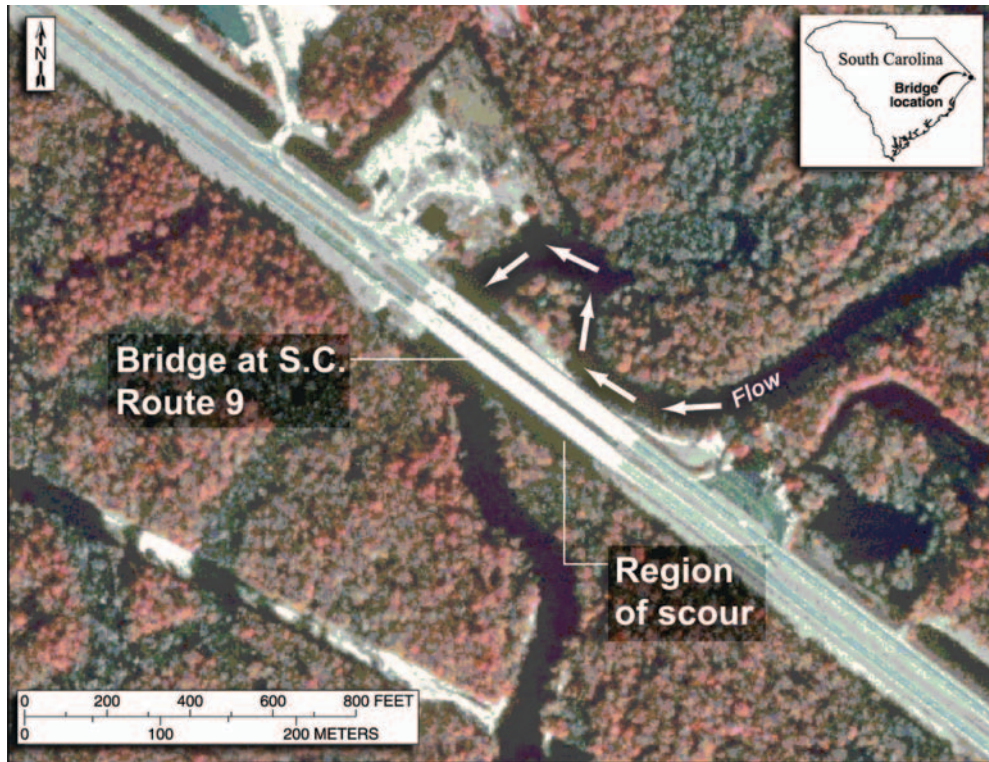
**Figure 80.** Severe meander on the Waccamaw River at Structure 264000920500 on S.C. Route 9 in Horry County, South Carolina. (Photograph from South Carolina DOQQ Archive, 1994.)

The Waccamaw River in Horry County has a sharp meander bend just upstream from the bridge on S.C. Route 9 (fig. 80). During the 1999 flood, flow measurements at this bridge (USGS gaging station 02110500, Waccamaw River at Longs, S.C.) exceeded the 100-year flow magnitude. During flood conditions, concentrated flows apparently overtopped the main channel and entered the left abutment area creating a scour hole that was approximately 15 ft deep and 150 ft wide (fig. 81). The

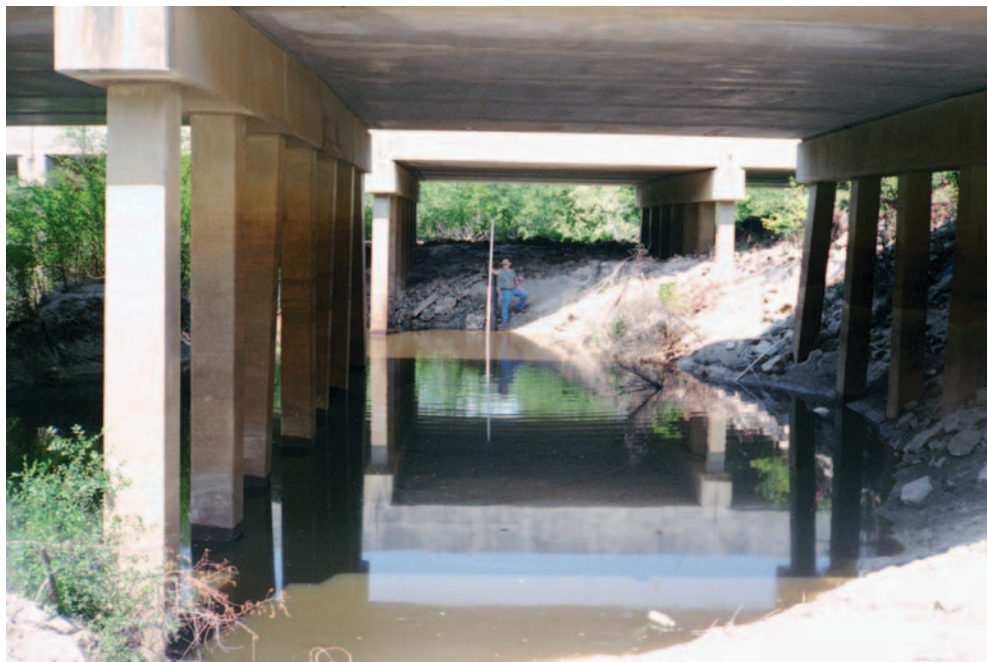
**Figure 81.** Scour hole at left abutment viewed from downstream at Structure 264000920500 on S.C. Route 9, crossing the Waccamaw River in Horry County, South Carolina. (Photograph by the South Carolina District, U.S. Geological Survey, June 2000.)

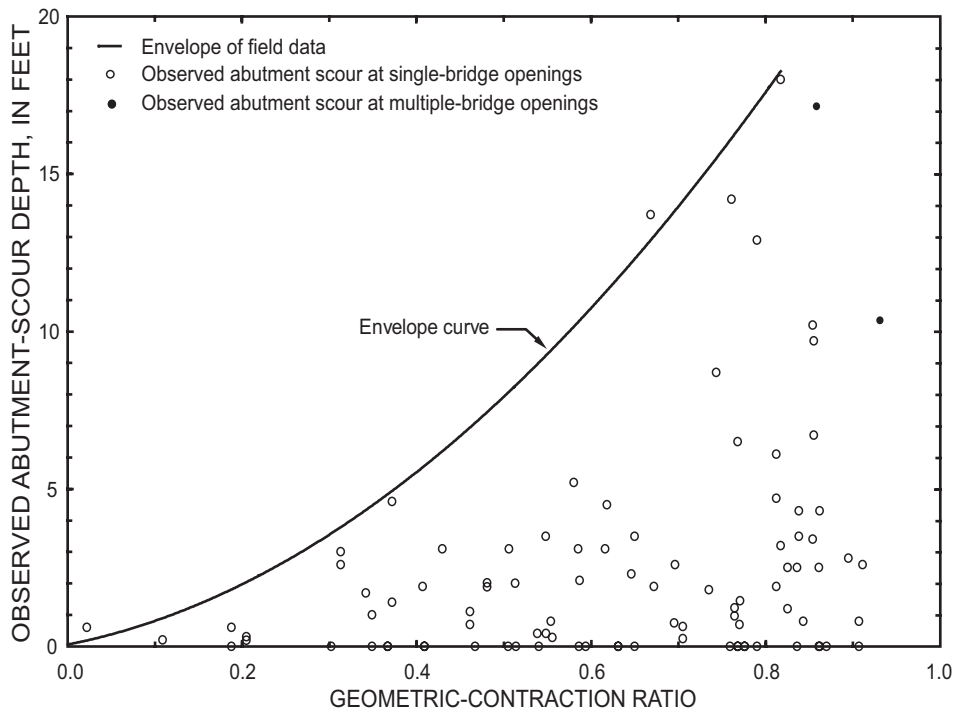
**Figure 83.** Relation of observed clear-water abutment-scour depth and 100-year-flow geometric-contraction ratio with the identification of multiple-bridge openings for the Piedmont of South Carolina.

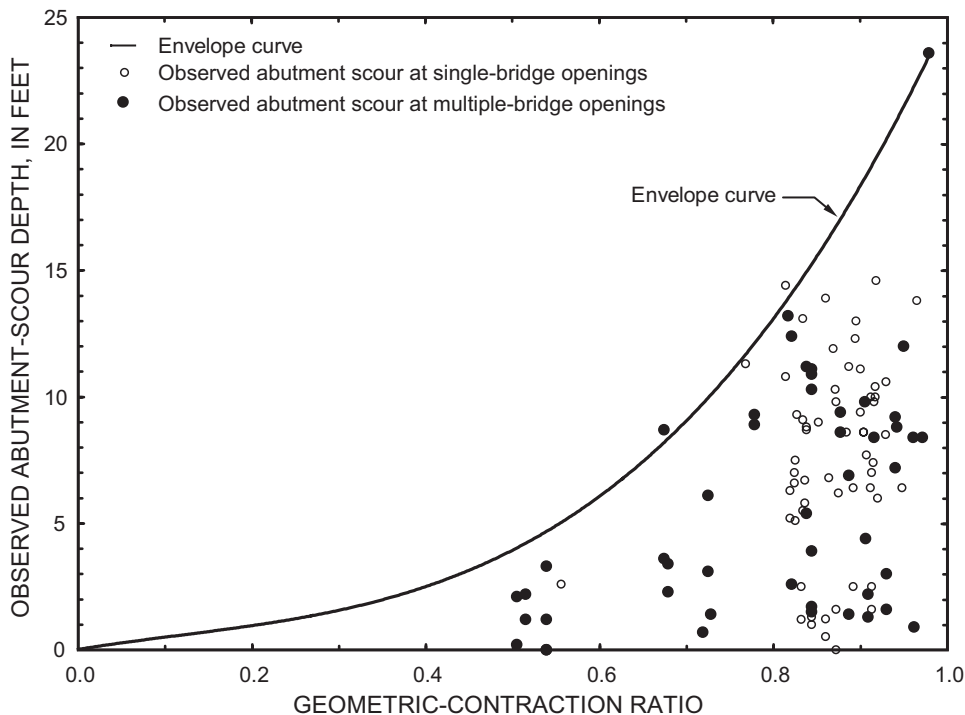
**Figure 85.** Relation of observed clear-water abutment-scour depth and the 100-year-flow geometric-contraction ratio with the identification of multiple-bridge openings in the Coastal Plain of South Carolina.

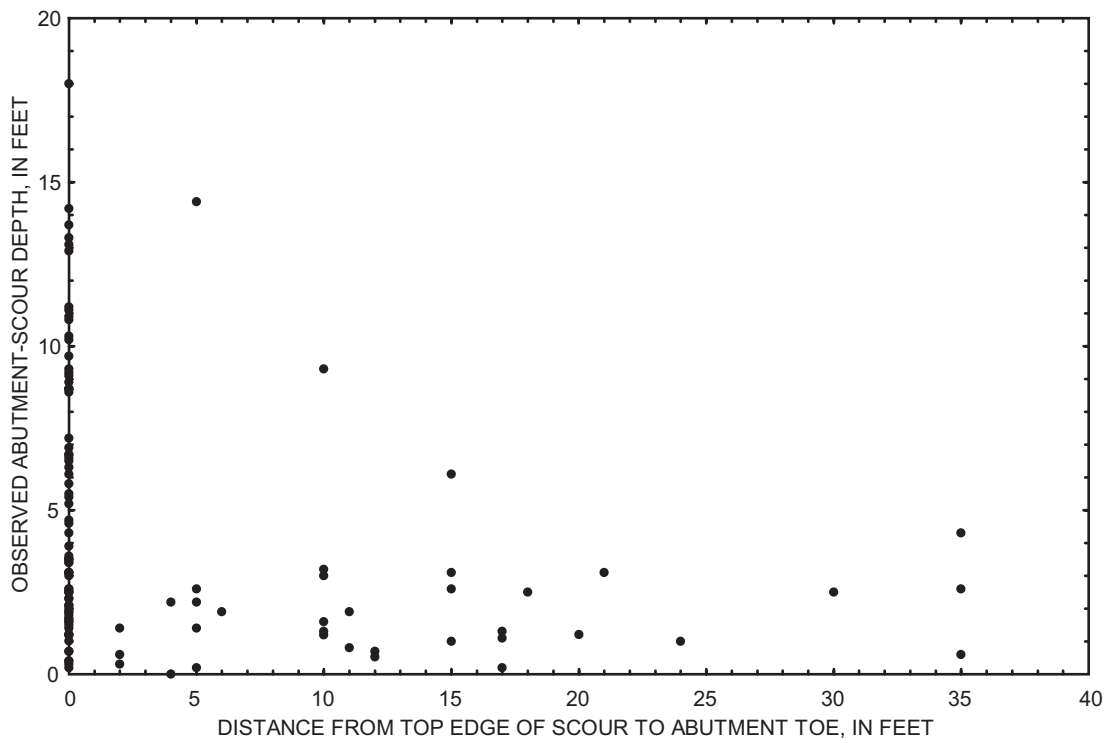
**Figure 88.** Lateral location of scour-hole bank in reference to the abutment toe for observed abutment scour in the Piedmont and Coastal Plain of South Carolina.

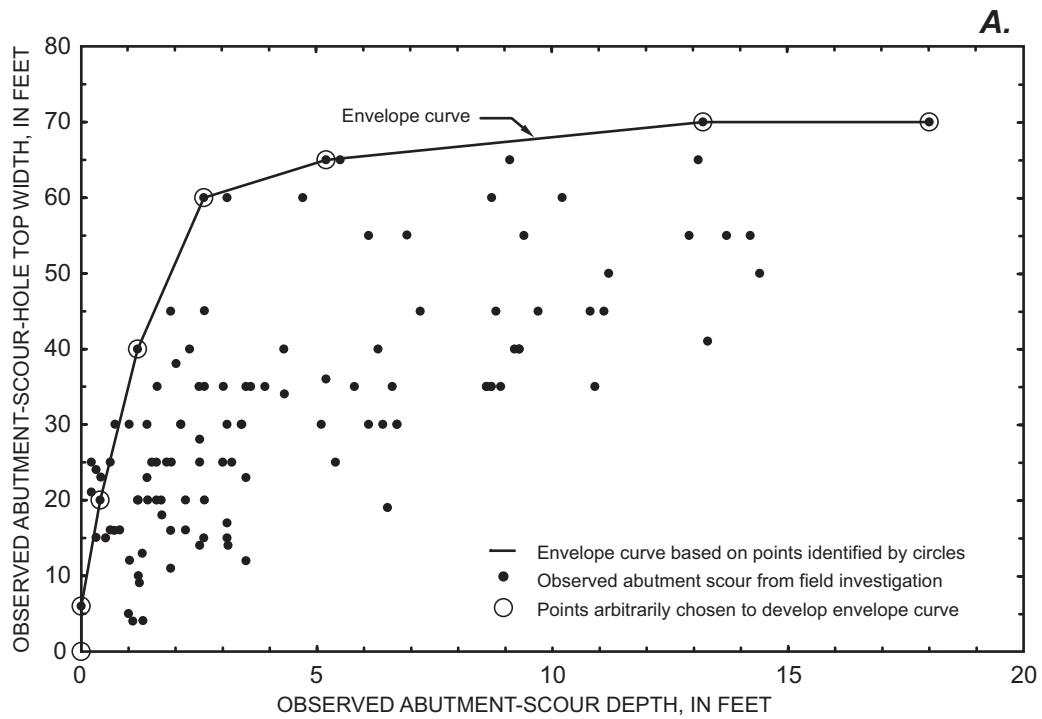
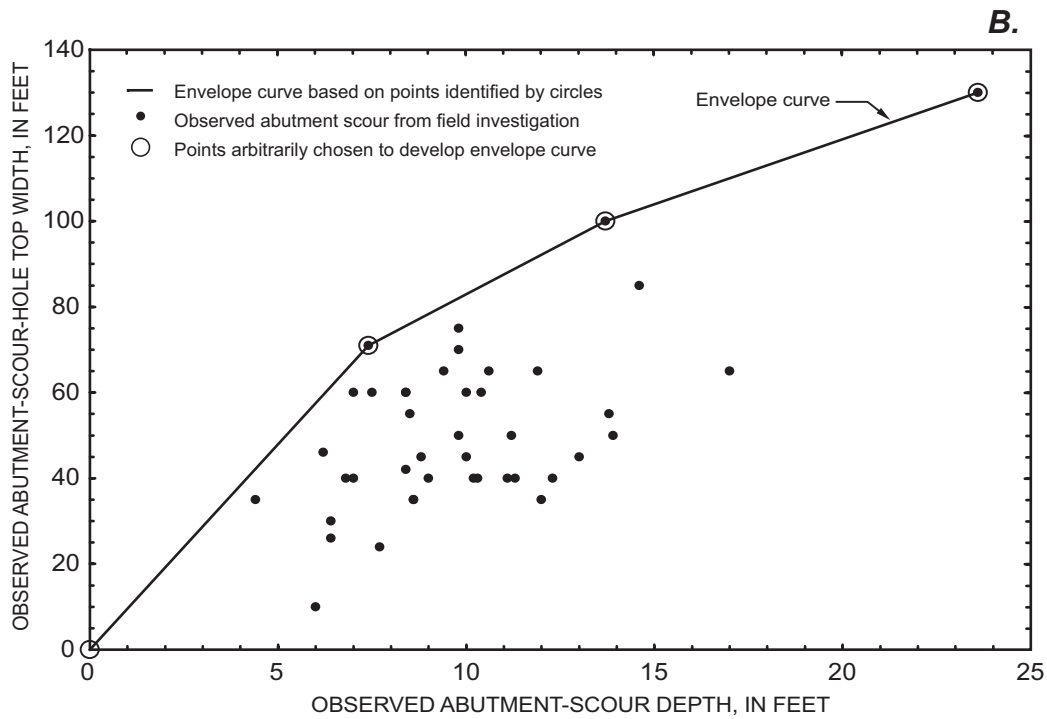
**Figure 89.** Relation of abutment-scour-hole top width and abutment-scour depth at bridges (A) greater than 240 feet in length, and (B) swampy and floodplain relief bridges, 240 feet or less in length in the Piedmont and Coastal Plain of South Carolina.

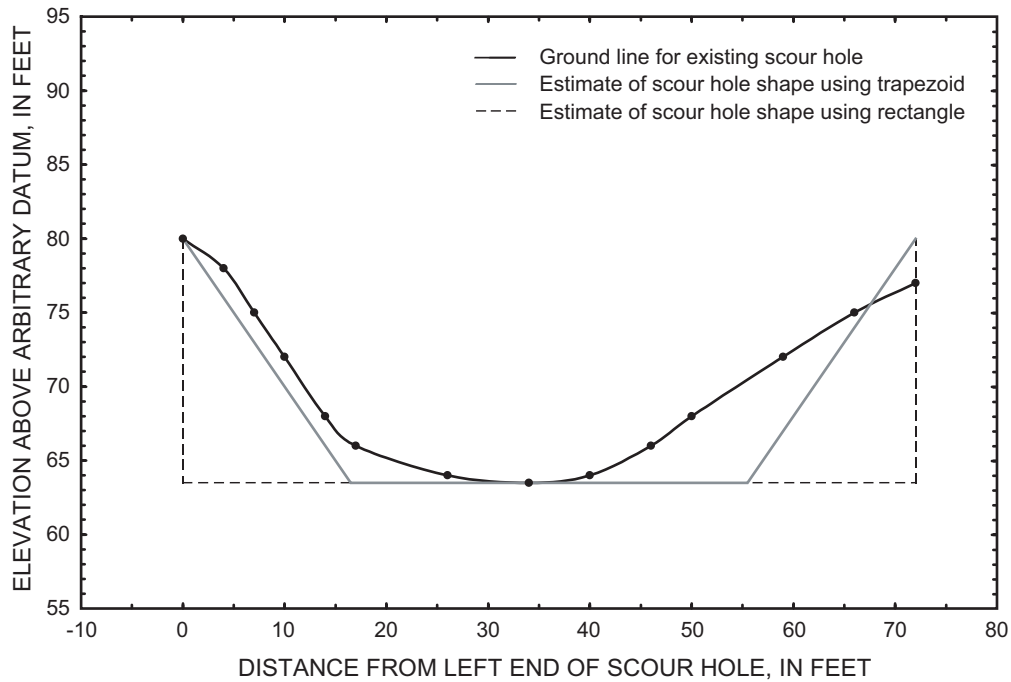
**Figure 93.** Ground line of existing scour hole compared with the shape of a trapezoid and rectangle.

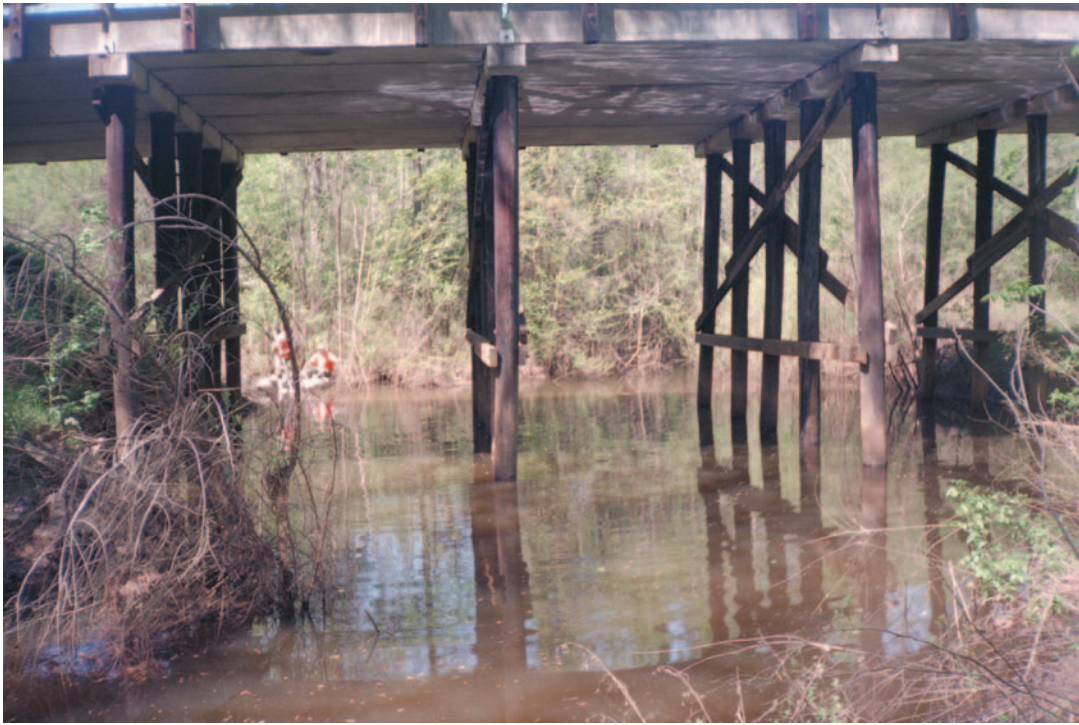
**Figure 97.** Right abutment-scour hole as viewed from downstream at Structure 367008100200 on Road S-81, crossing the Enoree River in Newberry County, South Carolina. The abutment-scour hole is inundated with ponded water. (Photograph by the South Carolina District, U.S. Geological Survey, April 7, 1997.)

In this study, field data were collected during low-flow conditions and the boundary between severely curved and straight flow patterns at a given site was not defined. This boundary can often be estimated from scour-hole patterns observed in the field. Deeper abutment-scour holes typically occurred near the abutment toe with a substantially shallower scour occurring beyond this region. An example of this pattern can be seen at Structure 367008100200 on Road S-81 crossing the Enoree River in Newberry County (fig. 96). The large abutment-scour hole (fig. 97) is 13.7 ft deep and is located in the abutment-scour region where severe flow curvature would be expected. Beyond the abutment-scour hole, the maximum clear-water contraction-scour depth is approximately 4 ft (fig. 98), and is in the overbank region where straighter flow patterns would likely occur. Piedmont sites with smaller abutment-scour depths, often display a similar pattern of distinct abutment- and clear-water contraction-scour regions. The idealized

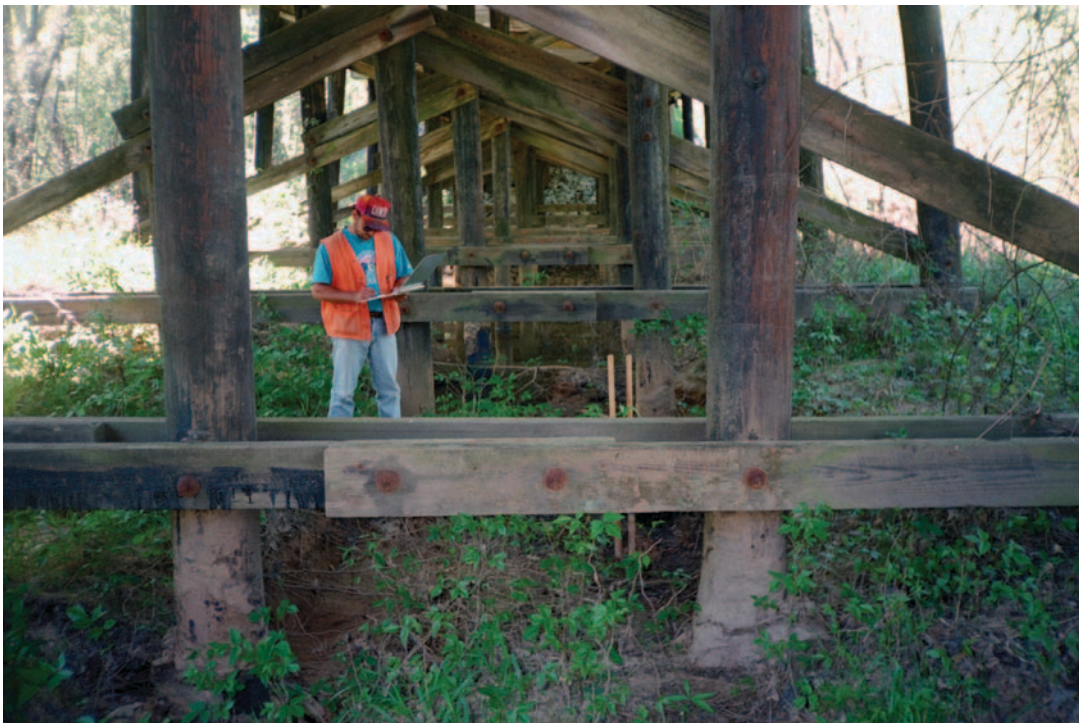
**Figure 98.** Clear-water contraction scour on the right overbank as viewed from the left at Structure 367008100200 on Road S-81, crossing the Enoree River in Newberry County, South Carolina. (Photograph by the South Carolina District, U.S. Geological Survey, April 7, 1997.)

shallow, parabolic depression running perpendicular to the flow (figs. 98, 99, and 100). Scour-hole patterns were commonly sufficient to distinguish clear-water contraction scour from abutment scour. When the scour-hole patterns were insufficient to distinguish these regions, clear-water contraction-scour data were collected away from the abutment toe. For small overbanks, the regions were often indistinguishable and judgment was required in classifying the scour as abutment or contraction. Table 14 lists the range of selected parameters associated with the 76 clear-water contraction-scour observations. Values for hydraulic data were estimated with the WSPRO model (Shearman, 1990) using the 100-year flow.
