# Clear-Water Abutment and Contraction Scour in the Coastal Plain and Piedmont Provinces of South Carolina, 1996-99

Water-Resources Investigations Report 03-4064  
Version 1.1, August 2016

*By* Stephen T. Benedict

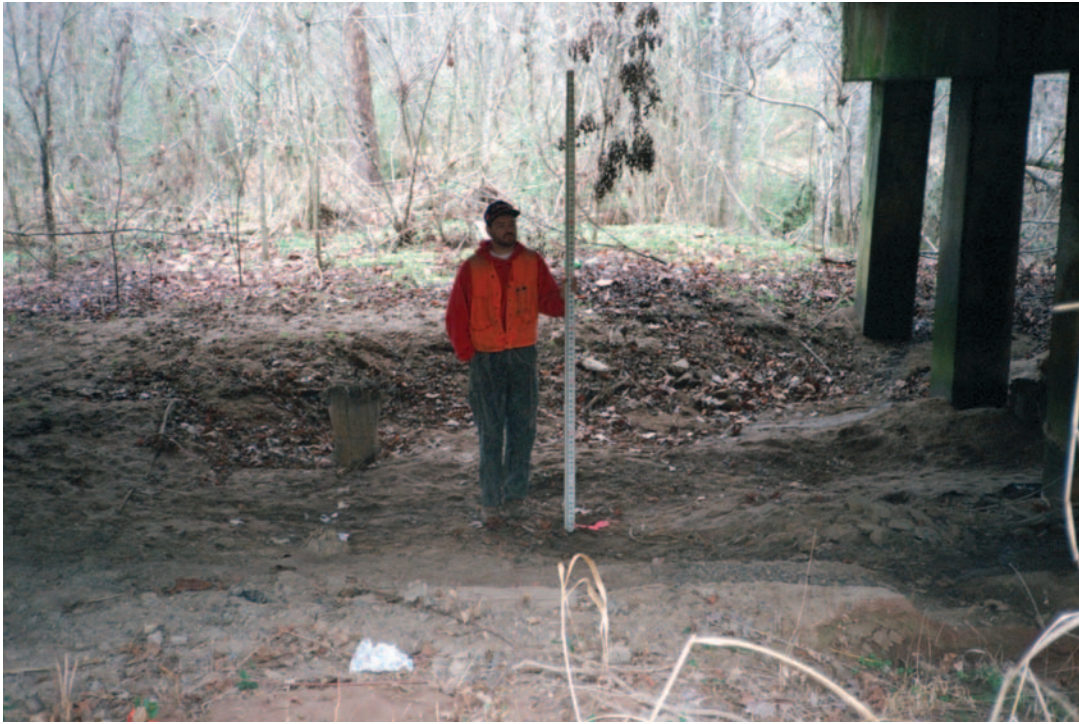
**Figure 99.** Example of shallow clear-water contraction scour at Structure 464032200300 on S.C. Route 322, crossing Fishing Creek in York County, South Carolina. (Photograph by the South Carolina District, U.S. Geological Survey, January 28, 1997.)

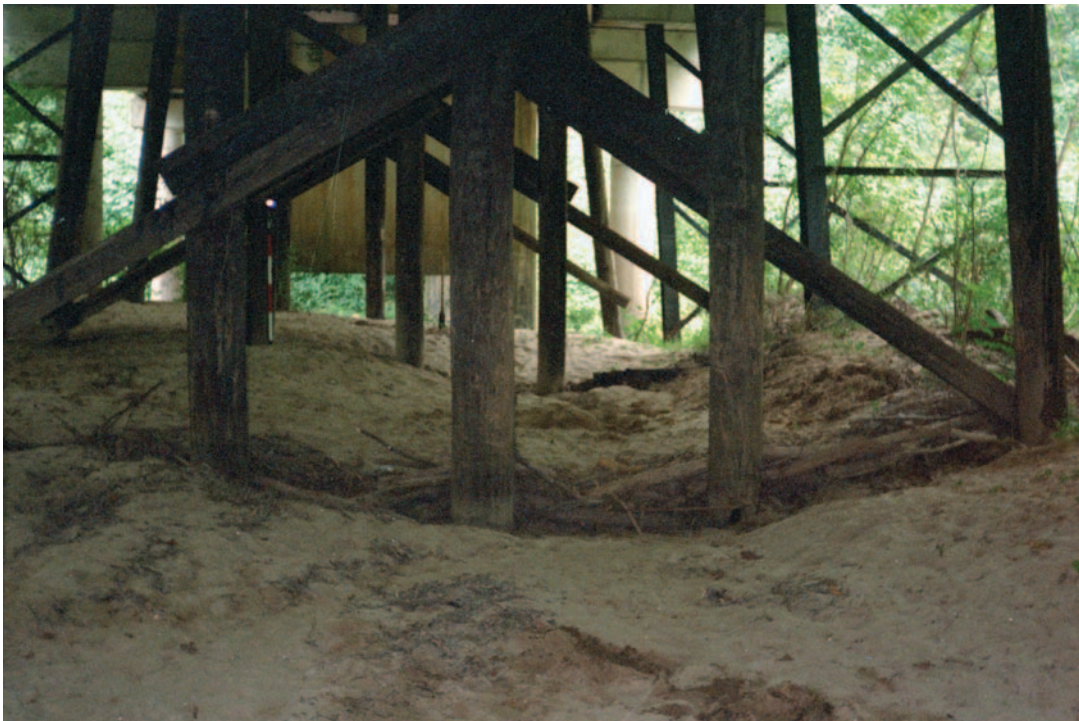
**Figure 100.** Example of shallow clear-water contraction scour at Structure 114000500200 on S.C. Route 5, crossing Buffalo Creek in Cherokee County, South Carolina. (Photograph by the South Carolina District, U.S. Geological Survey, October 7, 1996.)

shallow, parabolic depression running perpendicular to the flow (figs. 98, 99, and 100). Scour-hole patterns were commonly sufficient to distinguish clear-water contraction scour from abutment scour. When the scour-hole patterns were insufficient to distinguish these regions, clear-water contraction-scour data were collected away from the abutment toe. For small overbanks, the regions were often indistinguishable and judgment was required in classifying the scour as abutment or contraction. Table 14 lists the range of selected parameters associated with the 76 clear-water contraction-scour observations. Values for hydraulic data were estimated with the WSPRO model (Shearman, 1990) using the 100-year flow.

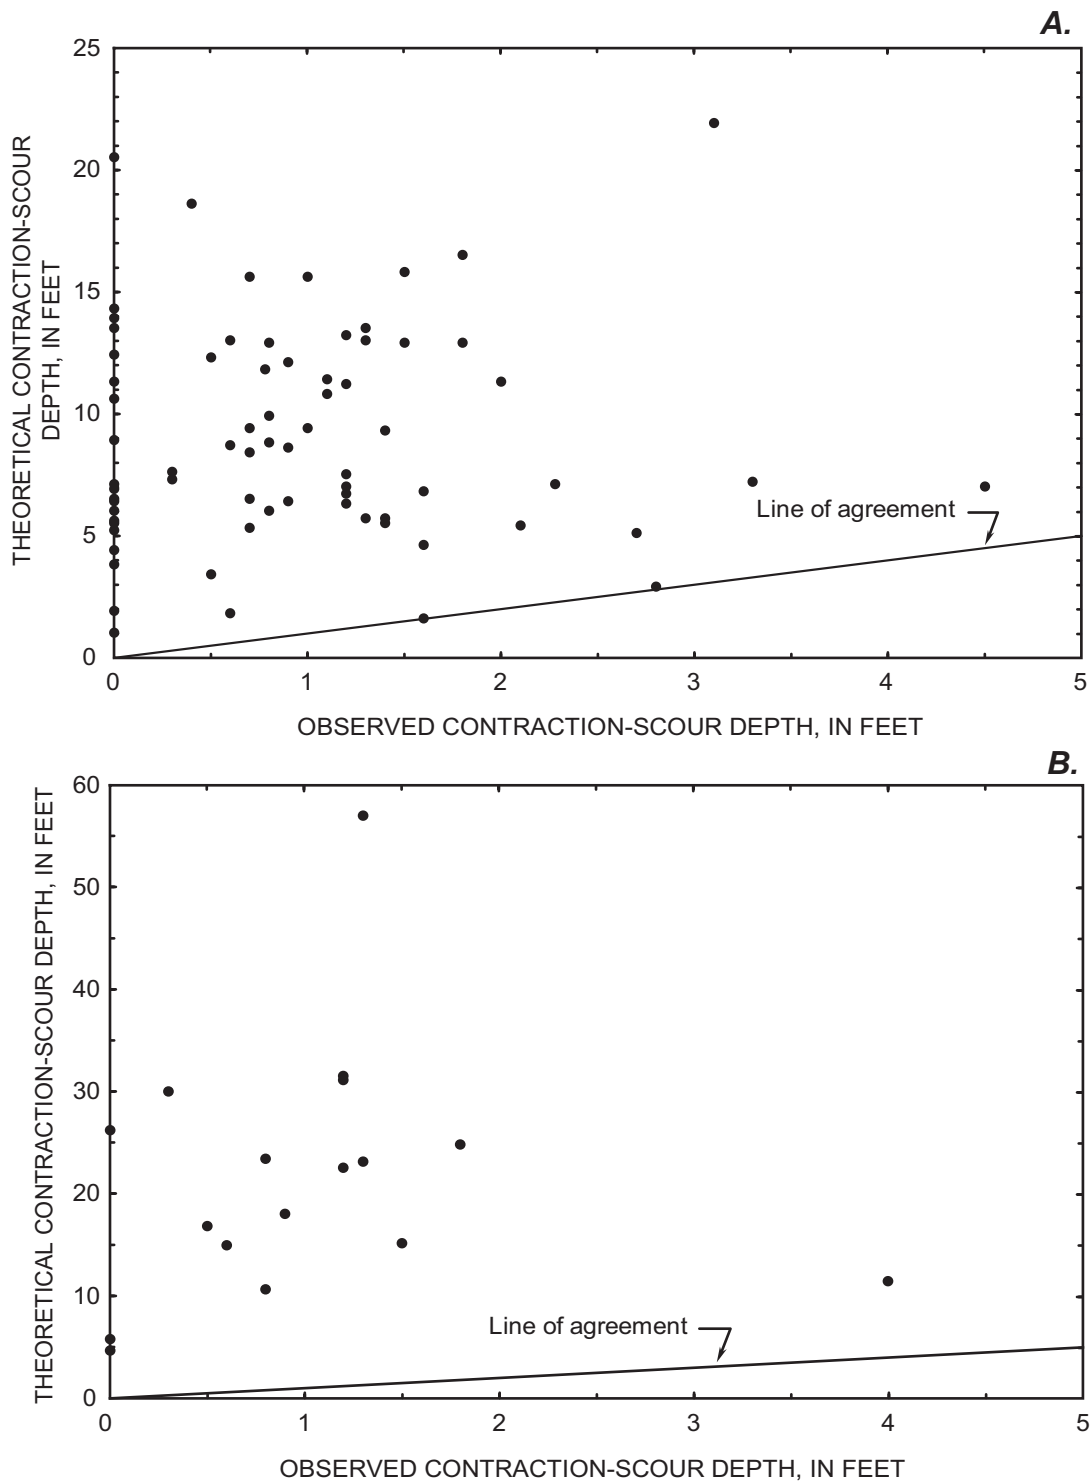
**Figure 101.** Relation of observed and theoretical clear-water contraction-scour depth for the (A) 100-year flow, and the (B) August 1995 flood at selected sites in the Piedmont of South Carolina. (Theoretical contraction scour calculated with the Laursen (1963) equation.)

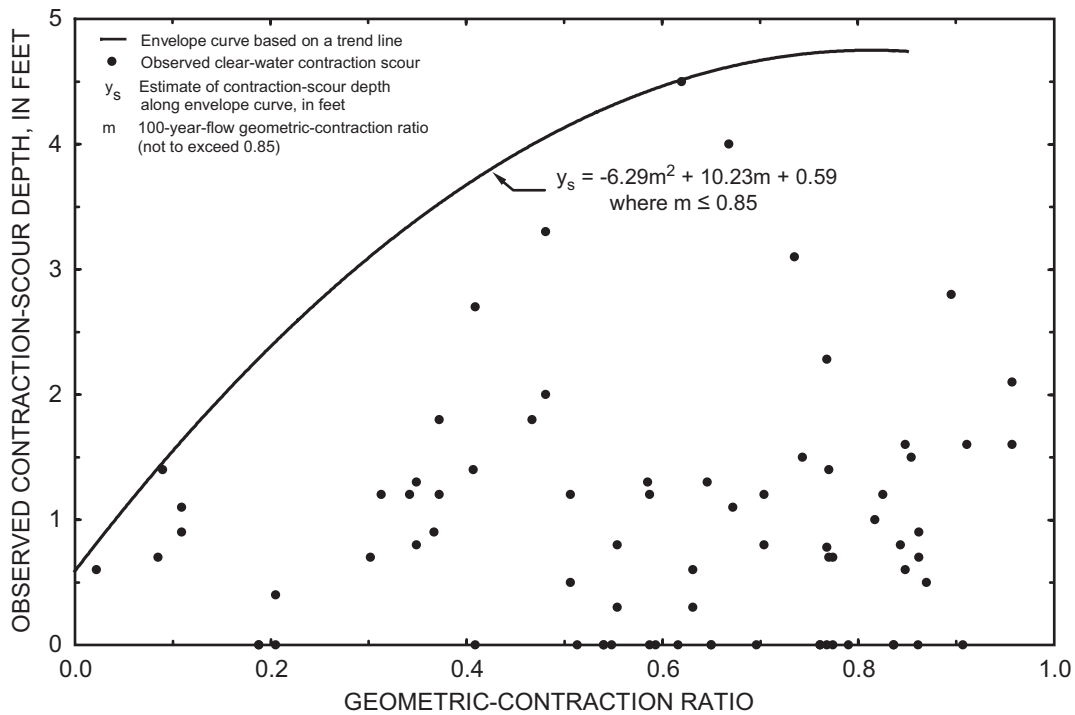
**Figure 102.** Relation of observed clear-water contraction-scour depth and the 100-year-flow geometric-contraction ratio in the Piedmont of South Carolina.

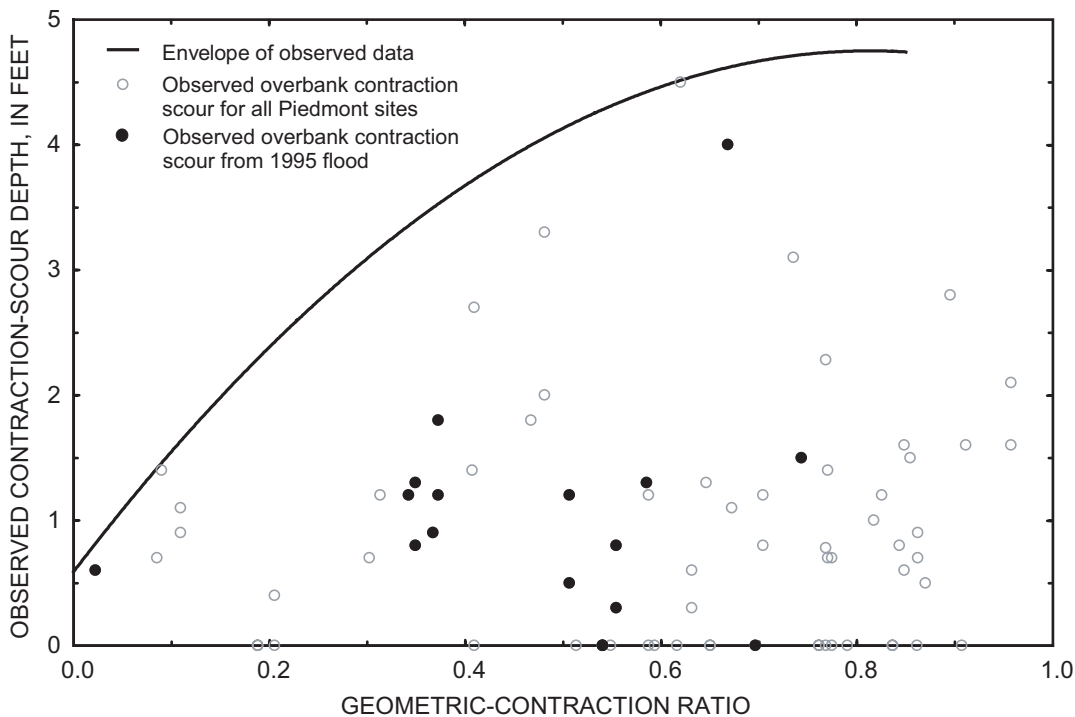
**Figure 103.** Relation of observed clear-water contraction-scour depth and the 100-year-flow geometric-contraction ratio identifying sites for the 1995 flood in the Piedmont of South Carolina.

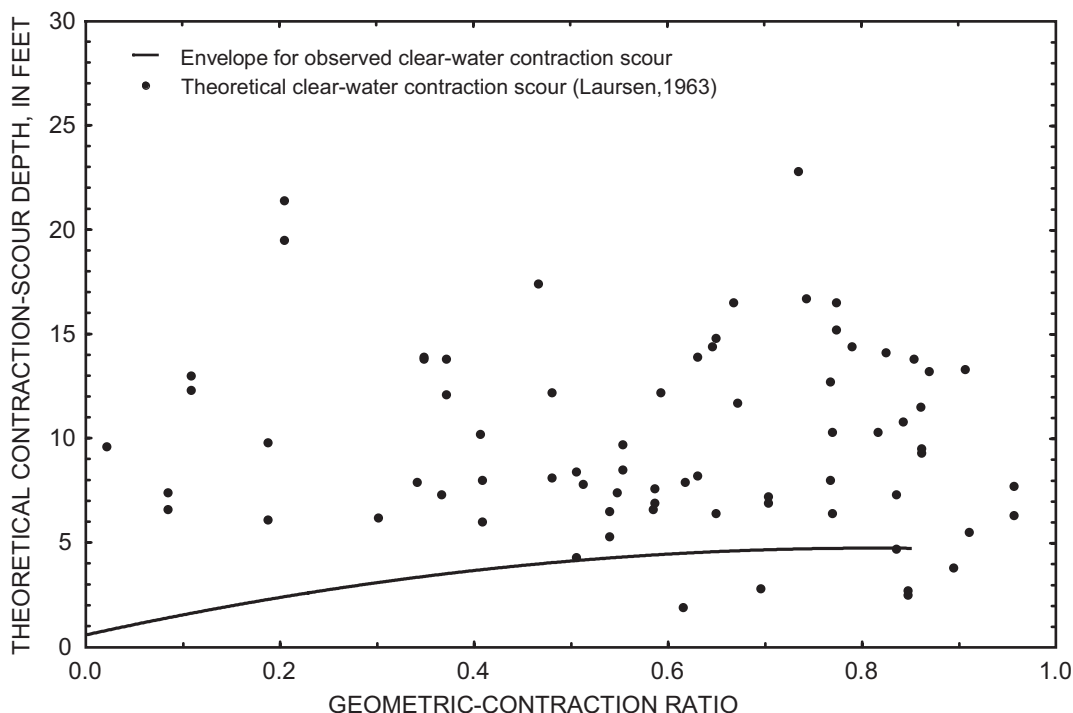
**Figure 104.** Relation of theoretical 100-year-flow clear-water contraction-scour depth and the 100-year-flow geometric-contraction ratio compared with the envelope of observed data in the Piedmont of South Carolina. (Theoretical clear-water contraction scour calculated with the Laursen (1963) equation.)

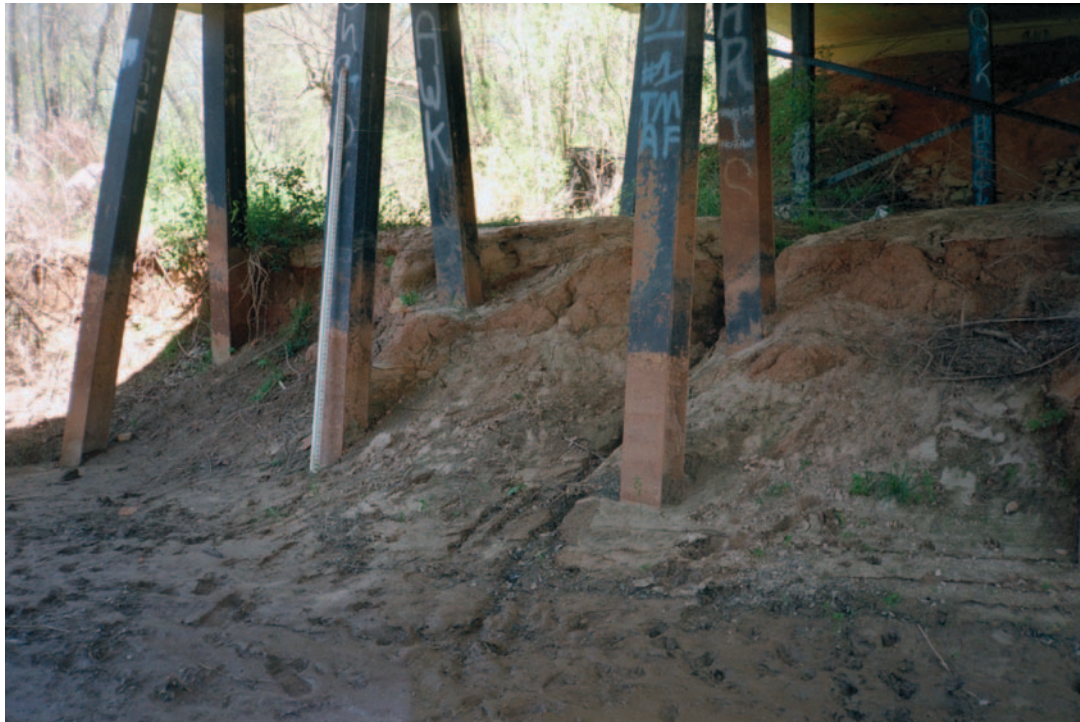
**Figure 105.** Erosion of bed material from around piles caused by bank widening from the August 1995 flood at Structure 307026300100 on Road S-263, crossing the Enoree River in Laurens County, South Carolina. (Photograph by the South Carolina District, U.S. Geological Survey, April 1, 1997.)
