Roadkill Observation Collection System (ROCS): Phase III Development

Robert Ament, Doug Galarus, Daniel Richter, Kelvin Bateman,
Marcel Huijser and James Begley

Western Transportation Institute
College of Engineering
Montana State University – Bozeman

April 26, 2011

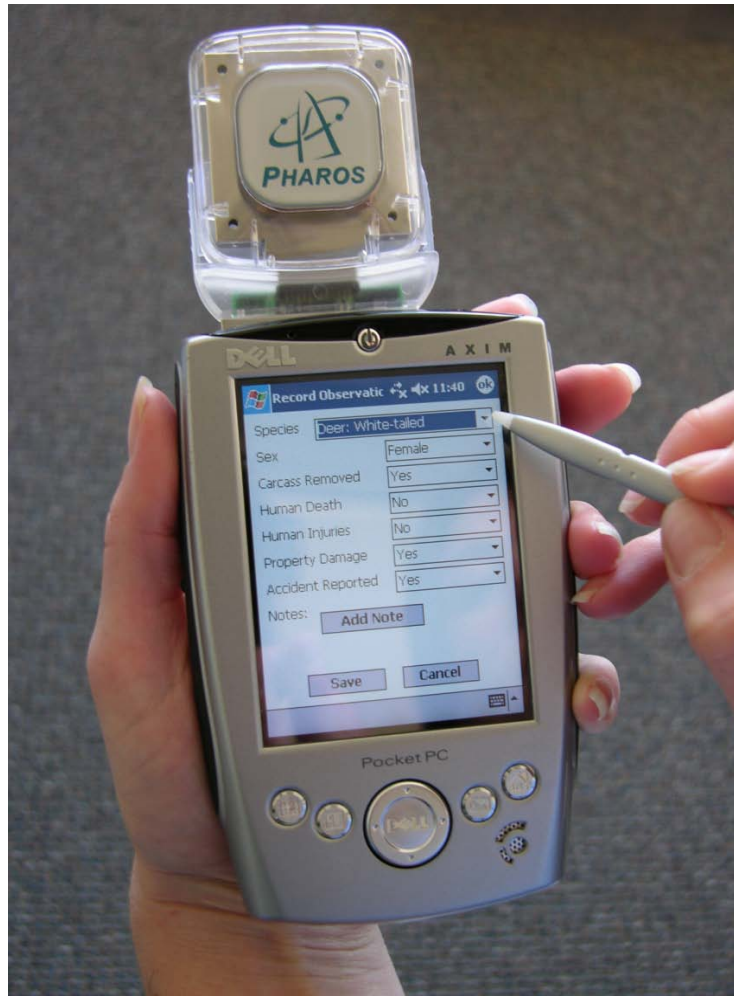
Figure 2: Photo. The original Phase I, Proof of Concept, handheld data collector.

The proof of concept PDA-GPS unit was field tested by WTI and demonstrated to a number of prospective users. WTI also developed a self-tutorial CD to demonstrate the operation of the unit. An evaluation of the project indicated that it was an effective and precise data collector and easy to operate. One weakness that was identified in the first phase was that the PDA-GPS combination was vulnerable to damage during field use. Furthermore, desktop computer applications would need to be developed to make the data easy to download, display on maps, and prepare for analyses. Phase I was completed in early 2006.

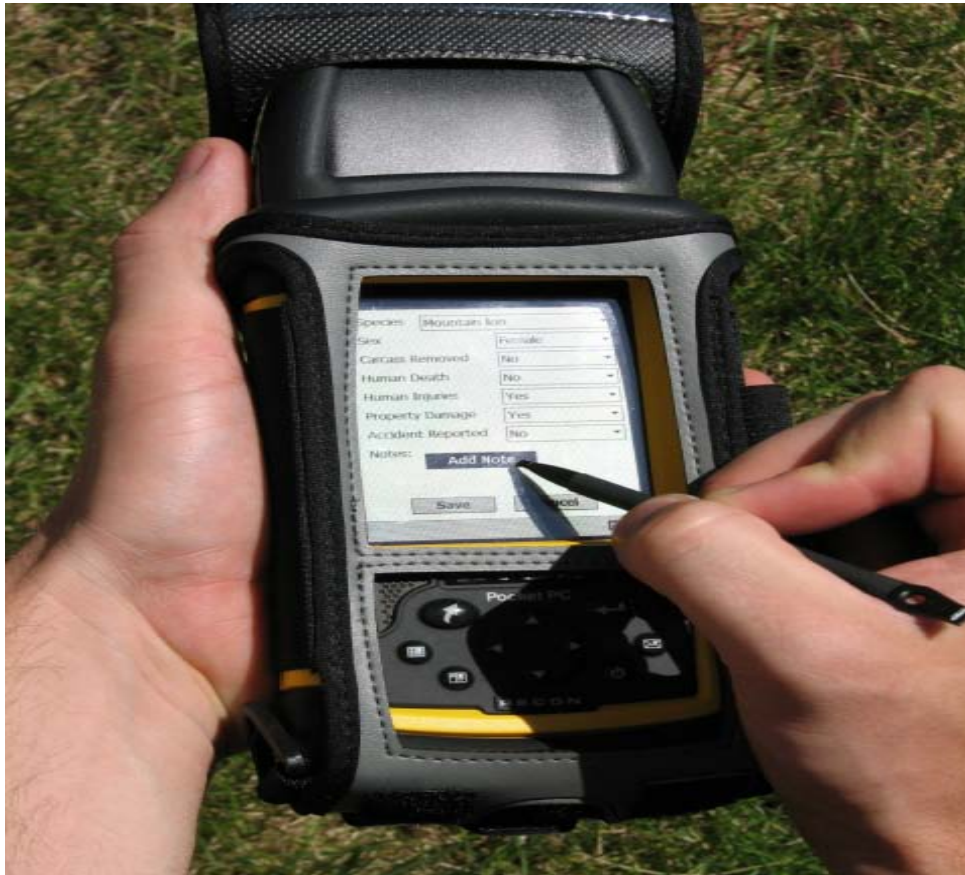
Figure 3: Photo. An integrated PDA-GPS handheld data collector developed and used in Phase II of the ROCS project.

- Requirement of locating three satellites (2-D fix).
- Accuracy (latitude/longitude): 5-10 meters.
- Accuracy (elevation): not as accurate.

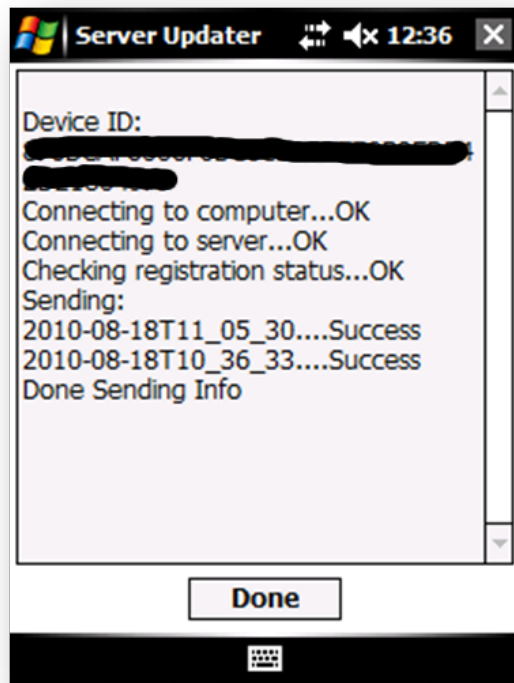
Figure 7: Screen shot. An example of ROCS PDA-GPS unit's data transfer status report indicating all systems worked and the data transfer to the central repository was completed.

When the ROCS Auto Upload program is enabled, it configures itself to automatically upload data when a PDA-GPS unit is connected to a local user's PC. Upon connection to a PC it verifies that the PC has Internet connectivity and that it can establish a connection to the central database. It then verifies that the PDA-GPS unit is registered in the ROCS database and automatically uploads data (Figure 6). Upon the successful transfer of the data from the handheld unit to the central repository via the PC's Internet connection, confirmation is displayed on the screen of the user's handheld unit (Figure 7).

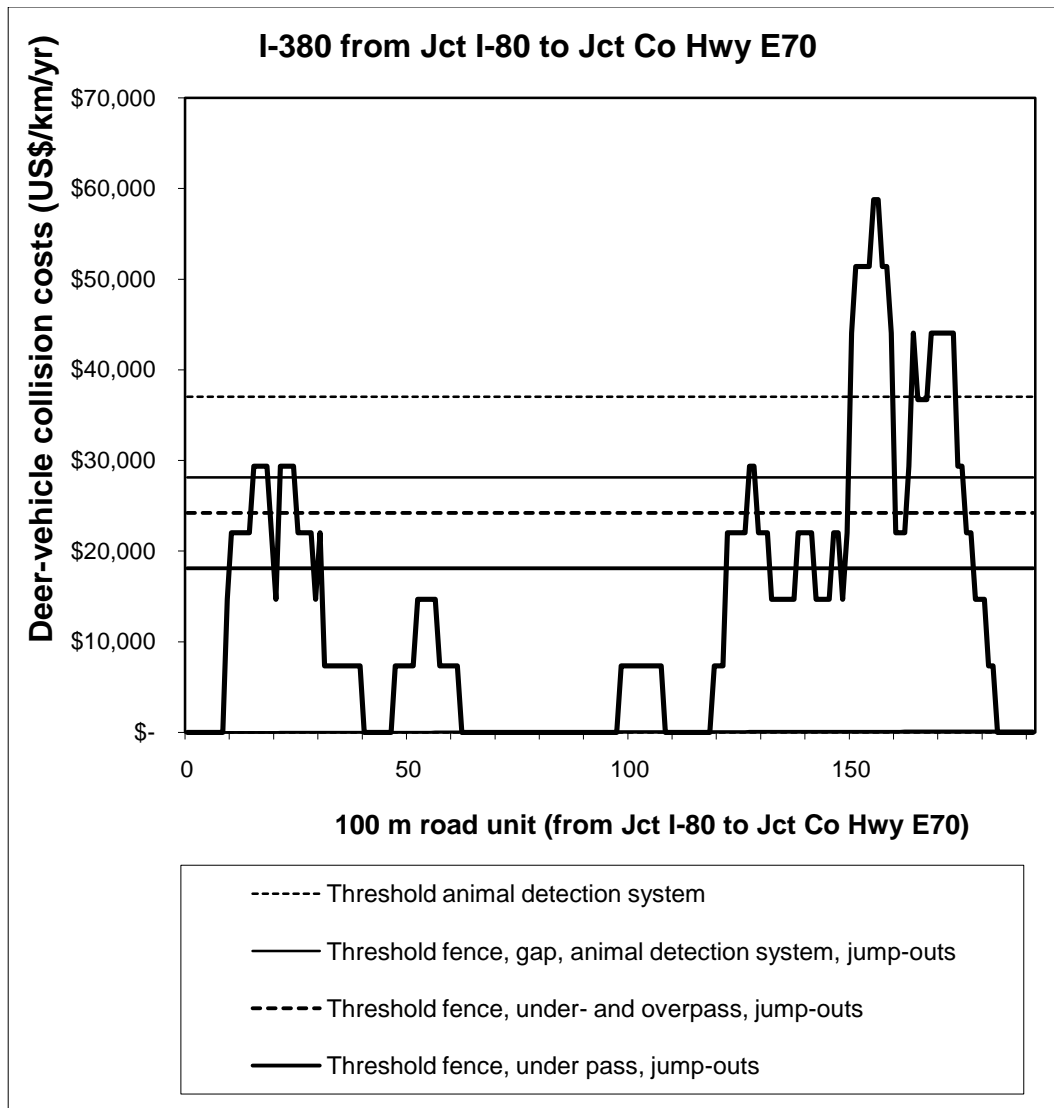
Figure 22: Graph. The costs (in 2007 US\$) per year (2010) associated with deer–vehicle collisions along the 19.1 km (11.9 mile) long section of I-380 from the junction with I-80 to the junction with County Hwy E70. Figure includes the threshold values (at 3% discount rate) that need to be met in order to have the benefits of individual mitigation measures exceed the costs over a 75-year time period. Note that the costs at each 100 m (0.062 mile) long road section included each 100 m unit on either side (“the running average”) to estimate the costs per kilometer for each 100m unit.

Figures 22 through 26 illustrate the road sections for which the number of recorded deer carcasses was high enough to meet or exceed thresholds for the implementation of four different types of mitigation measures. Each of the four road sections had road segments where the threshold values for all four mitigation measures were (nearly) met or exceeded. While the researchers strongly advise to use the cost–benefit analyses as a decision support tool, they also urge users to recognize that it is only one of the factors that may or should be considered in the decision making process (see Discussion and Conclusions).

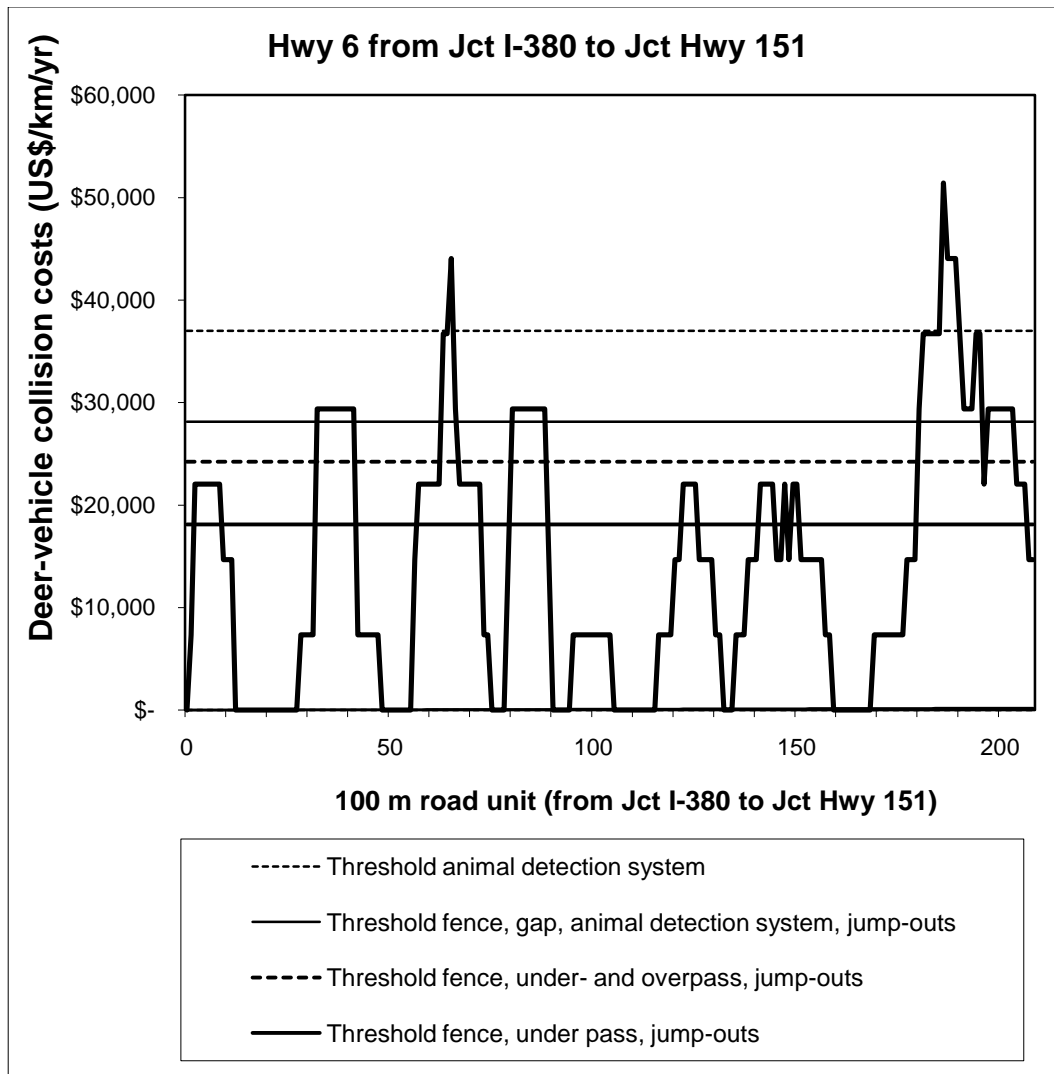
Figure 24: Graph. The costs (in 2007 US\$) per year (2010) associated with deer-vehicle collisions along the 20.8 km (12.9 mile) long section of Hwy 6, from the junction with I-380 to the junction with US Hwy 151. Figure includes the threshold values (at 3% discount rate) that need to be met in order to have the benefits of individual mitigation measures exceed the costs over a 75-year time period. Note that the costs at each 100 m (0.062 mile) long road section included each 100 m unit on either side (“the running average”) to estimate the costs per kilometer for each 100m unit.

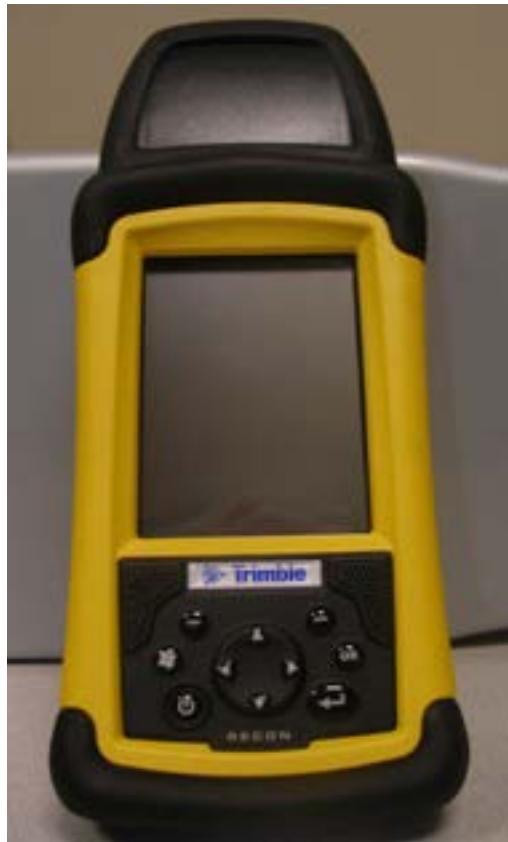
Figure 27: Photo. Trimble Recon

ROCS is installed on a fully functional Windows Mobile PDA device, the Trimble Recon (Figure 27). Users are encouraged to read through the supplied Trimble Recon handheld Getting Started Guide to familiarize themselves with the features of the PDA. This section serves to highlight some of the important features of the device.

The Trimble Recon is a rugged PDA designed to operate in hostile conditions. The Recon is rated to operate in temperatures from -22°F to 140°F. The sealed casing of the unit protects it from accidental liquid submersion (1 meter for up to 30 minutes), as well as contamination from dust and sand.

The top of the Recon contains two Compact Flash slots. Both are used by ROCS. One slot contains a GPS receiver and the other contains a compact flash storage card for roadkill data archiving and system backup files. The slots are enclosed in a plastic end cap and sealed to prevent contamination. The end cap may be removed by the user by unscrewing either side with the non-writing end of the stylus. However, it is recommended that the end cap remains tightly fastened to the unit for normal operation.

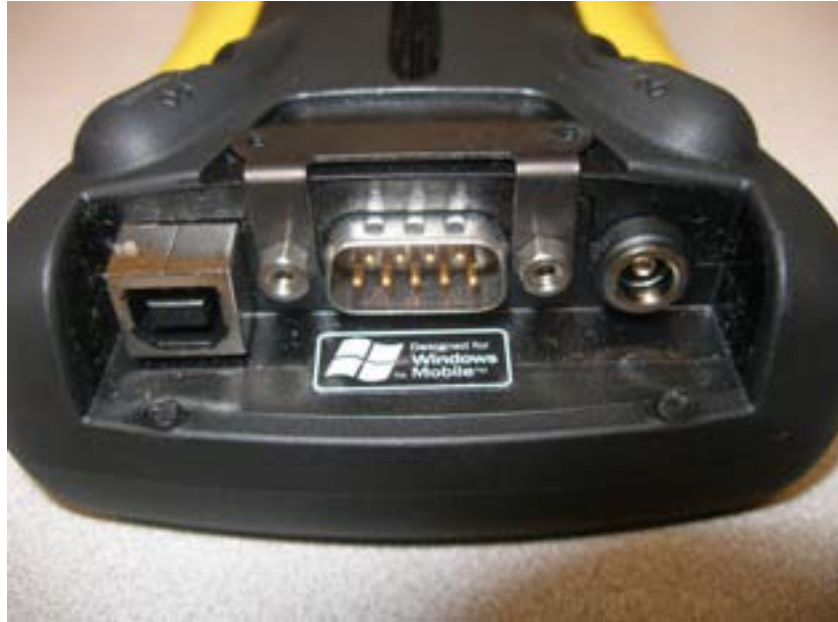
Figure 28: Photo. Recon Power Boot Module

The bottom of the Recon contains a power boot module (Figure 28). The module is interchangeable and contains the battery, power connector, serial connector, and USB connector. Either the supplied 12V DC automotive power adapter or the AC adapter may be plugged into the power connector. The serial port connector is not used by ROCS. The USB connector is used to transfer data from the PDA to a PC via the supplied USB cable.

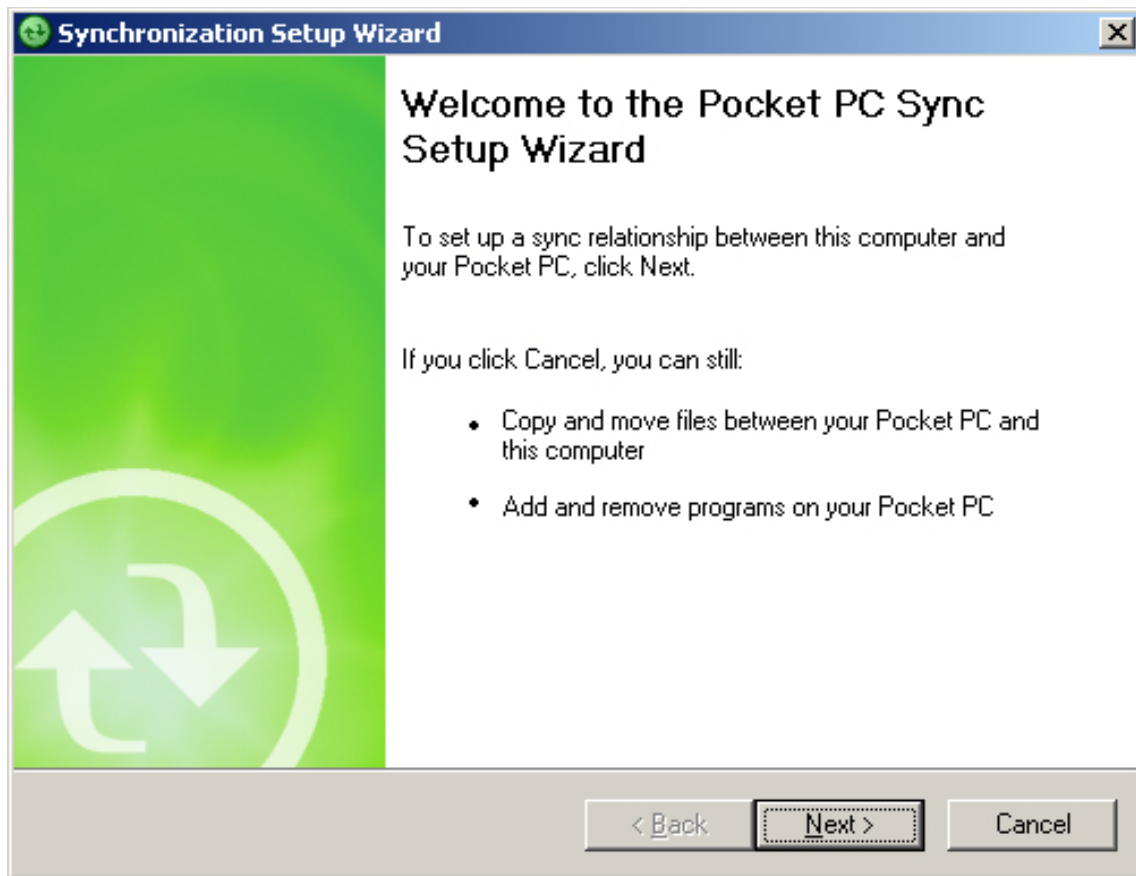
Figure 40: Screen Shot. ActiveSync Partnership Options

1. If the application is open and there is currently an active session, stop the session by pressing the "Stop GPS" button on the main application screen.
2. Make sure the PDA and the PC are running. Plug the USB cable into both the PDA and the PC.
3. In a few seconds, ActiveSync should recognize that the PDA has been plugged in and will attempt to initiate a synchronization partnership with the Pocket PC Sync Setup Wizard (Figure 40). Clicking the "Next" button on this screen sets up a standard partnership. **Clicking the "Cancel" button sets up a guest partnership, this is what we recommend.**
