A Regional Ecosystem Framework for Terrestrial and Aquatic Wildlife along the I-70 Mountain Corridor in Colorado

An Eco-Logical Field Test

September 2011

Report to the Federal Highway Administration and the Colorado Department of Transportation

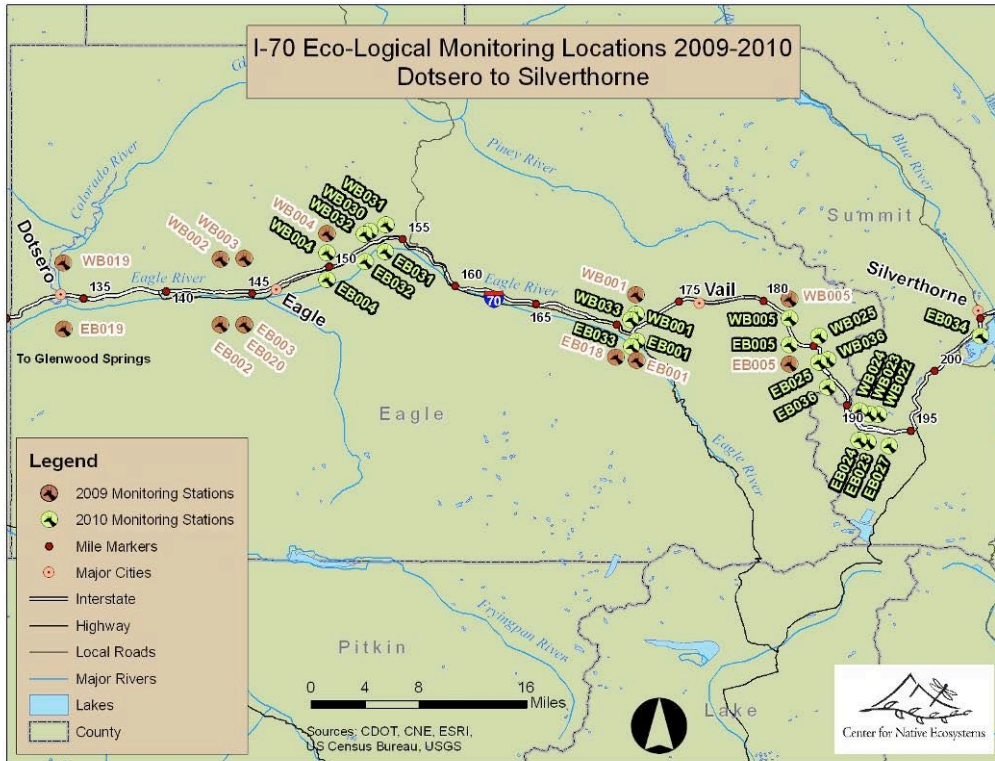
Map 2. Camera monitoring locations in 2009 and 2010 in the western portion of the study area, from Dotsero to Silverthorne.

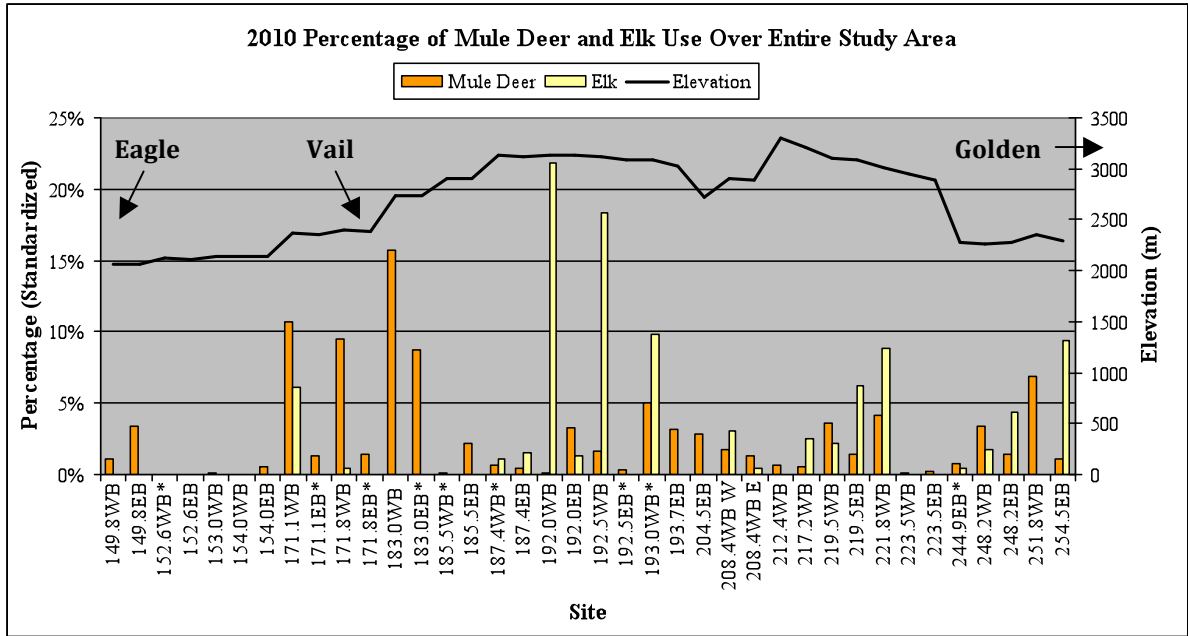
Figure 1: – Percentage of elk and mule deer use at monitoring locations in the I-70 Mountain Corridor in 2010.

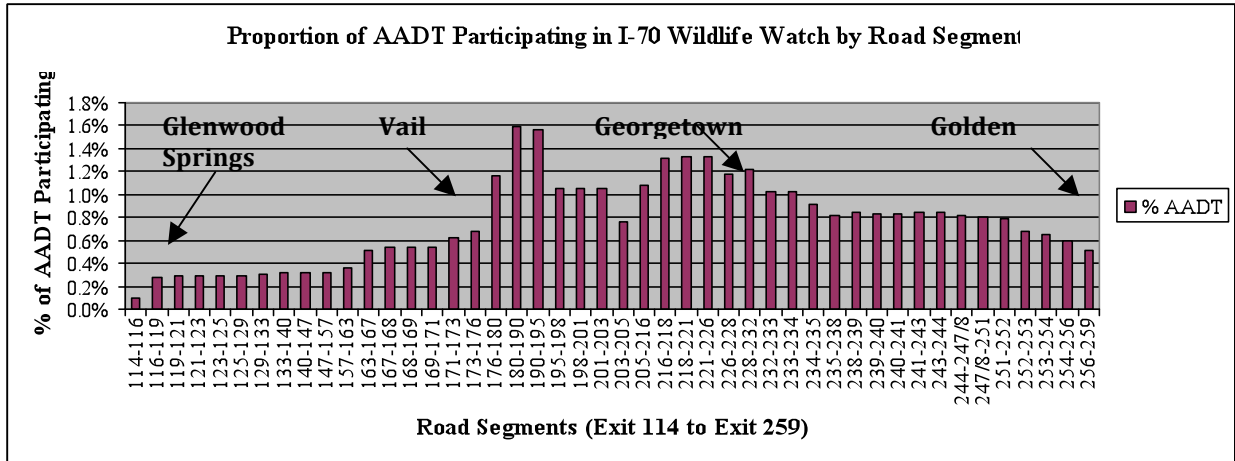
Figure 2: Proportion of Average Annual Daily Traffic (AADT) participating in I-70 Wildlife Watch for each roadway segment (Exit 114 to Exit 259).

By requiring users to note where they entered and exited the highway when a sighting was made, a general sense of reporting effort can be assessed, such that patterns of observations can be discerned while controlling for the number of times that a given segment has been travelled. In general, correcting for observers seemed to accentuate the number of sightings in the western portion of the study area while it minimized the number of sightings in the east. This is due to the fact that there were fewer drivers participating in the website in the west compared to those participating in the east. Comparing the exit data to the AADT also began to tell us where people are participating and where additional outreach is needed. The largest percentage of the AADT participating in the website occurred on West Vail Pass and the smallest between the two exits for Glenwood Springs (Figure 2).

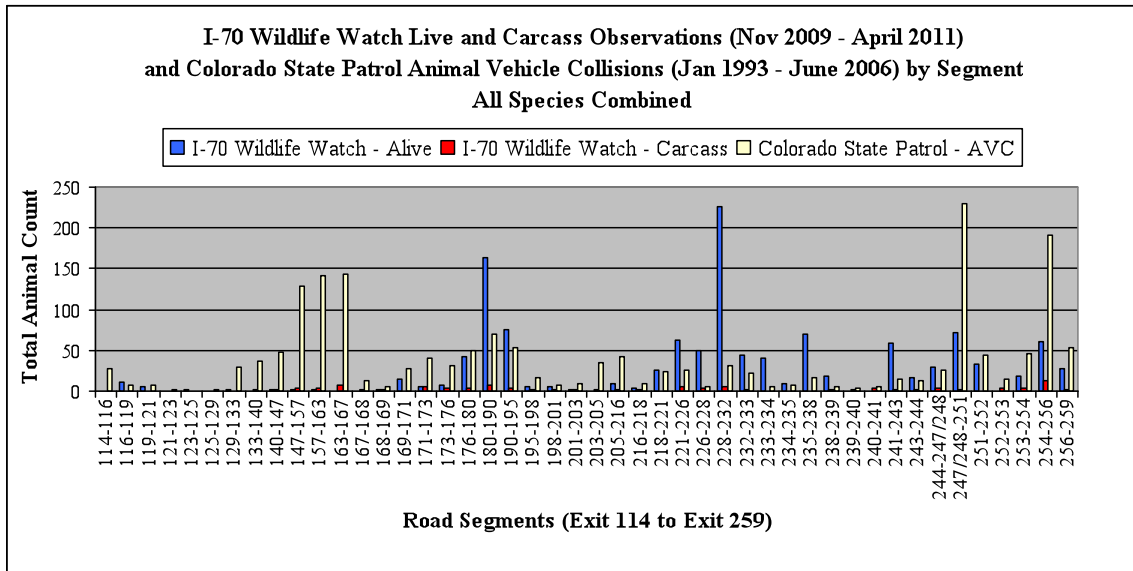
Figure 3: Comparison of I-70 Wildlife Watch observations (live animal and carcass) and AVC data from CSP per roadway segment. The CSP data covers 15 years, while the I-70 Wildlife Watch data captures only an 18 month period that does not overlap with the CSP data. Despite the different time frames, this graph demonstrates how these data sources capture different clusters of wildlife activity.

The sightings reported by motorists in the I-70 Mountain Corridor greatly expanded our knowledge of where live animals are most frequently seen along the roadway. Figure 3 displays live and carcass observations of all species across the Corridor as compared to AVC counts derived from CSP accident reports, demonstrating different clusters in activity captured by each of these sources. Notably, the timeframe for the CSP data is markedly longer than that of the I-70 Wildlife Watch data, and changes in traffic volumes, roadway barriers and adjacent development over the 13 years of CSP data and the resulting impacts to AVC rates along the Corridor are not evident in this analysis. The effects of approximately 32 miles of continuous wildlife fencing in the western portion of the Corridor are not captured here, and as updated CSP datasets become available, the spike in reported AVCs seen from mileposts 147-167 is likely to diminish significantly as a result of the recently completed fencing. Future analyses of these data over common time periods will provide a more informative comparison.

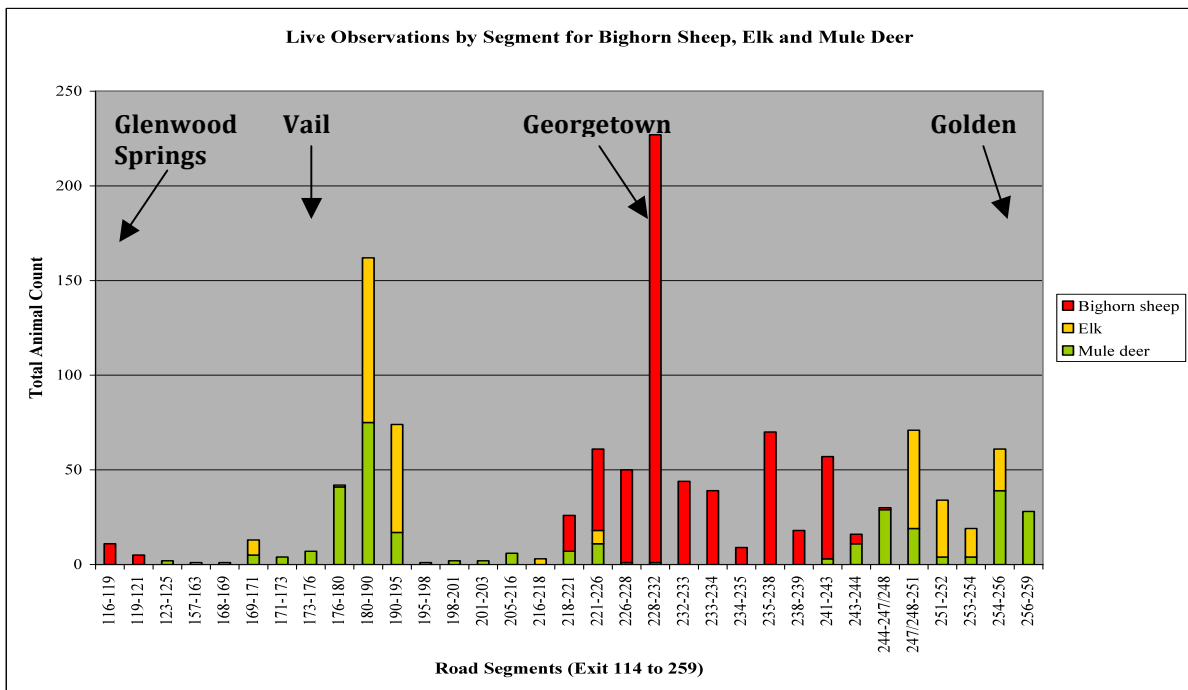
Figure 4: Total animal count by road segment for live observations of bighorn sheep, elk and mule deer. (Total n = 1196). Note roadway segments with no observations are not displayed in this graph.

The large spikes in I-70 Wildlife Watch observations at MP 228-232 relates to an area near Georgetown where bighorn sheep are known to linger near the roadway; however, other clusters of live observations would remain otherwise undocumented, such as the spike around MP 180-190 at West Vail Pass, which is primarily comprised of elk and mule deer observations. While mule deer, bighorn sheep and elk were most commonly recorded, observations of a number of other species were also made (Figs. 4 & 5).

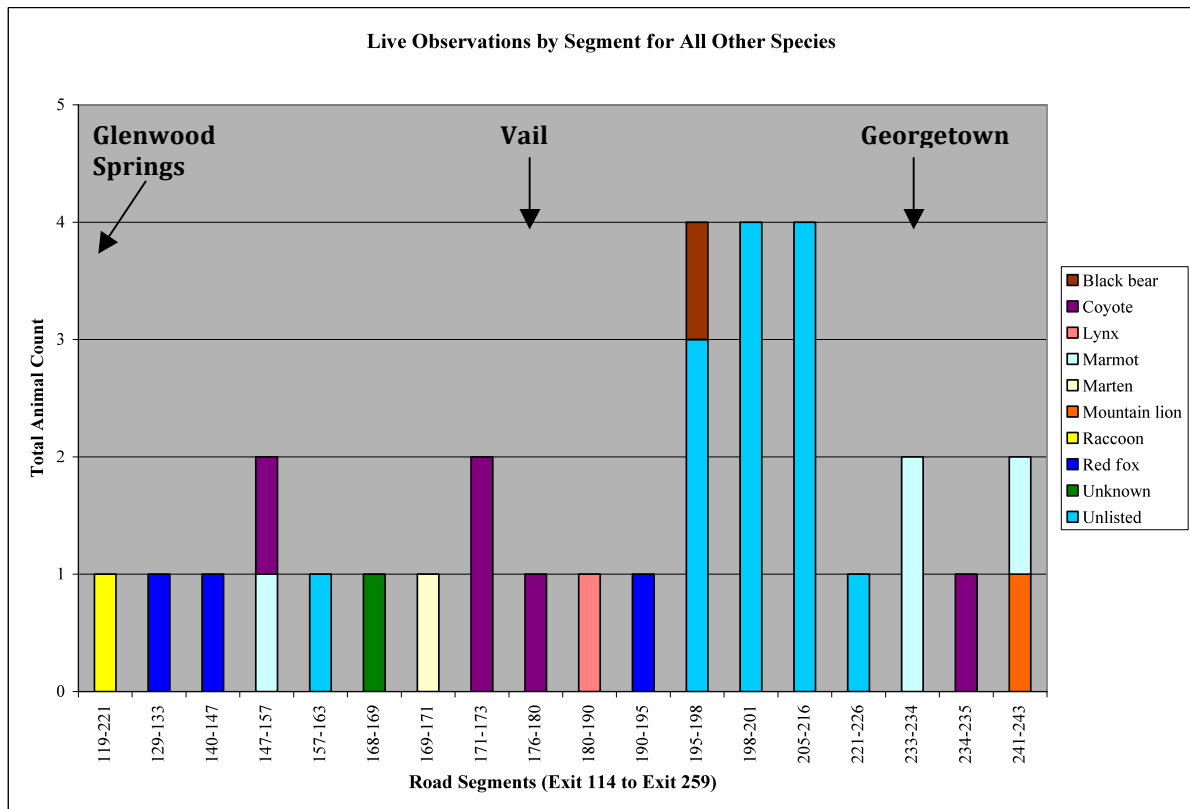
Figure 5: Total animal count by road segment for live observations on I-70 Wildlife Watch of black bear, coyote, lynx, marmot, marten, mountain lion, raccoon, red fox, and unknown and unlisted species. (Total n = 31). Note roadway segments with no observations are not displayed in this graph.
