Polymer Concrete Overlay Evaluation

tech transfer summary

June 2016

Federal Highway Administration
Iowa Department of Transportation
(InTrans Project 13-463)

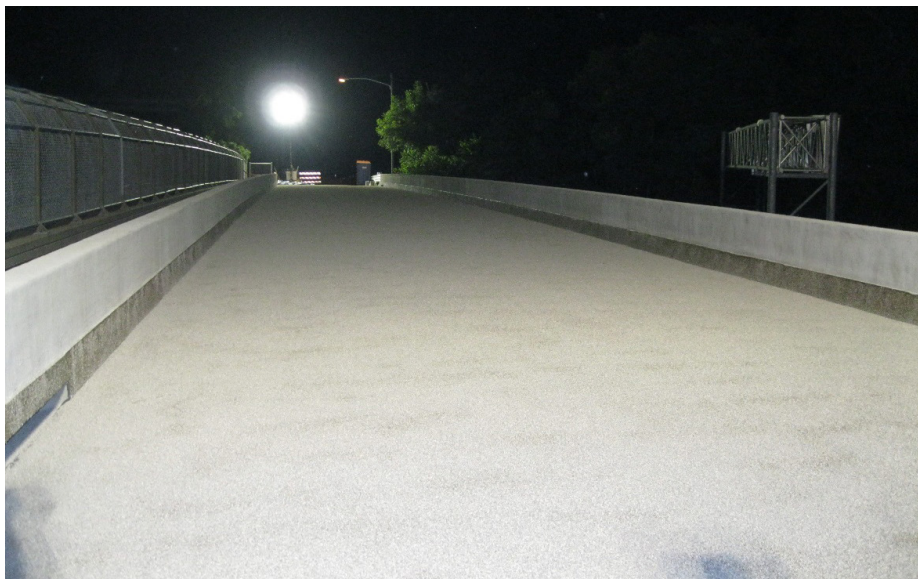
First polymer layer complete on the Johnson County bridge

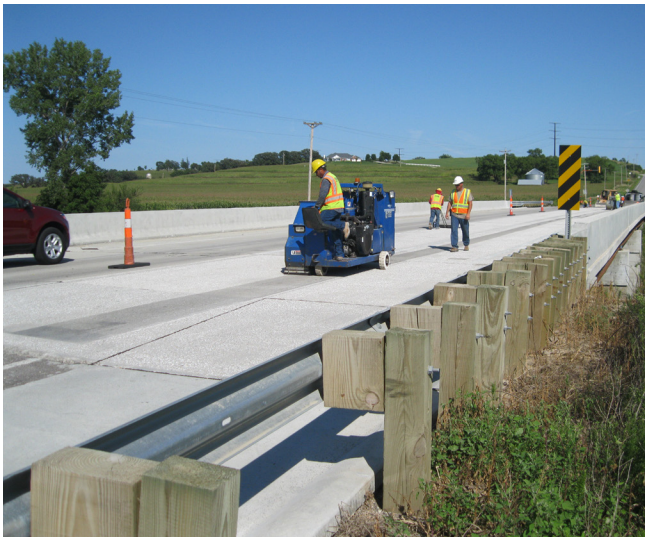
Shot blasting (and vacuuming) the Keg Creek Bridge deck to achieve deck surface relief as part of initial preparation

The deck preparation was completed similarly by shot blasting the deck to an approved surface roughness and blowing the deck free of debris. The blowing process differed slightly, but it appeared that the same result was achieved.

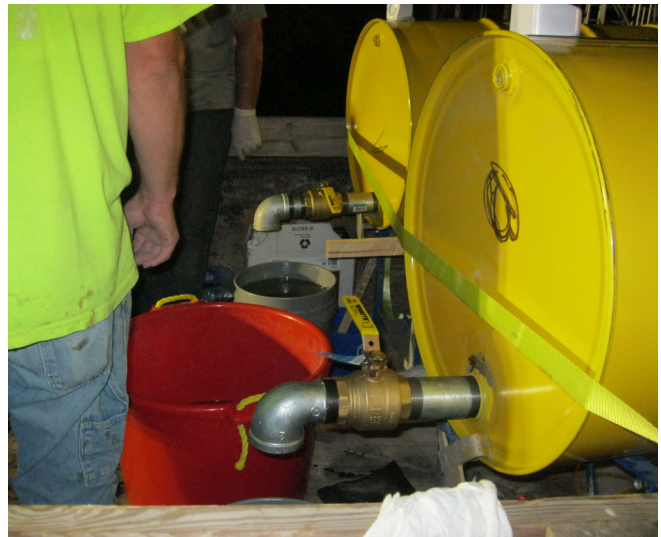
Two-part epoxy polymer mixing for the Johnson County bridge deck

The epoxy polymer for the Keg Creek Bridge deck was precisely measured using automated controls; whereas, the material used on the Johnson County bridge deck was closely approximated by dispensing each part into equally sized muck tubs.

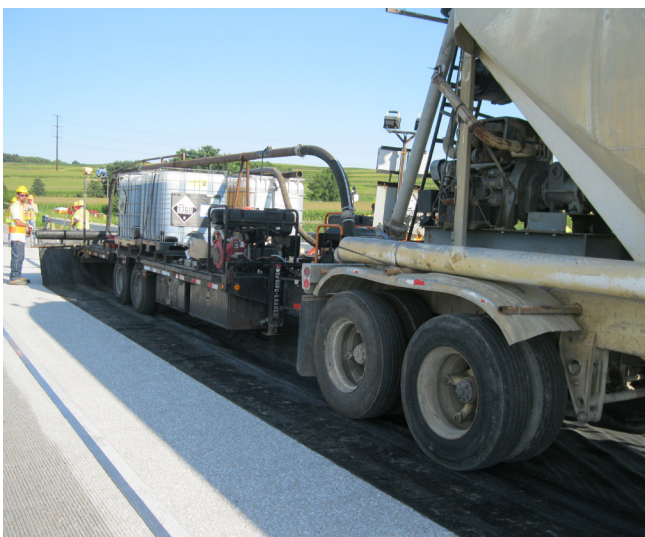
Semi-truck and trailer carrying hopper of flint chips, vats of epoxy polymer, and a blower on the Keg Creek Bridge

At Keg Creek, the aggregate was cast via a vacuum and blower; whereas, at the Johnson County bridge, the aggregate was cast via a more labor-intensive hand broadcasting method.

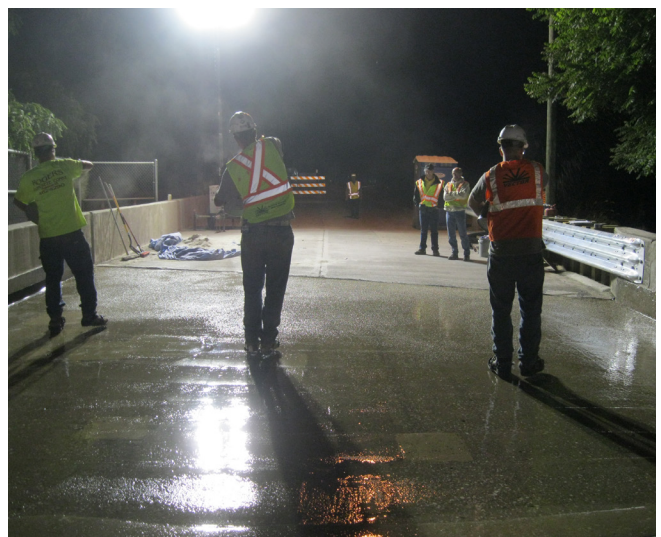
Hand-broadcasting flint chips on the first polymer layer of the Johnson County bridge deck

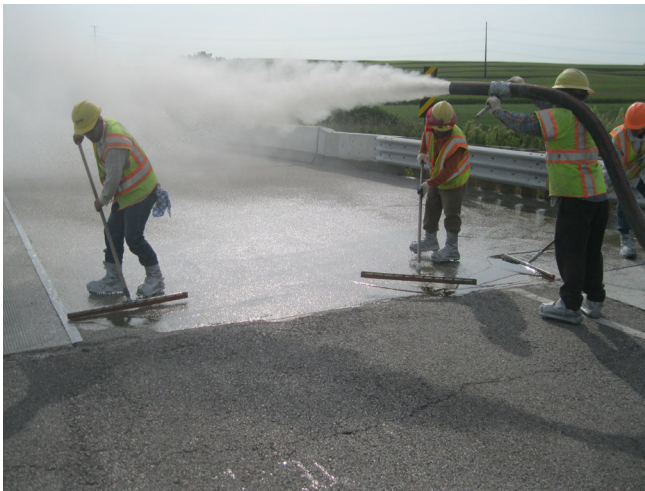
Spreading polymer and blowing flint chips on the Keg Creek Bridge deck

Aside from these differences, the process by which the polymer was mixed and spread onto each deck was nearly identical (Jiffy paddles and notched squeegees). In the end, the final product was quite similar with neither one appearing to be better than the other.

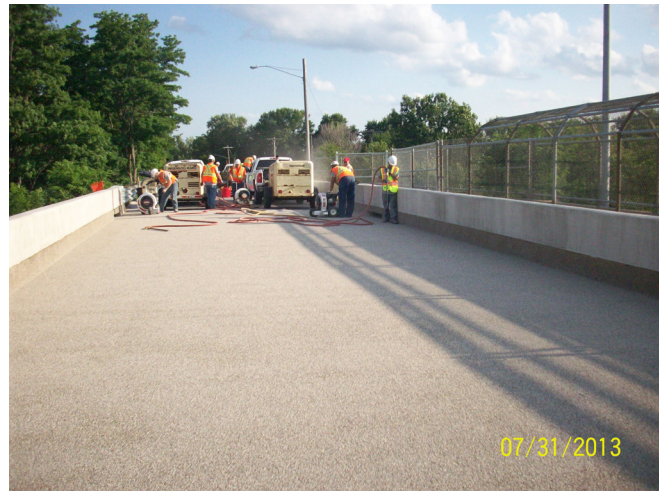
Second layer deck preparation on the Johnson County bridge deck

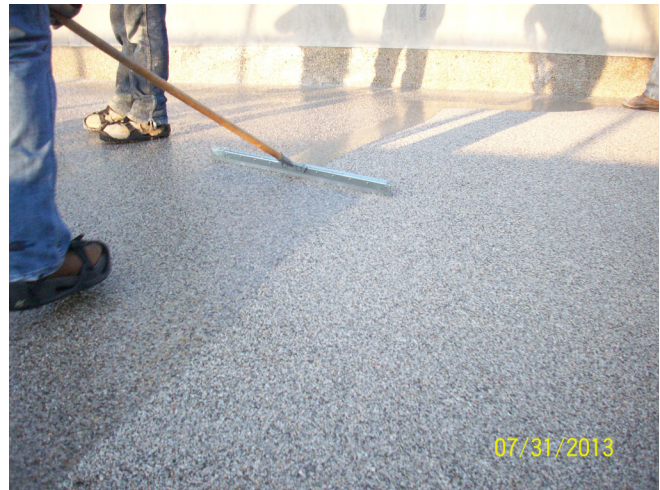
Spreading second layer of polymer on the Johnson County bridge deck
