Investigation of Tire/Pavement Noise for Concrete Pavement Surfaces: Summary of Four Years of Measurements

Authors:
A. Rezaei and J. Harvey

Work Conducted as Part of Partnered Pavement Research Center Strategic Plan Element No. 4.39:
Field and HVS Evaluation of Noise Benefits of Open-Graded and Other Quieter Surfaces

University of California
Pavement Research Center
Davis and Berkeley

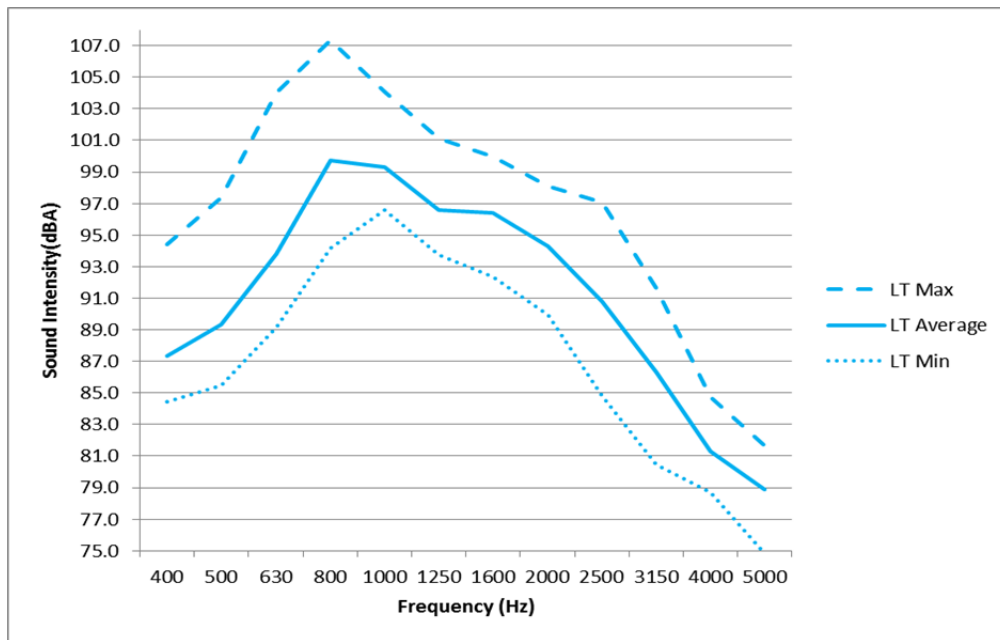
Figure 4.12: Average OBSI spectral content for 20 longitudinally timed (LT) sections over four years.

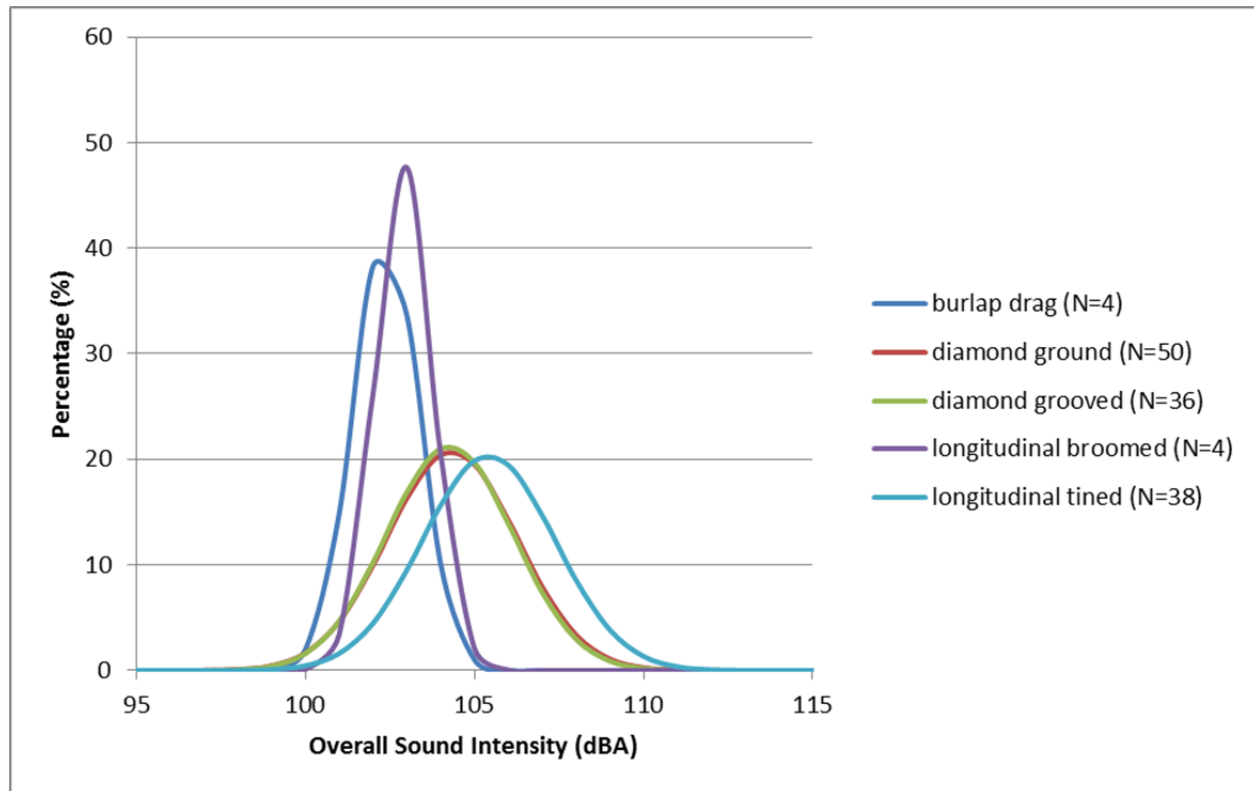
Figure 5.2: Normal distribution curves of OBSI results by texture type over four years of measurement.
 (Note: BD=burlap drag; DG=diamond ground, Gr=diamond grooved, LB=longitudinally broomed; LT=longitudinally tined; numbers in parentheses indicate the total number of sections.)

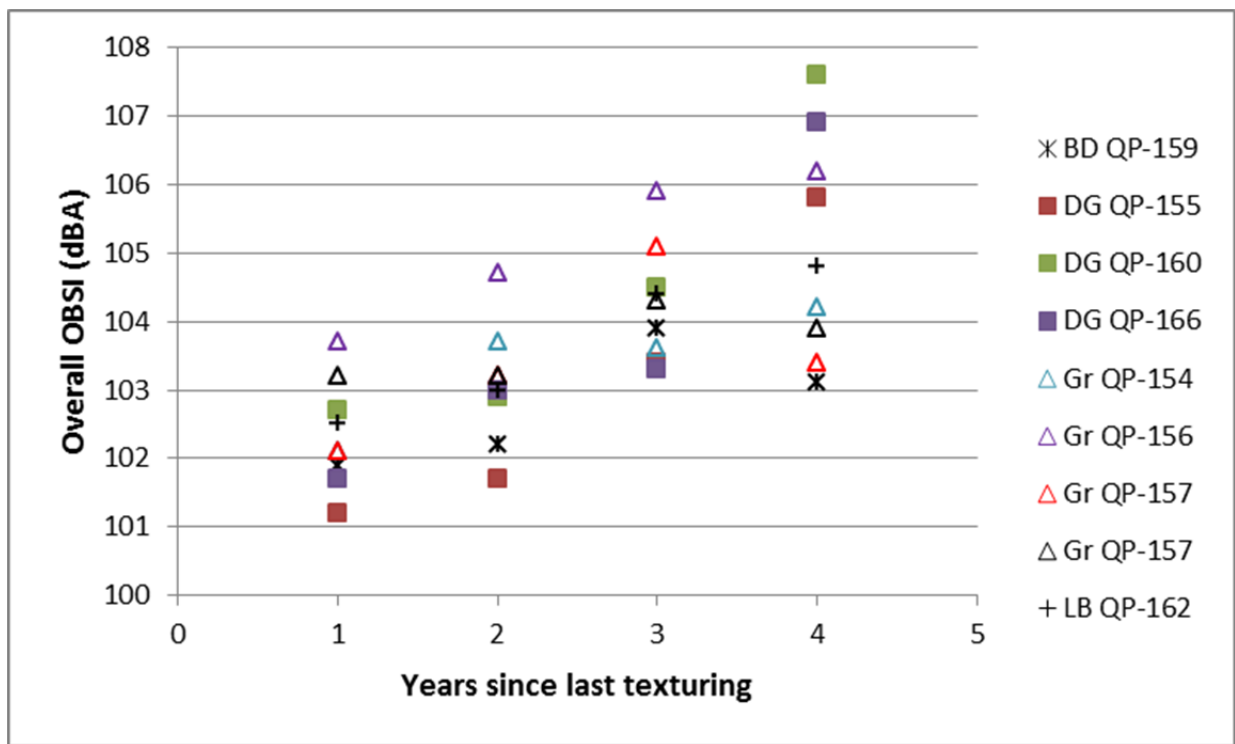
Figure 5.6: Overall OBSI for four years of testing on Mojave test sections.
 (Note: BD=burlap drag; DG=diamond ground, Gr=diamond grooved, LB=longitudinally broomed)

The results of four years of testing on the Mojave test sections, which were built in 2005 and last textured in 2006, are shown in Figure 5.6 in terms of overall OBSI (data for this plot is included in Appendix A). Over the four years of the study, the average values were 102.8 dBA for the burlap-drag section, 103.7 dBA for the three diamond-ground sections, 103.9 dBA for the four diamond-grooved sections, and 103.7 dBA for the longitudinally broomed section. From these results it can be seen that on average the overall OBSI was similar for all the textures, although there was a range of almost 5 dBA between the quietest and the noisiest in the fourth-year results. In the fourth year, the diamond-ground sections were generally noisier than the diamond-grooved sections, the opposite of the first three years of measurement.

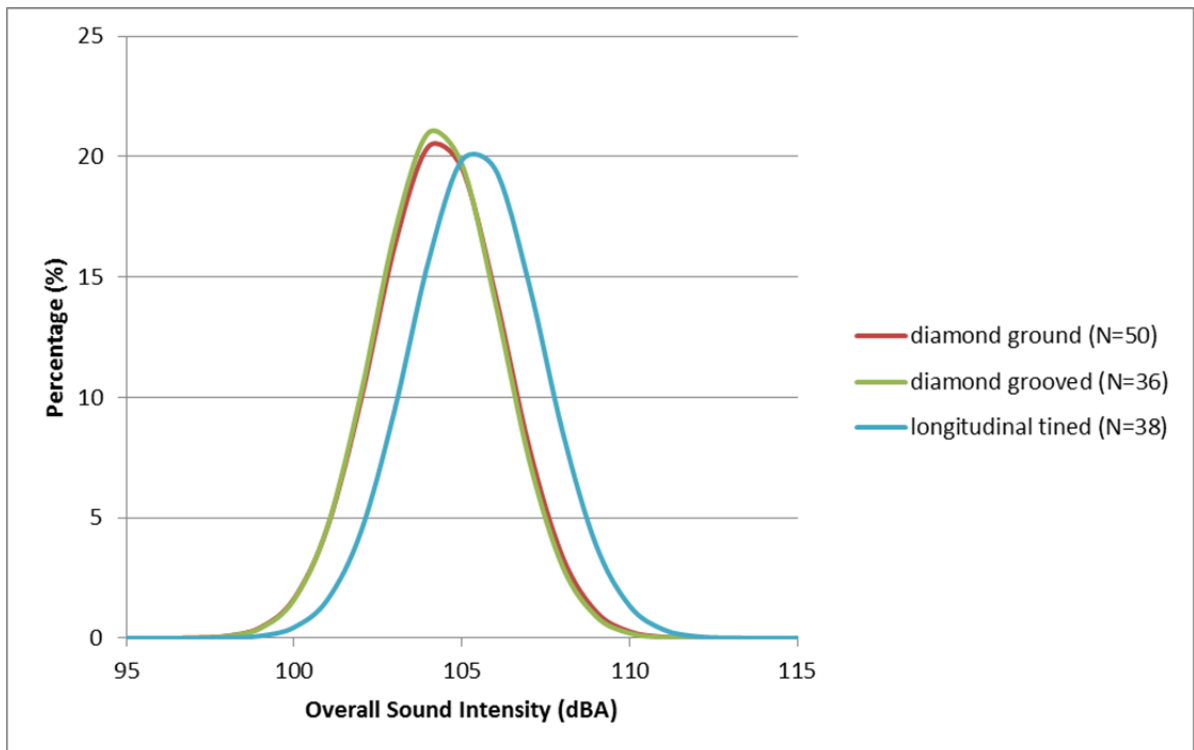
Figure 5.8: Distributions of OBSI noise levels over four years of measurement. (Note: numbers in parentheses indicate the total number of sections.)

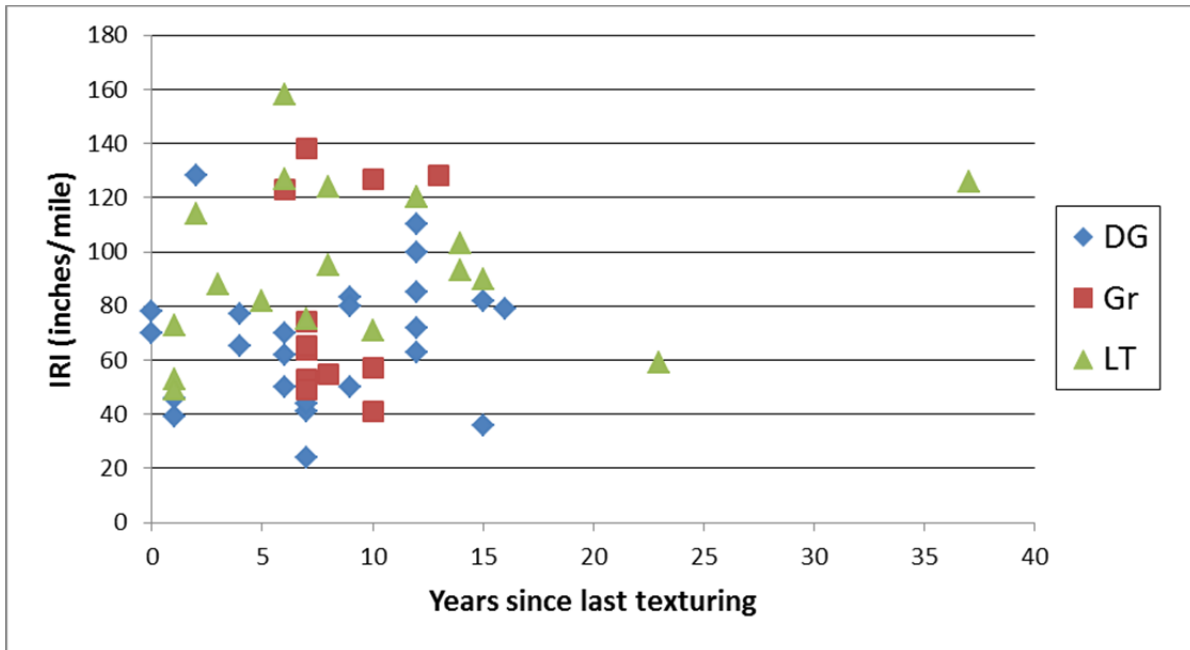
Figure 5.23: IRI versus age for different texture types. (DG=diamond ground, Gr=diamond grooved, LT=longitudinally tined)

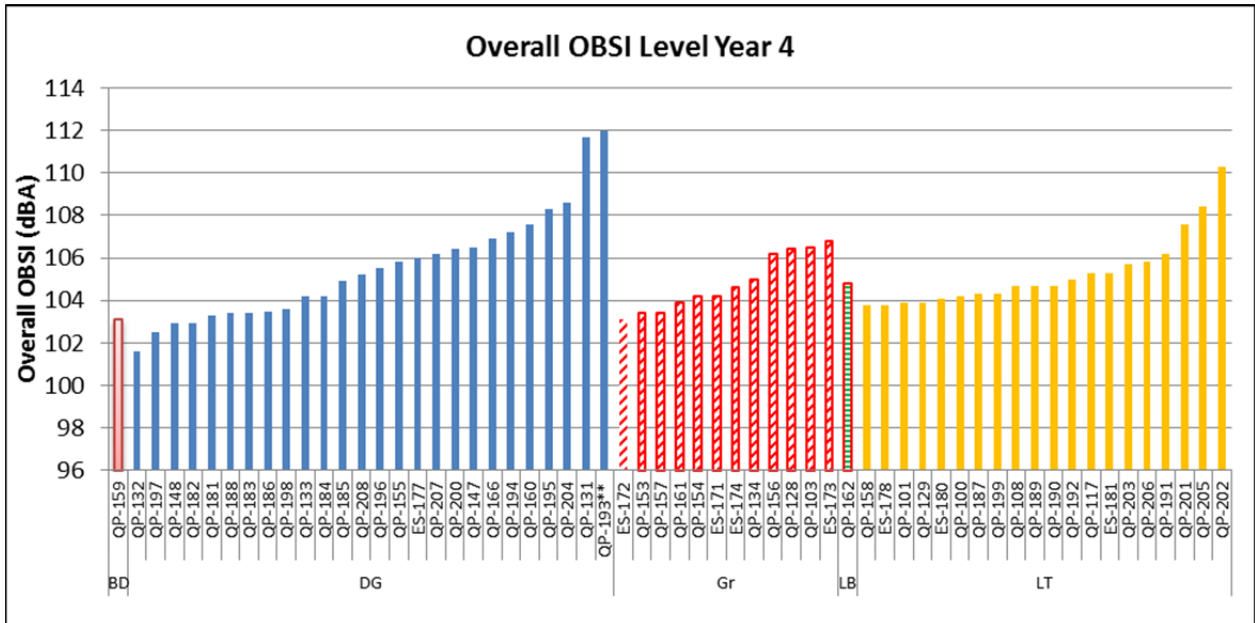
Figure C.4: OBSI for each section measured in Year 4 sorted by texture type and OBSI level.

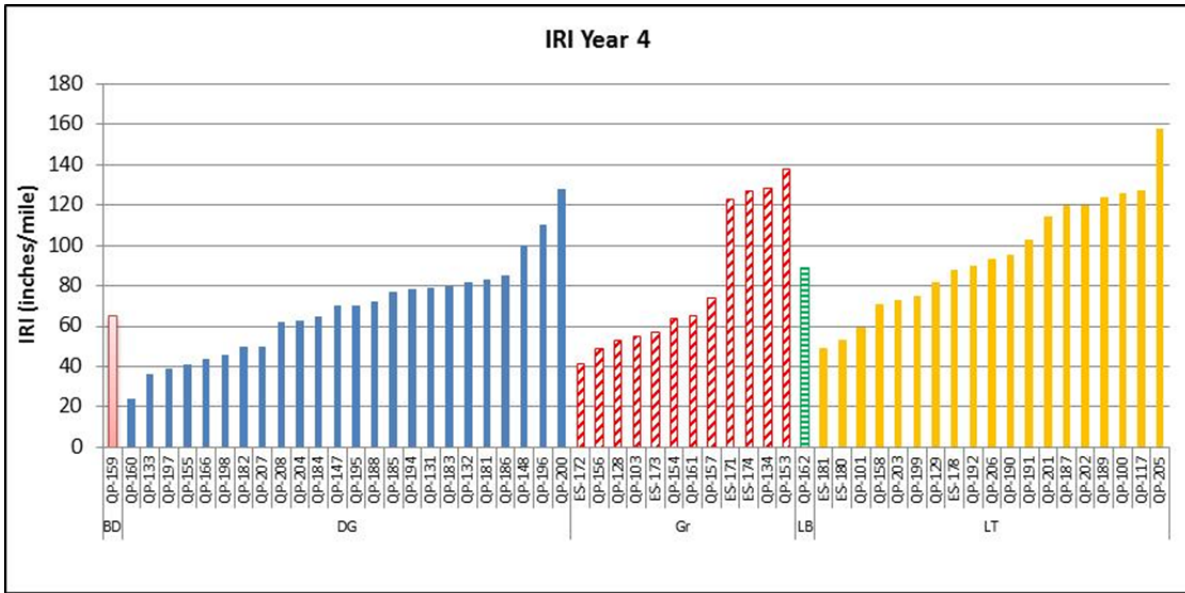
Figure C.5: IRI for each section measured in Year 4 sorted by texture type and IRI level.

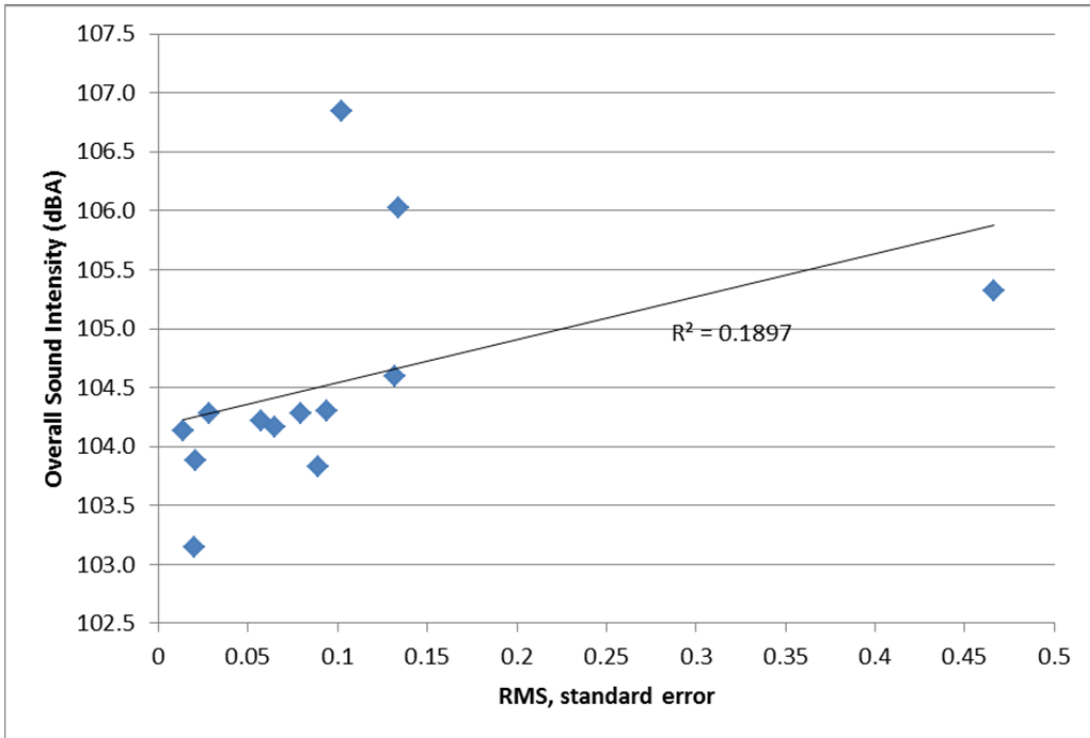
Figure F.8: Relationship between overall sound intensity and RMS standard error.

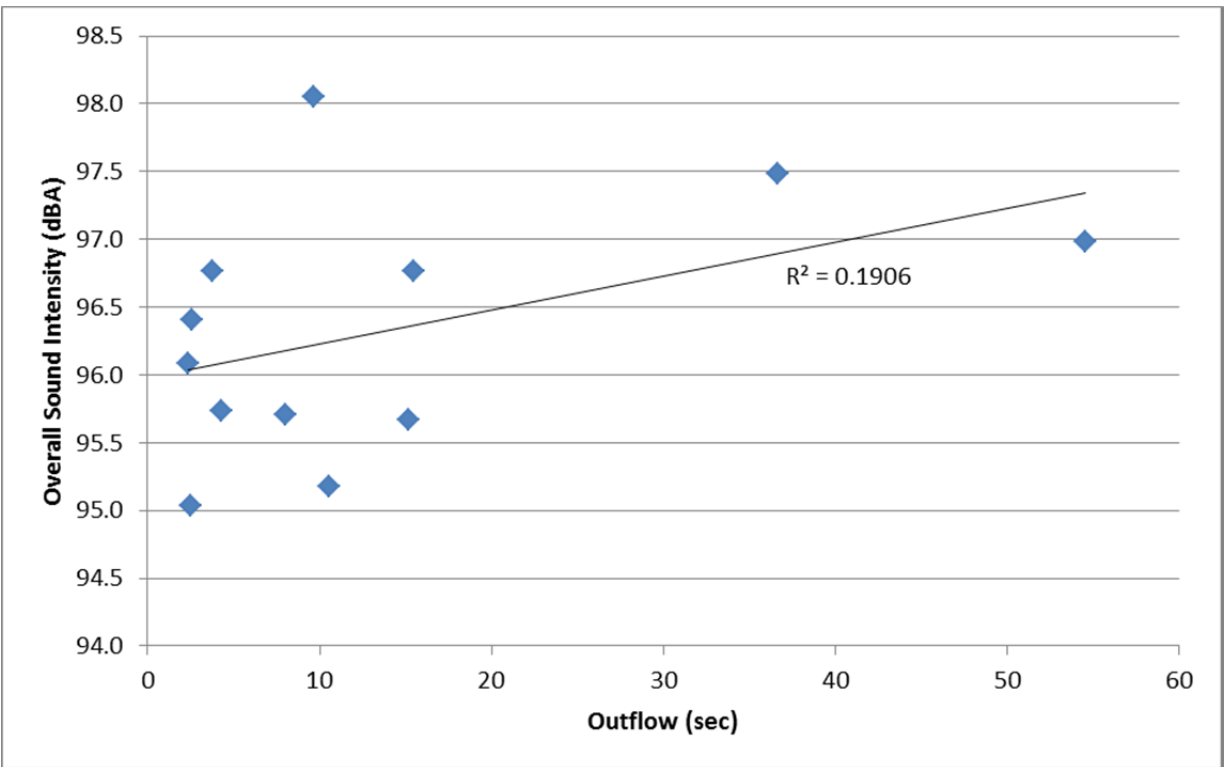
Figure F.17: Relationship between overall sound intensity and outflow time.
