RDT 00-005

# **Evaluation of Diamond Grinding New PCCP Route 60, Butler County**

RI 96-025

**EVALUATION OF DIAMOND GRINDING NEW PCCP  
ROUTE 60  
BUTLER COUNTY**

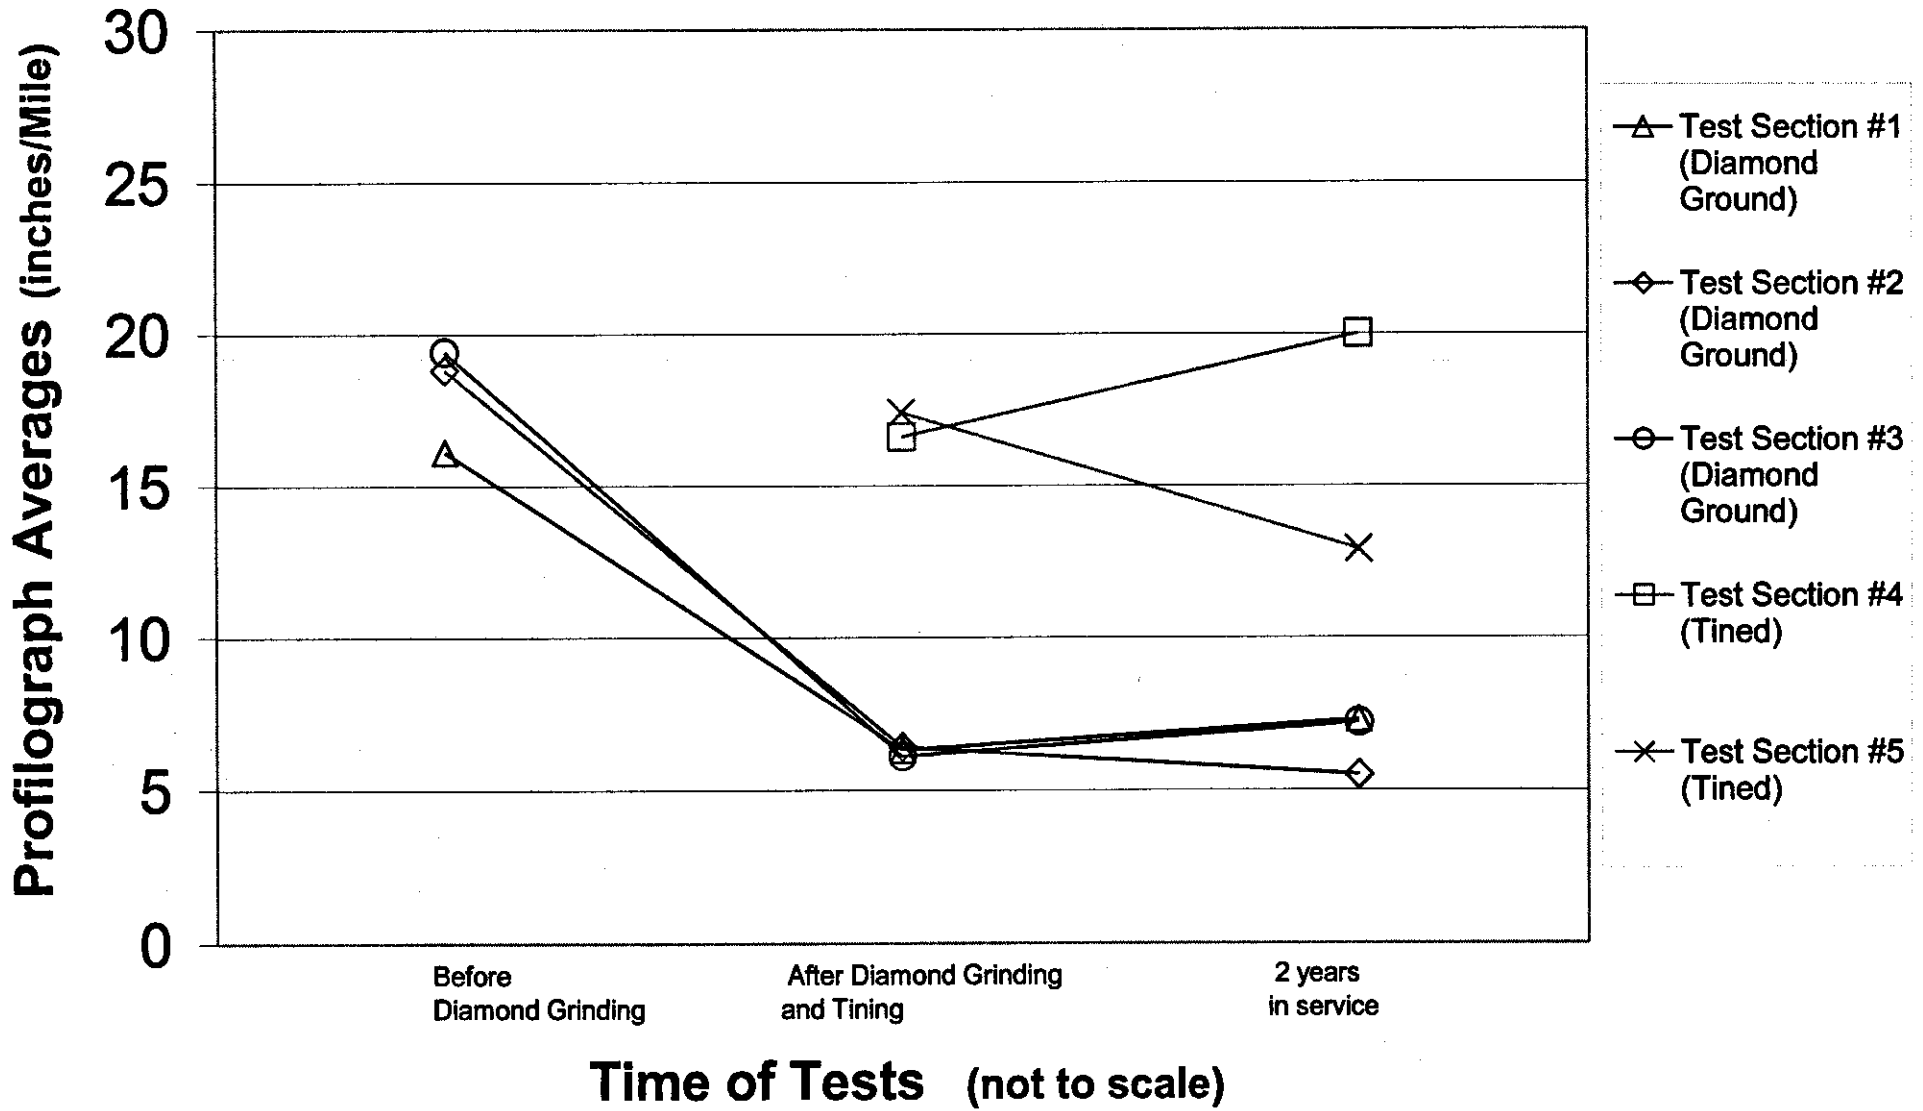
Figure 1

# Route 60 Profilograph Data

Illinois Valley Paving's effort on the paving portion of the job produced an average profile index of 18.1, smooth enough for 100% pay, before diamond grinding. However, after the diamond grinding was performed, the average profile index dropped to 6.8, with one day's grinding at 5.0, earning a 7% bonus. The profile measurements were done using the zero blanking band and indicates some very smooth pavement. The tined pavement had an average profile index of 17.0 following construction, earning a 3% bonus. Average profilograph data collected for each test section is shown in Figure 1. It can be stated that after two years of service, the diamond ground pavement continues to maintain a lower profile index than the conventionally tined pavement. It should be noted that the data for Test Section #5 (transverse tined) indicates that the profile index at 2 years is a considerable decrease from the index recorded following construction. No explanation can be given at this time, but continued monitoring should provide further clarification of the results obtained. The test sections will continue to be monitored on a yearly basis.

- The profilograph data indicates that after 2 years of service, the diamond ground pavement continues to maintain a lower profile index than the conventional tined pavement.

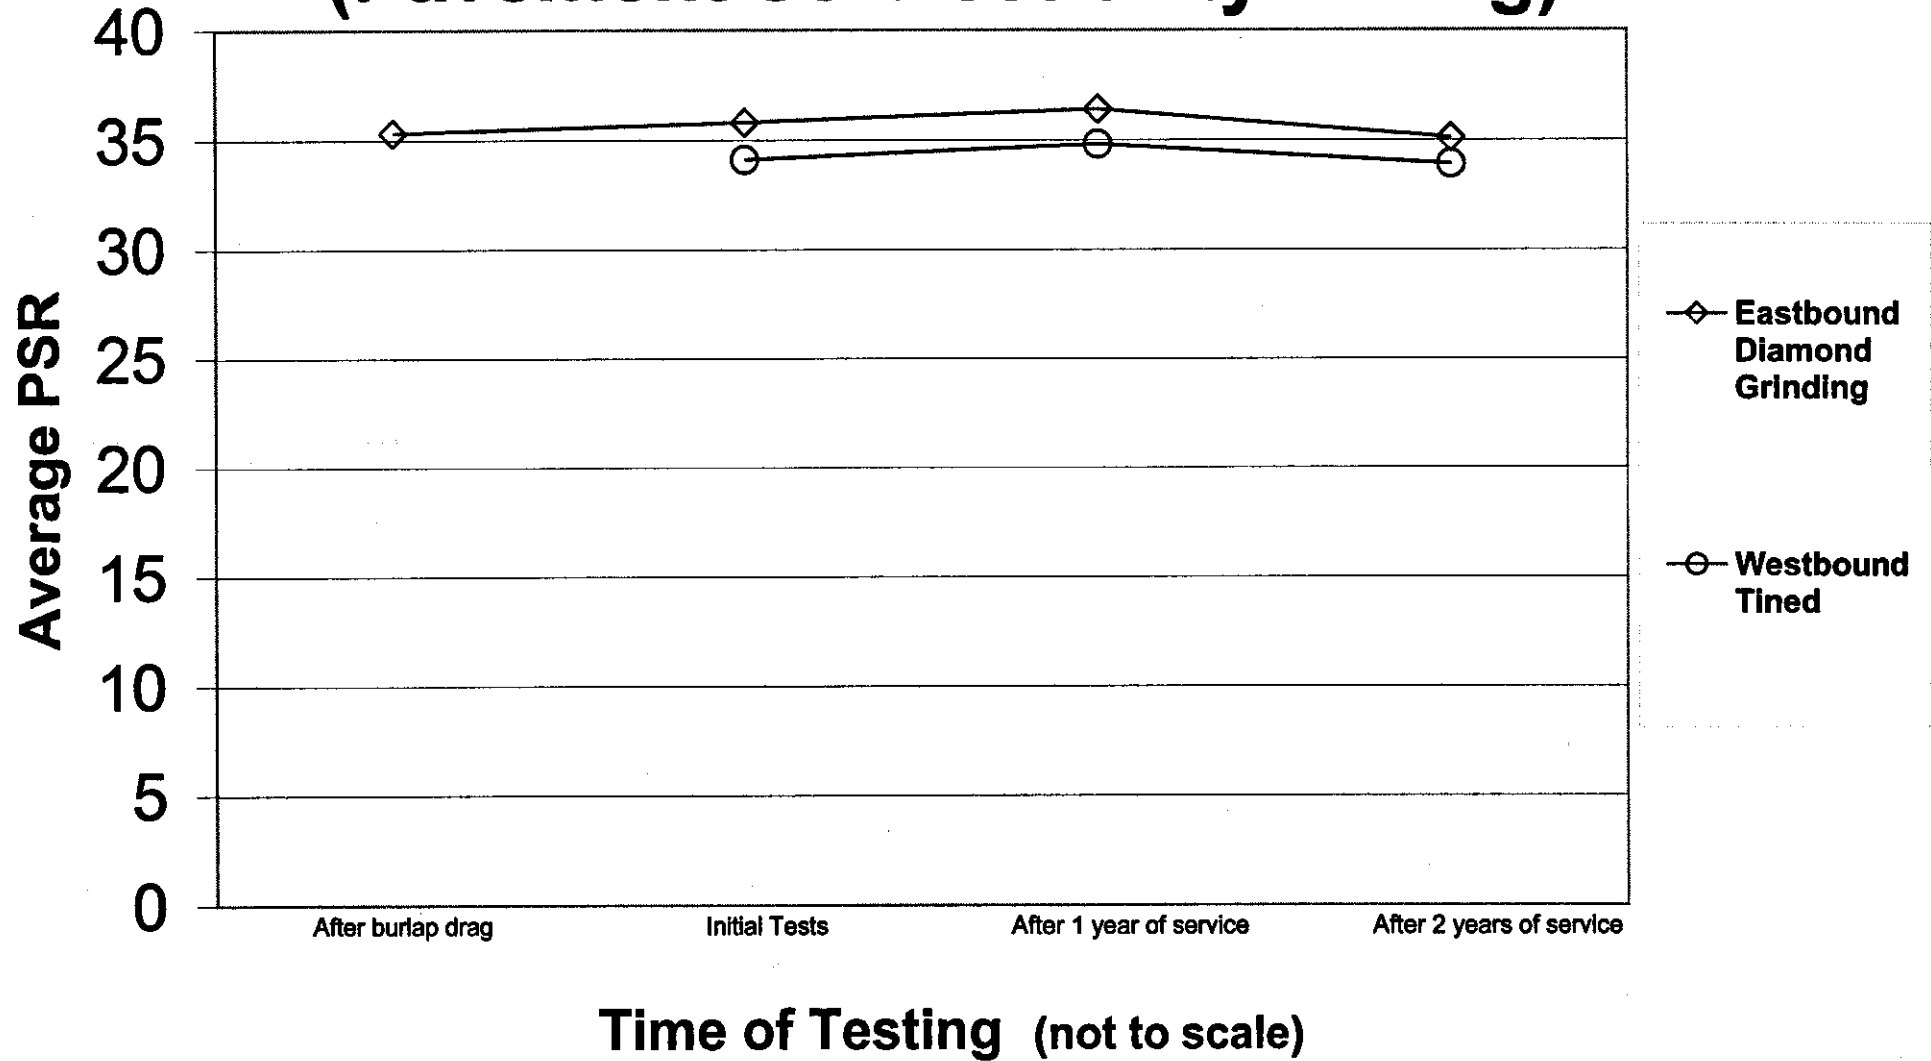
Figure 2

# Route 60 ARAN Data (Pavement Serviceability Rating)

The present serviceability rating (PSR) is determined by rating the joints, cracks, spalls, and patches from 0 to 5, with the combination of these measures then incorporated with the pavement's measured ride number. Pavements are rated on a scale of 0 to 40, with an increasing number indicating a pavement with a better surface condition and ride. According to the PSR values shown in Figure 2, the diamond ground pavement continues to maintain a higher PSR, currently 35.7, as compared to the tined pavement with a current PSR of 33.9.

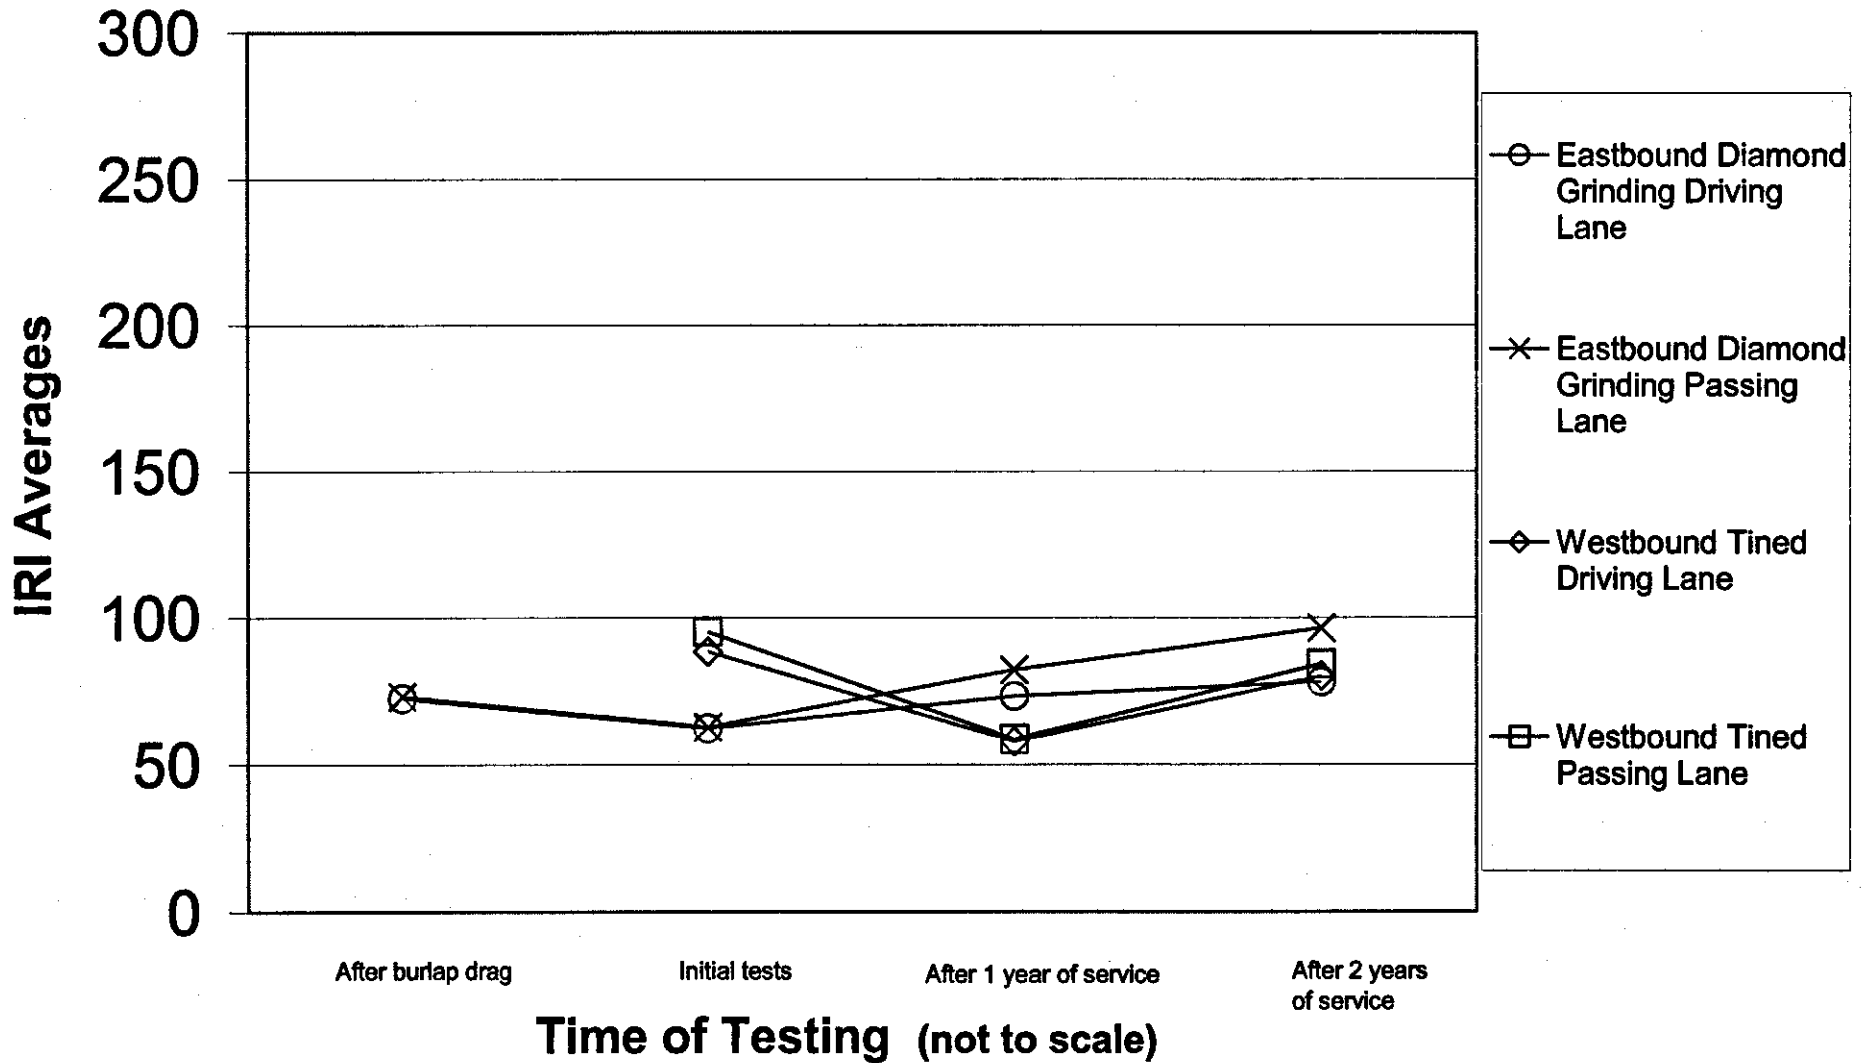
Figure 3

# Route 60 ARAN Data (International Roughness Index)

The IRI values for Route 60 are shown in Figure 3, according to the driving and passing lanes for both pavements. After 2 years of service the IRI values for both the diamond ground and tined sections have maintained well below 100, except for the eastbound diamond ground passing lane. However, despite the noted increase in the IRI number, the pavement is considered to ride smoothly.

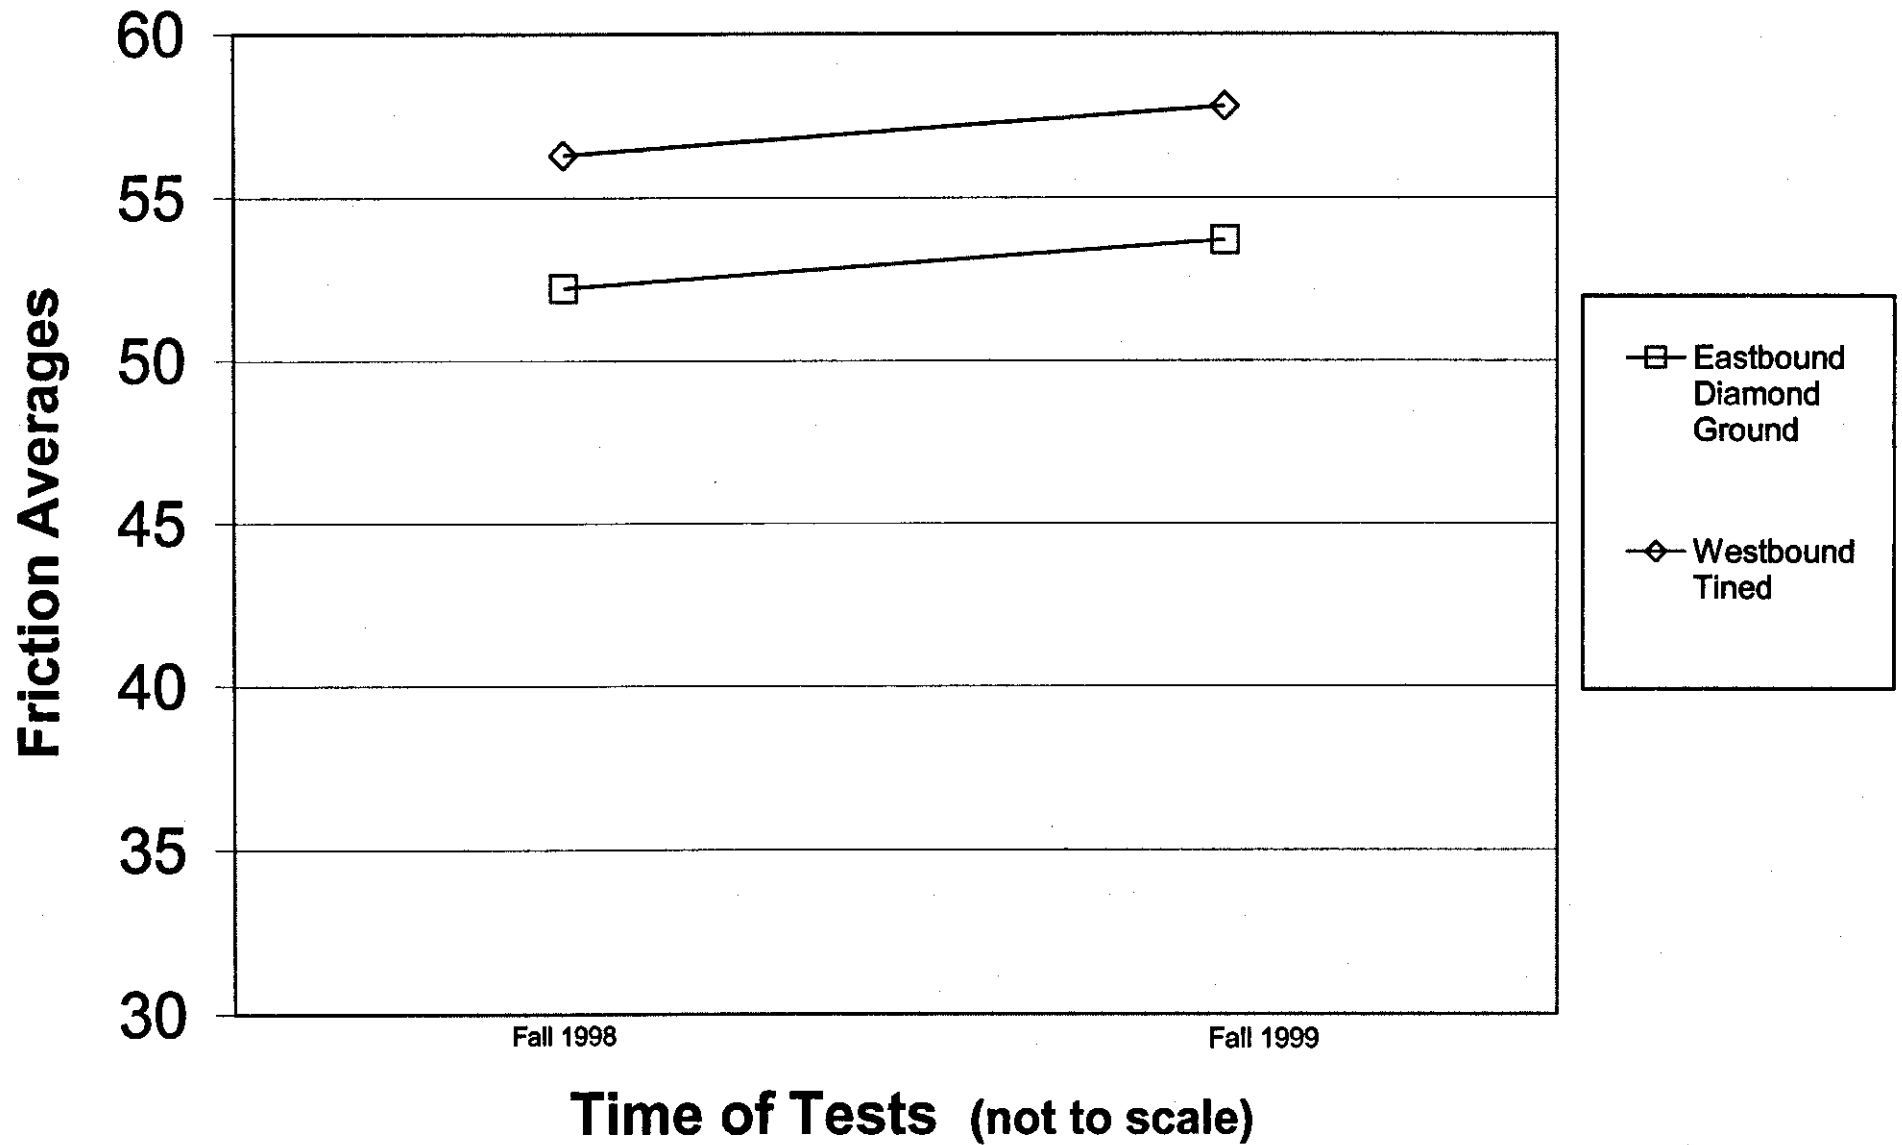
Figure 4

# Route 60 Friction Data

In an effort to address concerns that some have concerning the friction properties of diamond ground pavements versus transverse tined pavements, annual collection of friction data will be conducted as part of this study. Intentions were to collect initial friction data on this project following construction in 1997. Unfortunately, data was collected; however, it was inadvertently collected in the wrong locations. As a result, the first annual friction tests were performed in the fall of 1998, with the westbound tined section recording an average 56.3 and the eastbound diamond ground section recording an average of 52.2. Both averages are representative of good pavement friction. The 4.1 difference in average is relatively small. Data collected in the fall of 1999 indicate that the friction numbers for both the diamond ground and the transverse tined pavements have actually slightly increased, at approximately the same rate. To date, it is observed that the diamond ground pavement provides adequate friction properties and is comparable to the friction properties of the conventionally transverse tined pavement.

- The friction numbers are representative of good pavement friction and show an increase after two years of service, in both the diamond ground and the tined texture. To date, the diamond ground pavement provides adequate friction properties.
