**National Highway
Traffic Safety
Administration**

DOT HS 812 582

Examination of a Prototype Camera Monitor System For Light Vehicle Outside Mirror Replacement

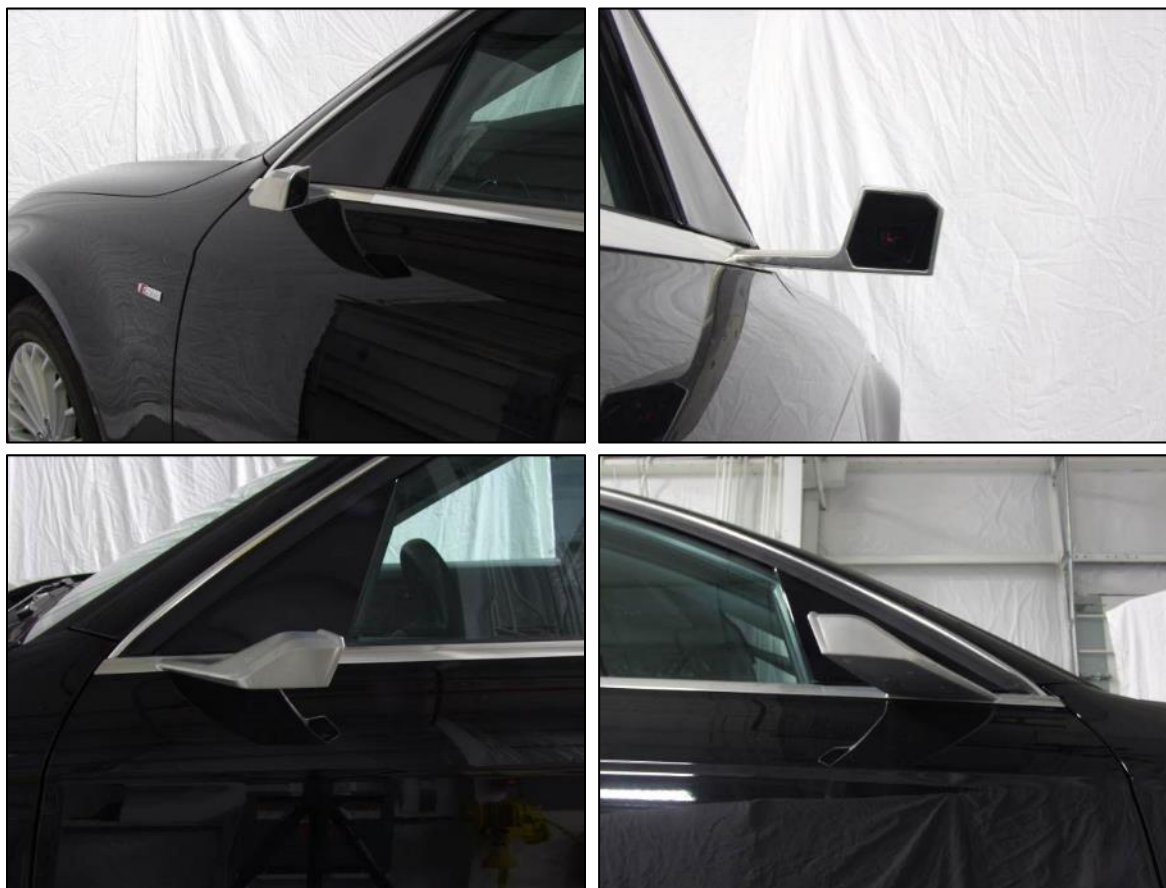
The following figures contain photos of the prototype side camera monitor system, providing examples of the camera components' size and mounting locations on the vehicle's exterior. As can be seen in Figure 1, the exterior cameras are mounted approximately where traditional mirrors would normally be located. The size of the camera, and therefore the impact on aerodynamics, is much smaller than typical outside mirrors.

Figure 1. Photos Showing Cameras of the Prototype Side Camera Monitor System

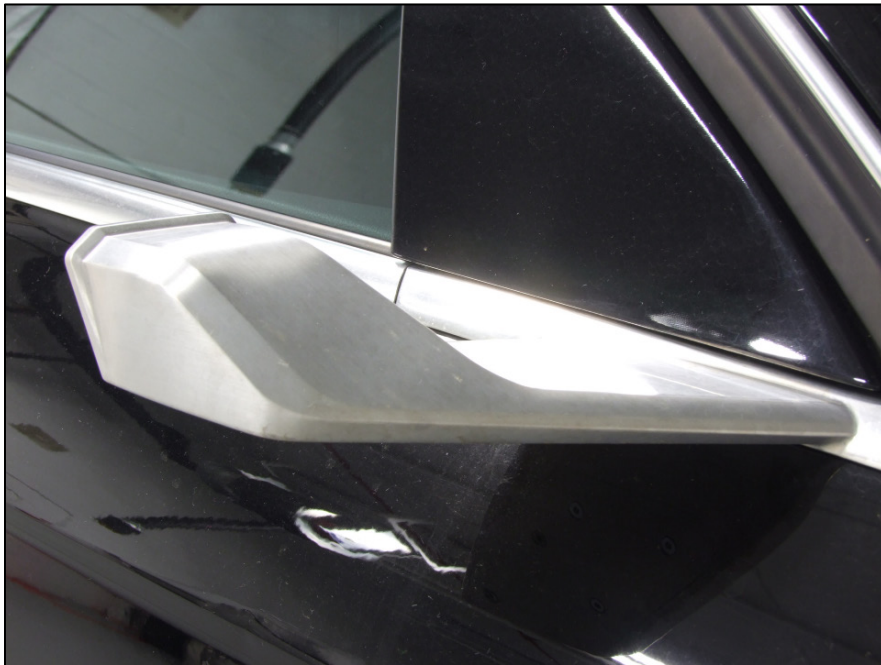
The following two figures provide a close-up look at the design and shape of the camera housing on the passenger side of the vehicle.

Figure 2. Passenger Side Camera Housing

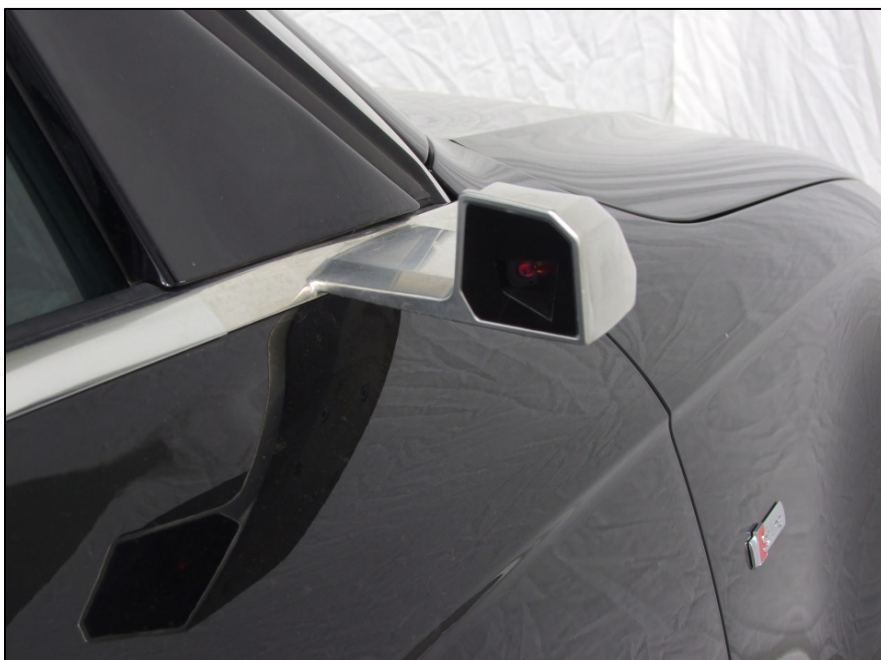
Figure 3. Passenger Side Camera

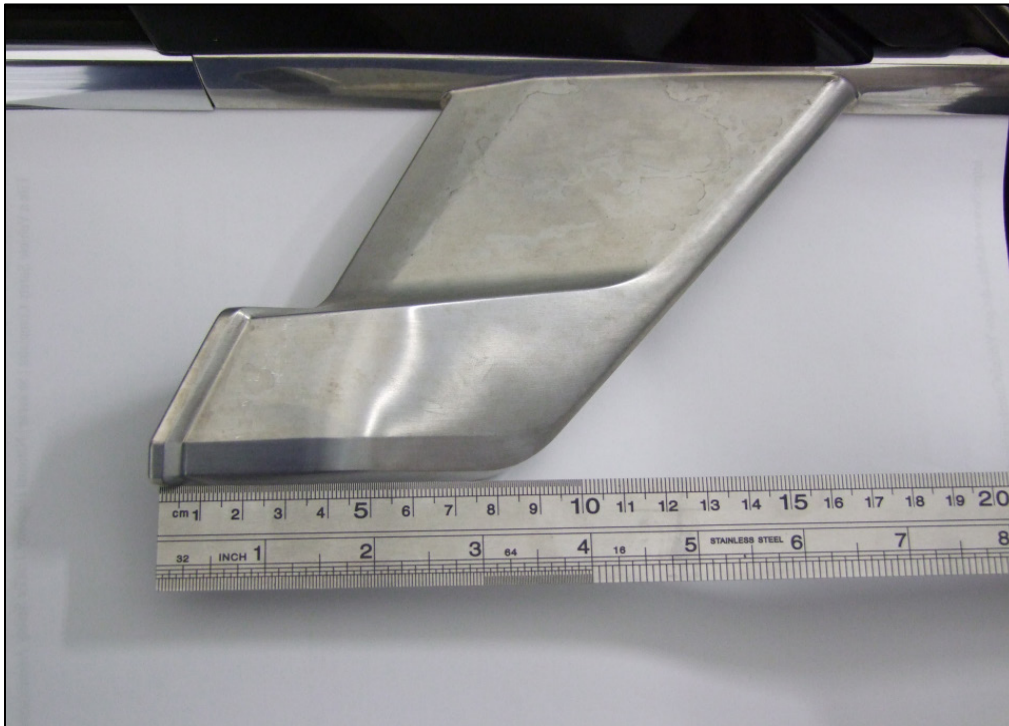
The following two figures provide a close-up view of the camera housing with a ruler included in the image to provide an idea of the length and width of the camera housing.

Figure 4. Camera Housing (Passenger Side), Top-Down View With Ruler in Image

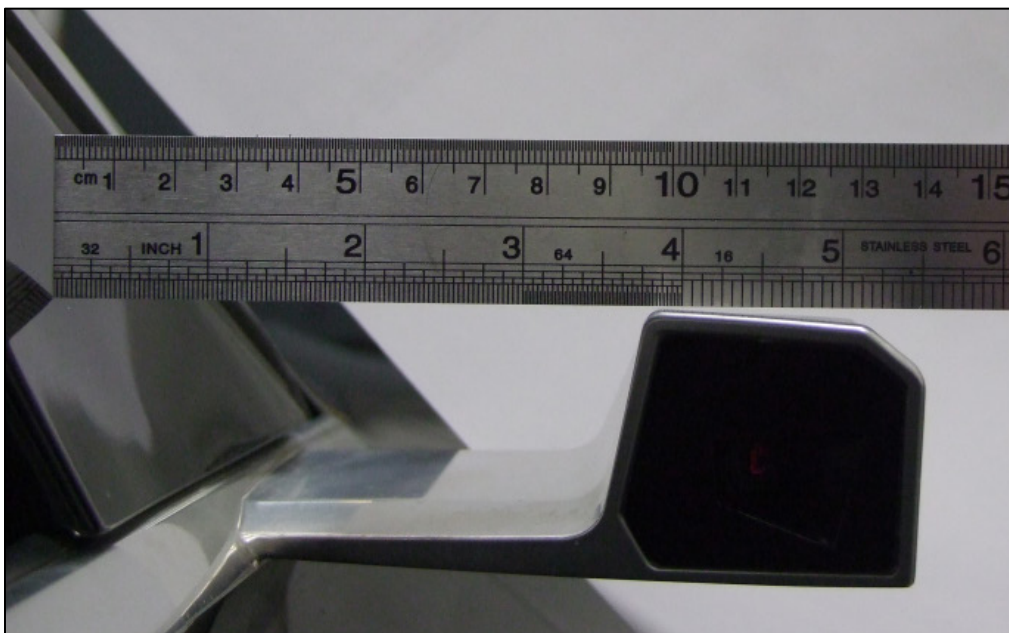
Figure 5. Camera Housing (Passenger Side), With Ruler in Image

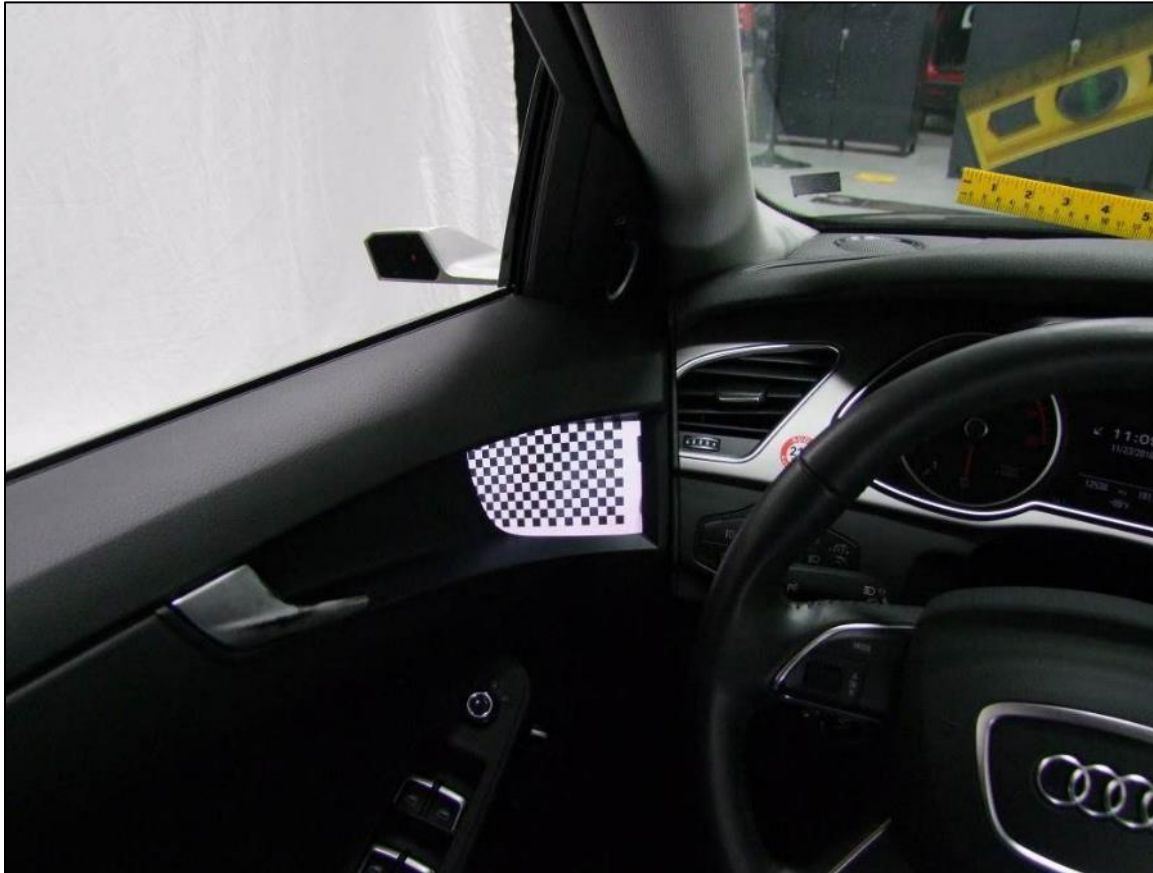
The driver and passenger side CMS displays were located at the leading edge of the corresponding door panels and had overhanging trim above to help block sunlight from striking the displays. Figures 6 and 7 contain photos of the driver and passenger side interior CMS displays, respectively, as viewed from the 50th percentile male driver's viewpoint. The CMS display shows an image of an ISO grid (chessboard chart) in the field of view to highlight the display location and clarity. See section 5.3 for more information on the ISO grid.

Figure 6. Driver-Side Interior Display, Driver's Viewpoint, ISO Grid in View

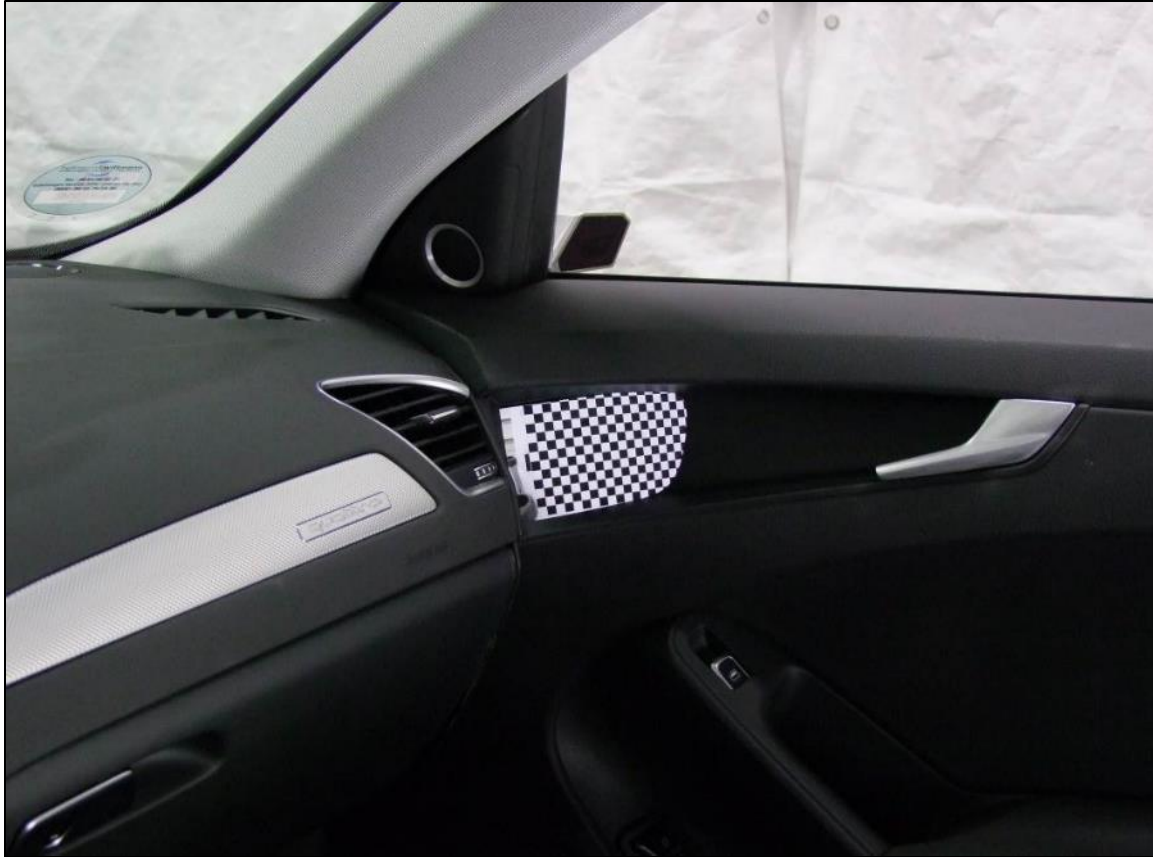
Figure 7. Passenger-Side Interior Display, Driver's Viewpoint, ISO Grid in View

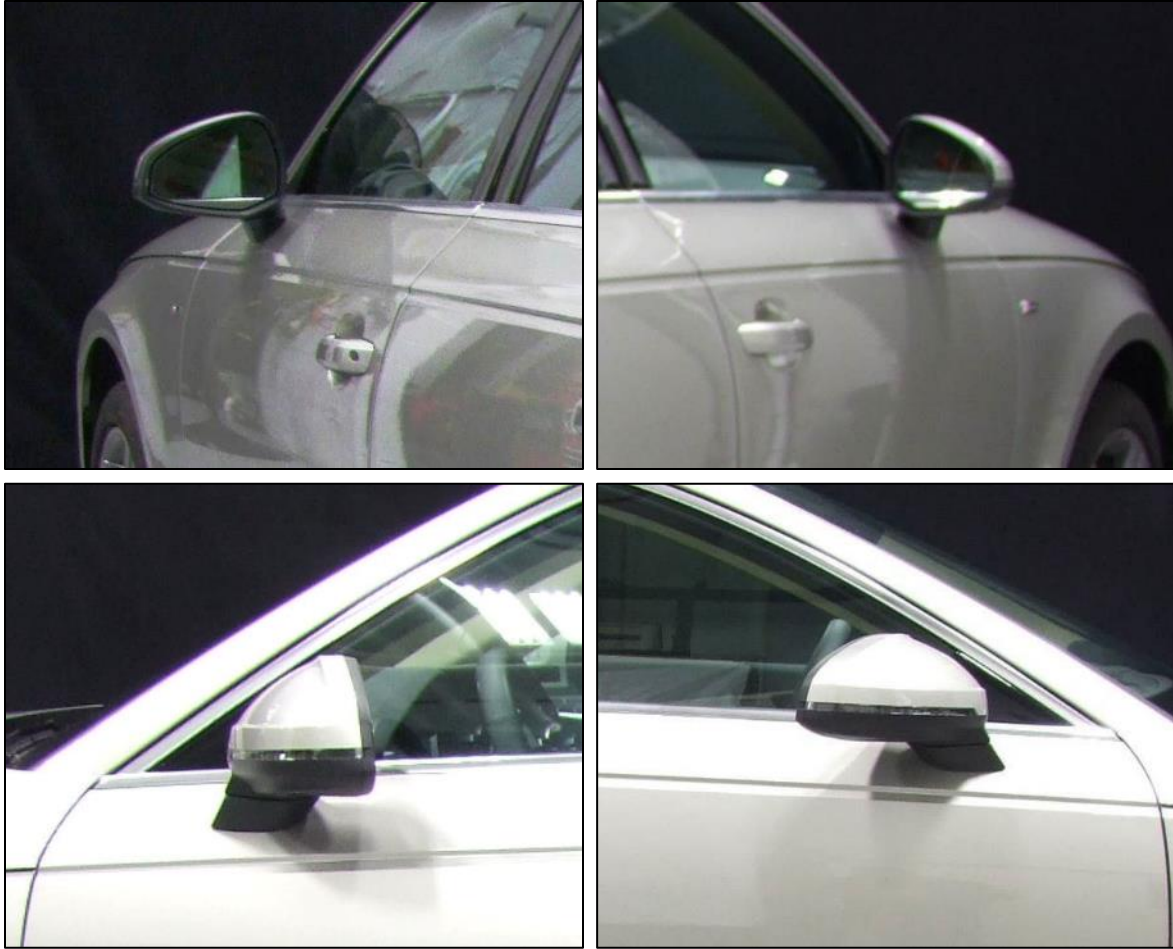
Figure 8 shows images of the comparison vehicle equipped with traditional mirrors. The dimensions of the mirrors were approximately 7 inches (17.8 cm) at the widest point and 4.5 inches (11.4 cm) at the highest point. A close-up view of the mirror housing with a tape measure included in the image is provided in the following figure to provide an idea of the size of the mirror and mirror housing for comparison with the CMS camera unit.

Figure 8. Photos of the Outside Rearview Mirrors on a 2017 Audi A4

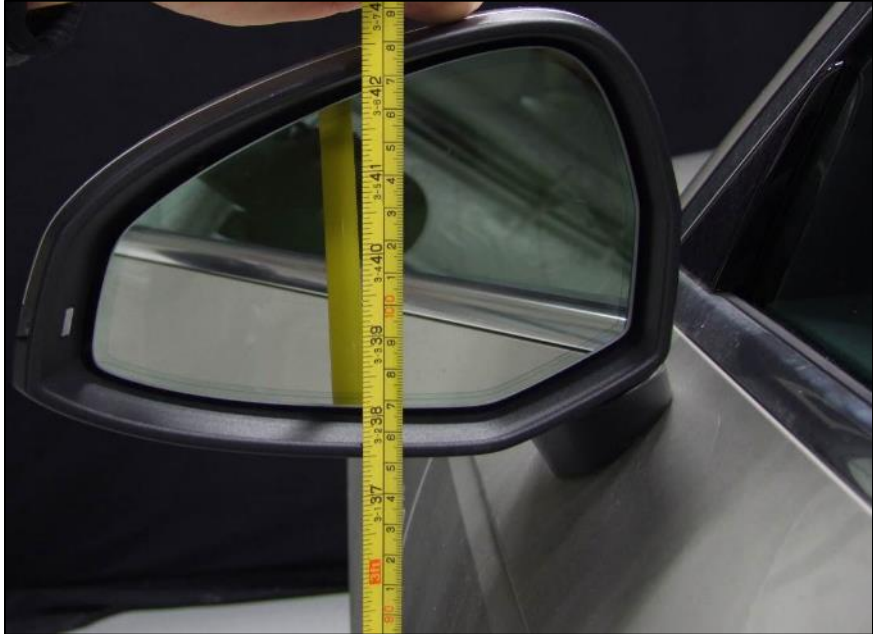
Figure 9. Driver-Side Outside Rearview Mirror

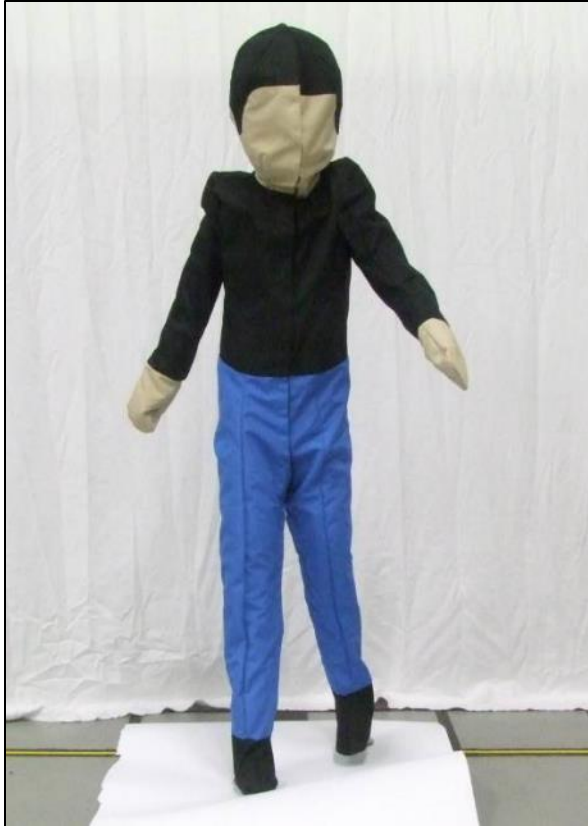
One of the test objects used in this program was a posable pedestrian child mannequin developed by 4a Engineering GmbH, Traboch, Austria. The mannequin is 46.5 inches (1.18 m) in height and was designed to simulate a 6-year-old child. This mannequin is used in EuroNCAP. The posable child mannequin test object is shown in the following figure.

Figure 10. Posable Child Mannequin Test Object, Front View

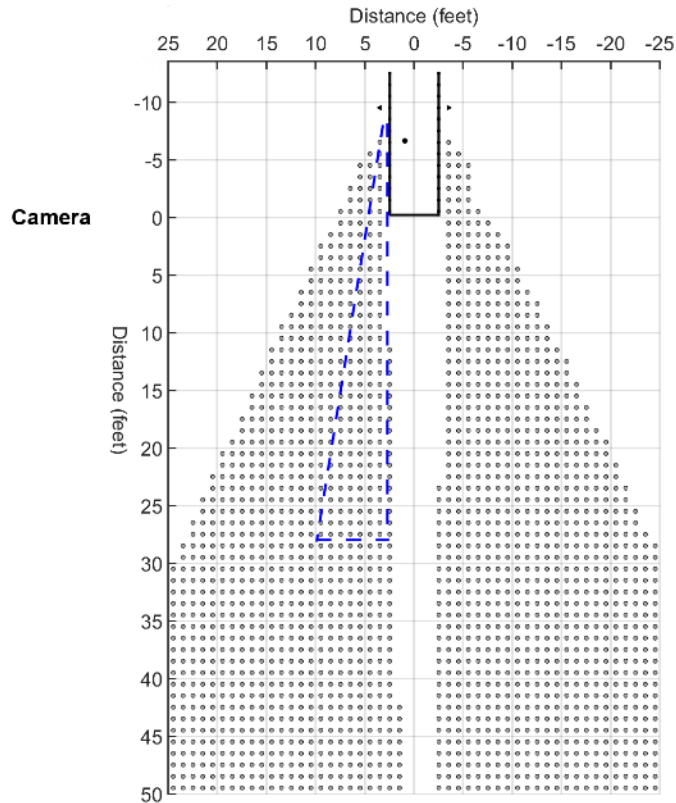
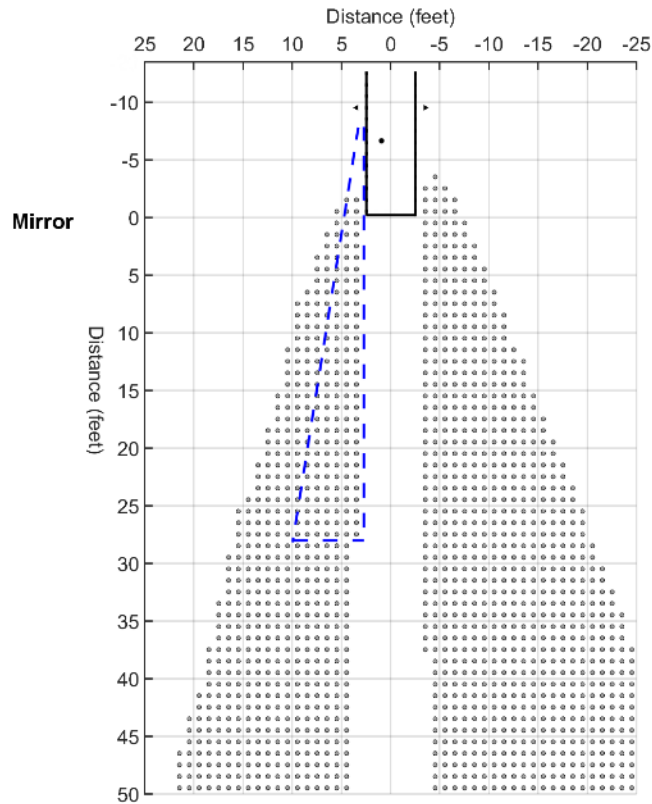
Figure 11 below shows the fields of view for the prototype side CMS and the original equipment mirror system (2017 Audi A4), respectively. Both figures show the test vehicle with its rear bumper face centered at the (0,0) location on the grid. The outside mirror and side camera locations are indicated with small triangles on both sides of the vehicle, which is represented by a rectangular outline. The driver's eye point location is also indicated using a small black circle within the vehicle's perimeter. Grid locations around the vehicle at which the visual target was visible via the mirror or camera system are indicated in both figures using gray circles. A horizontal green line is used to highlight the FMVSS No. 111 outside rearview mirror field of view requirement (S5.2) which states, "The mirror shall provide the driver a view of a level road surface extending to the horizon from a line, perpendicular to a longitudinal plane tangent to the driver's side of the vehicle at the widest point, extending 2.4 m out from the tangent plane 10.7 m behind the driver's eyes, with the seat in the rearmost position." The resultant area is indicated by an outlined triangular area on both sides of the vehicle.

Figure 11. Fields of View for Prototype Side Rearview CMS and Original Equipment Mirrors

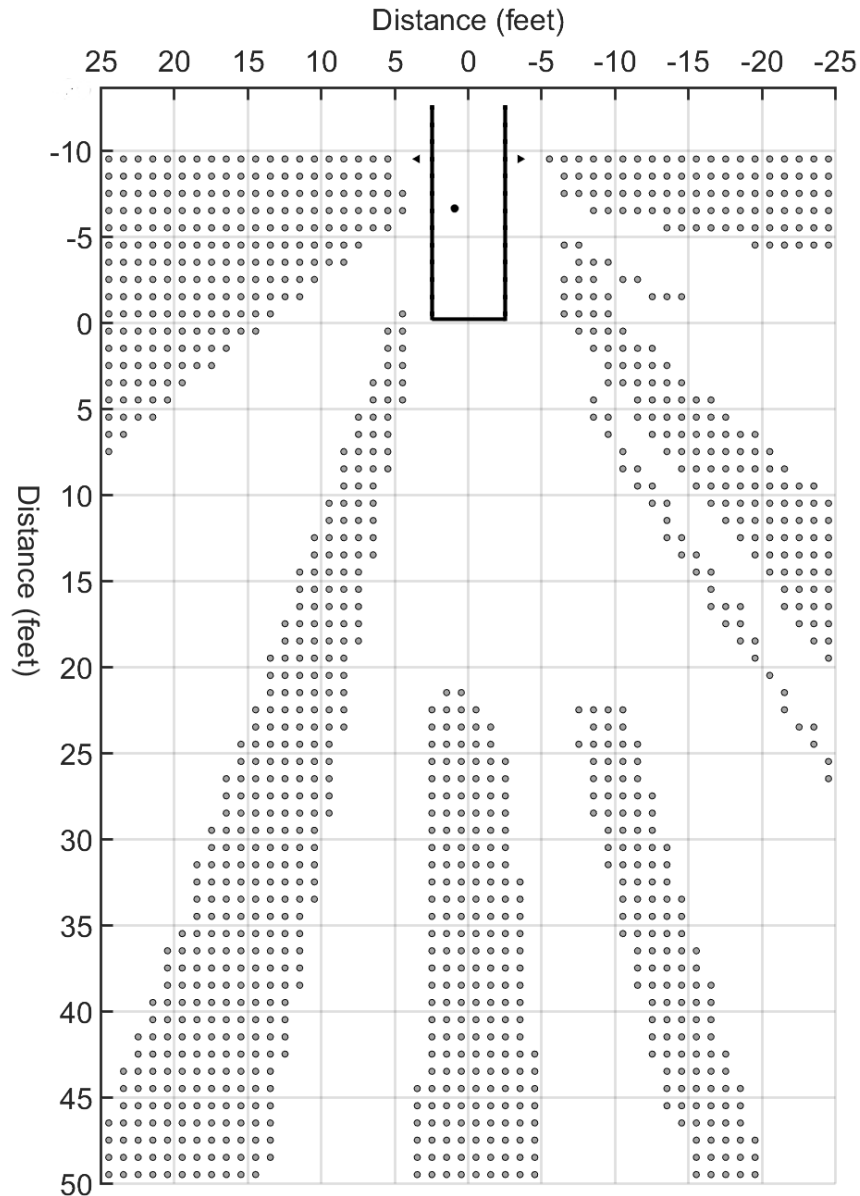
The direct vision field-of-view for the 2017 Audi A4 test vehicle is illustrated in Figure 12 below. This direct field of view was determined using the method outlined in the NHTSA report, *Direct Rear Visibility of Passenger Cars: Laser-Based Measurement Development and Findings for Late Model Vehicles* [4].

Figure 12. Direct Vision Field-of-View for the 2017 Audi A4 Test Vehicle

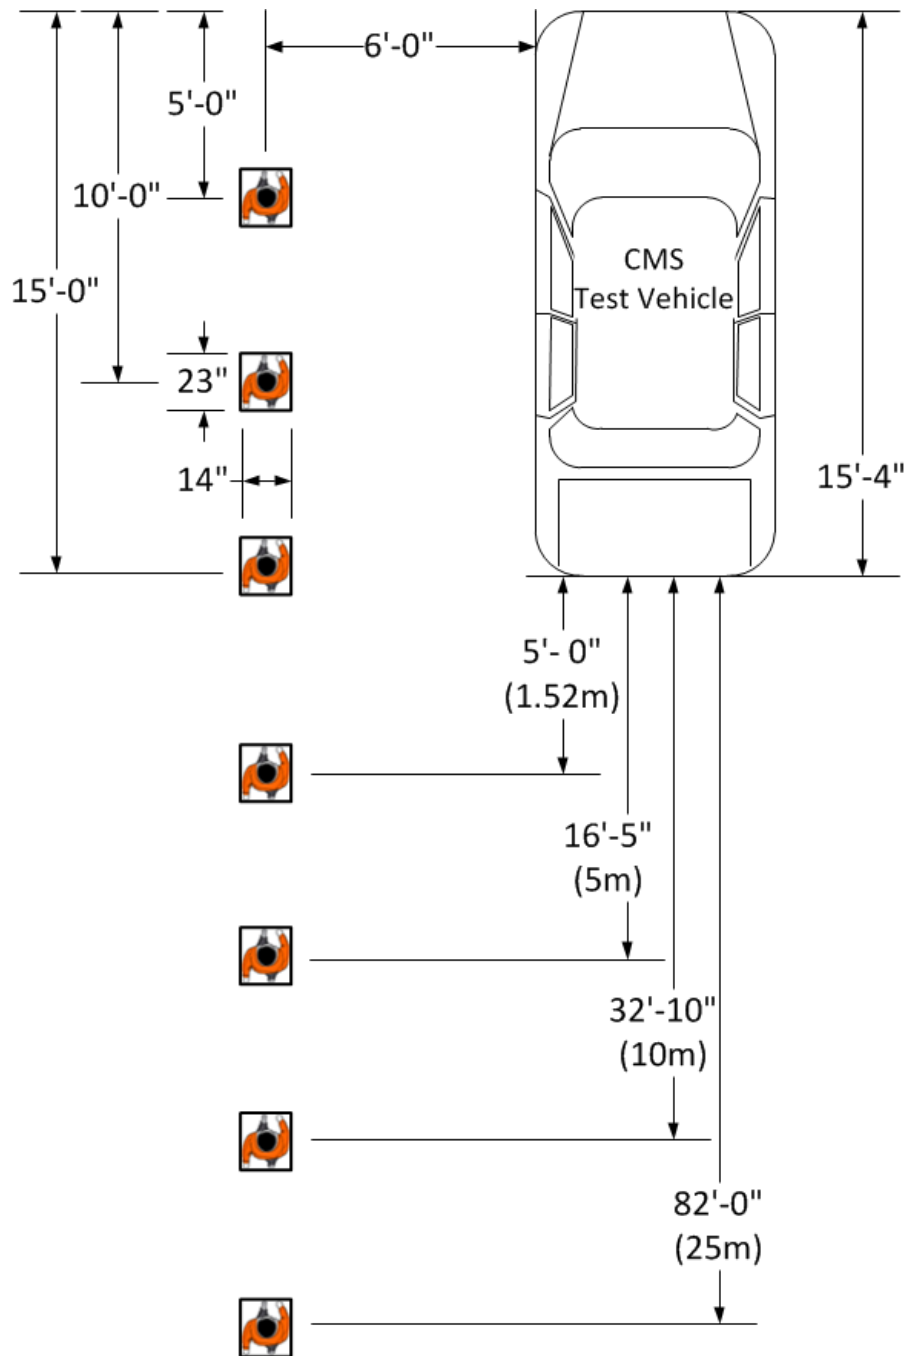
Figure 12 below illustrates how the CMS test vehicle and child mannequin were positioned for the 7 longitudinal test locations. Figure 13 depicts the CMS test vehicle and sedan as tested for the 100 feet aft of front bumper test location.

Figure 13. Illustration of Child Mannequin Test Object Positions With Respect to the CMS Test Vehicle Location.

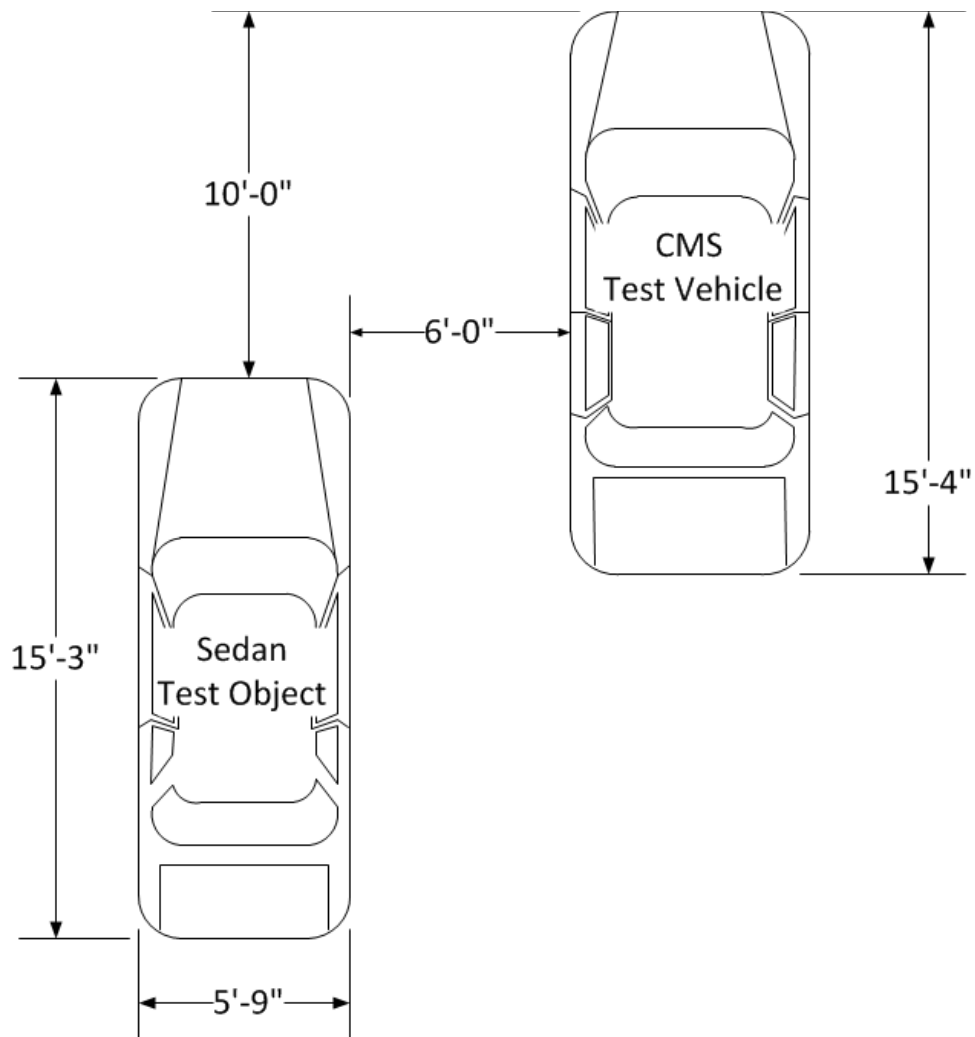
Figure 14. Illustration of Sedan Test Object Positioned 10 Feet Aft of CMS Test Vehicle Front Bumper.

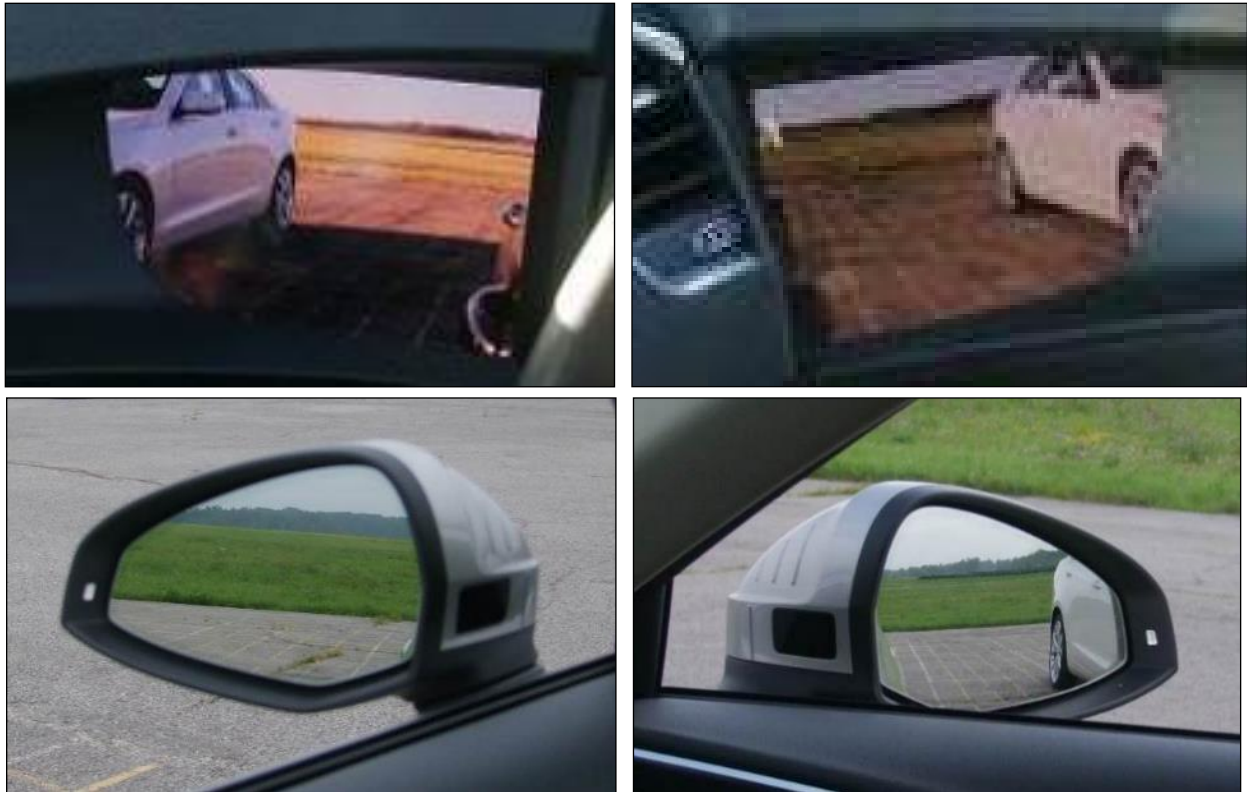
With its wider field of view, the CMS is able to display both test objects at locations next to the vehicle (the aft of front bumper locations) that cannot be seen with traditional mirrors. Figure 15 illustrates this observation for the sedan test object positioned 15 feet aft of the test vehicles' front bumpers.

Figure 15. Sedan Positioned 15 Feet (4.57 m) Aft of Front Bumper, as Viewed With Side CMS (top) and Mirrors (bottom) on Driver (left) and Passenger Side (right)

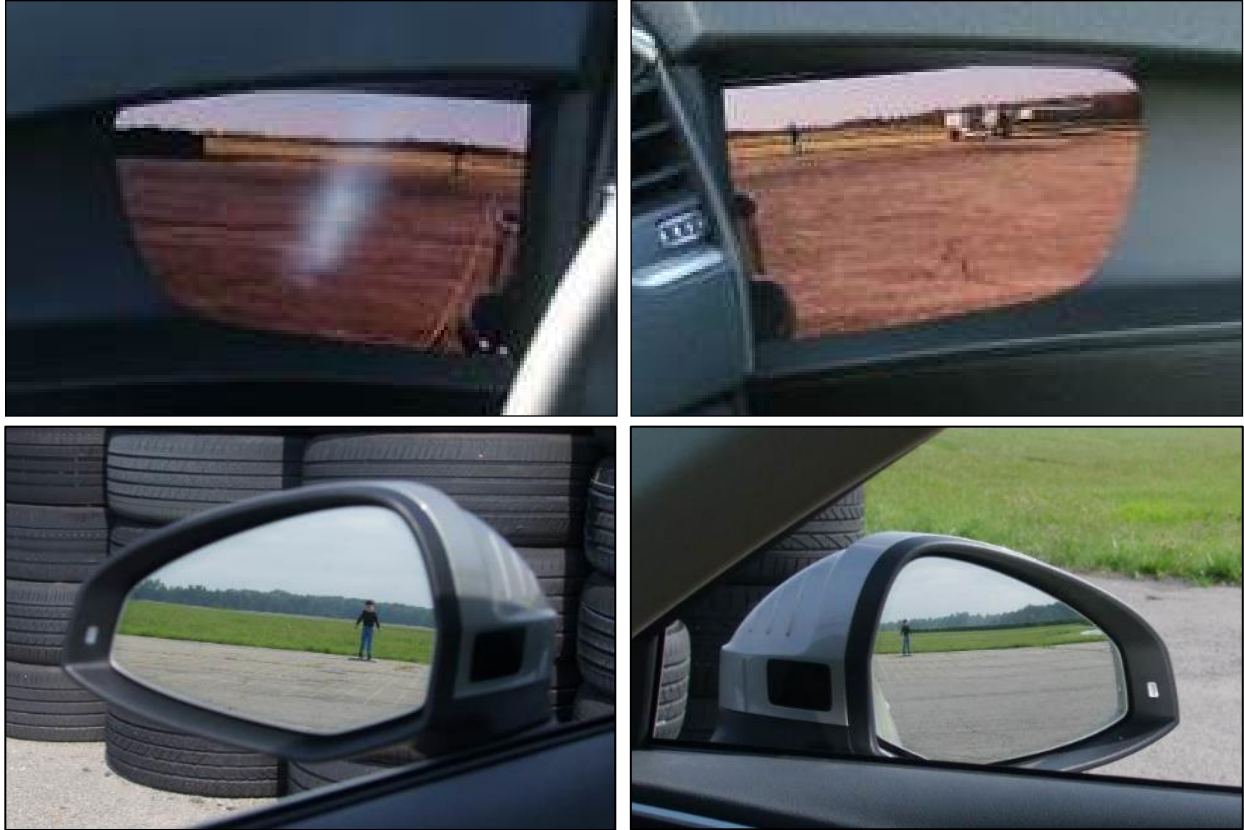
The CMS wider field of view presented over a similar area as a traditional mirror surface results in an image having minification resulting in the child mannequin appearing thinner at a distance of 82 feet aft of the vehicle's rear bumper, as can be seen in Figure 16.

Figure 16. Child Mannequin Positioned 82.0 Feet (25 m) Aft of Rear Bumper, as Viewed With Side CMS (top) and Mirrors (bottom) on Driver (left) and Passenger Side (right)

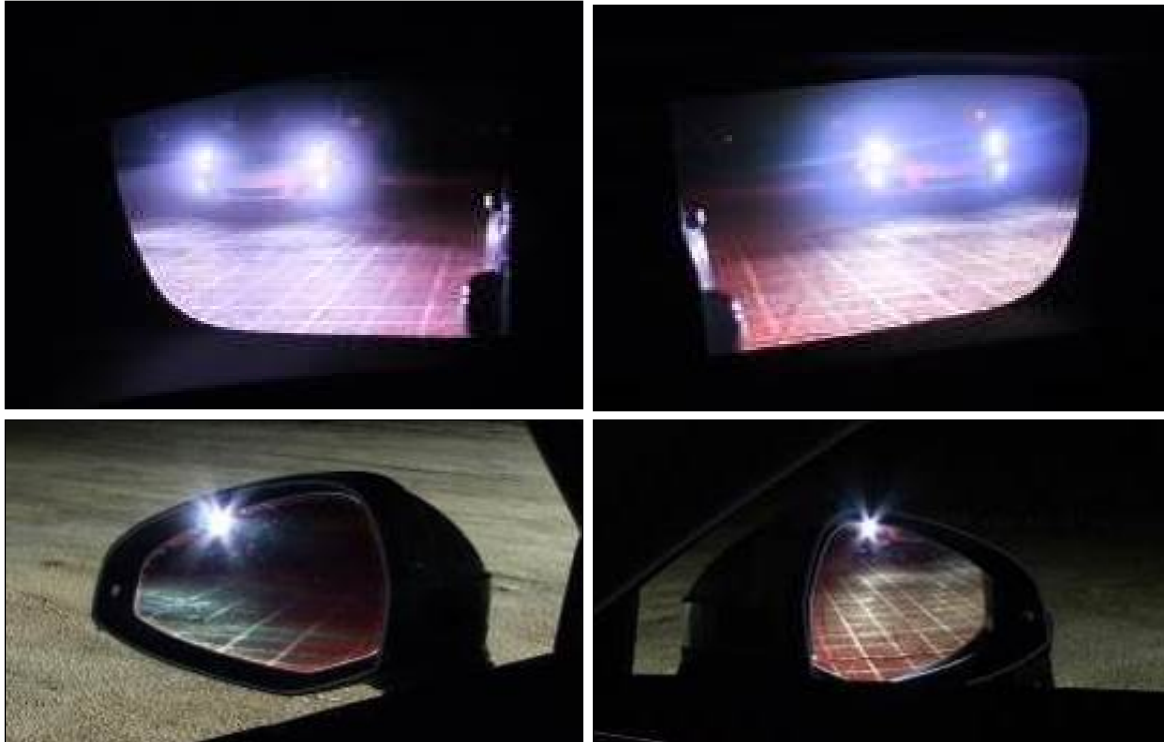
Figure 17 contains photos of the sedan test object positioned 16.4 Feet (5 m) aft of the test vehicle's rear bumper at night as seen with the CMS display and mirrors. This image comparison shows substantially more blooming and lens flare from the sedan test object's headlighting system in the CMS image than can be seen in the mirrors' images.

Figure 17. Sedan Positioned 16.4 Feet (5 m) Aft of Rear Bumper at Night Time, as Viewed With Side CMS (top) and Mirrors (bottom) on Driver (left) and Passenger Side (right)

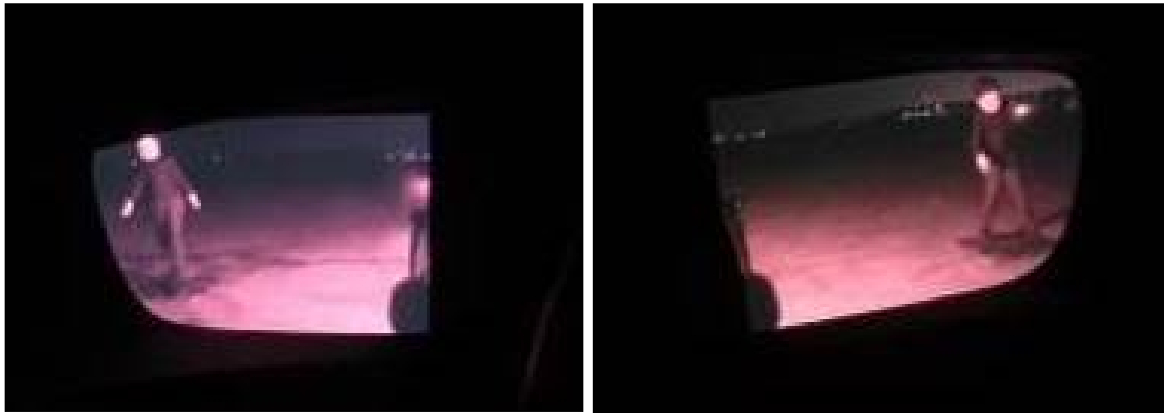
Figure 18 shows images of the CMS display with the child mannequin test object positioned 5 feet aft of the test vehicle's rear bumper in dark conditions. In dark conditions at multiple test object locations the child mannequin could be seen in the CMS display but not in the mirrors.

Figure 18. Child Mannequin Positioned 5 Feet (1.52 m) Aft of Rear Bumper, at Night Time as Viewed With Side CMS on Driver (left) and Passenger Side (right)

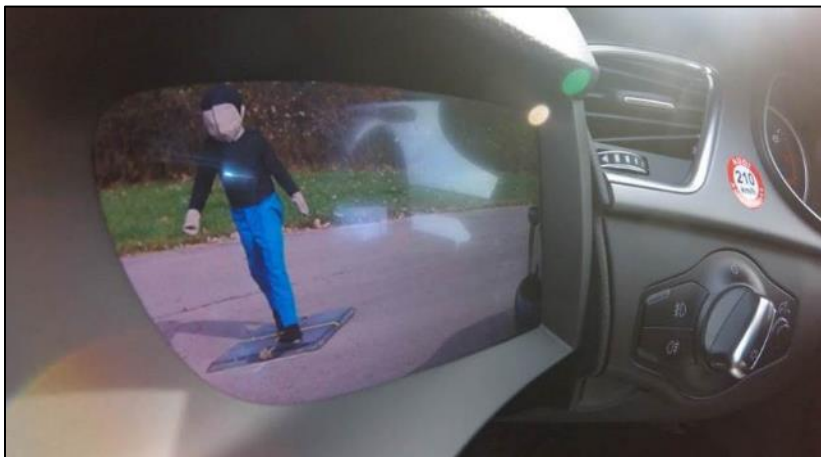
In general, the CMS displays appeared bright and clear under the conditions examined in this effort. In some cases, minor glare and reflections could be observed. Figures 19 and 20 contain photos of the posable child mannequin and sedan test objects in the CMS display's field of view during a bright sunny day, in which the effects of the bright light were noticed on the displays.

Figure 19. Posable Child Mannequin in Sunny Test Conditions, Glare/Reflection in CMS Display

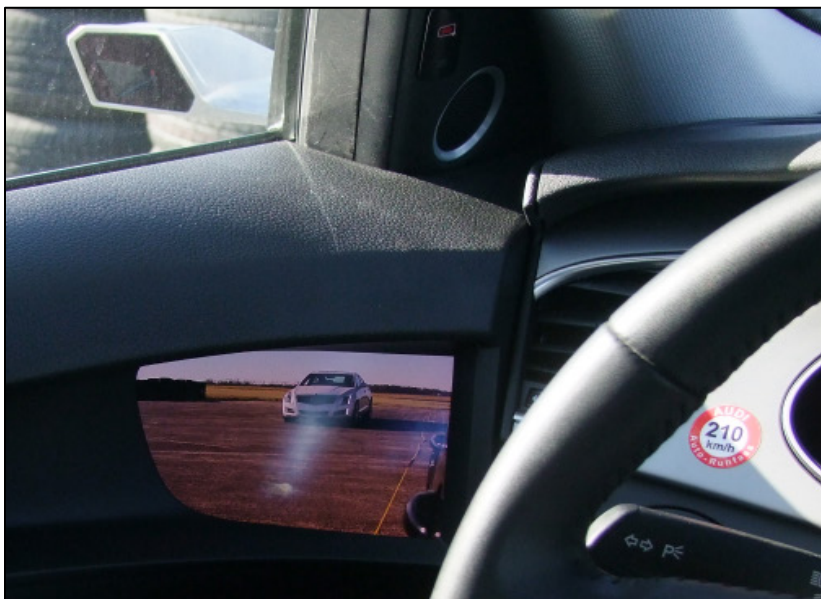
Figure 20. Sedan Test Object in Sunny Test Conditions, Glare/Reflection in CMS Display

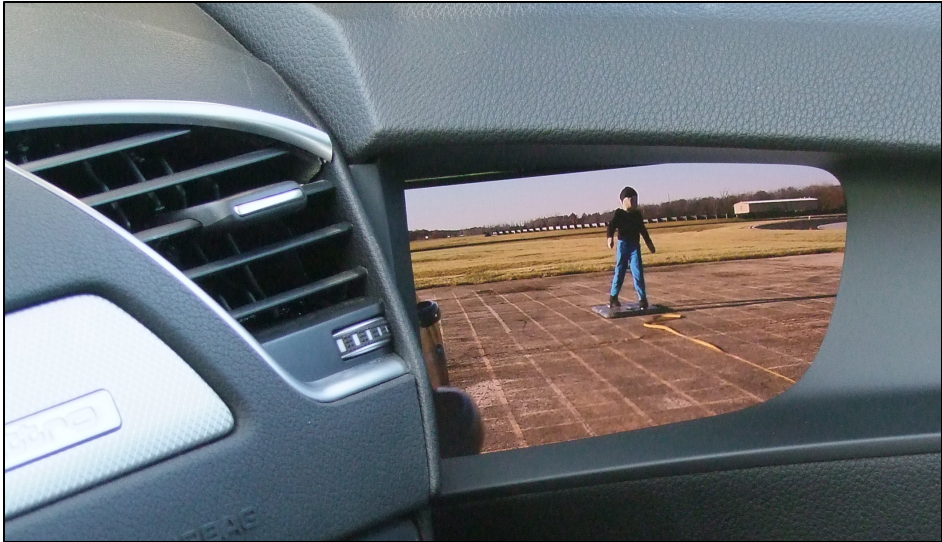
For comparison, the following figures are photos of the posable child mannequin and sedan test objects in the CMS display's field of view during a bright sunny day, in which the effects of the bright light were not noticeable on the displays.

Figure 21. Posable Child Mannequin in Sunny Test Conditions, Minimal Glare/Reflection in CMS Display

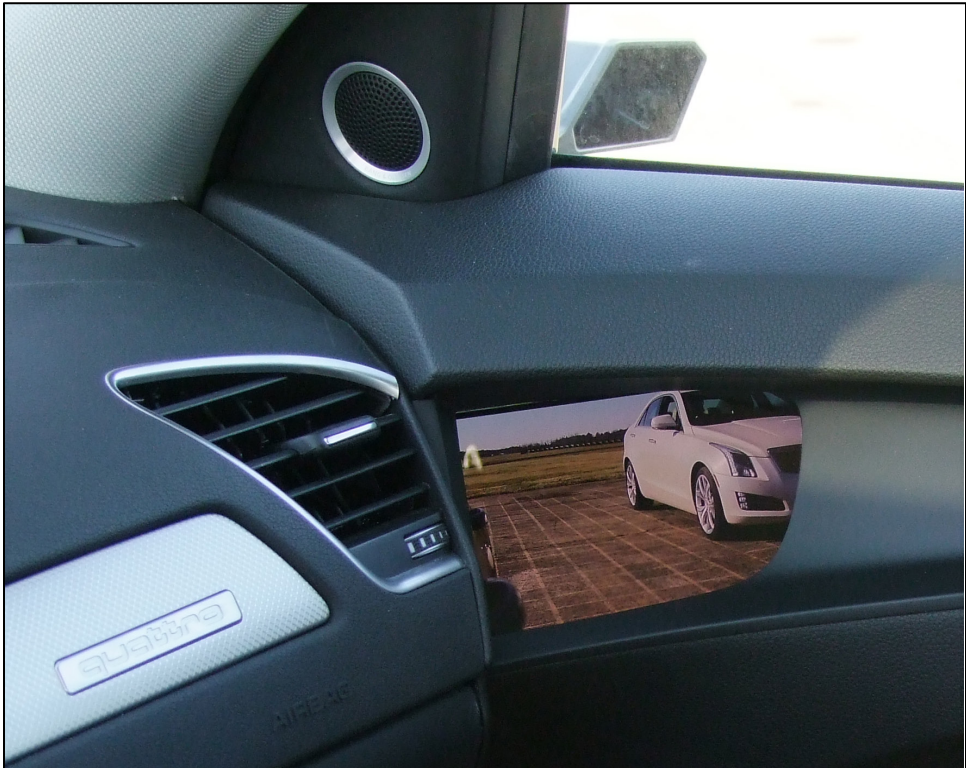
Figure 22. Sedan Test Object in Sunny Test Conditions, Minimal Glare/Reflection in CMS Display

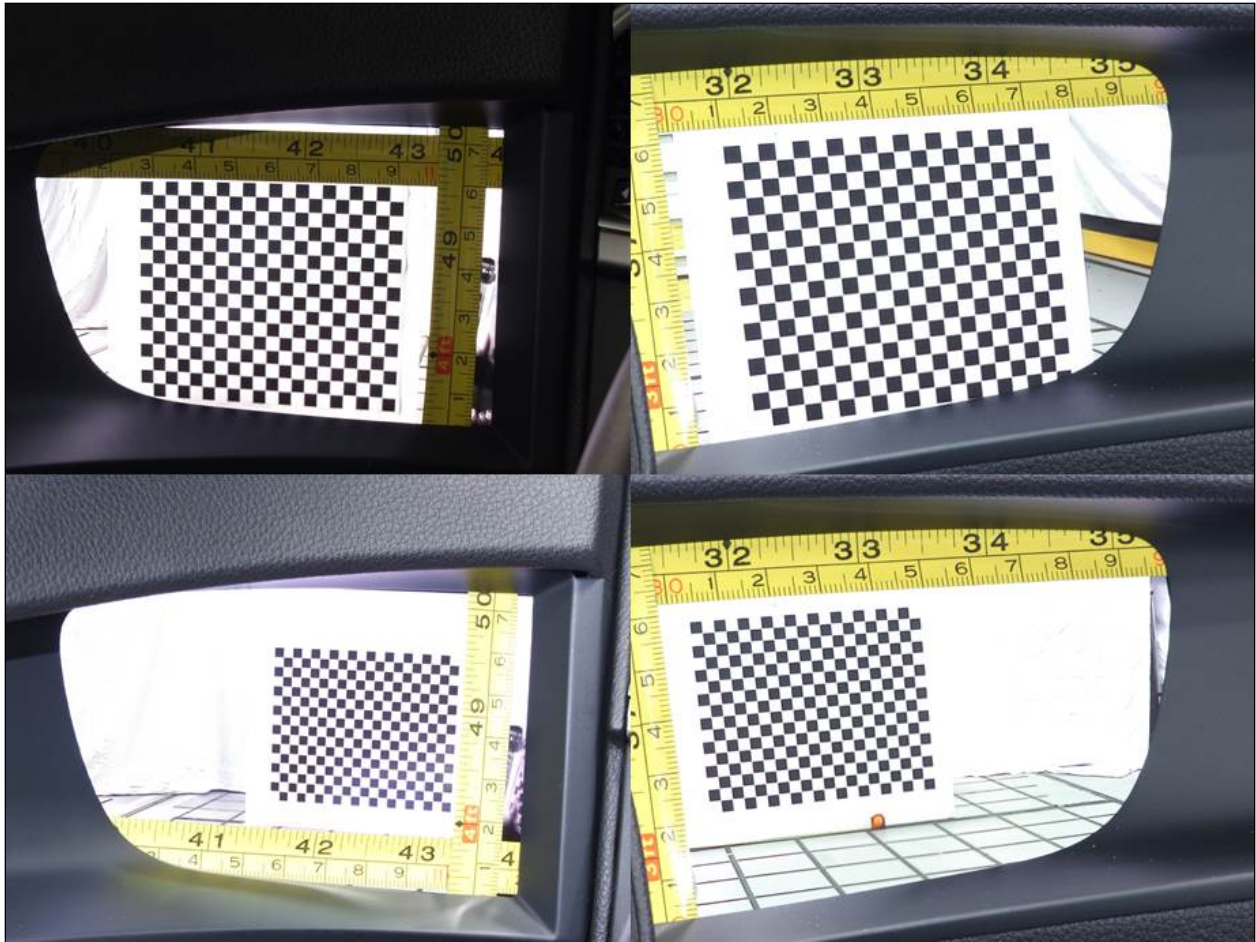
The following figures are examples of the chessboard chart in the field of view of the side-view cameras. As can be seen in the figures, segments of a tape measure were placed over the image surface to provide dimensions of the chessboard chart as it appeared in the displays. The chessboard image in both display types was generally clear.

Figure 23. Near and Far Chessboard in Lighted Environment as Viewed With Driver (left) and Passenger Side (right) CMS Displays

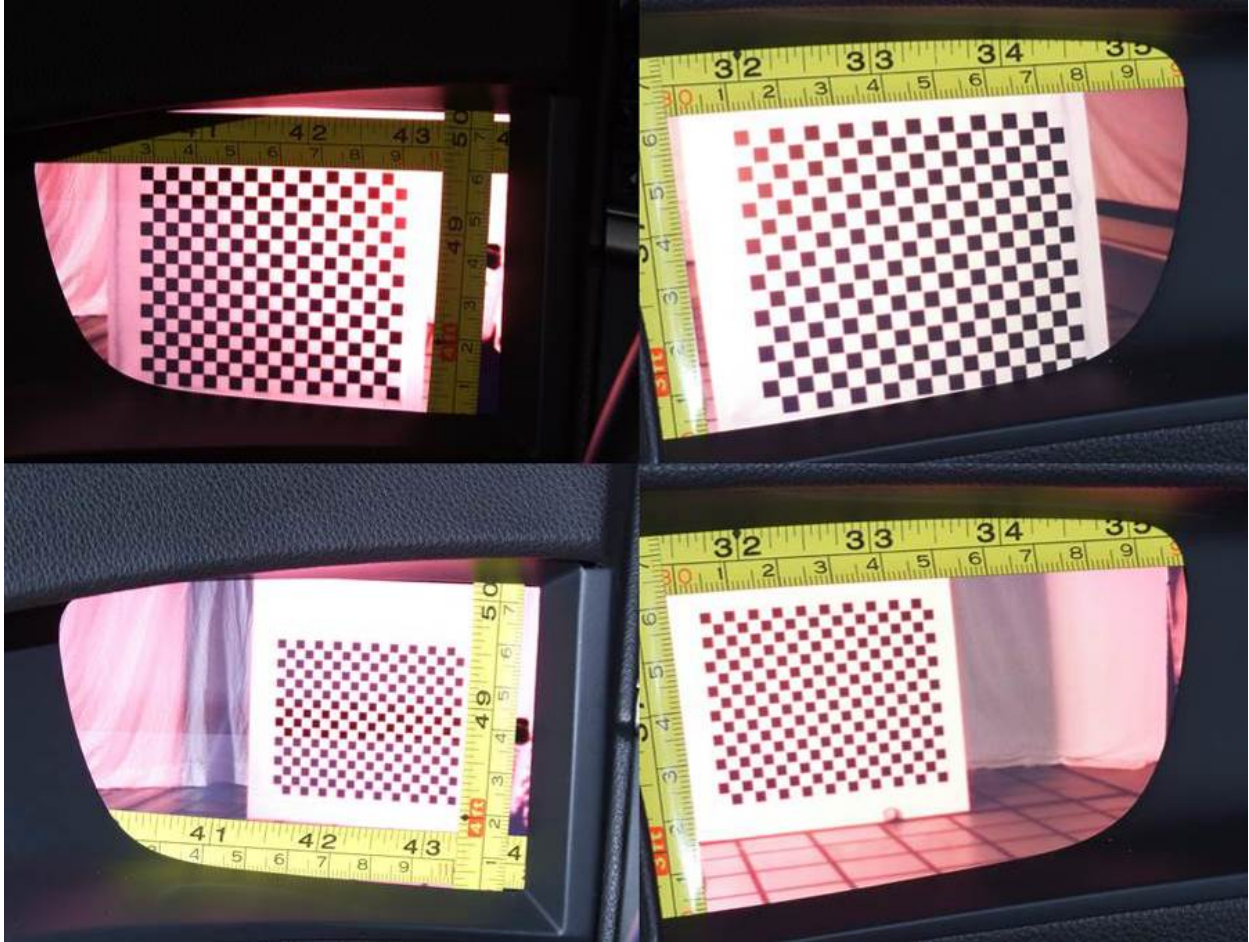
Figure 24. Driver (left) and Passenger Side (right) CMS Displays Showing Near (top) and Far (bottom) Chessboard, Dark Environment, Vehicle Tail Lights On

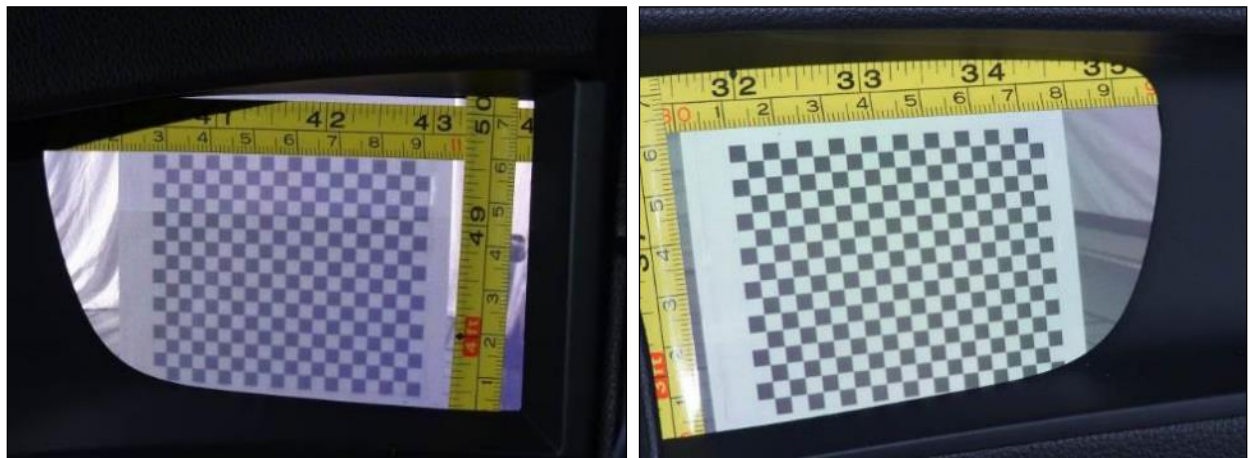
Figure 25. Near Chessboard in Dark Environment With Vehicle Tail Lights Off as Viewed With Driver (left) and Passenger Side (right) CMS Displays
