**National Highway
Traffic Safety
Administration**

DOT HS 812 582

Examination of a Prototype Camera Monitor System For Light Vehicle Outside Mirror Replacement

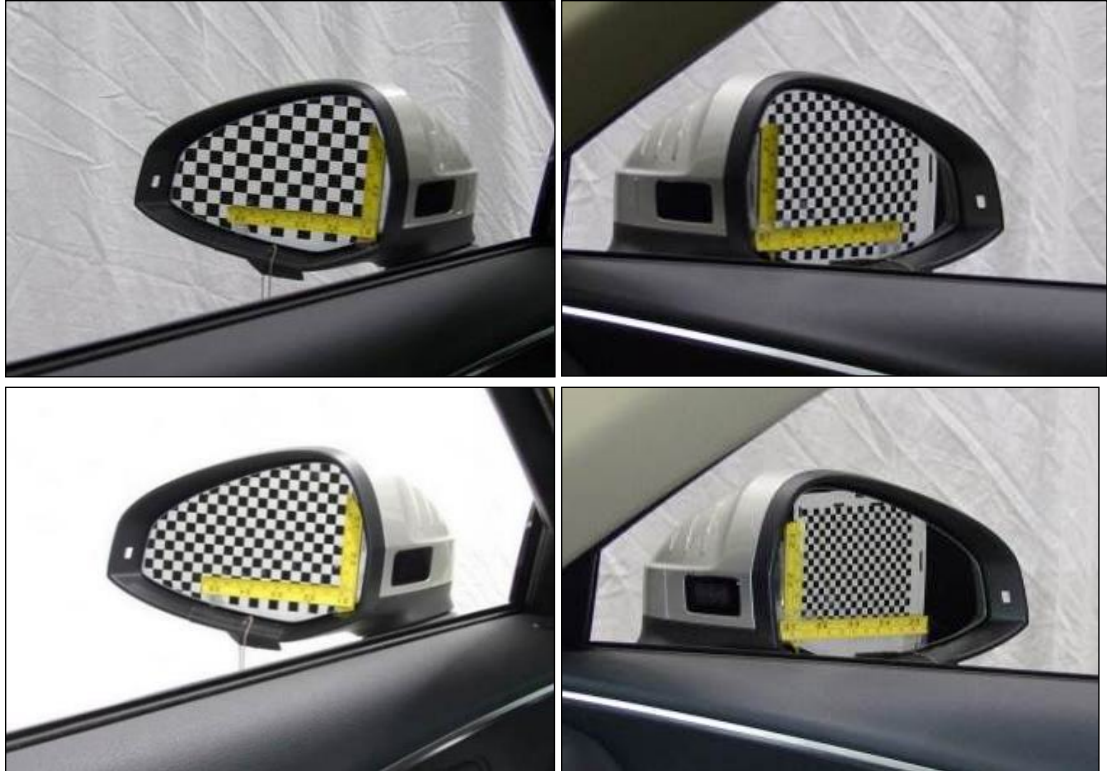
For comparison, the following figures are examples of the chessboard chart in the field of view of the test vehicle with standard outside rearview mirrors.

Figure 26. Near and Far Chessboard in Lighted Environment as Viewed With Driver (left) and Passenger Side (right) Mirrors

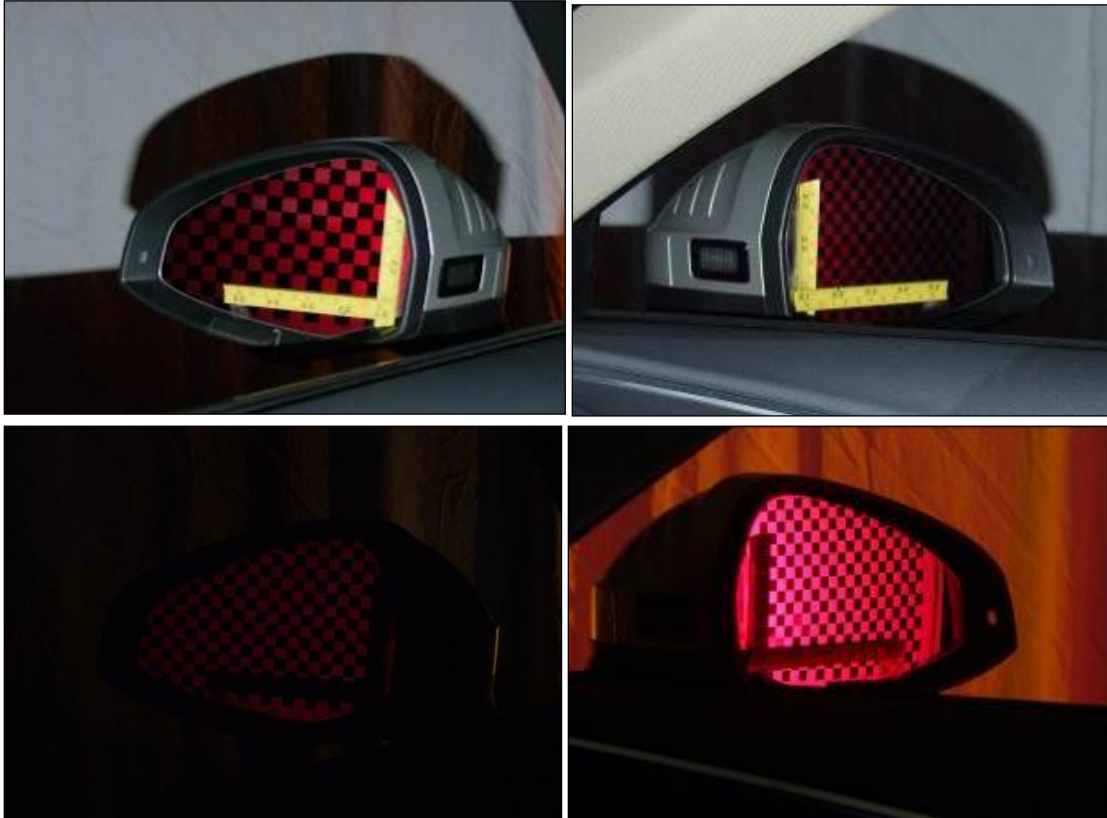
Figure 27. Near and Far Chessboard in Dark Environment as Viewed With Driver (left) and Passenger Side (right) Mirrors

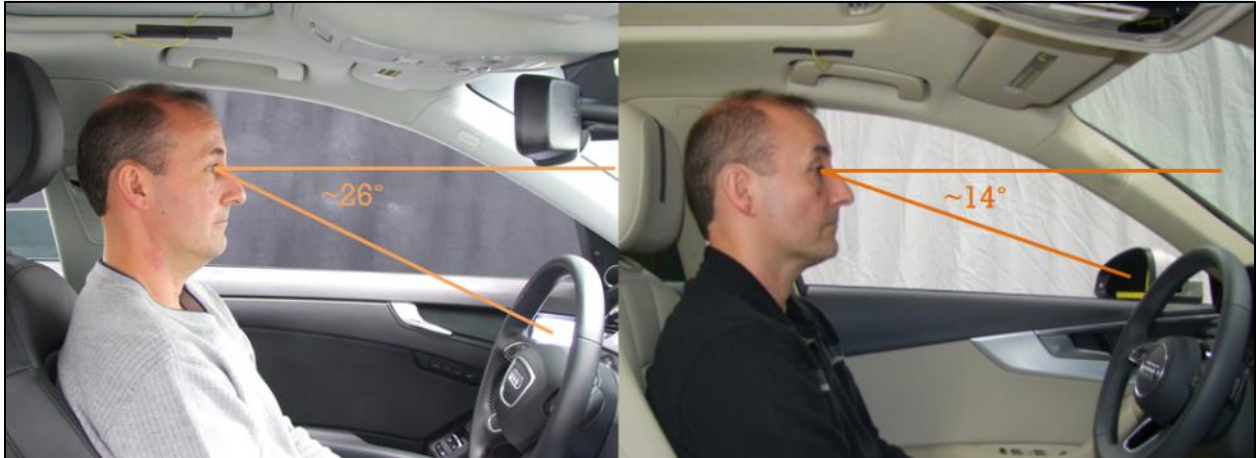
The following figure shows an approximation of the downward viewing angle for the CMS display versus a standard outside mirror, using a 50th percentile male seated in the comparable test vehicles.

Figure 28. Downward Viewing Angle, CMS Display Versus Mirror

As can be seen in the figure, the driver's side CMS display viewing angle is approximately 12 degrees lower than the height of the traditional mirror location. The ease with which drivers may acclimate from acquiring visual information from a traditional outside mirror location versus an interior display at a different visual angle is not known. At approximately 26 degrees below the horizontal, the CMS displays were located within the 30-degree down angle zone recommended in the NHTSA Visual-Manual Driver Distraction Guidelines.

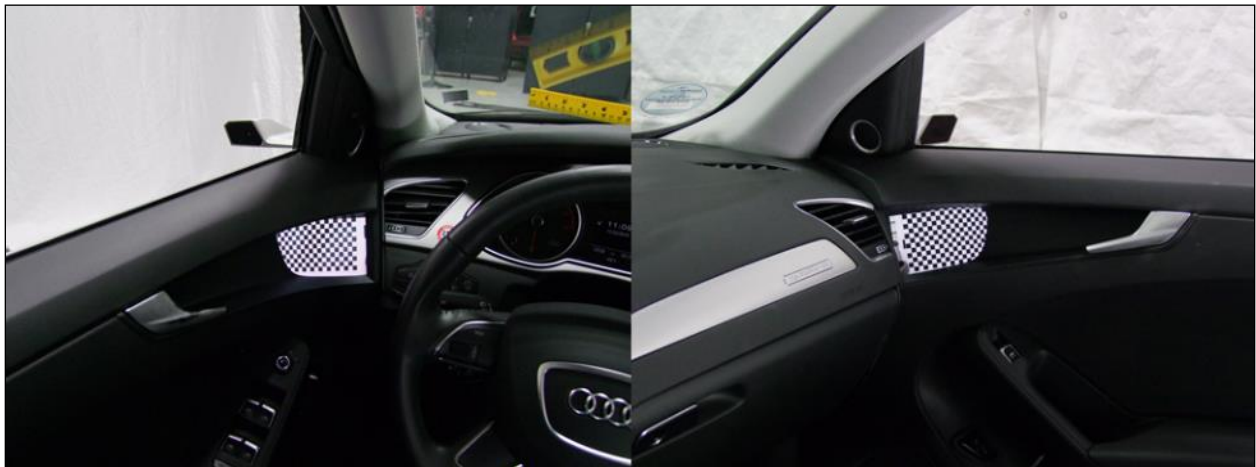
Figure 29. Side CMS Displays, Viewed From 50th Percentile Male Driver's Viewpoint

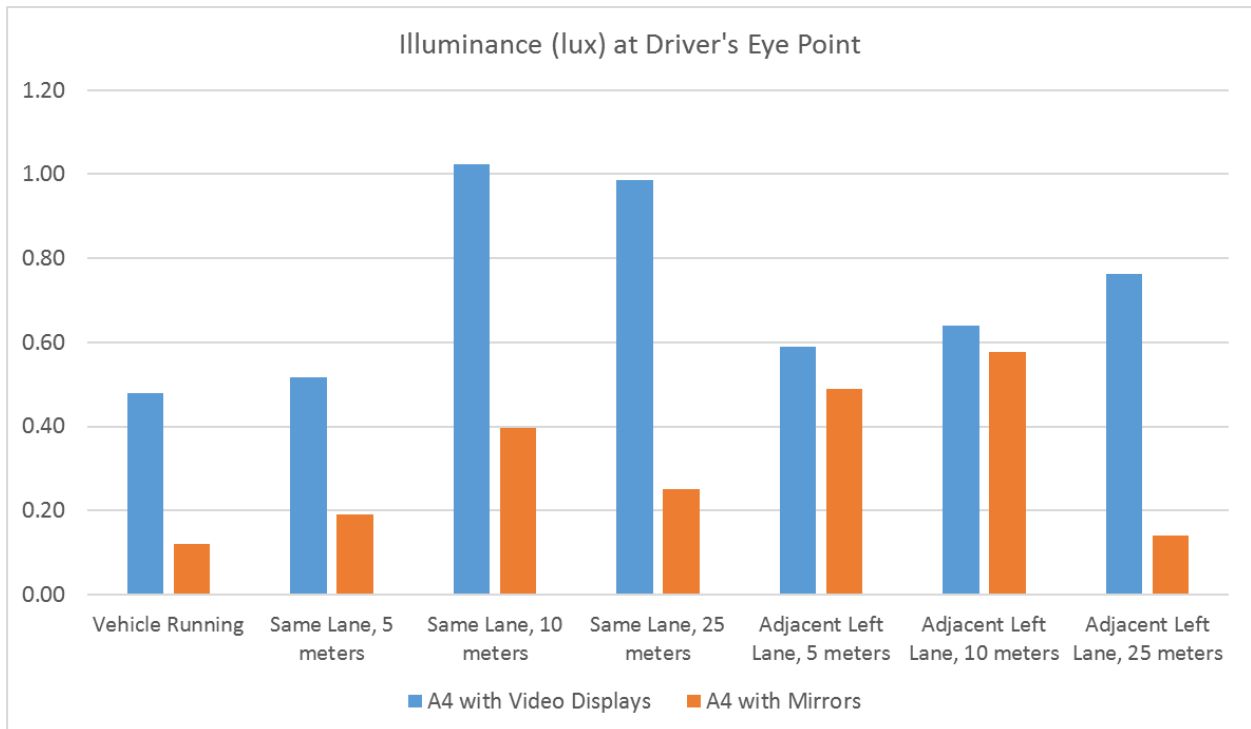
The following table describes each of the conditions in which interior illuminance data were obtained and the corresponding adjusted illuminance values. The subsequent figure illustrates the measured illuminance values.

Figure 30. Measured Illuminance, CMS Displays Versus Mirrors

Measured illuminance values were lower than the test staff anticipated they would be based on direct, subjective observation of the displays in nighttime conditions. While measured illuminance values did not approach a level that would be considered truly glaring to the driver, the constant unnecessary illumination coming from the CMS displays even when no other vehicle was nearby could be distracting or annoying to drivers in dark conditions, particularly in areas without street lights or other environmental lighting.

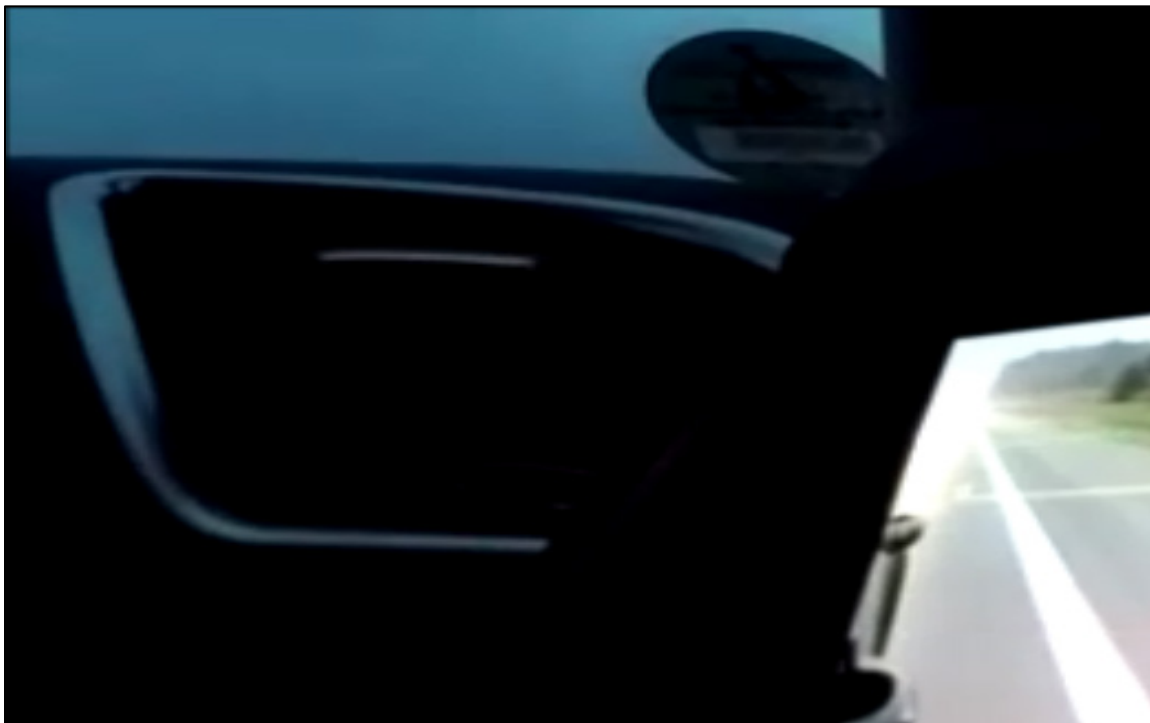
Figure 31. Photo of Passenger-Side CMS Display and Portion of Forward Windshield View, Highlighting the Disparity in Apparent Ambient Illumination at Dusk

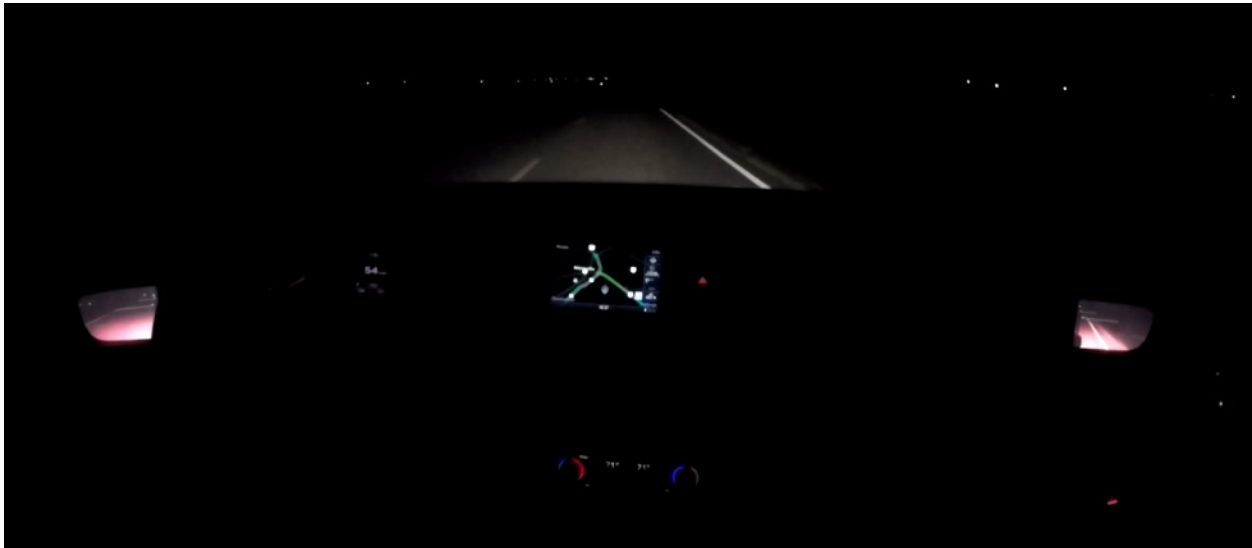
Figure 32. Photo of Side CMS Displays in Unlit Area, Vehicle Taillights Only

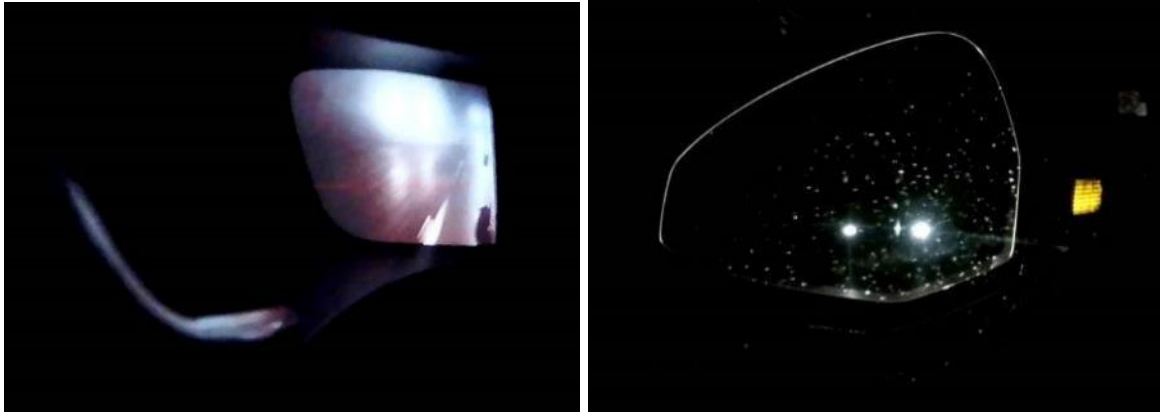
Figure 33. CMS Display Versus Mirror, Vehicle Behind in Adjacent Lane

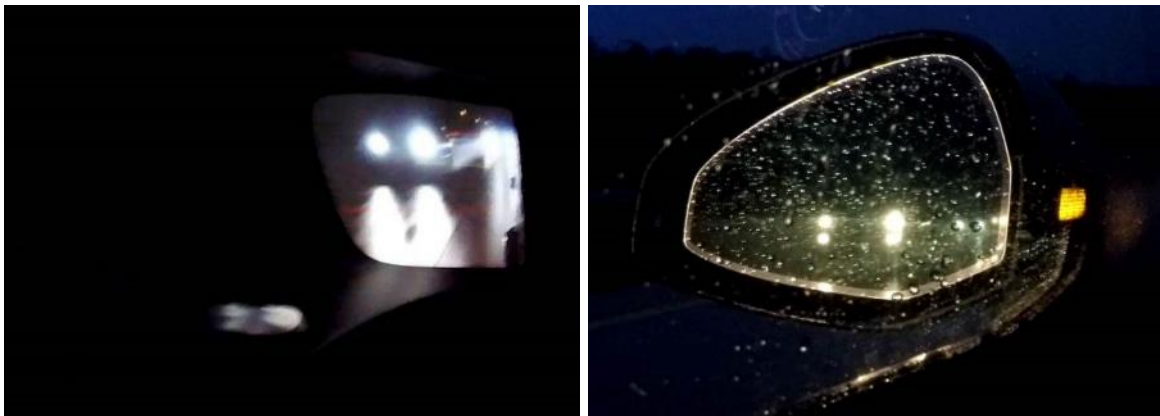
Figure 34. CMS Display Versus Mirror, Multiple Vehicles Behind in Adjacent Lane

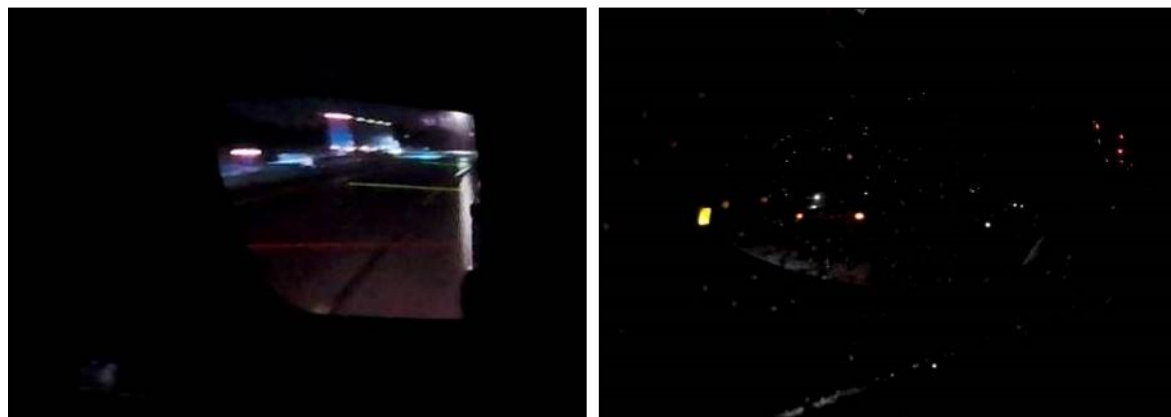
Figure 35. CMS Display Versus Mirror, Taillights of Other Traffic

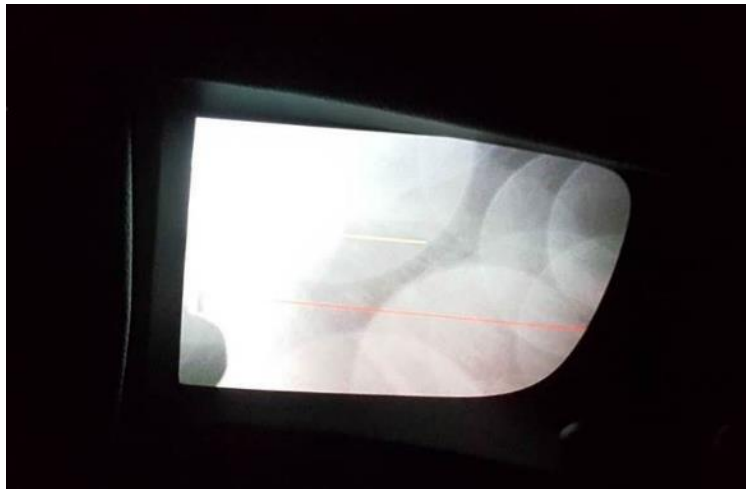
Figure 36. Photo of Passenger-Side CMS Display in Rainy Conditions

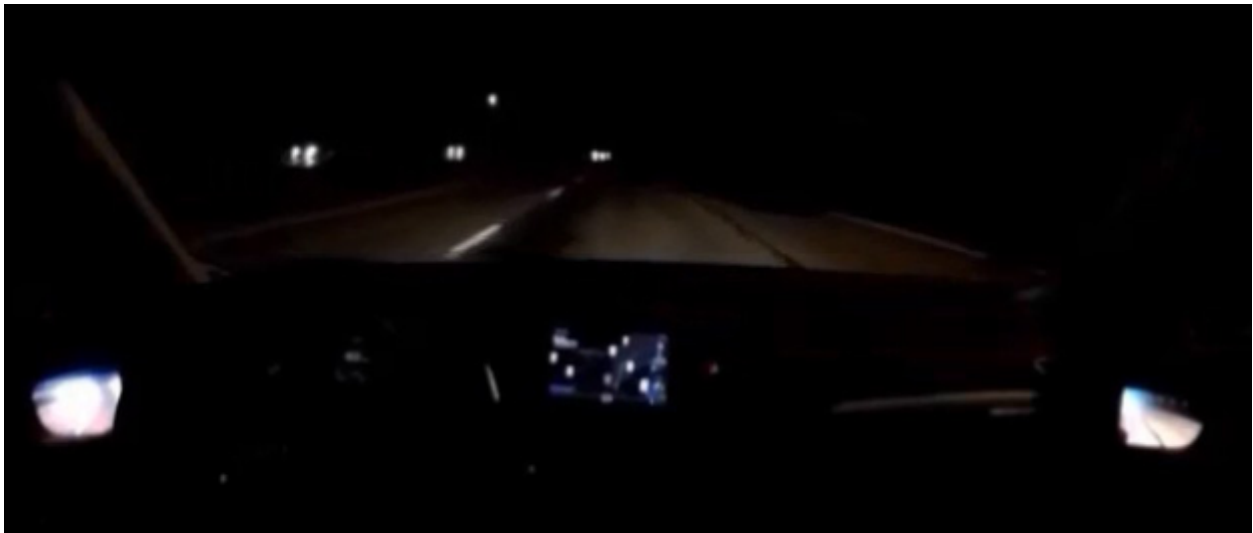
Figure 38. Image of Vehicle Headlights Passing on the Left at Night With Blooming Visible in CMS Display
