**Analyses of Drivers' Responses to In-Vehicle Receiver
(IVR) after Experiencing One Mode of Operation**

The Pilot Study of Advisory On-Board Vehicle Warning Systems
at Railroad Grade Crossings

Department of Civil and Environmental Engineering
University of Illinois at Urbana-Champaign

March 2004

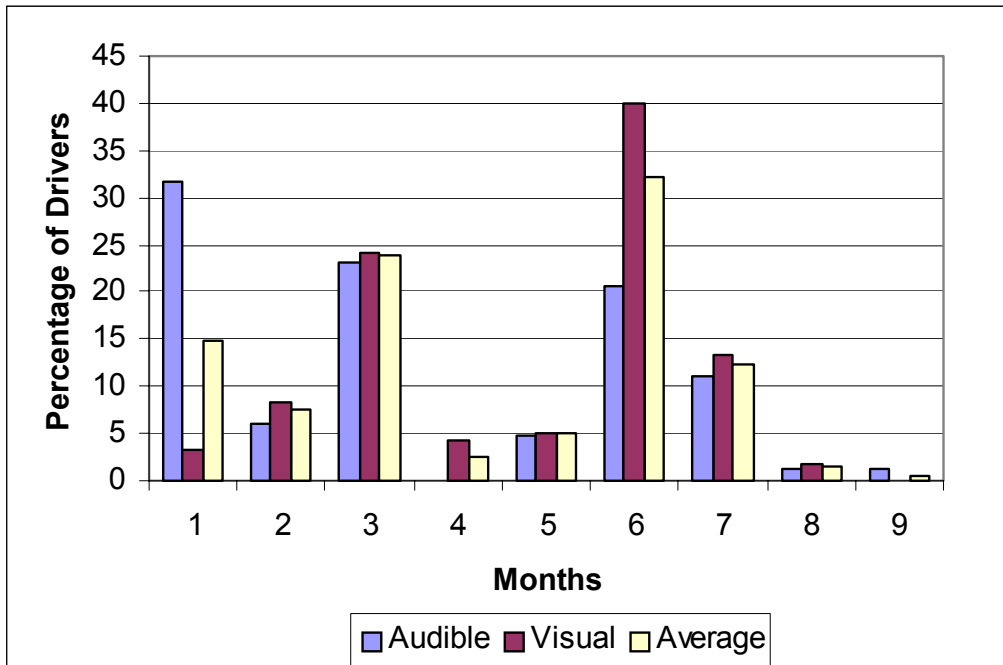
Figure 1: In the year 2000, how long have you driven a vehicle with the IVR?

On the average they drove an IVR equipped vehicle for 4.3 months. The average number of months the drivers had the IVR was 3.59 months for audible and 4.80 months for visual. The responses for the average number of months that the drivers had the IVR were significantly different for the visual and the audible mode. Approximately 31.7% of the drivers had the IVR in the audible mode for one month, compared to 3.3% for the drivers with the IVR in the visual mode. For both modes, more than 90% of the drivers had the IVR for a period of up to seven months.

The total number of drivers who responded to this question was 202, out of that 82 were in the audible and 120 in the visual mode. The distribution of the number of months that the participants had the IVR is given in Figure 1.

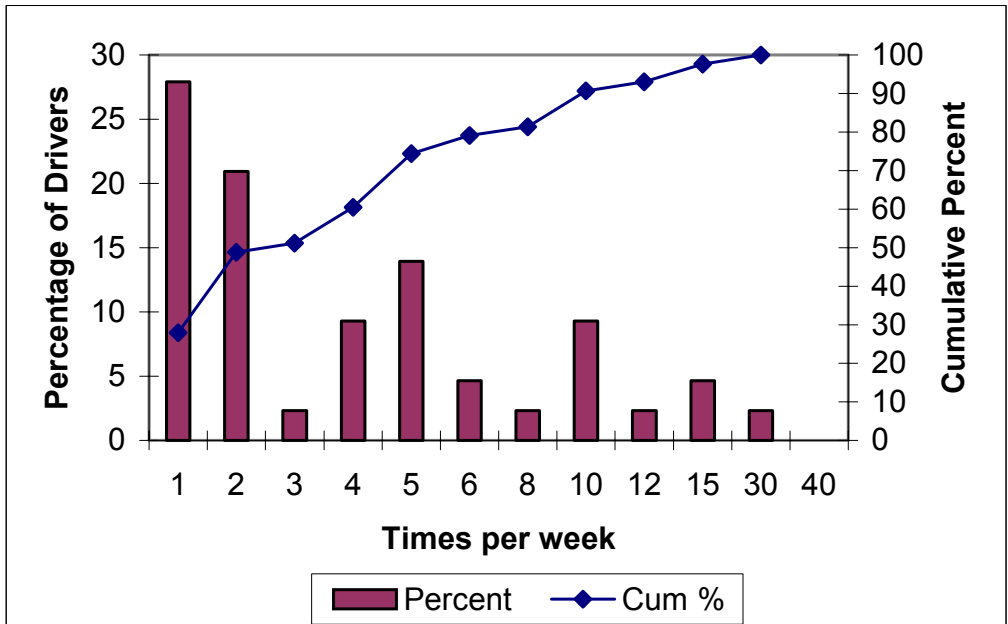
Beckwith Road in Morton Grove: A total of 43 drivers reported using the Beckwith Road crossing. Figure 2 shows the frequency of usage of the crossing by the drivers. On the average, the drivers used this location 4.9 times per week. The percentage of the drivers who used this crossing up to two times per week was 48.8%. About 90.7% of the drivers used this location up to 10 times per week. The maximum usage reported for this crossing was 30 times per week.

Figure 2: Distribution of number of times the drivers used Beckwith Road crossing.

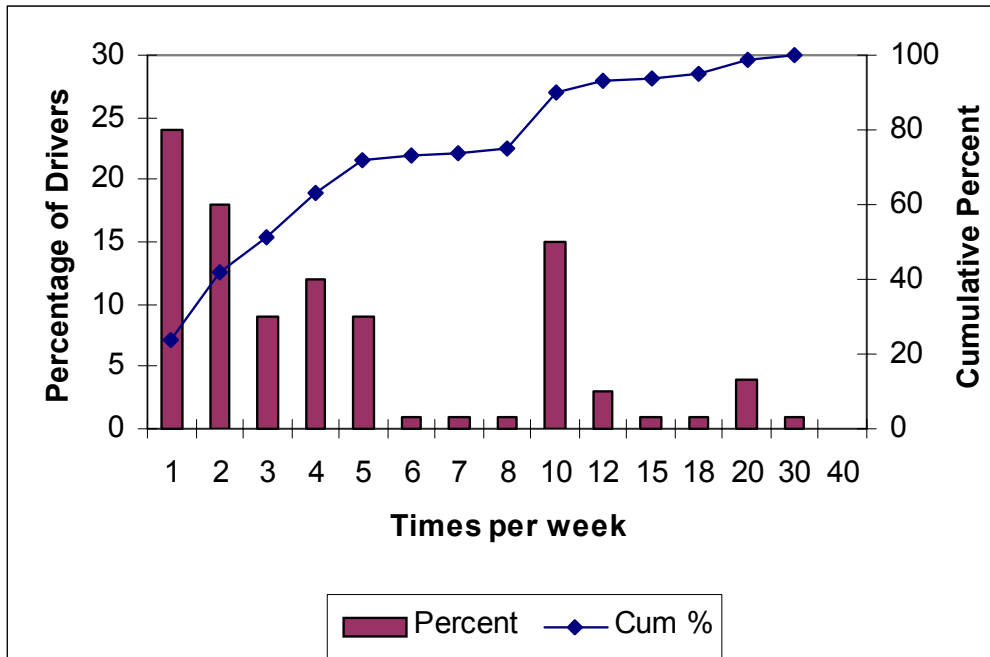
Chestnut Street in Glenview: A total of 103 drivers reported using the Chestnut Street crossing. Figure 3 shows the frequency of usage of the crossing by the drivers. On the average, the drivers used this location 5.2 times per week. The percentage of the drivers who used this crossing up to two times per week was 43.7%. About 90.3% of the drivers used this location up to 10 times per week. The maximum usage reported for this crossing was 30 times per week.

Figure 3: Distribution of number of times the drivers used Chestnut Street crossing.

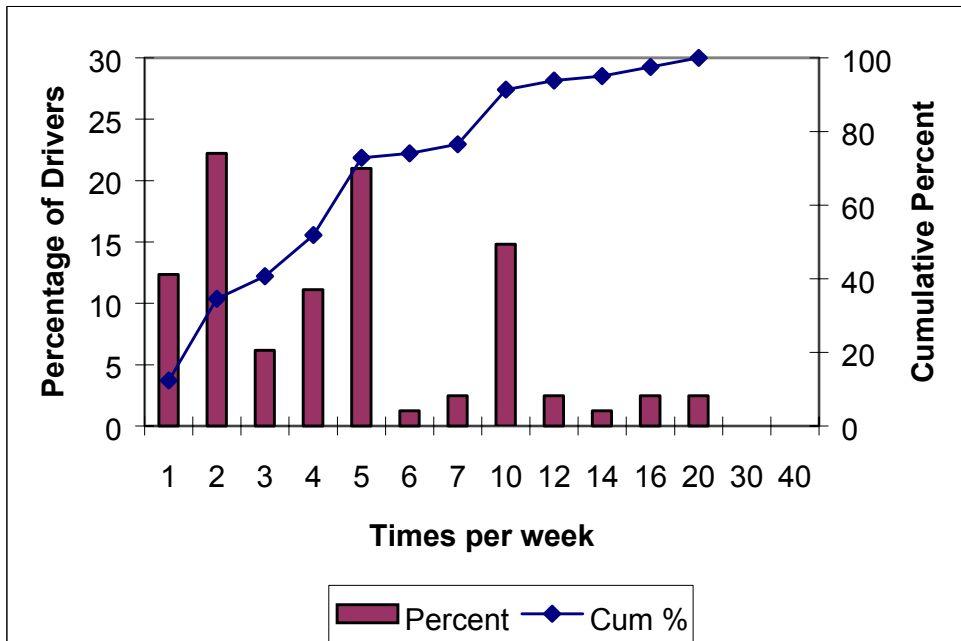
Shermer Road in Northbrook: A total of 81 drivers reported using the Shermer Road crossing. Figure 4 shows the frequency of usage of the crossing by the drivers. On the average, the drivers used this location 5.3 times per week. The percentage of the drivers who used this crossing up to two times per week was 34.6%. About 91.4% of the drivers used this location up to 10 times per week. The maximum usage reported for this crossing was 20 times per week.

Figure 4: Distribution of number of times the drivers used Shermer Road crossing.

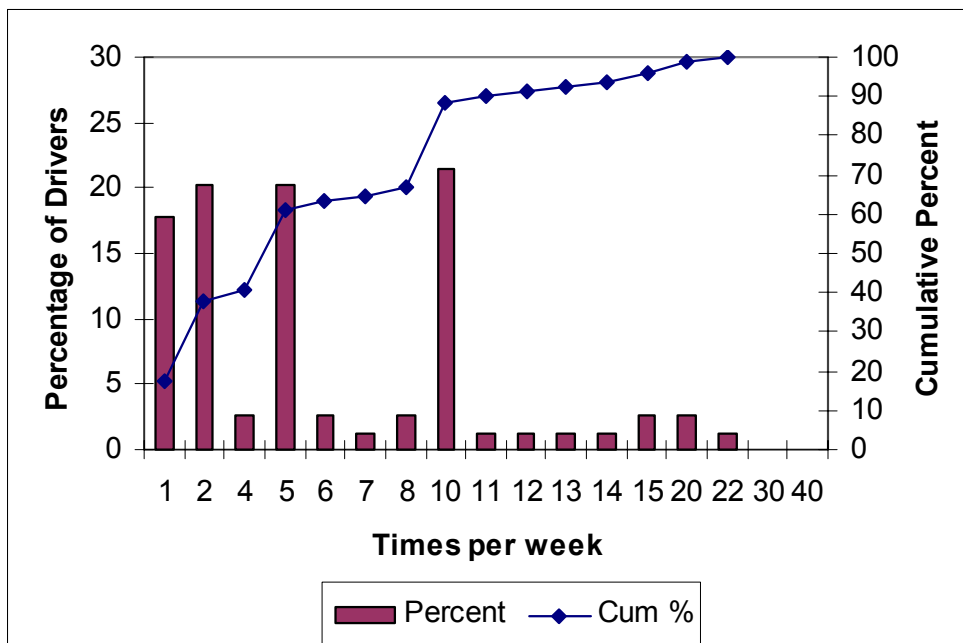
Dundee Road in Northbrook: A total of 79 drivers reported using the Dundee Road crossing. Figure 5 shows the frequency of usage of the crossing by the drivers. On the average, the drivers used this location 6.1 times per week. The percentage of the drivers who used this crossing up to two times per week was 38.0%. About 89.9% of the drivers used this location up to 11 times per week. The maximum usage reported for this crossing was 22 times per week.

Figure 5: Distribution of number of times the drivers used Dundee Road crossing.

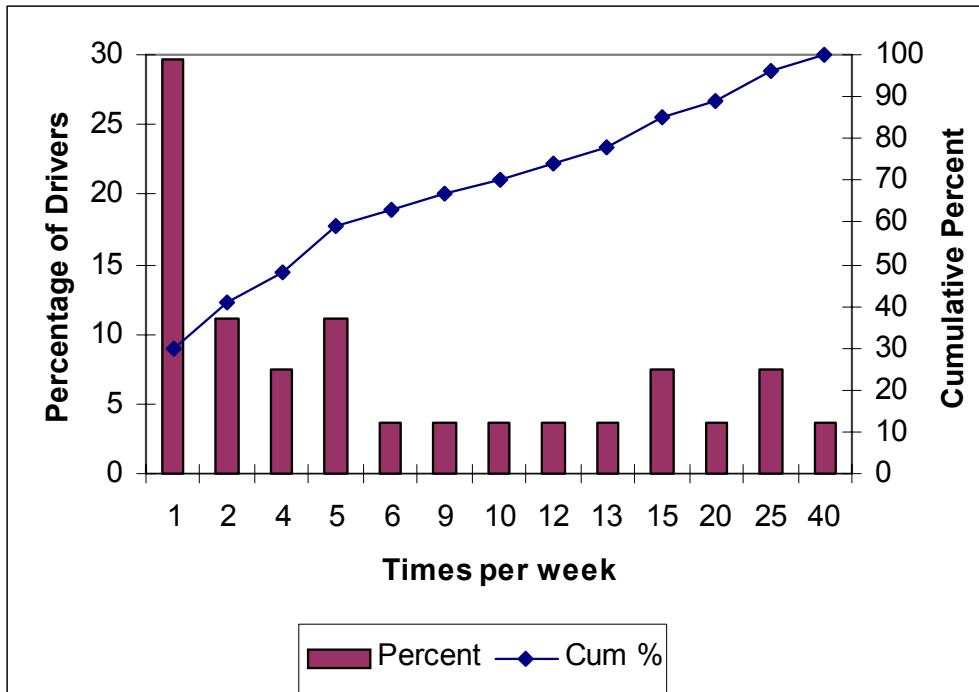
Greenwood Avenue in Deerfield: A total of 27 drivers reported using the Greenwood Avenue crossing. Figure 6 shows the frequency of usage of the crossing by the drivers. On the average, the drivers used this location 8.4 times per week. The percentage of the drivers who used this crossing up to two times per week was 40.7%. About 88.9% of the drivers used this location up to 20 times per week. The maximum usage reported for this crossing was 40 times per week.

Figure 6: Distribution of number of times the drivers used Greenwood Avenue crossing.

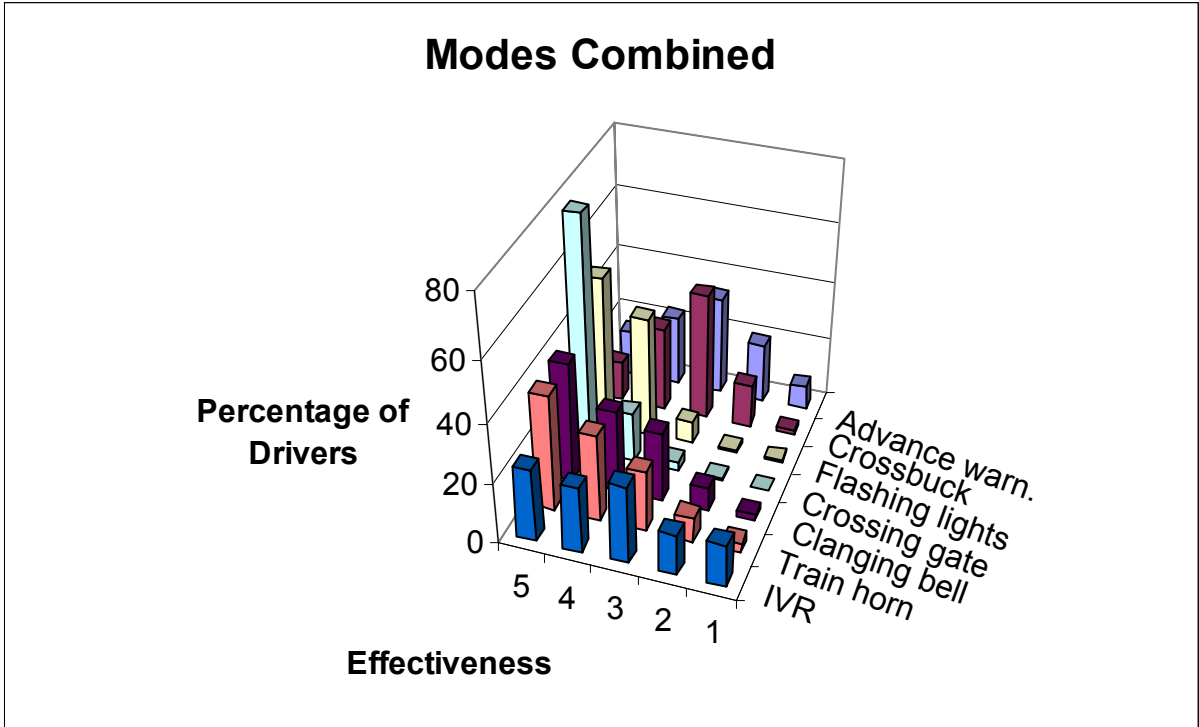
The number of drivers who answered this question varied from 189 to 195 depending on the warning device. The drivers were asked to select one of the five rating categories: very high (5 points), high (4 points), medium (3 points), low (2 points), and very low (1 point). The results showed that the crossing gate is perceived as the most effective warning device. As shown in Table 3, about 76.4% of the drivers rated its effectiveness as “very high”. Approximately 48.7% of the drivers said that the

effectiveness of the flashing lights was “very high”. The effectiveness of the train horn and clanging bell were rated as “very high” by 36.6% and 38.1%, respectively. The effectiveness of the IVR, the advance warning sign and the crossbuck sign were rated “very high” by 21.5%, 14.9% and 12.7% of the drivers, respectively. The distribution of the effectiveness ratings are given in Figure 7 and Table 3. The figure shows that the crossing gate was considered highly effective by a large majority of the drivers. In Table 3, the no opinion group for the IVR was the highest of all the warning devices.

Figure 7: Percentage of all drivers rating the effectiveness of each railroad warning device.

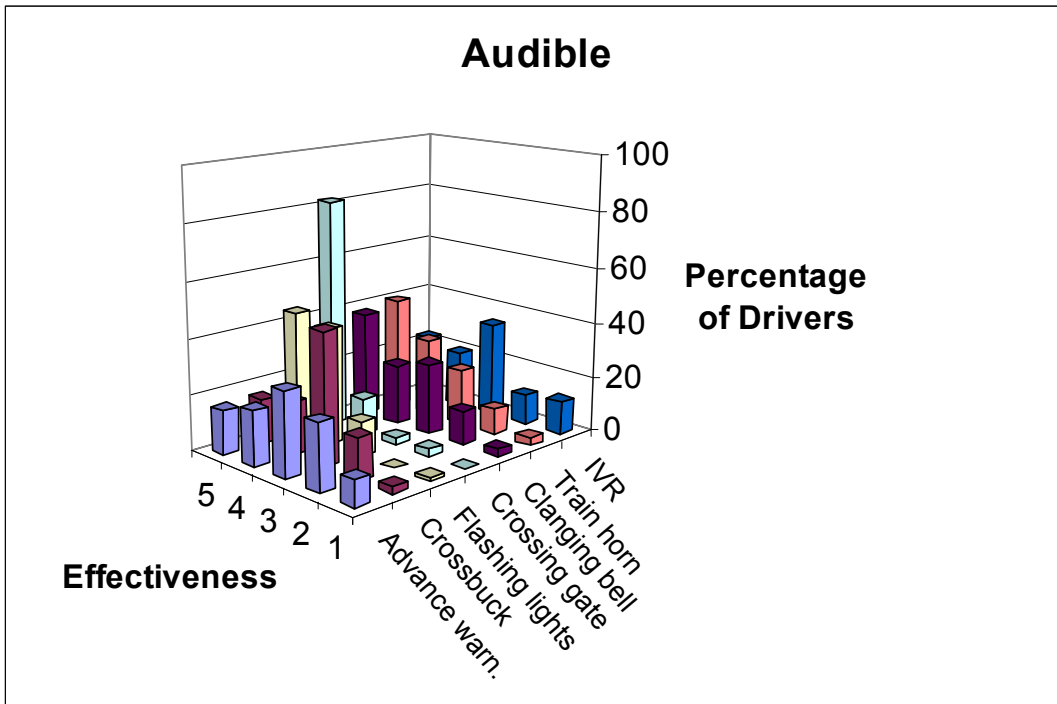
Figure 8: Percentage of drivers using audible mode, rating effectiveness of each railroad warning device.

In the previous section, we discussed the IVR effectiveness ratings for the audible and visual groups combined. In this section, the responses from the audible and visual groups are analyzed separately. Figures 8 and 9 (also Tables 3a and 3b) present the distribution of the effectiveness ratings for the warning devices given by the audible and visual groups. The average effectiveness ratings are summarized in Table 5. The t-test results indicate that the audible and visual groups gave similar effectiveness ratings for all warning devices except the clanging bell. The drivers in the visual group rated the effectiveness of the clanging bell higher than the audible group. The IVR average effectiveness rating from the audible group was 3.3 and from the visual group it was 3.4. One explanation for this is that the drivers in the visual mode had the IVR in the audible mode before, so they were paying more attention to its presence and thus, its effectiveness.

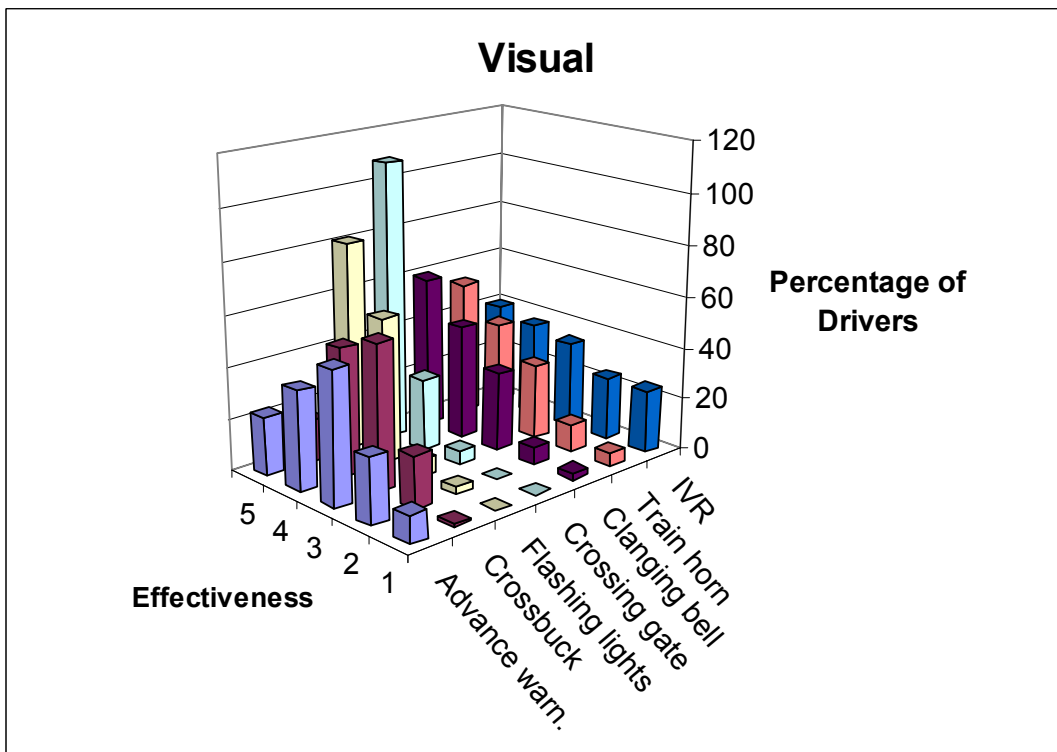
Figure 9: Percentage of drivers using visual mode, rating effectiveness of each railroad warning device.

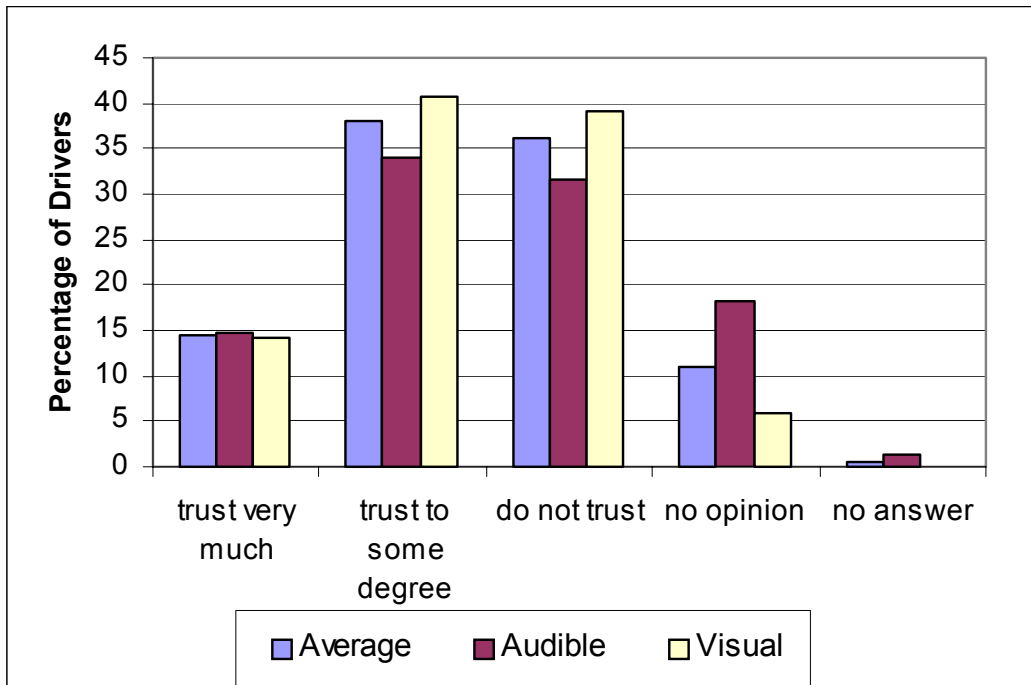
A total of 202 drivers responded this question. Overall, 14.4% of the drivers indicated that they trusted the IVR very much, 38.1% trusted the IVR to some degree, 36.1% did not trust the IVR at all, and 11.4% of the drivers had no opinion or did not answer. The distribution of the drivers’ responses is given in Figure 10. The Chi-square test between the audible and visual groups indicates that they trusted IVR to the same degree. The chi-square value is 0.311 with a p-value of 0.856. About 60.6% of the drivers using the audible mode and 58.4% of the drivers using the visual mode trusted their IVR. As can be seen from Table 8, there is no significant over or under representation.

Figure 10: Percentage of drivers that trust the IVR to give an accurate warning of train approaching or occupying equipped crossings.

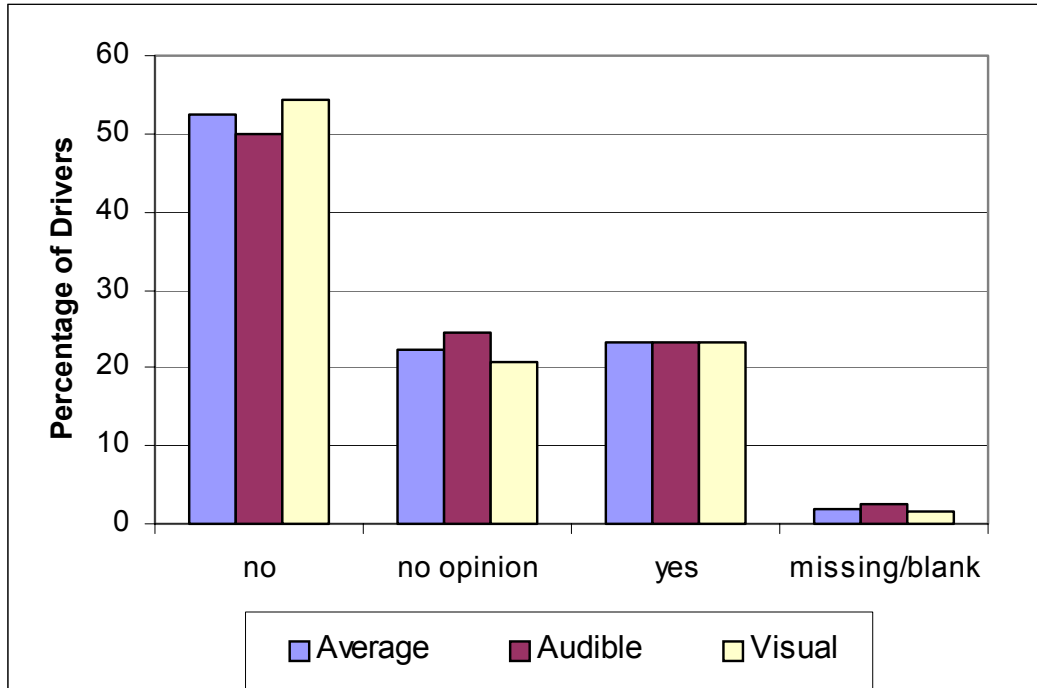
A comparison of the responses given by 198 drivers operating audible and visual modes is presented in Table 9. The chi-square test was used to see if the values obtained for audible and visual drivers were similar to the ones expected. The chi-square test shows that the responses were similar with 95% confidence. The chi-square value is 0.436 with a p-value of 0.804.

Figure 11: Distribution of drivers that experienced power-up problems.

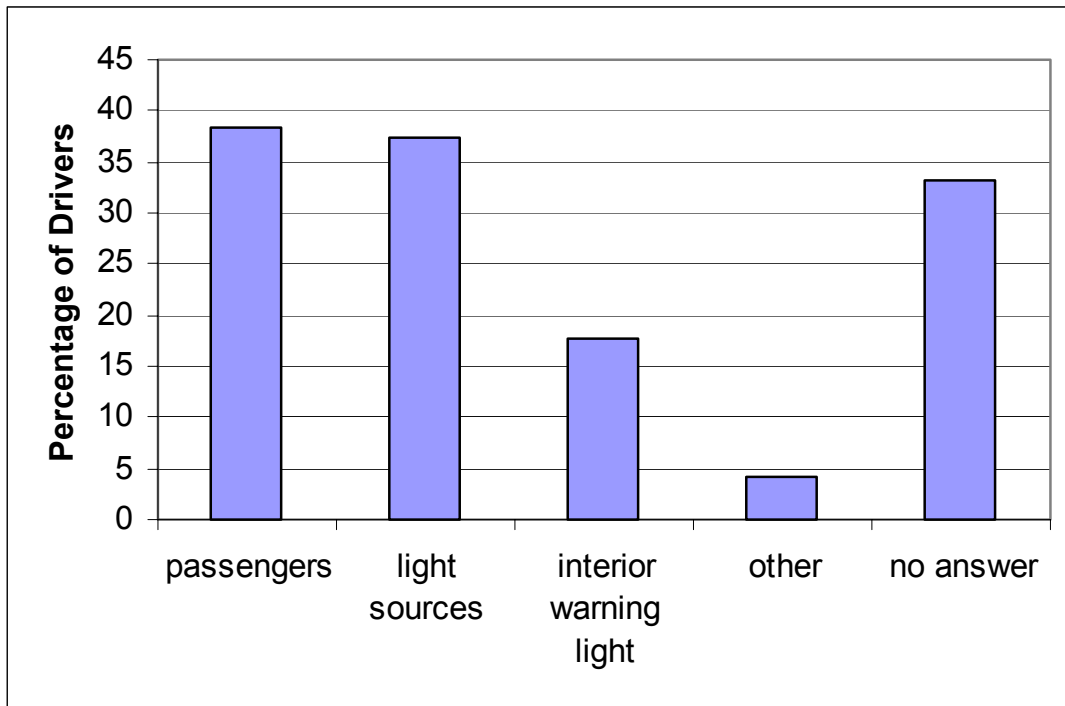
About 38.3% of the drivers said they were distracted from passengers during daily driving, 37.5% of the drivers were distracted by exterior light sources, 17.6% by interior warning lights, and 33.3% did not provide any answers. The distribution of the visual distractions is presented in Figure 12. Approximately 4.2% of the drivers complained of other distractions. These additional distractions are presented in Table 11. Please note that this is a “circle all that apply” and thus, the percentages do not add up to 100%.

Figure 12: Visual distractions drivers experienced during driving.

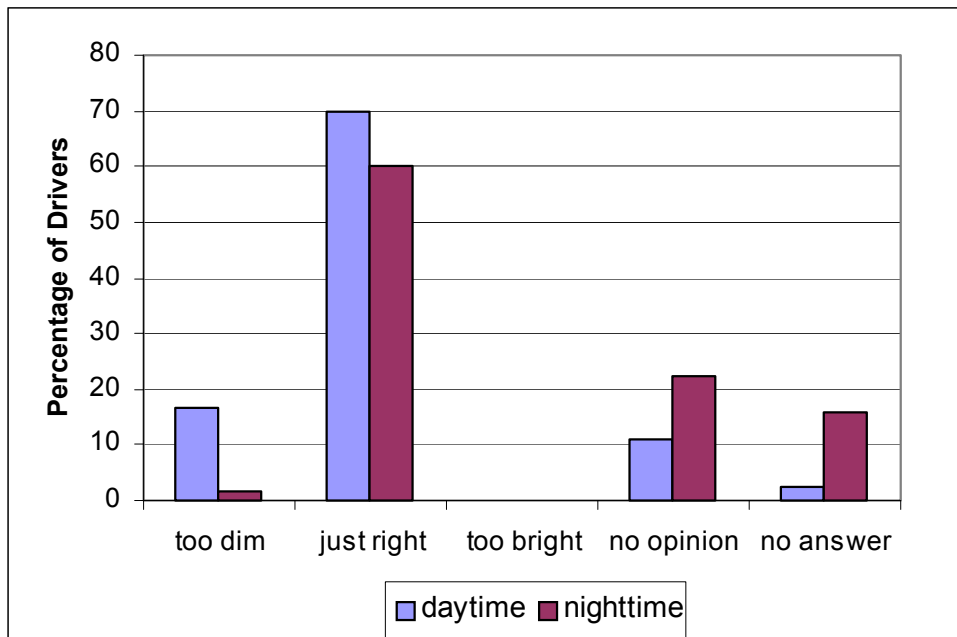
Figure 13 shows that the opinions of the drivers do not vary considerably from daytime and nighttime. During daytime, 70.0% the drivers stated the visual display was “just right”, 16.7% said that the display was too dim, and 13.3% had no opinion or did not answer the question. None of the drivers said that the display was too bright.

During nighttime, the majority of the drivers (60.0%) said that the visual display was “just right”, 1.7% said that it was too dim, and 38.3% of the drivers had no opinion or did not answer the question. None of the drivers thought that the display was too bright.

Figure 13: How well drivers can see the visual display during daytime and nighttime.

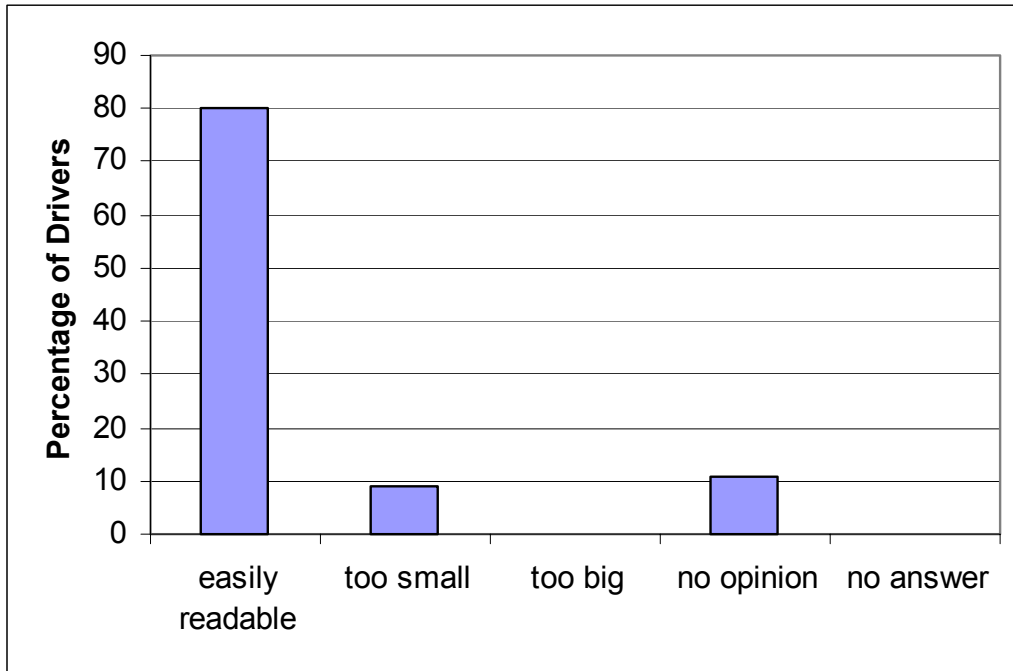
The distribution of the drivers' responses is shown in Figure 14. Approximately 80.0% of the drivers considered the lettering on the visual display to be easily readable. On the other hand, 9.2% found the lettering to be too small, and 10.8% of the drivers had no opinion.

Figure 14: Distribution of drivers' opinions on the size of the lettering on the visual display.

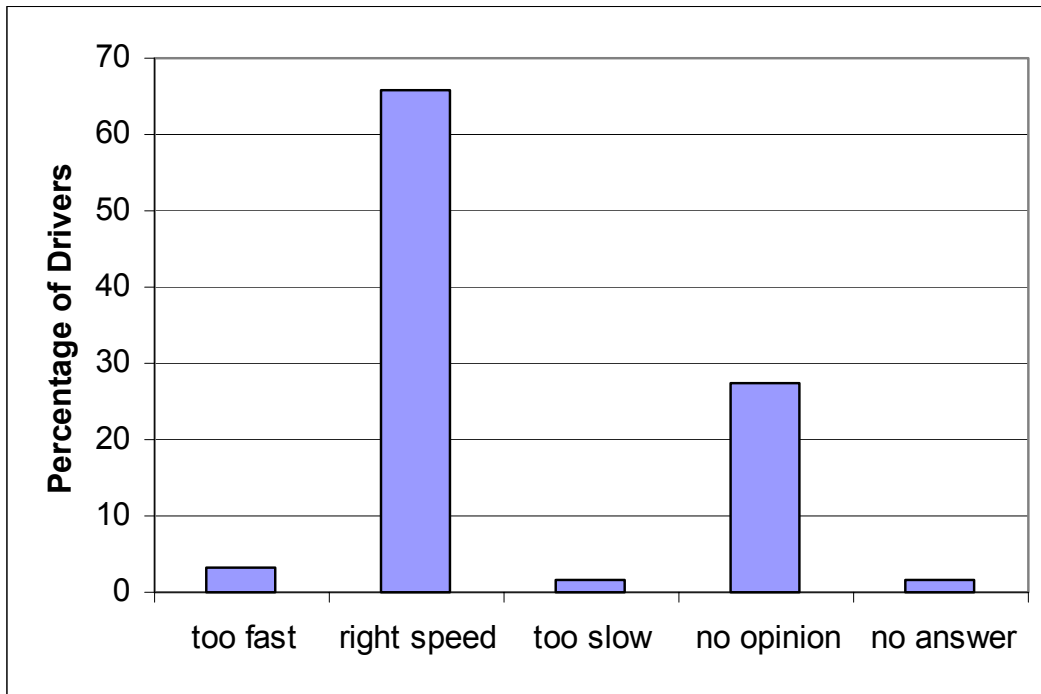
Figure 15 shows the distribution of the answers of the drivers on the blinking rate of the visual message. Approximately 65.8% of the drivers said that the visual message blinked at the right speed, 3.3% of the drivers said the message blinked too fast, while 1.7% thought that it blinked too slowly. Approximately 27.6% of the drivers had no opinion and 1.6% did not answer this question.

Figure 15: Distribution of the drivers' opinions on the visual message-blinking rate.

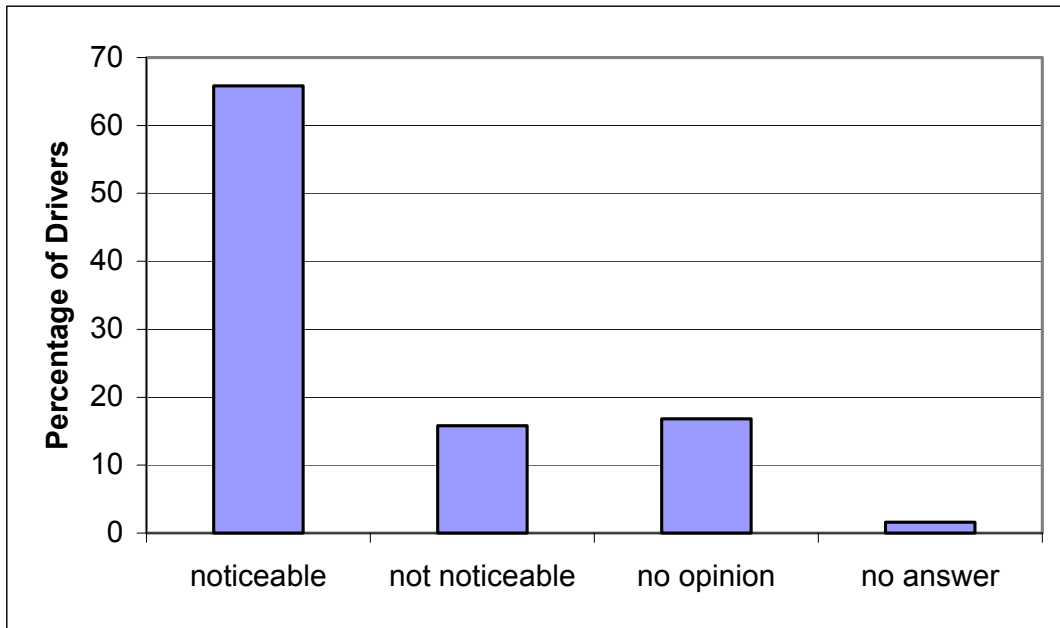
Figure 16 presents the distribution of the drivers' responses to this question. A large percentage of drivers (65.8%) said that the message was noticeable. On the other hand, 15.8% thought that the message was not noticeable enough compared to the other visual cues. Approximately 16.8% of the drivers did not have any opinion and 1.6% did not answer this question.

Figure 16: Is the visual message noticeable from other visual cues you receive while driving?

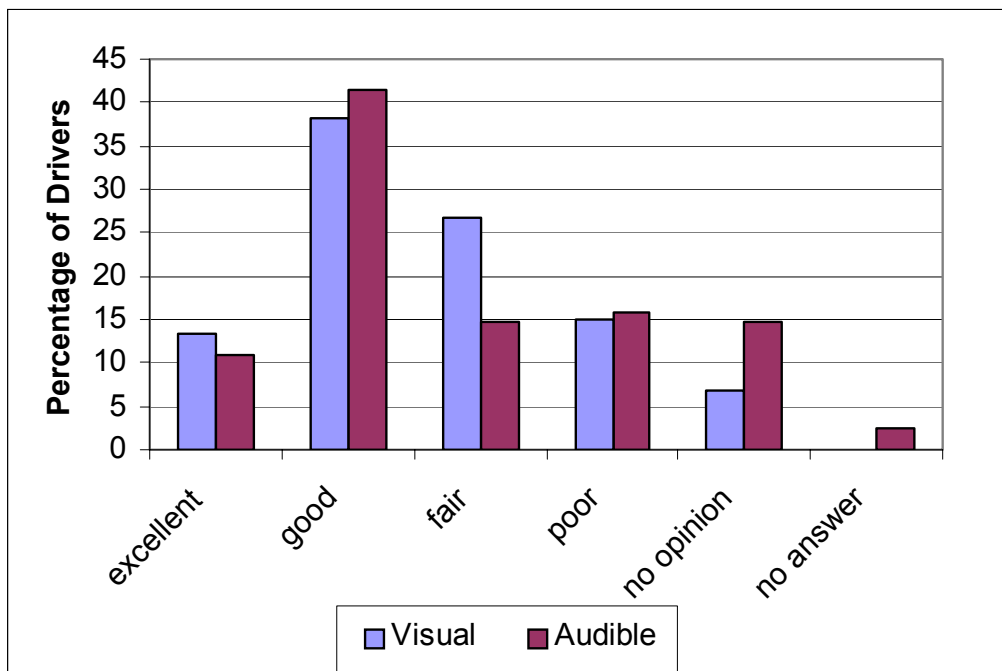
Figure 17 presents the distribution of driver responses to this question. Over half of the drivers (51.6%) rated the quality of the message as good or excellent. Approximately 26.7% of the drivers said that it was fair and 15.0% rated it poorly. Only 6.7% of the participants had no opinion.

Figure 17: Ratings on the overall quality of the visual and audible messages.

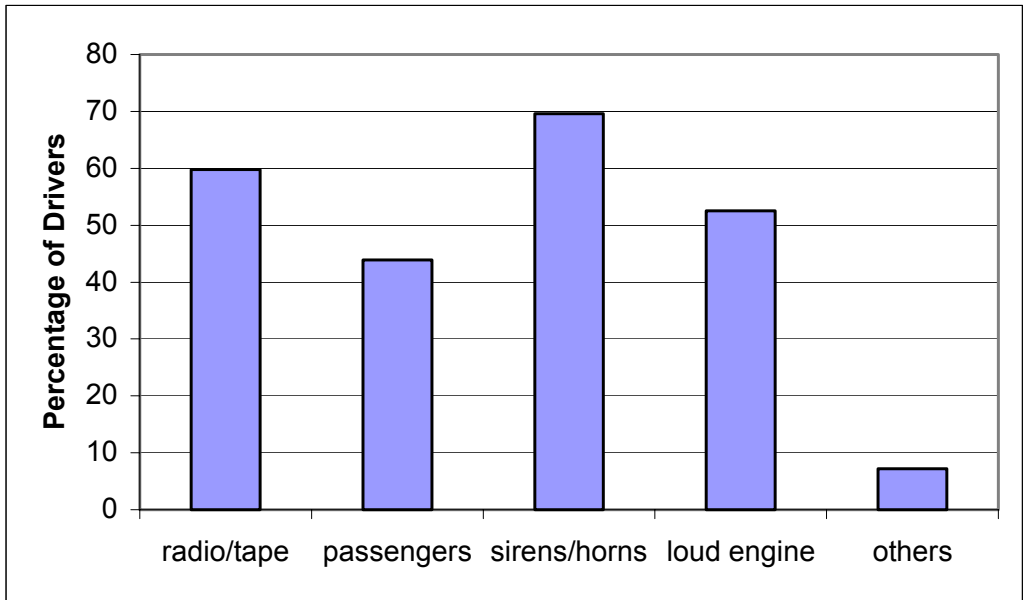
Figure 18 shows the distribution of responses from 82 drivers. A large portion of the drivers (69.6%) complained about the audible distractions caused by horns and sirens. About 59.8% of the participants found the background noise of radio and tapes disturbing. Approximately 43.9% complained about distractions caused by passengers. About 52.5% indicated that the engine of their vehicle was too loud and was in itself a distraction, and 7.2% mentioned other distractions that are listed in Table 12. Approximately 2.4% did not provide an answer. Some drivers gave more than one response to this question, so the percentages add up to more than 100%.

Figure 18: Audible distractions drivers experienced while driving.

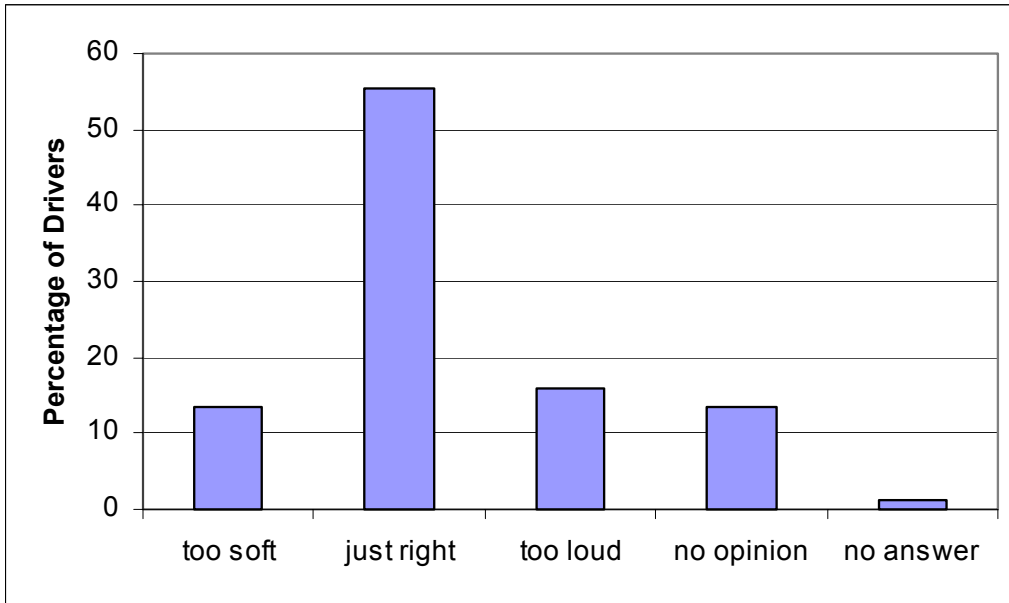
Figure 19 presents the distribution of driver responses. Approximately 55.6% of the drivers thought that the warning tone was just right, 13.6% of the drivers found the warning tone was too soft, while 16.0% thought that it was too loud, 13.6% of the drivers had no opinion, and 1.2% did not answer the question.

Figure 19: How well can drivers hear the warning tone?

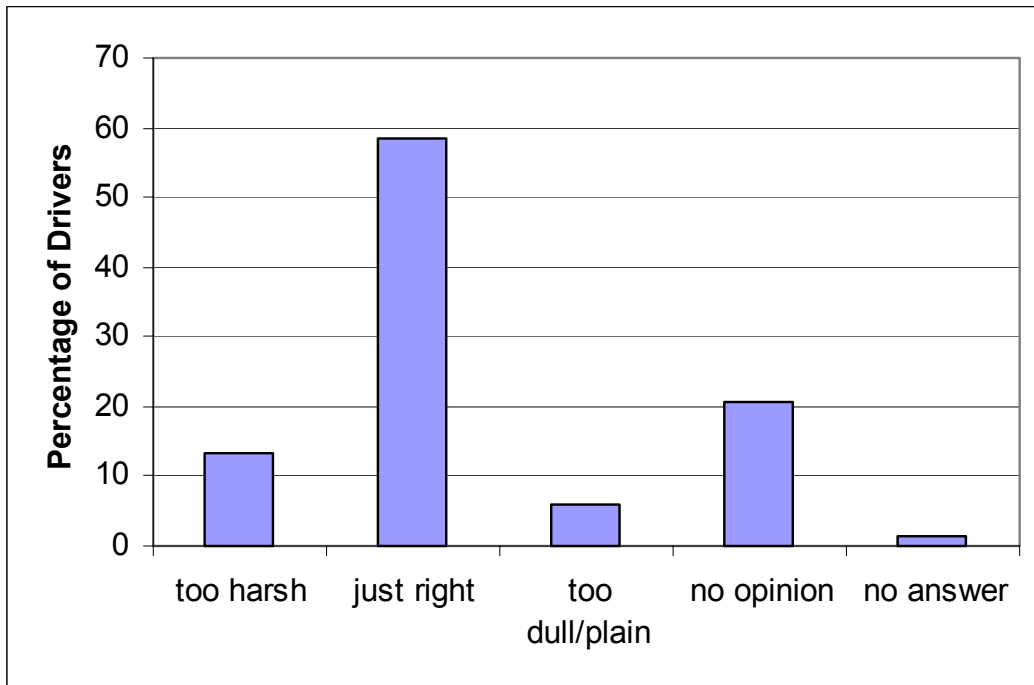
Figure 20 presents the distribution of the drivers' responses. A large percentage of the participants (58.5%) found the warning tone to be just right, 13.4% said that it was too harsh or piercing, but 6.1% thought that it was too dull or plain. About 20.7% of the drivers expressed no opinion and 1.3% of the drivers did not give an answer.

Figure 20: How is the quality of the warning tone?

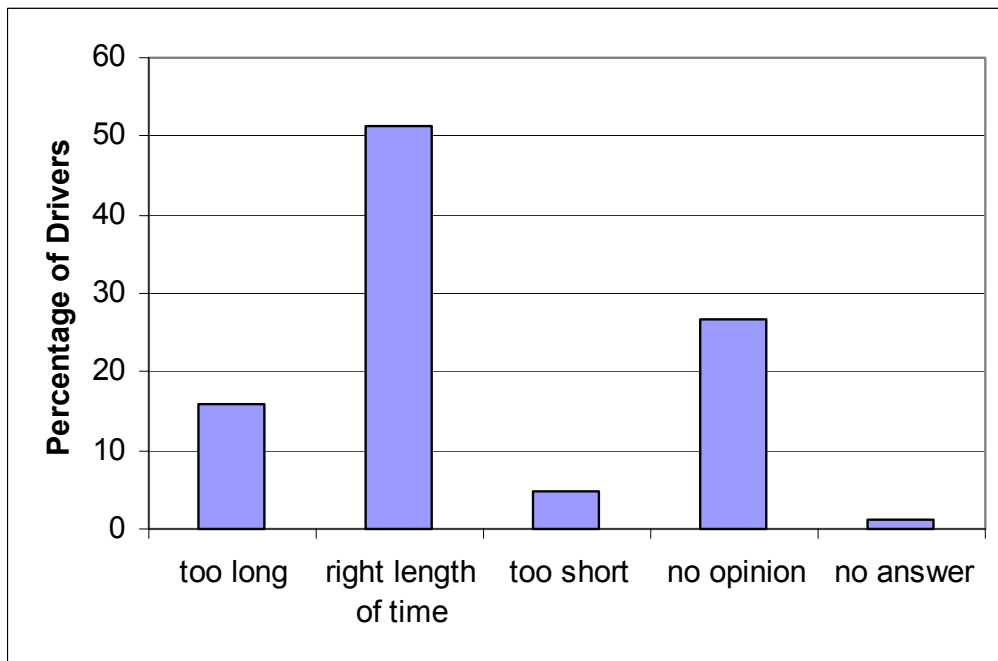
Figure 21 presents the distribution of the drivers' responses. Approximately 51.2% of the drivers thought that the warning tone beeped for the right length of time, 15.9% thought that the beeped warning tone was too long and 4.9% thought that it is too short. Approximately 28% of the drivers either had no opinion or did not give an answer to this question.

Figure 21: How is the length of the warning tone?

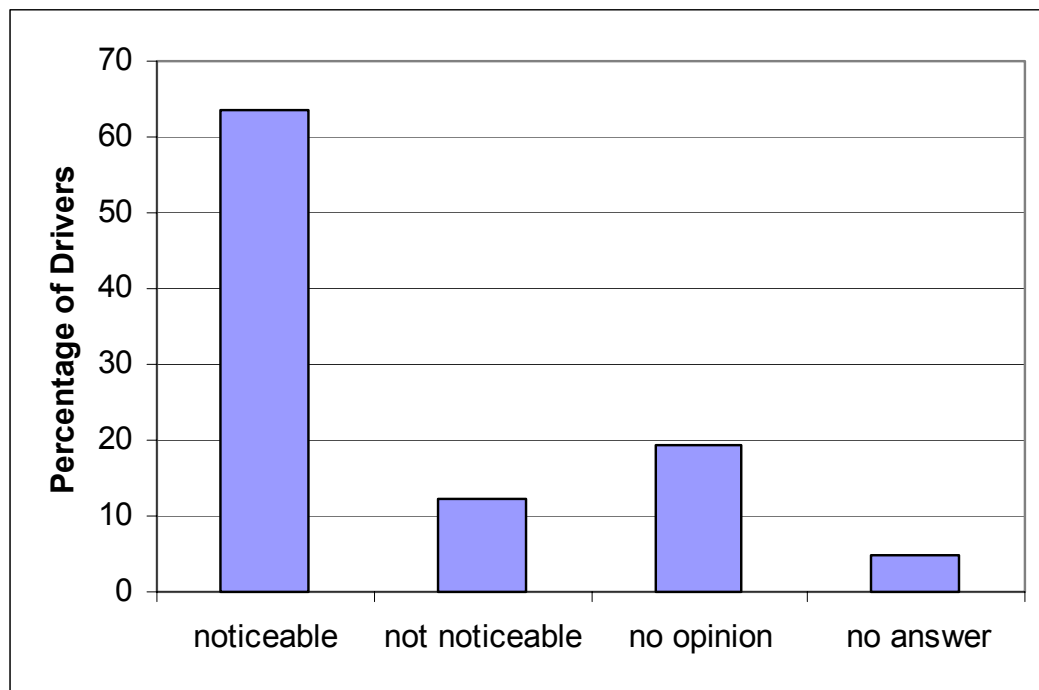
Figure 22 presents the distribution of the drivers' responses. About 63.4% of the drivers said that the warning tone was noticeable, but 12.2% found the warning tone not noticeable. Approximately 19.5% had no opinion and 4.9% of the drivers did not answer the question.

Figure 22: Is the warning tone noticeable from other audible cues you receive while driving?

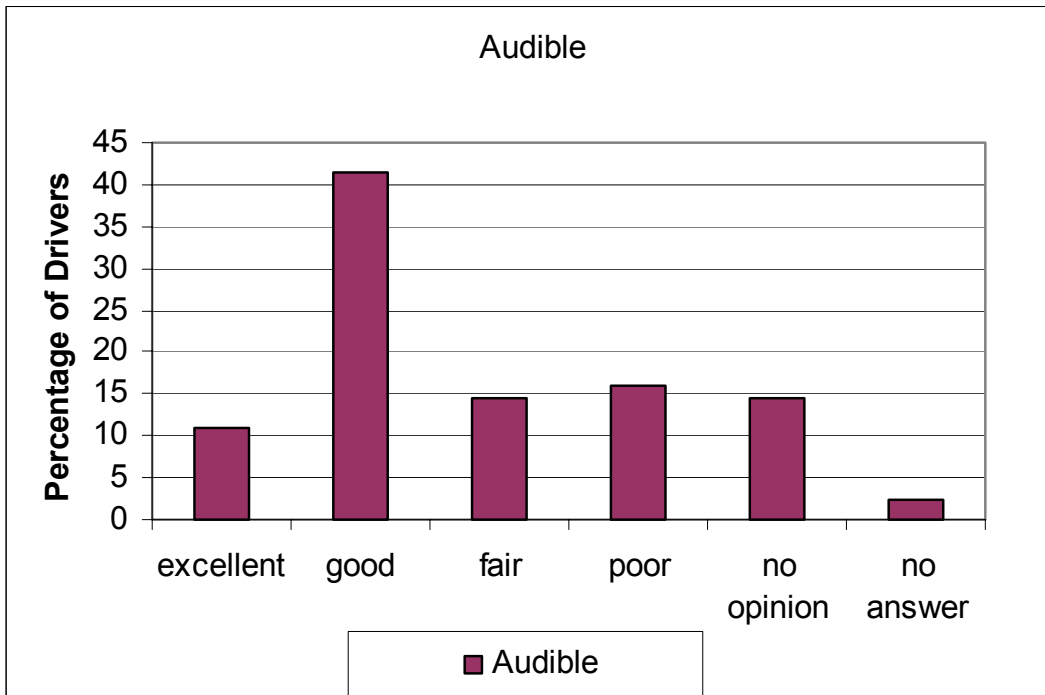
Figure 23 presents the ratings for the overall quality of the audible IVR message. About 11.0% of the drivers thought that the overall quality of the audible message was excellent, 41.5% thought it was good, 14.6% said that it was fair, and 15.9% thought it performed poorly. Approximately 14.6% of the drivers had no opinion and 2.4% left the question blank.

Figure 23: Ratings on the overall quality of the audible message
