University of Missouri-Rolla

Evaluation of Bridge Approach Slabs, Performance and Design

FINAL PROJECT REPORT

RDT 04-010

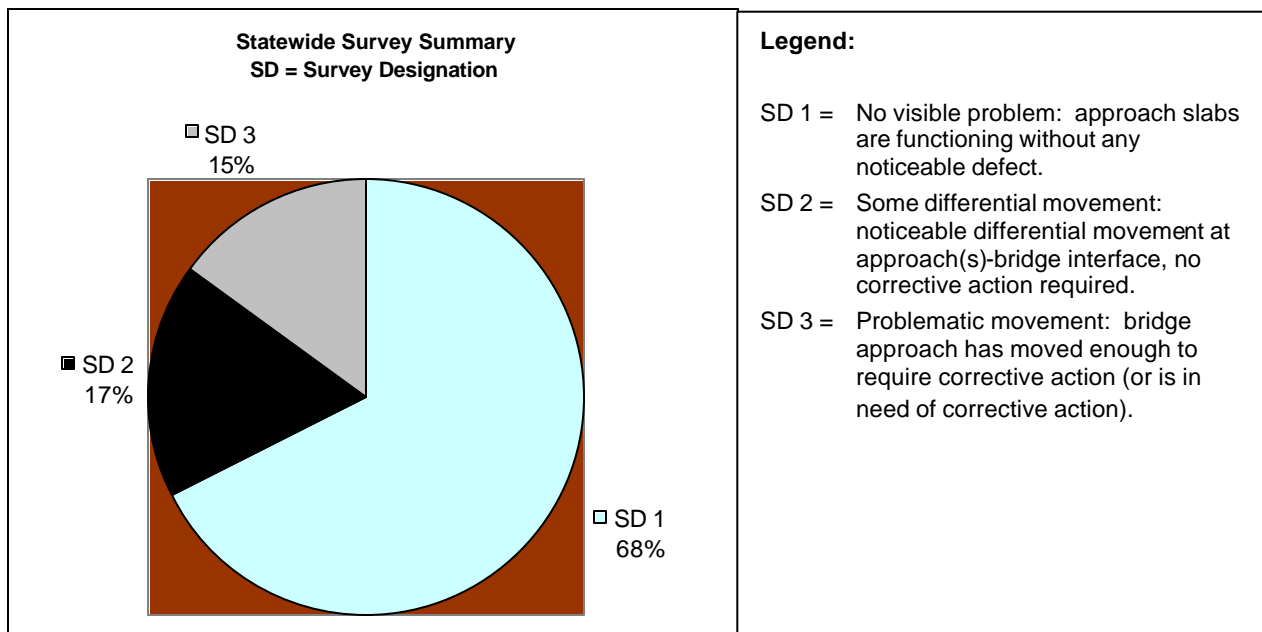
Figure 5.1 – Resident Engineers’ Survey Statewide Results Chart.

Fourteen of the 43 RE offices responded to the survey resulting in a response rate of 33%. Data from 185 bridges was collected and returned by the RE offices. Possible causes of the problem suggested by the Resident Engineers include: large fill heights, gumbo foundation soil (high organic content), insufficient or improper subgrade compaction, seismic activity, heavy truck loads dynamically impacting the approach, and water undermining the sleeper beam. These suggested causes are very similar to information available from other states and surveys.

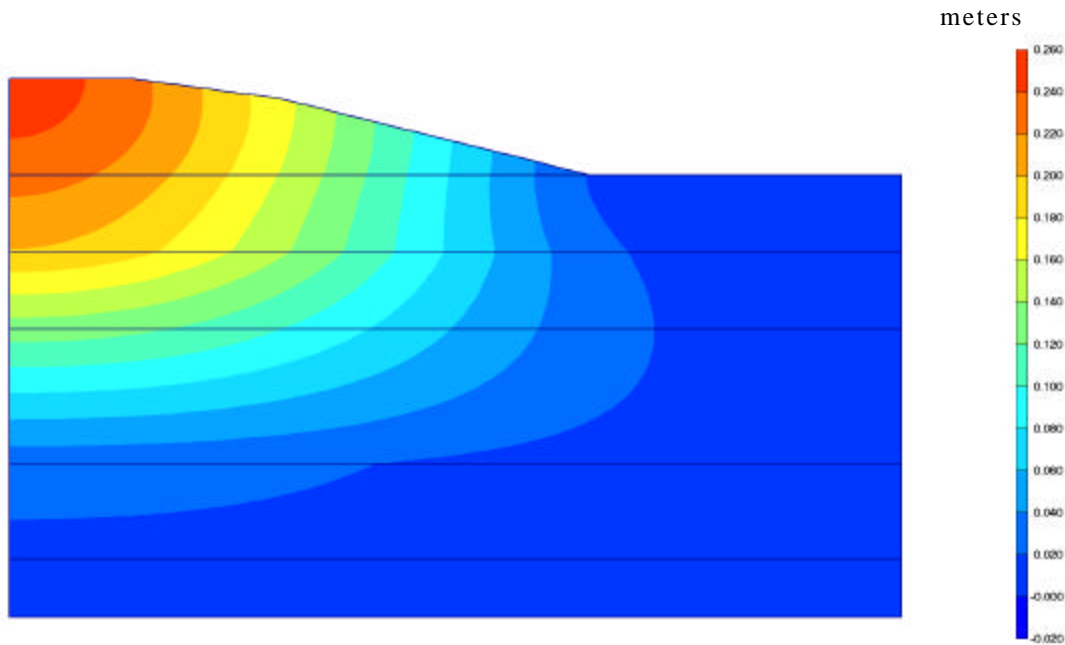
Figure 5.7- High Bound Total Displacement Shadings Br. A6031.

The displacement along the centerline of the embankment was computed to be 0.6 m for the low bound parameters and 0.25 m for the high bound parameters. It should be noted that this is the total deformation of the embankment including initial compression and consolidation that occurs before the construction of the approach pavement. This total displacement is not representative of the settlement of the roadway or any differential observed in the field. Figure 5.7 illustrates soil displacement within the embankment for the high bound condition.

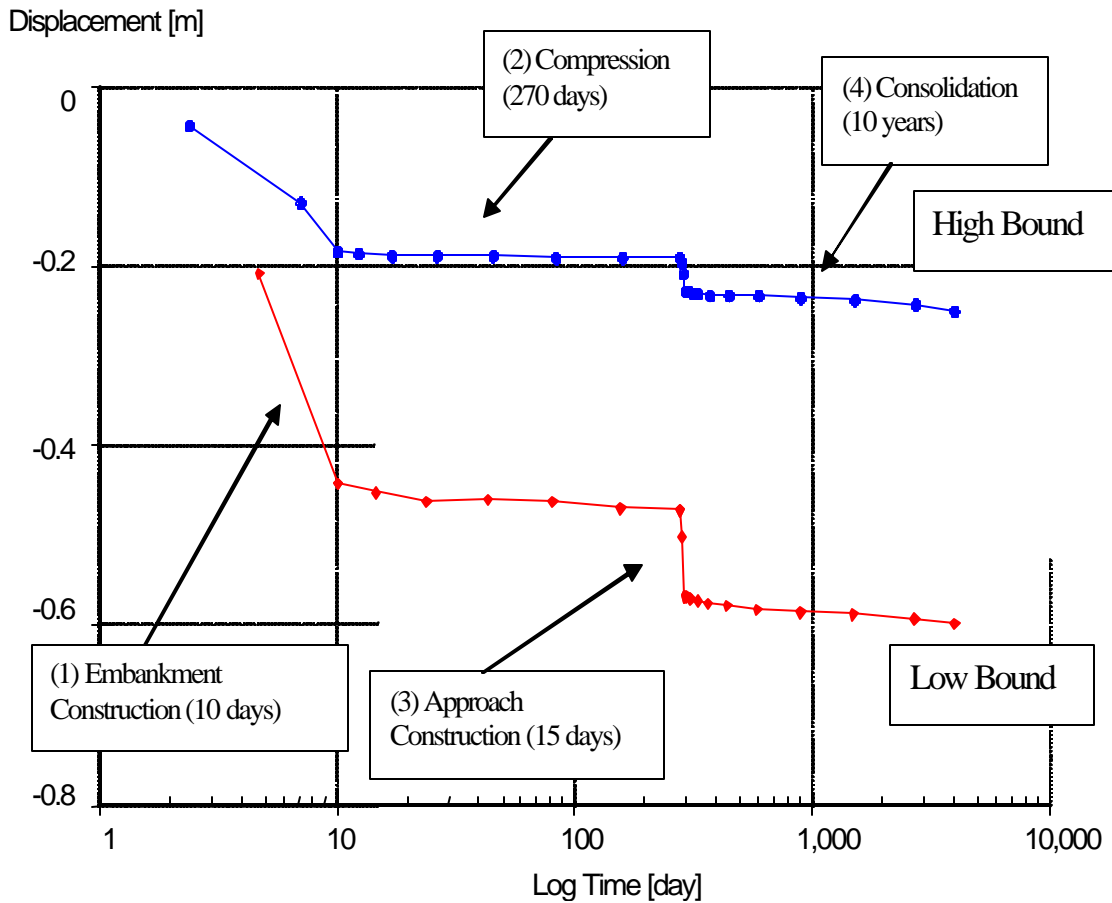
Figure - 5.8- High & Low Bound Displacement Curves East Abutment Embankment Br. A6031

The relative lack of sophistication of the input data when compared to the tool used to model the abutment should be mentioned. The predicted displacements, particularly in reference to the timing of construction operations are instructive, but not as accurate as they would be if high quality input data was available. This lack of accuracy is illustrated by the range between the high bound and low bound curves (Figure 5.8). As anticipated, the majority of deformations occur during the initial embankment construction. See Appendix C for complete PLAXIS generated reports from the individual runs.
