# Combined Aggregate Gradation as a Method for Mitigating Studded Tire Wear on PCCP

WA-RD 663.2

# Experimental Feature Report

Sprague Avenue Interchange Phase 3

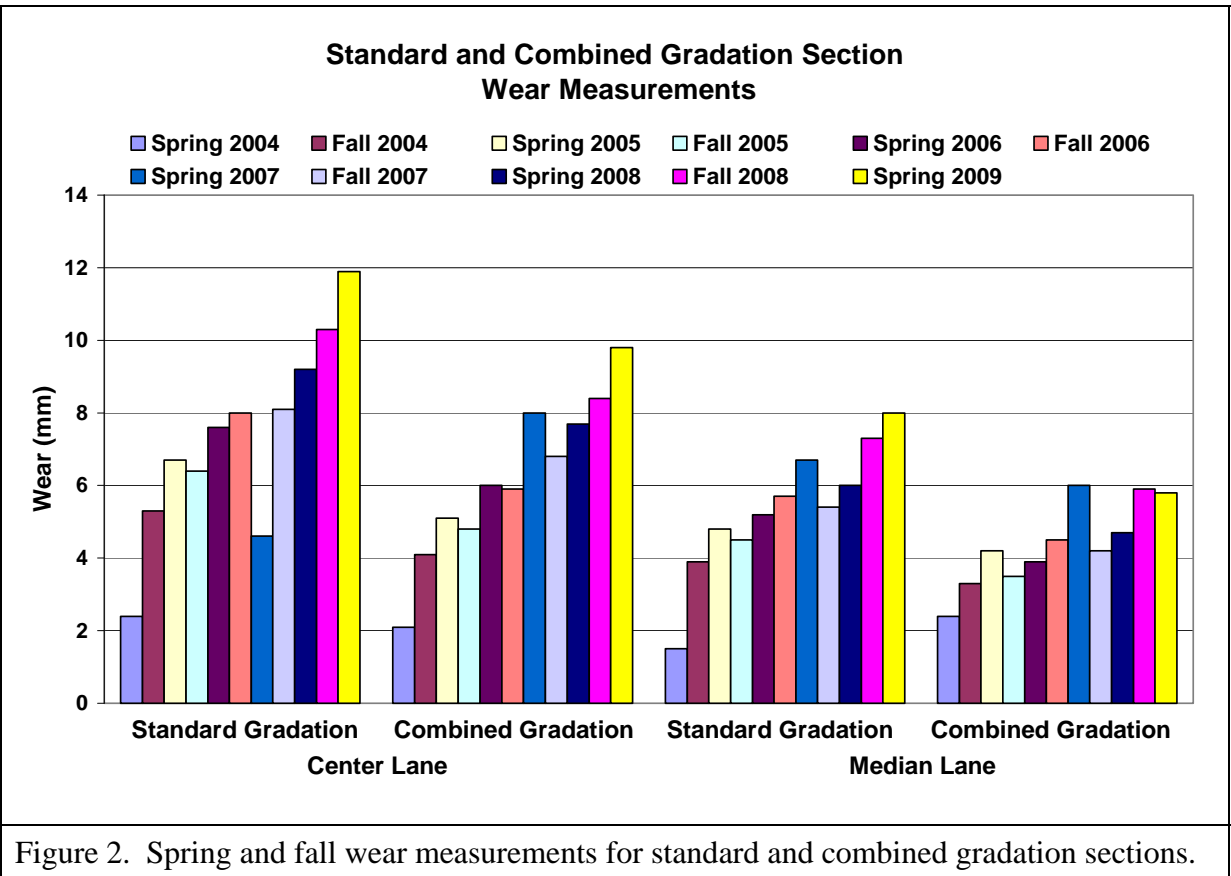
Figure 2. Spring and fall wear measurements for standard and combined gradation sections.

The two projects have been monitored for pavement wear since 2004. The WSDOT Pathway Van was used to collect rutting measurements in the spring and fall of 2004, 2005, 2006, 2007, 2008 and the spring of 2009. These wear measurements are listed in Tables 1 and 2 for the center and median lane, respectively. The tables show the increase in wear over the 5-1/2 years of measurement.

A direct one to one comparison cannot be made between the sections because they are not the same age and have not experienced the same amount of traffic. Two rate of wear calculations can be made, one based on the age of the sections and one based on the traffic experienced by both sections. The section with the standard aggregate gradation was built in 2000 and the section with the combined gradation one year later. Table 3 summarized the rate of wear for each section based on the age of the pavement. The rate of wear is calculated by dividing the average wear for both lanes by the age of the section. The age based rate of wear calculations indicates very little difference between the two sections with a difference of only 0.04 mm per year in favor of the combined gradation.
