# ASSESSMENT OF THE COMPOSITE ARCH BRIDGE

Ian Anderson, Research Engineer  
Vermont Agency of Transportation  
Research Section

Experimental Feature  
Reporting on 2013-PIF-01

Final Report 2018-08

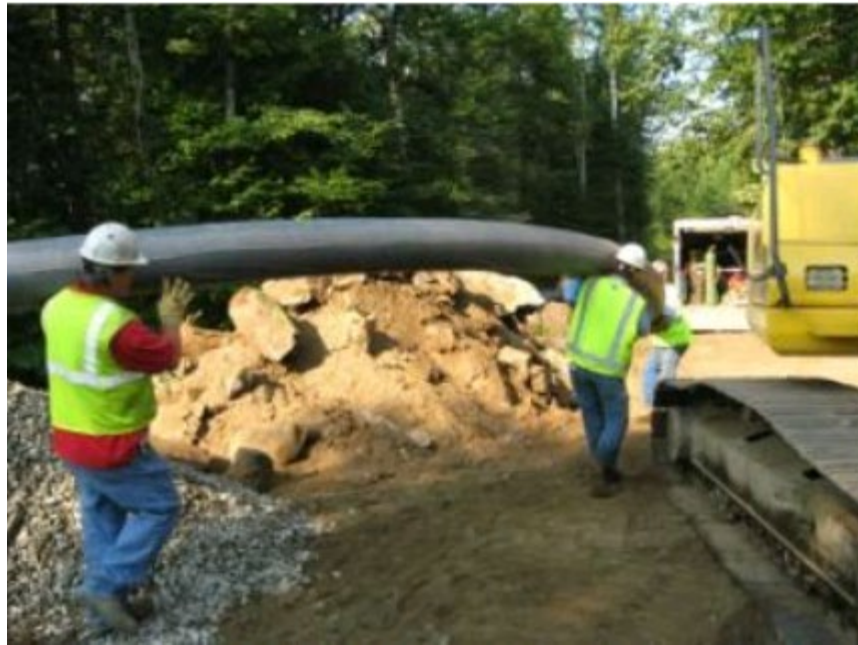
Figure 1: FRP tubes can be carried into place by hand labor (1)

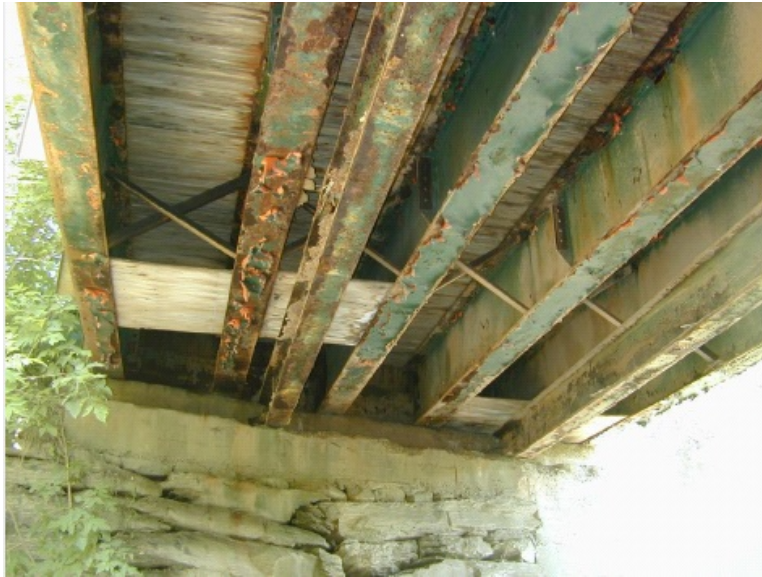
Figure 5: The underside of bridge showing the added beams

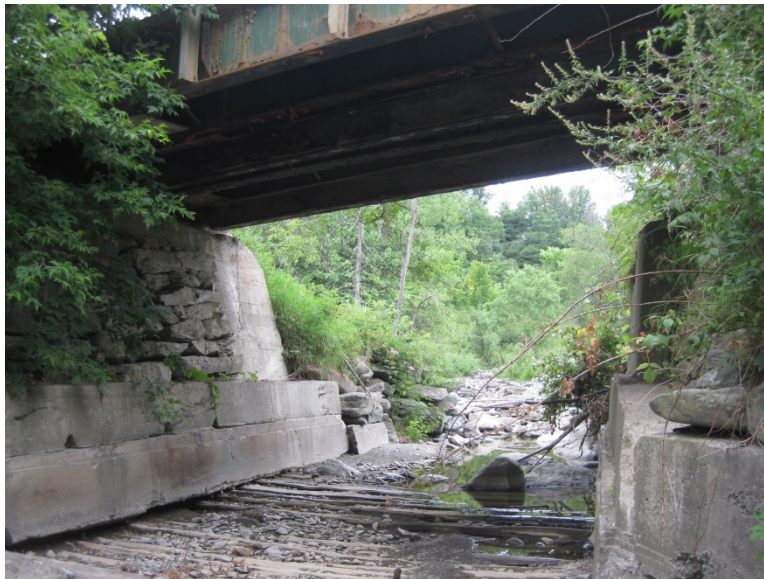
The existing substructure consisted of abutments comprising of a concrete cap on laid stone walls fortified at the base by concrete knee-walls. The abutments were placed on a timber mat to control downcutting (see Figure 6). The clear span was 25.5 ft, just below the bridge seats and above the knee-walls. The knee-wall clear span was 16 ft. Hydraulic engineering recommendations suggested that the knee-walls and timber matting could remain in place. Further recommendations suggested that a concrete wall should be constructed to a height that exceeded the Q25 storm event to keep debris from coming in contact with the FRP tubes. VTrans Structures design staff, working with AIT came up with a plan for FRP arches with a span of 30 ft, radius of 18.75 ft, which provides a rise of 7.5 ft. The initial assumption was that new integral abutments with steel piles would be used for the substructure.

Figure 6: Existing substructure

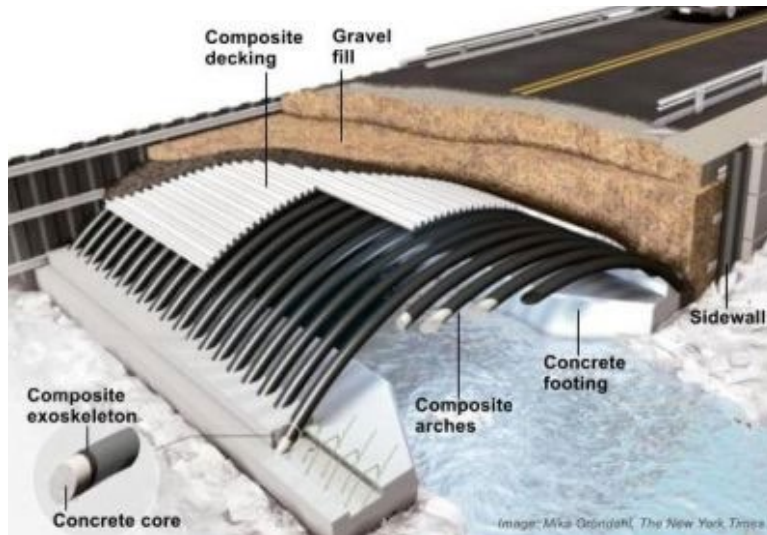
Once the ribbing is in place and anchored into the footings, corrosion resistant FRP corrugated decking is fastened over the top of them. The FRP decking is essentially higher-grade corrugated roofing panels one could purchase at any lumberyard. The decking is fastened using corrosive resistant screws, which will later act as concrete anchors. Though not taken advantage of in the Fairfield project, the panels can be used to shore up and accurately position the tubes, rather than using temporary bracing, thereby eliminating a construction step. At the crest of each tube, a single access hole is drilled with vent holes being drilled at points along the arch of each tube. Self-consolidating expansive concrete is placed through the access holes and allowed flow down the arches (5). Vent holes can show where the concrete is during the placement and can allow air to bleed out. The CAB system was initially designed to allow soil to be placed directly on the decking. Several installs have also included placing a reinforced concrete shell over the decking before placing the roadway materials. A headwall system is attached and the bridge is backfilled. The system components can be seen in Figure 7.

Figure 7: 3D rendering of the CAB (5)

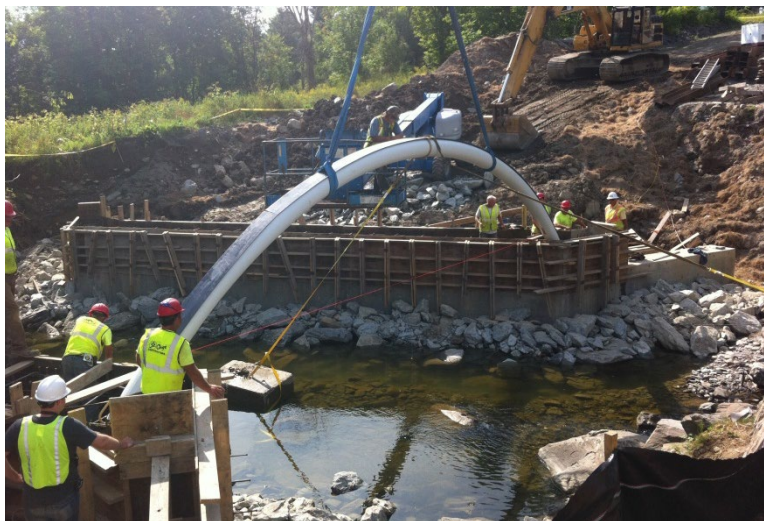
Construction of the superstructure began on August 20, with the setting of the first arch (see Figure 8.) The only superstructure steel reinforcing were anchors inserted in each end of the FRP tubes (see Figure 9.) FRP tube were placed using a medium duty crane. The contractor chose to use the crane due to the rough terrain for the safety of the construction workers and to prevent potential damage to the tubes. Within a week, the tubes were set and the decking was installed (see Figure 10.) In the next week, final concrete placement in the abutments, effectively anchoring the tubes in place, was completed. Grouting within the tubes followed. As mentioned earlier, grouting was done with self-consolidating concrete (SCC) with expansive admixtures included, to ensure the concrete expanded into and adhered to the FRP tubes during the concrete cure. SCC was chosen due to its ability to flow within and adhere to the walls of a form without segregation of the aggregate from the concrete matrix. SCC also does not require vibration. The desired slump of the SCC is 24 to 30 inches. Once the SCC was placed, no loads, other than light foot traffic was allowed on the structure for 48 hours. According to AIT, it took only 22 crew hours from the beginning of setting the first tube to completing the final placement of the SCC within all the tubes.

Figure 8: Installation of the first tube

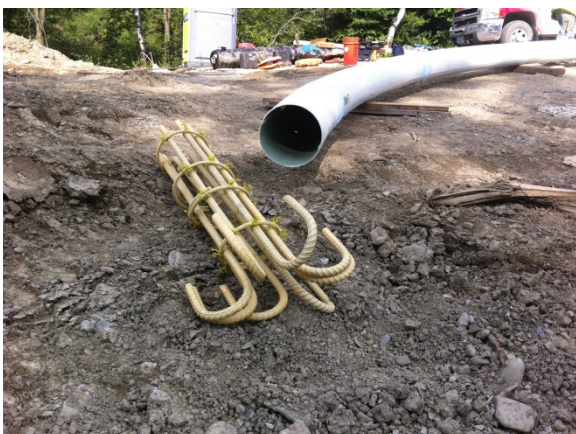
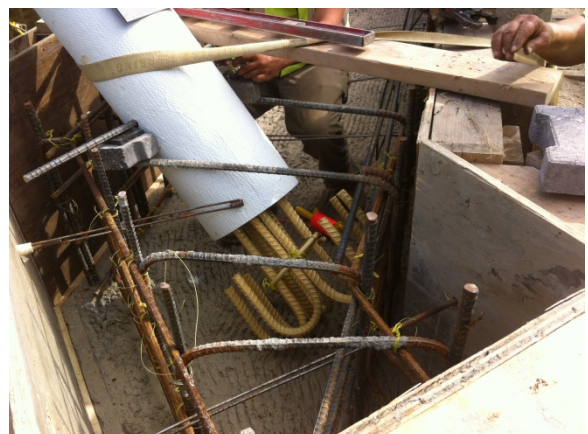
Figure 9: Anchorage reinforcement of the tubes

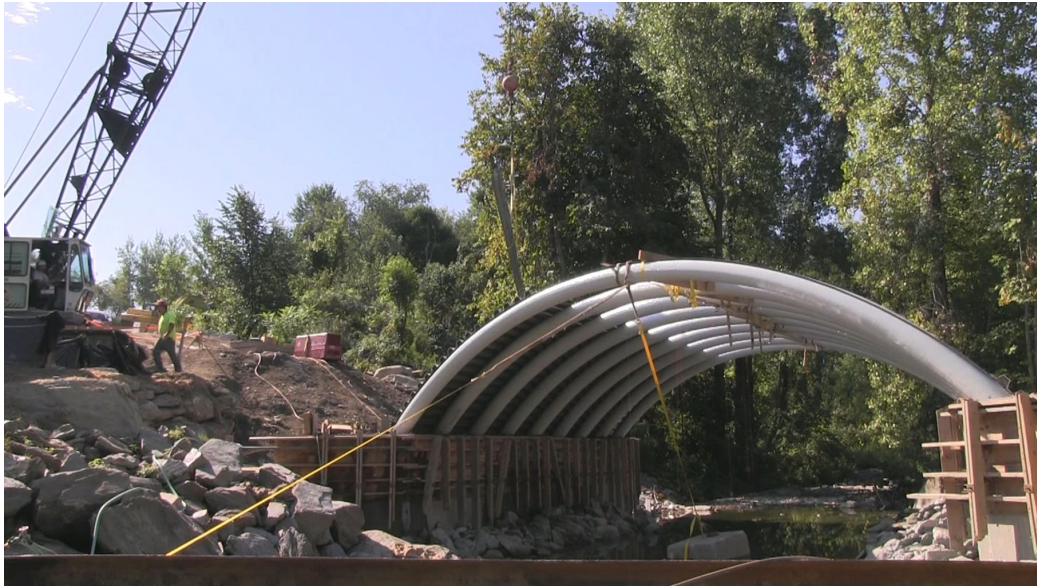
Figure 10: All tubes in place with decking being installed

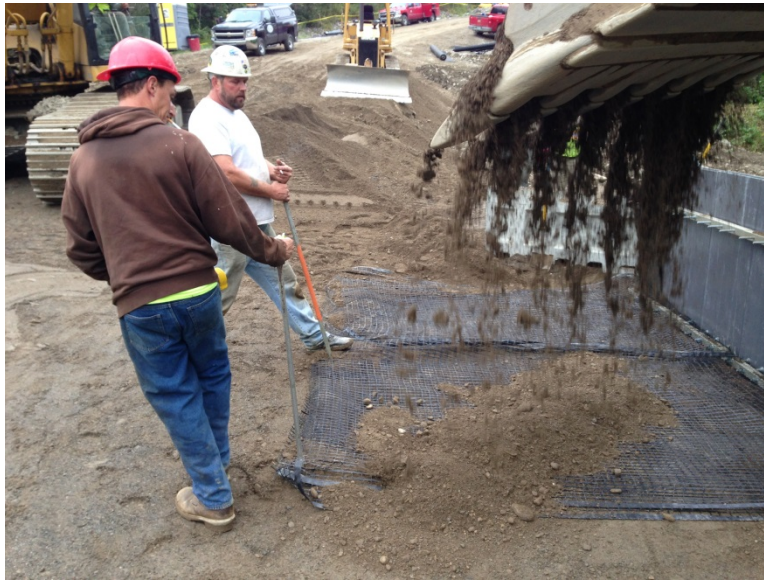
The headwalls are intended to contain the highway grade using MSE. MSE uses geogrids, which are rigid high strength synthetic polymer sheets, either woven or are manufactured in a grid configuration, that are bolted or otherwise attached to vertical panels, which then extend into the supported soil, in lifts, for the purpose of holding the panel in place. The layered system of strips forms a reinforced mass which is sufficiently stable to provide structural support. For the headwall panels, geogrid reinforcement was attached to the panels at vertical intervals in horizontal planes, which extended from the headwall into the highway gravel towards the centerline of the roadway with compacted gravel holding it in place (see Figure 12). Figure 13 shows the final bolting pattern where the geotextile was attached to the headwall. In September, the final effort involved constructing wingwalls from precast MSE panels, final grading of Wanzer Road, including constructing stone reinforced drainage and then the installation of specified safety features. Figure 13 and Figure 14 show the completed project.

Figure 12: Applying subbase material over geotextile layers (1)

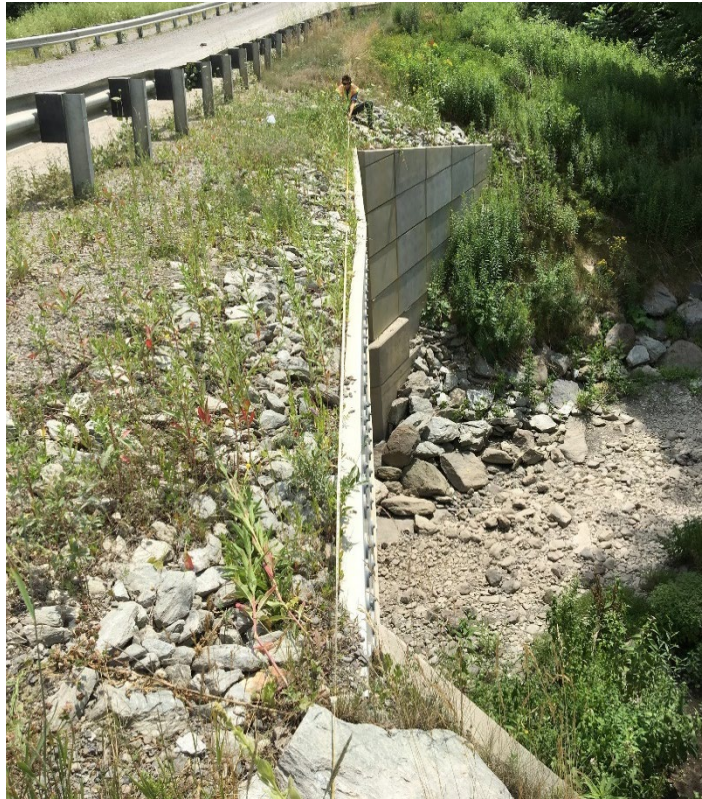
One area of close observation identified in 2015 was the headwall, which were noted to be bulging and bowing from lateral earth pressures. The western headwall is bowing throughout its entire length in a smooth curve, while the eastern headwall is showing shoving in some areas and not others. The westerly headwall appears to have a maximum deviation of 4 inches from straight. Bowing of the westerly headwalls can be seen in Figure 16. These deflections have been stable since 2015, with no increased spread detected in 2018.

Figure 16: Bowing on Western Headwall
