RAIL INTEGRITY AND INITIAL PERFORMANCE TESTING AT THE MEGA SITES

SUMMARY

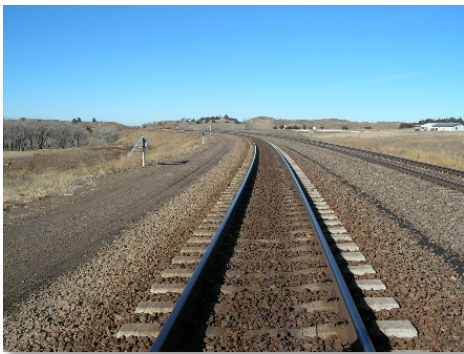
The test zone at the western mega site was comprised of one 1-degree curve and two 2-degree curves. These curves supported 200–250 million gross tons (MGT) of traffic annually under operating speeds ranging between 40 and 50 mph over near-flat grades. The track structure is comprised of concrete ties with elastic fasteners. [Figure 1](#) shows a photograph of one of those test curves.

Figure 1. Test curve at the western mega site.

The test zone on the western mega site, located on the Union Pacific Railroad's (UP) South Morrill Subdivision, had three different test curves: one 1-degree curve and two 2-degree curves. These curves supported 200–250 MGT of traffic annually under operating speeds ranging between 40 and 50 mph over near-flat grades. The track structure is comprised of concrete ties with elastic fasteners.

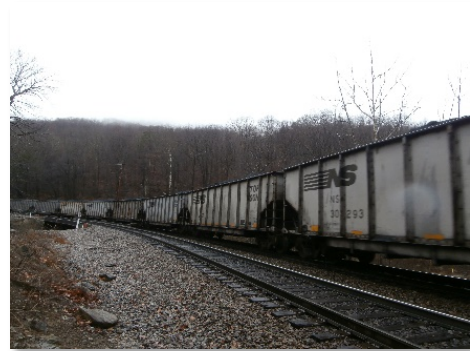
The test zone at the eastern mega site was comprised of two 6.8-degree curves and two 10-degree curves. These curves supported an estimated 55 MGT of traffic annually, under operating speeds ranging between 15 and 25 mph over grades as steep as 1.4 percent. The track structure was comprised of timber ties with cut spikes. [Figure 2](#) shows a photograph of one of those test curves.

Figure 2. Test curve at the eastern mega site.

The test zone on the eastern mega site, located on Norfolk Southern Railway's (NS) Virginia Division, had four different test curves: two 6.8-degree curves and two 10-degree curves. These curves supported an estimated 55 MGT of traffic annually, under operating speeds ranging between 15 and 25 mph over grades as steep as 1.4 percent in some areas. The track structure was comprised timber ties with cut spikes.
