DEVELOPMENT OF A SIMPLE DIAGNOSIS TOOL FOR DETECTING LOCALIZED ROUGHNESS FEATURES

Michigan State University

Final Report
Project RC-1505

February 2009

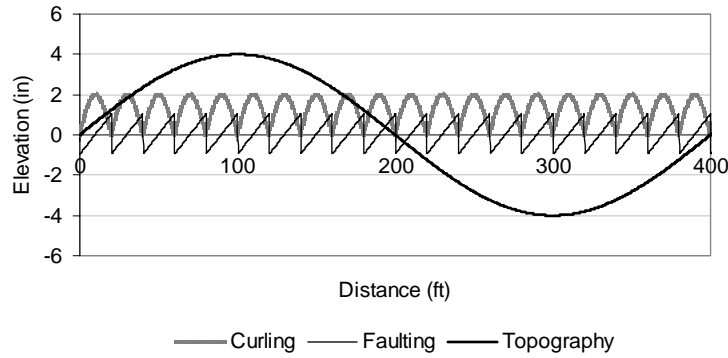
Figure 2.4 Components of the created dummy profile

- Long wave sinusoid that represents the topography of the site.
- Short wave sinusoid that represents the curling of the slabs.
- Discontinuous line that represents the faulting of the joints/cracks.

Figure 2.4 shows the components of the dummy profile listed above. The dummy profile is the sum of these three functions and is shown in Figure 2.5. A sample interval of 3 inches was used to meet the current sampling interval used by MDOT.

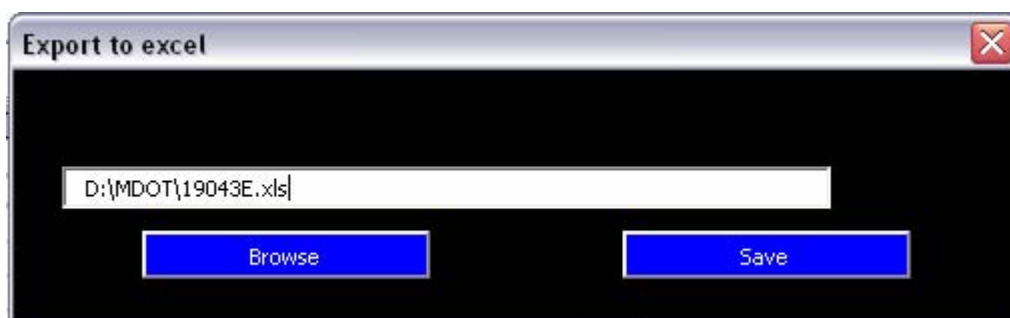
Figure 3.8 Export results window

The “*Export*” button in the localized roughness window opens a new screen asking the user to choose a file name and its path. Then, users could export to excel results using the “*Save*” button. Users should enter a file name followed by the extension “.xls” to export to excel file (Figure 3.8).
