# ALKALI SILICA REACTIVITY SURVEYING AND TRACKING GUIDELINES

July 2012

1. Report No. FHWA-HIF-12-046		2. Government Accession No.		3. Recipient's Catalog No.	
4. Title and Subtitle Alkali-Silica Reactivity Surveying and Tracking Guidelines				5. Report Date July 2012

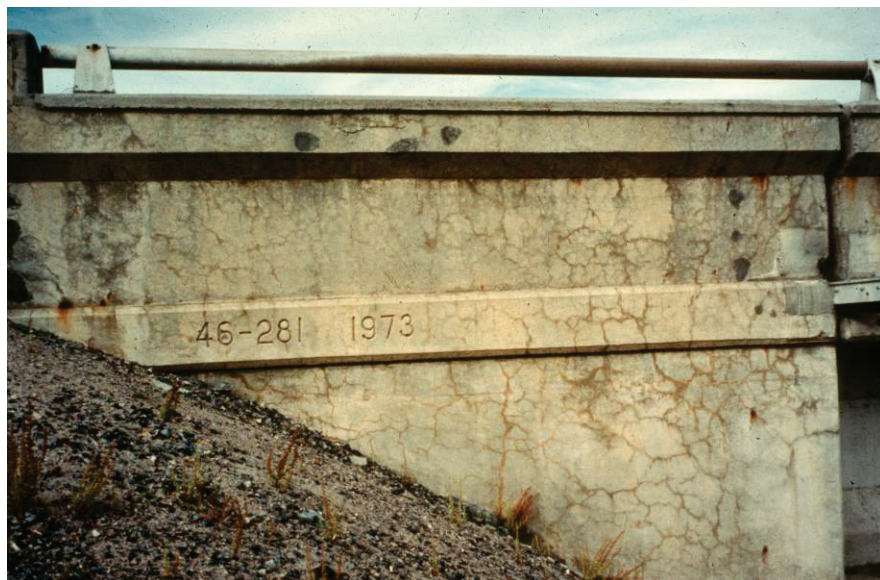
**Figure 2 – Map cracking on bridge abutment (Condition State 3)**

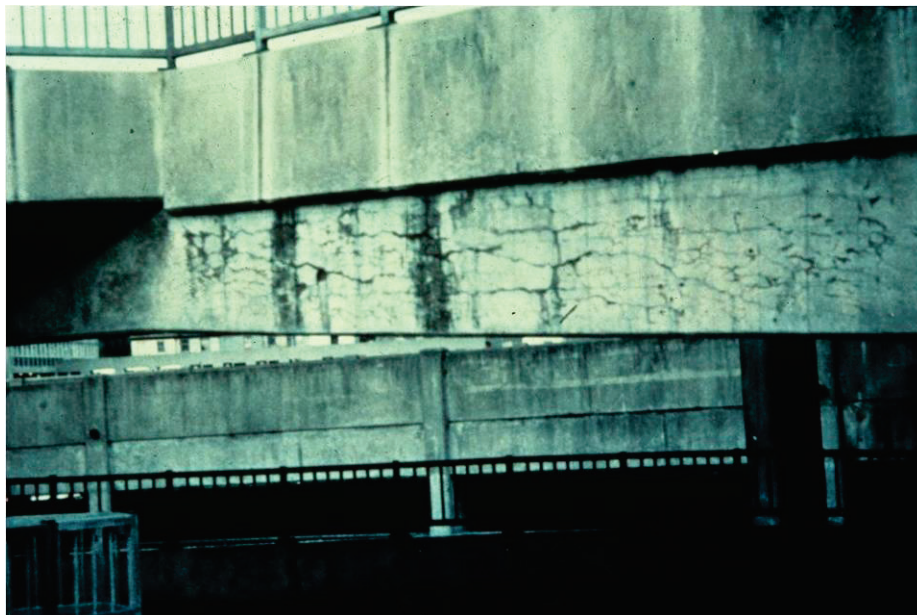
**Figure 4 – Aligned cracking in beam (Condition State 3)**

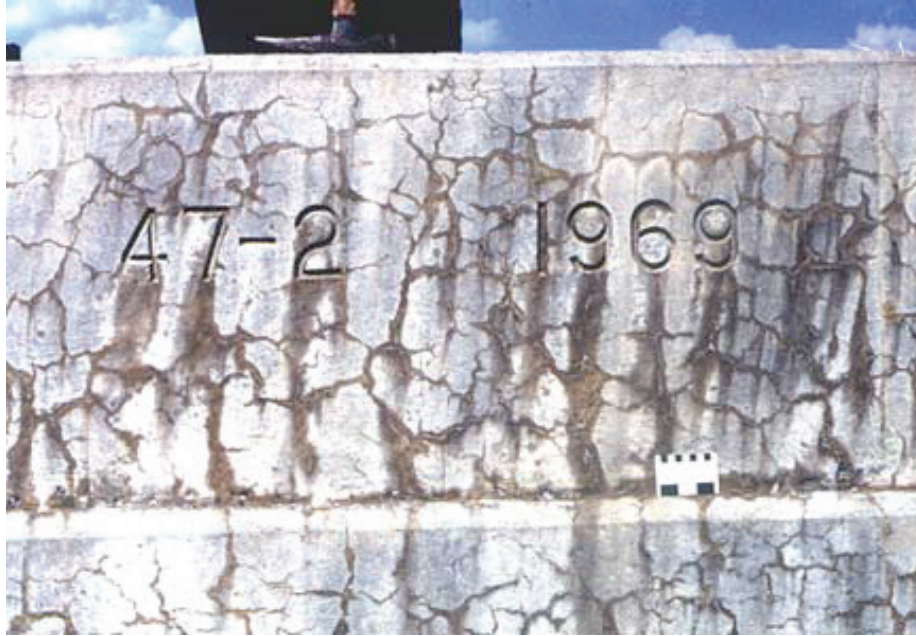
**Figure 5 – Gel Exudation (Condition State 3)**

**Gel exudation** (Figure 5) has been added as a defect to track ASR-affected tunnels. A more detailed, ASR-specific description has been added to aid in the quantification of ASR gel exudation and build-up and to differentiate this defect from typical efflorescence and staining, which may result from durability problems other than ASR, such as typical leaching, freezing and thawing, or sulfate attack.

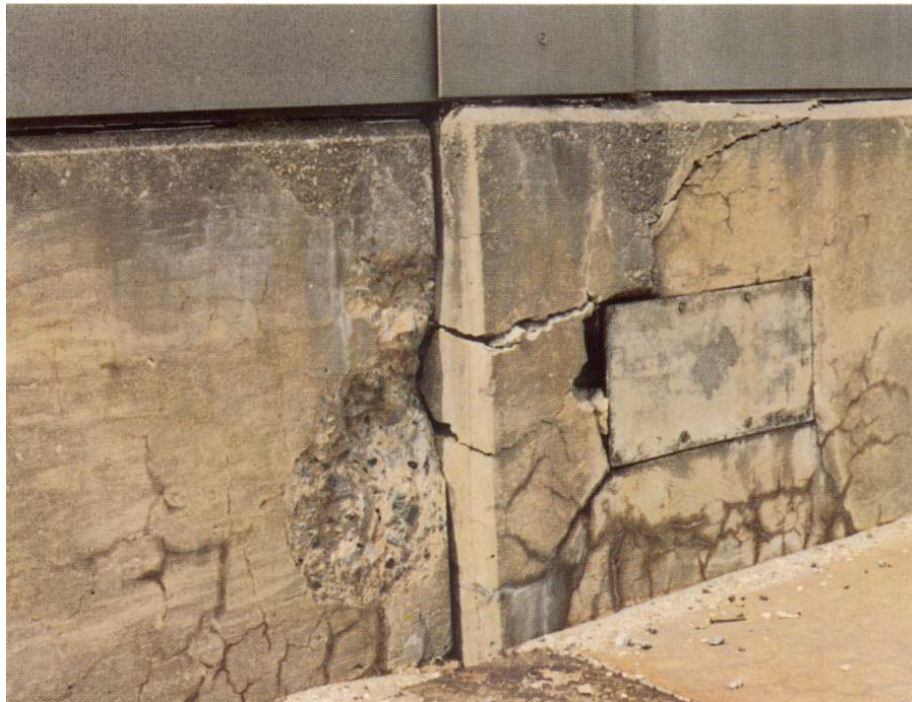
**Figure 6 – Relative dislocation/misalignment, leading to loss of clearance and cracking  
(photo from SHRP C-315, 1991)  
(Condition State 3)**

**Expansion or relative dislocation** (Figure 6) has been added as a defect, along with defect criteria, to try to capture the manifestations of ASR-induced expansion that may have a significant effect on the serviceability and longevity of a given tunnel. ASR-induced expansion within a given tunnel element may result in various operating difficulties, whether the entire tunnel is expanding or certain elements are expanding relative to adjacent, non-expanding elements. As an example, expansion of precast tunnel liners can cause failure of the gaskets and bolts that clamp the sections together, potentially increasing the risk for concrete crushing at this interface or increased potential for leakage at joints. In addition, utilities that are contained in tunnels may be adversely impacted by ASR as the displacements and resultant misalignments can cause operational difficulties.

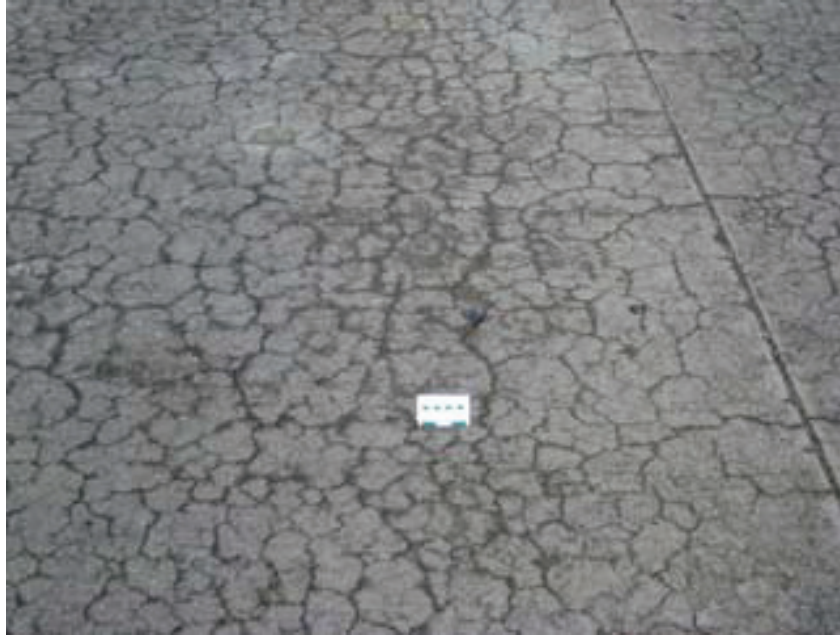
**Figure 7 – Map Cracking of Concrete Pavement (Condition State 3)**

with varying degree of severity. Figures 7 through 9 show manifestations of ASR-induced expansion and cracking in pavements.

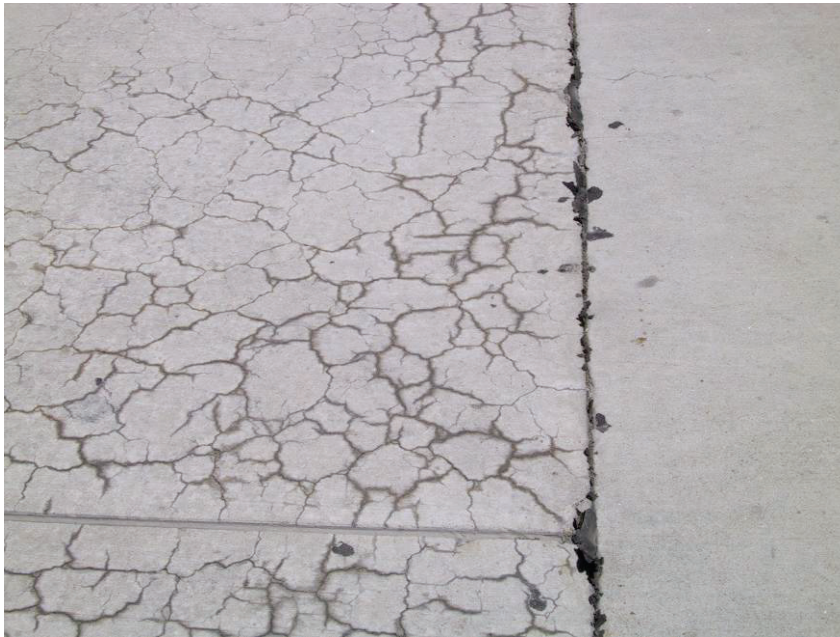
**Figure 8 – Joint Sealant Failure in Concrete Pavement (Condition State 3)**

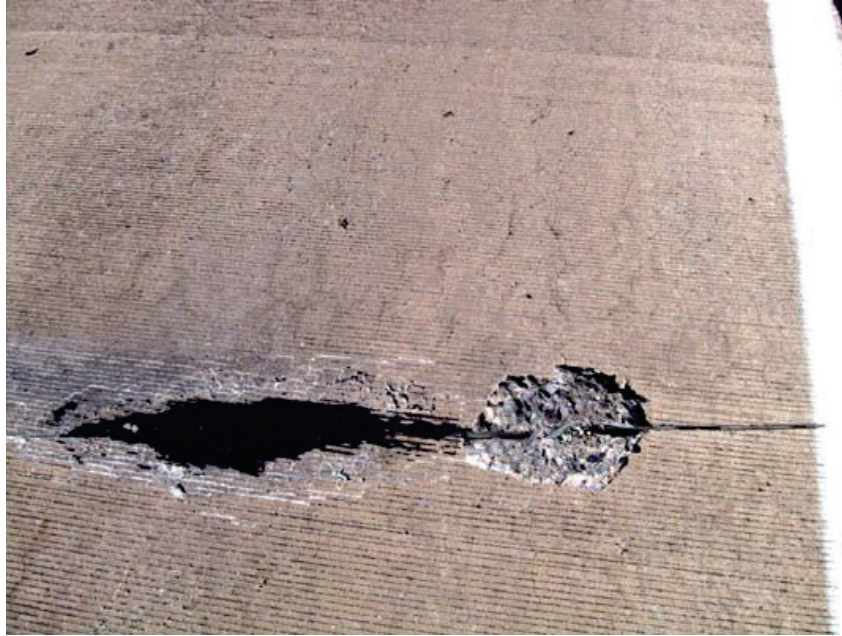
**Figure 9 – Joint Deterioration in Concrete Pavement (Condition State 3)**
