# Synthesis on the Use of Accelerated Bridge Construction Approaches for Bridge Rehabilitation

**Final Report**  
**December 2015**

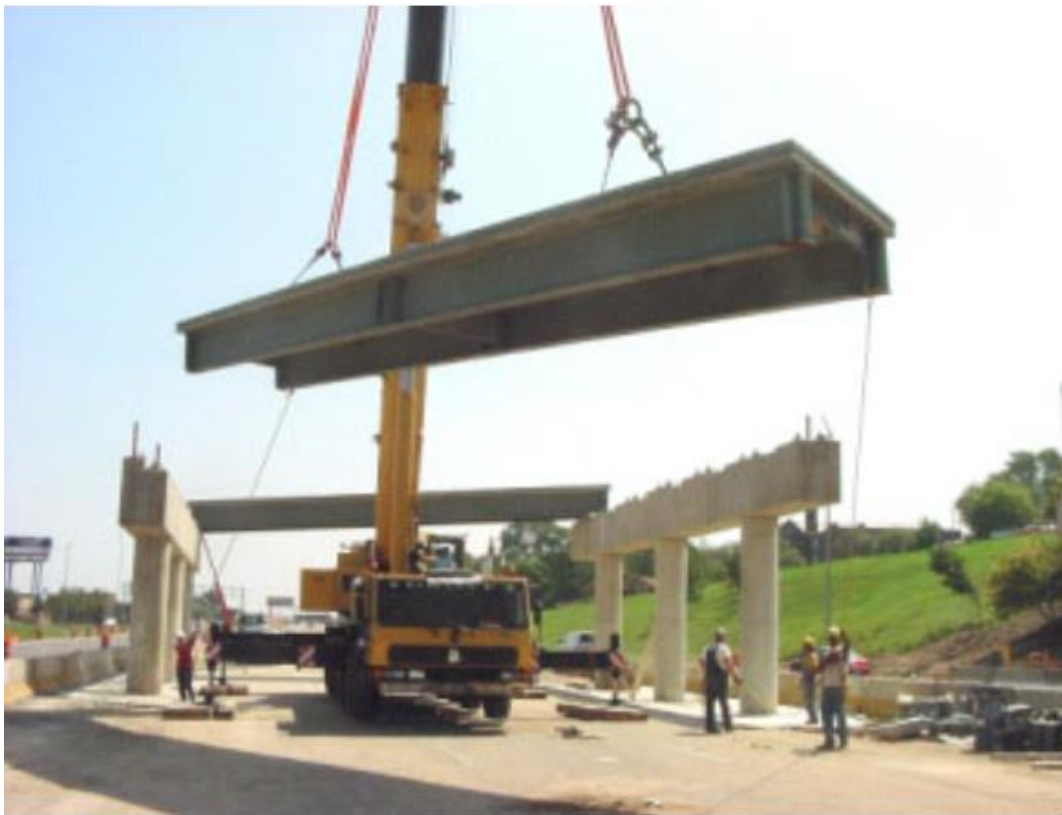
**Figure 25. Inverset panel being lifted into place**

Inverset girders are beams that are cast inverted in forms so that, when they are turned upright, the tension areas are already precompressed, leading to a potential increase in durability. This system is shown in Figure 25.
