**Federal Railroad  
Administration**

## **A New Method for Detecting the Onset of Scour and Managing Scour Critical Bridges**

9. SPONSORING/MONITORING AGENCY NAME(S) AND ADDRESS(ES) U.S. Department of Transportation Federal Railroad Administration Office of Railroad Policy and Development Office of Research, Development and Technology Washington, DC 20590			10. SPONSORING/MONITORING AGENCY REPORT NUMBER  DOT/FRA/ORD-19/32

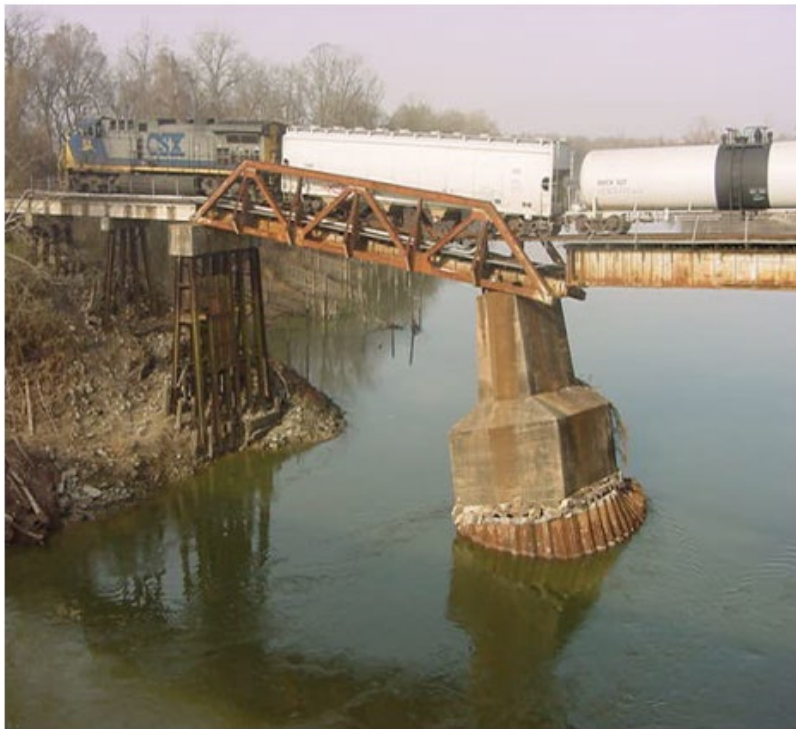
Many railroad bridge piers are susceptible to damage caused by scour and other changing soil conditions. Scour is the engineering term for the erosion of soil surrounding a bridge foundation (piers and abutments). Bridge scour occurs when fast-moving water around a bridge removes sediment from around the bridge foundation, leaving behind scour holes. These holes, in turn, can greatly compromise the bridge's integrity. Settlement and misalignment can lead to track outages and even bridge failure if not detected early enough. [Figure 1](#) shows bridge failure due to scour. Through sponsorship from the Federal Railroad Administration's (FRA) Office of Research, Development and Technology, a new detection system was developed using a combination tiltmeter and accelerometer sensor. The system continuously measures the structural response of each railroad bridge pier in the U.S. If a dangerous condition is detected, an automatic alert is sent to bridge inspectors over text message or email.

**Figure 1 – Bridge Failure due to Scour**

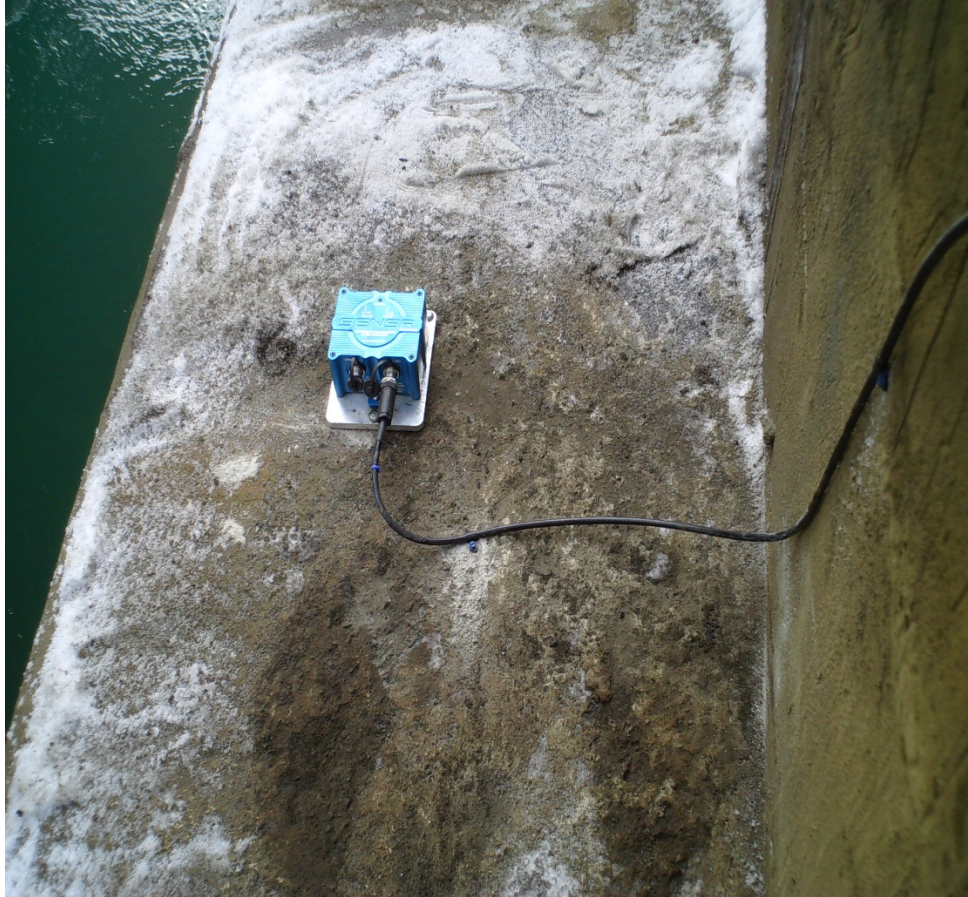
**Figure 2 – CX1 Sensor Mounted on Bridge Pier**

An example of a CX1 sensor mounted on a bridge pier is shown in [Figure 2](#). The sensor is installed onto an aluminum bracket with machine screws. The aluminum bracket is fastened to the concrete pier with anchor bolts.

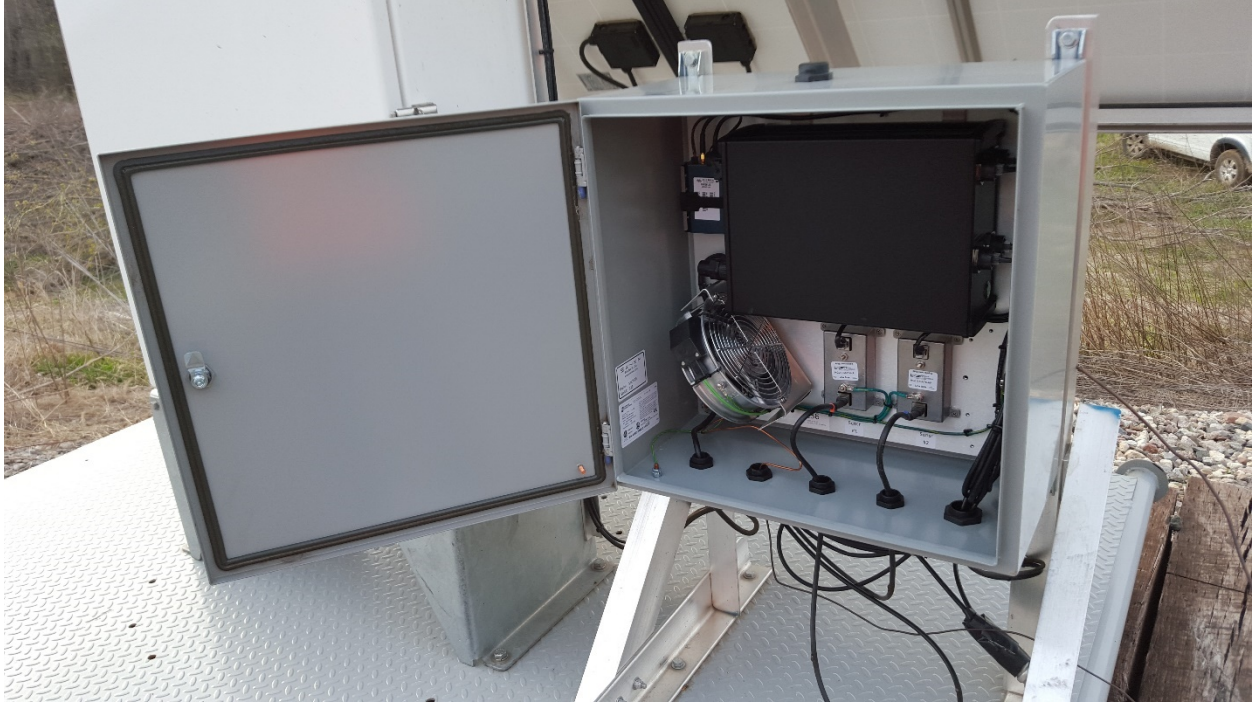
**Figure 3 – SENSnet Installed Inside Electrical Enclosure**

An example of a SENSRnet is shown in [Figure 2](#). The device is installed inside of a sealed electrical enclosure for protection from the elements.

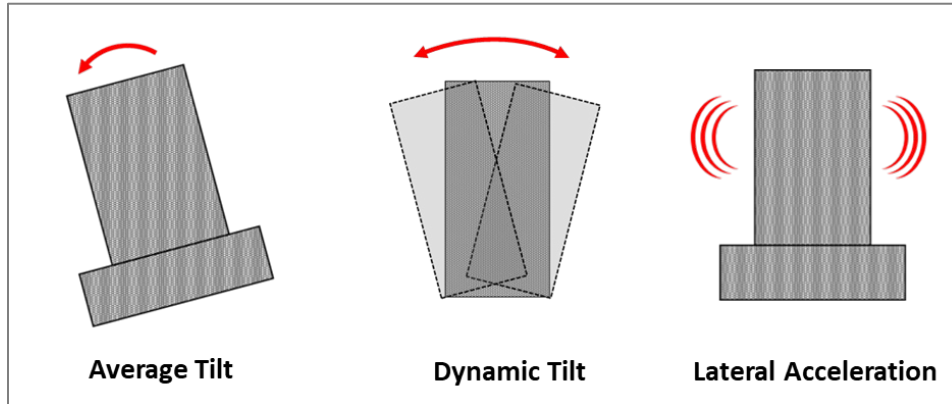
The three Key Performance Indicators (KPIs) used for detecting the onset of bridge scour and changing soil conditions are Average Tilt, Dynamic Tilt, and Lateral Acceleration. Graphical depictions of the indicators are shown in Figure 4.

Figure 4 – Graphical Depictions of Key Performance Indicators

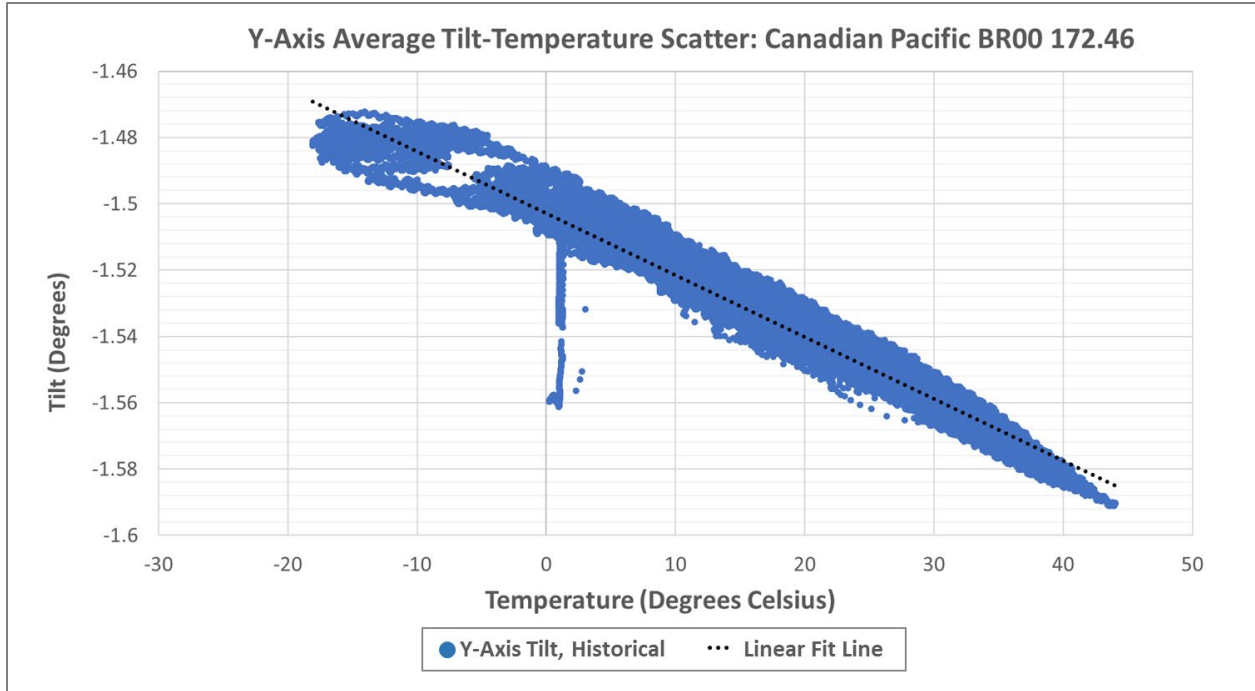
**Figure 5 – Example of Tilt-Temperature Relationship, Canadian Pacific BR00 172.46 West Pier**

An example scatter plot showing the relationship between tilt and temperature is shown in Figure 5. The data presented in the plot was collected from July 1, 2016, to January 1, 2017, from Canadian Pacific Railway (CPR) BR00 172.46 in Calgary, AB. This period covers a wide range of temperatures as well as the transition to near-permanent freezing temperatures. A well-defined linear relationship can be established between tilt and temperature. The total change in tilt due to thermal effects is relatively small: 0.12 degrees. However, very small changes in tilt can have a significant impact on the overall alignment of the structure. The corresponding displacement can be approximated by assuming a lever arm based on pier height and calculating the arc length using the following equation:

This equation requires tilt in units of radians. If a 30-ft. lever arm is assumed, the corresponding displacement for 0.12 degrees of tilt is 0.75 inches.

Further visual analysis can be conducted by shading the most recent week of data a separate color from the historical data. If the recent data has drifted outside of the historical data band, permanent deformation has possibly occurred. The data in Figure 5 shows that the current position of the West Pier is within the historical band. Additionally, the outliers that occurred near 0 °C temperatures did not represent a permanent shift. These outliers were likely the result of the freeze/thaw cycle.

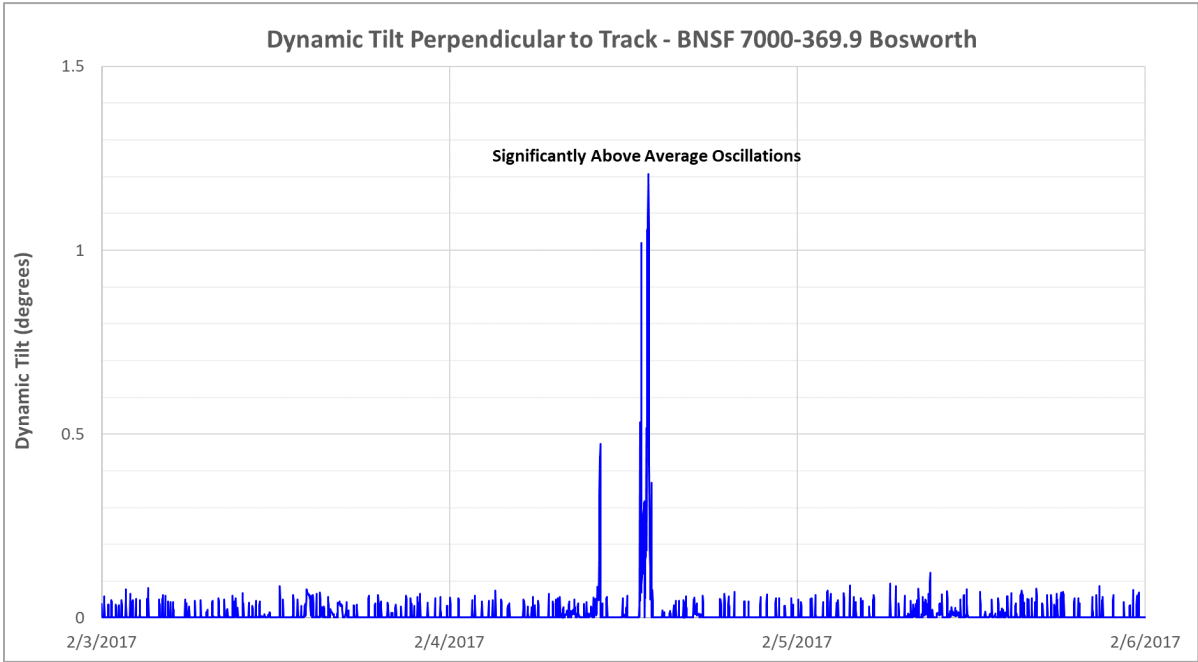
The dynamic tilt is determined by calculating the difference between the maximum and minimum tilt recorded for a given minute of data. This characteristic shows the magnitude of oscillation for a bridge pier under loading. Above normal dynamic tilt is an indicator of changing soil conditions that can affect the pier stability.

**Figure 8 – Example of Above Average Dynamic Oscillations**

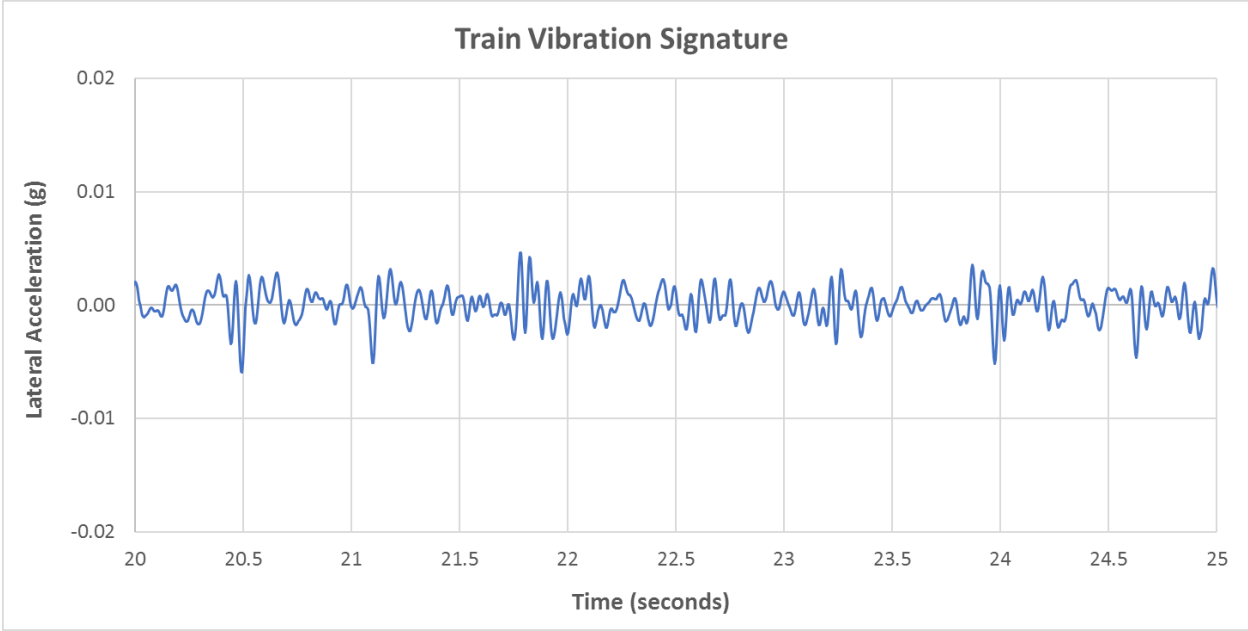
Acceleration data is sampled at a much higher rate and is more prone to outliers causing false alarms. To make the best use of acceleration, a signal level analysis is recommended. Patterns in the data signature and frequency characteristics can be used to distinguish normal train loading from other types of loading. For example, train loading will produce vibrations with high variability and randomness as shown in Figure 8. Vibrations measured from construction equipment such as a vibration hammer will have a consistent high frequency as shown in Figure 9. Other types of equipment such as an impact hammer will have its own unique signature as shown in Figure 10.

**Figure 9 – Example Response Signature from Train Loading**

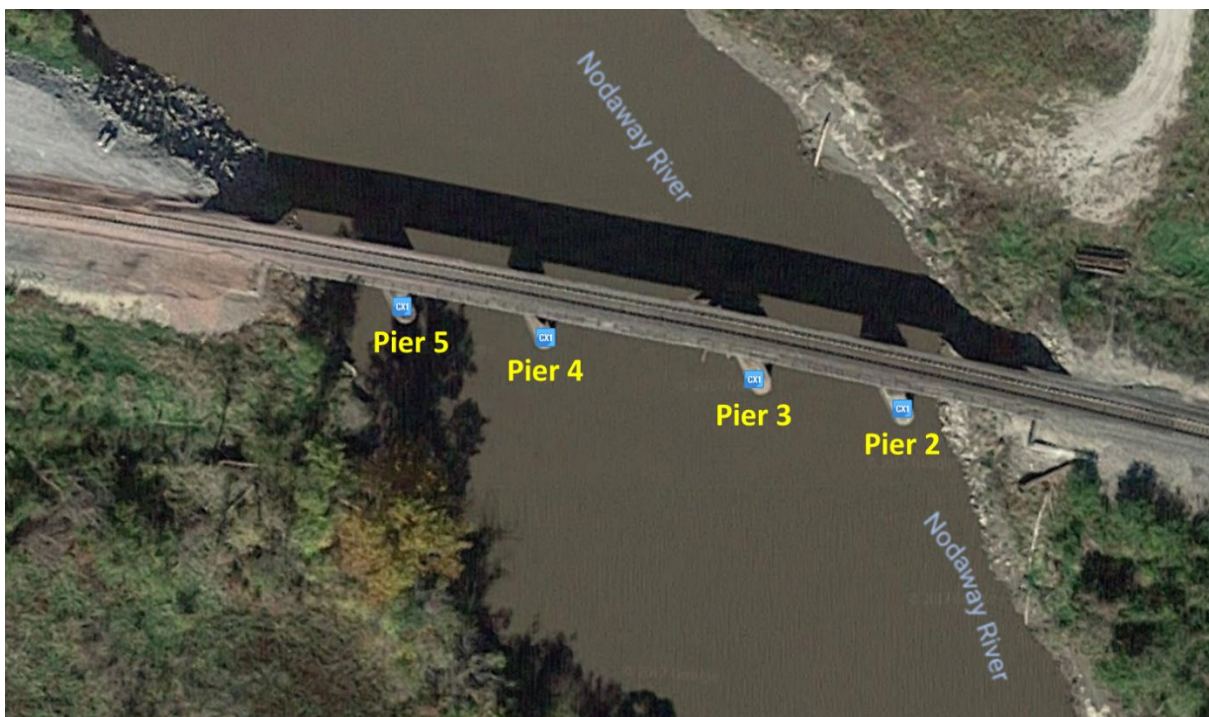
This bridge is a five span, 327-foot-long single-track bridge over the Nodaway river. The bridge was originally constructed in 1906. Between 1906 and 1922, the bridge underwent pier stabilization by means of pinning the piers; washouts and scour were chronic problems. One of the peculiar features of the Nodaway river is the large draining acreage and the subsequent amount of drift which enters the bridge at an angle. In 2007 a high-water event caused a 10 ft. scour hole to develop around Pier 2. The pier was stabilized and grouted to prevent settlement.

Piers 2, 3, 4, and 5 are each instrumented with a CX1 monitoring device. The system has been in place since September 2013.

Figure 12 – BNSF Bridge 77.54, Nodaway, MO

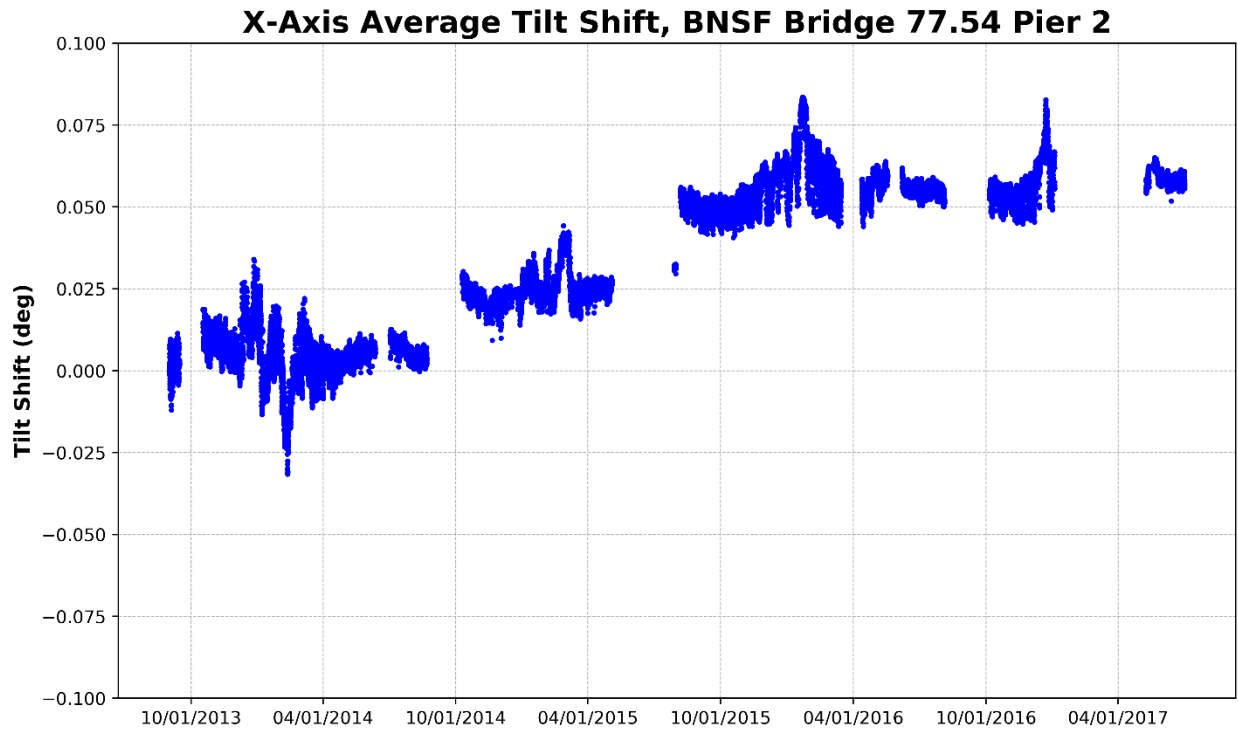
Since September 2013, Pier 2 has shifted over 0.05 degrees parallel to the track and 0.075 degrees perpendicular to the track. This magnitude of tilt is likely associated with 0.25 to 0.50 inches of settlement. Pier 2 has shown indications of changing soil conditions. Given the scour history of Pier 2, an underwater inspection is recommended.

**Figure 13 – Pier 2, X-Axis Average Tilt (Parallel to Track)**

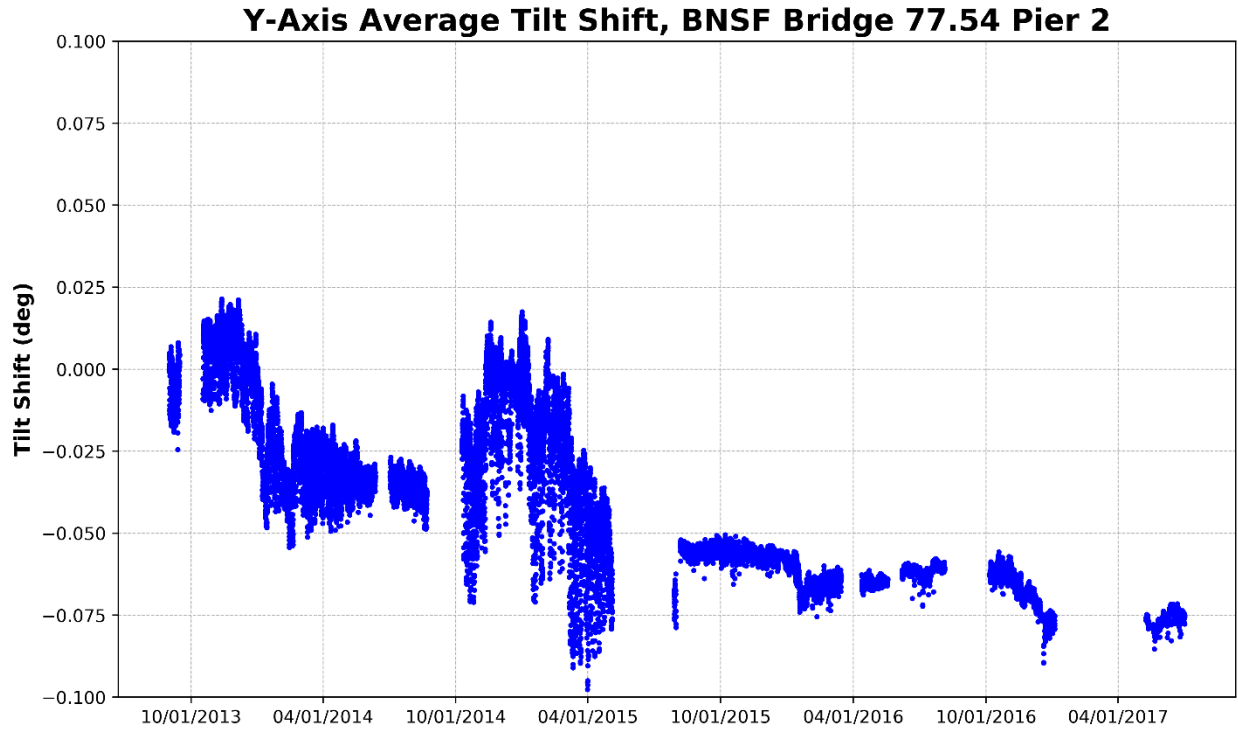
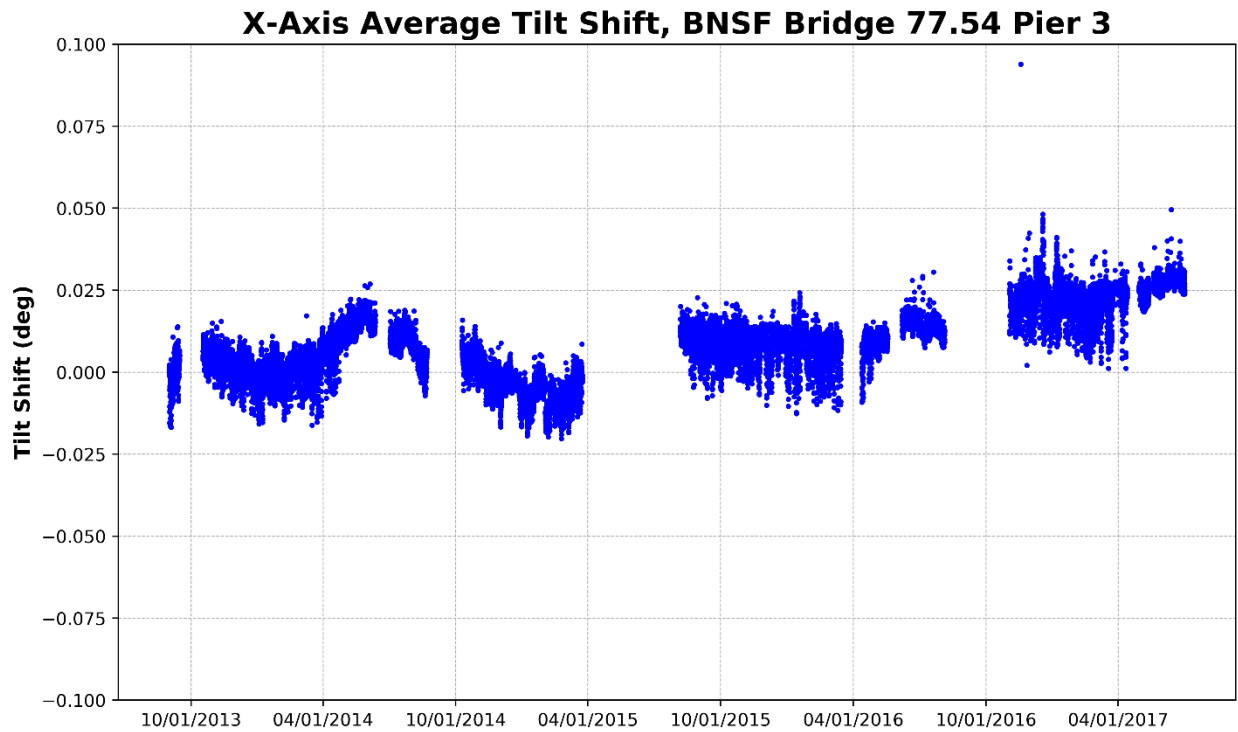
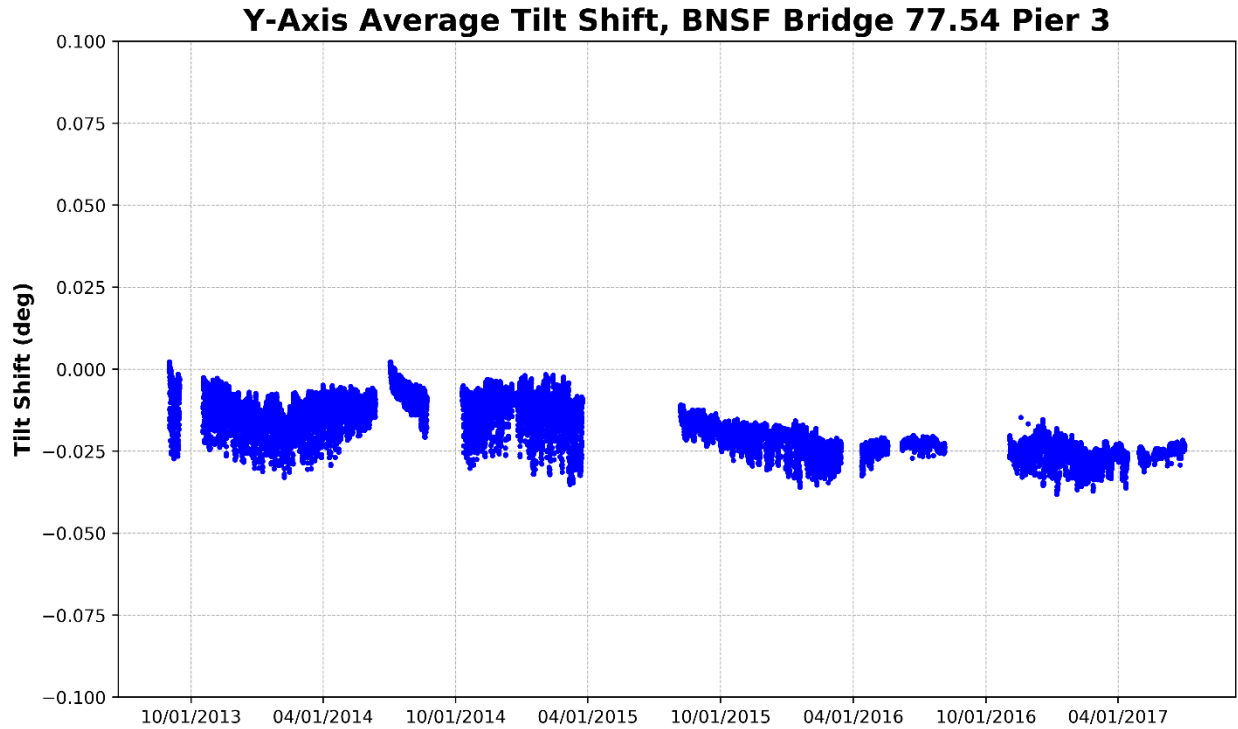
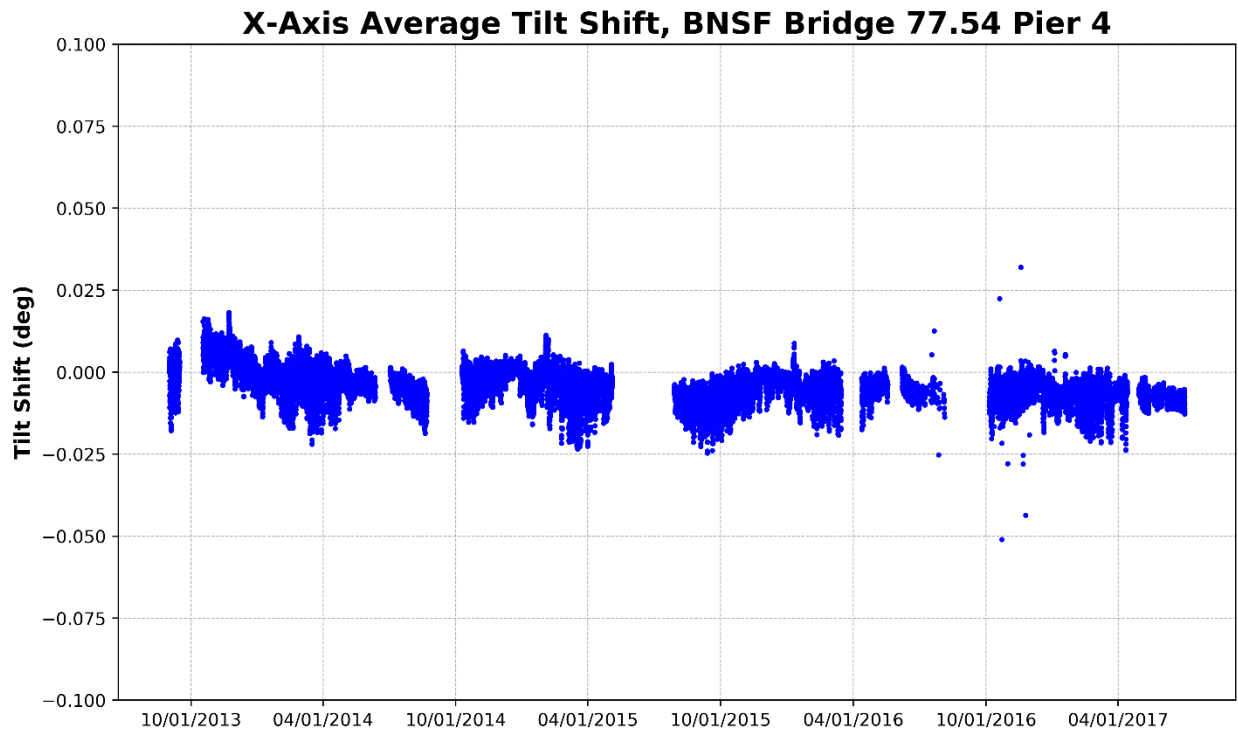
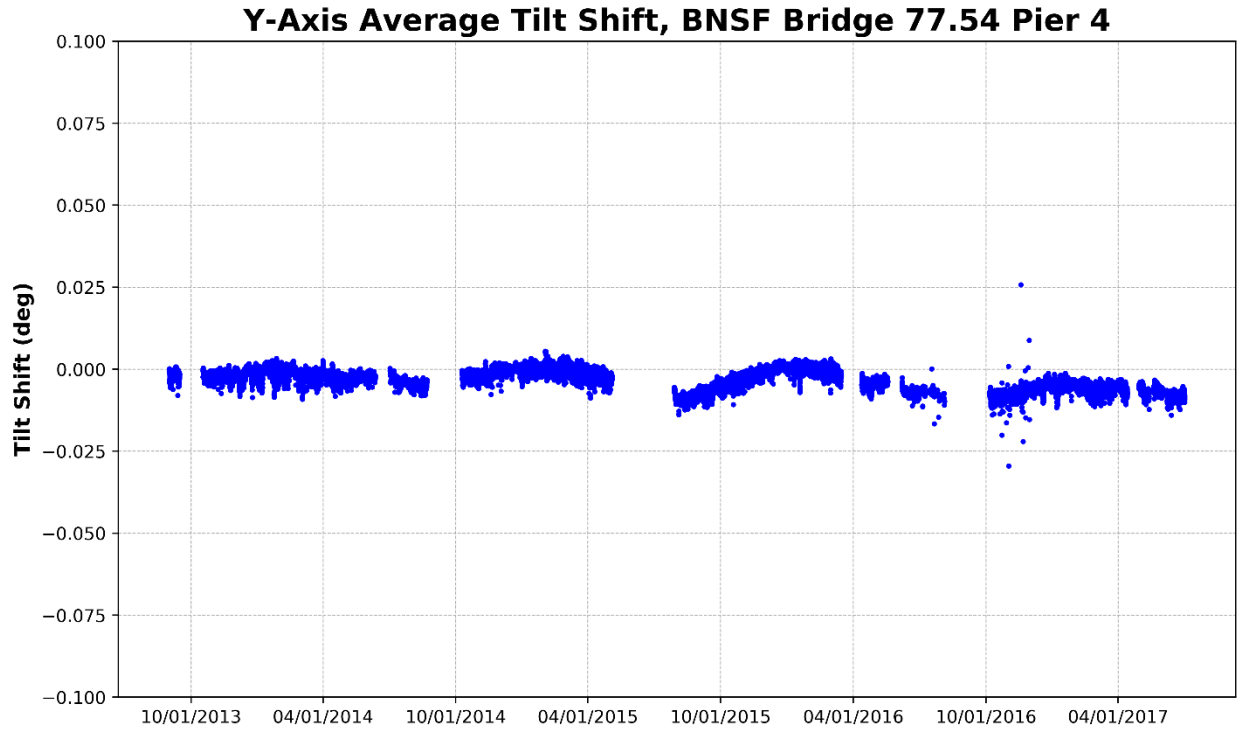
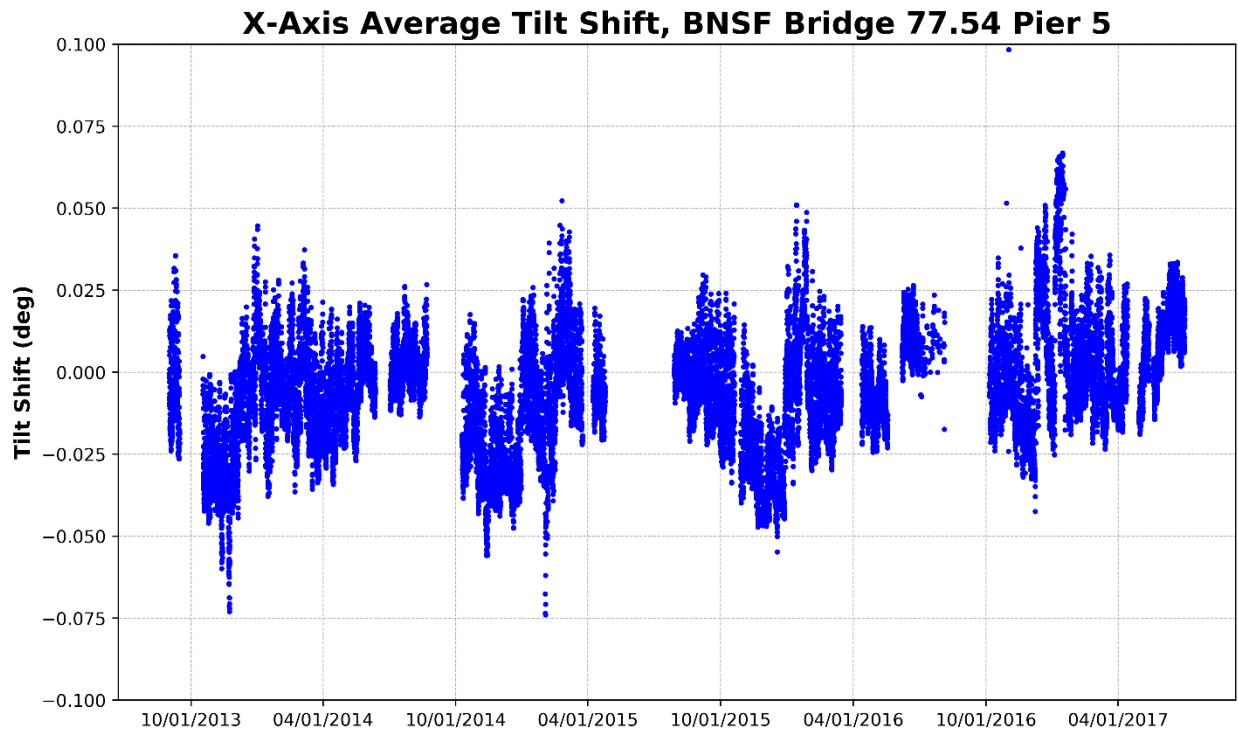
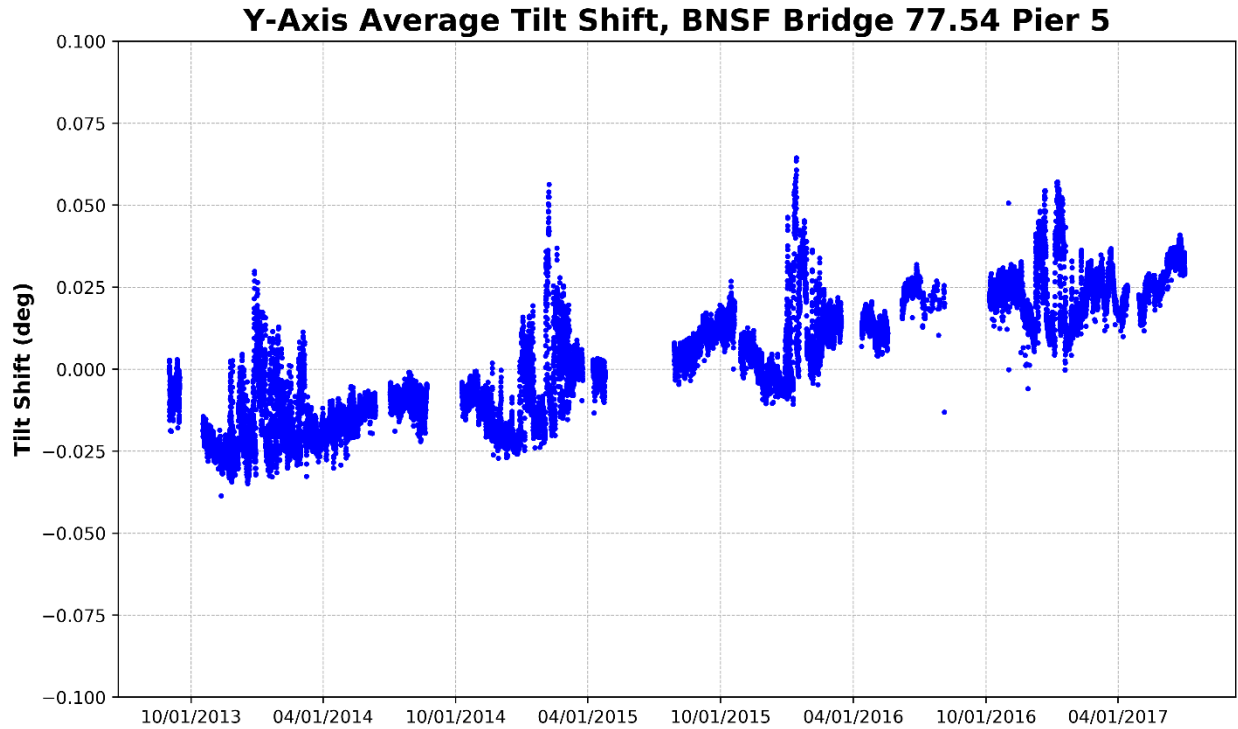
The average tilt measurements collected for Piers 2, 3, 4, and 5 are shown in [Figure 12](#) through [Figure 19](#). The measurements recorded in the sensor X-Axis are parallel to the track, and measurements in the sensor Y-Axis are perpendicular to the track.

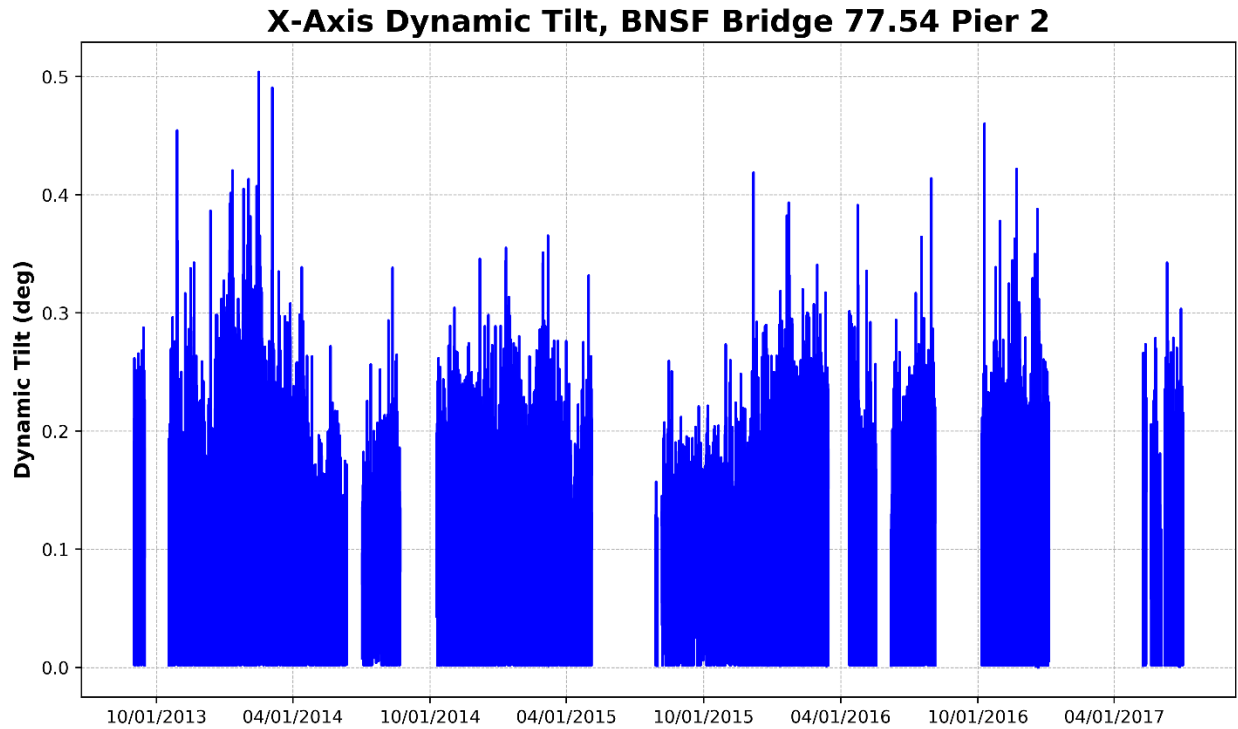
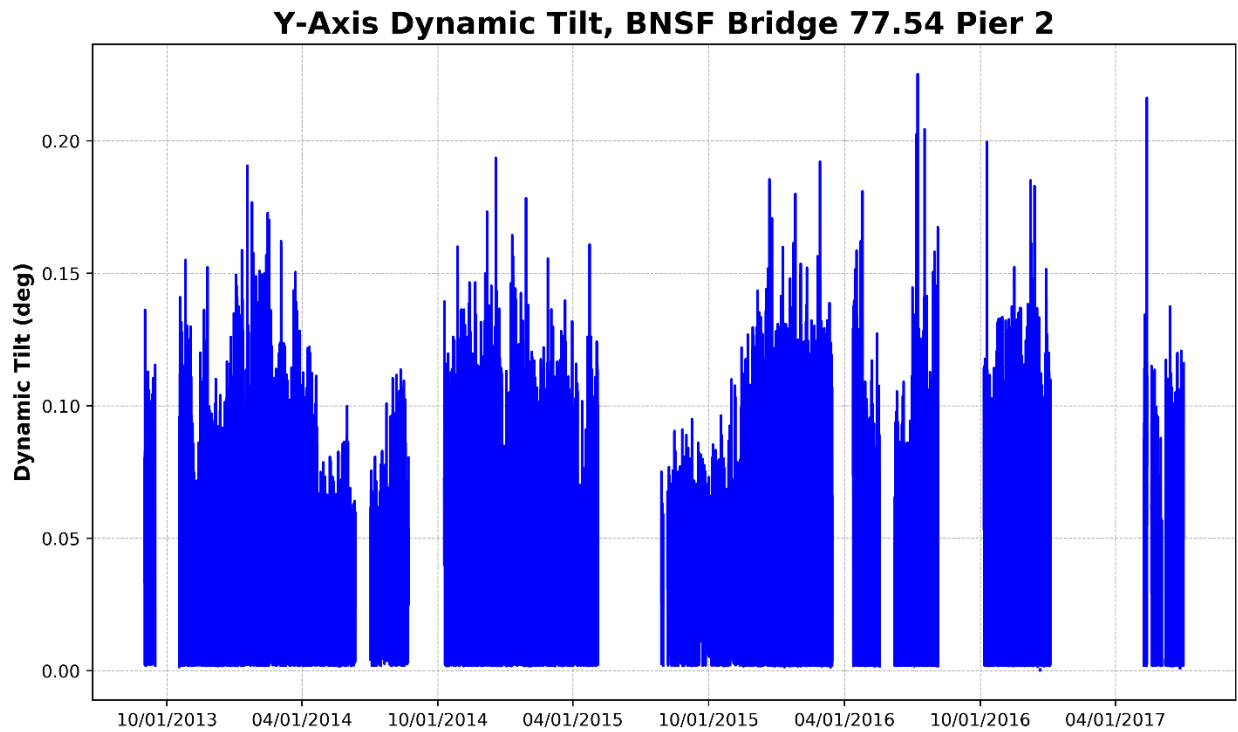
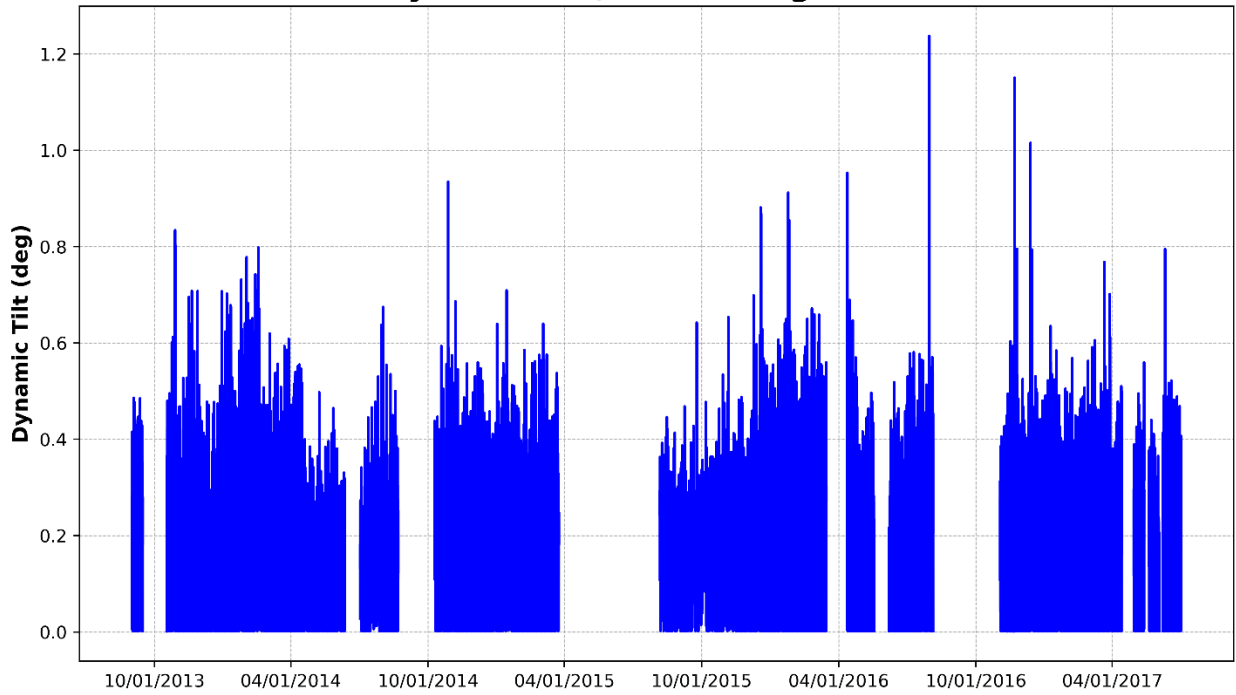
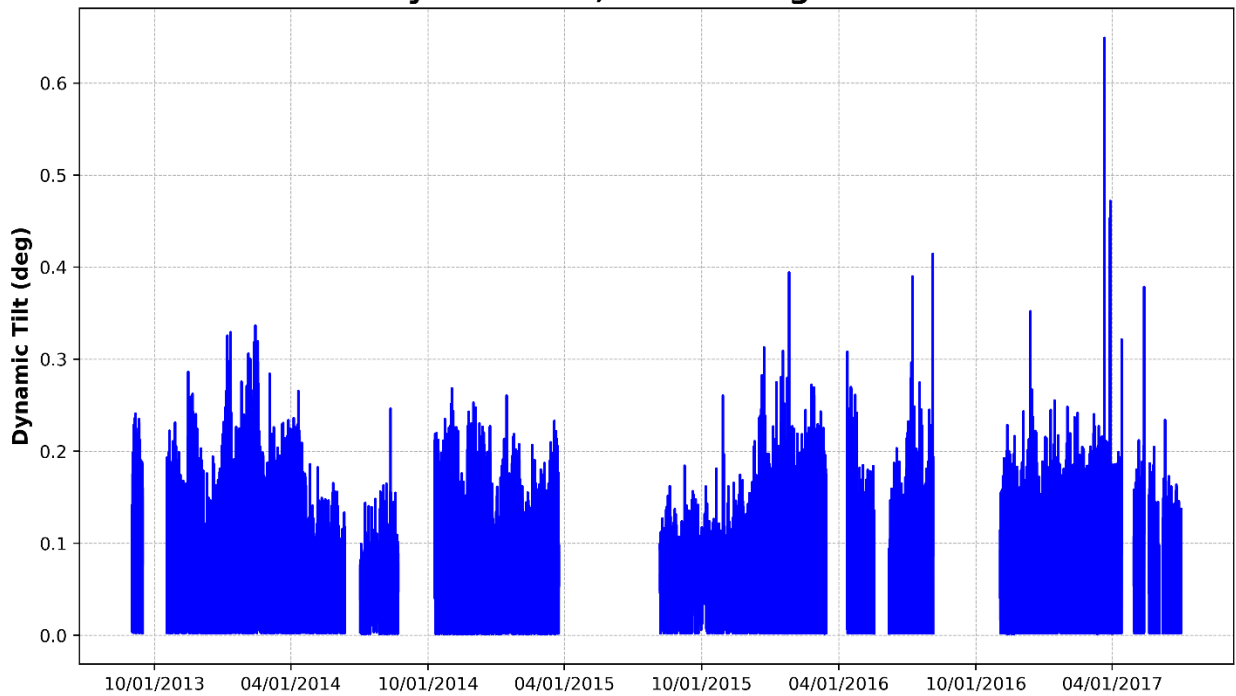
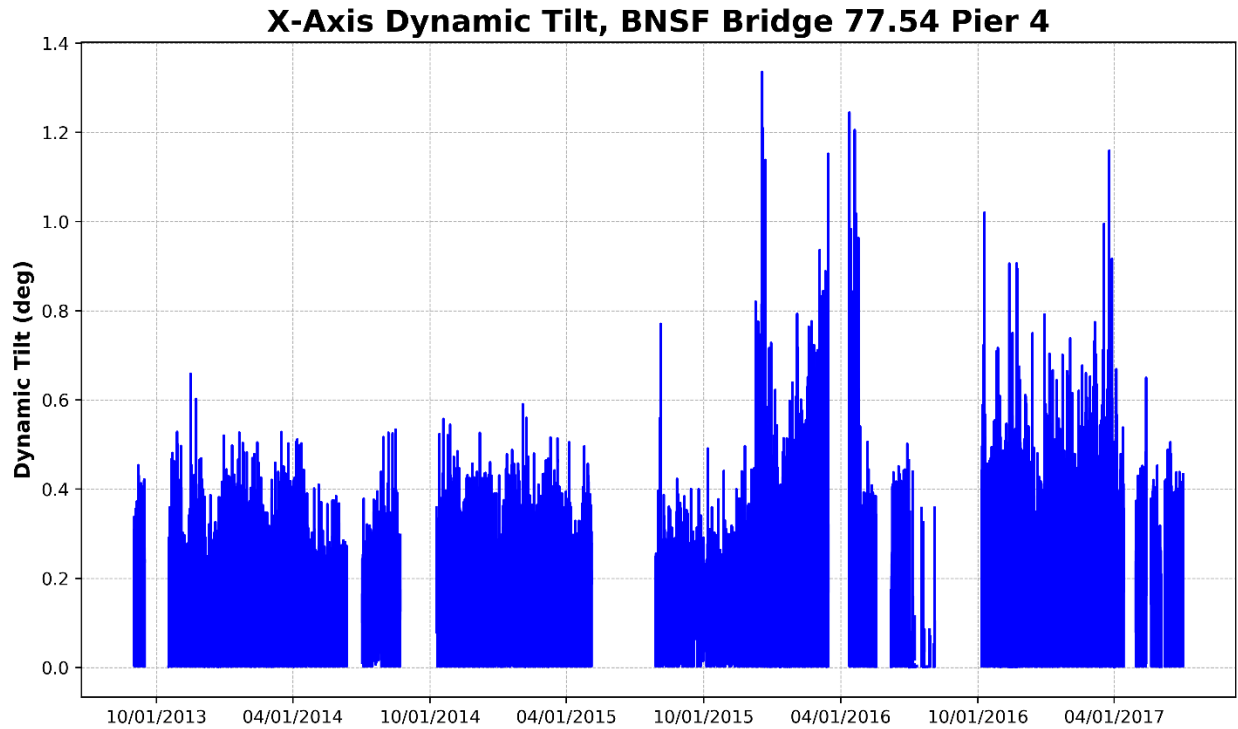
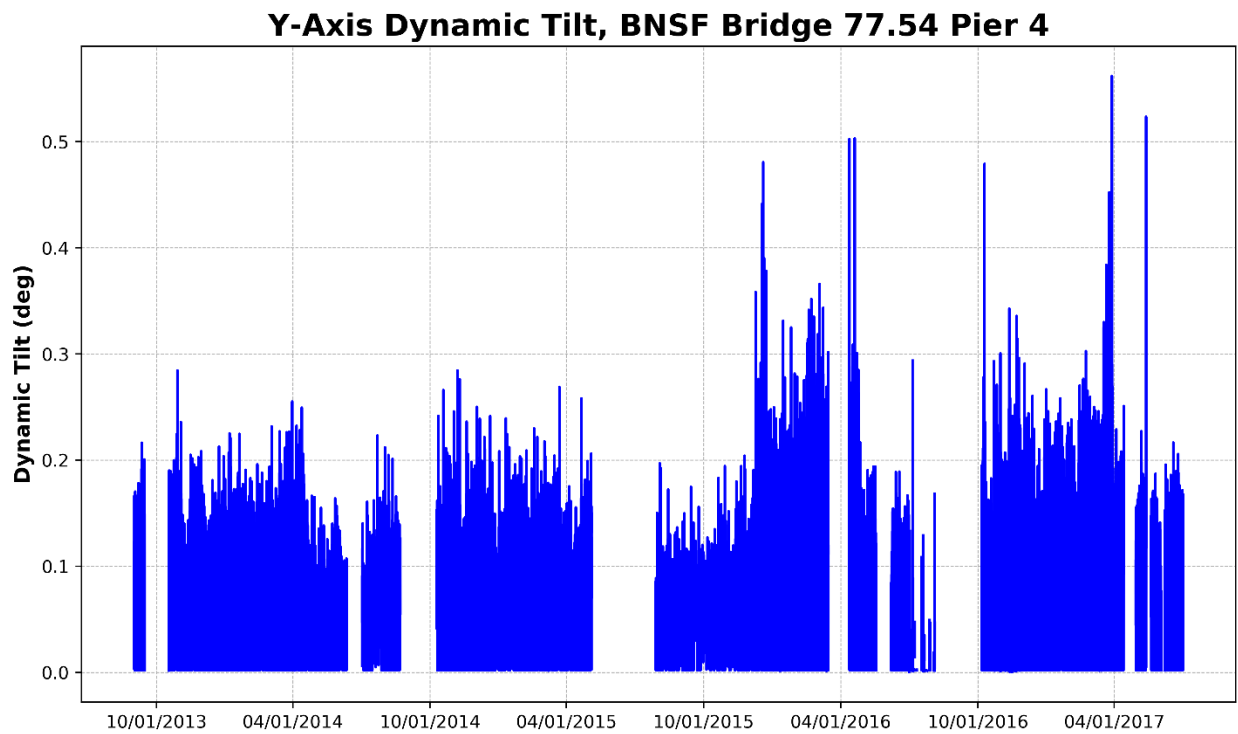
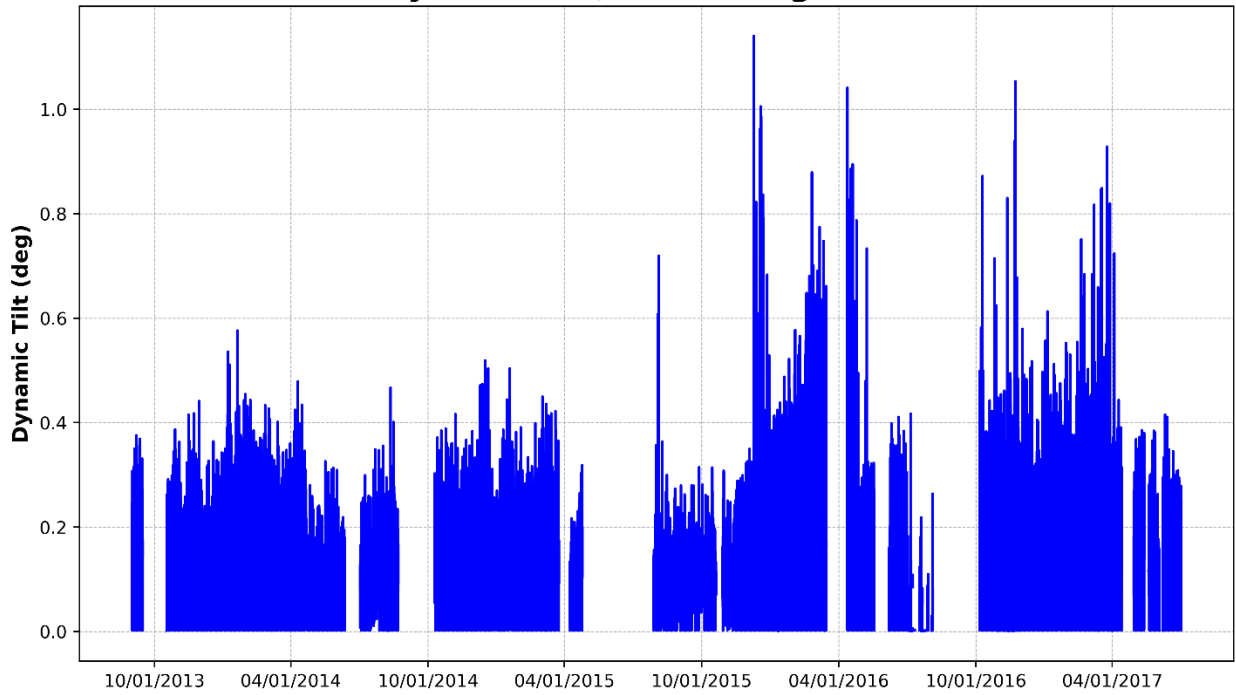
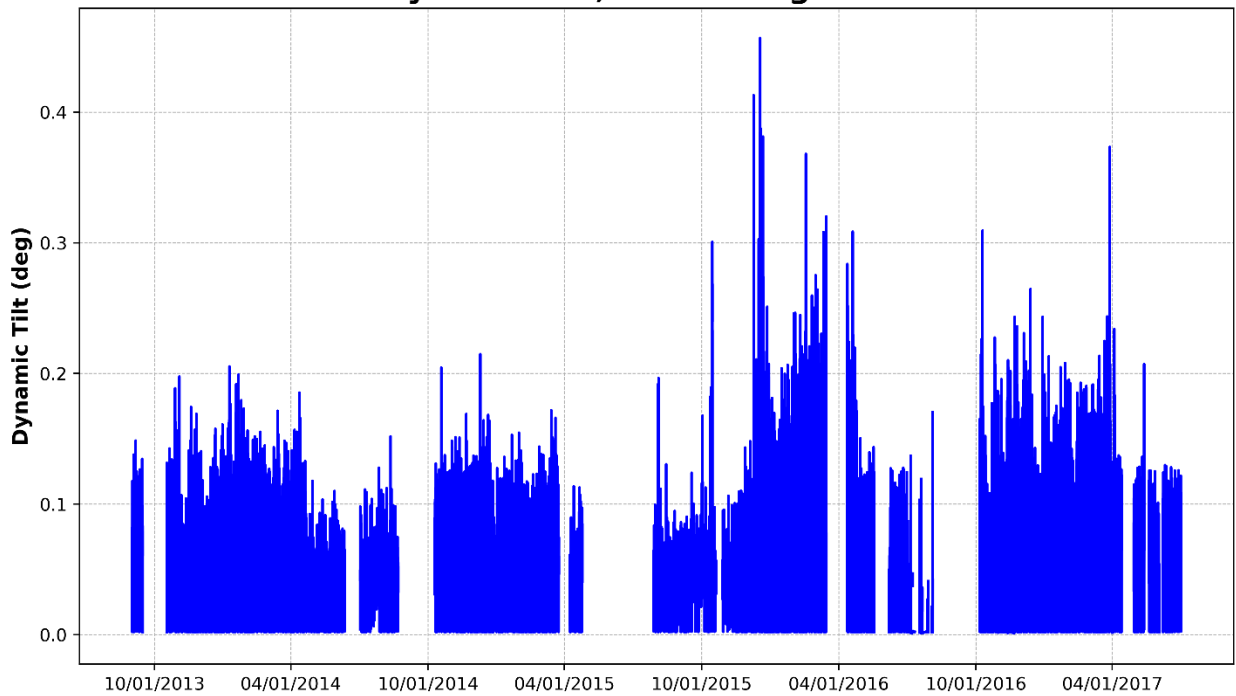
The dynamic tilt measurements are shown in [Figure 20](#) through [Figure 27](#). The measurements for Pier 2 and Pier 3 have remained steady for both piers in both directions (perpendicular and parallel to track). The dynamic tilt of Pier 4 and Pier 5 have shown a tendency for larger motion starting in 2016 compared to previous years. This is a possible indicator of changing soil conditions, but the change in response is relatively small and inconsistent. Further monitoring of Piers 4 and 5 is recommended to observe the trend.
