**Federal Railroad  
Administration**

## **A New Method for Detecting the Onset of Scour and Managing Scour Critical Bridges**

9. SPONSORING/MONITORING AGENCY NAME(S) AND ADDRESS(ES) U.S. Department of Transportation Federal Railroad Administration Office of Railroad Policy and Development Office of Research, Development and Technology Washington, DC 20590			10. SPONSORING/MONITORING AGENCY REPORT NUMBER  DOT/FRA/ORD-19/32

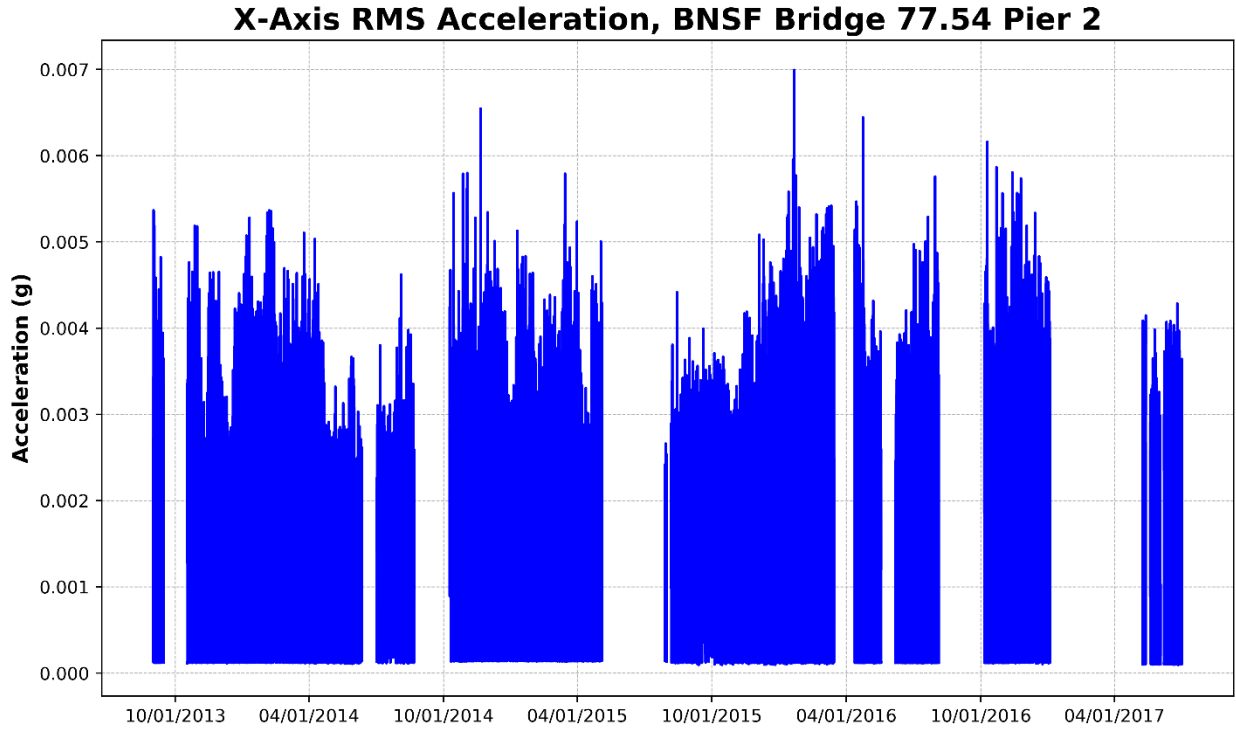
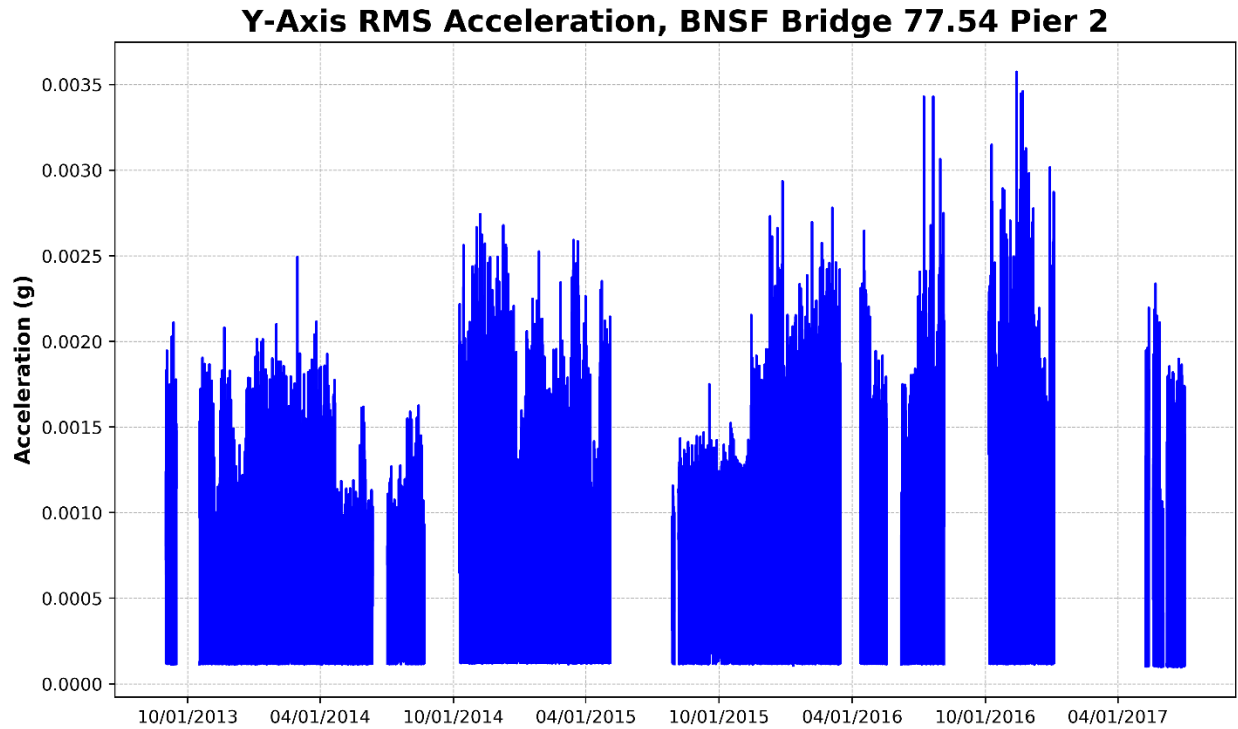
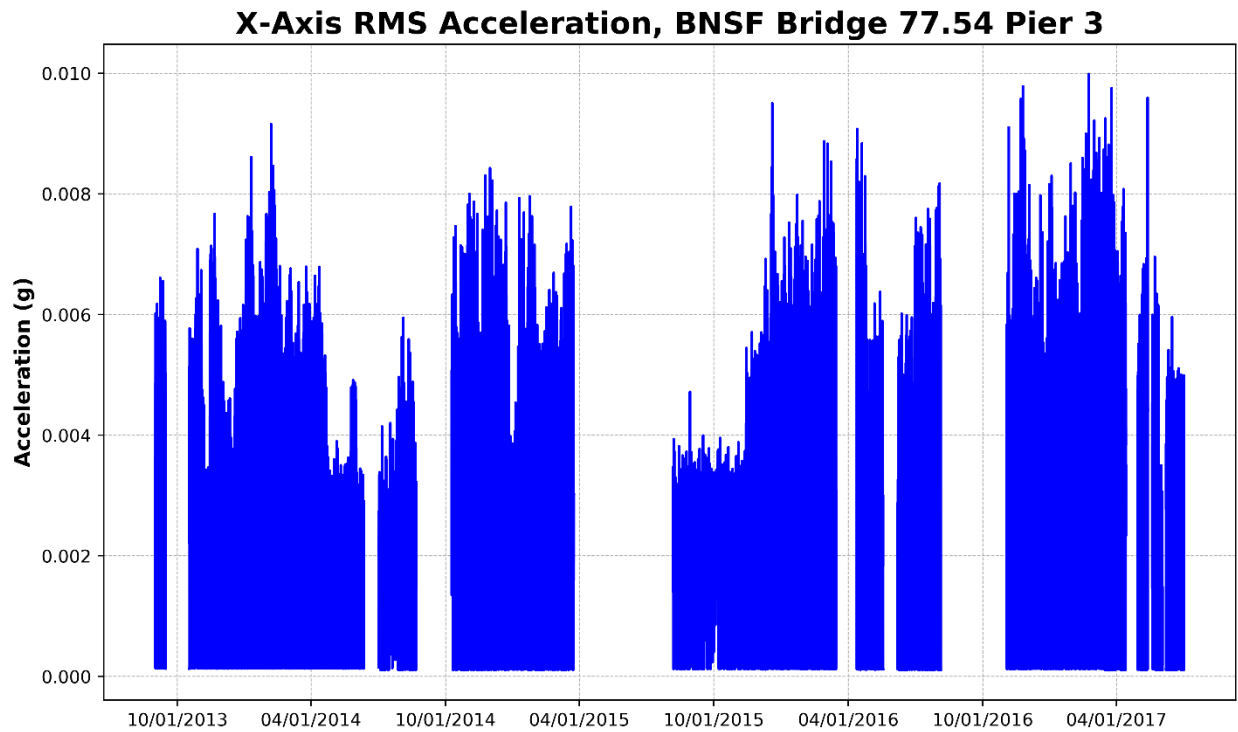
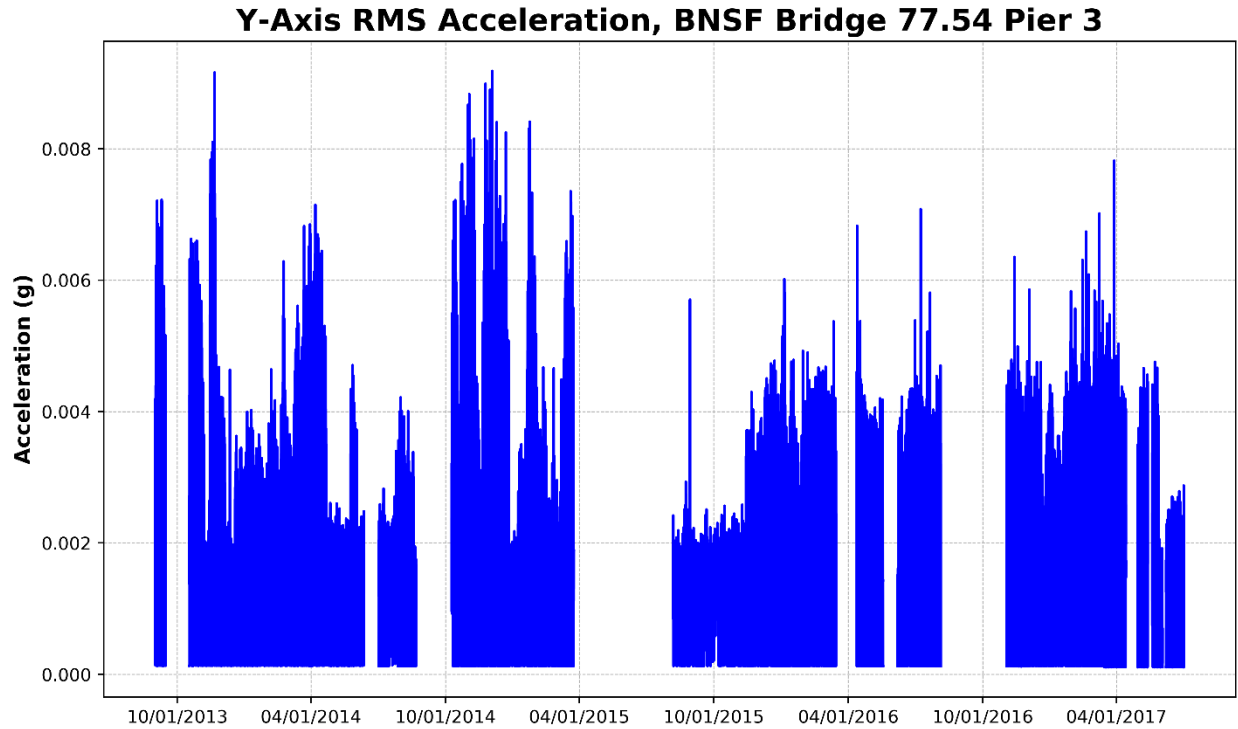
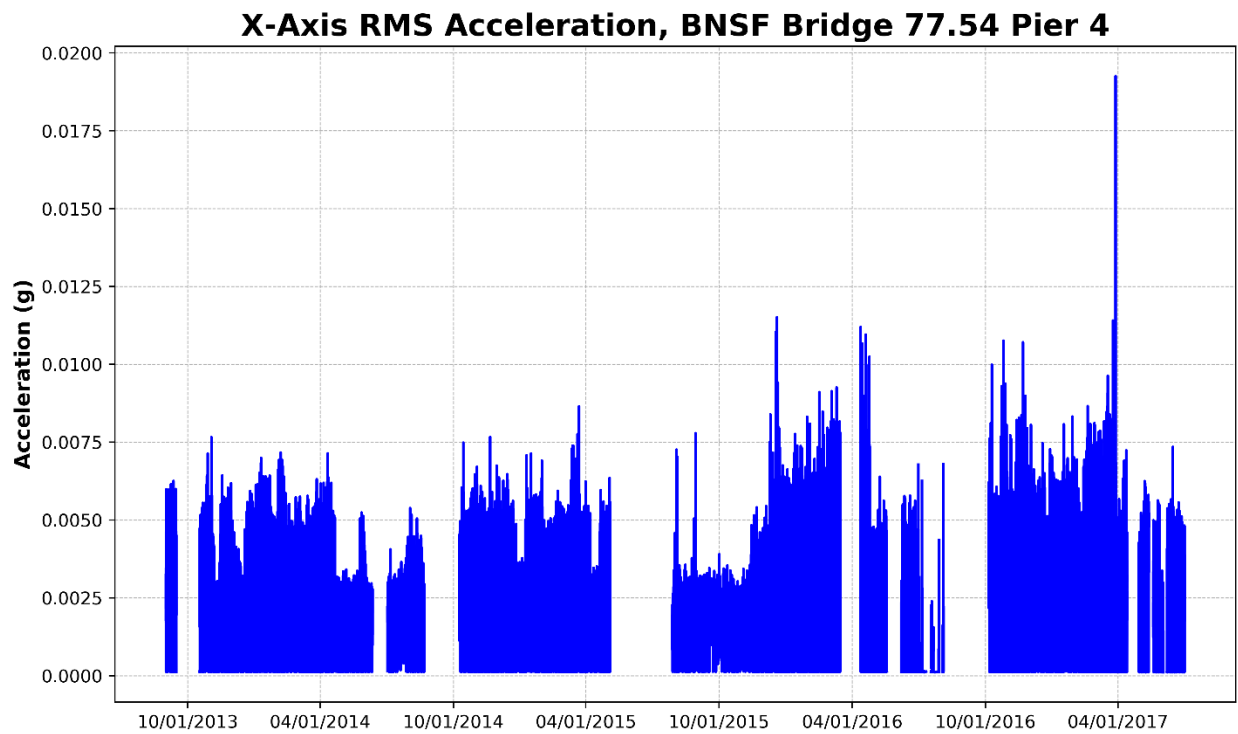
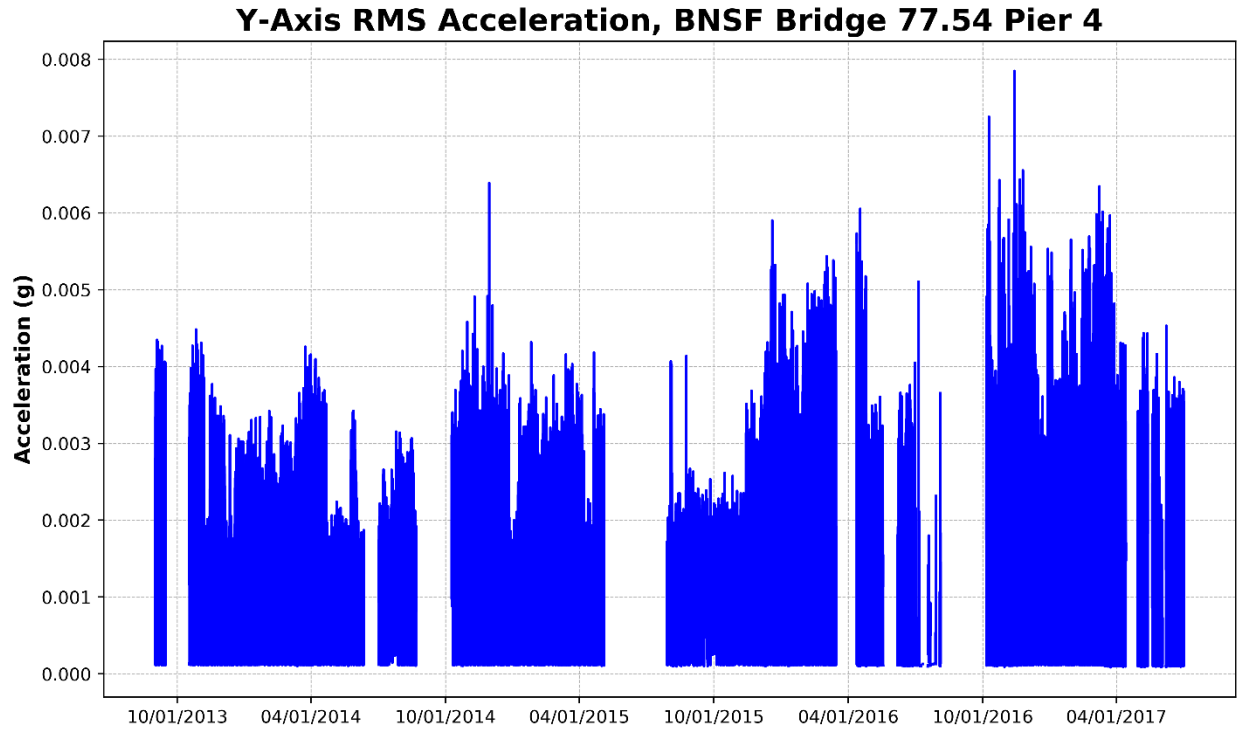
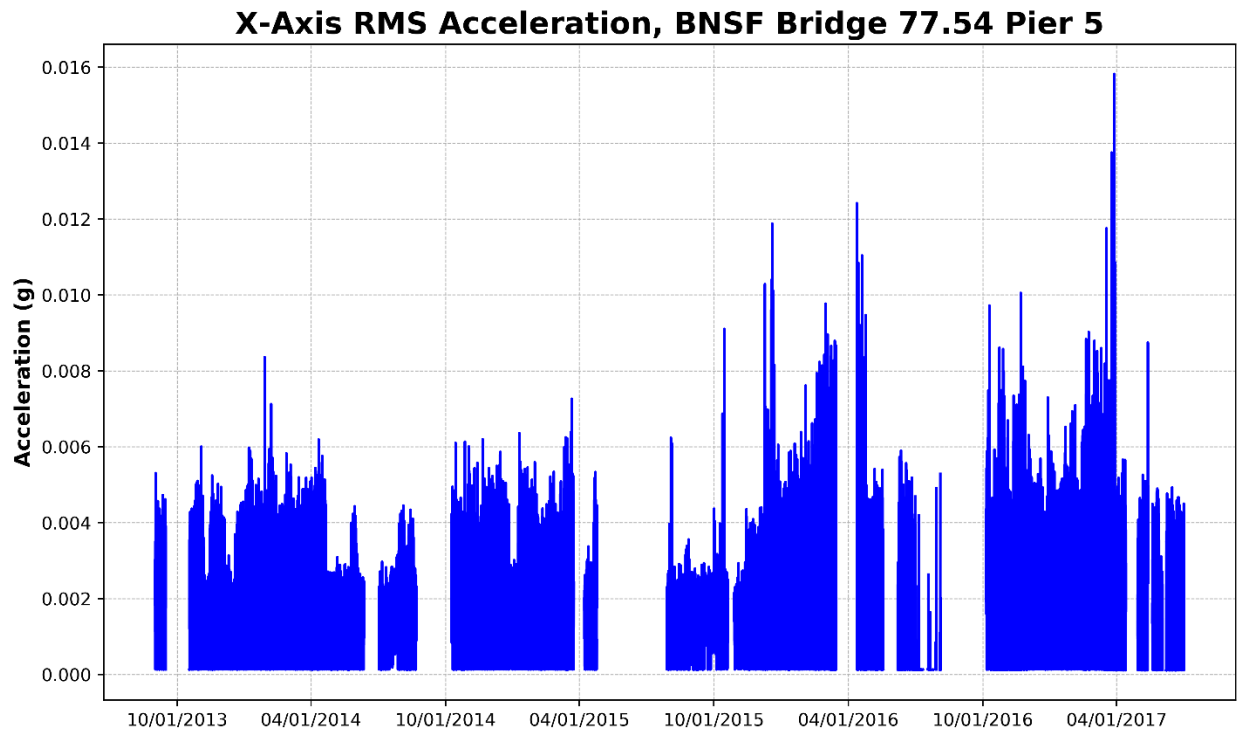
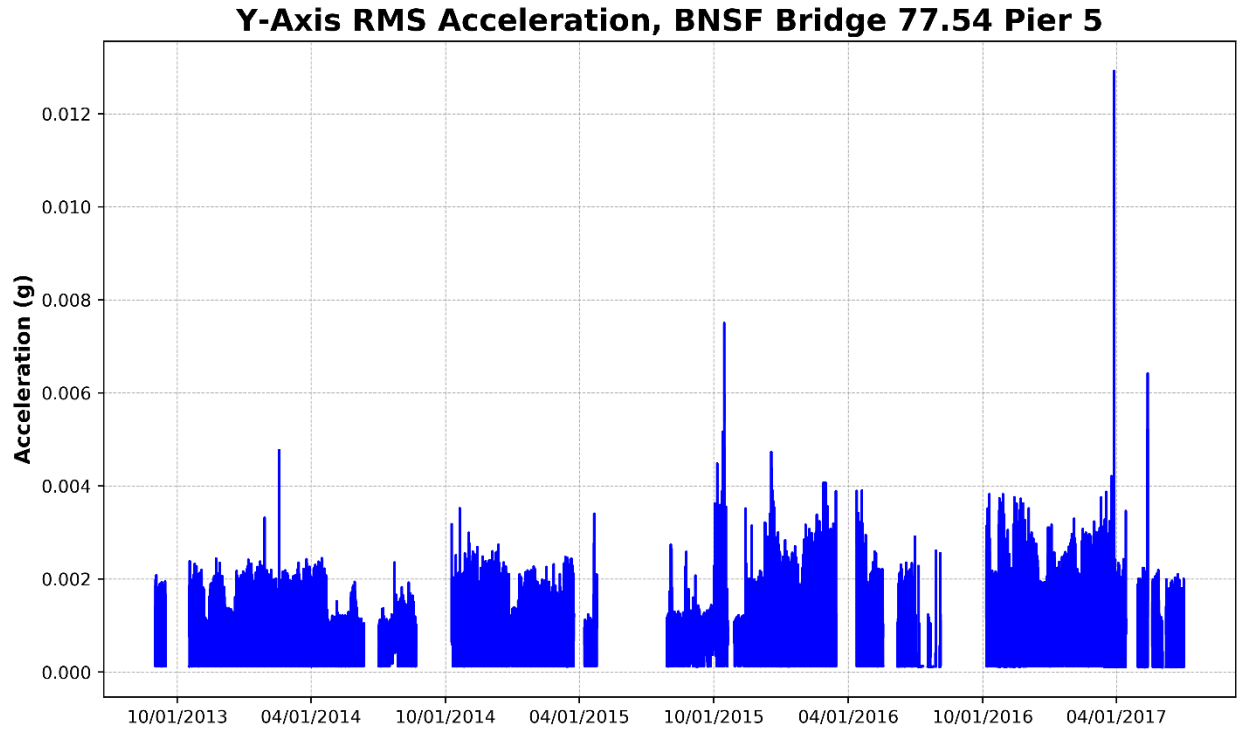
The acceleration measurements are shown in Figure 28 through Figure 35. Pier 2 and Pier 3 do not show any indications of increasing vibrations. The vibrations of Pier 4 and Pier 5 have shown a tendency for larger motion starting in 2016 compared to previous years. This is similar to the trend observed for dynamic tilt.

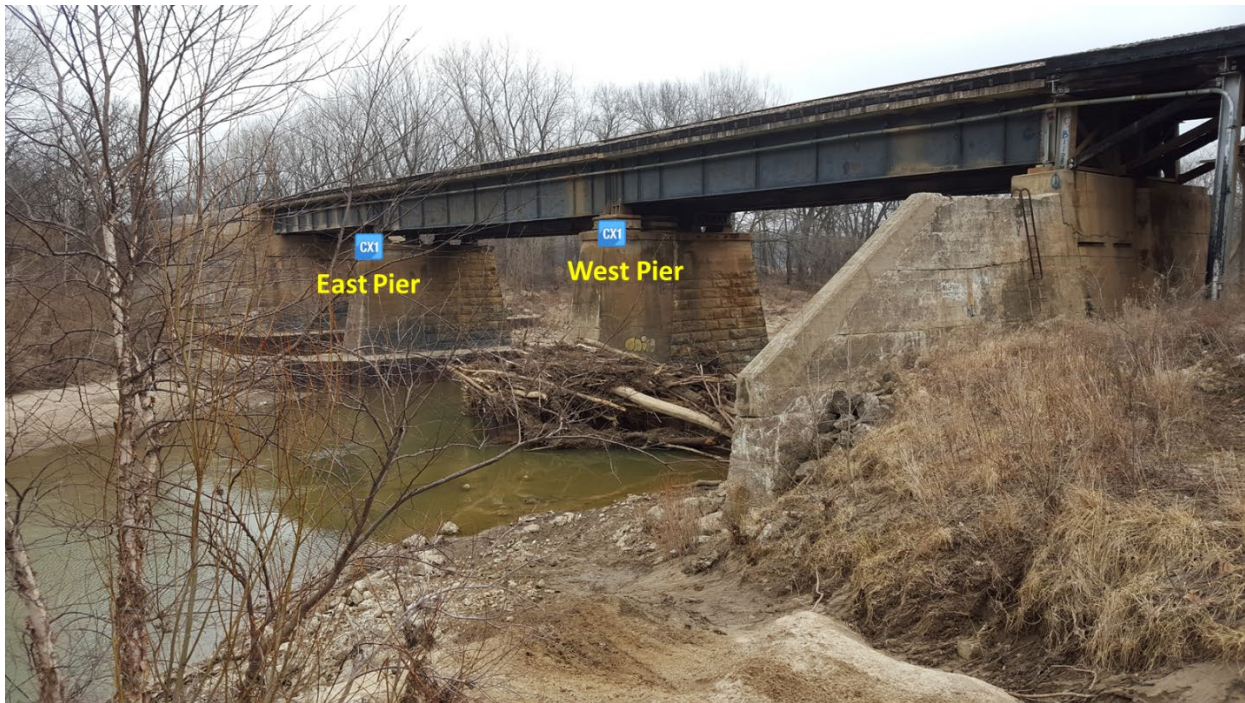
This three-span, 264 ft.-long, double track bridge is located near Gorin, MO. This bridge has a history of scour challenges along with sheet pile, grouting and riprap repairs. The piers also collect a significant amount of drift during high-water events. The pier foundations are masonry elements on relatively short timber piles. The East and West Piers are both instrumented with one CX1 sensor each as shown in [Figure 36](#). The monitoring system on this bridge has been collecting data since February 2016.

**Figure 37 – BNSF Bridge 279.7 Sensor Locations**

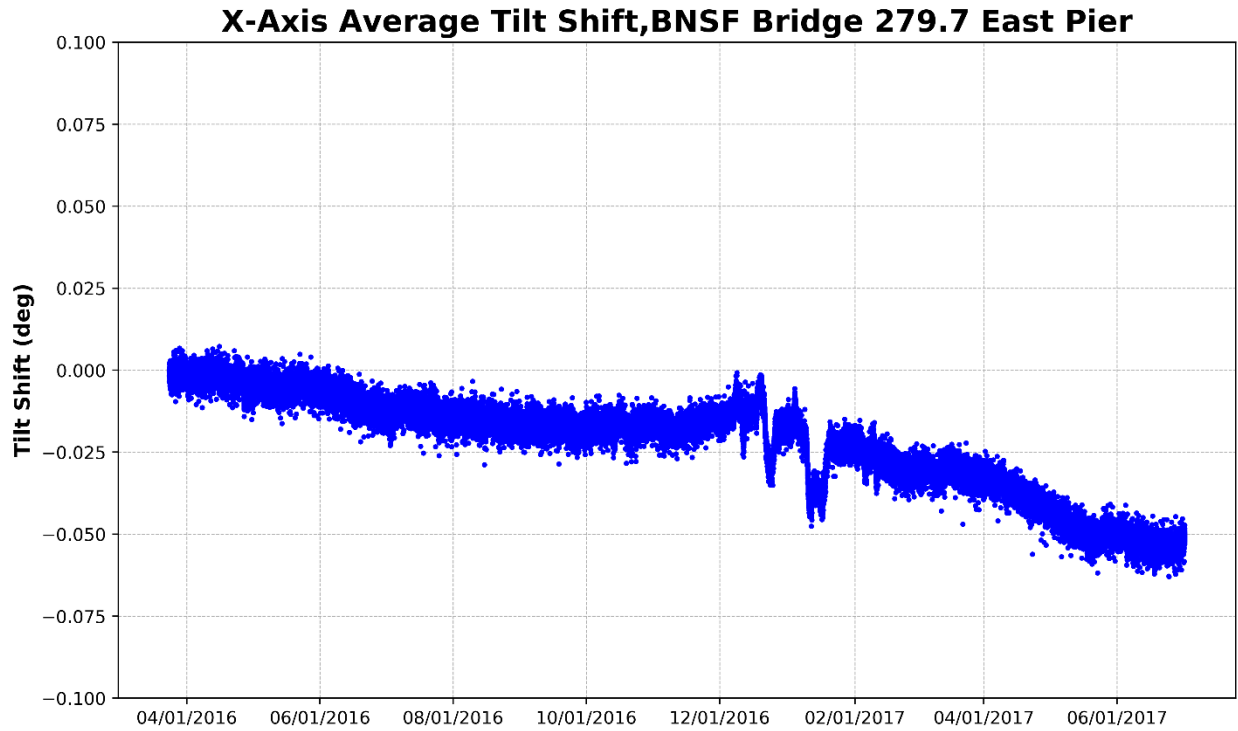
The average tilt measurements collected for the east and west pier are shown in [Figure 37](#) through [Figure 40](#). The East Pier has shifted over 0.05 degrees perpendicular to the track, indicating possible differential settlement of 0.25 inches. It is recommended to continue monitoring the East Pier for further movement that could result in disruptions to railroad operations.

**Figure 38 – East Pier, X-Axis Average Tilt (Perpendicular to Track)**

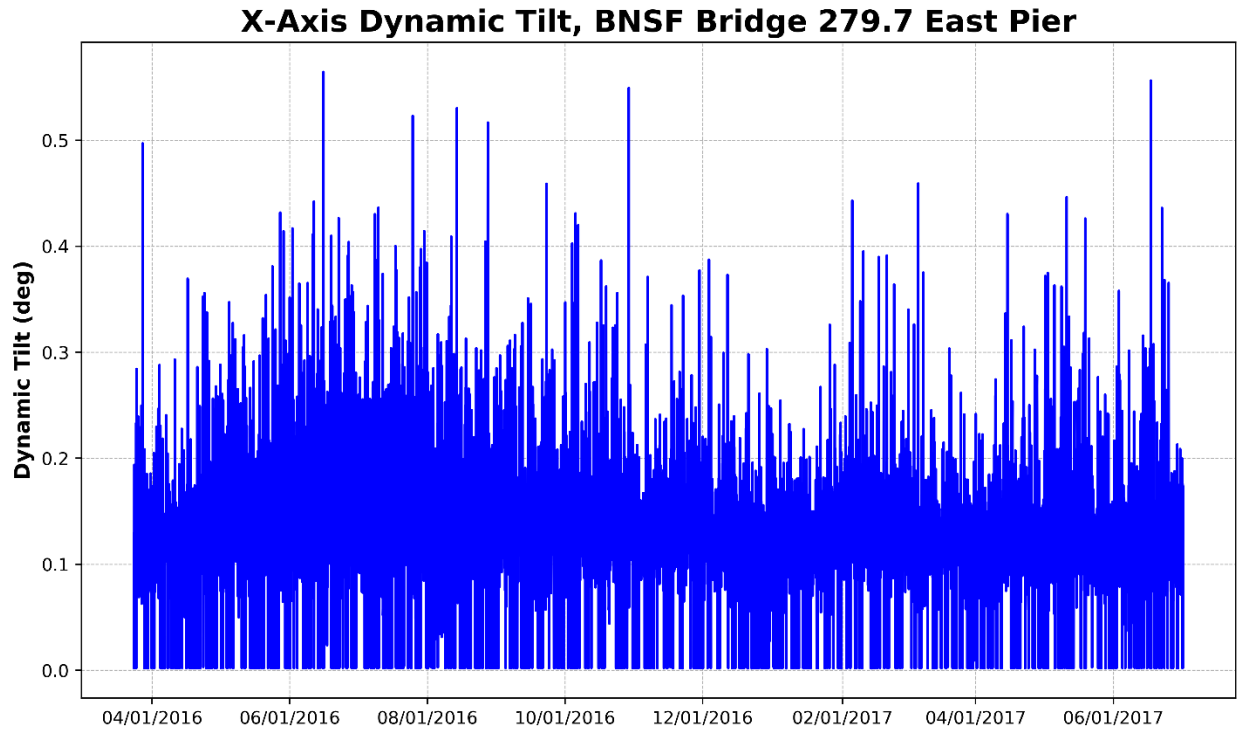
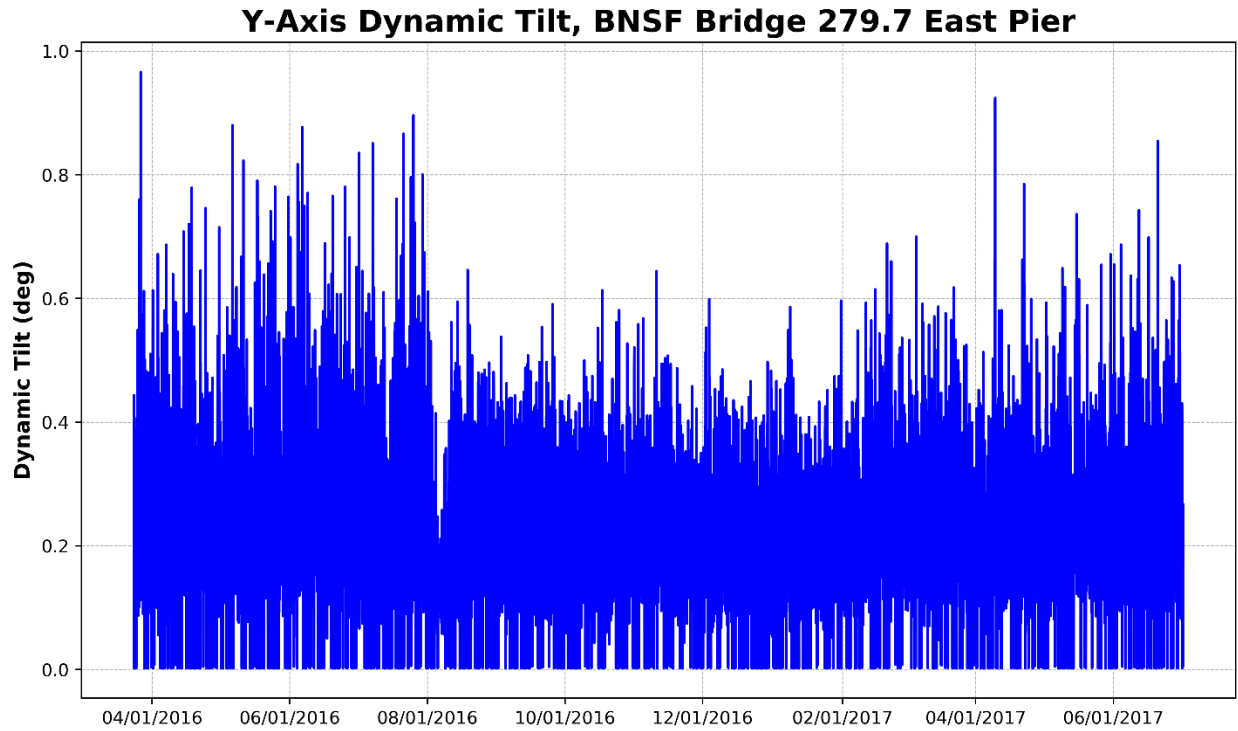
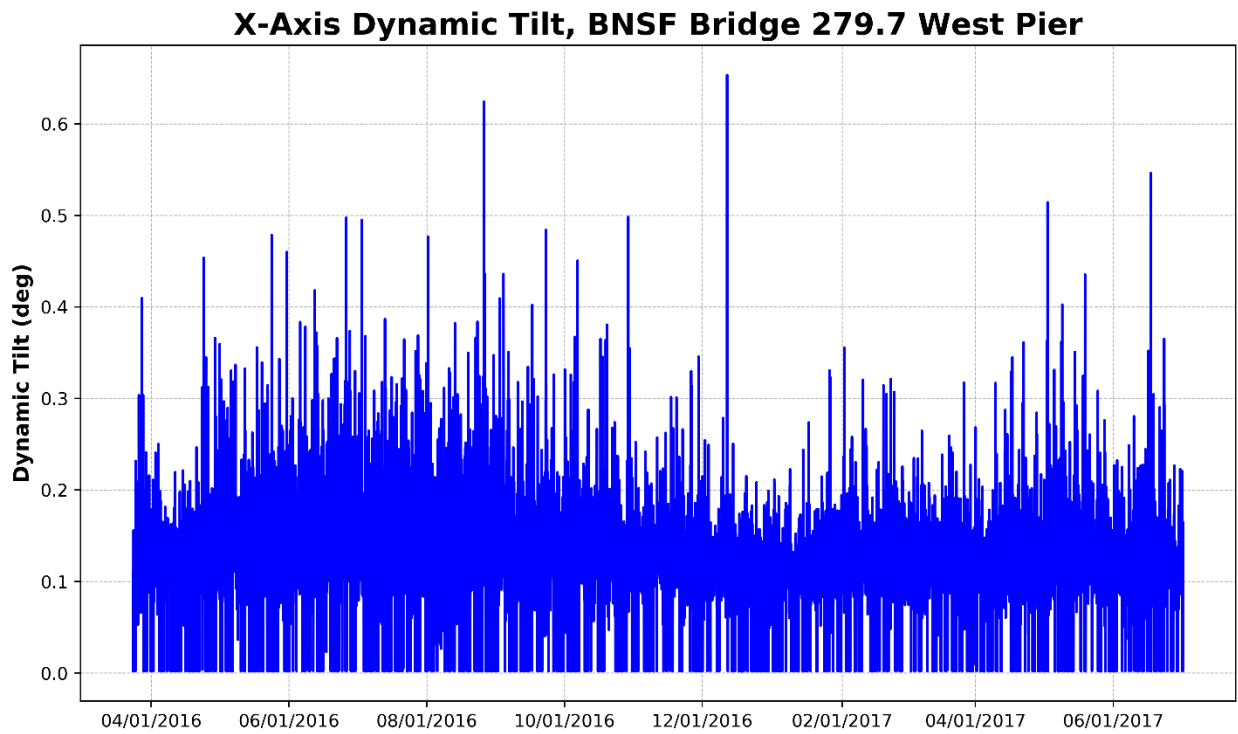
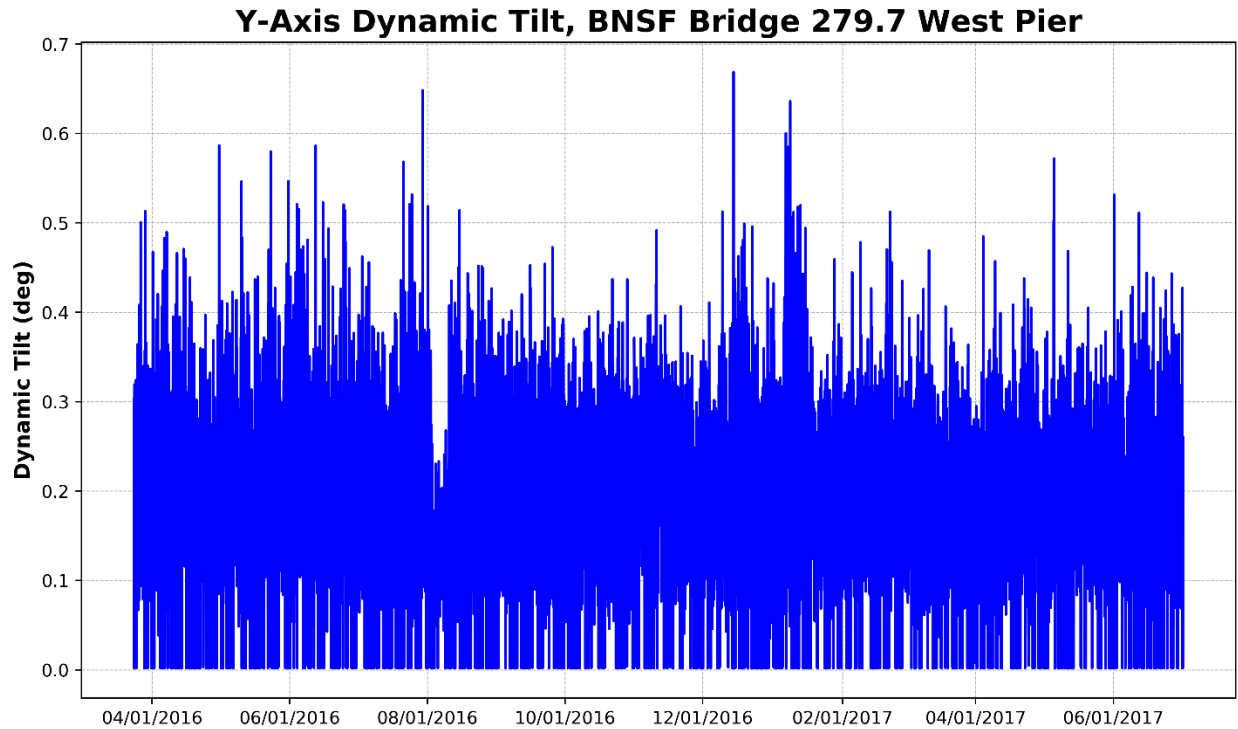
The dynamic tilt measurements collected from the east and west piers are shown in Figure 41 through Figure 44. The measurements have remained steady for both piers in both directions (perpendicular and parallel to track). This indicates that the piers dynamic response under live load has not changed since April 1, 2016.

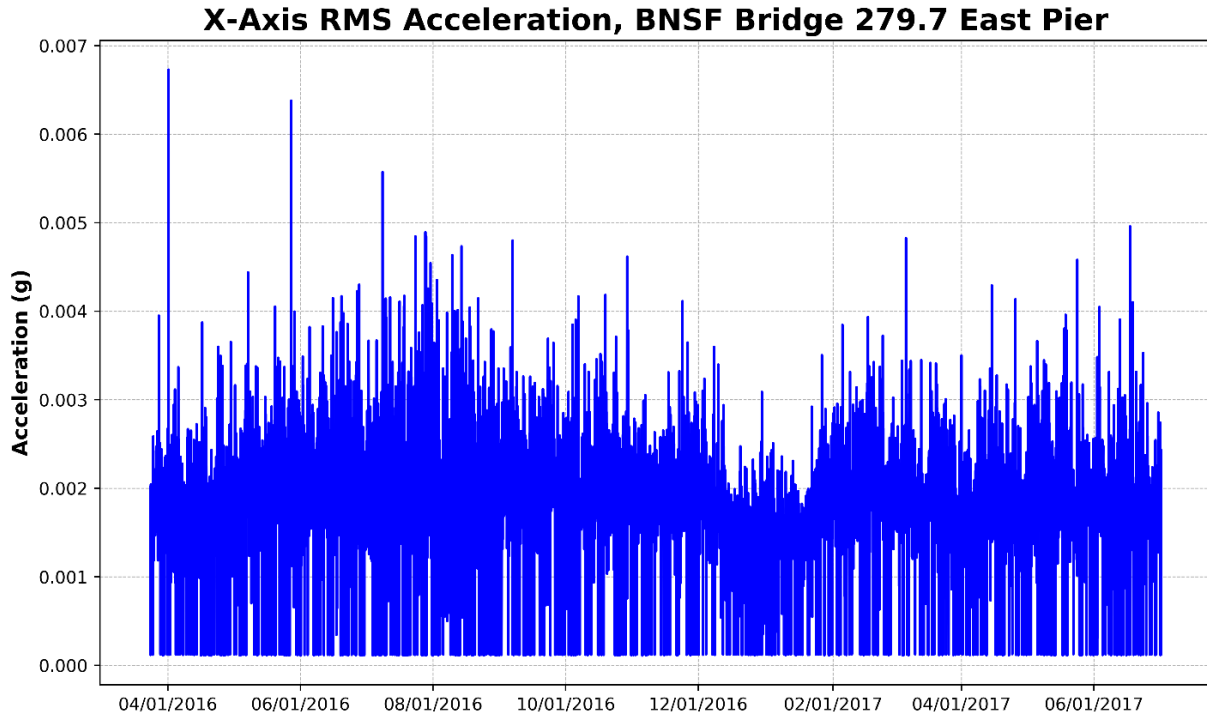
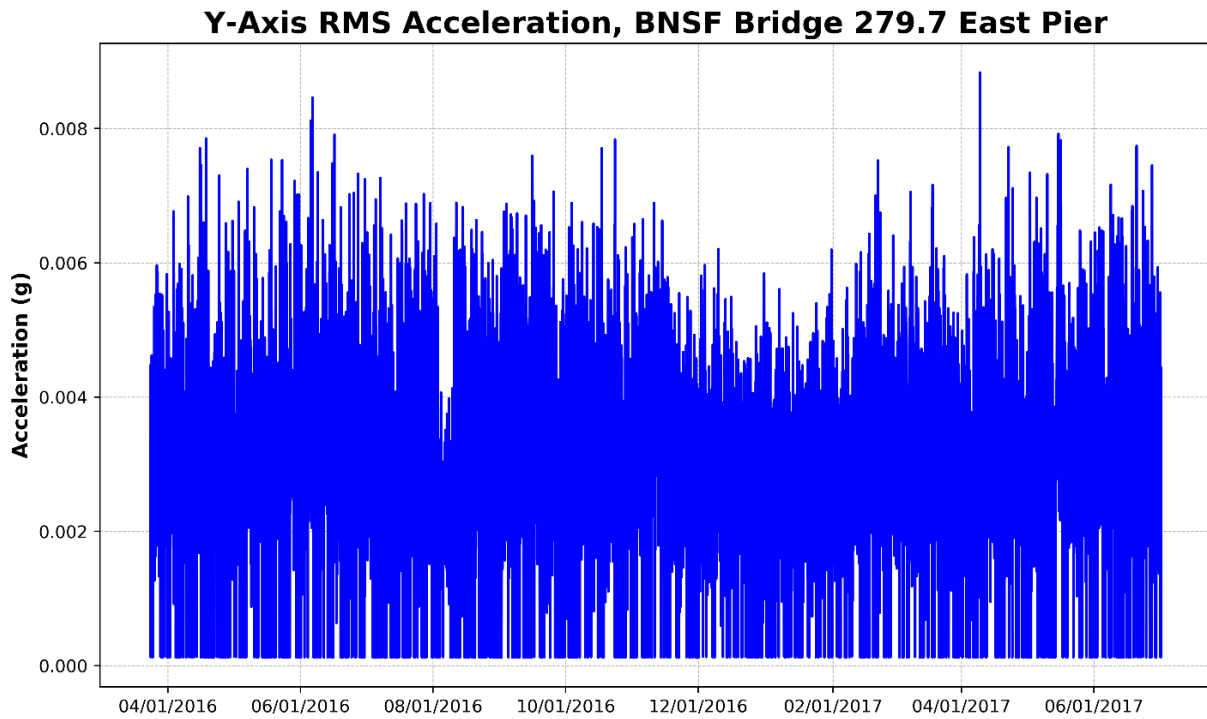
The acceleration measurements collected for the east and west piers are shown in [Figure 45](#) through [Figure 48](#). Similar to the dynamic tilt, the acceleration measurements have remained steady for both piers in both directions (perpendicular and parallel to track). There are no indications of increasing vibrations.

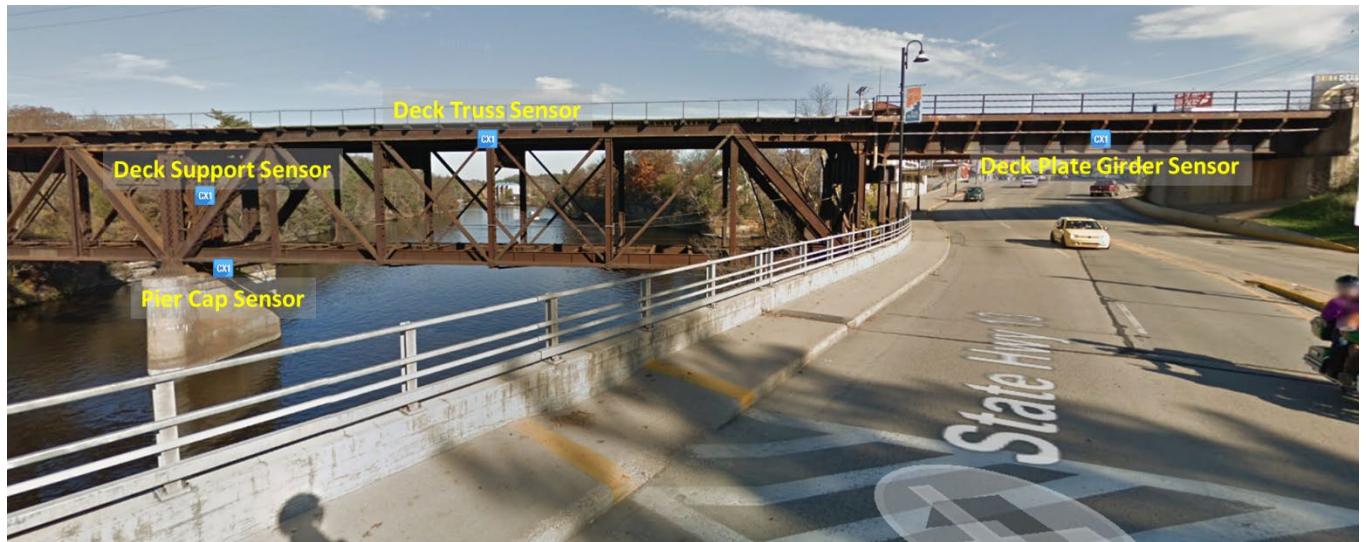
Figure 50 – CPR 195.20 Tomah Sensor Locations

This bridge is a four-span, 465-foot long, single track bridge in Wisconsin Dells, WI. Due to the configuration of this bridge, a mixture of substructure (1) and superstructure (3) elements are being monitored. The monitoring system was installed in April 2013. The location of each CX1 sensor is shown in [Figure 49](#).

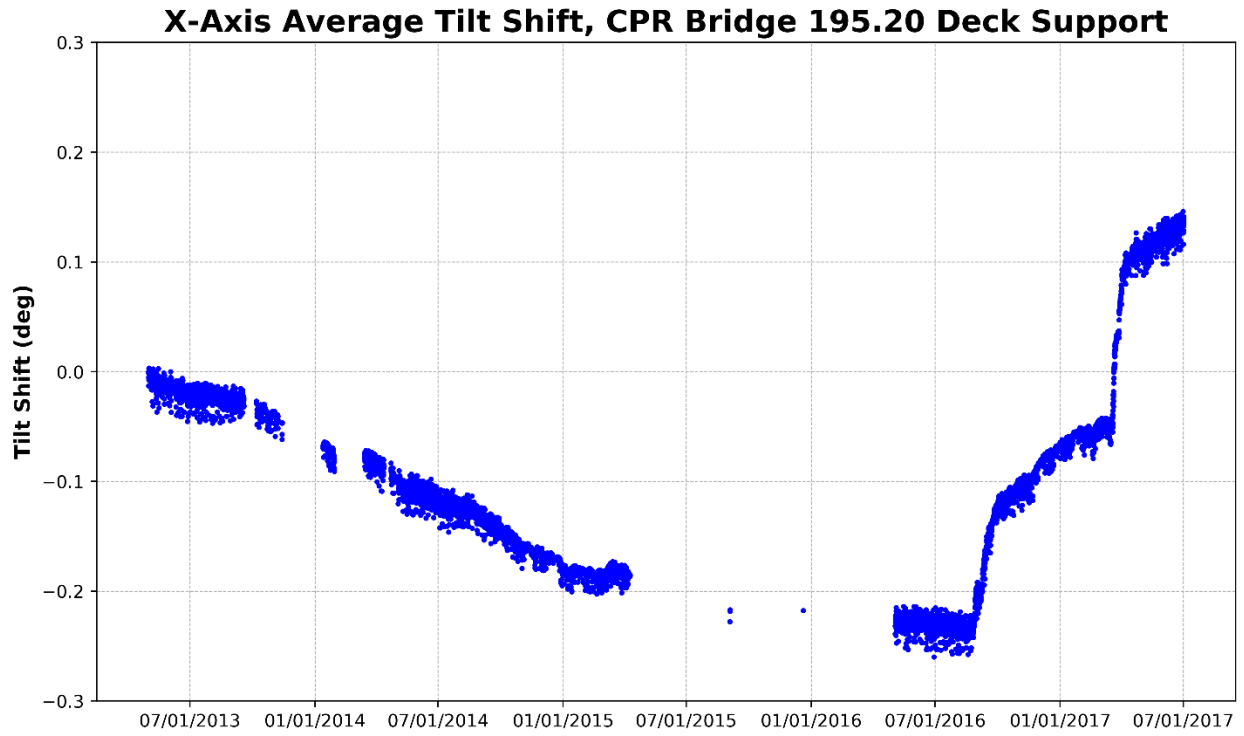
The data from the Deck Support sensor and Deck Plate Girder sensor show wide swings of variability. The parallel tilt in the Deck Support shifted 0.25 degrees from 2013 to mid-2016 before moving back the other direction. Both the parallel and perpendicular tilt shifted for the Deck Plate Girder sensor. Overall, the measurements from sensors mounted on steel are harder to interpret and less useful than data from sensors mounted directly on the piers.

**Figure 51 – Deck Support, X-Axis Average Tilt (Parallel to Track)**

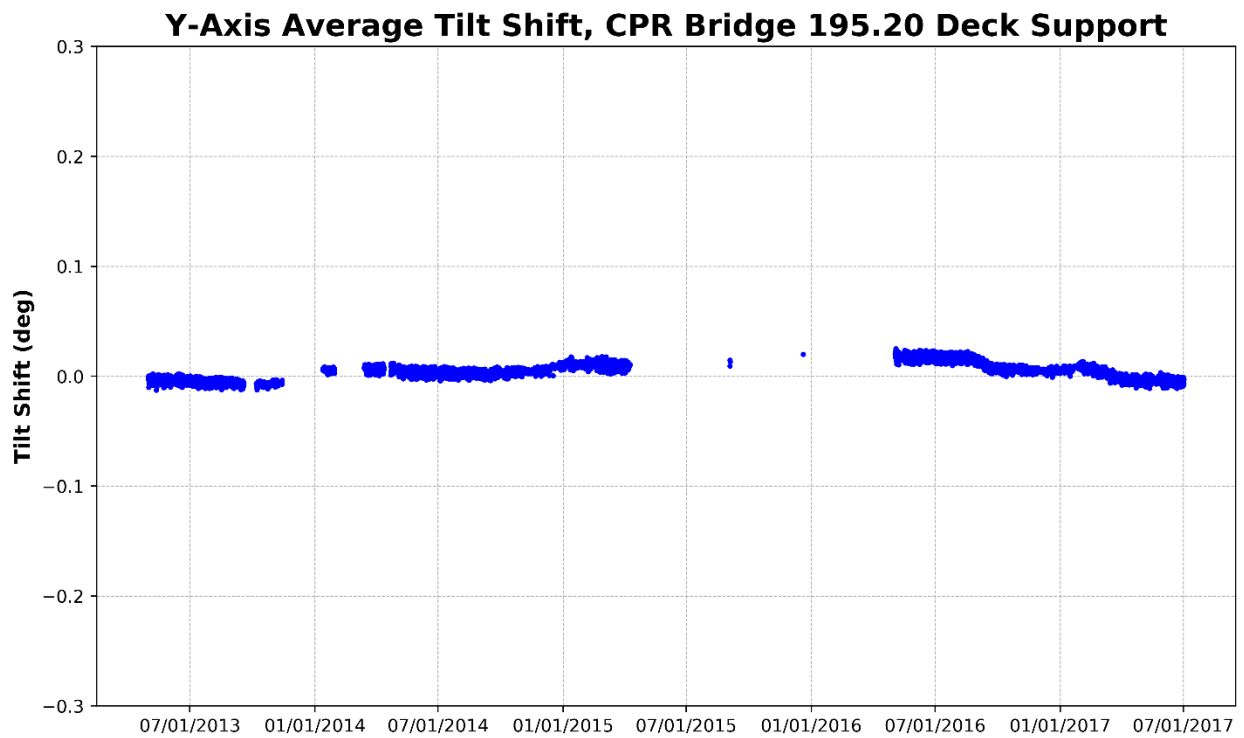
**Figure 52 – Deck Support, Y-Axis Average Tilt (Perpendicular to Track)**

The average tilt measurements collected from the Tomah bridge are shown in [Figure 50](#) through [Figure 57](#). Throughout the duration of monitoring, the tilt of the Pier Cap sensor stayed within 0.025 degrees of the starting position indicating stable behavior.
