**Federal Railroad  
Administration**

## **A New Method for Detecting the Onset of Scour and Managing Scour Critical Bridges**

9. SPONSORING/MONITORING AGENCY NAME(S) AND ADDRESS(ES) U.S. Department of Transportation Federal Railroad Administration Office of Railroad Policy and Development Office of Research, Development and Technology Washington, DC 20590			10. SPONSORING/MONITORING AGENCY REPORT NUMBER  DOT/FRA/ORD-19/32

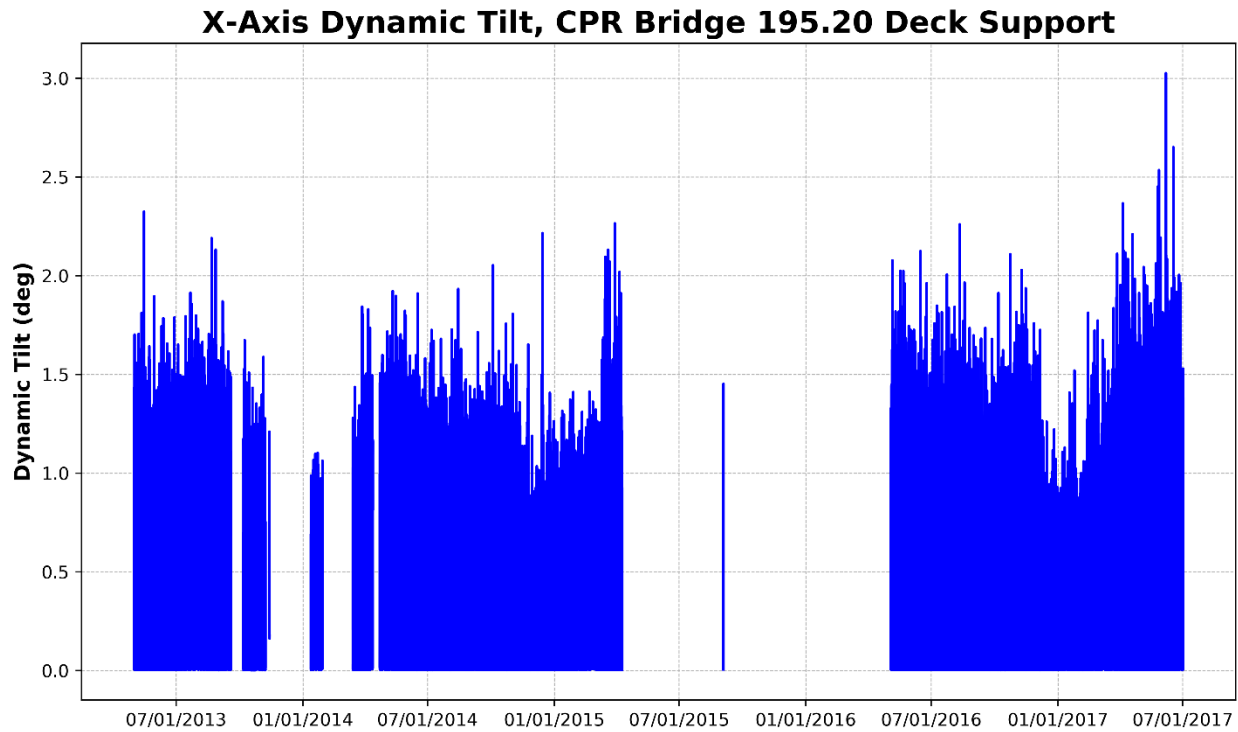
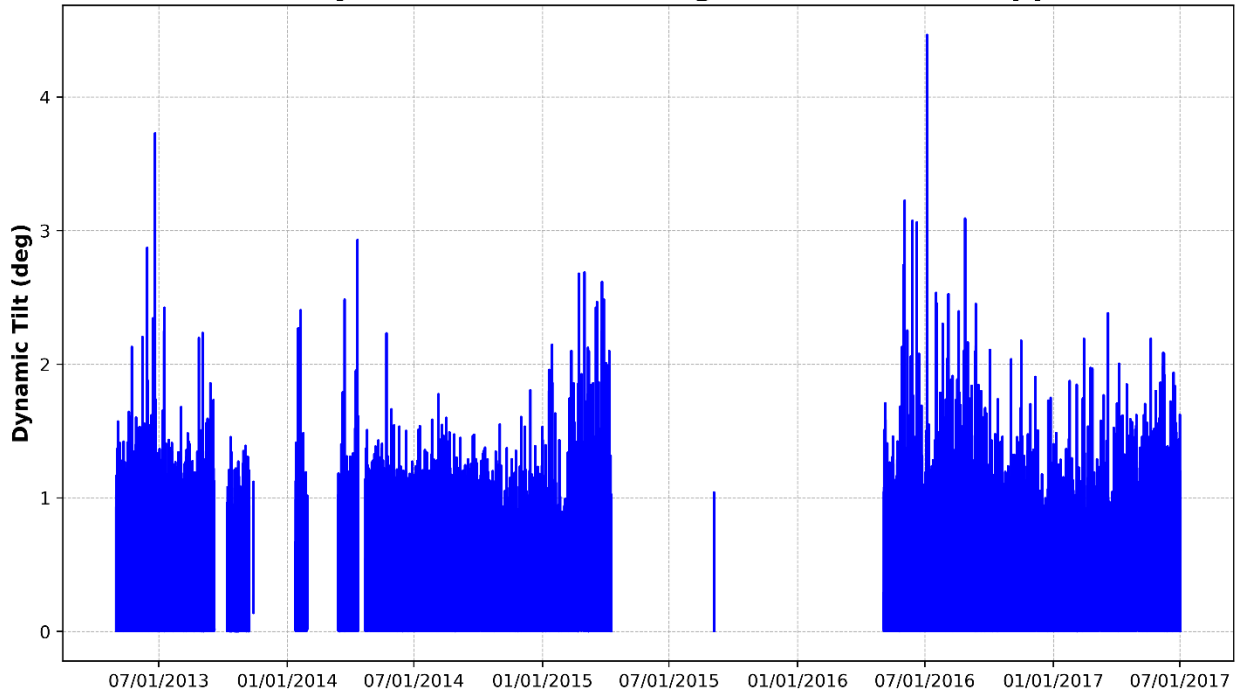
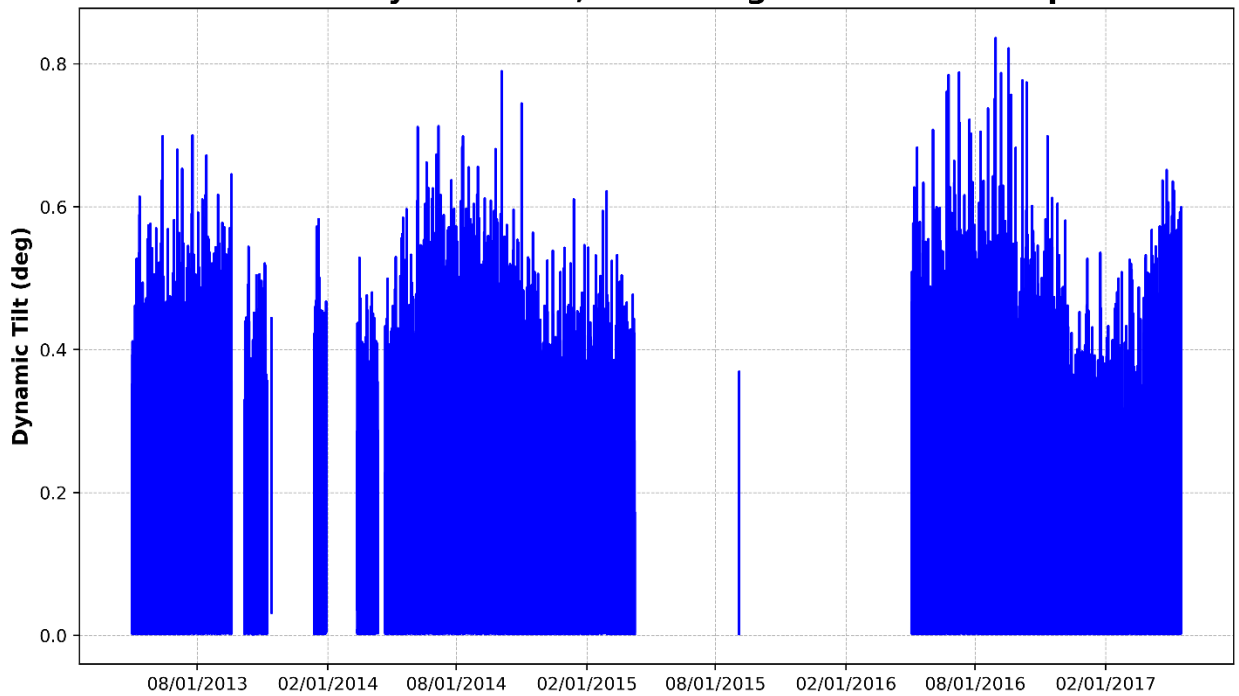
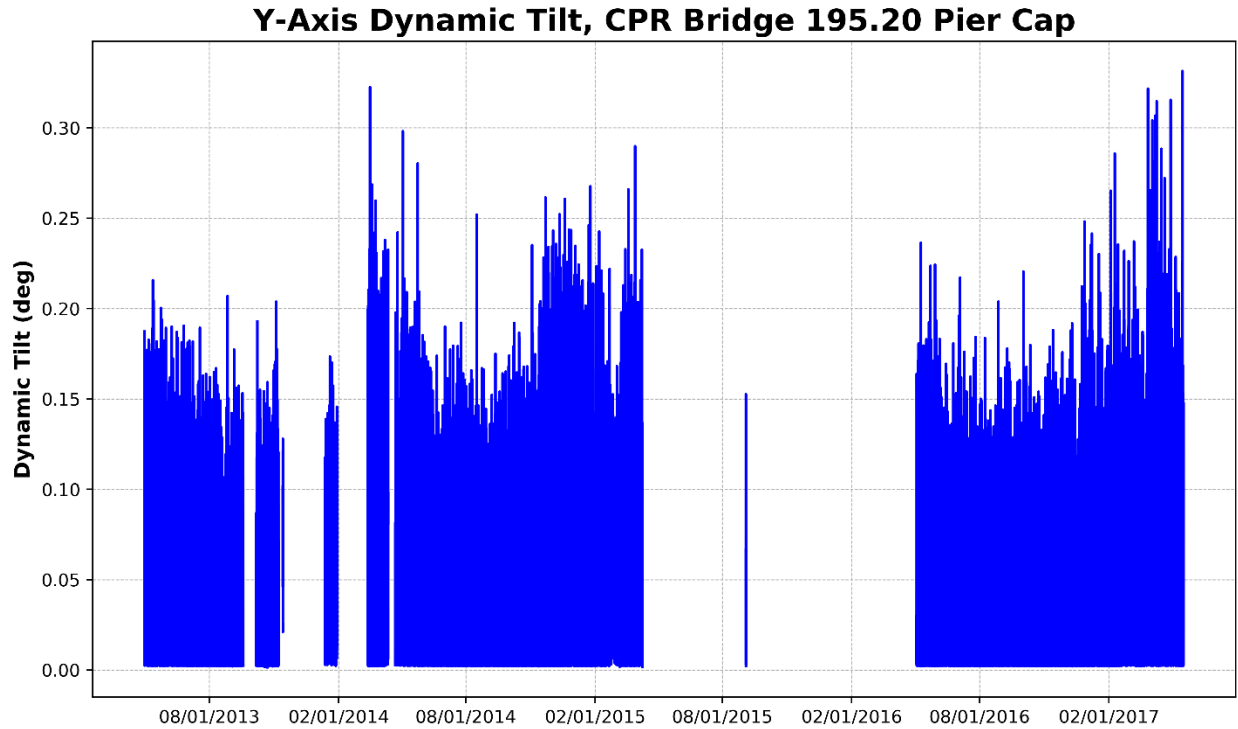
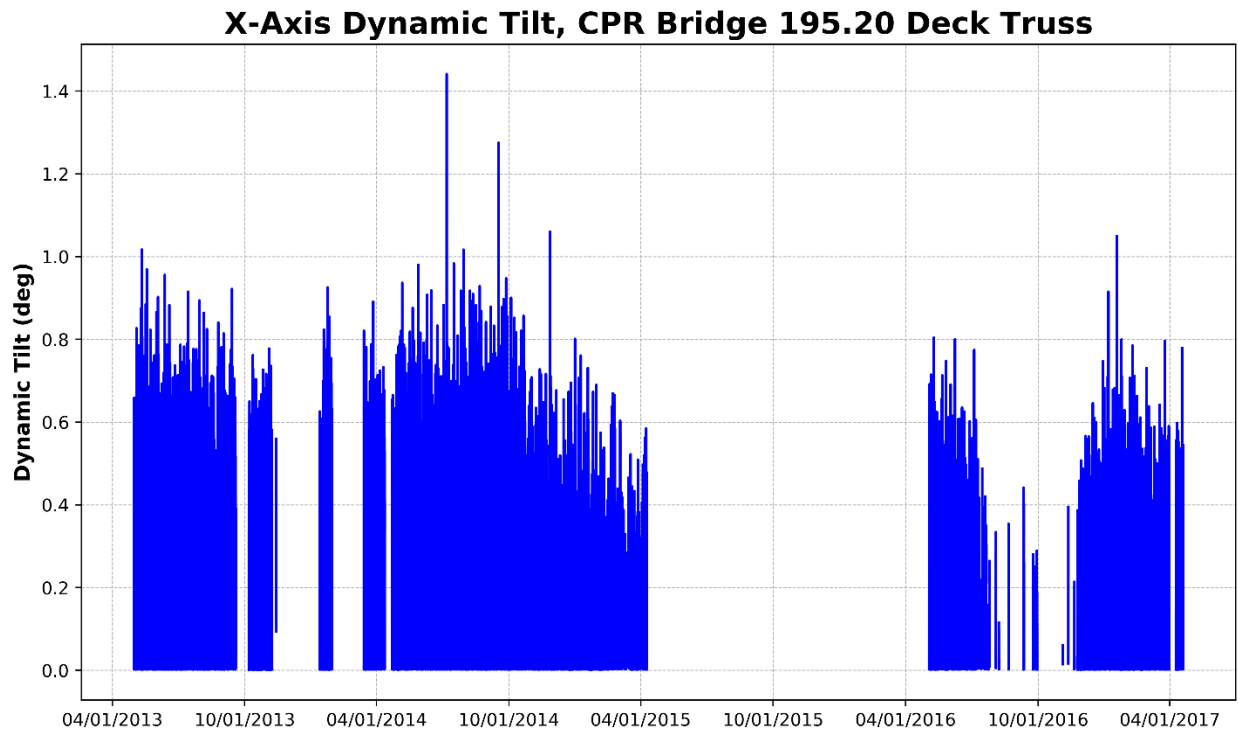
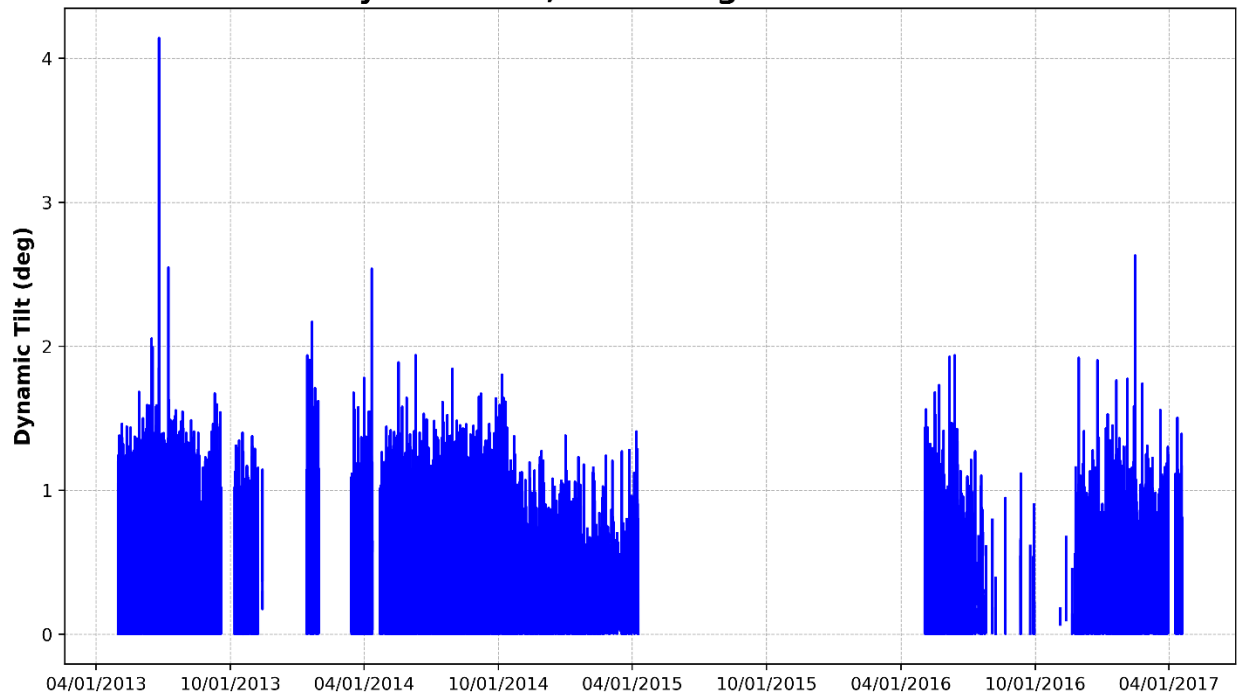
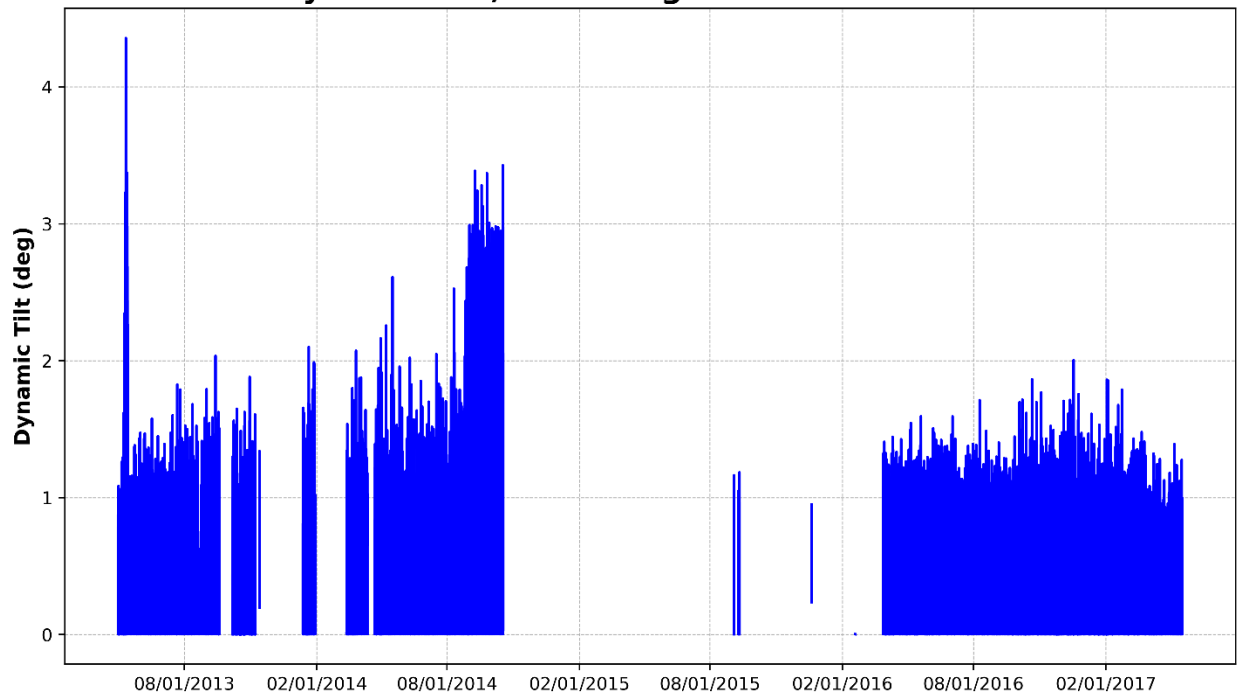
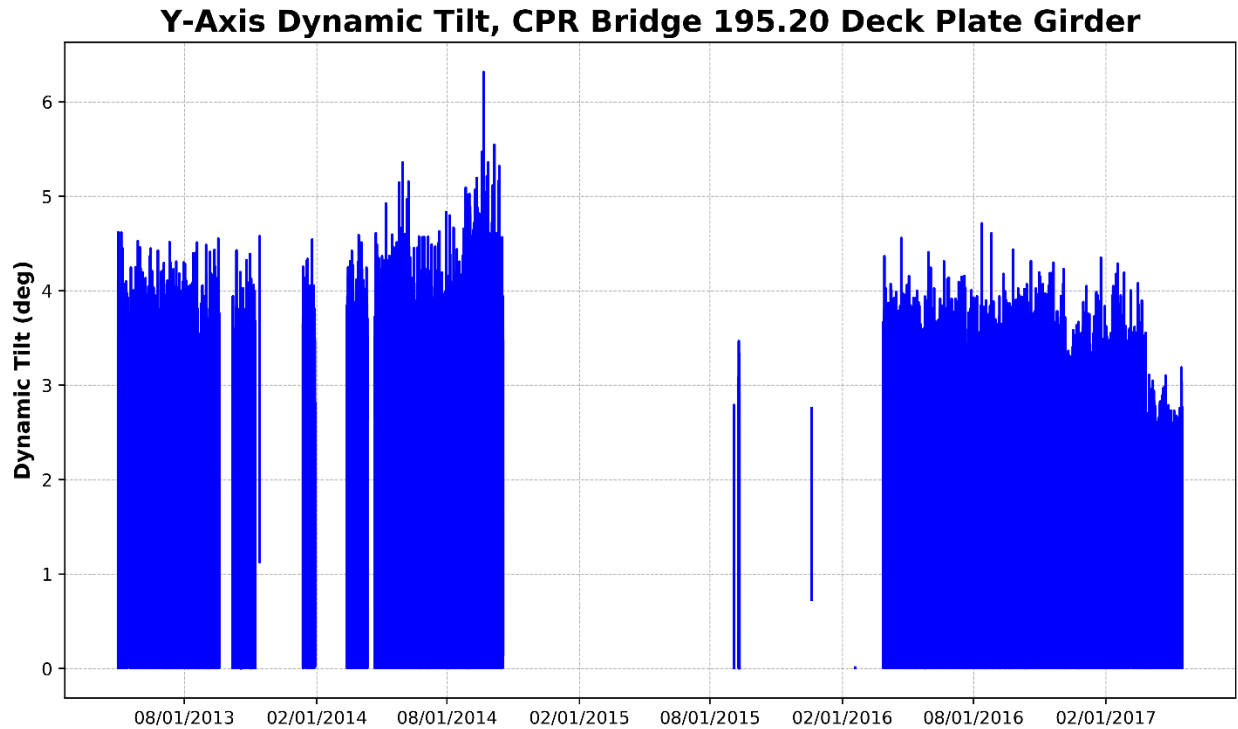
The dynamic tilt measurements collected from the Tomah bridge are shown in [Figure 58](#) through [Figure 65](#). The sensors mounted on steel record significantly higher dynamic tilt compared to the sensor on the pier cap. Overall, there are no increasing trends or outliers in the dynamic tilt data that indicate unstable conditions.

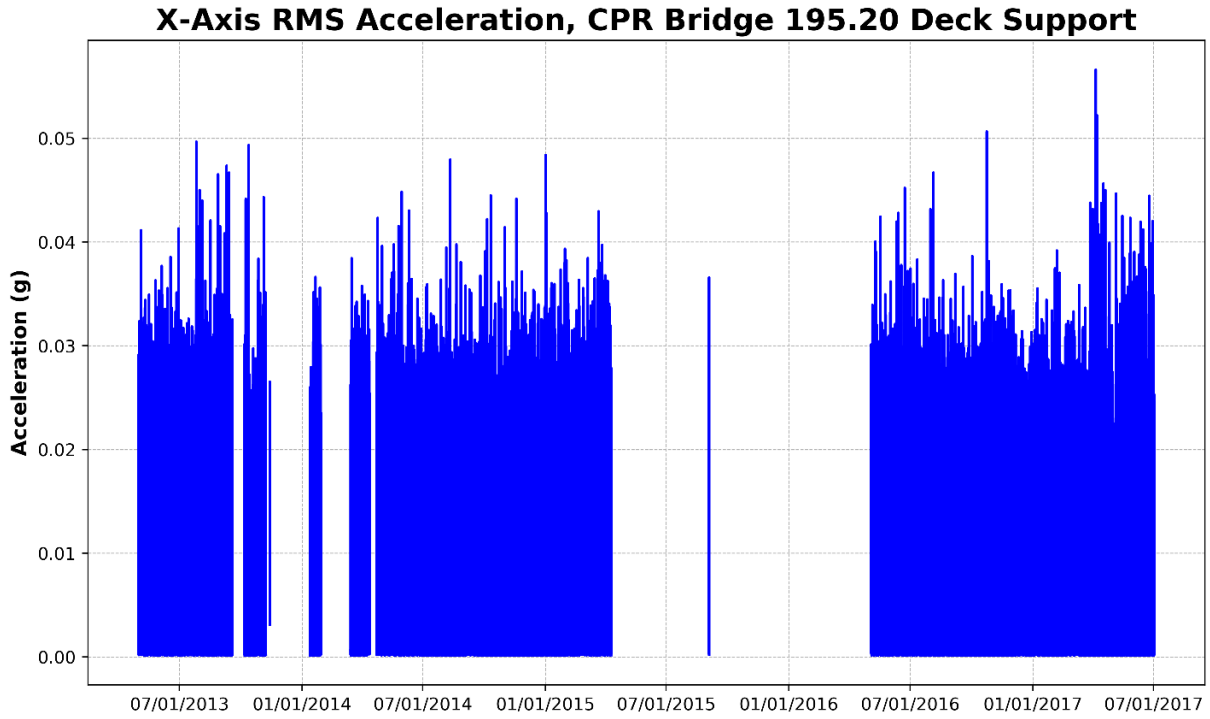
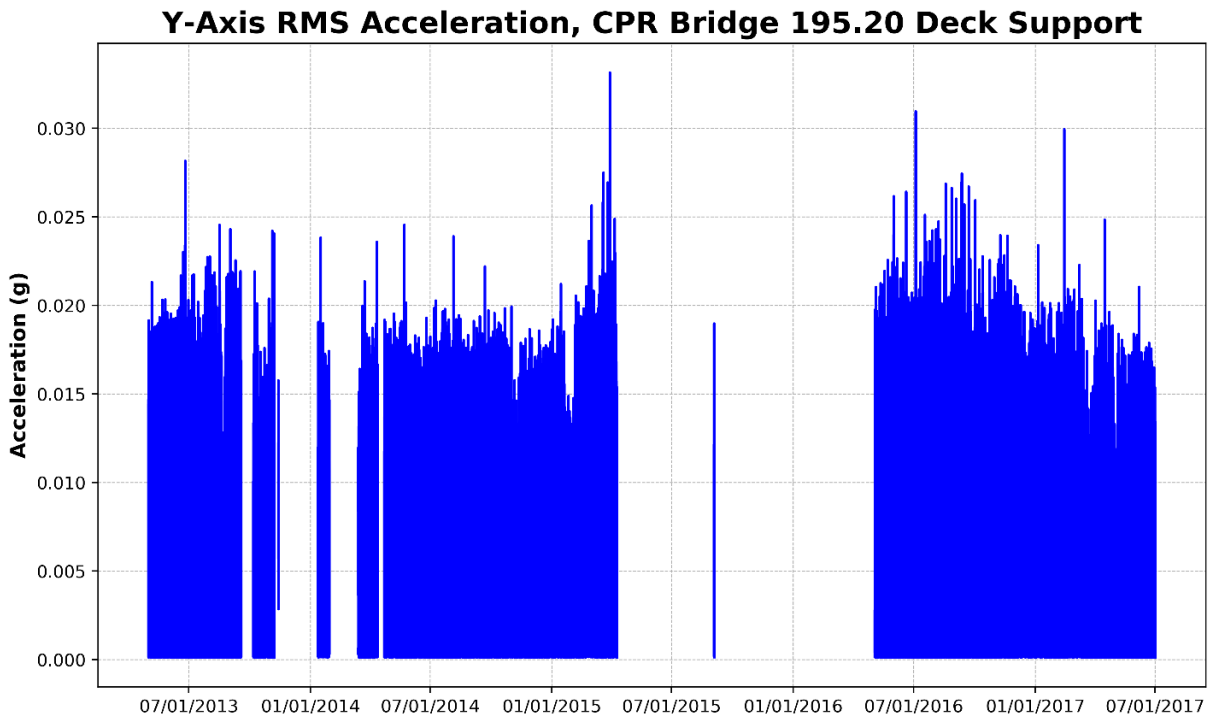
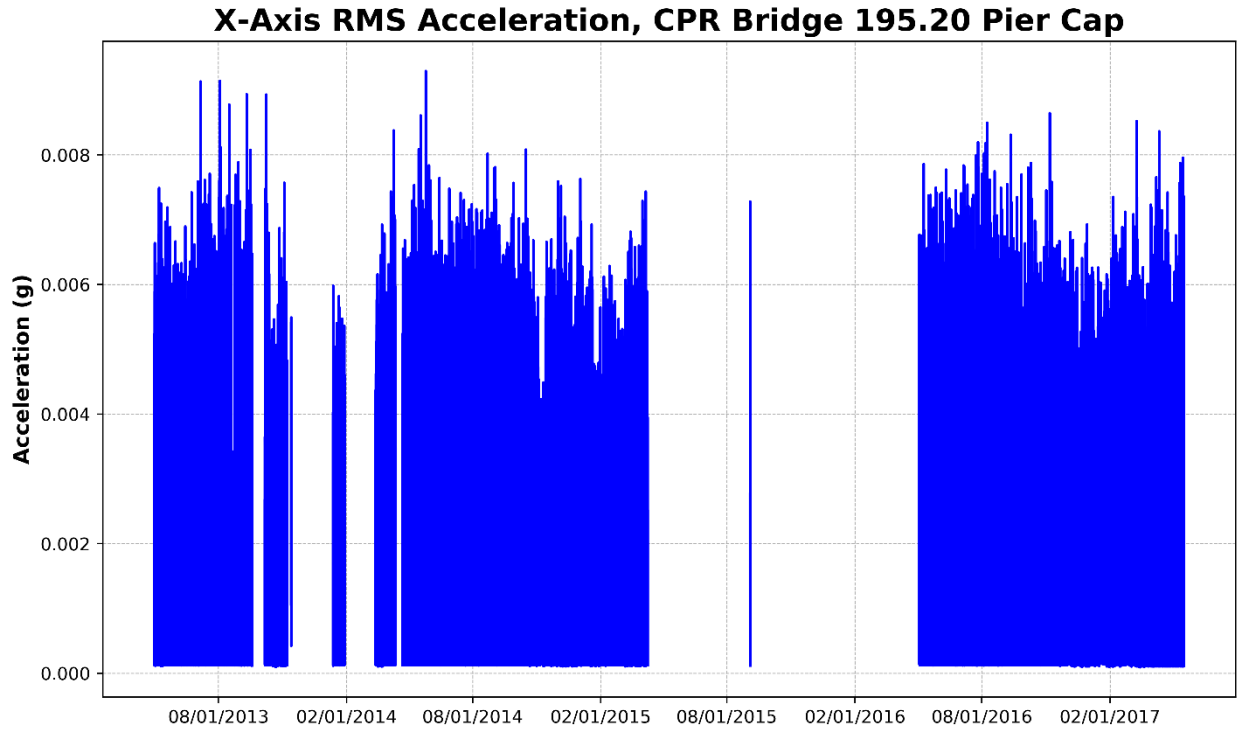
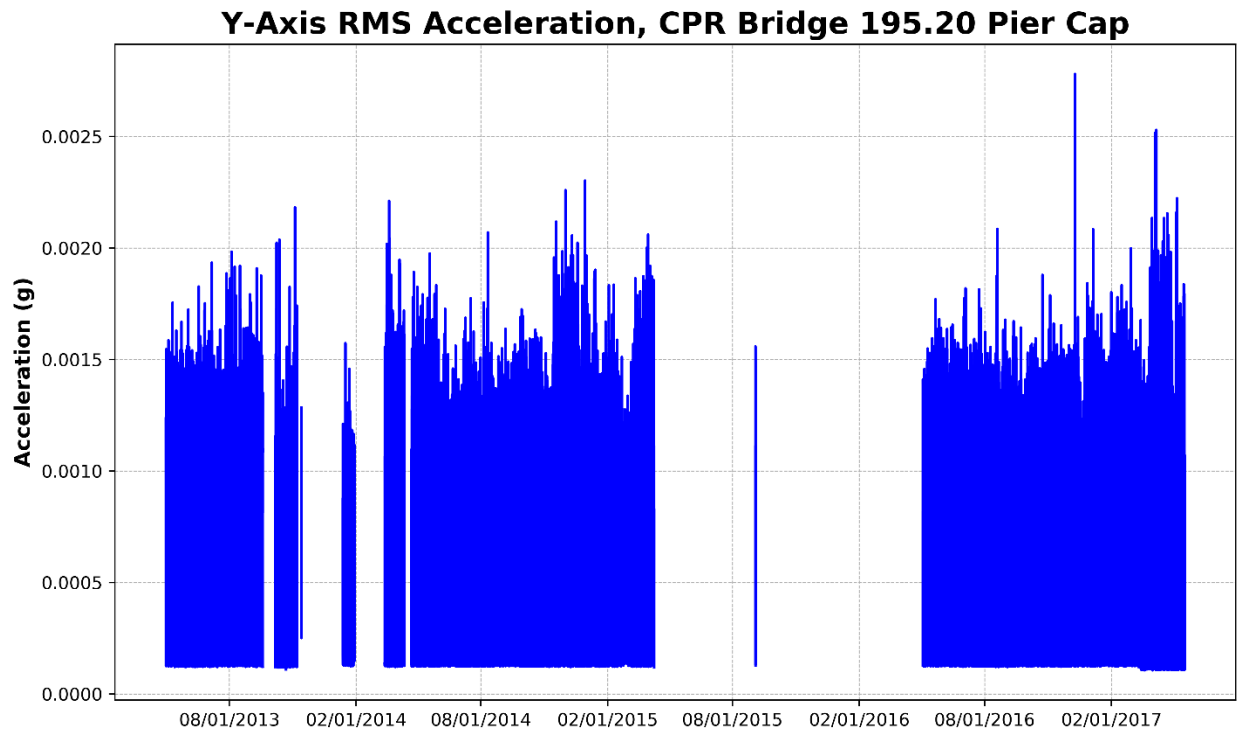
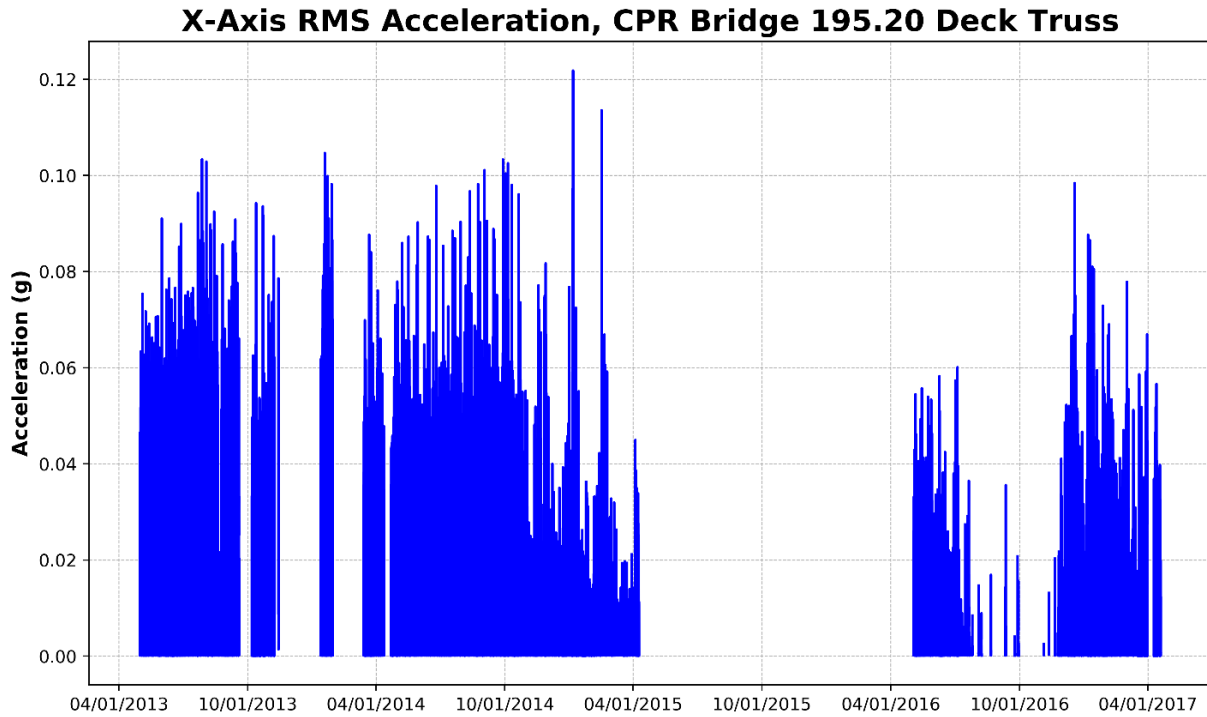
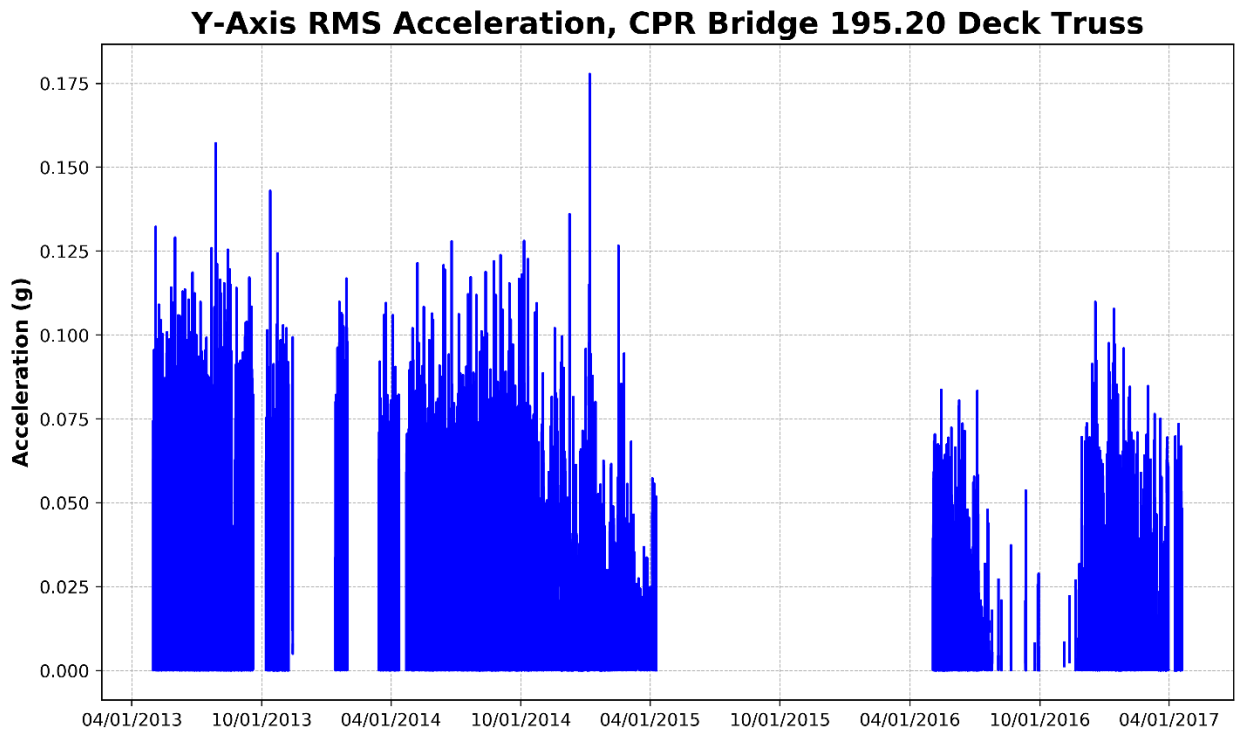
The acceleration measurements are shown in [Figure 67](#) through [Figure 73](#). The deck plate girder sensor shows a noticeable step change in December 2016 indicating an increased level of vibrations. It is recommended to investigate the girder and data to determine the cause. The acceleration data recorded from the other sensors has been relatively stable throughout the duration of monitoring.

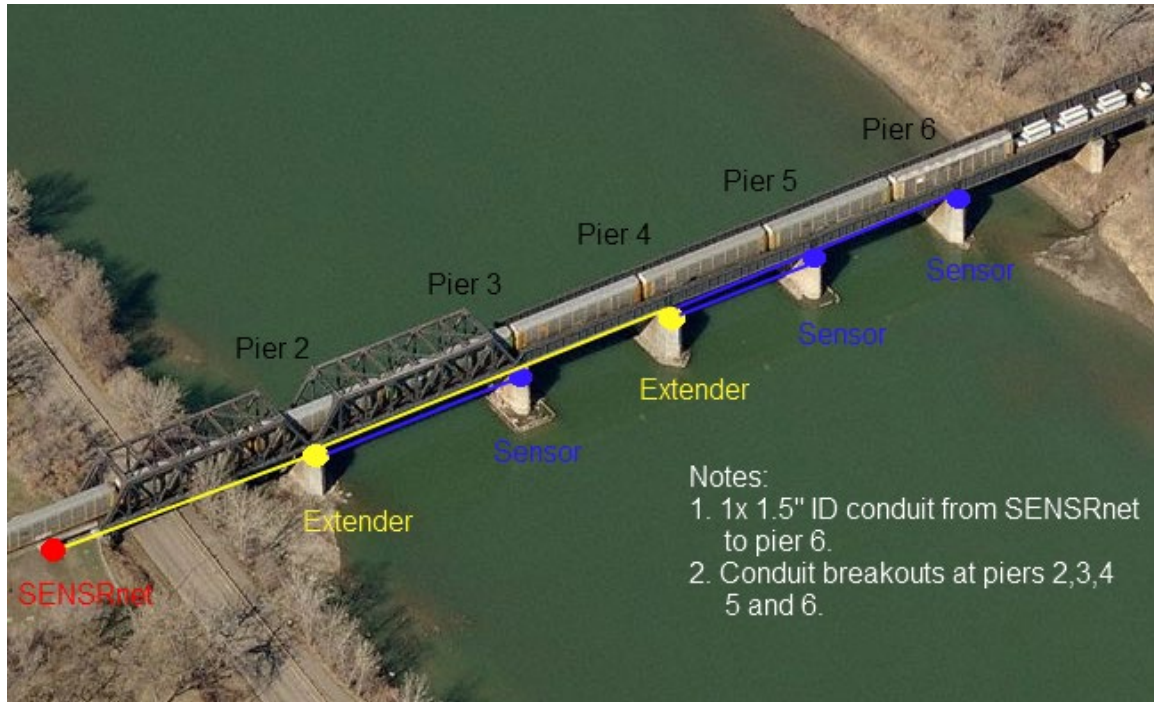
Figure 75 – CPR Medicine Hat Monitoring System Layout

This bridge is a seven-span, 1,012-foot long double track bridge located in Medicine Hat, AB. The bridge spans the South Saskatchewan River. Piers 3, 5, and 6 are being monitored as shown in Figure 74. The monitoring system was installed in November 2013.

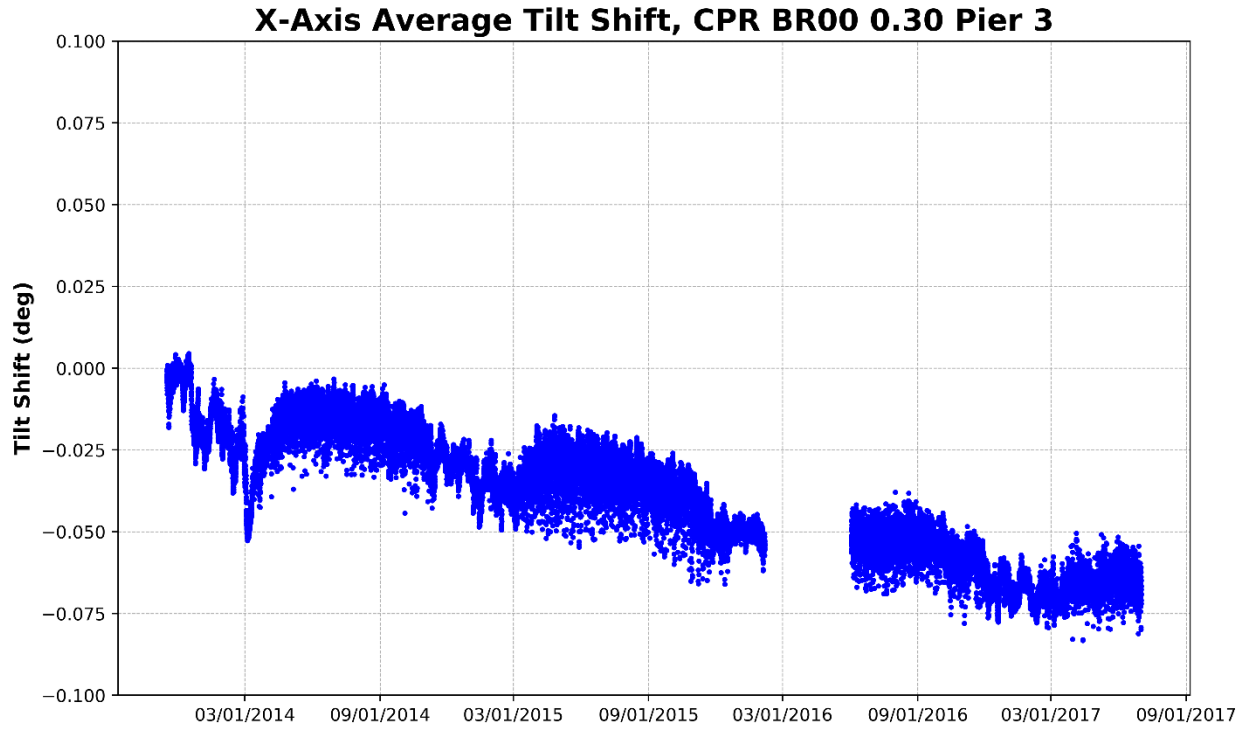
The average tilt charts are shown in Figure 75 through Figure 80. For all piers monitored, the tilt perpendicular to the track has remained within 0.03 degrees of the starting point since November 2013. The tilt parallel to the track has been more variable. The parallel tilt of Pier 3 has shifted approximately 0.075 degrees, indicating a possible change in conditions.

**Figure 76 – Pier 3, X-Axis Average Tilt (Parallel to Track)**

The tilt of Pier 3 has shifted up to 0.075 degrees since monitoring began. This magnitude of change warrants continued monitoring to watch for further changes. The data collected from Piers 5 and 6 does not indicate any changing conditions or alarming behavior.

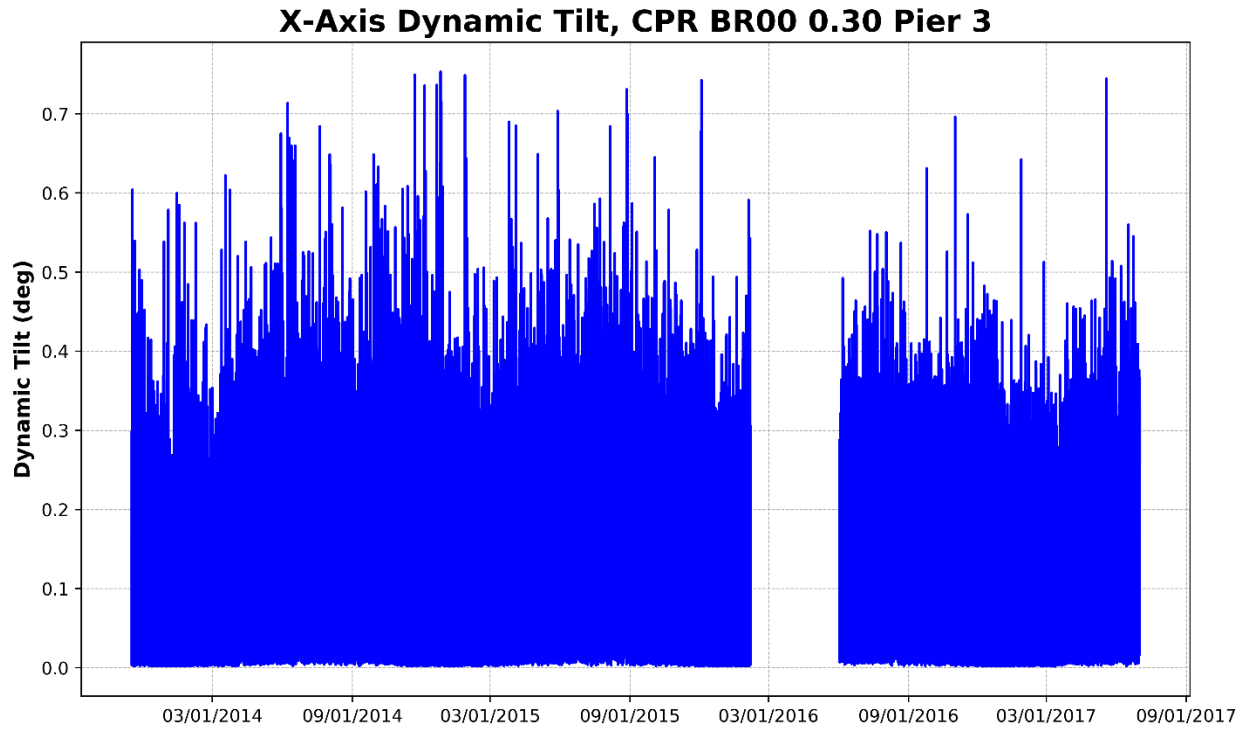
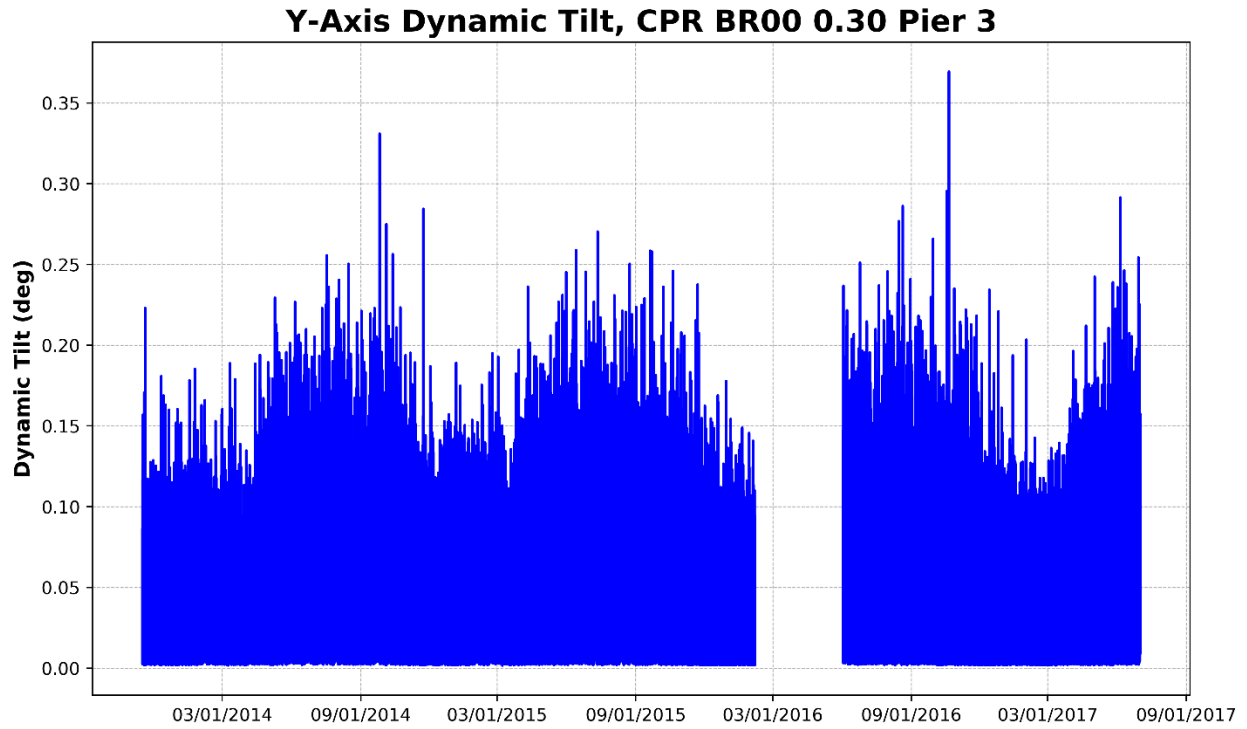
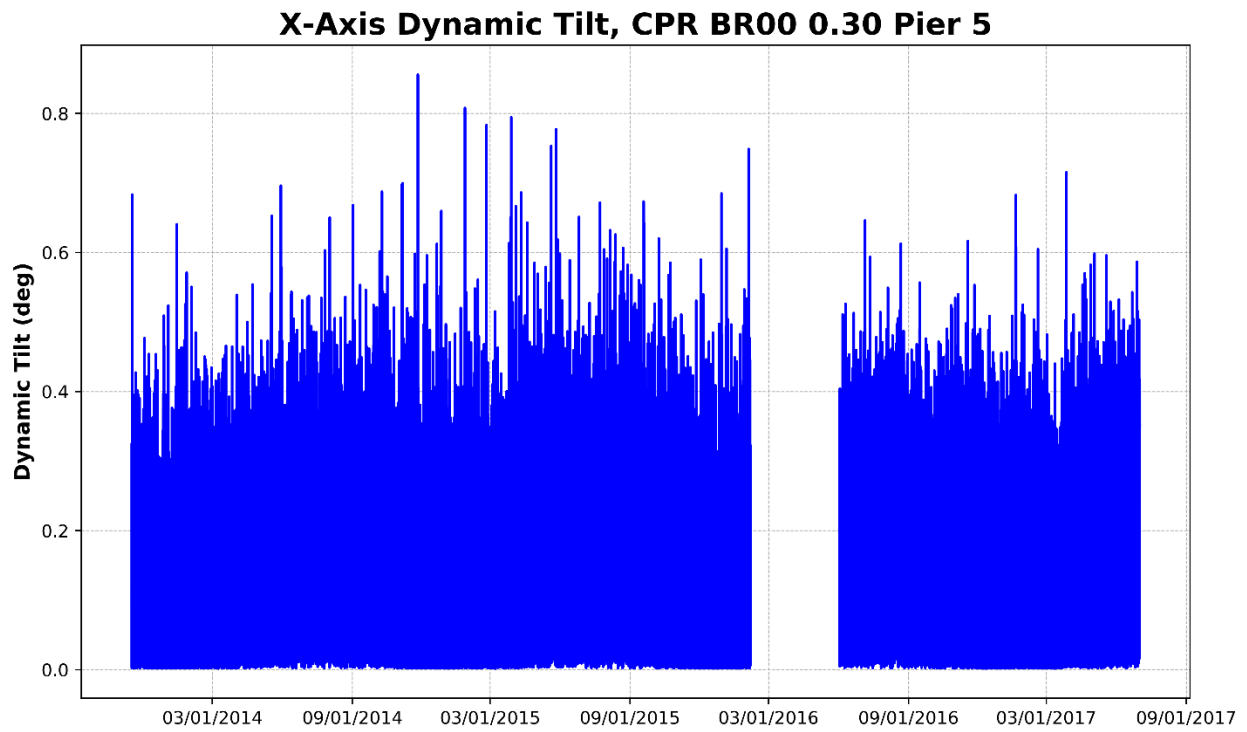
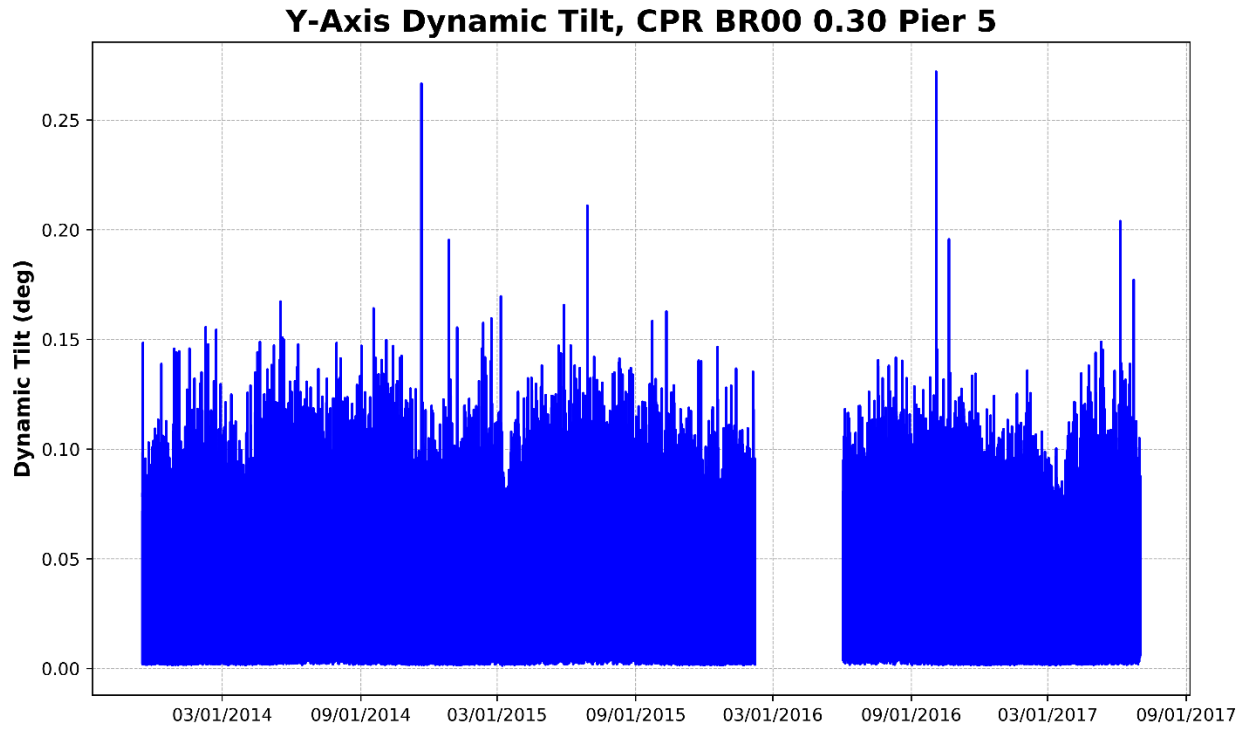
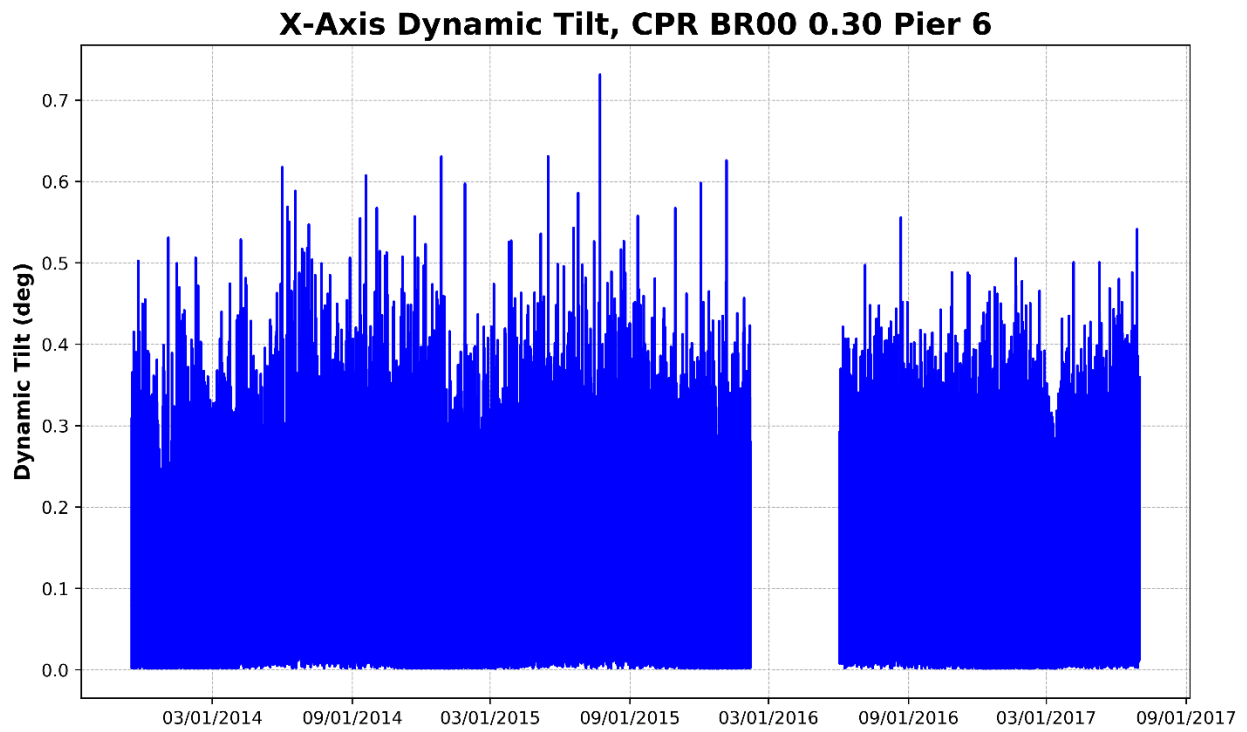
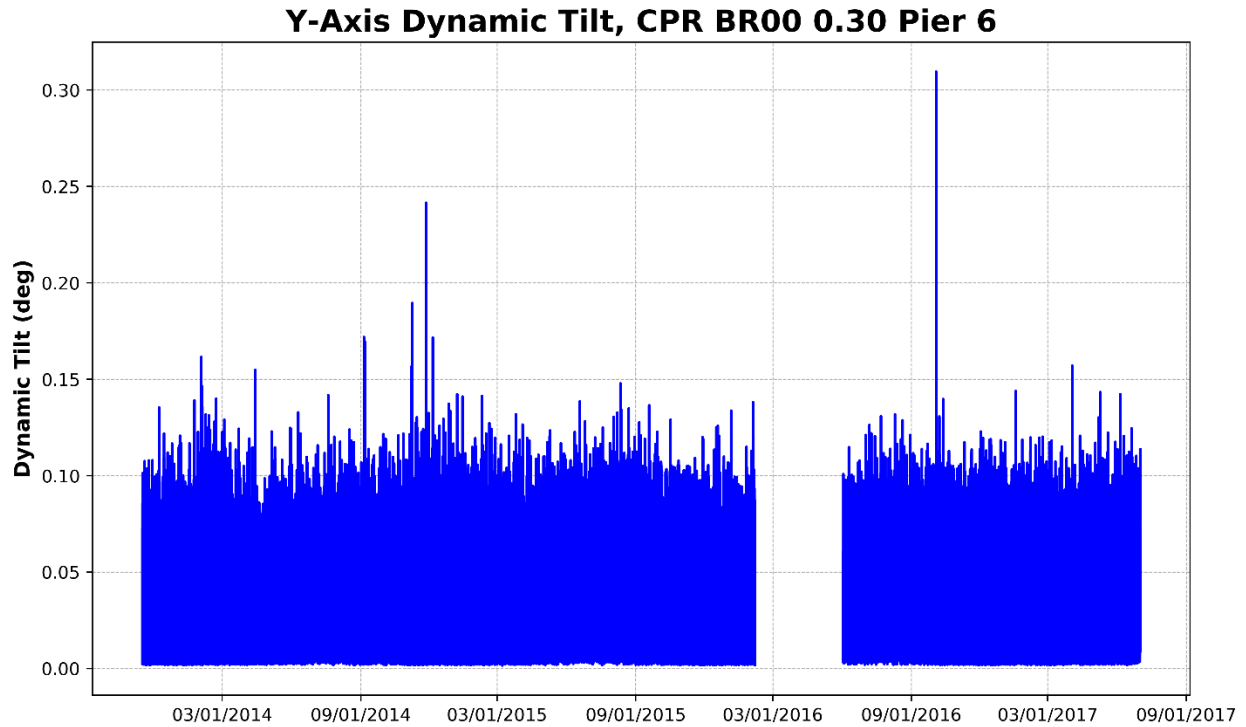
The dynamic tilt charts are shown in [Figure 81](#) through [Figure 86](#). Overall, there are no increasing trends or outliers that indicate unstable conditions.

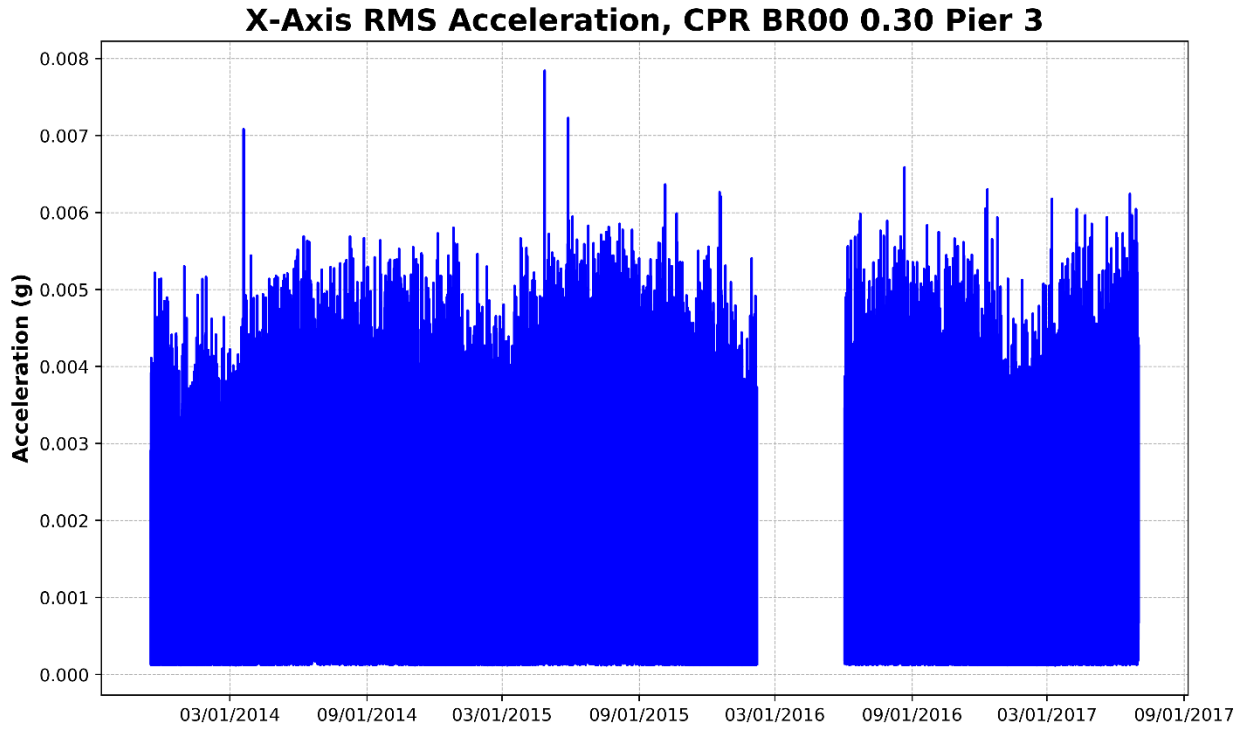
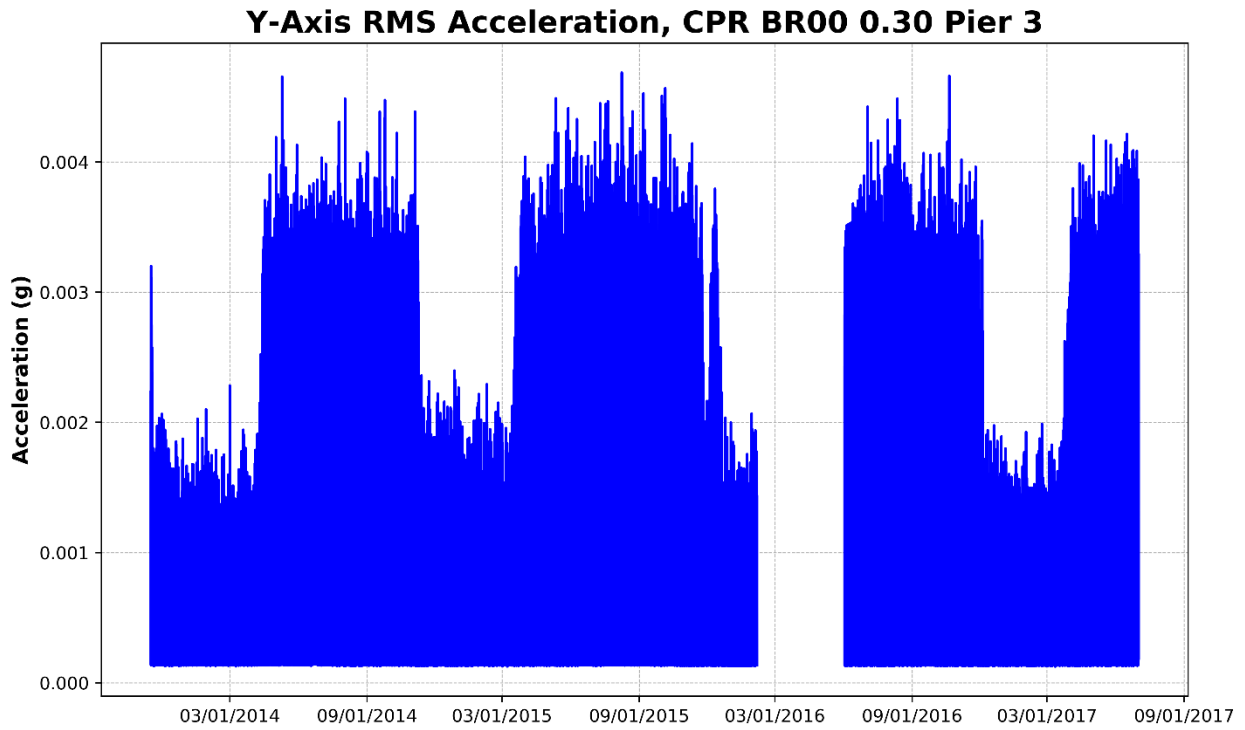
The acceleration plots are provided in [Figure 87](#) through [Figure 92](#). The data collected from Piers 3 and 5 show an interesting trend of lower vibration during the winter compared to the warmer months. This is likely related to the water level of the river and formation of ice.

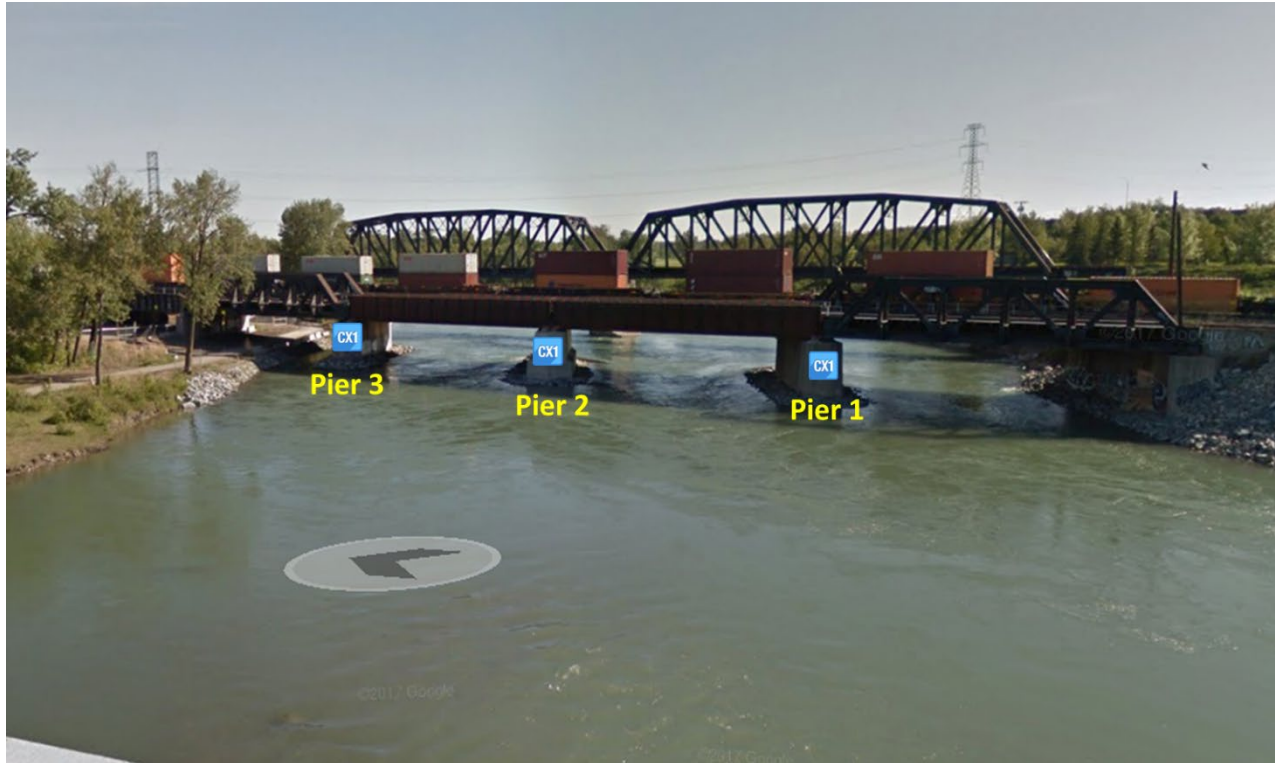
CPR BR00 172.46 is a five-span, 465-foot long bridge located in Calgary, AB. This bridge underwent reconstruction throughout the course of monitoring. Piers 1, 2, and 3 have a single CX1 installed as shown in [Figure 93](#).

**Figure 94 – Sensor Locations on CPR Calgary Bridge 172.46**
