**Federal Railroad  
Administration**

## **A New Method for Detecting the Onset of Scour and Managing Scour Critical Bridges**

9. SPONSORING/MONITORING AGENCY NAME(S) AND ADDRESS(ES) U.S. Department of Transportation Federal Railroad Administration Office of Railroad Policy and Development Office of Research, Development and Technology Washington, DC 20590			10. SPONSORING/MONITORING AGENCY REPORT NUMBER  DOT/FRA/ORD-19/32

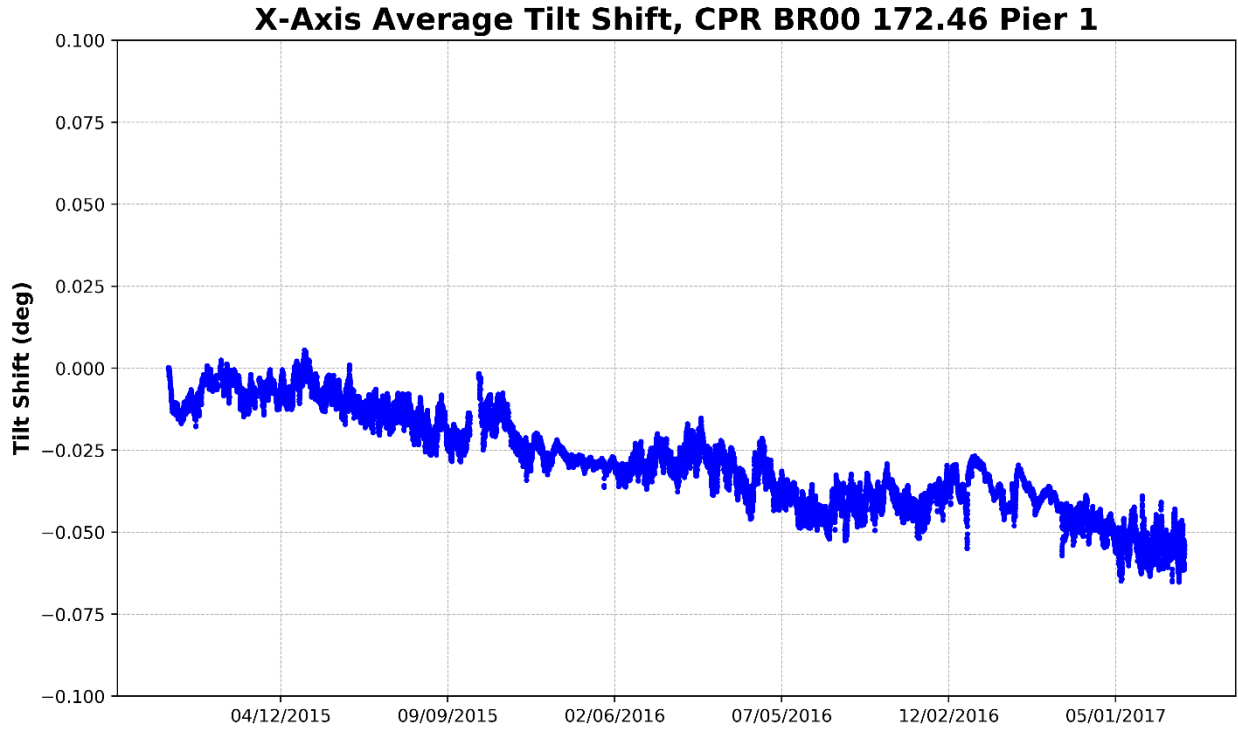
**Figure 95 – Pier 1, X-Axis Average Tilt (Perpendicular to Track)**

The average tilt charts are shown in [Figure 94](#) through [Figure 99](#). Piers 2 and 3 are within 0.03 degrees of their starting points both perpendicular and parallel to the track. Pier 1 has shifted over 0.05 degrees perpendicular to the track at a steady rate since monitoring began. It is recommended to continue watching this trend to see if it continues.

Pier 1 has shifted over 0.05 degrees perpendicular to the track at a steady rate since monitoring began. Continued monitoring is recommended to determine if the movement will continue. Piers 2 and 3 have not shown any alarming data.

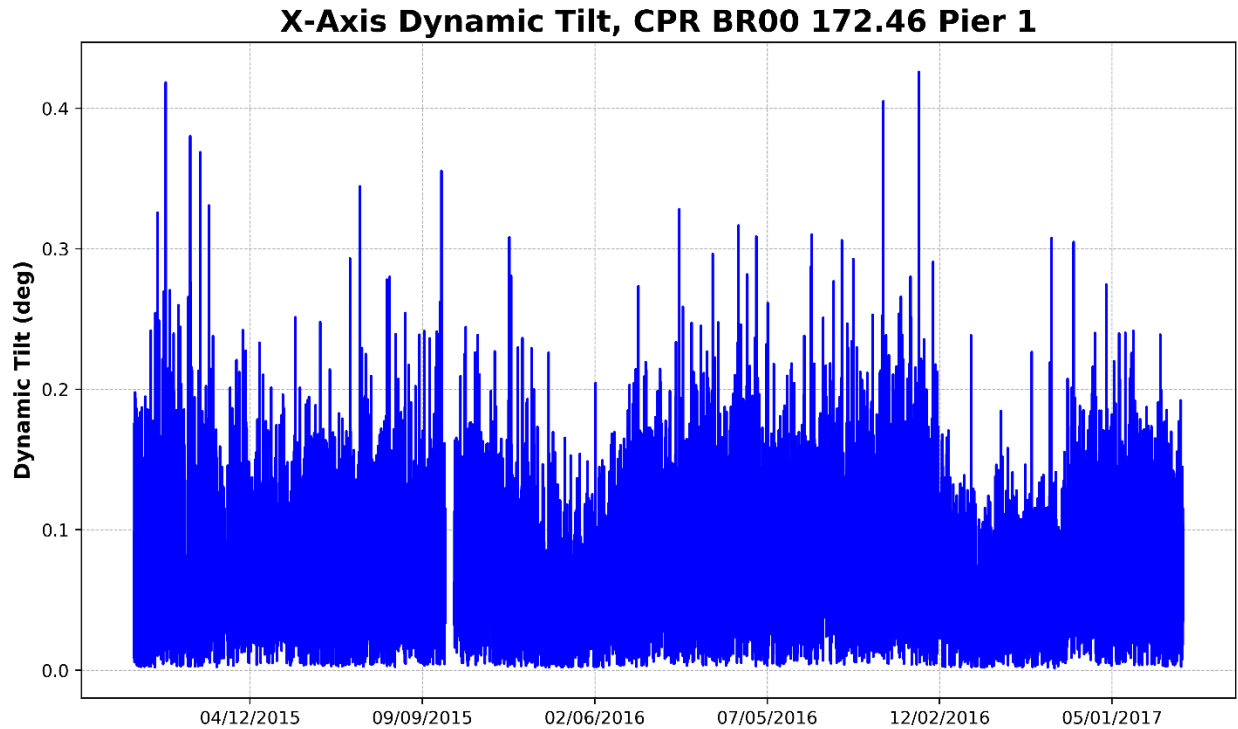
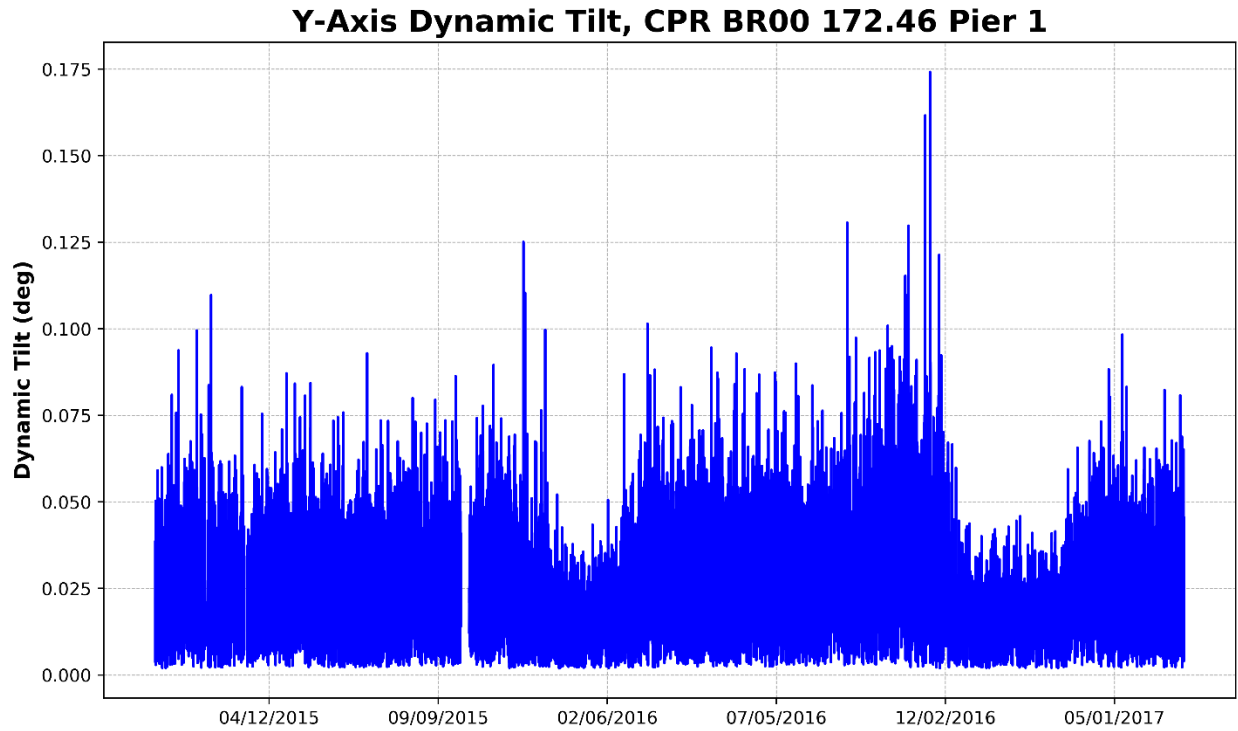
The dynamic tilt charts are shown in [Figure 100](#) through [Figure 105](#). The Pier 2 sensor recorded two outlier responses with magnitudes well above the normal range. The first was recorded in September 2015 and the second in April 2016. It is possible these correspond to construction related activities.

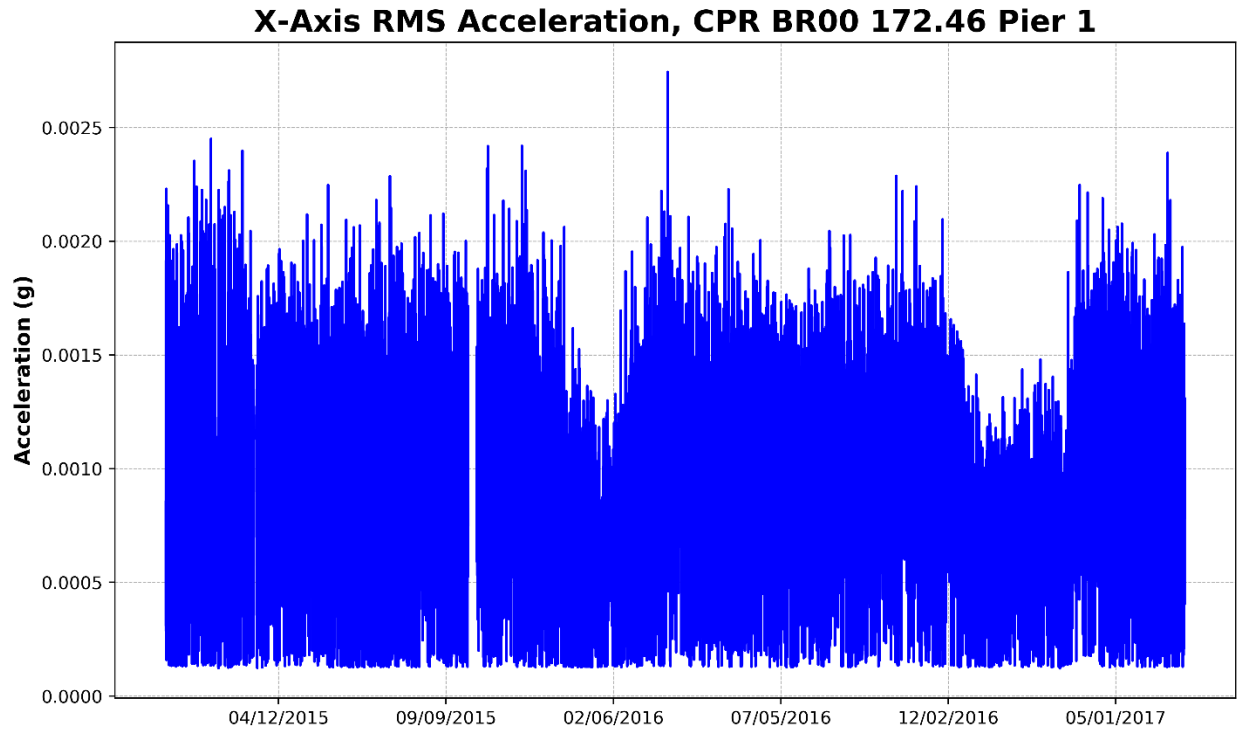
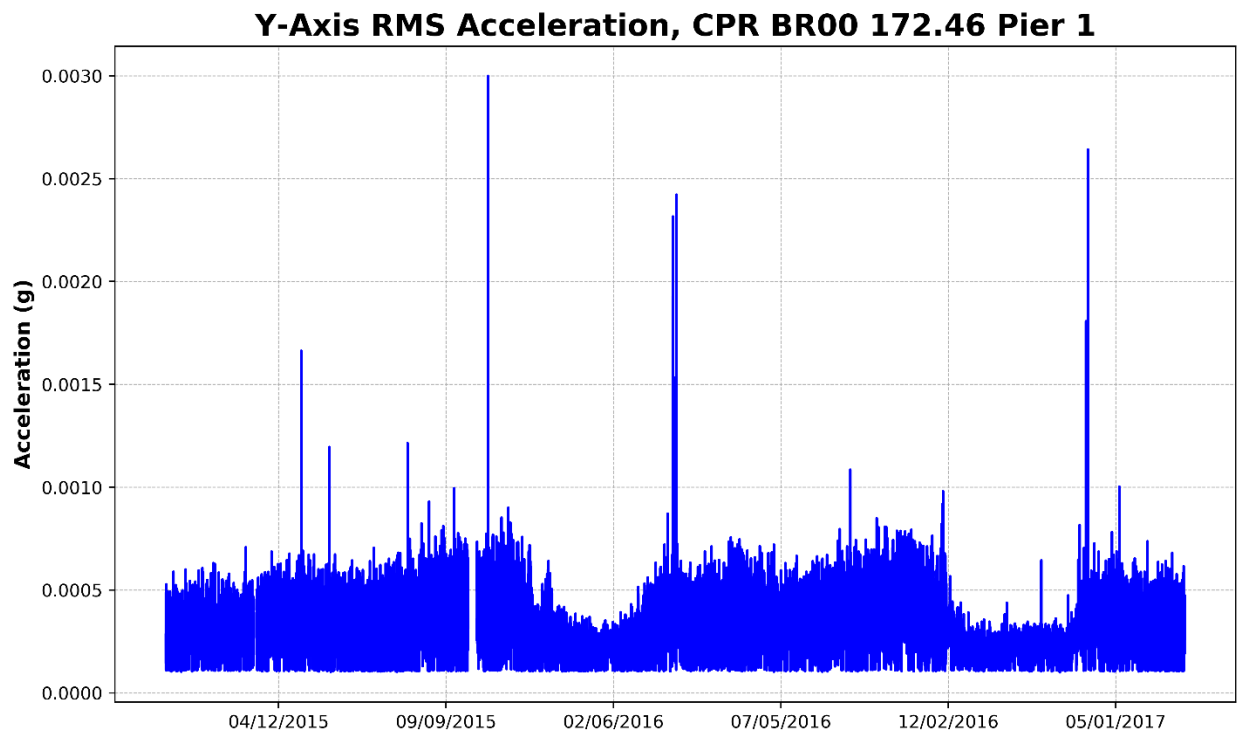
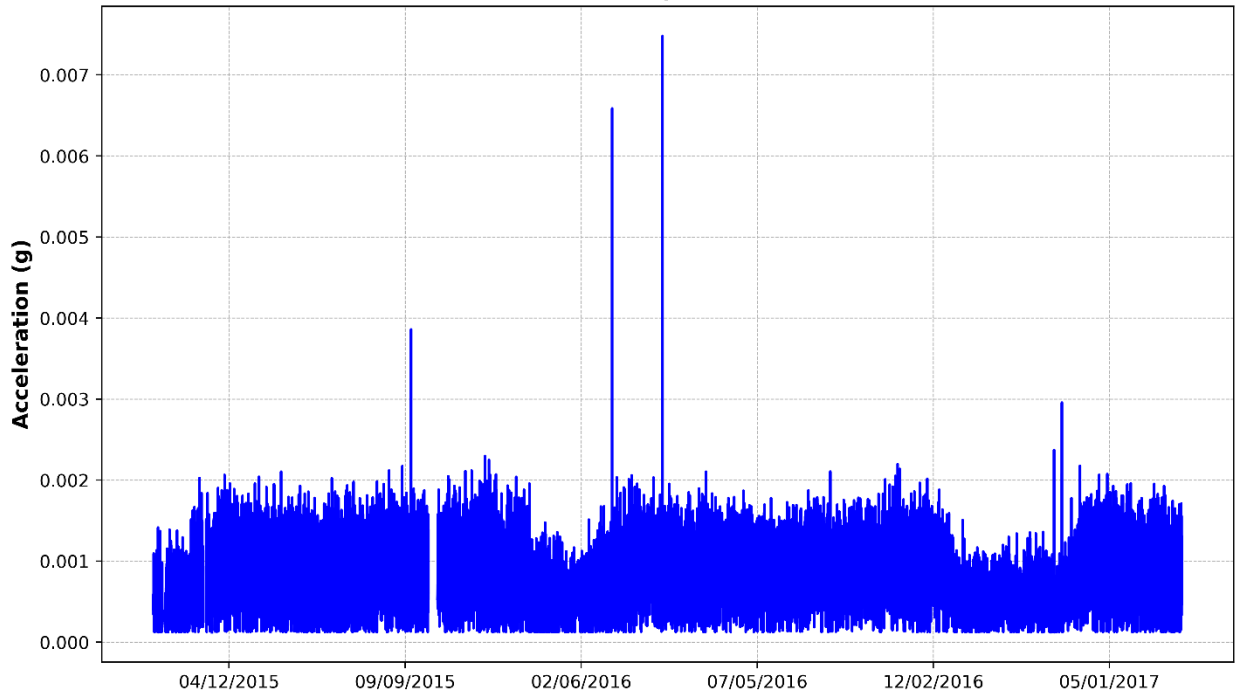
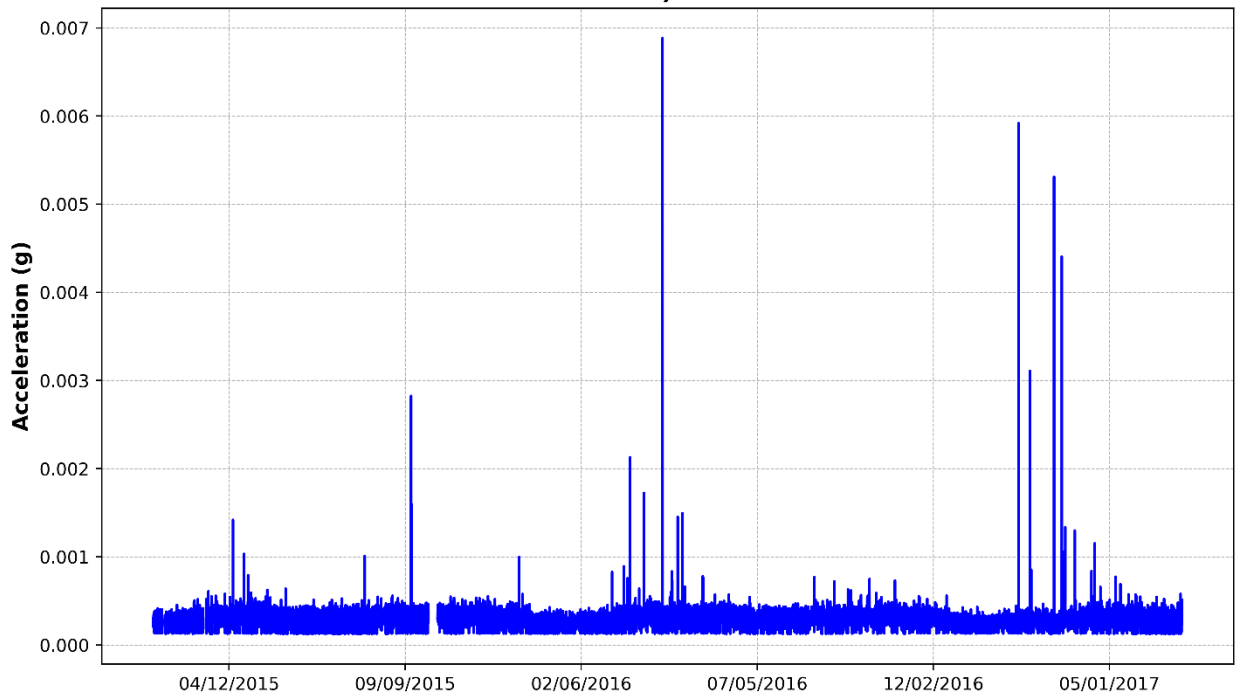
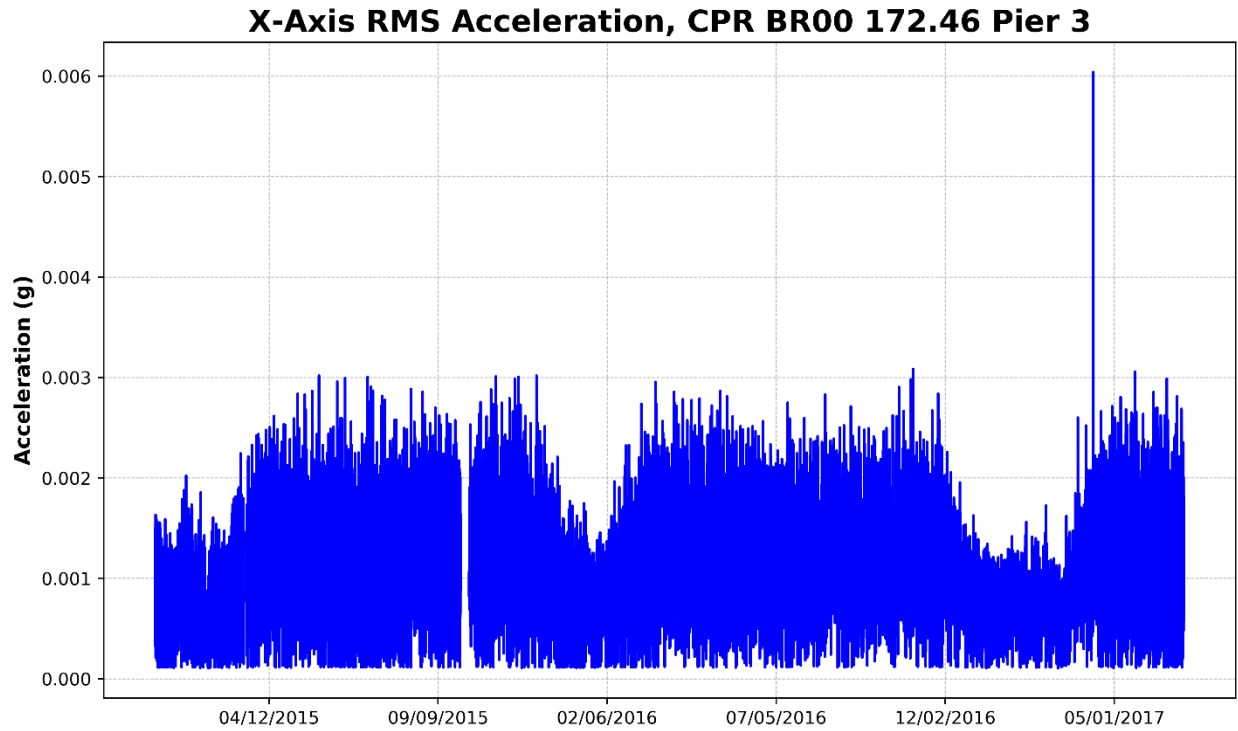
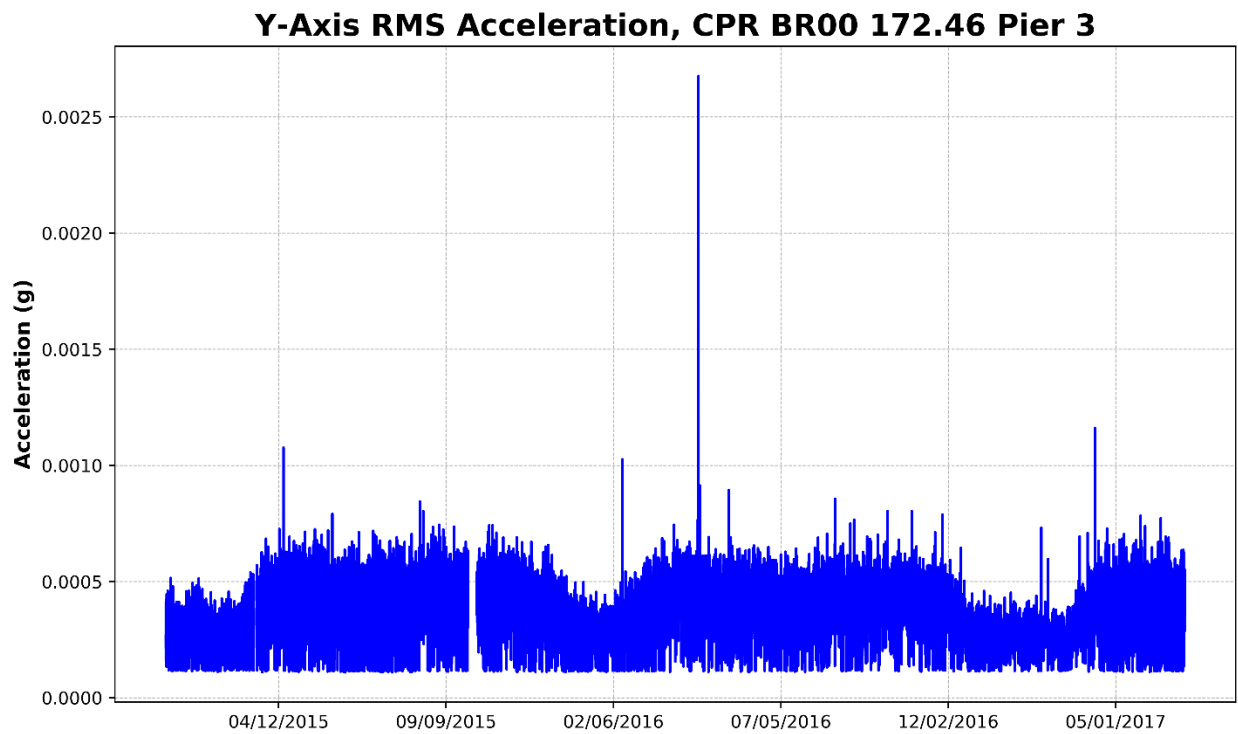
The acceleration charts are shown in [Figure 106](#) through [Figure 111](#). Numerous outliers have been recorded by all three sensors. None of the outliers are indicative of a permanent change in structural response, but can be noted for future reference.

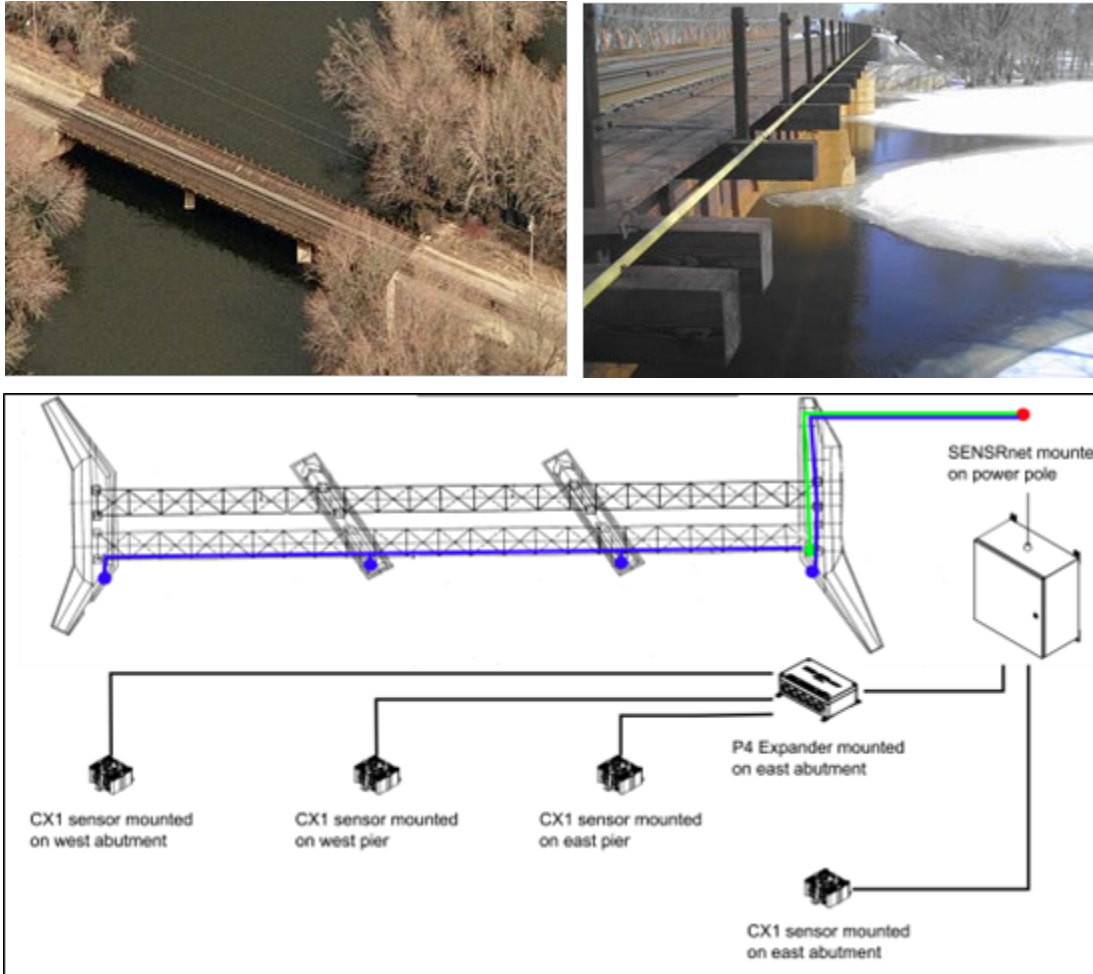
This bridge is a three-span, 190-foot long single-track bridge located near Ixonia, WI. For this bridge, all substructure elements (4) are being monitored as shown in Figure 112. The piers of this bridge are skewed 30 degrees and the abutments are square. The monitoring system was installed in April 2013.

Figure 113 – CPR 121.95 Watertown Sensor Locations

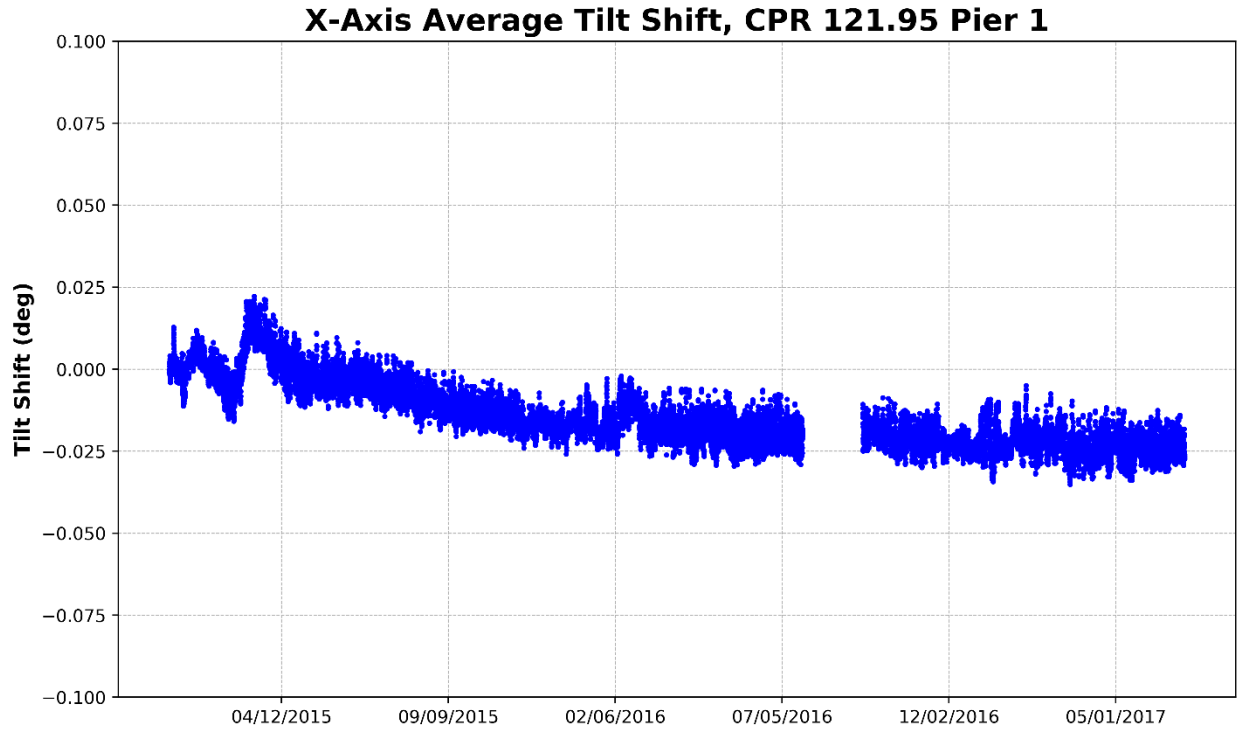
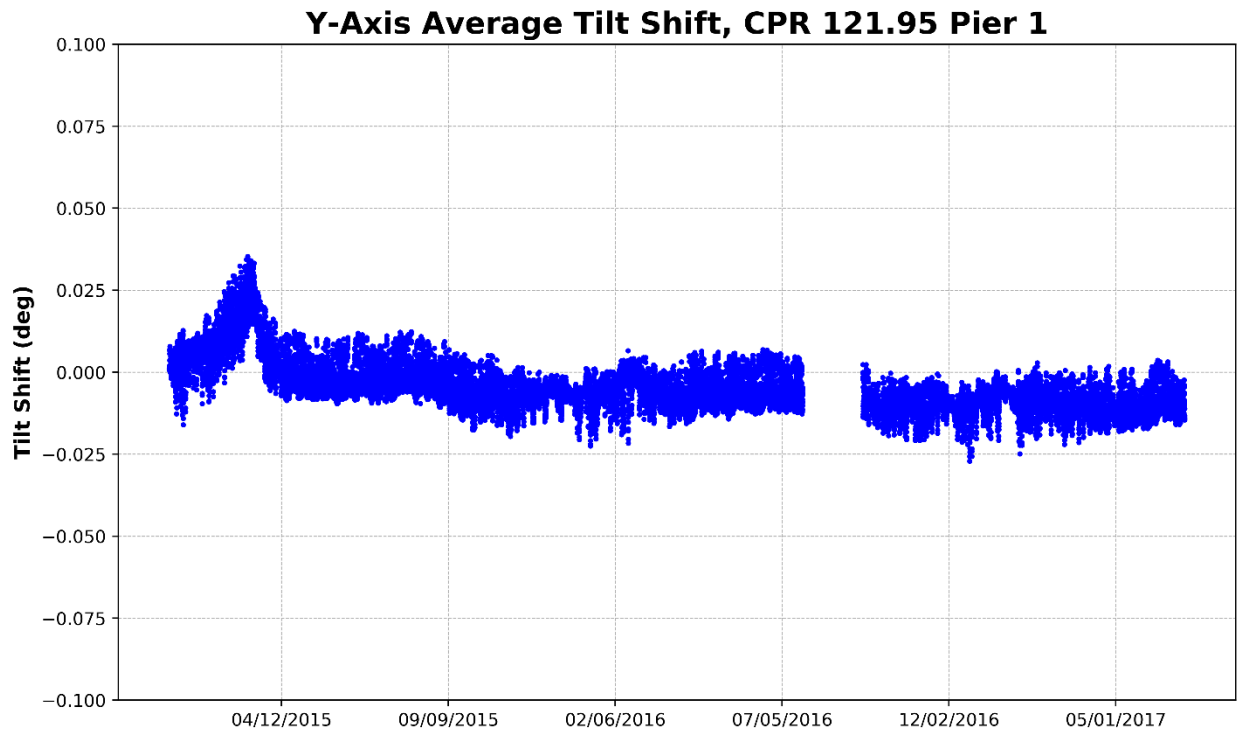
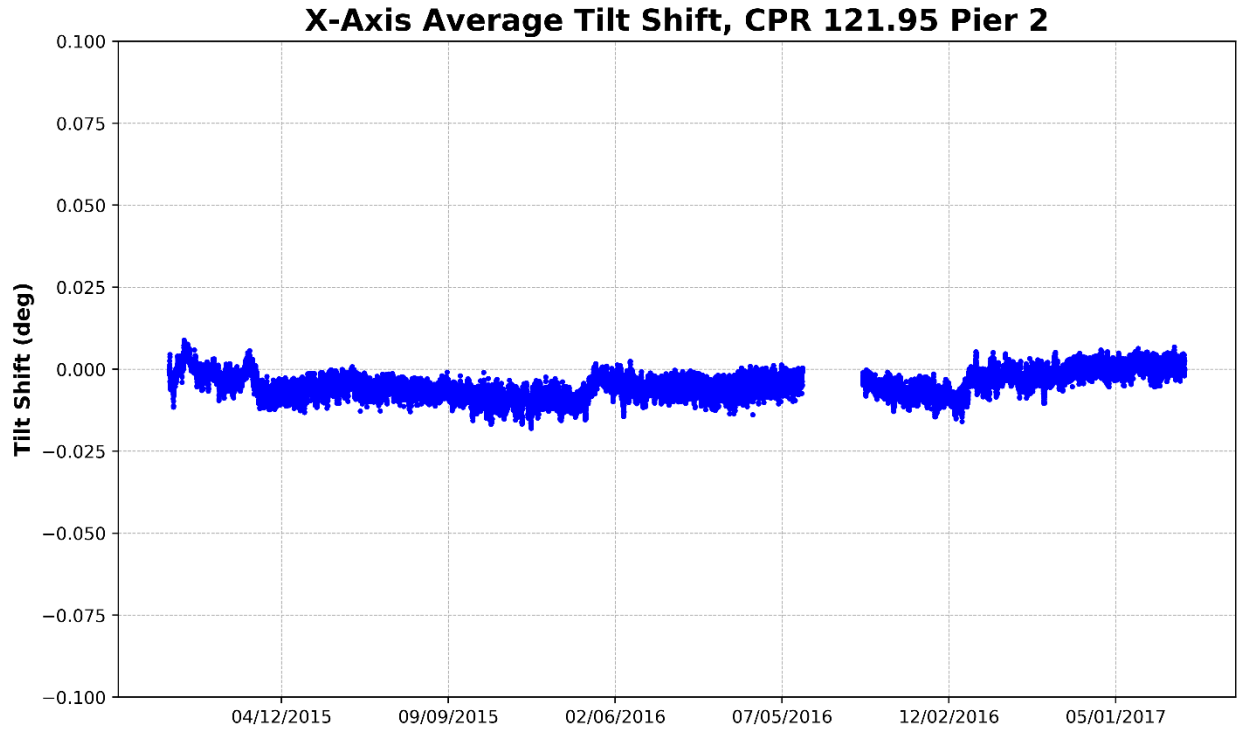
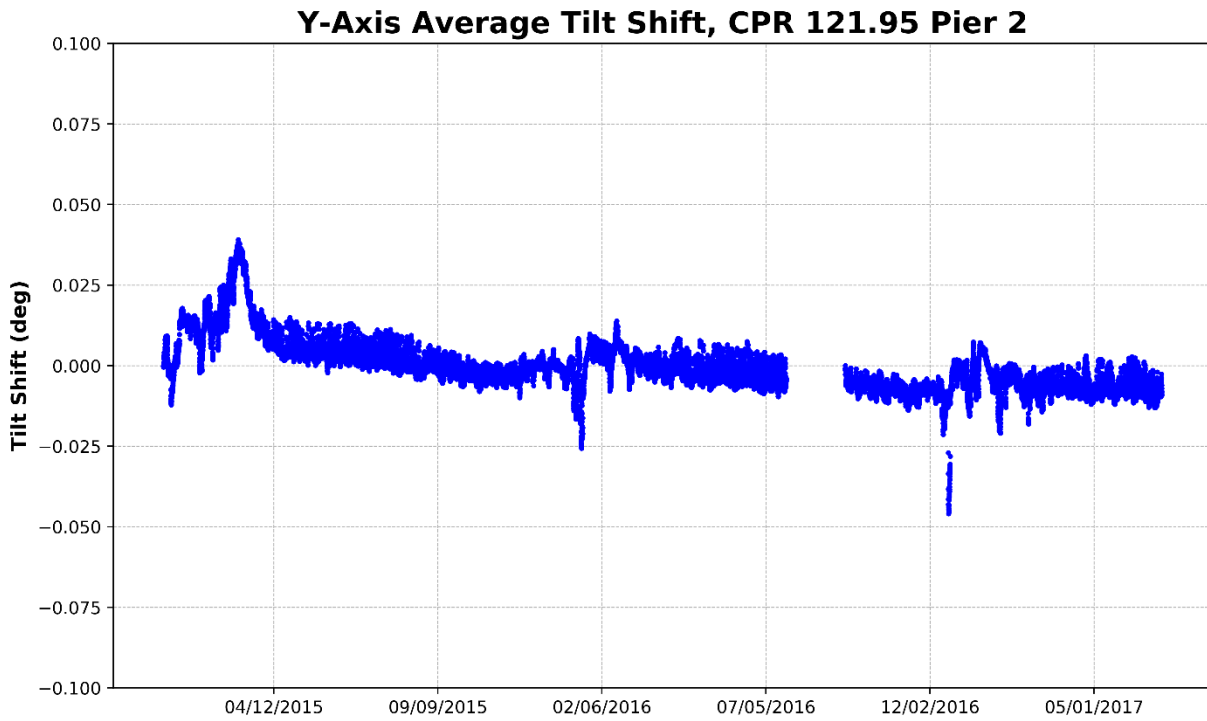
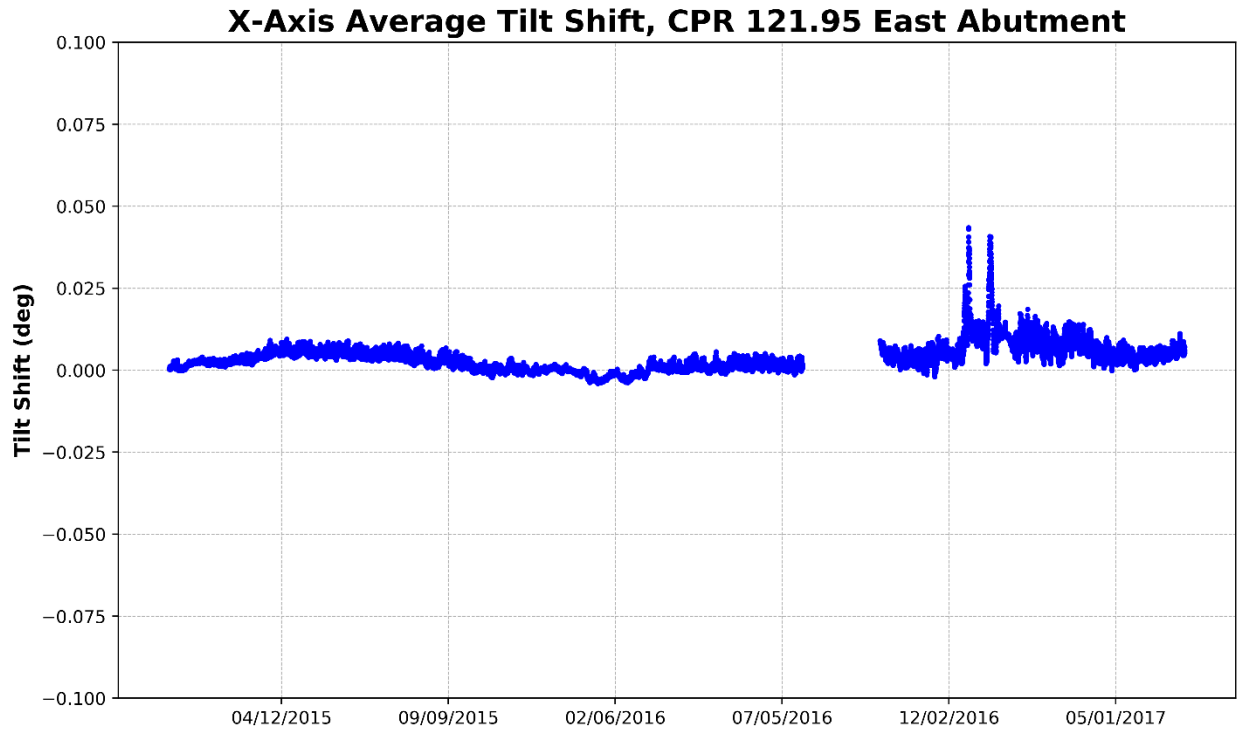
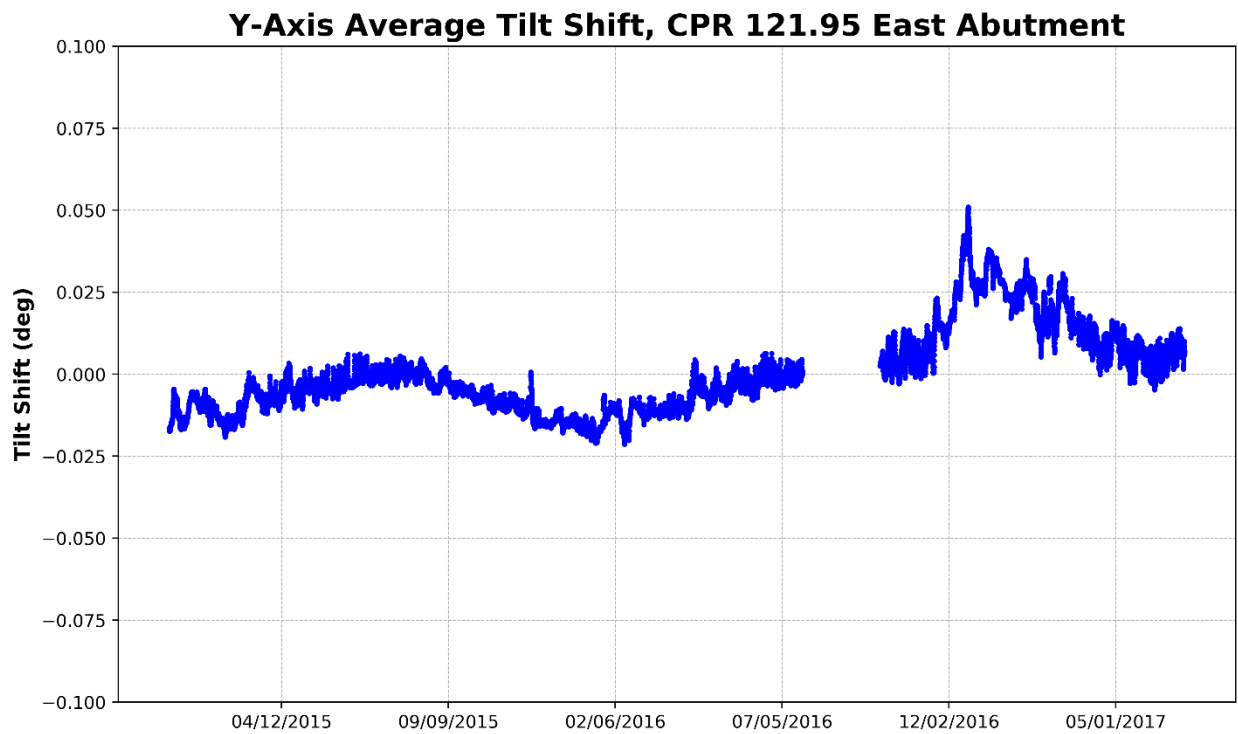
The average tilt charts are shown in Figure 113 through Figure 120. The West abutment has shifted more than any substructure element from any bridge monitored as part of this project. The magnitude of the shift is over 0.15 degrees and the direction is parallel to the track. Continuous monitoring of the abutment is recommended. The other substructure elements on this bridge have shown stable tilt behavior.

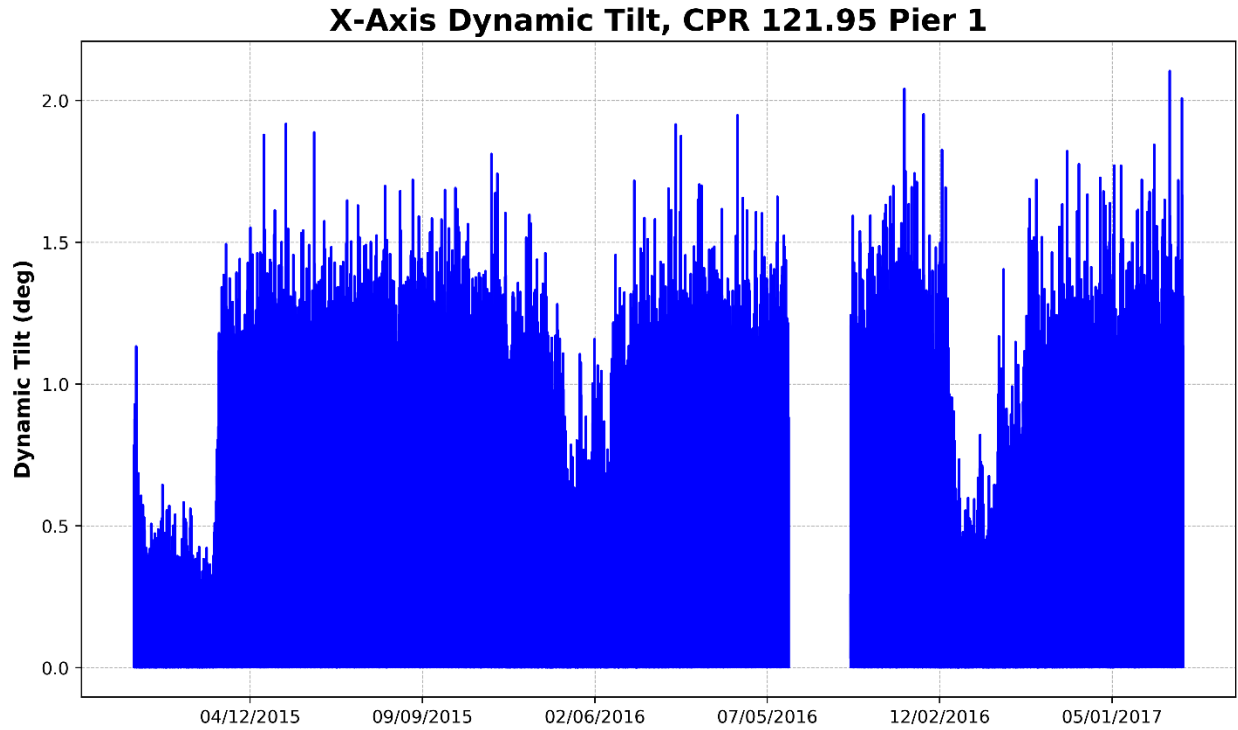
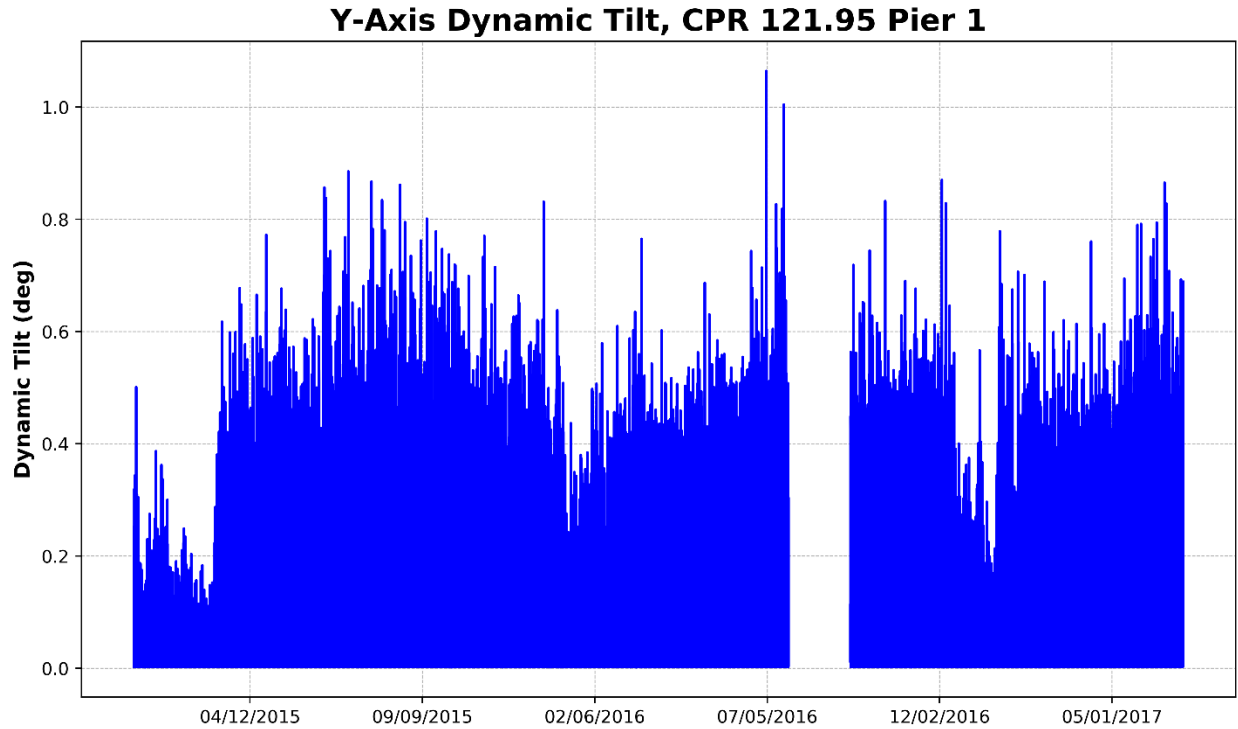
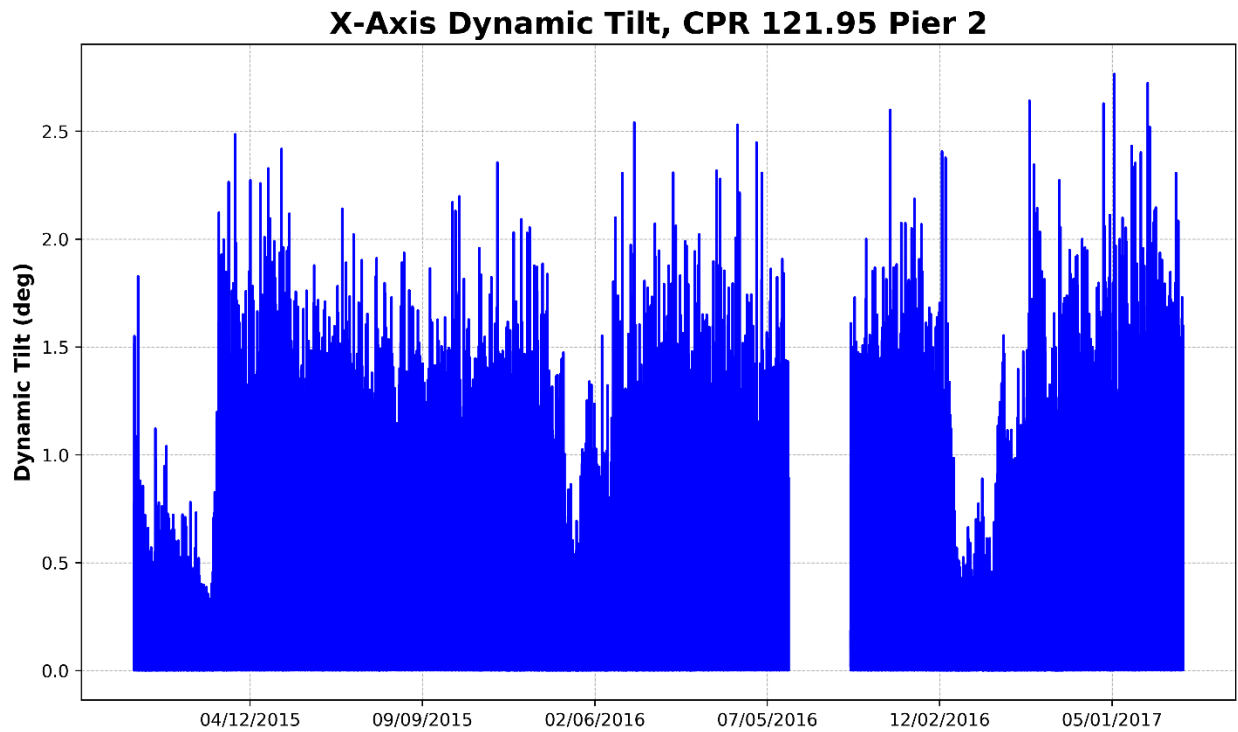
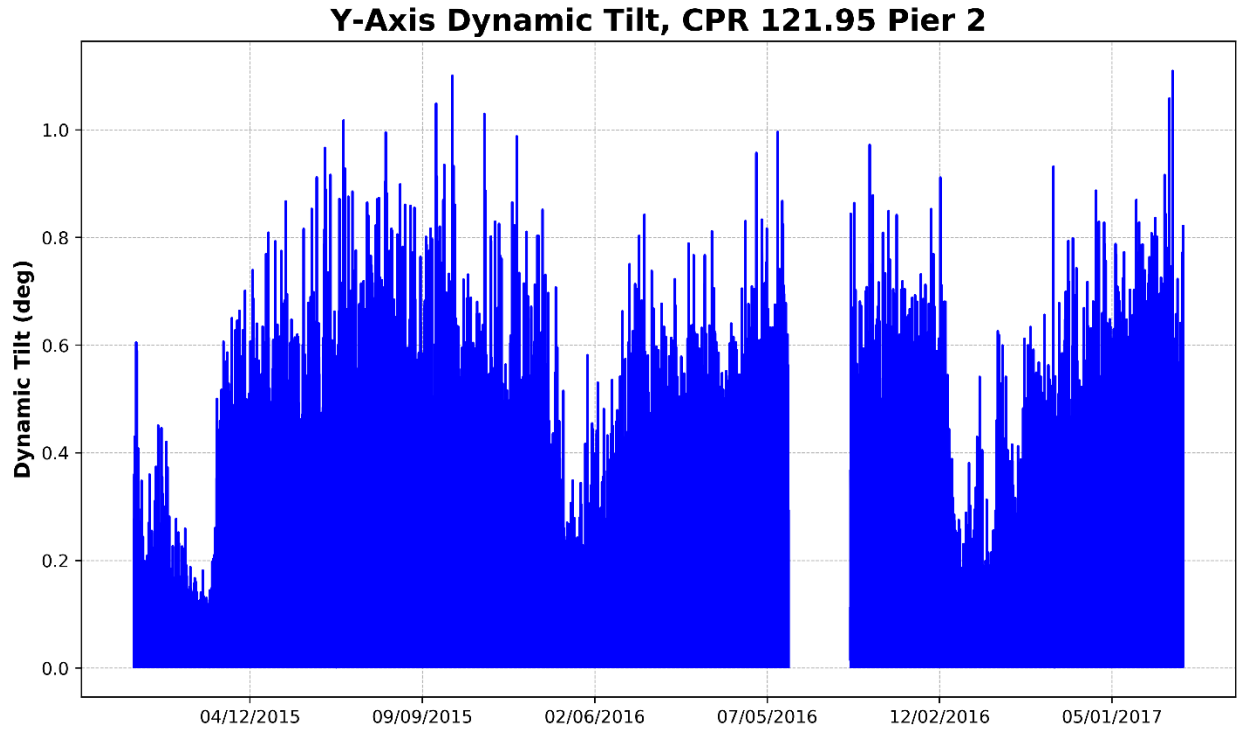
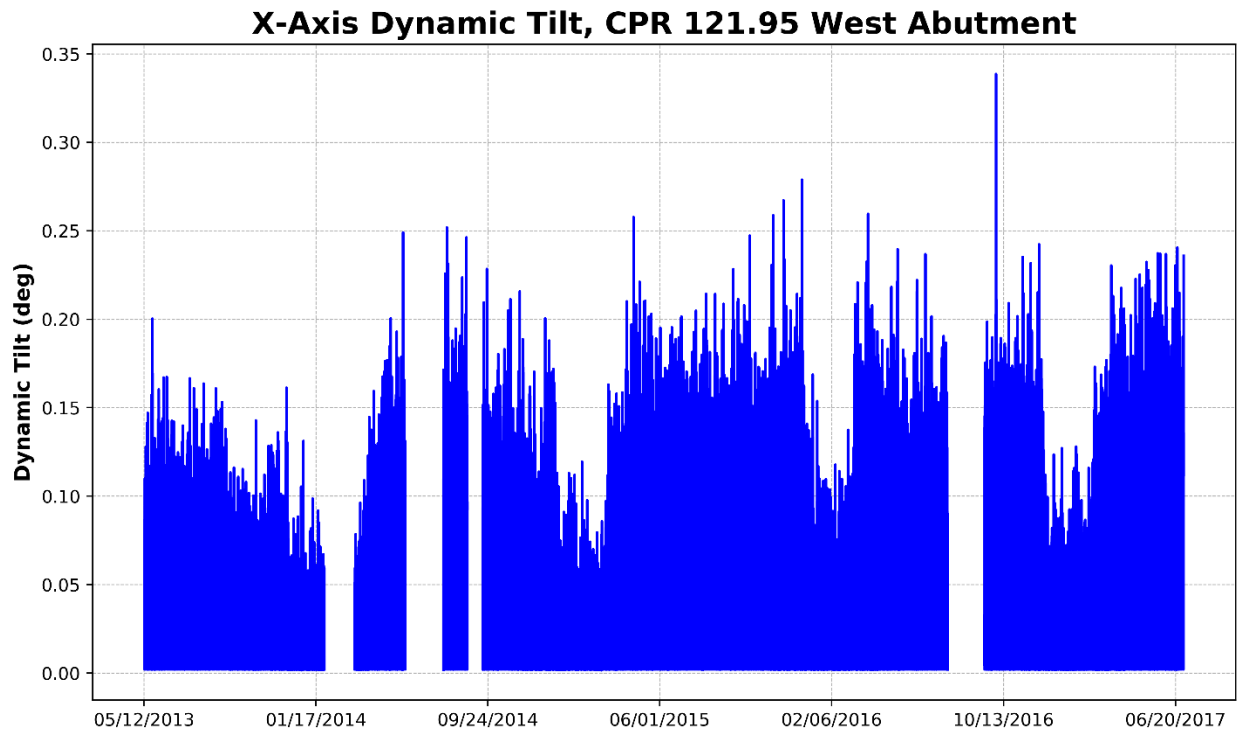
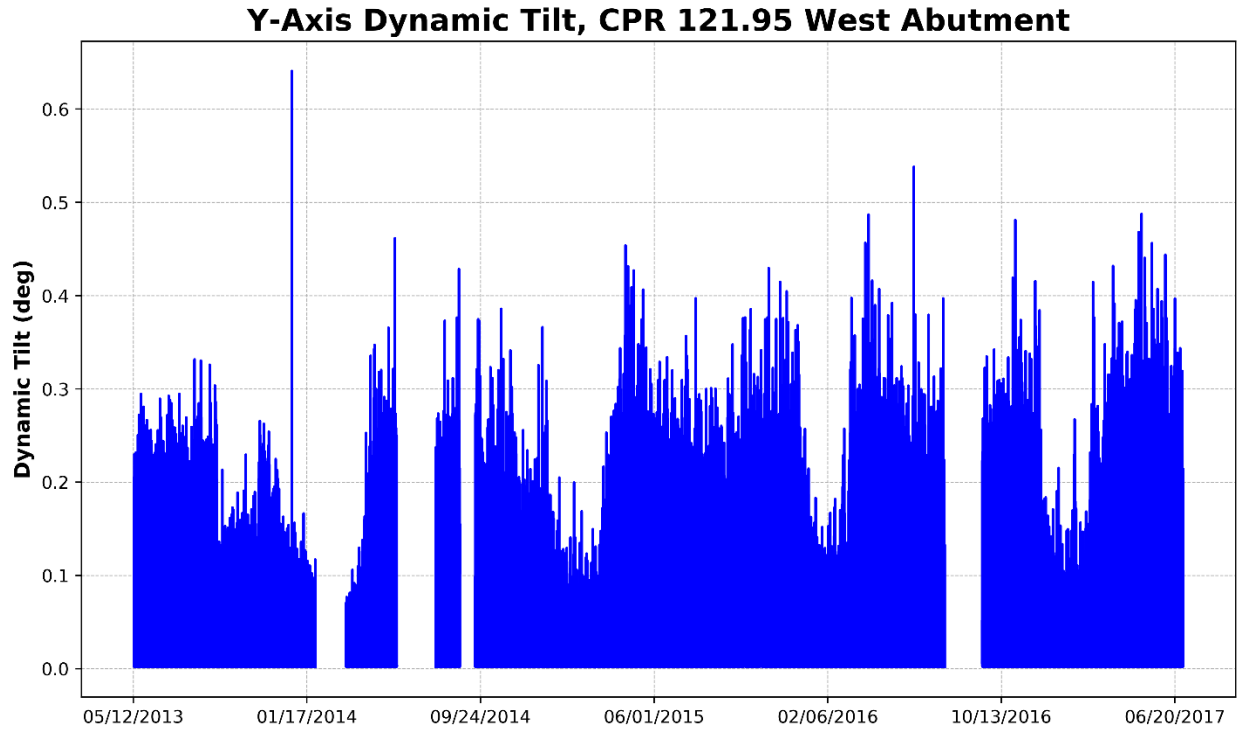
The dynamic tilt charts are shown in [Figure 121](#) through [Figure 128](#). Similar to the other bridges, the dynamic response magnitude is smaller in the winter compared to the rest of the year. No alarming trends in the dynamic tilt are identified in the data.

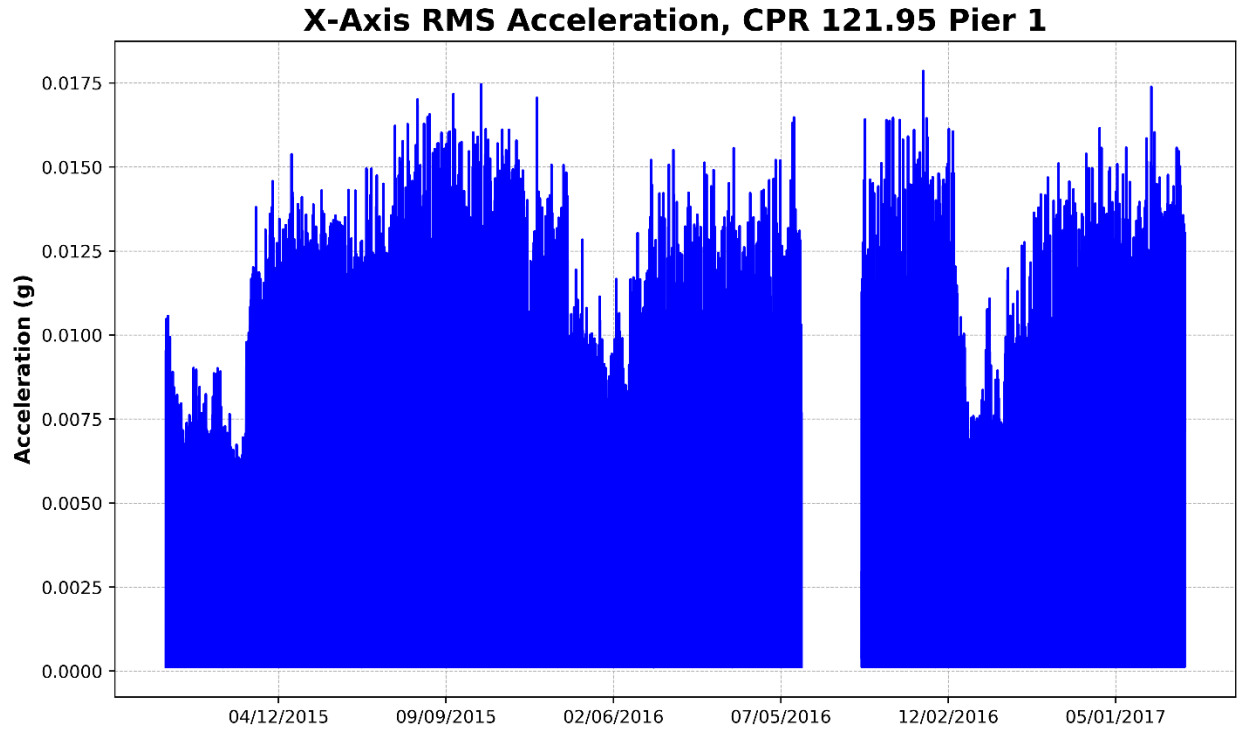
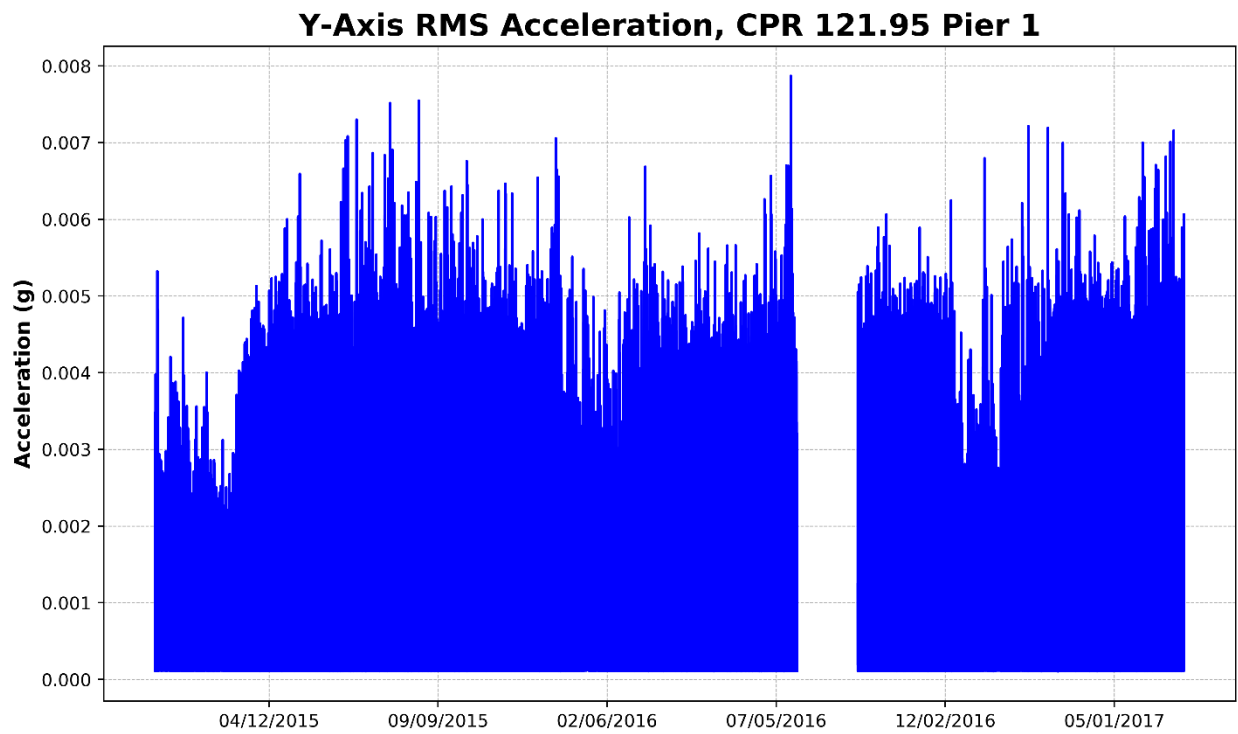
The acceleration charts are shown in [Figure 129](#) through [Figure 136](#). Various outliers in acceleration were recorded by the East and West abutments. Despite the outliers, no alarming trends in the acceleration data are identified.
